NC DEPARTMENT OF TRANSPORTATION  
 DIVISION OF HIGHWAYS  
 STRUCTURE MANAGEMENT UNIT

# Structure Safety Report

## Supplemental Element Inspection

DIVISION: 13 COUNTY: BUNCOMBE STRUCTURE NUMBER: 100382 FREQUENCY: None

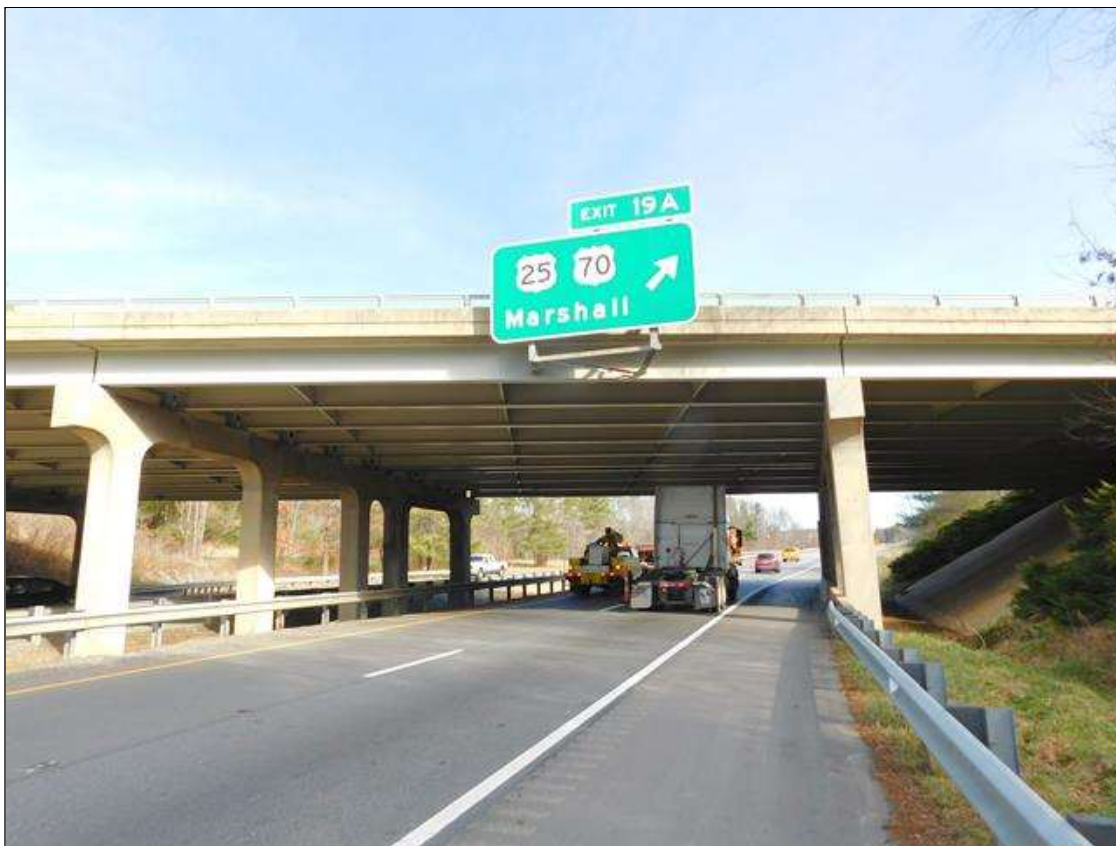
LOOKING WEST

| Element Number | Defect Type | Defect Description | CS | CS Qty | Maint Qty | |
|---|---|--|---|---|---|---|
| 107 | Damage | BEAM 10 IS OUT OF PLUMB FOR A TOTAL LENGTH OF 20 FEET. THE BEAM IS SWEEP WESTWARD AND OUT OF PLUMB 1" | 3 | 20 | 20 | Feet |

BEAM 10 IS OUT OF PLUMB WESTWARD FOR 1" FOR A TOTAL LENGTH OF 20 FEET

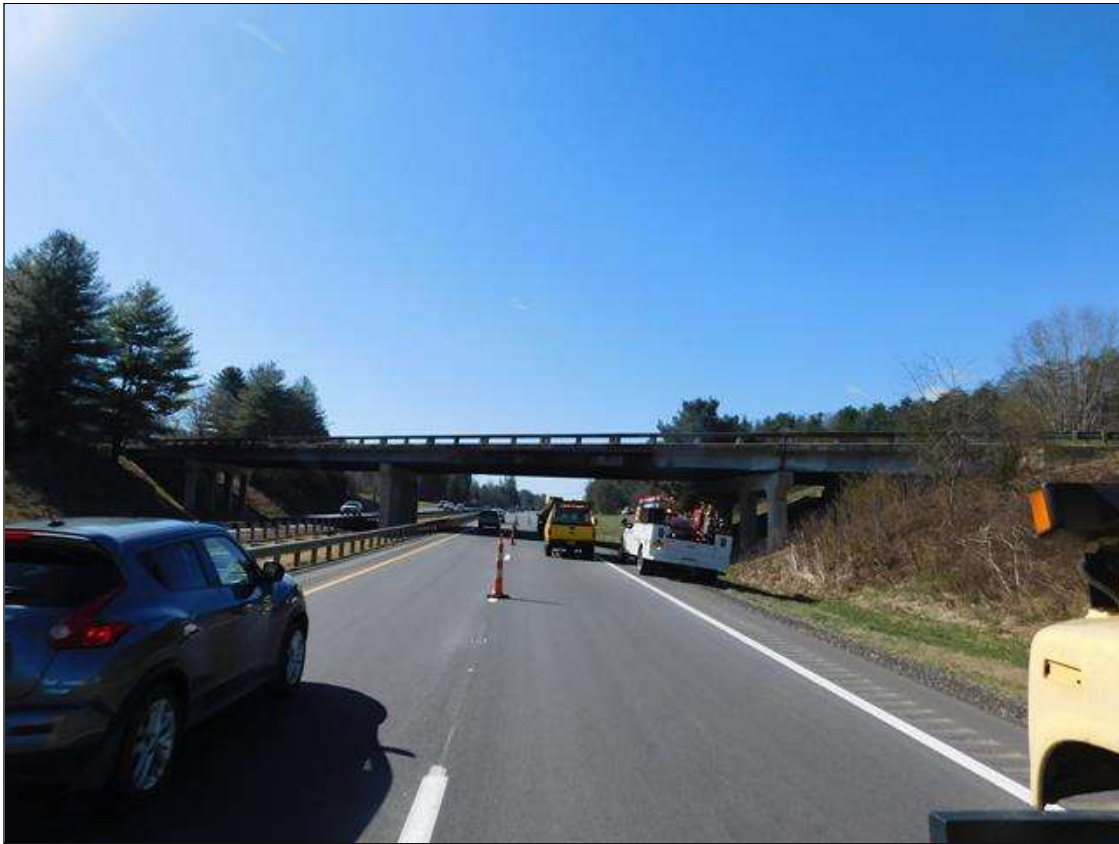
LOOKING EAST

PREVIOUS IMPACT DAMAGE TO DIAPHRAGM 4 BAY 5. SWPET NORTHWARD 1/2"

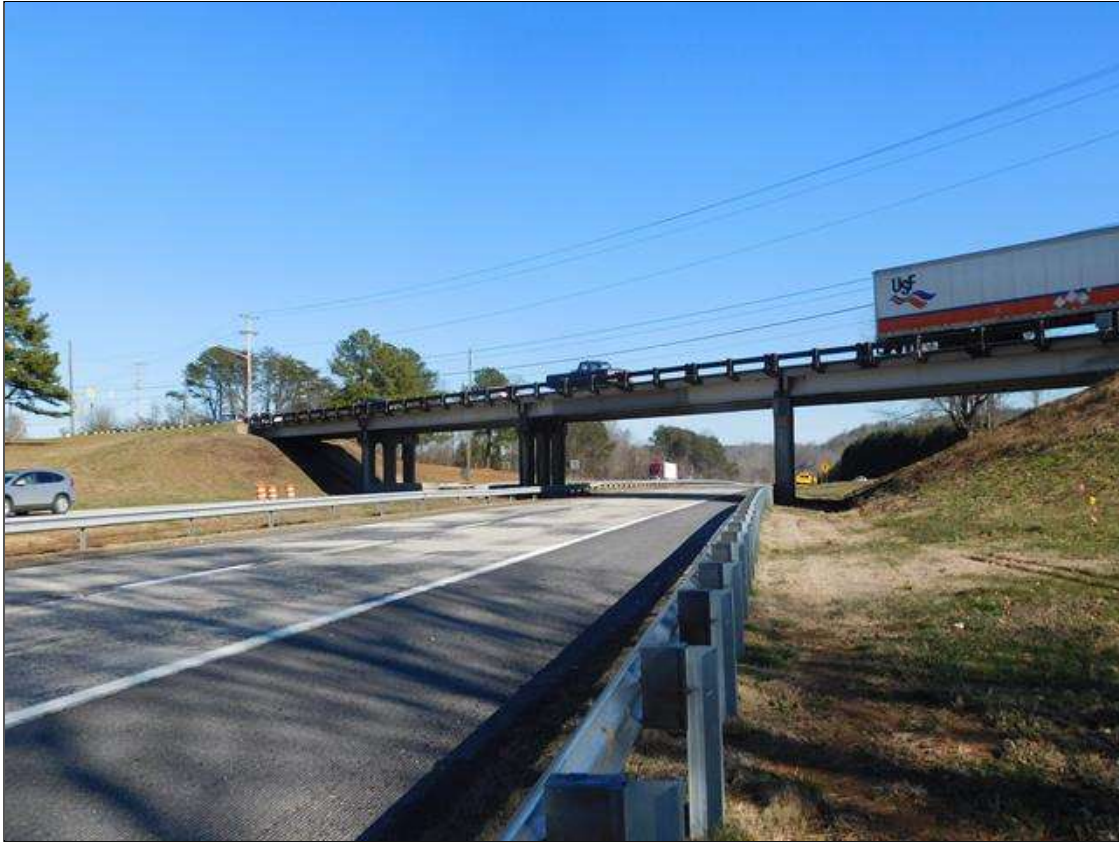
LOOKING EAST

End Bent 1 Abutment/Backwall : 1'3" WIDE X 1' HIGH X 2" DEEP SPALL ON THE LEFT SIDE OF BEAM 1, WITH ONE REBAR EXPOSED .
