NC DEPARTMENT OF TRANSPORTATION
 DIVISION OF HIGHWAYS
 STRUCTURE MANAGEMENT UNIT

Structure Safety Report

Supplemental Element Inspection

DIVISION: 13 COUNTY: BUNCOMBE STRUCTURE NUMBER: 100387 FREQUENCY: None

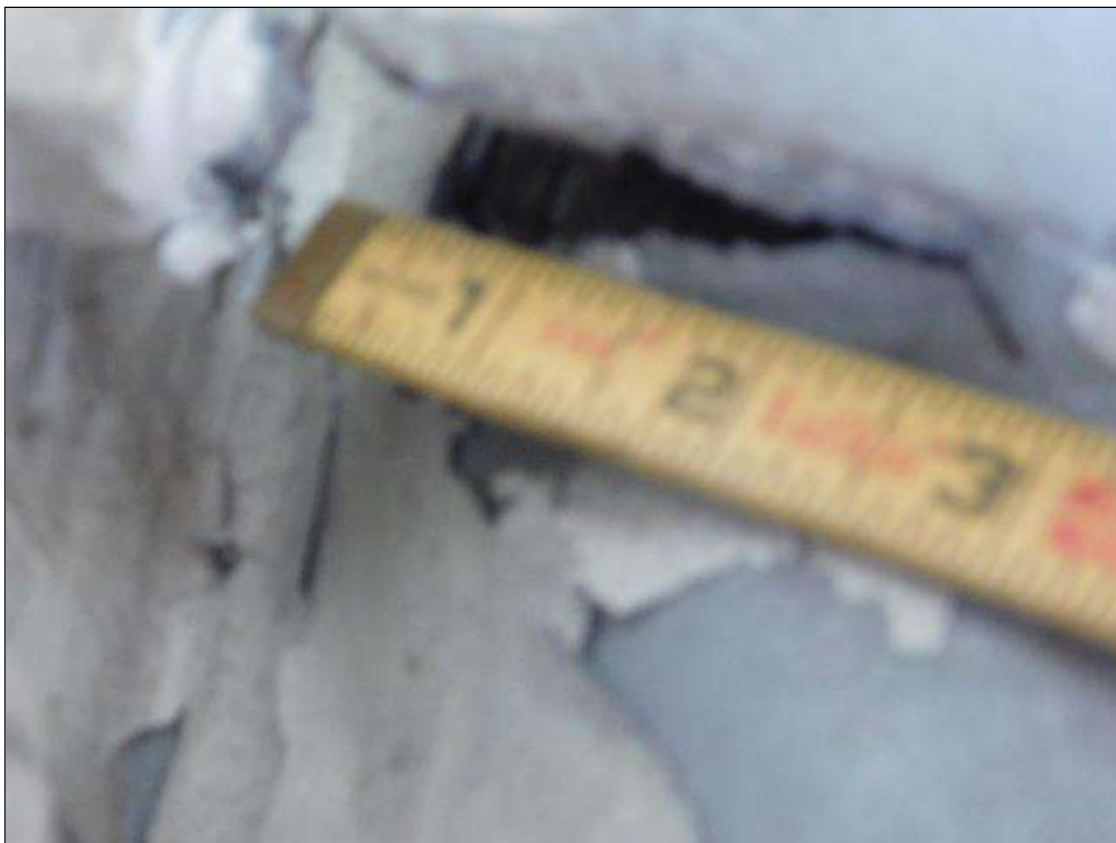
DIAPHRAGM 1 BAY 1 SPAN 2 WELD BROKEN LOOSE ON THE BACK SIDE 3" LONG .(PAR)

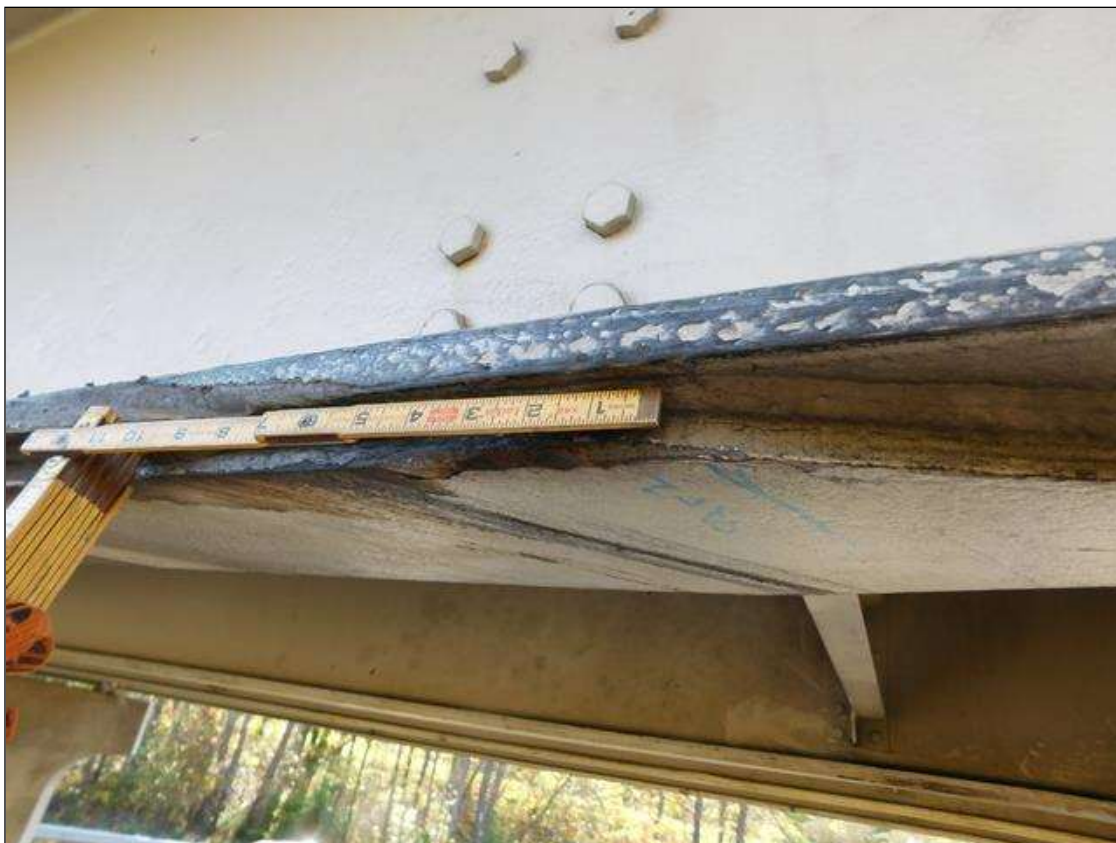
BEAM 1 SPAN 2 POINT OF IMPACT 2' LONG X WITH 1/16" INDENTIONS AT 14'-6" OUT FROM INT. BENT 1(PAR)

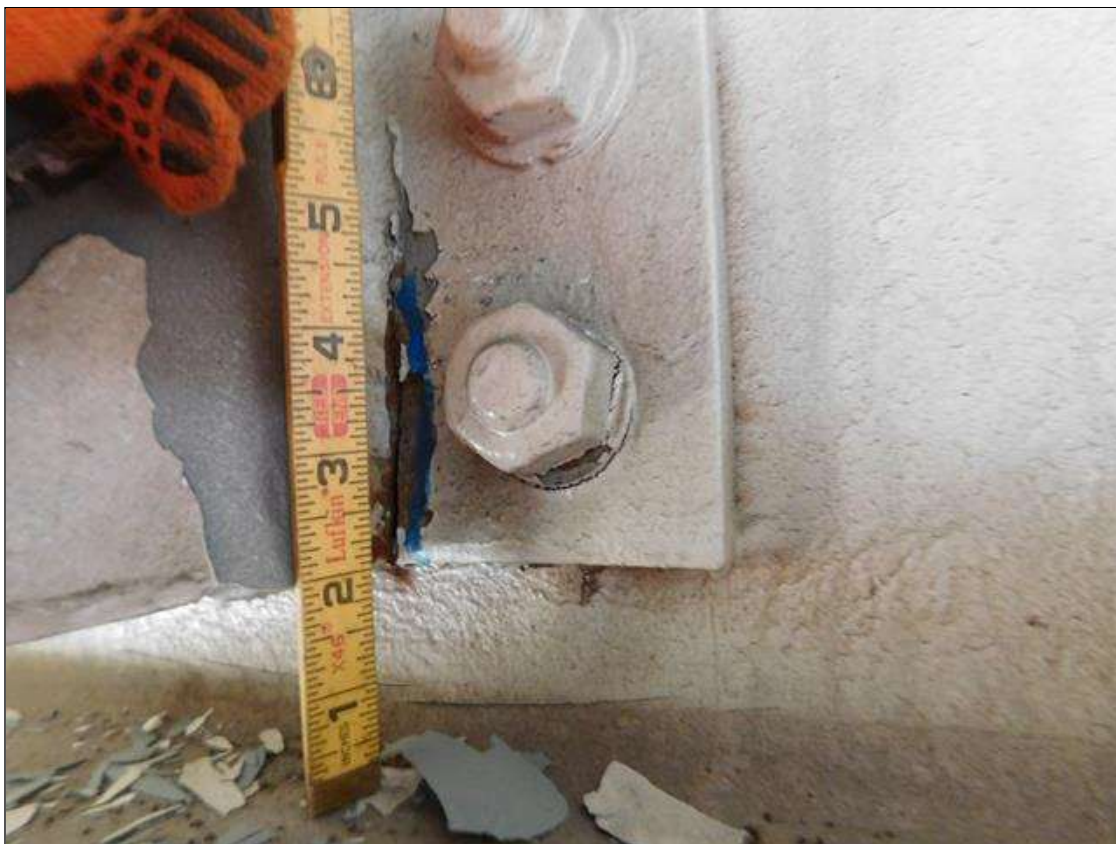
DIAPHRAGM 1 BAY 1 SPAN 2 CRACK IN BASE OF DIAPHRAGM 3" LONG X 1/16" WIDE

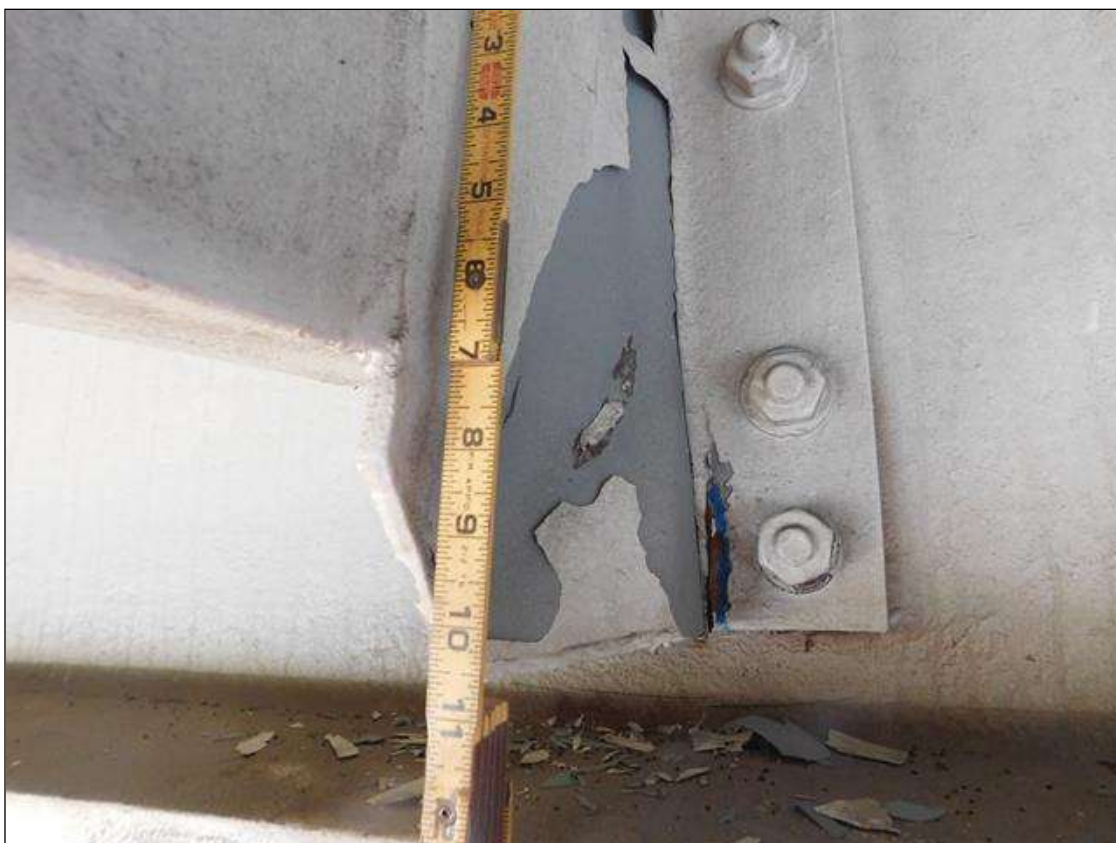
DIAPHRAGM 1 BAY 1 SPAN 2 BOWED

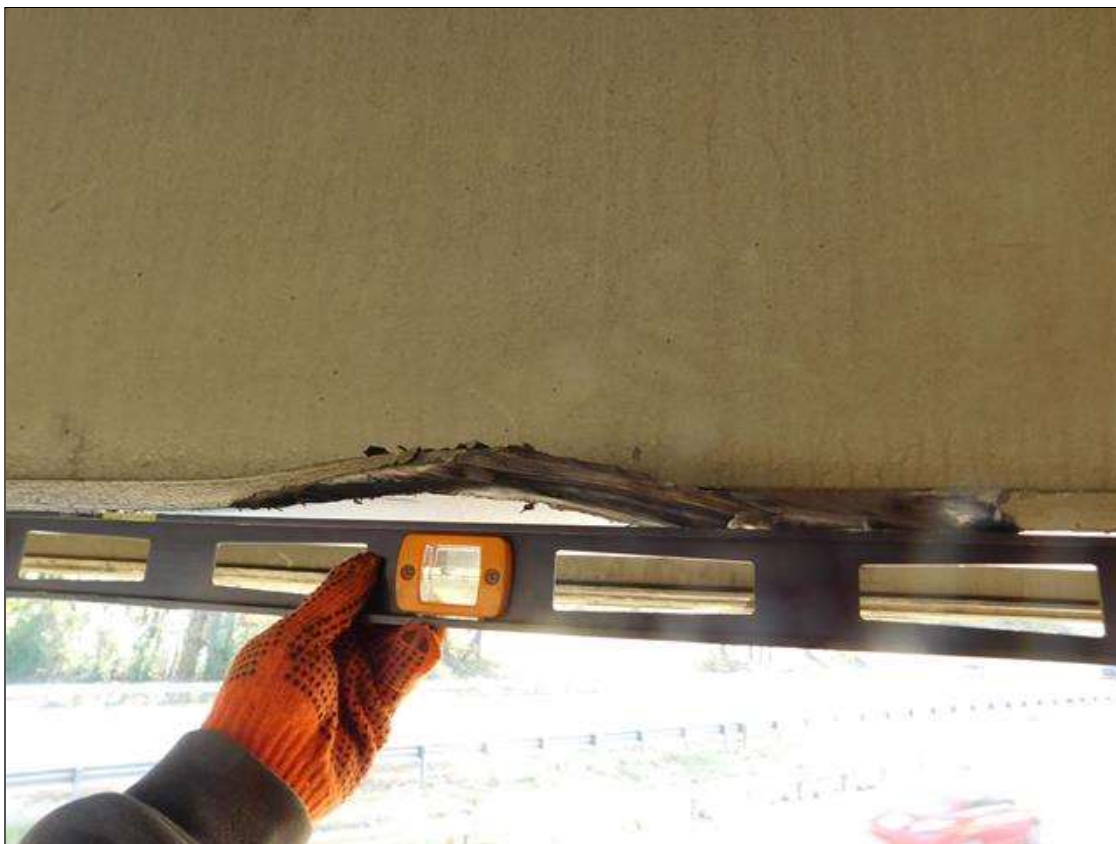
BEAM 2 SPAN 2 POINT OF IMPACT 20" LONG X BOWED UPWARD 1 1/2" LEFT FLANGE AT 4'-3" OUT FROM INT. BENT 1

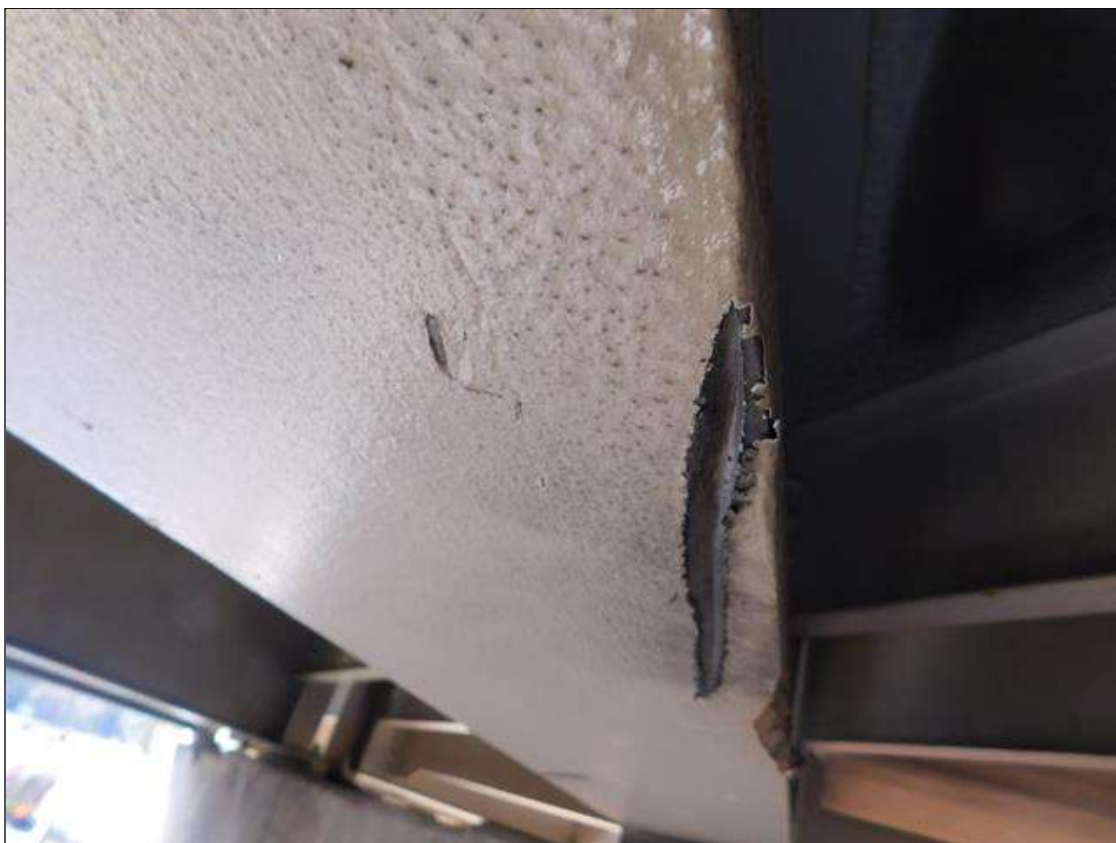
BEAM 2 SPAN 1 , 12" LONG X 1/16" DEEP SCRAPES ALONG THE BOTTOM FLANGE OF BEAM

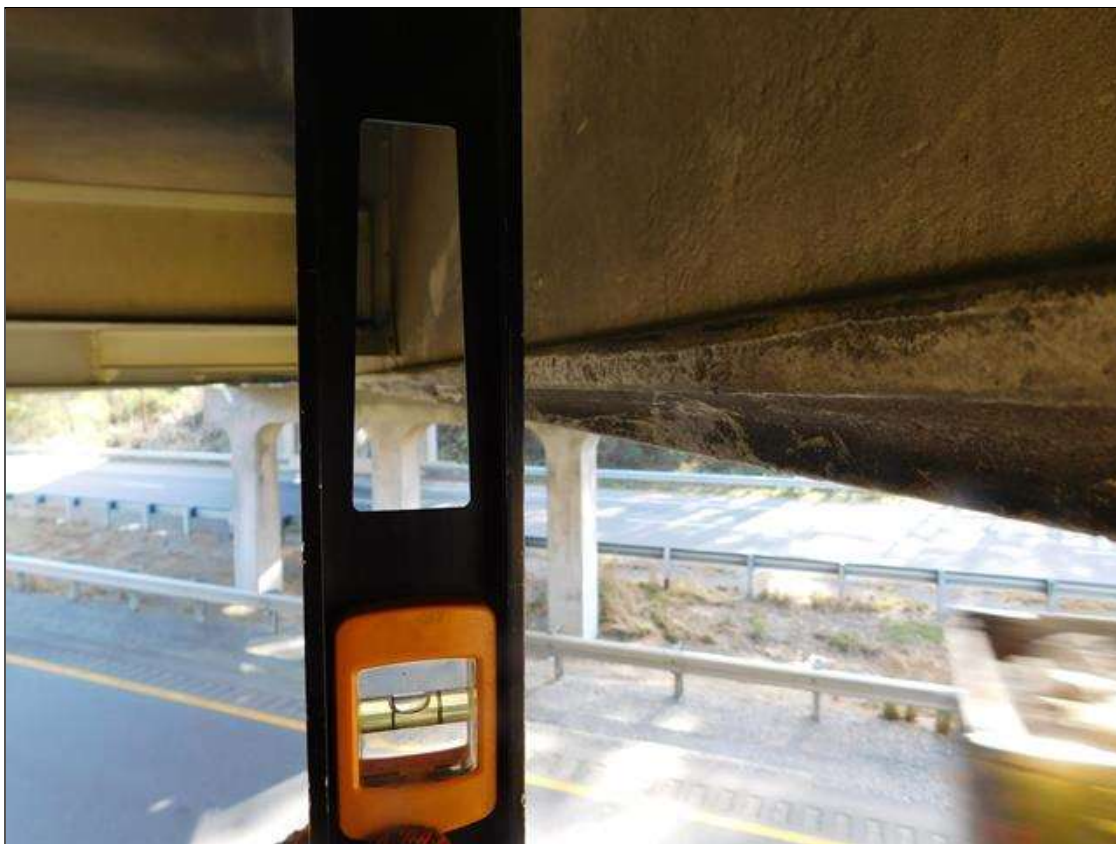
BEAM 2 SPAN 1 SWEPT EASTWARD 1 1/2" (PAR)

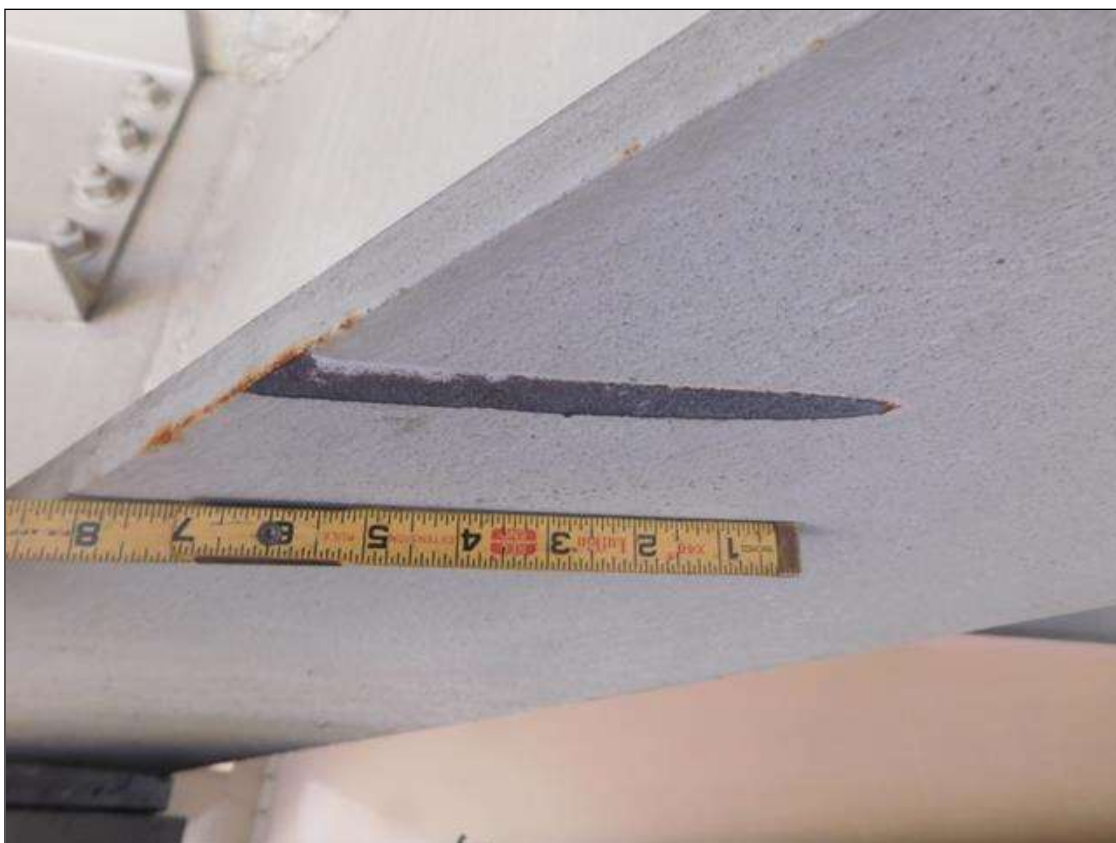
BEAM 2 SPAN 1 SCATTERED SCRAPES BOTTOM FLANGE OF BEAM 2

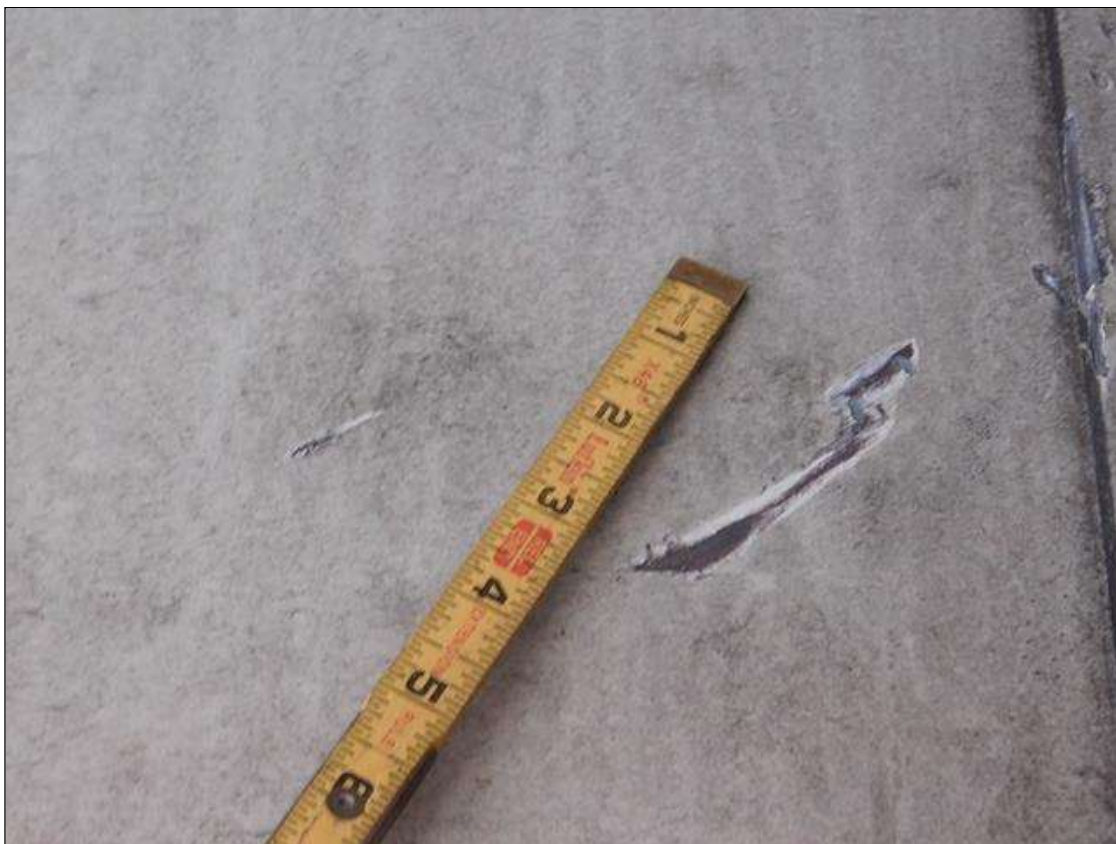
BEAM 3 SPAN 1 SCATTERED SCRAPES ALONG THE WEB OF BEAM 3

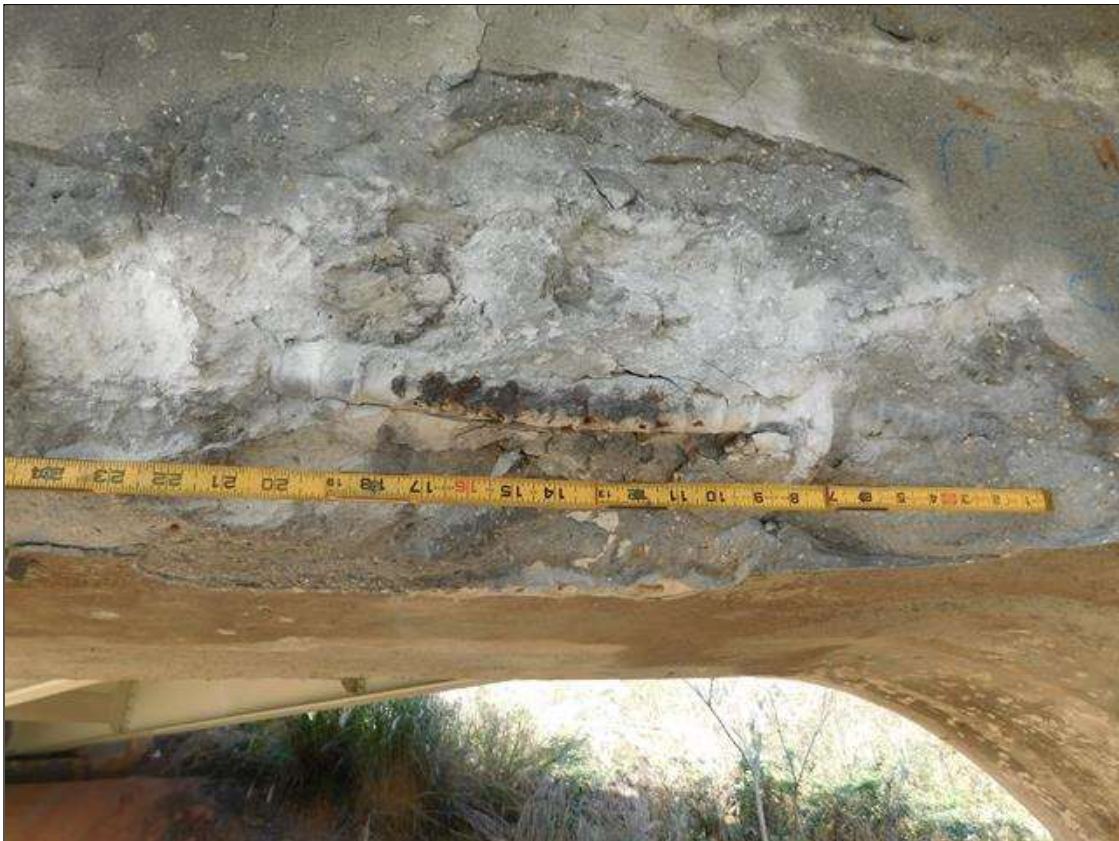
INT. BENT 1 CAP SPALLING BENEATH BEAM 3 AT THE BOTTOM OF CAP 3'-3" LONG X 11" HIGH X 8" DEEP WITH 1 REINFORCING BAR EXPOSED (PAR)

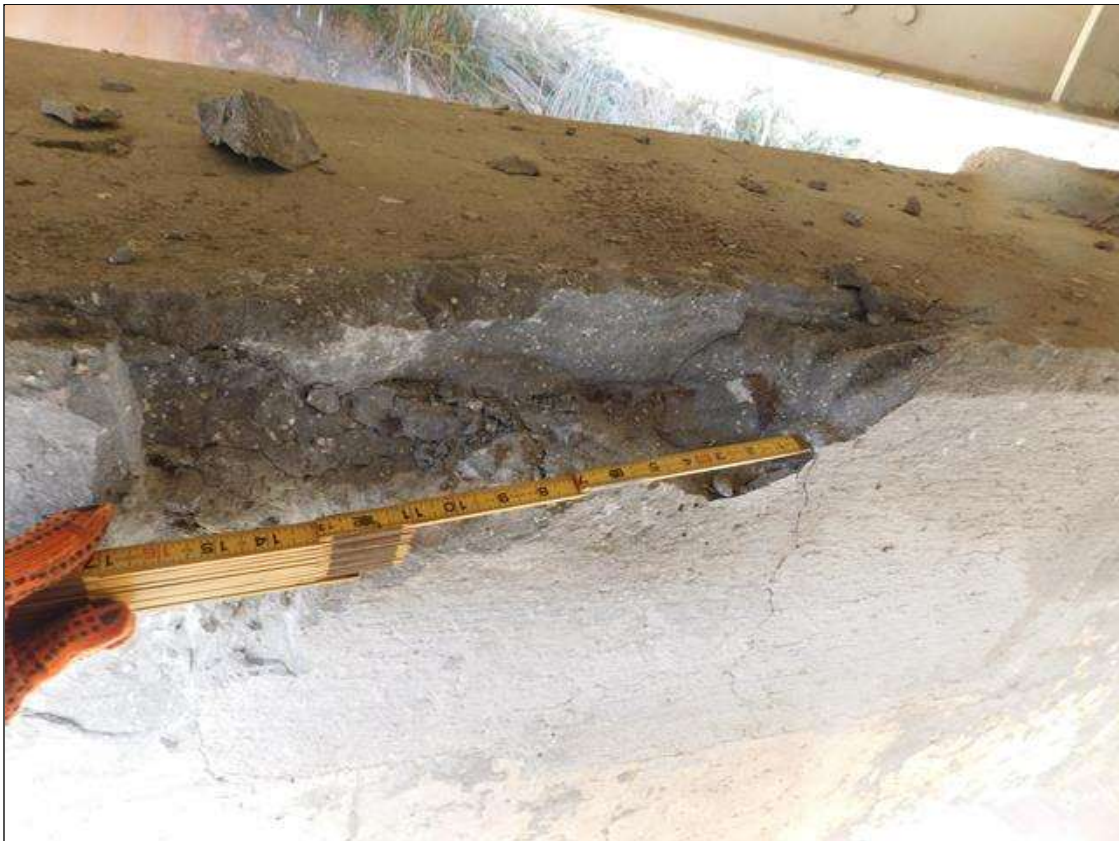
INT. BENT 1 CAP SPALL 26" LONG X 9" HIGH X 5" DEEP AT 8'-6" FROM EAST END BAY 3 WITH 1 REINFORCING BAR EXPOSED (PAR)

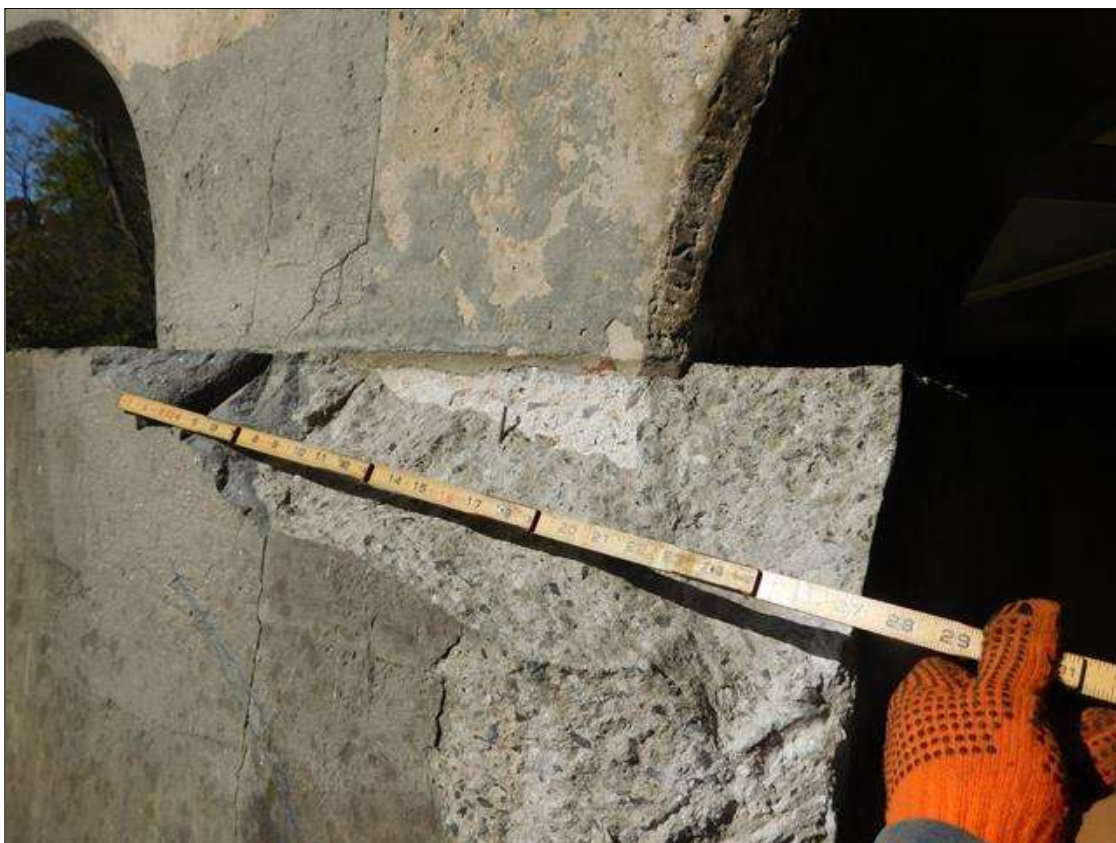
COLUMN 3 INT. BENT 1 SPALL 2'-10" HIGH X 2'-88" LONG X 7" DEEP AT THE TOP OF NEW SECTION (PAR)

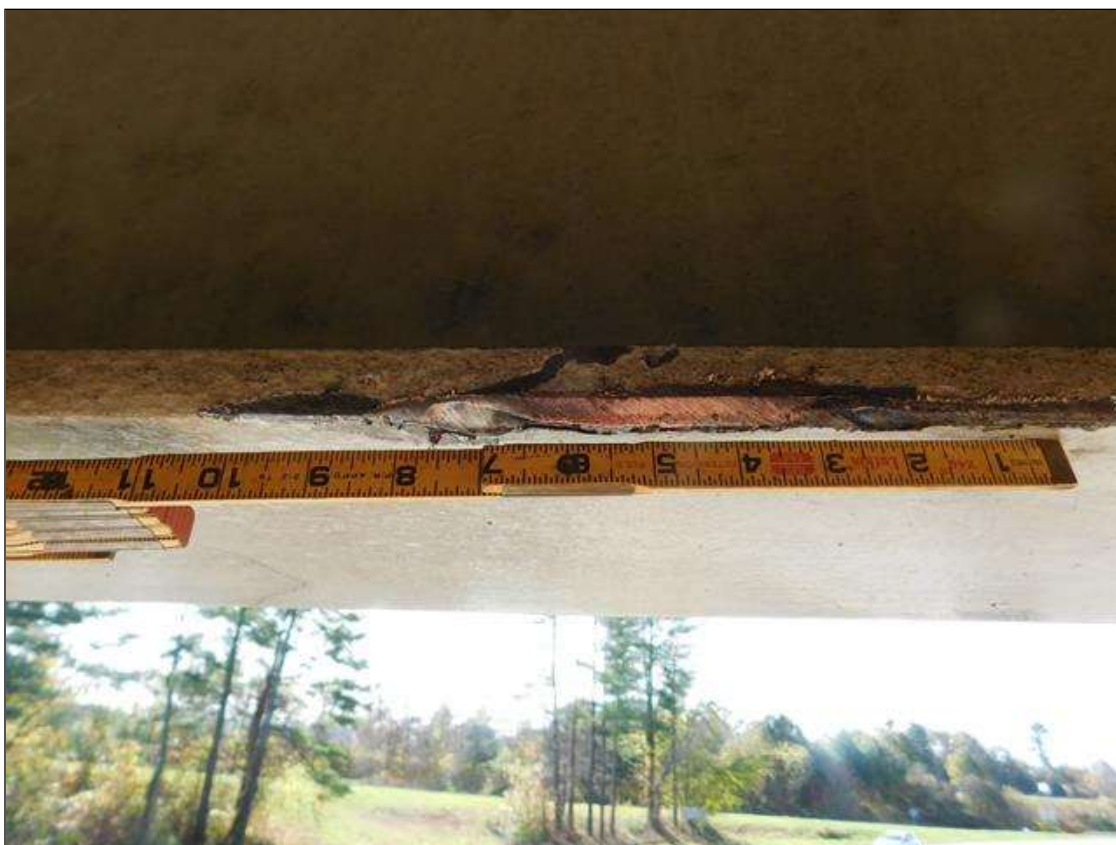
BEAM 4 SPAN 1 SCRAPE 11" LONG X 1/16" DEEP AT 9'-3" OUT FROM INT. BENT 1

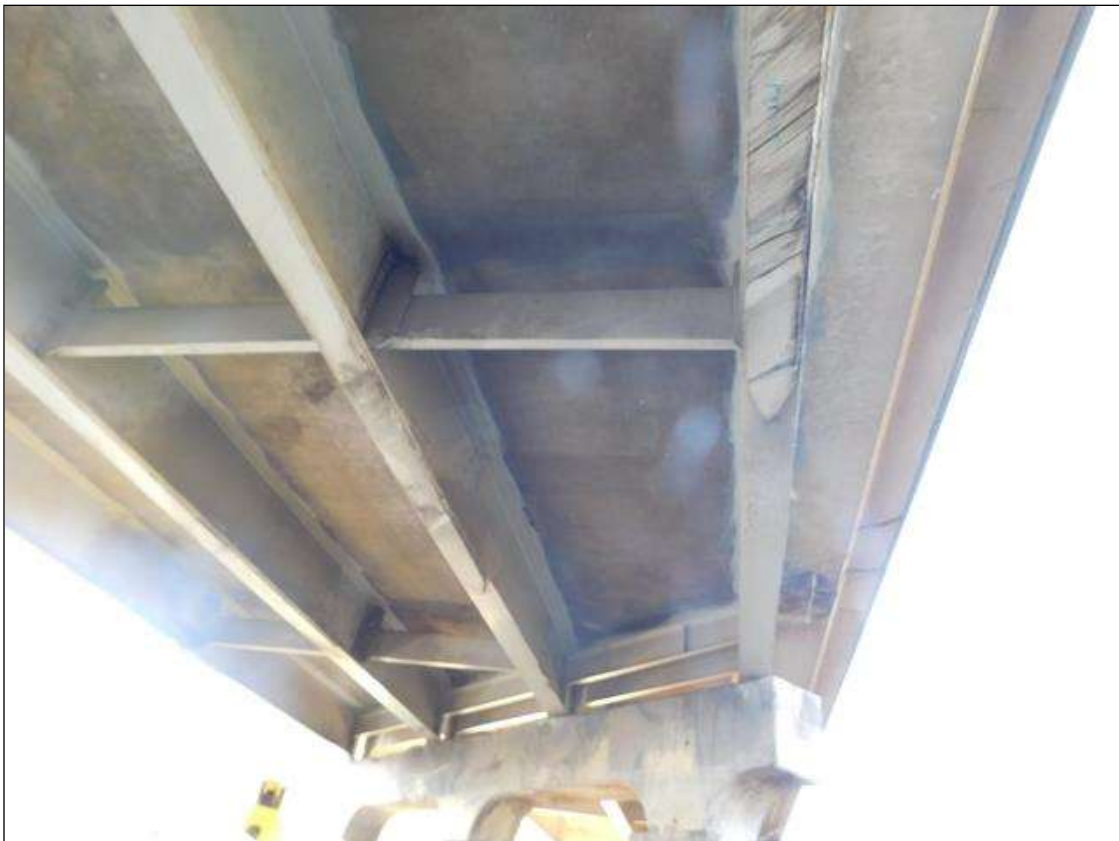
OVERVIEW OF DAMAGE SPAN 2 INT. BENT1

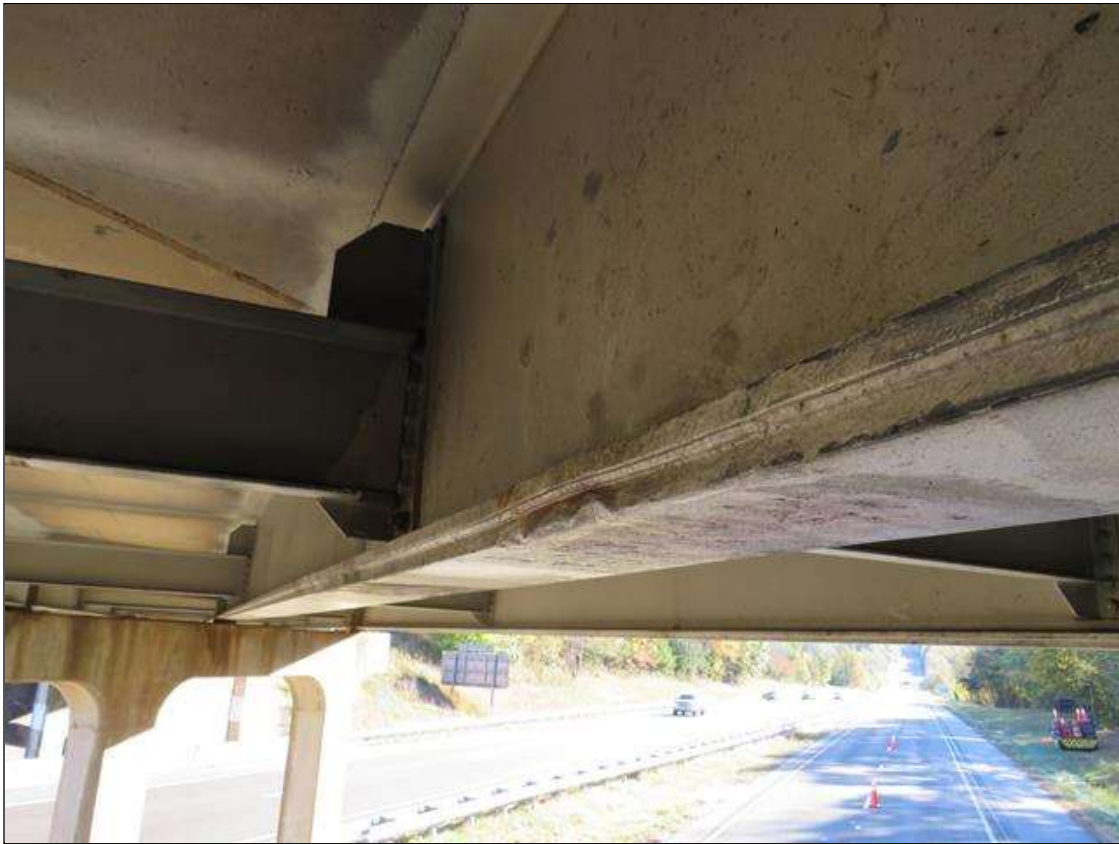
Span 2 Beam 3: SUPPLEMENTAL INSPECTION 2021: Point of impact on beam 3 West approach slab 26'-1" from face of bent 1. Beam 1 is out of plumb 2 1/2" +/- in the direction of traffic and a indentation in cover plate 3" X 1/2" and a 2" X 1/2" in the impact area.

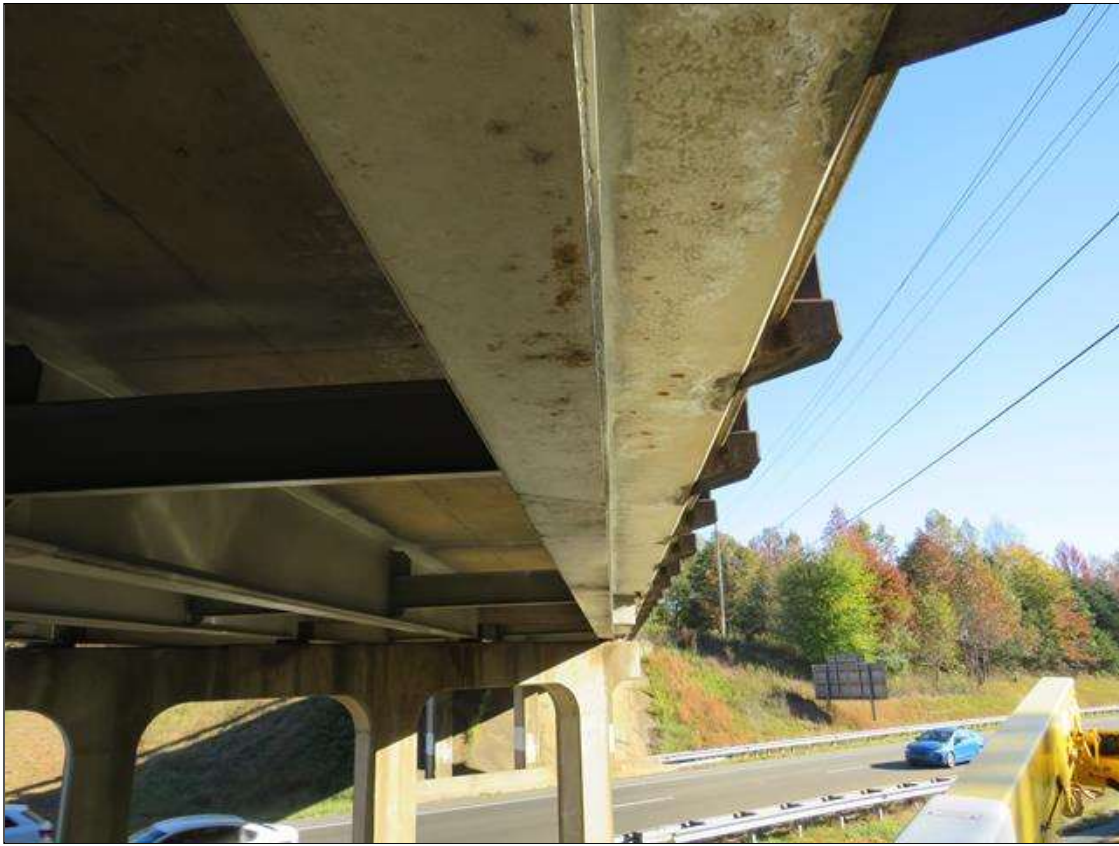
Span 2 Beam 4: SUPPLEMENTAL INSPECTION 2021: SCATTERED SCRAPS THROUGHOUT ON BOTTOM COVER PLATE

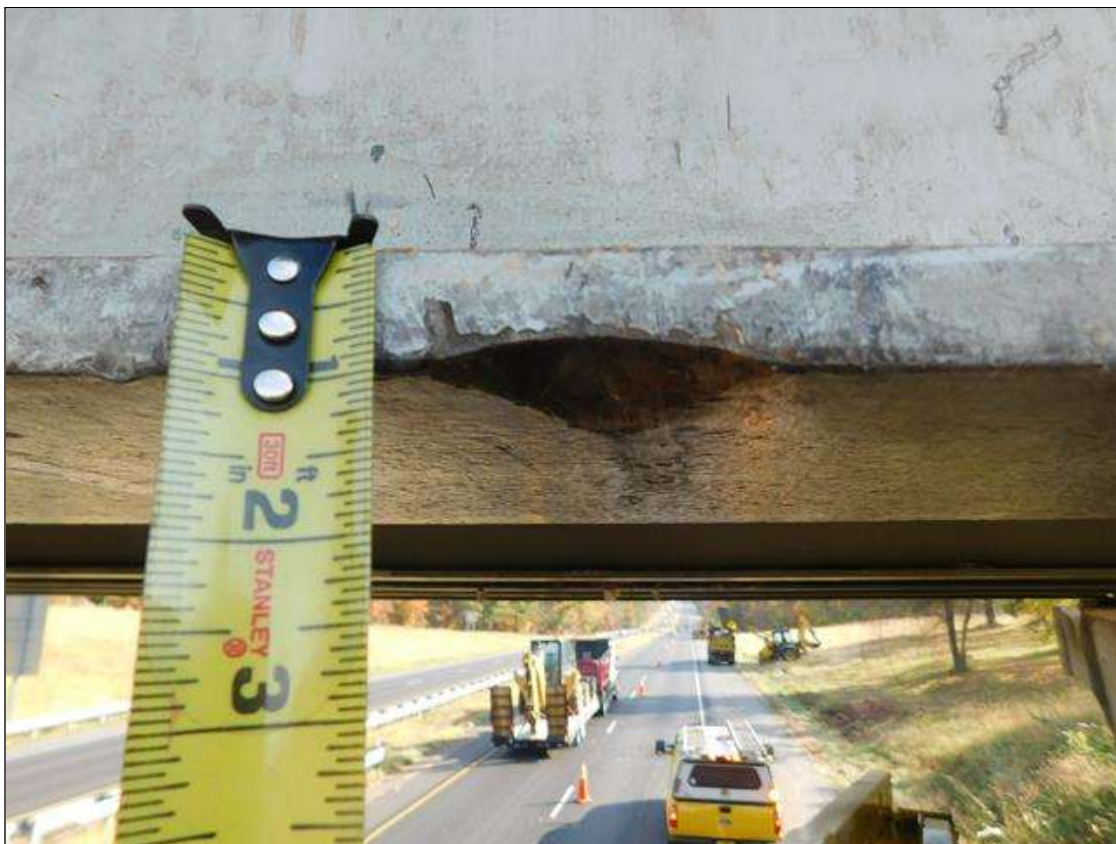
Span 2 Beam 1: INDENTION IN LEFT SIDE OF BOTTOM FLANGE AT 147" FROM INT. BENT 1, 2" LONG X 1" WIDE X 1/8" DEEP (PAR)

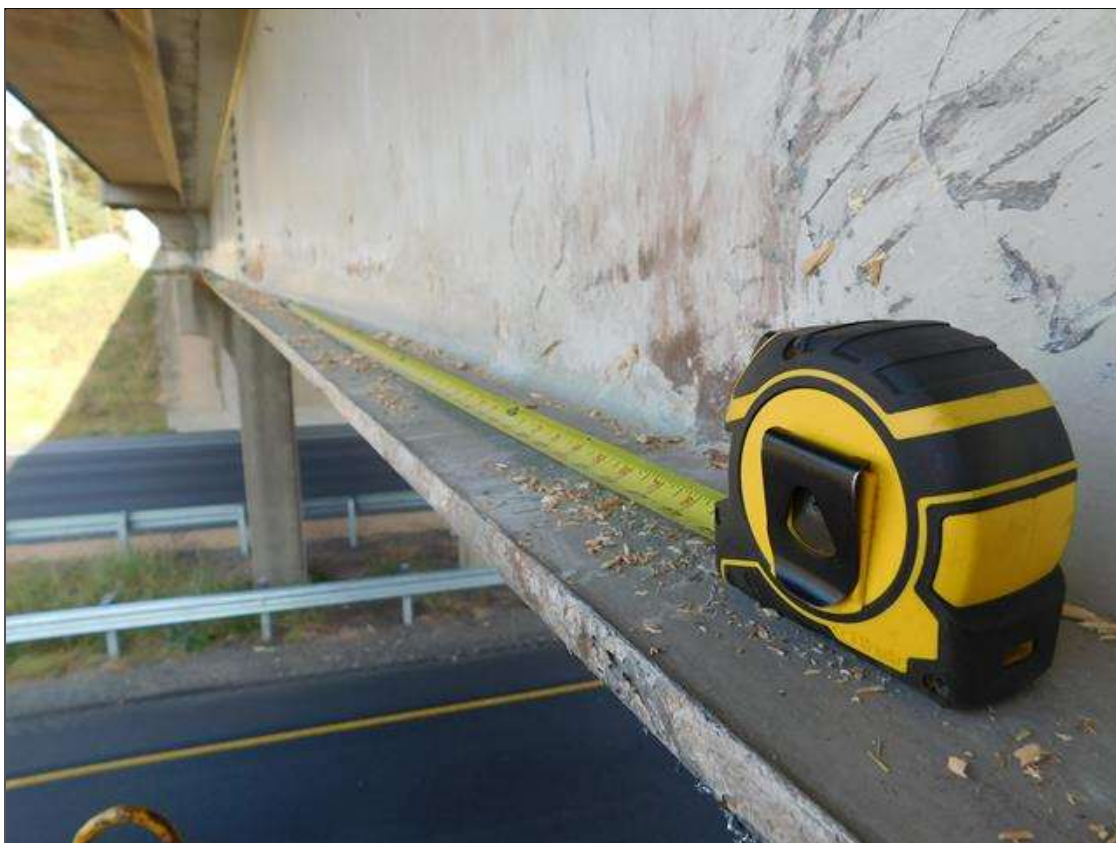
Span 2 Beam 1: POINT OF IMPACT TO BEAM 1 AT 24'8" FROM INT. BENT 1 FOR A LENGTH OF 15'.

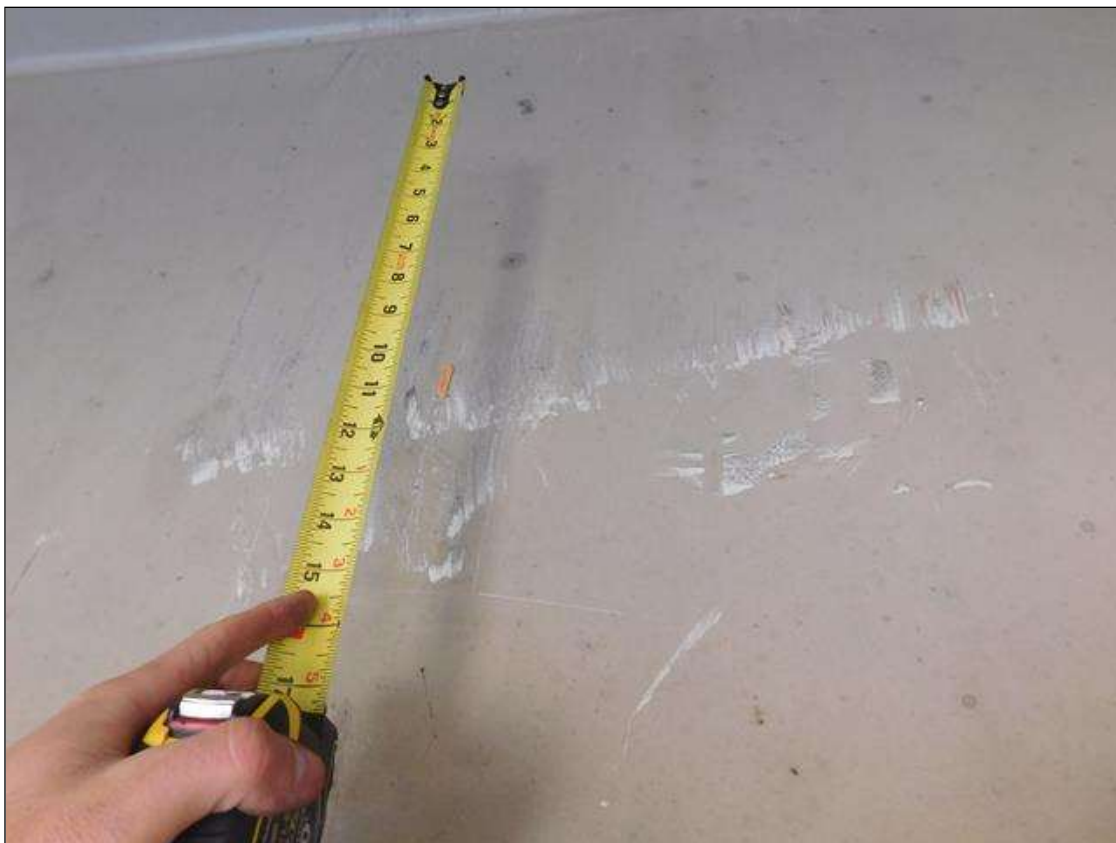
Span 2 Beam 3: SCATTERED SCRAPES TO LEFT SIDE OF WEB THROUGHOUT BEAM 3 SPAN 2

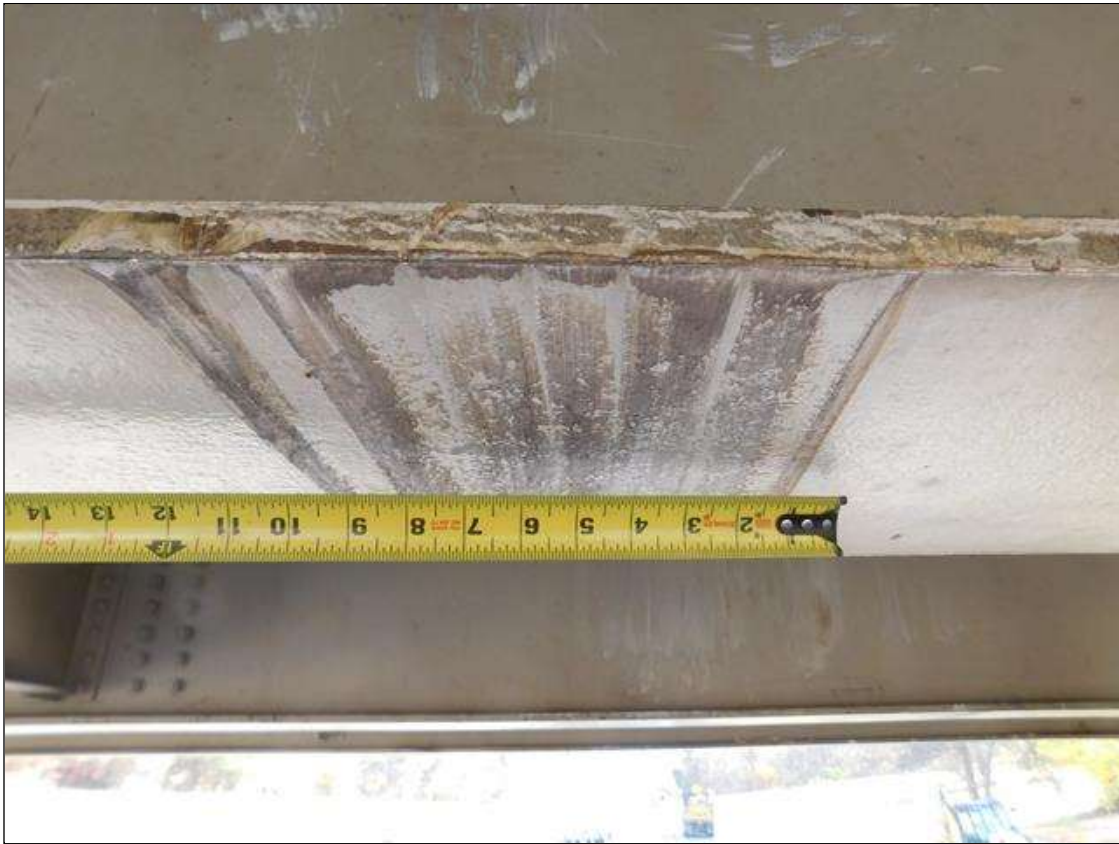
Span 2 Beam 3: SCRAPES TO BOTTOM FLANGE AT 20'9" FROM INT. BENT 1

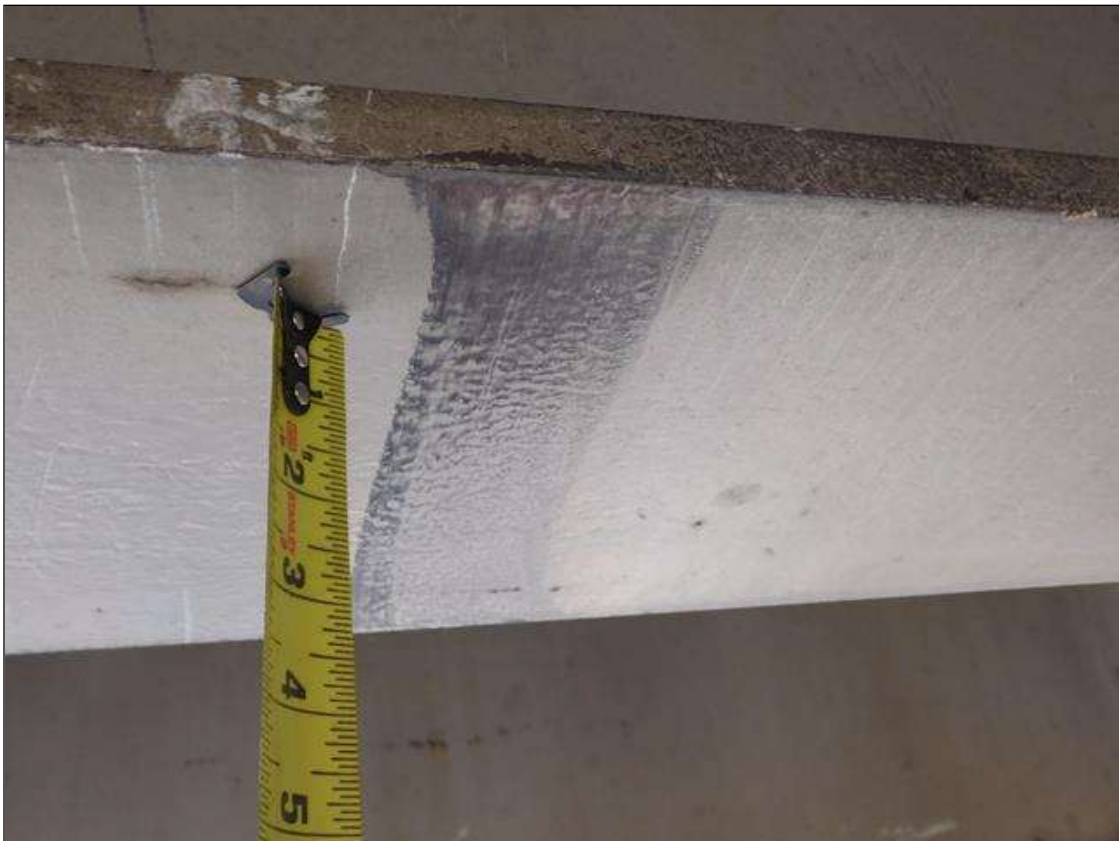
Span 2 Beam 4: SCATTERED SCRAPES TO BOTTOM FLANGE

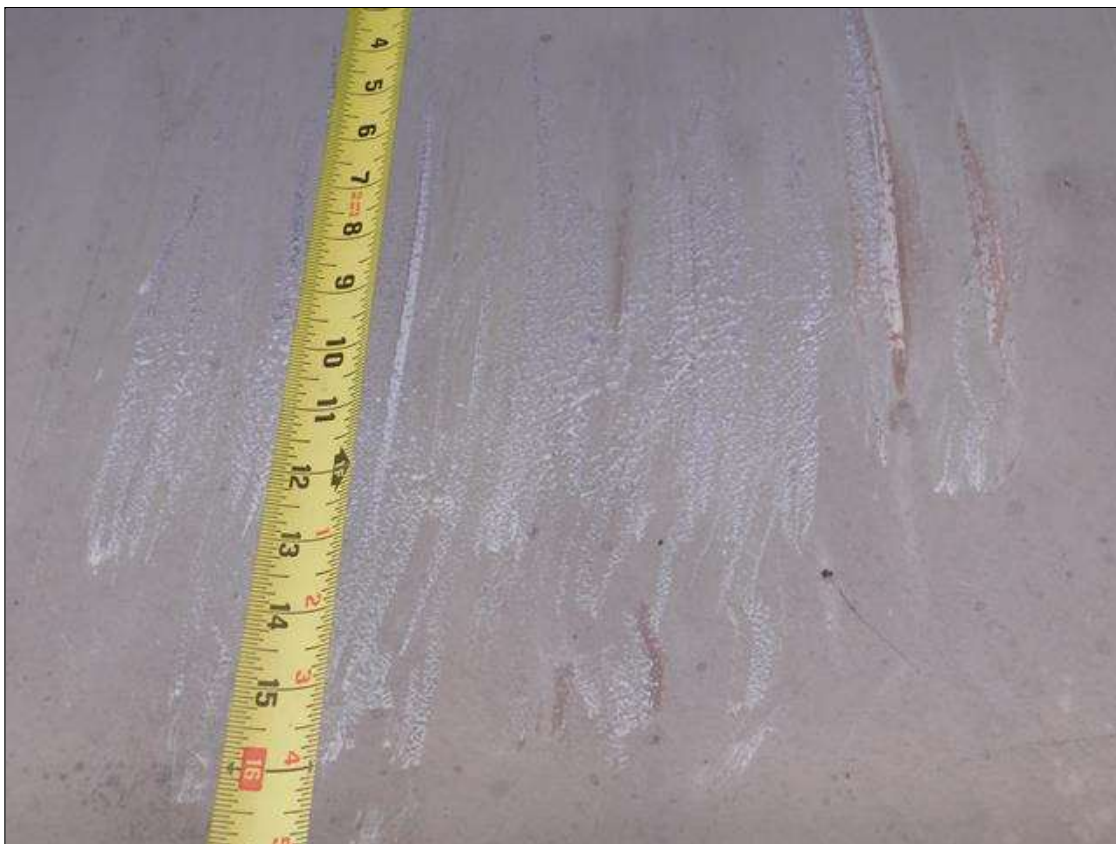
Span 2 Beam 4: SCATTERED SCRAPES TO LEFT SIDE OF WEB.

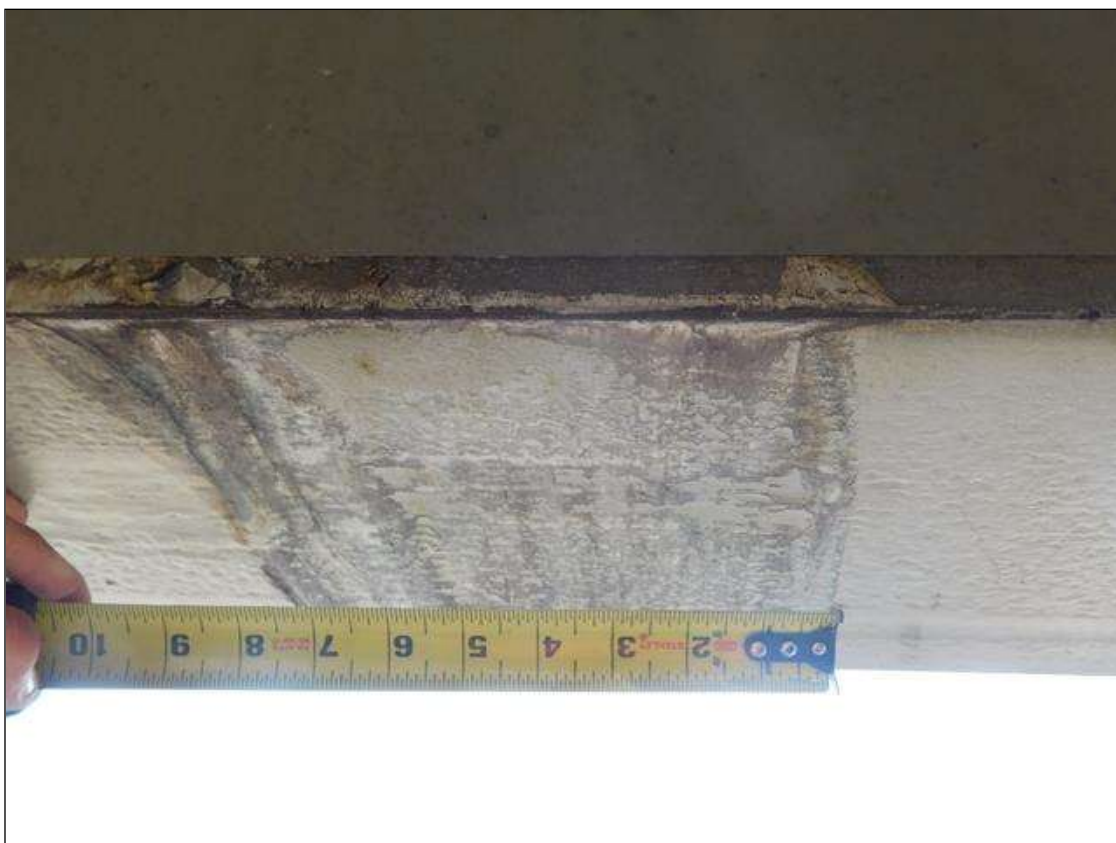
Span 2 Beam 5: SCATTERED SCRAPES TO BOTTOM FLANGE

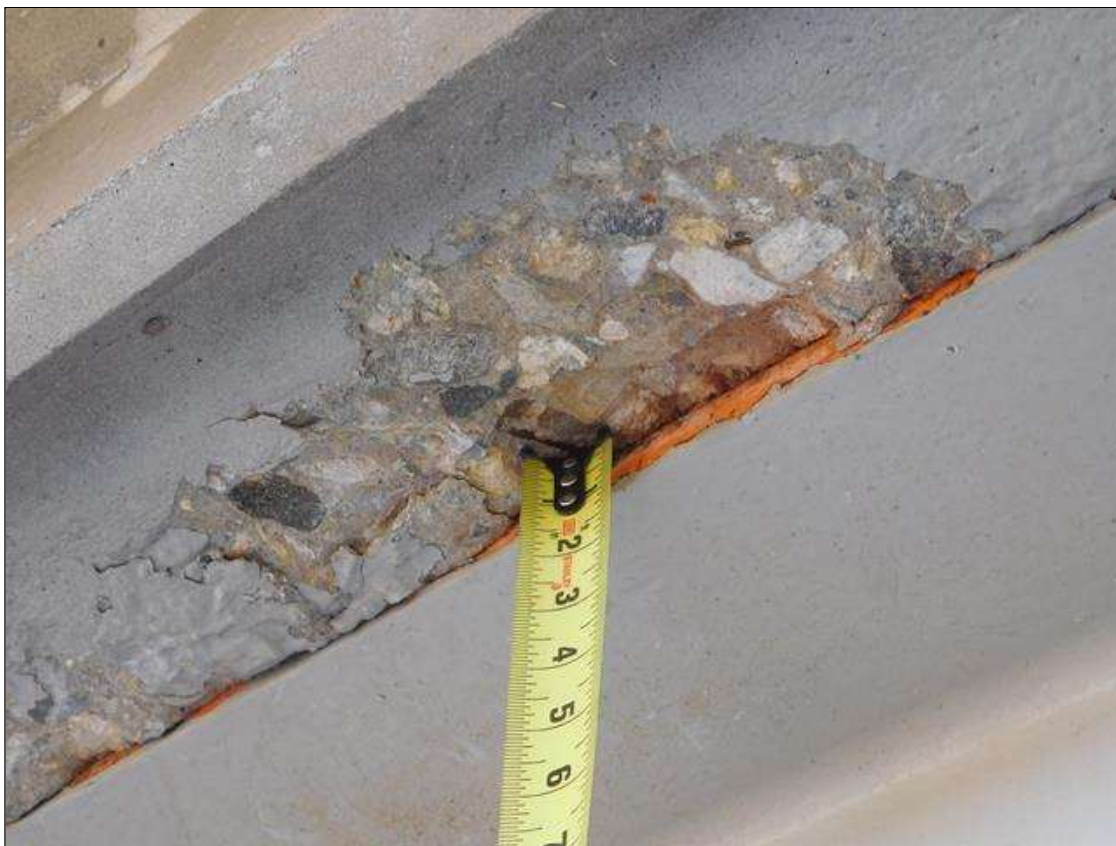
SCATTERED POPOUTS IN BOTTOM DECK AT LEFT SIDE OF BEAM 1 AT BOTTOM FLANGE
