NC DEPARTMENT OF TRANSPORTATION
 DIVISION OF HIGHWAYS
 STRUCTURE MANAGEMENT UNIT

Structure Safety Report

Supplemental Element Inspection

DIVISION: 13 COUNTY: BUNCOMBE STRUCTURE NUMBER: 100387 FREQUENCY: None

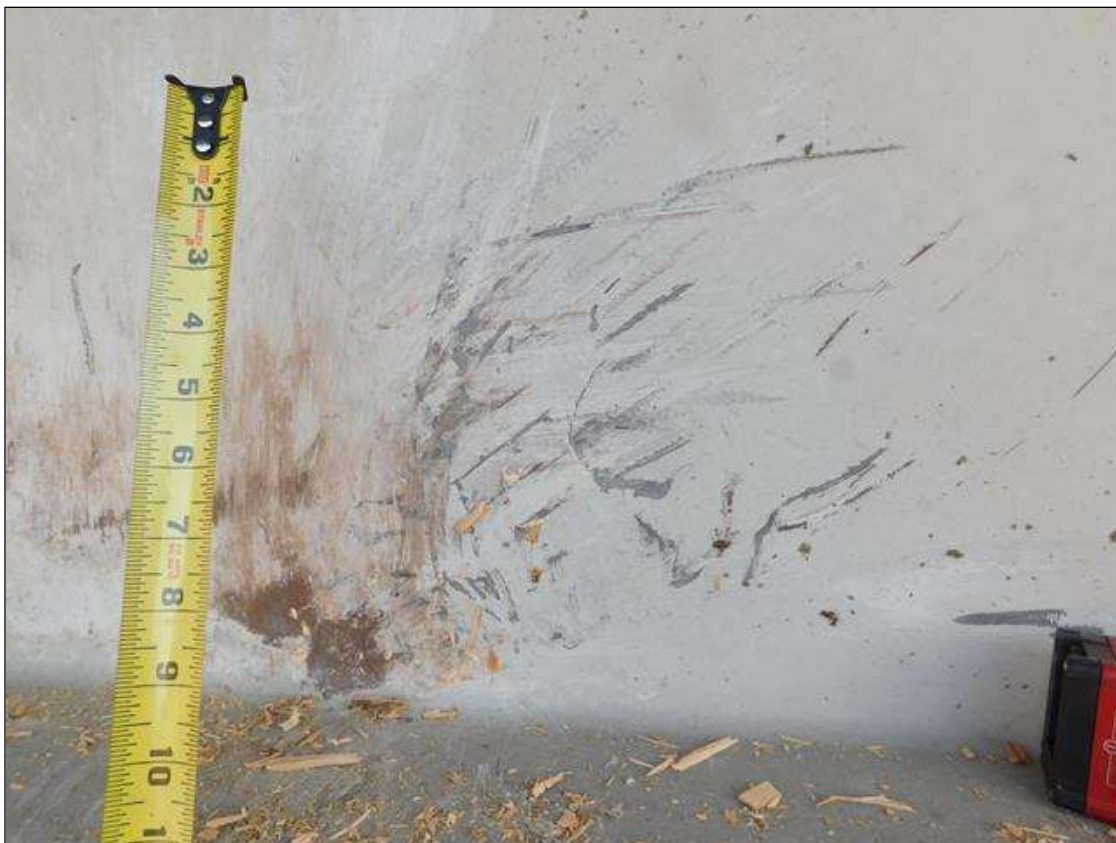
SPAN 2 BEAM 1: SCATTERED SCRAPES IN LEFT SIDE OF BOTTOM WEB

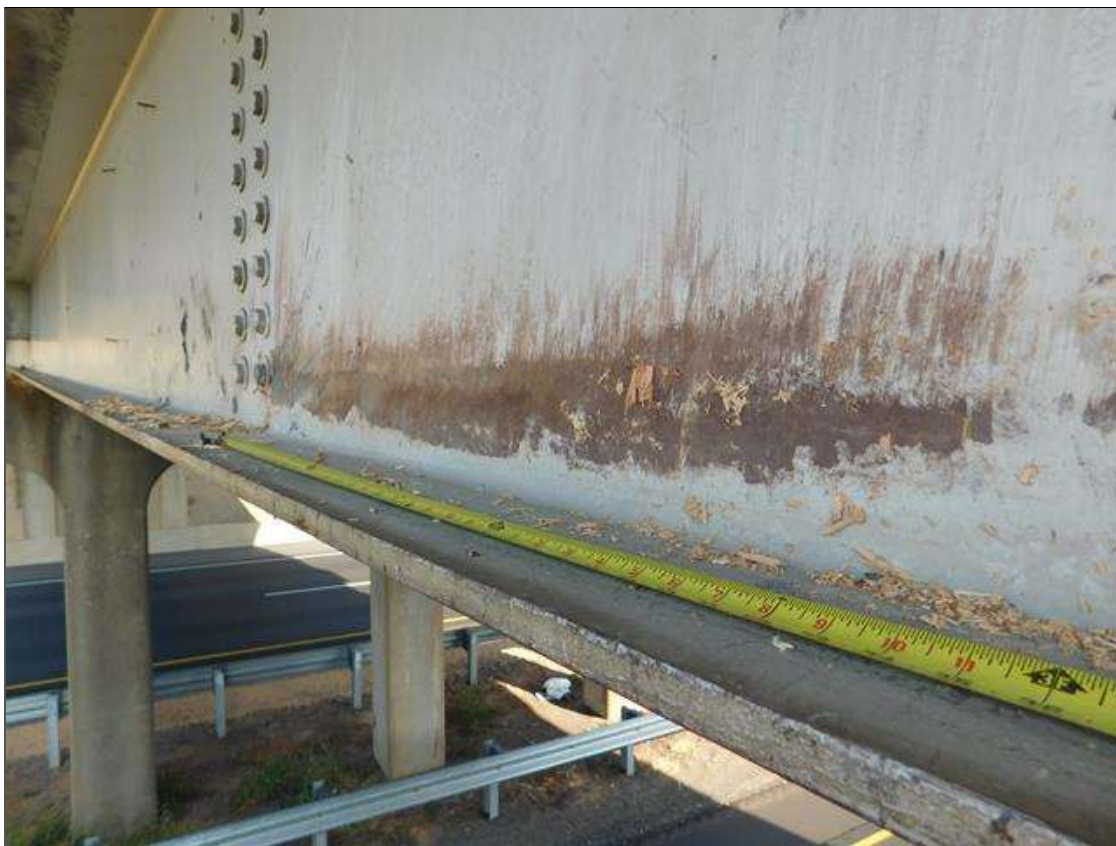
SPAN 2 BEAM 1: SCATTERED SCRAPES TO BOTTOM WEB

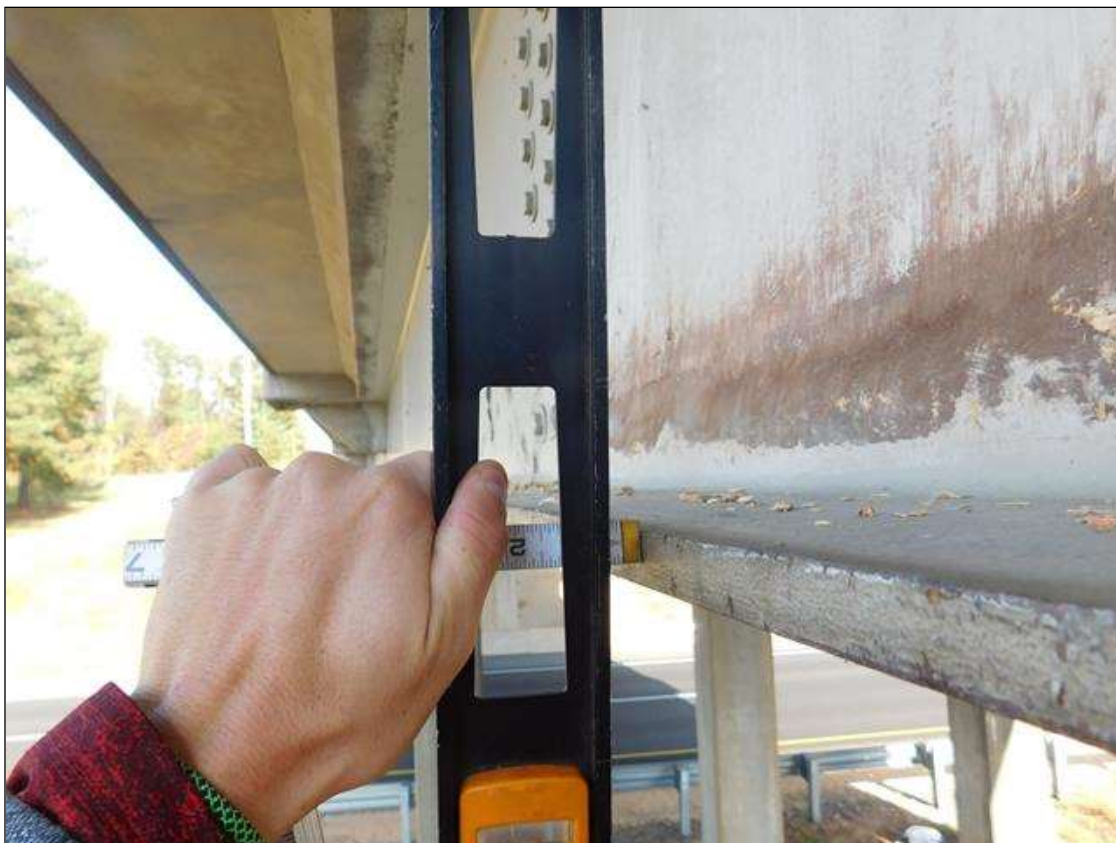
SPAN 2 BEAM 1: BEAM 1 SWEEPED EASTWARD 1" FOR A LENGTH OF 20' (PAR)

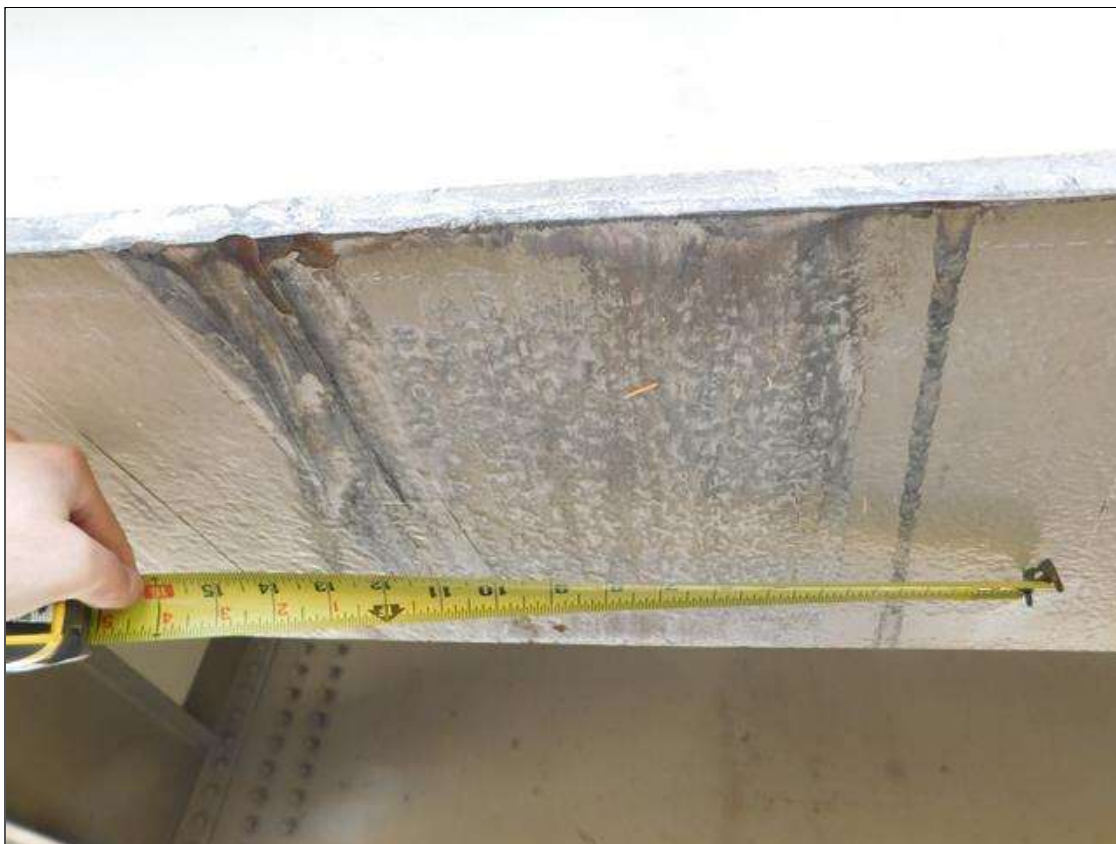
SPAN 2 BEAM 1: SCATTERED SCRAPES TO BOTTOM FLANGE

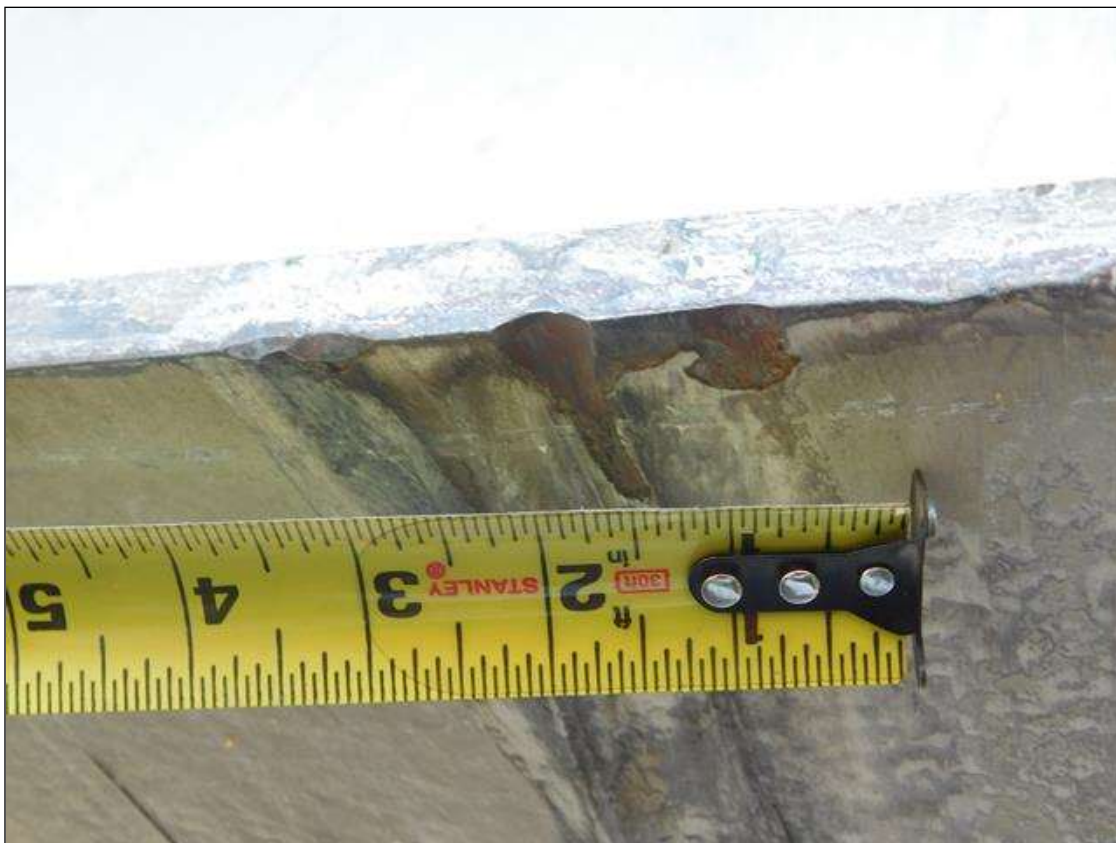
SPAN 2 BEAM 1: INDENTION TO LEFT SIDE OF BOTTOM FLANGE AT 20' 9" FROM INT. BENT 1, 2" LONG X 1" WIDE X 1/8" DEEP (PAR)

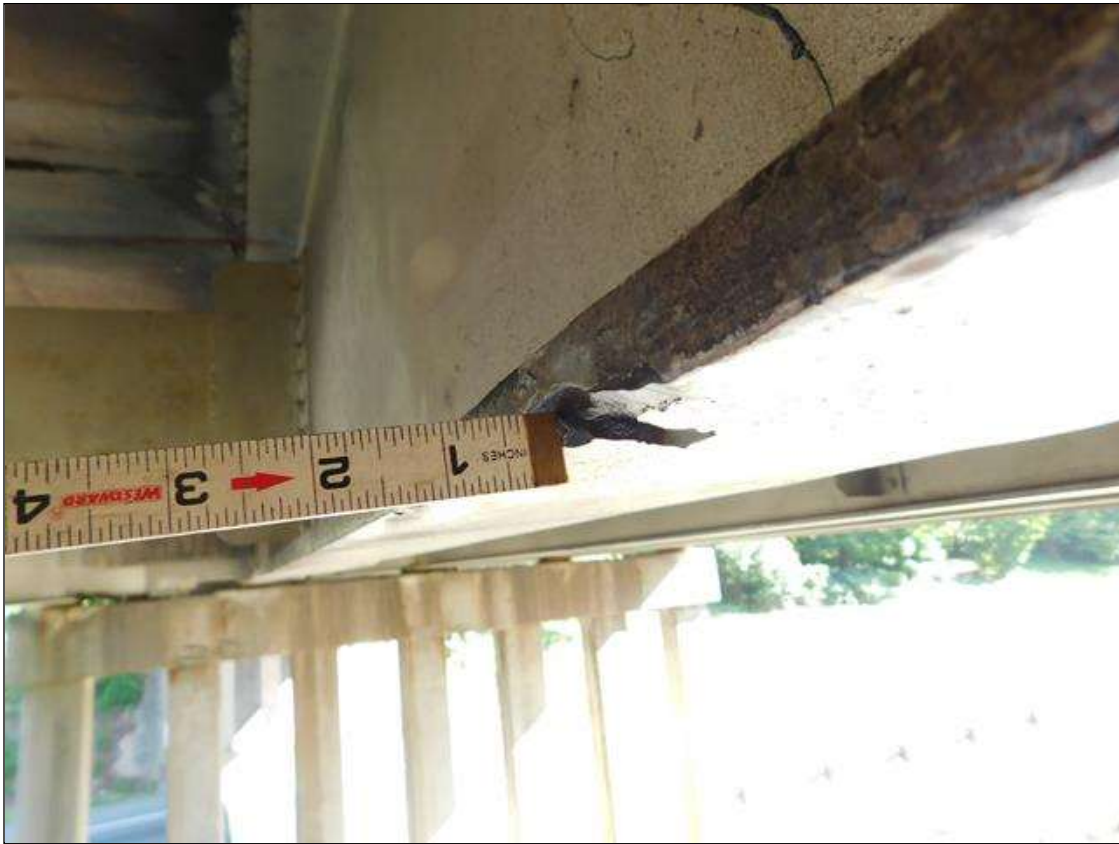
Span 2 Beam 2: SUPPLEMENTAL INSPECTION 2021: POINT OF IMPACT 8" LONG WITH A 1/2" DEEP GOUGE AT 18'-8" FROM INT. BENT 2 , WITH BEAM BEING SWEEP EASTWARD 1/2". SCATTERED SCRAPES ALONG THE BEAM (PAR) THERE IS A BENT UP SECTION ON THE WEST BOTTOM FLANGE 4" LONG X 1" HIGH AT 20' OUT FROM INT. BENT 1 (PAR)

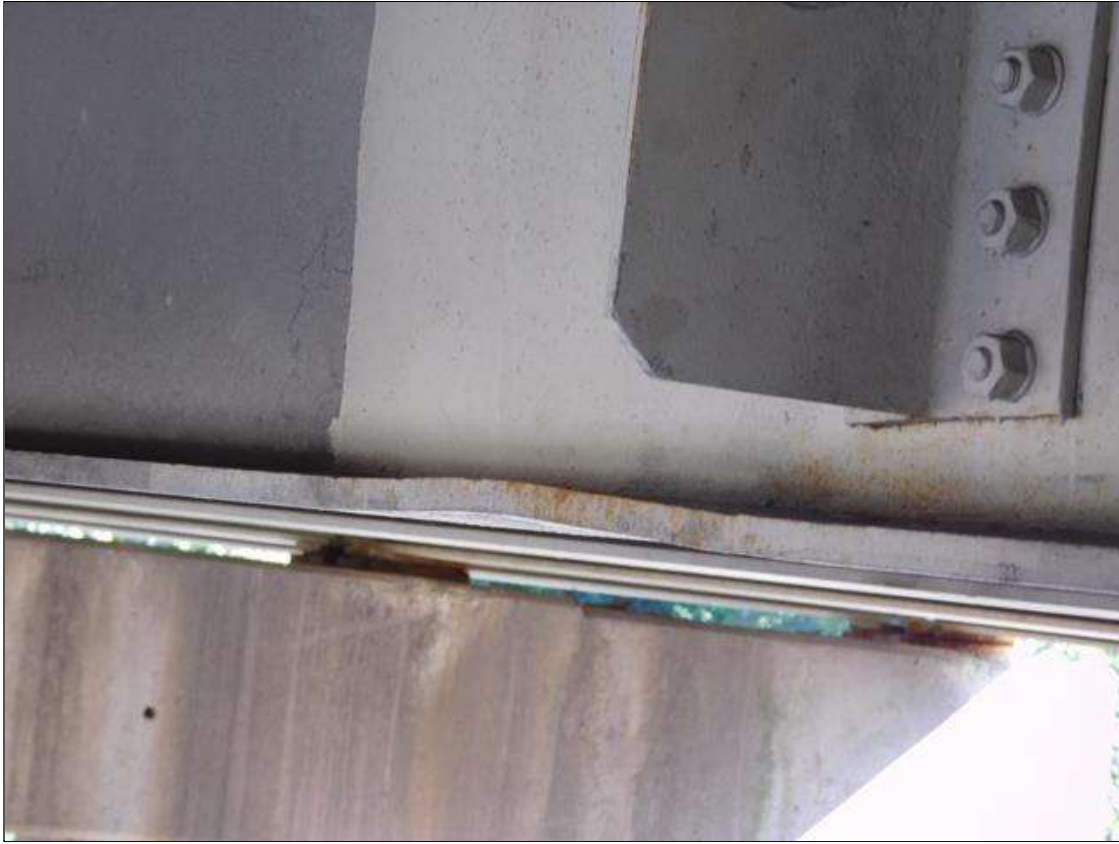
Span 2 Beam 2: SUPPLEMENTAL INSPECTION 2021: POINT OF IMPACT 8" LONG WITH A 1/2" DEEP GOUGE AT 18'-8" FROM INT. BENT 2 , WITH BEAM BEING SWEEPED EASTWARD 1/2". SCATTERED SCRAPES ALONG THE BEAM (PAR) THERE IS A BENT UP SECTION ON THE WEST BOTTOM FLANGE 4" LONG X 1" HIGH AT 20' OUT FROM INT. BENT 1 (PAR)

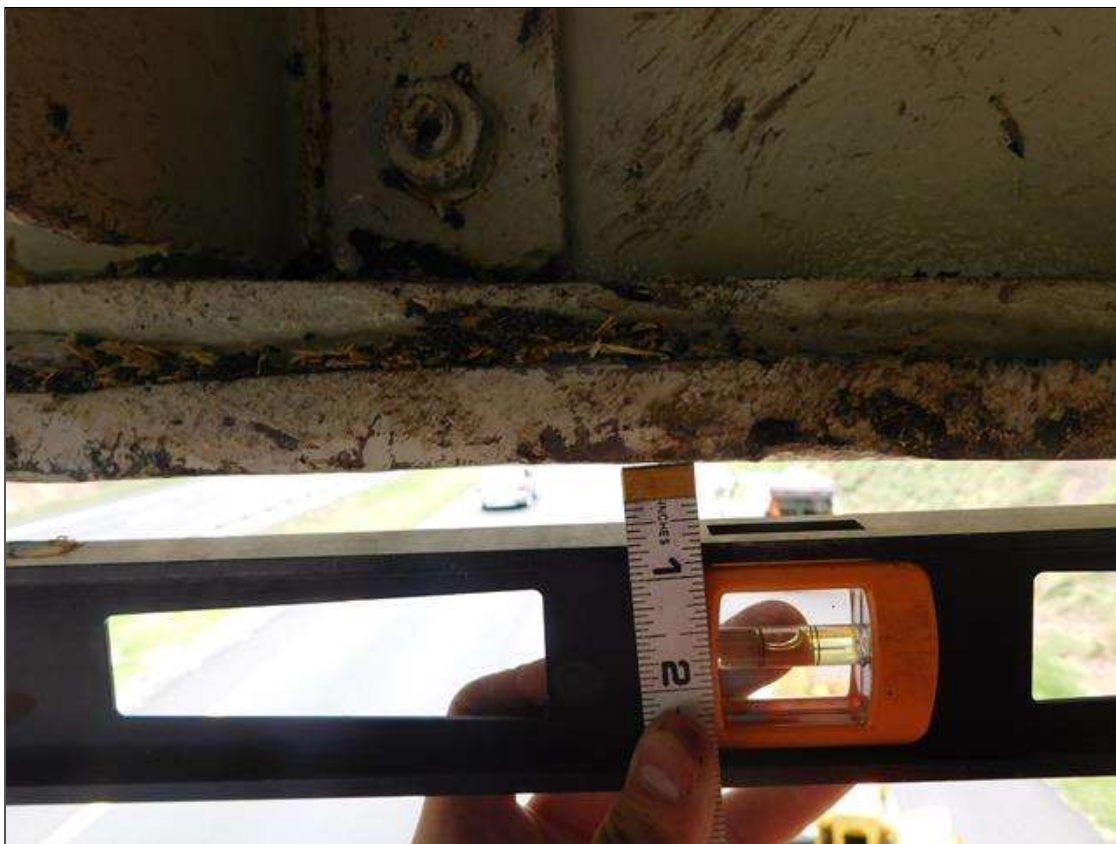
Span 3 Beam 1: BEAM 1 SPAN 3 IS DEFLECTED UPWARD 1" STARTING AT 14.583' FROM INTERIOR BENT 3 FOR A TOTAL LENGTH OF 6'

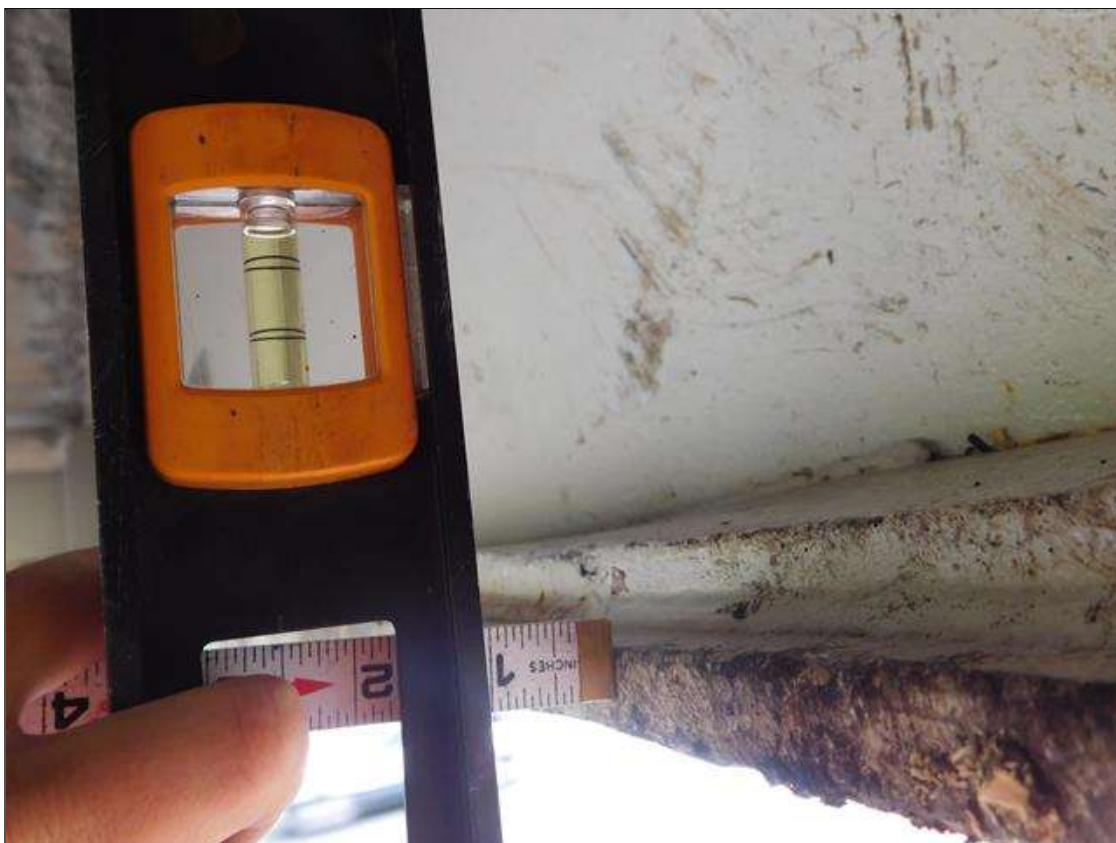
Span 3 Beam 1: BEAM 1 SPAN 3 IS DEFLECTED WESTWARD 1" FOR A TOTAL LENGTH OF 10'. PAR

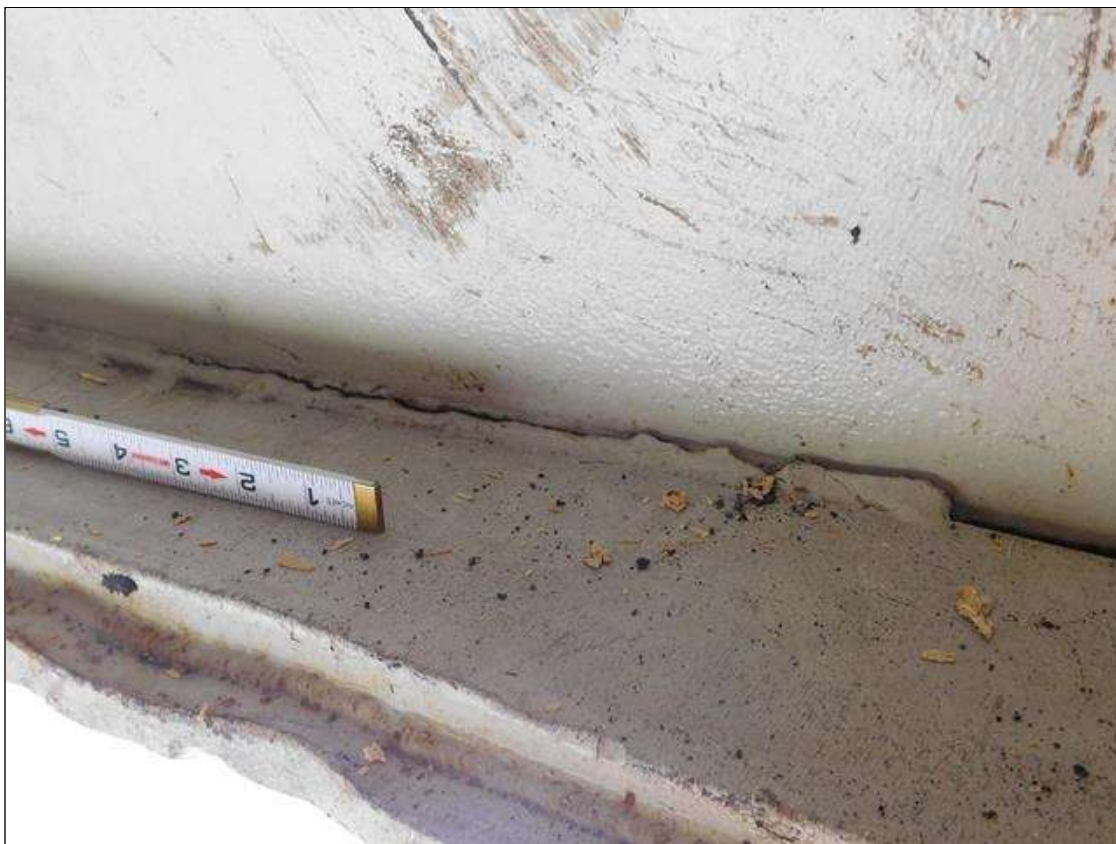
Span 3 Beam 1: CRACK IN WELD OF PLATE AT BOTTOM FLANGE OF BEAM 1 SPAN 3 MEASURED AT 17' FROM INTERIOR BENT 3 FOR A LENGTH OF 1'

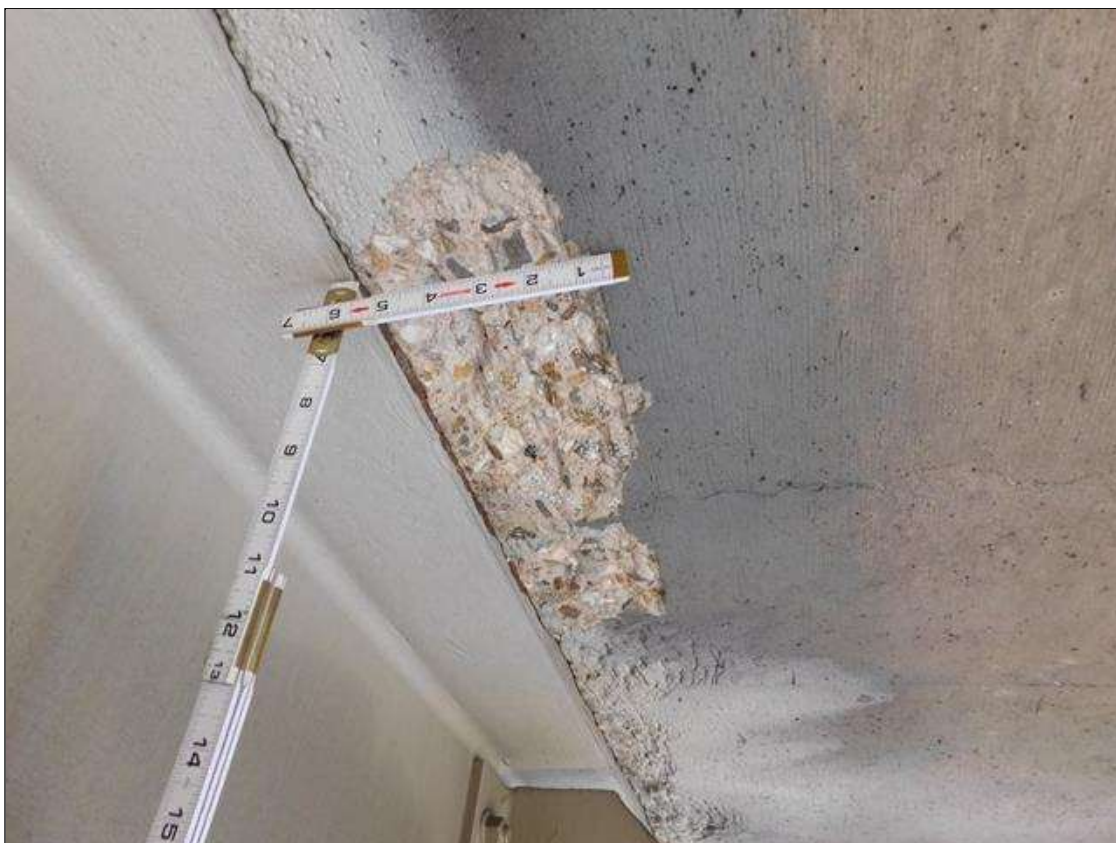
Span 3 Beam 2: SPALL AT TOP FLANGE OF WEST SIDE OF BEAM 2 SPAN 3. 17" LONG BY 6" WIDE BY 1/4" DEEF MEASURED AT 15.417' FROM INTERIOR BENT 3

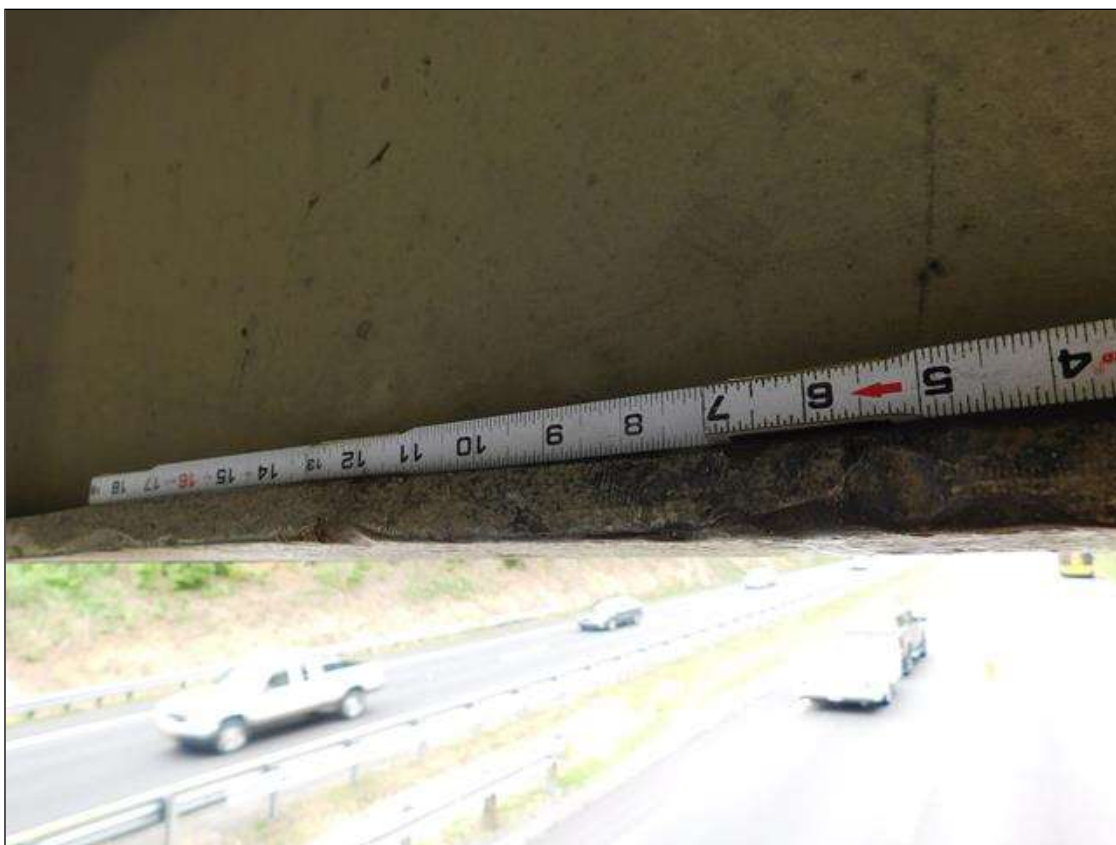
Span 3 Beam 2: MINOR INDENTIONS IN BEAM 2 SPAN 3 STARTING AT 18.167' FROM INTERIOR BENT 3 FOR A TOTAL LENGTH OF 2'

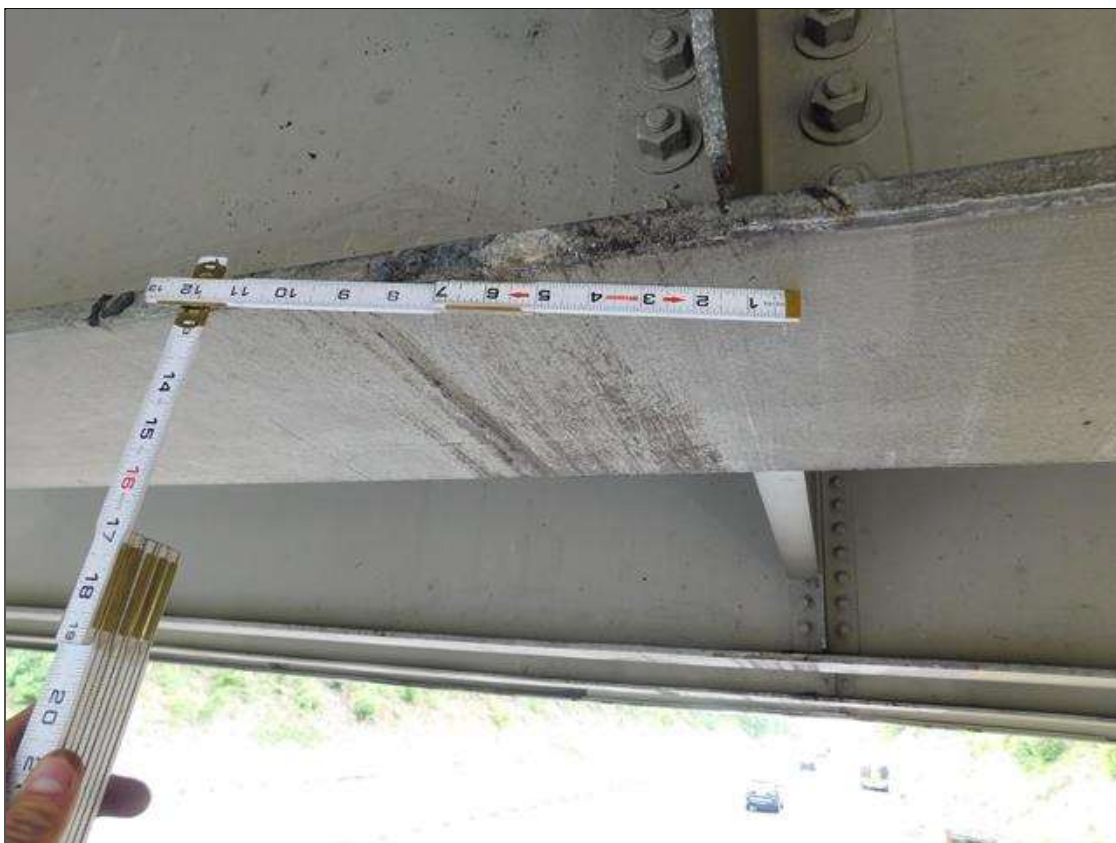
Span 3 Beam 4: BEAM 4 SPAN 3 HAS SCRAPES TO BOTTOM FLANGE AT 16.75' FROM INTERIOR BENT 3 FOR A TOTAL LENGTH OF 1'

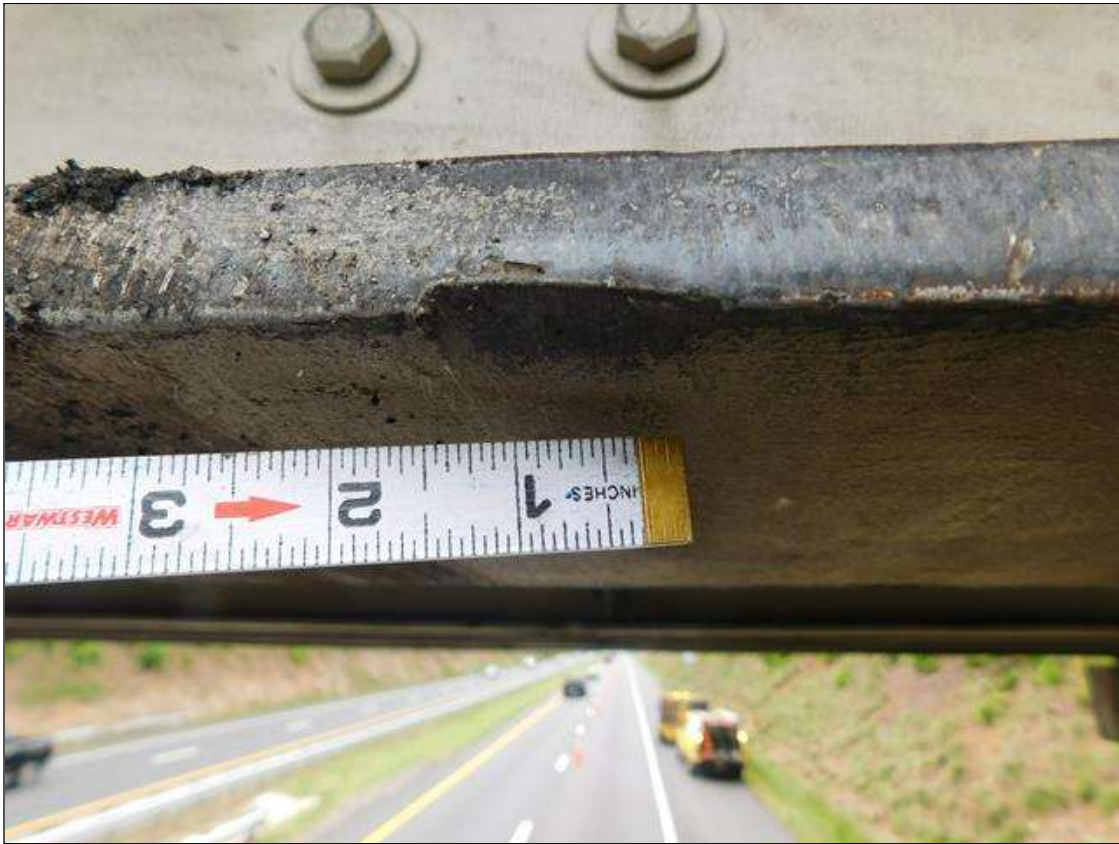
Span 3 Beam 5: BEAM 5 SPAN 3 HAS SCRAPES ON BOTTOM FLANGE AT 16.5' FROM INTERIOR BENT 3 FOR A TOTAL LENGTH OF 1'. INDENTATION AT 16.417' FROM INTERIOR BENT 3, 1" LONG BY 1/4" DEEP

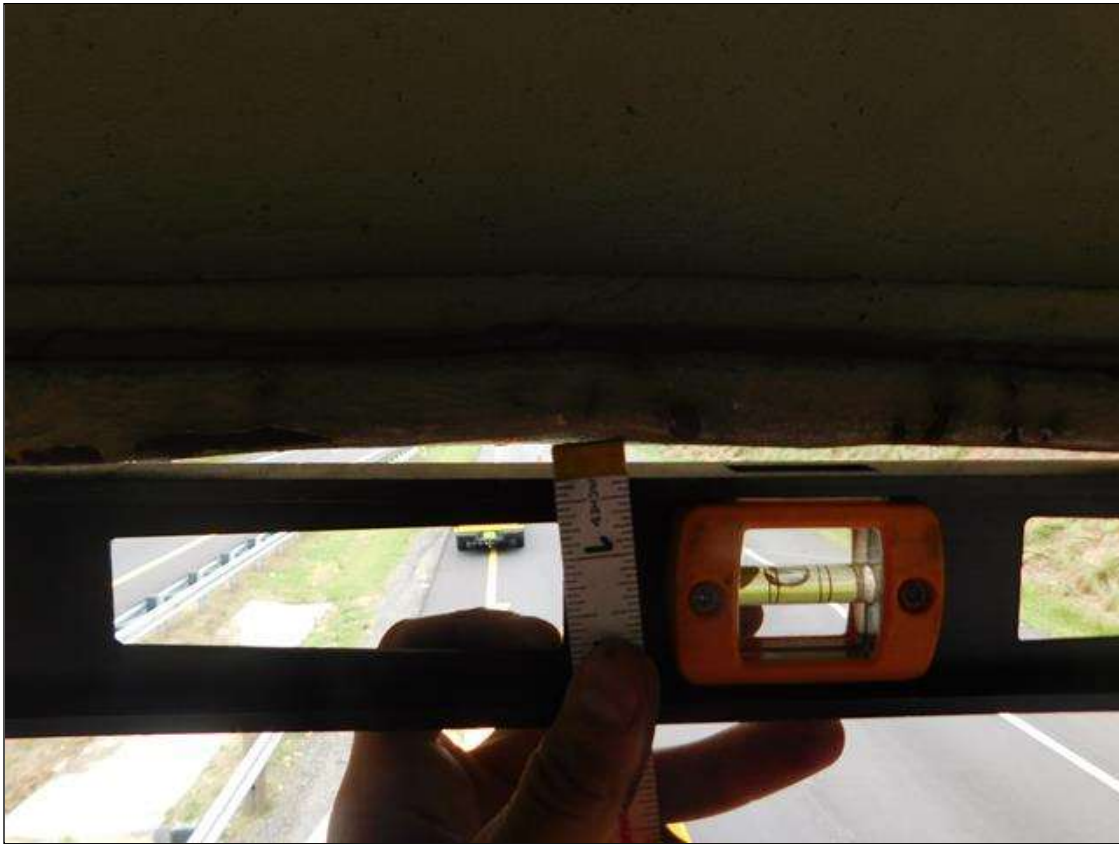
Span 3 Beam 1: BEAM 1 SPAN 3 HAS INDENTION AT 21.167' FROM INTERIOR BENT 2 FOR A LENGTH OF 2', WITH UPWARD DEFLECTION OF 1/2". ONE INDENTION 15.5' FROM INTERIOR BENT 2 FOR A LENGTH OF 1', WITH UPWARD DEFLECTION OF 1/4"

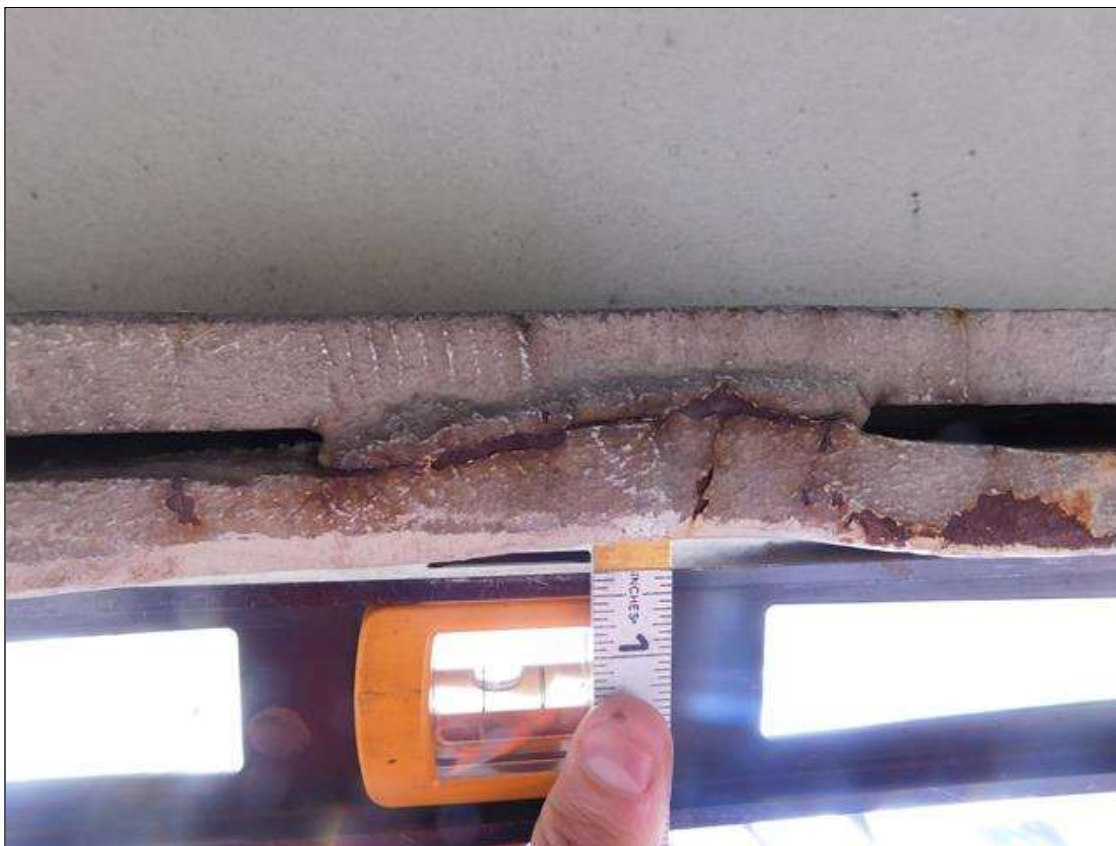
Span 3 Beam 1: BEAM 1 SPAN 3 HAS INDENTATION AT 21.167' FROM INTERIOR BENT 2 FOR A LENGTH OF 2', WITH UPWARD DEFLECTION OF 1/2". ONE INDENTION 15.5' FROM INTERIOR BENT 2 FOR A LENGTH OF 1', WITH UPWARD DEFLECTION OF 1/4"

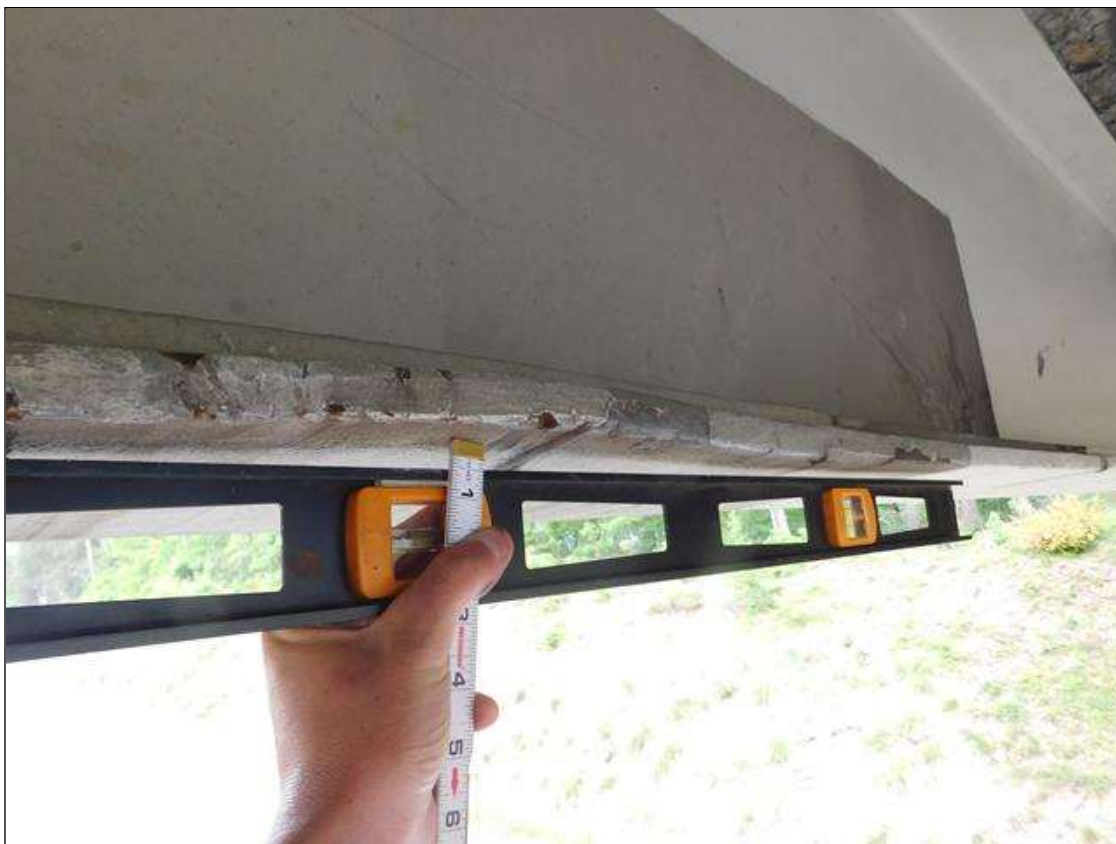
Span 3 Beam 1: BEAM 1 SPAN 3 DEFLECTED UPWARD 1/2" AT 22.75' FROM INTERIOR BENT 2 FOR A LENGTH OF 1'

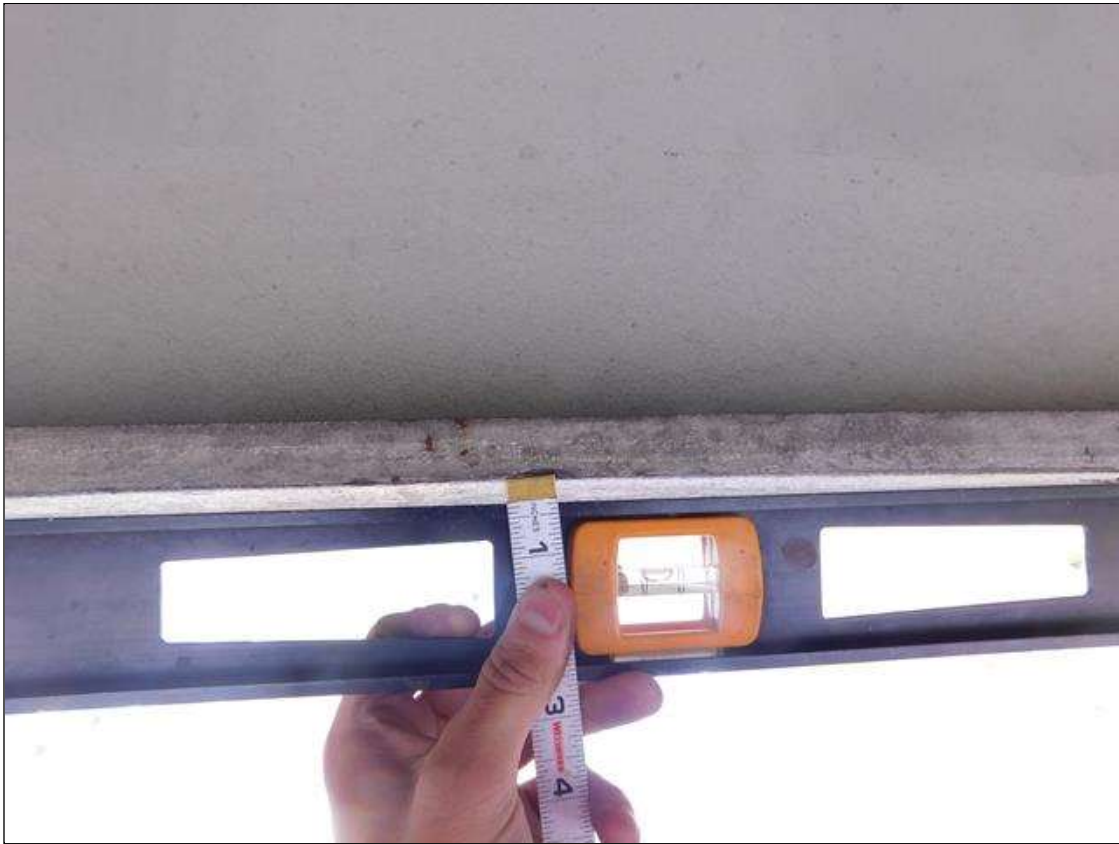
Span 3 Beam 2: BEAM 2 SPAN 3 DEFLECTED UPWARD 1/2" AT 19.5" FROM INTERIOR BENT 2 FOR A LENGTH OF 4', WITH SCRAPES ON BOTTOM FLANGE

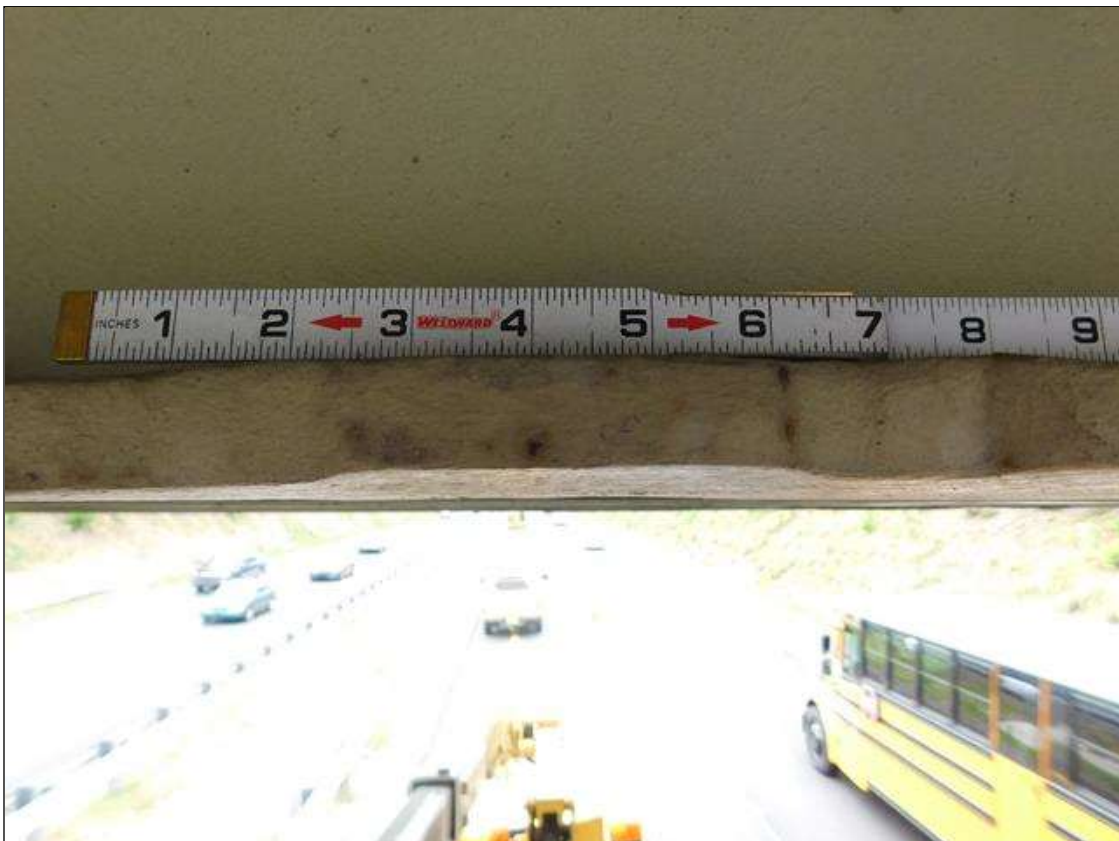
Span 3 Beam 3: TWO INDENTIONS IN BOTTOM FLANGE OF BEAM 3 SPAN 3. ONE 1/4" DEEP AND ONE 1/2" DEEP AT 15.583" FROM INTERIOR BENT 2 FOR A TOTAL LENGTH OF 1'

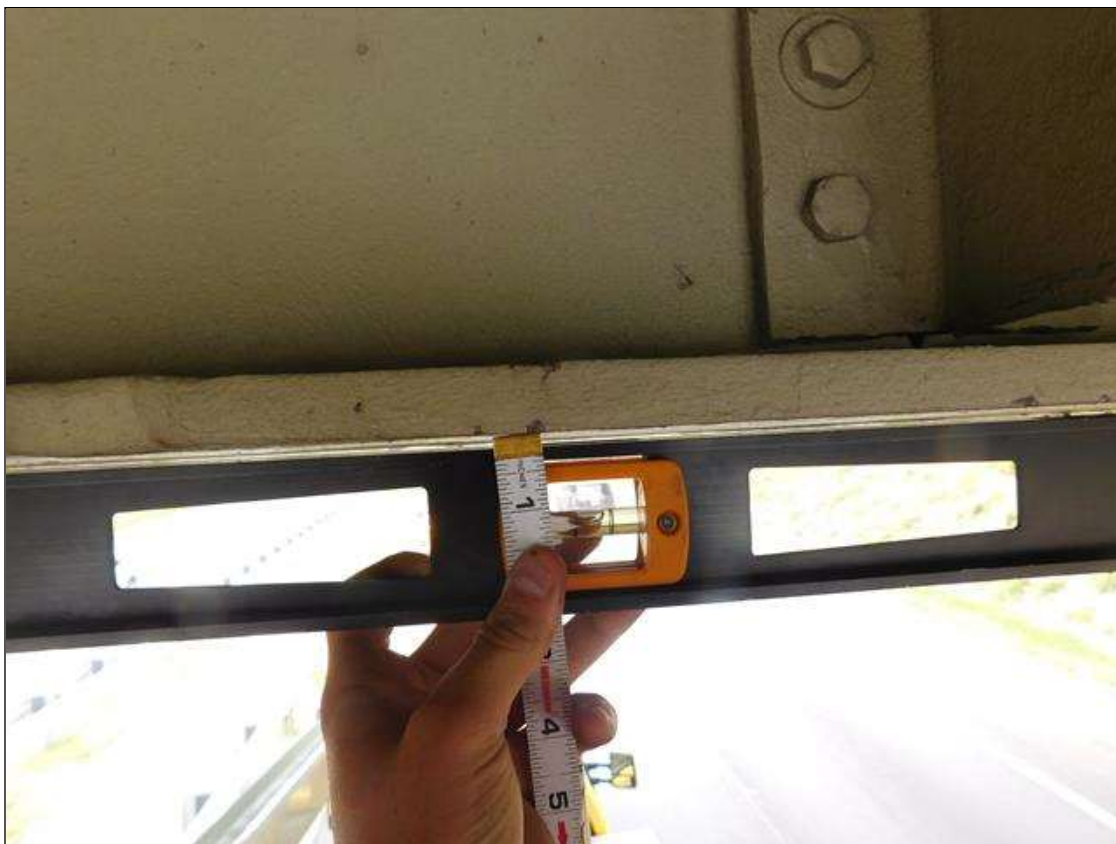
Span 3 Beam 3: BEAM 3 SPAN 3 DEFLECTED UPWARD 1/4" FOR A LENGTH OF 3' AT 15' FROM INTERIOR BENT 2

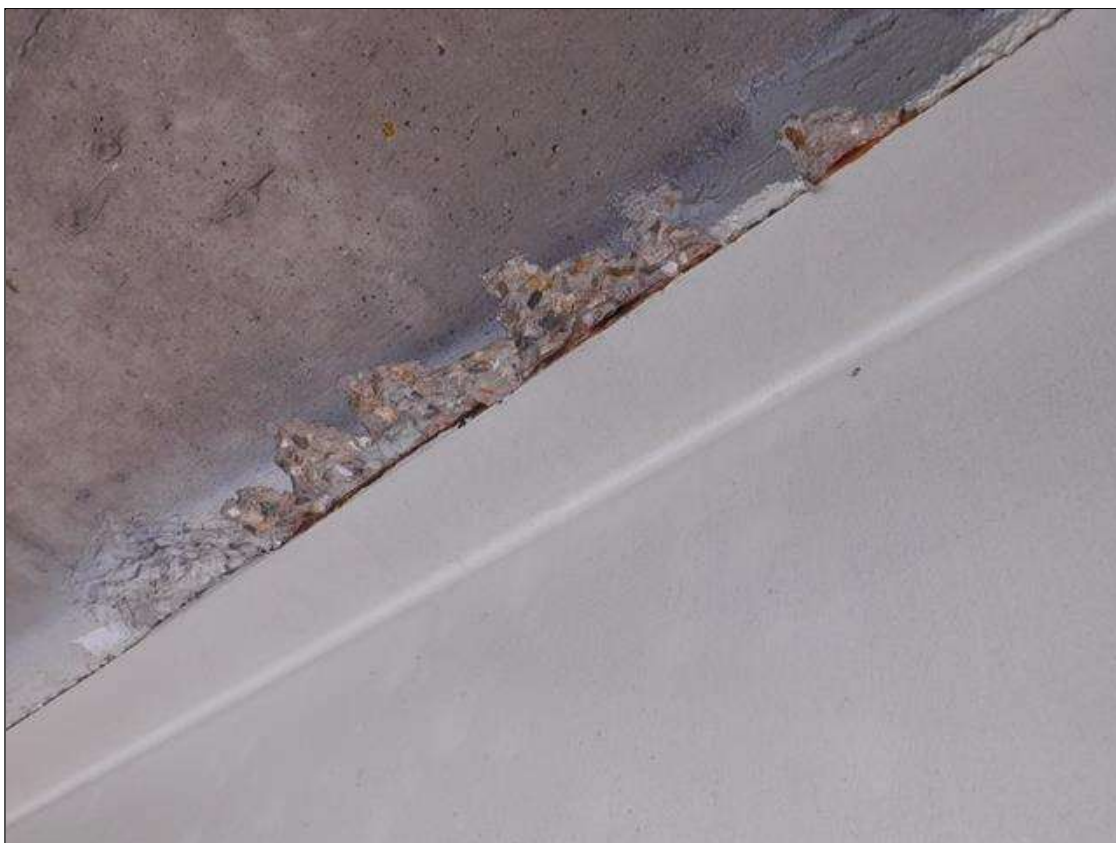
Span 3 Beam 3: SPALL AT EAST SIDE OF TOP FLANGE OF BEAM 3 SPAN 3. 3' LONG AT 12' FROM INTERIOR BENT 2

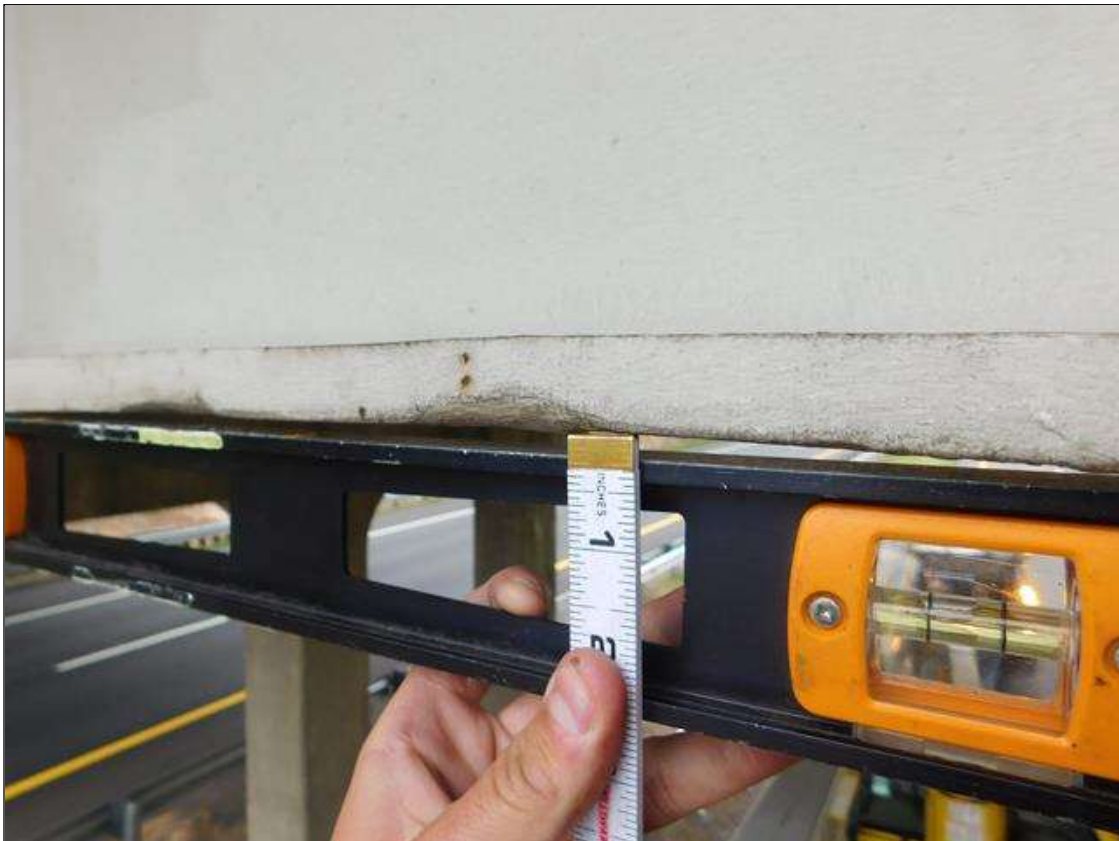
Span 3 Beam 5: BEAM 5 SPAN 3 IS DEFLECTED UPWARD 1/4" AT 16.417' FROM INTERIOR BENT 2 FOR A LENGTH OF 3'

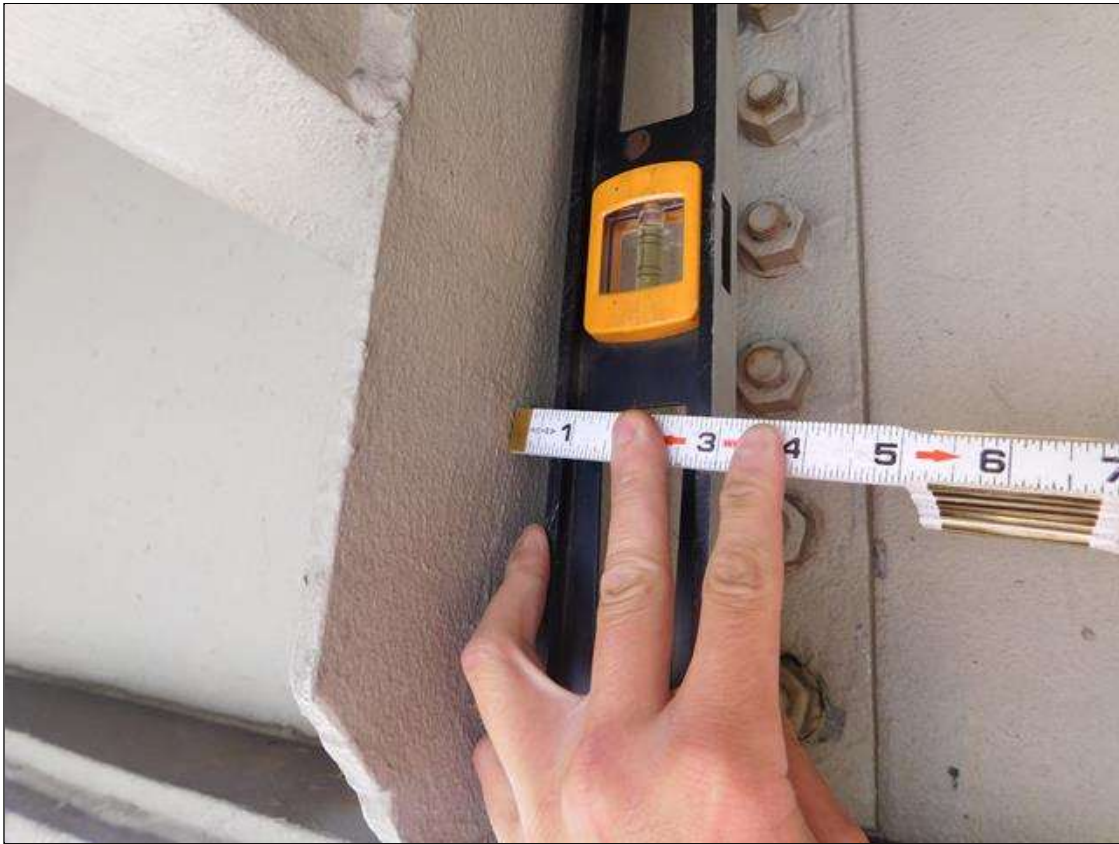
BEAM 1 SPAN 3: DIAPHRAGM 2 BAY 2 DEFLECTED SOUTHWARD FOR 1/2"
