NC DEPARTMENT OF TRANSPORTATION
 DIVISION OF HIGHWAYS
 STRUCTURE MANAGEMENT UNIT

Structure Safety Report

Supplemental Element Inspection

DIVISION: 13 COUNTY: BUNCOMBE STRUCTURE NUMBER: 100387 FREQUENCY: None

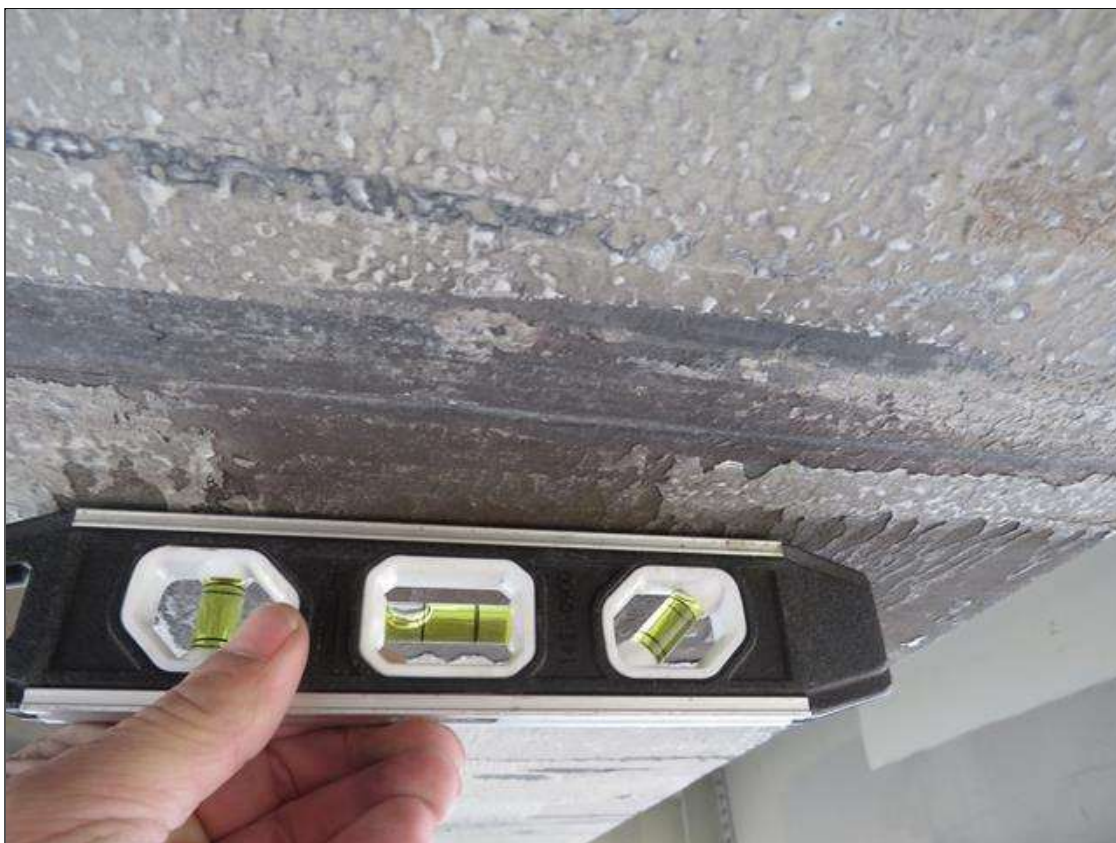
Span 3 Beam 2: SUPPLEMENTAL INSPECTION IMPACT DAMAGE 2022.: beam 2 span 3 deflected upward 1/2in at 19.5in from bent 2 for a length of 4ft, with scrapes on bottom flange

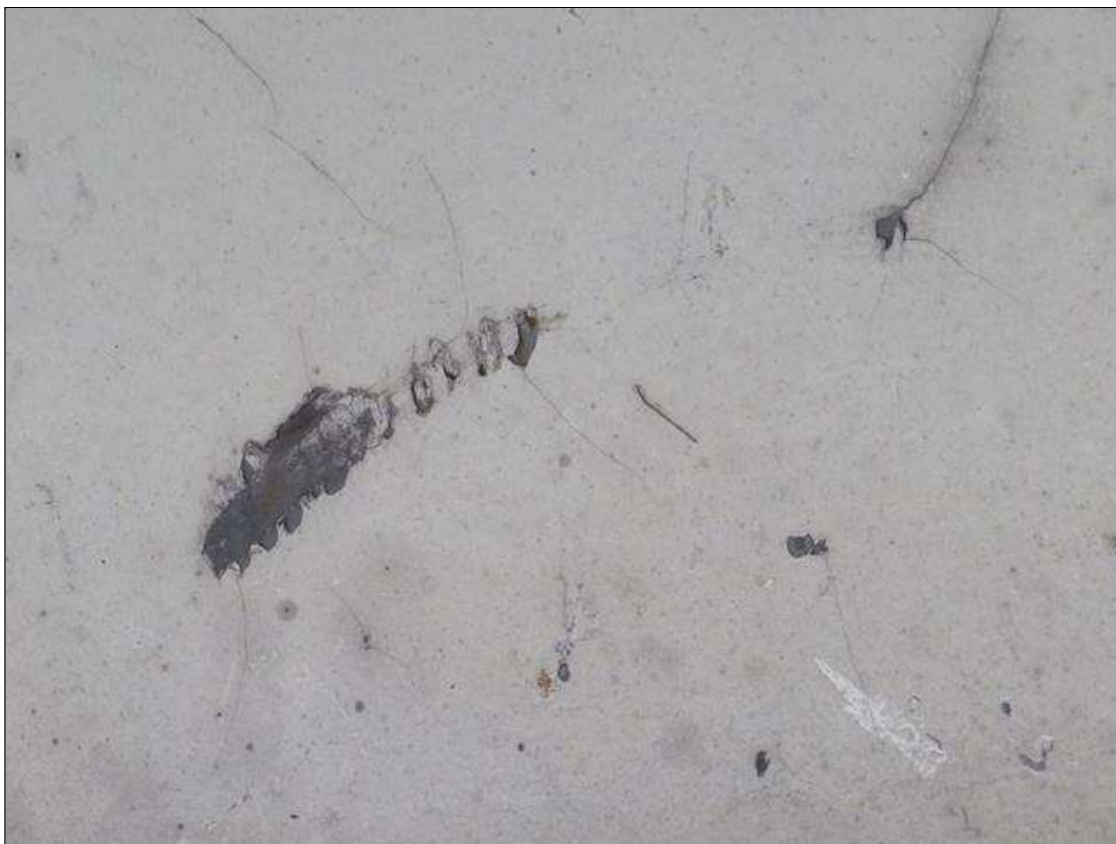
Span 3 Beam 2: SUPPLEMENTAL INSPECTION IMPACT DAMAGE 2022.: SCATTERED SCRAPES WEB OF BEAM 2 .

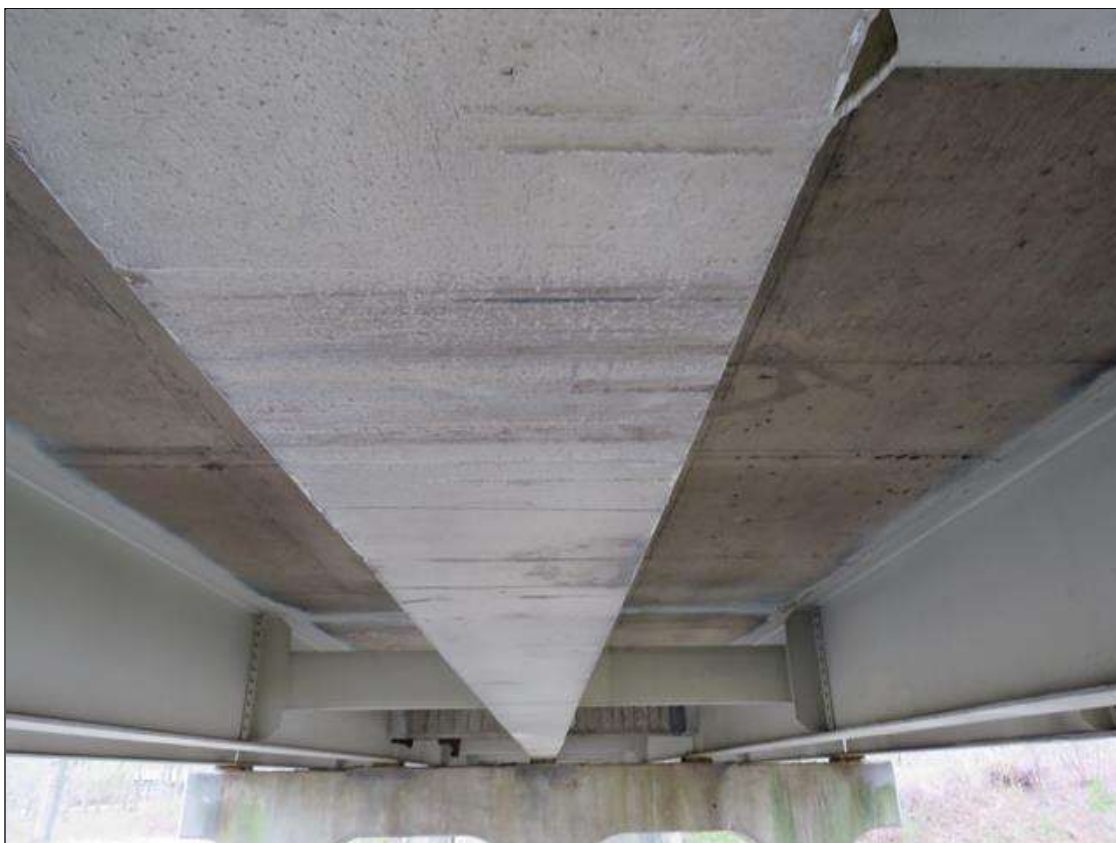
Span 3 Beam 3: SUPPLEMENTAL INSPECTION IMPACT DAMAGE 2022. : SCATTERED SCRAPES ALONG BOTTOM FLANGE OF BEAM 3

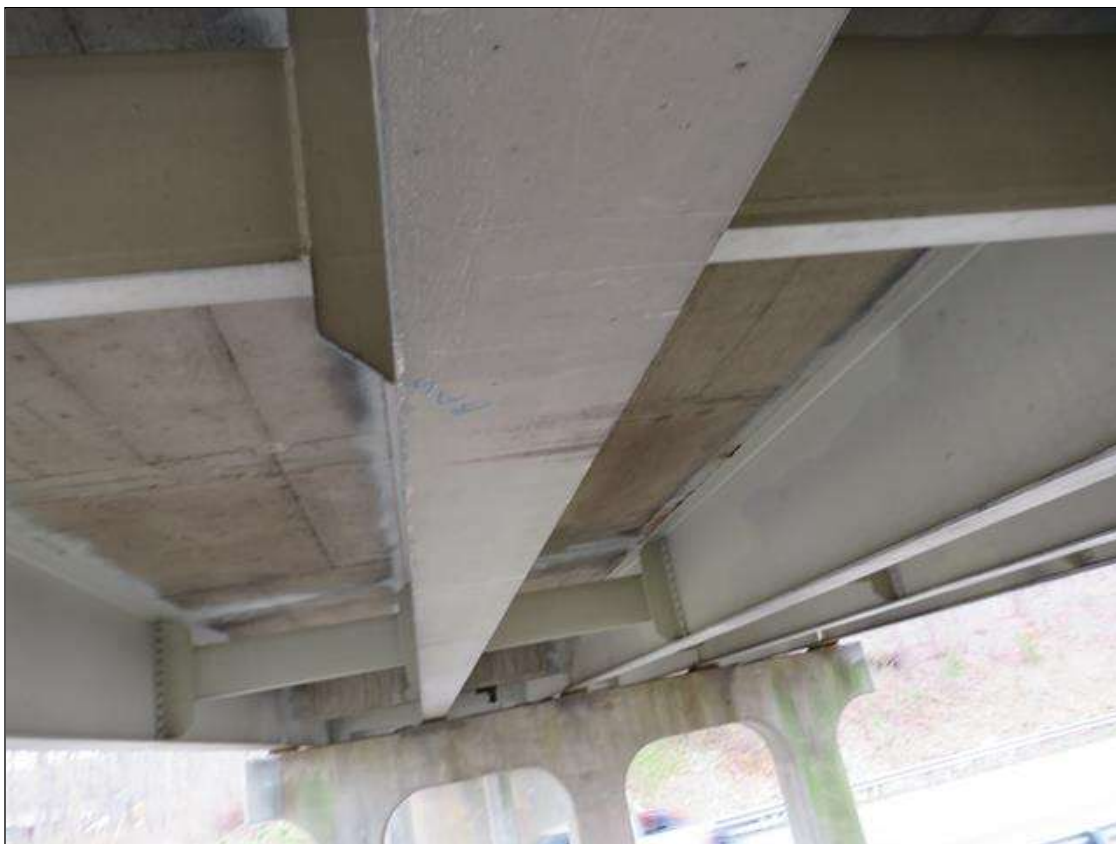
Span 3 Beam 4: bSUPPLEMENTAL INSPECTION IMPACT DAMAGE 2022.: Beam 4 Span 3 has scrapes to bottom flange at 16.75ft from bent 3 for a total length of 1ft

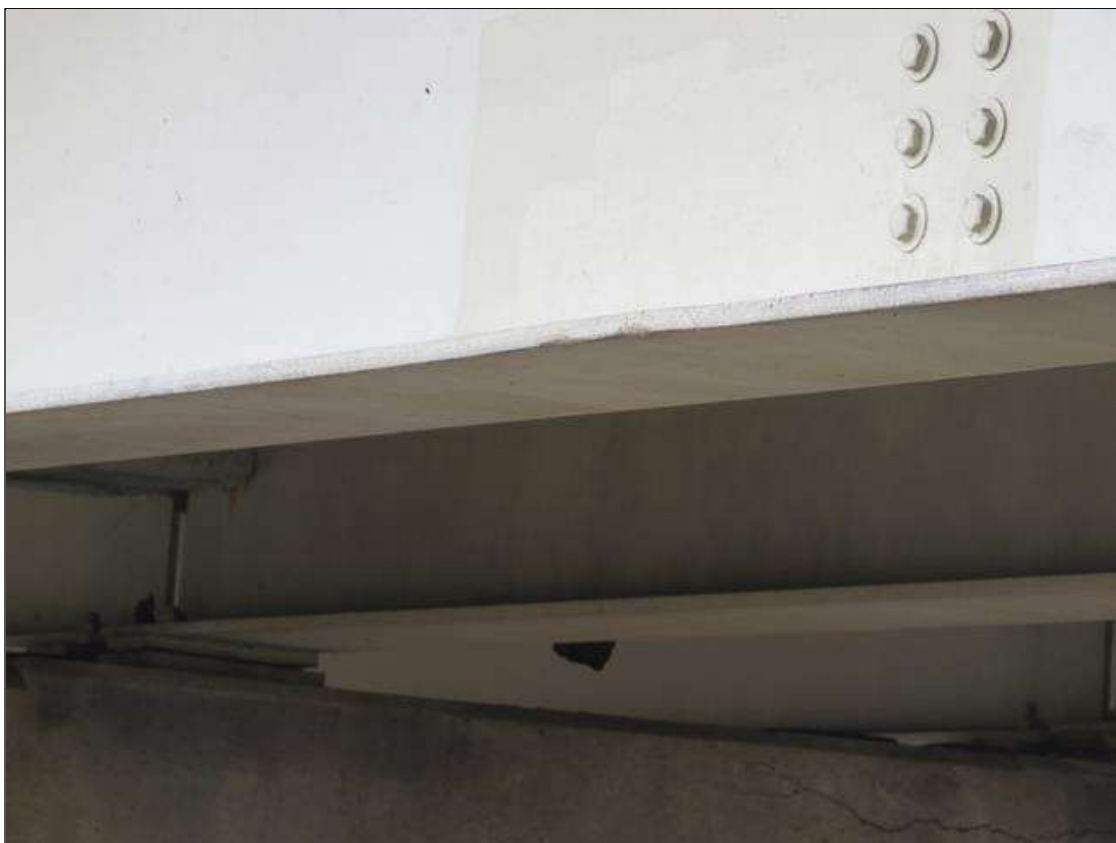
Span 3 Beam 5: SUPPLEMENTAL INSPECTION IMPACT DAMAGE 2022.: two 1/4in deep indentions in bottom flange of beam 5 span 3 at 16.5ft from bent 2 for a length of 1ft

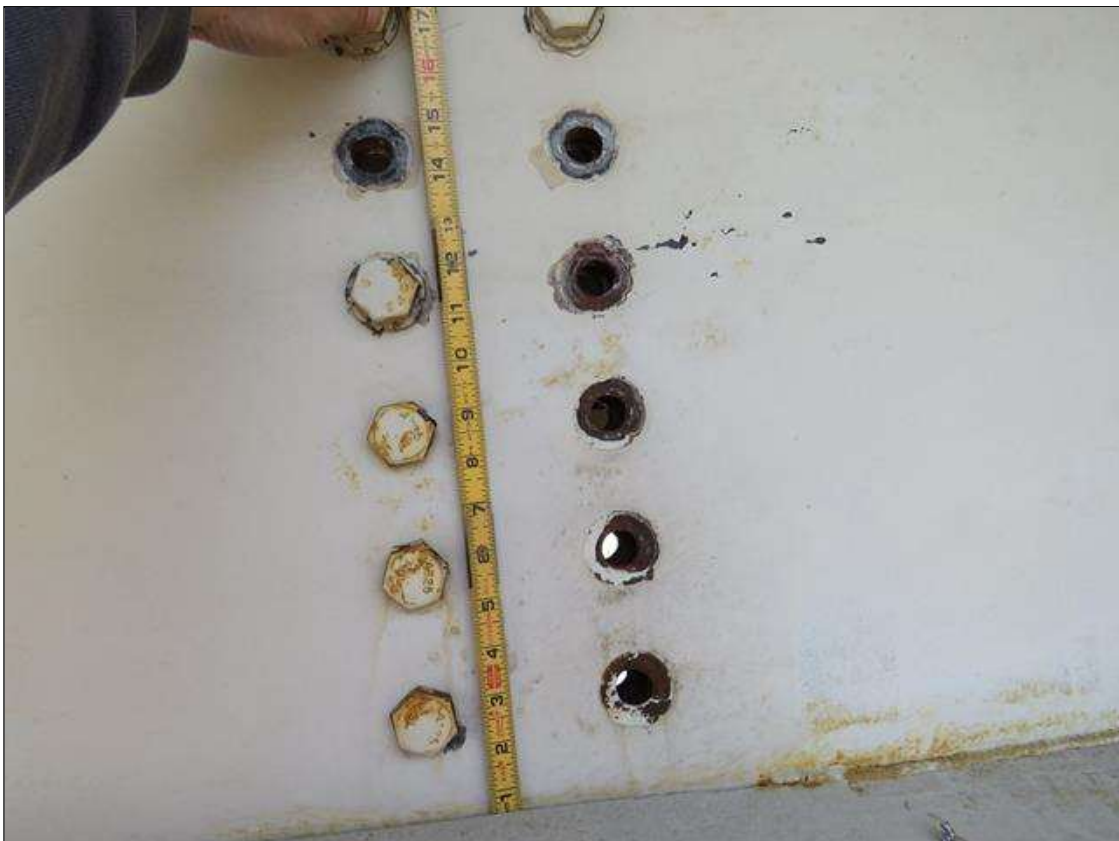
SPAN 3 DIAPHRAGM 2 BAY 1: 20 BOLTS WITH 6 MISSING ON BEAM 1, UP TO 1' HIGH CRACKING STRATING AT 1/32" WIDE AT TOP AND UP TO 1 1/8" AT BOTTOM OF DIAPHRAGM (PAR) .

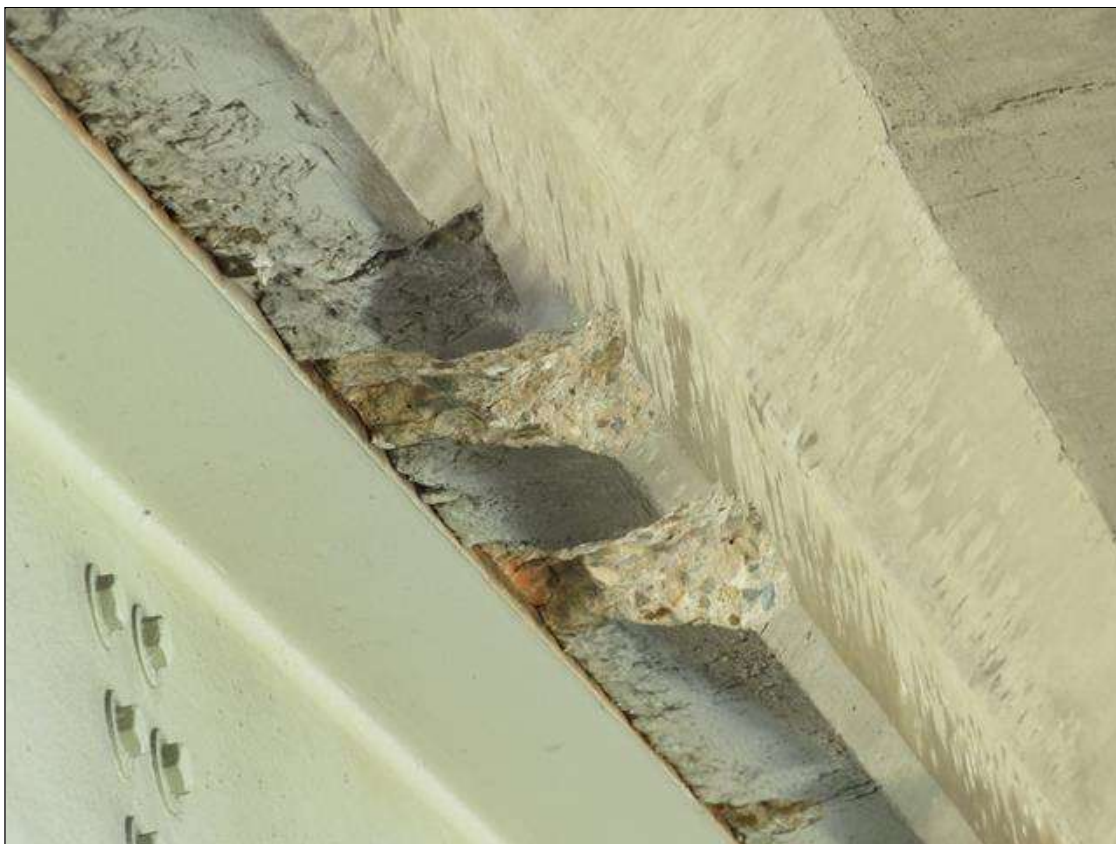
Span 3 Deck: SUPPLEMENTAL INSPECTION IMPACT DAMAGE 2022.surface spalling up to 1/2in deep, full length, underside of deck along both sides of beam 1.

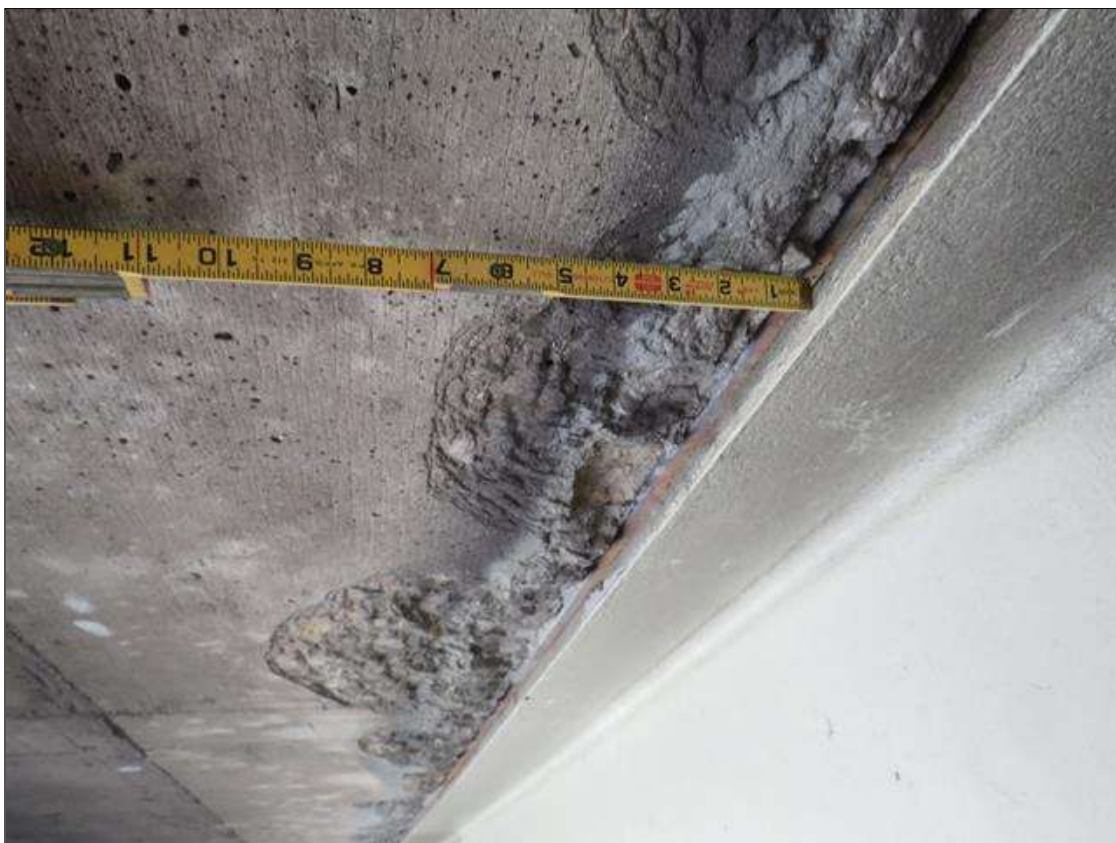
Span 3 Deck: SUPPLEMENTAL INSPECTION IMPACT DAMAGE 2022.surface spalling up to 1/2in deep, full length, underside of deck along both sides of beam 2.

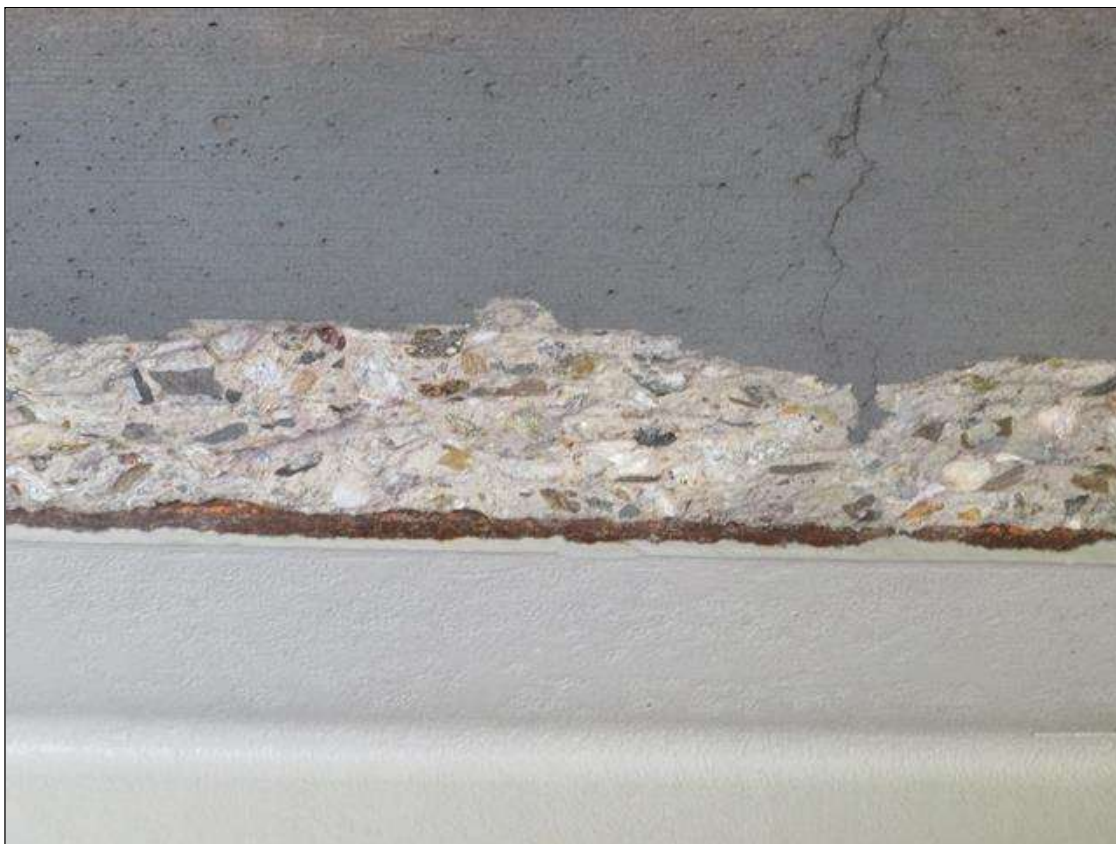
Span 3 Deck: SUPPLEMENTAL INSPECTION IMPACT DAMAGE 2022.: full length x up to 1/2in deep surface spalling, in underside of deck, along edges of beam 3.

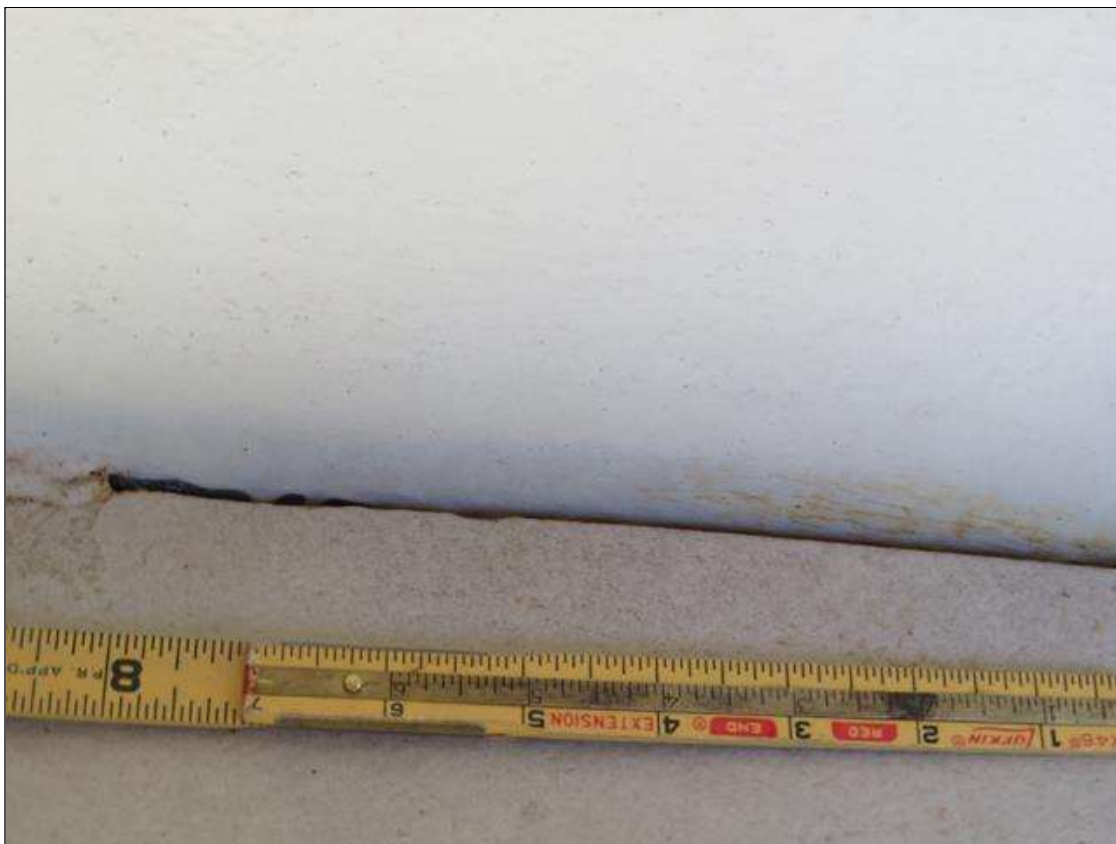
Span 3 Beam 1: SUPPLEMENTAL INSPECTION IMPACT DAMAGE 2022. Crack in weld of plate at TOP flange of beam 1 span 3 measured at 17ft from bent 3 for a length of 1ft

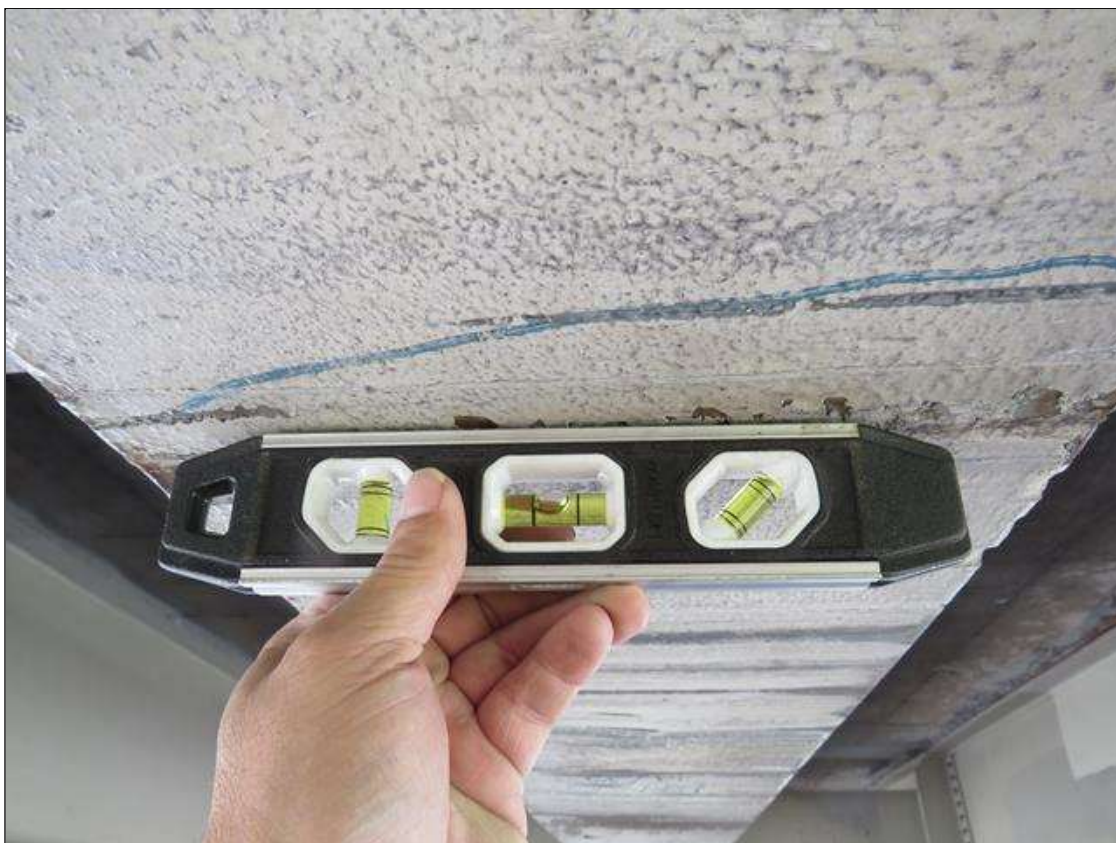
Span 3 Beam 2: SUPPLEMENTAL INSPECTION IMPACT DAMAGE 2022.: beam 2 span 3 deflected upward 1/2in at 19.5in from bent 2 for a length of 4ft, with scrapes on bottom flange . SCATTERED SCRAPES ALONG THE WEB .

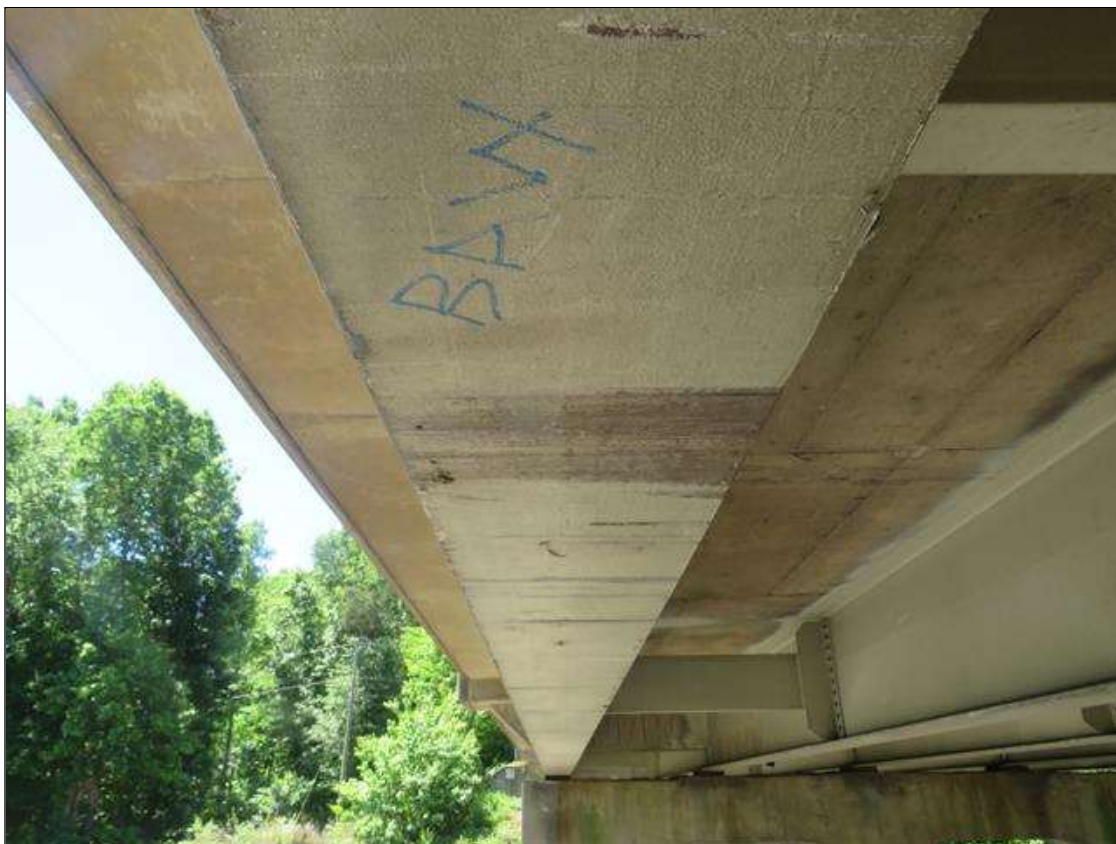
Span 3 Beam 5: SUPPLEMENTAL INSPECTION IMPACT DAMAGE 2022.: two 1/4in deep indentions in bottom flange of beam 5 span 3 at 16.5ft from bent 2 for a length of 1ft . SCATTERED SCRAPES

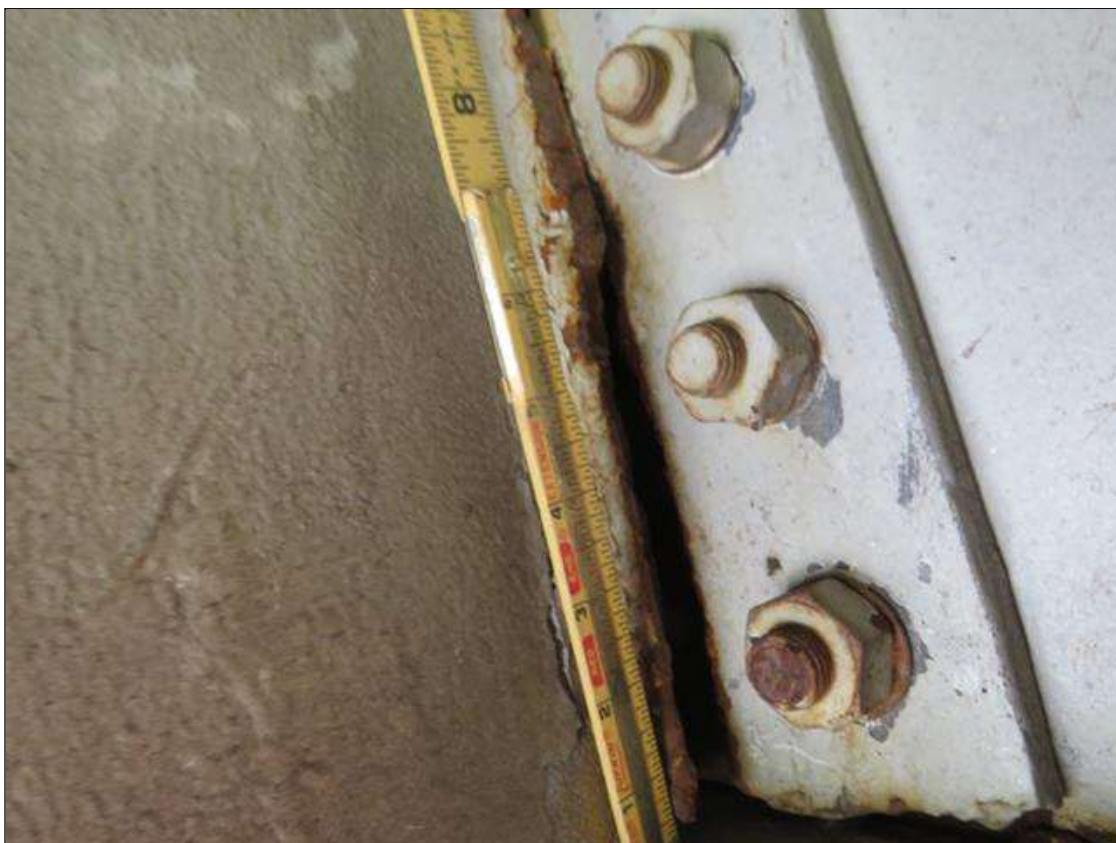
UP TO 1" WIDE CRACKING DIAPHRAGM 2 BAY 1

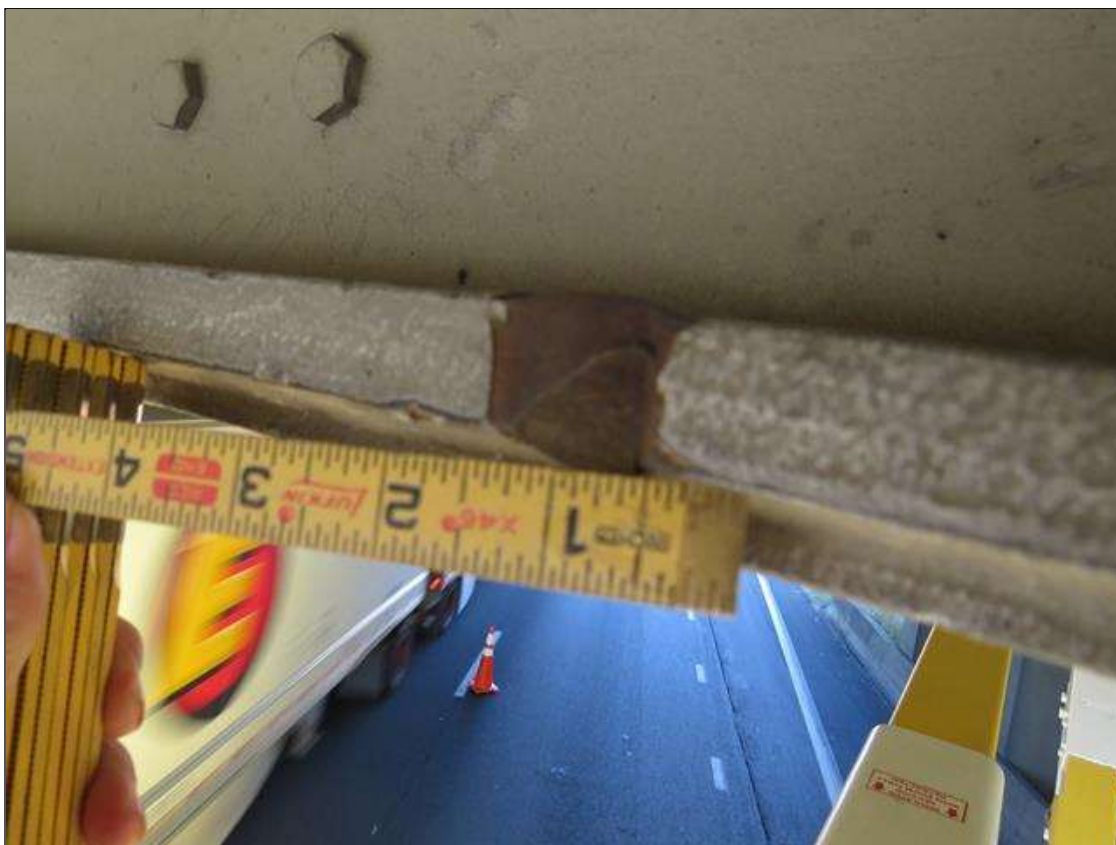
Span 3 Beam 9: SUPPLEMENTAL INSPECTION IMPACT DAMAGE 2021: 1 indentation 1" long x 1/4" deep at 18'-7" from int. bent 3

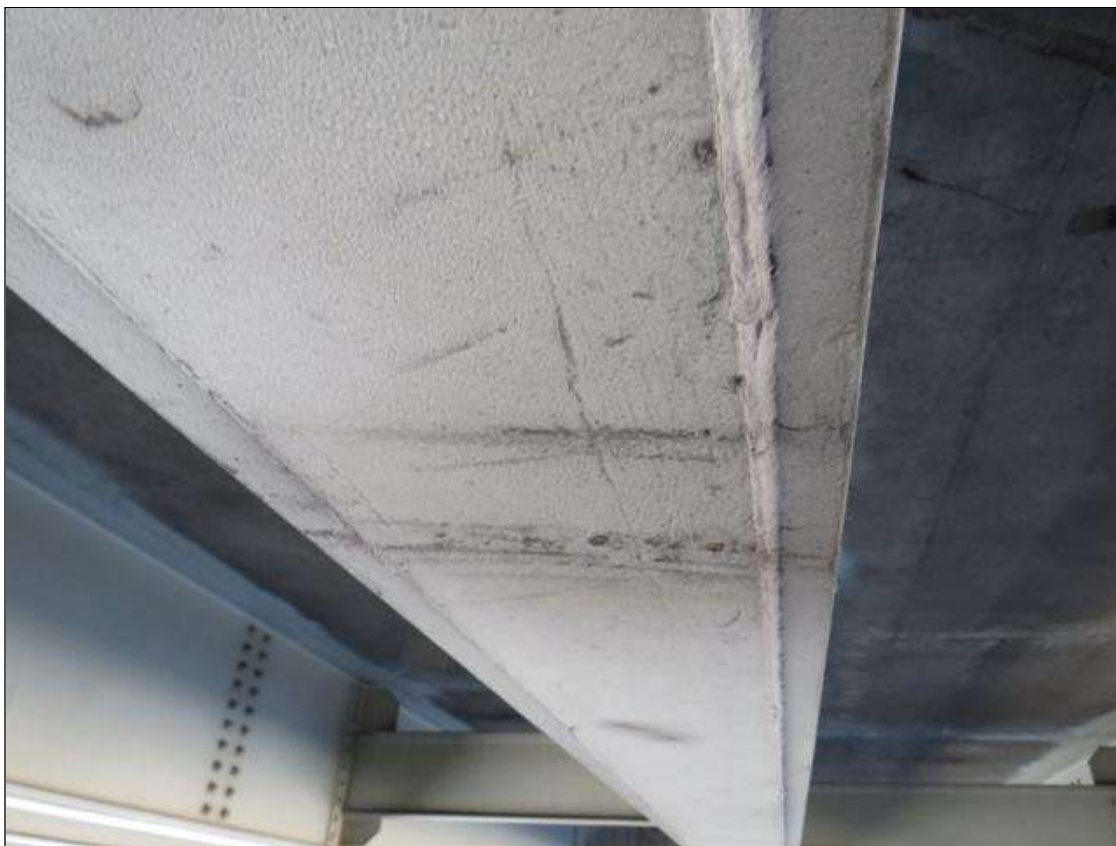
Span 3 Beam 4: SUPPLEMENTAL INSPECTION IMPACT DAMAGE 2021: scattered scrapes

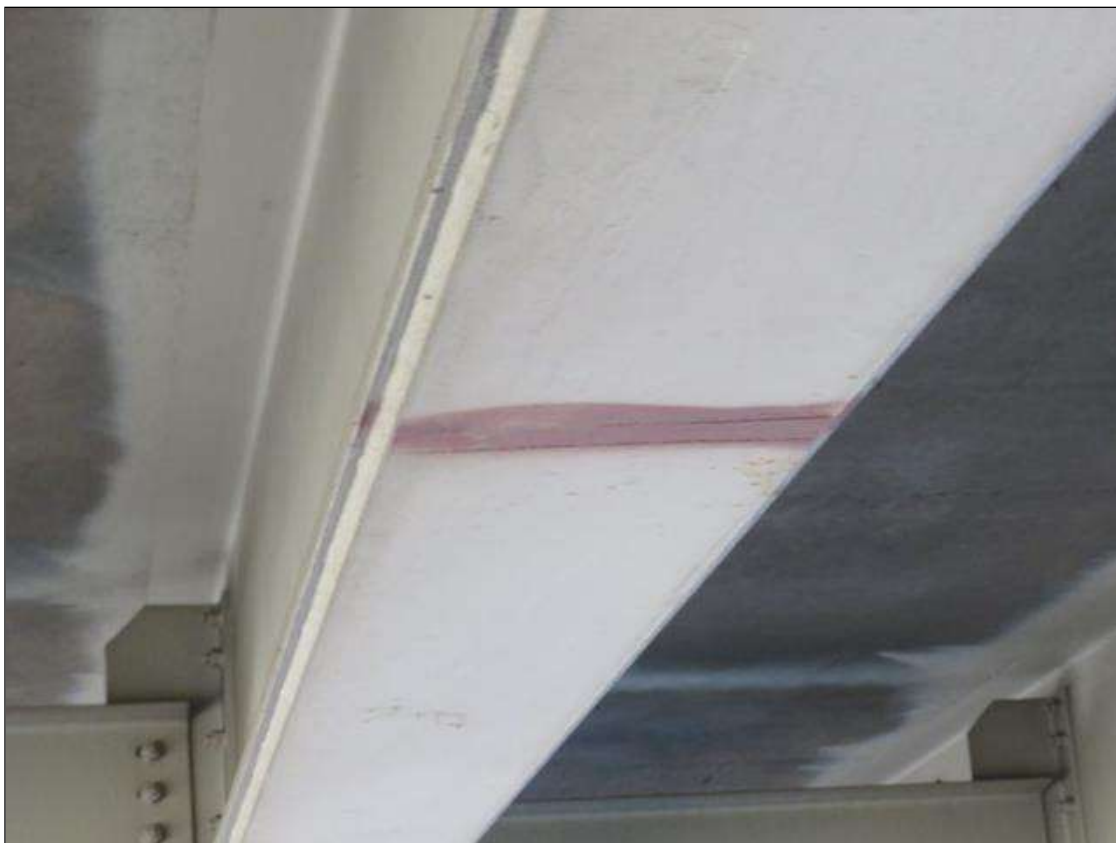
Span 3 Beam 3: SUPPLEMENTAL INSPECTION IMPACT DAMAGE 2021 :scattered scrapes

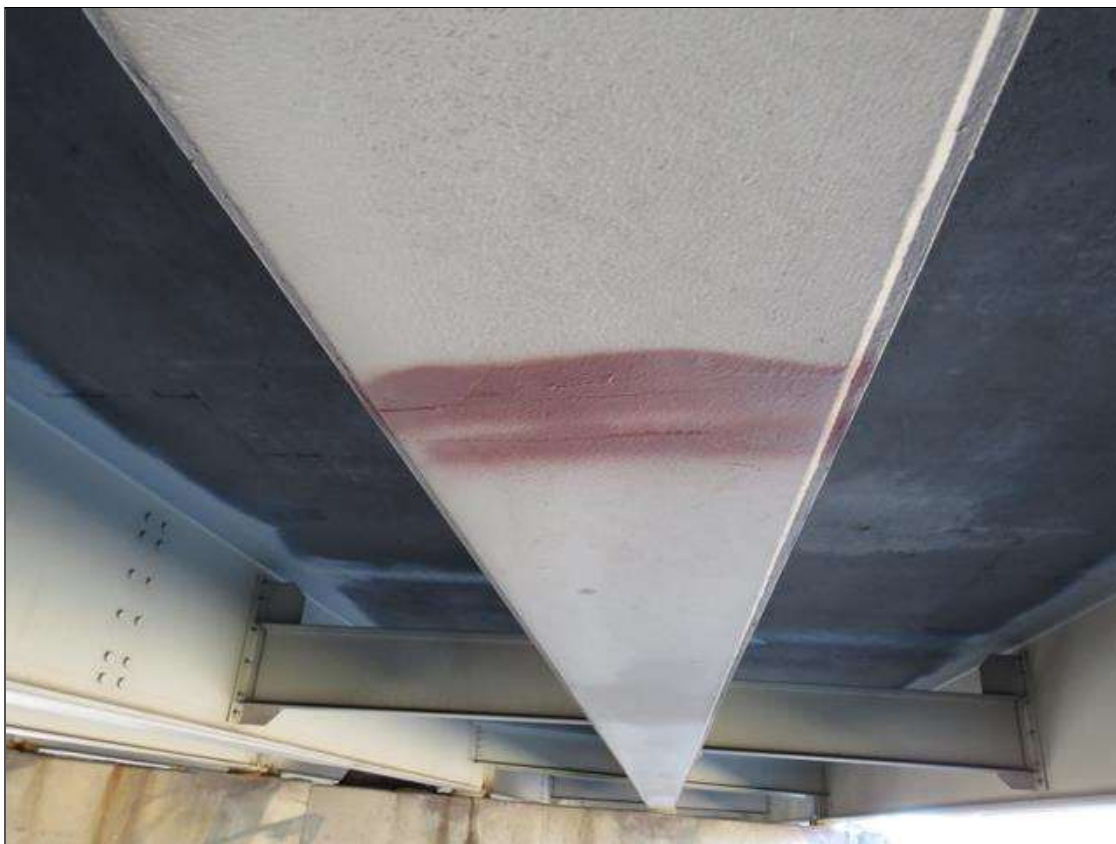
Span 3 Beam 2: SUPPLEMENTAL INSPECTION IMPACT DAMAGE 2021 :scattered scrapes

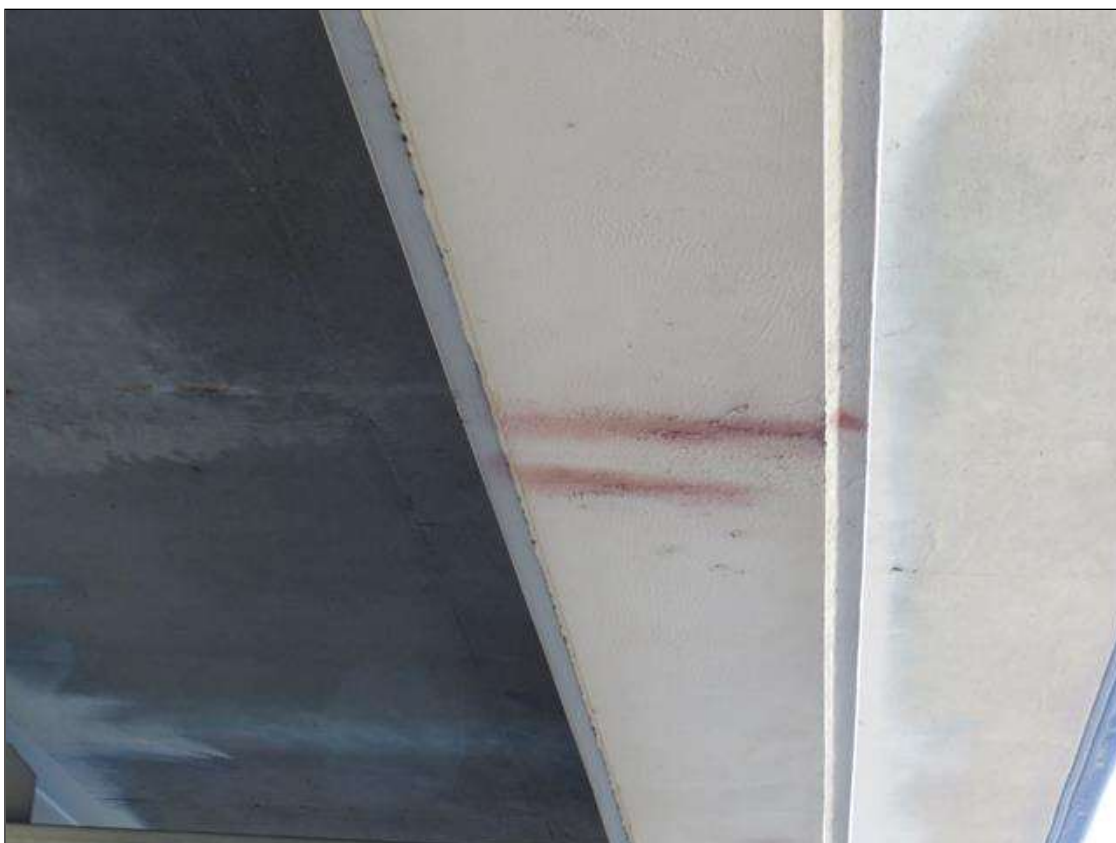
Span 3 Beam 1: SUPPLEMENTAL INSPECTION IMPACT DAMAGE 2021 :scattered scrapes

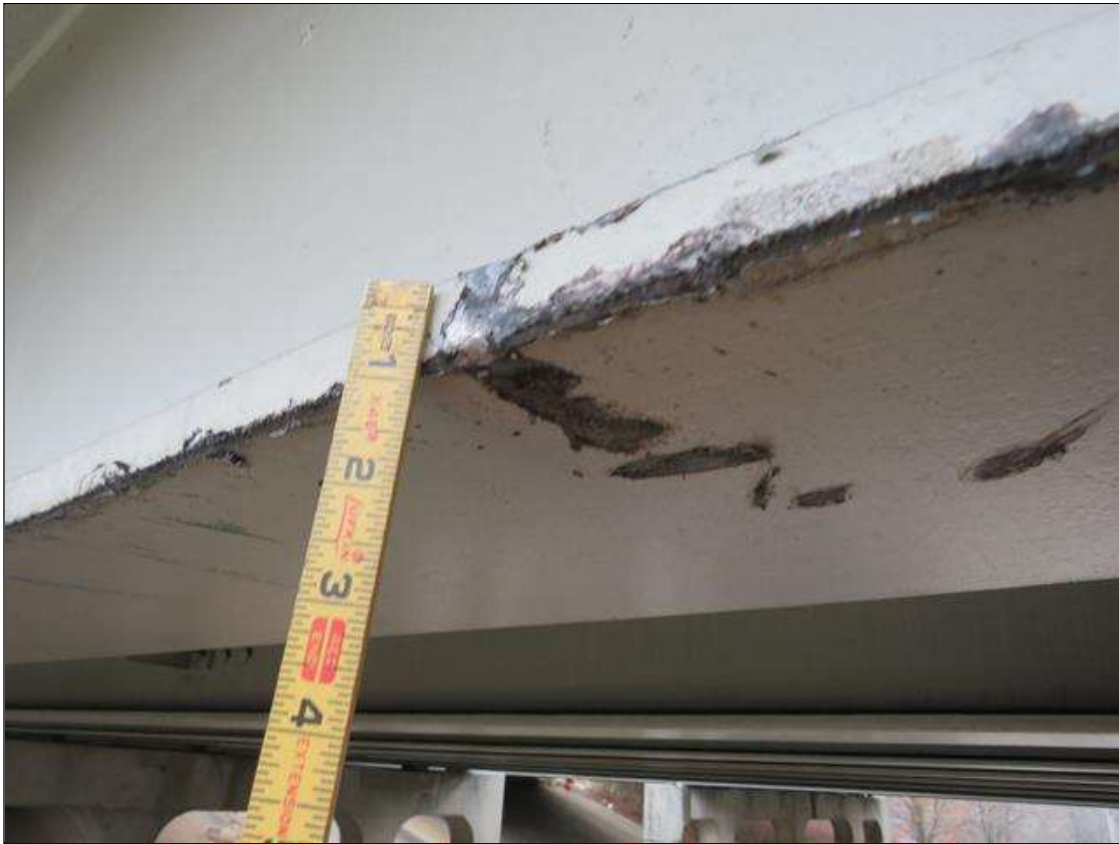
Span 2 Beam 1: SUPPLEMENTAL INSPECTION IMPACT DAMAGE 2022: SPAN 2 BEAM 1 ,BEAM SWEEP SOUTHWARD UP TO 3" X 25' LONG . (POI)8' OUT FROM INT. BENT 1 WITH A LENGTH OF 10' . 1 INDENTION 1/8" DEEP X 3" LONG AT 10' OUT FROM INT. BENT 1. WITH 2 OTHER INDENTIONS AT 16'-7" OUT FROM INT. BENT 1 , 22" LONG 1/4" WIDE X 1/16" DEEP AND 1/2" LONG X 1/4" DEEP . BOTTOM FLANGE OF BEAM BOWED UPWARD 1/2" . ANCHOR BOLT 1 LEFT SIDE BEAM 1 BENT WESTWARD . SCATTERED SCRAPES BEAM 1 BOTTOM FLANGE . (PAR)

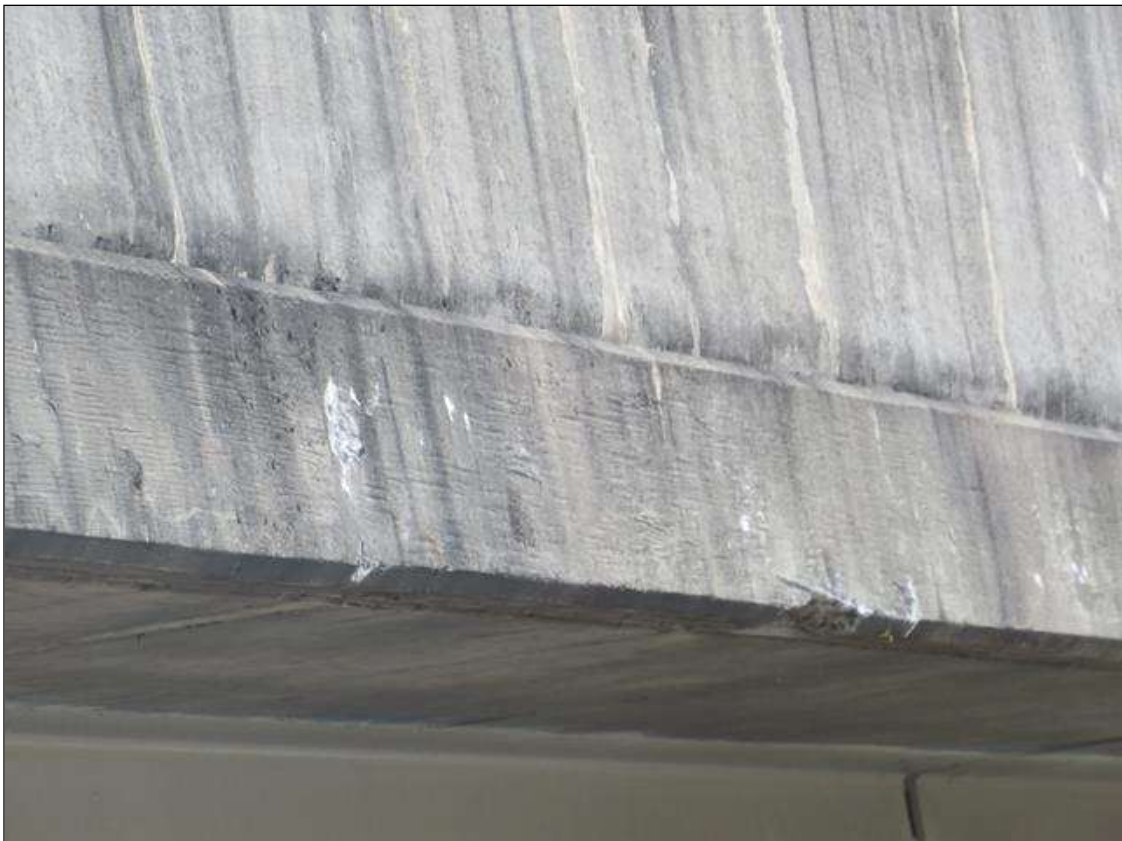
Span 2 LEFT RAIL SCATTERED INDENTIONS BOTTOM

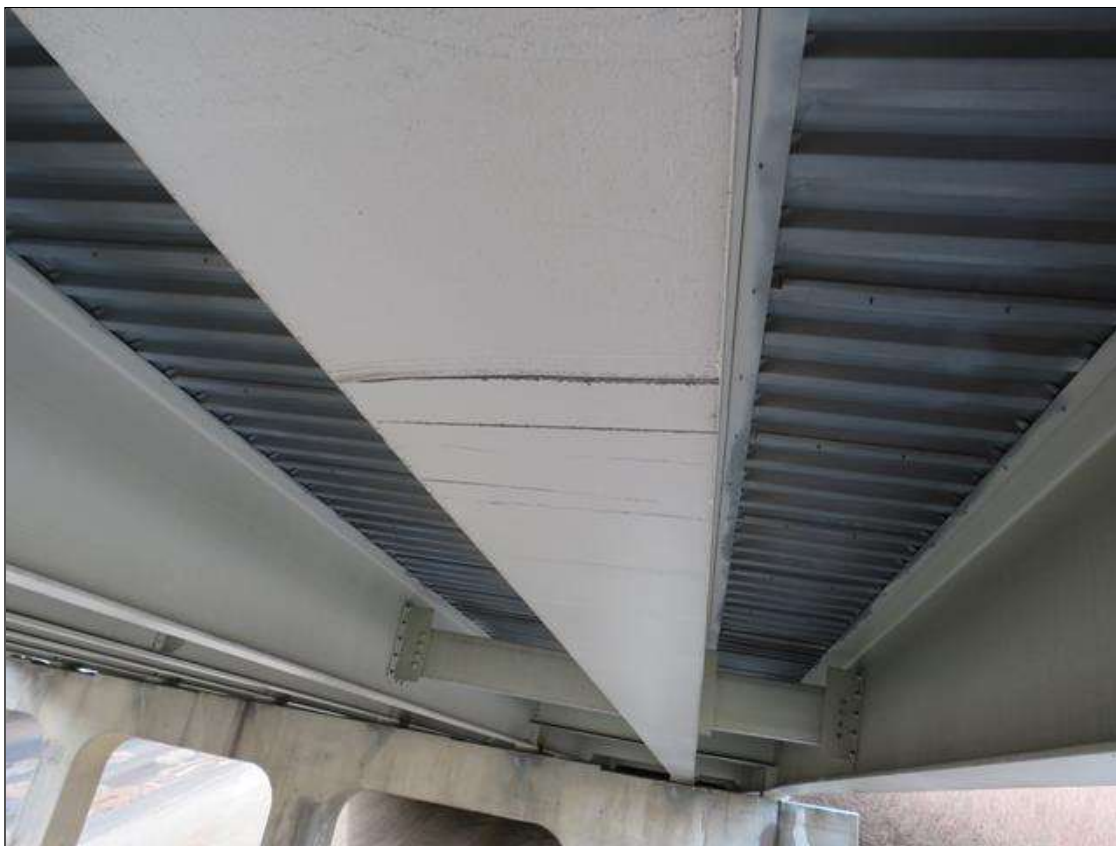
Span 2 Left Bridge Rail: 2022 SUPPLEMENTAL INSPECTION SCATTERED SCRAPES ON BEAM 2

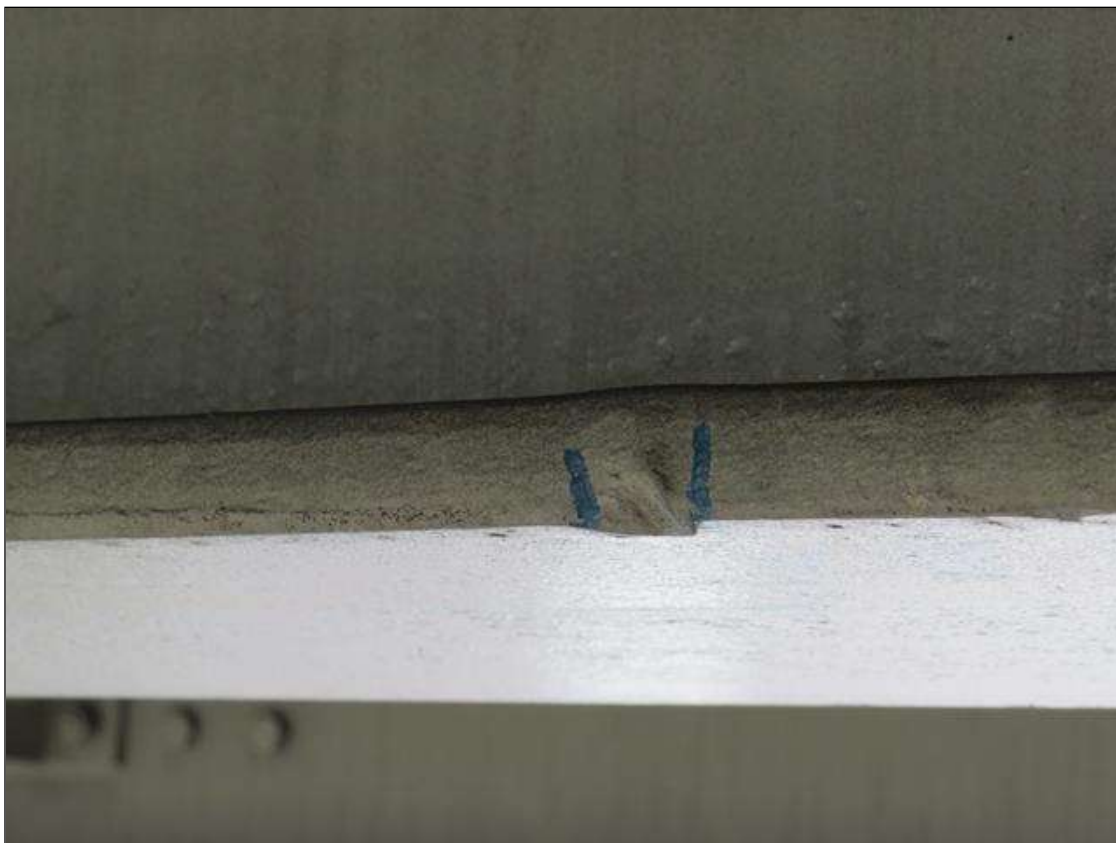
Span 2 Beam 2: 2022 OLD INDENTIONS BEAM 4

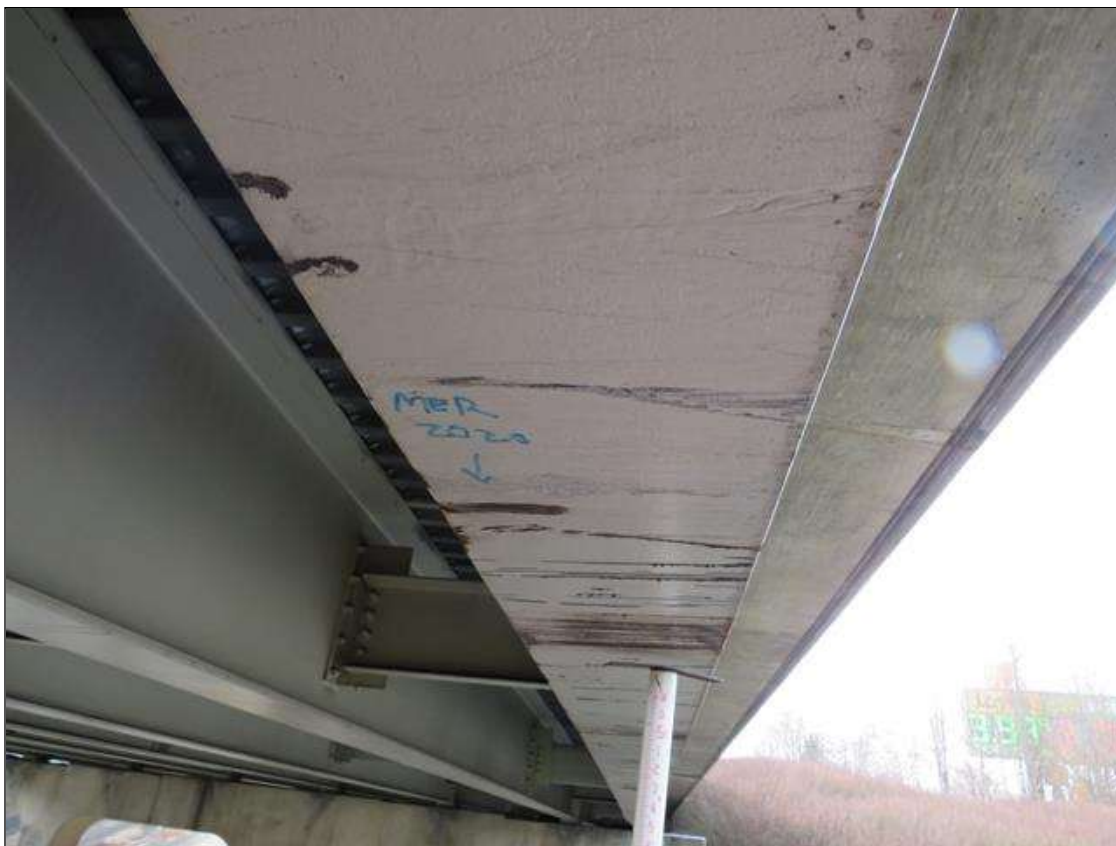
Span 2 Beam 1: SCATTERED SCRAPES
