NC DEPARTMENT OF TRANSPORTATION
 DIVISION OF HIGHWAYS
 STRUCTURE MANAGEMENT UNIT

Structure Safety Report

Supplemental Element Inspection

DIVISION: 13 COUNTY: BUNCOMBE STRUCTURE NUMBER: 100387 FREQUENCY: None

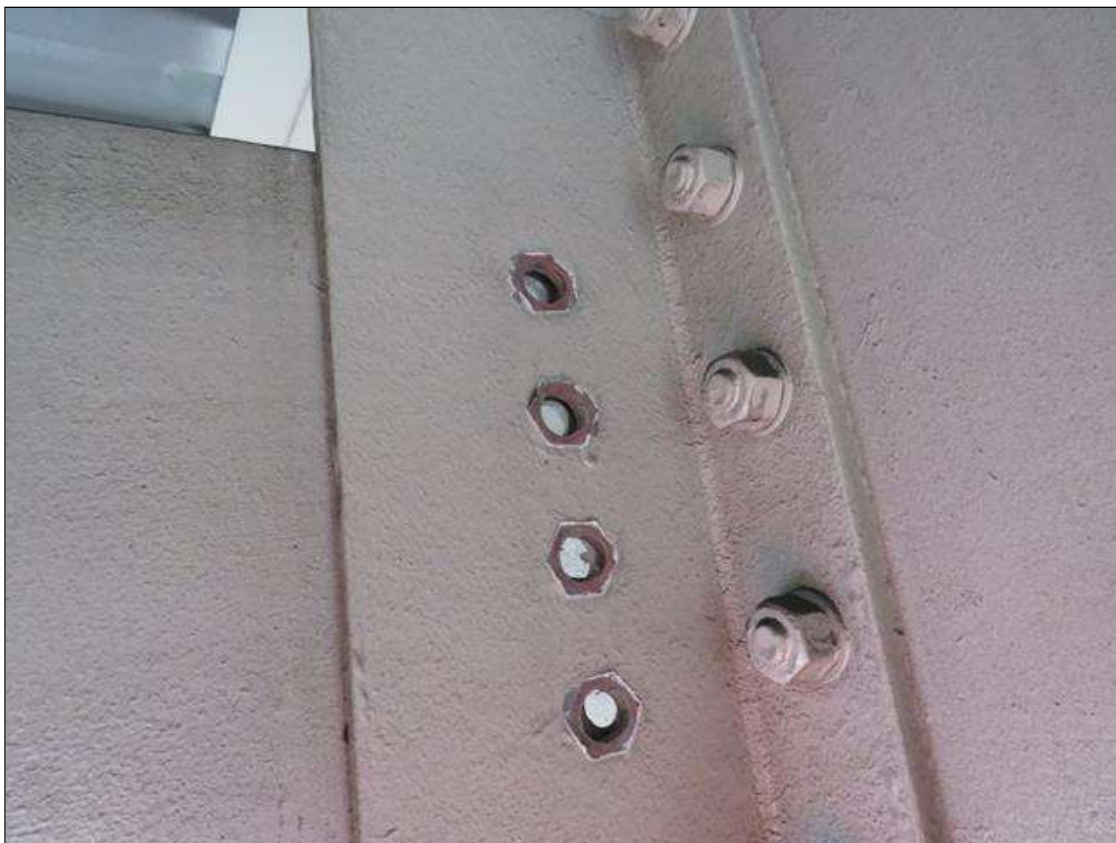
SPAN 2 BAY 1 DIAPHRAM 2 ALL 4 BOLTS MISSING AT DIAPHRAM ATTACHMENT TO BEAM 1 (PAR)

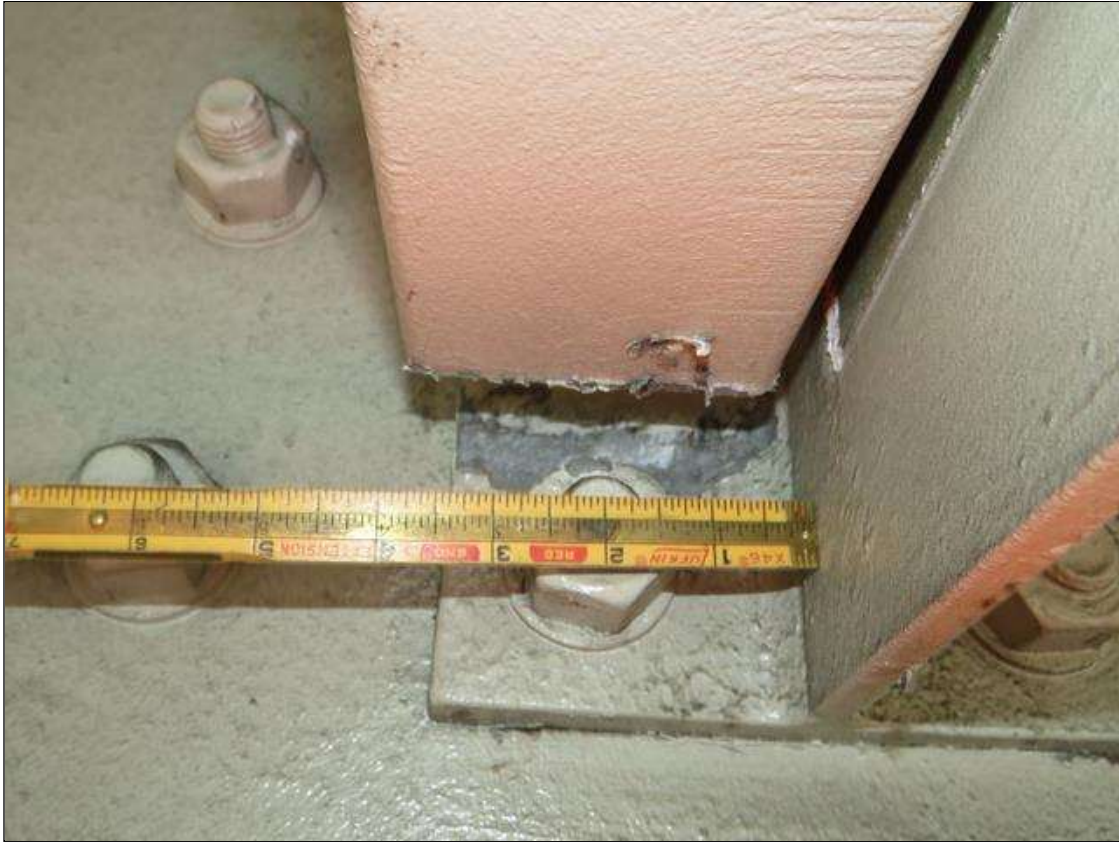
SPAN 2 BAY 1 BOTTOM LOWER BASE PLATE WELD BROKEN LOOSE FROM BEAM 1 DIAPHRAM 2 , 3 3/4" LONG X 1/16" DEEP AT 3" UP FROM BOTTOM OF PLATE .(PAR)
