NC DEPARTMENT OF TRANSPORTATION
 DIVISION OF HIGHWAYS
 BRIDGE MANAGEMENT UNIT

BRIDGE INSPECTION REPORT

COUNTY SAMPSON BRIDGE NUMBER 810233 INSPECTION CYCLE 2 YRS
 ROUTE SR1742 ACROSS SIX RUN CREEK M.P. 0

INSPECTION DATE 07/22/2010 OPERATING RATING H8-01

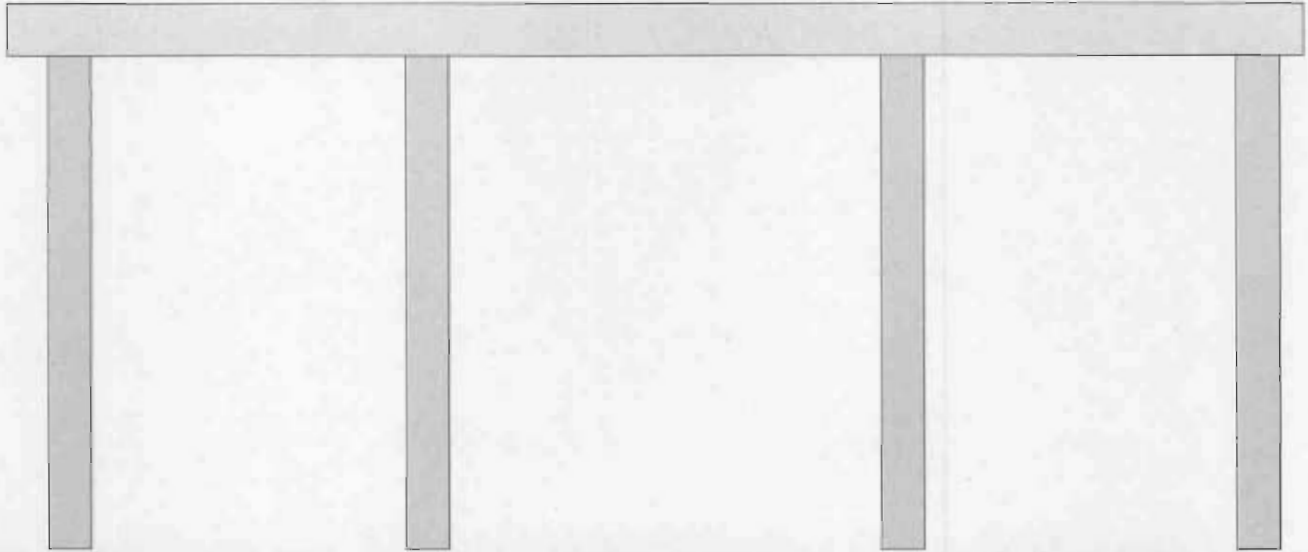
Title END BENT 1 CRUTCH	Description END BENT 1 CRUTCH
Bridge No: 810233	Drawn By: WCM
Date: 7/21/2010	File Name: S0014003911

35a	6	<p>TIMBER CAPS 6 END BENT CAPS ARE ROLLED 1/2 IN TOWARD THE BACKFILL AND NOT BEARING COMPLETELY ON PILES. END BENT 2 CROWNSTRIIP IS DECAYED UNDER JOIST 1 TO JOIST 4 UP TO 8 IN DEEP. STEEL CRUTCH BENTS HAVE BEEN PLACE AT END BENTS. (SEE DRAWINGS)</p>

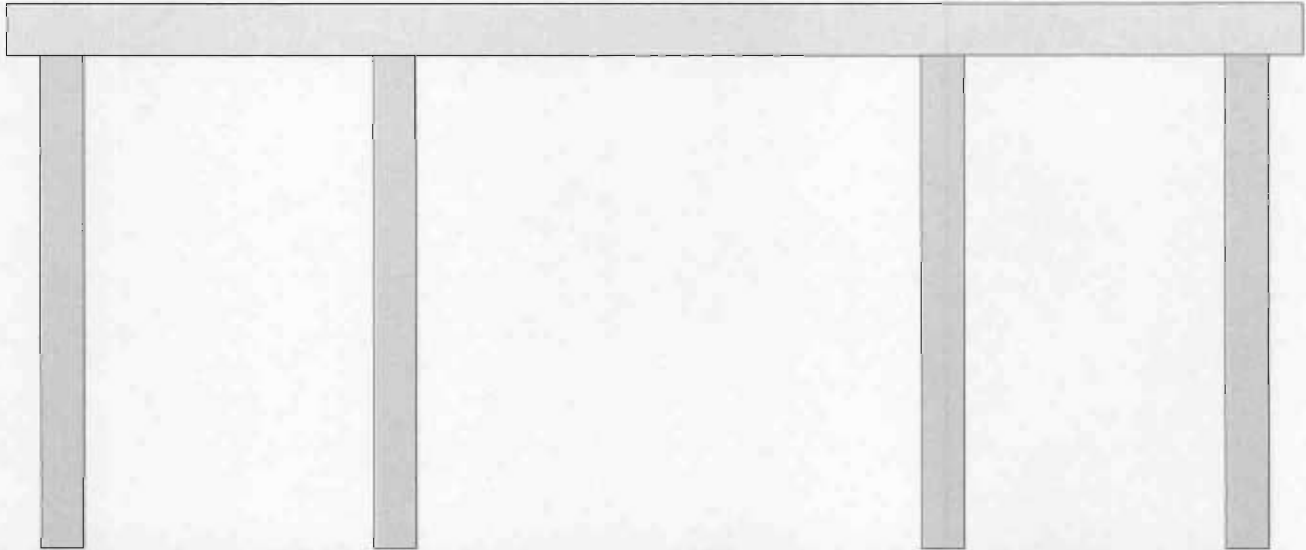
Title END BENT 2 CRUTCH	Description END BENT 2 CRUTCH
Bridge No: 810233	Drawn By: WCM
Date: 7/21/2010	File Name: S0014003912

3304	Maintain/Replace Timber Superstructure Components	LF	2 TSC 8/17/10	JOIST 17 SPAN 2 NOT BEARING ON END BENT 2 CRUTCH BENT. JOIST 18 SPAN 2 NOT BEARING ON END BENT 2 CRUTCH BENT.

MMS Code	MMS Description	Quantity
3304	Maintain/Replace Timber Superstructure Components	2 LF
Location:		
Beams and Girders	Bent/Span No. 2	JOIST 17
Priority Level	Status	
Priority Maintenance	SIA Updates in Process	
Submitted Date:	Submitted By:	Assisted By:
07/22/2010	WILLIS C MAY	WAYNE T WILKINSON
Details		
JOIST 17 SPAN 2 NOT BEARING ON END BENT 2 CRUTCH BENT. JOIST 18 SPAN 2 NOT BEARING ON END BENT 2 CRUTCH BENT.

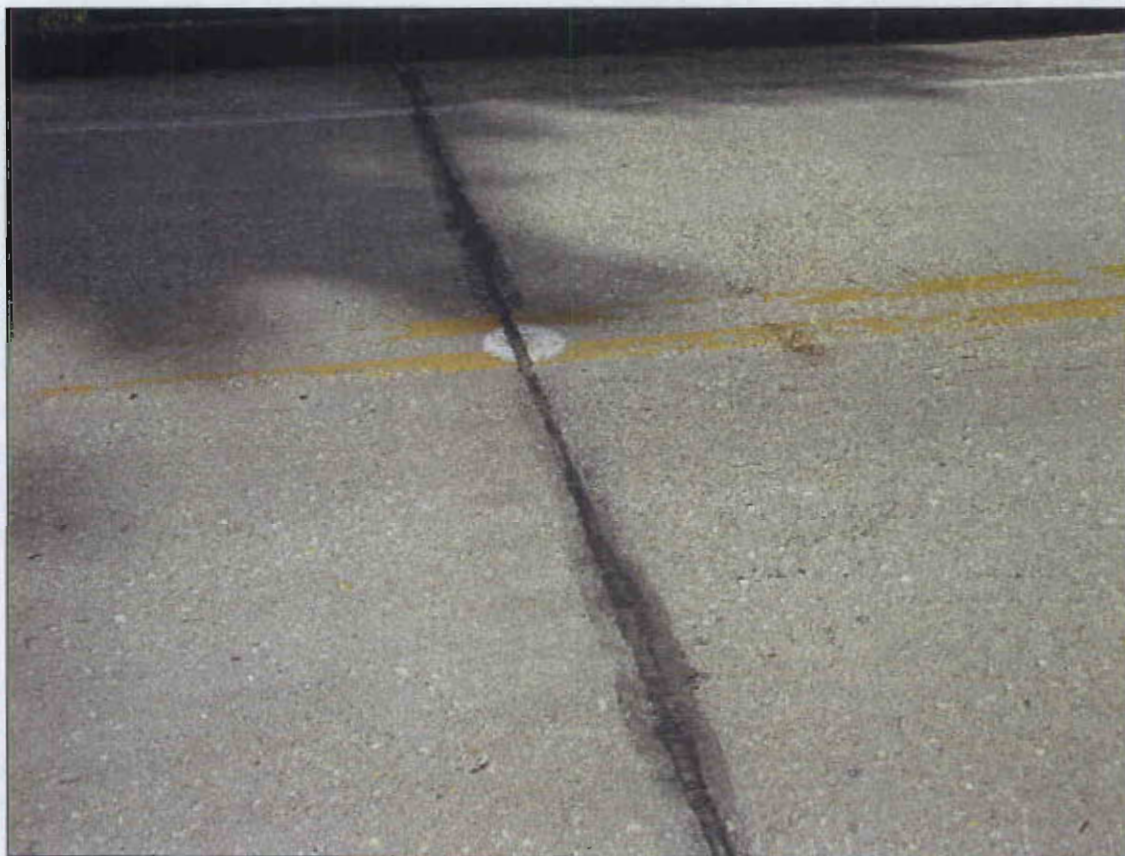
JOINT AT INTERIOR BENT
