NC DEPARTMENT OF TRANSPORTATION
 DIVISION OF HIGHWAYS
 STRUCTURE MANAGEMENT UNIT

Structure Safety Report

Routine Element Inspection - Contract

COUNTY: HALIFAX STRUCTURE NUMBER: 410198 FREQUENCY: 24 MONTHS

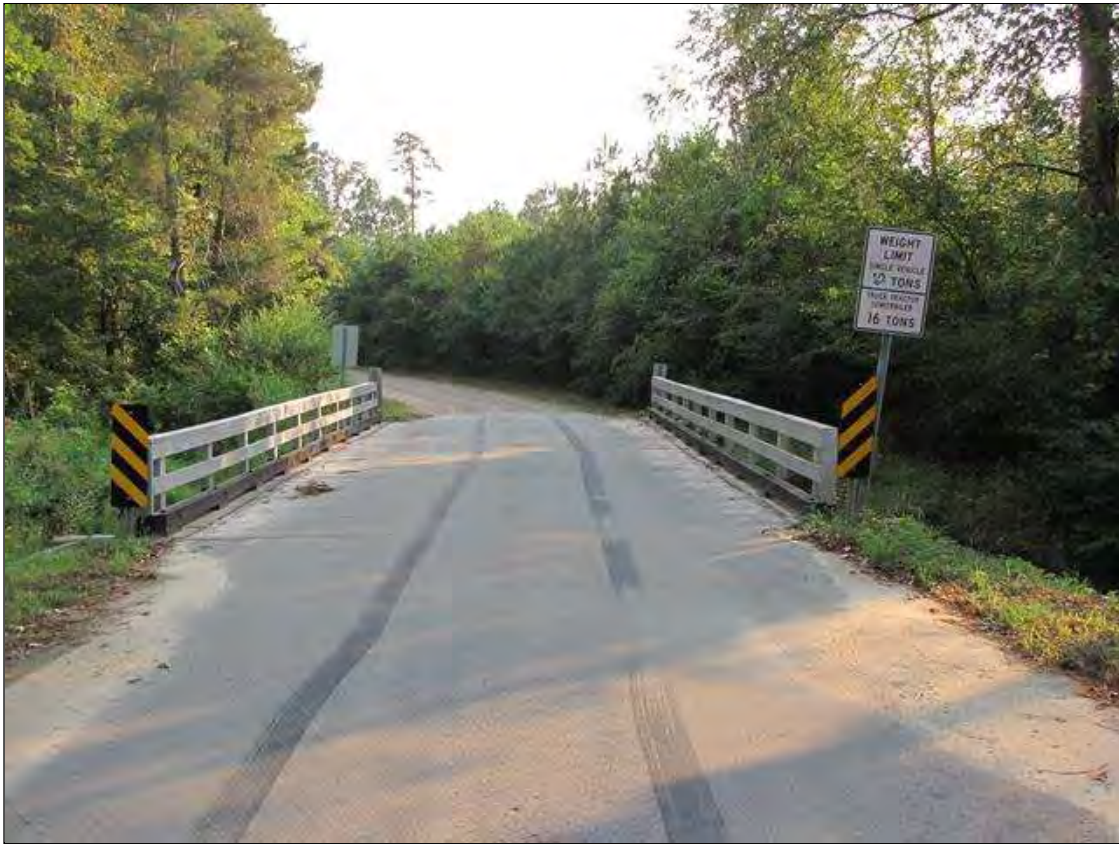
LOOKING NORTH

330 Square Feet of Crack (Wearing Surface) (CS3): TRANSVERSE REFLECTIVE CRACKS UP TO 1/4" WIDE THROUGHOUT WEARING SURFACE.

Span 1 Wearing Surface: TRANSVERSE REFLECTIVE CRACKS UP TO 1/4" WIDE THROUGHOUT WEARING SURFACE.

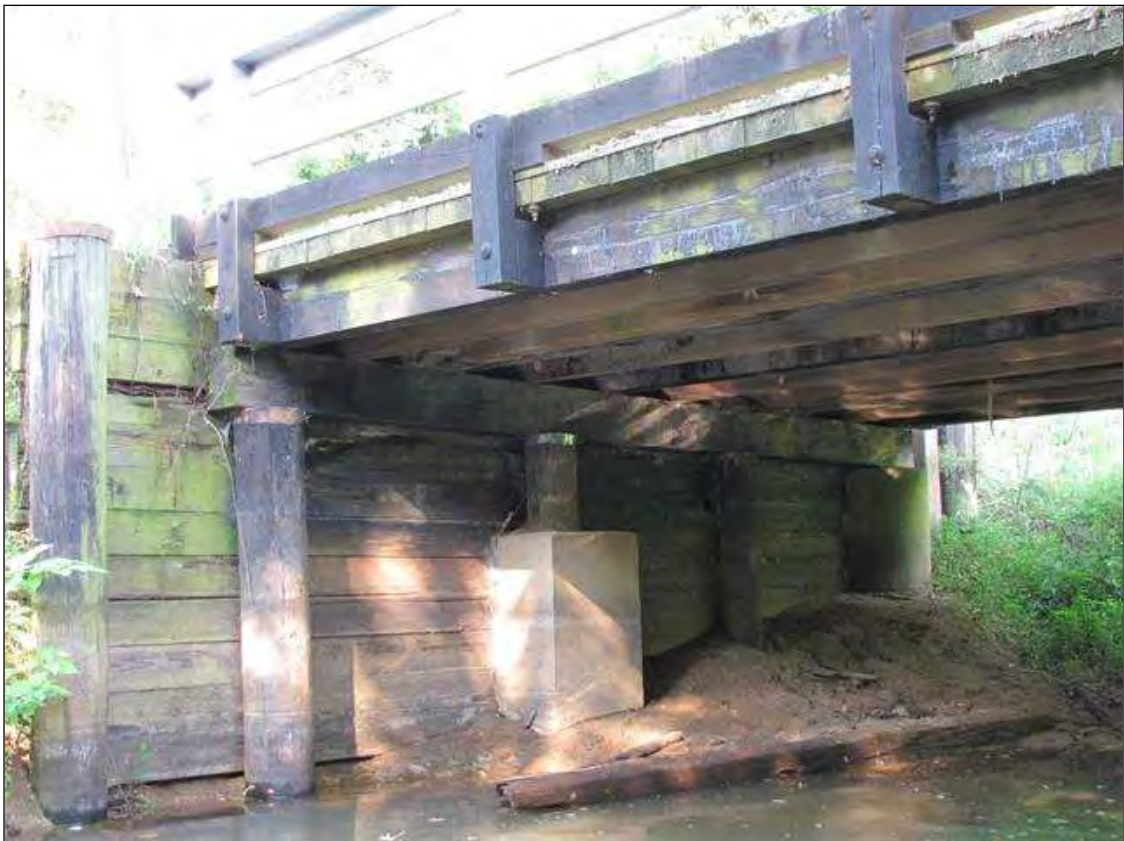
END BENT 1 PROFILE

5 Feet of Decay/Section Loss (CS3): 5 FT X 1 FT AREA OF DECAY IN RIGHT END.
8 Feet of Scour (CS2): 8 FT OF UNDERMINING AT RIGHT SIDE.

End Bent 1 Abutment/Backwall : 5 FT X 1 FT AREA OF DECAY IN RIGHT END.

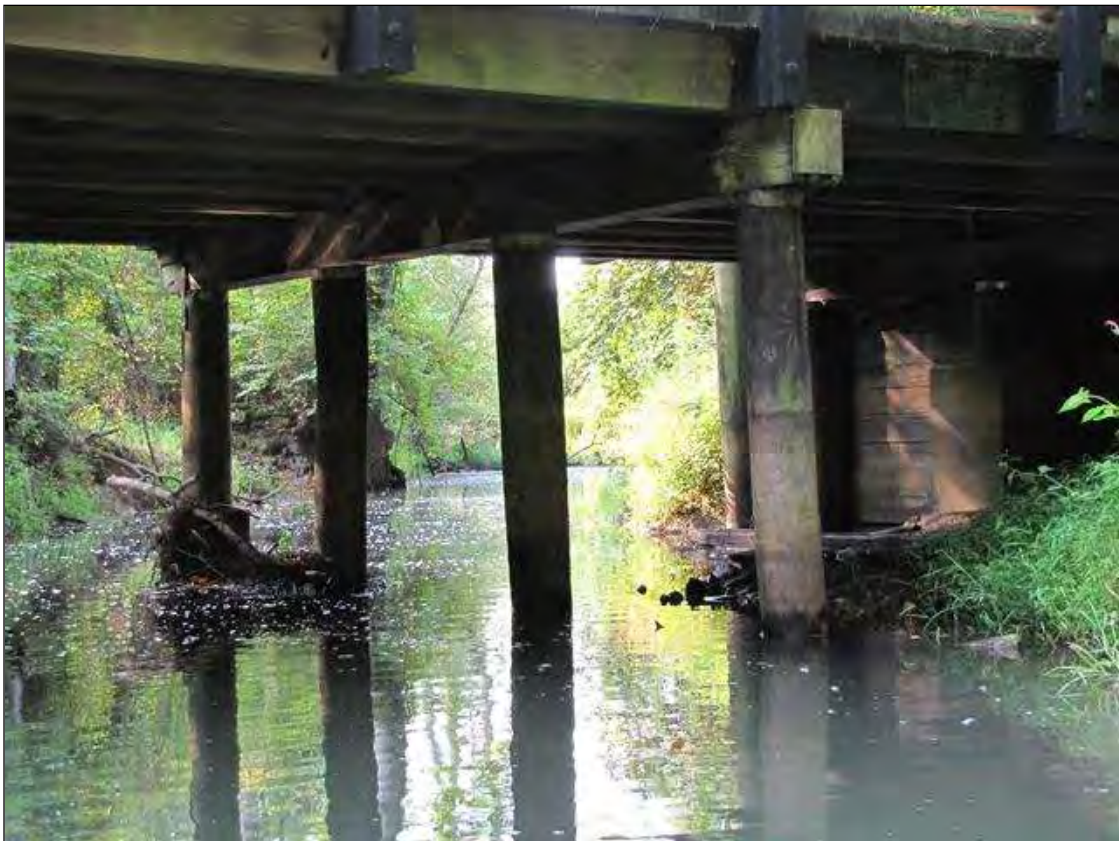
BENT 1 PROFILE

CONCRETE COLLAR AT PILE 4 BENT 1. COLLAR HAS CRACK ON WEST FACE.

Bent 1 Pile 4: CONCRETE COLLAR IS CRACKED ON WEST FACE.

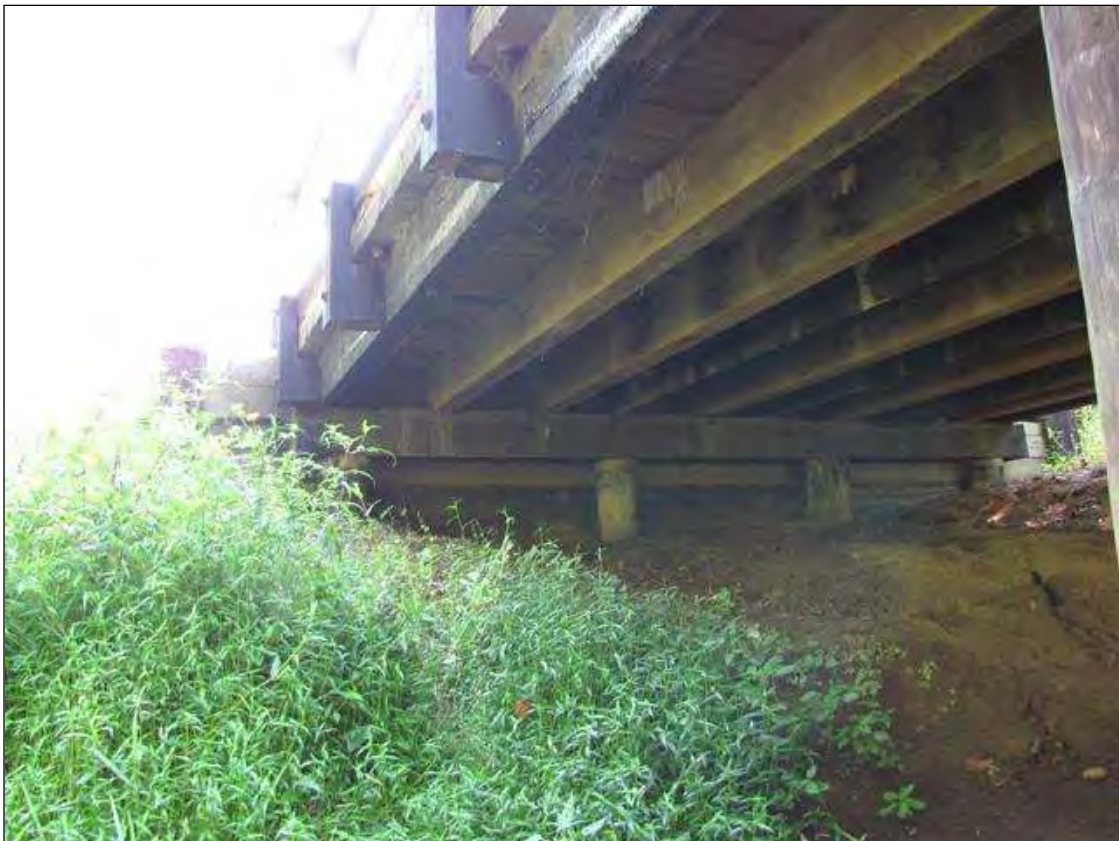
END BENT 2 PROFILE

6 Feet of Decay/Section Loss (CS3): 6 FT X 2 FT AREA OF DECAY AT LEFT SIDE AT PILE 1.

End Bent 2 Abutment/Backwall : 6 FT X 2 FT AREA OF DECAY AT LEFT SIDE AT PILE 1.
