NC DEPARTMENT OF TRANSPORTATION
 DIVISION OF HIGHWAYS
 BRIDGE MANAGEMENT UNIT

PRIORITY MAINTENANCE - RUST AND CORROSION
 WITH SECTION LOSS ON BEAMS 1, 2, 9 AND 10

BRIDGE INSPECTION REPORT

COUNTY EDGEcombe BRIDGE NUMBER 320076 INSPECTION CYCLE 0 YRS
 ROUTE SR1527 ACROSS CONETOE CRK. OVERFLOW M.P. 0

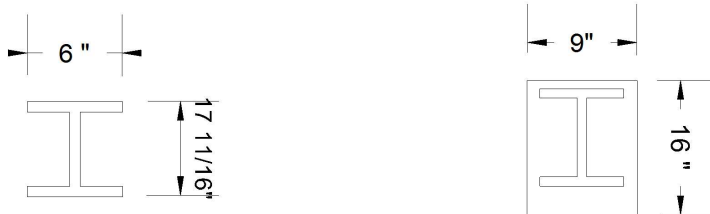
FLANGE THICKNESS: 7/16 " TAPERED FLANGES
 WEB THICKNESS: 3/8" WEB
BEAMS 1,2,9,& 10

CONCRETE ENCASED BEAMS 3 - 8

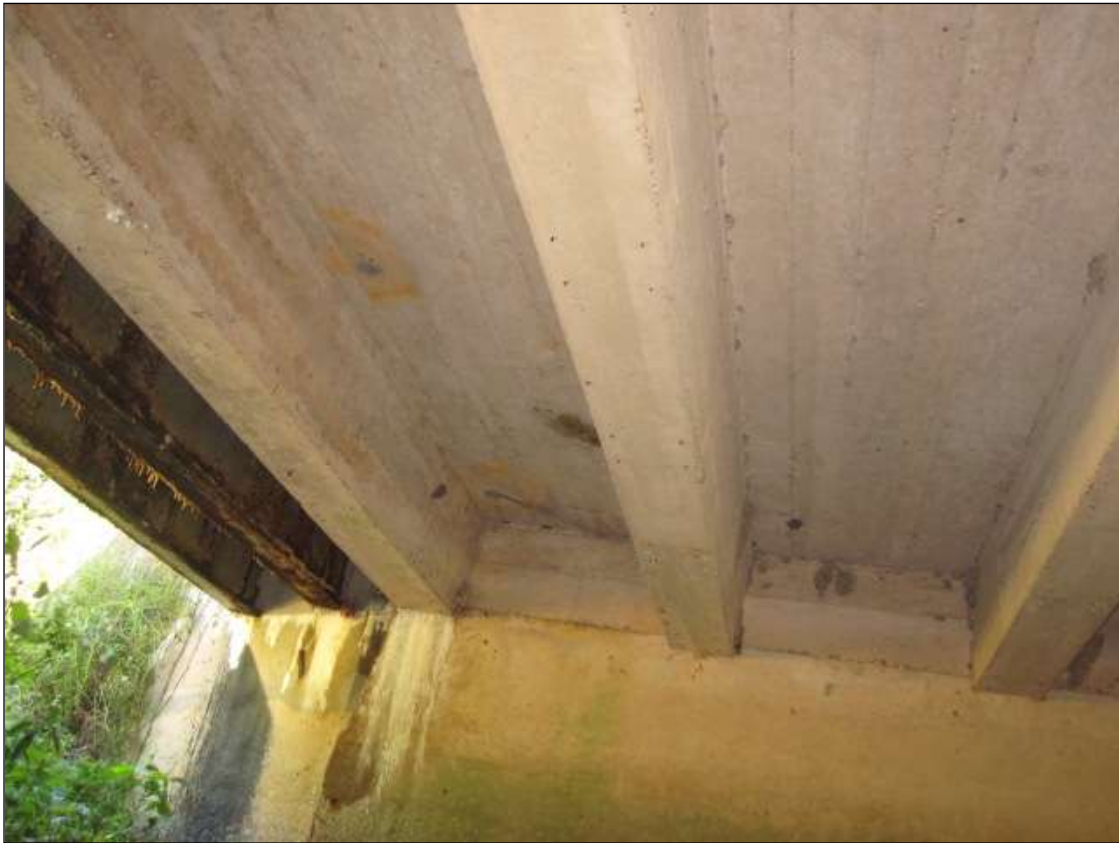
SUPERSTRUCTURE

10A	NO	NO CURVED GIRDERS	
52	P	RUST AND CORROSION WITH SECTION LOSS ON BEAMS	
36a	F	SCALING AND HAIRLINE CRACKS WITH EFFLORESCENCE IN FACE OF CAP AT ABUTMENTS 1 AND 2	
36b	F	SCALING WITH EXPOSED AGGREGATE AND HAIRLINE CRACKS WITH EFFLORESCENCE IN FACE OF BREASTWALL AT ABUTMENTS 1 AND 2
