Structure: 750009

# Priority Action Repair Report

PM 24 Month

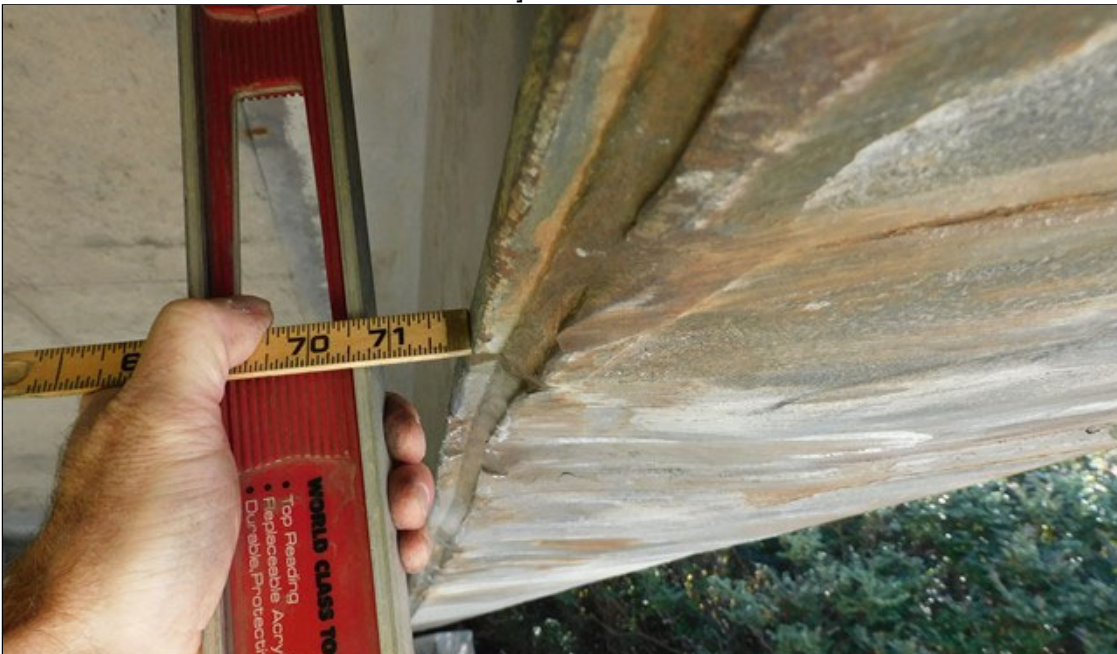
Span 2 Beam 10: IMPACT-11/19/2025- PRIOR DAMAGE; LOCATED 21.2 FEET FROM INTERIOR BENT 1 - AREA 8 FEET LONG DEFLECTED TOWARDS SOUTH 1.25 INCHES WITH SEGMENT OF BOTTOM FLANGE DEFLECTED UPWARDS 1.5 INCHES - ALONG BOTTOM FLANGE AT MID SPAN, AREA OF IMPACT DAMAGE [8 FOOT LONG] WITH AREA OF DELECTION [1/4 INCH X 3 FOOT LONG] ON SOUTH FACE AND DEFLECTED UP [1.25 INCH X 4 FOOT LONG] ON NORTH FACE.
