# STRUCTURE BULLETIN

## NCDOT Construction Unit

### Current Issues: Payment for PPC overlays

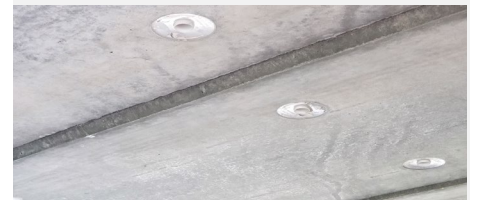
#### Box Beam Void Drains

The holes in the picture are on the bottom of box beams. They are supposed to be there and do not need to be patched. They are there in order to drain the void formed inside the beam in case any water finds its way inside. They have a sticker over the pipe to keep grout out during casting. Sometimes this sticker is still there when they arrive on the job, or sometimes the sticker fails and the hole is blocked with grout. In either case the hole should be cleared, not patched, so it can perform as designed.
