Investigation of Primary Causes of Fatigue Cracking in Asphalt Pavement in North Carolina

NCDOT Project 2010-01

FHWA/NC/2010-01

March 2015

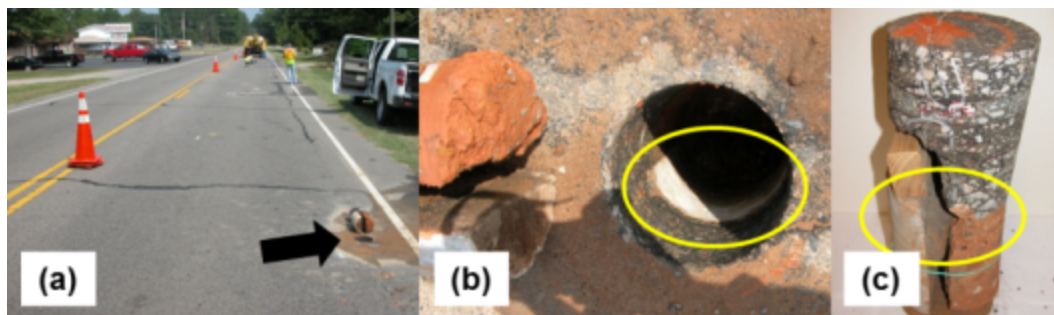
Evidence of road widening includes pavement marking/paint lines in the cores taken from the outer wheel path as well as characteristics of the actual structure of a pavement that clearly indicate that the road has been widened beyond the original substructure. Figure 4.12 (a), (b) and (c) show the pavement substructure as evidence of road widening. Figure 4.12 (a) shows the cracking pattern at the site (US 220). Figure 4.12 (b) and (c) clearly show evidence of road widening that extends beyond the original pavement structure. Figure 4.13 is a schematic illustration based on the findings for the pavement structure shown in Figure 4.12 (a), (b) and (c). In Figure 4.14 (a) to (c), the ovals show traces of marking paint on the delaminated surface and in the middle of cores extracted from the outer wheel path; these paint lines indicate road

Figure 4.12 Field core with pavement substructure as evidence of road widening.

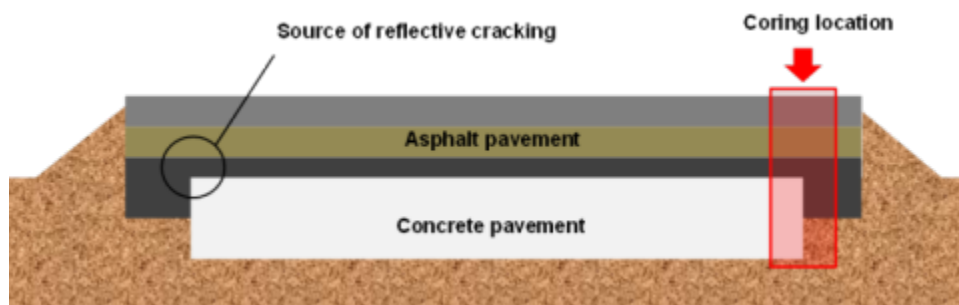
Figure 4.13 Illustration of pavement structure shown in Figure 4.12 (US 220, Montgomery County).

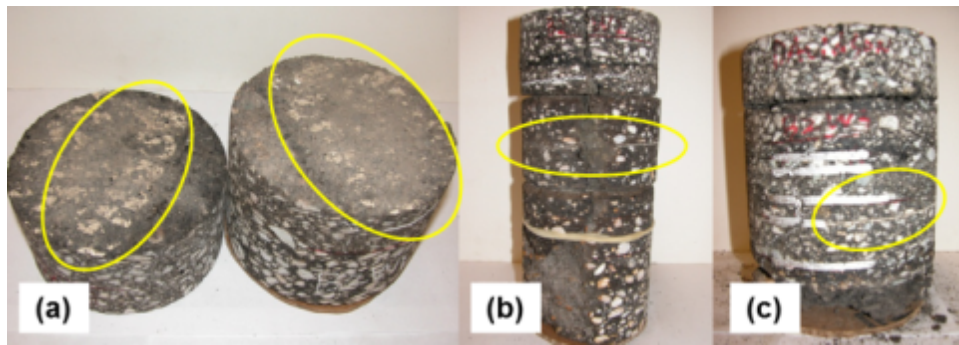
Figure 4.14 Field cores with marking paint as evidence of road widening.

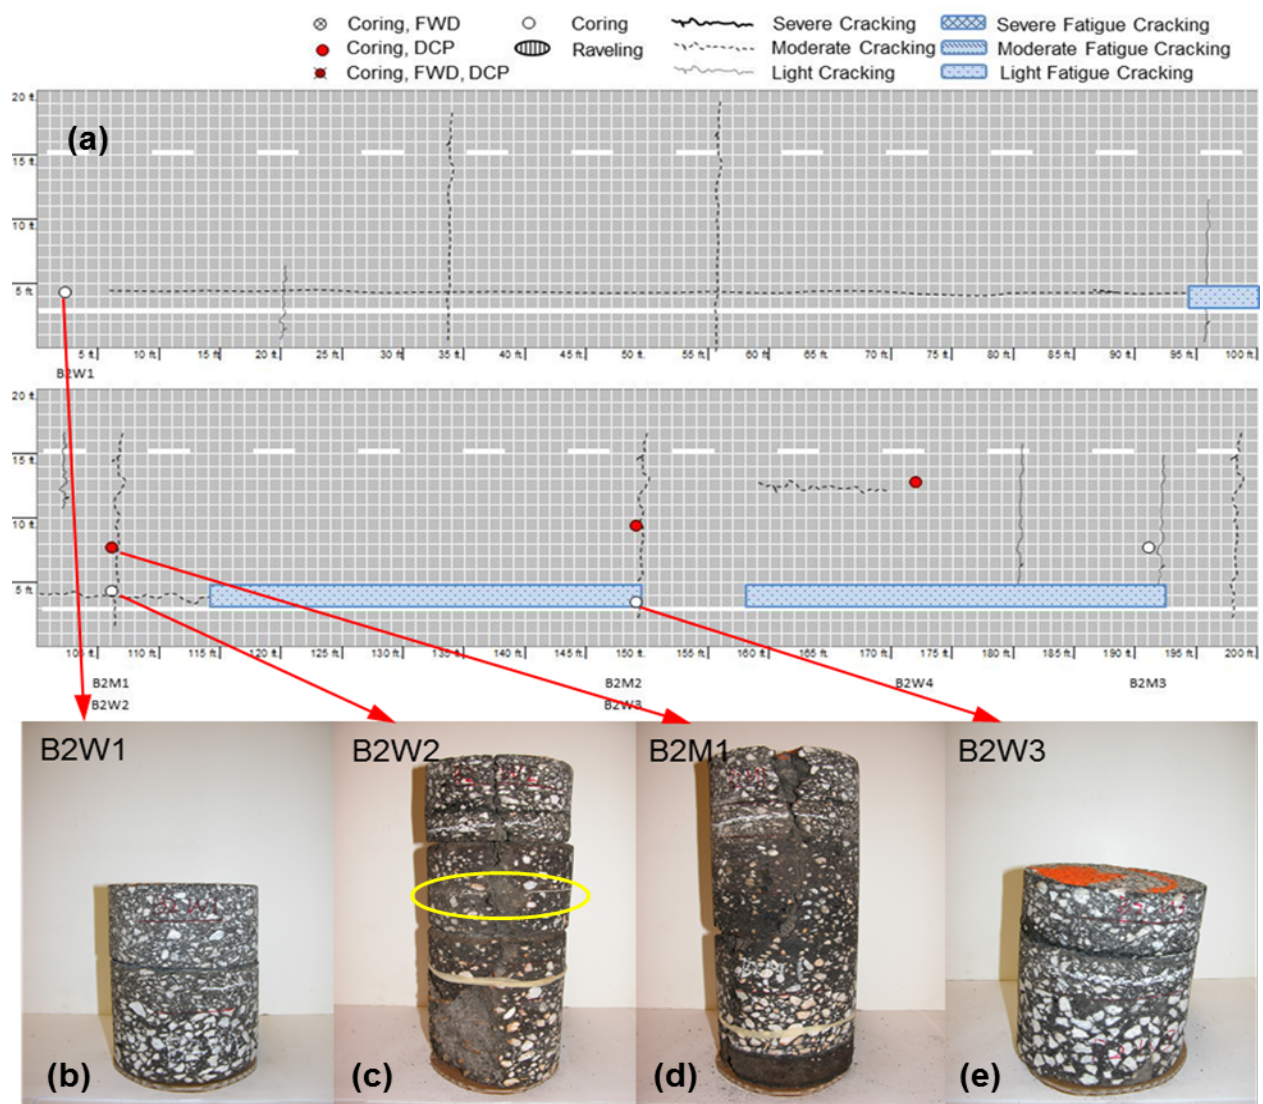
widening. Even clearer evidence of road widening from marking paint lines is presented in Figure 4.15 (a) to (e). Figure 4.15 (a) shows the condition survey from the NC 87 pavement site and also shows the coring locations and pavement conditions presented in the condition survey map. As indicated in Figure 4.15 (a), the cores shown in Figure 4.15 (b) and (e) were extracted from slightly outside the outer wheel path area, and the cores shown in Figure 4.15 (c) and (d) were extracted from inside the outer wheel path area. The cores taken from outside the outer wheel path area exhibit a different pavement structure than those extracted from the inside of the wheel path, and the core shown in Figure 4.15 (c) has a paint line on the core. These observations clearly indicate that pavement marking was on top of the core in Figure 4.15 (c) and the road was widened at least the distance between the core location and the current pavement marking location that is presented in Figure 4.15 (a).

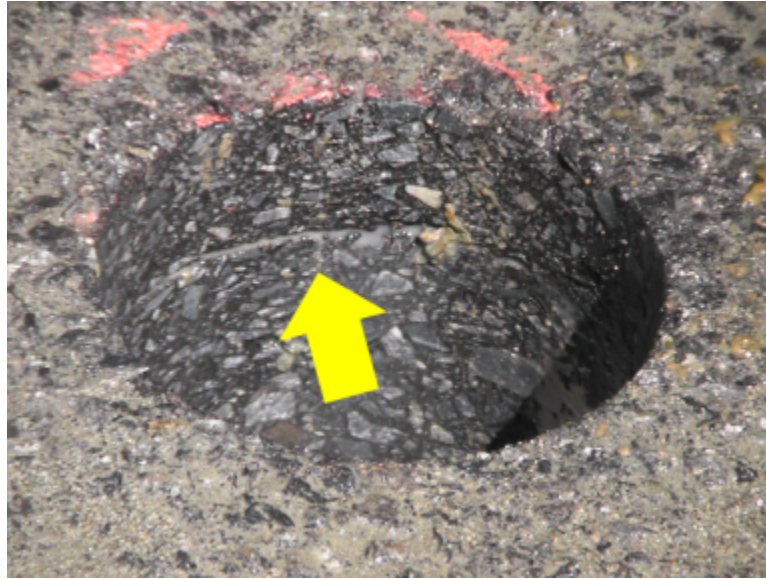
As noted earlier, the 19 sites selected for this research contain 56 different condition regions. Debonding was observed in 29 different condition regions; 23 out of these 29 condition regions showed a history of overlay and 6 regions had single-construction histories. Table 4.4 and Figure 4.16 present details regarding the debonding occurrence in terms of frequency and frequency percentages. Debonding was observed in cores extracted from both cracked areas and areas with no cracking. Because the size of the drill bit used for the research is 6 inches for its inner diameter, high torsional shear force during coring may have caused or accelerated debonding in the cores. Sometimes the layer interface separation can be clearly observed in a cored hole (e.g., as seen in the photograph in Figure 4.17), but not all cases of debonding are so obvious. The photograph in Figure 4.17 was taken immediately after the core was extracted and

shows the water used for coring coming out of the separated layer interface. Therefore, it is noted that all observations and records are based on the visual observation of both cores and core-extracted holes.

Figure 4.17 Debonding (layer interface separation) in core-extracted hole (NC-24).

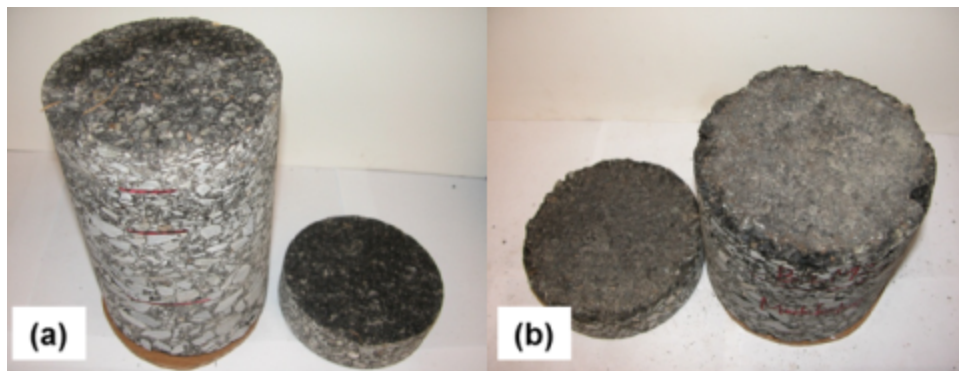
One major cause of debonding that can be discussed with confidence is the quality of the bonding material (tack coat) or poor construction practices for applying tack coats. Many cores that show debonding have a very smooth surface where the debonding occurred. If a quality tack coat was used at a certain site, and debonding was caused only by the penetration of water, at least one of the cores should have partial debonding with a non-smooth surface. However, most of the field sites with cores with smooth debonding surfaces do not have cores with partial debonding. Figure 4.18 (a) and (b) show a smooth debonding surface for cores extracted from US-70 and NC-24, respectively.

Figure 4.18 Photographs of smooth debonding (layer interface separation) surfaces in field cores.

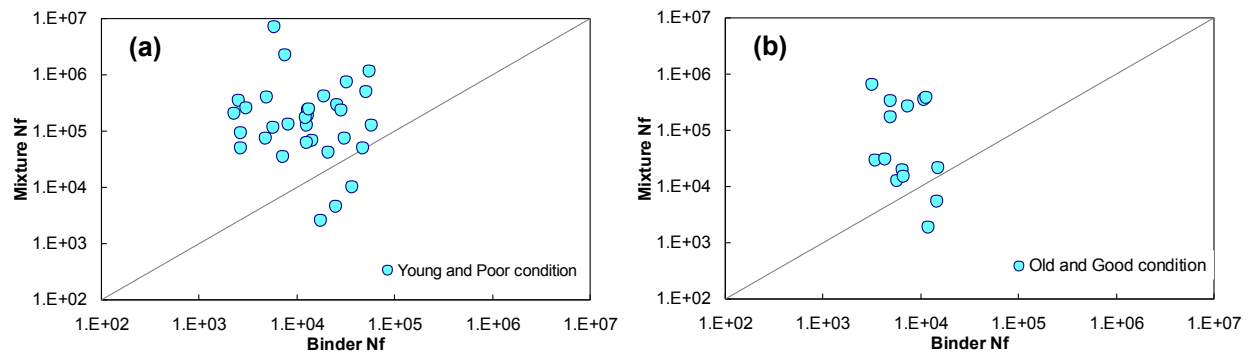
Figure 4.27 Comparison of number of cycles to failure of asphalt binder and mixtures from different information categories: (a) young and poor condition regions and (b) old and good condition regions.

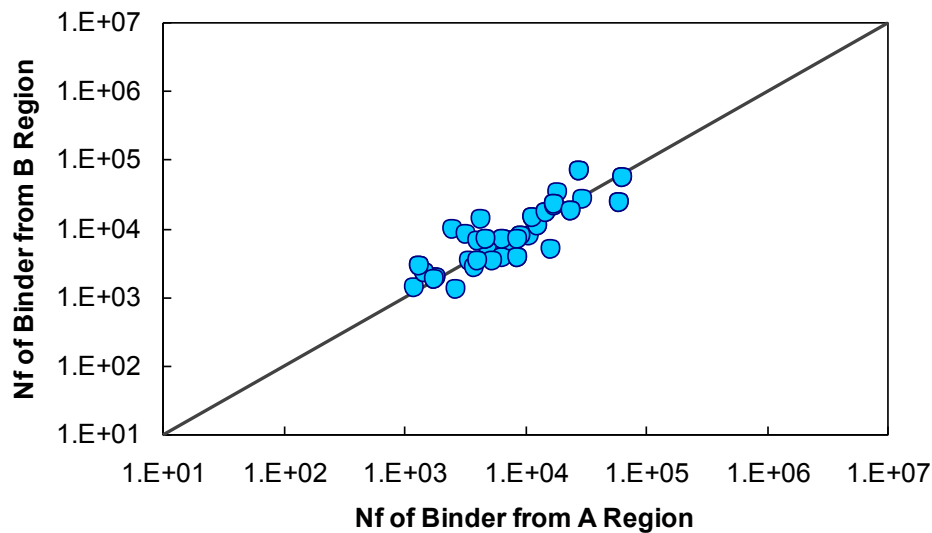
A comparison of the LAS test results for a relatively *good* condition region and *bad* condition region within one site indicates that the number of cycles to failure for the asphalt binder in different condition regions correlates in log-log space, as presented in Figure 4.28. Note that all the presented values of the number of cycles to failure of asphalt binder in different condition regions were calculated at 2% strain amplitude. The linear correlation of the number of cycles to failure obtained from different condition regions indicates that the pavement performance condition at the material level is not directly related to the asphalt binder. This phenomenon can be seen more clearly by comparing the figures in Figure 4.29. The numbers of cycles to failure from the A condition region (relatively *good* condition region) are higher than those from the B condition region, and there is no linear relationship found between the values from the different condition regions shown in Figure 4.29 (b).

Figure 4.28 Comparison of number of cycles to failure of asphalt binder from different condition regions.

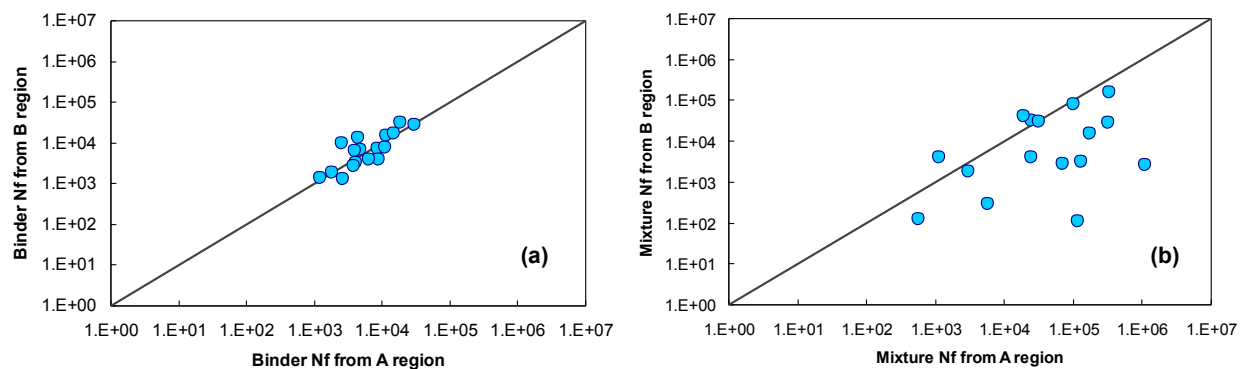
differing mixture volumetric properties. This observation is reflected more clearly by comparing the relative fatigue life data of asphalt mixtures from the corresponding condition A and B regions, as presented in Figure 4.29. From the asphalt mixture results, it is seen that the numbers of cycles to failure from the A condition region are consistently higher than those from the B condition region, as expected. Thus, the results suggest that mixture variables, other than the constituent asphalt binder, can lead to differences in the performance of the condition A and B regions (in terms of air void content, asphalt content, etc.).

Figure 4.29 Comparison of number of cycles to failure of (a) asphalt binder and (b) mixtures from different condition regions.

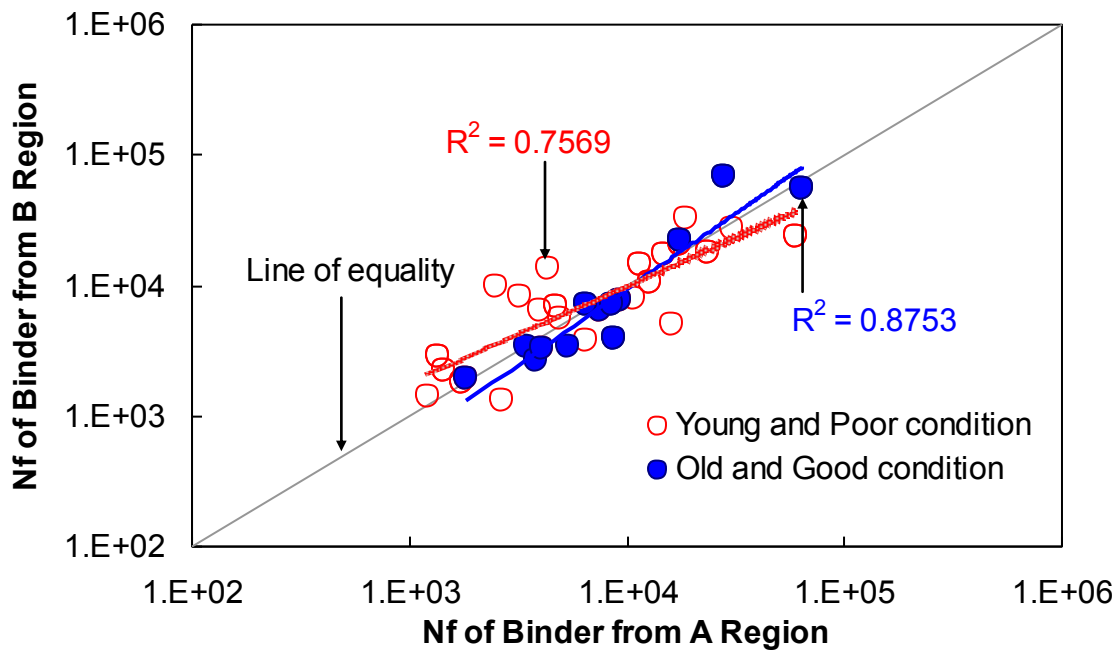
In Figure 4.30, all the data points are the same as those in Figure 4.28, but the research team divided those data into different categories as *old and good* condition sites and *young and poor* condition sites. It is observed that more data points from the *old and good* condition sites converge on the line of equality (LOE) than the data points from the *young and poor* condition sites. This finding may indicate that the less variable the material property, the better the pavement condition.

Figure 4.30 Comparison of number of cycles to failure of asphalt binder from different condition regions in different categories.

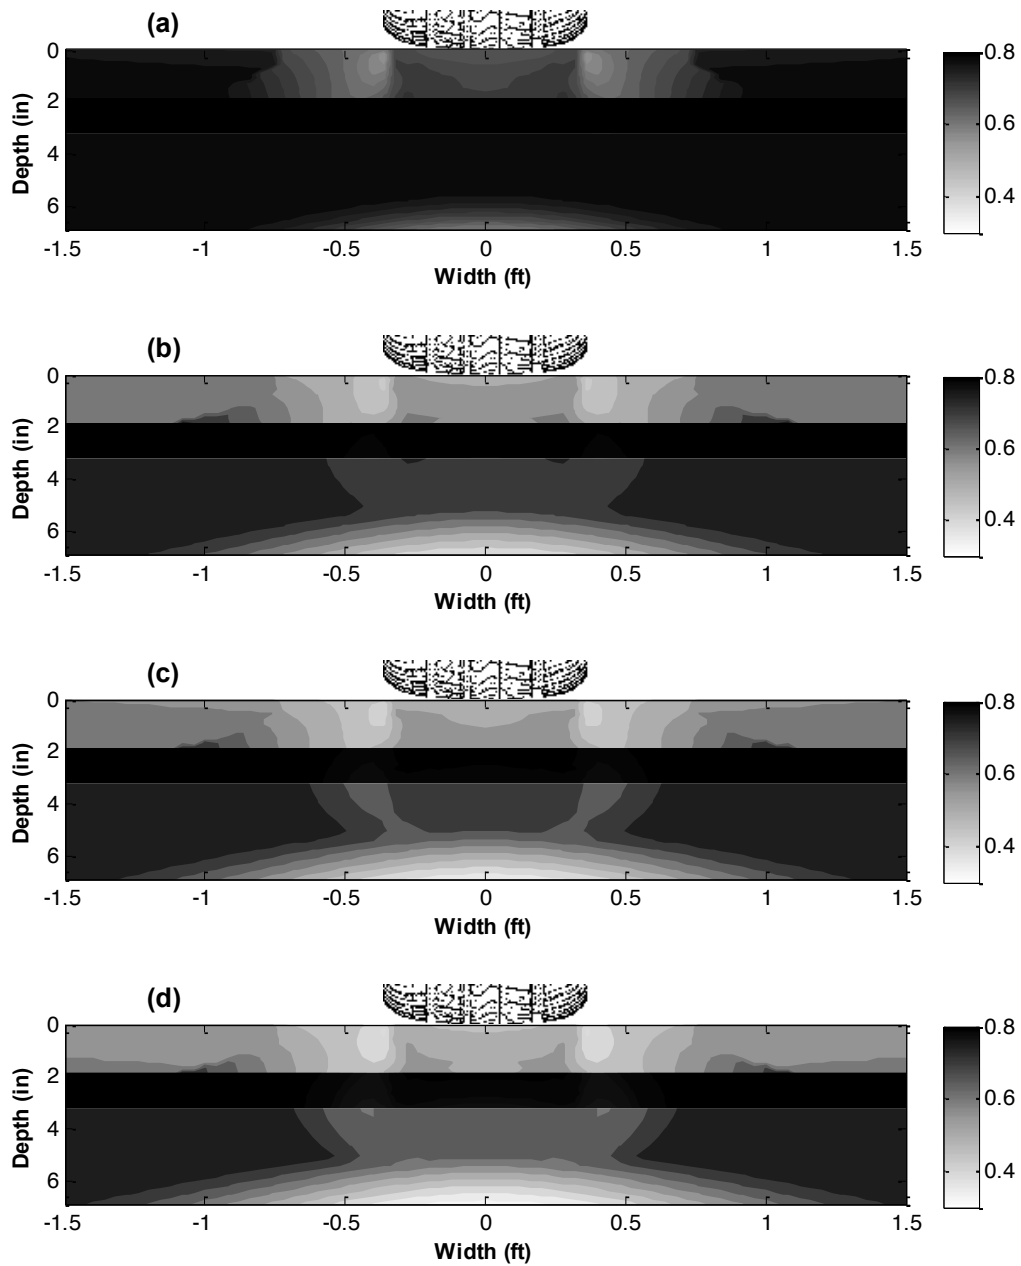
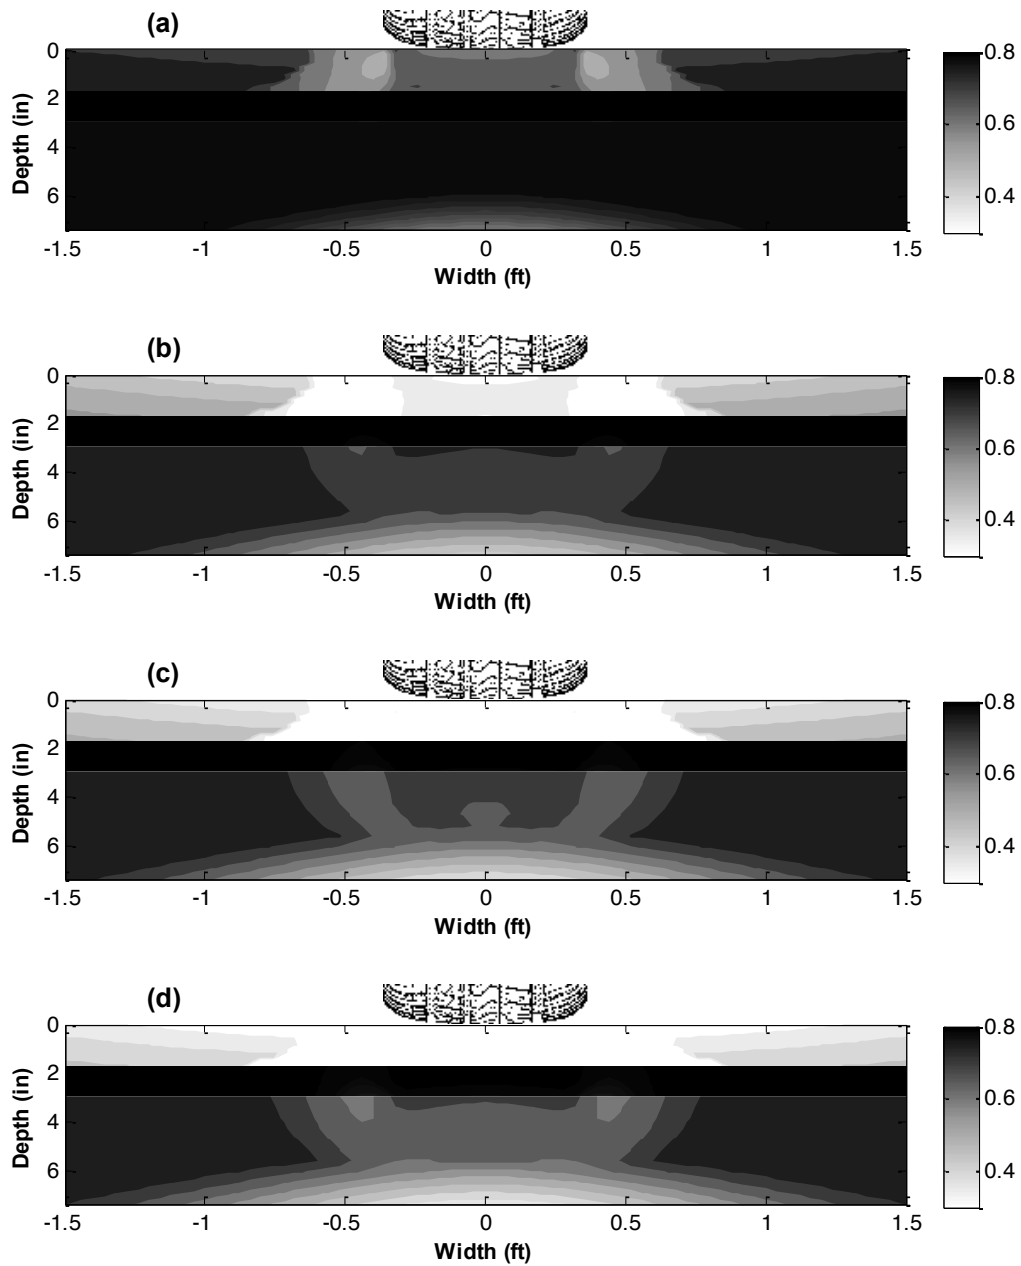
- A noteworthy finding from NC-24 and US-74 is presented in Figure 5.1 to Figure 5.2 and Figure 5.15 to Figure 5.16. The thicknesses of the asphalt layers in these two sections are similar (about 7 in.), and higher base and subgrade modulus values were measured from US-74 than from NC-24. If the asphalt layer properties were the same, these conditions would give the NC-24 section a greater potential for BUC. However, TDC was observed from NC-24 and BUC was observed from US-74 due to the different asphalt mixtures used in these two sections. The predicted simulation results shown in Figure 5.1 to Figure 5.2 and Figure 5.15 to Figure 5.16 match these field core observations.

Figure 5.1 Damage contours for the B1 region in NC 24 pavement: (a) 1 year, (b) 5 years, (c) 10 years, and (d) 20 years.

Figure 5.2 Damage contours for the A1 region in NC 24 pavement: (a) 1 year, (b) 5 years, (c) 10 years, and (d) 20 years.

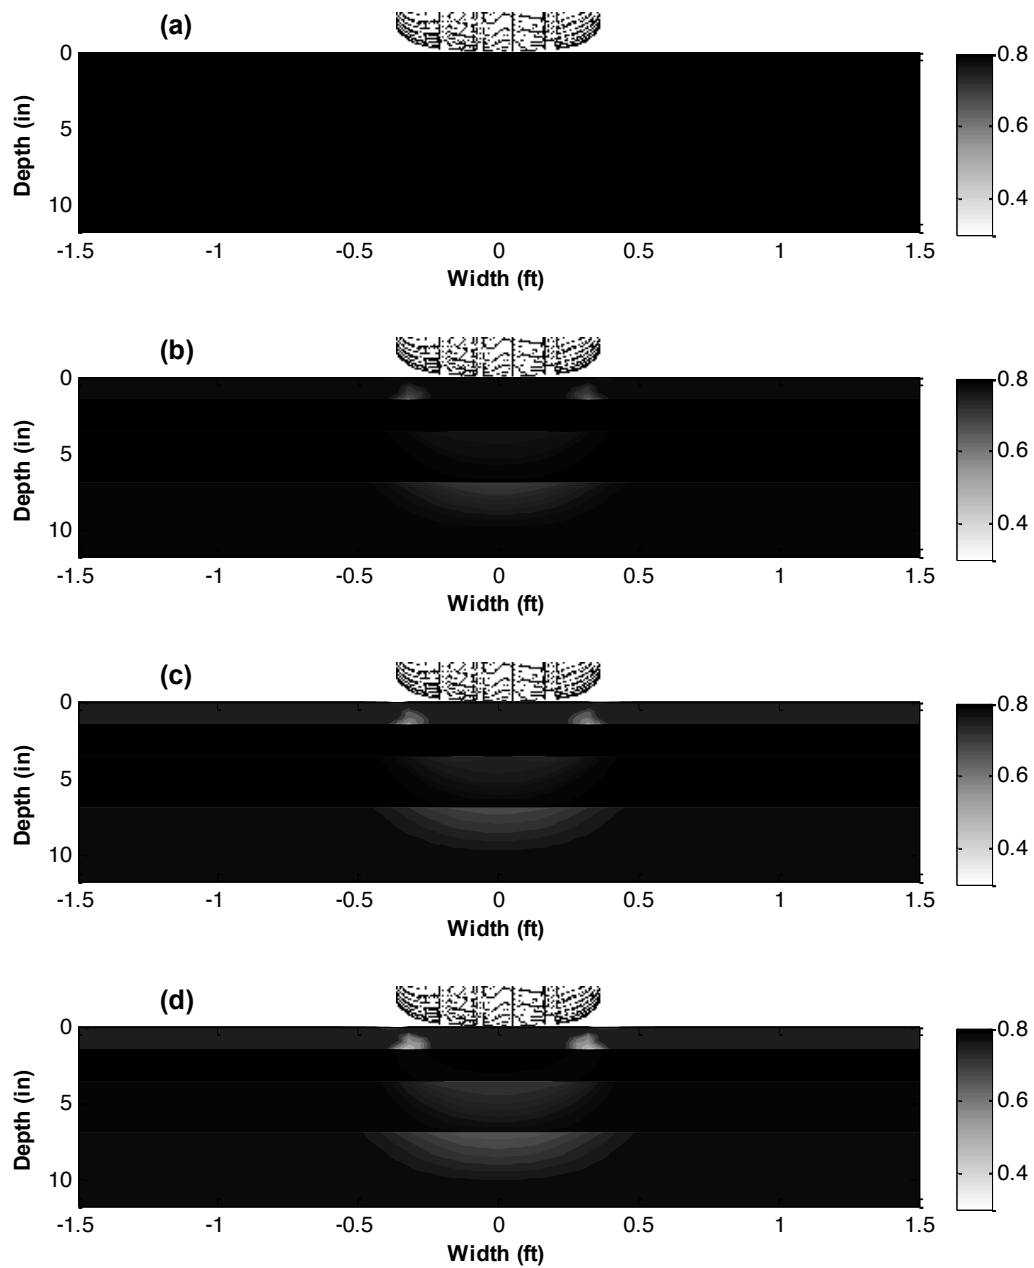
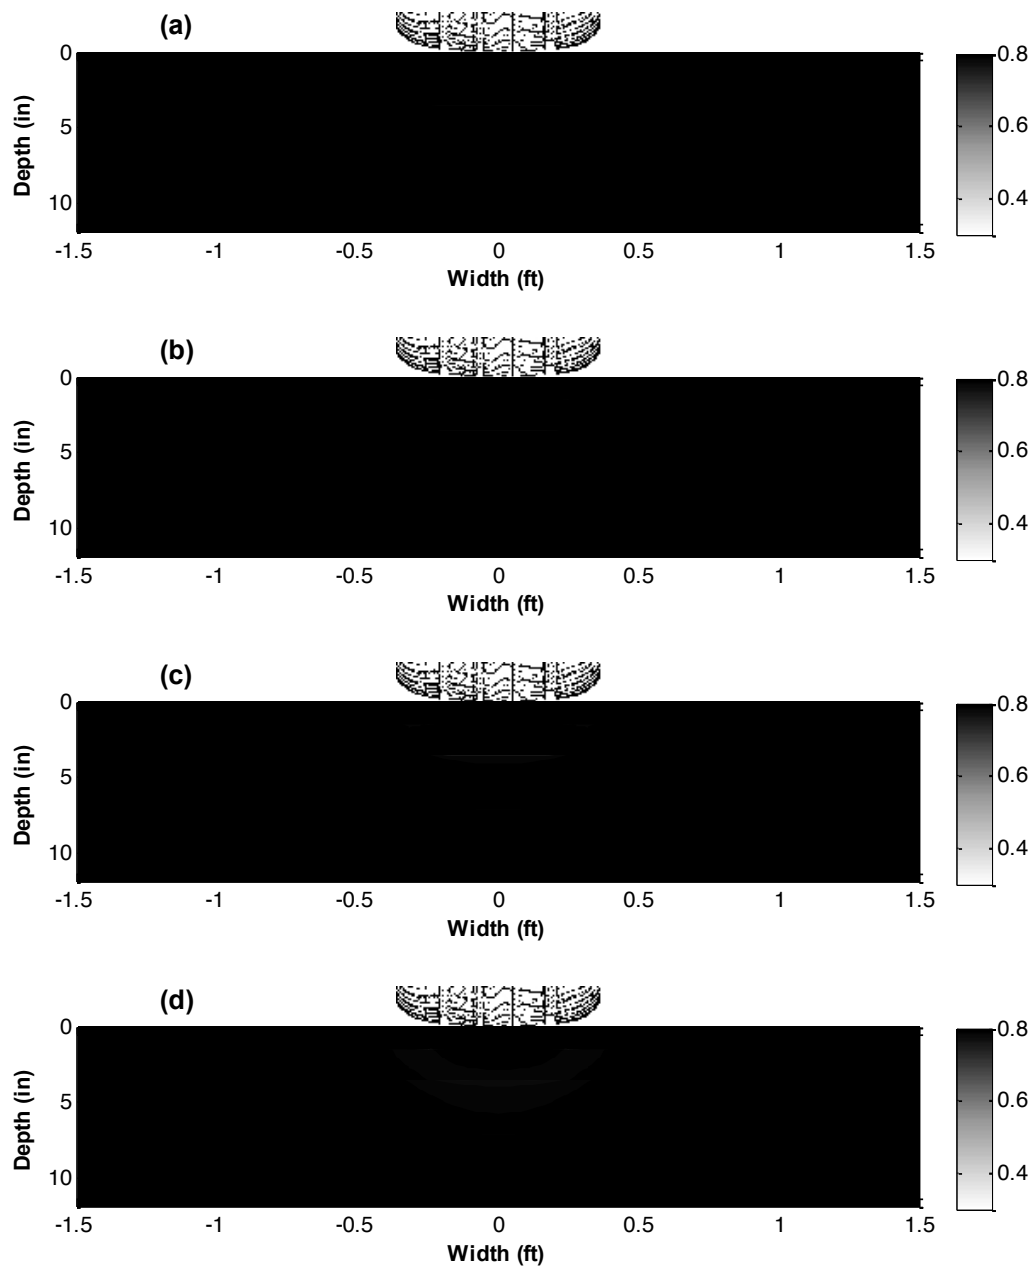
- The *old* and *good* pavements, i.e., US 17 and NC 209, show relatively minor damage from the 20-year pavement simulations.
- The predicted simulation results presented in Figure 5.3 and Figure 5.5 and Figure 5.13 to Figure 5.14 indicate that the TDC simulation results for US-70 and I-540 are in agreement with the field core observations.

Figure 5.3 Damage contours for the B2 region in I 540 pavement: (a) 1 year, (b) 5 years, (c) 10 years, and (d) 20 years.

Figure 5.5 Damage contours for the A2 region in I 540 pavement: (a) 1 year, (b) 5 years, (c) 10 years, and (d) 20 years.

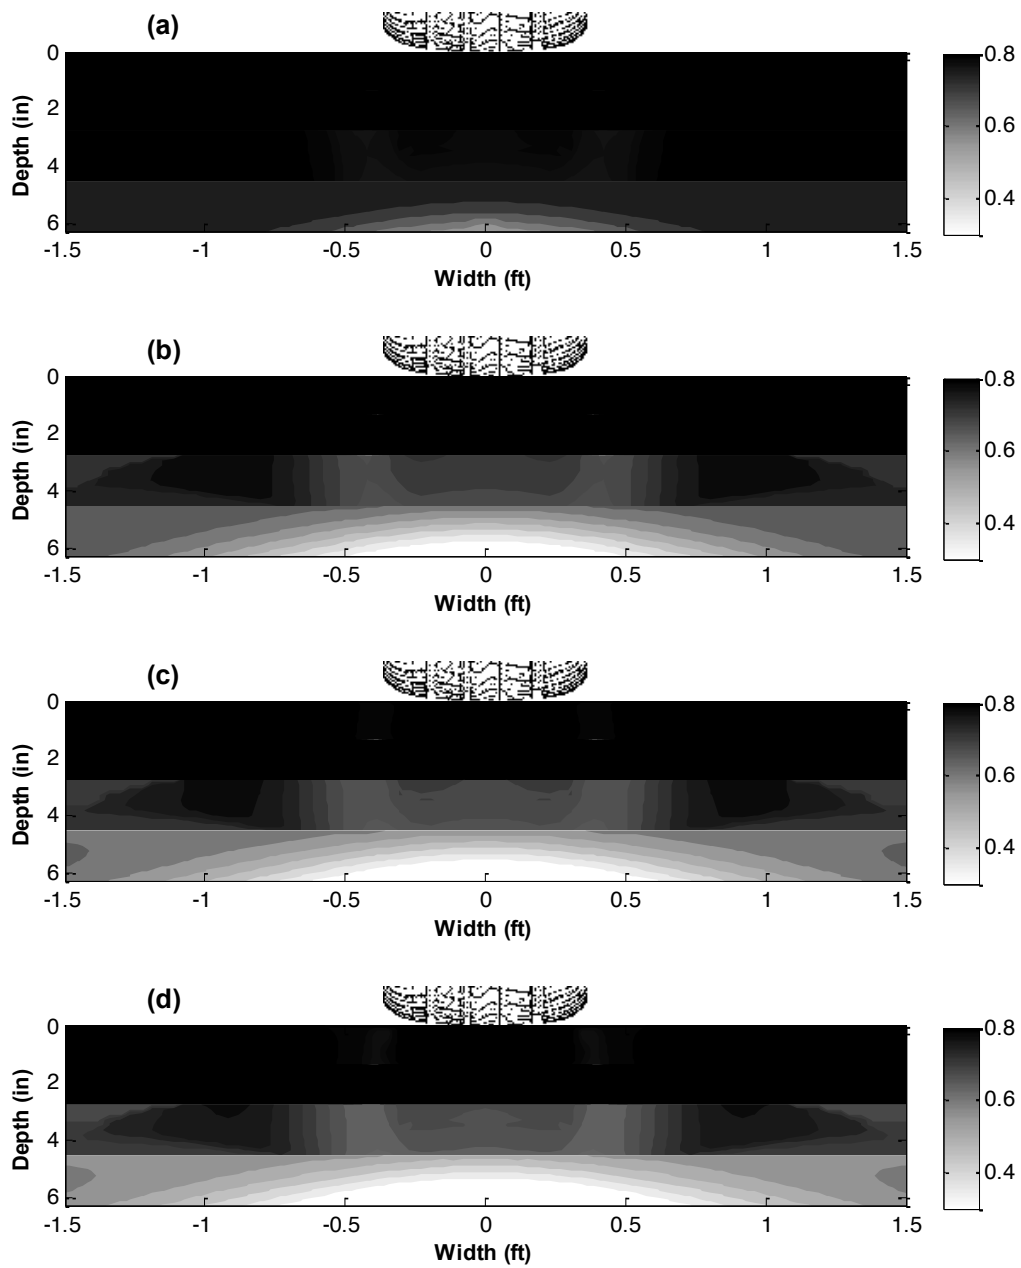
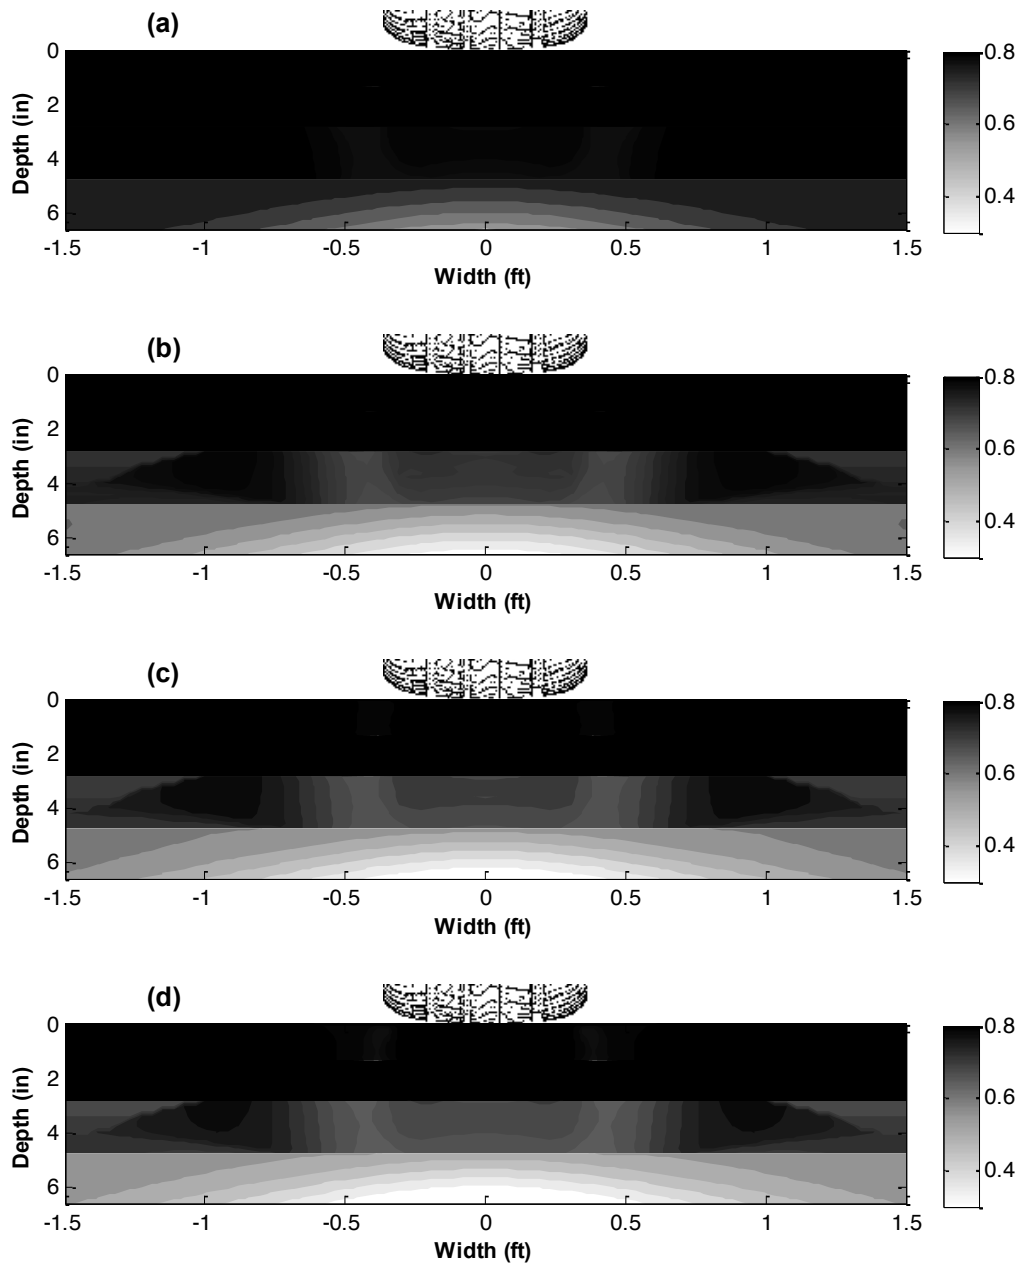
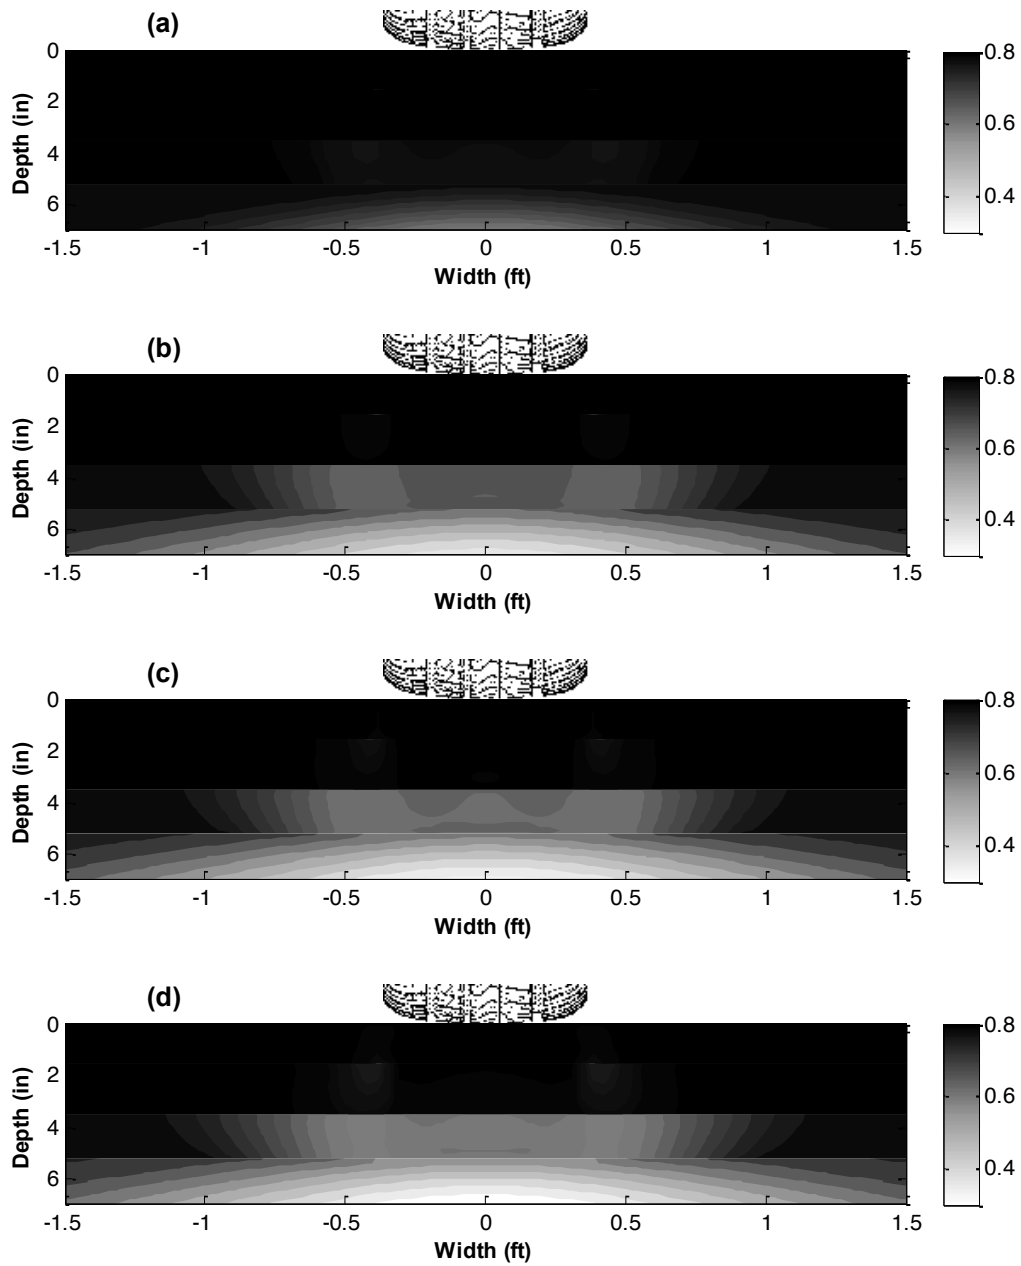
- The TDC that is observed in the field cores from the A condition region of US-601 is not observed in the predicted simulations presented in Figure 5.6 to Figure 5.8.

Figure 5.6 Damage contours for the B1 region in US 601 pavement: (a) 1 year, (b) 5 years, (c) 10 years, and (d) 20 years.

Figure 5.7 Damage contours for the B2 region in US 601 pavement: (a) 1 year, (b) 5 years, (c) 10 years, and (d) 20 years.

Figure 5.8 Damage contours for the A1 region in US 601 pavement: (a) 1 year, (b) 5 years, (c) 10 years, and (d) 20 years.

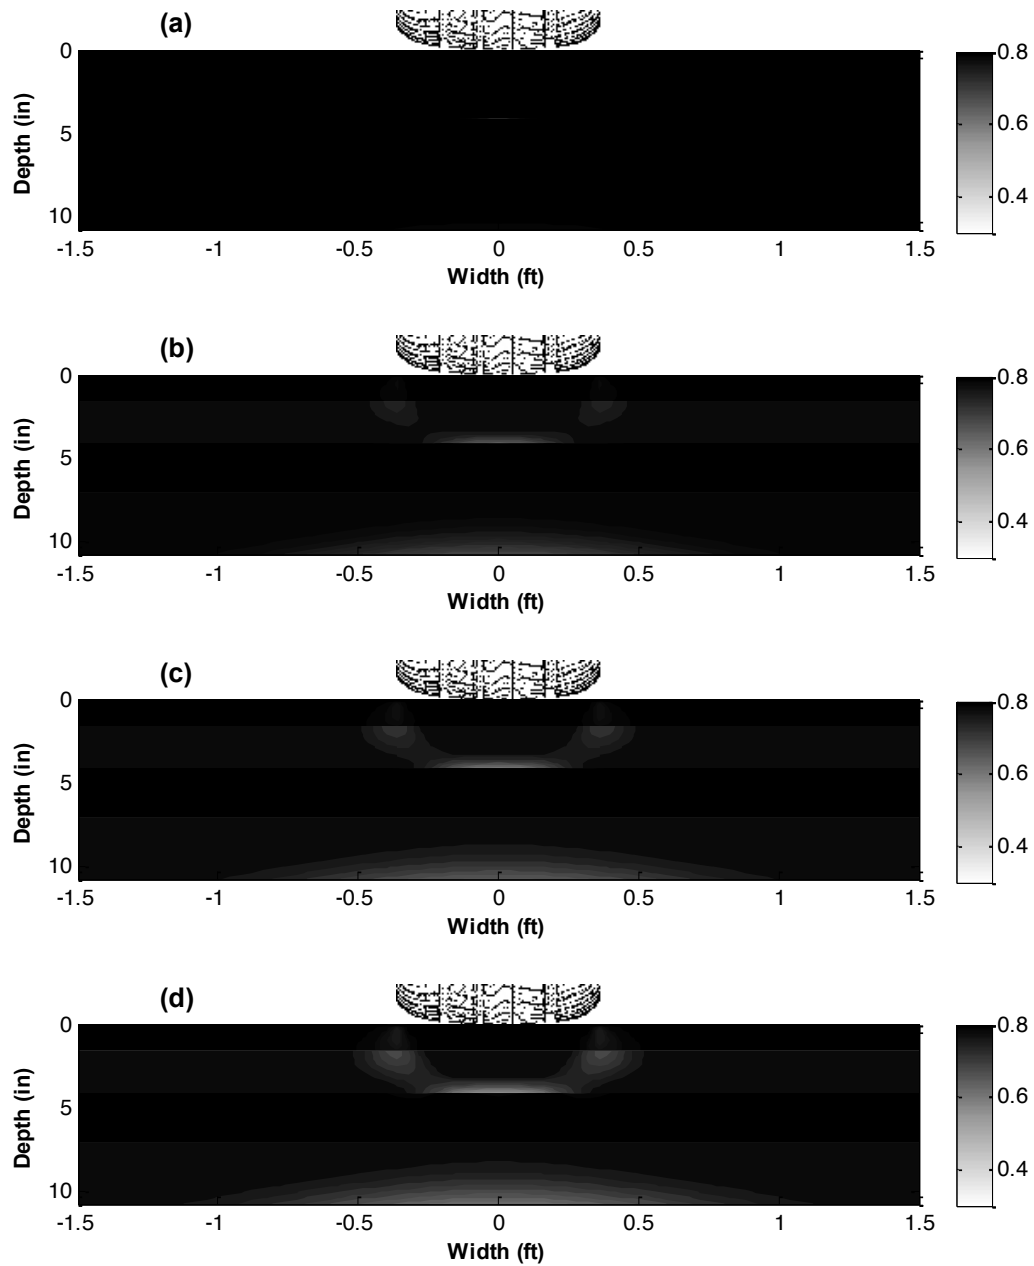
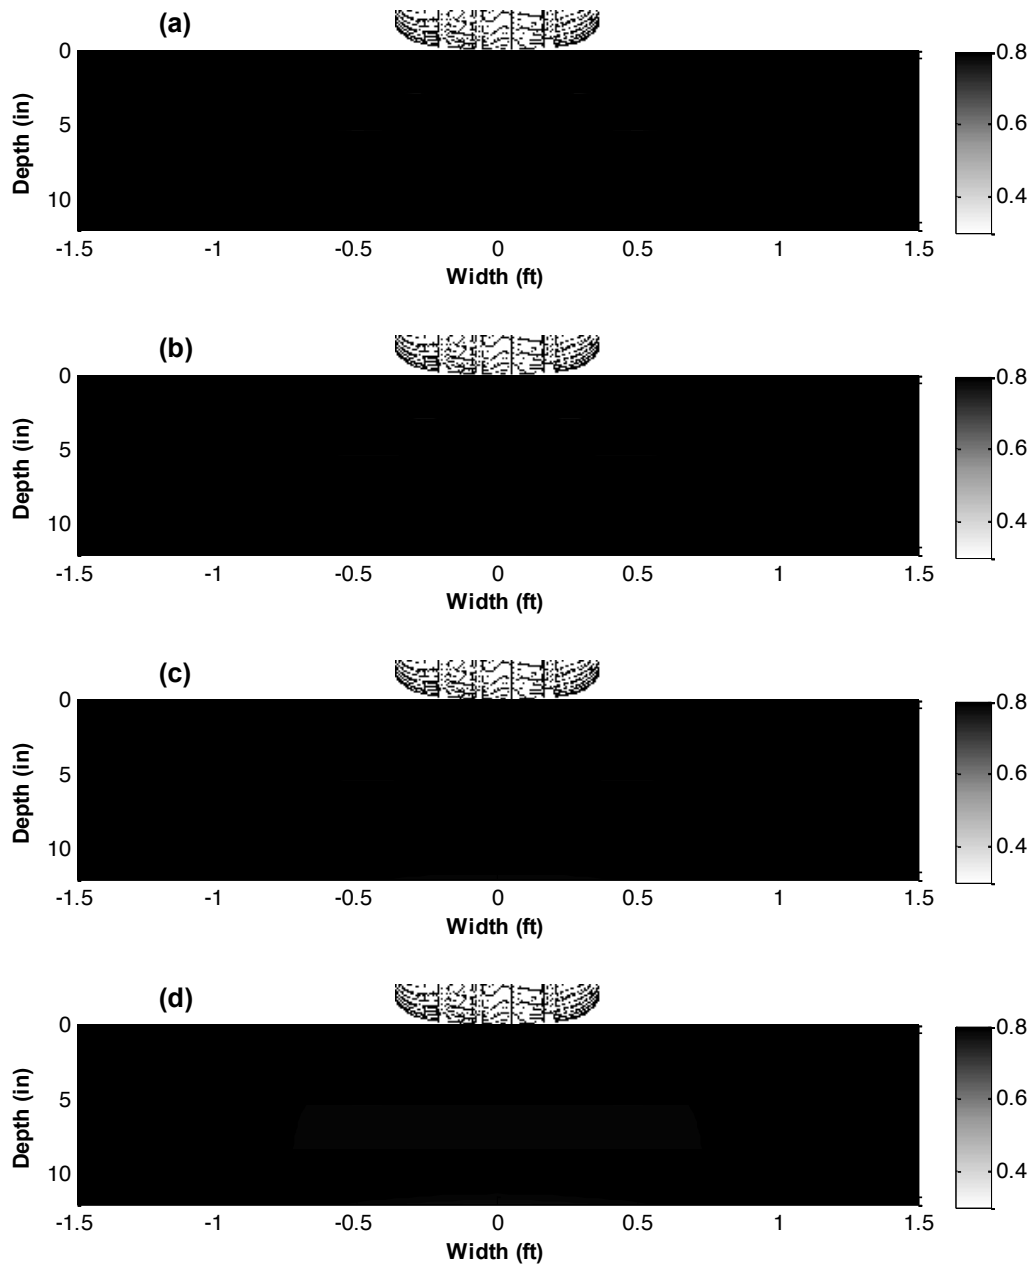
Figure 5.13 Damage contours for the B2 region in US 70 pavement: (a) 1 year, (b) 5 years, (c) 10 years, and (d) 20 years.

Figure 5.14 Damage contours for the A2 region in US 70 pavement: (a) 1 year, (b) 5 years, (c) 10 years, and (d) 20 years.

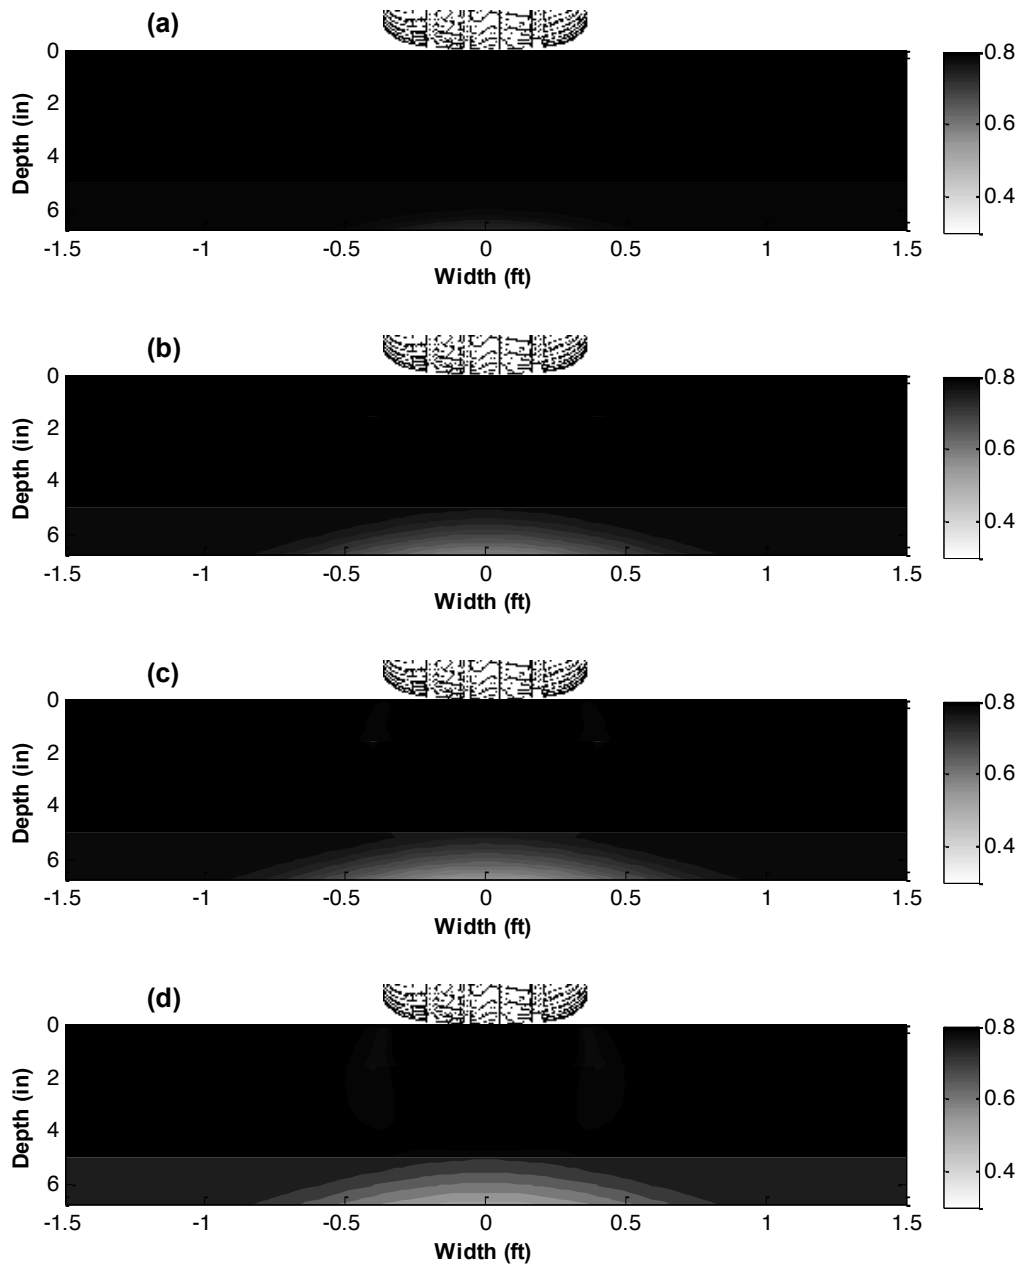
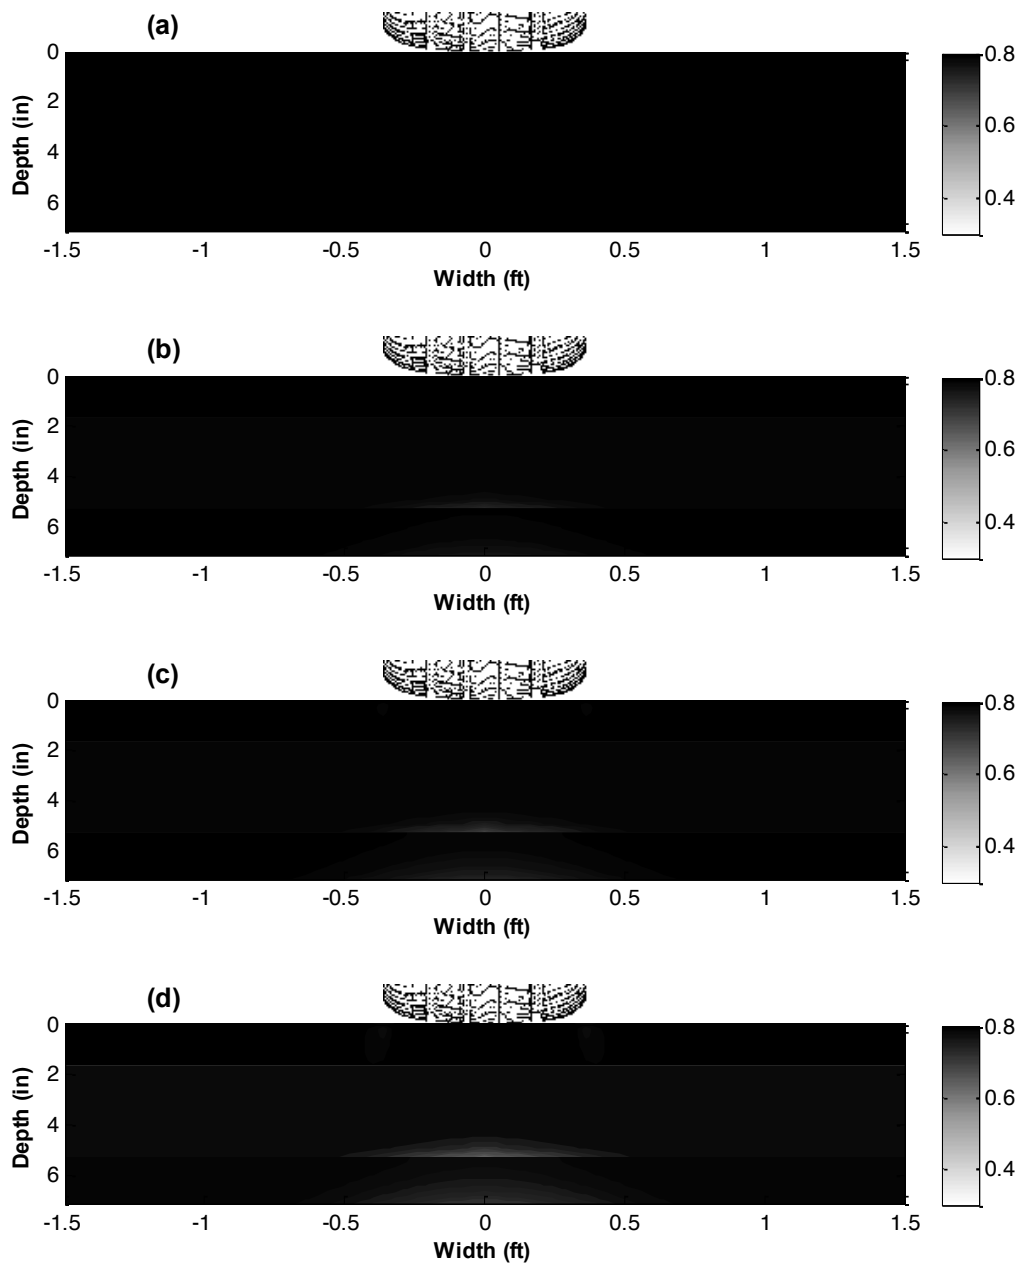
Figure 5.15 Damage contours for the B1 region in US 74 pavement: (a) 1 year, (b) 5 years, (c) 10 years, and (d) 20 years.

Figure 5.16 Damage contours for the A1 region in US 74 pavement: (a) 1 year, (b) 5 years, (c) 10 years, and (d) 20 years.
