Investigation of Primary Causes of Fatigue Cracking in Asphalt Pavement in North Carolina

NCDOT Project 2010-01

FHWA/NC/2010-01

March 2015

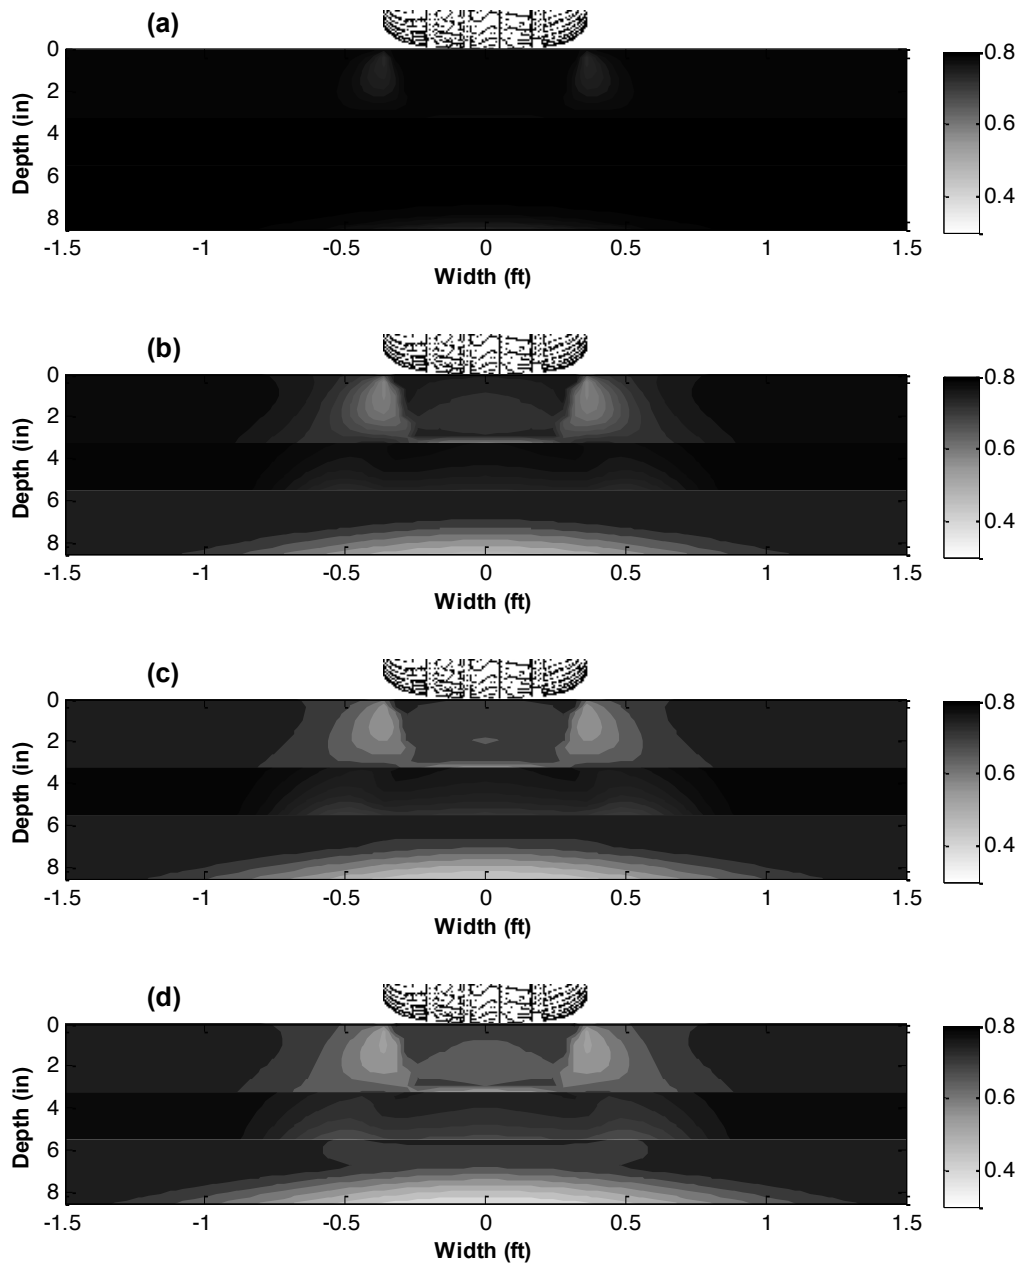
- The predicted results from the A condition region of US-76 presented in Figure 5.18 match the field core observations, but none of the field core observations are captured by the simulations of the B condition region. According to the 2010 NCDOT condition survey, as denoted by the highlighted areas of Table 5.1, this site contains oxidized pavement. Accordingly, it appears that the TDC observed from the field cores is caused by excessive oxidization. This oxidization is not captured by the LVECD program because an aging model has not been implemented in the LVECD model yet.

Figure 5.18 Damage contours for the A1 region in US 76 pavement: (a) 1 year, (b) 5 years, (c) 10 years, and (d) 20 years.

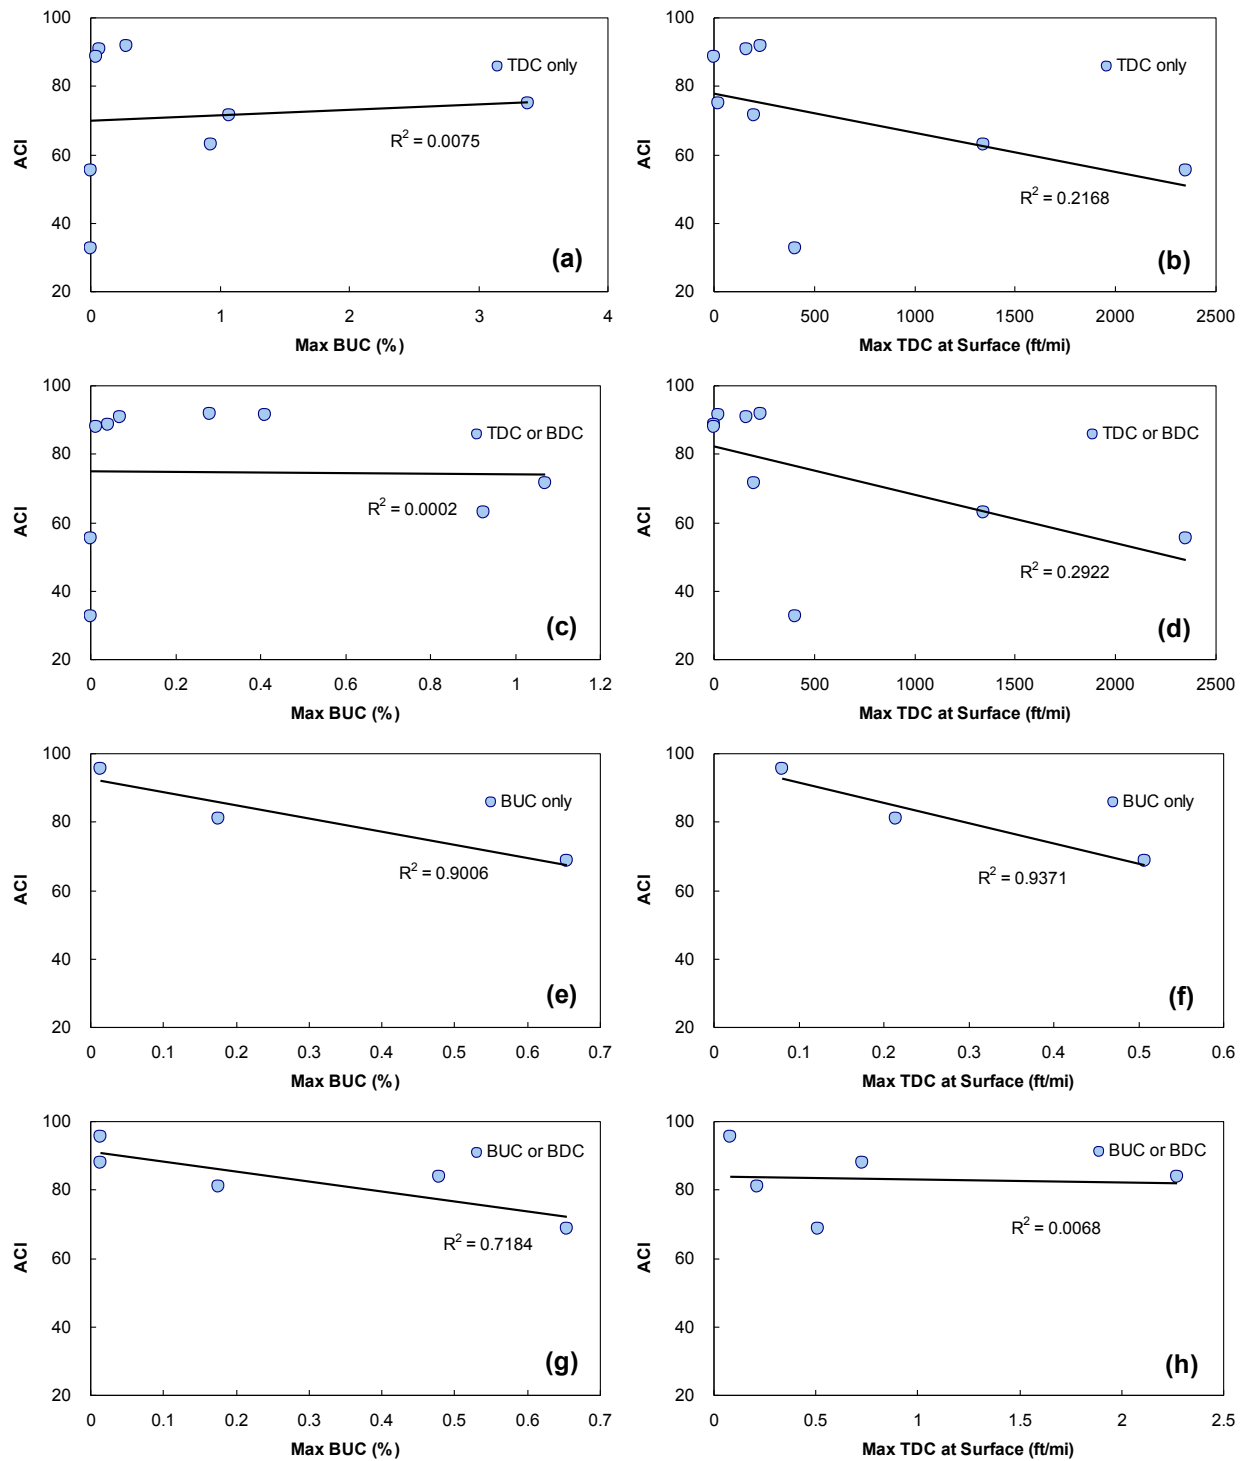
Among the key distress types that were generated by the DARWin-ME simulations (i.e., the terminal international roughness index (IRI), permanent deformation of the total pavement, bottom-up fatigue cracking, thermal cracking on the surface, and top-down cracking on the surface), the *asphalt concrete BUC (%)* and *asphalt concrete TDC (ft/mile)* were considered for comparison with the ACI values described in Section 4.3. Note that *BUC (%)* indicates the possibility of BUC at a certain percentage after 20 years of service, and *asphalt concrete TDC (ft/mile)* indicates that a certain amount of TDC will appear on the surface after 20 years of service. A summary of the comparison results is presented in Figure 5.21 and Figure 5.23 for Level 1 input and in Figure 5.22 and Figure 5.24 for Level 3 input. The data presented in subfigures (a) and (b) in Figure 5.21 and Figure 5.22 present all of the data points, which are divided into different cracking direction groups in the subsequent subfigures in Figure 5.23 and Figure 5.24. These comparative results show a very weak correlation between the ACI values

and simulation results, although the overall trend is reasonable. Among those subfigures presented in Figure 5.23, Figure 5.23 (b), (d), (e), and (g) show better correlations than the other subfigures. This observation is quite reasonable because the value of the length of the TDC at the surface needs to correlate with the ACI values from the TDC-observed condition regions. Likewise, a maximum BUC percentage needs to correlate with the ACI values from the BUC-observed sites. It is noteworthy that strong correlations are observed from the comparison between the maximum BUC percentage and the ACI values from the BUC-observed sites, although the pass and fail comparisons with the field core observations do not capture the BUC propensity. Among those subfigures presented in Figure 5.24, Figure 5.24 (a), (c), (f), and (h) show slightly better correlations than the other subfigures. For these subfigures of Figure 5.24, the same conclusions can be drawn as described for Figure 5.23, which is the Level 1 input simulation case; however, the correlations are significantly lower in Figure 5.24 than in Figure 5.23.

Figure 5.23 Comparison between ACI values and 20-year simulation results of maximum BUC% and maximum length of TDC at surface from DARWin-ME with higher-level inputs: (a) and (b) from TDC observed sites, (c) and (d) from TDC or BDC observed sites, (e) and (f) BUC observed sites, (g) and (h) from TDC or BDC observed sites.

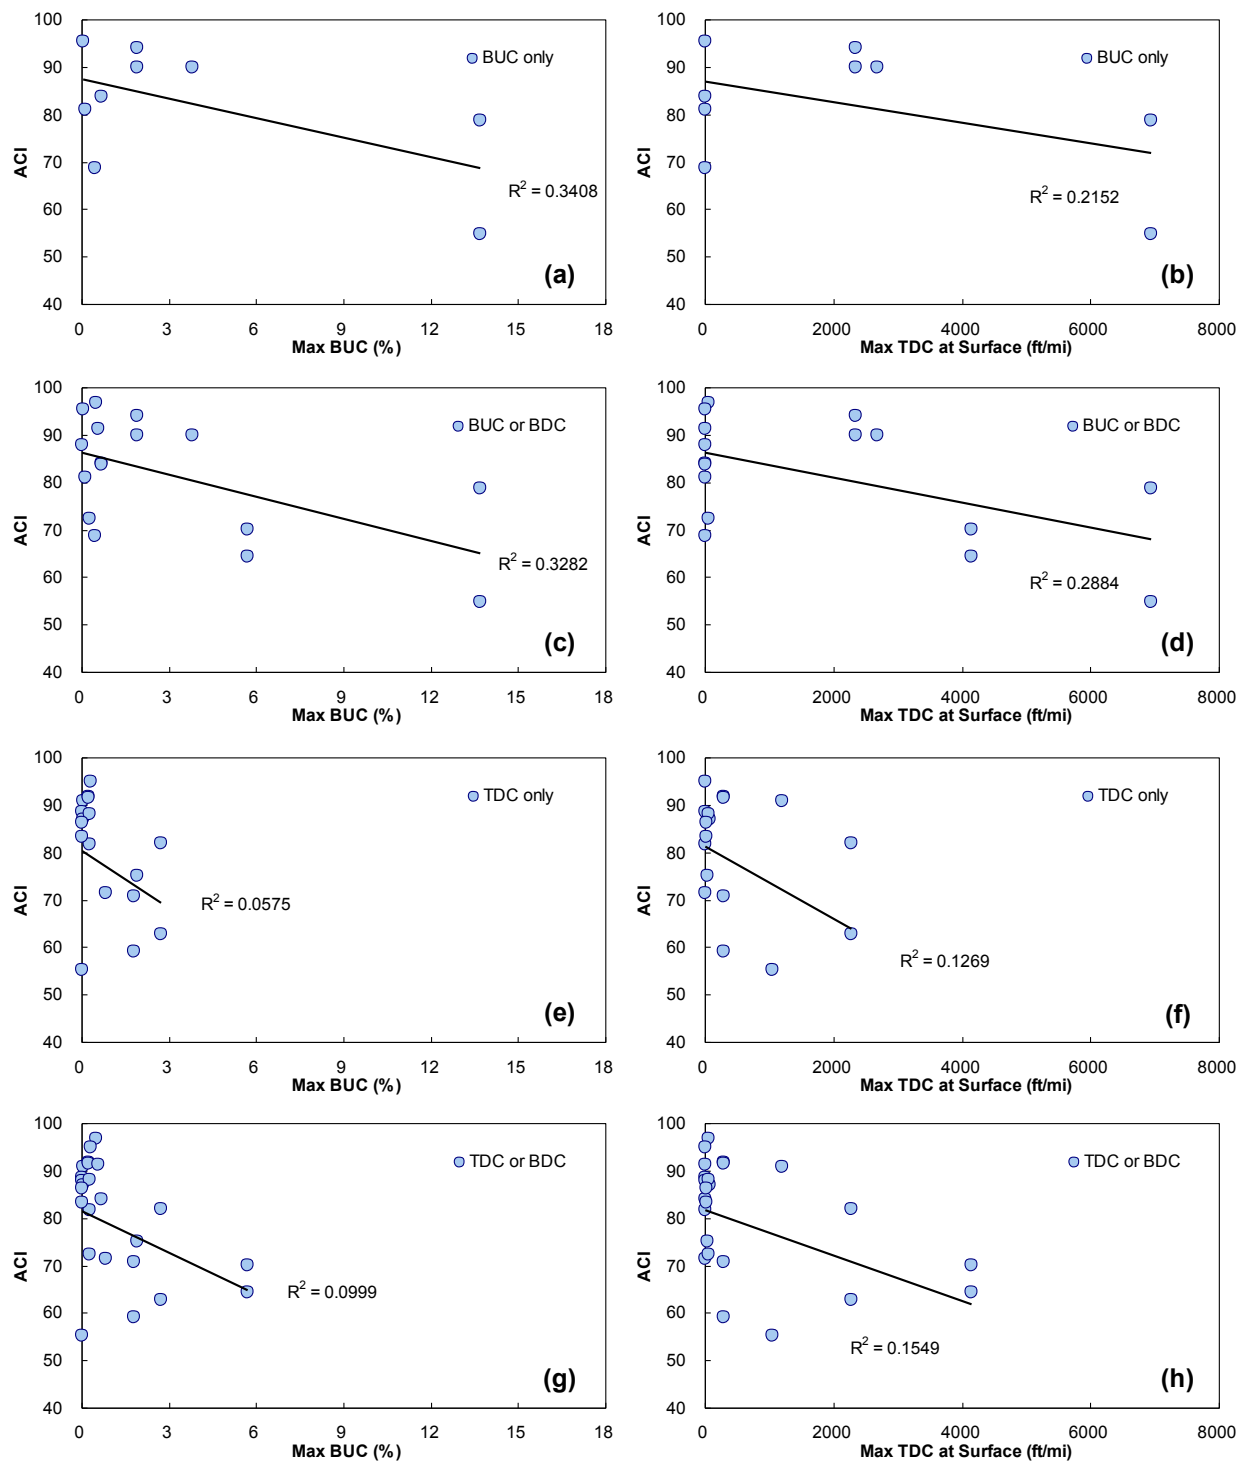
Figure 5.24 Comparison between ACI values and 20-year simulation results of maximum BUC% and maximum length of TDC at surface from DARWin-ME with lower-level inputs: (a) and (b) from BUC observed sites, (c) and (d) from BUC or BDC observed sites, (e) and (f) TDC observed sites, (g) and (h) from TDC or BDC observed sites.

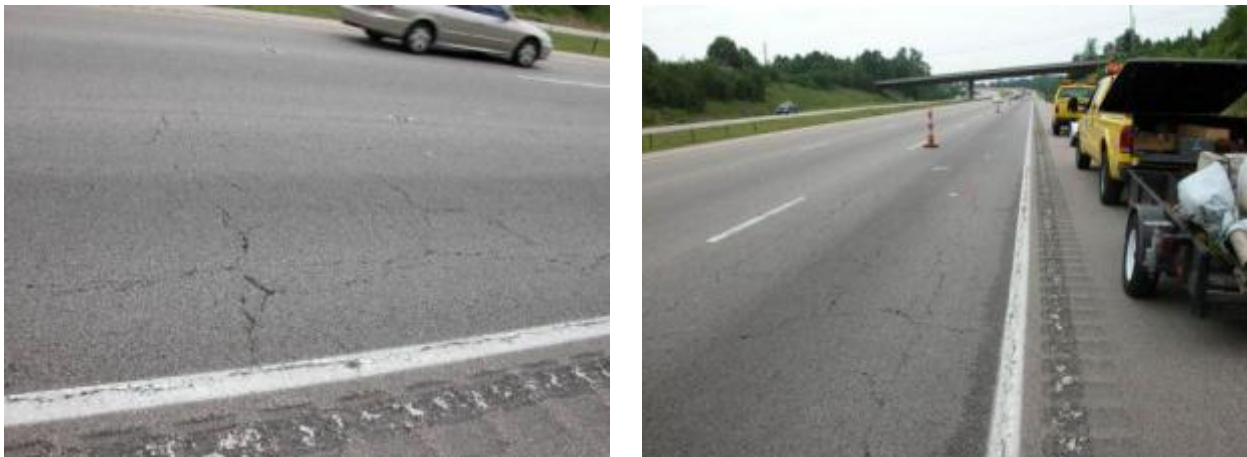
On June 22, 2011, NCDOT personnel and the research team took falling weight deflectometer (FWD) and dynamic cone penetrometer (DCP) measurements and extracted 26 cores from I-540 eastbound (EB) in Raleigh in Wake County. According to the NCDOT construction history and profile database, this section was constructed or resurfaced in 2002 using S12.5D, I19.0B, and B25.0B mixes and a cement treated aggregate base (CTAB). The thicknesses of each layer are $2\frac{3}{4}$, 3, and $4\frac{1}{4}$ inches, respectively. The Pavement Condition Rating of this section is marked as 84.2 in the 2010 condition survey. The field test level of this section is Level 1, and the condition of this section falls in the category of *Young and Poor* roadways. Of the 26 cores extracted from this section, 15 cores, including cores with smooth delamination, were in sound condition such that horizontal coring for lab testing could be completed. Figure B.1 shows representative cracking patterns in the section investigated.

Figure B.1 Photographs of cracking in ‘bad’ condition region of I-540, Raleigh, Wake County

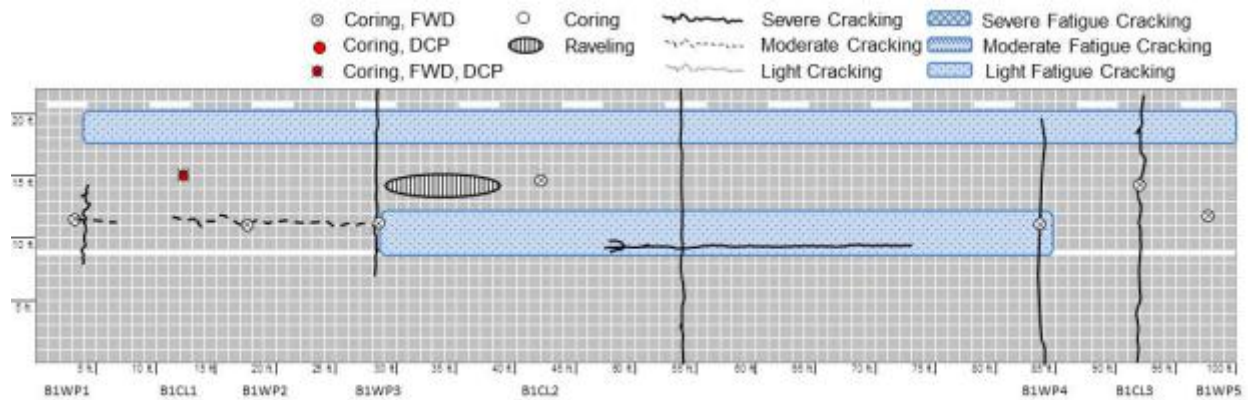
Figure B.3 Crack condition survey mapping of B1 region in I-540

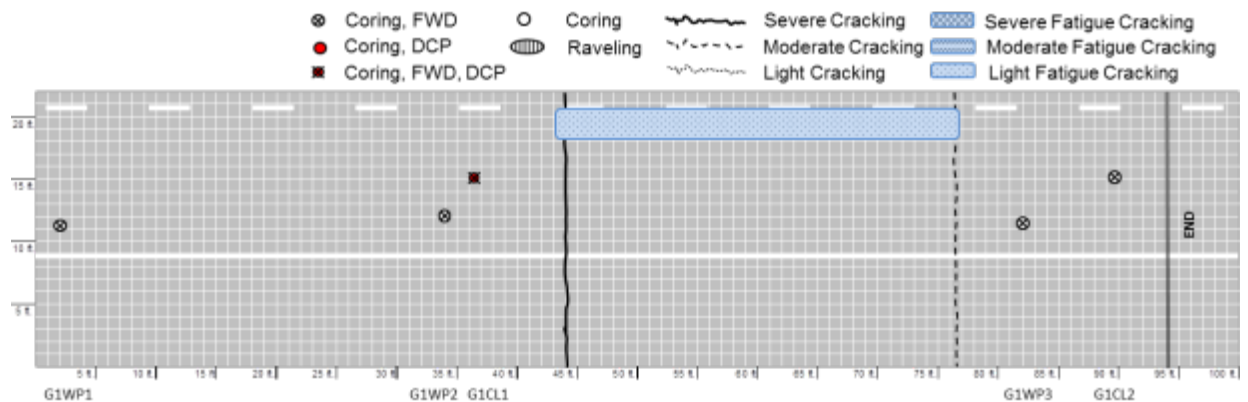
Figure B.4 Crack condition survey mapping of A1 region in I-540

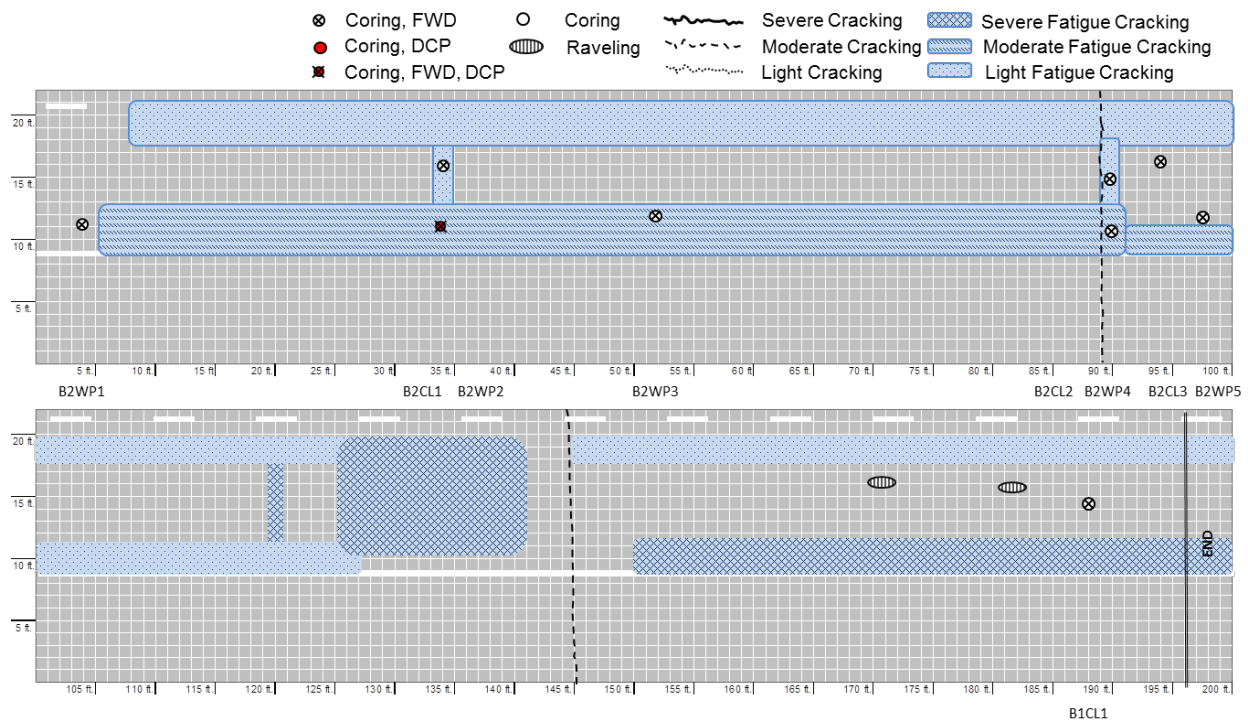
Figure B.5 Crack condition survey mapping of B2 region in I-540

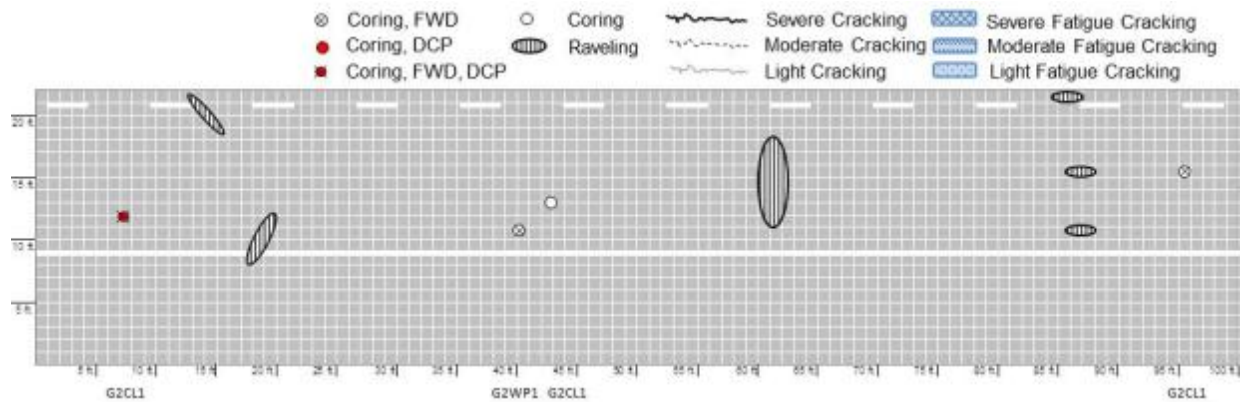
Figure B.6 Crack condition survey mapping of A2 region in I-540

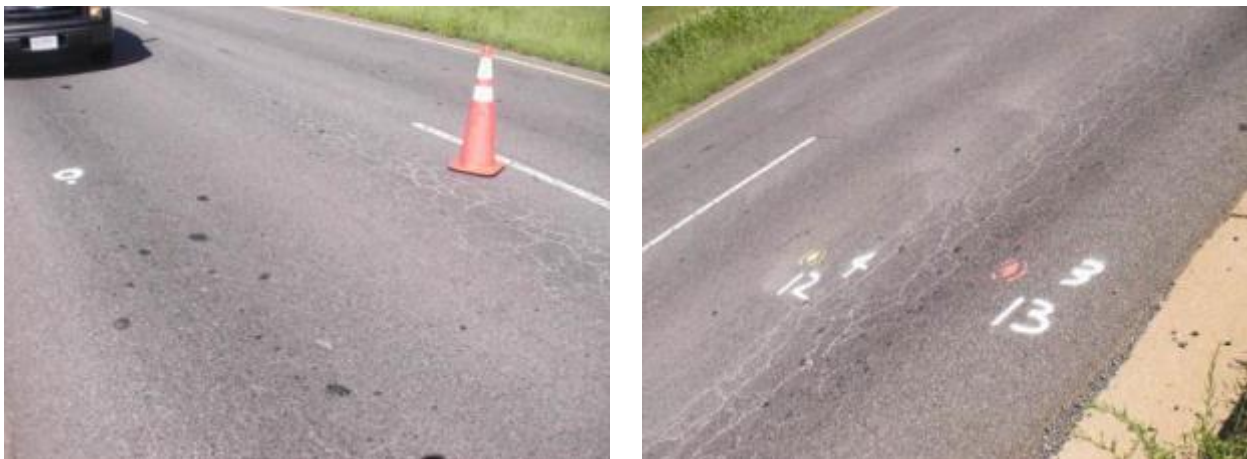
Although the entire section has the same construction history, and the condition survey targeted 1.4 miles in length, only a 0.6-mile segment was selected due to safety issues. This section is on one side only of a signal light. The overall cracking condition of the section is ‘moderate to severe’, but severe fatigue cracking was evident in a region of curved road. Fatigue cracking was found in both the inner and outer wheel paths, but was more prevalent in the outer wheel path. Figure B.7 shows fatigue cracking patterns in the ‘bad’ condition region.

Figure B.7 Photographs of cracking patterns in the ‘bad’ condition region of NC-24

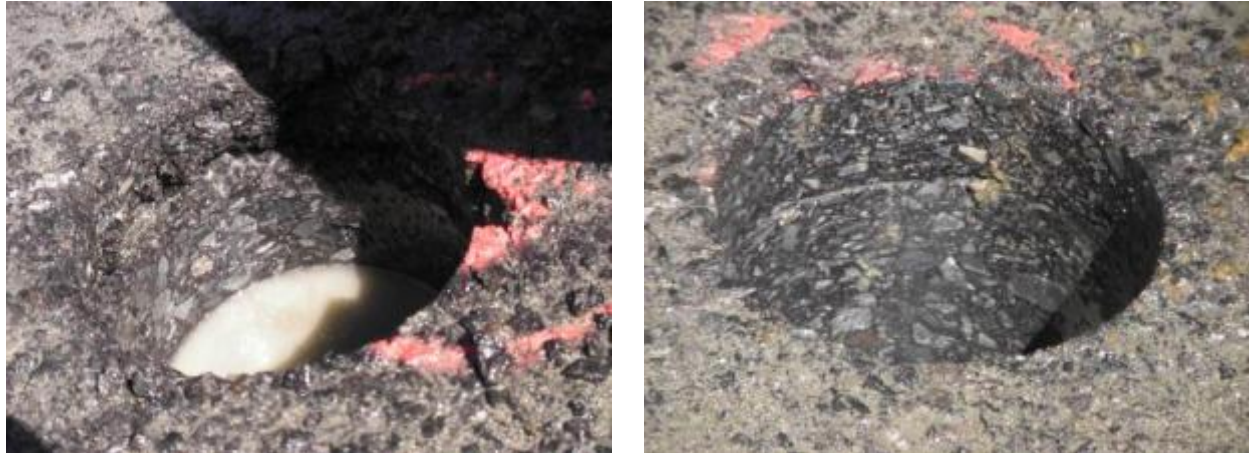
Some of the delamination found in other sections may be caused by the shear force caused by the movement of the core drill bit. However, the delamination in this section clearly shows that delamination was present prior to coring. Figure B.8 shows delamination lines in the material of the extraction holes. The photograph on the left-hand side of the figure shows the

delaminated areas of the hole, and the photograph on the right-hand side shows water that has leaked from a delamination line in the hole. Water leaked for quite a long time after coring, which indicates that the delaminated area near the hole was extensive.

Figure B.8 Photographs of delamination in ‘bad’ condition region of NC-24

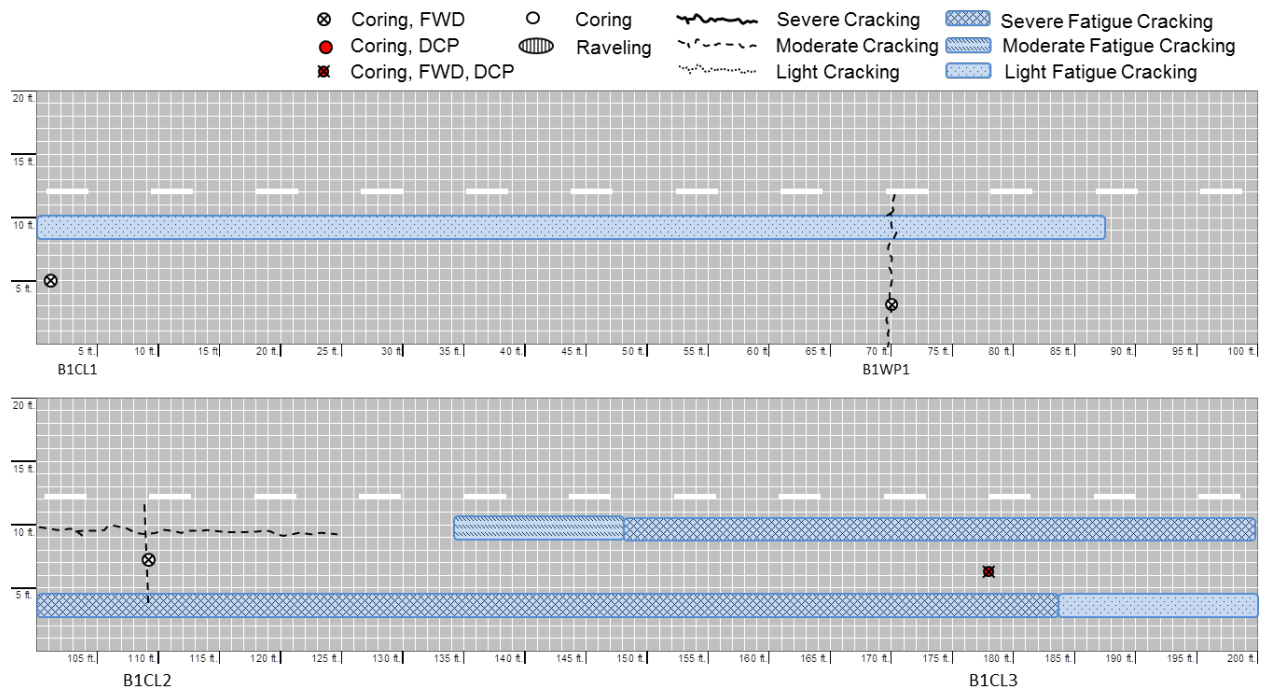
Figure B.10 Crack condition survey mapping of B1 region in NC-24

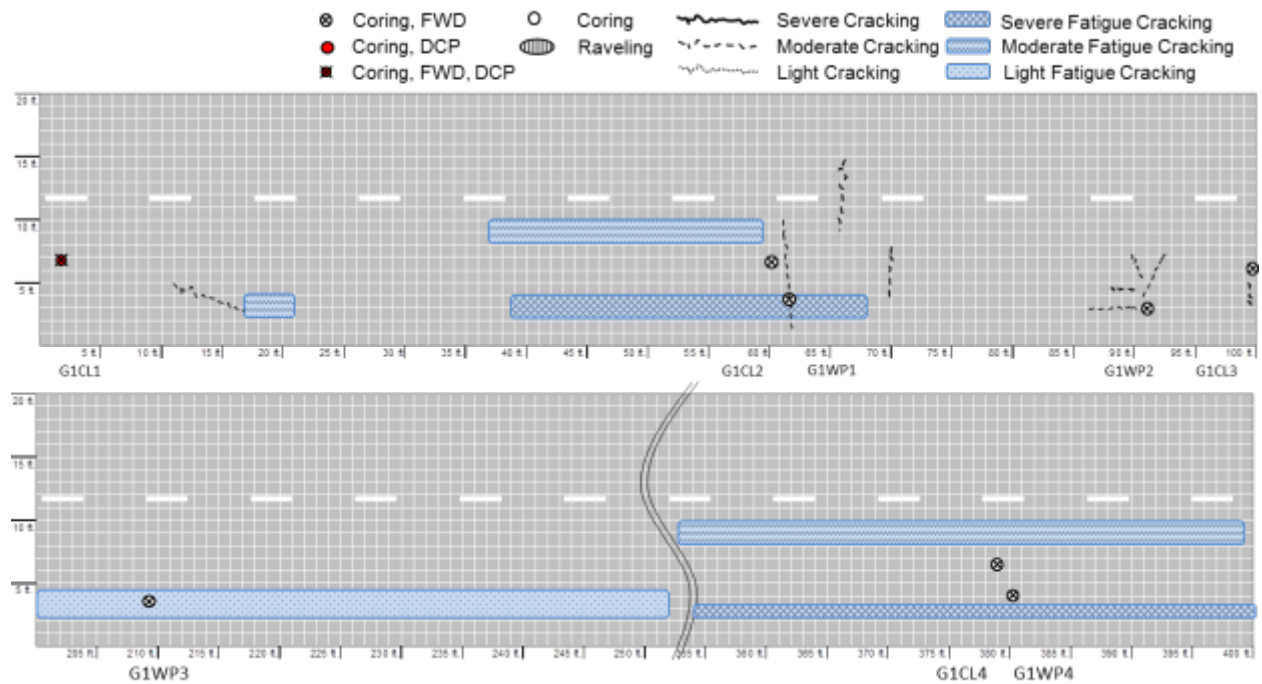
Figure B.11 Crack condition survey mapping of A1 region in NC-24

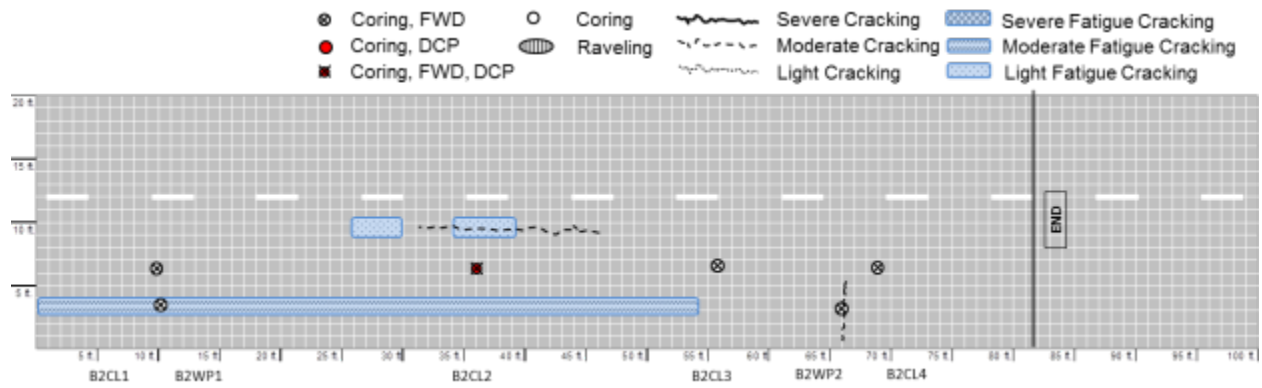
Figure B.12 Crack condition survey mapping of B2 region in NC-24

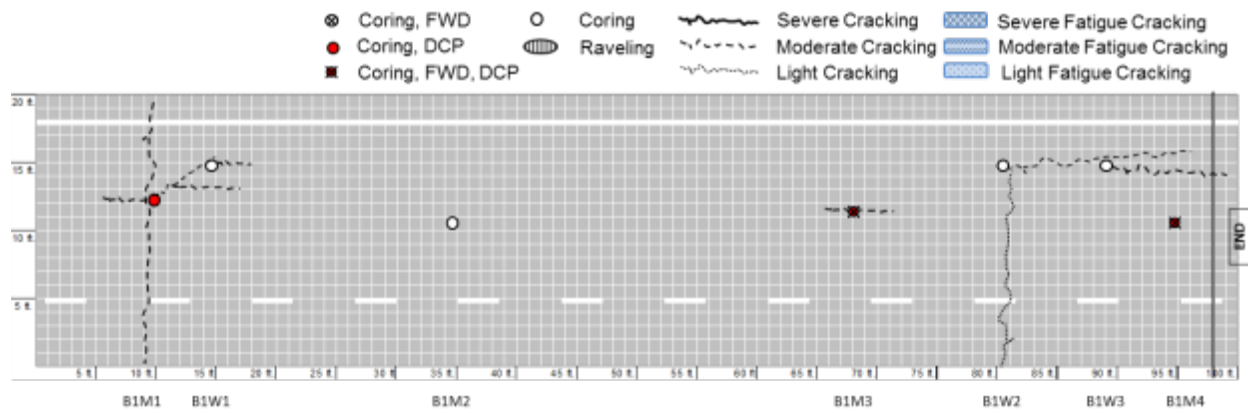
Figure B.14 Crack condition survey mapping of B1 region in US-17

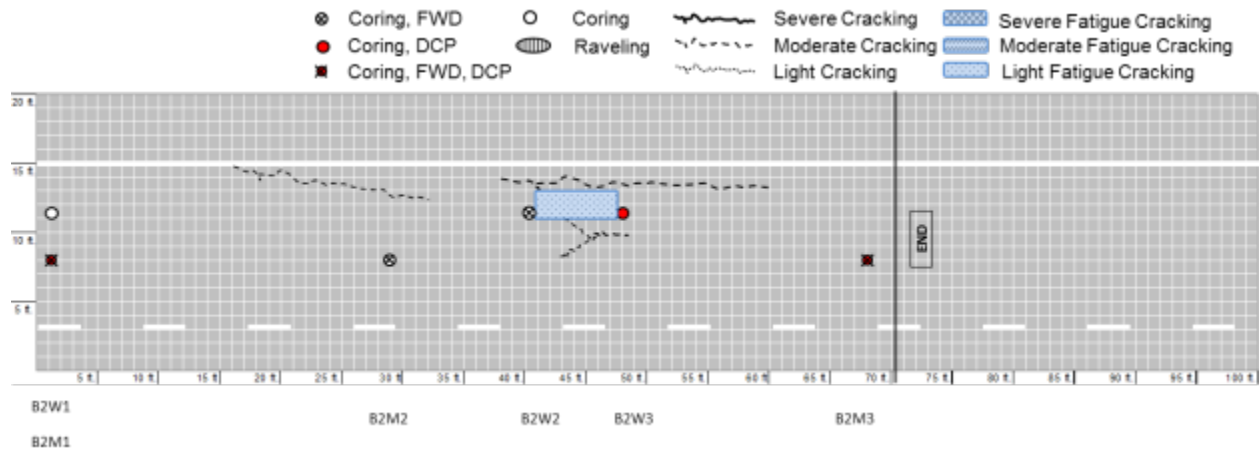
Figure B.15 Crack condition survey mapping of B2 region in US-17

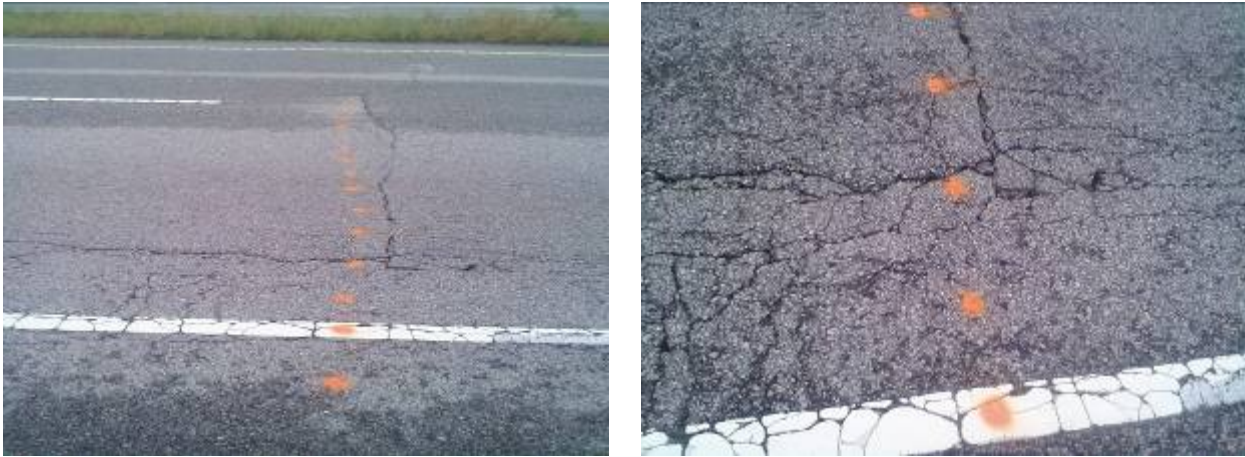
This section also is divided into two good regions and two bad regions like the other sections. In the second bad region of the section, severe longitudinal cracking and pavement drops were observed on the outer wheel-path. However, the overall longitudinal cracking on the wheel-path in this section was neither severe, as found in this particular location, nor is there a pavement drop. This cracking is only 218 feet long out of 0.98 mile. Such localized cracking appears to be caused by structural failures that, in turn, are caused by widening the roadway, because the thickness of the cores (B2-WP1, B2-WP3, and B2-WP3) from the adjacent areas is thinner than for the other cores. Further detailed investigation of this phenomenon will be needed in the upcoming quarter. Figure B.18 shows part of the severe longitudinal cracking on the outer wheel-path and the pavement drop.

Figure B.18 Photographs of cracking and pavement drop in second bad region in the section (same location but difference in detail)

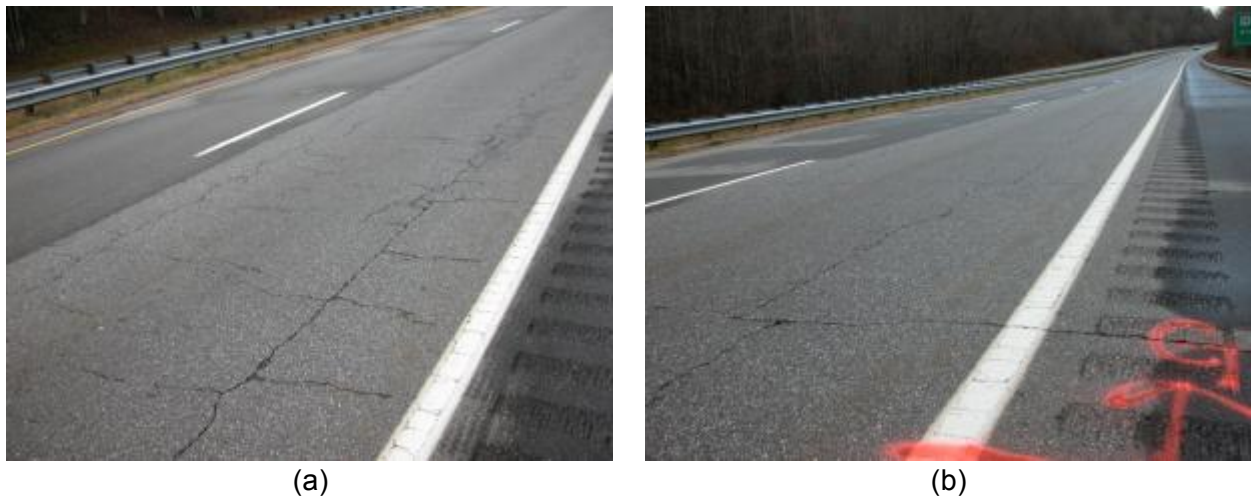
On November 17, 2011, NCDOT personnel and the research team took FWD measurements and extracted 15 cores from US-74 westbound in Bryson City, Swain County. This section is a 2-lane divided highway in the Smoky Mountains. The total length of the section that was constructed at the same time is 2.23 miles. A 12,000 foot segment on relatively straight and flat ground was selected for testing because the safety of field personnel is compromised on extremely winding and steep roadways in the Smoky Mountains. According to the NCDOT construction history and profile database, previous surface treatments include: 1½ inches of S9.5B mixture, 1 inch of I-2 mixture, 2 inches of BCSC mixture, and 2 inches of bituminous concrete binder (BCBIN) that were constructed in 2002, 1988, 1976 and 1976, respectively. The field test level of this section is Level 1, and the condition of this section falls in the category of *Young and Poor* roadways. The overall condition of this section is *Poor*, and distinguishing between *good* condition locations and *bad* condition locations was difficult. Therefore, the test results from the *good* and *bad* locations are not expected to differ significantly. Representative cracking patterns in a *bad* location (a) and a *good* location (b) are shown in Figure B.29.

Figure B.29 Photographs of representative cracking patterns on US-74, Bryson City, Swain County: (a) *bad* location, and (b) *good* location

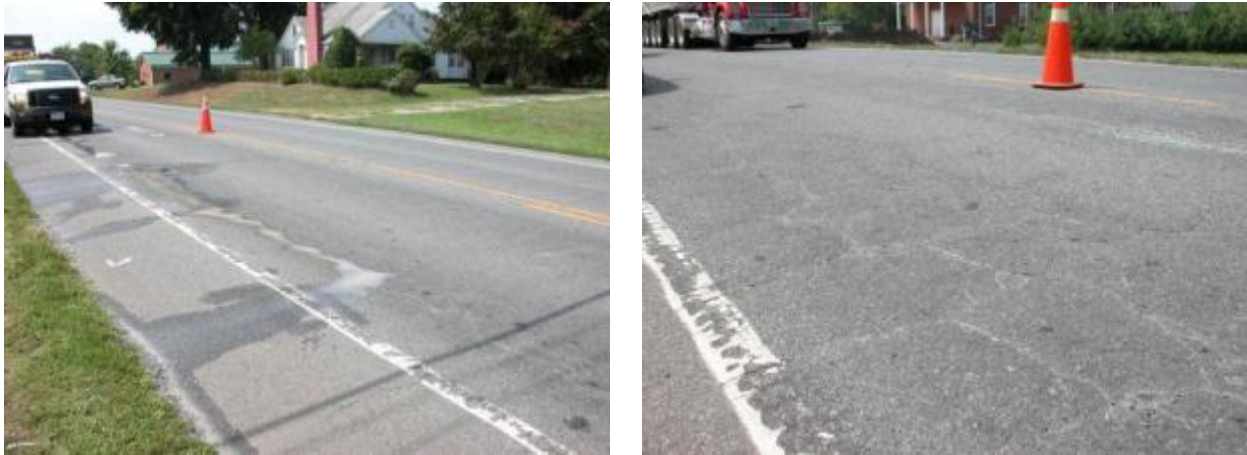
Figure B.33 shows cracking patterns in the section. Longitudinal cracking and irregular interval transversal cracking are distributed throughout the entire section. Permanent deformation on the outer wheel path is more severe than for the other sections. This distress may be caused by the high volume of truck traffic and the low speed limit.

Figure B.33 Photographs of cracking patterns on US-601

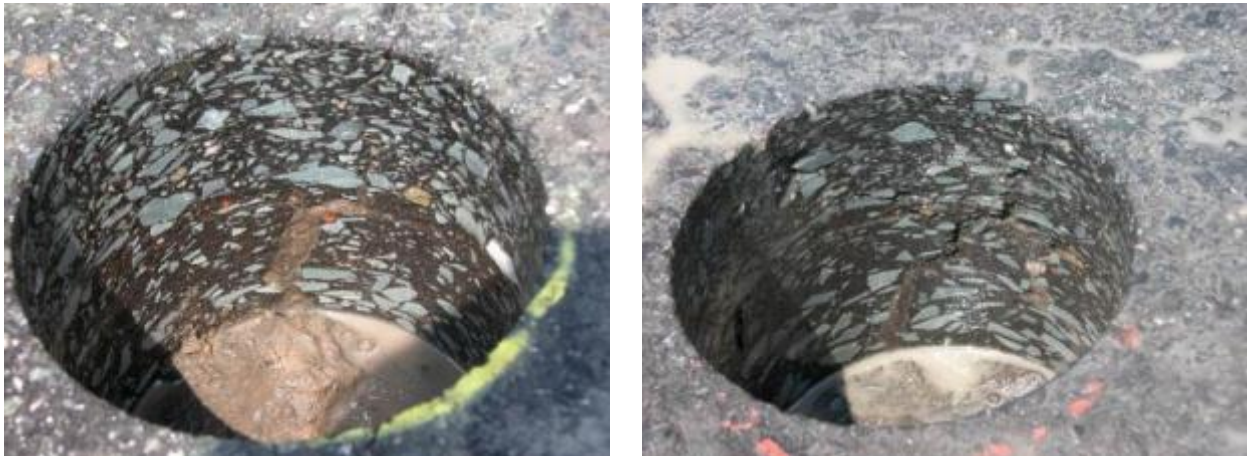
Summaries of all the pavement core data are given in Table B.9 and Table B.9, and photographs of those cores are shown in Figure B.35. Three cores have wide soil-filled cracks at the bottom of the cores. It is not clear when the soil filled these cracks, but there is a high possibility that the soil-filled cracks were not milled or cleaned prior to the overlay construction. That is, most of the soil-filled cracks are not connected to the vertical cracks that begin from the

top surface of the cores. Figure B.34 shows the cracks and delamination line filled with soil or dust.

Figure B.34 Photographs of delamination and cracks filled with soil on US-601

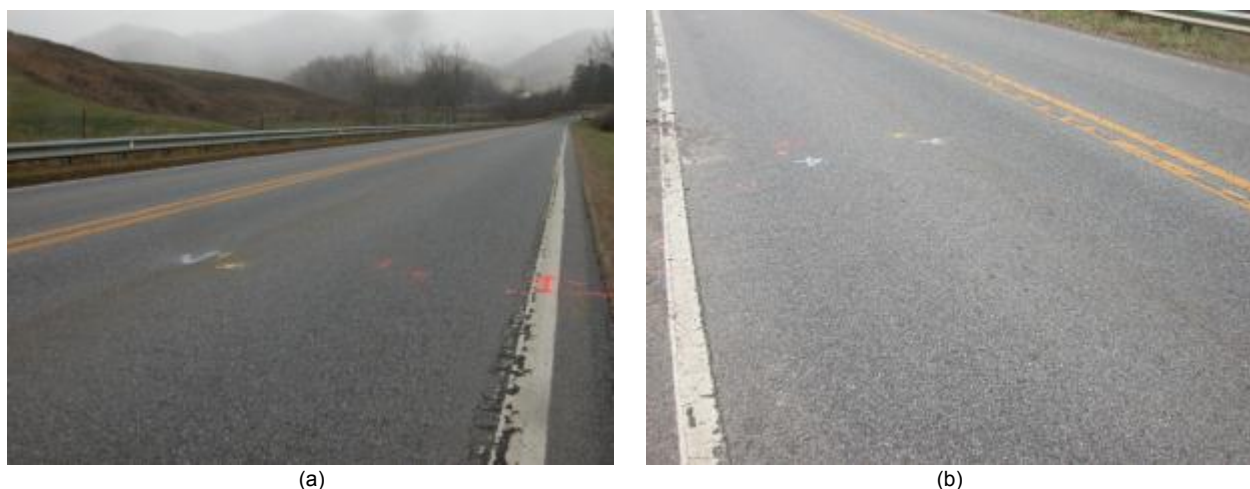
Of the 16 cores extracted from this section, all 16 cores were in sound condition, so horizontal coring for lab testing could be completed. The noticeable characteristic of this section is that, although it was constructed in 1994, it contained no cracks at all, according to observations made by the research team. Therefore, the research team contacted the Division maintenance engineer to query the NCDOT database record; the Division maintenance engineer replied that no resurfacing had been conducted after initial construction. Therefore, distinguishing between *good* condition locations and *bad* locations in this section was based on surface smoothness rather than cracking conditions. Similar test results from the two different condition locations were expected. The photographs in Figure B.39 show a *good* condition location (a) and a *bad* condition location (b). A summary of all pavement core data is given in Table B.11, and photographs of the cores are shown in Figure B.40.

Figure B.39 Photographs of cracking patterns on NC-209, Clyde, Haywood County: (a) *good* condition location, and (b) *bad* condition location

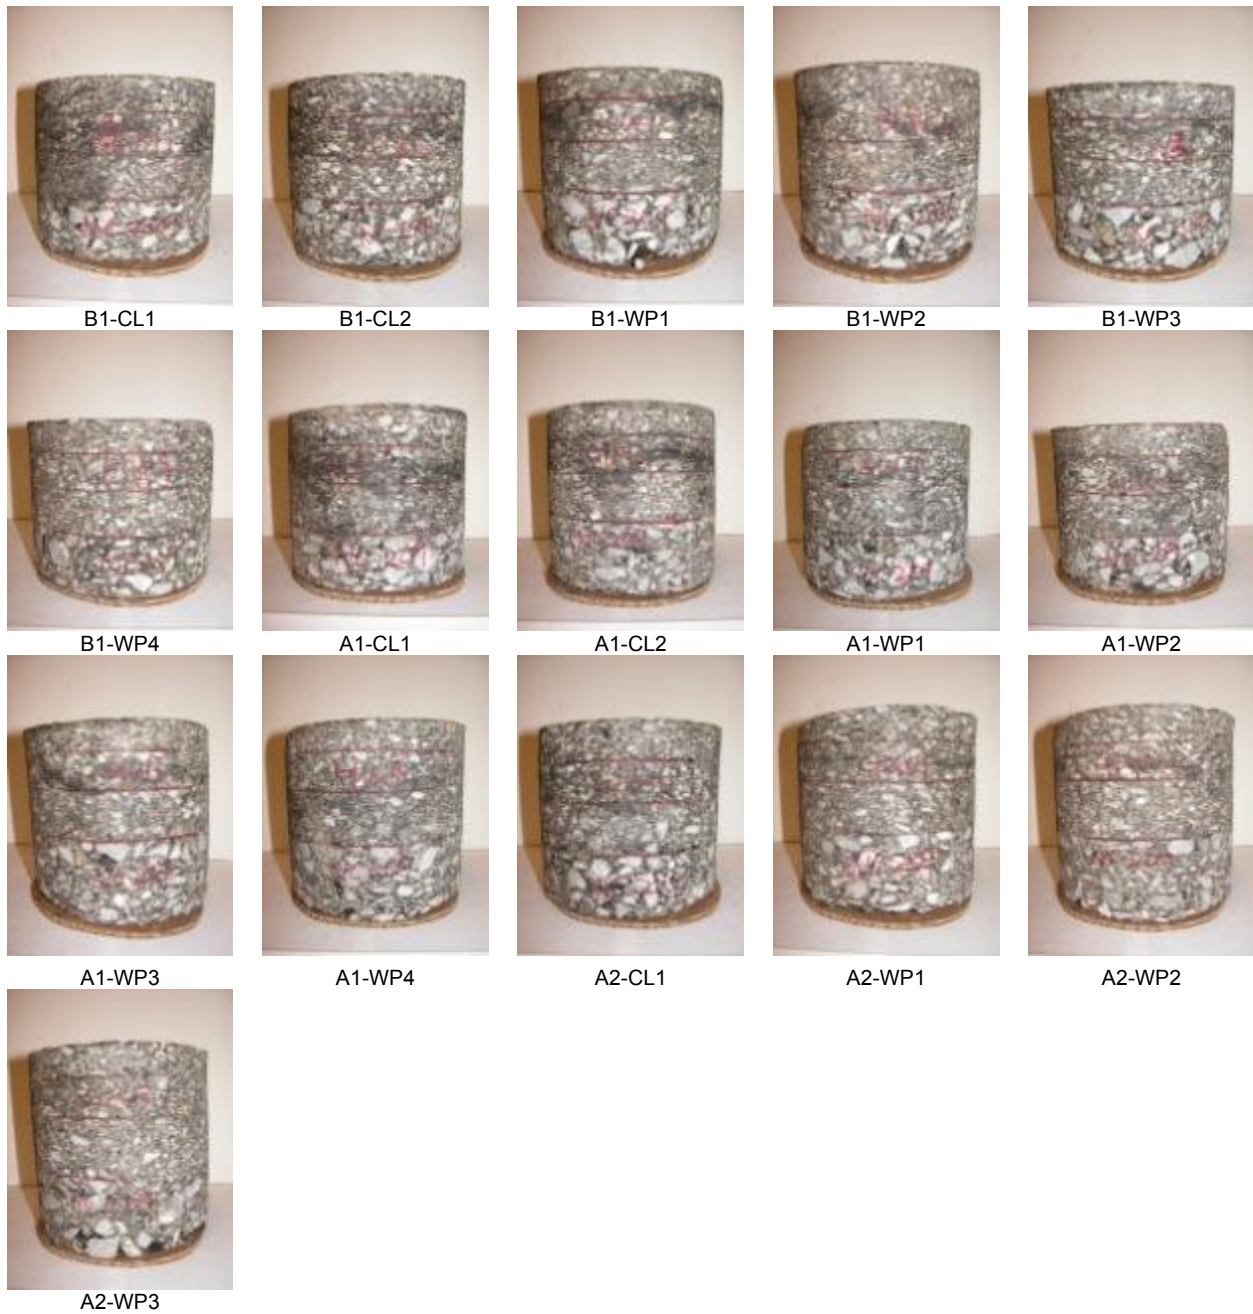
Figure B.40 cores taken from NC-209, Clyde, Haywood County

ID	Layer Thickness (inch)				Condition
	Layer 1			Layer 2	
	Sub 1	Sub 2	Sub 3		
A1-CL1	1	1	1 1/4	1 5/8	Sound condition
A1-CL2	7/8	1	1/4	2	Sound condition
A1-WP1	3/4	7/8	1 1/4	1 7/8	Sound condition
A1-WP2	3/4	7/8	1 1/16	1 5/8	Sound condition
A1-WP3	3/4	7/8	1 1/4	2	Sound condition
A1-WP4	3/4	1	1 3/8	2	Sound condition
B1-CL1	3/4	1 1/8	1	1 5/8	Sound condition
B1-CL2	1	1 1/16	1 1/8	1 3/4	Sound condition
B1-WP1	3/4	1	1 1/4	2	Sound condition
B1-WP2	1 7/8	1	1 1/4	2	Sound condition
B1-WP3	3/4	1	1 1/8	1 3/4	Sound condition
B1-WP4	3/4	7/8	1 1/8	1 5/8	Sound condition
A2-CL1	1	1	1 3/8	1 3/4	Sound condition
A2-WP1	7/8	1 1/8	1 1/4	2 1/4	Sound condition
A2-WP2	15/16	7/8	1 1/2	2 1/4	Sound condition
A2-WP3	3/4	1	1 5/8	2 1/4	Sound condition

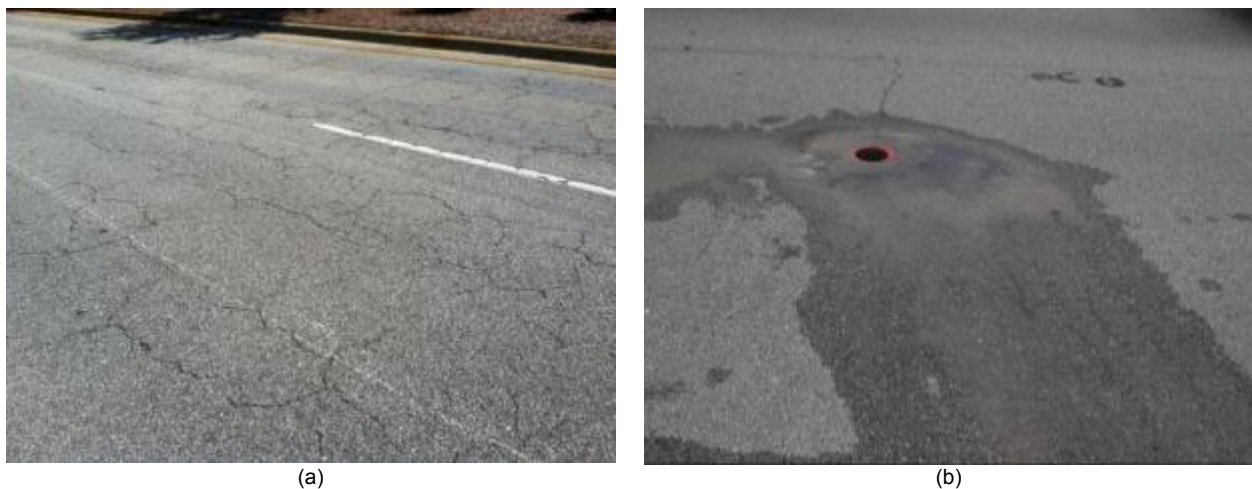
Figure B.44 (a) and (b) show severe fatigue cracking in the bad condition region, and the good condition region shows a dramatically better surface condition and a different cracking pattern from that seen in the bad region. Also, cores taken from the good condition region have more layers than the cores extracted from the bad condition region. This pavement structural difference may be the cause of the dramatically different cracking patterns seen on the surface. It is not clear to judge from a visual inspection, but it appears that the construction history data match the cores from the good condition region better than those from the bad condition region. Once the gradation analysis is complete, this hypothesis can be confirmed or denied. The BW1 core shown in Figure B.45 clearly exhibits top-down cracking.

Figure B.44 Photographs of representative cracking patterns on US-76, Wilmington, New Hanover County: (a) *bad* location and (b) *good* location

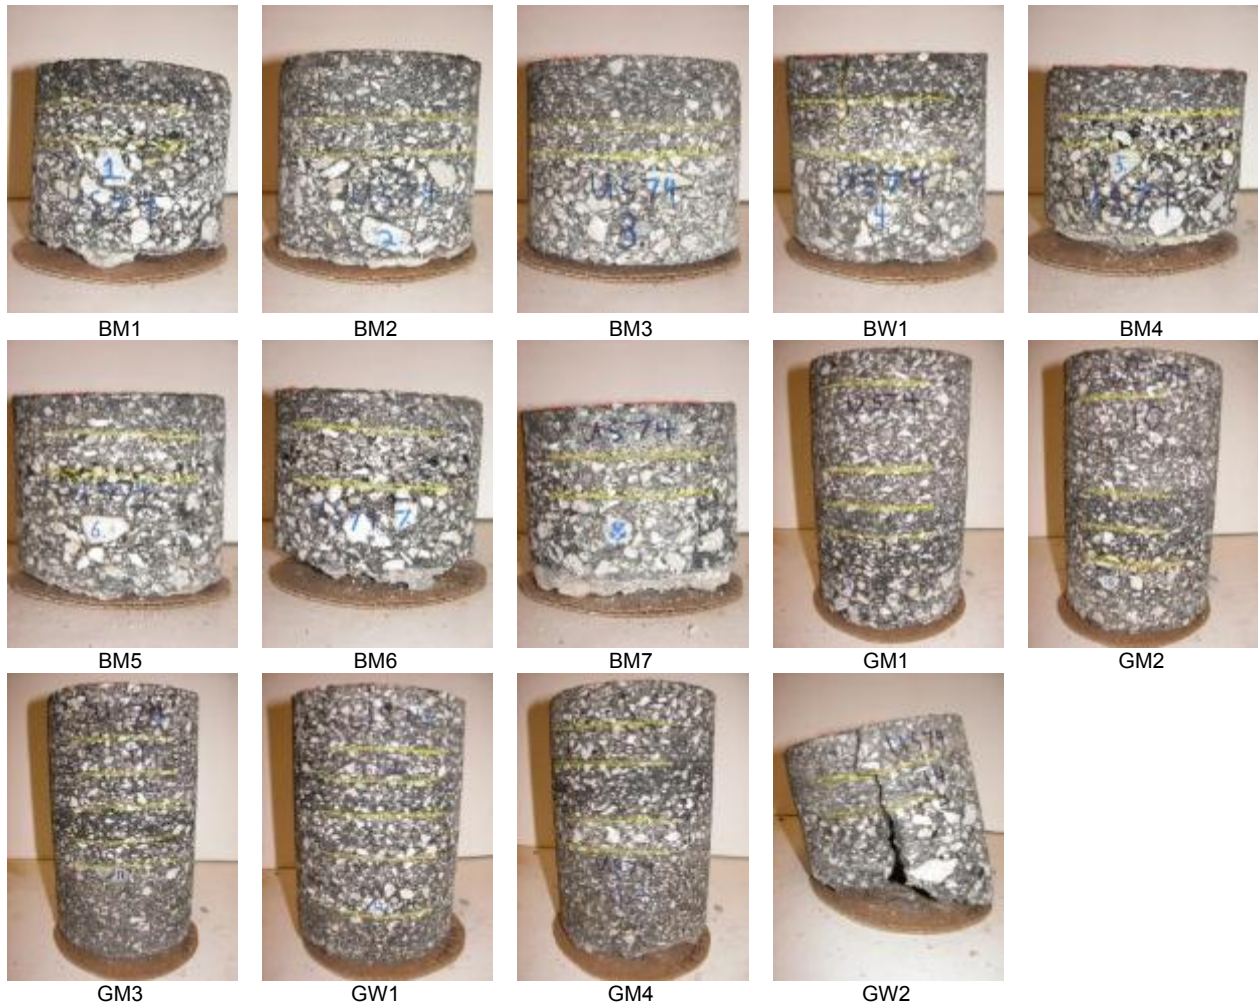
Figure B.45 Photographs of cores taken from US-76, Wilmington, New Hanover County

ID	Layer Thickness (inch)					Condition
	1st	2nd	3rd	4th	5th	
BM1	1 1/8	1	2 3/8			Sound
BM2	1 4/8	7/8	2 5/8			Sound
BM3	1 4/8	6/8	2 4/8			Sound
BW1	1 1/8	1 4/8	2 4/8			Cracks on surface connected to vertical crack through the middle of 2nd layer
BM4	1 1/8	6/8	2			Sound
BM5	7/8	1	2 5/8			Sound
BM6	7/8	1 2/8	2			Sound
BM7	1 1/8	7/8	1 7/8			Sound
GM1	1	2 3/8	1 1/8	1	3 2/8	Sound
GM2	1 3/8	2 6/8	1 1/8	1 1/8	2 4/8	Sound
GM3	1 4/8	1	1 1/8	1	6/8	Cracks on surface connected to vertical crack through the middle of 1st layer
GW1	1 5/8	7/8	7/8	1 1/8	1 5/8	Cracks on surface but no vertical cracks
GM4	1 1/8	1	1 5/8	7/8	3 2/8	Sound
GW2	1 1/8	7/8	1 7/8			Full-depth vertical crack
