Investigation of Primary Causes of Fatigue Cracking in Asphalt Pavement in North Carolina

NCDOT Project 2010-01

FHWA/NC/2010-01

March 2015

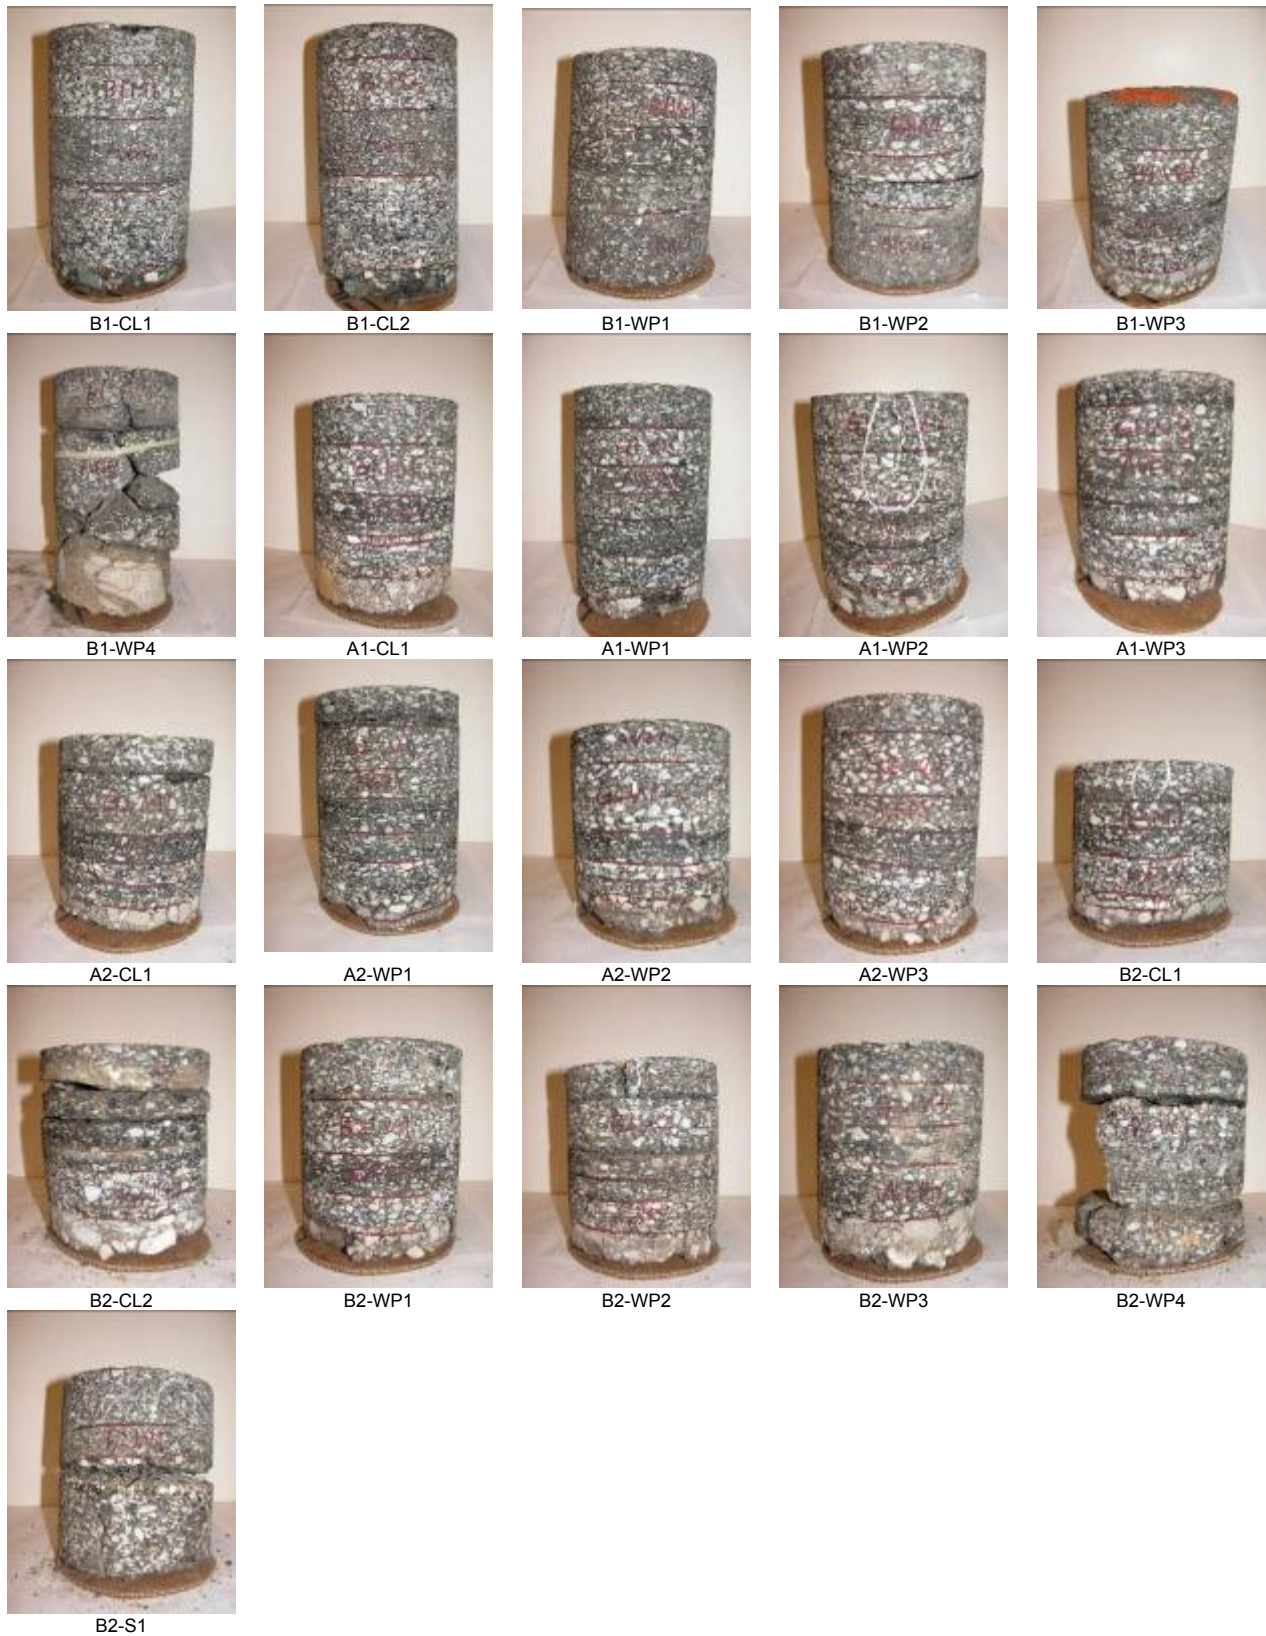
Figure B.49 Cores taken from NC-194 EB, Banner Elk, Avery County

ID	Note
B1-CL1	Sound condition
B1-CL2	Sound condition
B1-W1	Delamination between 3rd & 4th layers, marking paint on delamination surface, vertical crack from surface to delamination line
B1-WP2	Thickness of 4th layer not measured due to loose mixture condition material, cracks on top surface but no vertical crack, delamination between 3rd & 4th layers
B1-WP3	Delamination between 3rd & 4th layers, cracks on top surface but no vertical cracks
B1-WP4	Totally broken in pieces, no thickness measurement possible
A1-CL1	Sound condition
A1-WP1	Sound condition
A1-WP2	Vertical cracks begin from surface to top of 3rd layer, resembles top-down cracking, crack on surface
A1-WP3	Delamination between 3rd & 4th layers, looks like 3rd & 4th layers are same mixture and/or construction period
A2-CL1	Delamination between 1st & 2nd layers, vertical crack in 1st layer connected to cracks on surface
A2-WP1	Delamination between 1st & 2nd layers

A2-WP2	Sound condition
A2-WP3	Cracks on top surface but no vertical cracks
B2-CL1	Partial delamination between 1st & 2nd layers, vertical crack in 1st layer connected to cracks on surface
B2-CL2	Delamination between 1st & 2nd layers and 2nd & 3rd layers, vertical crack in 2nd layer, no cracks on surface.
B2-WP1	Cracks on top surface but no vertical cracks
B2-WP2	Delamination between 1st & 2nd layers and 2nd & 3rd layers, cracks on top surface connected to 2 vertical cracks in 1st layer
B2-WP3	Macrocrack on top surface but no vertical cracks
B2-WP4	Delamination between 1st & 2nd layers and 2nd & 3rd layers, totally broken except for top layer
B2-S1	Horizontal crack in middle of 3rd layer, thickness of 3rd layer could not be measured, marking paint on surface, vertical crack in 4th layer

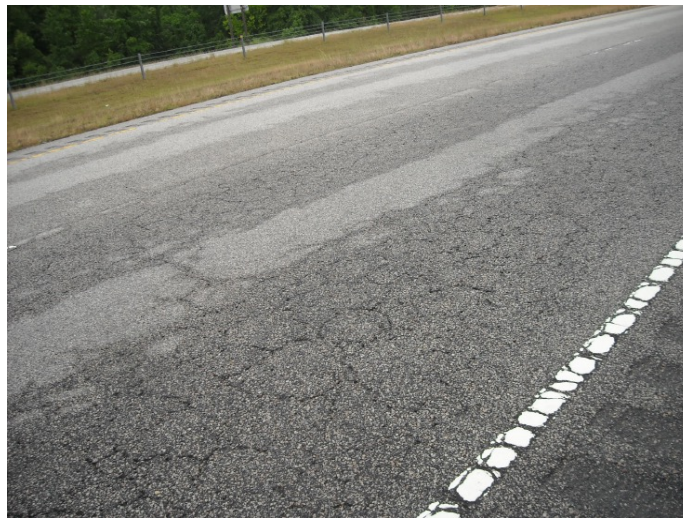
On June 9, 2010, PMU personnel and the research team took FWD and DCP measurements and extracted 19 field cores from US-13 westbound (WB) near Williamston in Martin County. The research team also conducted crack mapping of the sections where the cores were extracted. This test section is estimated to be seven years old and was showing significant wheel path cracking, as shown in

Figure B.54 Example of fatigue cracking along the US-13 Williamston test section.

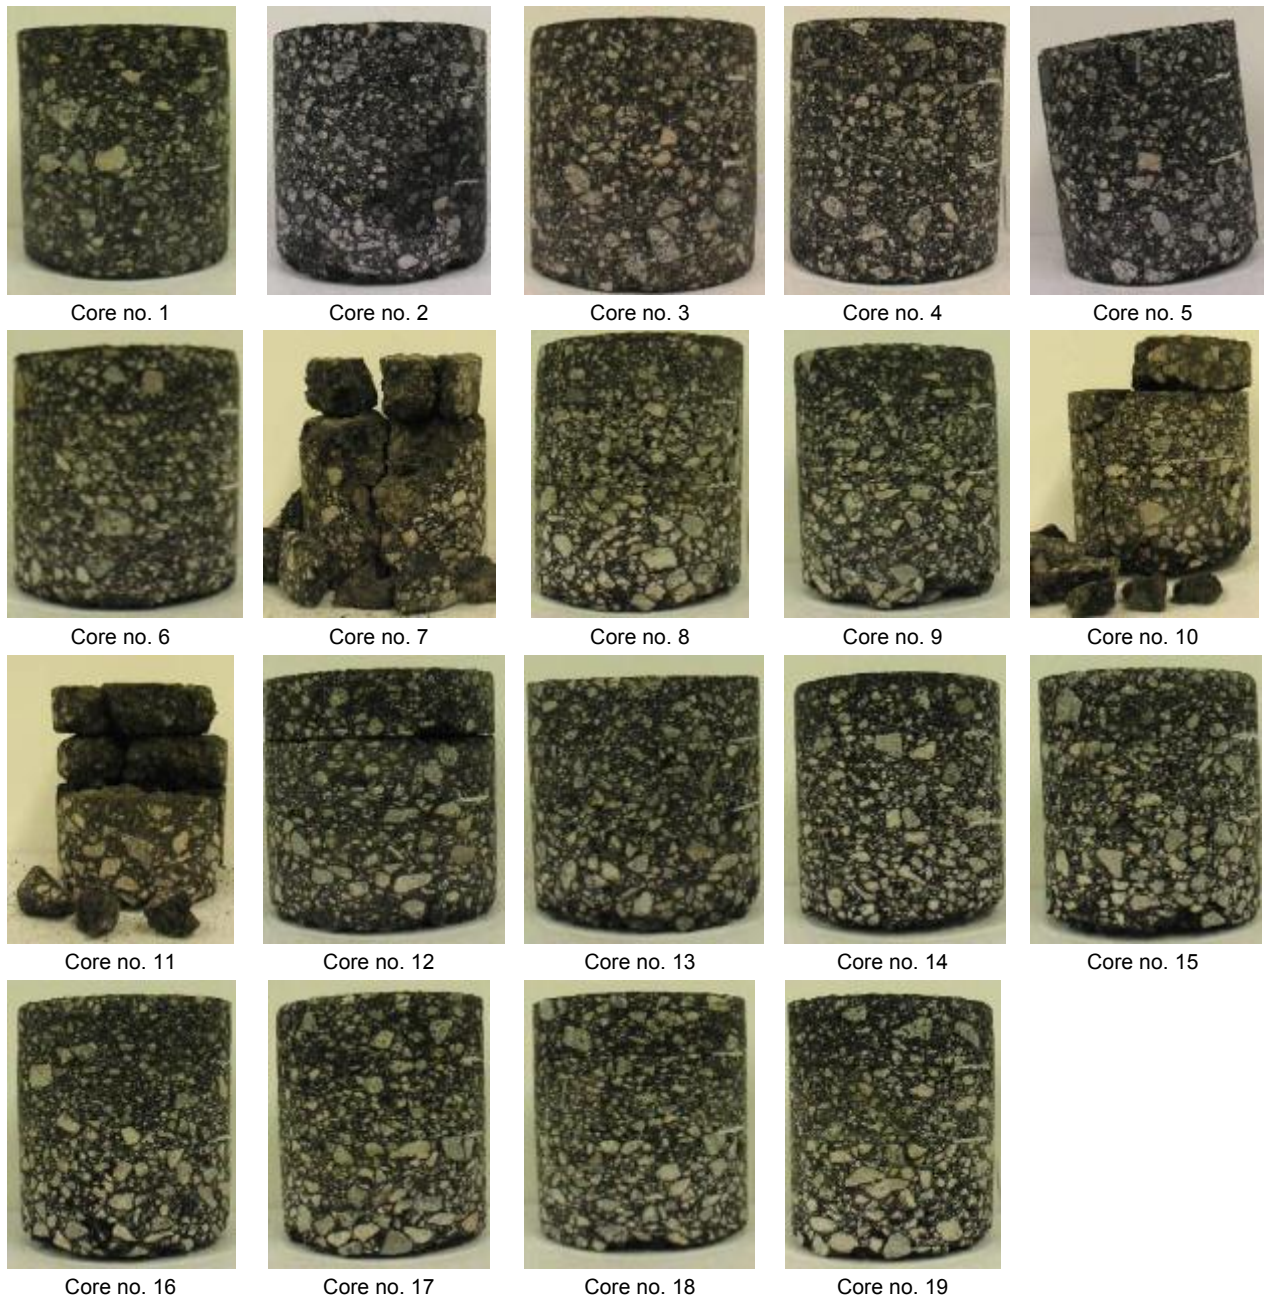
Figure B.55 Cored field samples taken from US-13 West bound, Williamston, Martin County, North Carolina.

Of the 19 cores taken, 14 were obtained in sound condition so that horizontal coring for lab testing could be completed. The remaining 5 cores were taken from cracked areas to examine issues of top-down versus bottom-up cracking and to check for delamination. Most of the cores clearly showed that a tack coat had been applied between the layers. However, the four cores that were observed to have delamination did not show the presence of a tack coat between the layers. In North Carolina, a tack coat is not required if the upper layer is placed immediately after the lower layer. It is unclear if the application or non-application of a tack coat will be a reoccurring trend in study sections that show delamination; nonetheless, this finding does suggest that it may be necessary to obtain detailed construction records for this project. Delamination also may be caused by a structural collapse near the cored location that is caused by an insufficient sub-base layer or sub-grade support. Insufficient support may be the result of a drainage problem,

localized structural weakness, or bottom-up cracking. Additional and detailed investigation will be needed in the upcoming quarter.

Images of all of the pavement cores are shown in Figure B.55, and a summary of each is given in Table B.15. Core 5 is one of primary interest because it shows a crack in the surface layer and the upper part of the intermediate layer. This core can be regarded as either top-down cracking or a trace of bottom-up cracking that has spread diagonally through the pavement thickness. Photographs and crack mapping data will be used to try to clarify whether the observed cracking is in fact top-down cracking or a reflection of nearby bottom-up cracking. None of the other 19 cores show evidence of top-down cracking, but several of the cores show clear evidence that cracking had spread through the thickness (cores 7, 10, and 11). It is also worth noting that, although core 12 shows delamination between the top and second lifts, it is not clear if this delamination occurred while in service or through the coring operation.

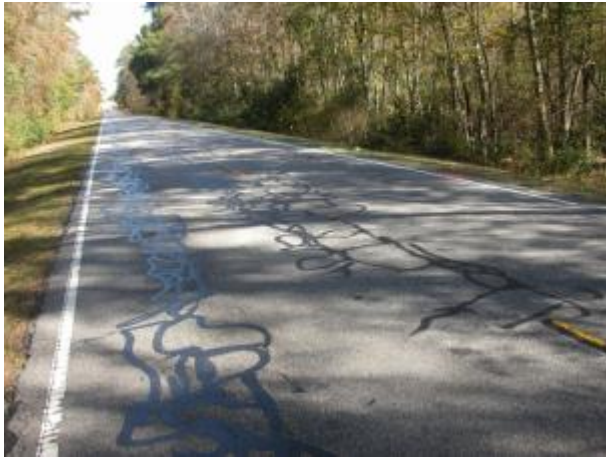
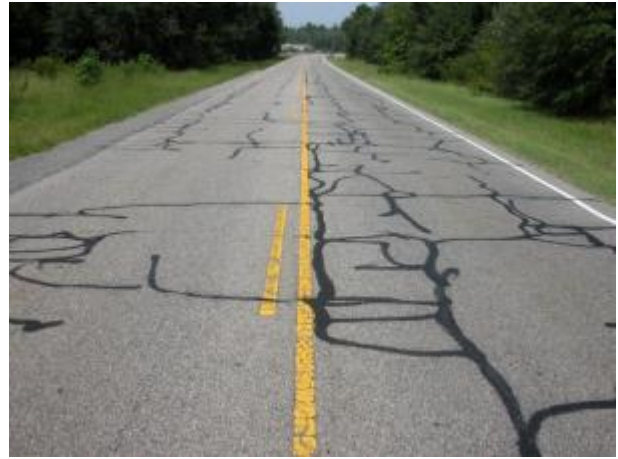
Figure B.60 shows crack sealing that was conducted several years ago. (Note: the research team asked the Division maintenance engineer for exact dates for this project, but written records of the project date could not be found.) A noticeable characteristic of this section is the pavement color, which is lighter than other sections that were constructed during approximately the same period. This color differential indicates that excessive oxidization may have caused the fatigue cracking that is evident in this section. Therefore, the research team was very interested in testing the binder in this section. Also, as shown in Figure B.61, this section has about 5 mm of natural gravel (6th layer) that exhibits a weak bond. Of the 24 cores extracted, 23 cores have a broken layer in the middle of the 6th layer due to the shear force caused by the core drill bit during the coring procedure. The yellow circles in each of the photographs presented in Figure B.61 show the material used for the 6th layer.

Figure B.60 Photographs of crack seal section

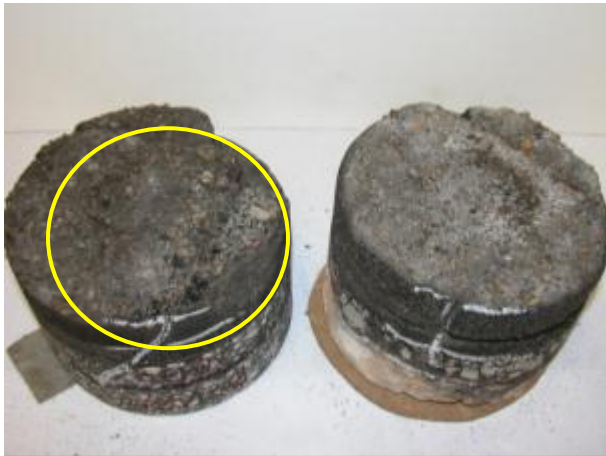
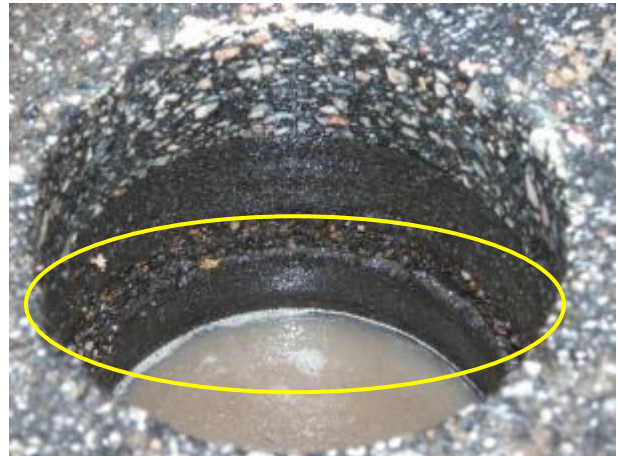
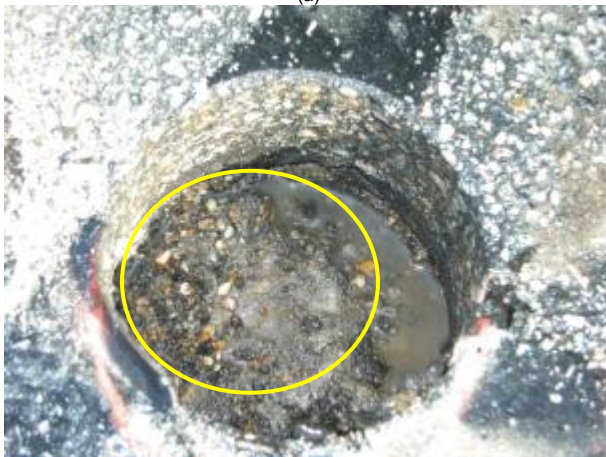
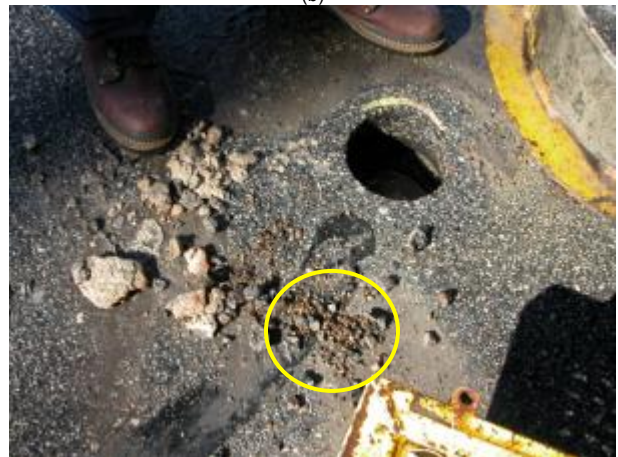
Figure B.61 Photographs of material used for 6th layer of the cores: (a) broken 6th layer in B2-WP4 core, (b) 6th layer in a coring hole, (c) broken surface of 6th layer stuck in a coring hole, and (d) broken material found in 6th layer

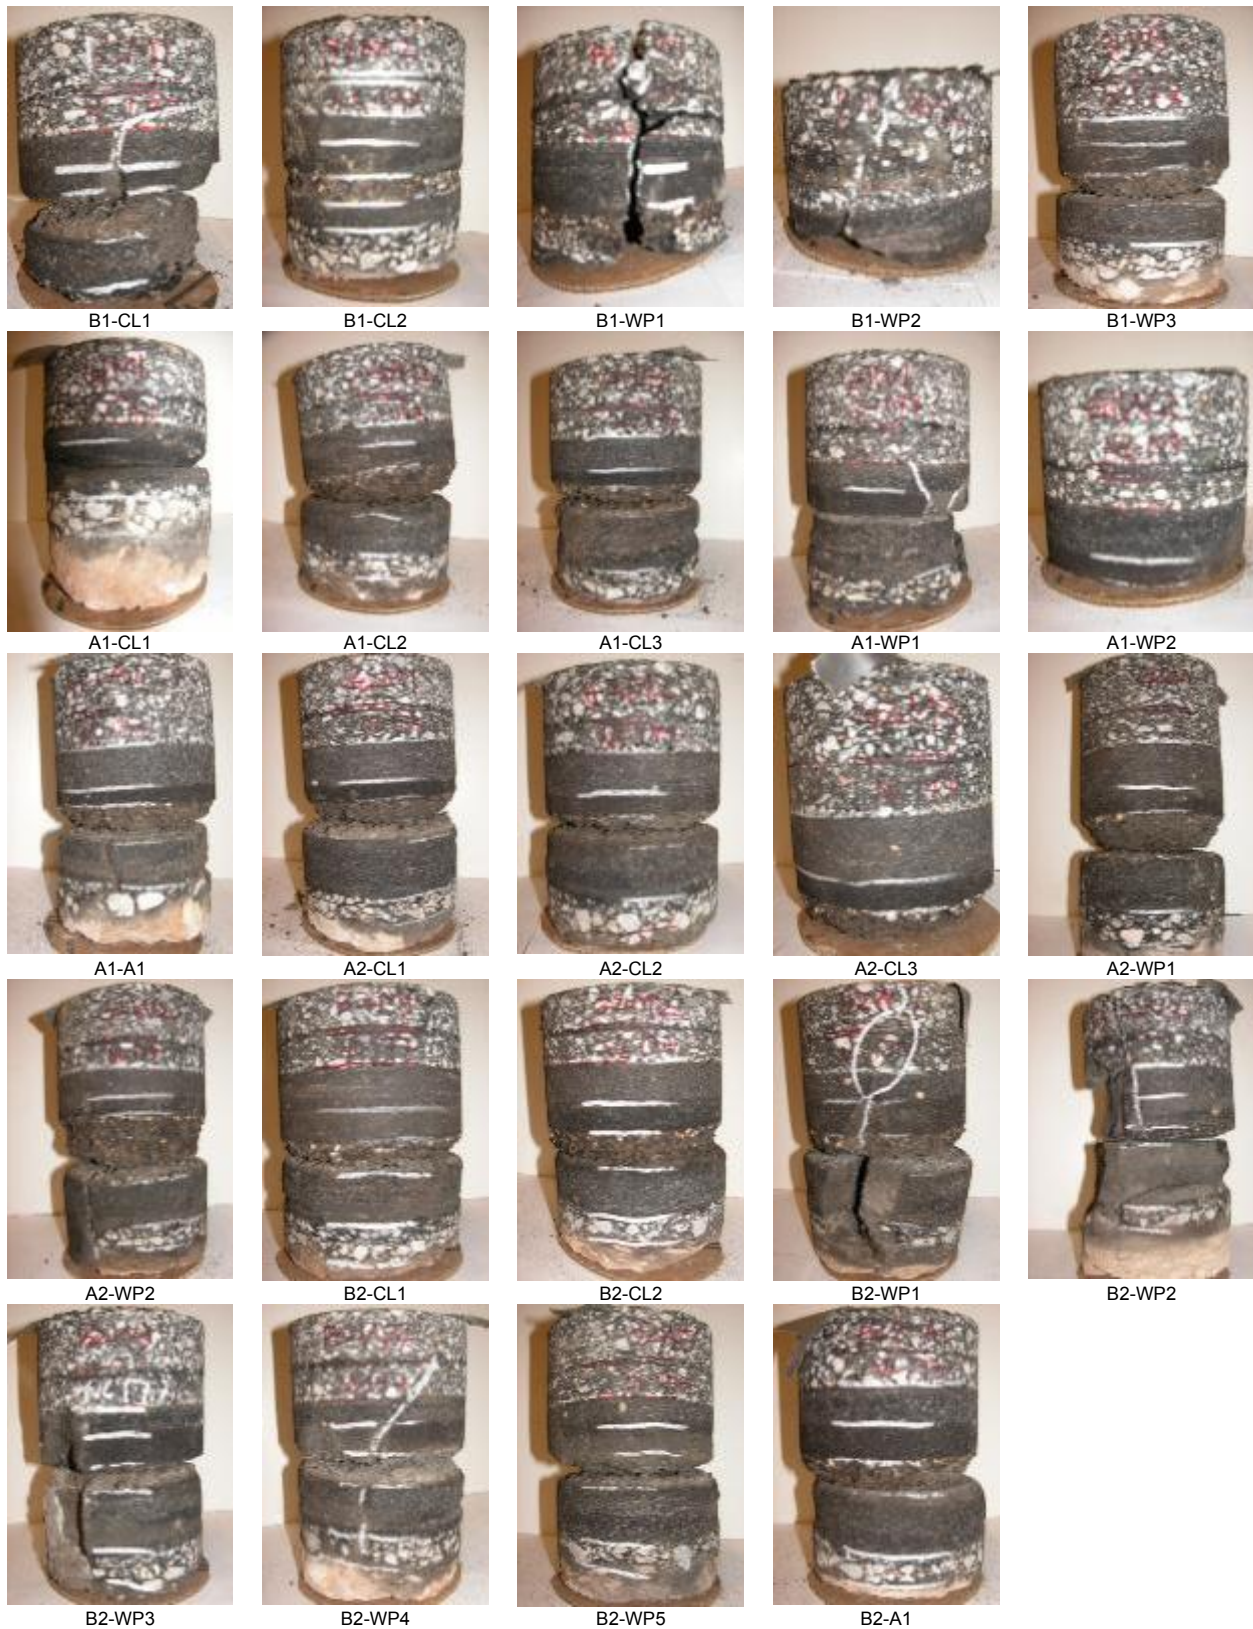
ID	Note
B1-WP1	Macrocrack on top surface connected to 3 vertical cracks; layers below 6th layer were stuck in the coring hole; horizontal crack in 3rd layer
B1-WP2	Crack sealer on entire top surface; 3 vertical full-depth cracks
B1-WP3	Sound condition, except for 6th layer
B1-CL1	Horizontal crack in 3rd layer connected to vertical crack in 4th & 5th layers; cracks on top surface
B1-CL2	Sound condition
A1-CL1	Partial chip out on 3rd and 4th layers; 6th layer disappeared due to shear force during coring
A1-CL2	Intact, except for 6th layer
A1-CL3	Partial vertical cracks in 7th and 8th layers
A1-WP1	Vertical crack in 4th and 5th layers
A1-WP2	Part of sample (below 6th layer) was stuck in the coring hole
A1-A1	Vertical crack in 7th and 8th layers; sound condition down to 5th layer
A2-CL1	Sound condition, except for 6th layer
A2-CL2	Crack on top surface connected to vertical cracks in 1st layer
A2-CL3	Part of sample (below 6th layer) was stuck in the coring hole

A2-WP1	Sound condition down to 5th layer, but vertical crack in 7th and 8th layers filled with dust
A2-WP2	Sound condition down to 5th layer, but vertical crack in 7th and 8th layers filled with material used for 7th layer
B2-CL1	Sound condition, except for 6th layer
B2-CL2	Sound condition, except for 6th layer
B2-WP1	Vertical cracks from 6th layer to the bottom of core; a crack on top surface connected to 2 vertical cracks that begin from 1st layer and extend to the top of 6th layer; sand mix layer (9th layer) at the bottom of core
B2-WP2	Macrocrack on top surface connected to 3 vertical cracks in 4th and 5th layers
B2-WP3	Partially broken sand mix layers (4th and 5th layers); horizontal crack begins from the middle of 3rd layer and extends to 5th layer; material used for 6th layer fills vertical cracks in 7th and 8th layers; sand mix layer at the bottom of core
B2-WP4	Vertical cracks from 2nd layer down to the middle of 8th layer; wide vertical crack in 7th and 8th layers filled with dust (may be 6th layer material)

B2-WP5	Sound condition, except for 6th layer
B2-A1	Sound condition, except for 6th layer

Figure B.62 Cores taken from NC-177, Hamlet, Richmond County

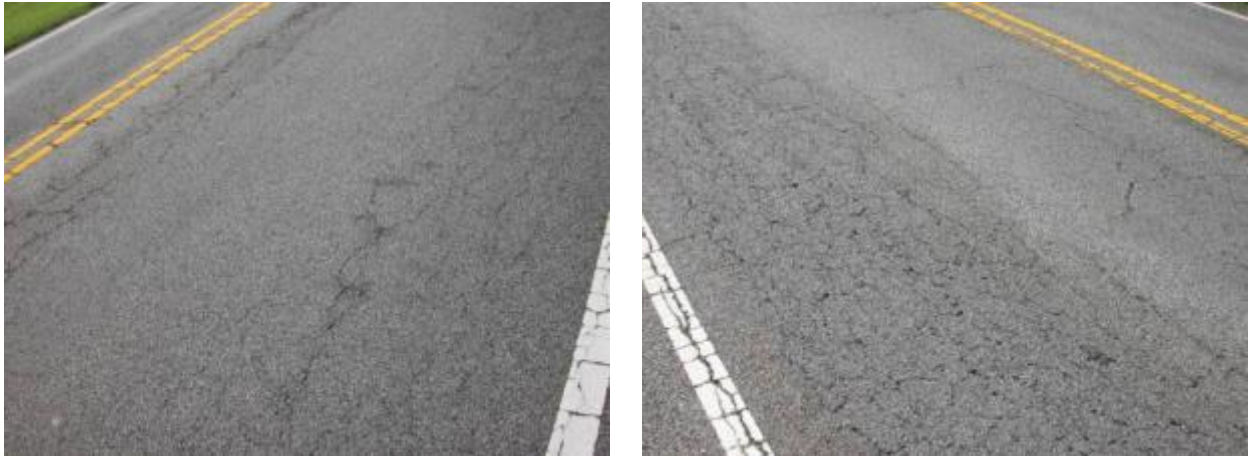
Figure B.71 Photographs of cracking patterns on NC-47, Lexington, Davidson County

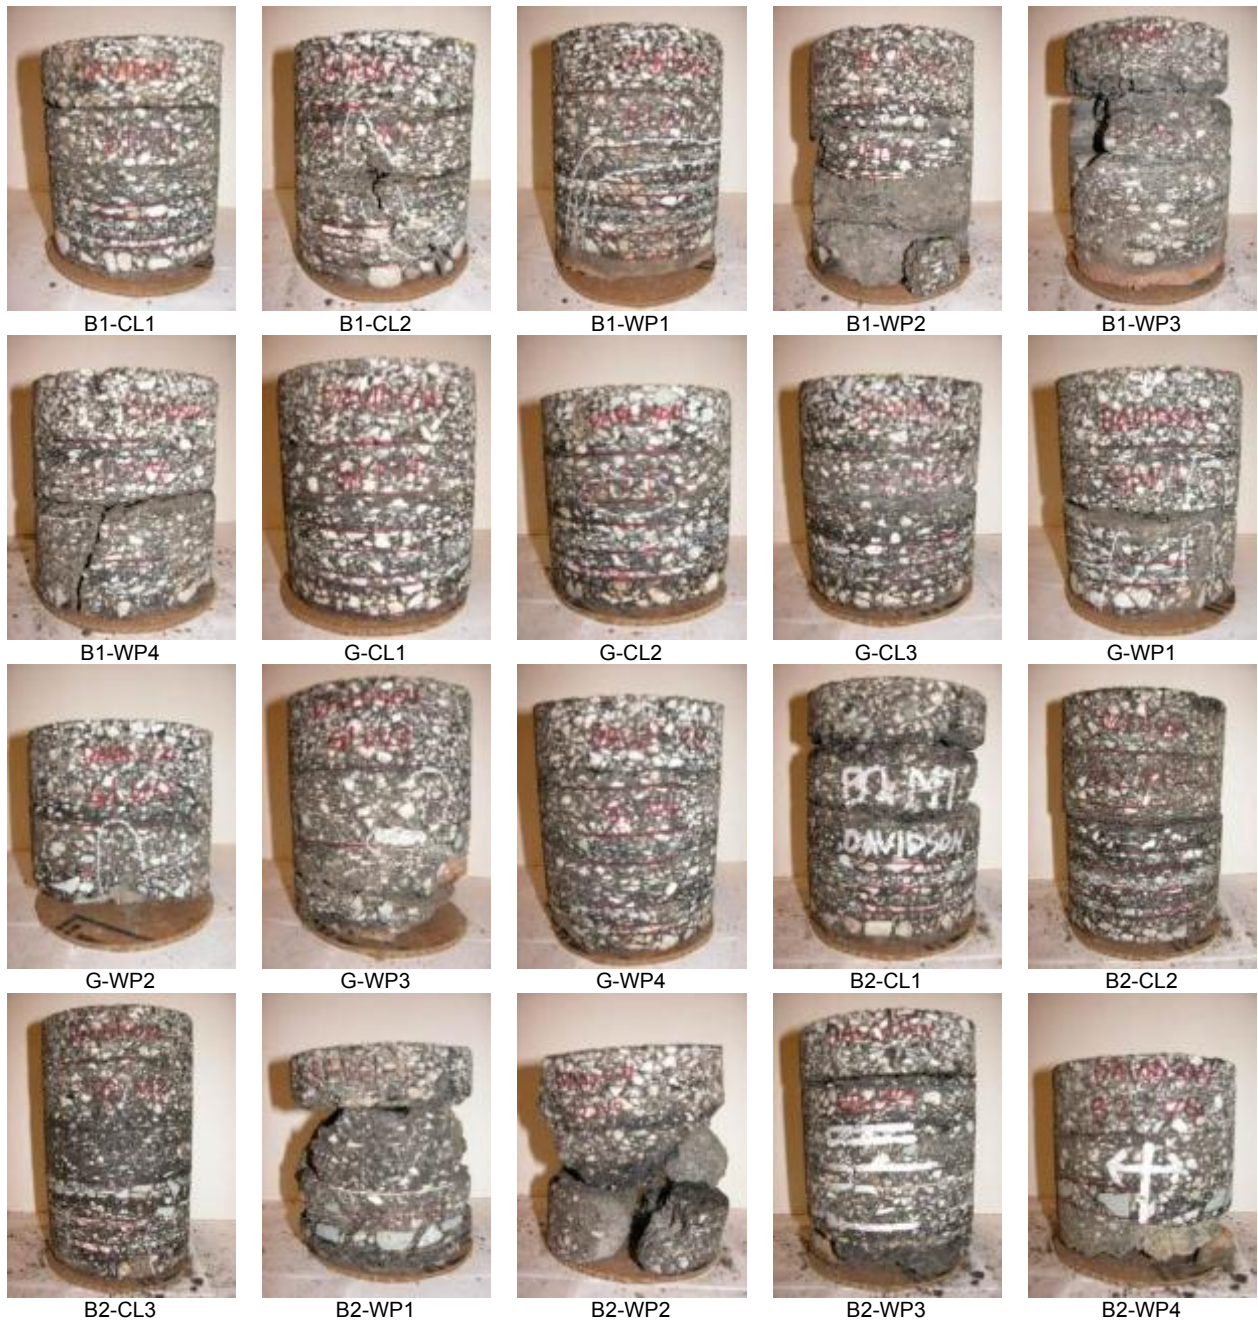
Table B.20, and photographs of the cores are shown in Figure B.72. As shown in the summary tables and photographs, because the number of sound condition cores is less than for the other sections, it is highly possible that the cores contain some minor cracking. Therefore, special care must be taken for horizontal coring and lab testing.

ID	Note
B1-CL1	Delamination between 1st & 2nd layers and 2nd & 3rd layers
B1-CL2	1 vertical crack connected to cracks on top surface, broken into 2 major pieces from 2nd layer to the bottom of core, marking paint at bottom of 2nd layer, thickness of broken layer could not be measured
B1-WP1	Vertical crack from bottom to horizontal crack in middle of 3rd layer, no cracks on top surface
B1-WP2	2 vertical cracks in 1st layer connected to cracks on top surface, totally broken from horizontal crack in middle of 2nd layer to bottom of core
B1-WP3	Totally broken into 2 major pieces from horizontal crack at bottom of 1st layer to bottom of core, vertical macrocracks in bottom of core filled with soil, delamination between 1st & 2 nd , 2nd & 3rd, and 3rd & 4th layers, thickness of broken layer could not be measured
B1-WP4	1 macrocrack on top surface connected to 2 vertical cracks in 1st layer, broken into 2 major pieces from horizontal crack at bottom of 2nd layer to bottom of core, marking paint between 2nd & 3rd layers

A1-CL1	Sound condition
A1-CL2	Overall sound condition but looks like beginning phase of delamination between 2nd & 3rd layers
A1-CL3	Not smooth delamination between 2nd & 3rd layers
A1-WP1	1 vertical crack connected to cracks on top surface, partial delamination and horizontal crack at bottom of 2nd layer, looks like 2nd and 3rd layers constructed in same period due to visually same mixture, marking paint between 3rd & 4th layers, soil-filled wide cracks from bottom of core to middle of 3rd layer
A1-WP2	2 Soil-filled wide cracks from 2nd layer to bottom of core, no cracks on top surface
A1-WP3	Vertical crack in middle of 2nd layer, horizontal crack in middle of 3rd layer, marking paint between 2nd & 3rd layers
A1-WP4	2 vertical cracks on top surface connected to cracks on top surface, horizontal crack near bottom of 1st layer, vertical cracks begin from horizontal crack and end at soil-filled wide crack at bottom of core

B2-CL1	1st layer broken into 2 pieces, not smooth delamination between 1st & 2nd layers and 2nd & 3rd layers, vertical cracks from bottom of core to delamination surface of 3rd layer
B2-CL2	Delamination in middle of 3rd layer
B2-CL3	Vertical cracks from middle of 2nd layer to bottom, soil-filled wide cracks from bottom of core to 6th layer
B2-WP1	Totally broken except for 1st layer, marking paint between 2nd & 3rd layers, thickness of broken layer could not be measured
B2-WP2	Totally broken, thickness of broken layer could not be measured
B2-WP3	Delamination between 1st & 2nd layers, vertical crack from middle of 3rd layer to bottom of core, marking paint between 4th & 6th layers
B2-WP4	Macrocrack on top surface but no vertical crack, vertical roadway expansion trace from 2nd layer to bottom (exceptional case)

Figure B.72 Cores taken from NC-47, Lexington, Davidson County

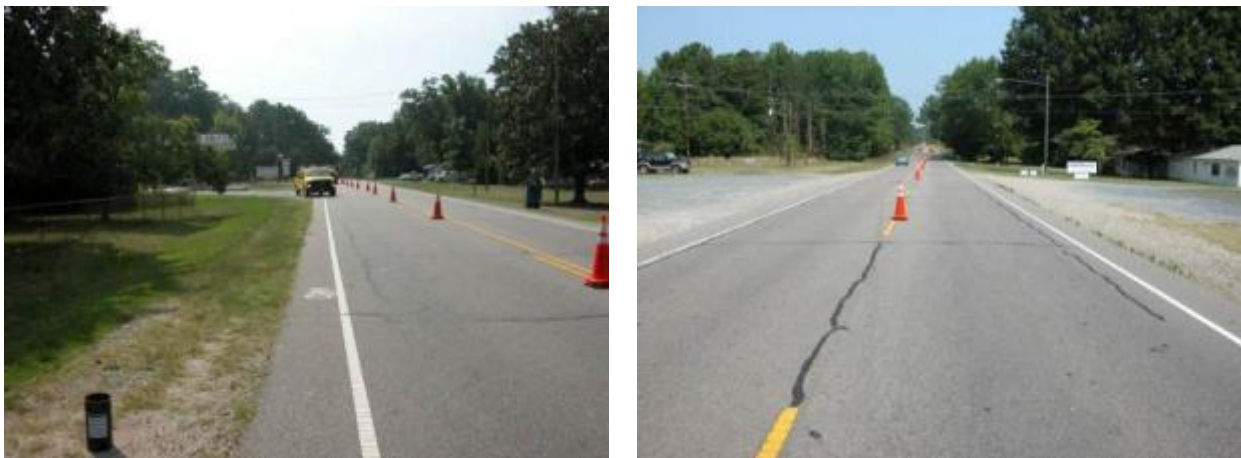
The NCDOT's construction history and profile database showed debug errors after changing contractors, and because this section was scheduled for resurfacing in late July 2011, the research team selected and scheduled this section for Level 1 investigation. As shown in Figure B.76, most of the macrocracks in the section were sealed, but some were not sealed. It is not clear when the Montgomery County maintenance engineers conducted the crack sealing, nor whether the cracks that were not sealed appeared after sealing or whether the contractor simply missed some of the cracks. The cracking pattern shows transversal cracking at regular intervals and shows also that most of the longitudinal cracking is located in the outer wheel path. Because this cracking pattern is similar to reflective cracking caused by joint concrete pavement (JCP), the NCDOT personnel and the research team decided to core the outer wheel path for verification. The photographs in Figure B.77 show the coring location and extracted core. The location of the longitudinal crack on top of the sample core was exactly the same as that at the edge of the concrete pavement layer. Therefore, the research team decided to change the test level of the section from Level 1 to Level 2. After repairing the debug error in the database, it was found that the section has a JCP layer constructed in 1941.

Figure B.76 Photographs of cracking pattern on US-220 Alt. NB, Star, Montgomery County

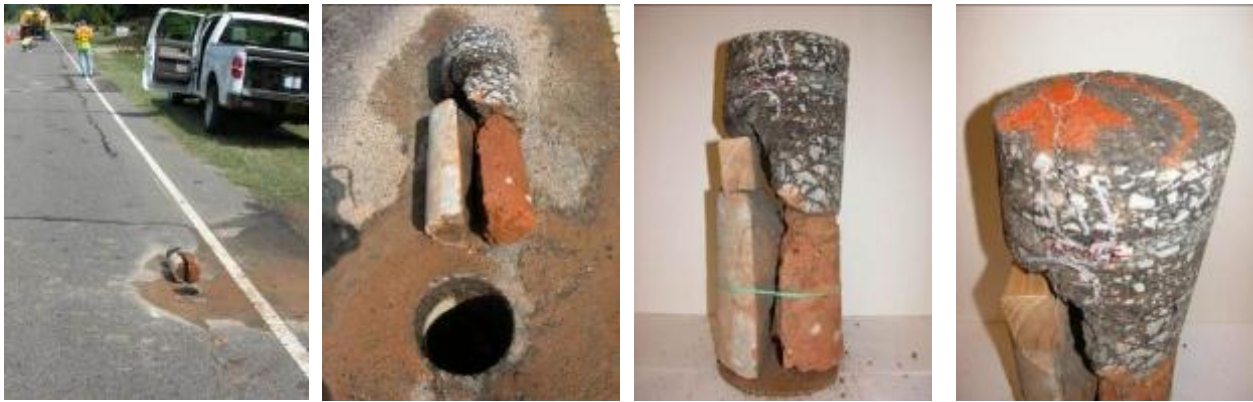
Figure B.77 Photographs of Sample Core Taken for the Verification of Roadway Expansion

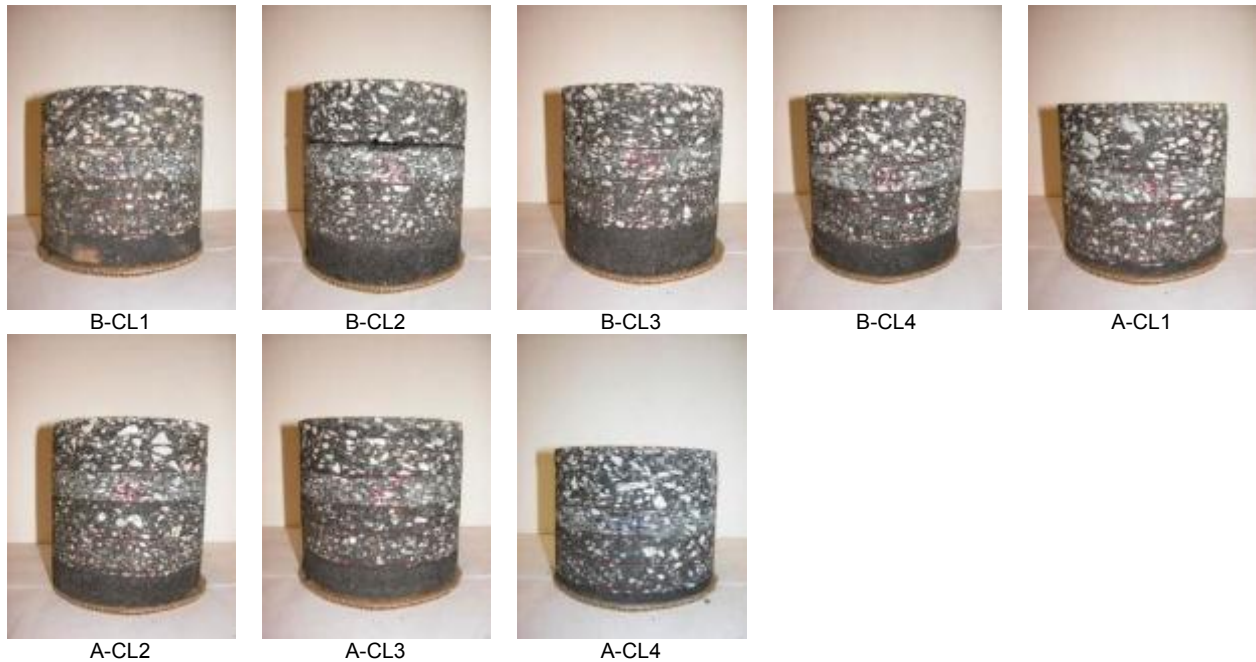
ID	Layer Thickness (inch)					Condition	Note
	1st	2nd	3rd	4th	sand mix layer		
B-CL1	1 3/4	7/8	5/8	1	7/8	Intact	Sound condition, no crack
B-CL2	1 7/8	1	3/8	1 1/4	7/8	Delamination/ Intact	Delamination between 1st and 2nd layers, no crack
B-CL3	1 7/8	1	1/4	1	1 5/8	Intact	Sound condition, no crack
B-CL4	1 3/4	7/8	5/8	1	1 1/4	Intact	Sound condition, no crack
A-CL1	1 3/4	7/8	7/8	1	1/2	Intact	Sound condition, no crack
A-CL2	1 5/6	7/8	1 1/2	1 1/2	1	Intact	Sound condition, no crack
A-CL3	1 5/8	7/8	3/4	1	1 1/8	Intact	Sound condition, no crack
A-CL4	1 3/4	3/4	7/8	7/8	3/8	Intact	Sound condition, no crack

Figure B.78 Cores taken from US-220 Alt. NB, Star, Montgomery County

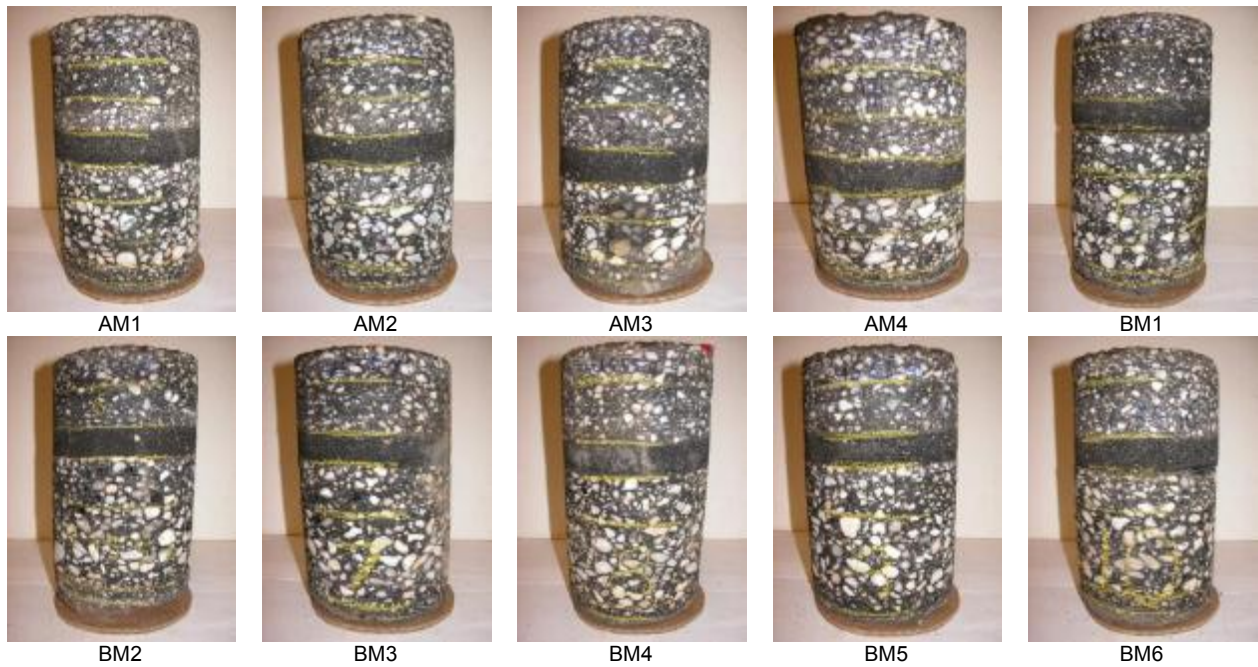
Photographs of all of the pavement cores are shown in Figure B.82, and a summary of each is given in Table B.22. Because this site is one of the sites in the Level 2 investigation, all of the cores were taken from the middle of the lane, i.e., between the wheel-paths. A sand mix layer was observed in the middle of each core, and two different mixtures were observed both above and below the sand mix layer.

Figure B.82 Photographs of cores taken from NC-55, Angier, Harnett County

ID	Layer Thickness (inch)						Condition
	1st	2nd	3rd	4th	5th	6th	
AM1	1 4/8	2 1/8	1	1 1/8	2 2/8	5/8	Sound
AM2	1 2/8	2 1/8	7/8	1 2/8	1 7/8	5/8	Sound
AM3	1 3/8	2 4/8	1 1/8	1 1/8	1 3/8	6/8	Sound
AM4	1 4/8	2 2/8	1	1 1/8	1 3/8	4/8	Sound
BM1	1 1/8	1 5/8	1	1 4/8	3 2/8	5/8	Debonding between 3 rd and 4 th layers; vertical crack from 1 st through 3 rd layers
BM2	1 2/8	1 2/8	1	1 4/8	2 6/8	4/8	Sound
BM3	1	1 3/8	1	1 4/8	3 1/8	3/8	Sound
BM4	1 2/8	1 6/8	1	1 5/8	3 1/8	4/8	Sound
BM5	1	1 3/8	7/8	1 5/8	2 7/8	3/8	Sound
BM6	1 1/8	1 5/8	1	1 1/8	3	5/8	Debonding between 3 rd and 4 th layers

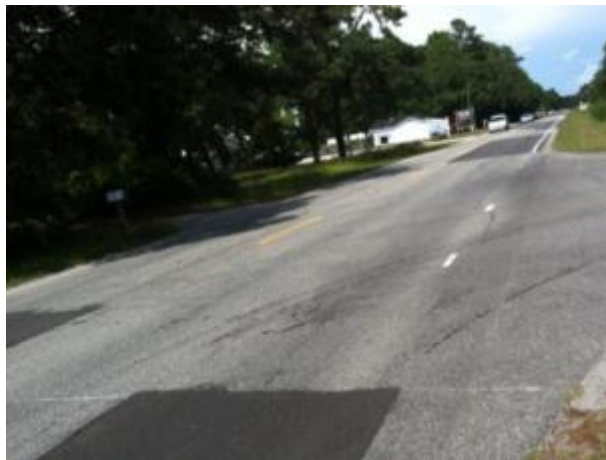
According to the Division engineer's comments, partial patching was done at the site in 2011. Figure 5 shows this partial patching condition. Because patching was done at the site, cores were taken from an unpatched area with and without surface cracks. Most of the patching is located on the outer wheel-path and between the wheel-path areas. The BA core taken from the outside of the lane has a different pavement layer structure from the other cores that were taken from the middle or inner wheel-path area. Therefore, it is expected that reflective cracking caused by road widening has resulted in the longitudinal cracking seen in the outer wheel-path area. This recurrence of longitudinal cracking in the outer wheel-path may have required resurfacing with patching after reconstruction in 2009; or it may reflect that the NCDOT database contains the 2009 construction record only for the road widening effort and not the patching effort.

Figure B.85 Photographs of NC 179, Ocean Isle Beach, Brunswick County

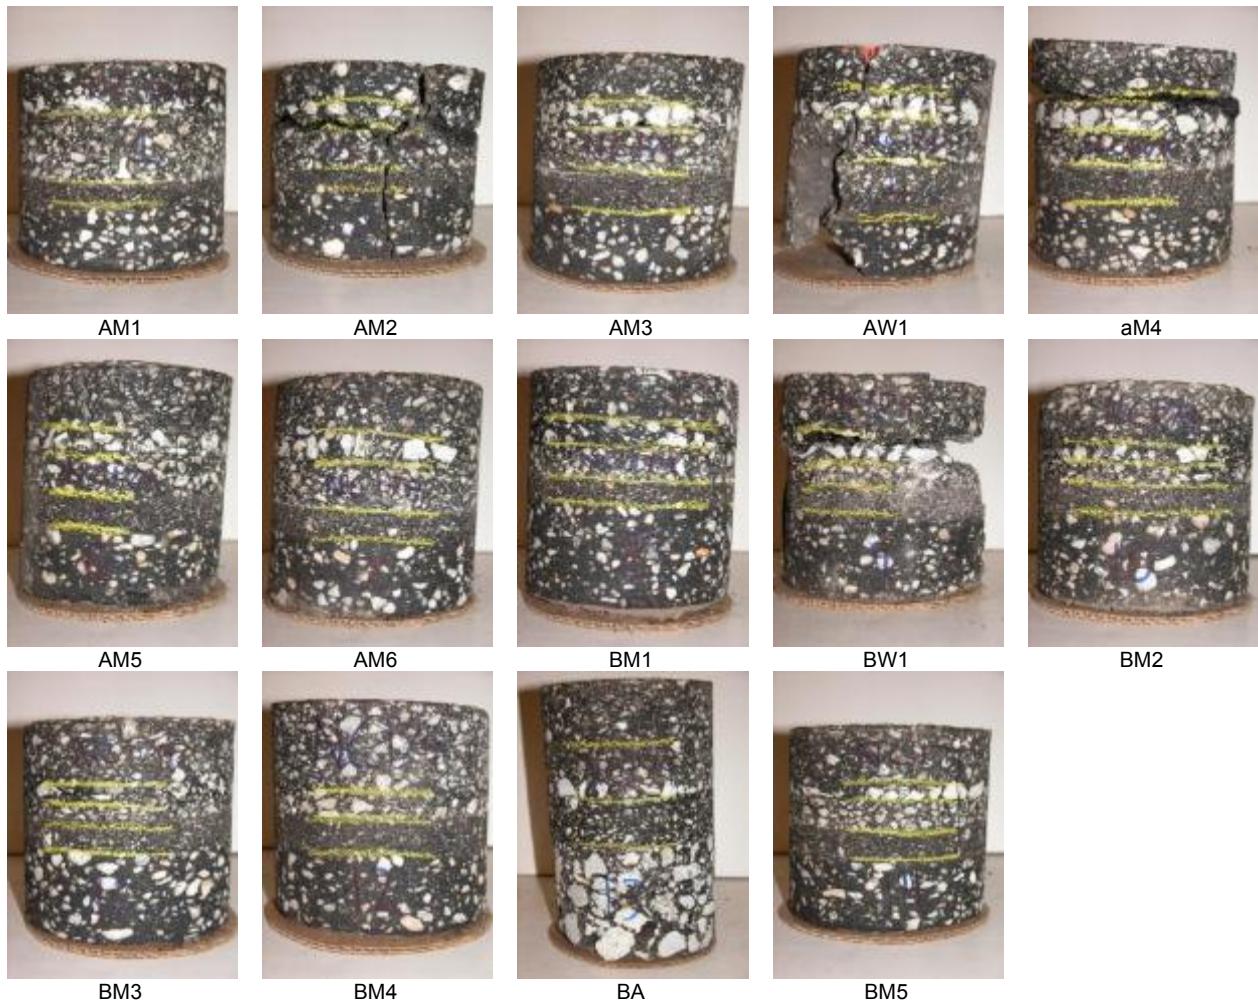
Figure B.86 Photographs of cores taken from NC 179, Ocean Isle Beach, Brunswick County

ID	Layer Thickness (inch)				Condition
	1st	2nd	3rd	4th	
GM1	1 1/8	1 5/8	3/8	1 4/8	Sound
GM2	7/8	4/8	3/8	1 5/8	Full-depth vertical cracking; debonding between 2nd and 3rd layers
GM3	1 1/8	5/8	6/8	1 6/8	Sound
GW1	1 1/8	5/8	1 2/8	1 4/8	Full-depth vertical cracking
GM4	1 1/8	6/8	7/8	1 6/8	Debonding between 1st and 2nd layers
GM5	1 4/8	4/8	6/8	1 6/8	Cracks of surface connected to vertical crack through 2nd layer
GM6	1 2/8	5/8	5/8	1 6/8	Sound
BM1	1 1/8	4/8	4/8	2 3/8	Sound
BW1	1 2/8	5/8	5/8	2	Full-depth vertical cracking; debonding between 2nd and 3rd layers
BM2	1 3/8	4/8	5/8	2 1/8	Sound
BM3	1 3/8	5/8	5/8	2 1/8	Sound
BM4	2	6/8	1 6/8		Sound
BA	1 7/8	1 4/8	3 6/8		Sound; extracted from shoulder
BM5	1 2/8	6/8	5/8	1 6/8	Sound

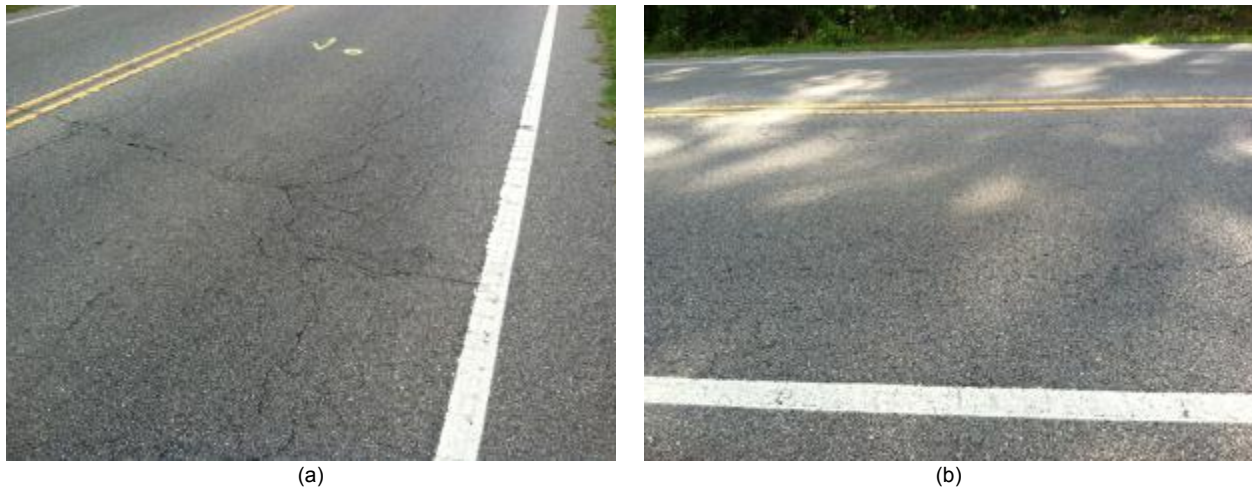
Figure B.89 Photographs of representative cracking patterns on US-401, Linden, Cumberland County: (a) *bad* location and (b) *good* location

A marking paint layer lies between the 2nd and 3rd layers of the 3rd core extracted from the middle of the *bad* condition region. A school zone marking was located near the coring location in the middle of the traffic lane. Therefore, the marking paint does not indicate roadway widening. The pavement condition of the southbound lane of the site was worse than that of the northbound lane, even though the site is a one lane per direction rural roadway with an unpaved shoulder.

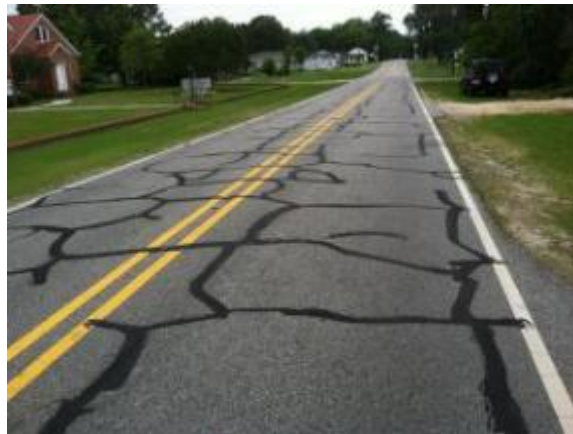
Figure B.93 Photograph of representative cracking patterns on NC 82, Godwin, Cumberland County

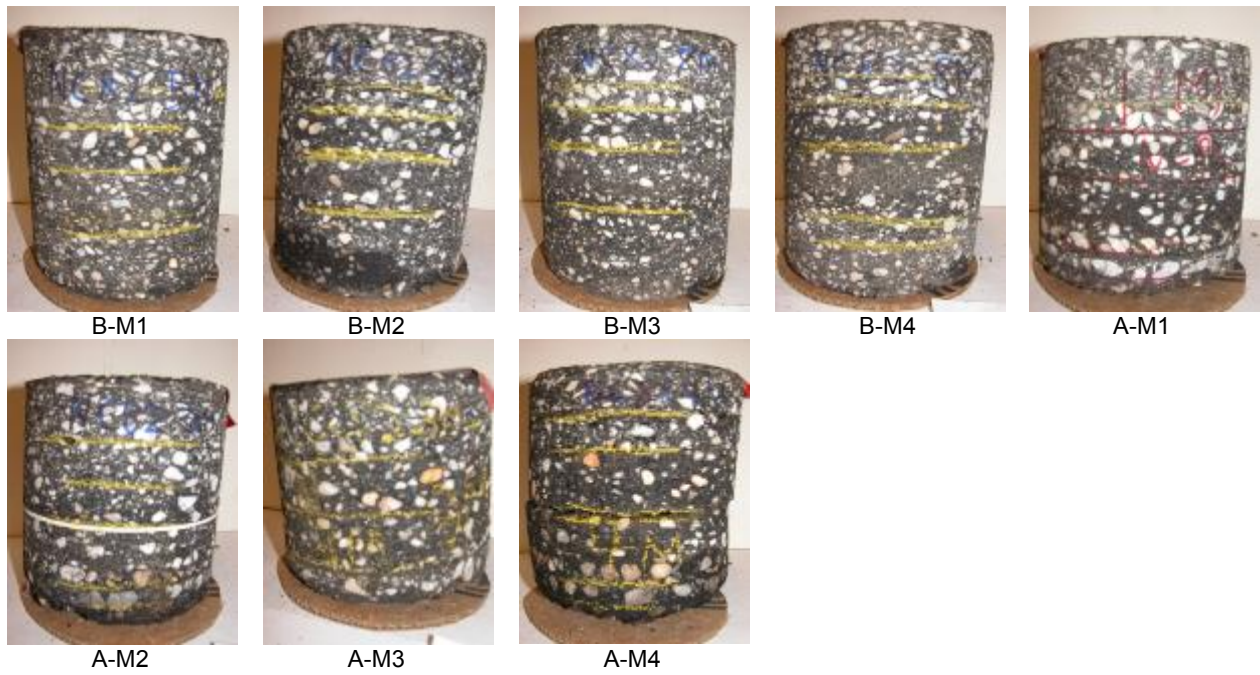
ID	Layer Thickness (inch)					Condition
	1st	2nd	3rd	4th	5th	
B-M1	1.42	0.71	1.18	1.57	1.77	Sound
B-M2	1.34	0.59	0.98	0.98	2.36	Sound
B-M3	1.42	0.63	0.98	1.42	2.17	Sound
B-M4	1.26	0.71	0.98	1.65	2.05	Sound
G-M1	1.38	0.59	0.98	1.57	0.55	Sound
G-M2	1.38	0.94	0.94	1.38	0.55	Sound; school marking paint in between 3 rd and 4 th layers
G-M3	1.10	0.63	1.06	1.18	0.39	Sound
G-M4	1.18	0.79	1.26	1.10	0.59	Delamination in between 3 rd and 4 th layers

Figure B.94 Photographs of cores taken from NC 82, Godwin, Cumberland County
