Final Report

**EVALUATION OF STREAM CROSSING CULVERTS TO ASSESS  
IMPACTS ON STREAM MORPHOLOGY AND AQUATIC PASSAGE-Part  
II**

Daniel E. Line and James D. Blackwell

September 25, 2013

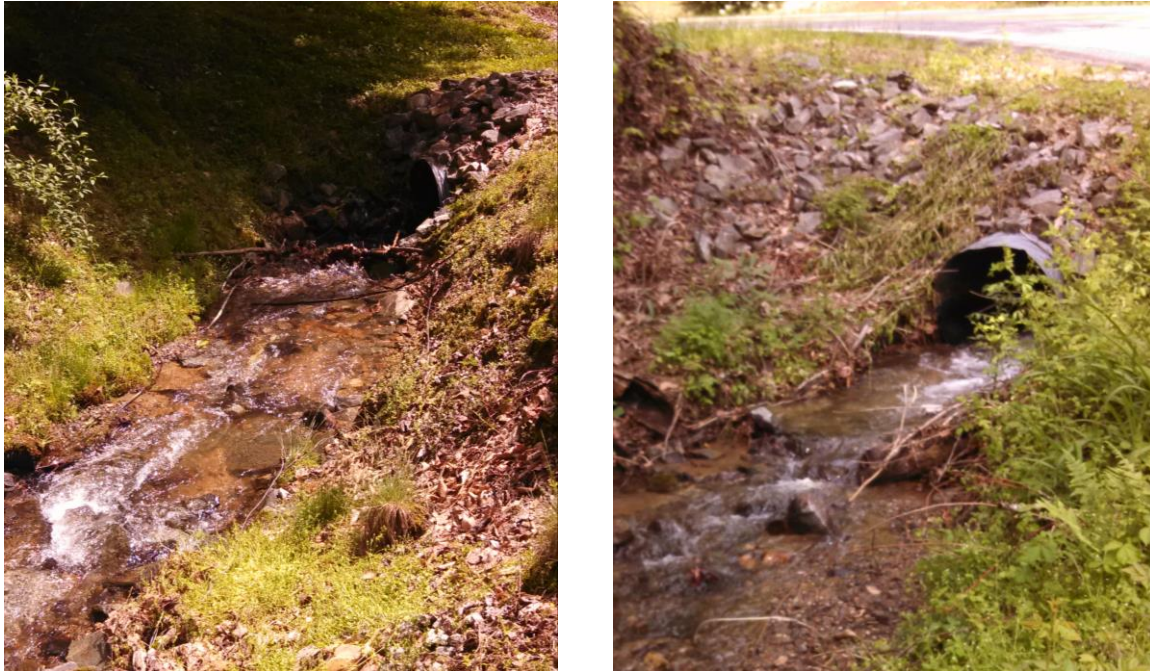
Figure 23. Upstream inlet (left) and downstream invert (right) of culvert at Pine Mountain site.

The culvert inlet was embedded, but the outlet was perched 0.14 ft above the channel. Discharge at the time of the survey was measured at 0.93 cfs. Both the inlet and outlet were under water (figure 23) so it appeared that the culvert would not be a detriment to the movement of swimming aquatic organisms, but those that moved on the channel bed would likely have difficulty getting upstream.

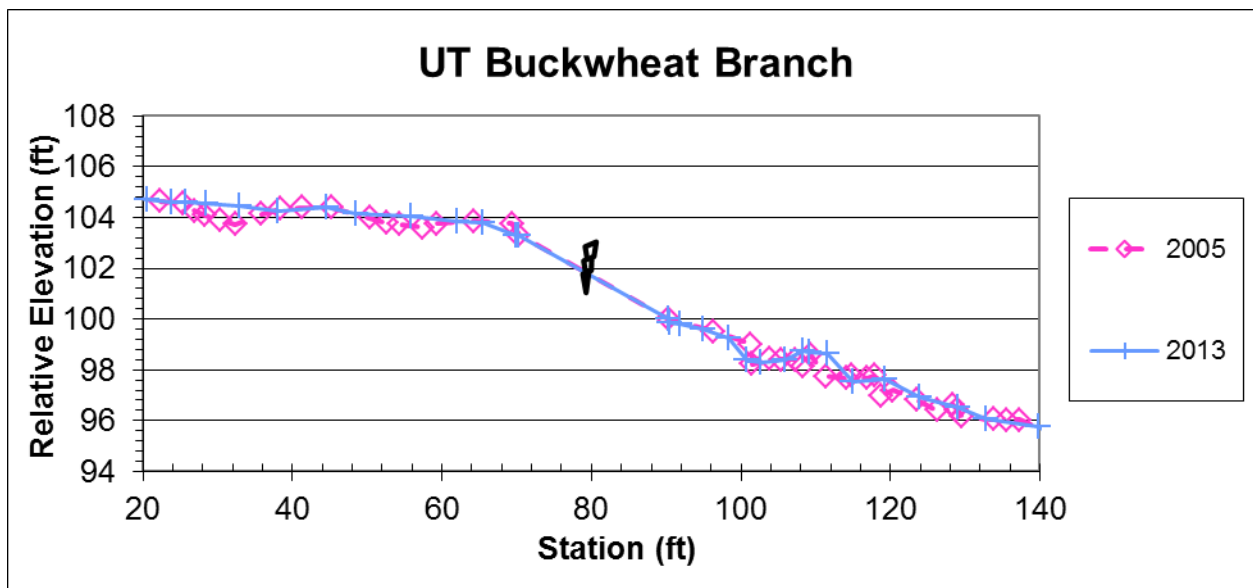
Figure 24. Longitudinal profile for an unnamed tributary (UT) to Buckwheat Branch site.

The longitudinal profile for the thalweg of the stream channel and the road culvert is shown in figure 24. The slope of the culvert (shortened to fit better) was greater than the stream channel upstream, but less than the channel downstream (Table 2). Comparing the 2005 and 2013 survey data shows that the stream channel upstream and downstream of the culvert have remained basically the same, with the exception of a few relatively small differences that appear to be associated with natural stream dynamics. Thus, the channel appeared to be stable during the period. This was not surprising given that the most of the channel was on bedrock or cobble.

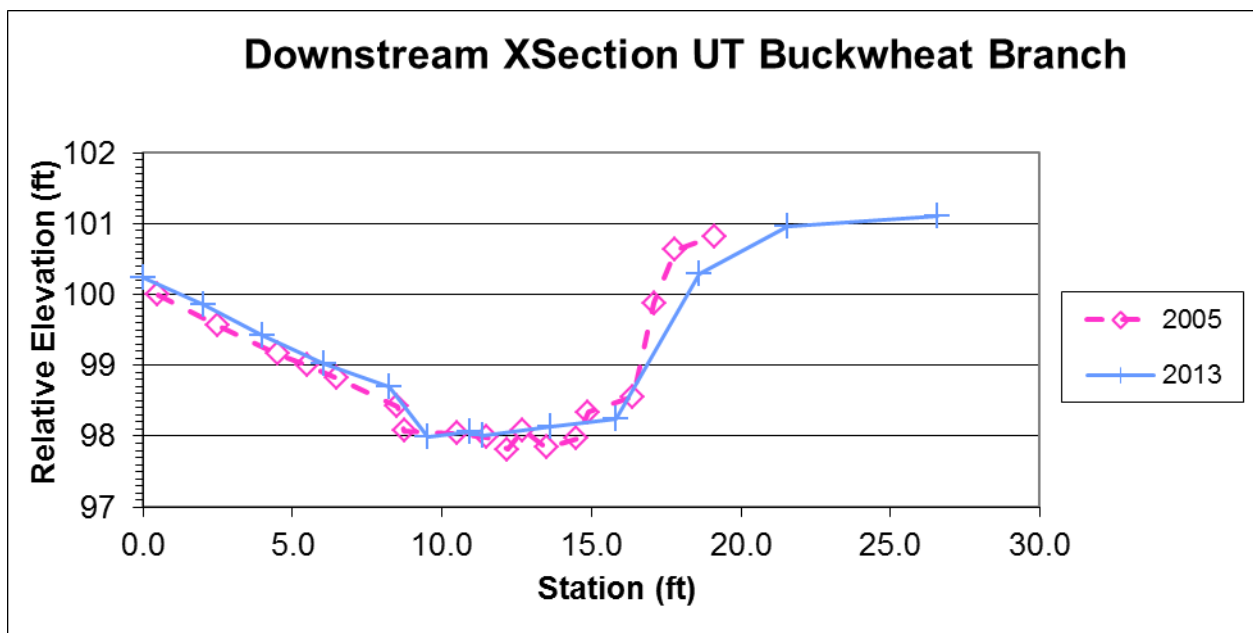
Figure 26. Downstream cross section for the UT Buckwheat Branch site.

The 2005 and 2013 surveys of the upstream cross section are shown in figure 25. As shown, the cross sections are similar indicating a stable channel. Comparing the downstream cross section survey data (figure 26) similarly shows little change indicating a stable cross section. The relatively small differences were likely caused by survey uncertainty and/or differences in cross section location or orientation (whether perpendicular to the channel or not).

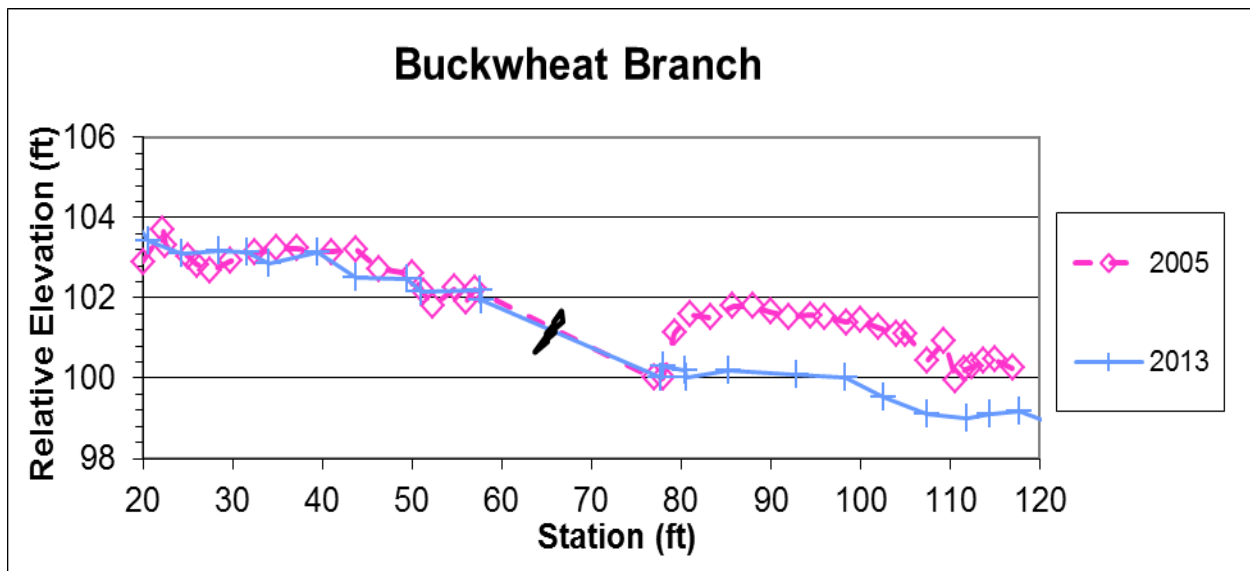
Figure 27. Longitudinal survey of stream at the Buckwheat Branch site.

The longitudinal profile for the thalweg of the stream channel and the road culvert is shown in figure 27. The slope of the two culverts (shortened to fit better) was less than the stream channel upstream, but was about equal to the downstream (Table 2). Comparing the 2005 and 2013 survey data shows that while the stream channel upstream of the culvert remained basically the same, it appears that the downstream channel has downcut ~1.5 ft over the whole length of the survey. After reviewing photos from 2005 and 2013 and the embedded data (0.0ft) from 2005, it can reasonably be concluded that there was an error in the 2005 longitudinal survey of the downstream section. Thus, the stability of the channel downstream of the culvert cannot be

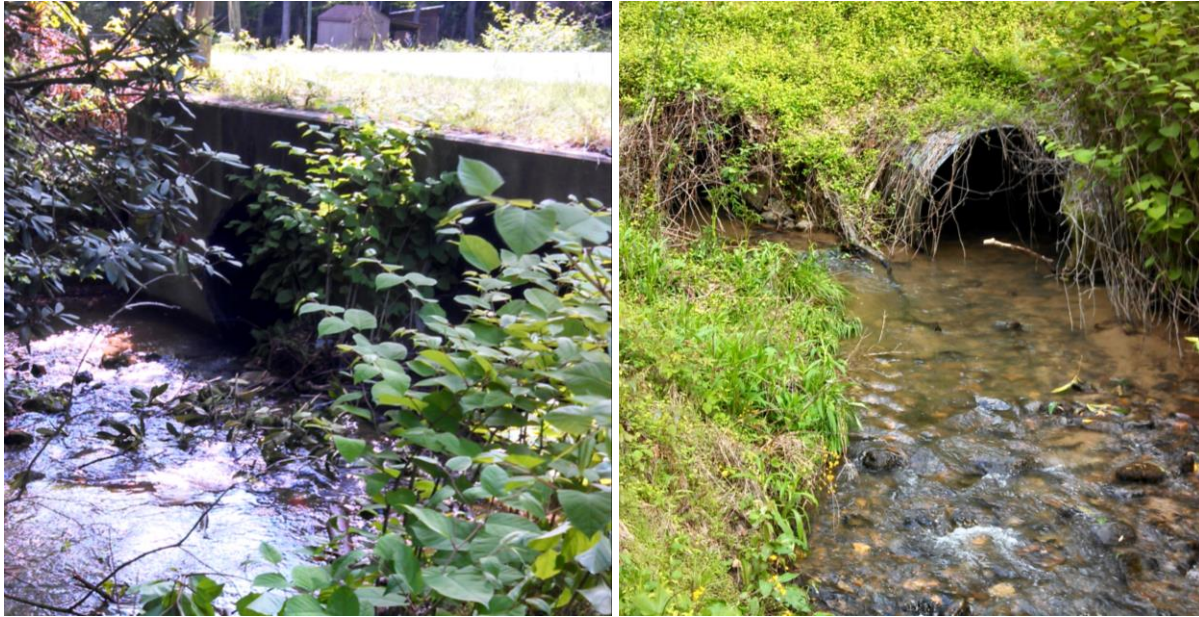
Figure 29. Upstream (left) and downstream (right) ends of culvert at Buckwheat Branch site.

Both the inlet and outlet inverts of the culverts were embedded (Table 2) and underwater so it appeared that the culvert would not be a detriment to the movement of aquatic organisms (figure 29). However, like all of the culverts there was no sediment or bed material over the length of much of the culvert to allow organisms that move in or on the substrate to navigate through the culvert. Discharge at the time of the survey was measured at 2.65 cfs.

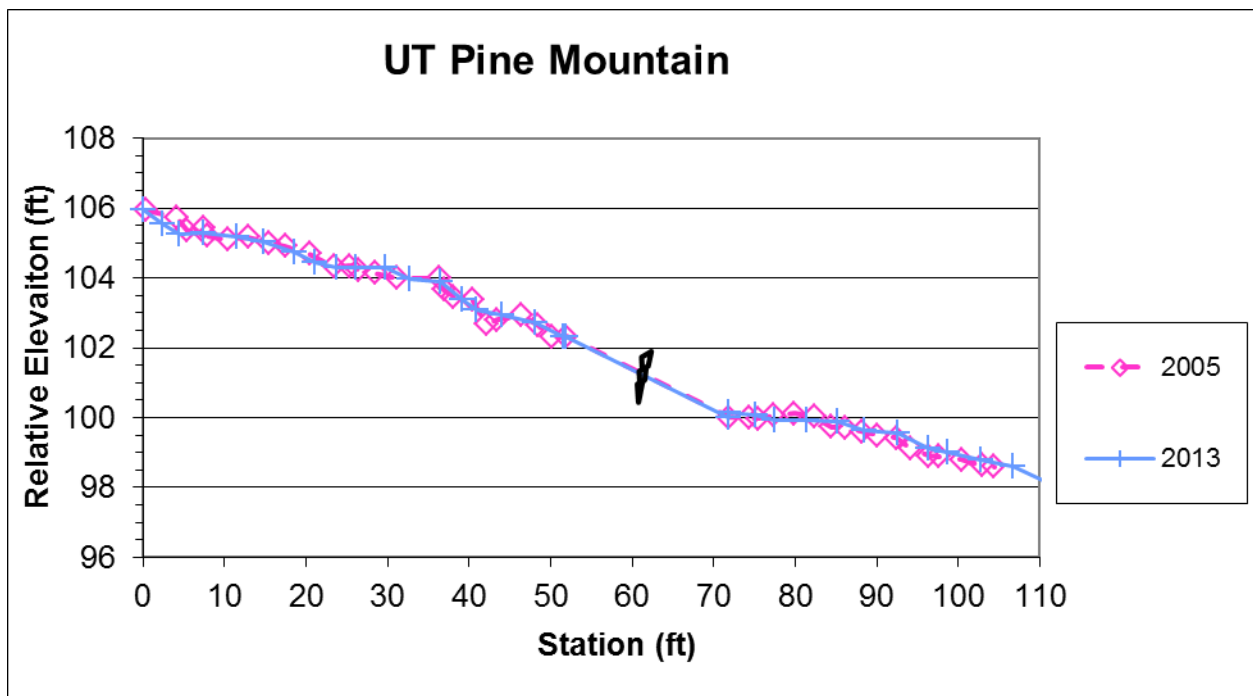
Figure 30. Longitudinal profile of stream at UT Pine Mountain site

The longitudinal profile for the thalweg of the stream channel and the road culvert is shown in figure 30. The slope of the culvert (shortened in figure 20 to fit better) was less than the upstream and downstream stream channel indicating albeit only slightly less than the downstream section. Comparing the 2005 and 2013 survey data shows that the stream channel upstream of the culvert and downstream are basically the same thereby indicating a stable channel.

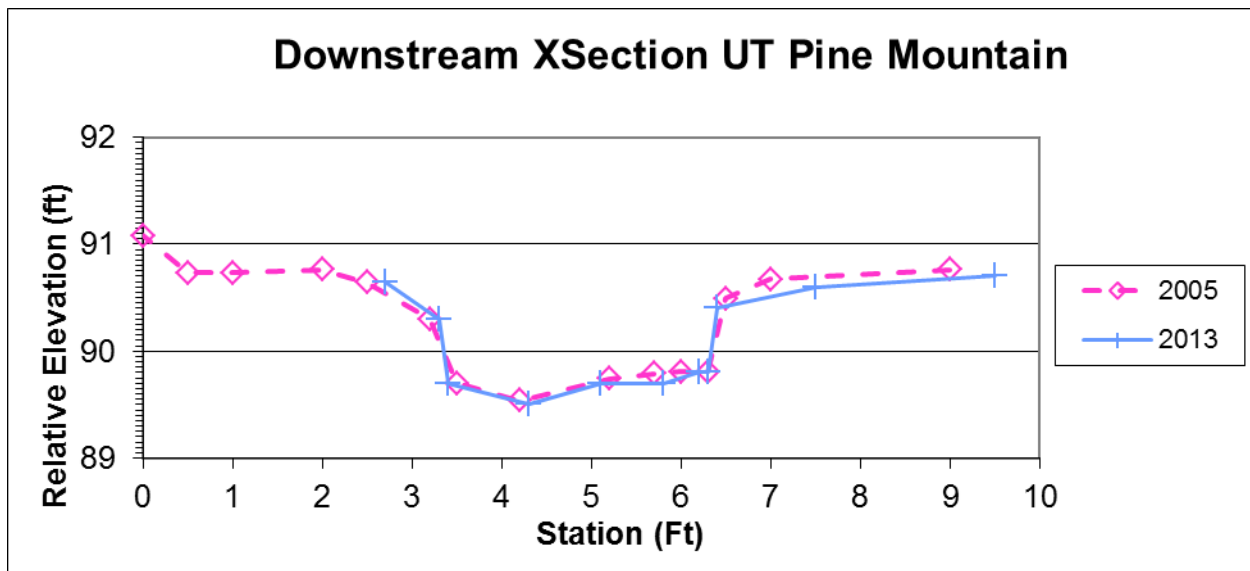
Figure 31. Downstream cross section for the stream at UT Pine Mountain site.

The 2013 surveys of the upstream and downstream cross sections were similar to those conducted in 2005, so only the downstream section is shown (figure 31).

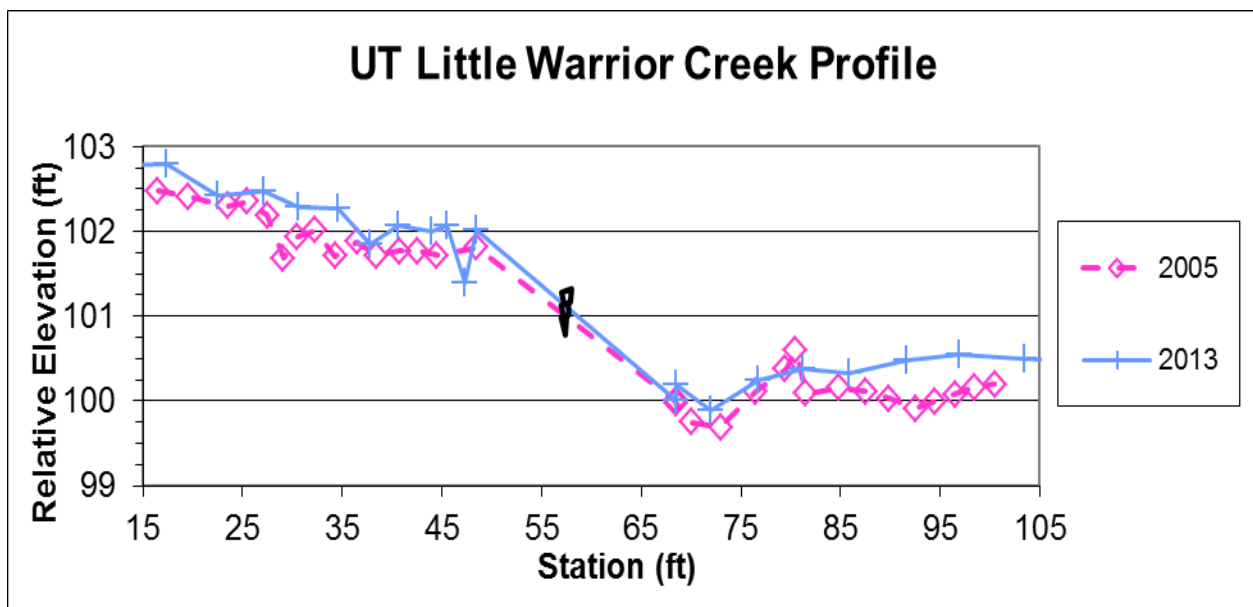
Figure 34. Longitudinal profile for UT Little Warrior Creek site.

The longitudinal profile for the thalweg of the stream channel and the road culvert is shown in figure 34. The slope of the culvert (shortened to fit better) was slightly greater than the

upstream channel and much greater than the downstream stream channel (Table 2). The 'v' just upstream of the culvert inlet was due to the roadside drainage ditch. Comparing the 2005 and 2013 survey data it first appears that the stream channel upstream of the culvert aggraded 0.2-0.4 ft; however, the difference in elevation of the upstream culvert invert was about 0.2ft, which was likely the result of a survey error in the 2005 data as it is unlikely the culvert moved upward. If the elevation of the stream was decreased 0.2ft, then the channel aggraded only slightly in a few places. Downstream of the culvert the channel also aggraded from about 0.2 to 0.5 ft, except for one small section where the data showed that the channel appeared to erode a highpoint. The downstream channel was relatively flat, which would facilitate sediment deposition if excess sediment was transported from upstream. The channel bed appeared to have a significant amount of relatively fine sediment in it (figure 35) thereby indicating an aggrading channel. Thus, the channel has been aggrading during the period, but this does not appear to be related to the culvert.
