Assessment of Deteriorated Cored Slabs Bridges No.: 150035 and 150039

**Department of Civil, Construction, and Environmental
Engineering
North Carolina State University**

**FHWA/NC/2014-35
February 2016**

Prepared for:
North Carolina Department of Transportation
Research and Development Unit

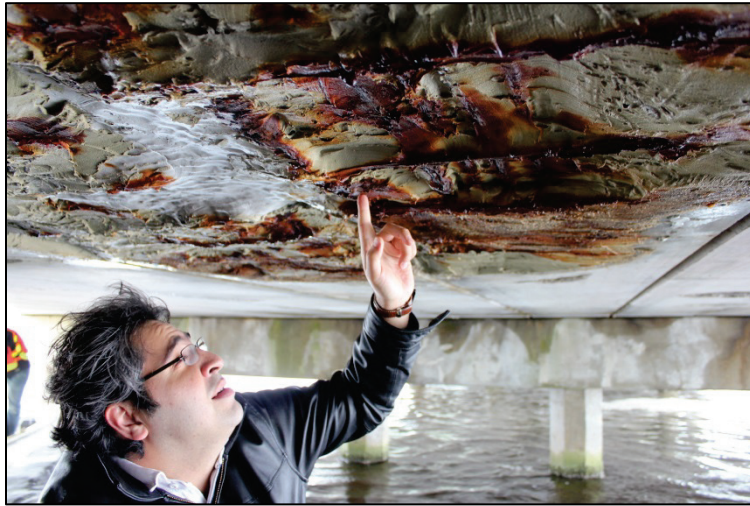
Figure 1.2 – Severe rust stains on patched slab soffit, Ward Creek Bridge

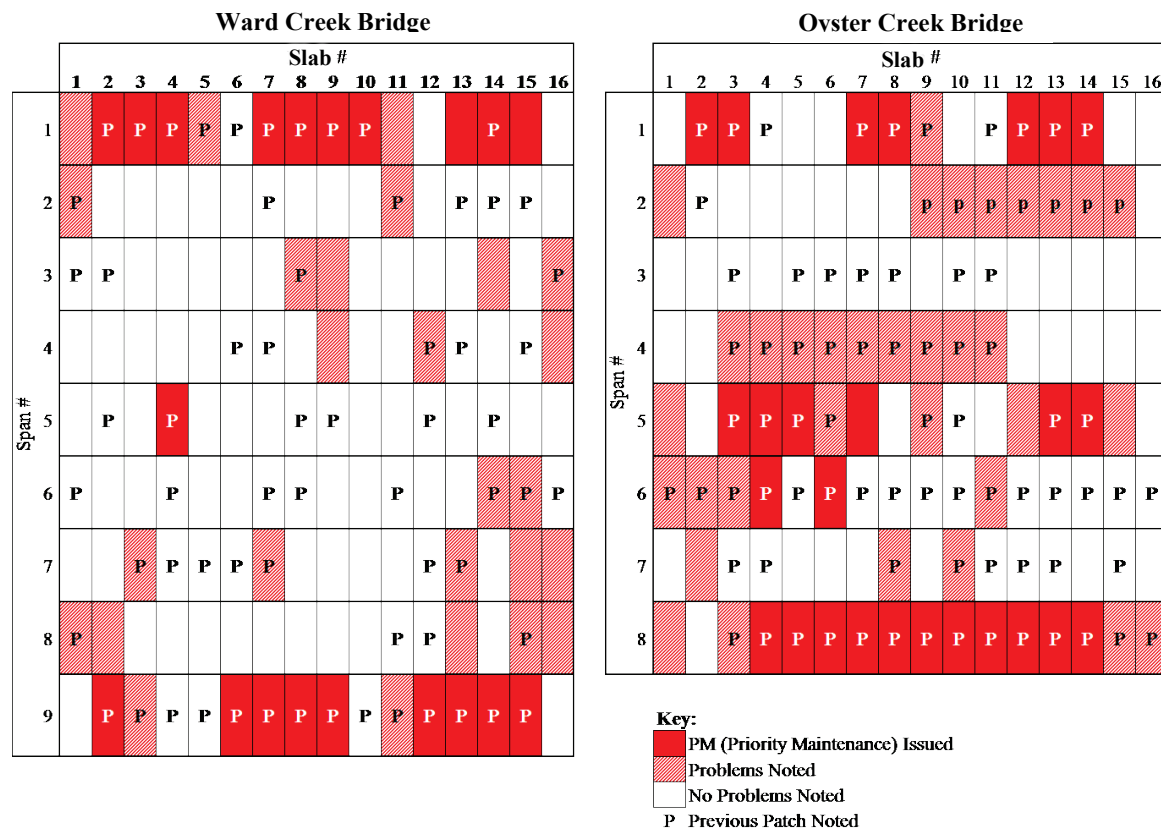
Figure 2.2 - Slab conditions per 2013 report

Inspection reports from routine biennial inspections were provided by the NCDOT from 1997 to 2013 for both bridges. The condition of slabs from the 2013 report is shown diagrammatically in Figure 2.2, with each row representing one span of the bridge, and each column representing one slab number (1 to 16). In these reports, inspectors stated whether each slab had been patched in the past, and whether it needed “priority maintenance.”

Both bridges showed similar levels of deterioration, with 37 of 64 slabs (58%) in the four end spans needing priority maintenance, and 144 of 272 (53%) having been previously patched.

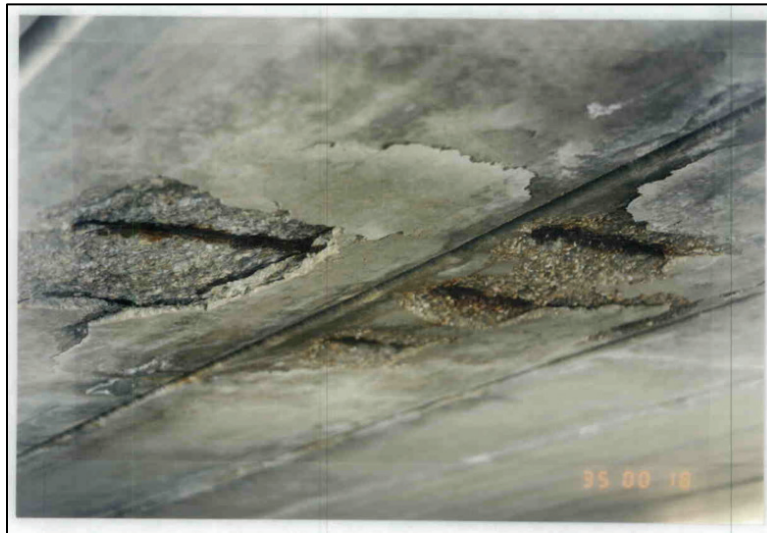
Figure 2.3 - 1997: "Delaminated and/or spalled with rusty exposed steel"

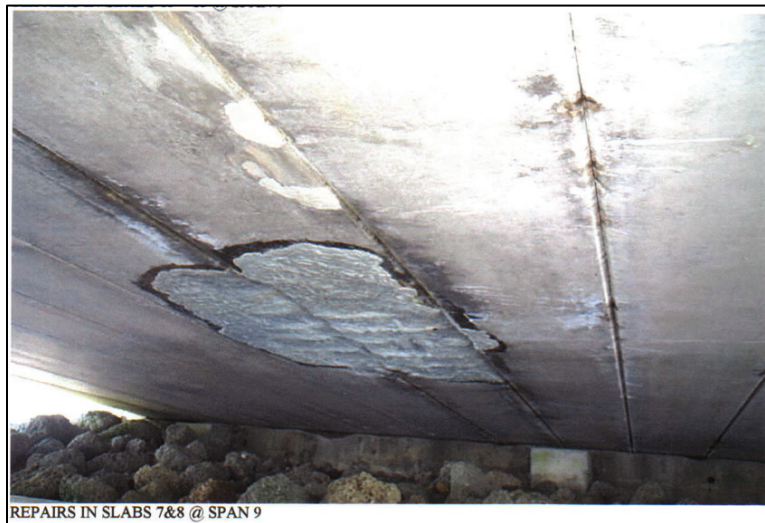
Figure 2.4 - 2003: "[...]were delaminated and/or spalled with rusting rebars exposed but are [...] repaired"

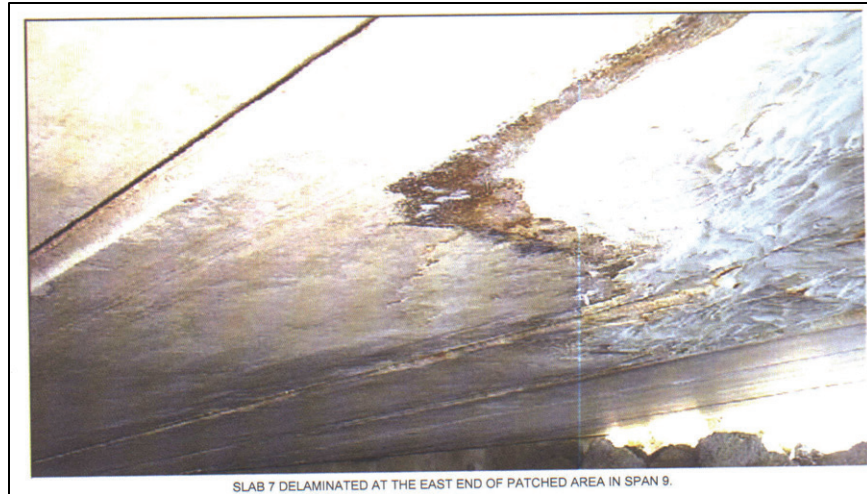
Figure 2.5 - 2005: "Slabs 6 and 7 are delaminated"

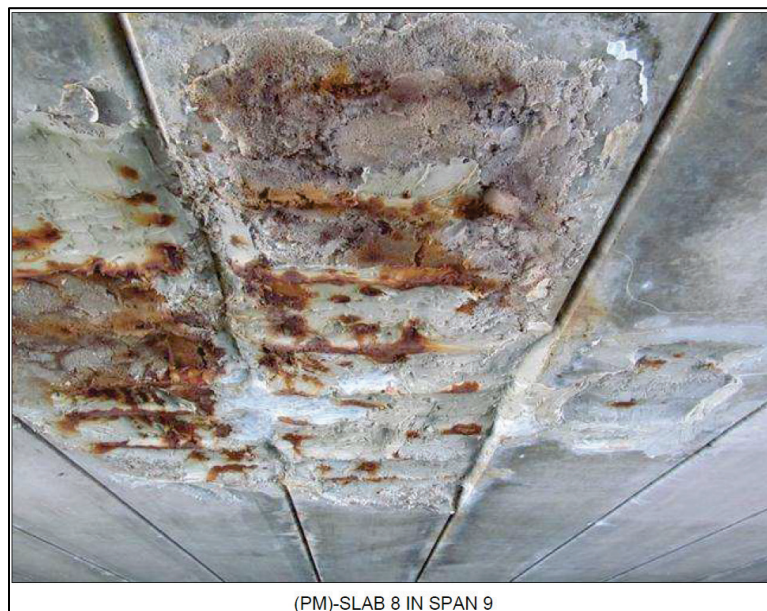
Figure 2.8 - 2013: "Delamination at previous patch with heavy longitudinal and transverse rust"

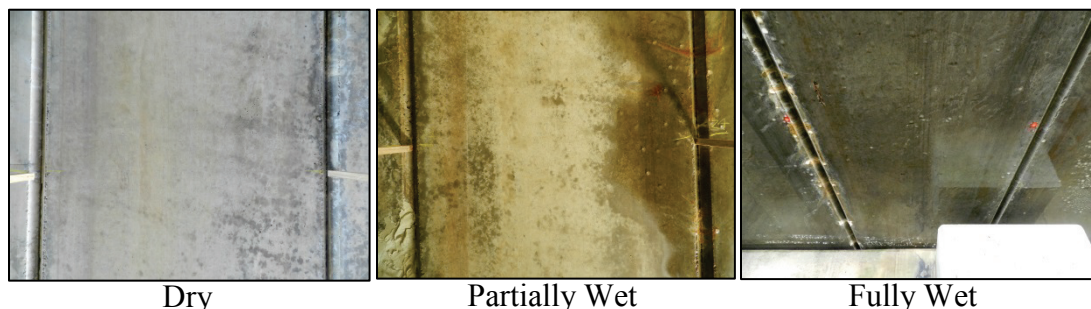
Variable environmental conditions presented a challenge for collecting resistivity data. Based on the literature review and experience, it was known that the ultimate use of the data was to compare resistivity readings within a single span to understand the relative condition of one slab to another. Because resistivity varies with the moisture content and temperature of the slabs, resistivity is ideally measured on days with limited weather and humidity variations. The constraints of field inspection mean these ideal conditions are not always met. A single span typically took 4-6 hours to record resistivity measurements, during which time temperature varied up to 20°F and slabs sometimes transitioned from the soffit appearing completely dry to dripping wet. This can be seen in Figure 3.6, showing photographs taken at varying times on one trip.

Figure 3.6 - Varying moisture on slab soffits, Ward Creek Bridge – Span 1

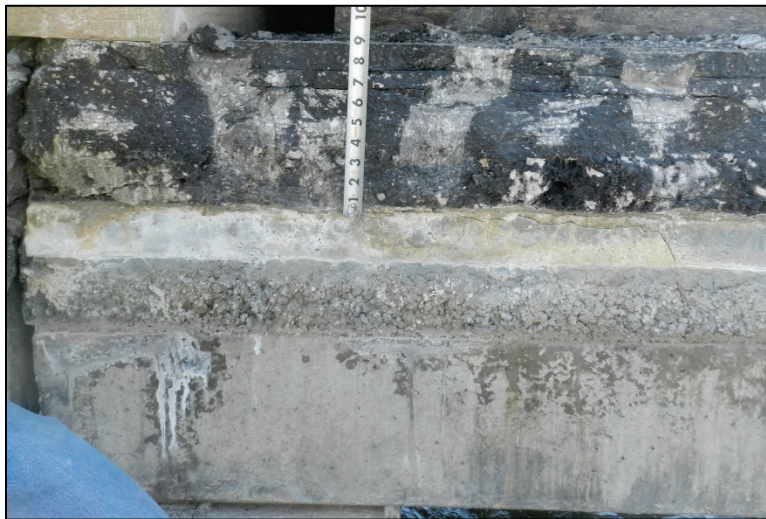
Figure 3.7 – Asphaltic overlay thickness near roadway centerline

Demolition of the superstructure was phased, with one side (lane) of the bridge replaced prior to the other. This allowed for several observations that are not possible in a typical inspection process. Asphalt thickness could be measured accurately at midspan. Original plans call for the crown of the road to be made of up to 6 in. of asphalt, and it appeared that over 36 years of service two additional wearing surfaces ~1 in. thick each had been applied, leading to a total thickness of approximately 8 in., as is visible in Figure 3.7 (showing asphalt between approximately 1 in. and 9 in. marks, due to perspective of the picture).

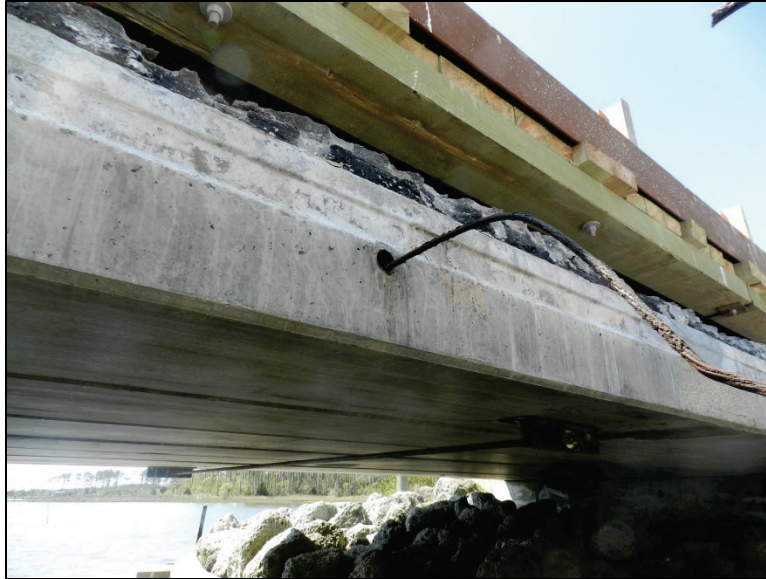
Figure 3.8 - Transverse post-tensioning strand

Transverse post-tensioning strands were cut and removed in the process of demolition, and generally appeared to be undamaged, with no significant corrosion. A strand can be seen extending from the duct in Figure 3.8.

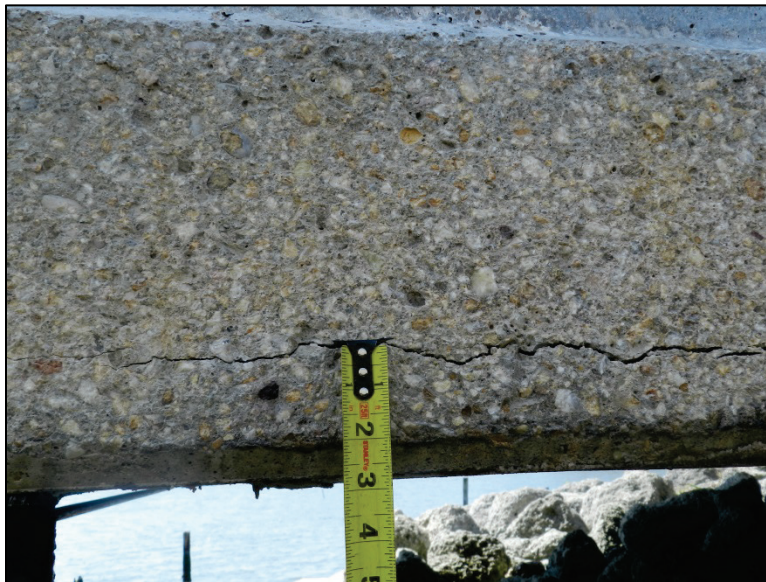
Figure 3.9 - Depth of spalling, Ward Creek – Span 1 – Slab 9

A crack visible on the side of Ward Creek – Span 1 – Slab 9 shows delaminated concrete extended up to 3 in. into the slab, as visible in Figure 3.9.

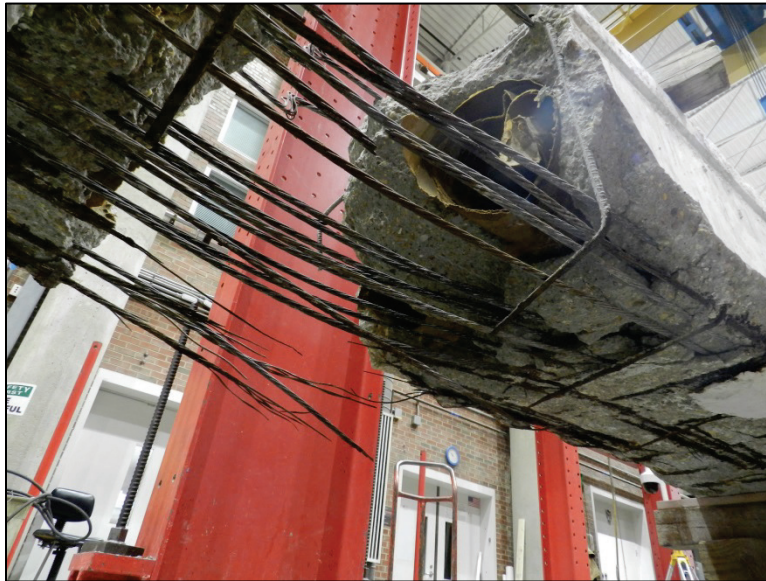
Figure 3.28 – Post-test demolition in laboratory (Oyster Creek – Span 8 – Slab 12)

After flexural testing slabs were broken apart at the failed region, and the extent of deterioration was examined in more detail with full access to all strands. Initial stages of this activity were conducted in the laboratory with hand tools, with more extensive efforts using a hydraulic jackhammer outside the laboratory to determine the full extent of corrosion near the failed region. Photographs from this process can be seen in Figure 3.28 and Figure 3.29.

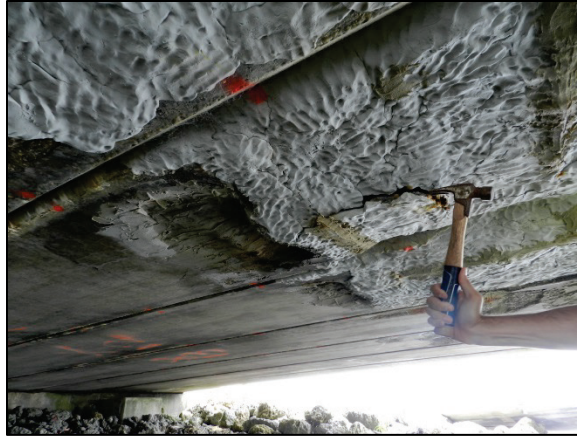
Figure 4.1 - Area surrounding Oyster Creek - Span 8 - Slab 11

Immediately prior to slab removal by the contractor, patching material from Oyster Creek – Span 8 – Slab 11 was removed to examine the condition of the strands underneath. This slab was not one of the slabs selected for laboratory testing, but it was covered by a large icolastic patch that was fully delaminated (based on hammer tapping) across the full width of the slab. An overview of this region is visible in Figure 4.1. The slab soffit as seen before and after removal of the patch is shown in Figure 4.2. The strands on the left side of the slab not visible in Figure 4.2 are shown in Figure 4.3. All 11 strands in the bottom layer were fully corroded (100% section loss), and delamination extended above the first layer of strands.

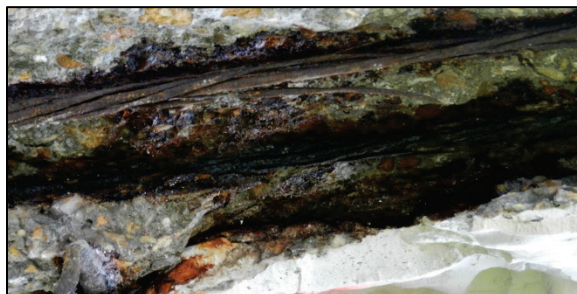
Figure 4.3 – Left 3 strands, not visible in Figure 4.2

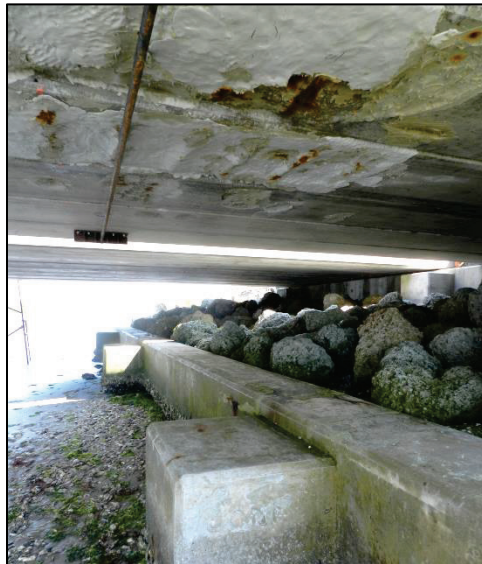
The most heavily deteriorated regions of the bridge generally coincided with the location of support blocks for the riprap retaining wall near the abutments. A photograph of this region at Ward Creek bridge – Span 9, is shown in Figure 4.4 (taken during slab replacement) and Figure 4.5 (after slab replacement).

Figure 4.4 - Deterioration of slabs above retaining wall blocks

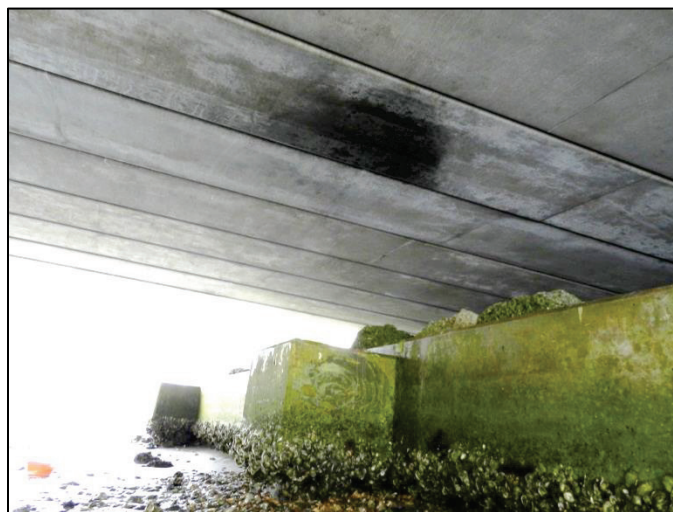
Figure 4.5 - Wetting of slabs above retaining wall blocks

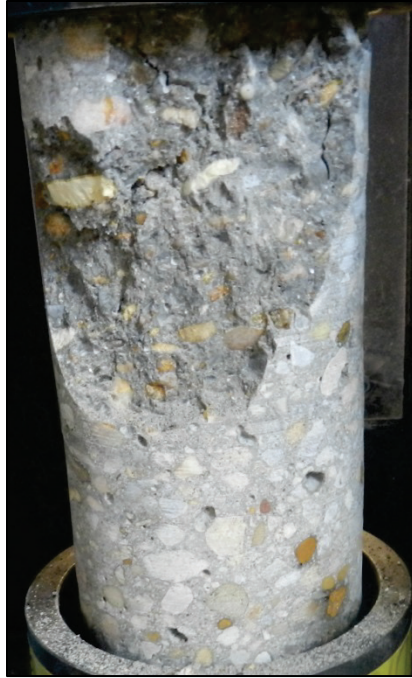
Figure 4.9 - Concrete core from Ward Creek – Span 1 – Slab 13

All cores exceeded the assumed concrete strength of 5000 psi used in NCDOT analysis and in the calculation of available moment for an undamaged slab, with measured concrete strengths for 6 of the cores ranged from 6400 to 7620 psi. A typical tested core is shown in Figure 4.9. The core taken from Ward Creek – Span 9 – Slab 6 appeared to include a darker stone aggregate in comparison to the varied river rock present in other cores, and this core was substantially stronger, with a compressive strength of 10,460 psi. Average compressive strength for the cores (excluding Ward Creek – Span 9 – Slab 6, taken as an outlier) was 7130 psi. Including that outlier, the average is 7600 psi. Density of cores varied from 142 to 150 pcf, with median value of 145 pcf.

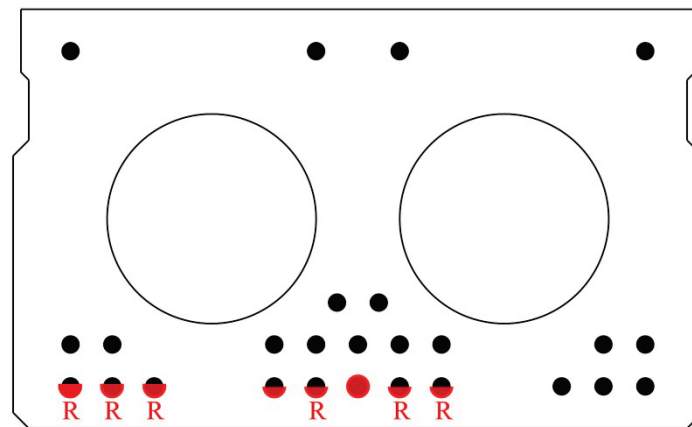
Figure 4.10 - Oyster Creek - Span 1 - Slab 14 - 19 to 21 ft

information are presented for each slab tested. Information about strand corrosion is presented on cross-sections like the one shown in Figure 4.10. Strands that were ruptured during testing are marked with an 'R'. Even after removal of concrete, the precise extent of corrosion for each strand is difficult to determine. Estimated extent of corrosion is represented visually by showing varying amounts of each strand in red. In Figure 4.10, for example, the bottom-left strand had been described as “moderate to heavy rusting & pitting. At least 4 wires ruptured,” while the middle strand was described as, “Heavy Rust. More or less completely gone.” Though depicted as a cross-section, deterioration recorded is anywhere in the failed region, here 19 to 21 ft. All prestressing strands not otherwise noted as deteriorated displayed light to very light surface rust.

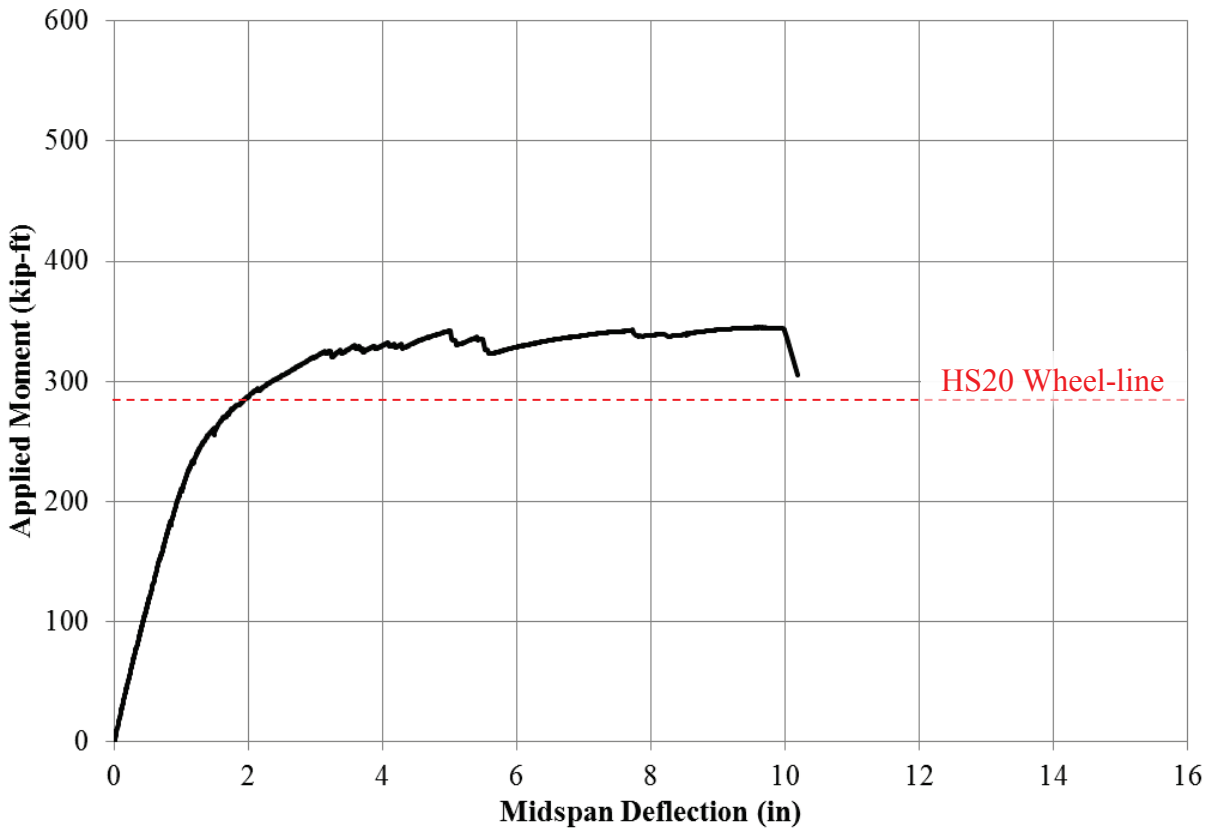
Figure 4.11 - Ward Creek - Span 1 - Slab 13 flexural test results

Flexural testing produced a total maximum moment of 429 kip-ft, corresponding to an applied moment of 345 kip-ft, 75% of the calculated available moment capacity. Measured applied top strain was 3270 $\mu\epsilon$. The moment-deflection response recorded during testing is shown in Figure 4.11.

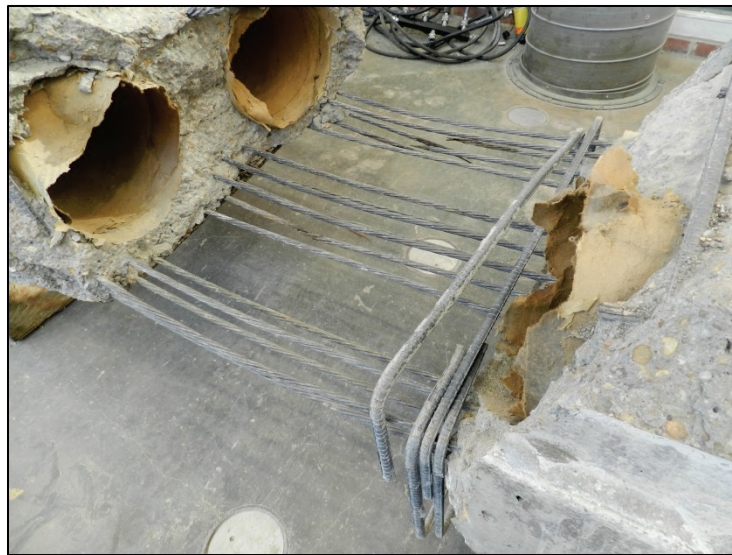
Figure 4.13 - Ward Creek - Span 1 - Slab 13, crushed concrete removed

Examination of the slab after testing revealed the failure region, 17 to 20 ft, was a region of audible delamination. Stirrups showed significant section loss (~50%), with 6 of 11 bottom strands rusty, pitted, and significantly damaged. All strands above the bottom layer were in good condition. Photos of the failed region are shown in Figure 4.12 to Figure 4.14.

Figure 4.13 shows the cross-section in the failed region after concrete was removed.

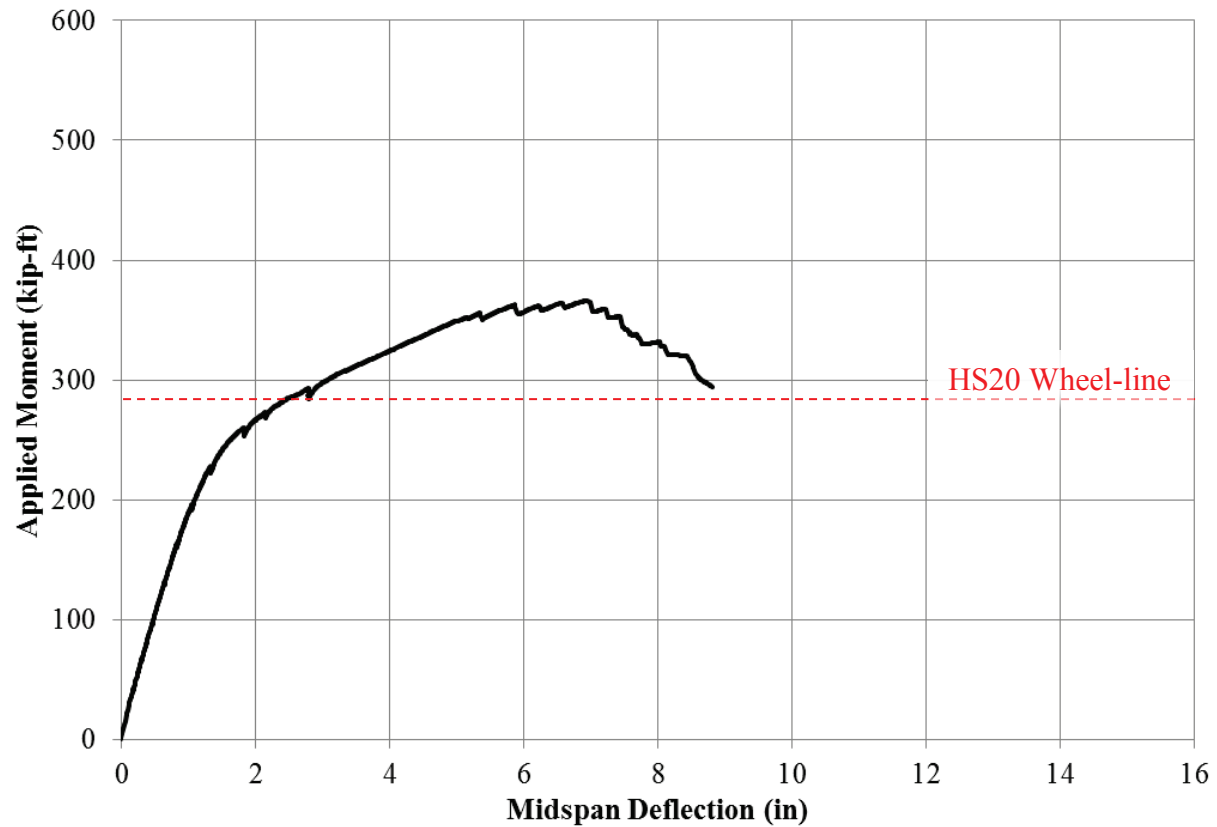
Figure 4.15 - Ward Creek - Span 1 - Slab 14 flexural test results

Flexural testing produced a total maximum moment of 451 kip-ft, corresponding to an applied moment of 367 kip-ft, 80% of the calculated available moment capacity. Measured applied top strain was 2770 $\mu\epsilon$. The moment-deflection response recorded during testing is shown in Figure 4.15.

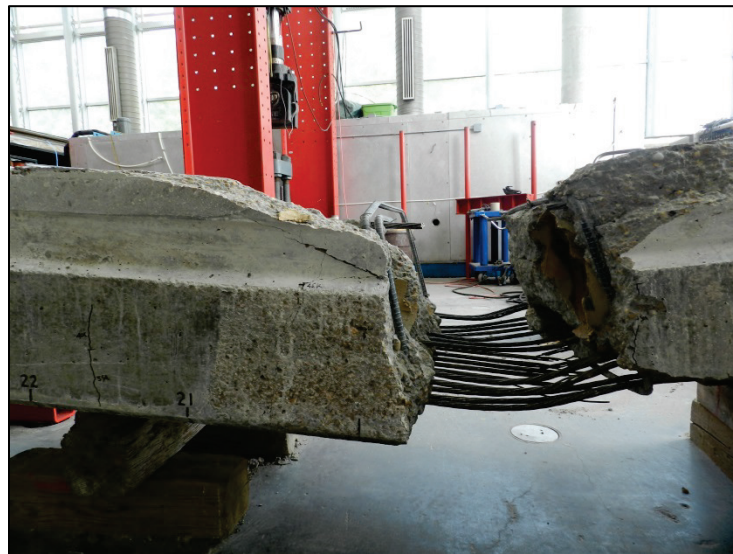
Figure 4.17 - Ward Creek - Span 1 - Slab 14, overview of failed region

The failure region, 17 to 21 ft, was a region with a single spall with rust stains surrounded by audible delamination. Stirrups showed some corrosion, with 5 of 11 bottom strands displaying some pitting near the stirrups, and minor rusting of 4 additional strands. All strands above the bottom layer were in good condition. Photos of the failed region are shown in Figure 4.16 and Figure 4.17.

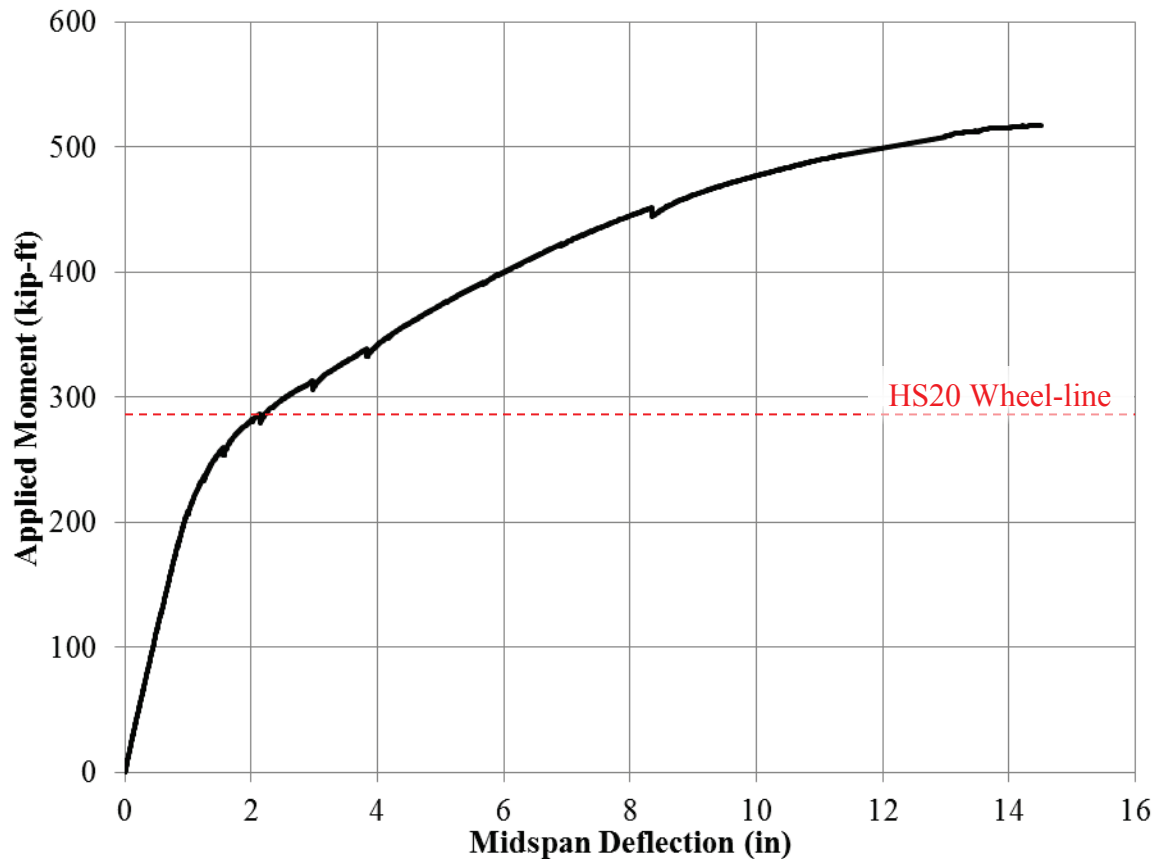
Figure 4.18 - Ward Creek - Span 4 - Slab 5 flexural test results

Flexural testing produced a total maximum moment of 602 kip-ft, corresponding to an applied moment of 518 kip-ft, 112% of the calculated available moment capacity. Measured applied top strain was 3430 $\mu\epsilon$, the maximum recorded for all slabs. The moment-deflection response recorded during testing is shown in Figure 4.18.

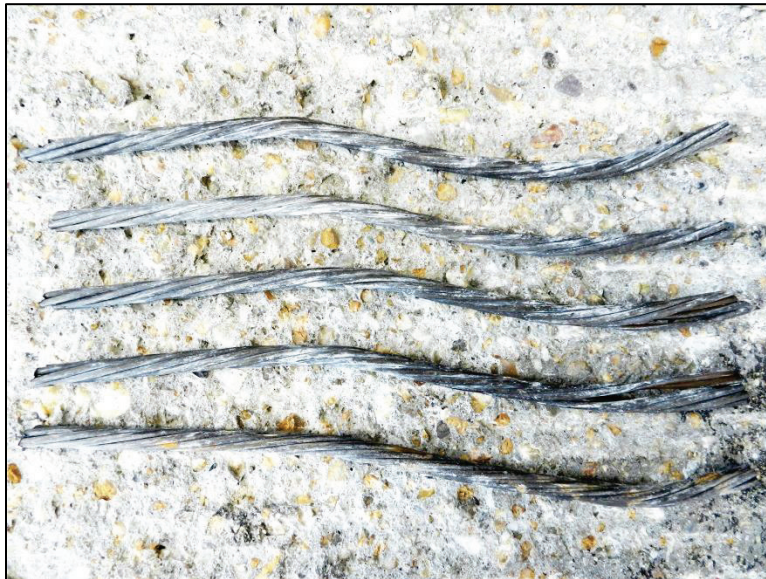
Figure 4.20 – Ward Creek - Span 4 - Slab 5, typical strands

The failure region, 16 to 18 ft, was a region with no visible deterioration. All strands were in good condition, with only typical light surface rust on some strands. Photos of the failure region are shown in Figure 4.19. Figure 4.20 shows a closer view of a typical group of strands.

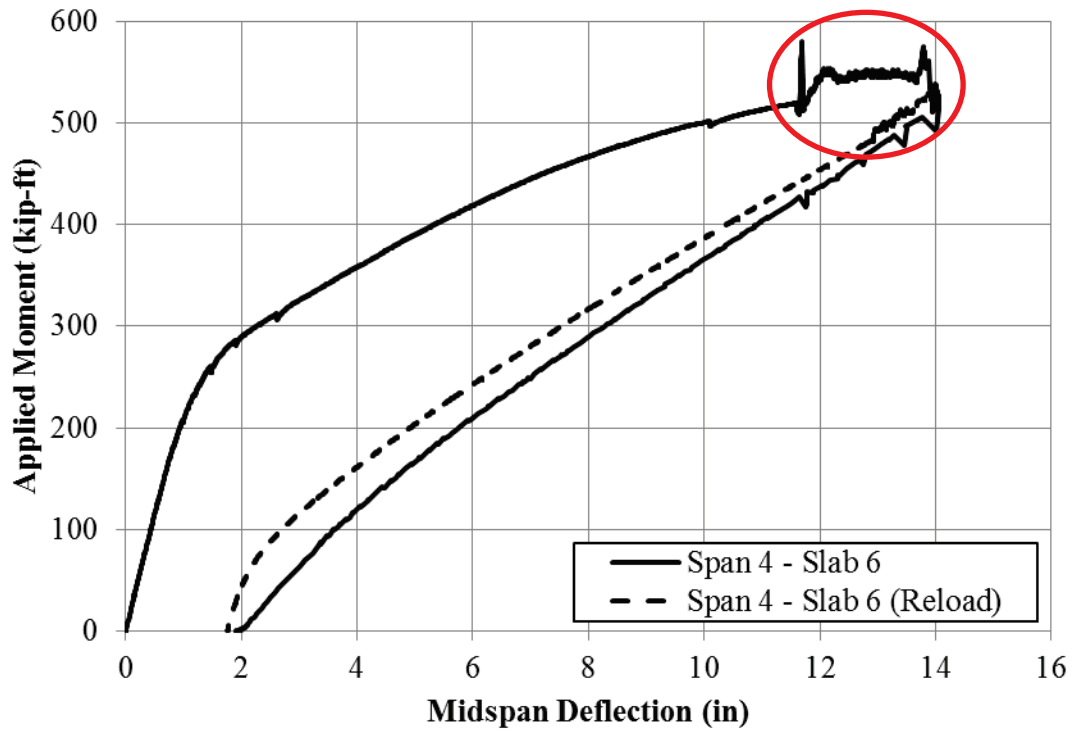
Figure 4.21 - Ward Creek - Span 4 - Slab 6 flexural testing results

During testing, this slab reached deflections close to the maximum achievable with the 40 ft test setup. Results for Ward Creek – Span 4 – Slab 6 are shown in Figure 4.21. Initial loading proceeded smoothly until 11.6 in. midspan deflection and 519 kip-ft applied moment, at which point the hydraulic jacks were stroked out. Supplemental loading jacks affixed to the setup were used to continue testing, but binding of threaded rods produced erroneous load readings, circled in Figure 4.21. The decision was made to fully unload the beam and reload with better sheathing of the threaded rods. Reloading proceeded smoothly, with maximum midspan deflection of 14.0 in., and maximum applied moment of 525 kip-ft. It can thus be concluded that the slab was close to its maximum capacity at the end of the initial loading. Permanent deformation was 1.70 in. after unloading and approximately 2.5 hours with no applied load.

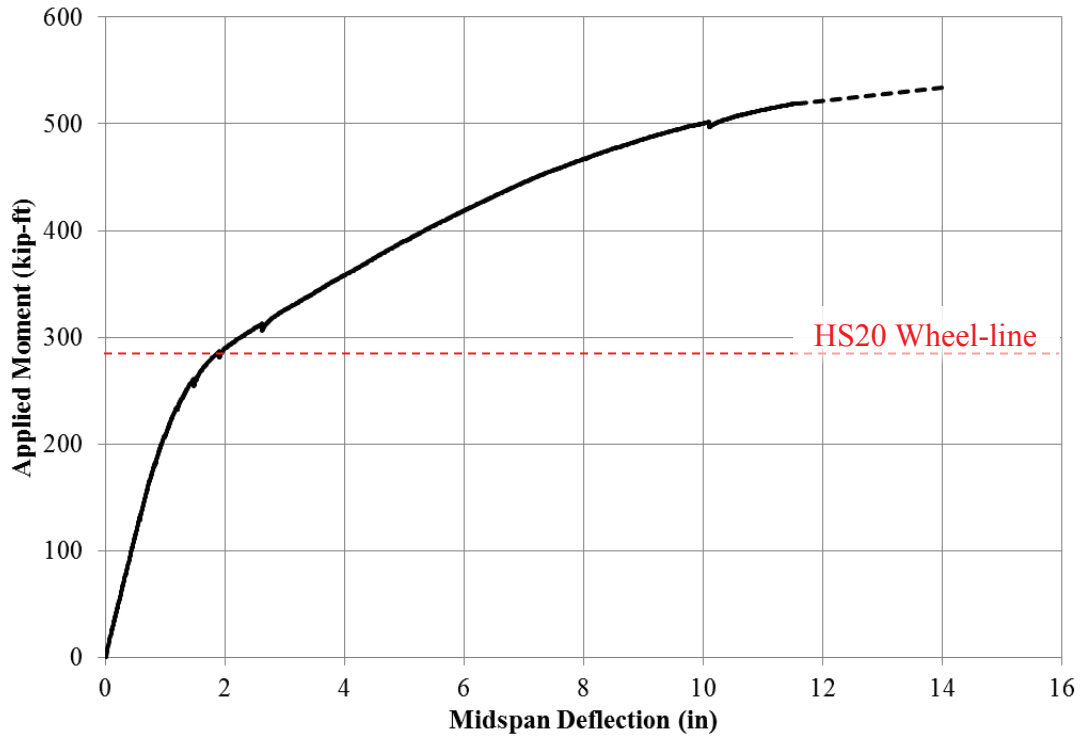
Figure 4.22 - Ward Creek - Span 4 - Slab 6 flexural test results combined

Flexural testing produced a total maximum moment of 618 kip-ft, corresponding to an applied moment of 534 kip-ft, 116% of the calculated available moment capacity. The top pi gauge debonded during testing. The moment-deflection response recorded during testing is shown in Figure 4.22. This was the strongest of the 6 Ward Creek slabs.

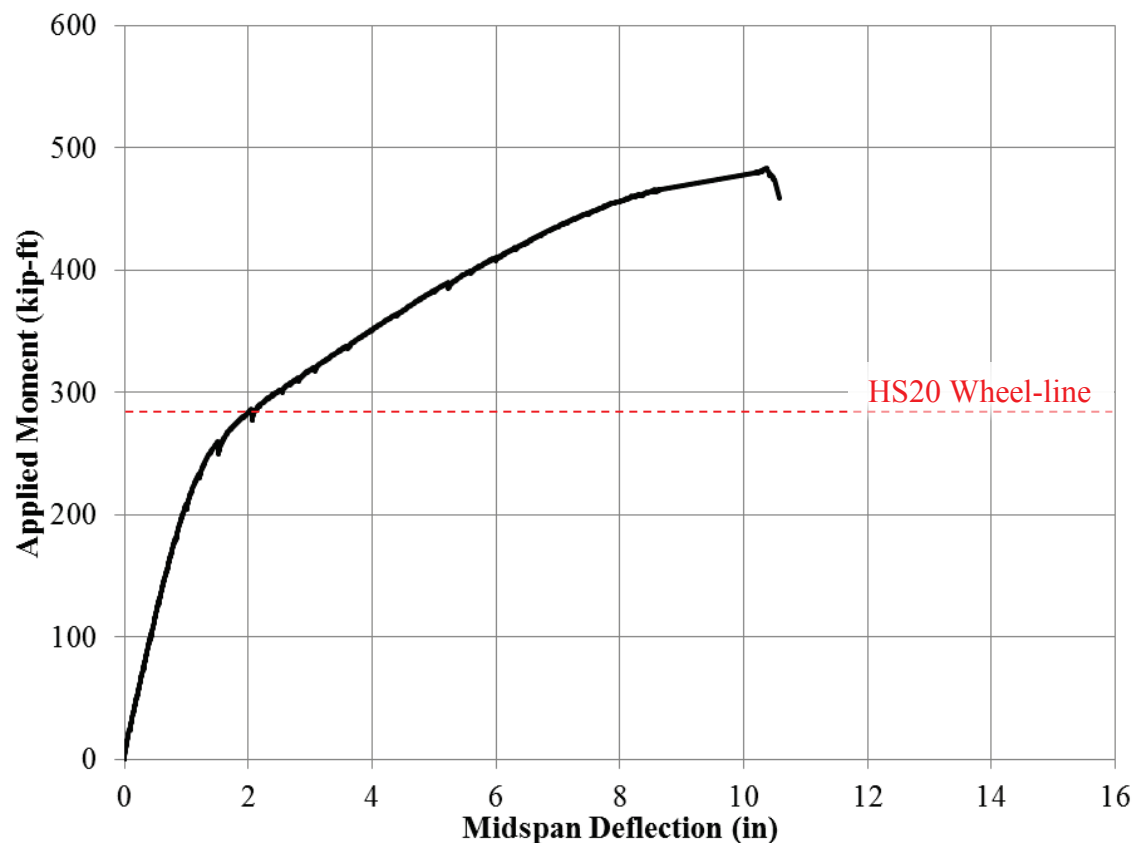
Figure 4.24 - Ward Creek - Span 9 - Slab 6 flexural test results

Flexural testing produced a total maximum moment of 568 kip-ft, corresponding to an applied moment of 484 kip-ft, 105% of the calculated available moment capacity. Measured applied top strain was 2120 $\mu\epsilon$. The moment-deflection response recorded during testing is shown in Figure 4.24.

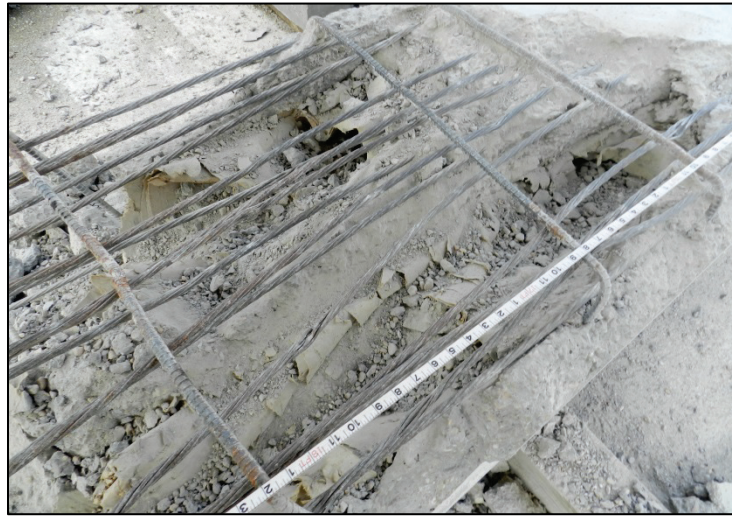
The failure region, 19 to 21 ft, contained a small spall with a rust stain. Stirrups showed some corrosion, with 5 of 11 bottom strands displaying some pitting near the stirrups, and minor rusting of 4 additional strands. All strands above the bottom layer were in good condition. A photo showing strand conditions in the area surrounding the failure region is shown in Figure 4.25.

Figure 4.25 - Ward Creek - Span 9 - Slab 6, strands exposed around failure region

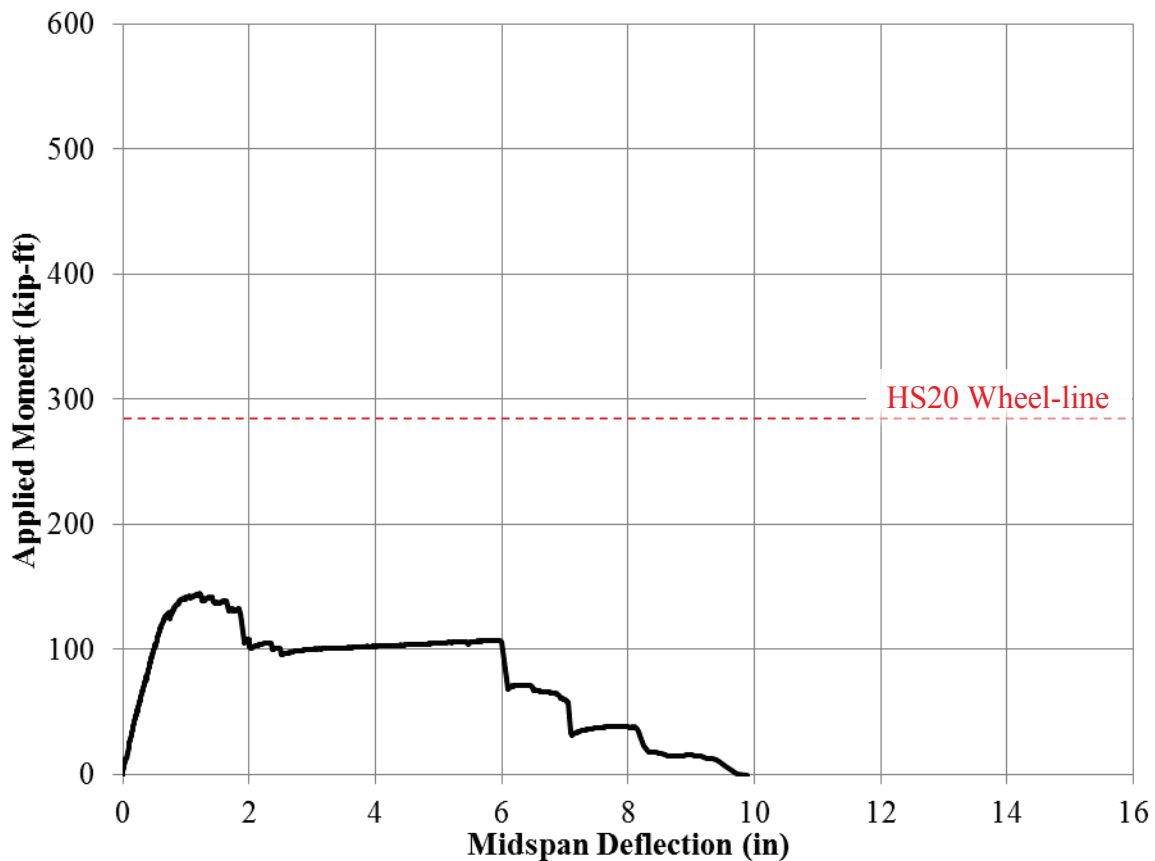
Figure 4.26 - Ward Creek - Span 9 - Slab 7 flexural test results

Flexural testing produced a total maximum moment of 229 kip-ft, corresponding to an applied moment of 145 kip-ft, 31% of the calculated available moment capacity. This was the weakest of the 6 Ward Creek slabs. Measured applied top strain was 1950 $\mu\epsilon$. The moment-deflection response recorded during testing is shown in Figure 4.26.

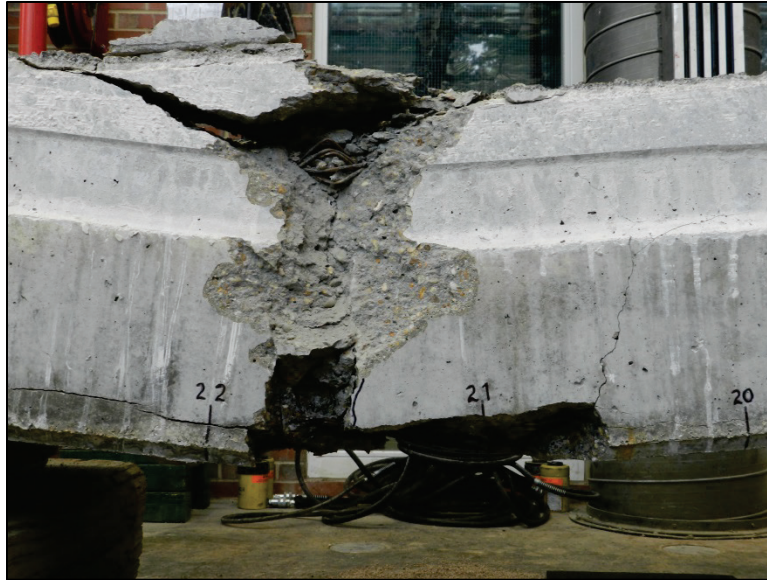
The failure region, 20 to 23 ft, was in a region with a large patched spall with some prestressing strands visible, and heavy longitudinal and transverse rust stains. The bottom parts of stirrups were completely corroded, and 8 of 11 bottom strands were completely rusted (100% section loss), with 7 additional strands in the bottom and second layer displaying moderate rust. Photos of the failure region are shown in Figure 4.27 to Figure 4.30.

Figure 4.27 - Ward Creek - Span 9 - Slab 7, delamination visible at failed region

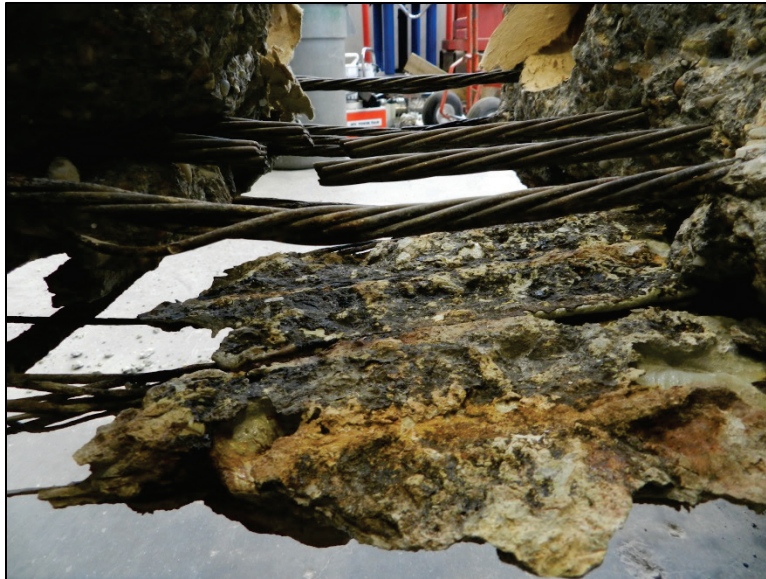
Figure 4.29 - Ward Creek - Span 9 - Slab 7, patching material bonded with strands

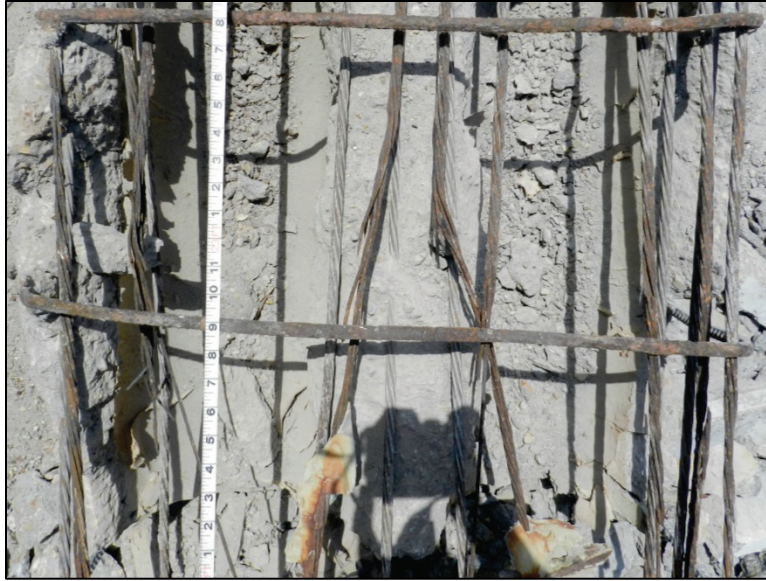
Figure 4.30 - Ward Creek - Span 9 - Slab 7, heavy rust and pitting extends through patched region

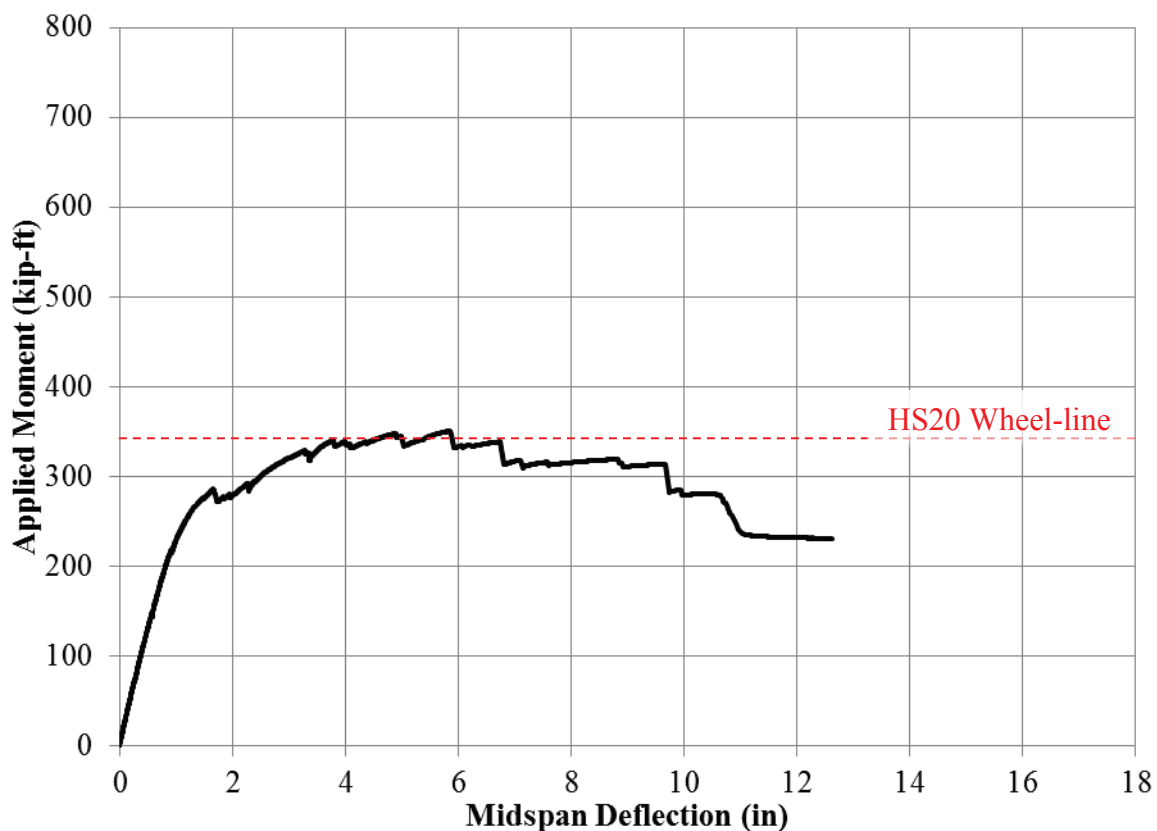
Figure 4.31 - Oyster Creek - Span 1 - Slab 13 flexural test results

Flexural testing produced a total maximum moment of 483 kip-ft, corresponding to an applied moment of 351 kip-ft, 56% of the calculated available moment capacity. The top pi gauge debonded during testing. The moment-deflection response recorded during testing is shown in Figure 4.31.

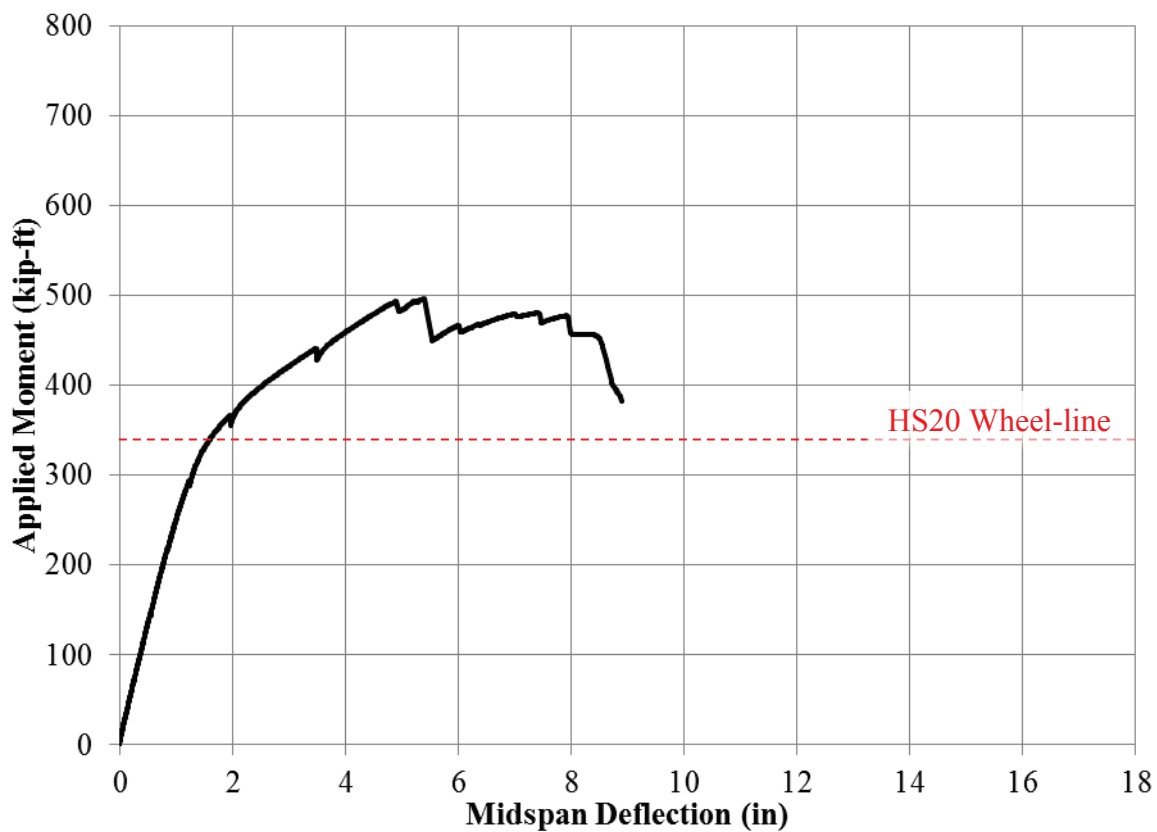
Figure 4.33 - Oyster Creek - Span 1 - Slab 14 flexural test results

Flexural testing produced a total maximum moment of 628 kip-ft, corresponding to an applied moment of 496 kip-ft, 79% of the calculated available moment capacity. Measured applied top strain was 2870 $\mu\epsilon$. The moment-deflection response recorded during testing is shown in Figure 4.33.

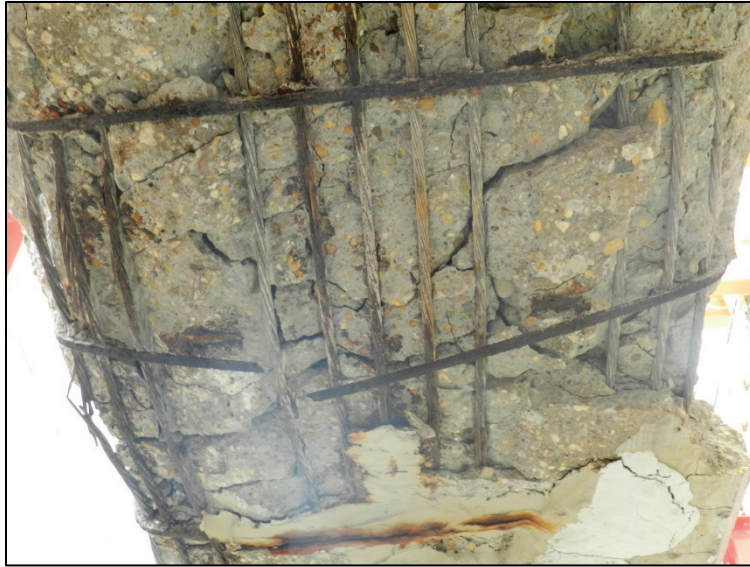
The failure region, 18 to 22 ft, contained a patchwork of spalls and patching materials, with transverse and indistinct longitudinal rust stains. Eight of eleven bottom strands ranged from moderate surface rust and pitting to heavy rust and loss of wires, while the three right bottom strands had only light surface rust. All strands above the bottom layer were in good condition. Photos of the failure region are shown in Figure 4.34 and Figure 4.35.

Figure 4.34 - Oyster Creek - Span 1 - Slab 14, slab soffit after failure, showing broken stirrup

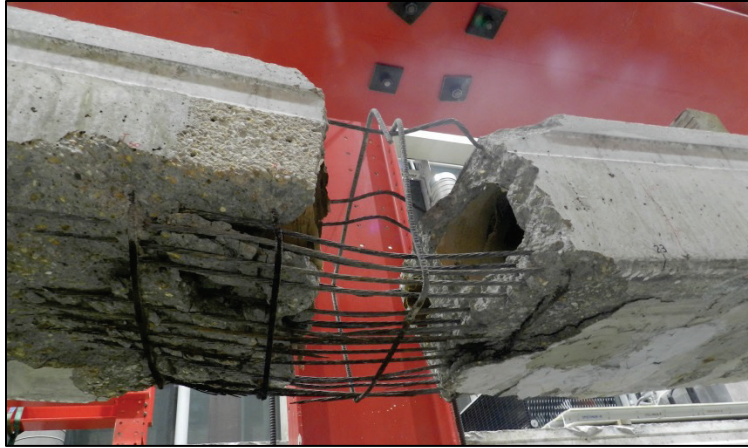
Figure 4.35 - Oyster Creek - Span 1 - Slab 14, failed region
