Assessment of Deteriorated Cored Slabs Bridges No.: 150035 and 150039

**Department of Civil, Construction, and Environmental
Engineering
North Carolina State University**

**FHWA/NC/2014-35
February 2016**

Prepared for:
North Carolina Department of Transportation
Research and Development Unit

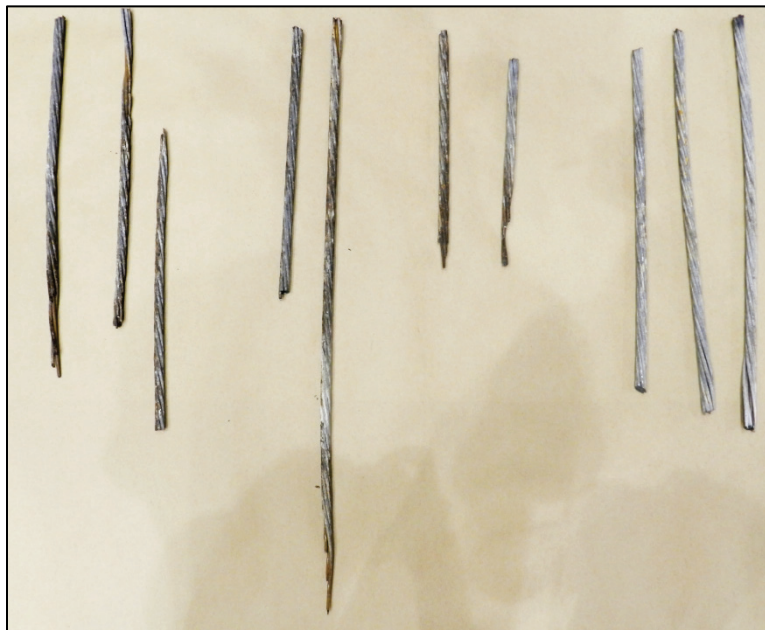
Figure 4.36 to Figure 4.38 show steel removed from the failure. The strands are laid out in the same order (left to right) as they are shown in the cross-section in Table 4.15.

Figure 4.36 - Oyster Creek - Span 1 - Slab 14, bottom layer strands from failed region

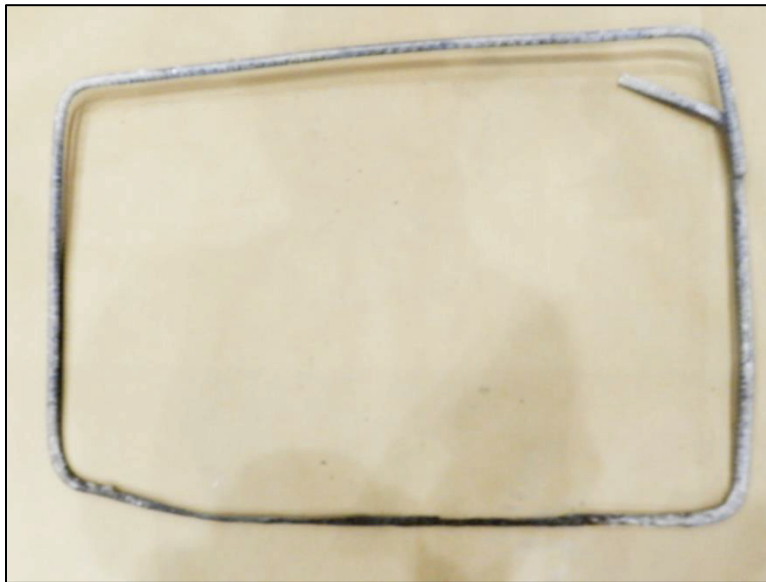
Figure 4.38 - Oyster Creek - Span 1 - Slab 14, corroded stirrup from failed region

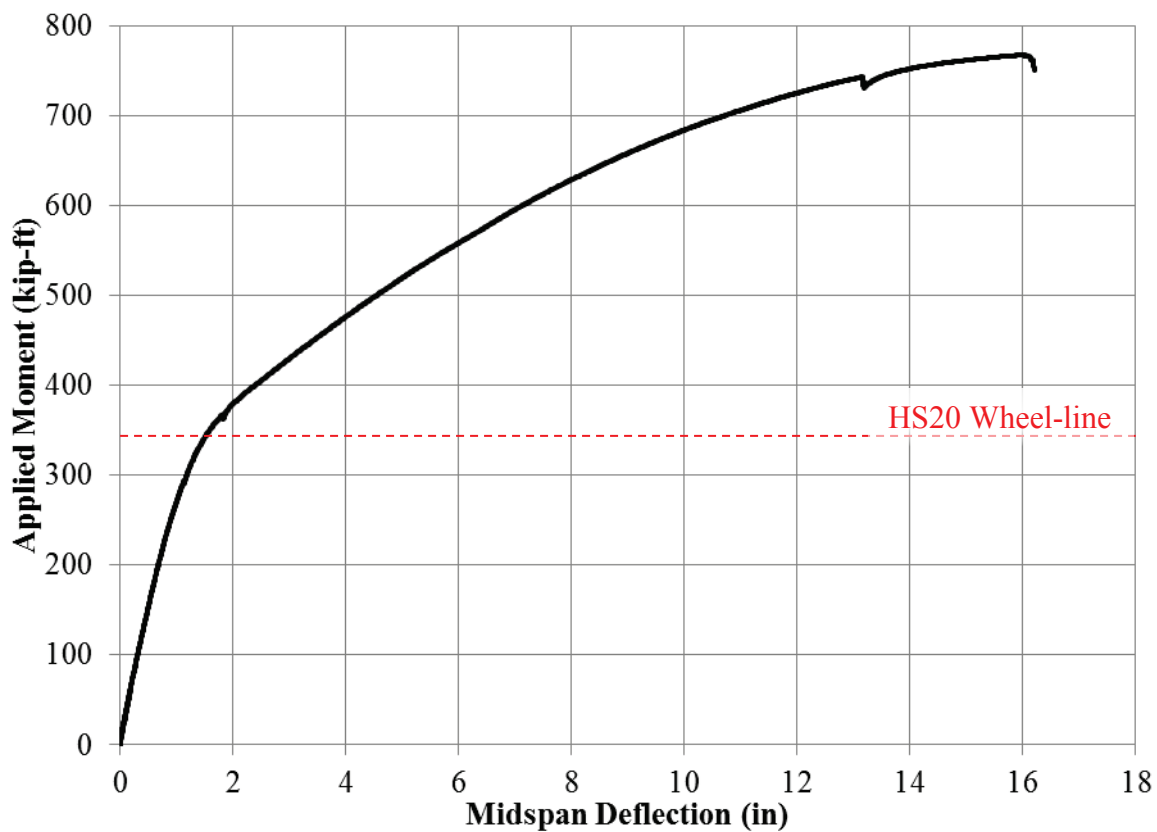
Figure 4.39 - Oyster Creek - Span 2 - Slab 4 flexural test results

Flexural testing produced a total maximum moment of 900 kip-ft, corresponding to an applied moment of 767 kip-ft, 122% of the calculated available moment capacity. This was the strongest of 6 Oyster Creek slabs. Measured applied top strain was 3100 $\mu\epsilon$. The moment-deflection response recorded during testing is shown in Figure 4.39.

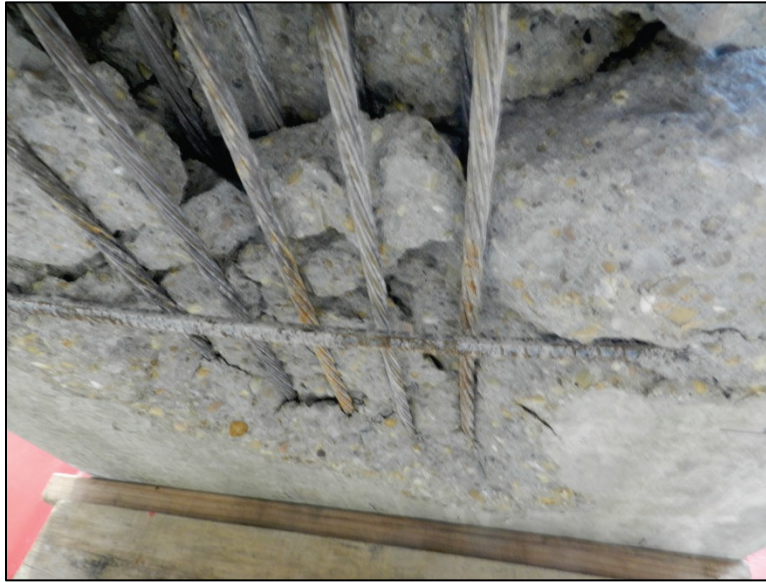
The failure region, 16 to 19 ft, contained a couple of shallow, patched spalls. All strands were in generally good condition, with slightly more surface rust near stirrups but no visible section loss.

Figure 4.40 - Oyster Creek - Span 2 - Slab 4, central strands at failed region

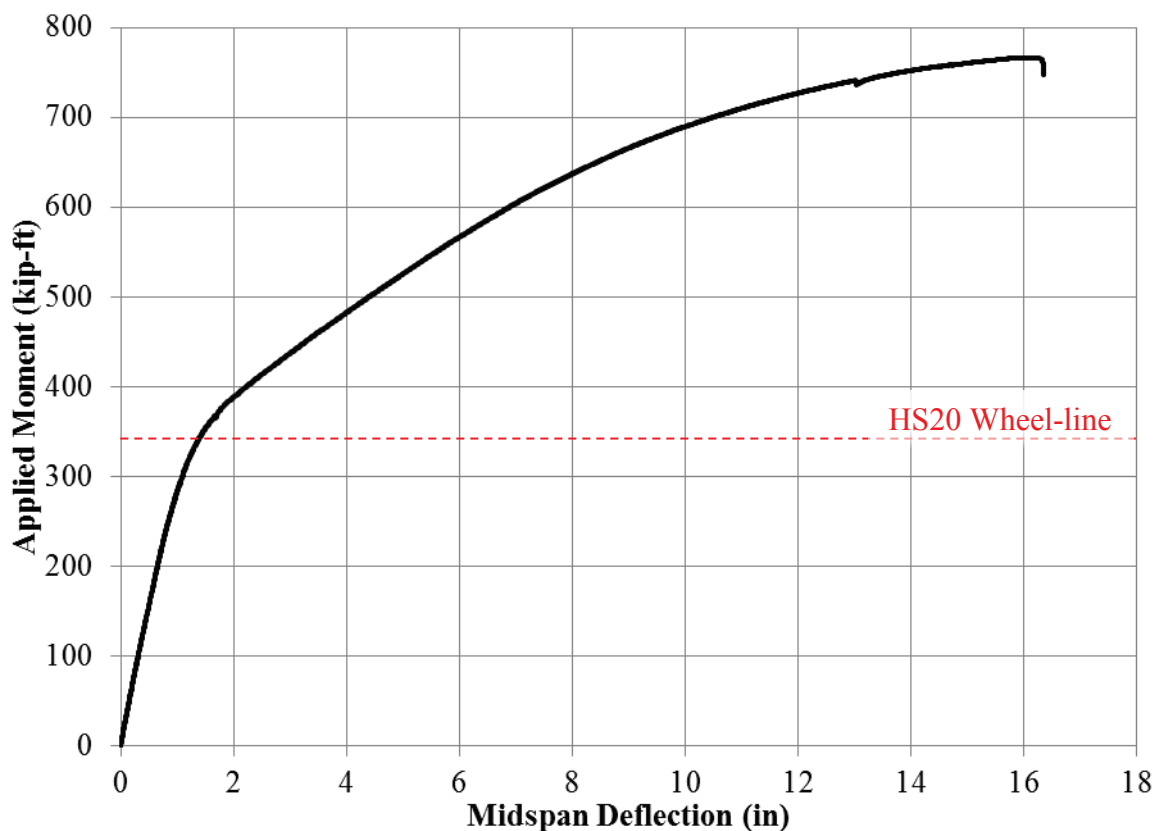
Figure 4.41 - Oyster Creek - Span 2 - Slab 5 flexural test results

Flexural testing produced a total maximum moment of 899 kip-ft, corresponding to an applied moment of 766 kip-ft, 121% of the calculated available moment capacity. Measured applied top strain was 3020 $\mu\epsilon$. The moment-deflection response recorded during testing is shown in Figure 4.41.

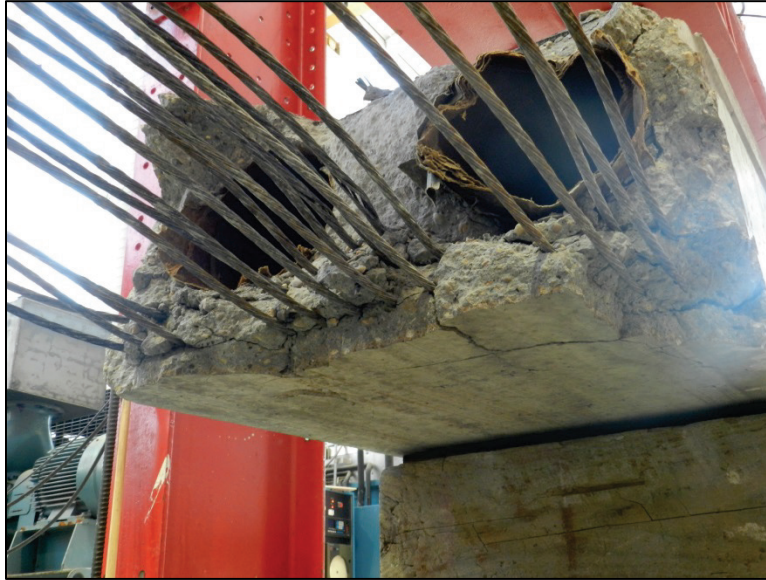
The failure region, 17 to 19 ft, had no visible deterioration. All strands were in good condition, displaying only typical light surface rust. A photo of the failure region is shown in Figure 4.42.

Figure 4.42 - Oyster Creek - Span 2 - Slab 5, strands at failed region

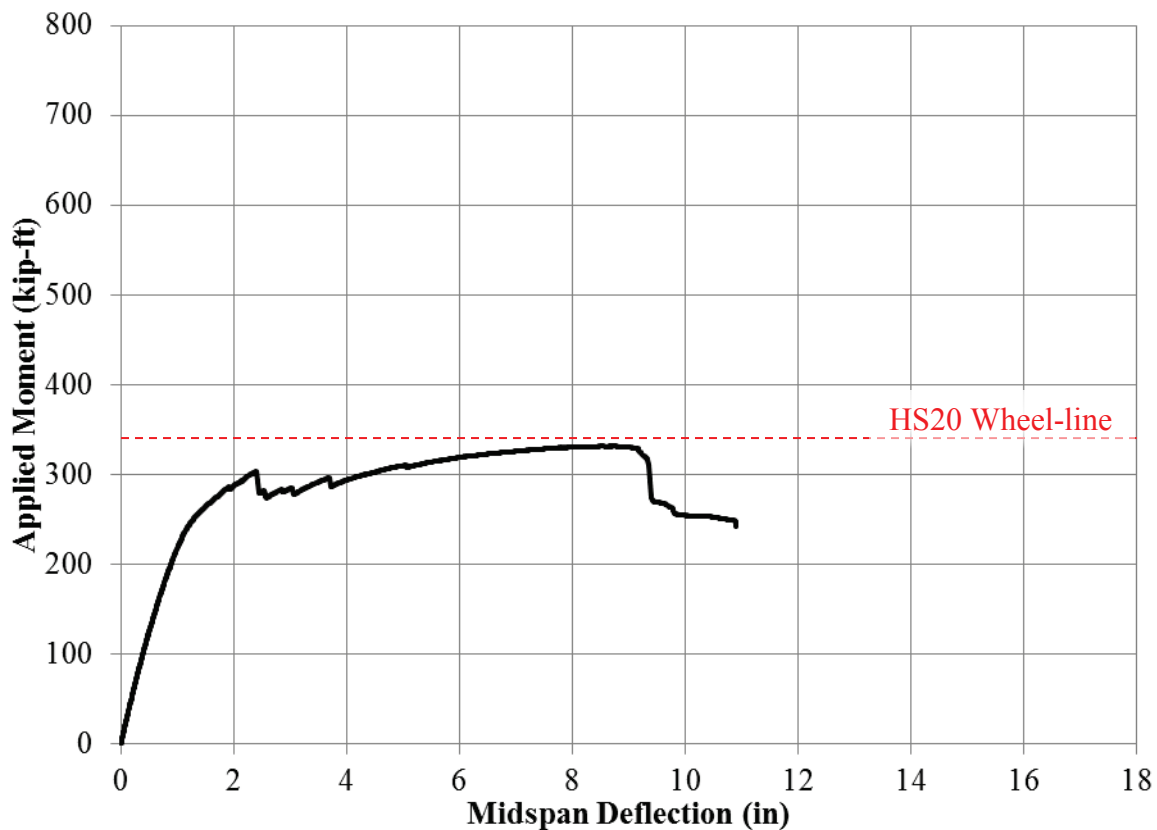
Figure 4.43 - Oyster Creek - Span 8 - Slab 12 flexural test results

Flexural testing produced a total maximum moment of 465 kip-ft, corresponding to an applied moment of 332 kip-ft, 53% of the calculated available moment capacity. Measured applied top strain was 2440 $\mu\epsilon$. The moment-deflection response recorded during testing is shown in Figure 4.43.

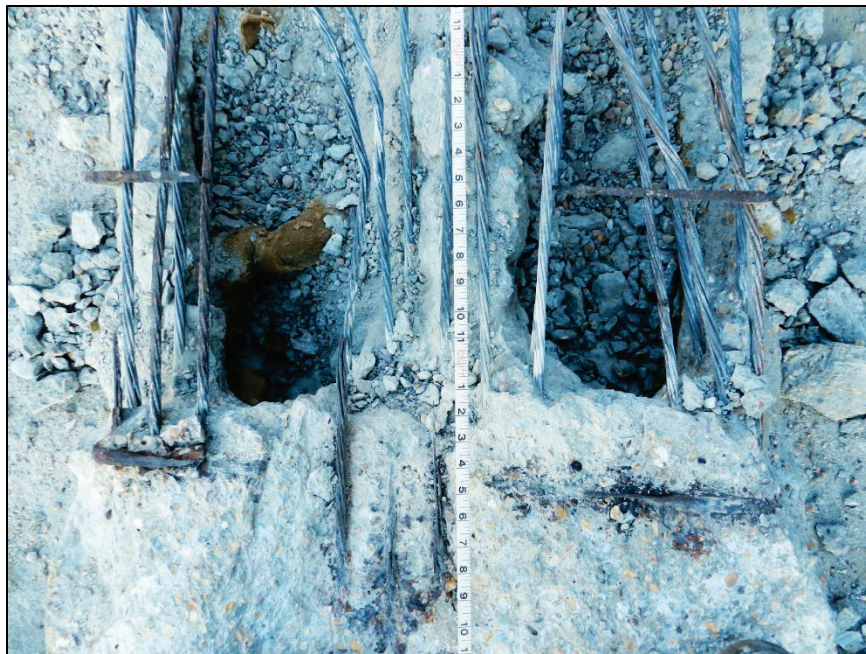
The failure region, 19 to 22 ft, was visually a single large, clearly delaminated icolastic patch, with no visible deterioration. Five of eleven bottom strands were fully corroded, with remaining bottom strands heavily corroded and ruptured during testing. One strand in the second layer was heavily rusted and pitted, and effectively completely lost, while one other strand in the second layer displayed significant pitting on all 7 wires. All other strands above the first layer were in very good condition. Photos of the failure region are shown in Figure 4.44 and Figure 4.45.

Figure 4.45 - Oyster Creek - Span 8 - Slab 12, strand section loss extends full length of icolastic patch

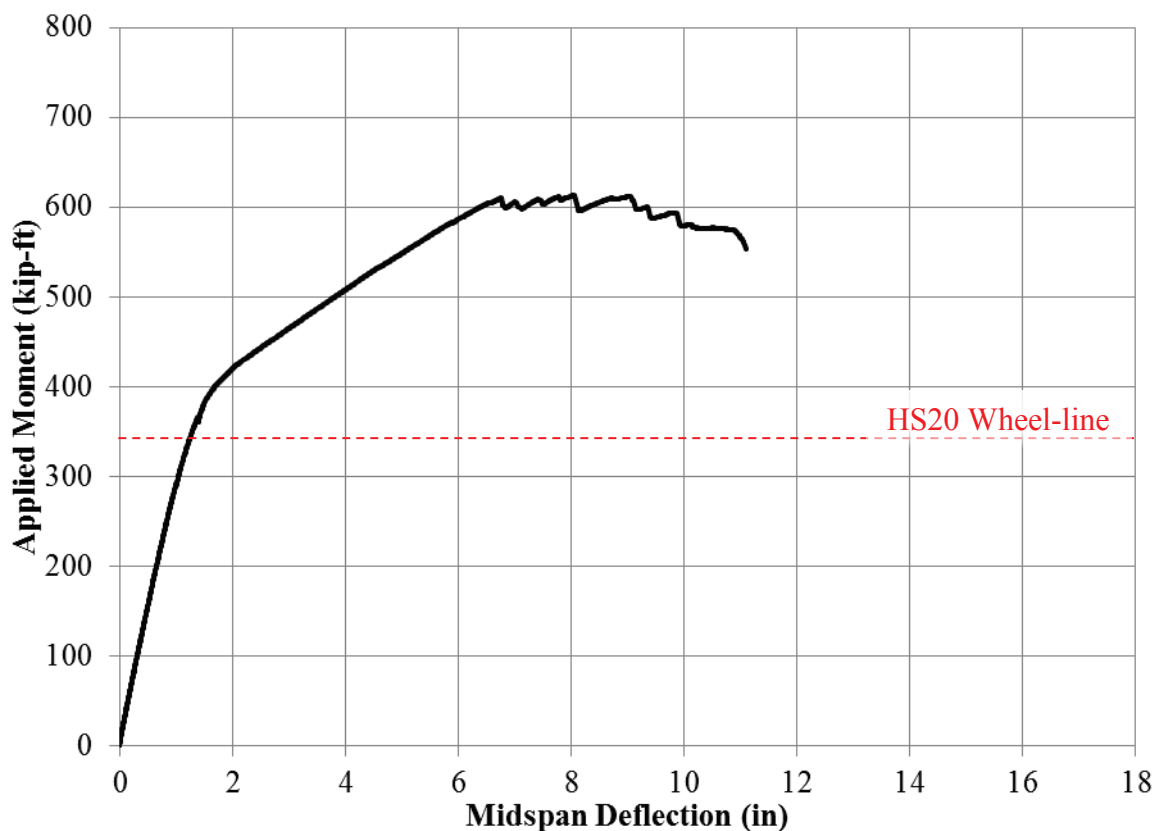
Figure 4.46 - Oyster Creek - Span 8 - Slab 13 flexural test results

Flexural testing produced a total maximum moment of 746 kip-ft, corresponding to an applied moment of 613 kip-ft, 97% of the calculated available moment capacity. Measured applied top strain was 3320 $\mu\epsilon$. The moment-deflection response recorded during testing is shown in Figure 4.46.

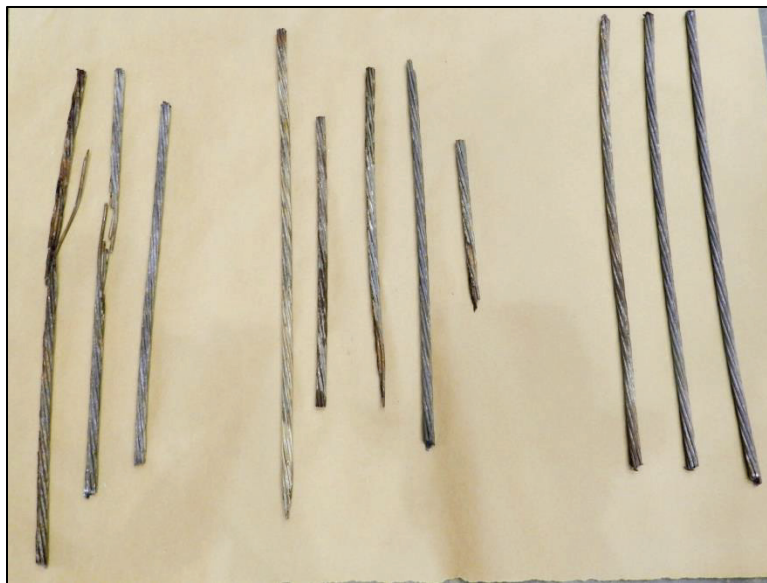
The failure region, 22 to 25 ft, contained a large, asymmetrical, patched spall which appeared deeper close to the edge of the slab and contained rust stains of indistinct orientation. Five of eleven bottom strands displayed minor to moderate rust and pitting, with the equivalent of 2 strands worth of wires fully corroded. Other strands in the bottom layer displayed only minor rust. All strands above the bottom layer were in good condition. Photos of the failure region and bottom layer strands removed from it are shown in Figure 4.47 to Figure 4.49.

Figure 4.49 - Oyster Creek - Span 8 - Slab 13, bottom layer strands removed from failed region

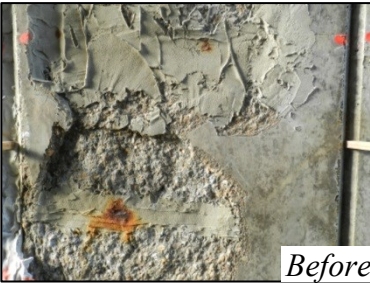
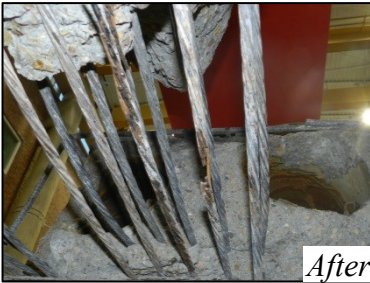
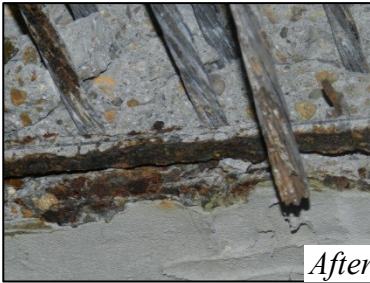
Region of Failure - 22 to 25 ft

Qualitative Description: Moderate spalled region with rust stains
Priority Maintenance Request: Yes

Average Resistivity	68.6 kΩ-cm	Applied Moment	
Average Half-Cell	-0.269 V	613 kip-ft	97%

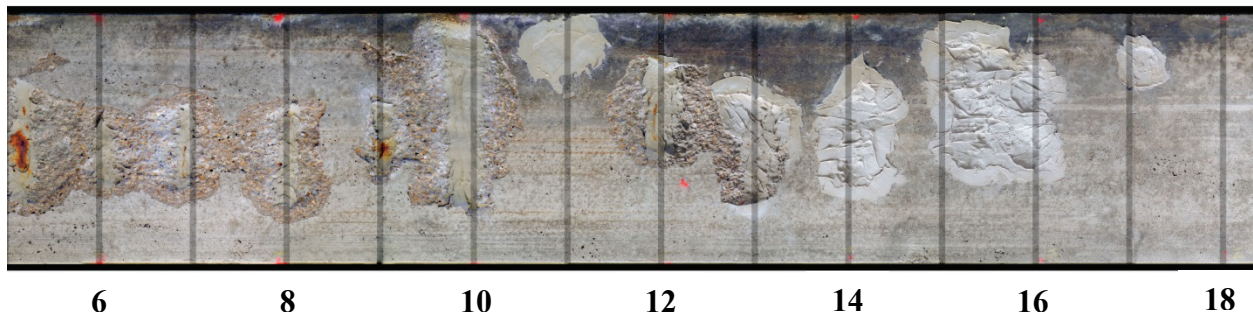
Figure 5.2 - Typical intermediate span spalling, Oyster Creek - Span 2 - Slab 4

Deterioration was not limited to the end spans, with spalling or delamination observed on 19 of 32 slabs in the two intermediate spans examined in this research. Slabs chosen for laboratory testing (Slabs 5 and 6 from Ward Creek – Span 4, and Slabs 4 and 5 from Oyster Creek – Span 2) were initially selected to capture a spread of apparent deterioration, with one slab from each bridge chosen with no visible deterioration, and one slab chosen to have more visible deterioration. The region of the slab soffit of Oyster Creek – Span 2 – Slab 4, shown in Figure 5.2, is representative of the typical soffit of an intermediate span slab in “worse” condition.

In flexural testing, no difference in flexural strength was observed between the slabs in visually excellent condition and their more heavily spalled partners. This suggests that based solely on the condition of slabs prior to replacement, the flexural capacity of intermediate spans was not of significant concern.

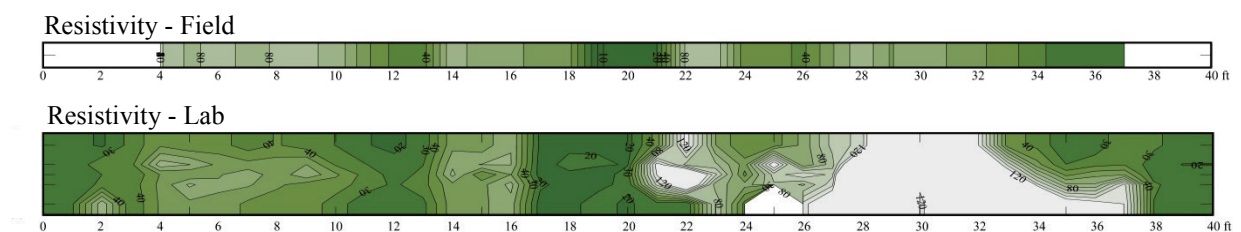
Figure 5.3 - Resistivity Contours, Ward Creek - Span 1 - Slab 14

As an example, this process was used for Ward Creek – Span 1 – Slab 14 (shown in Figure 5.3) to identify 3 areas in field resistivity and 4 areas in laboratory resistivity to further examine.

Areas of interest for field resistivity were 13, 19 – 21, and 36 – 40 ft, while those for laboratory resistivity are 0 – 3, 12, 17 – 20, and 36 – 40 ft. Flexural testing and demolition revealed the area from 16.5 – 21 ft to contain rusting of strands that contributed to a decrease in flexural strength, but this area, shown in Figure 5.4, was also visibly and audibly delaminated. Other areas were not observed to have deterioration contributing to loss of flexural strength, therefore no areas identified through resistivity added value.

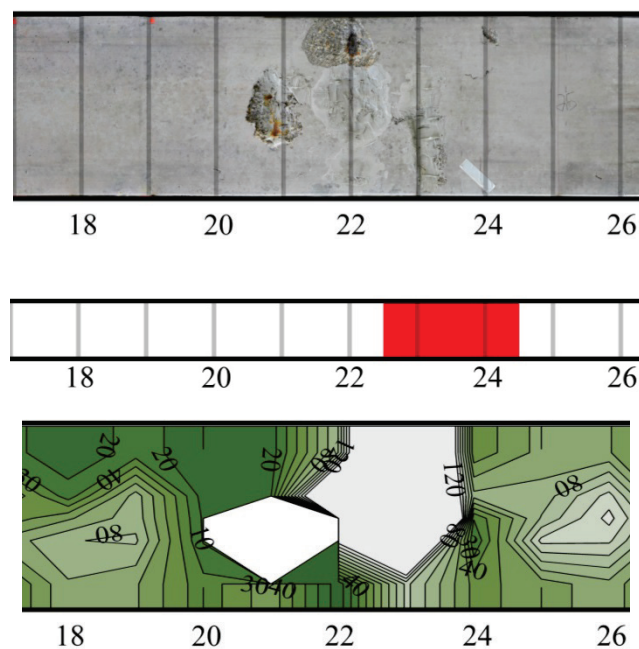
Figure 5.5 - Ward Creek - Span 9 - Slab 6, 17 - 26 ft

Resistivity clearly did not add value to the inspection process. Of the 37 areas of interest, one of them possibly yielded additional information useful to assessing the strength of the slab. This was Ward Creek – Span 9 – Slab 6, from 18 – 22 ft, shown in Figure 5.5. This region contained visible deterioration from 21 to 24 ft, and audible delamination at 23 and 24 ft. Resistivity values were below 20 kΩ-cm for a region from 18 to 21 ft that did not appear to be clearly damaged, but demolition suggested that the corrosion of this slab extended into that region.

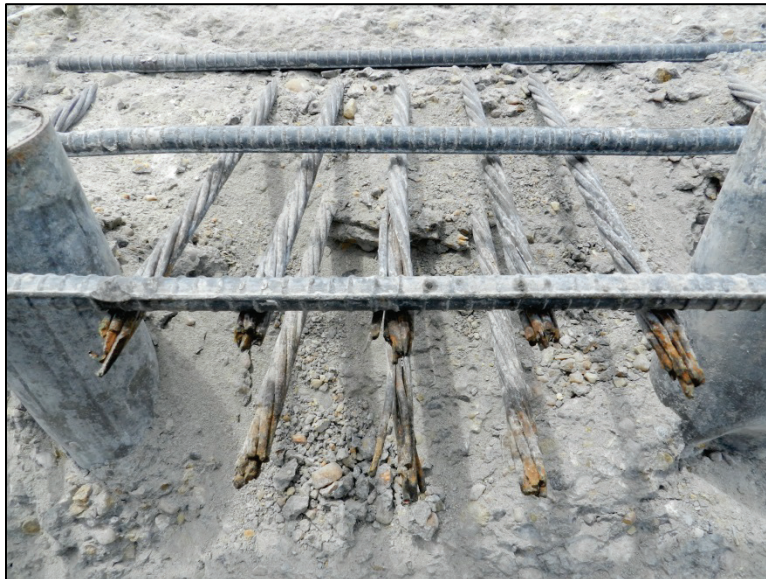
Figure 5.8 - Center strands, Ward Creek - Span 1 - Slab 14, 0 - 1 ft

The ends of slabs were consistently locations of low resistivity, representing 21 of 37 areas of interest (and 21 of 24 slab ends). This is consistent with expectations, as slab ends are frequently subject to additional moisture due to leaking joints and debris buildup around bearing pads. Most slab soffits appeared undamaged in the field, but hairline cracks were visible in the field on a couple, as may be seen in Figure 5.7. Hairline cracks were commonly seen on the sides of slabs near the ends during laboratory testing. The final 1 to 2 in. of strand ends had been encased in grout after casting, and were commonly at least partially rusted, with some pitting and section loss. Despite this deterioration, slab ends exposed during jackhammering after flexural testing were in uniformly good condition. The typical condition of strand ends is shown in Figure 5.8.

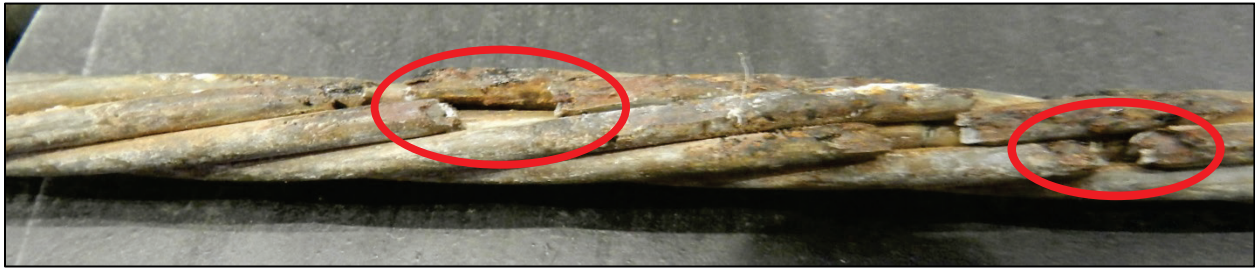
Figure 5.30 – Ruptured wires in strand, Oyster Creek - Span 8 - Slab 13

with stiffness indicative of less deterioration, followed by progressive rupture of deteriorated strands. This implies that deterioration works as much to increase the brittleness of strands as it does to reduce their cross-sectional area, possibly due to high stress concentrations in pitted sections of strands. This can be observed visually in the section of strand from Oyster Creek – Span 8 – Slab 13 shown in Figure 5.30, where some wires (left) ruptured earlier in testing (greater distance between failure surfaces) than others (right).

This effect is not reflected in the model, hence the deviation between estimated and observed response for weaker slabs despite good agreement in slab flexural strength.

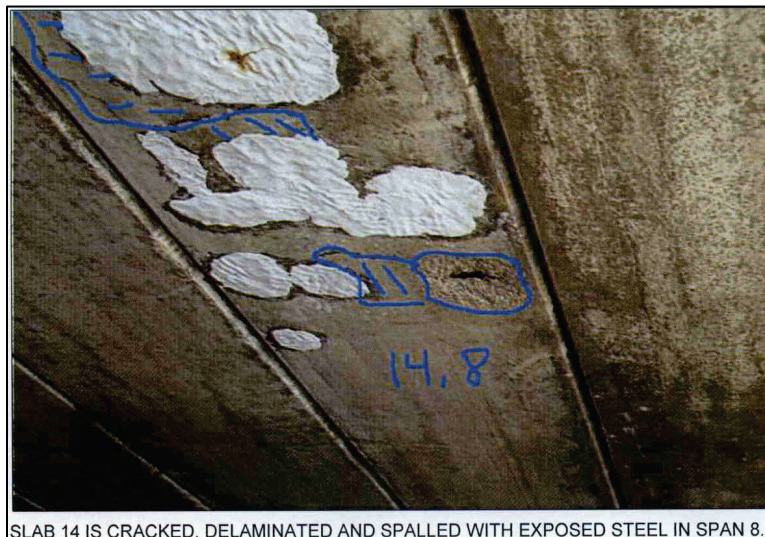
Figure 5.33 – Delamination, 2007 Inspection, Oyster Creek Bridge

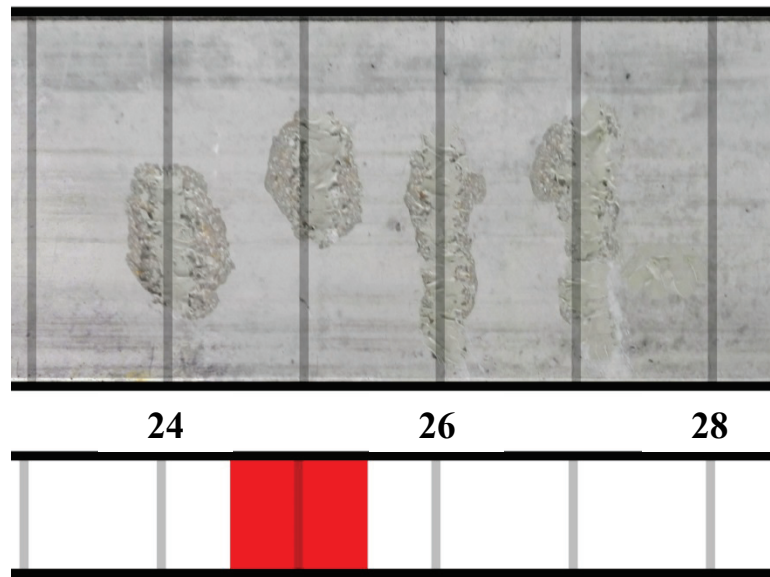
- **Small delaminations**, generally sounding higher-pitched, generally less than 1 ft long are frequently located under stirrups that are corroding. Typically these will be accompanied by several locations on the same (or adjacent) slabs where delaminated concrete has already spalled off. Demolition did not find any significant deterioration of strands under these locations, and they are generally an indication of the early stages of deterioration. A typical location of this type of delamination is visible at 25 ft on Ward Creek – Span 4 – Slab 6 (Figure 5.34), where a small delamination indicates the continuation of the same stirrup corrosion that has caused shallow spalling in the surrounding area. No strands were corroded in this section.

Figure 5.34 - Delaminated region, Ward Creek - Span 4 - Slab 6

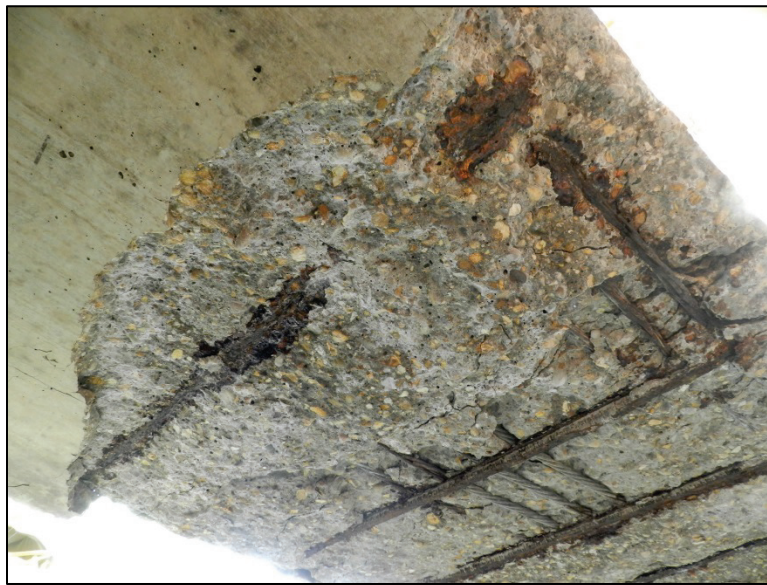
- **Large delaminated regions** stretching across multiple stirrups and covering more than half the width of a slab indicate substantial underlying corrosion. These are sometimes accompanied by multiple longitudinal cracks and visible sagging of the soffit concrete. In the case of visibly sagging concrete it appears the delaminated concrete layer is being held to the slab by its existing bond to stirrups. This necessarily means the bottoms of stirrups have debonded from the concrete above them and are sagging to some extent as well, leading to greater strand exposure. One slab was chosen for laboratory testing displaying this type of corrosion, Ward Creek, Span 1 – Slab 13 (Figure 5.35, visible cracks circled). This region spalled off during flexural testing (Figure 5.36), with 6 of the 11 bottom strands estimated to be lost.

Figure 5.36 - Delaminated region after testing, Ward Creek - Span 1 - Slab 13

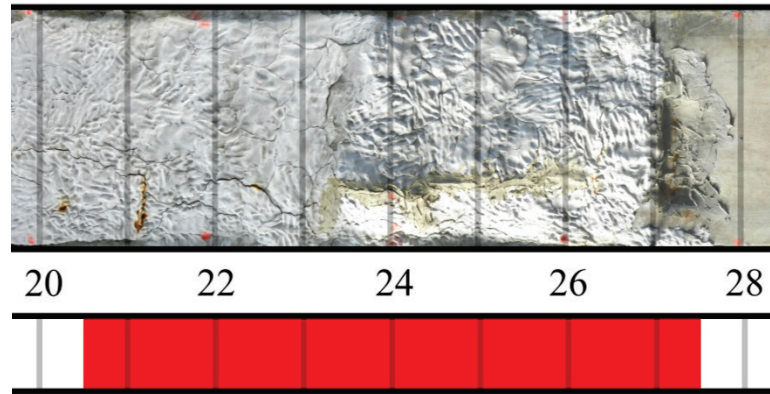
- **Further delamination of existing spalls and patches** generally can be taken as a deepening of whatever spall was there before. The condition of strands underneath these delaminated areas varies depending on the extent of spalling that had existed before. If existing spalls and rust stains indicate corroding of strands, further delamination indicates total loss of those strands. The worst deterioration observed of this type in laboratory testing was on Oyster Creek – Span 8 – Slab 12 (Figure 5.37), where the entire icolastic patch had delaminated and was hanging from what remained of heavily corroded stirrups. This patch continued to the adjacent slab and was separated by several inches from the concrete above when the slab arrived at the CFL. All bottom strands displayed corrosion, and this was 1 of only 2 locations where strands above the bottom layer showed deterioration. An estimated equivalent 10 of 11 bottom strands were lost.

Figure 5.37 – Delaminated patched region, Oyster Creek - Span 8 - Slab 12

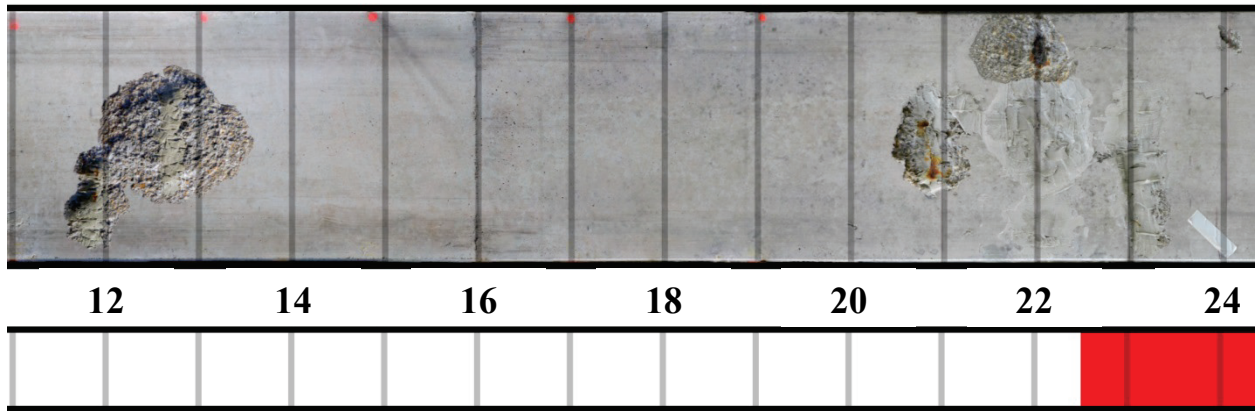
Figure 5.39 – Ward Creek - Span 9 - Slab 6

- *Ward Creek – Span 9 – Slab 6*: Two regions of deterioration, at 13 ft and 21-24 ft. Neither show longitudinal rust stains. Assume 0 strands lost. Structural analysis predicts $M_n = 622$ kip-ft. Tested strength = 568 kip-ft; analysis over-predicting by 10%.

- *Ward Creek – Span 9 – Slab 6*: Two regions of deterioration, at 13 ft and 21-24 ft. Neither show longitudinal rust stains. No spalls appear to be to level of strands. Assume 0 strands lost. Structural analysis predicts $M_n = 622$ kip-ft. Tested strength = 568 kip-ft; analysis over-predicting by 10%.
- *Ward Creek – Span 9 – Slab 7*: One region of deterioration, 16 to 26 ft. Longitudinal rust stains and clearly spalled to depth of strands in middle group and right group (top in picture), possibly to depth of strands in left group. Assume 9.5 strands lost. Structural

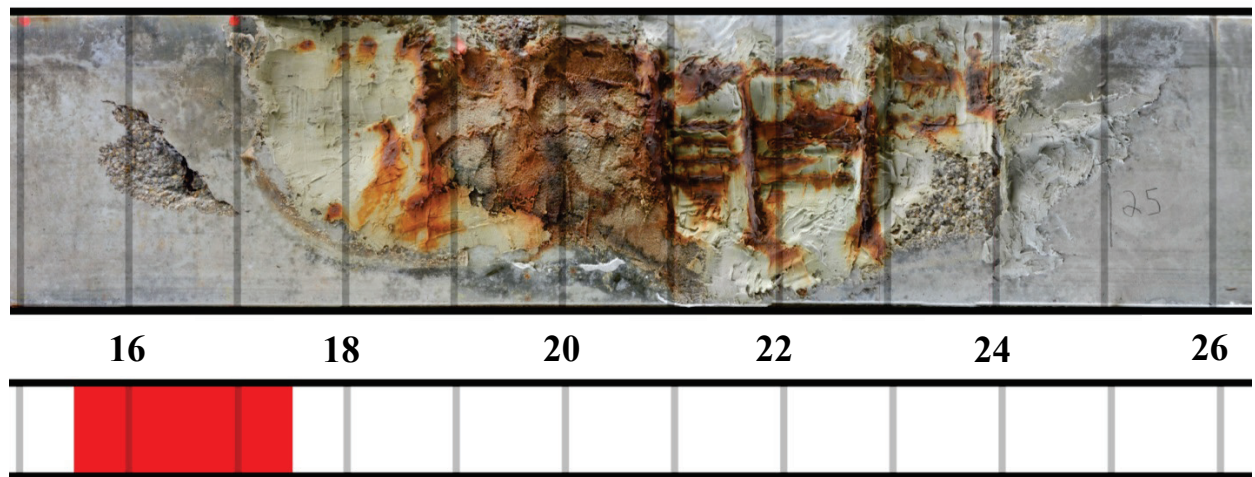
Figure 5.40 - Ward Creek - Span 9 - Slab 7

- *Ward Creek – Span 9 – Slab 7*: One region of deterioration, 16 to 26 ft. Not entirely clear, 4 to 5 longitudinal rust stains. Assume 4.5 strands lost. Structural analysis predicts $M_n = 476$ kip-ft. Tested strength = 229 kip-ft; analysis over-predicting by 46%.
- *Oyster Creek – Span 1 – Slab 13*: One region of deterioration, 17 to 25 ft. Not entirely clear, 2 to 4 longitudinal rust stains. Assume 2 strands lost. Structural analysis predicts $M_n = 815$ kip-ft. Tested strength = 483 kip-ft; analysis over-predicting by 43%
- *Oyster Creek – Span 8 – Slab 12*: One region of deterioration, 16 to 28 ft. No visible longitudinal rust stains. Assume 0 strands lost. Structural analysis predicts $M_n = 896$ kip-ft. Tested strength = 465 kip-ft; analysis over-predicting by 56%.

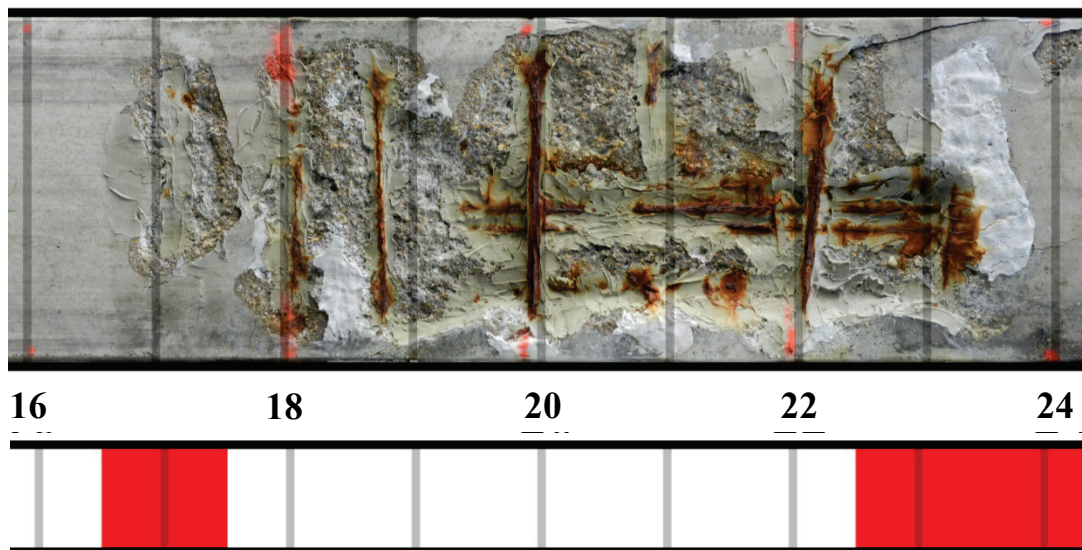
Figure 5.41 - Oyster Creek - Span 1 - Slab 13

- *Oyster Creek – Span 1 – Slab 13*: One region of deterioration, 17 to 25 ft. Longitudinal rust stains in middle group. Clearly to depth of strands on middle group and left group (bottom in picture). Assume 8 strands lost. Structural analysis predicts $M_n = 561$ kip-ft. Tested strength = 483 kip-ft; analysis over-predicting by 10%.
- *Oyster Creek – Span 8 – Slab 12*: One region of deterioration, 16 to 28 ft. No visible longitudinal rust stains. Patch is visibly to bottom layer of strands, and is completely delaminated. Assume 11 strands lost. Structural analysis predicts $M_n = 430$ kip-ft. Tested strength = 465 kip-ft; analysis under-predicting by 5%.

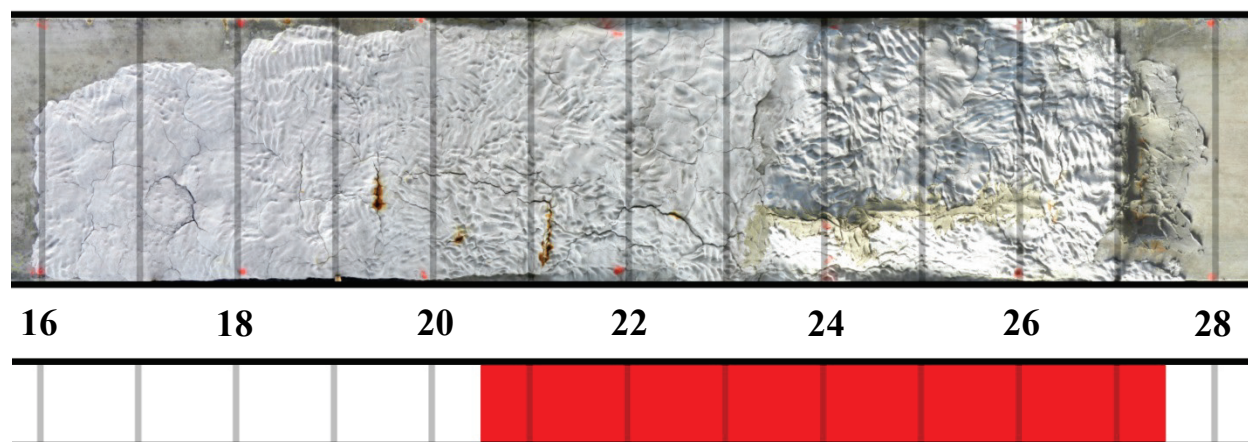
Figure 5.42 - Oyster Creek - Span 8 - Slab 12

Based on observations made in deterioration, the assumption that only the bottom layer of strands had appreciable deteriorated was appropriate for all but two slabs. These were the two slabs with the lowest strengths: Ward Creek – Span 9 – Slab 7; and Oyster Creek – Span 8 – Slab 12.

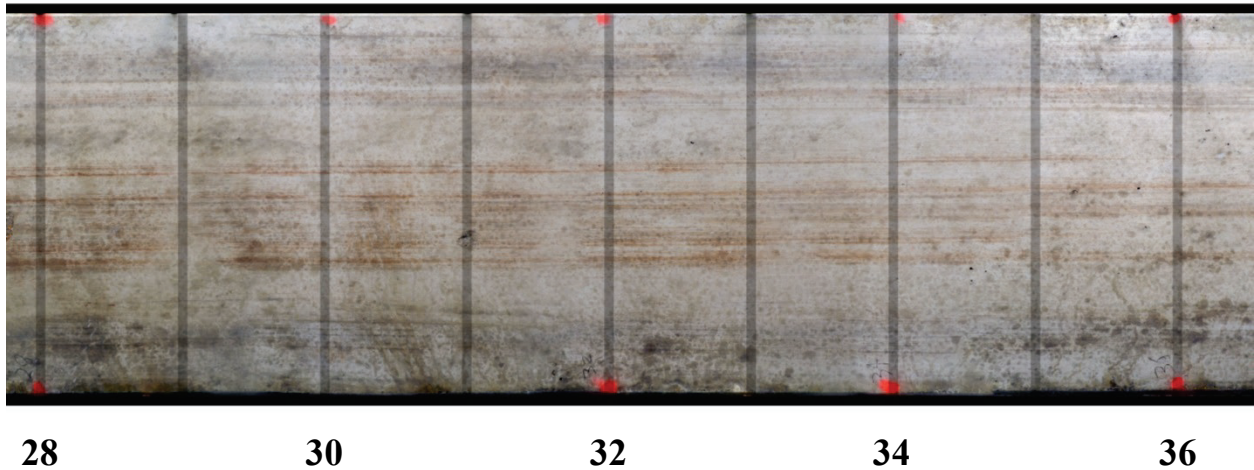
Light reddish longitudinal stains of the type visible in Figure 5.45 were observed on a number of slabs, and were considered as a possible indication of rust. No such relationship was observed, and the marks are potentially staining of concrete from the formwork during casting.

Figure 5.45 - Parallel red marks, Oyster Creek - Span 1 - Slab 13

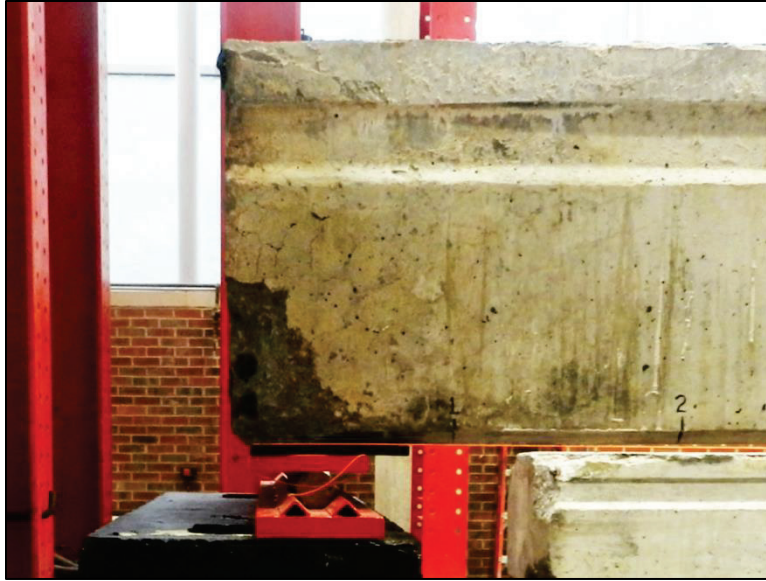
Map-pattern cracking was observed on a number of slab ends similar to that visible in Figure 5.46. Some of these slab ends were damaged in the process of slab removal and transportation to the CFL, with some small reduction in bearing area. Despite apparent deterioration and reduction of the concrete bearing area, end regions did not control in any laboratory testing.

Figure 5.46 - Map-pattern cracking and minor spall at slab end, Oyster Creek - Span 1 - Slab 14

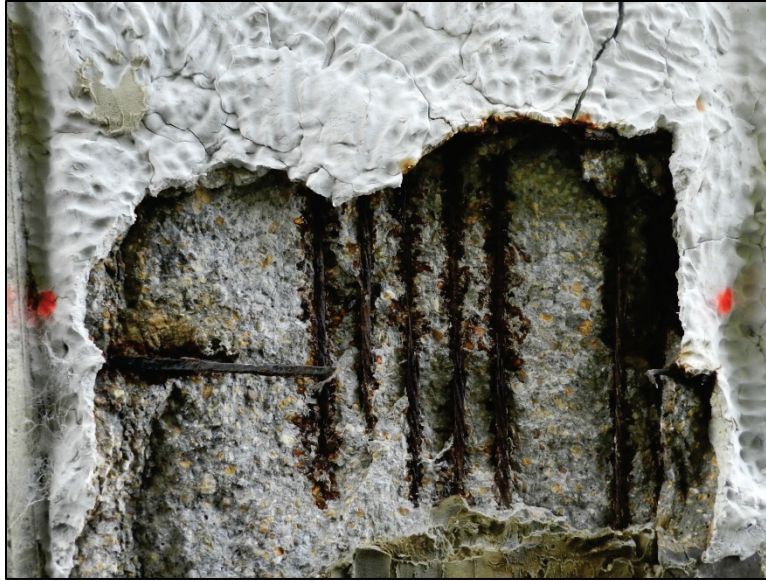
The scope of the testing and analysis done within this research did not include examination of shear capacity. However in the course of field and laboratory testing, two types of deterioration were observed that could be construed as affecting shear strength of the beams. These are map-pattern cracking observed near beam ends, as seen in Figure 5.46 in Section 5.5.2, and heavy rusting and total section loss of the bottom of hoop stirrups in the beams, as seen in Figure 5.47. These are mentioned here to note that no damage was observed in testing or transportation that appeared related to shear.

Figure 5.47 – Total section loss of bottom of stirrup, Oyster Creek – Span 8 – Slab 14

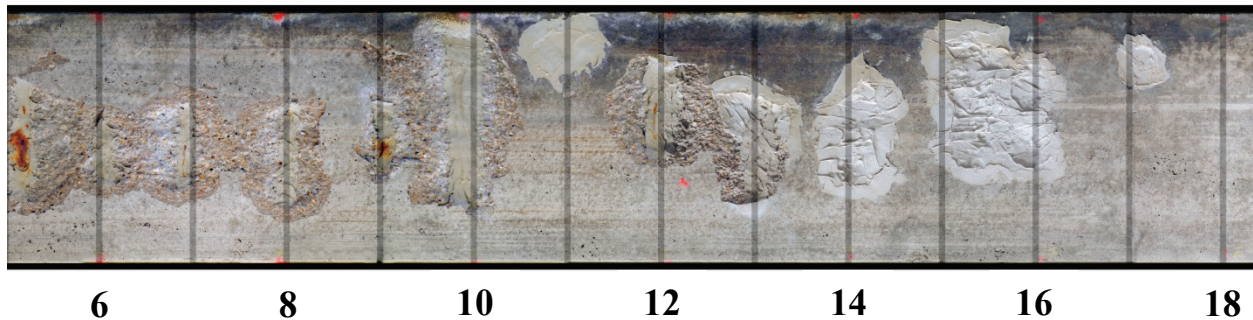
The typical deterioration observed in intermediate (not end-span) slabs was a series of spalls and delaminations extending to the bottom of stirrups as well as surface rust staining indicative of stirrups rusting. A large number of such spalls are visible in the photograph in Figure 6.1. In the absence of other information, this type of damage did not correlate to structural performance.

That is, strands in such slabs were structurally in a good condition. A total of two slabs with this type of deterioration were tested and their flexural capacities were within 3% of slabs that did not show any visible deterioration and were located adjacent to these deteriorated slabs.

Figure 6.1 - Typical intermediate span spalling, Oyster Creek - Span 2 - Slab 4

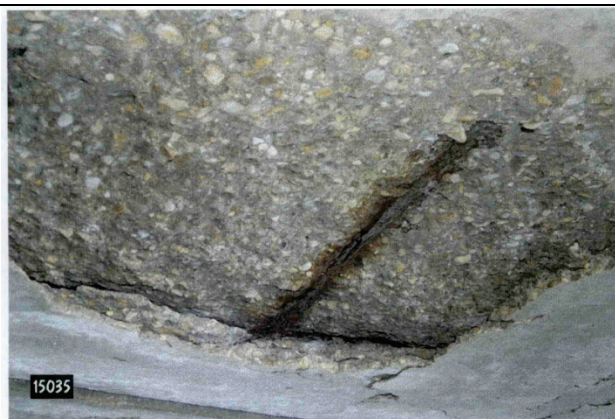
SIMILAR SPALLS AT SLABS, SP 9

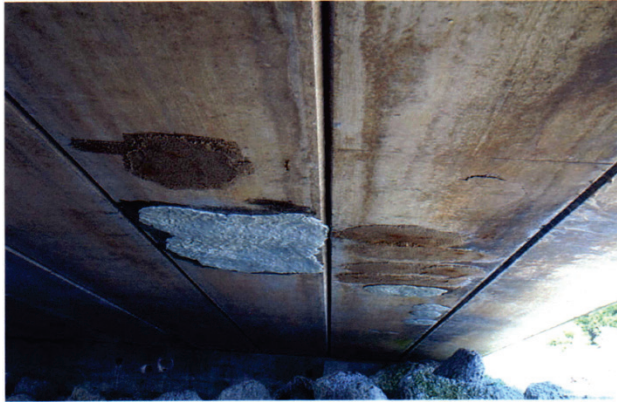
REPAIRS @ SLABS 2&3, SPAN 1

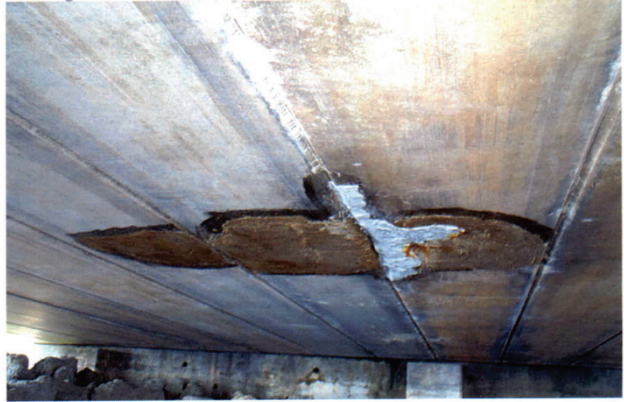
REPAIRS @ SLABS 9&10, SPAN 1

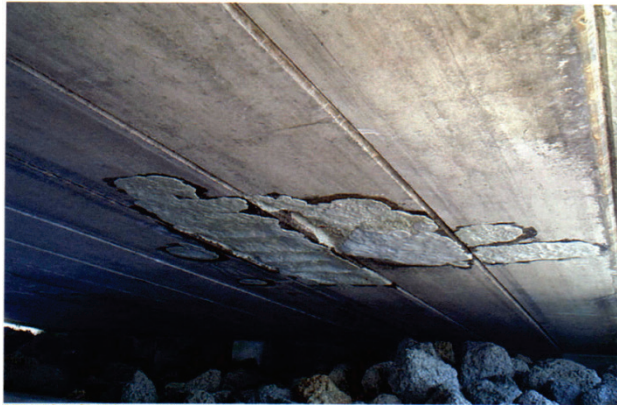
REPAIRS IN SLABS 13 - 15 @ SPAN 9

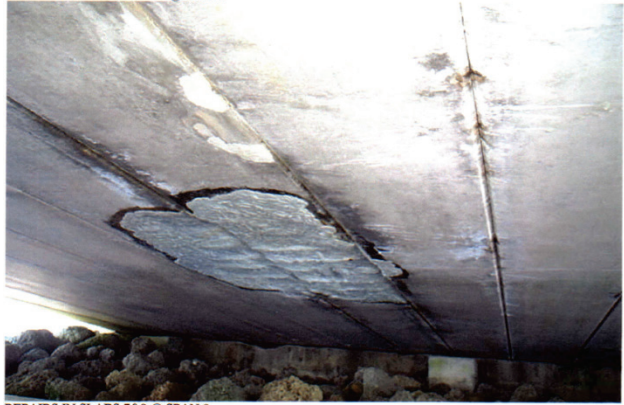
REPAIRS IN SLABS 7&8 @ SPAN 9

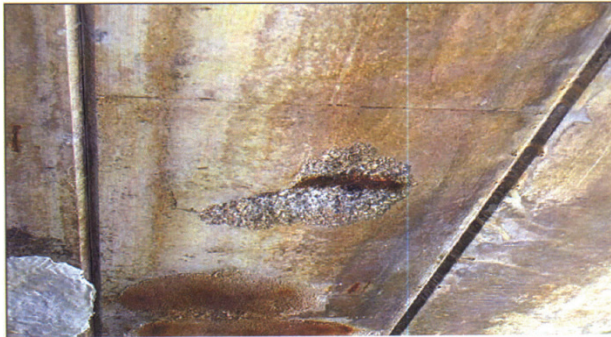
SPALLED AND DELAMINATED AREA 16 INCH DIA. WITH 8 INCHES OF EXPOSED REBAR IN SLAB 2 AT SPAN 1.

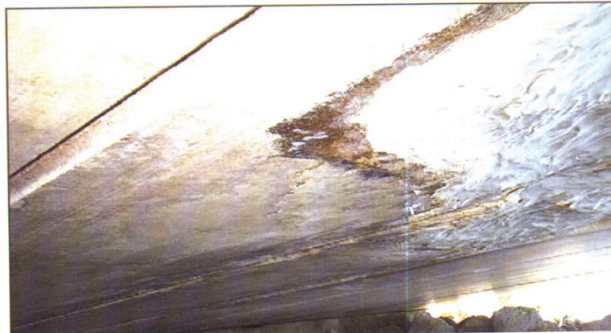
SLAB 7 DELAMINATED AT THE EAST END OF PATCHED AREA IN SPAN 9.

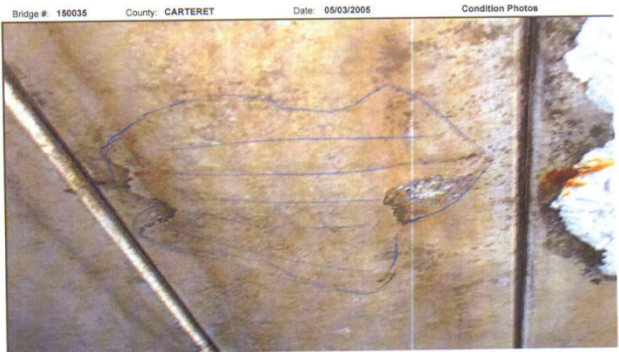
SPALLED AND DELAMINATED AREA 38 INCHES LONG X 28 INCHES WIDE X UP TO ONE HALF INCH DEEP IN SLAB 4 AT SPAN 1.

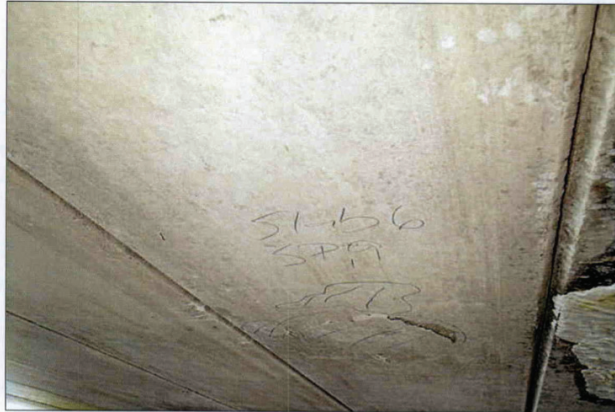
SLAB 6 IS CRACKED AND DELAMINATED IN SPAN 9.

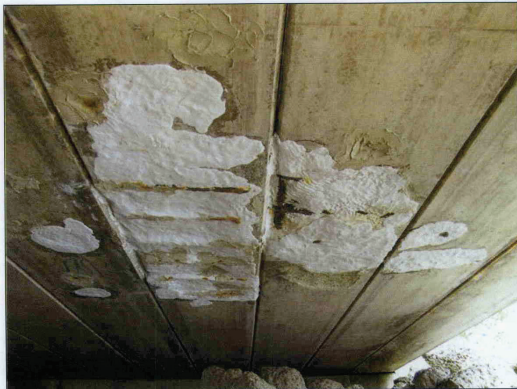
SLABS 12- 15 @ MIDSPAN IN SPAN 9 WITH PATCHES & RUST STAINS BLEEDING THRU. SAME AS PHOTO

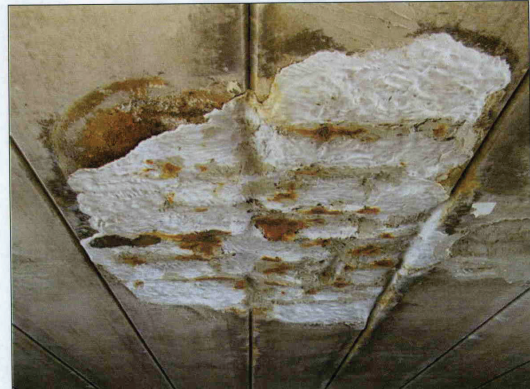
SLABS 7, 8 & 9 @ MIDSPAN IN SPAN 9 WITH PATCHES RELEASING RUST STAINS & CORROSION ON THE STEEL @ THE EDGES WHERE VISIBLE. (PM ISSUED)

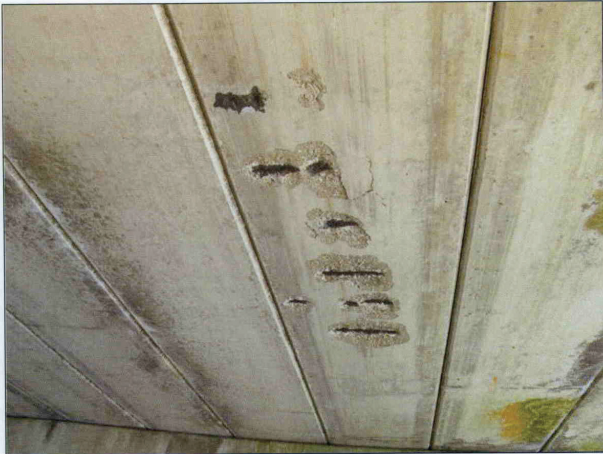
14 IN SPAN 6 WITH SURFACE SPALLS & EXPOSED STEEL WITH COATING APPLIED TO THE SIMILAR AREAS IN SLAB 11, SPAN 6 & SLAB 13, SPAN 7.

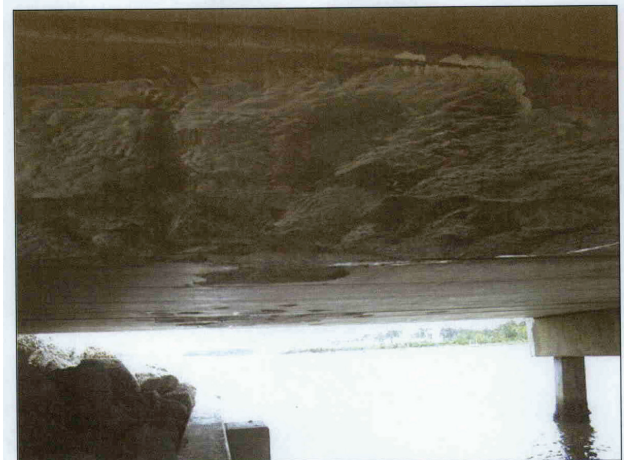
7, 8 & 9 @ MIDSPAN IN SPAN 9 WITH PATCHES RELEASING RUST STAINS & CORROSION STEEL @ THE EDGES WHERE VISIBLE. (PM ISSUED)

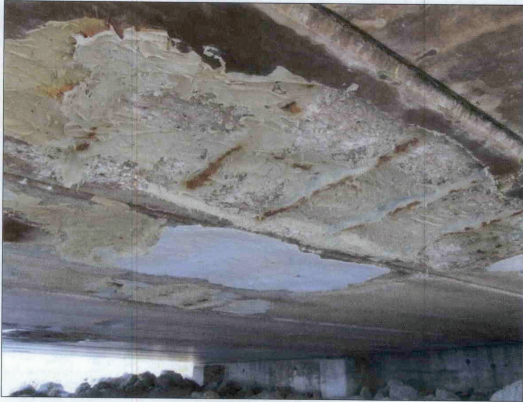
SLABS 2 THRU 4 IN SPAN 1 HAVE RUST STAINS BLEEDING THRU PREVIOUS PATCHED AREAS ON THE BOTTOM FACE.
