Assessment of Deteriorated Cored Slabs Bridges No.: 150035 and 150039

**Department of Civil, Construction, and Environmental
Engineering
North Carolina State University**

**FHWA/NC/2014-35
February 2016**

Prepared for:
North Carolina Department of Transportation
Research and Development Unit

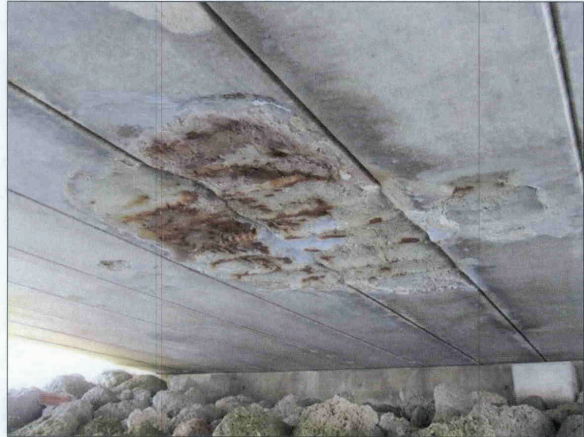
SLABS 7 THRU 9 IN SPAN 9 HAVE NEW PATCH MATERIAL WITH MODERATE RUST BLEED THRU PER PREVIOUS PROMPT ACTION LAST CYCLE.

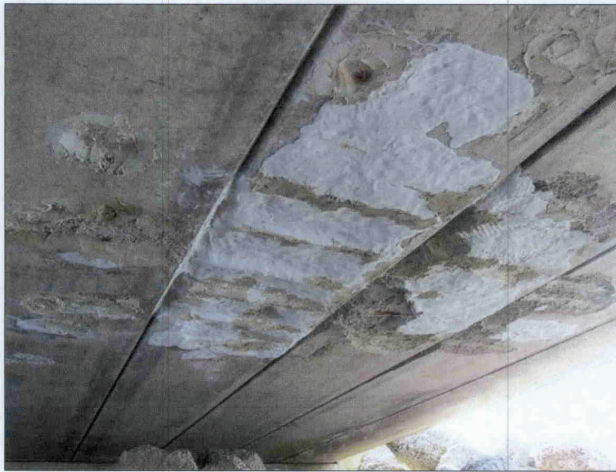
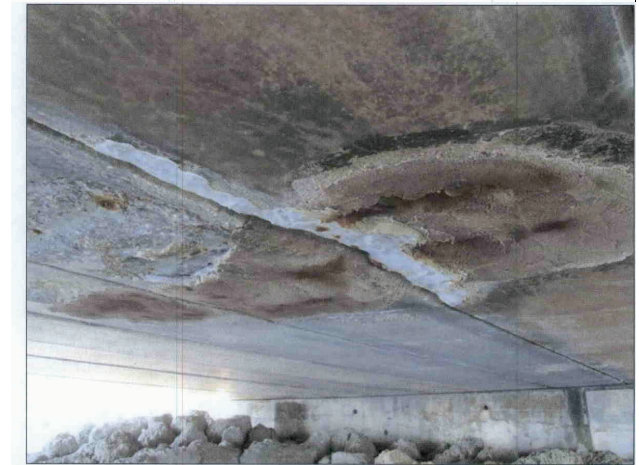
SLABS 8 THRU 10 IN SPAN 1 HAVE DELAMINATION AND RUST STAINS AT PREVIOUS PATCHED AREAS ON THE BOTTOM FACE.

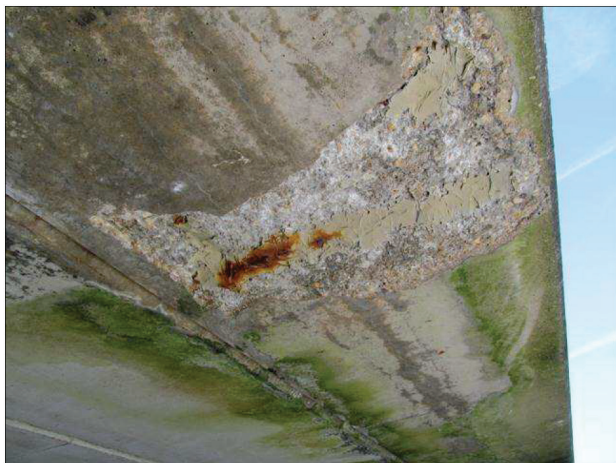
SPAN 8 HAS PREVIOUS PATCH WITH RUST STAINS. THIS REPAIR REPRESENTS THE CATEGORY OF SLABS NOT ITEMIZED FOR PRIORITY MAINTENANCE.

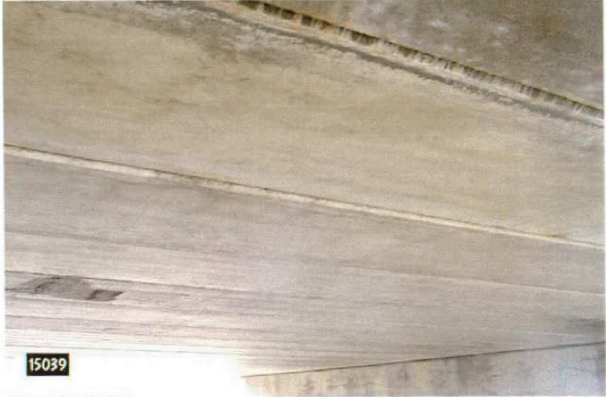
<p>SIMILAR SLABS, SP 8</p>	
2001

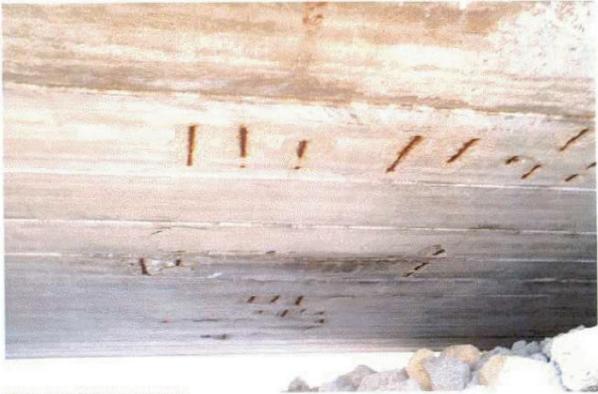
<p>SIMILAR UNDERSIDE (SPAN 8)</p>	<p>BRIDGE# 150039 CARTERET 08/09/01 BGL/BW</p>

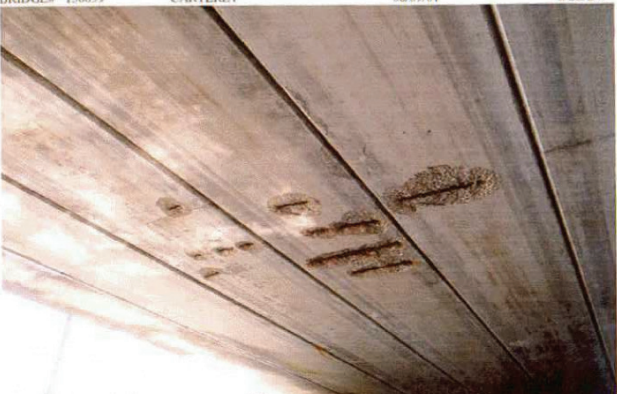
<p>SPALLS AT CORED SLABS 12, 13, AND 14 IN SPAN 1 (PROMPT ACTION)</p>

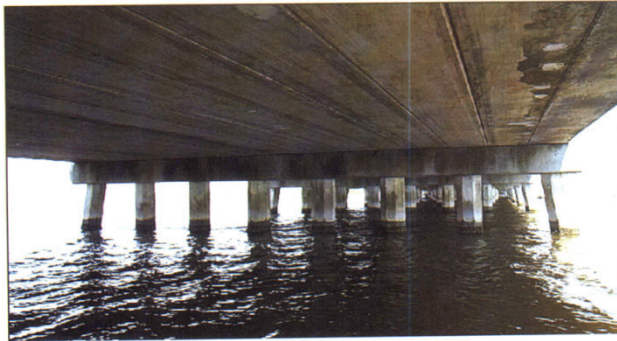
SPAN 2 SIDE OF BENT 2. INTERIOR BENTS 1 3 4 5 6 AND 7 ARE SIMILAR.

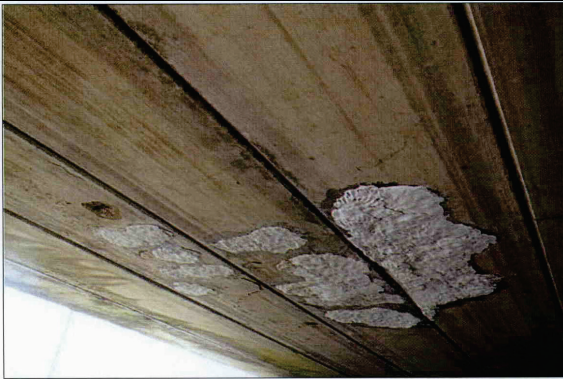
GUNIT PATCHES, CRACKS, DELAMINATED AREAS AND SPALLS IN SLABS 3, 4 AND 5 IN SPAN 1.

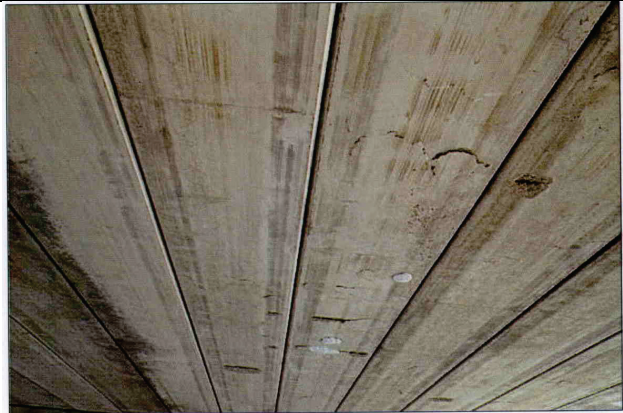
SLABS 10, 11 AND 12 CRACKED, DELAMINATED AND SPALLED IN SPAN 2.

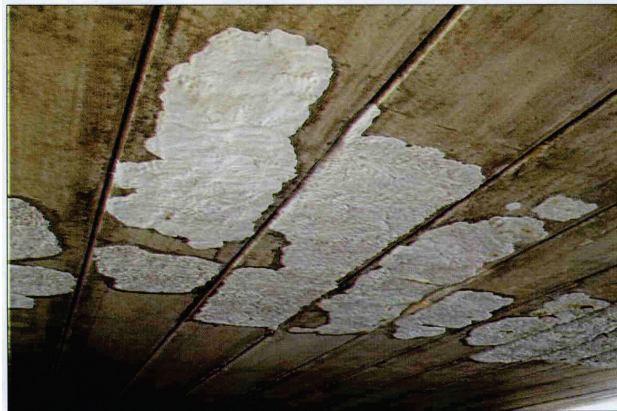
GUNIT PATCHES IN SPAN 8.

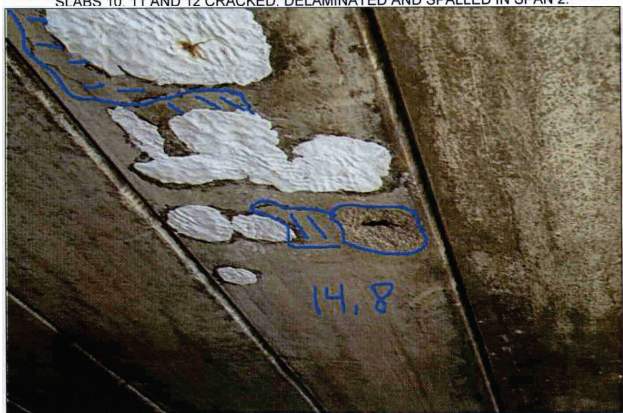
SLAB 14 IS CRACKED, DELAMINATED AND SPALLED WITH EXPOSED STEEL IN SPAN 8.

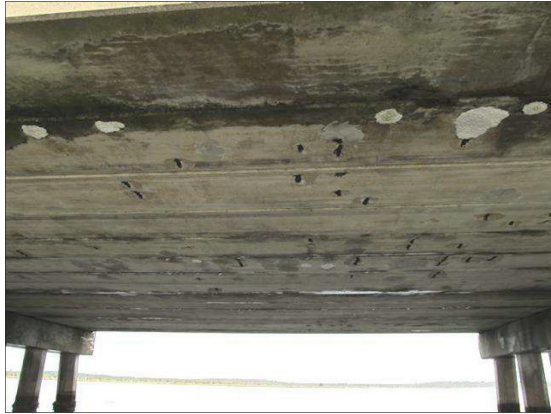
SPAN 2 HAS SEVERAL SURFACE SPALLS WITH THE EXPOSED STEEL BEING COATED SINCE LAST INSPECTION.

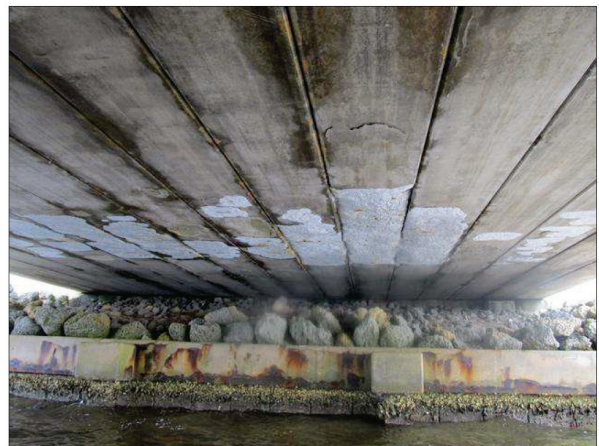
SLABS IN SPAN 8 HAVE PATCHES, SOME WITH RUST STAINS AND ADJACENT DELMINATION.
