Improving Resilience of Transportation Infrastructure to Hurricane Damage

NCDOT Project 2021-08
FHWA/NC/2021-08
September 2023

B. Shane Underwood, Ph.D.
Brina Montoya, Ph.D..
Department of Civil, Construction, and
Environmental Engineering
North Carolina State University

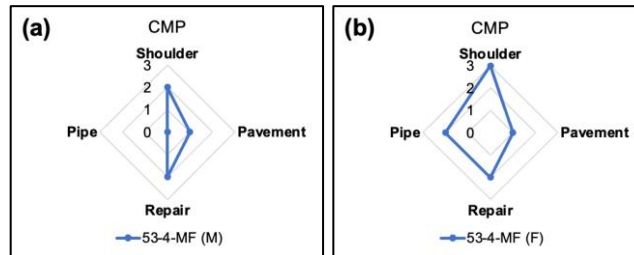
Figure 34. Radar plot for Site 53-4-MF after: (a) Matthew and (b) Florence.

Radar plots were also evaluated in each site for Hurricanes Matthew and Florence and current conditions. Figure 34, Figure 35, and Figure 36 are presented here as examples. Figure 34(a) and (b) show the radar plots for Site 53-4-MF after Matthew and Florence, respectively. In this case, the pipe was the same in both events and there was no headwall in the structure. Figure 34(b) in comparison to Figure 34(a) has higher damage in all components. It could be due to more severe stressors or due to the accumulation of damage or vulnerabilities through the two events. Figure 35(a) and (b) show the radar plots for Site 23-5-M after Matthew and in the current condition, respectively. In this case, the pipe was kept the same after Matthew and there was no headwall in

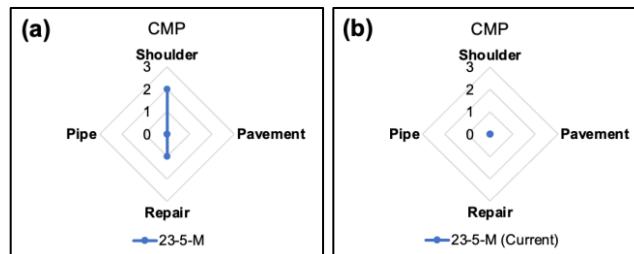
Figure 35. Radar plot for Site 23-5-M: (a) after Matthew and (b) in current condition.

the structure. Figure 35(a) shows a minimal damage and Figure 35(b) indicates no damage. This result suggests that the repair that was done after Matthew was successful, and it is still in good shape. Figure 36(a) and (b) show the radar plots for Site 25-2-M after Matthew and in the current condition, respectively. In this case the pipe was upsized, and headwall was added to the structure. Figure 36(a) shows a significant damage and Figure 36(b) indicates no damage. It shows that damage after Matthew required the pipe change and the improvement and addition of headwall was successful so that it was not damaged after Florence, and it is still in good shape.

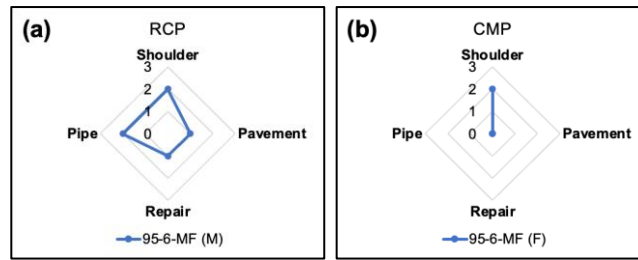
Figure 37. Radar plot for Site 95-6-MF after: (a) Matthew and (b) Florence.

Further investigation of the damage level radar plots indicated that in most of the CMP cases, the same type of structure existed in both events. The pipe may have been the same size, or it could have been upsized. This situation was not the case for RCP pipes. In three cases the RCP was

considerably damaged after Matthew and pipe was upsized to a CMP pipe, damage after Florence was relatively lower, especially on pipe and pavement component. For example, radar plots for Site 95-6-MF are presented in Figure 41(a) and (b).

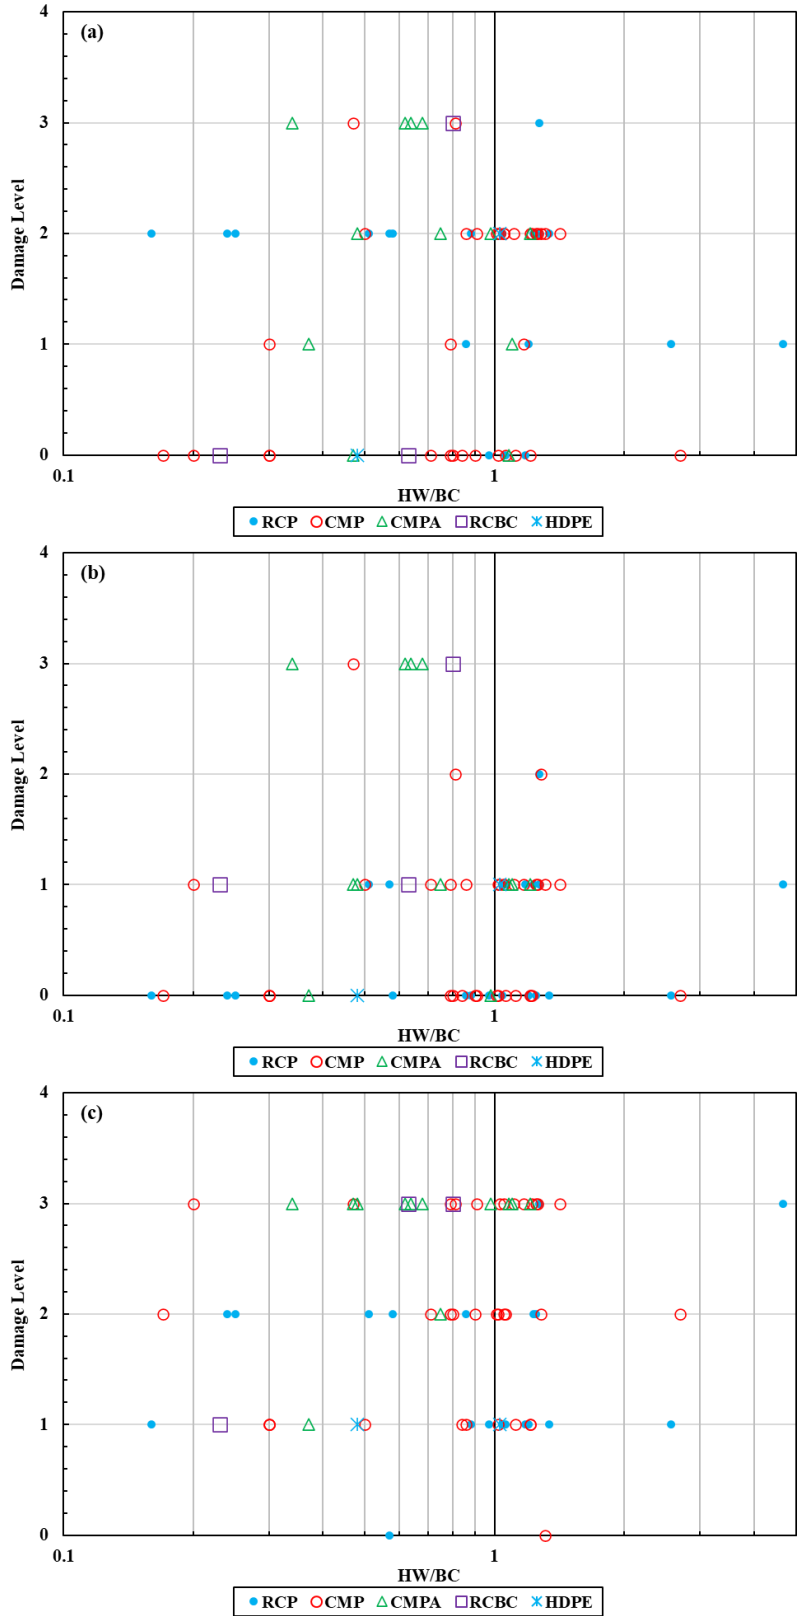
Figure D.13. Correlation between Damage Level and HW/BC for categories: (a) pipe damage, (b) pavement damage and (c) shoulder damage.

In 35 of the 73 cases considered, overtopping ($HW/BC \geq 1$) was estimated to occur during the design event: 12 RCPs, 19 CMPs, three CMPAs, and one HDPE culverts. Figure D.13 shows the relationship of the calculated HW/BC against each damage level category. As discussed earlier, and shown in Table 19, 61% of overtopped cases had a damage level of 2 for pipe damage, 58% had a damage level of 1 for pavement damage, and 40% had a damage level of 3 for shoulder damage. These findings suggest that calculated overtopping potential is a weak indicator of potential damage during a storm, particularly for pipe and pavement damage.

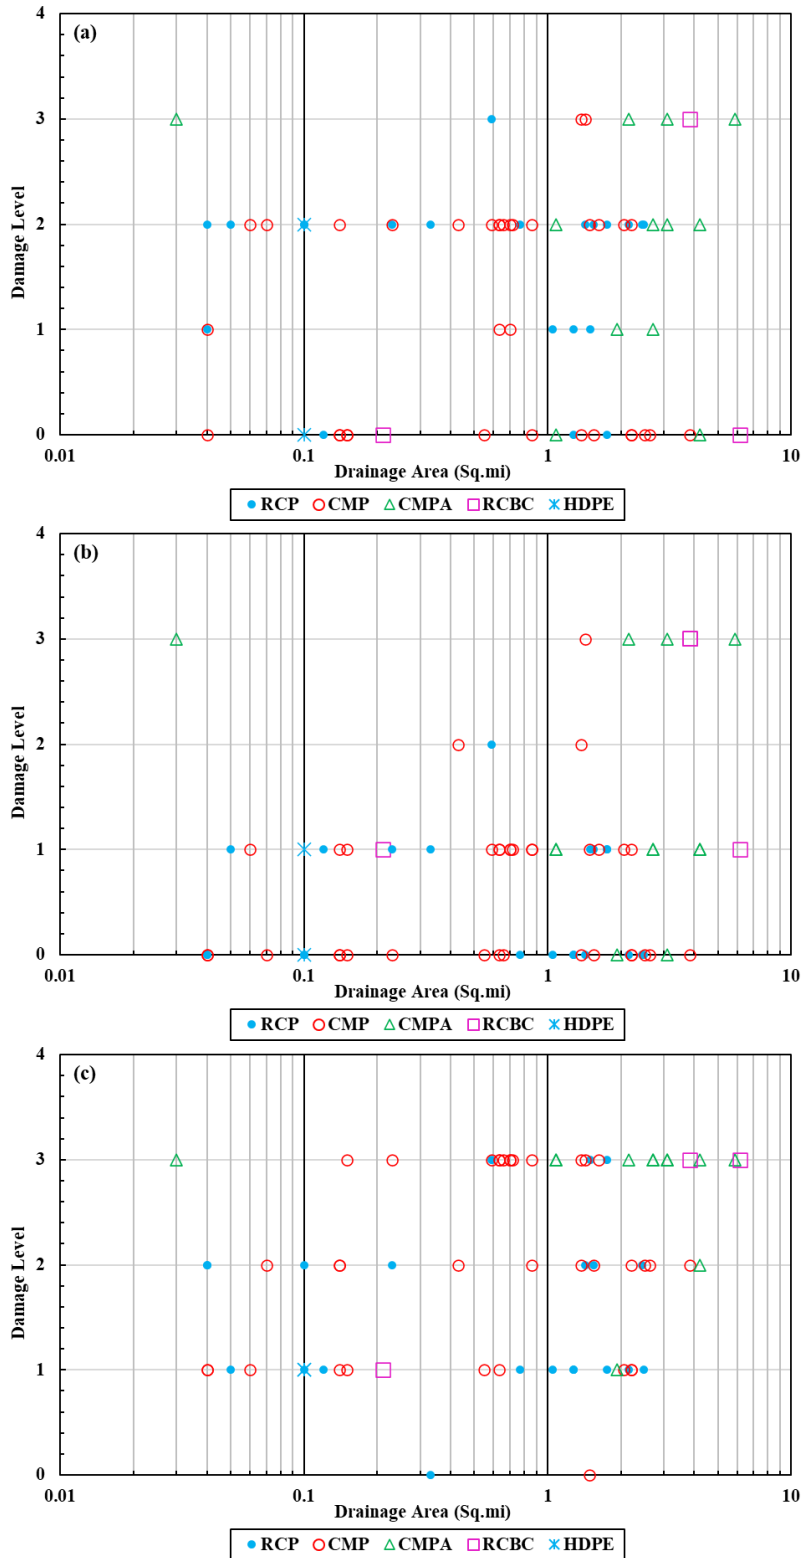
Figure D.14. Correlation between Damage Level and Drainage Area for categories: (a) pipe damage, (b) pavement damage and (c) shoulder damage.

To interpret the results of this analysis, it should be recognized that design methods change depending on the drainage area. As earlier stated, for drainage areas of 0 to 0.1 square miles, the Rational Method is used. For drainage areas between 0.1 and 1 square mile, USGS Urban and Small Rural (2014) is used, while all other drainage areas (>1 square mile) use USGS Rural (2009). Figure D.14 shows the results of this analysis and in this figure the delineations between design methods can be easily observed by noting that the black vertical lines along the x-axis are at drainage areas of 0.1 and 1 square miles. For this analysis, the initial expectations were that there would be a potential for higher damage levels with increases in drainage. As shown in Figure D.14 as well as Table 20, results suggest that the relationship between higher levels of damage and increasing drainage areas is a weak indicator of potential damage during a storm for shoulder, pavement, and pipe damage.

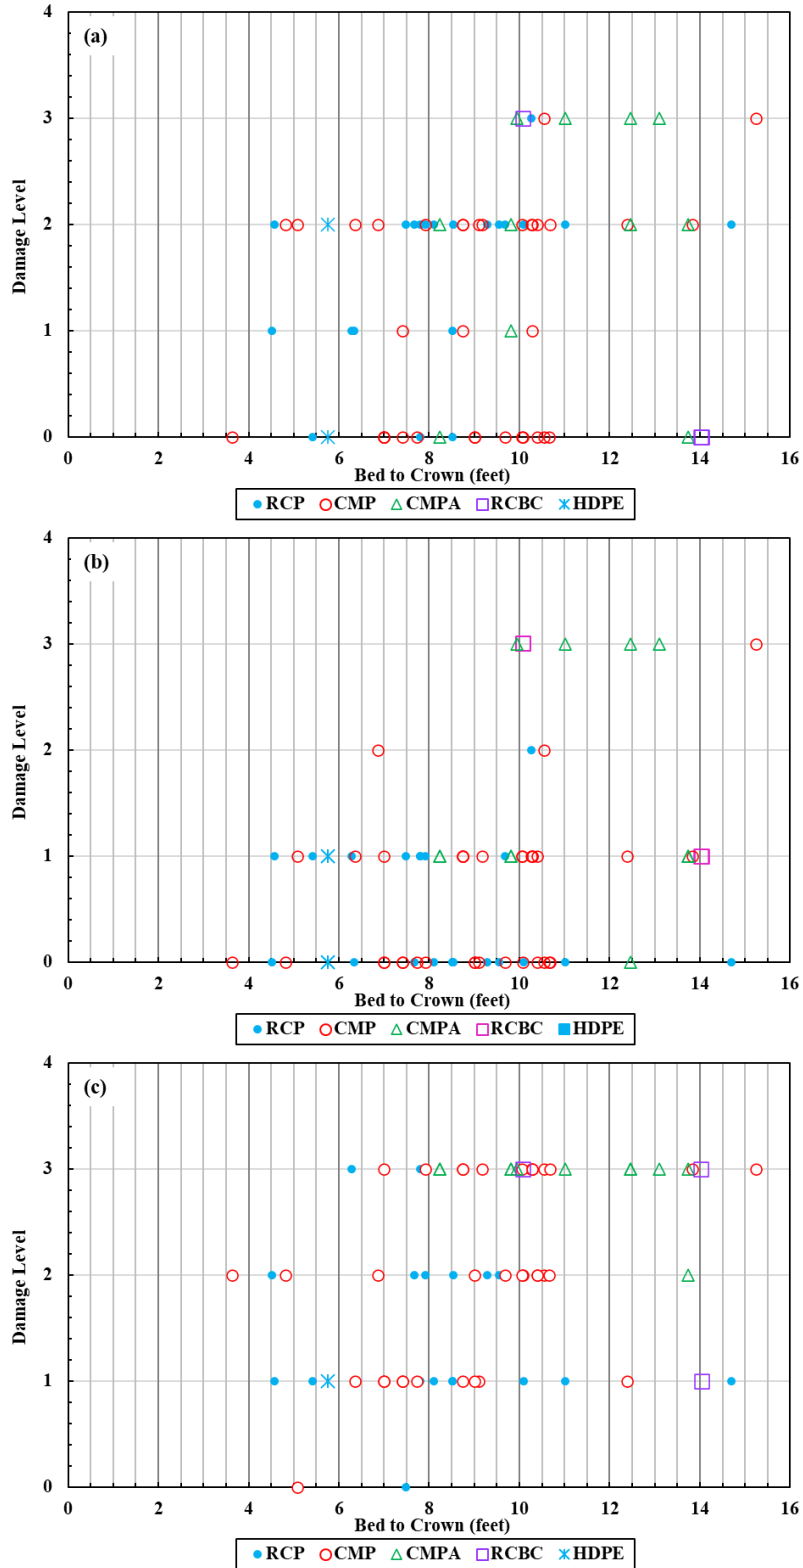
Figure D.15. Correlation between Damage Level and Bed to Crown for categories: (a) pipe damage, (b) pavement damage and (c) shoulder damage.

Contrary to expectations, the correlation between Damage level and Bed-to-Crown (BC), as depicted in Figure D.15, did not manifest elevated damage levels at shorter BC values. Consequently, the current analysis may not be deemed reliable for the purpose of assessing culvert resilience under storm conditions.

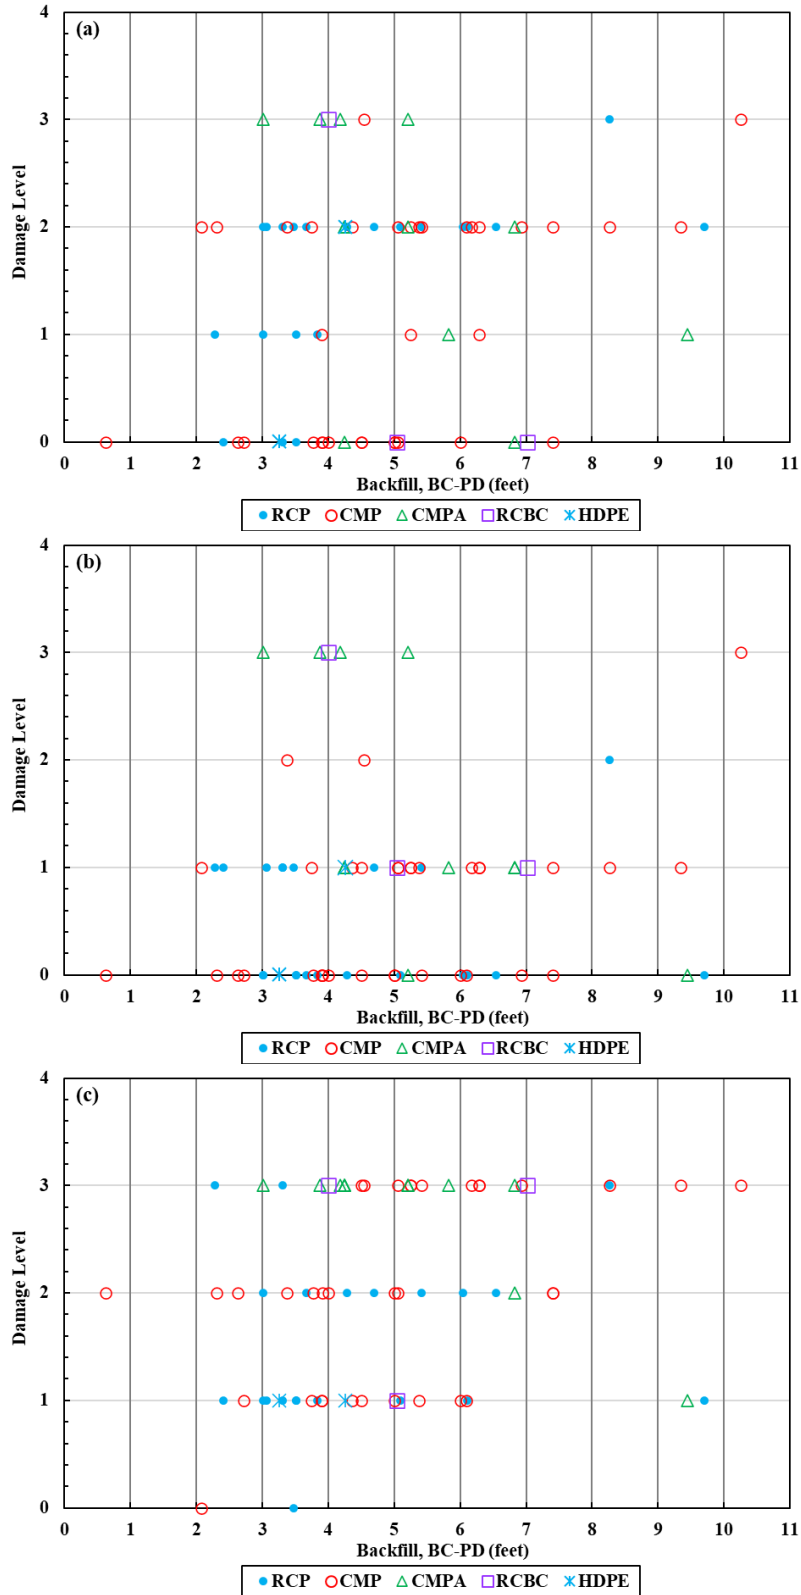
Figure D.16. Correlation between Damage Level and Bed to Crown for categories: (a) pipe damage, (b) pavement damage and (c) shoulder damage.

Figure D.16 showing the relationship between damage level and height of backfill showed no significant impact of the amount of backfill (difference between Bed-to-Crown and Pipe Diameter, BC-PD) to culvert performance in terms of either pipe, pavement, or shoulder damage.
