NC DEPARTMENT OF TRANSPORTATION
DIVISION OF HIGHWAYS
STRUCTURE MANAGEMENT UNIT

Structure Safety Report

Routine Element Inspection - Contract

DIVISION: 3 COUNTY: NEW HANOVER STRUCTURE NUMBER: 640013 FREQUENCY: 24 MONTHS

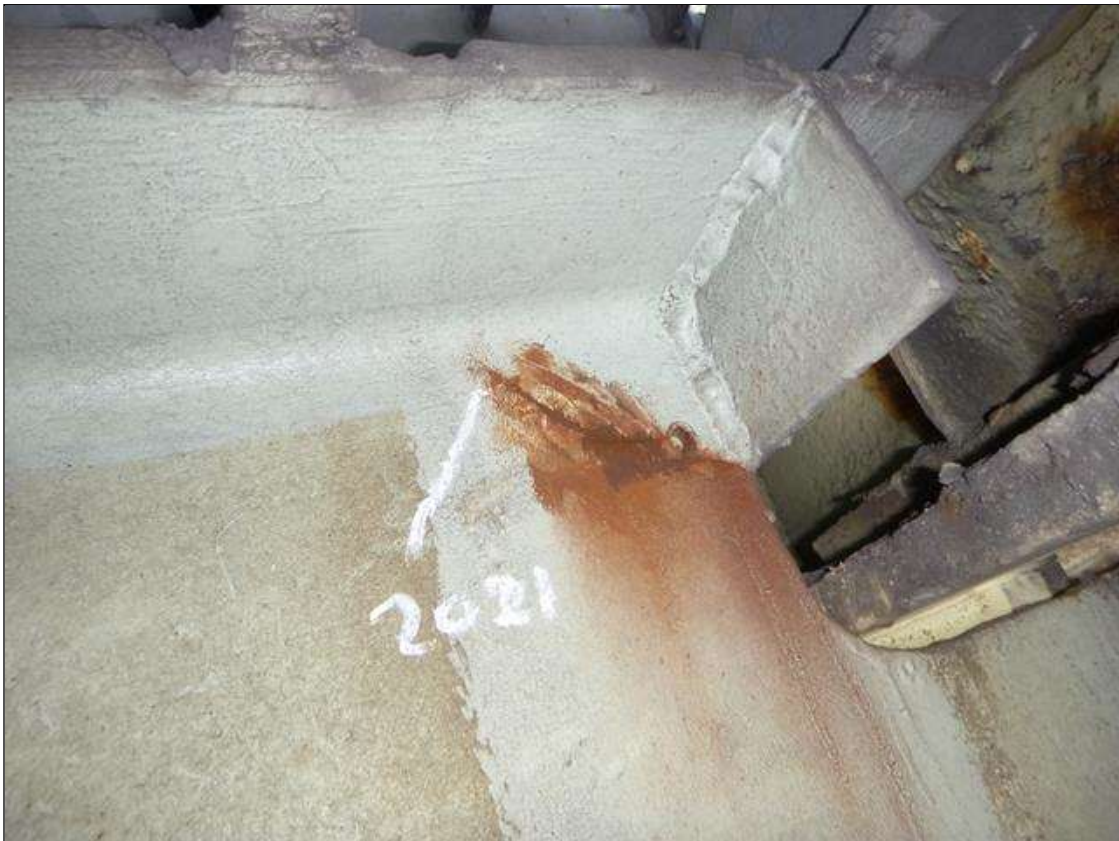
Span 18 Lift Span Floor Beam 0: PITTED AREAS UP TO 3/8" DEEP SCATTERED ALONG BOTH SIDES OF BOTTOM FLANGE AND STIFFENERS- CLEANED AND PAINTED.

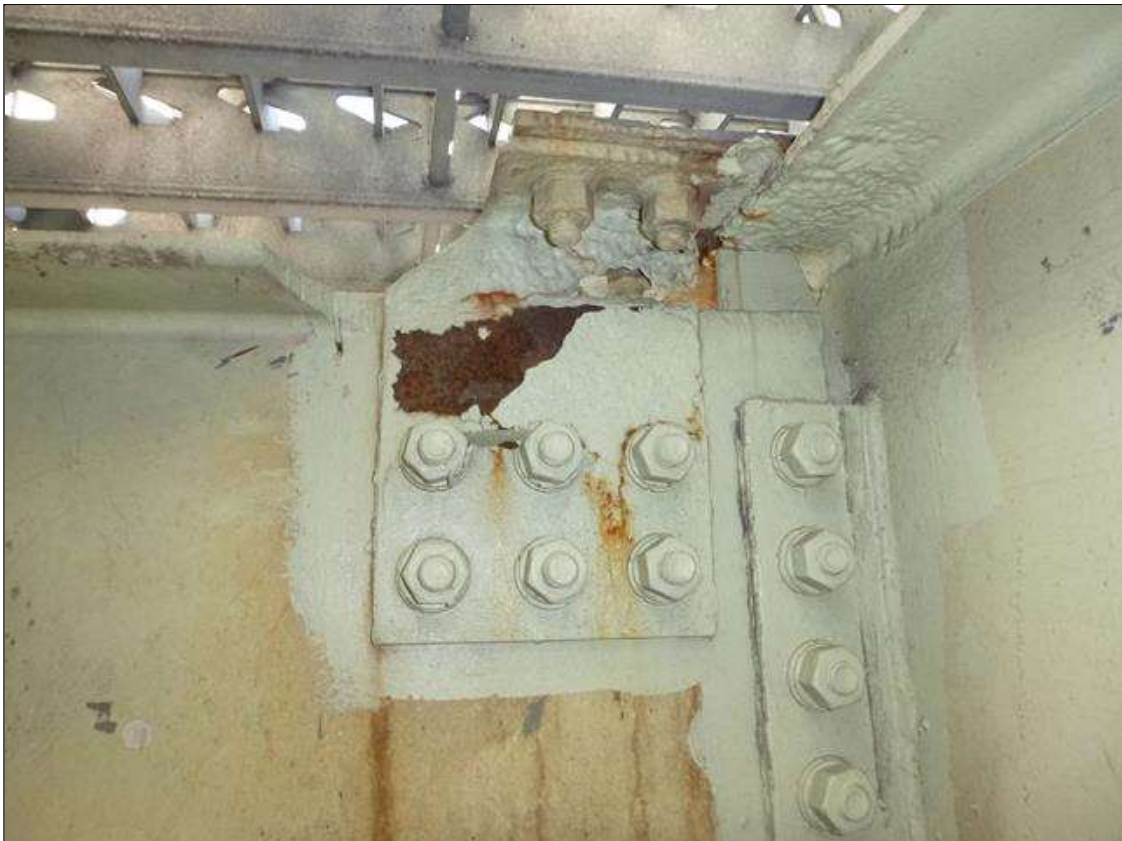
Span 18 Lift Span Stringer 14: BETWEEN FB's 0-1 - AREAS ALONG EDGES OF TOP FLANGE UP TO 8" LONG x 2" WIDE / 5/16" REMAINING - CLEANED AND PAINTED

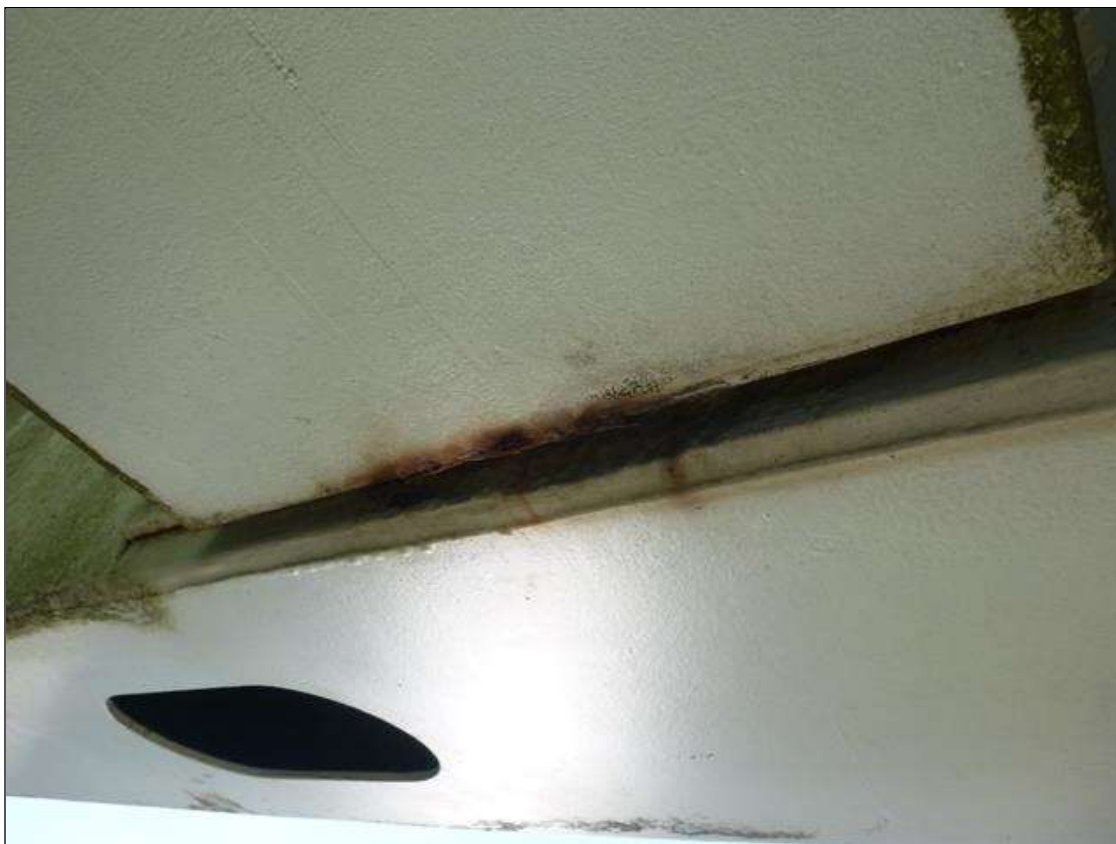
CENTER BOTTOM LATERAL GUSSET - SOUTH SIDE - UP TO 1/2" PACK RUST BETWEEN GUSSET AND BOTTOM FLANGE ON EAST AND WEST SIDES - 10"L x 4" AREA OF GUSSET AT BOTTOM FLANGE REDUCED TO 3/8" - 60% LOSS TO (2) FASTENERS.

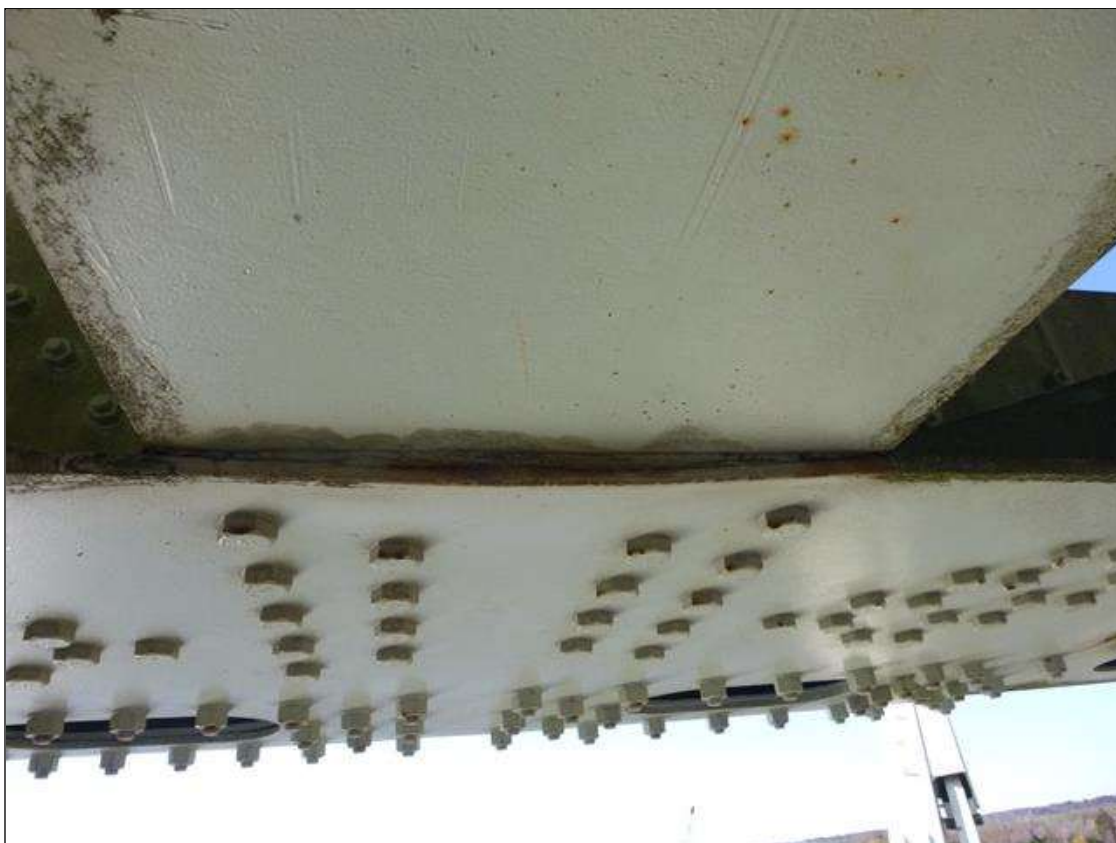
PITTED AREA UP TO 2"W x 5/16"D ACROSS BOTTOM OF BOTTOM FLANGE AT L1 SOUTH LATERAL GUSSET CONNECTION

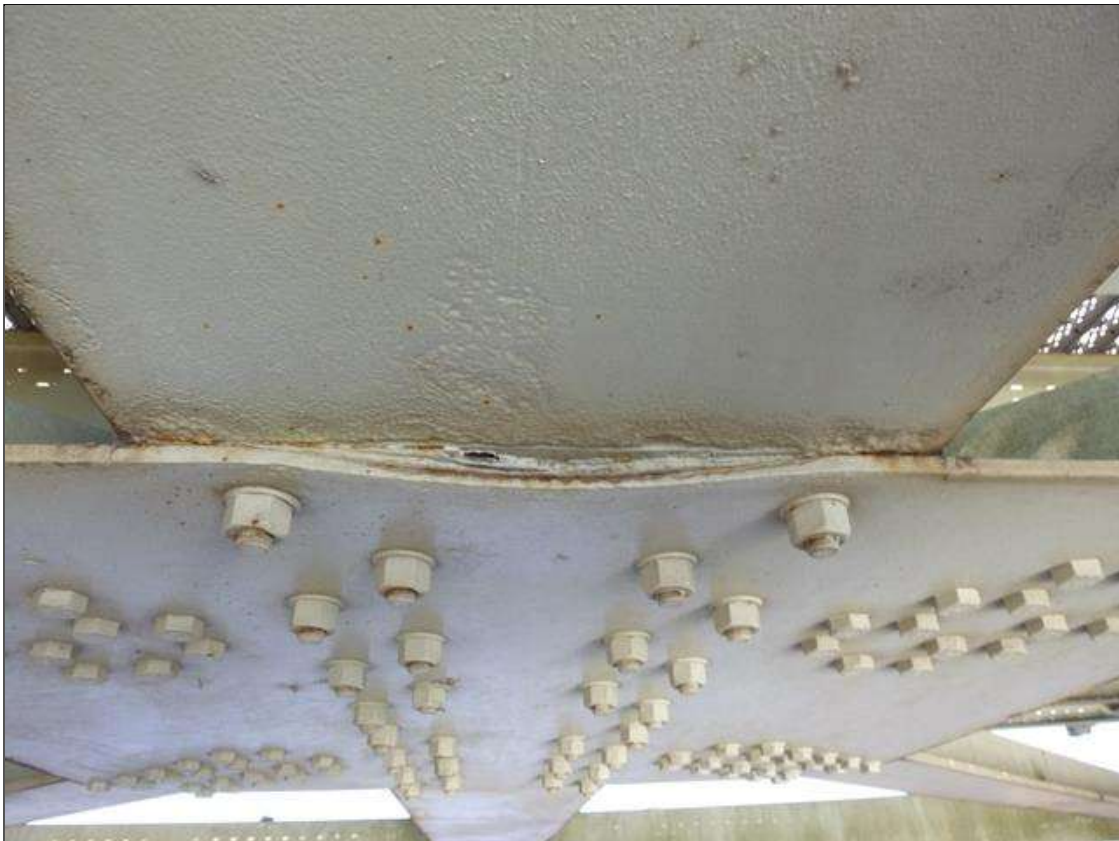
Span 18 Lift Span Stringer 13: (PAR) BETWEEN FB's 2-3 - 1 1/4" LONG CRACK IN WEB ACROSS BOTTOM OF WELD AT DIAPHRAGM CONNECTION ON SOUTH SIDE.

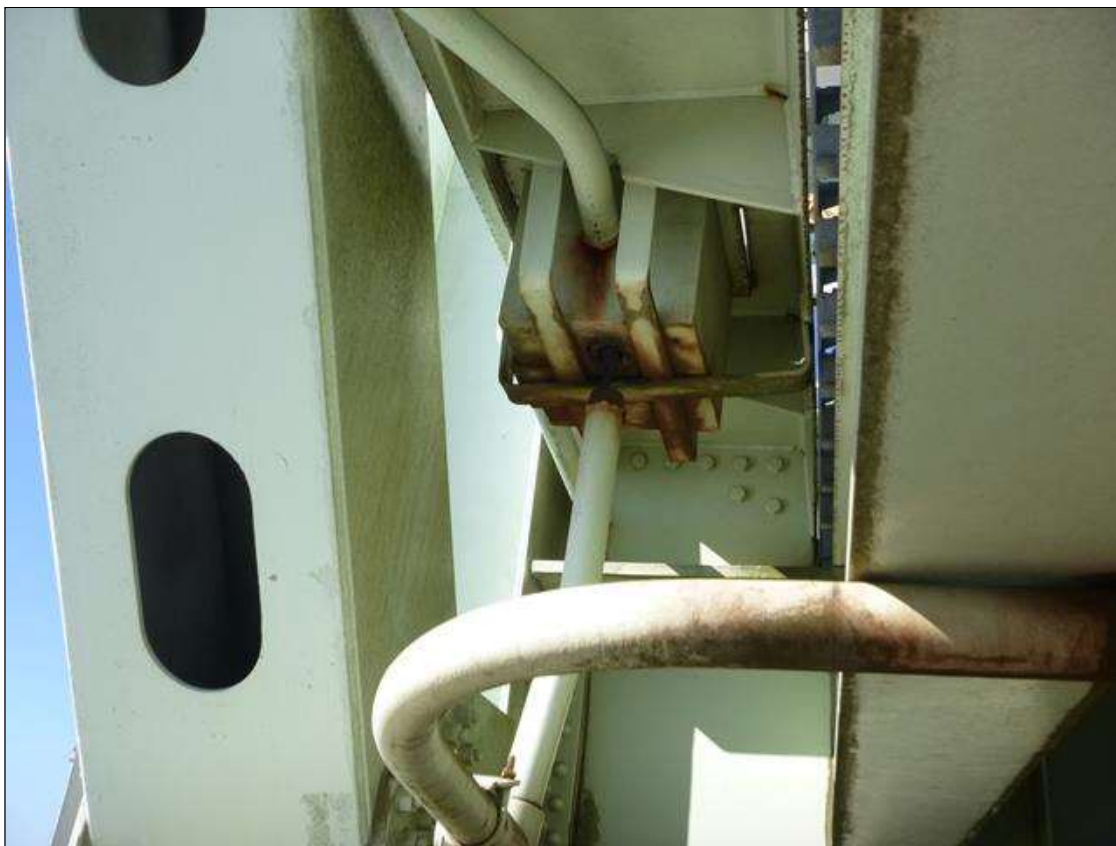
Span 18 Lift Span Floor Beam 3: 3/4" PACK RUST BETWEEN BOTTOM FLANGE AND CENTER BOTTOM LATERAL GUSSET - SOUTH SIDE

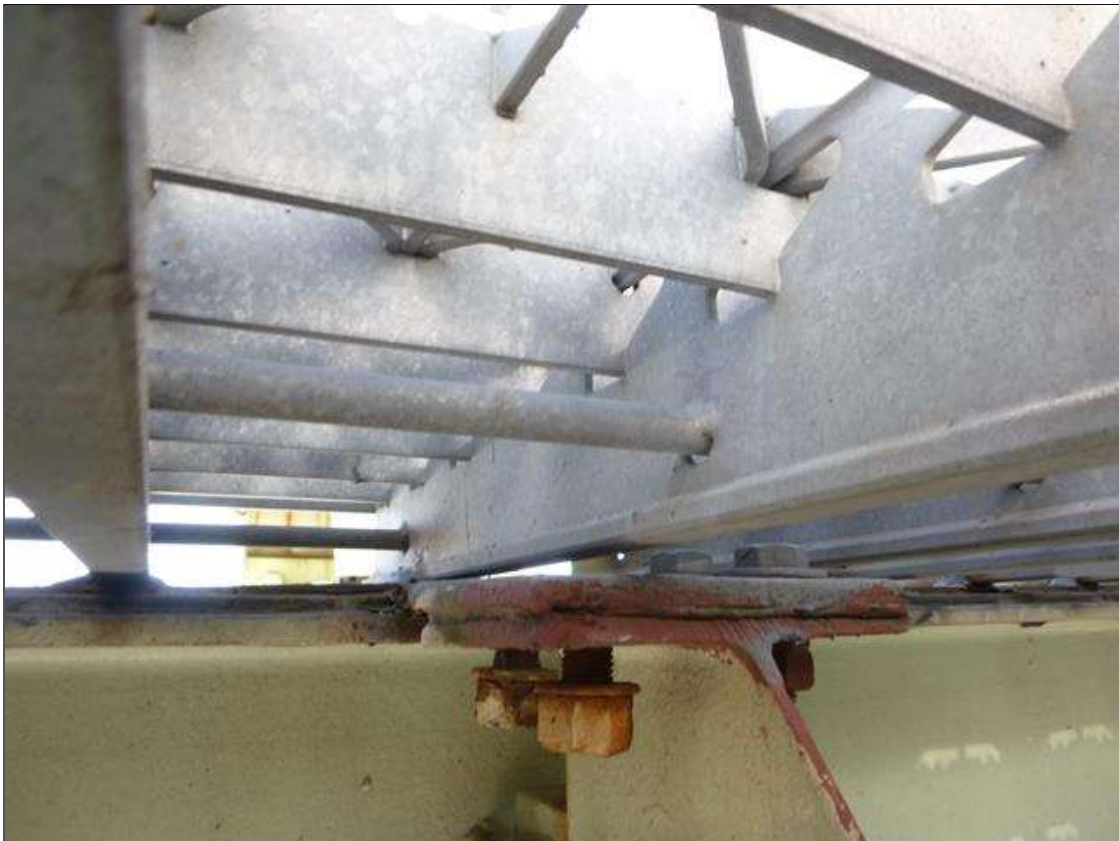
Span 18 Lift Span Stringer 11: BETWEEN FB's 4-5 - CRACK PROPAGATED 3/16" PAST ARREST HOLE AT TOP OF DIAPHRAGM CONNECTION - PROMPT ACTION REQUEST

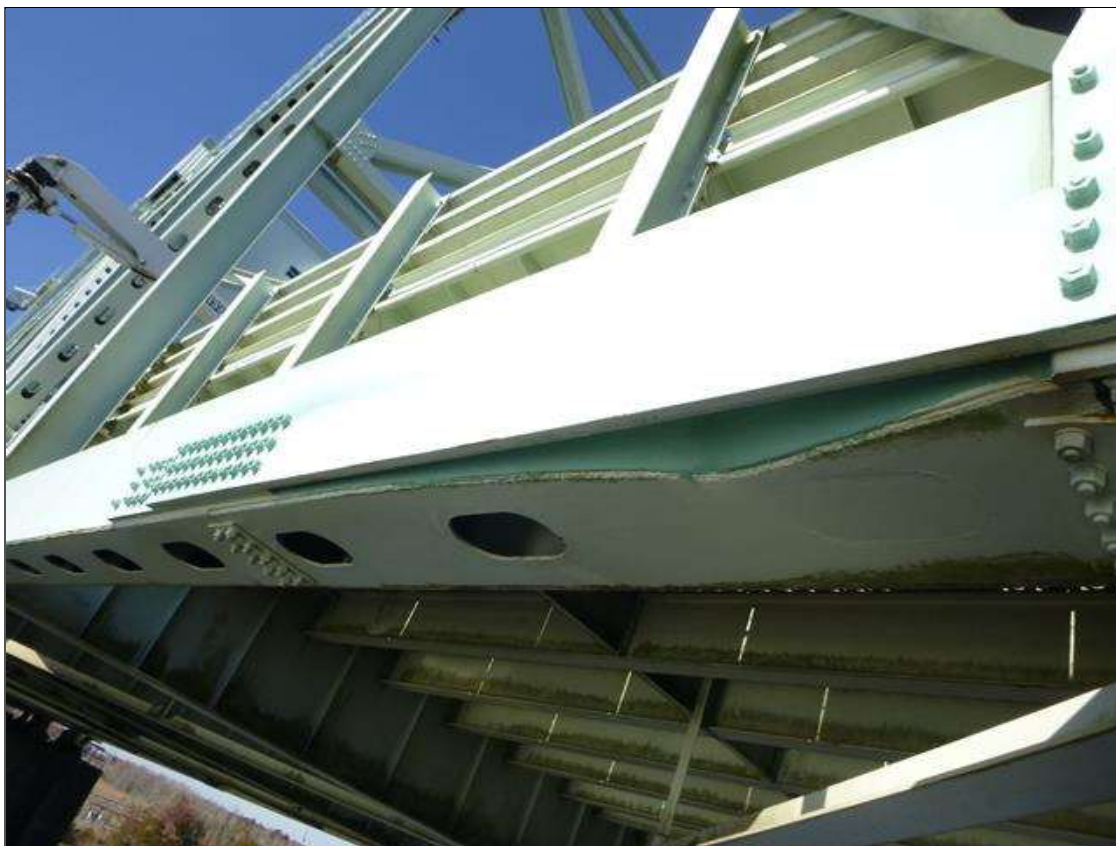
Span 18 Lift Span Stringer 10: REPAIR OBSERVED IN 2021 INSP: CRACK NOT VISIBLE AREA HAS BEEN PAINTED OVER. 2020 REPORT BETWEEN FB's 5-6 - 1" LONG CRACK IN WEB ACROSS TOP OF WELD AT DIAPHRAGM CONNECTION

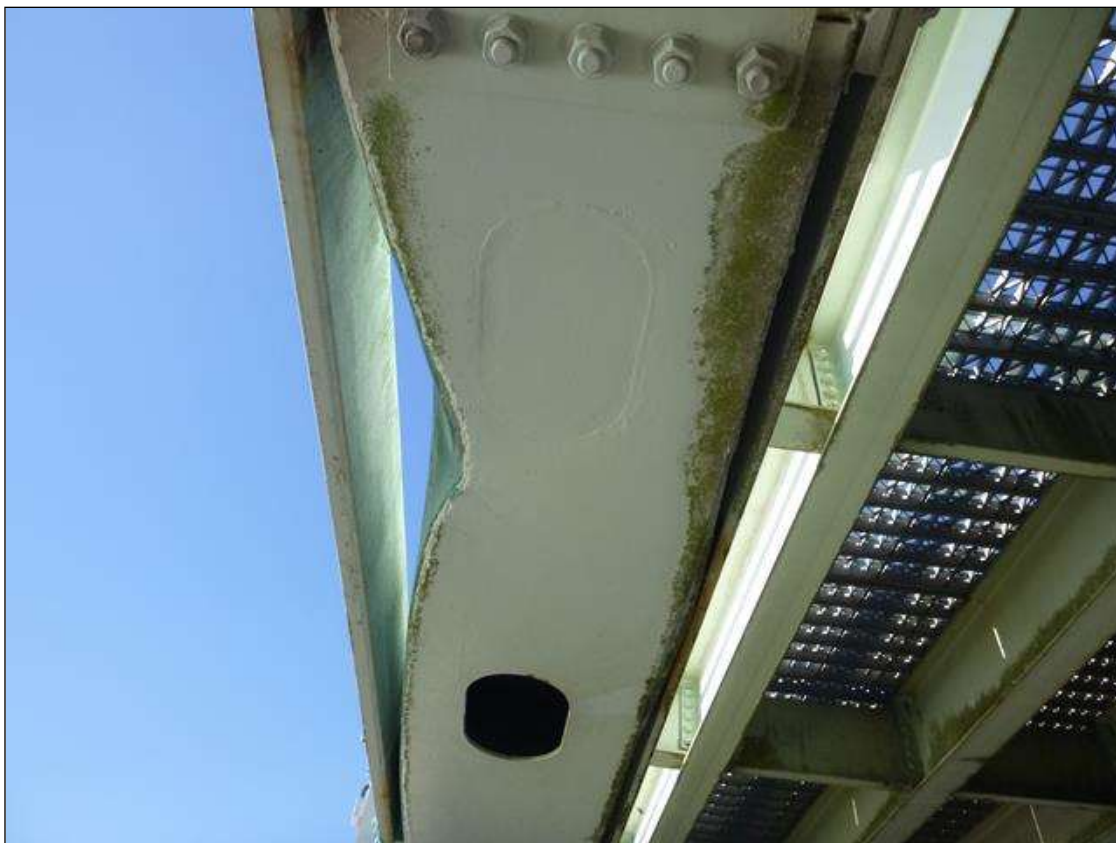
Span 18 Lift Span L5L6 SOUTH: IMPACT DAMAGE REPAIR TO CHORD AT L6

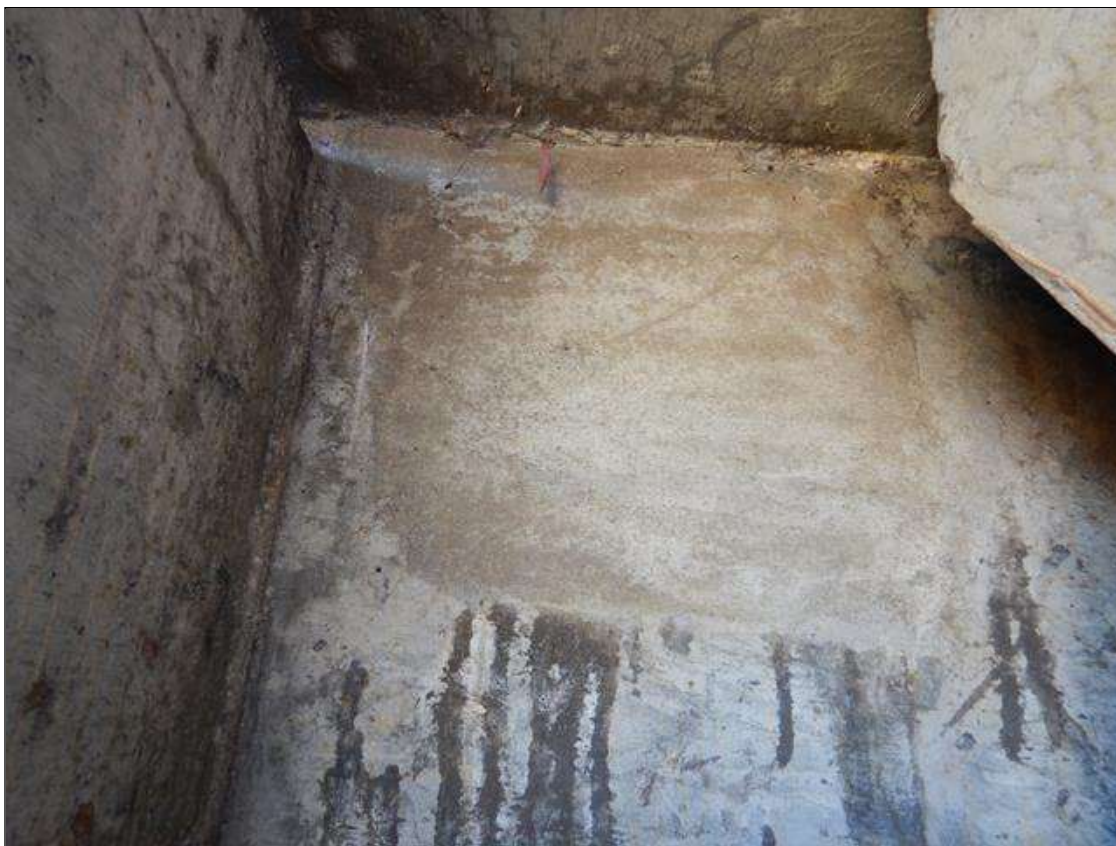
Ramp End Bent Ramp End Bent Cap: horizontal cracking on the west face under girder 1 up to (1/2") wide for 5.5ft long (surface efflorescence present)

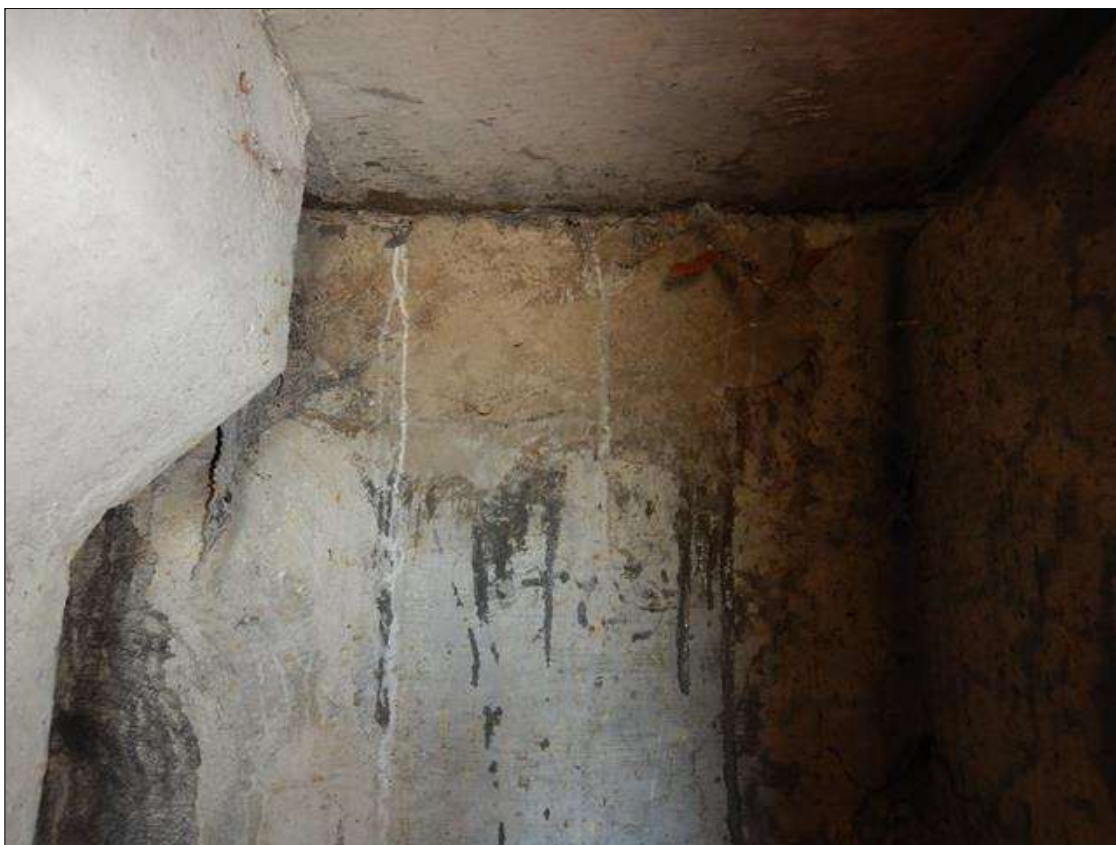
Ramp End Bent Abutment: [NEW REPAIR-PATCHING] FORMERLY --> spall with exposed rebar behind girder 1 (18" x 16" x 4")

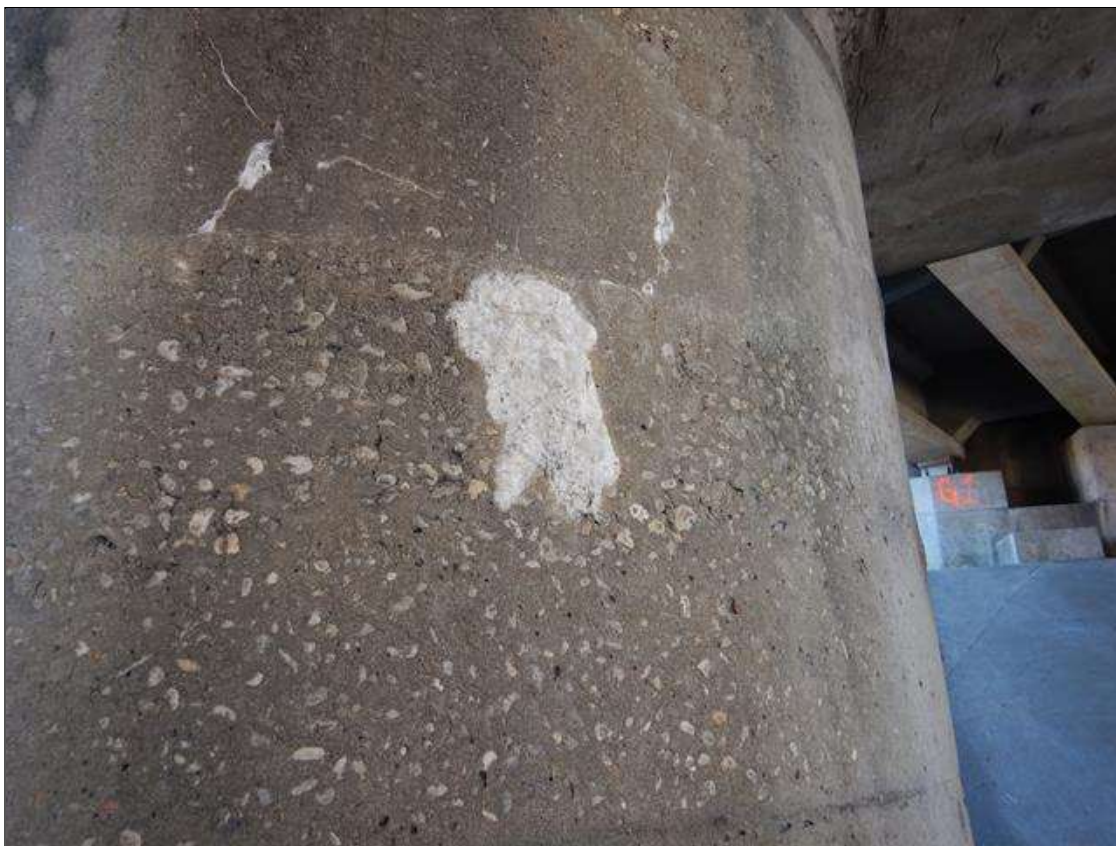
Bent 31 - Ramp Bent Cap 1: spall with no exposed rebar on the bottom face between the columns (10" x 3" x 1/4")

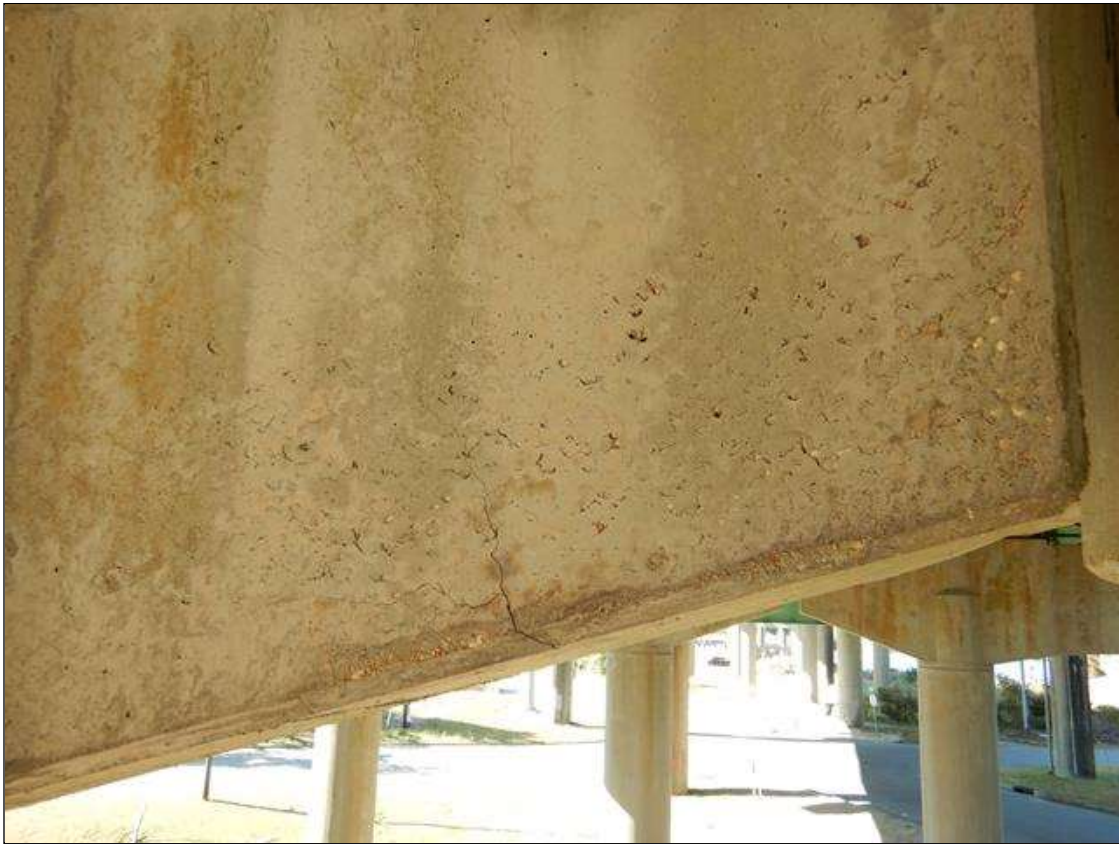
Bent 25 Cap 2: area of delamination on the west face of the cap under girder 8, 20" long x 15" high with hairline map cracking.

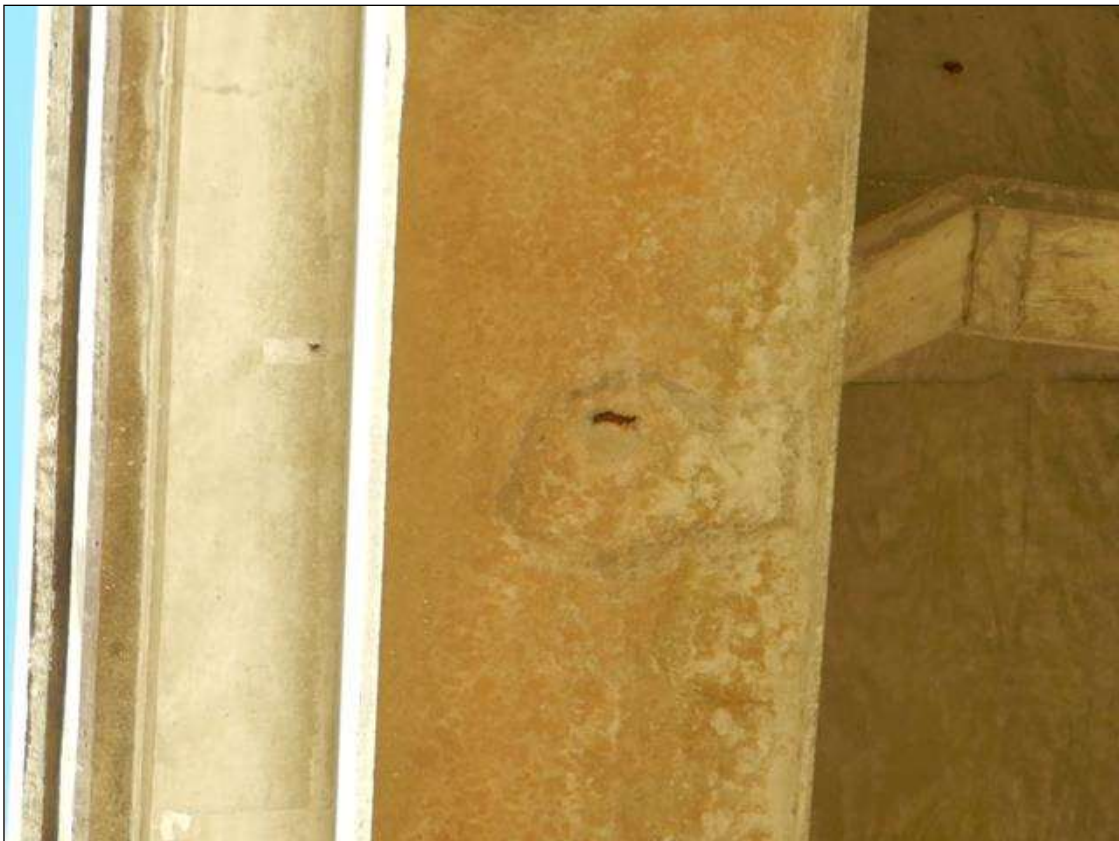
Bent 25 Cap 2: area of DELAMINATION (30" x 20") and cracking up to (1/16") wide on the west face left of column 3

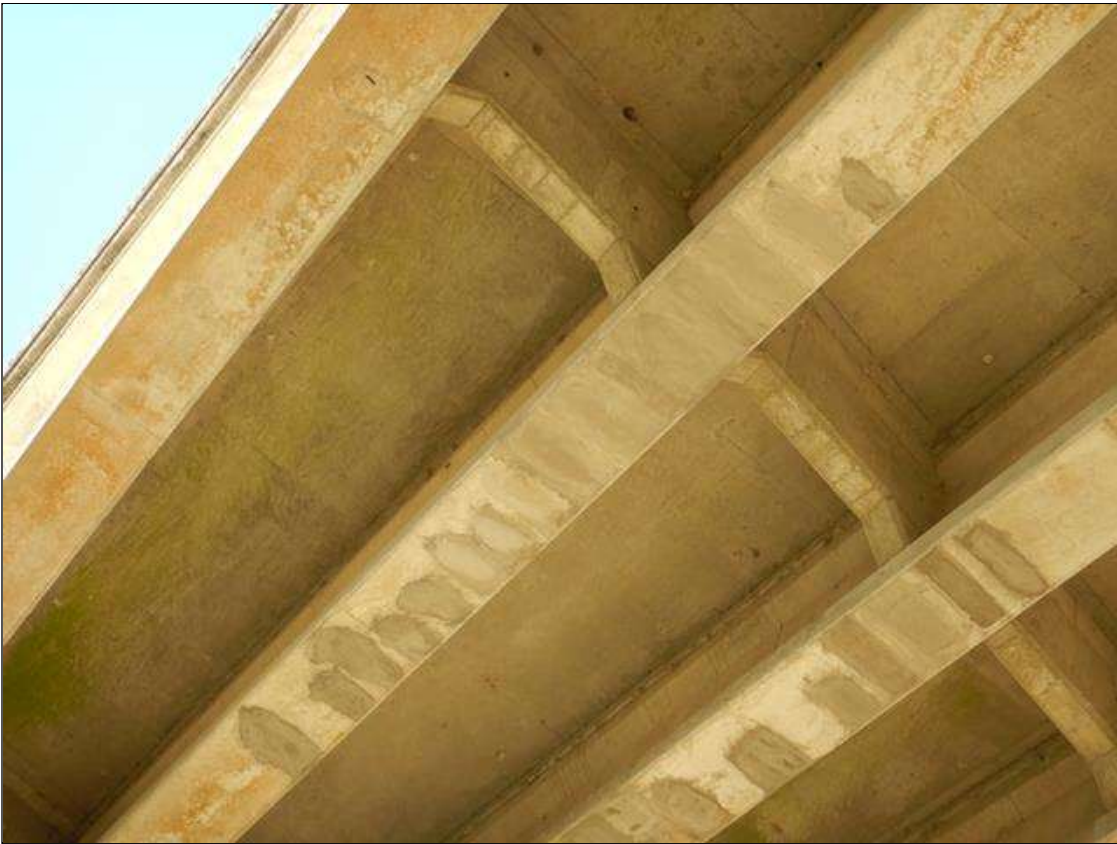
Span 27 Beam 15: [PROMPT ACTION REQUEST] (3" x 3" x 1/4") spall with exposed rebar on the bottom face at 21ft from bent 24

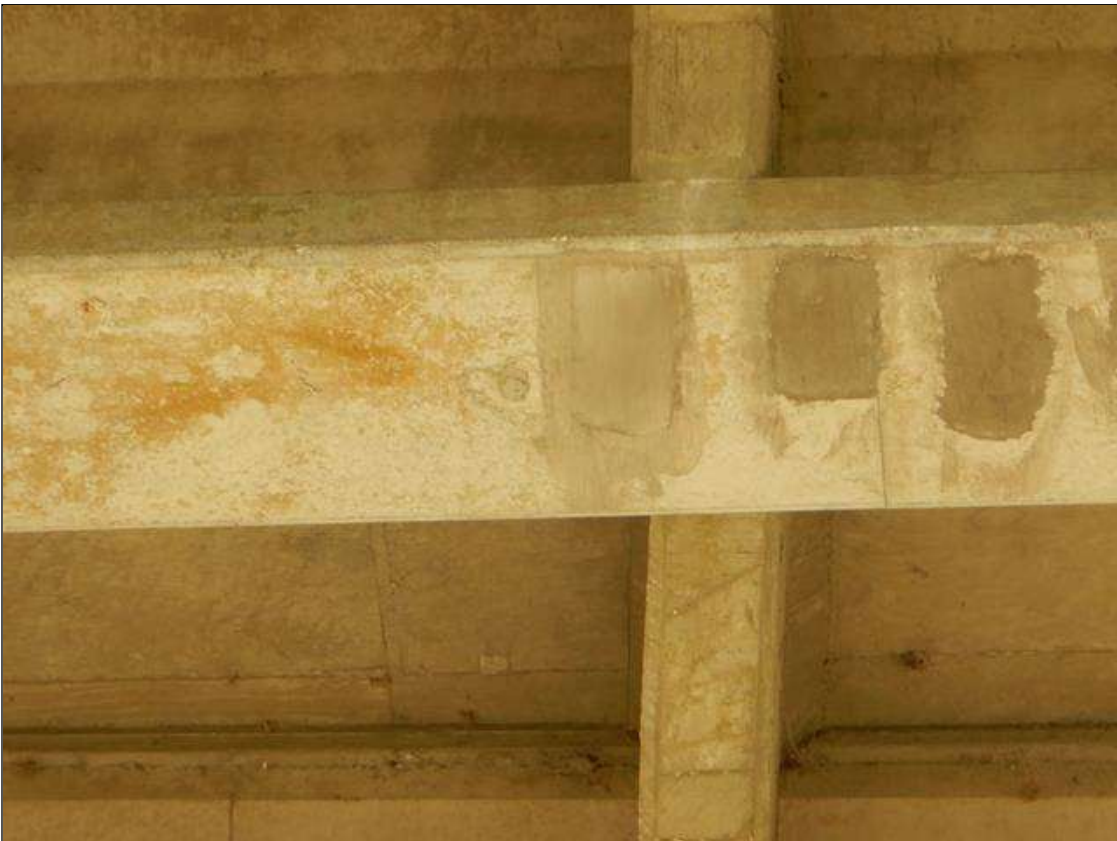
Span 27 Beam 14: [NEW REPAIR-PATCHING] FORMERLY --> (x13) DELAMINATION areas on the bottom face at 10f from bent 24 up to (10" x 2 1/2" x 1/4")

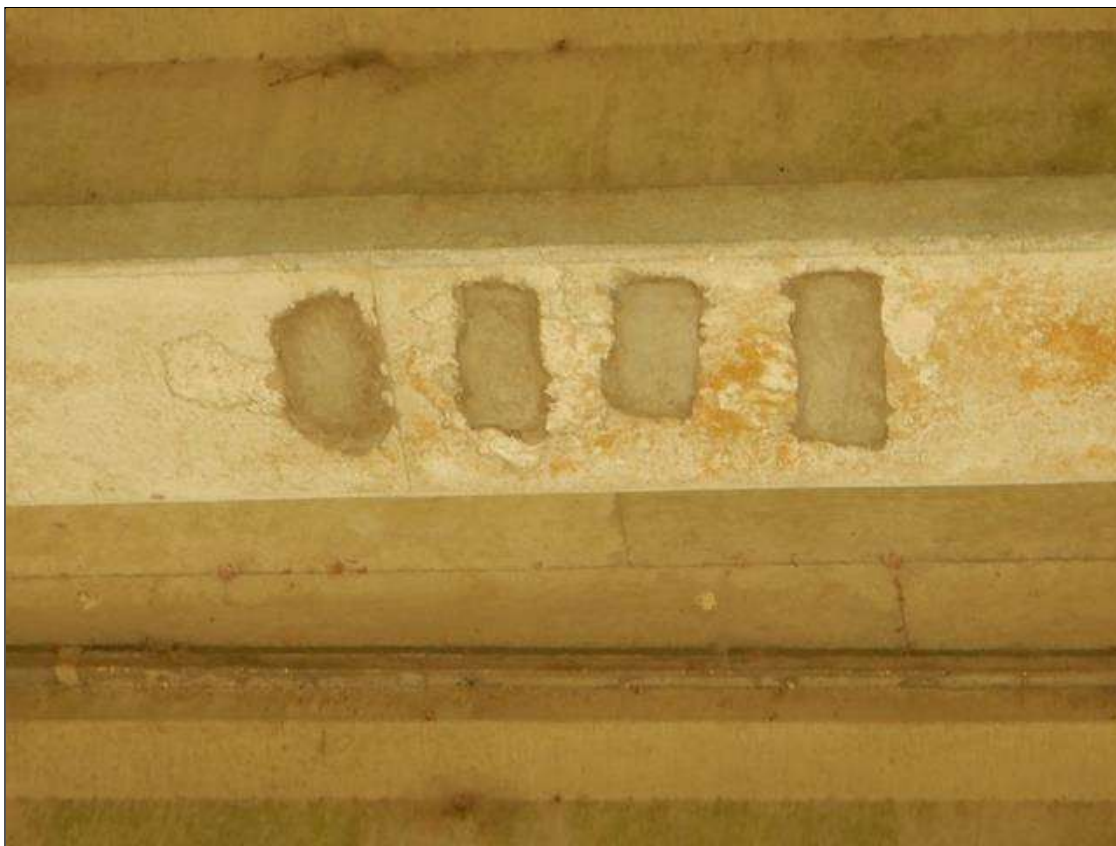
Span 27 Beam 11: [NEW REPAIR-PATCHING] FORMERLY --> (8" x 3" x 1/2") spall with exposed rebar on the bottom face at 21ft from bent 24

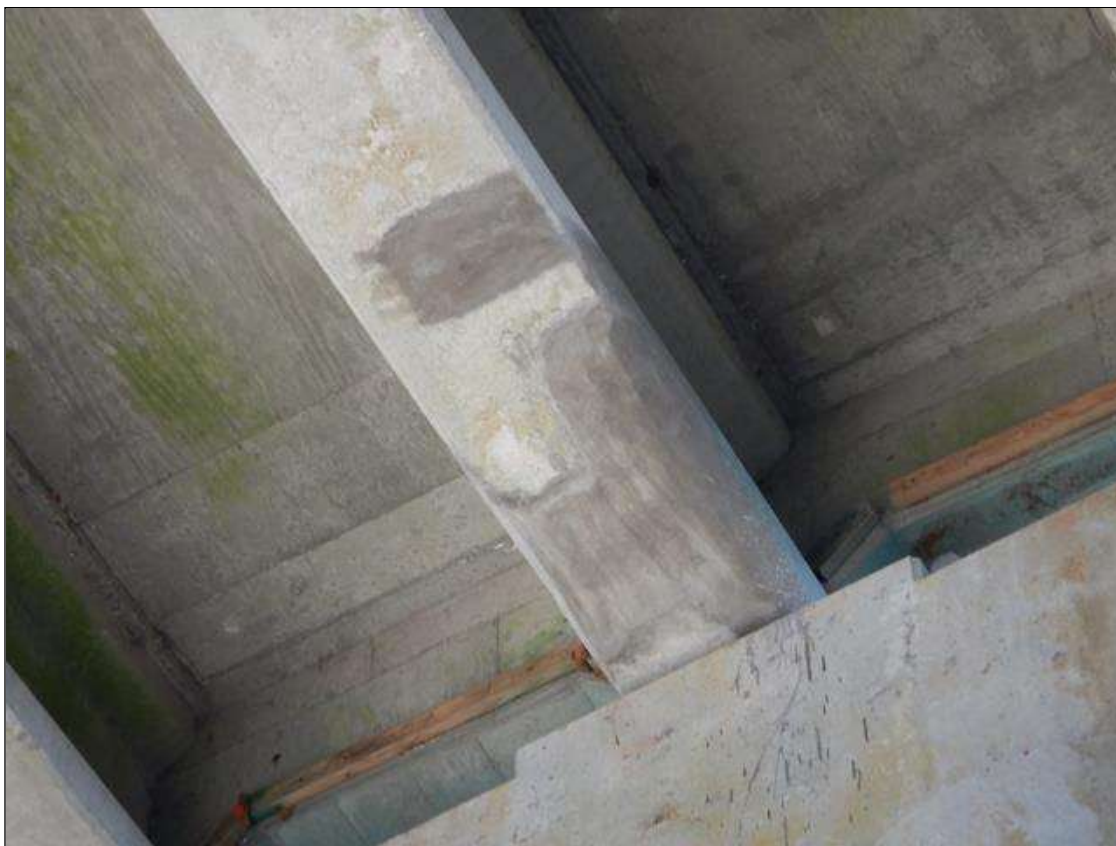
Span 27 Beam 11: [NEW REPAIR-PATCHING] FORMERLY --> (x4) DELAMINATION areas on the bottom face at mid span up to (6" x 6")

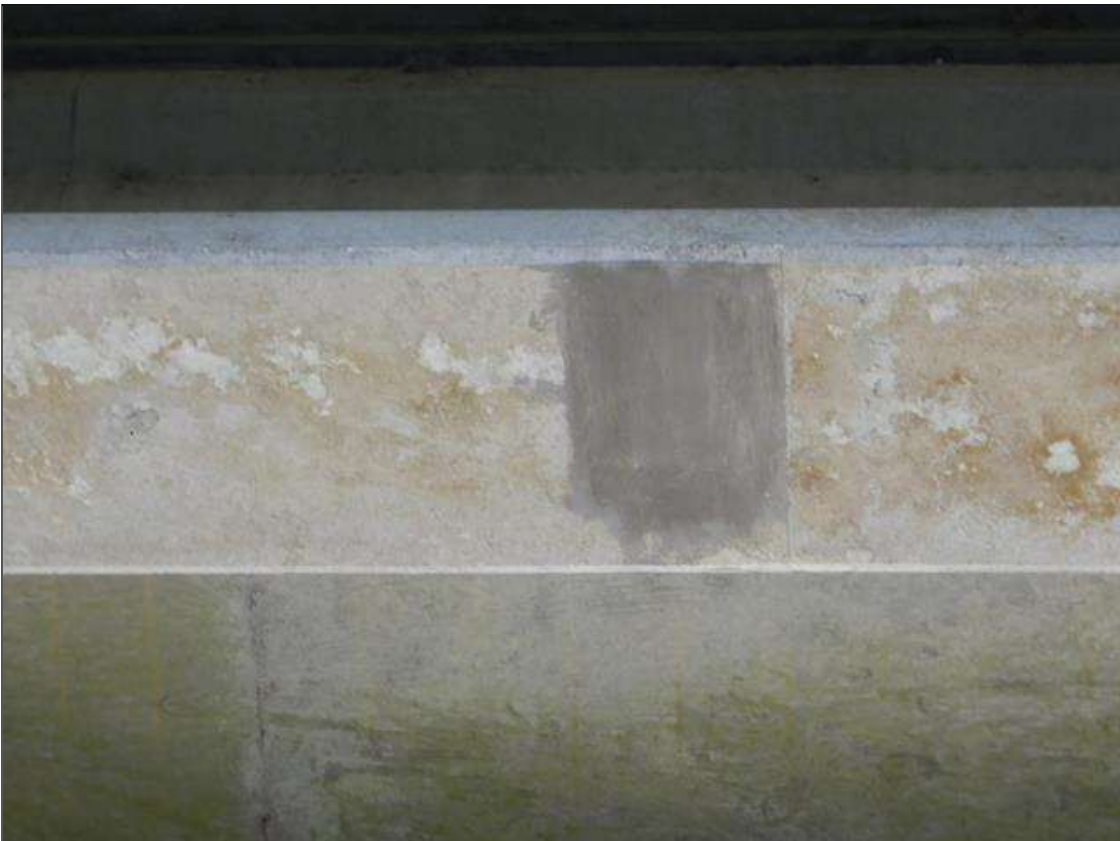
Span 27 Beam 6: [NEW REPAIR-PATCHING] FORMERLY --> (x23) spalls with exposed rebar on the bottom face up to (18" x 5" x 1/2")

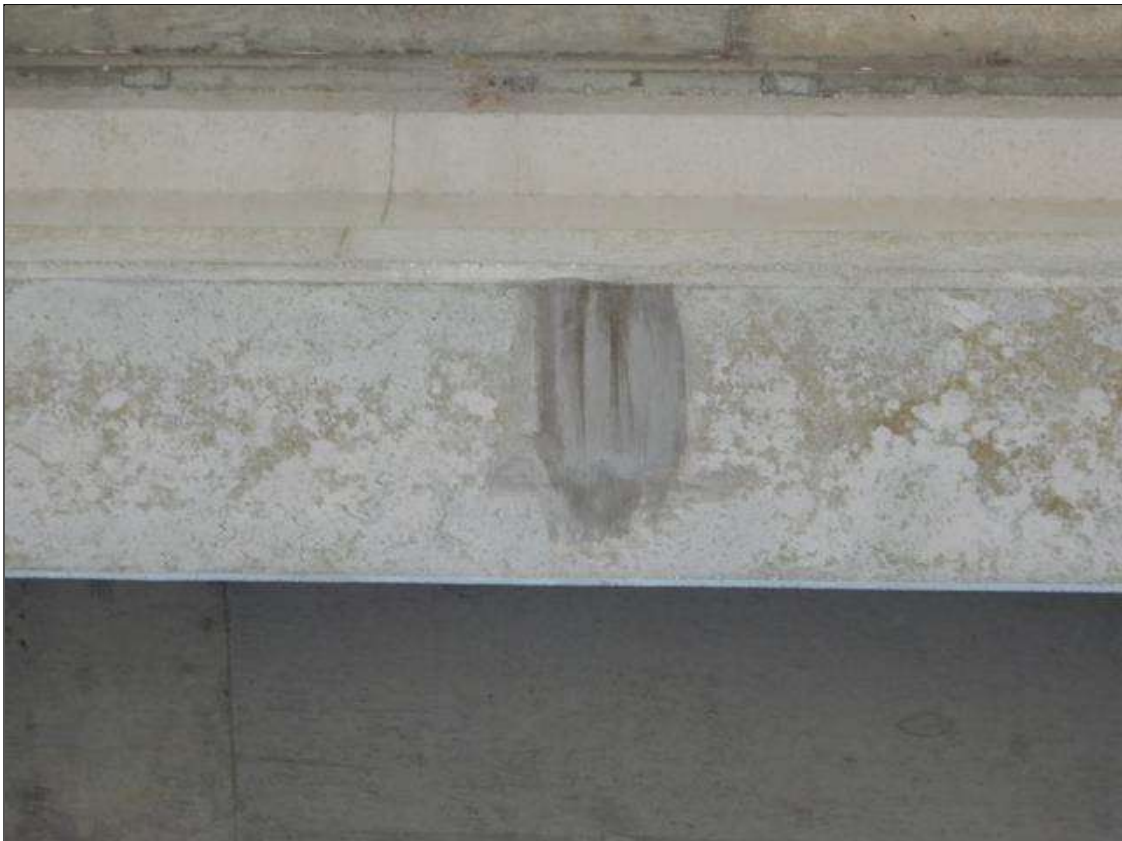
Span 27 Beam 5: [NEW REPAIR-PATCHING] FORMERLY --> spall with exposed rebar on the bottom face at 23ft from Bent 25 (7" x 5" x 1/2")

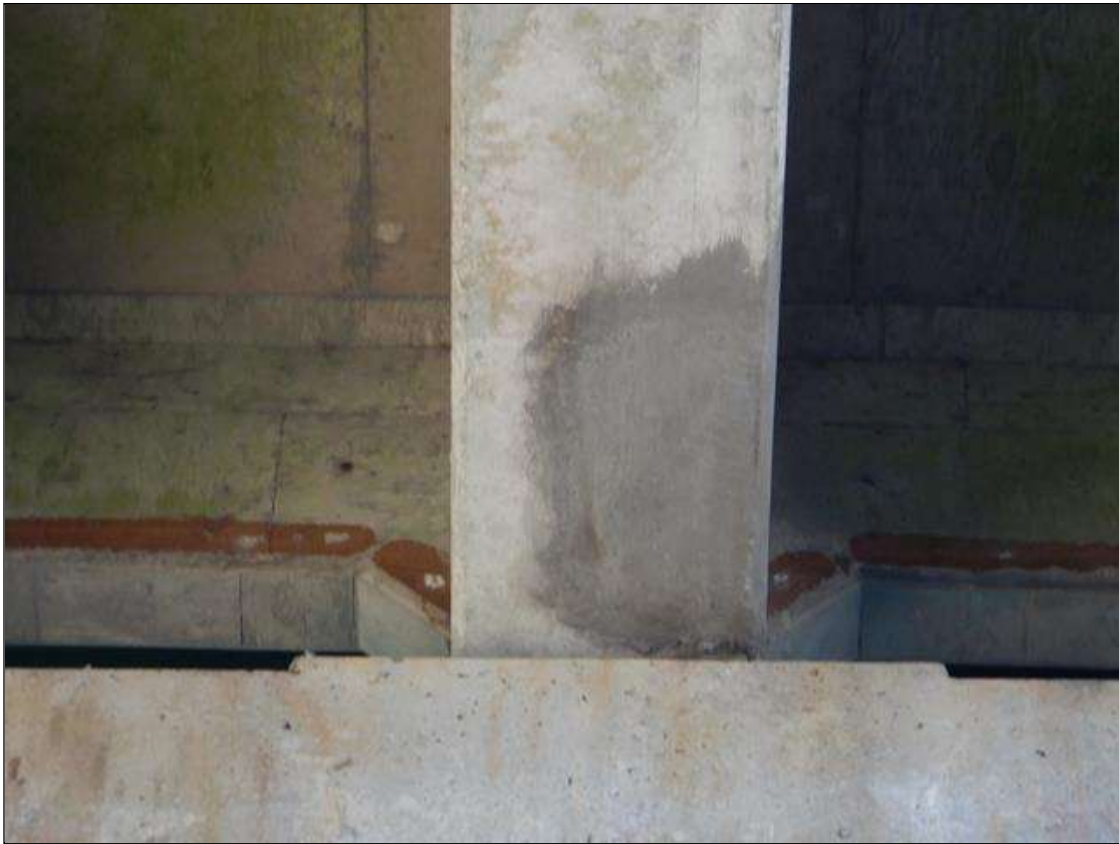
Span 27 Beam 4: [NEW REPAIR-PATCHING] FORMERLY --> spall with exposed rebar on the bottom face at 28ft from bent 24 (5" x 3" x 1/2")

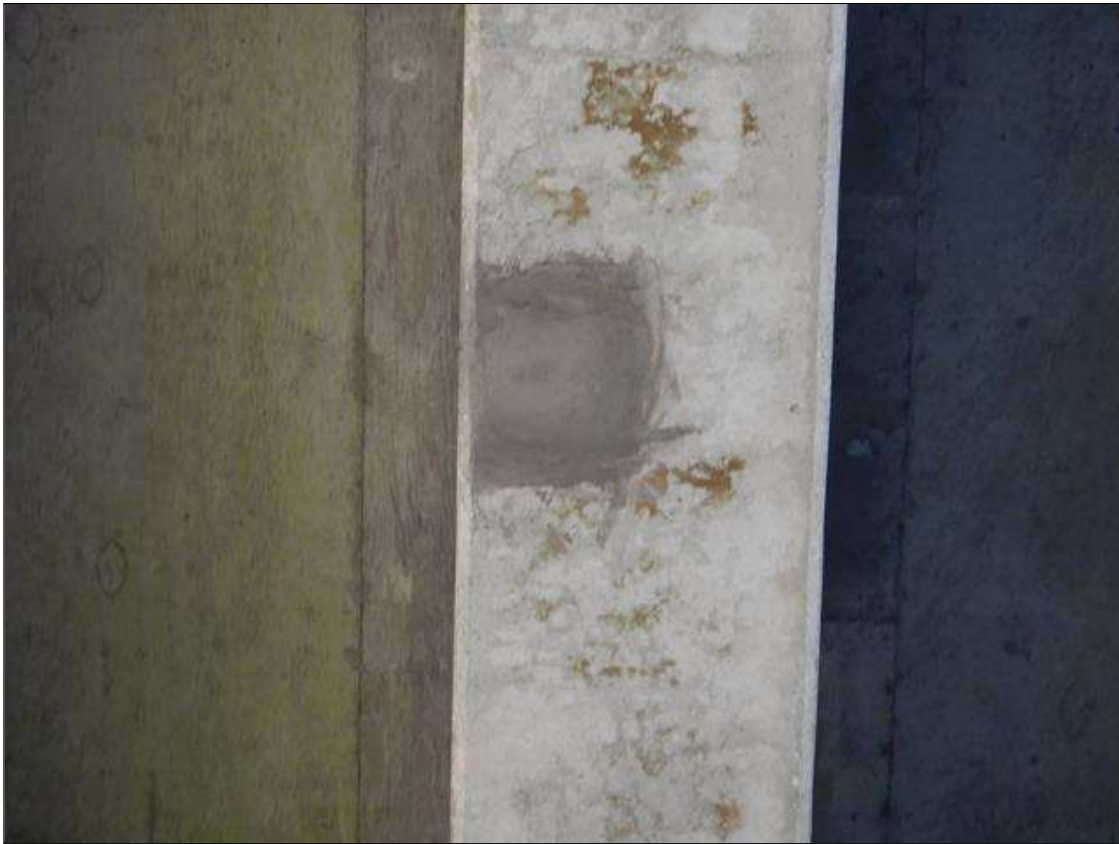
Span 27 Beam 2: [NEW REPAIR-PATCHING] FORMERLY --> spall with exposed rebar (27" x 4" x 2 1/2") and (1) strand exposed on the bottom left flange at Bent 24, strand exposed for (16") long, active corrosion on strand with no measureable section loss

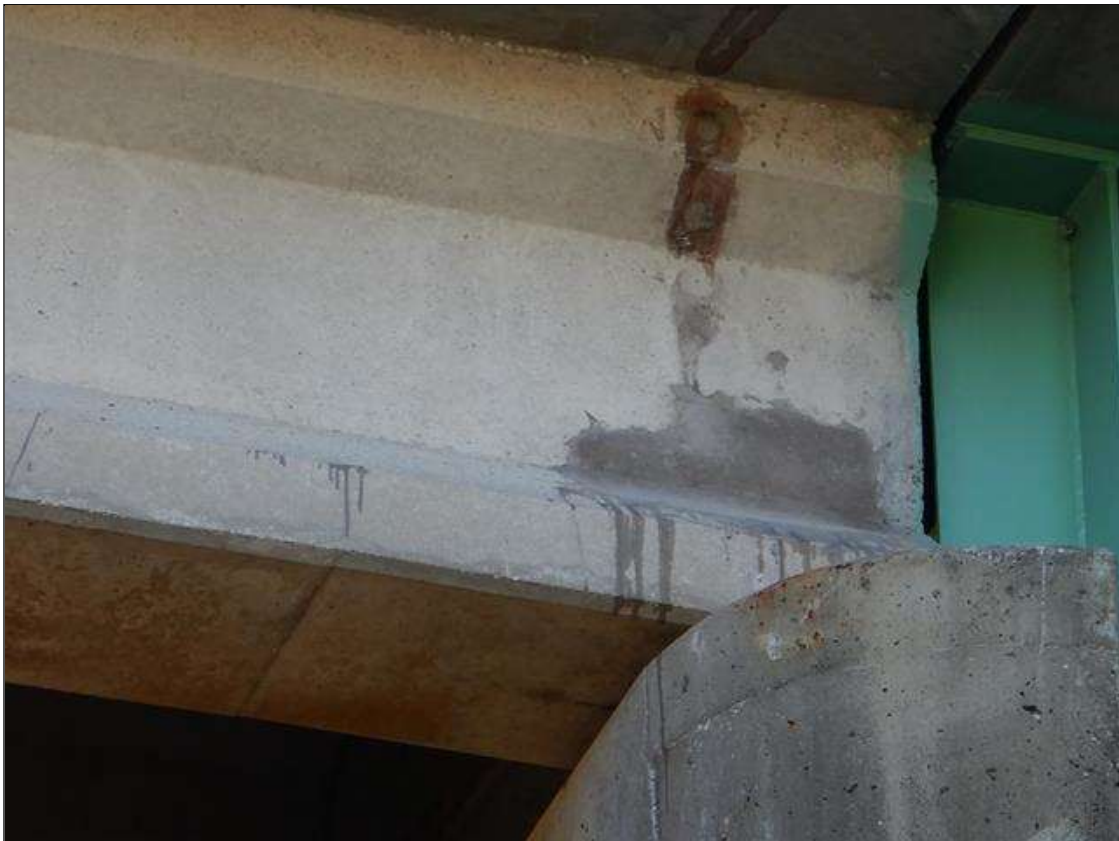
Span 27 Beam 2: [NEW REPAIR-PATCHING] FORMERLY --> DELAMINATION area on the bottom face at 10ft from bent 24 (4" x 2")
