NC DEPARTMENT OF TRANSPORTATION
DIVISION OF HIGHWAYS
STRUCTURE MANAGEMENT UNIT

Structure Safety Report

Routine Element Inspection - Contract

DIVISION: 3 COUNTY: NEW HANOVER STRUCTURE NUMBER: 640013 FREQUENCY: 24 MONTHS

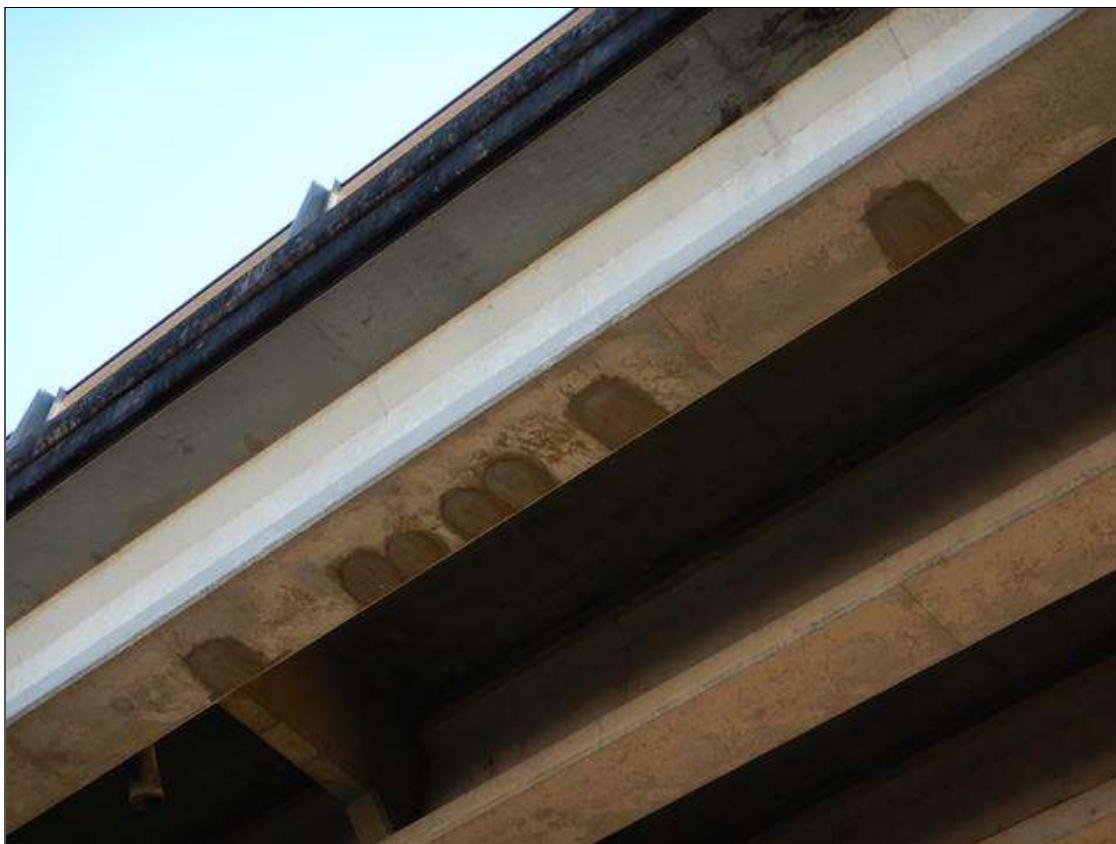
Span 27 Beam 1: [NEW REPAIR-PATCHING] FORMERLY --> spall with exposed rebar on the left web at bent 24 (20" x 2" x 1/4")

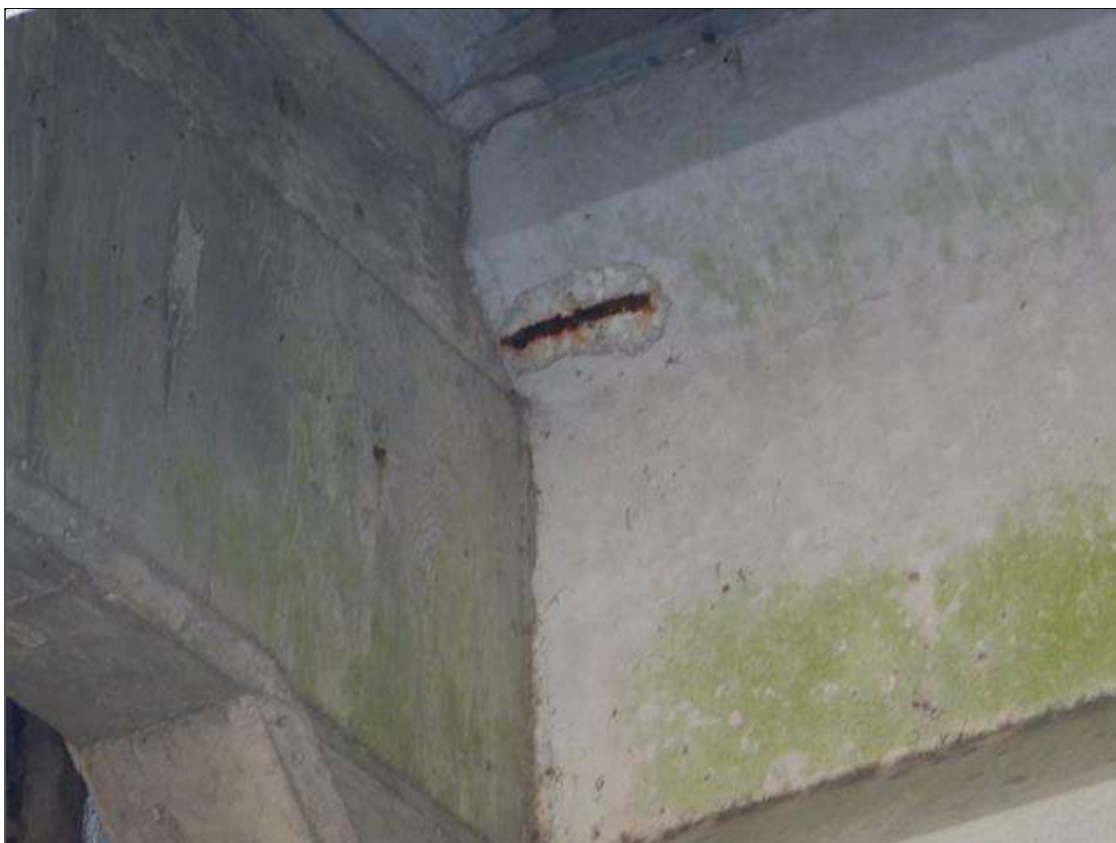
Span 27 Beam 1: [NEW REPAIR-PATCHING] FORMERLY --> (x7) spalls with exposed rebar on the bottom face at mid span up to (7" x 4" x 1/2")

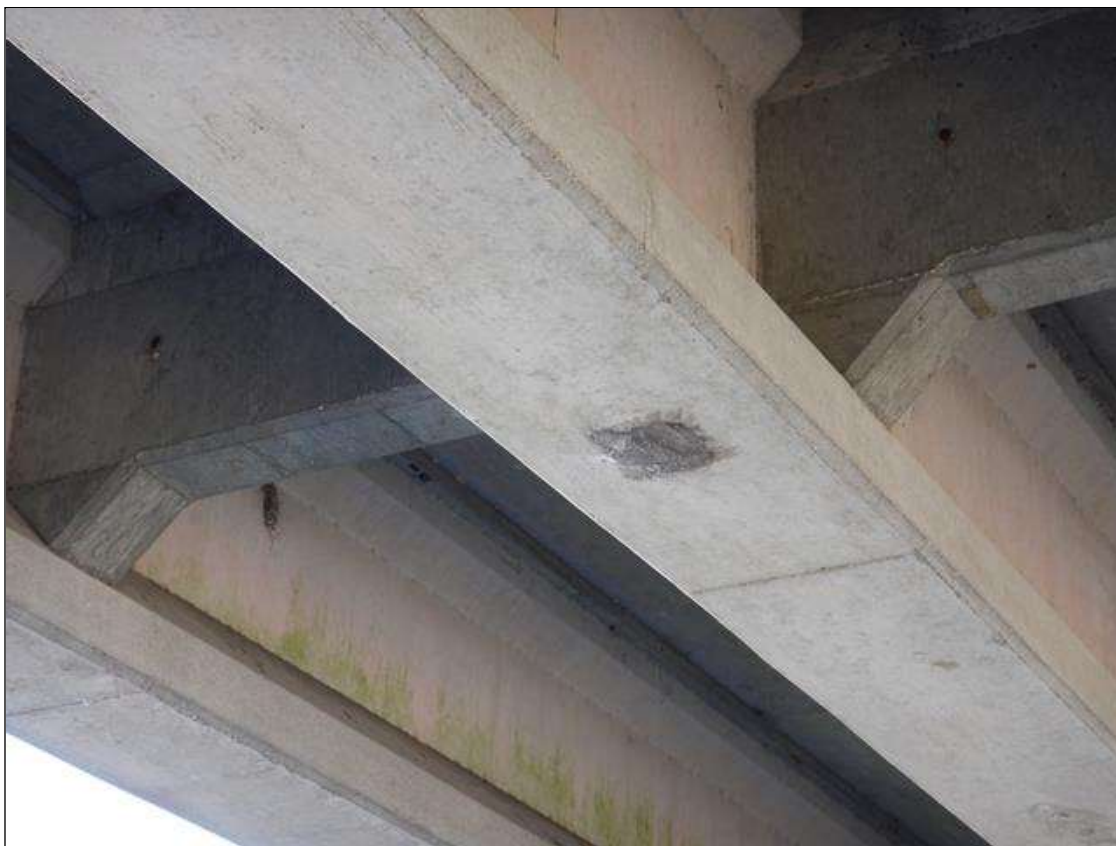
Span 28 Beam 1: [PROMPT ACTION REQUEST] spall with exposed rebar on the top right flange at bent 25 (7" x 3" x 1/2")

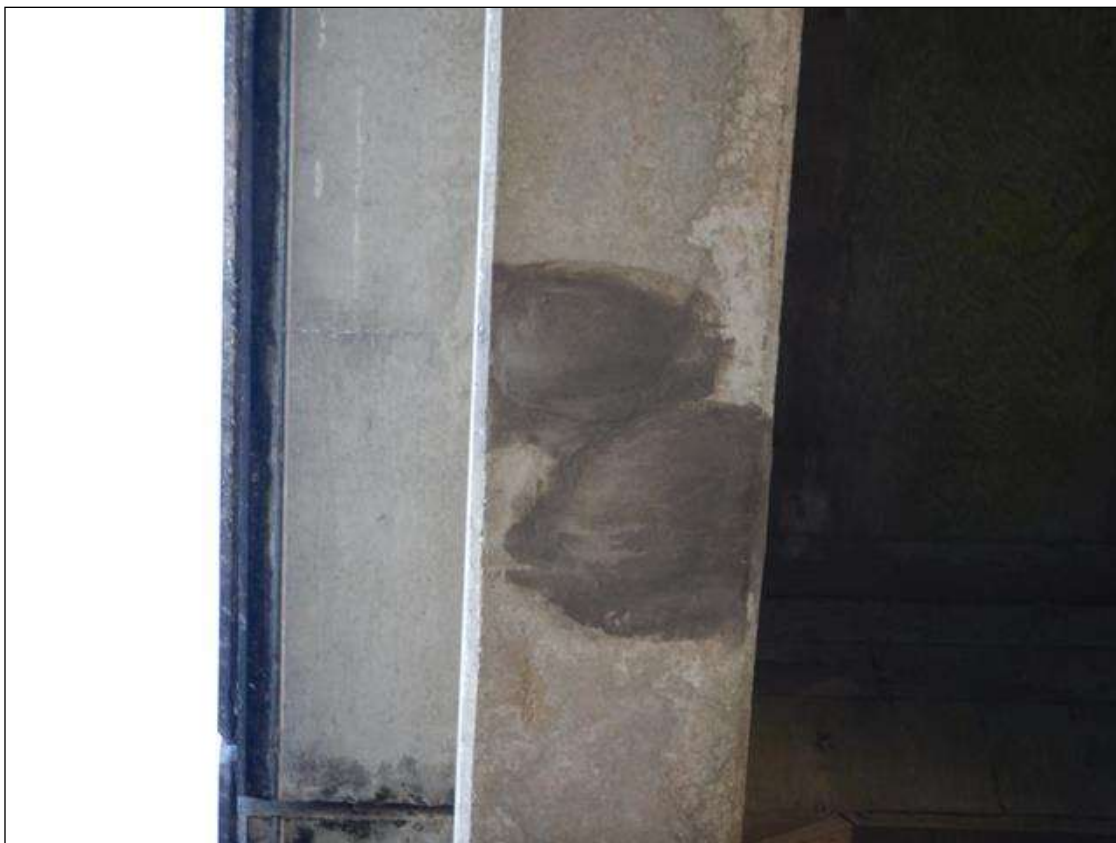
Span 28 Beam 2: sound patch on the bottom face, 10" x 10", at 1/3 point

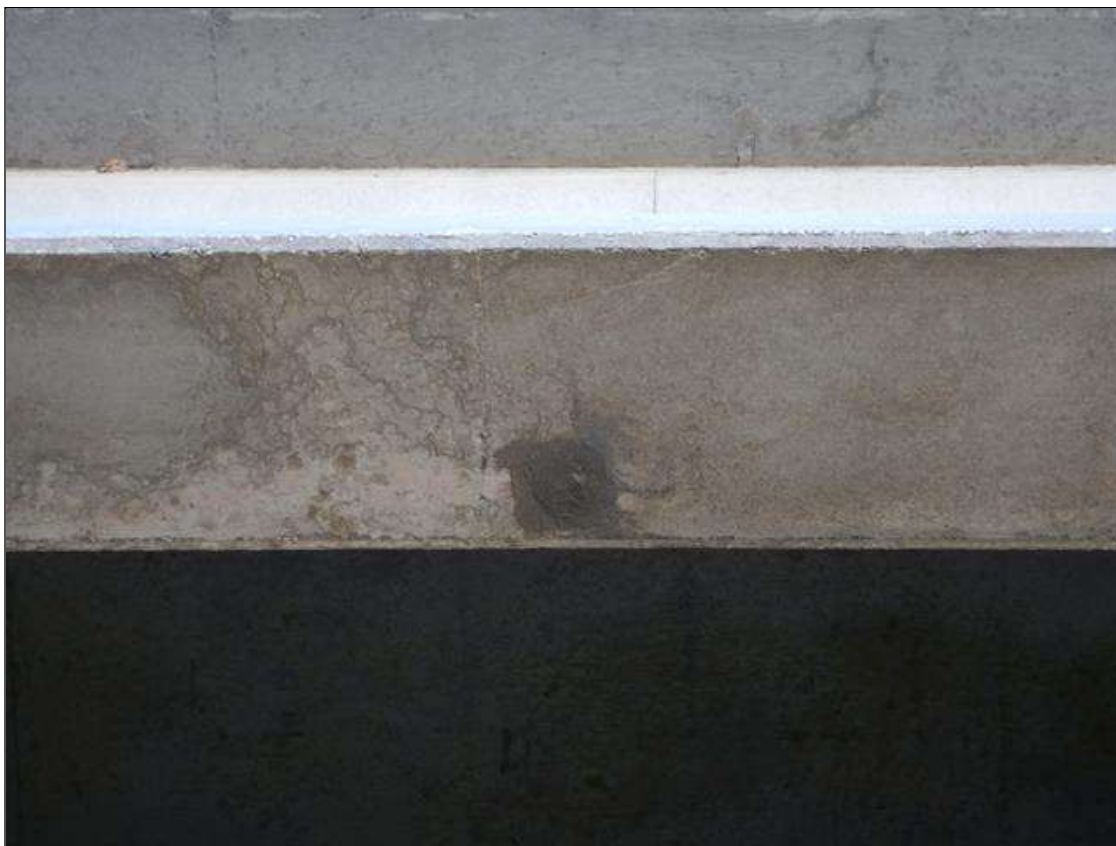
Span 28 Beam 1: [NEW REPAIR-PATCHING] FORMERLY --> (x2) spalls with exposed rebar on the bottom face at 3ft from bent 26 up to (8" x 6" x 3/4")

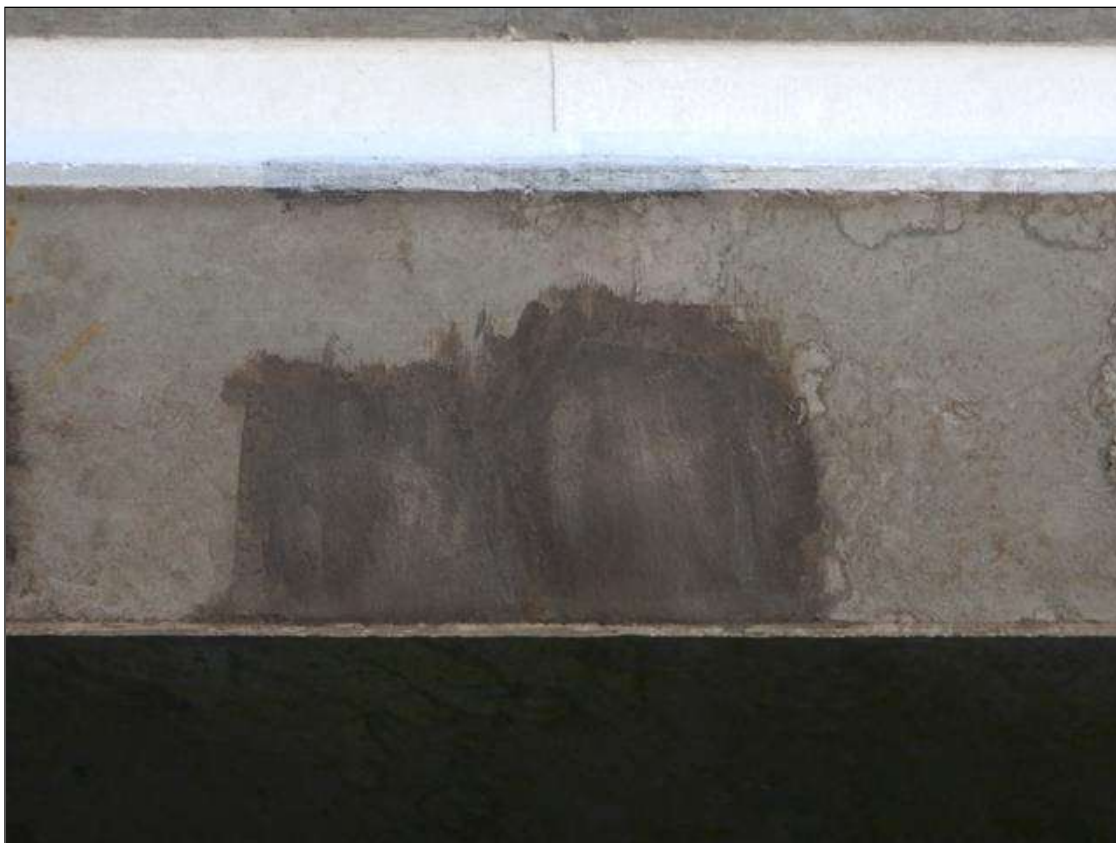
Span 28 Beam 1: sound patch on the bottom face at 12.5ft from bent 26 (7" x 6")

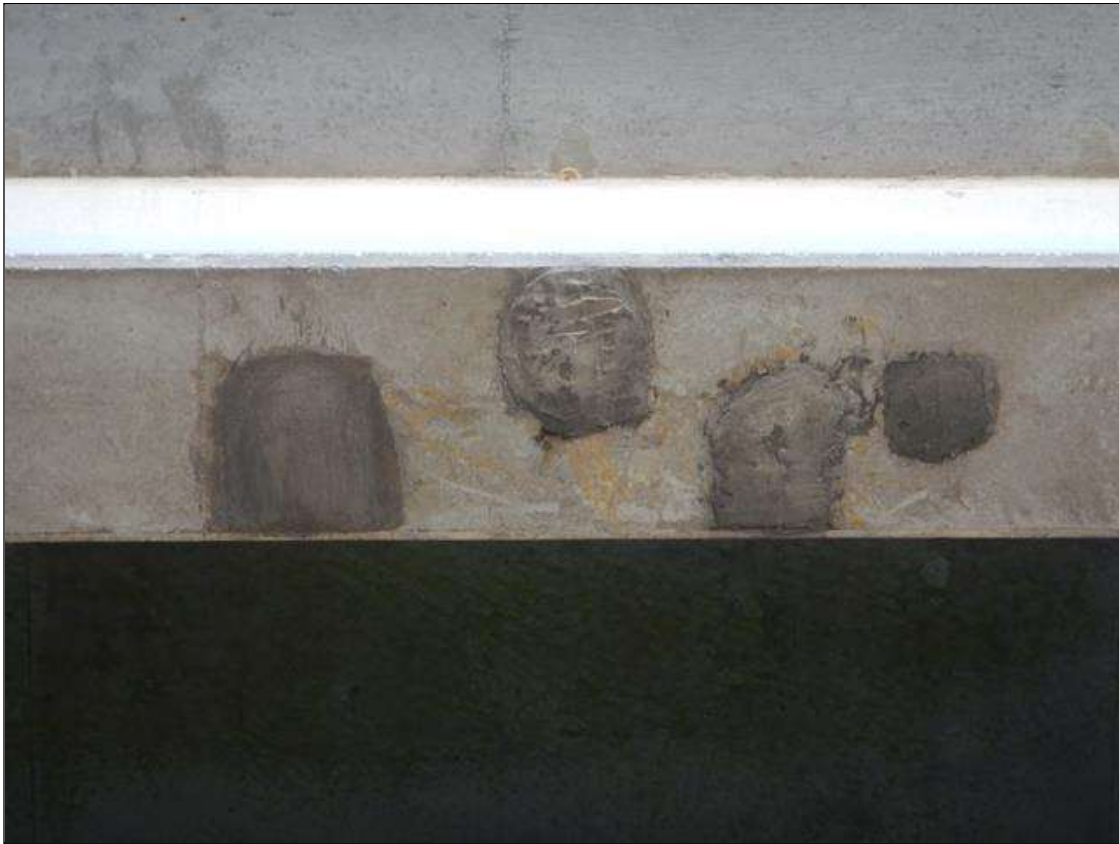
Span 28 Beam 1: (x2) sound patches on the bottom face at mid span up to (8" x 7")

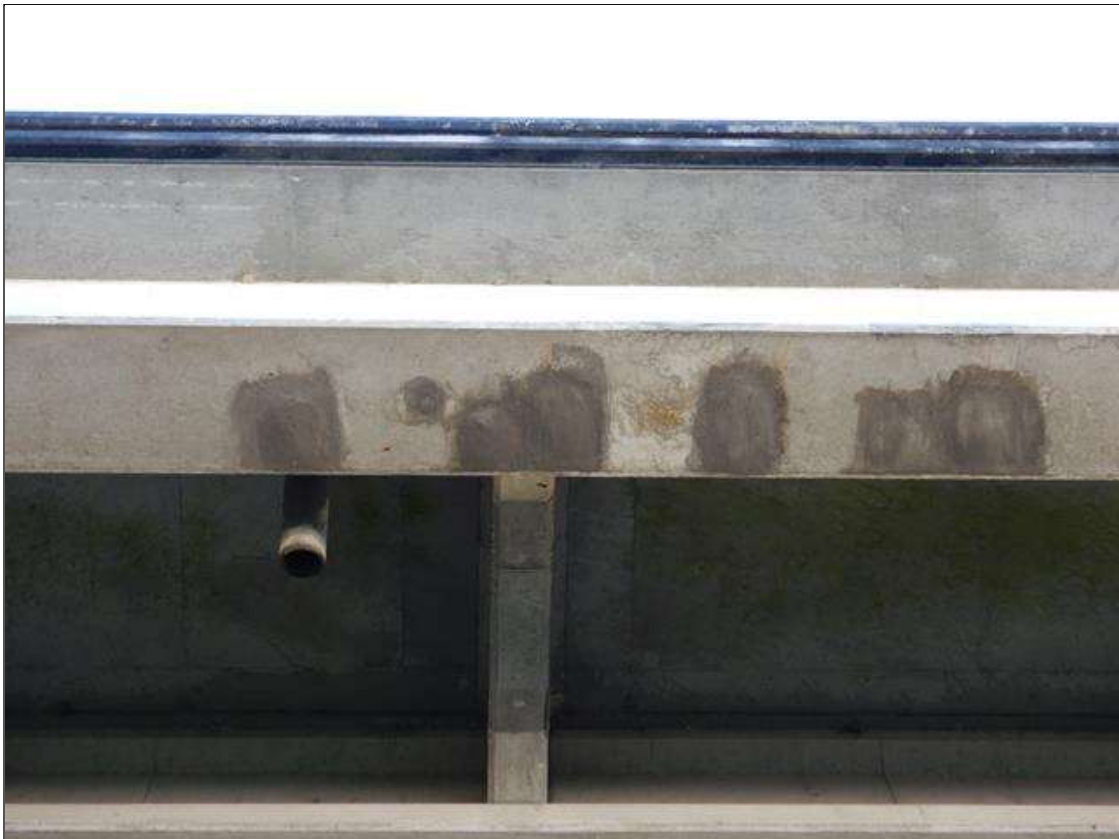
Span 28 Beam 1: [NEW REPAIR-PATCHING] FORMERLY --> (x4) spalls with exposed rebar on the bottom face near mid span up to (4" x 2 1/2" x 1/2")

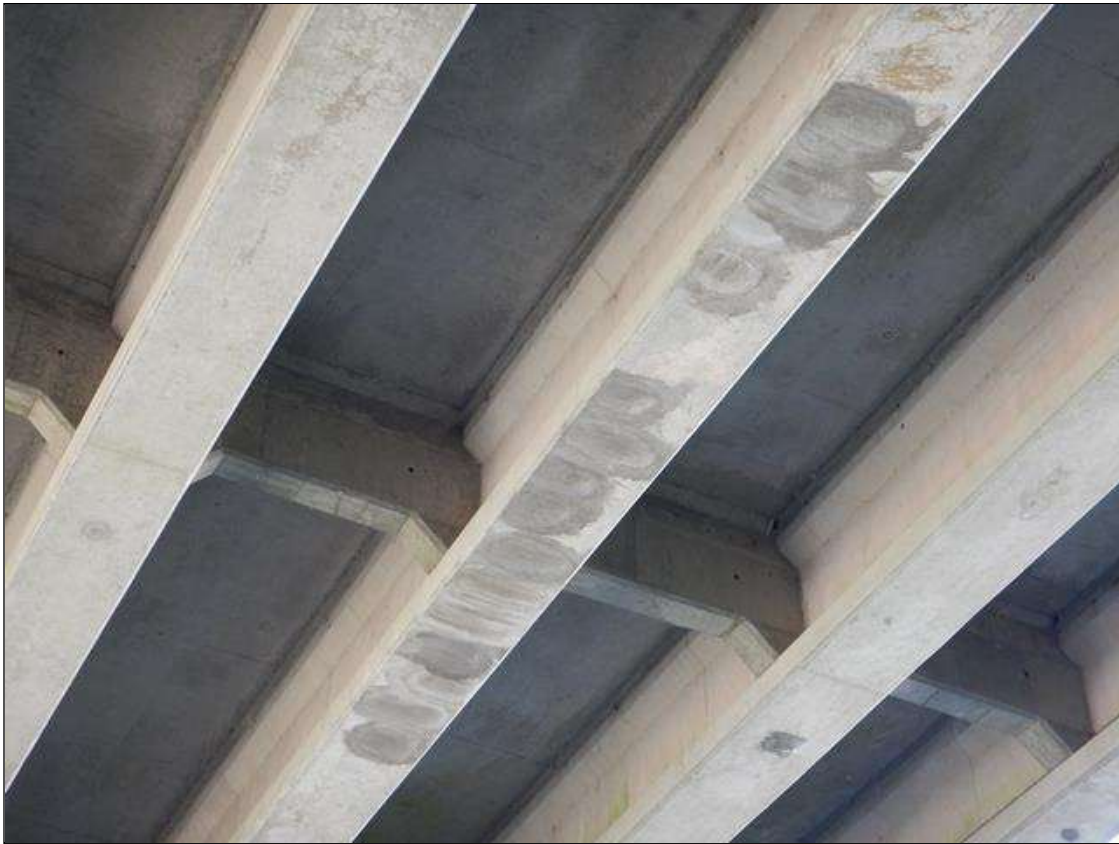
Span 28 Beam 1: [NEW REPAIR-PATCHING] FORMERLY --> (x5) spalls with with exposed rebar on the bottom face a 18.5ft from bent 26 up to (6" x 6" x 1/2")

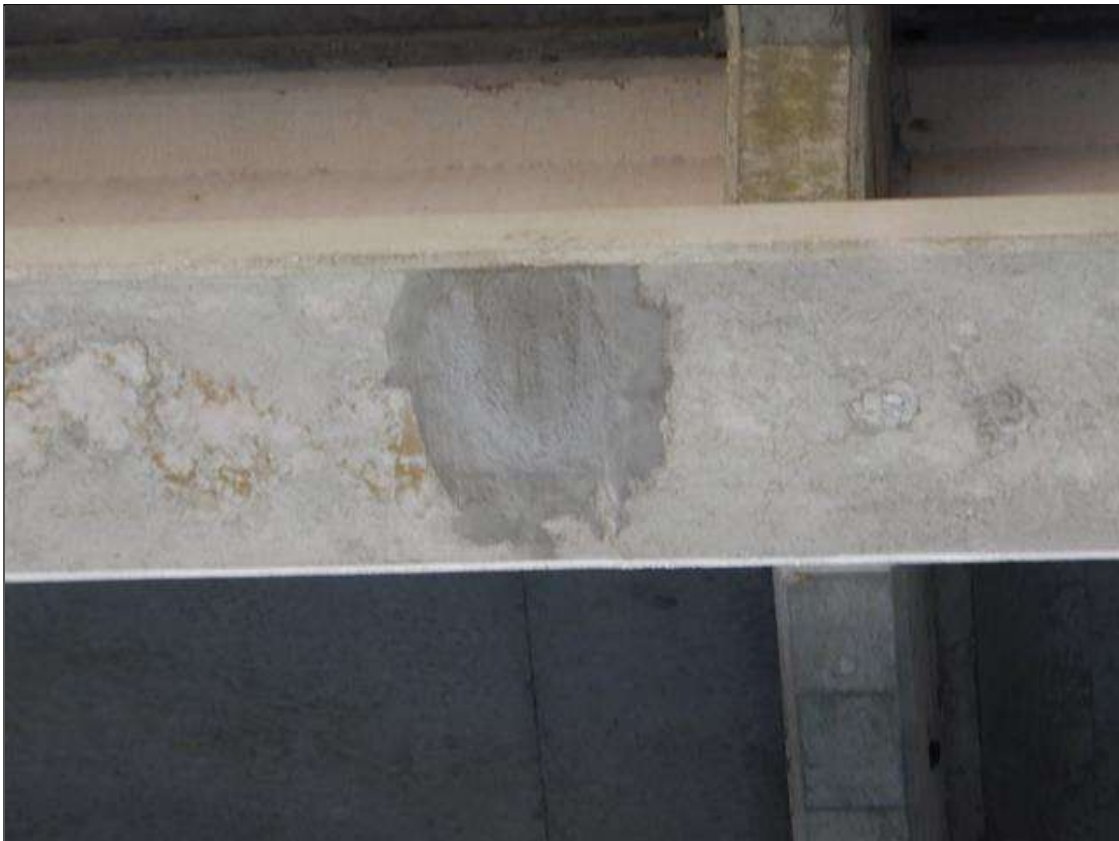
Span 28 Beam 3: REPAIR observed in 2020 insp: 15 sound patches up to 18" wide x 12" long. 2018 report had (x10) spalls with exposed rebar at mid span on the bottom face up to (14" x 6" x 1/2")

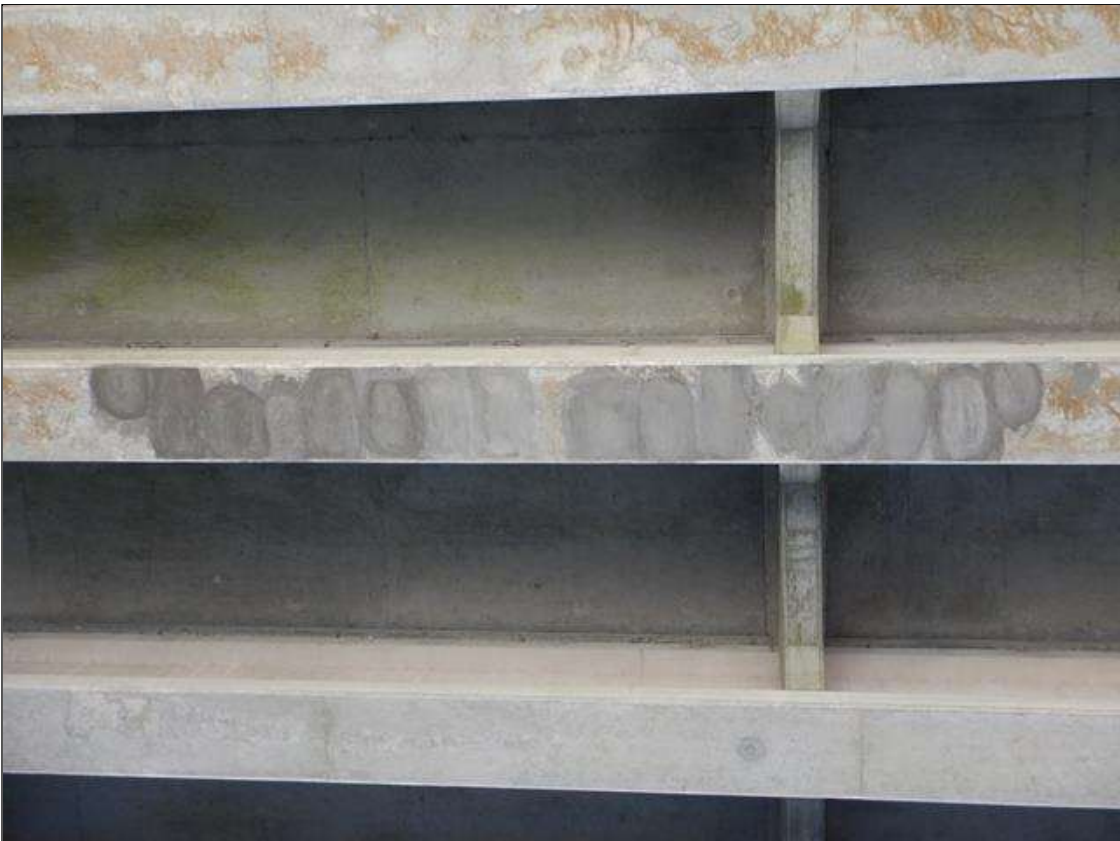
Span 28 Beam 5: [NEW REPAIR-PATCHING] FORMERLY --> (x2) spalls with exposed rebar on the bottom face at bent 25 up to (7" x 7" x 1/2")

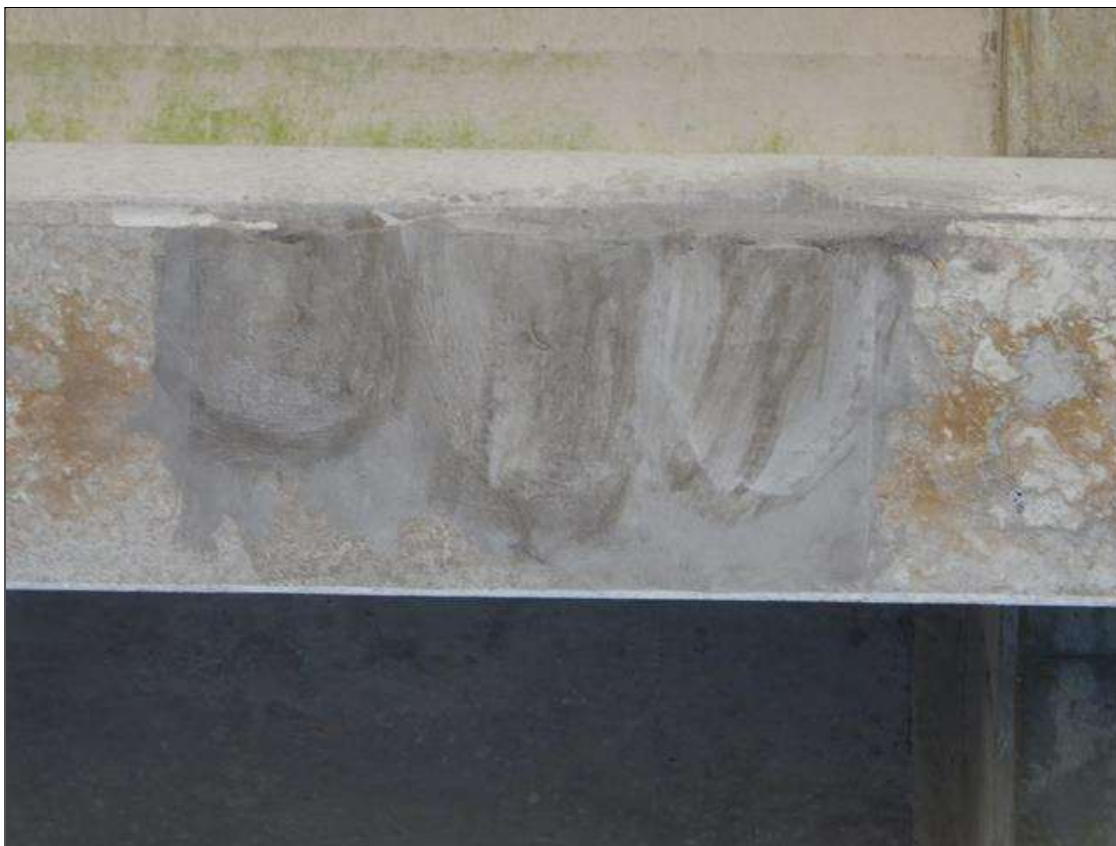
Span 28 Beam 5: [NEW REPAIR-PATCHING] FORMERLY --> multiple spalls with exposed rebar on the bottom face starting at 9ft from bent 25 up to (18" x 6" x 1/2")

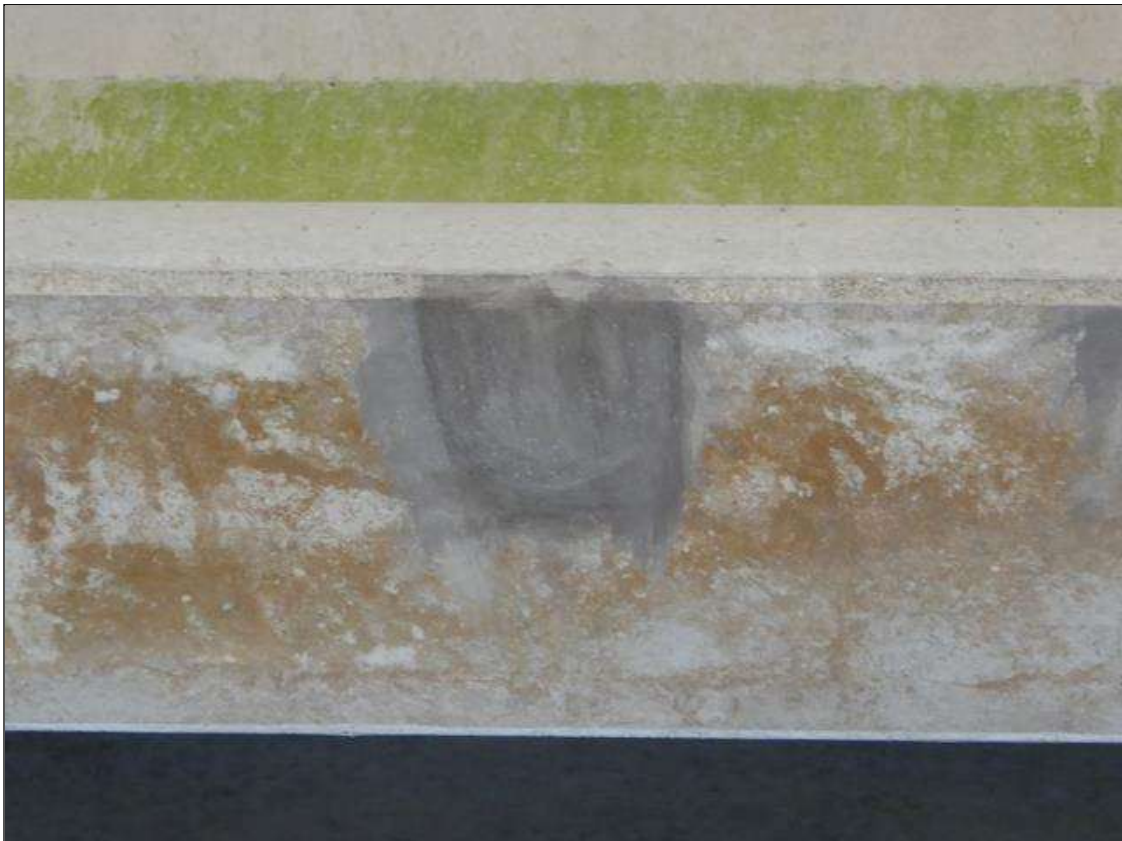
Span 28 Beam 5: [NEW REPAIR-PATCHING] FORMERLY --> (x3) spalls with exposed rebar on the bottom face starting at 22.5ft from Bent 26 up to (6" x 4" x 1/2")

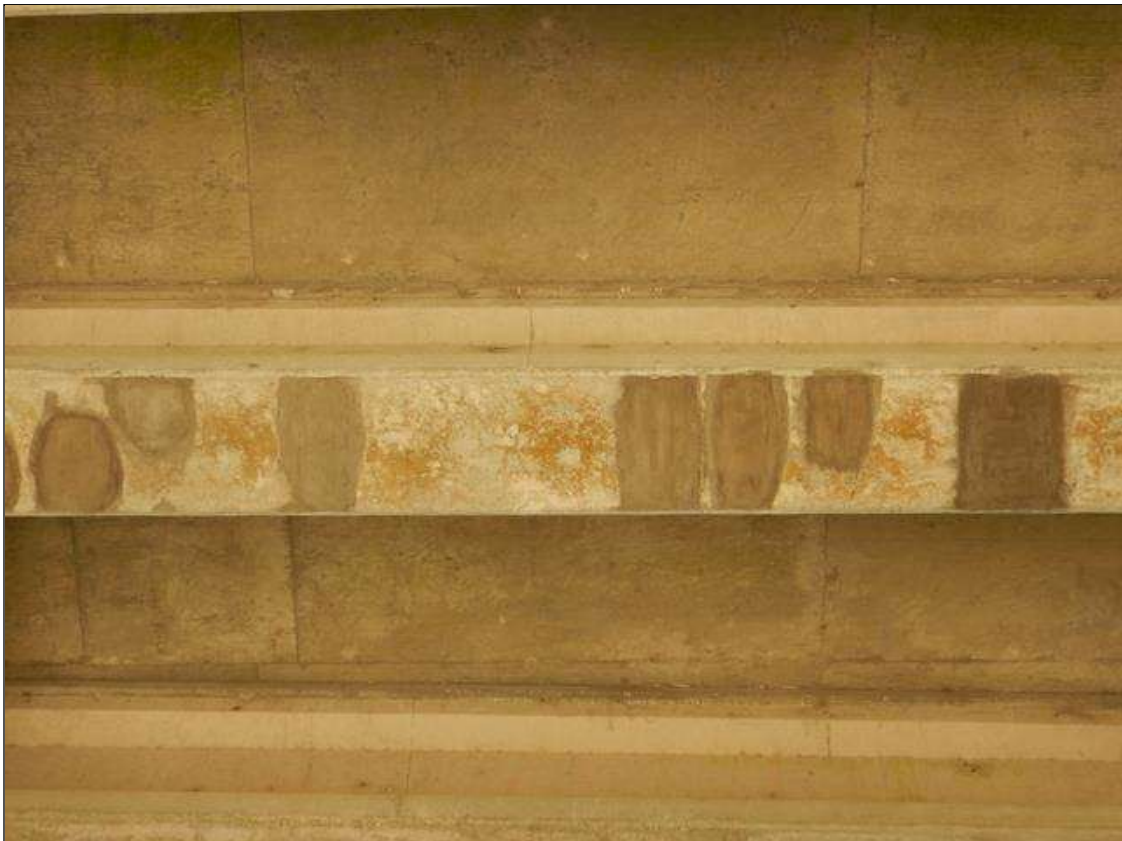
Span 28 Beam 8: [PROMPT ACTION REQUEST] spall with exposed rebar on the top right flange at bent 25 (5" x 1 1/2" x 1/4")

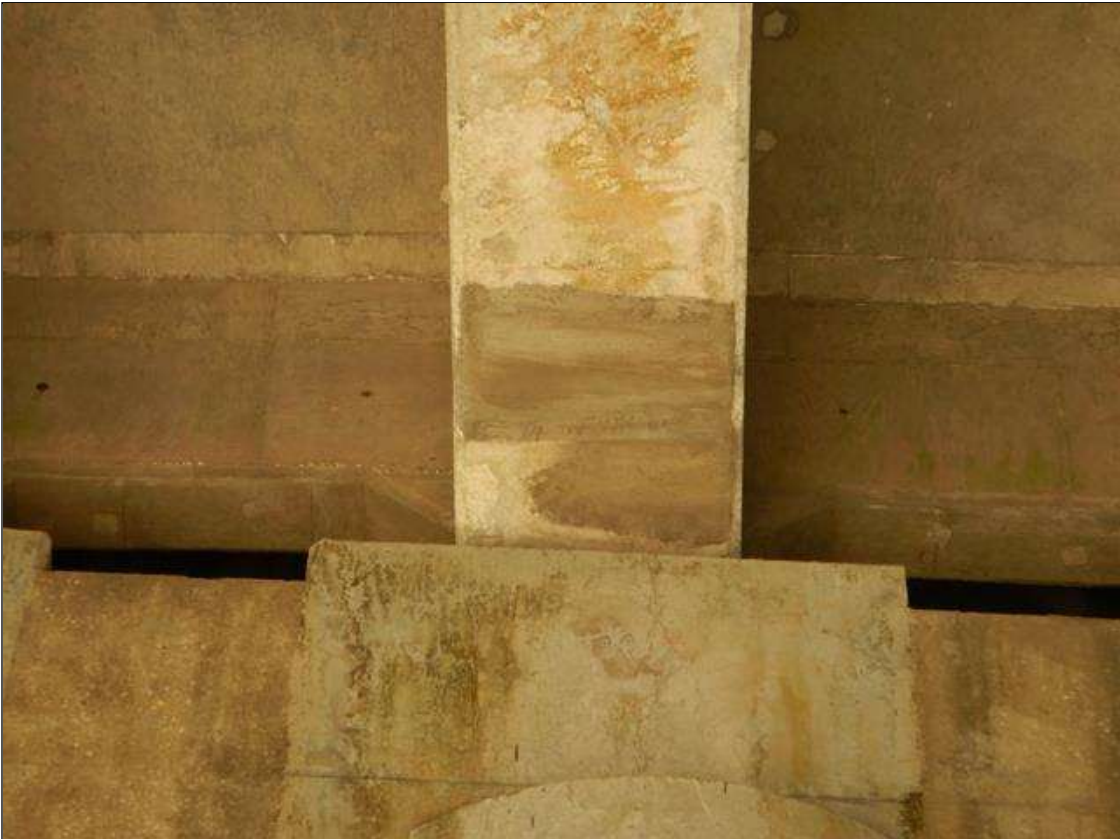
Span 28 Beam 9: [NEW REPAIR-PATCHING] FORMERLY --> multiple spalls with exposed rebar and sound patches on the bottom face up to (13" x 6" x 1/2")

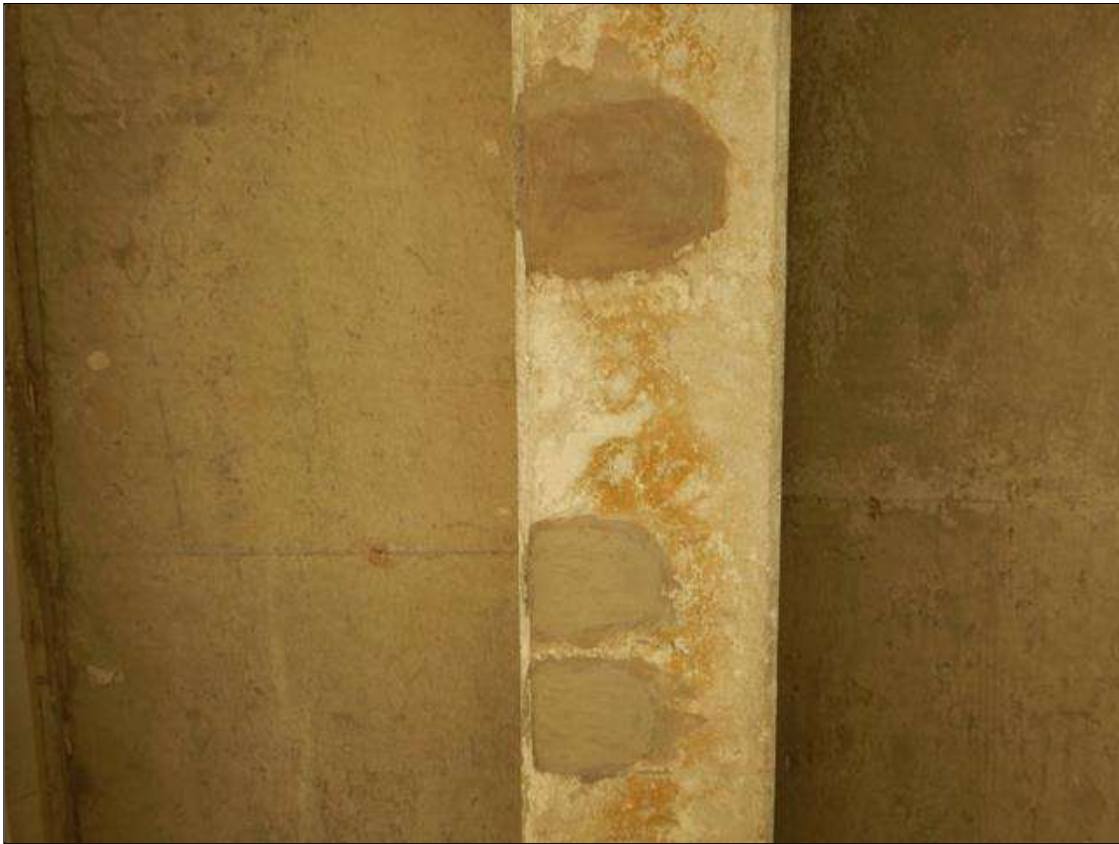
Span 28 Beam 10: [NEW REPAIR-PATCHING] FORMERLY --> spall with exposed rebar on the bottom face at bent 25 (6" x 4" x 1/2")

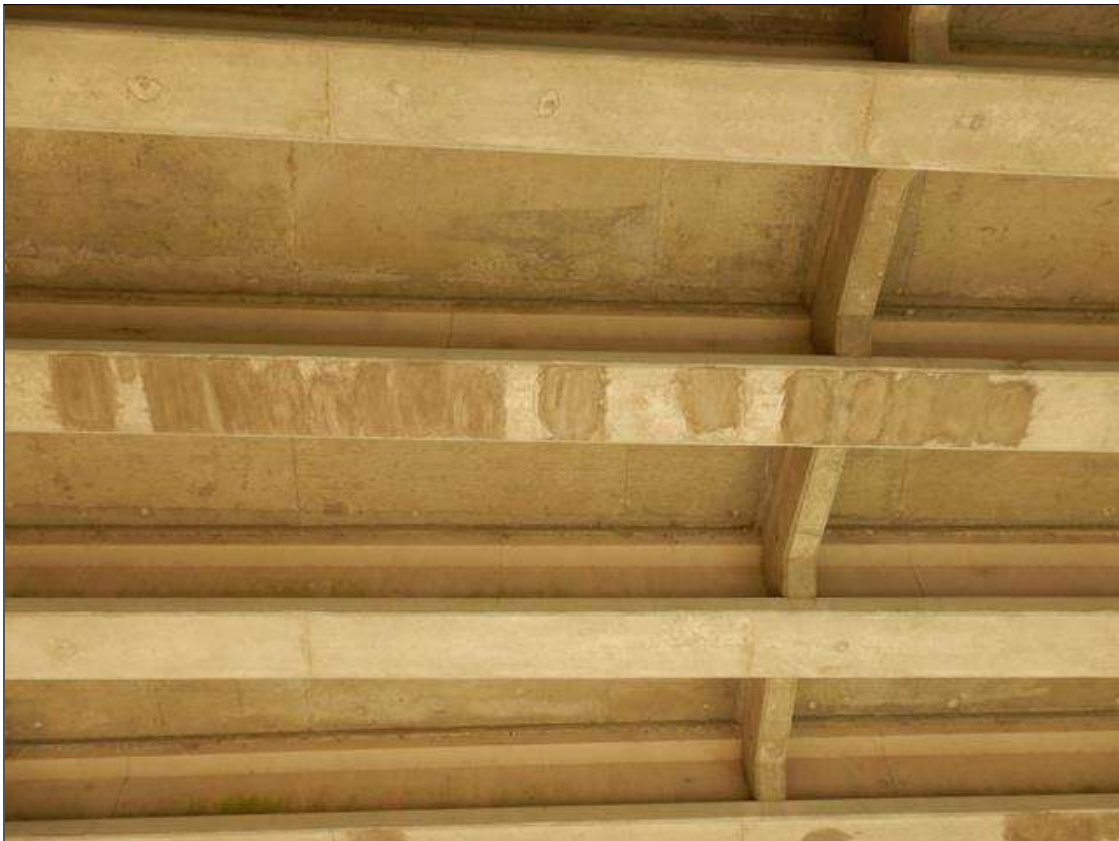
Span 28 Beam 10: [NEW REPAIR-PATCHING] FORMERLY --> (x3) spalls with exposed rebar on the bottom face at 12ft from Bent 25 up to (5" x 5" x 1/2")

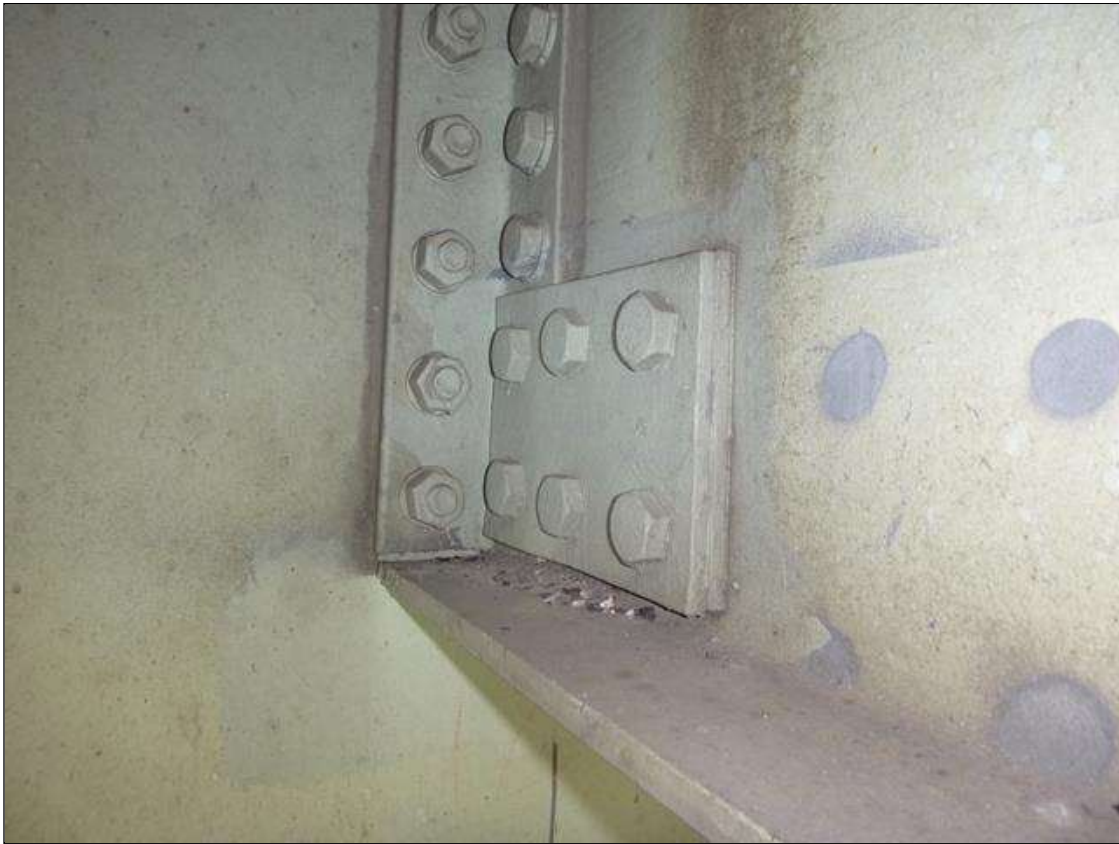
Span 18 Lift Span Stringer 12: BETWEEN FB's 7-8 - NEW REPAIR (2) 9.5" X 7" X 3/8" PLATES ON BOTH SIDES OF THE WEB AT FLOORBEAM 8, 2020 INSPECTION HAD - 5/8" HOLE IN WEB AT BOTTOM FLANGE AT FB 8 CONNECTION WIDE/ 8"HIGH x 3"WIDE PITTED AREA - CLEANED AND PAINTED - PROMPT ACTION REQUEST

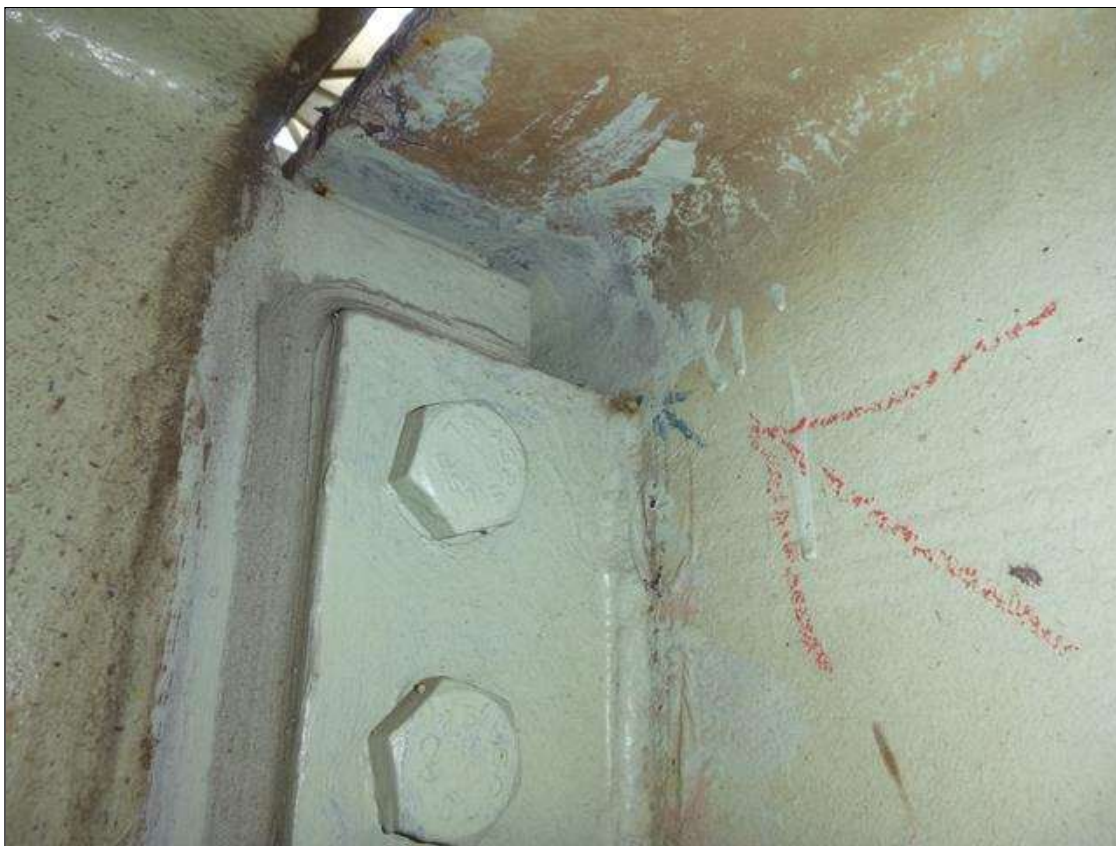
Span 18 Lift Span Stringer 12: BETWEEN FB's 7-8 - NEW REPAIR (2) 9.5" X 7" X 3/8" PLATES ON BOTH SIDES OF THE WEB AT FLOORBEAM 8, 2020 INSPECTION HAD - 5/8" HOLE IN WEB AT BOTTOM FLANGE AT FB 8 CONNECTION WIDE/ 8"HIGH x 3"WIDE PITTED AREA - CLEANED AND PAINTED - PROMPT ACTION REQUEST

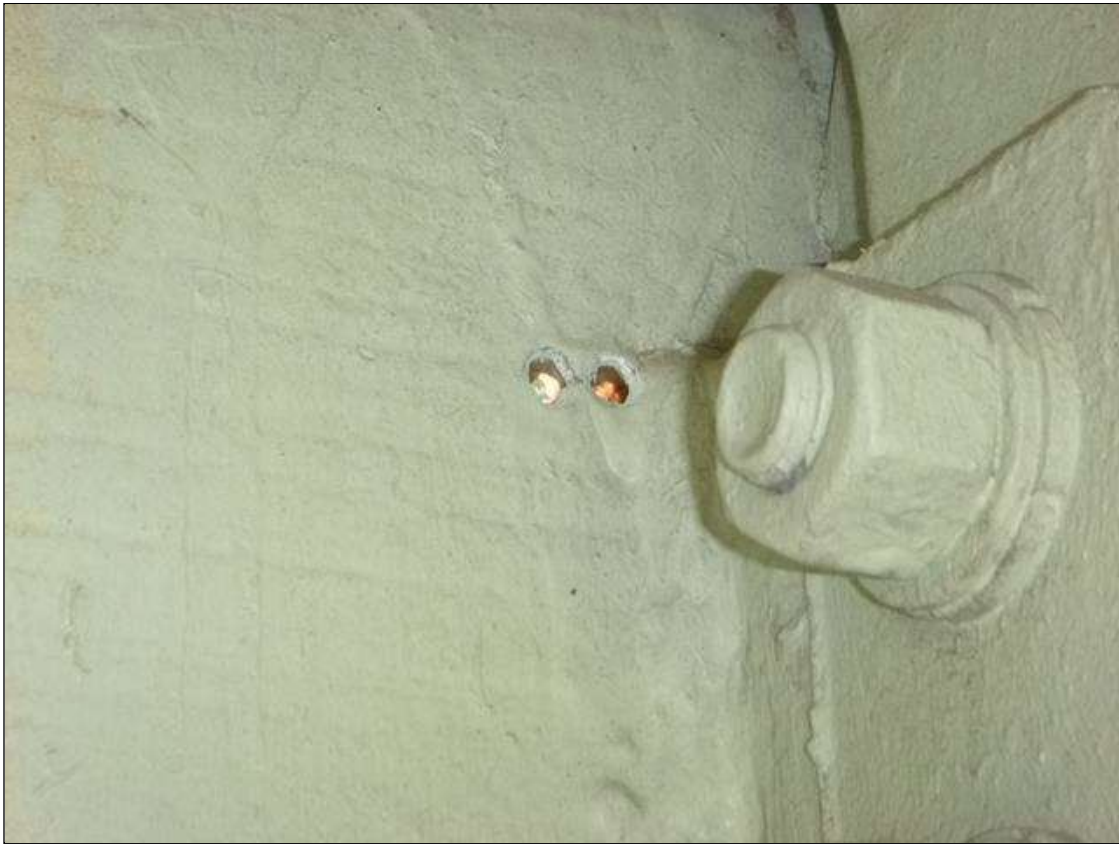
Span 18 Lift Span Stringer 8: REPAIR OBSERVED IN 2020 INSP: CRACKS NOT VISIBLE, AREA HAS BEEN PAINTED OVER. 2018 REPORT HAD BETWEEN FB's 8-9 - 1" CRACK IN WEB ACROSS TOP OF DIAPHRAGM CONNECTION, WIDE/ (2) 3/4" CRACKS IN CONNECTION WELD AT TOP

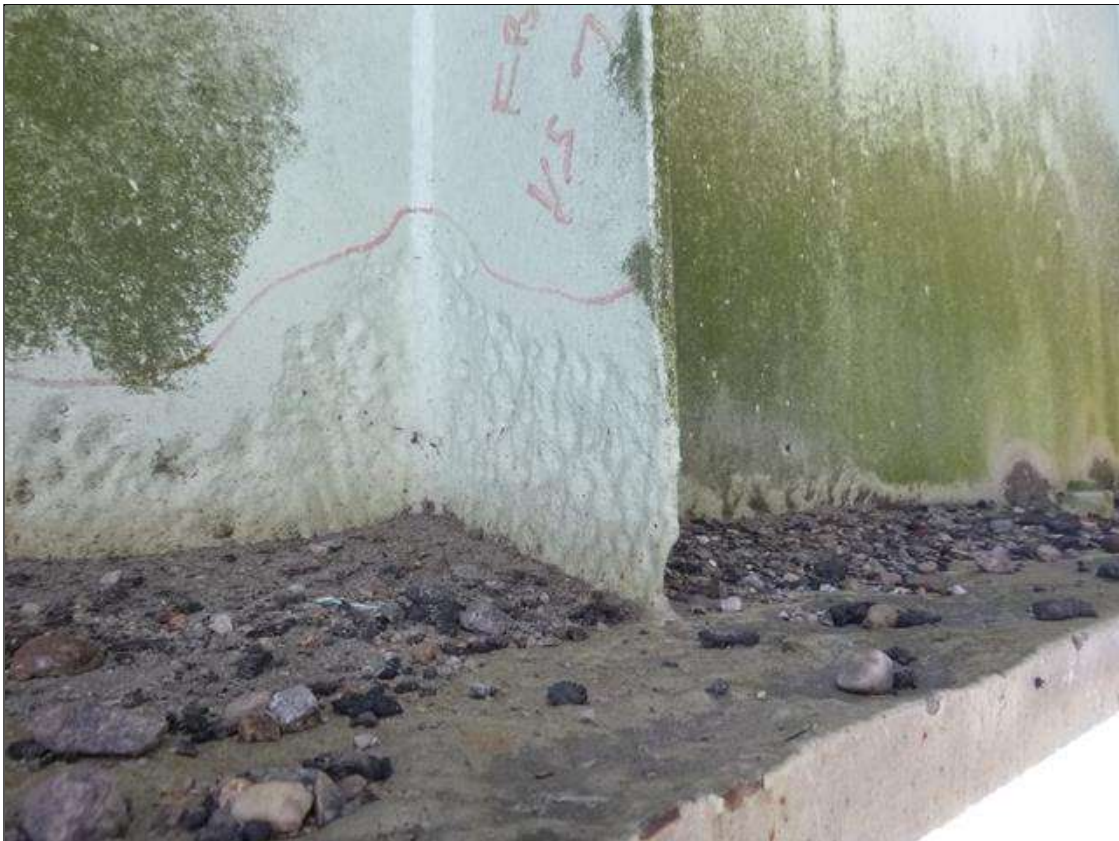
Span 18 Lift Span Stringer 11: BETWEEN FB's 8-9 - ARRESTED CRACK IN WEB AT TOP OF DIAPHRAGM CONNECTION

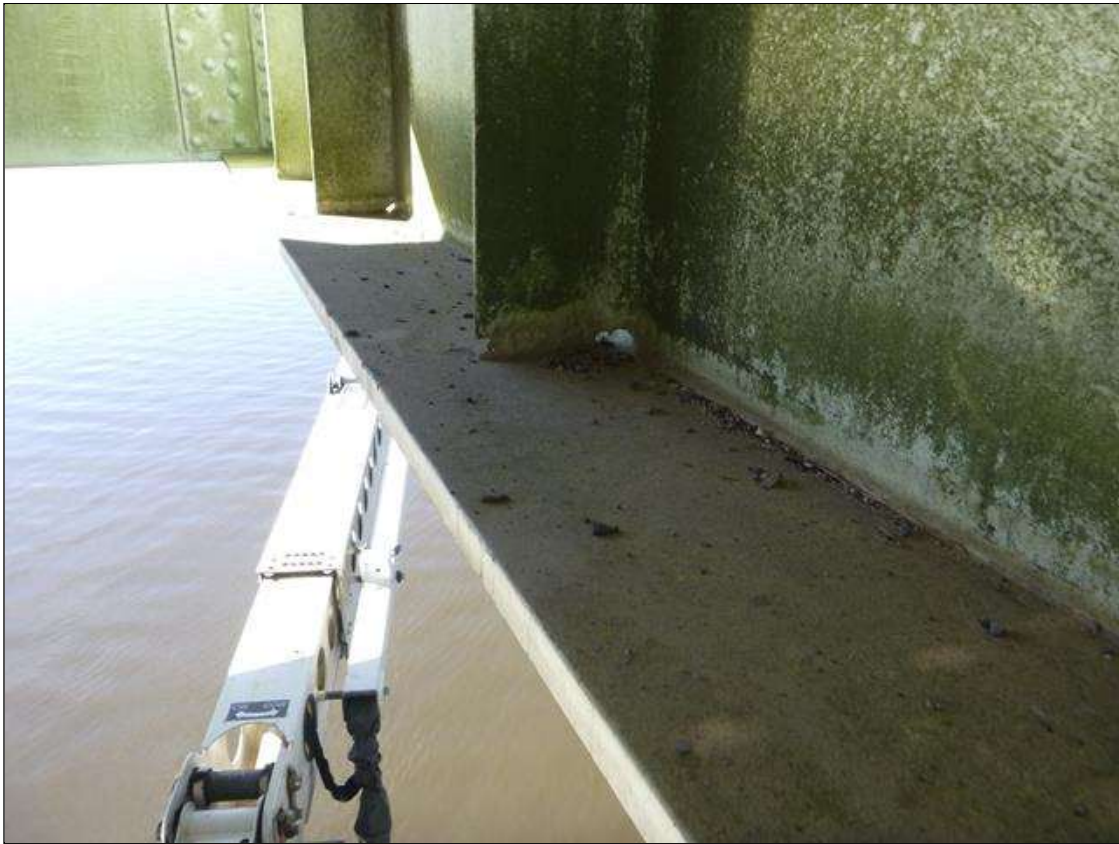
Span 18 Lift Span Floor Beam 9: NEW REPAIR OBSERVED IN 2021 INSPECTION (6) NEW BOLTS AT CENTER BOTTOM LATERAL CONNECTION, 2020 INSPECTION REPORT - CENTER BOTTOM LATERAL GUSSET - 30% - 90% LOSS TO (8) FASTENERS AT BOTTOM FLANGE ON EAST SIDE - CLEANED AND PAINTED

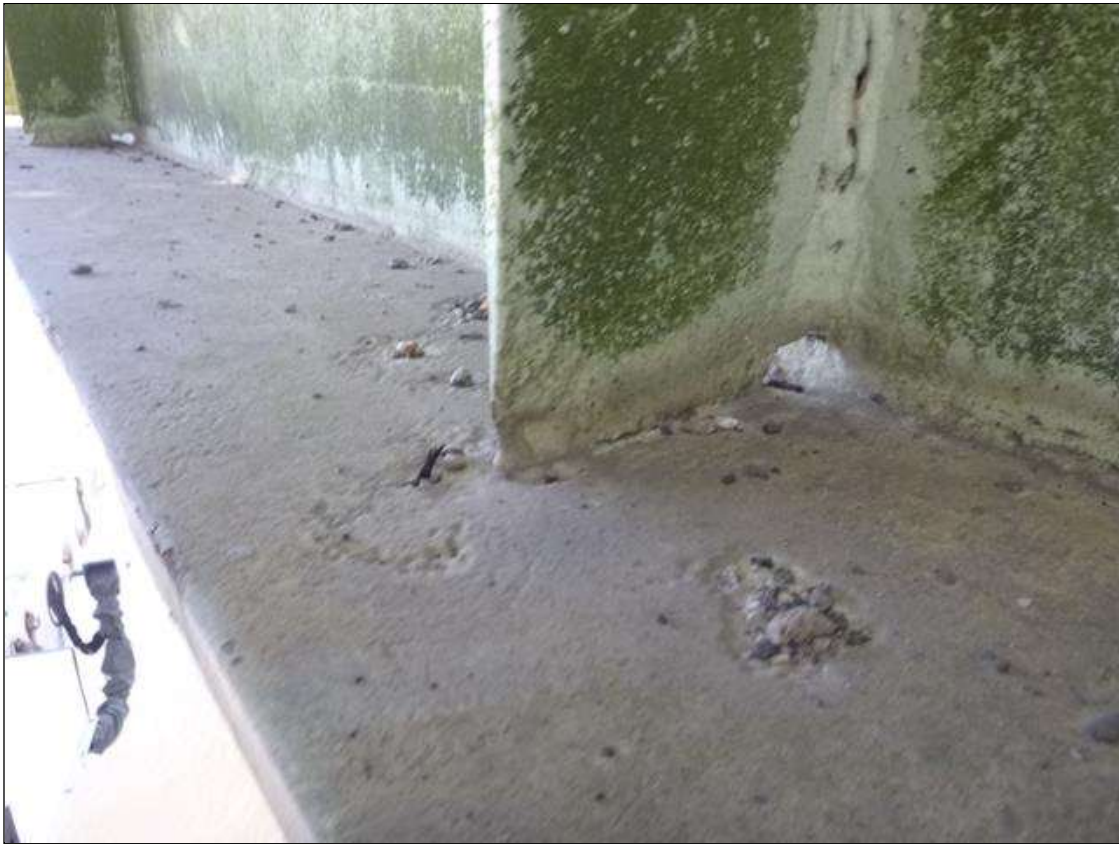
Span 18 Lift Span Floor Beam 9: VERTICAL STIFFENER 12 AND 13 ON EAST SIDE - 4" HIGH PITTED AREA AT BOTTOM FLANGE - LOWER 1" OF AREA REDUCED TO 1/16" WIDE/ ~3/4" HOLES AT EDGES - AREA CLEANED AND PAINTED
