NC DEPARTMENT OF TRANSPORTATION
DIVISION OF HIGHWAYS
STRUCTURE MANAGEMENT UNIT

Structure Safety Report

Routine Element Inspection - Contract

DIVISION: 3 COUNTY: NEW HANOVER STRUCTURE NUMBER: 640013 FREQUENCY: 24 MONTHS

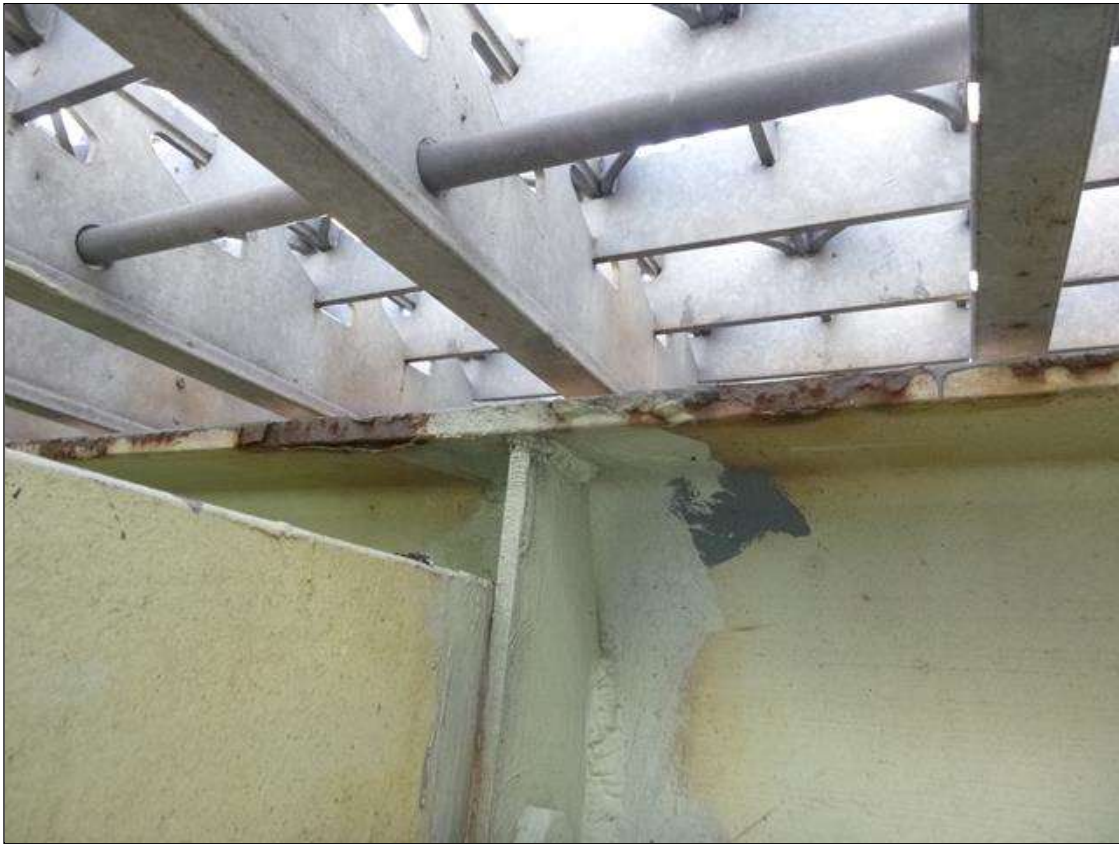
Span 18 Lift Span Floor Beam 9: VERTICAL STIFFENER 12 AND 13 ON EAST SIDE - 4" HIGH PITTED AREA AT BOTTOM FLANGE - LOWER 1" OF AREA REDUCED TO 1/16" WIDE/ ~3/4" HOLES AT EDGES - AREA CLEANED AND PAINTED

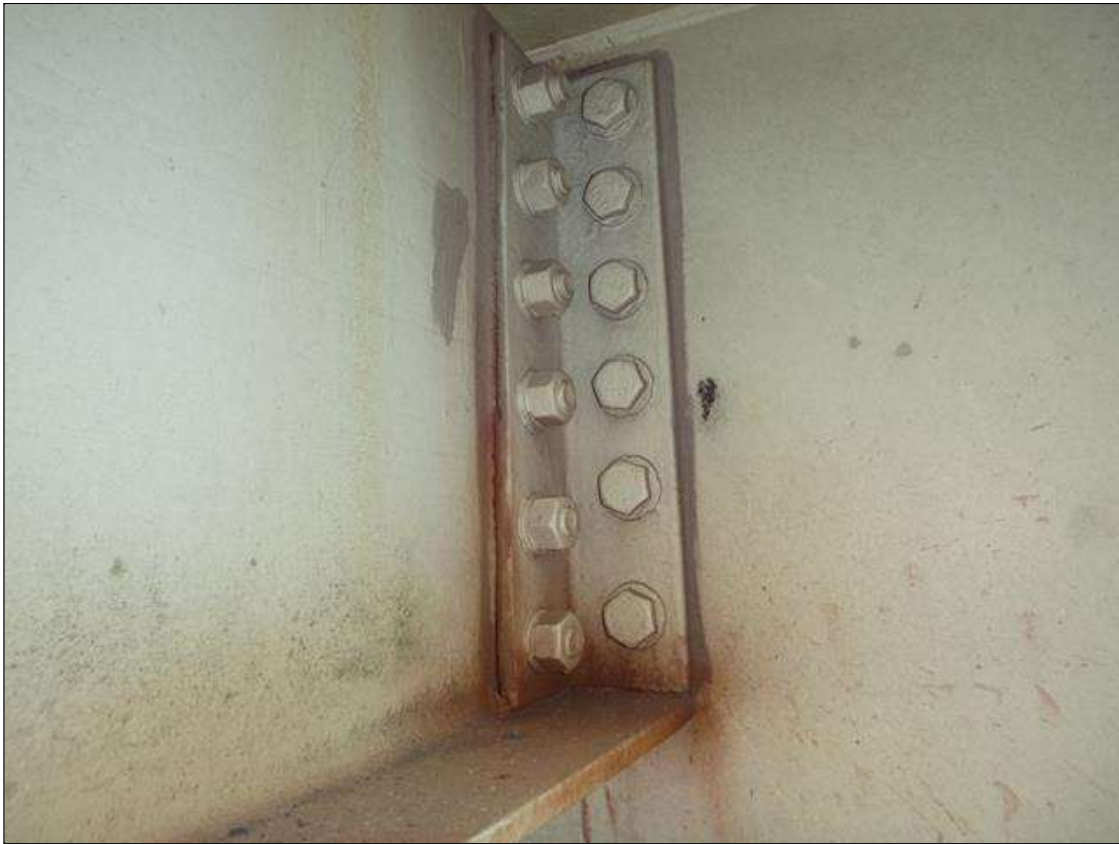
Span 18 Lift Span Stringer 10: BETWEEN FB's 9-10 - SLIGHT MOVEMENT UNDER LIVE LOAD AT FLOOR BEAM 10 - LOWER BOLTS AT STRINGER WEB CONNECTION ARE SECURE BUT NOT FULLY TIGHTENED - PROMPT ACTION REQUEST

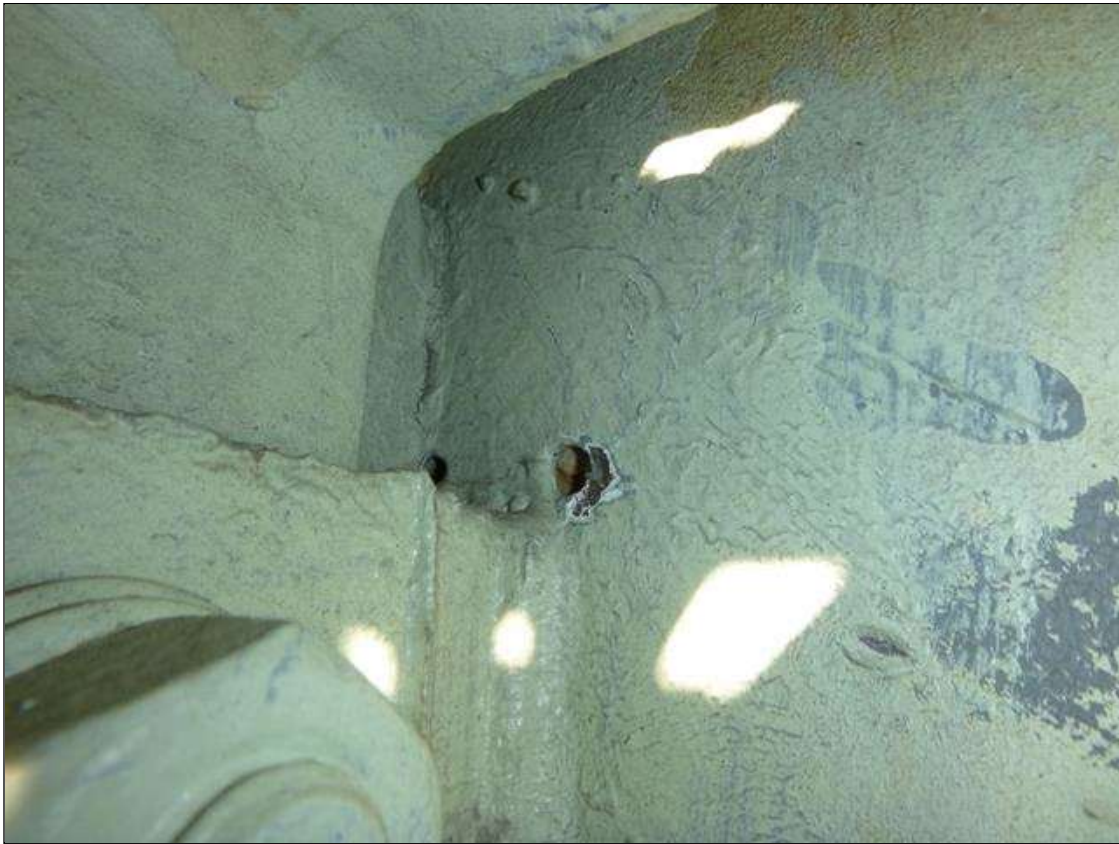
Span 18 Lift Span Stringer 9: BETWEEN FB's 9-10 - SLIGHT MOVEMENT UNDER LIVE LOAD AT FLOOR BEAM 10
- LOWER BOLTS AT STRINGER WEB CONNECTION ARE SECURE BUT NOT FULLY TIGHTENED - PROMPT
ACTION REQUEST

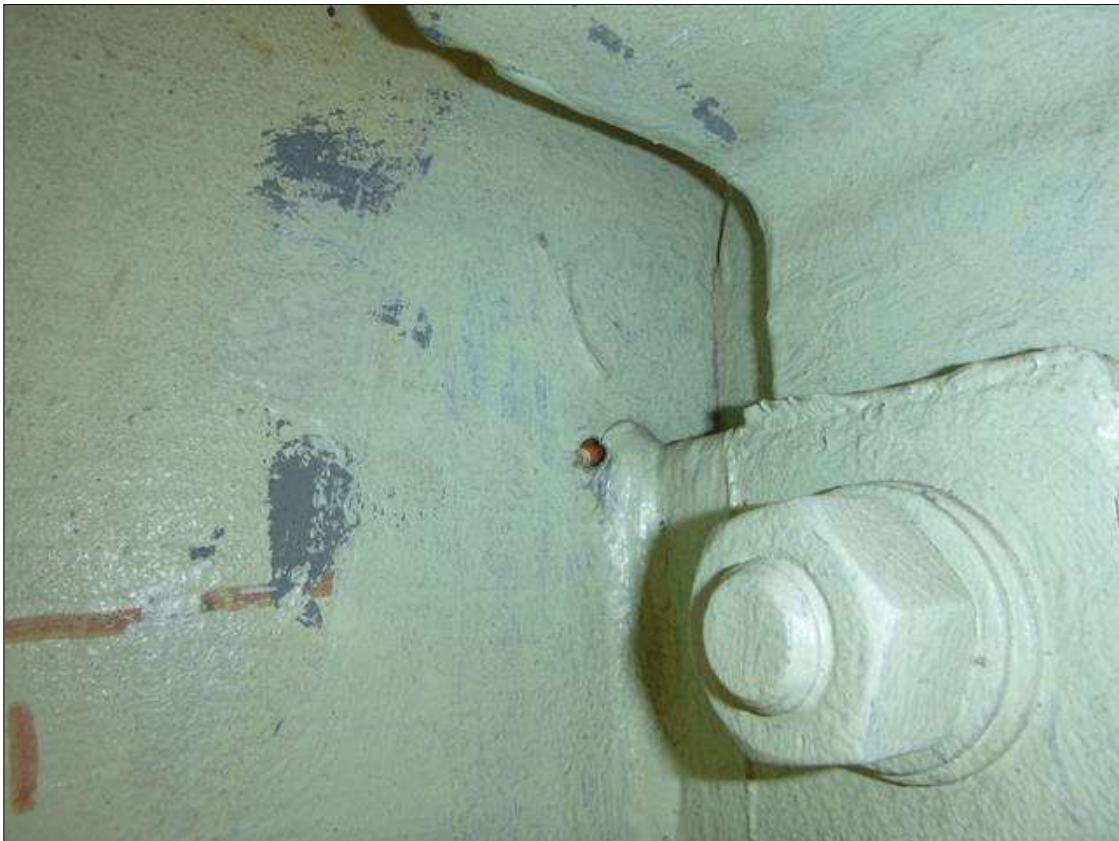
Span 18 Lift Span Stringer 10: BETWEEN FB's 9-10 - (2) CRACKS PROPAGATED PAST ARREST HOLE AT TOP OF DIAPHRAGM CONNECTION - (1) 1/8" AND (1) 1/4" – PROMPT ACTION REQUEST

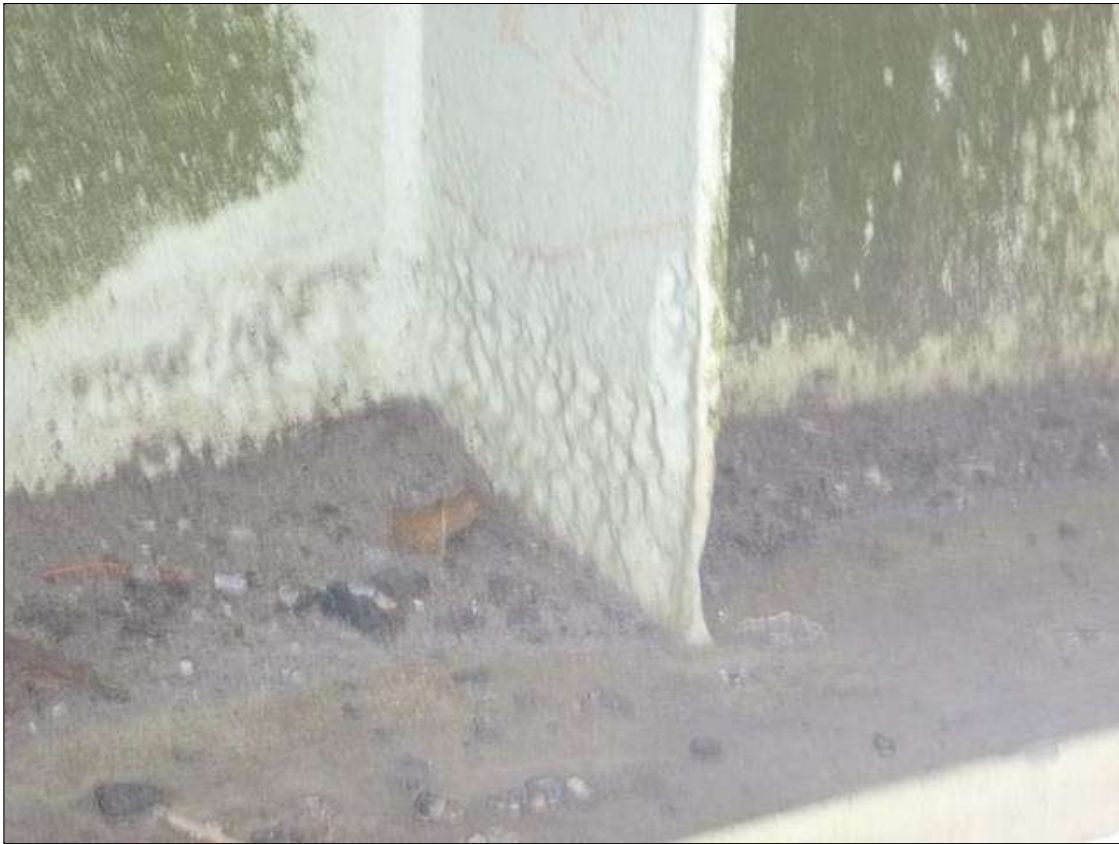
Span 18 Lift Span Stringer 11: OBSERVED IN 2020 INSP; BETWEEN FB's 9-10 - (1) 1/2" LONG CRACK PROPAGATING PAST ARREST HOLE AT TOP OF DIAPHRAGM CONNECTION, PAR ISSUED.

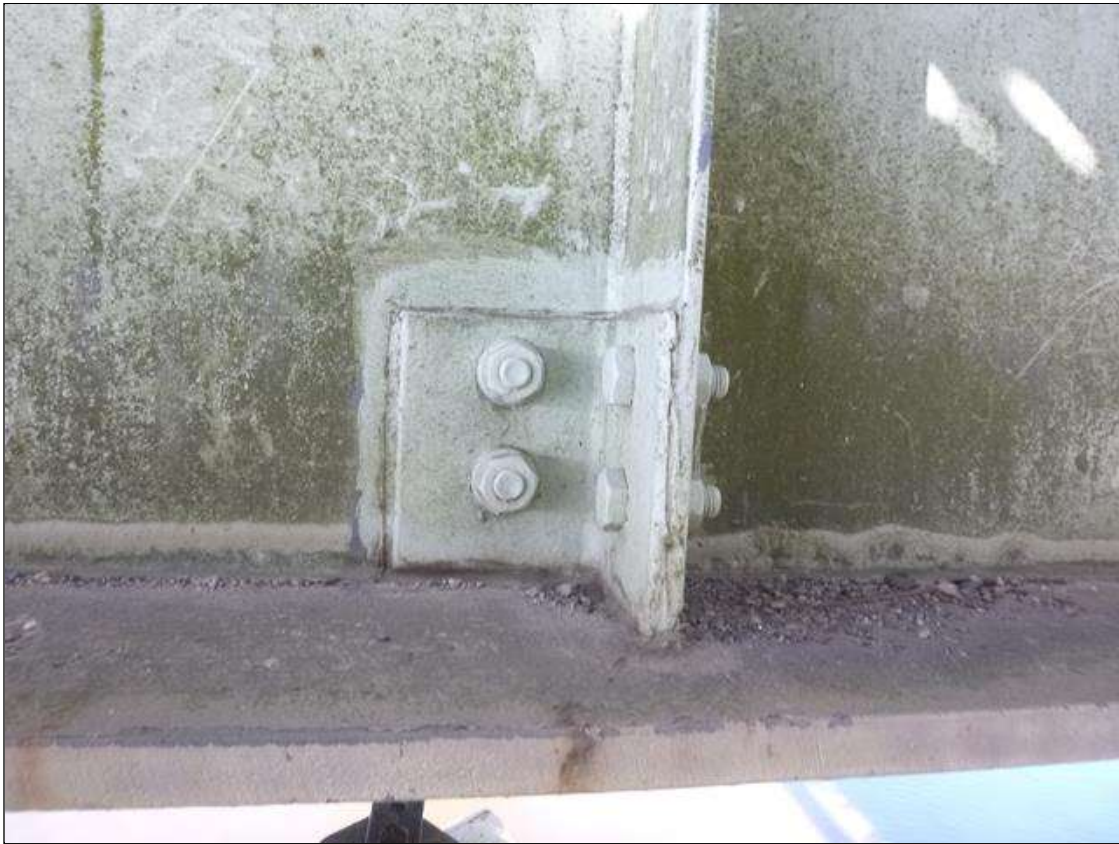
Span 18 Lift Span Floor Beam 10: VERTICAL STIFFENER 6 ON WEST SIDE - 2-1/2" HIGH PITTED AREA AT BOTTOM FLANGE - LOWER 1" OF AREA REDUCED TO 1/16" - CLEANED AND PAINTED

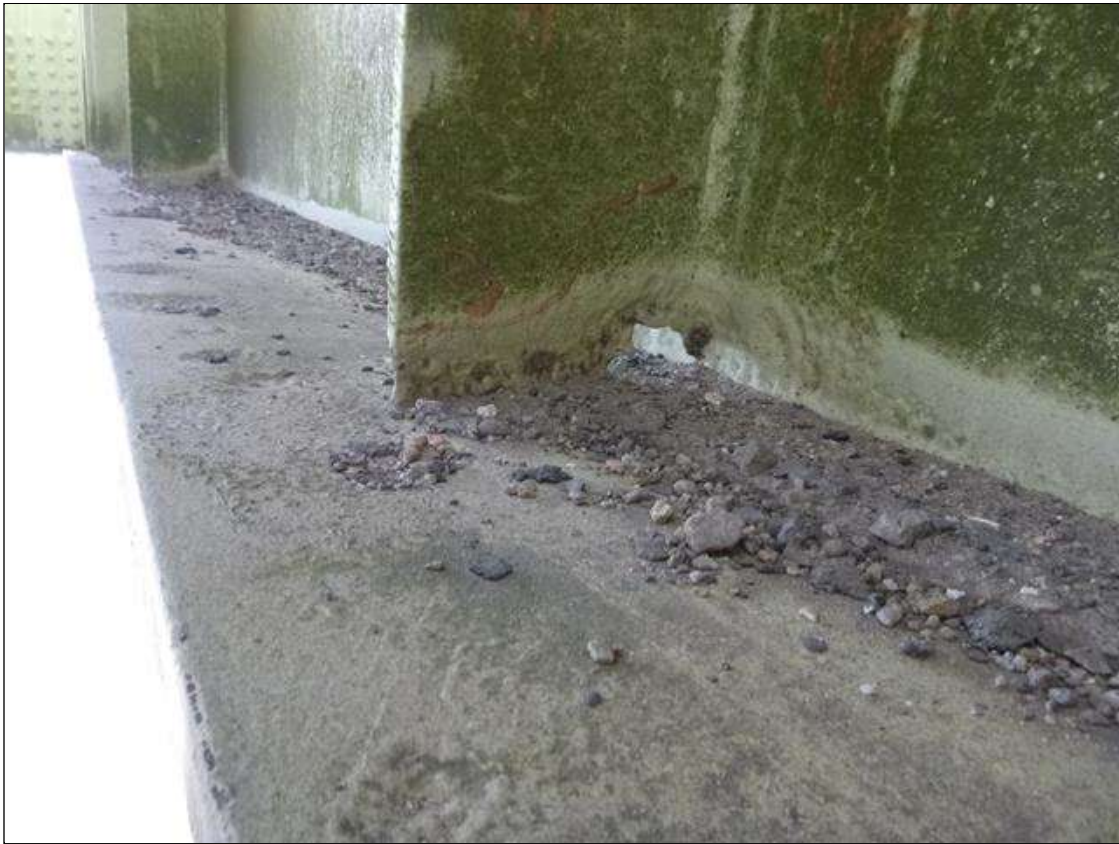
Span 18 Lift Span Floor Beam 10: FB 10, EAST SIDE, STIFFENER 9 HAS BEEN REPAIRED ADJACENT TO THE BOTTOM FLANGE, WITH A 6" X 6" X 7" HIGH X 1/2" THICK ANGLE BOLTED TO THE STIFFENER AND WEB ON THE SOUTH SIDE OF THE WEST AND EAST FACES.

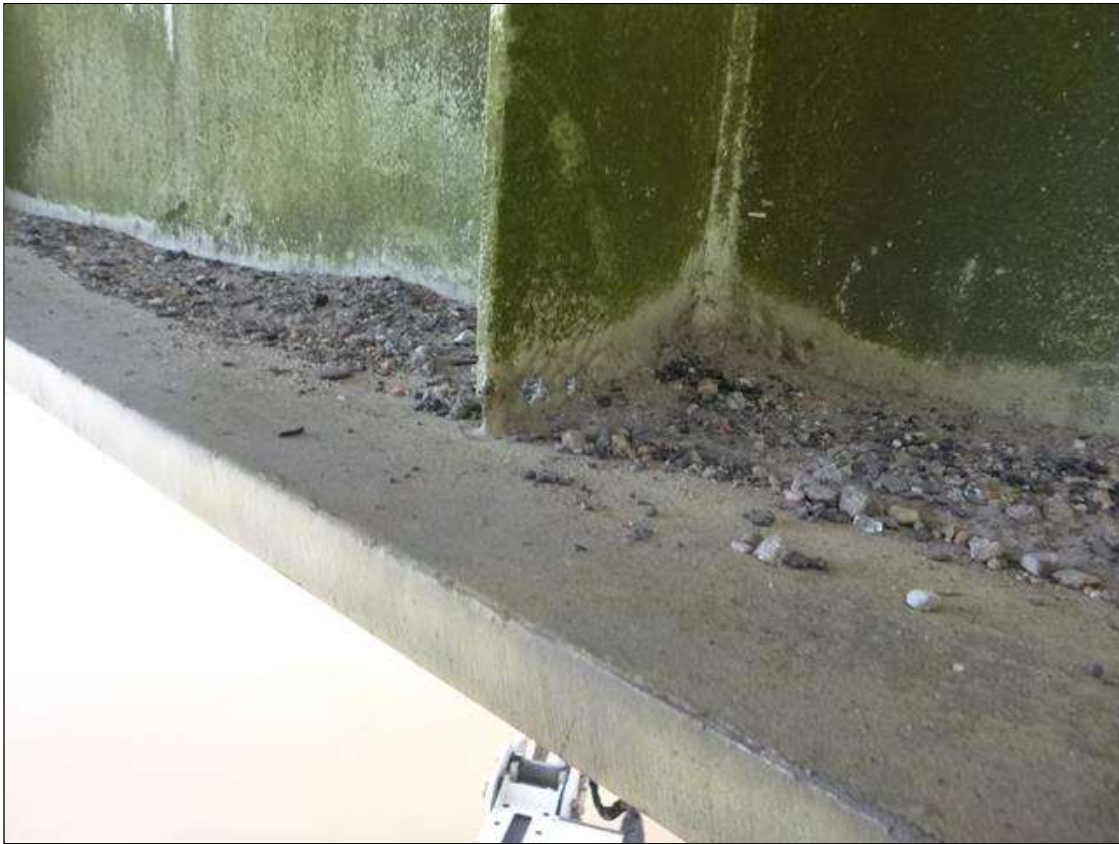
Span 18 Lift Span Floor Beam 10: OBSERVED IN 2020 INSP: VERTICAL STIFFENER 11 EAST SIDE - 4" HIGH PITTED AREA AT BOTTOM FLANGE WIDE/ 1-1/2" DIAMETER HOLE AT WEB - 1/16" TO 1/8" REMAINING SECTION IN LOWER 1" OF AREA, PAR ISSUED.

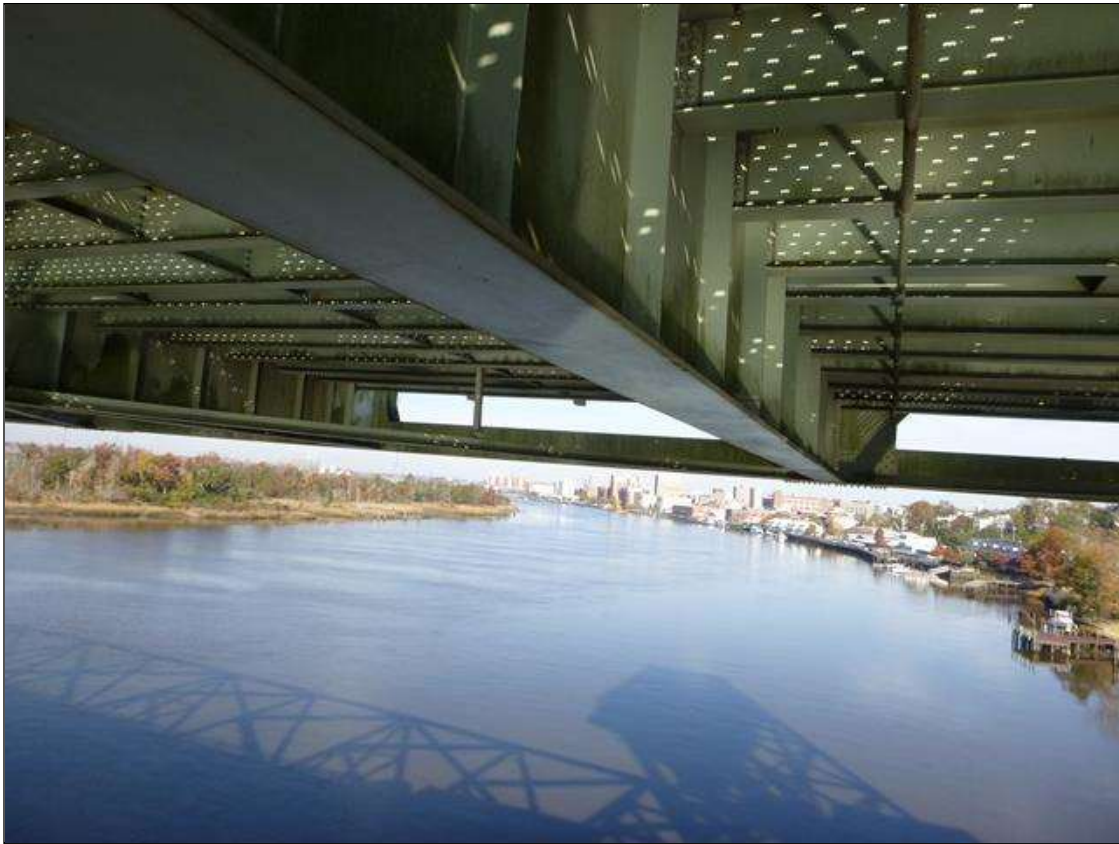
Span 18 Lift Span Floor Beam 10: (PAR) VERTICAL STIFFENER 12 EAST SIDE - 4" HIGH PITTED AREA AT BOTTOM FLANGE WIDE/ (3) HOLES FROM 1/4" TO 1/2" IN DIAMETER - 1/16" TO 1/8" REMAINING SECTION IN LOWER 1" OF AREA

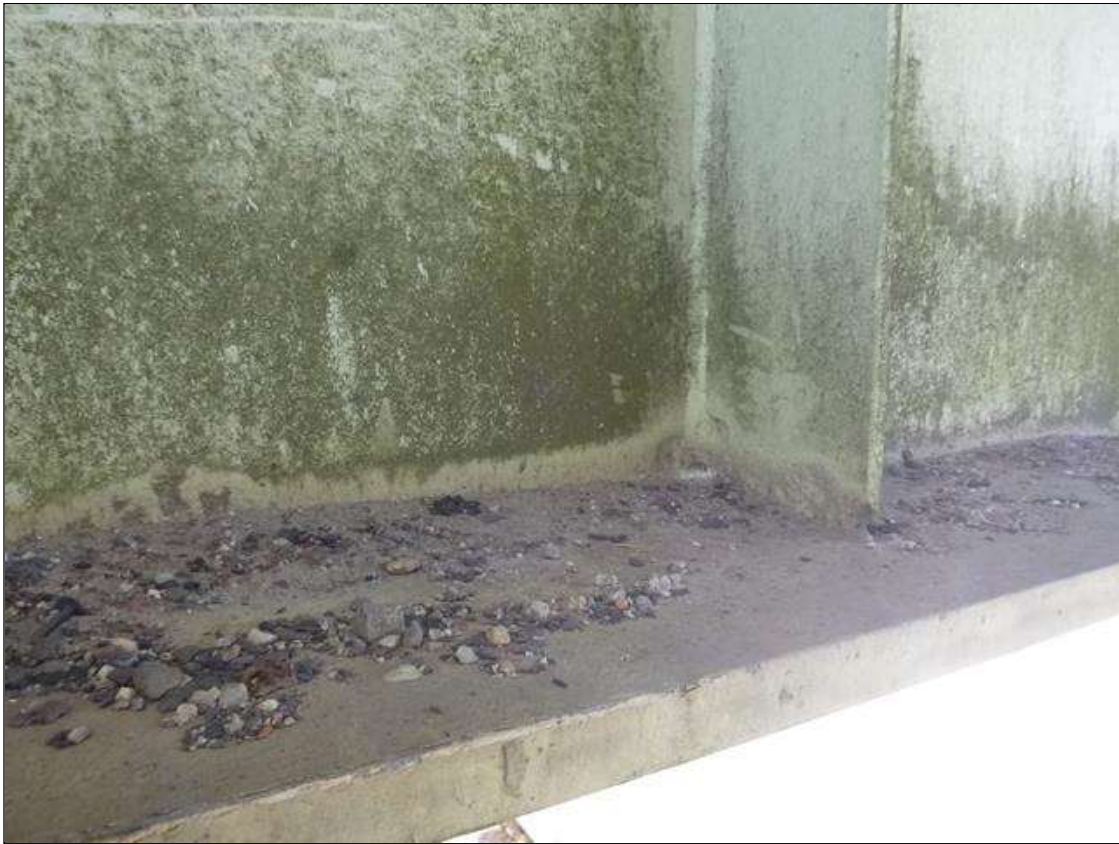
Span 18 Lift Span Floor Beam 10: 2021 INSPECTION THERE IS NO CENTER GUSSET PLATE 2020 INSPECTION HAD BOTTOM FLANGE HAS PITTED AREAS AROUND BOTH SIDES OF CENTER GUSSET PLATE, .25"DEEP X 2"WIDE X FULL WIDTH OF BOTTOM FLANGE.

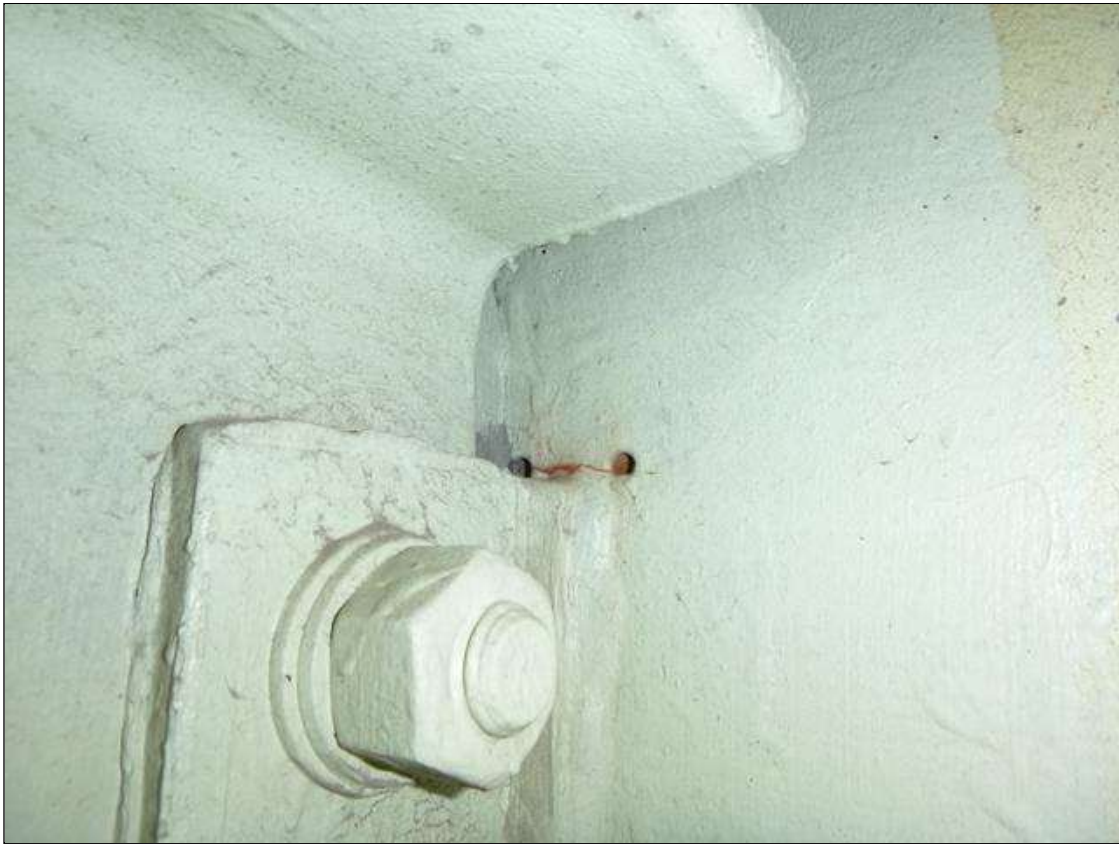
Span 18 Lift Span Floor Beam 10: VERTICAL STIFFENER 12 WEST SIDE - 2" HIGH PITTED AREA AT BOTTOM FLANGE WIDE/ 1/2" DIAMETER HOLES AT EDGES - 1/16" TO 1/8" REMAINING SECTION IN LOWER 1" OF AREA - PROMPT ACTION REQUEST

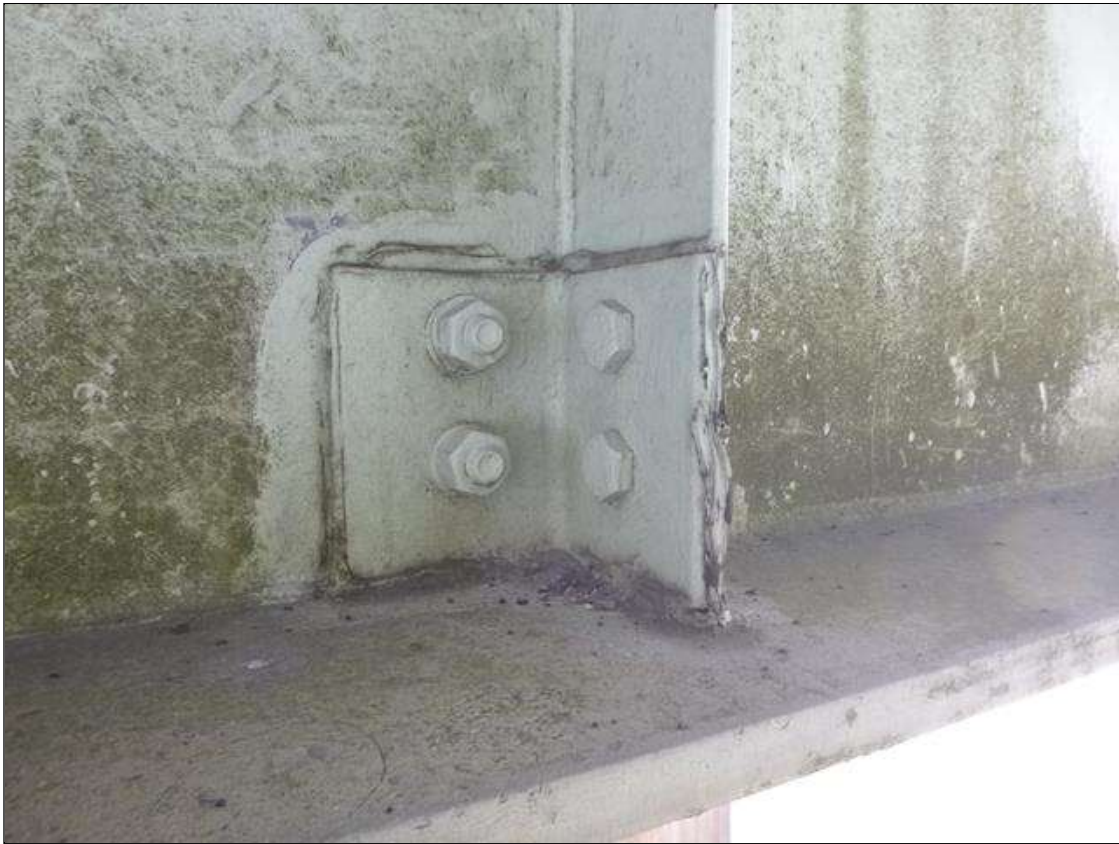
Span 18 Lift Span Floor Beam 11: VERTICAL STIFFENER 12 WEST - PITTED AREA AT BOTTOM FLANGE OF FLOOR BEAM UP TO 3" HIGH WIDE/ 2" LONG x 1/2" HIGH HOLE AT WEB - 1/16" TO 1/8" REMAINING SECTION IN LOWER 1/2" OF AREA - CLEANED AND PAINTED - PROMPT ACTION REQUEST

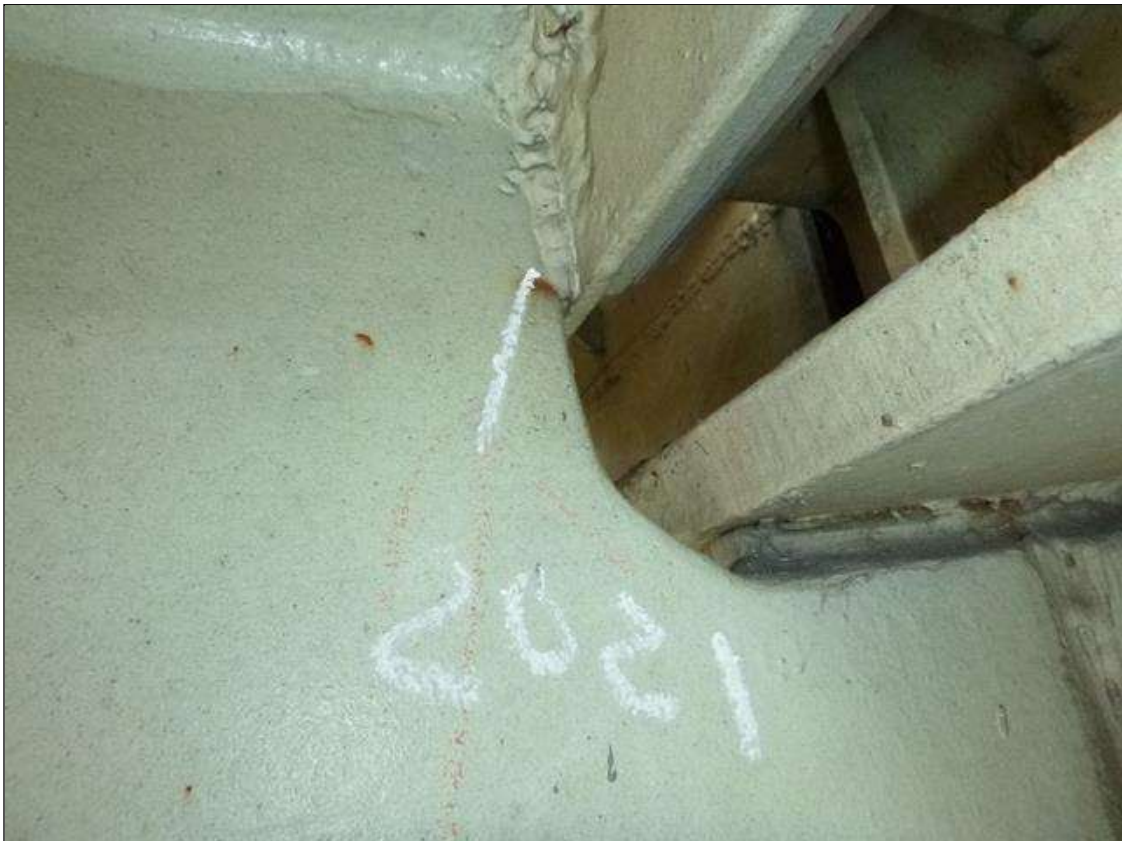
Span 18 Lift Span Stringer 8: BETWEEN FB's 11-12 - CRACK PROPAGATED 1/4" PAST EAST ARREST HOLE AT TOP OF DIAPHRAGM CONNECTION – PROMPT ACTION REQUEST

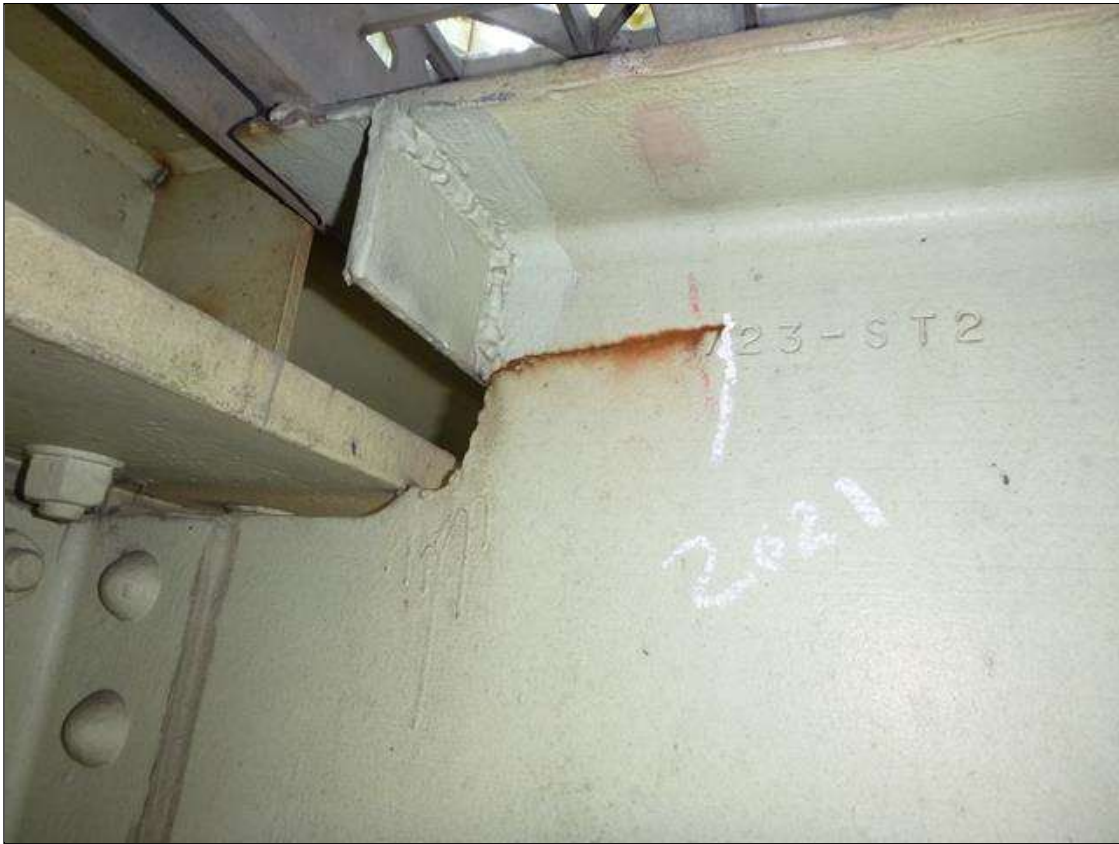
Span 18 Lift Span Stringer 8: LONGITUDINAL CRACK, 1/2" LONG IN THE TOP OF THE WEB AT FB 12, PAR ISSUED.

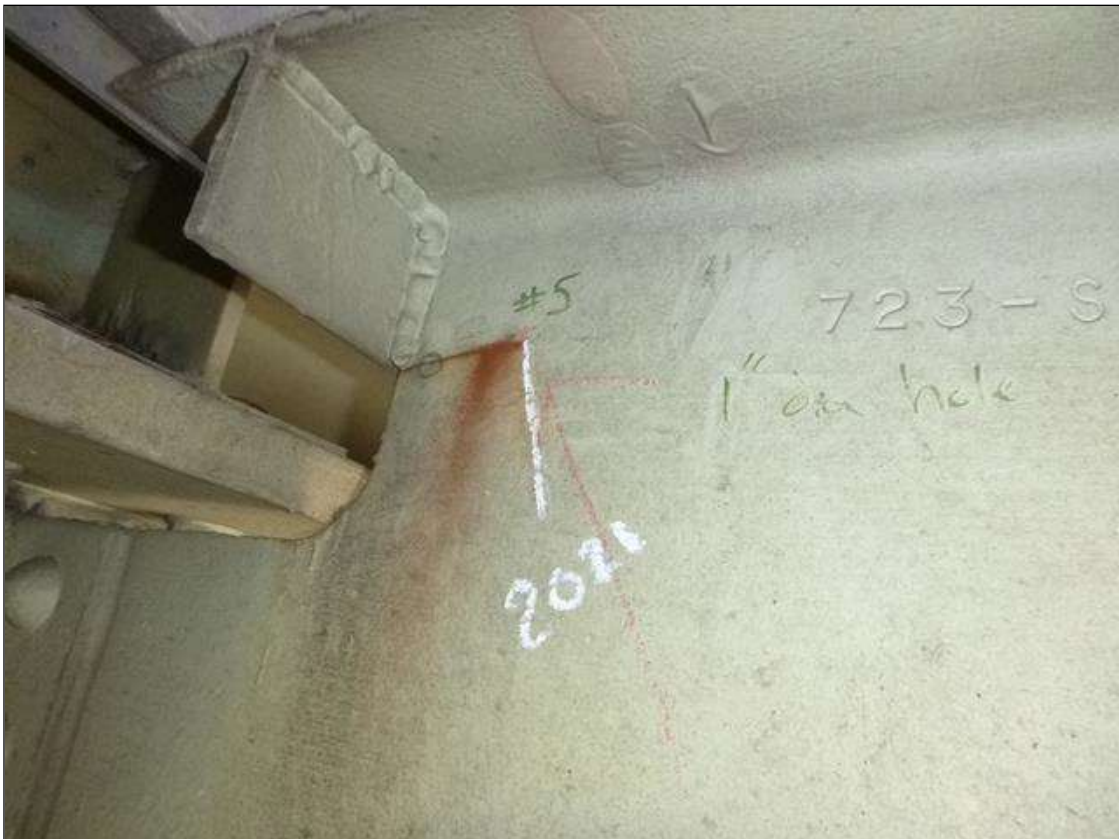
Span 18 Lift Span Stringer 9: LONGITUDINAL CRACK, 5" LONG IN THE TOP OF THE WEB AT FB 12, PAR ISSUED.

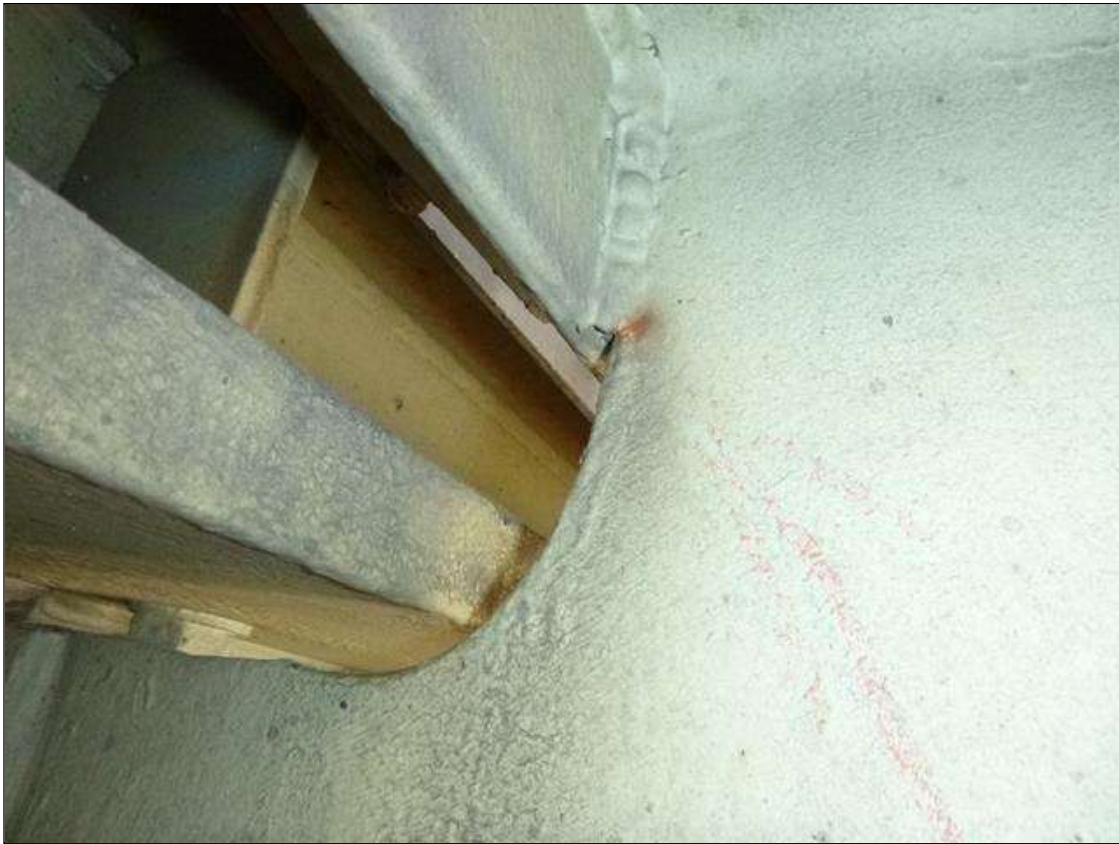
Span 18 Lift Span Stringer 12: LONGITUDINAL CRACK, 2.5" LONG IN THE TOP OF THE WEB AT FB 12, PAR ISSUED.

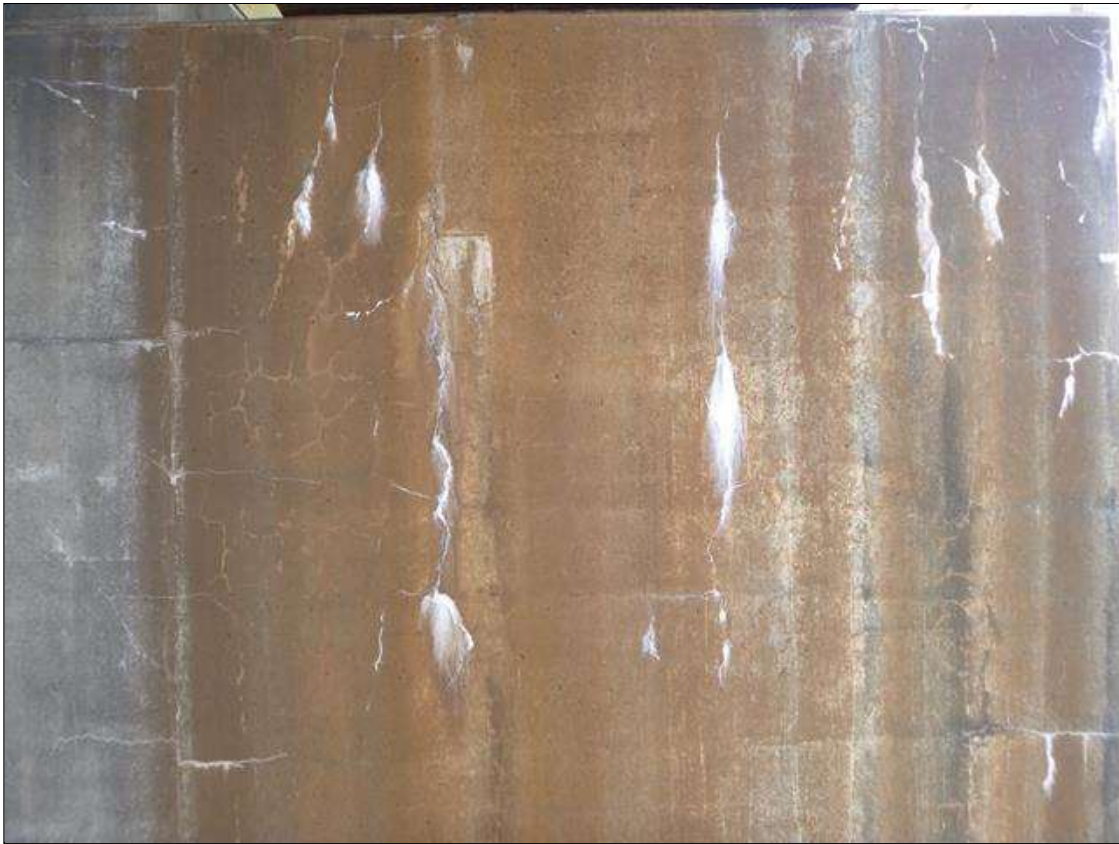
Bent 17 - Lift Span Bent Cap 1: 1/2" WIDE HORIZONTAL CRACK ALONG TOP EDGE OF WEST FACE AT SOUTH END - VISIBLE FROM TRUSS PANEL 2 BEARING

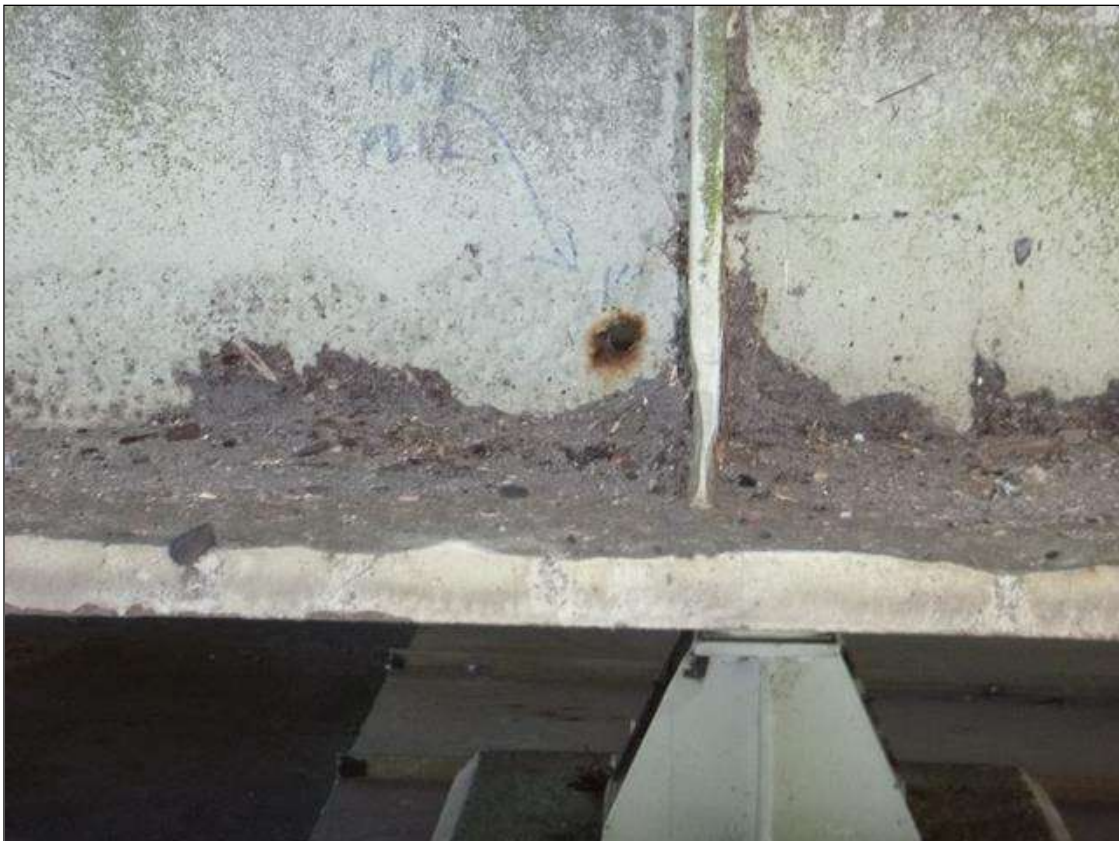
Span 18 Lift Span Floor Beam 12: 1" HOLE IN WEB AT BOTTOM FLANGE BETWEEN STRINGERS 4 & 5 - PROMPT ACTION REQUEST

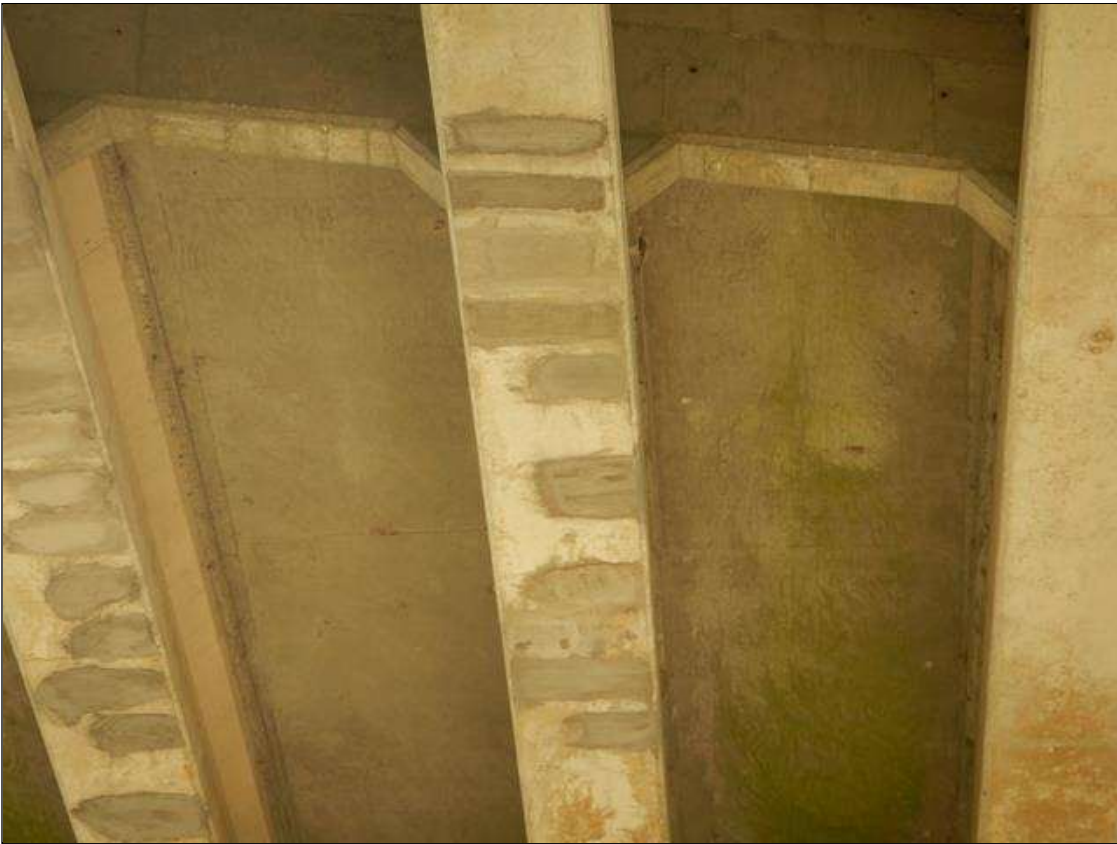
Span 27 Beam 13: [NEW REPAIR-PATCHING] FORMERLY --> (x12) DELAMINATION areas on the bottom face at 10f from bent 24 up to (18" x 1 1/2" x 1/4")

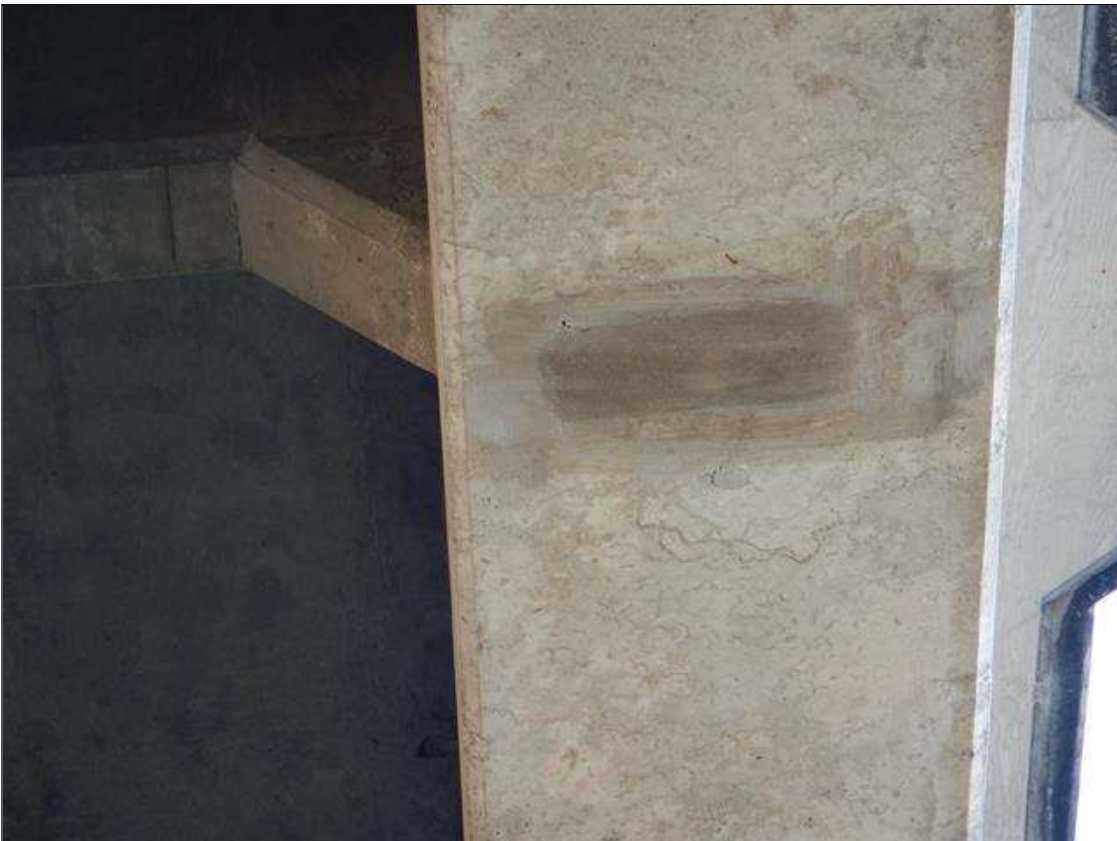
Span 30 Beam 1: [NEW REPAIR-PATCHING] FORMERLY --> spall with exposed rebar on the bottom face at 22ft from bent 28 (9" x 4" x 1/2")

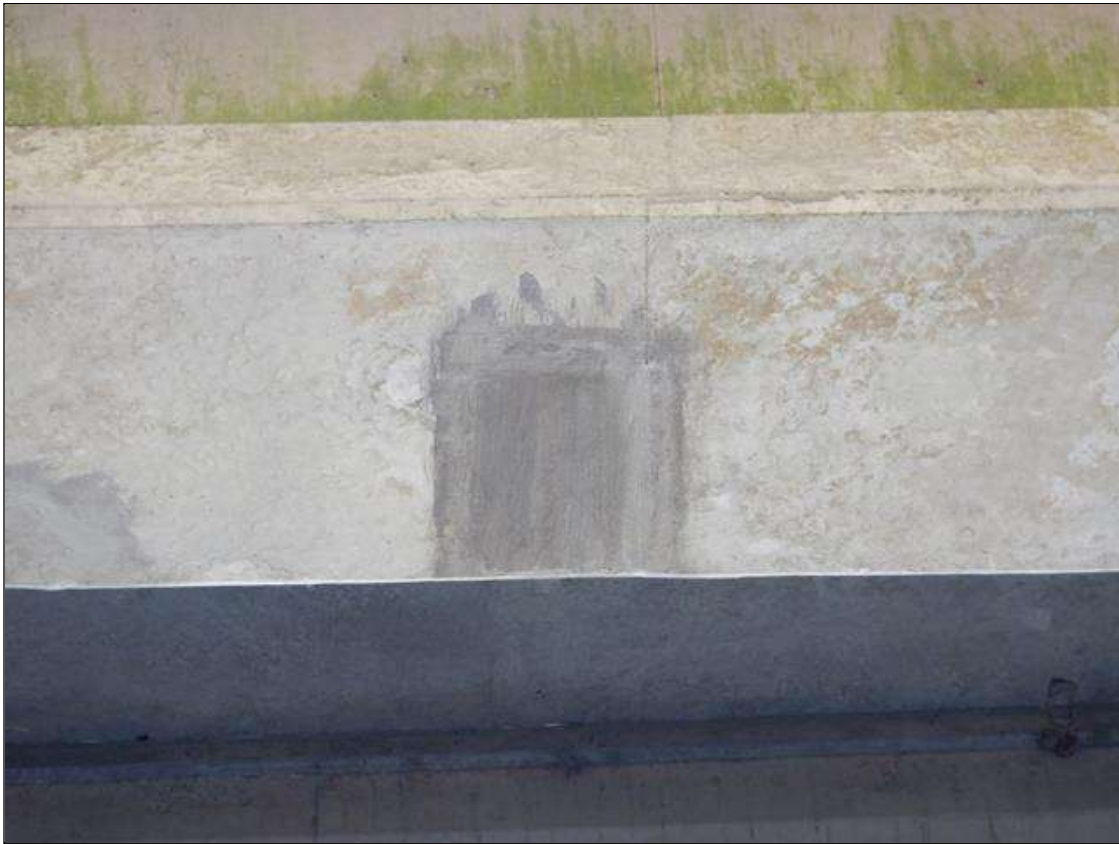
Span 30 Beam 2: [NEW REPAIR-PATCHING] FORMERLY --> spall with exposed rebar on the bottom left face at 16ft from bent 27 (7" x 2" x 1 1/2")

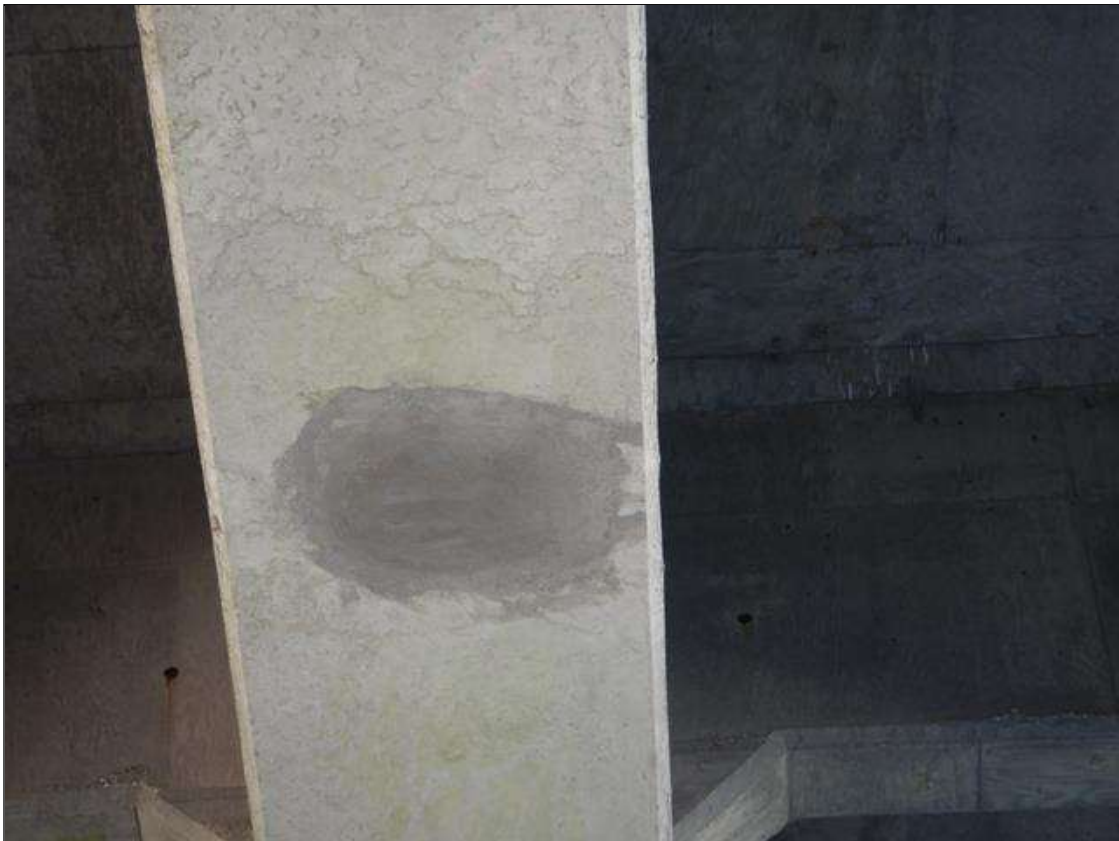
Span 30 Beam 3: [NEW REPAIR-PATCHING] FORMERLY --> spall with exposed rebar on the bottom face at 18ft from bent 27 (11" x 10" x 1/4")

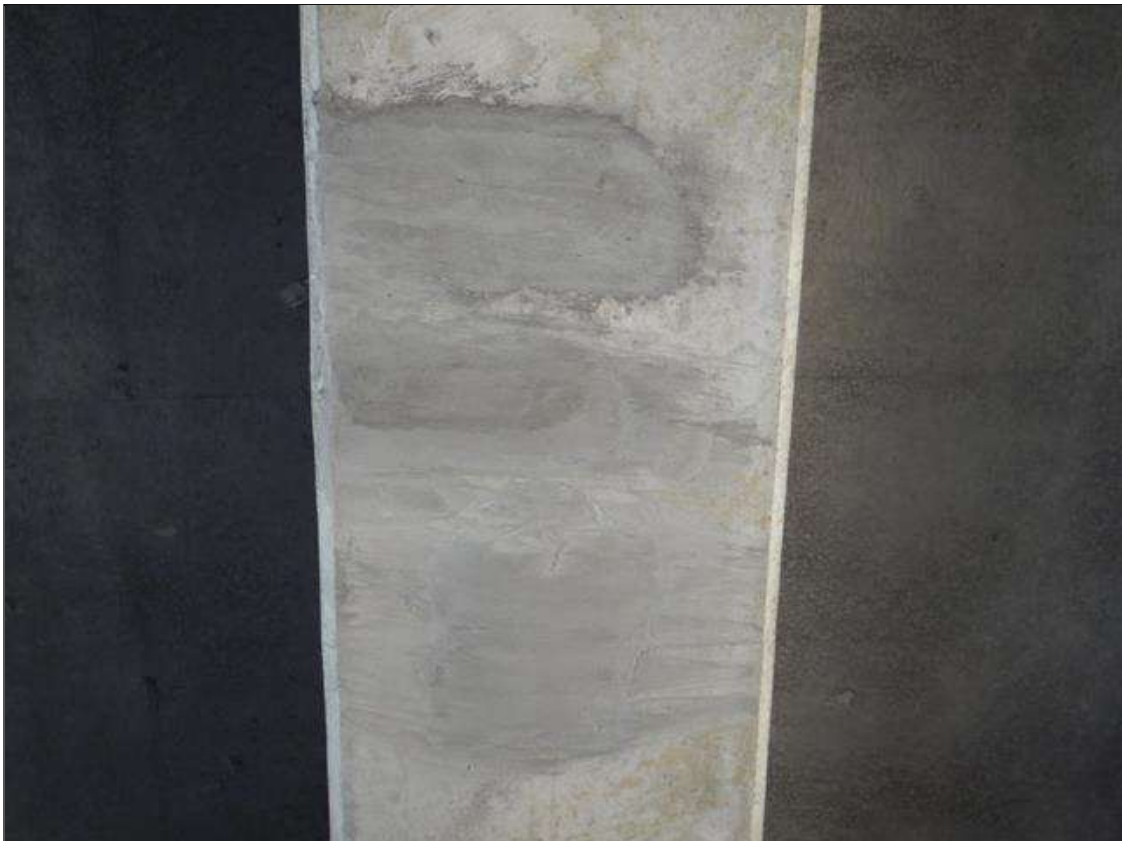
Span 30 Beam 4: [NEW REPAIR-PATCHING] FORMERLY --> Spall with exposed rebar in bottom of girder, approximately 32' from face of Bent 27 Cap
