NC DEPARTMENT OF TRANSPORTATION
DIVISION OF HIGHWAYS
STRUCTURE MANAGEMENT UNIT

Structure Safety Report

Routine Element Inspection - Contract

DIVISION: 3 COUNTY: NEW HANOVER STRUCTURE NUMBER: 640013 FREQUENCY: 24 MONTHS

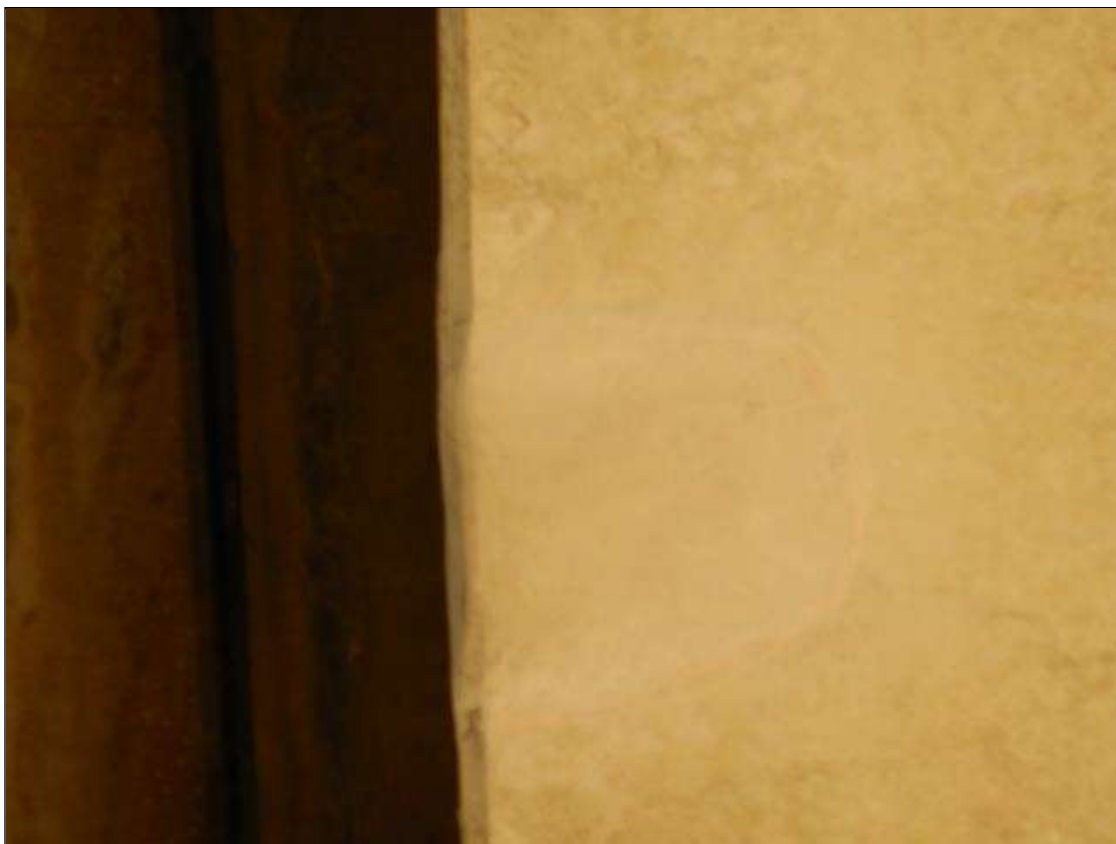
Span 30 Beam 7: [NEW REPAIR-PATCHING] FORMERLY --> failed patch on the bottom face at 25ft from Bent 27 exposing steel (6" x 6" x 1/2")

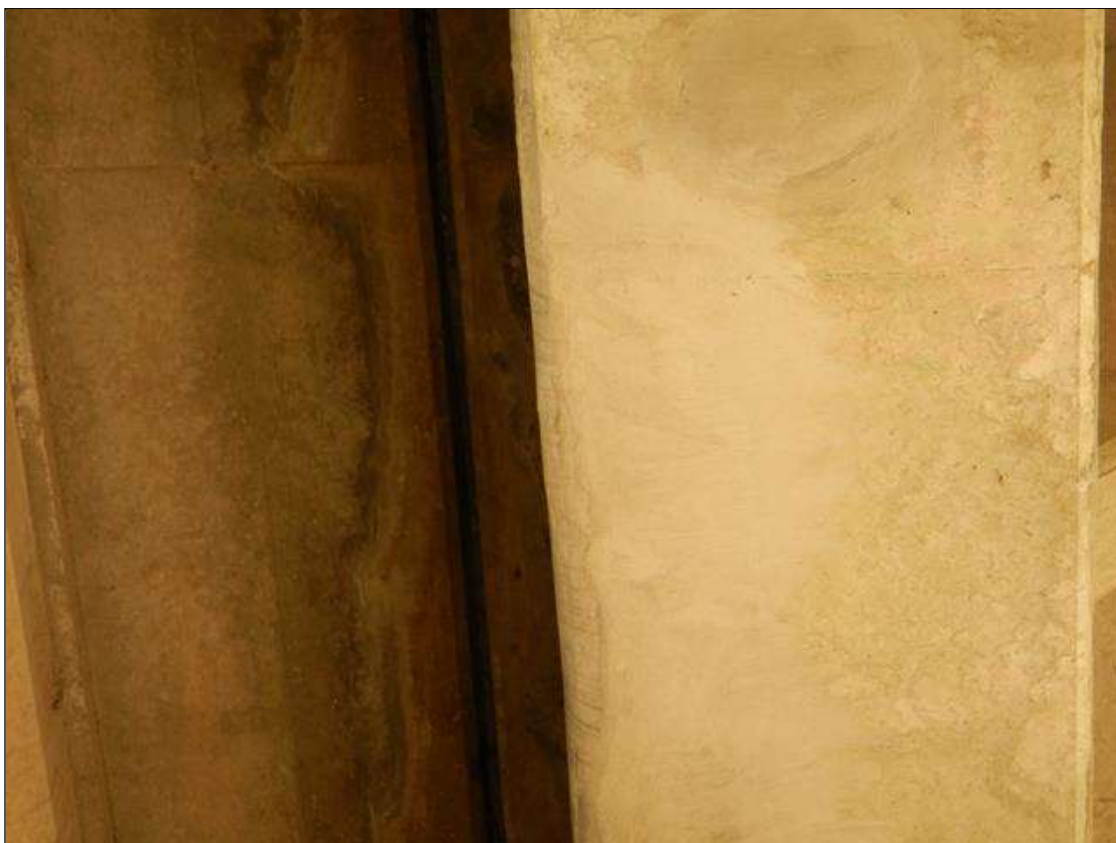
Span 30 Beam 7: [NEW REPAIR-PATCHING] FORMERLY --> spall with no exposed steel on the bottom face at 23.5ft from Bent 27 (6" x 6" x 1/2")

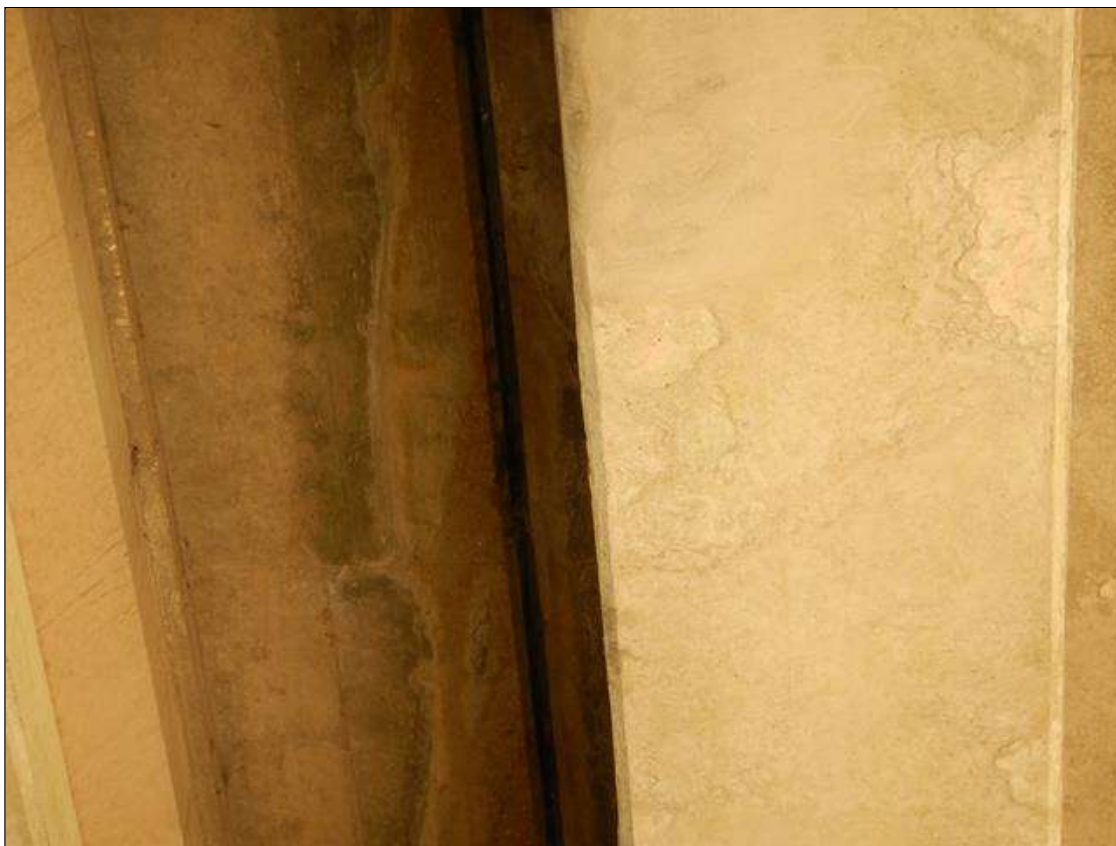
Span 30 Beam 7: [NEW REPAIR-PATCHING] FORMERLY --> spall with exposed rebar (12" x 9" x 1") and (1) exposed strand on the bottom face at 24.5ft from Bent 27, strand exposed for (2") long, active corrosion with no measureable section loss on strand

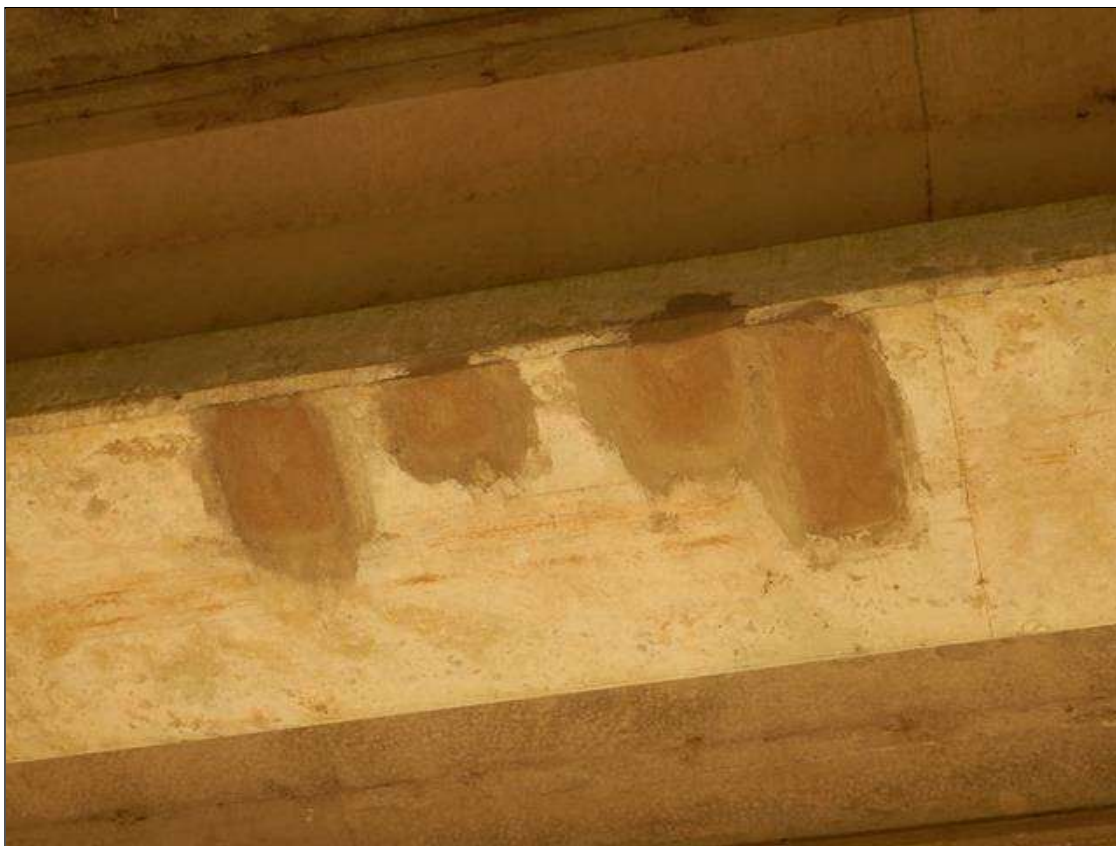
Span 30 Beam 9: [NEW REPAIR-PATCHING] FORMERLY --> (x4) spalls with exposed rebar on the bottom face starting at 30ft from bent 27 up to (13" x 3" x 1/4")

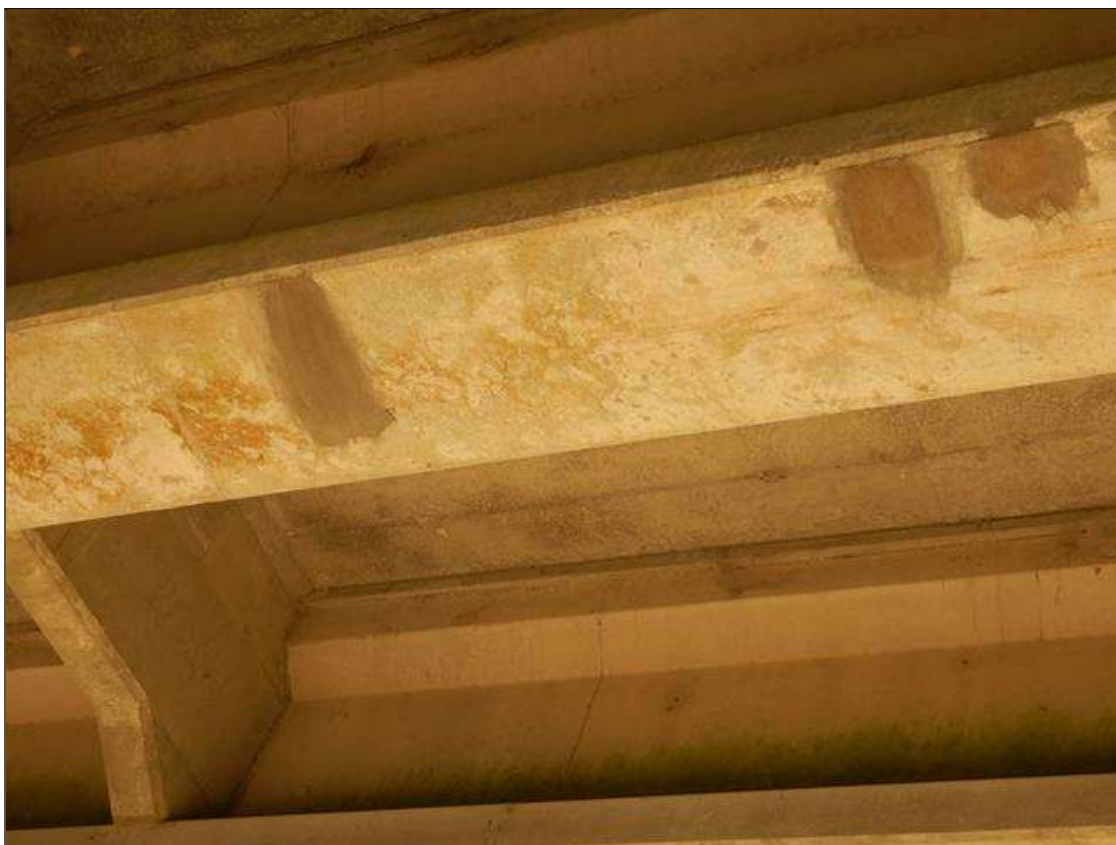
Span 30 Beam 9: [NEW REPAIR-PATCHING] FORMERLY --> spall with exposed rebar on the bottom face at mid span (11" x 5" x 1/4")

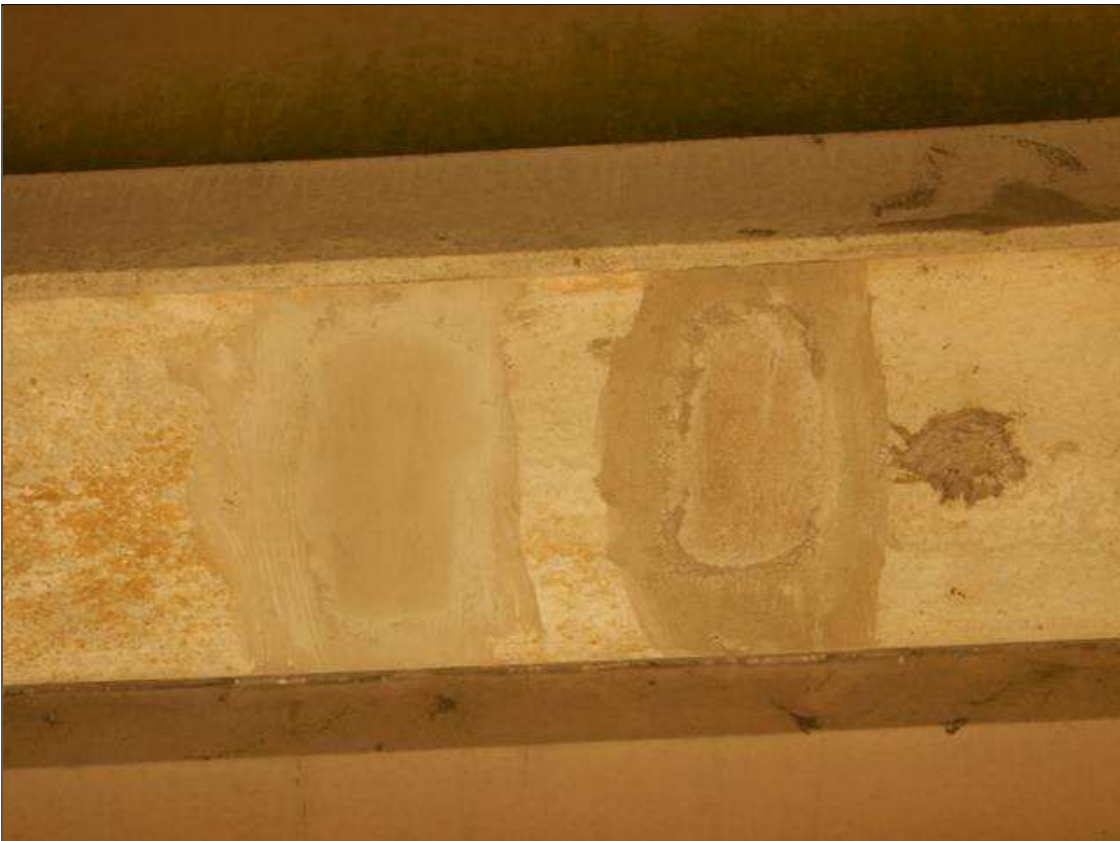
Span 30 Beam 10: [NEW REPAIR-PATCHING] FORMERLY --> (x3) spalls with exposed rebar on the bottom face at
20ft from ben 28 up to (10" x 3" x 1/4")

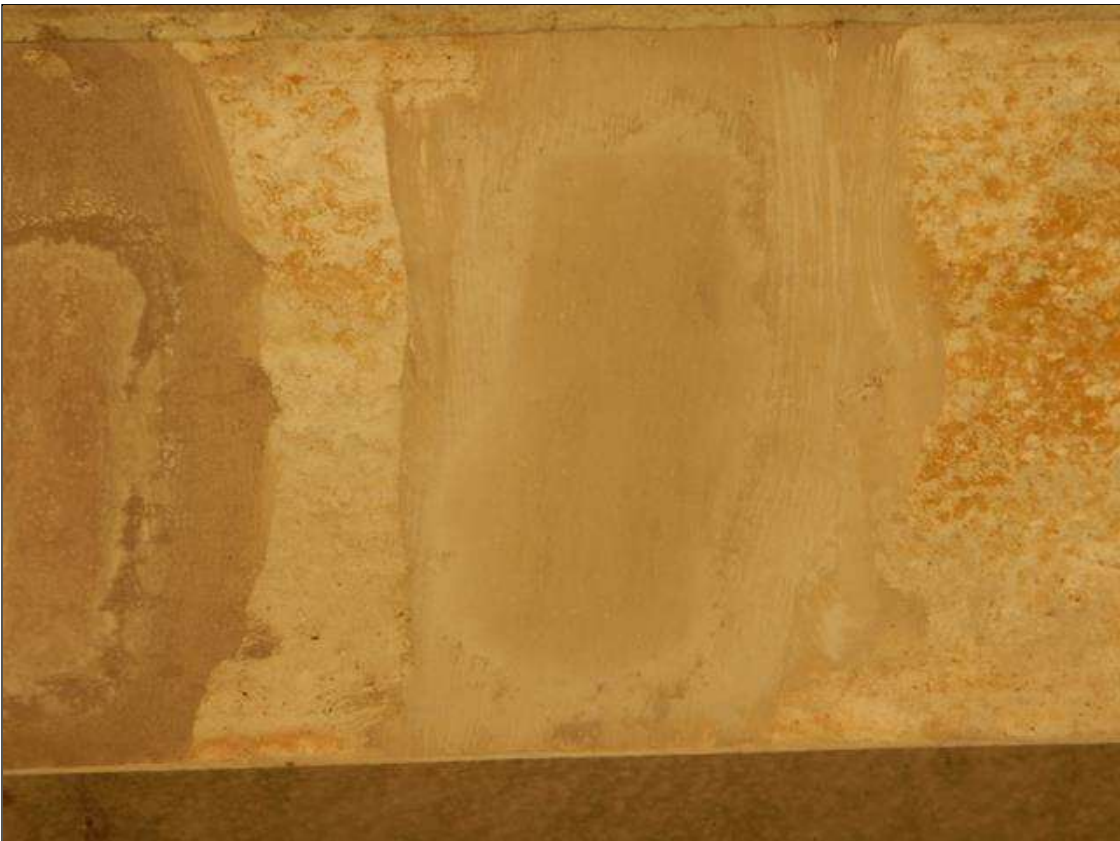
Span 30 Beam 10: [NEW REPAIR-PATCHING] FORMERLY --> area of delamination on the bottom face, 5" in diameter, 15' from bent 28, with 3/16" separation

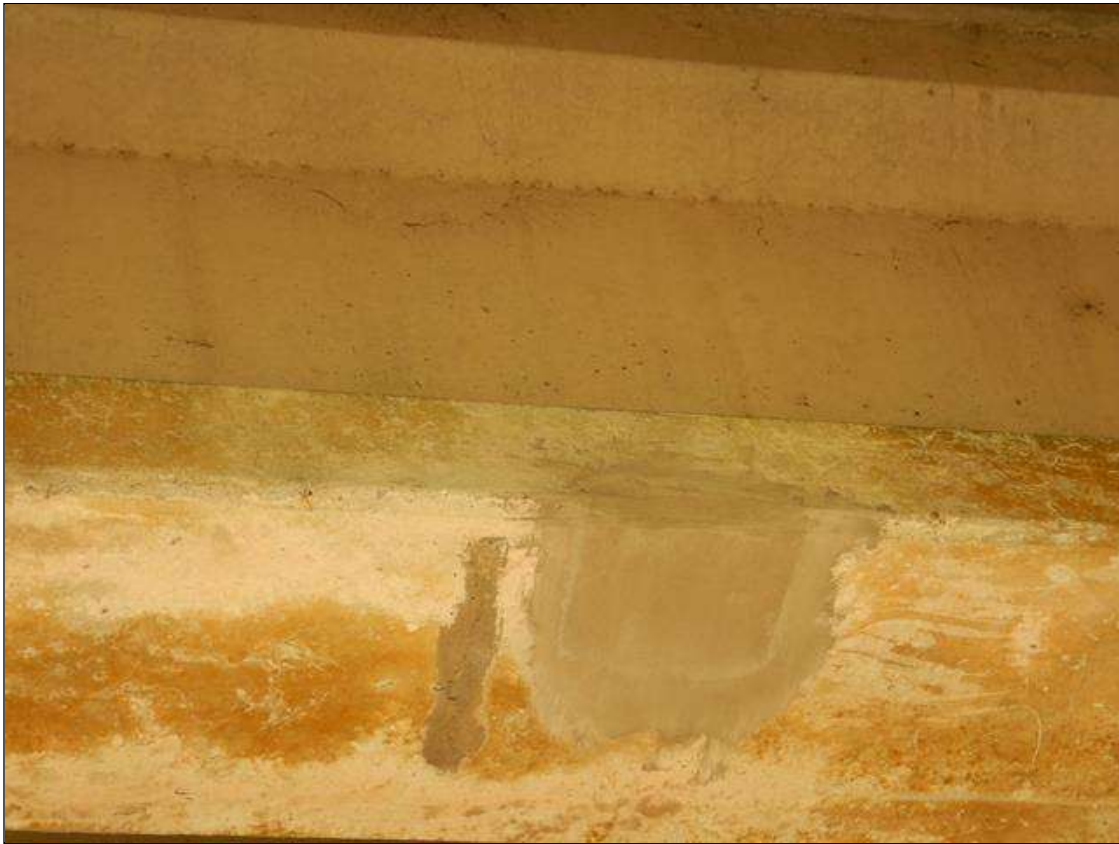
Span 30 Beam 10: [NEW REPAIR-PATCHING] FORMERLY --> spall with exposed rebar on the bottom right flange with exposed strand (11" x 7" x 1") at 6ft from bent 28, strand exposed for 6" long

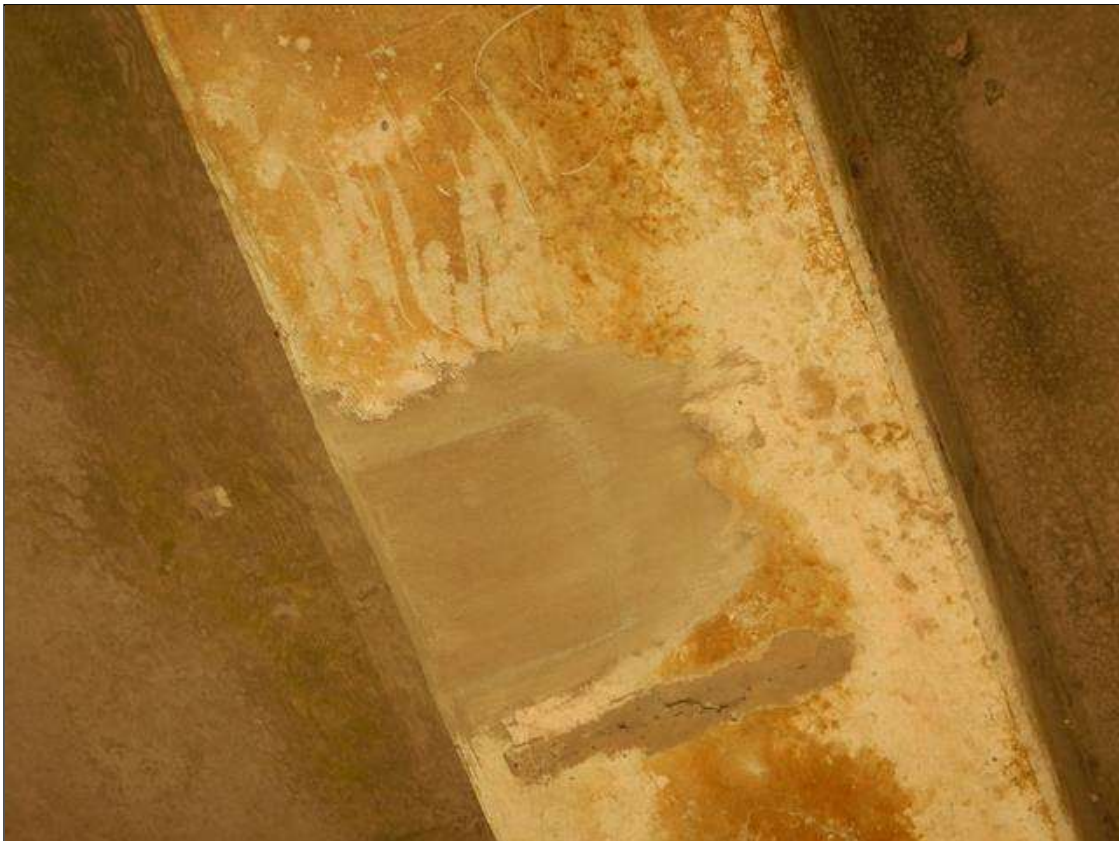
Span 30 Beam 10: [NEW REPAIR-PATCHING] FORMERLY --> spall with exposed rebar on the bottom right flange with exposed strand (11" x 7" x 1") at 6ft from bent 28, strand exposed for 6" long

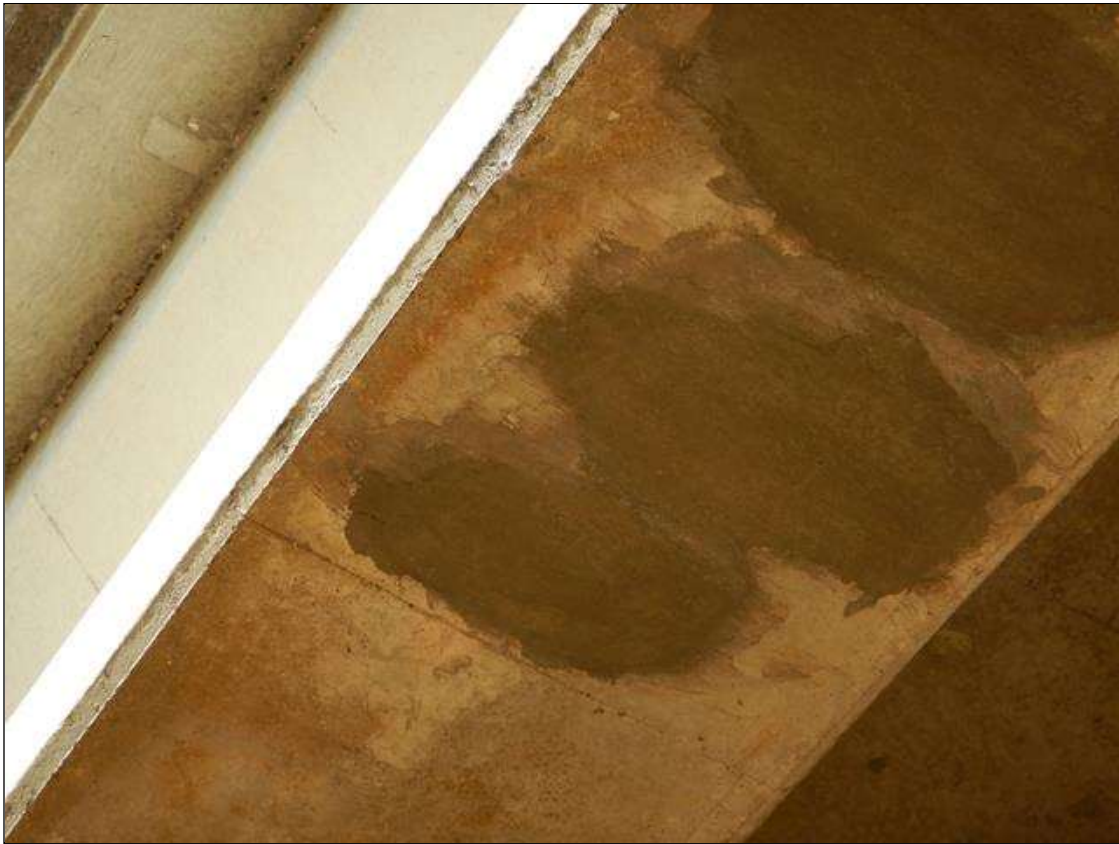
Span 30 Beam 11: [NEW REPAIR-PATCHING] FORMERLY --> spall with exposed rebar on the bottom face at 24ft from bent 28 (6" x 1" x 1/4")

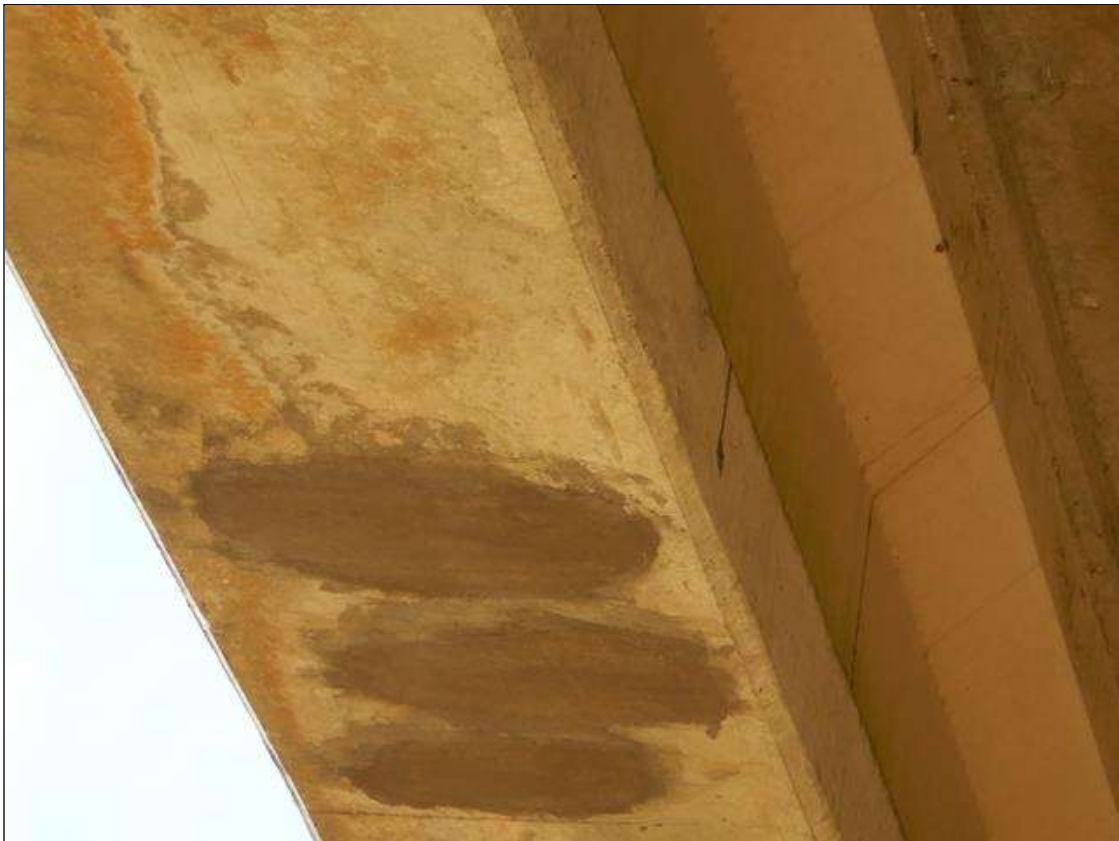
Span 30 Beam 11: [NEW REPAIR-PATCHING] FORMERLY --> spall with exposed rebar on the bottom face at 22ft from Bent 28 (12" x 6" x 1/2")

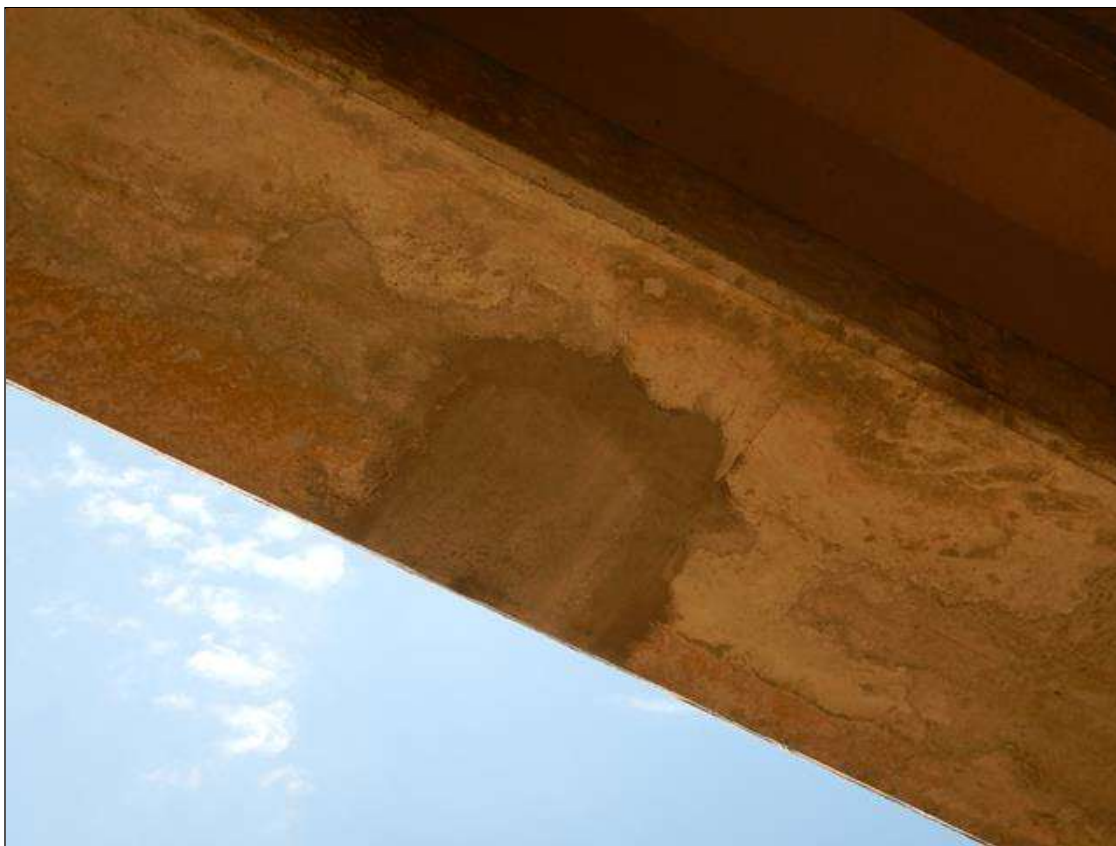
Span 30 Beam 11: [NEW REPAIR-PATCHING] FORMERLY --> DELAMINATION on the bottom face at 6ft from bent 28
(6" x 6")

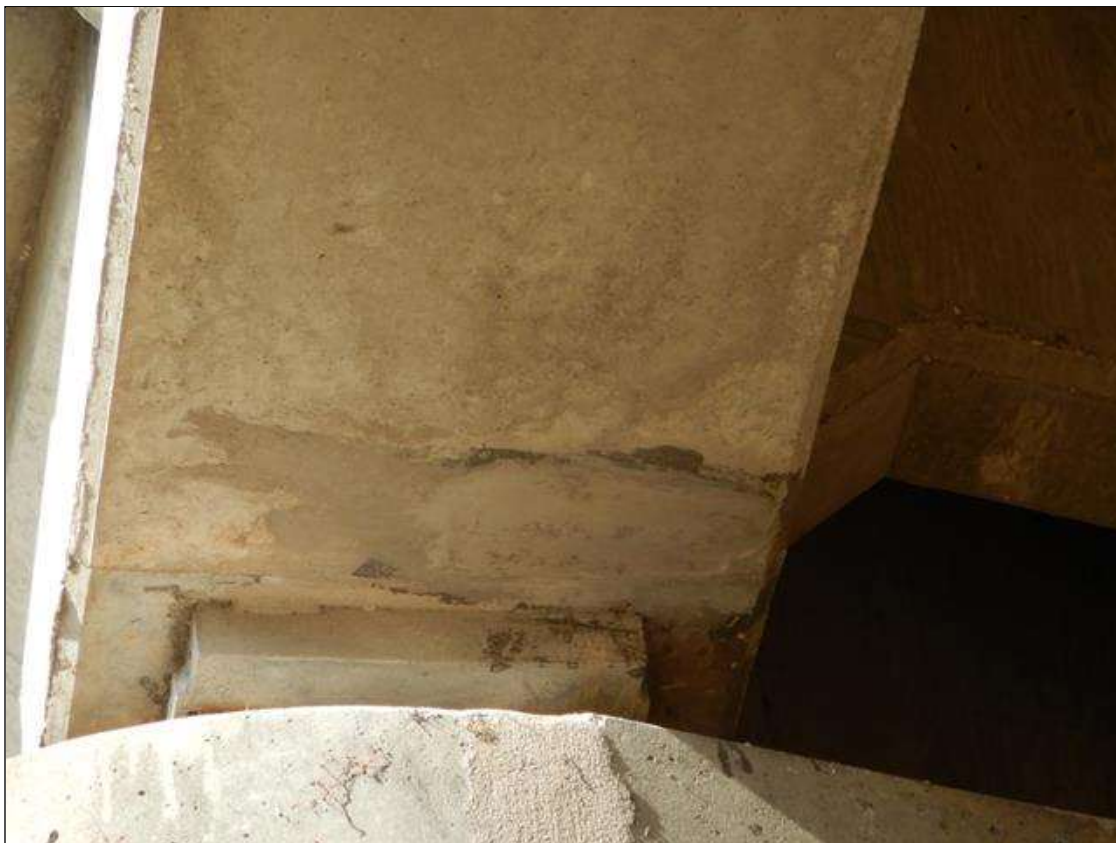
Span 30 Beam 11: [NEW REPAIR-PATCHING] FORMERLY --> spall with exposed rebar on the bottom face at bent 27
(11" x 4" x 1/2")

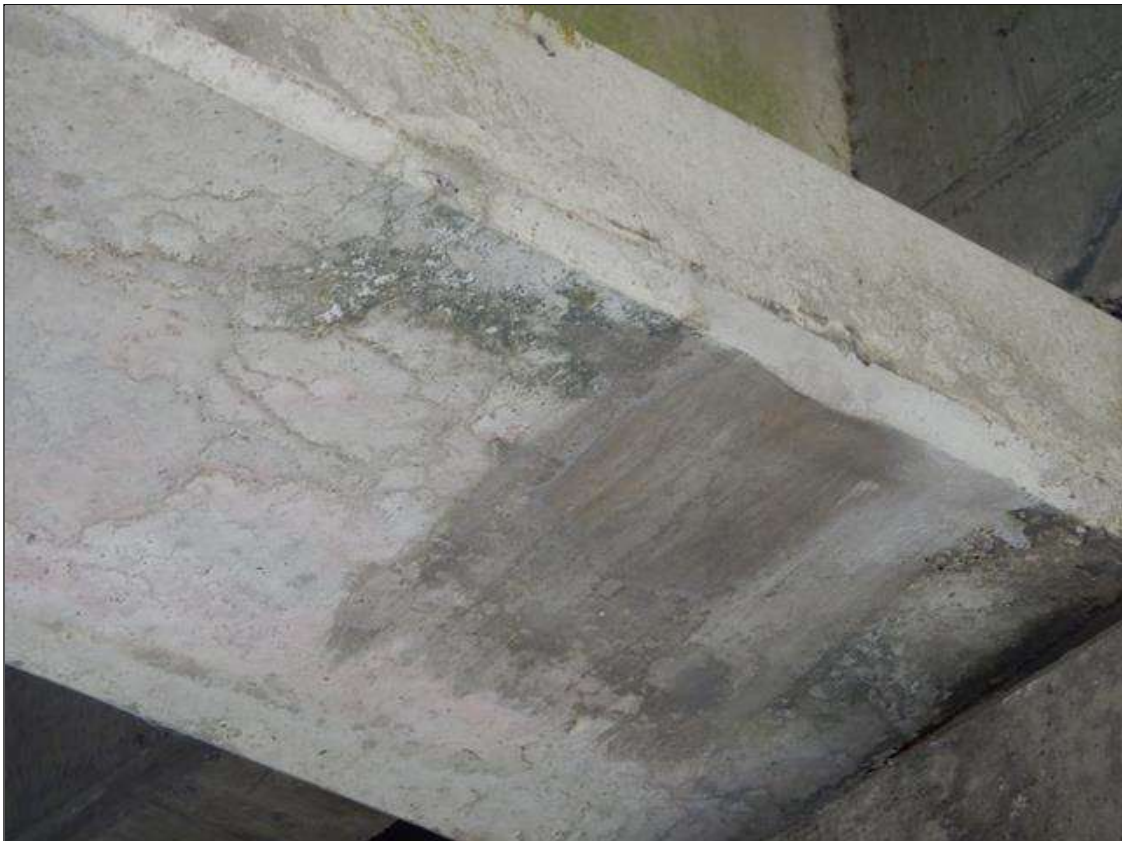
Span 35 - Ramp Span Beam 4: [NEW REPAIR-PATCHING] FORMERLY --> spall with exposed rebar on the bottom face at 1ft from bent 31 (7" x 6" x 1/2")

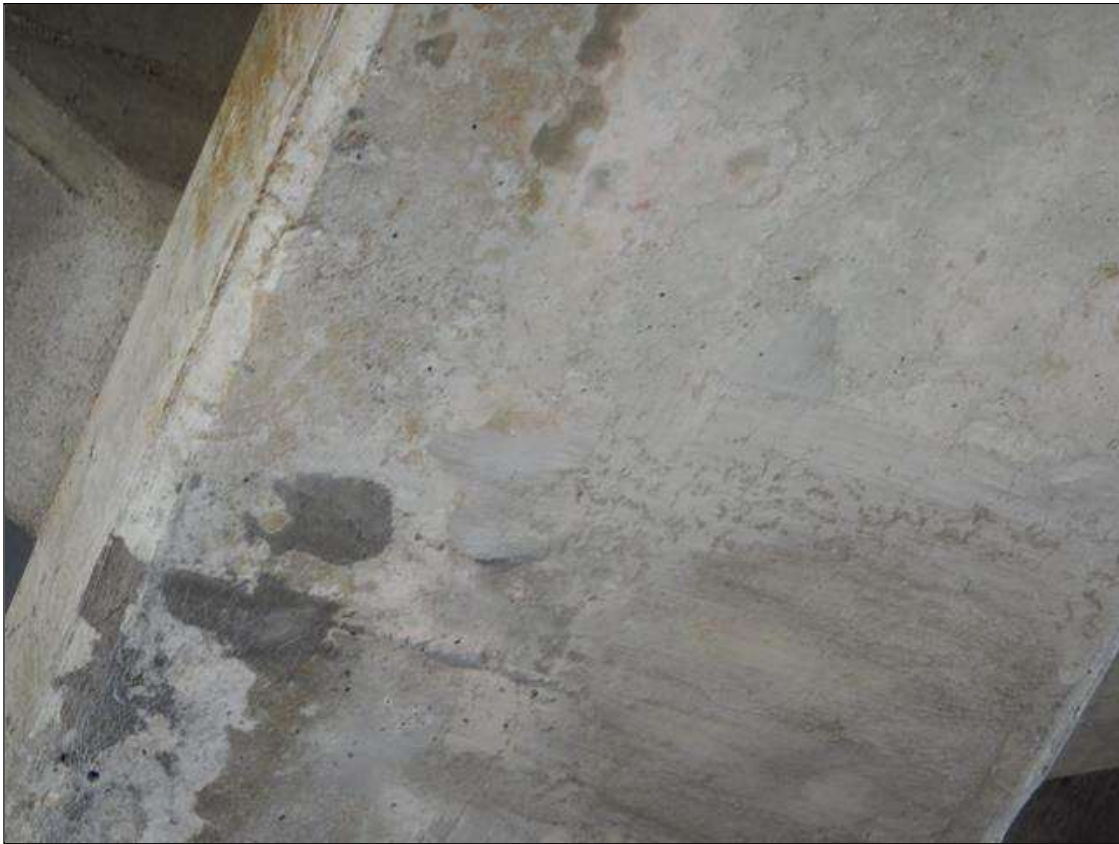
Span 35 - Ramp Span Beam 4: [NEW REPAIR-PATCHING] FORMERLY --> spall with exposed rebar on the bottom face at 19ft from Bent 31 (10" x 7" x 1/2")

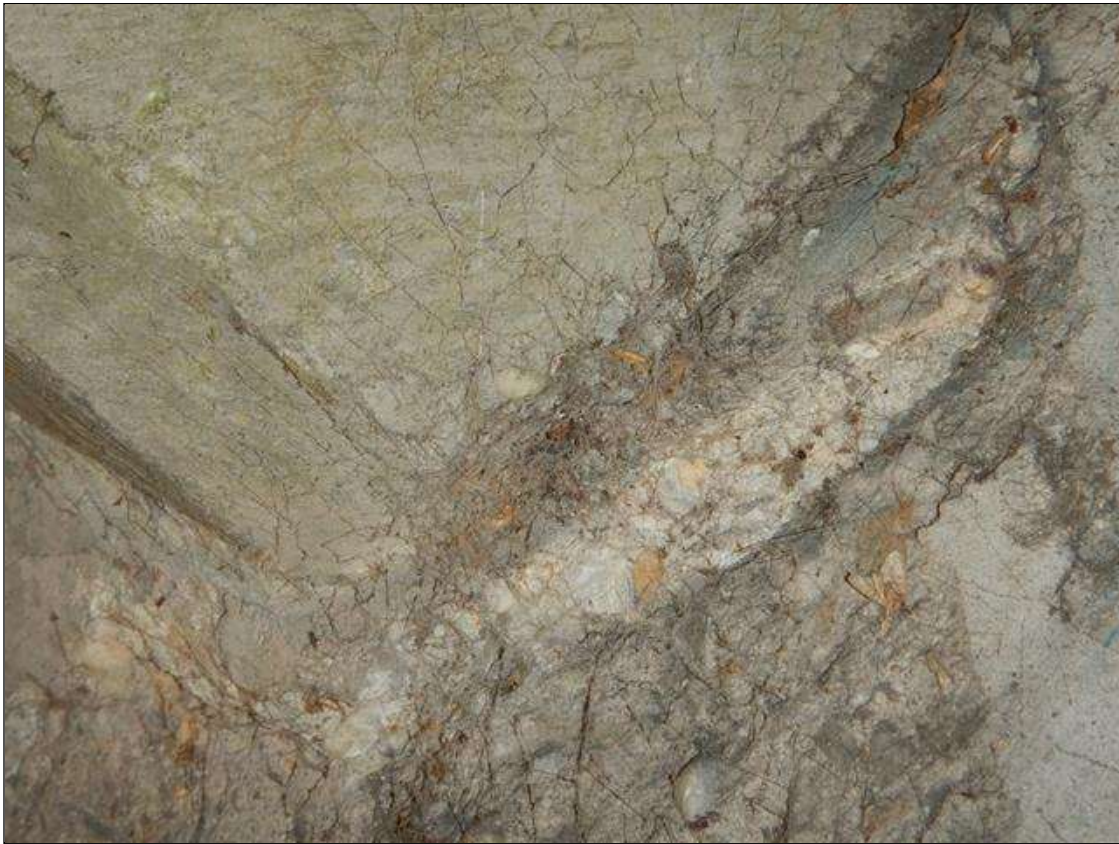
Span 35 - Ramp Span Beam 5: spall with no exposed steel on the bottom left flange under the end diaphragm at the Ramp End Bent (10" x 7" x 1/2" deep), DELAMINATION area at the back of the beam on the bottom left face at the same location (9" x 6")

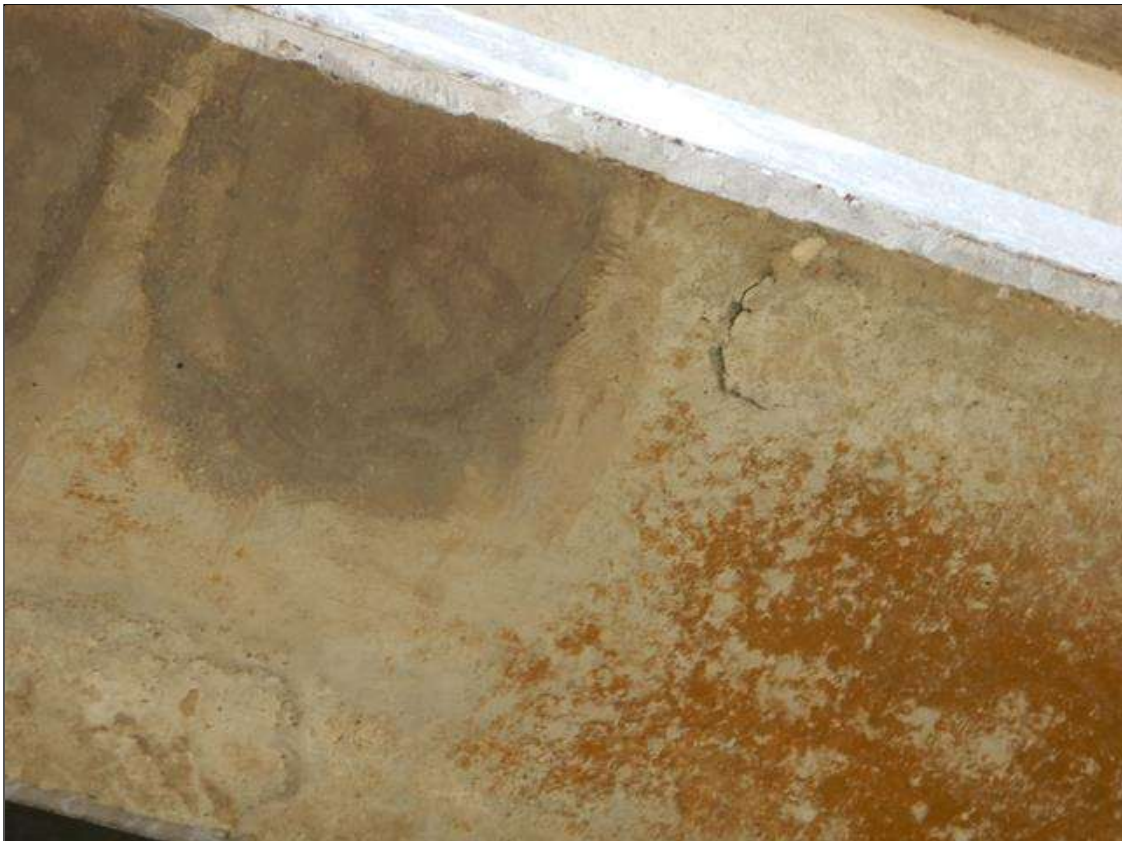
Span 34 - Ramp Span Beam 1: [NEW REPAIR-PATCHING] FORMERLY --> (x9) spalls with exposed rebar on the bottom face starting 16ft from Bent 30 up to (16" x 7" x 2")

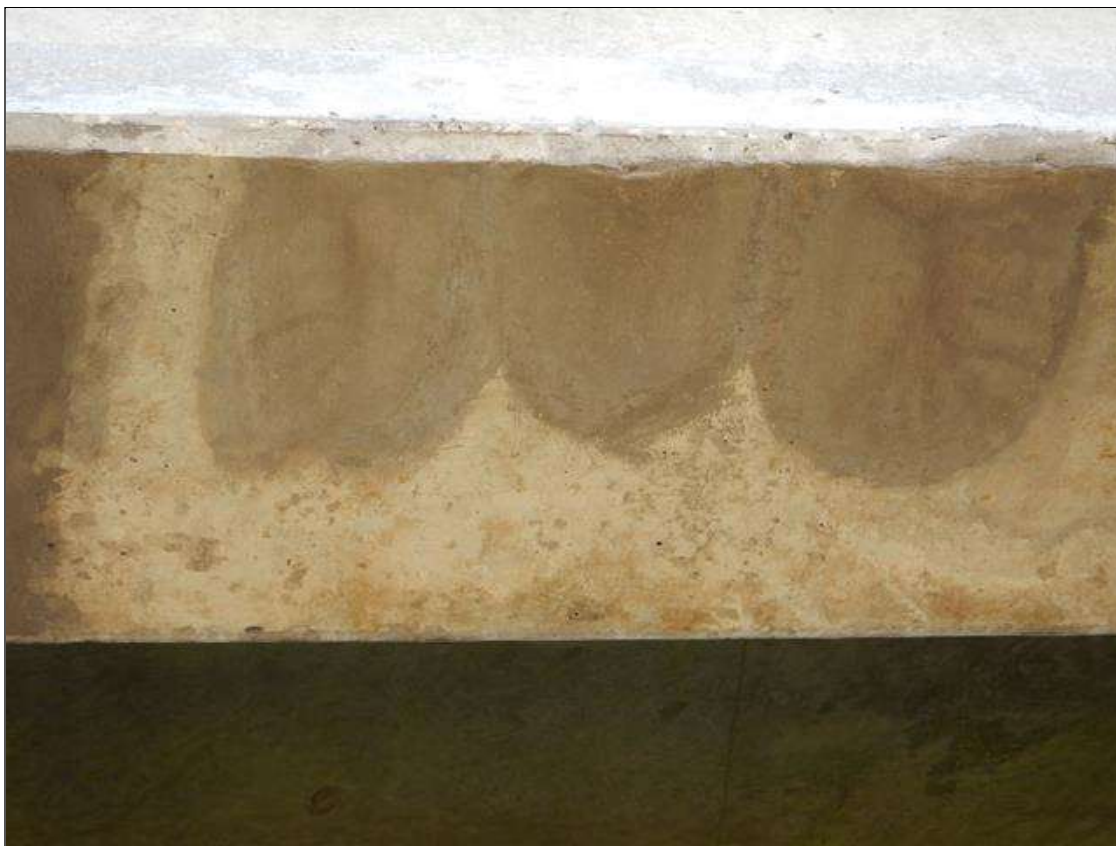
Span 34 - Ramp Span Beam 1: [NEW REPAIR-PATCHING] FORMERLY --> (x2) spalls with exposed rebar on the bottom face at 14ft and 18ft from Bent 30 up to (6" x 6" x 1/2")

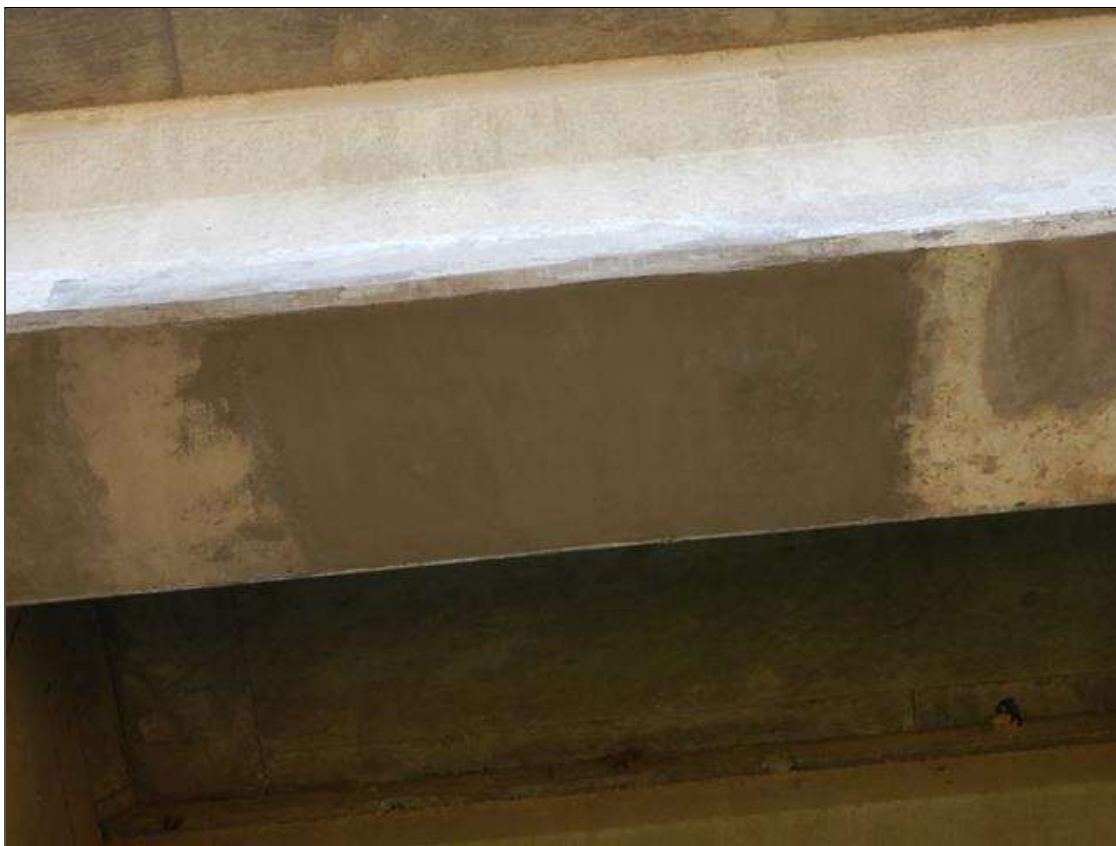
Span 34 - Ramp Span Beam 1: [NEW REPAIR-PATCHING] FORMERLY --> spall with exposed rebar (45" x 7" x 2") and (1) exposed strand 16ft from Bent 30, strand exposed for (24") long, active corrosion with section loss less than (1/16") on strand

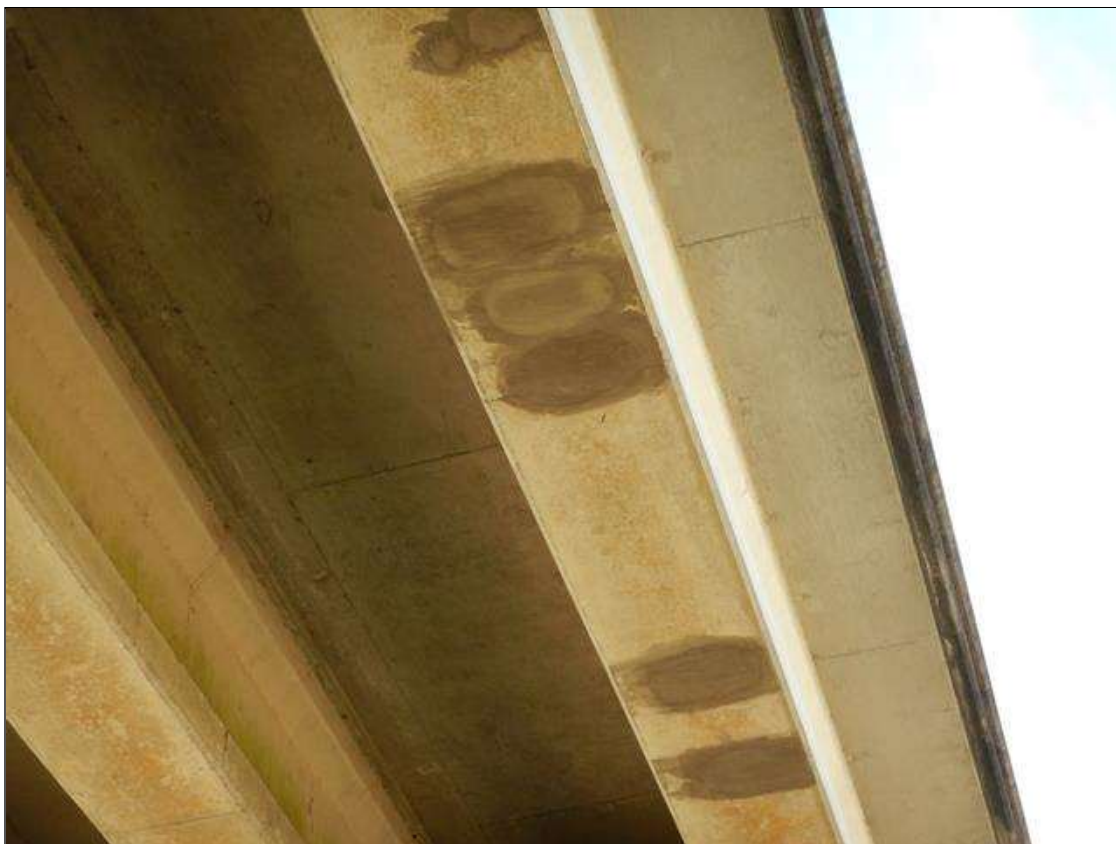
Span 33 - Ramp Span Beam 1: [NEW REPAIR-PATCHING] FORMERLY --> (x4) spalls with exposed rebar on the bottom face up to (5" x 5" x 1/2") at several locations

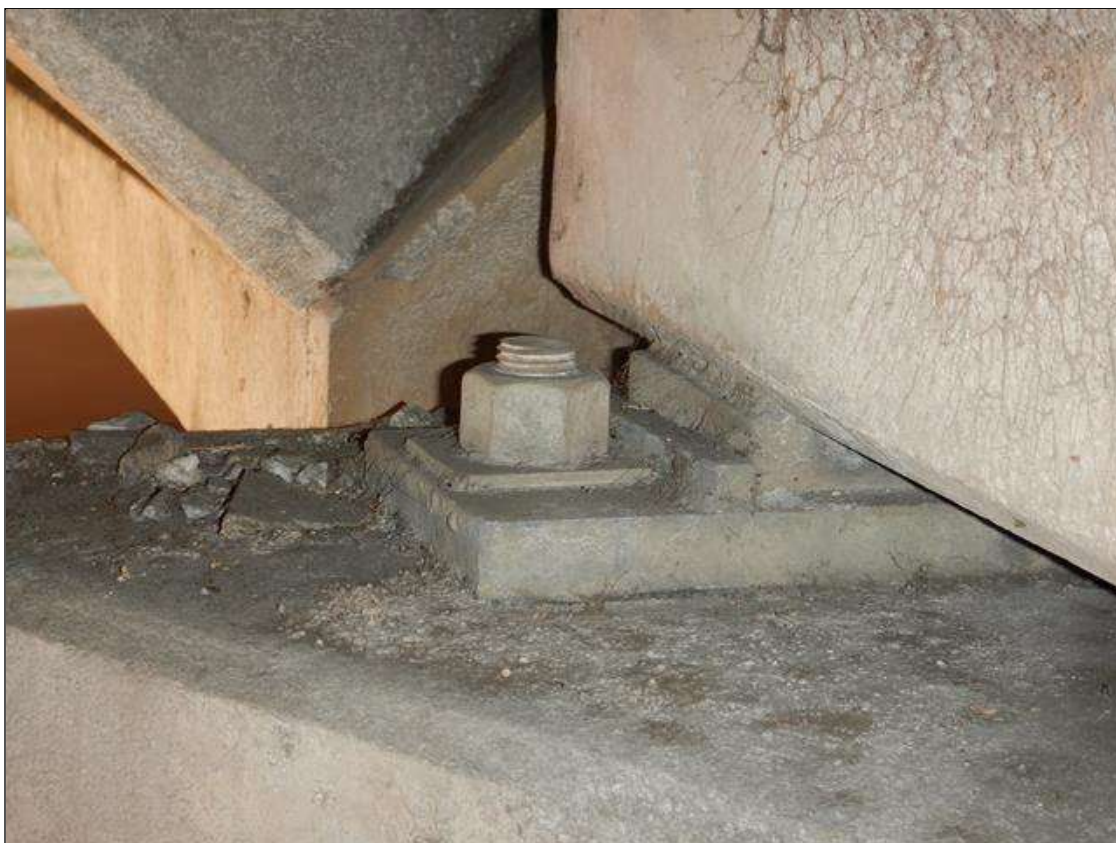
Span 32 Beam 9 - Beam 9 Far Bearing: [NEW REPAIR-NUT INSTALLED] FORMERLY --> missing right anchor rod nut

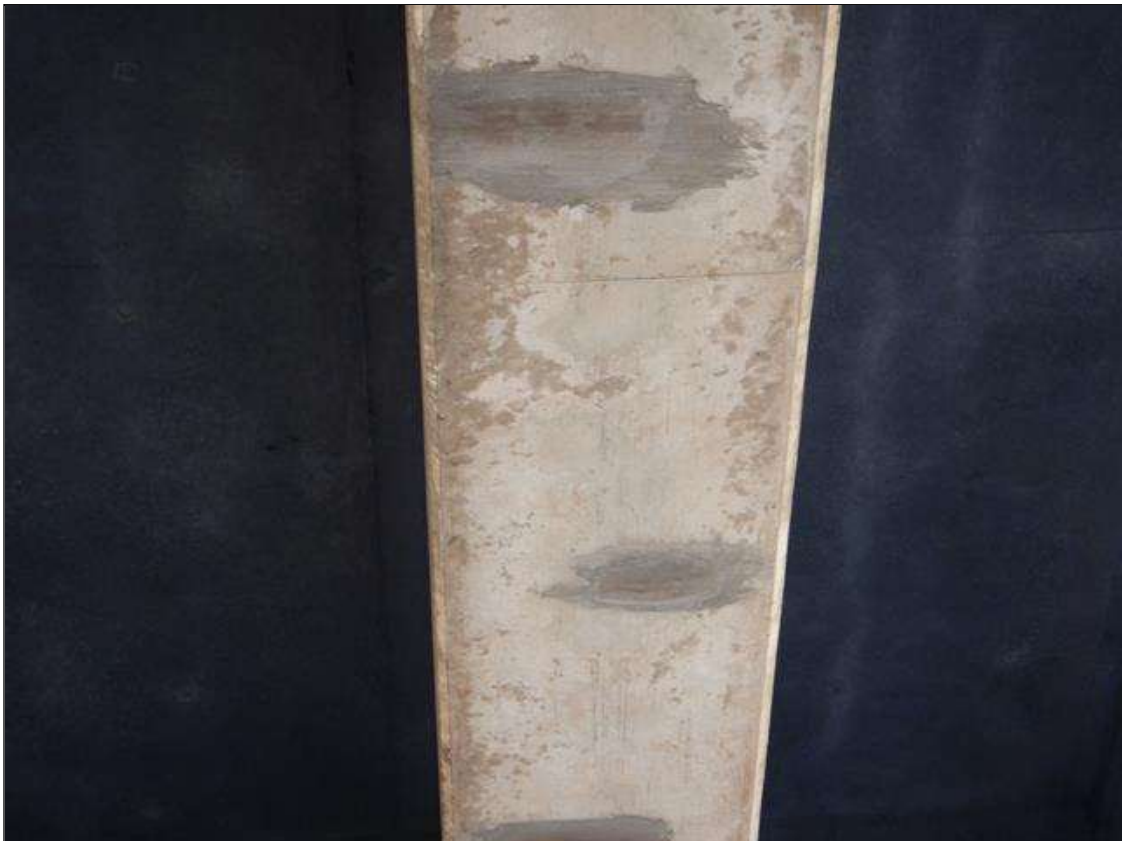
Span 31 Beam 2: [NEW REPAIR-PATCHING] FORMERLY --> (x2) spalls with exposed rebar on the bottom face at 14ft
and 21ft from Bent 29 up to (10" x 4")

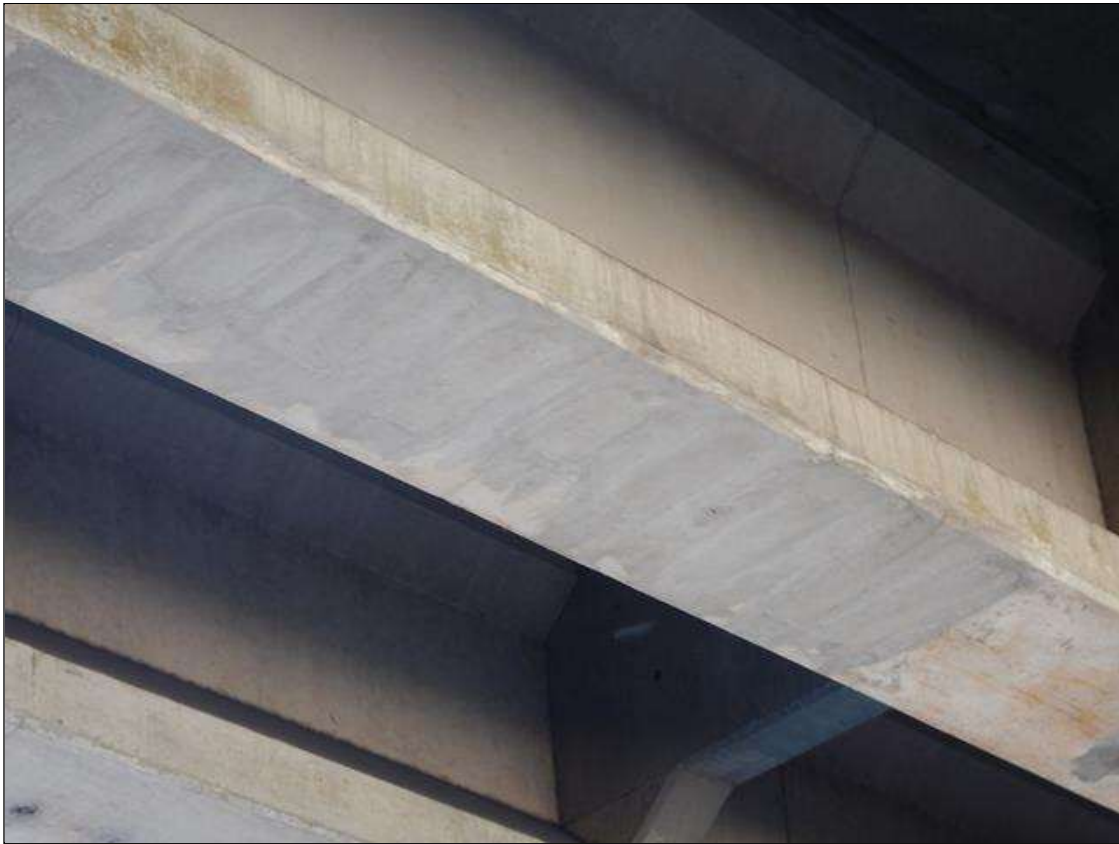
Span 31 Beam 2: [NEW REPAIR-PATCHING] FORMERLY --> (x25) spalls with exposed rebar on the bottom face at mid span up to (20" x 5" x 1/2")
