NC DEPARTMENT OF TRANSPORTATION
DIVISION OF HIGHWAYS
STRUCTURE MANAGEMENT UNIT

Structure Safety Report

Routine Element Inspection - Contract

DIVISION: 3 COUNTY: NEW HANOVER STRUCTURE NUMBER: 640013 FREQUENCY: 24 MONTHS

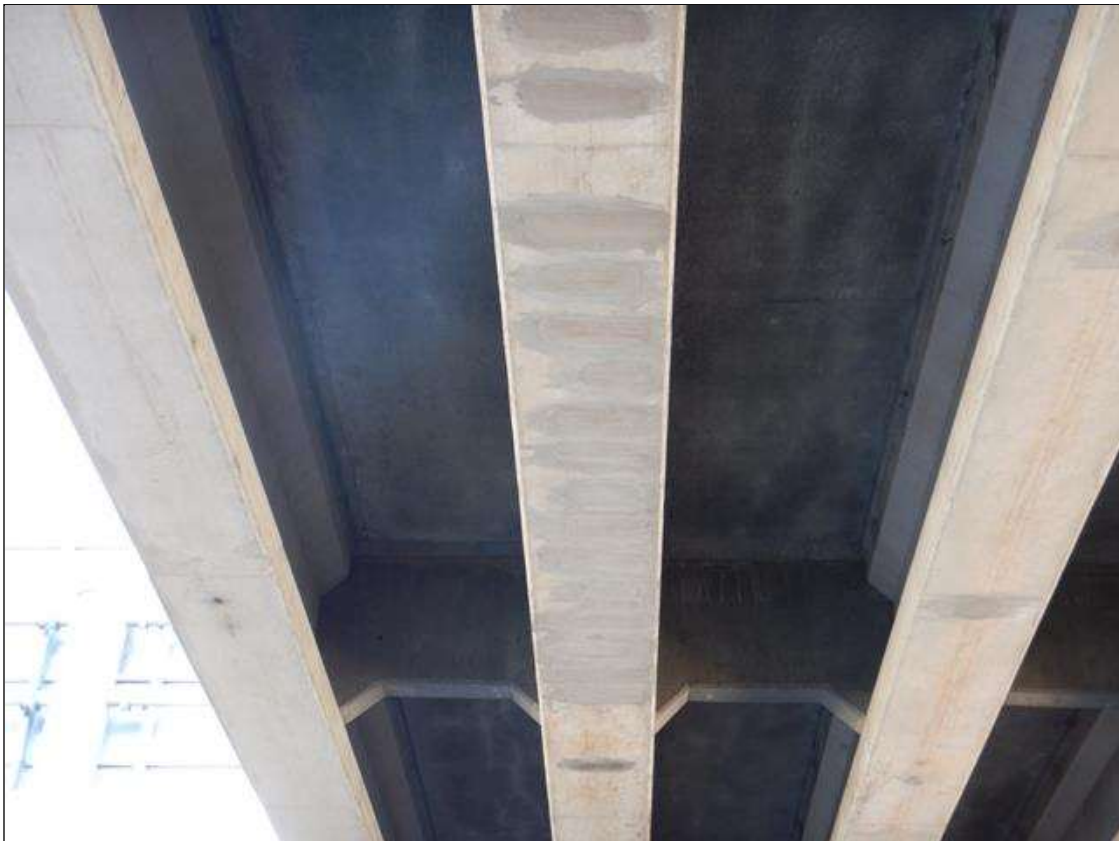
Span 31 Beam 2: [NEW REPAIR-PATCHING] FORMERLY --> (x25) spalls with exposed rebar on the bottom face at mid span up to (20" x 5" x 1/2")

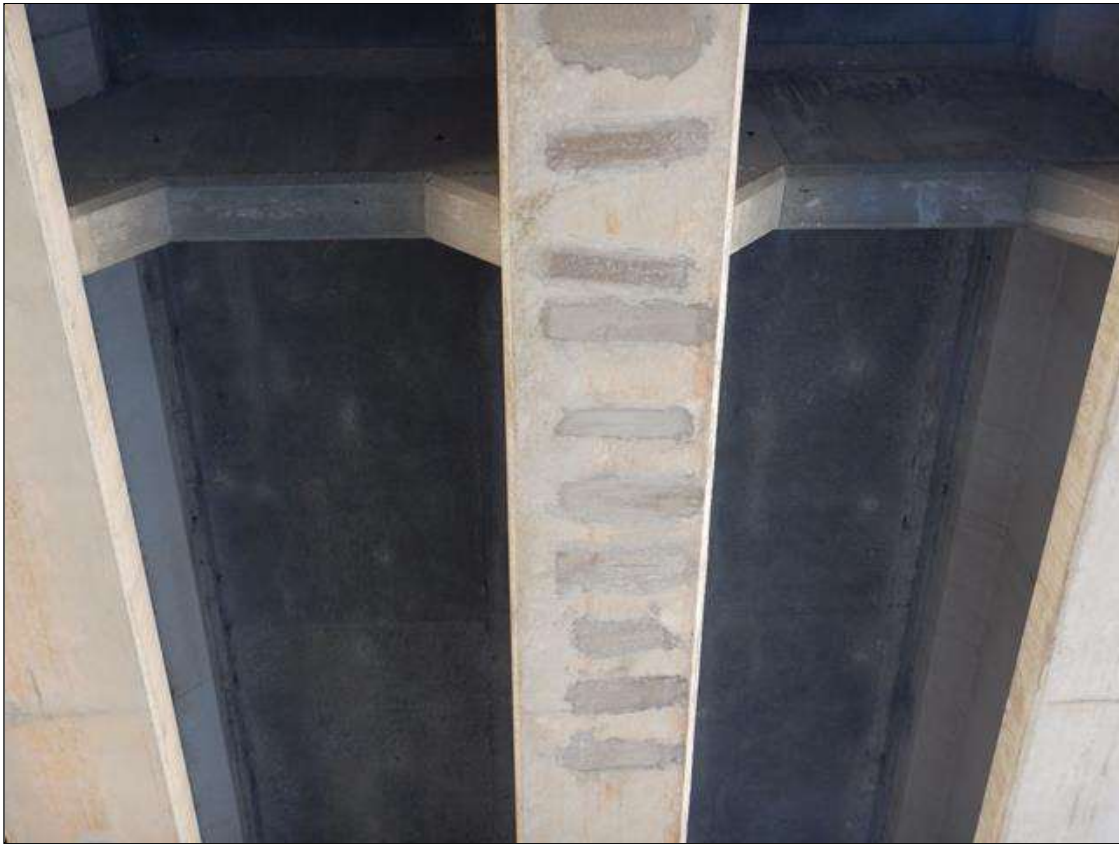
Span 31 Beam 2: [NEW REPAIR-PATCHING] FORMERLY --> spall with exposed rebar on the bottom face at 30ft from Bent 28 (8" x 5" x 1/2")

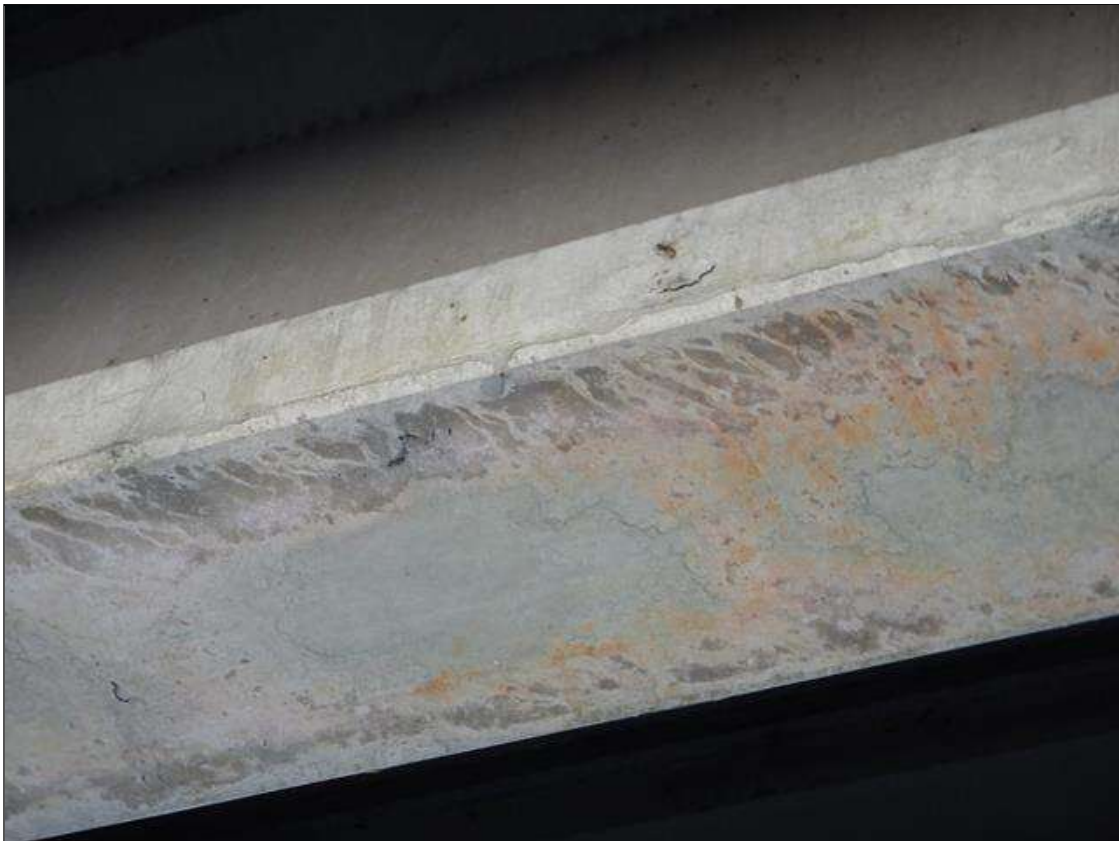
Span 31 Beam 4: [NEW REPAIR-PATCHING] FORMERLY --> (x2) DELAMINATION areas on the bottom right flange a 10ft from Bent 29 up to (6" x 3") (loose concrete over roadway)

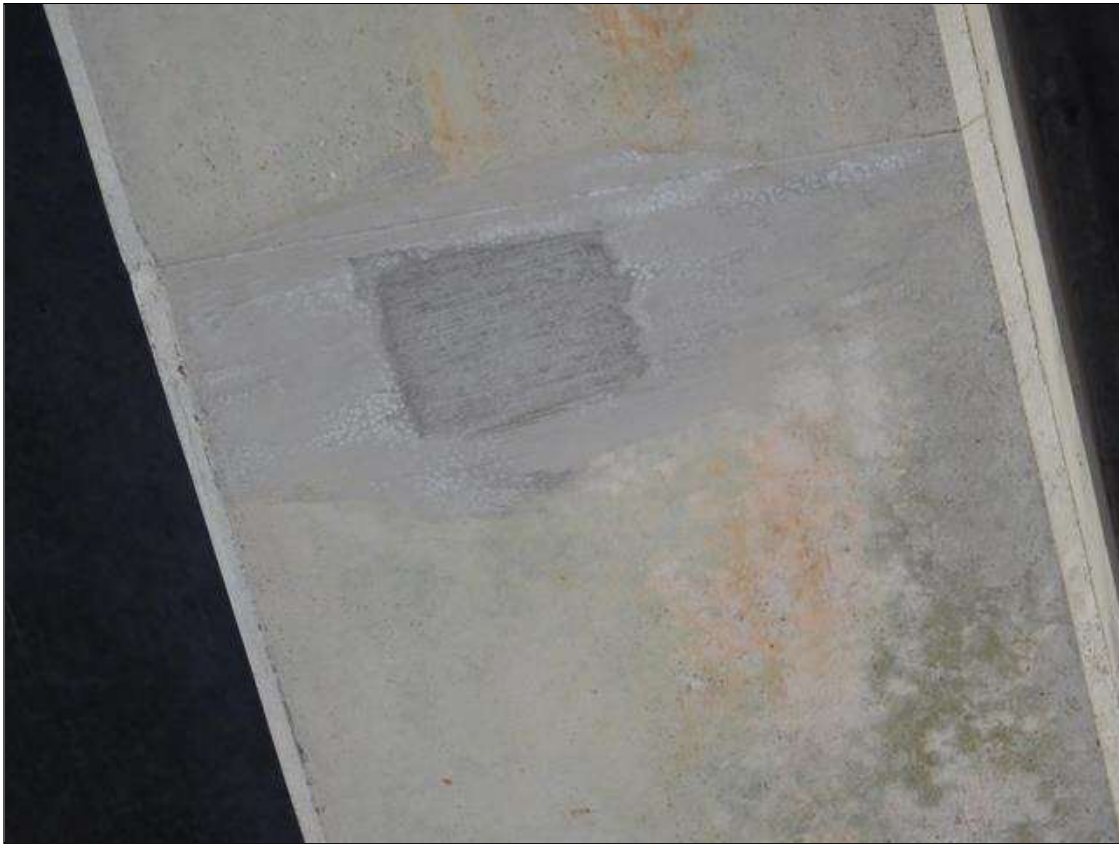
Span 31 Beam 5: [NEW REPAIR-PATCHING] FORMERLY --> spall with exposed rebar on the bottom face at 16ft from Bent 28 (5" x 4" x 1/4")

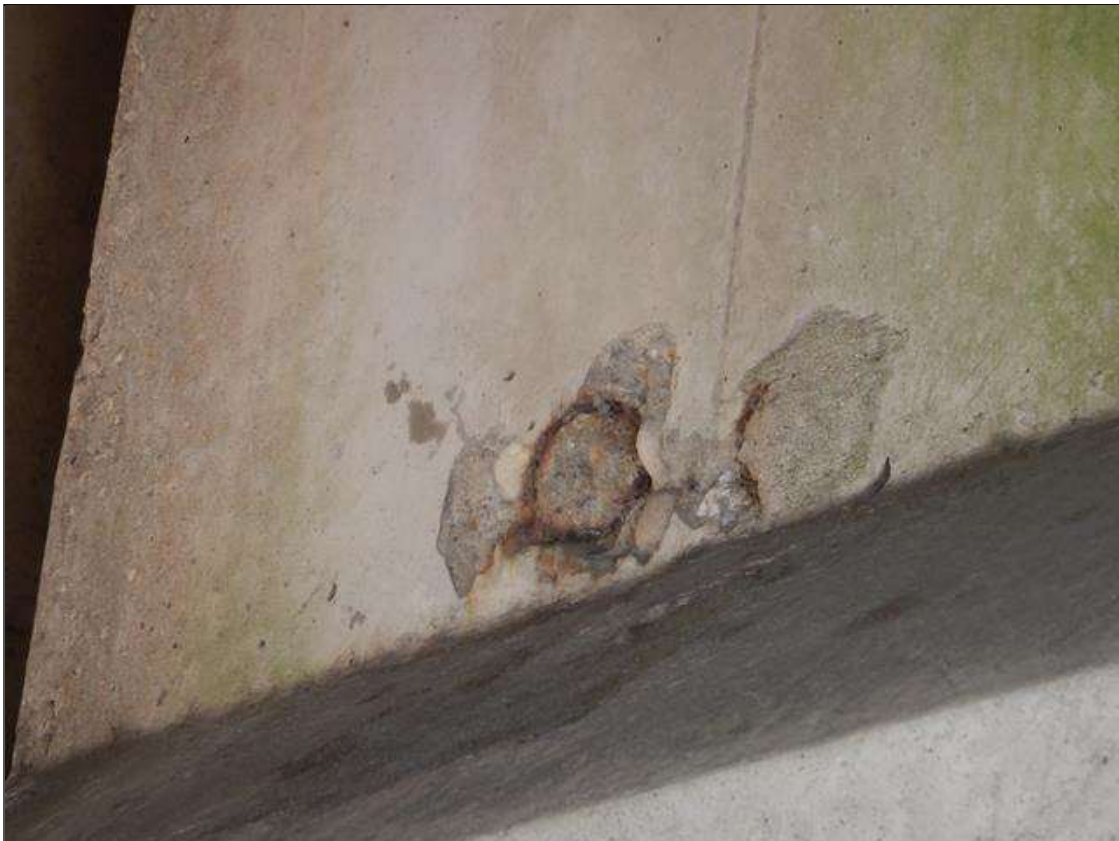
Span 31 Beam 7: [PROMPT ACTION REQUEST] spall with exposed rebar on the right web at 1ft from Bent 28 (7" x 3" x 1/2")

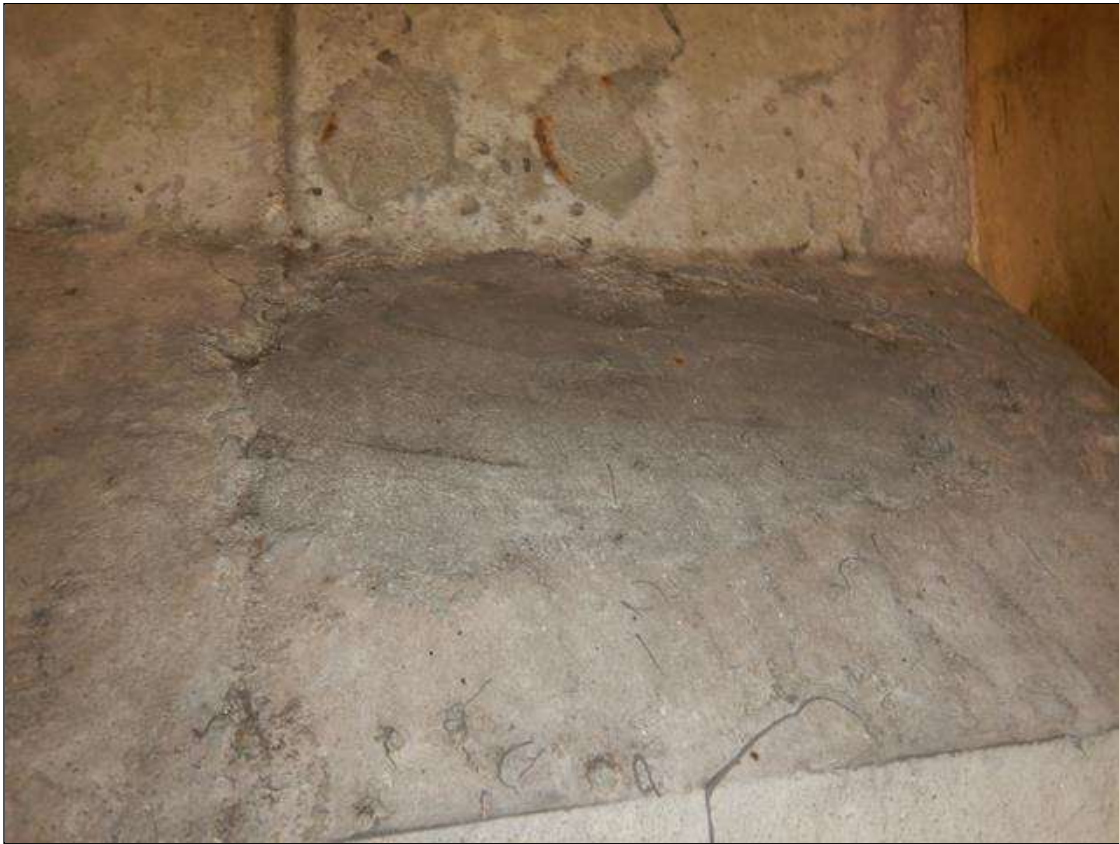
Span 31 Beam 8: [NEW REPAIR-PATCHING] FORMERLY --> spall with exposed rebar on the bottom left flange chamfer at 0.5ft from Bent 28 (14" x 8" x 1")

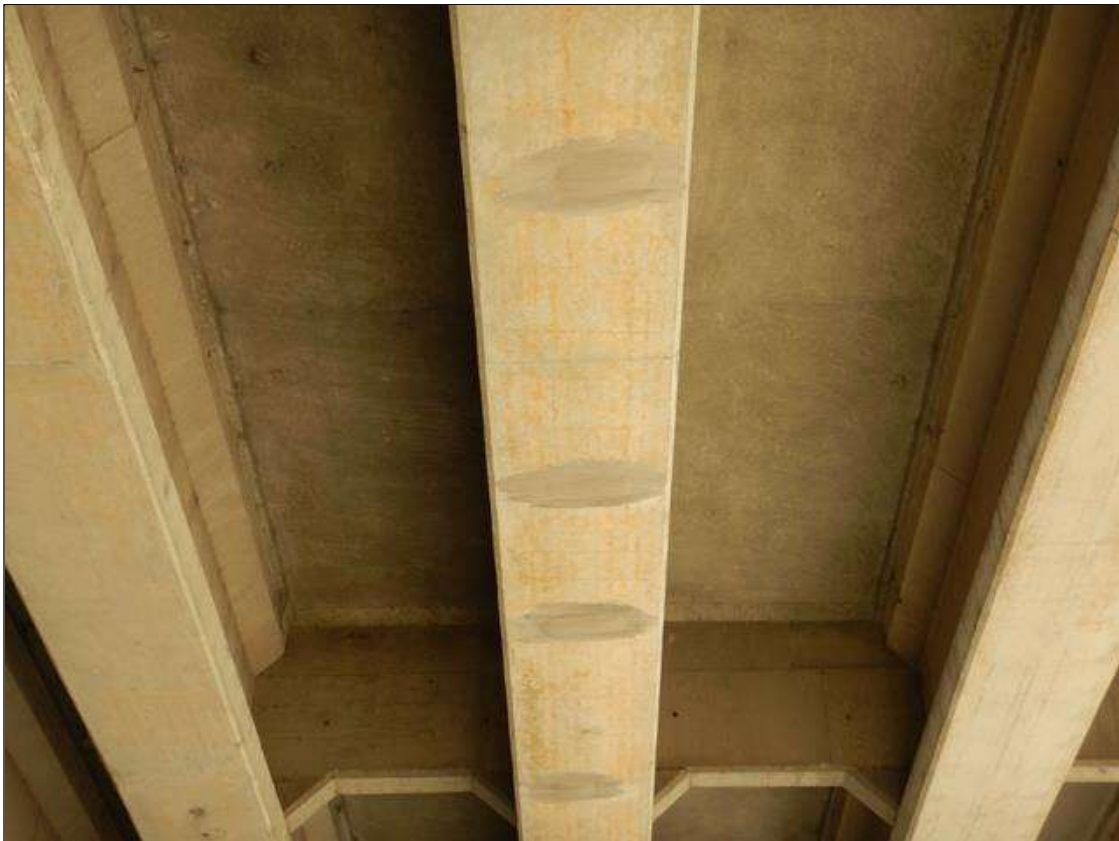
Span 31 Beam 9: [NEW REPAIR-PATCHING] FORMERLY --> (x4) spalls with exposed rebar on the bottom face near mid span up to (7" x 4" x 1/2")

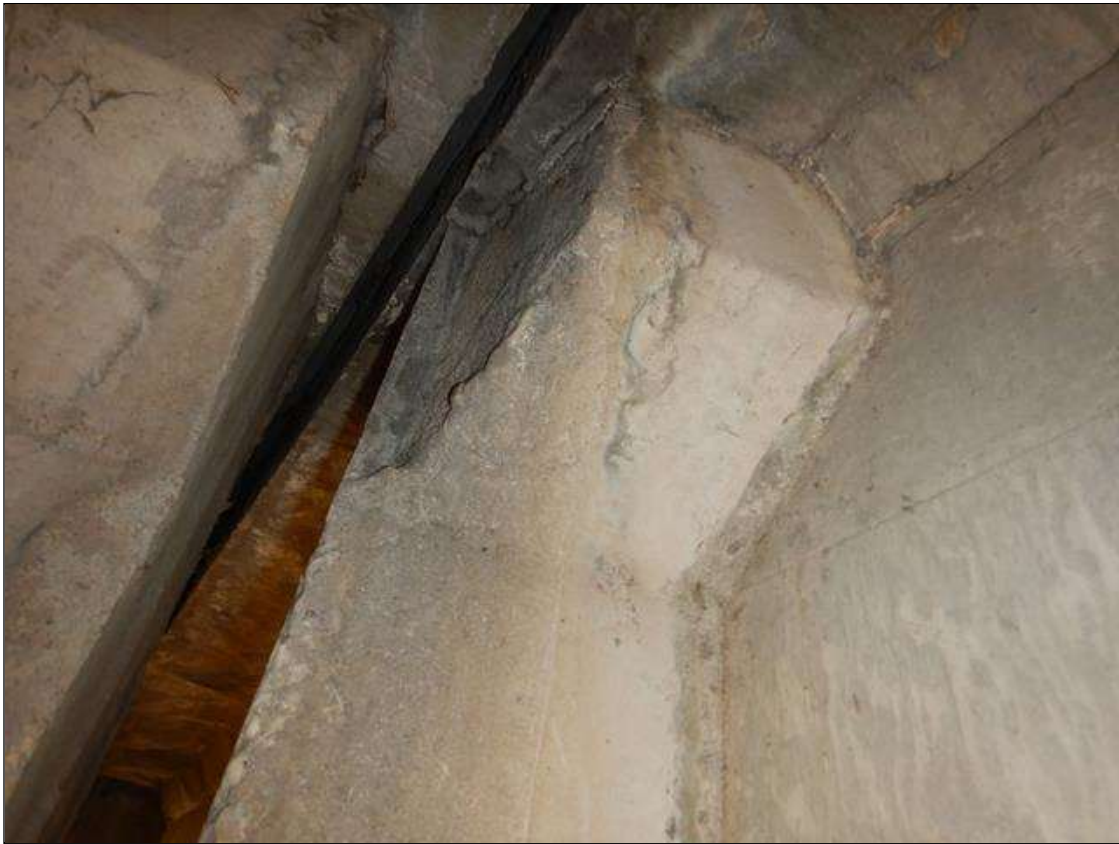
Span 31 Beam 11: [NEW REPAIR-PATCHING] FORMERLY --> spall with exposed rebar on the top of the back face at Bent 27 (6" x 5" x 1/2")

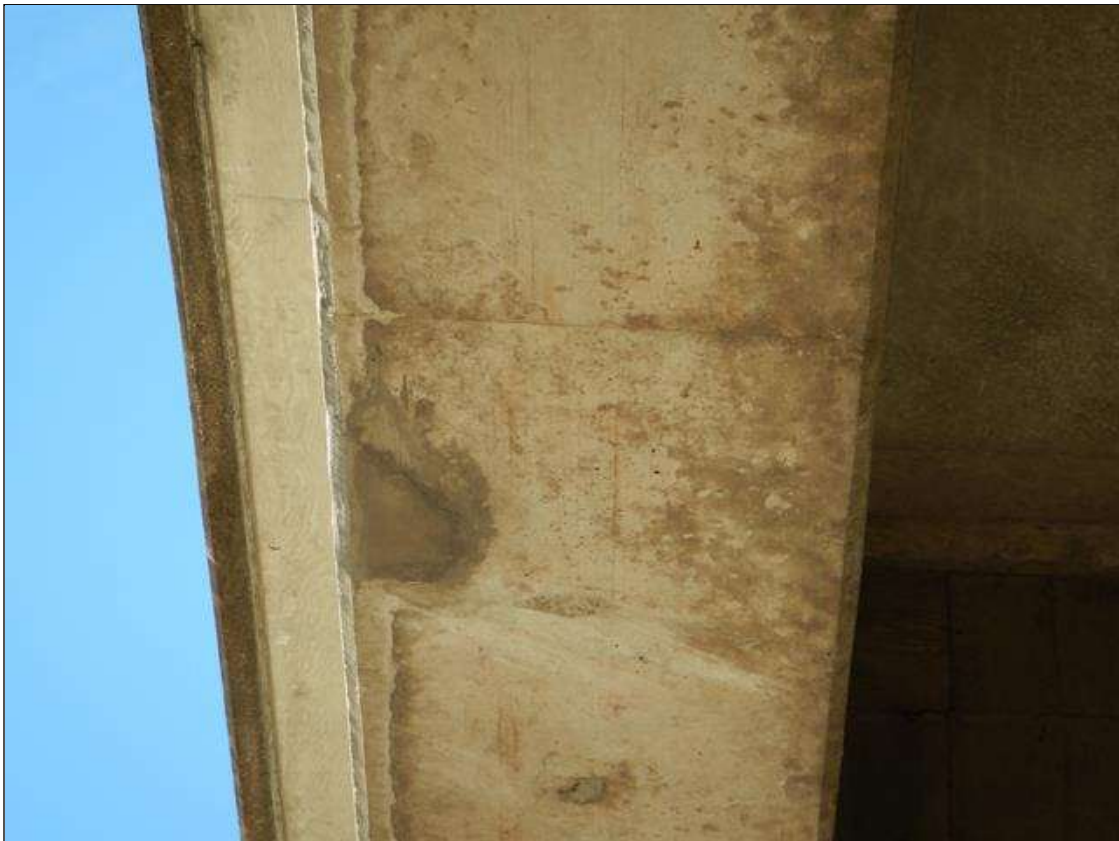
Span 31 Beam 12: [NEW REPAIR-PATCHING] FORMERLY --> Impact Damage (apparent) on the bottom right flange over exit ramp, spall with no exposed steel (8" x 3" x 1/2") - Clearance 16.25ft at this location

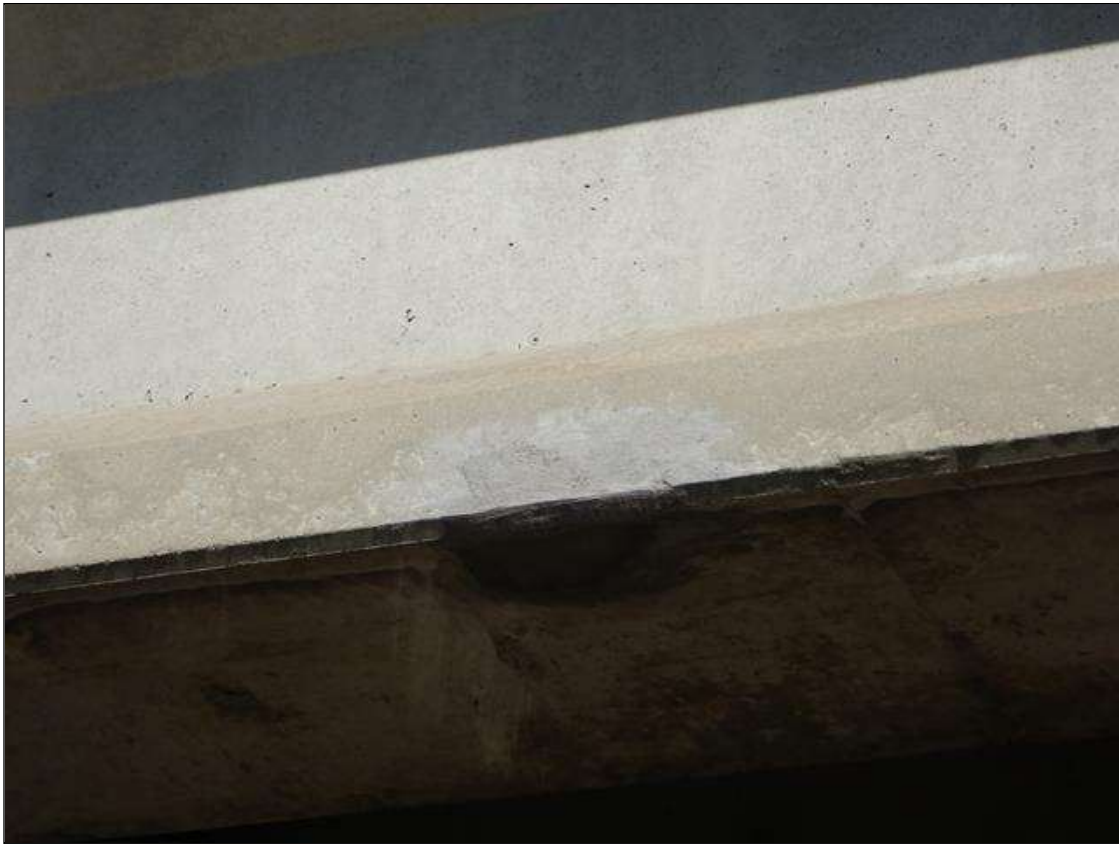
Span 31 Beam 12: [NEW REPAIR-PATCHING] FORMERLY --> Impact Damage (apparent) on the bottom right flange over exit ramp, spall with no exposed steel (8" x 3" x 1/2") - Clearance 16.25ft at this location

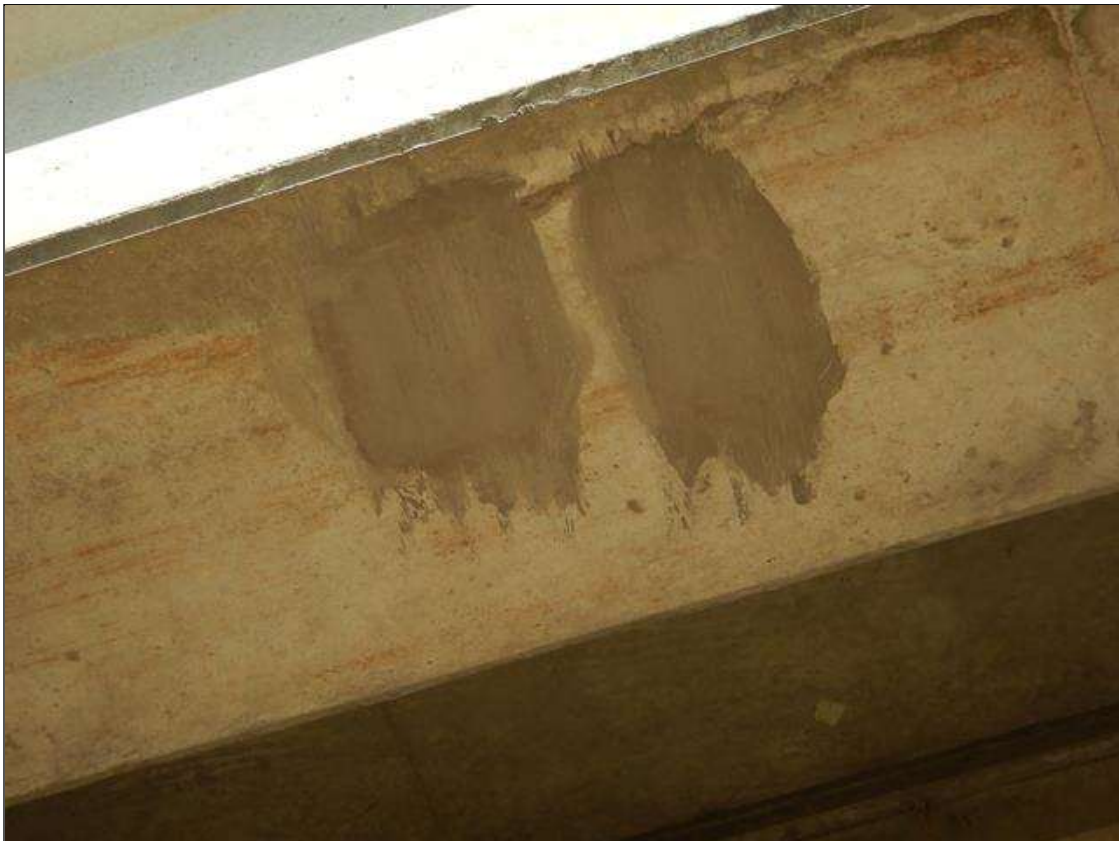
Span 31 Beam 12: [NEW REPAIR-PATCHING] FORMERLY --> spall with exposed rebar over the southbound bike lane (1 1/2" x 2" x 1/2")

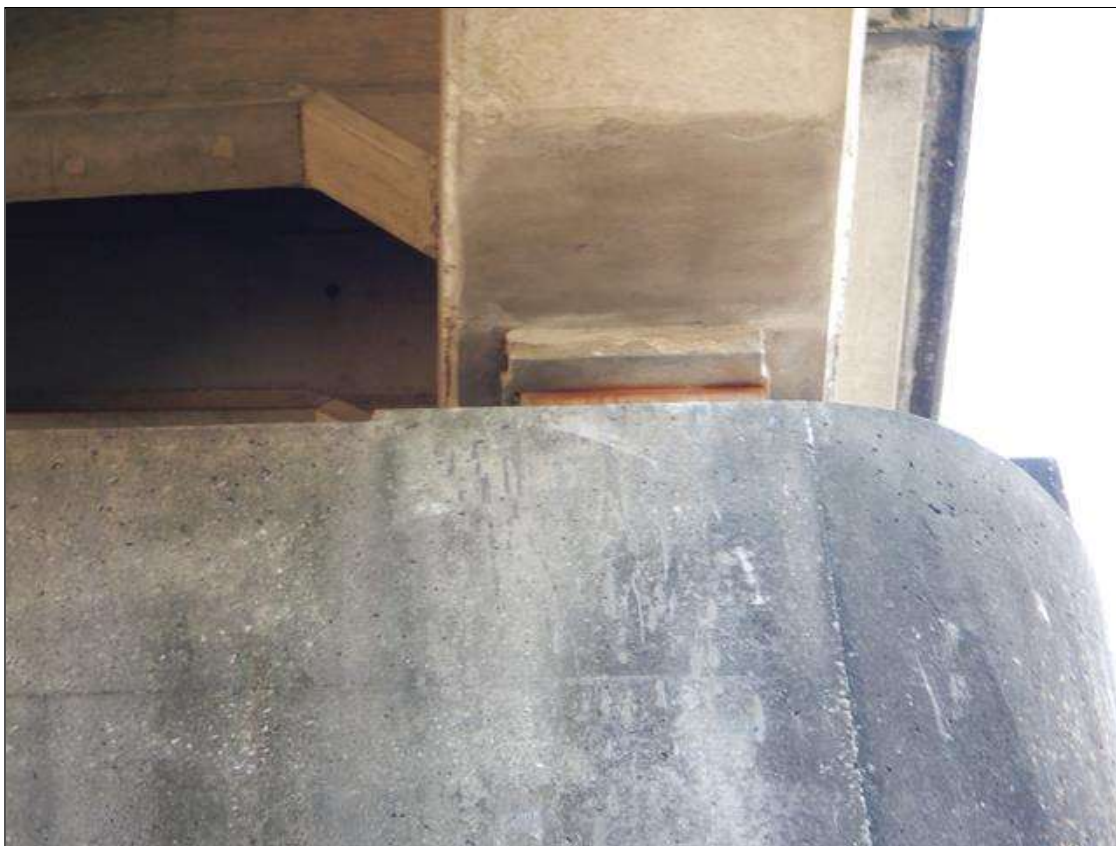
Span 29 Beam 1: [NEW REPAIR-PATCHING] FORMERLY --> spall with exposed rebar on the bottom face at bent 27
(3" x 3" x 1/8")

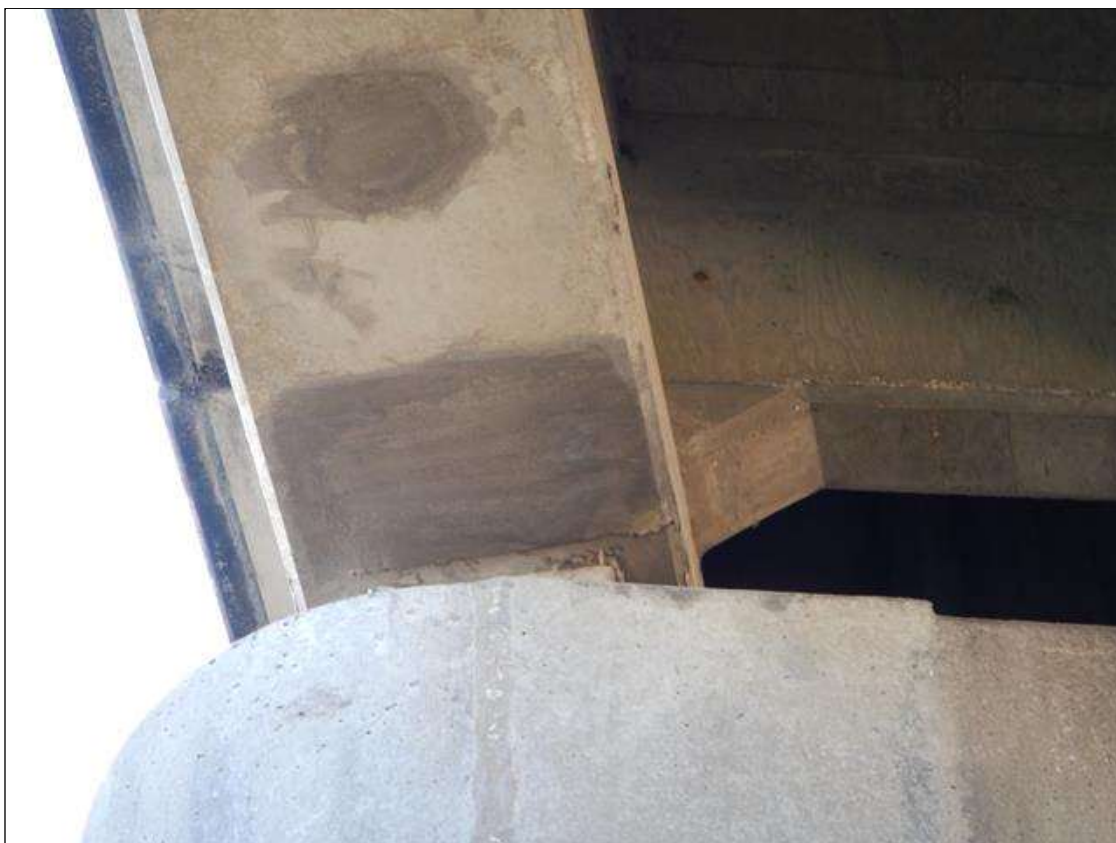
Span 29 Beam 1: [NEW REPAIR-PATCHING] FORMERLY --> spall with exposed rebar on the bottom face at bent 26
(11" x 6" x 1/2')

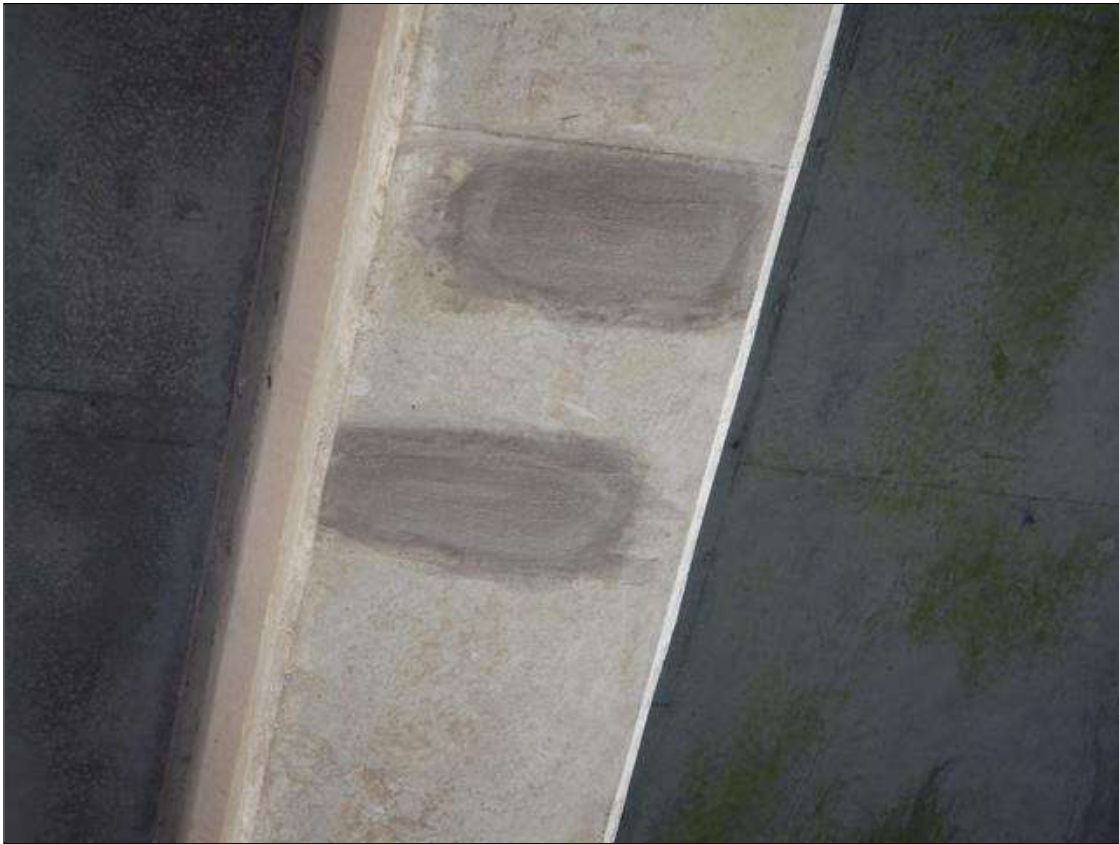
Span 29 Beam 2: [NEW REPAIR-PATCHING] FORMERLY --> spall with exposed rebar and unsound patch on the bottom face at 18ft and 20ft from Bent 27 (7" x 5" x 1/2") spall and (10" x 5") patch

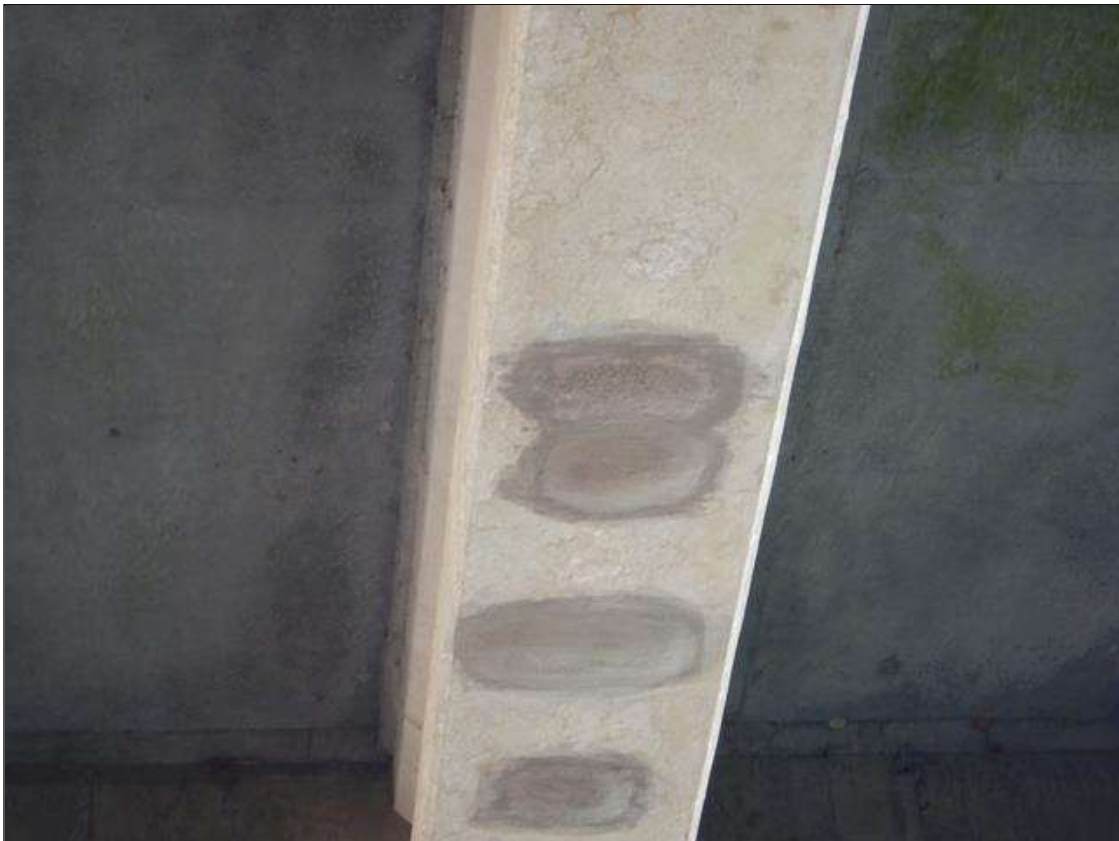
Span 29 Beam 2: [NEW REPAIR-PATCHING] FORMERLY --> (x2) spalls with exposed rebar on the bottom face at mid span up to (6" x 5" x 1/2")

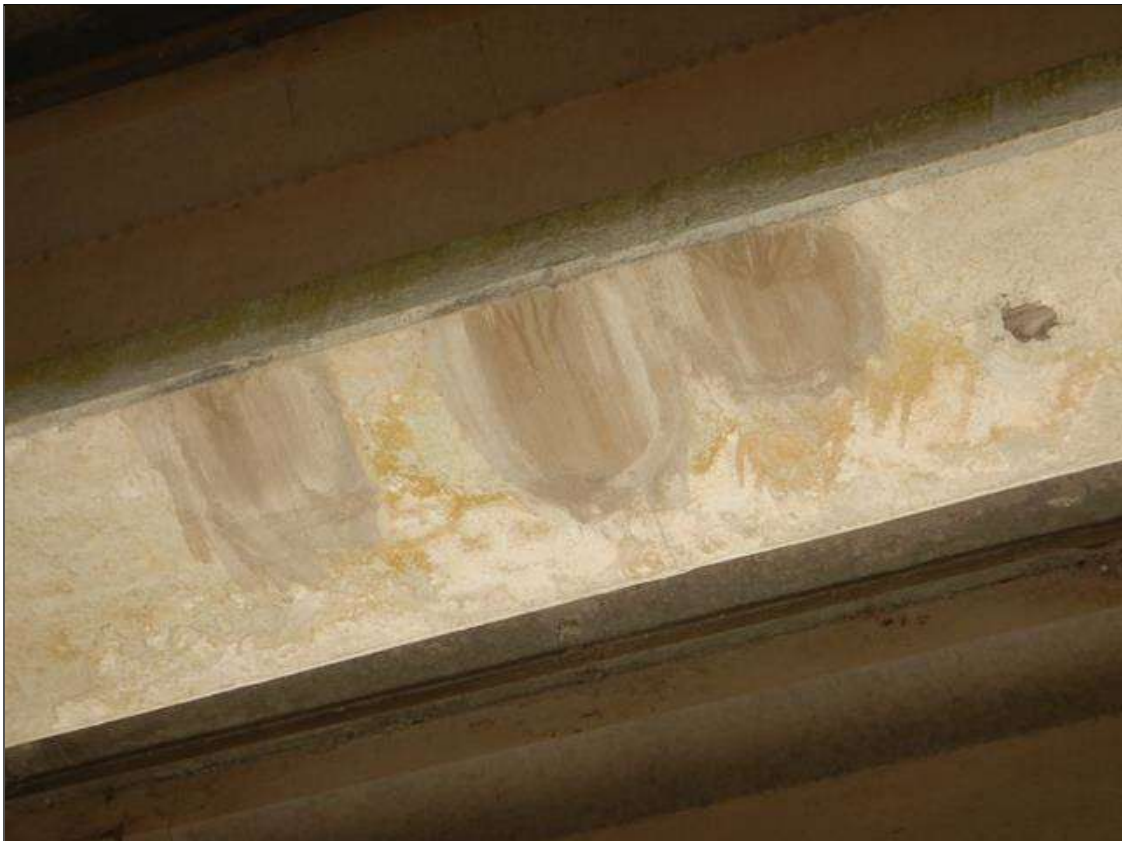
Span 29 Beam 7: [NEW REPAIR-PATCHING] FORMERLY --> (x3) spalls with exposed rebar on the bottom face at 17ft from Bent 27 up to (5" x 3" x 1/4")

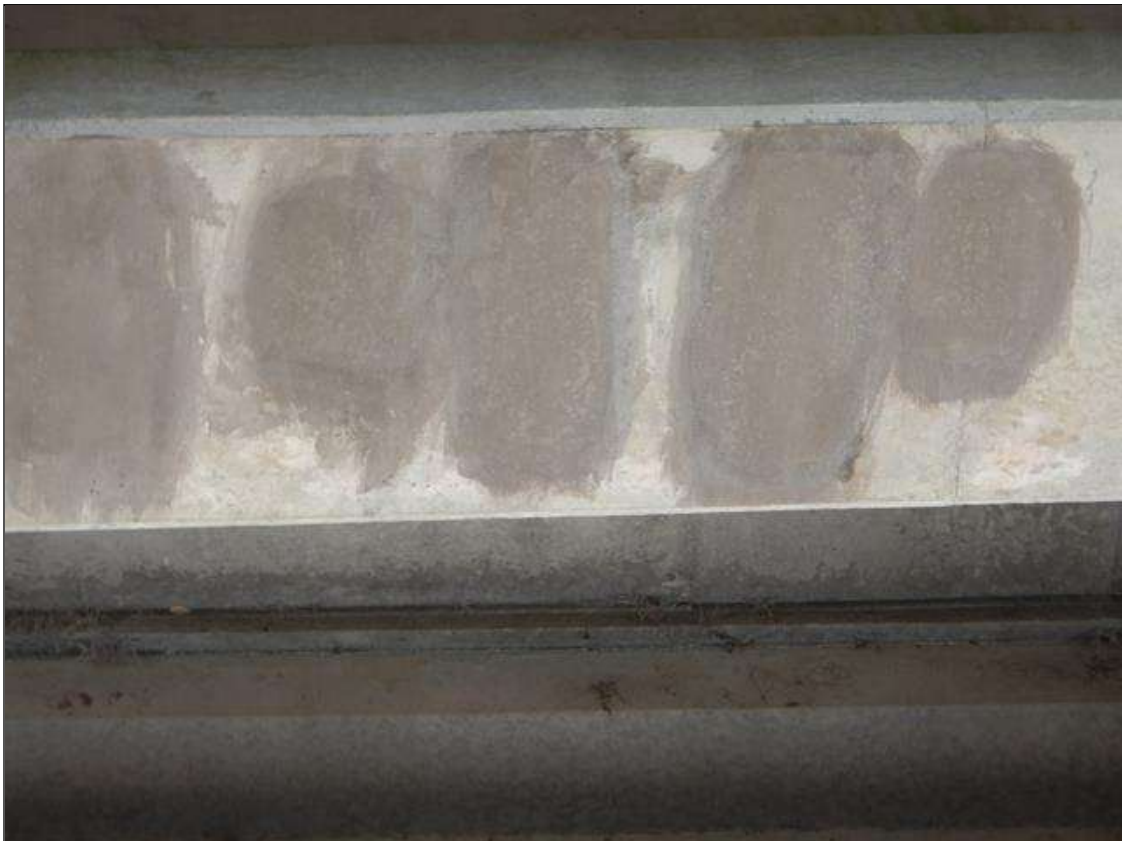
Span 29 Beam 7: [NEW REPAIR-PATCHING] FORMERLY --> (x2) spalls with exposed rebar on the bottom face at 23ft from Bent 27, (10" x 7") and (18" x 6")

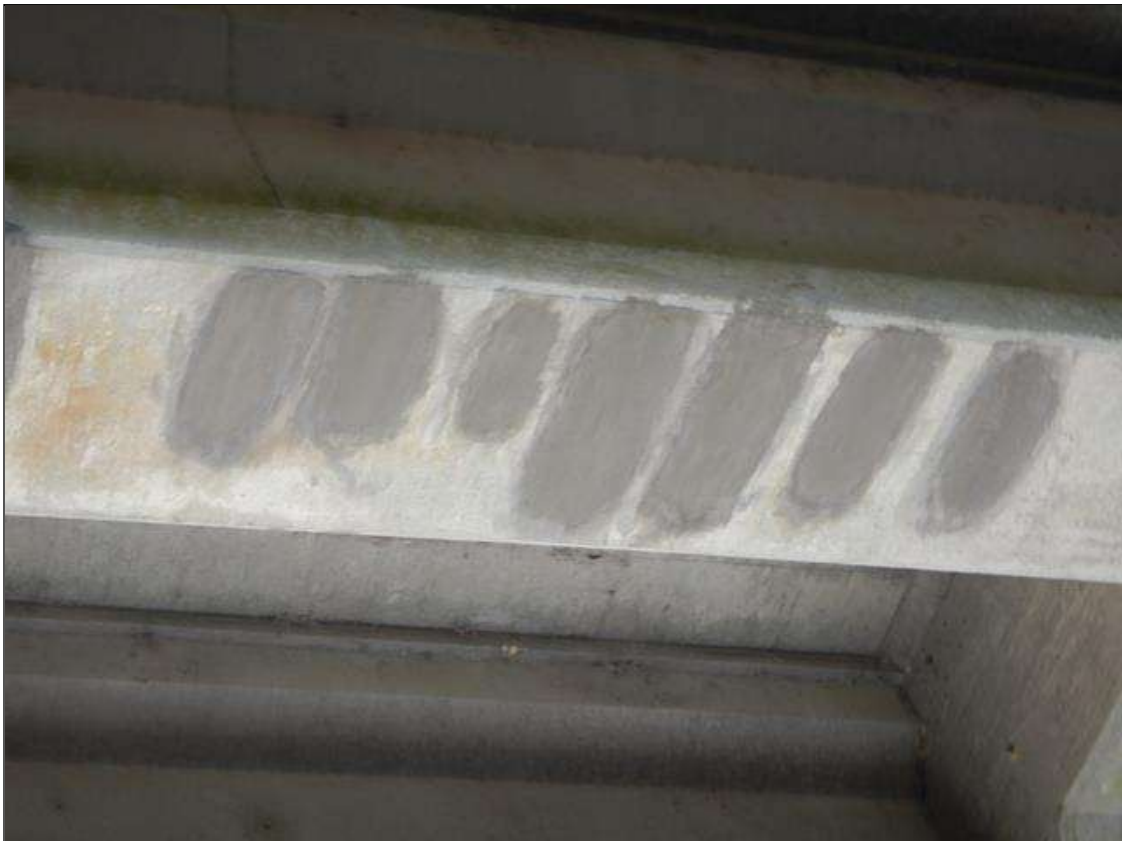
Span 29 Beam 7: [NEW REPAIR-PATCHING] FORMERLY --> spall with exposed rebar near large patched area near mid span (8" x 4" x 1/2")

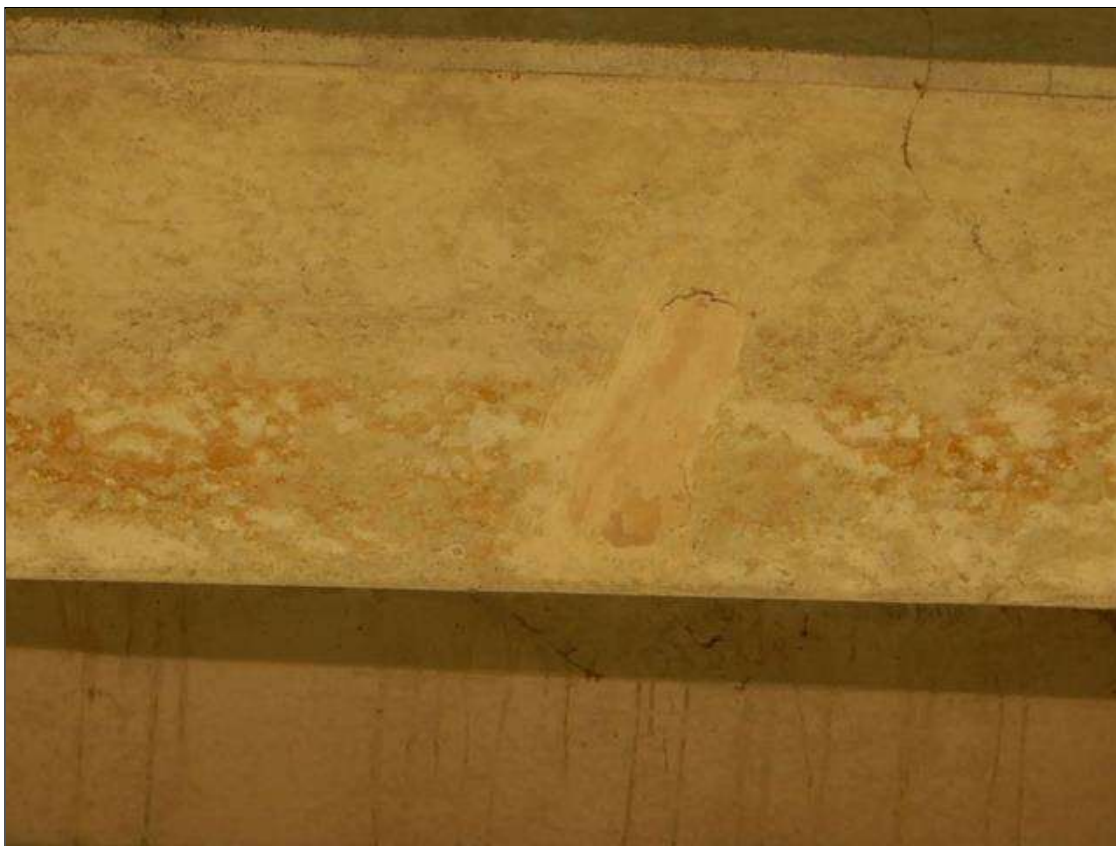
Span 29 Beam 10: (11" x 5") unsound patch on the bottom face near mid span

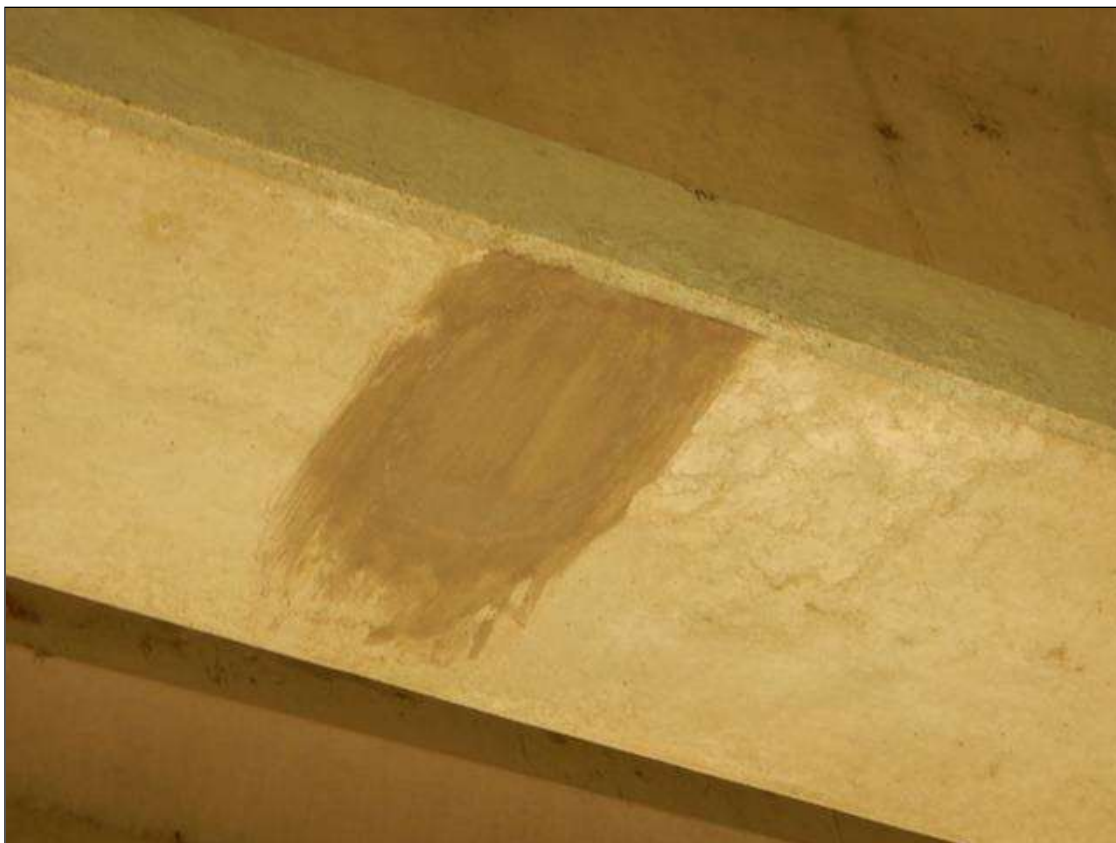
Span 29 Beam 11: [NEW REPAIR-PATCHING] FORMERLY --> spall with exposed rebar on the bottom face at 30ft from bent 27 (10" x 6" x 1/4")

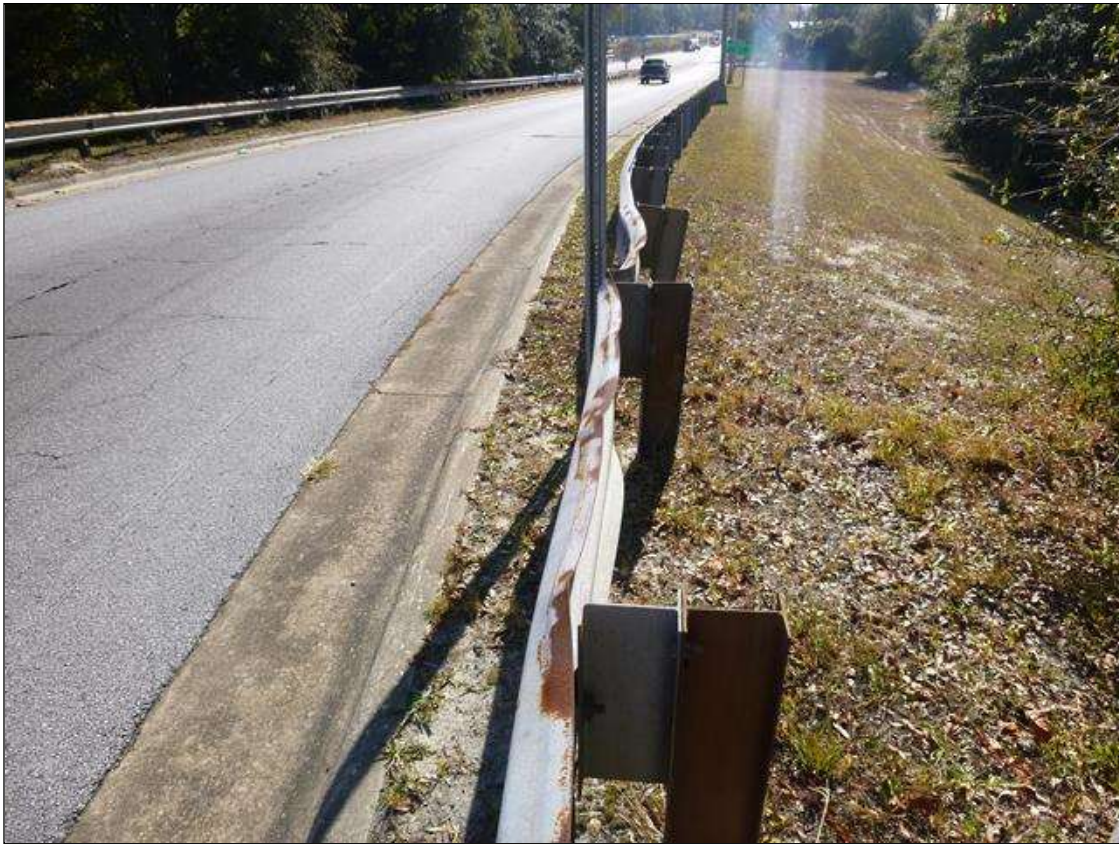
AT THE RAMP ABUTMENT SOUTHEAST CORNER GUARDRAIL, APPROXIMATELY 10' OUT FROM THE BRIDGE RAIL, DAMAGE WITH FLATTENED RAIL AND POSTS DEFLECTED UP TO 6" AT THE TOP [APPROXIMATELY 20' LONG AFFECTED]

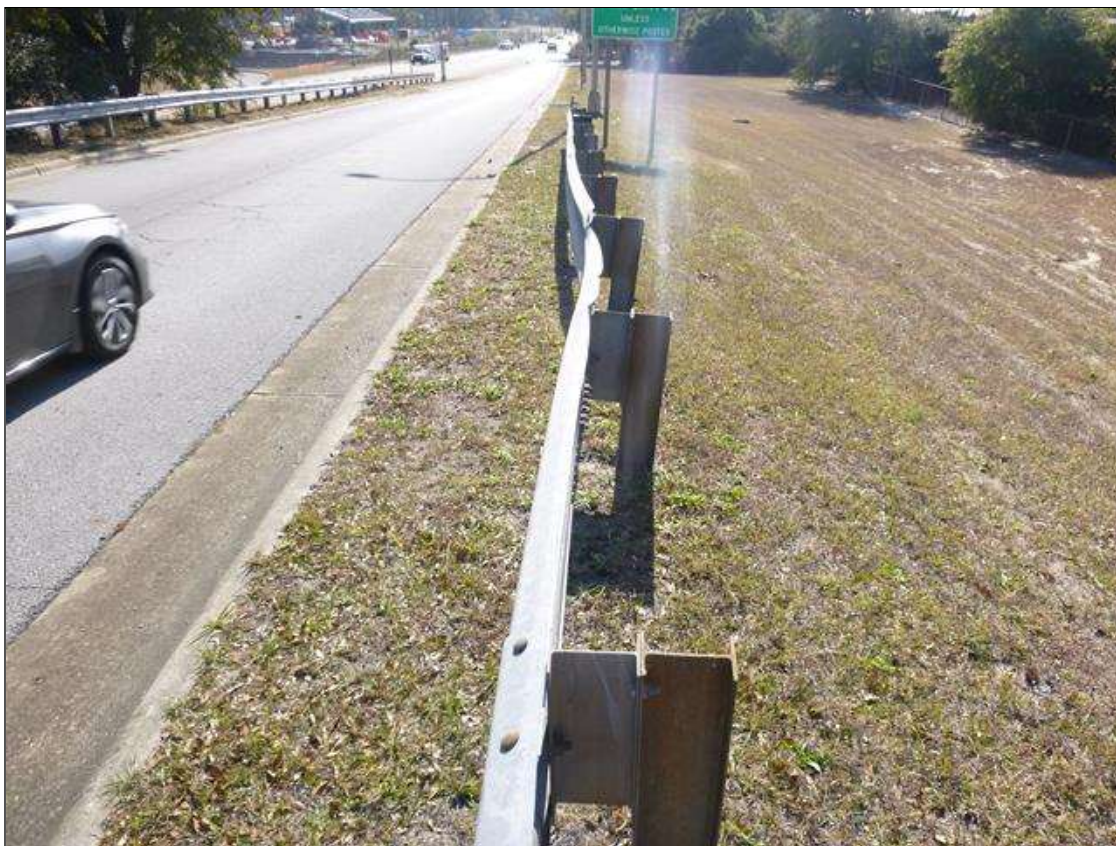
AT THE RAMP ABUTMENT SOUTHEAST CORNER GUARDRAIL, APPROXIMATELY 30' OUT FROM THE GUARDRAIL END, DAMAGE WITH FLATTENED RAIL AND POSTS DEFLECTED UP TO 6" AT THE TOP [APPROXIMATELY 18' LONG AFFECTED]

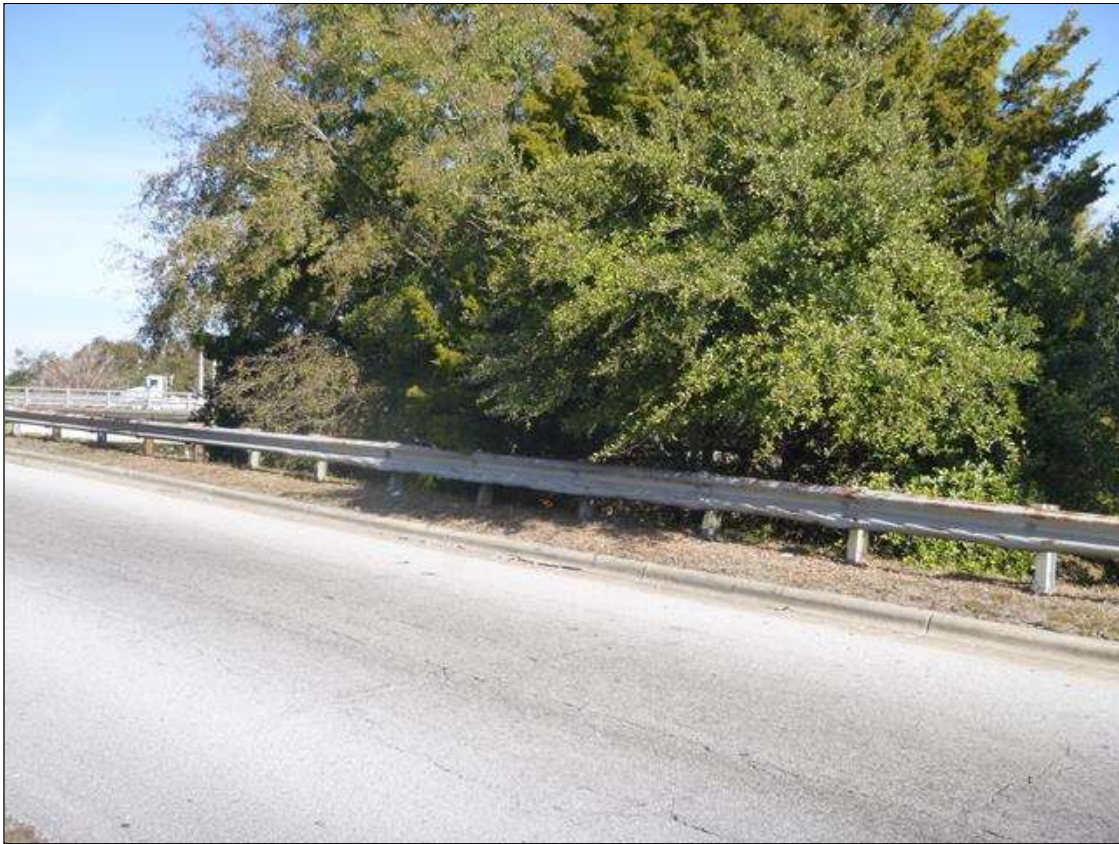
AT THE RAMP ABUTMENT NORTHEAST CORNER GUARDRAIL, SCATTERED ALONG THE LENGTH AND CONCENTRATED NEAR THE MIDDLE, DAMAGE WITH FLATTENED RAIL AND POSTS DEFLECTED UP TO 6" AT THE TOP [APPROXIMATELY 75' LONG AFFECTED]
