NC DEPARTMENT OF TRANSPORTATION
DIVISION OF HIGHWAYS
STRUCTURE MANAGEMENT UNIT

Structure Safety Report

Routine Element Inspection - Contract

DIVISION: 3 COUNTY: NEW HANOVER STRUCTURE NUMBER: 640013 FREQUENCY: 24 MONTHS

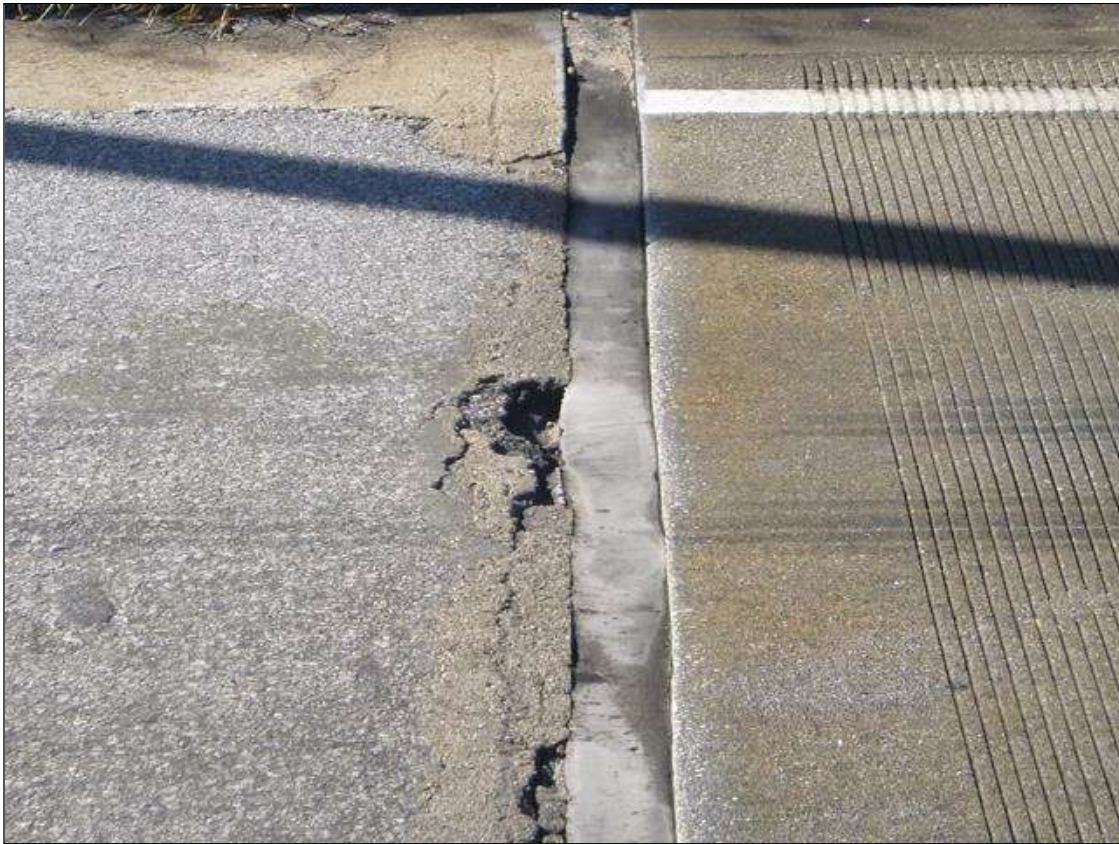
Span 35 - Ramp Span Expansion Joint: SCATTERED ALONG THE ADJACENT DECK HEADER, MAP CRACKING TO 1/4" WIDE WITH POPOFFS UP TO 8" LONG X 2" WIDE X UP TO 1.5" DEEP

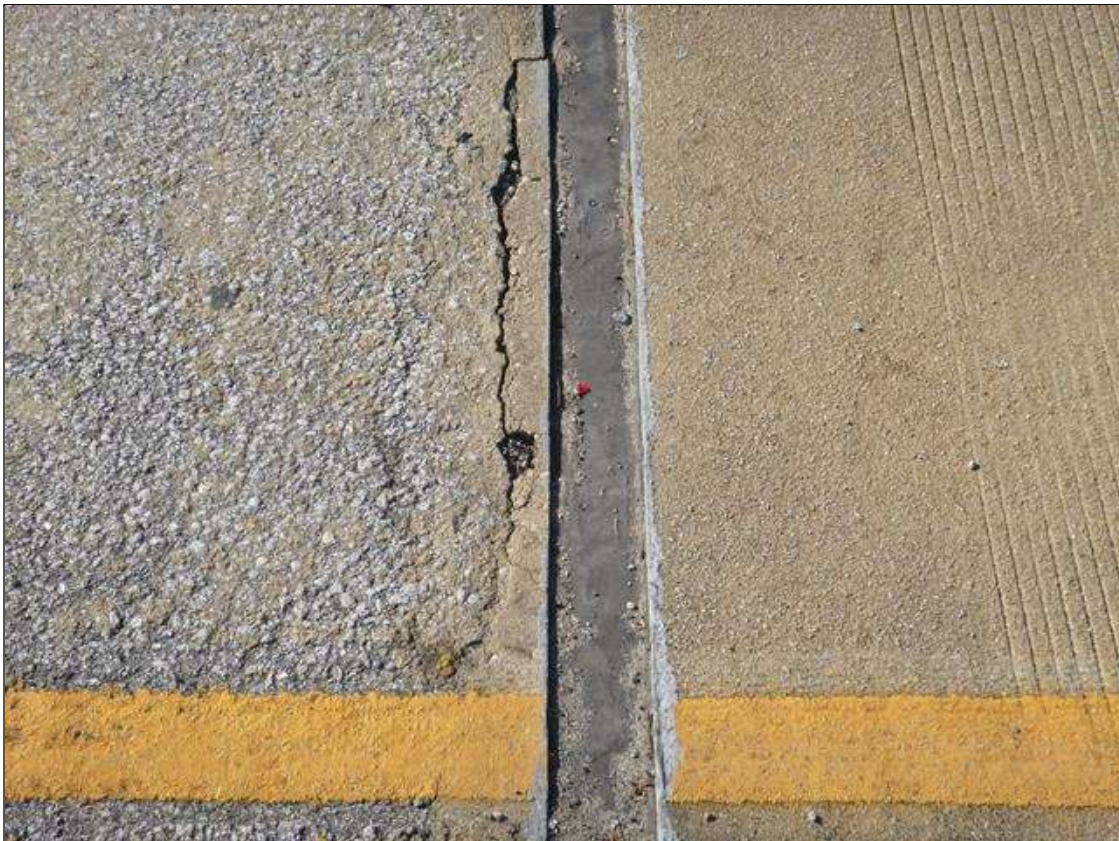
Span 35 - Ramp Span Expansion Joint: SCATTERED ALONG THE ADJACENT DECK HEADER, MAP CRACKING TO 1/4" WIDE WITH POPOFFS UP TO 8" LONG X 2" WIDE X UP TO 1.5" DEEP

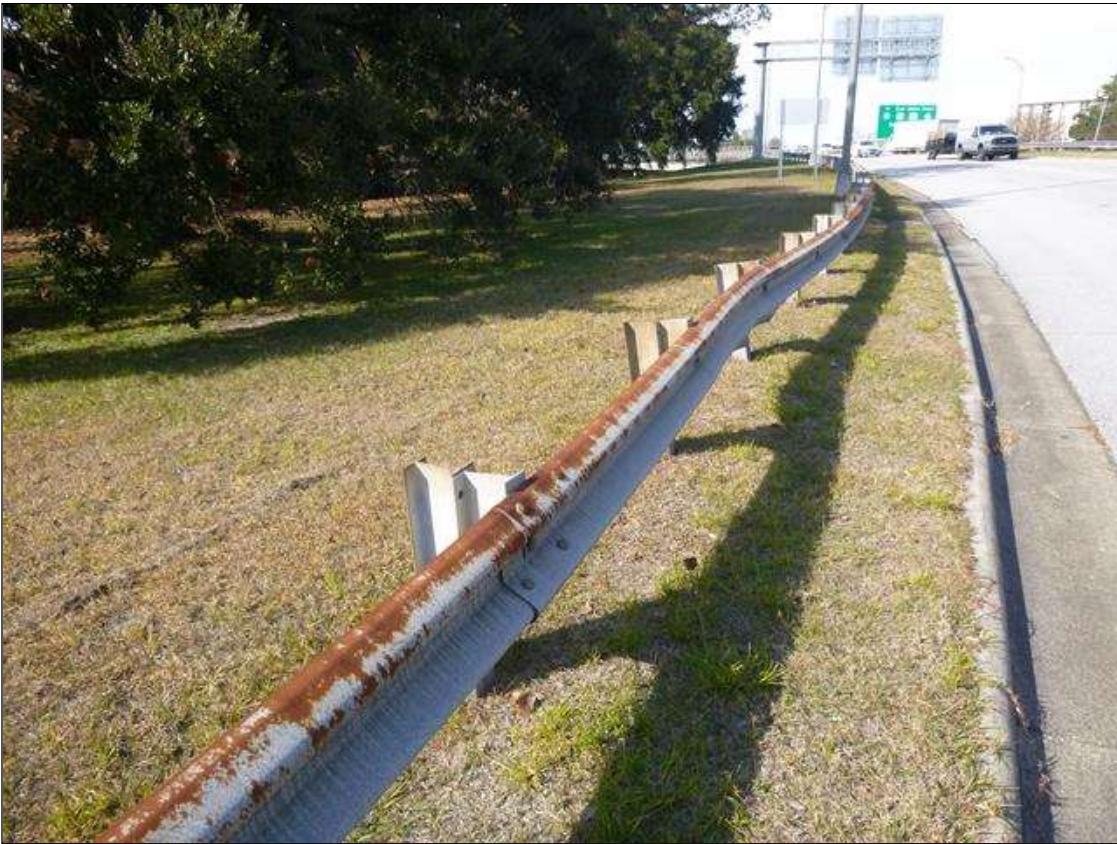
SOUTHEAST CORNER, THE GUARDRAIL HAS SCATTERED MINIMAL IMPACT DAMAGE ALONG THE LENGTH
[APPROXIMATELY 80' LONG AFFECTED]

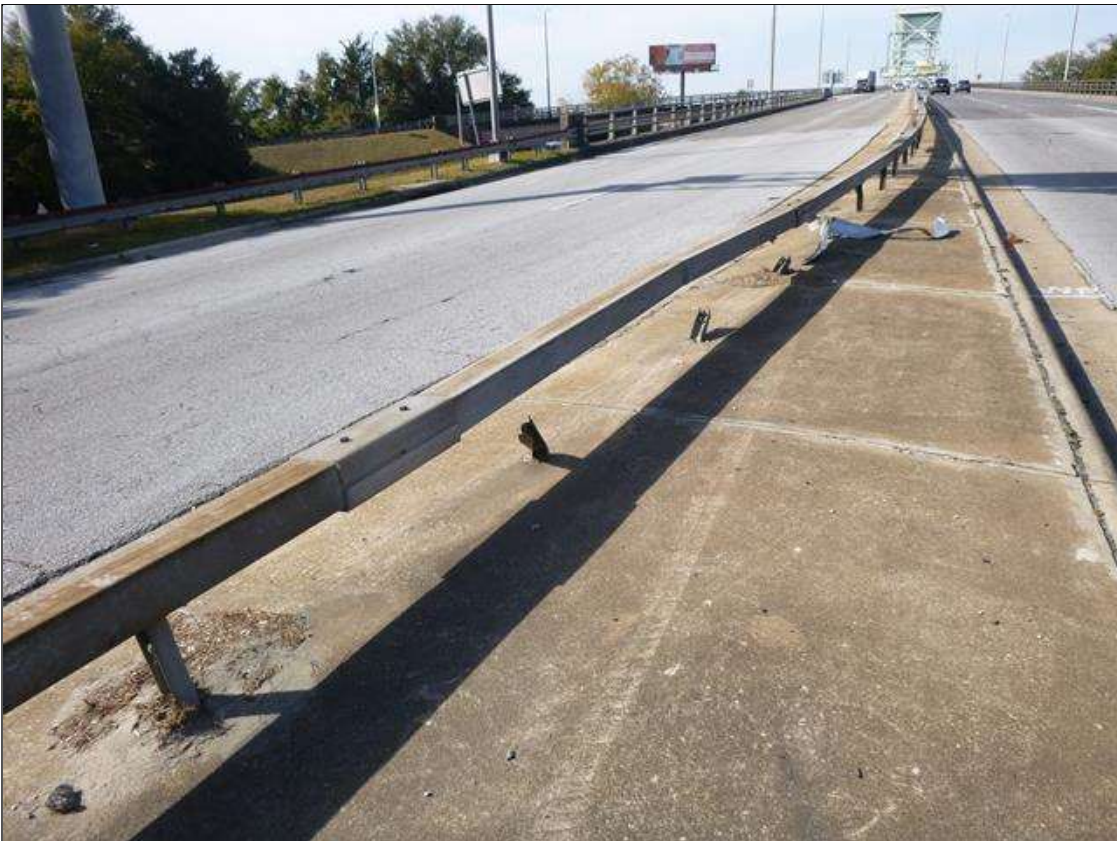
[PROMPT ACTION REQUEST] AT THE ABUTMENT 2 APPROACH, THE MEDIAN RAIL HAS IMPACT DAMAGE
WITH FIVE BROKEN POSTS

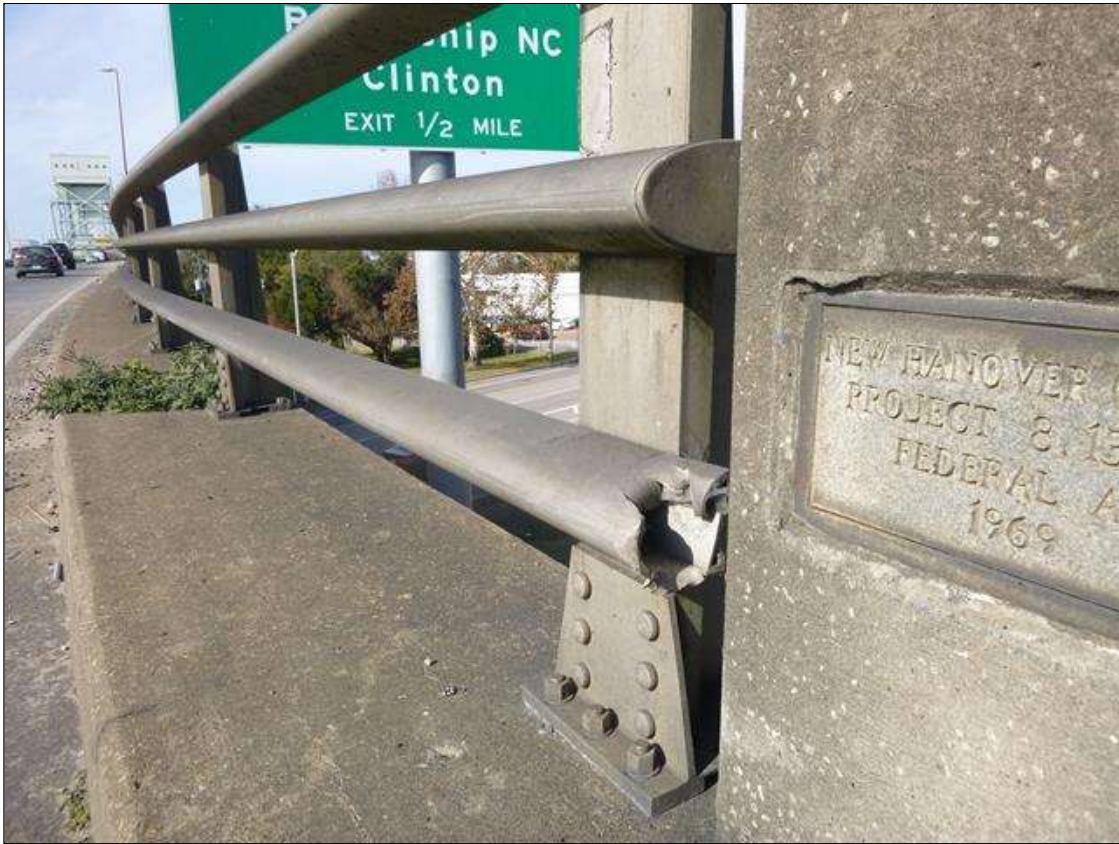
Span 32 Left Bridge Rail: damage to the bottom rail at End Bent 2

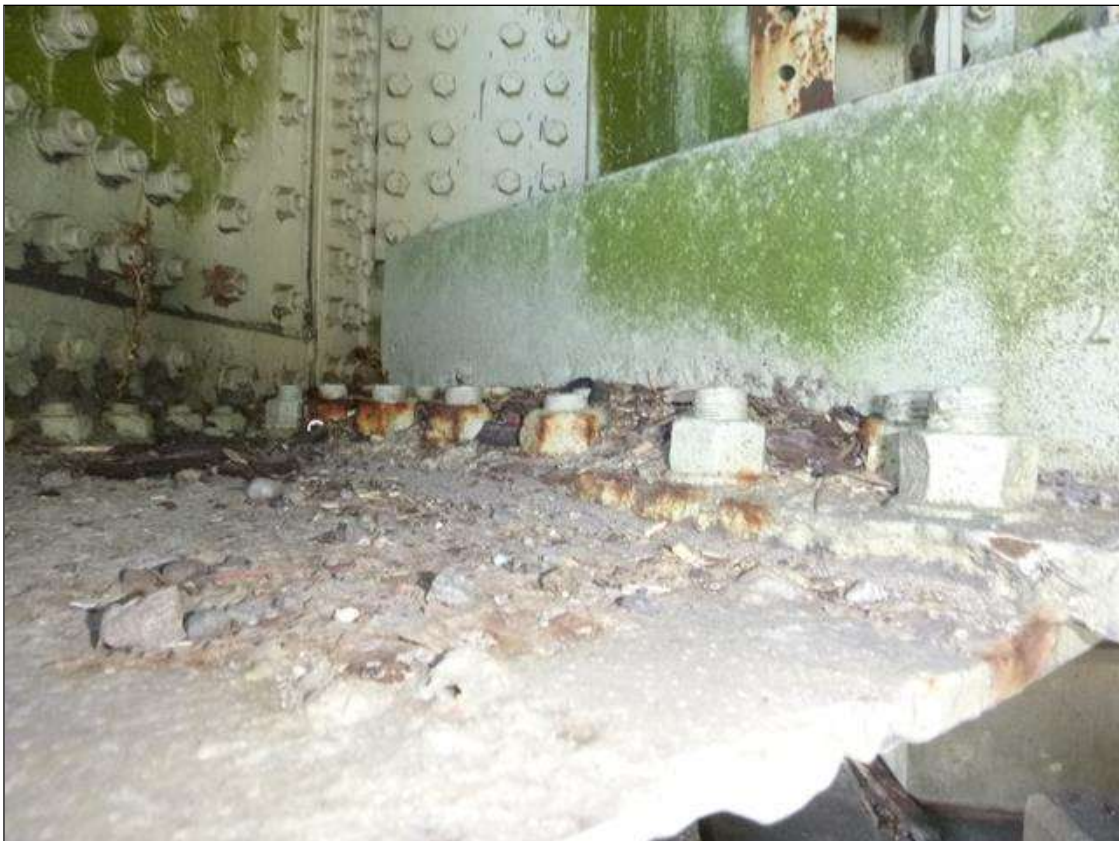
Span 18 Lift Span Floor Beam 12: LATERAL BRACING FROM FLOORBEAM 11 TO U12 AT U12 SURFACE RUST ON BOLTS.

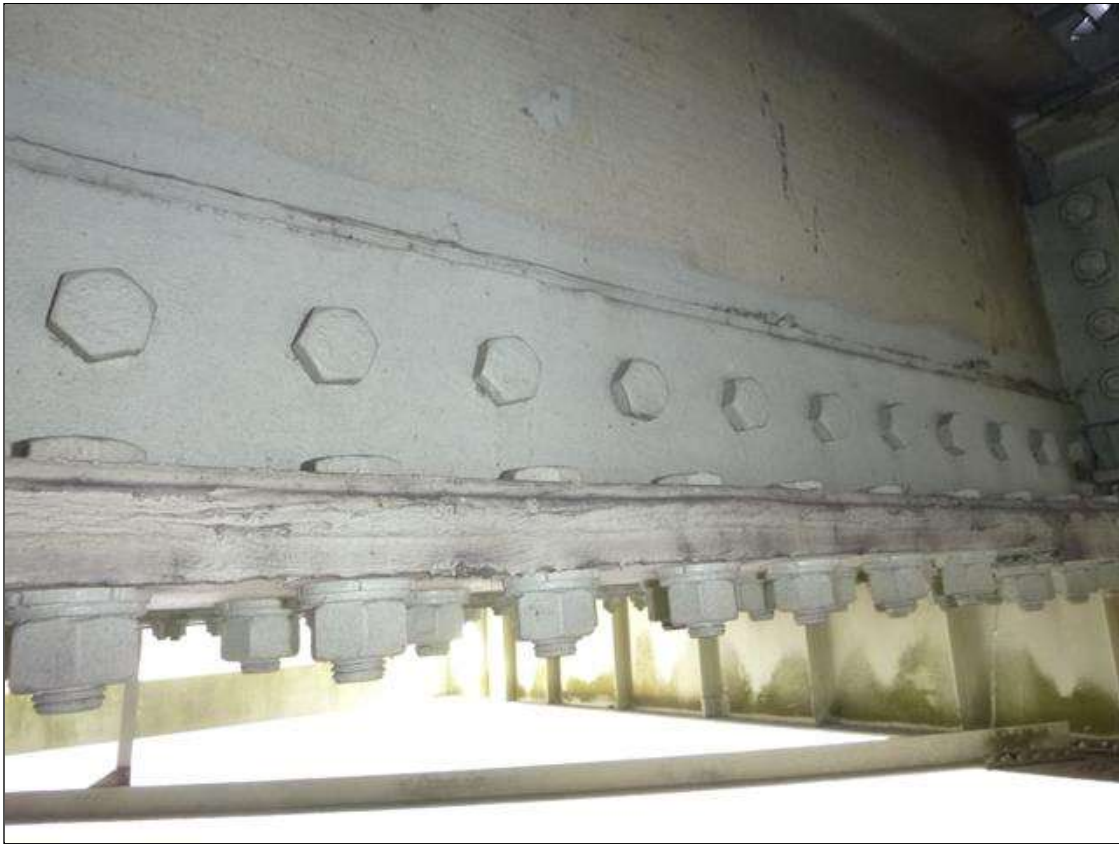
Span 18 Lift Span Stringer 7: REPAIR OBSERVED IN 2021 INSPECTION 6" X 4" X 3/8" THICK ANGLE AND 9" WIDE X 1/2" THICK PLATE HAS BEEN BOLTED TO BOTH SIDES OF THE WEB AND BOTTOM FLANGE, FULL LENGTH, 2020 INSPECTION REPORT HAD BETWEEN FB's 11-12 - PITTED AREA IN WEB ON SOUTH SIDE AT BOTTOM FLANGE AT FB 11 CONNECTION UP TO 3"LONG x 4"HIGH x 3/16"DEEP- CLEANED AND PAINTED

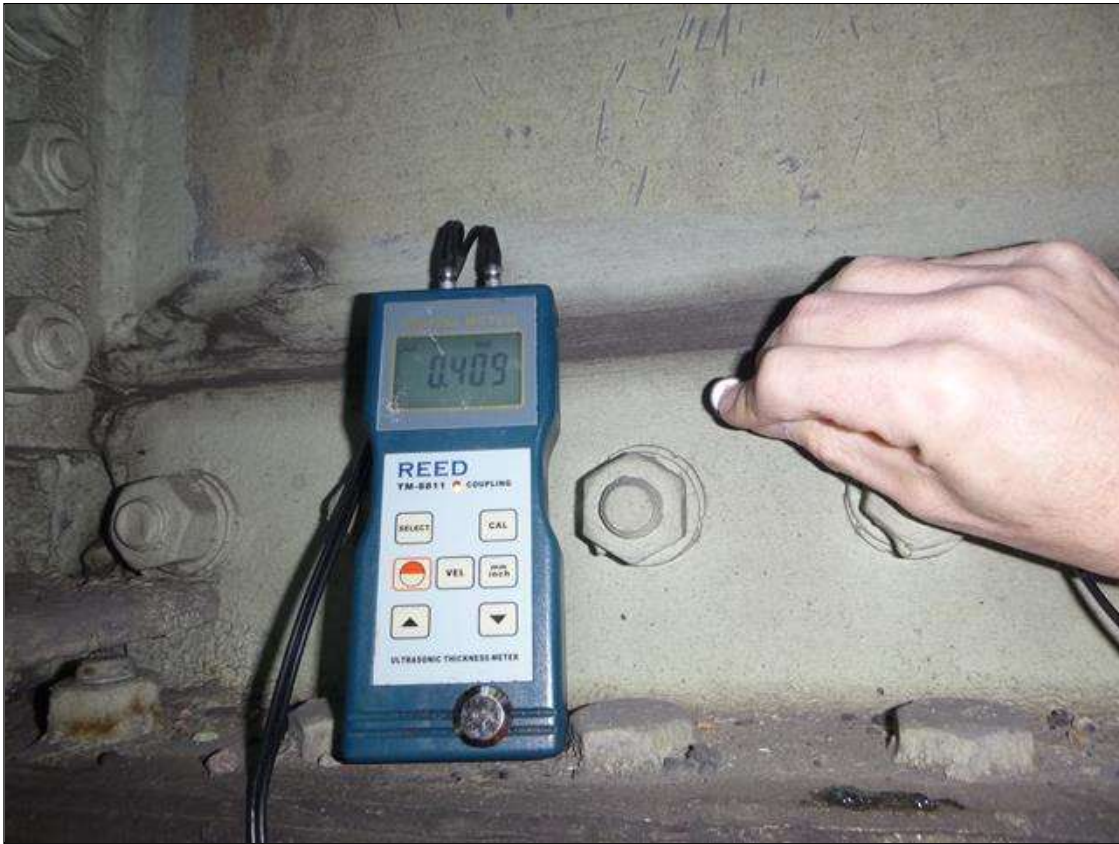
Span 18 Lift Span Stringer 2: REPAIR OBSERVED IN 2020 INSP: BETWEEN FB 11 - 12, REPAIR TO THE BOTTOM FLANGE AND LOWER WEB, 30 FOOT. LONG. 6" X 4" X 3/8" THICK ANGLE HAS BEEN BOLTED TO BOTH SIDES OF THE WEB. A 9" WIDE X 1/2" THICK PLATE HAS BEEN BOLTED TO THE BOTTOM FLANGE IN THE SAME AREA. A 5" X 3.5" X 3/8" THICK ANGLE HAS BEEN WELDED TO BOTH SIDES OF THE TOP FLANGE AND WEB, 2018 REPORT HAD BETWEEN FB's 11-12 - PITTED AREAS UP TO 1/4" DEEP SCATTERED THROUGHOUT TOP OF BOTTOM FLANGE ON NORTH AND SOUTH SIDES - CLEANED AND PAINTED.

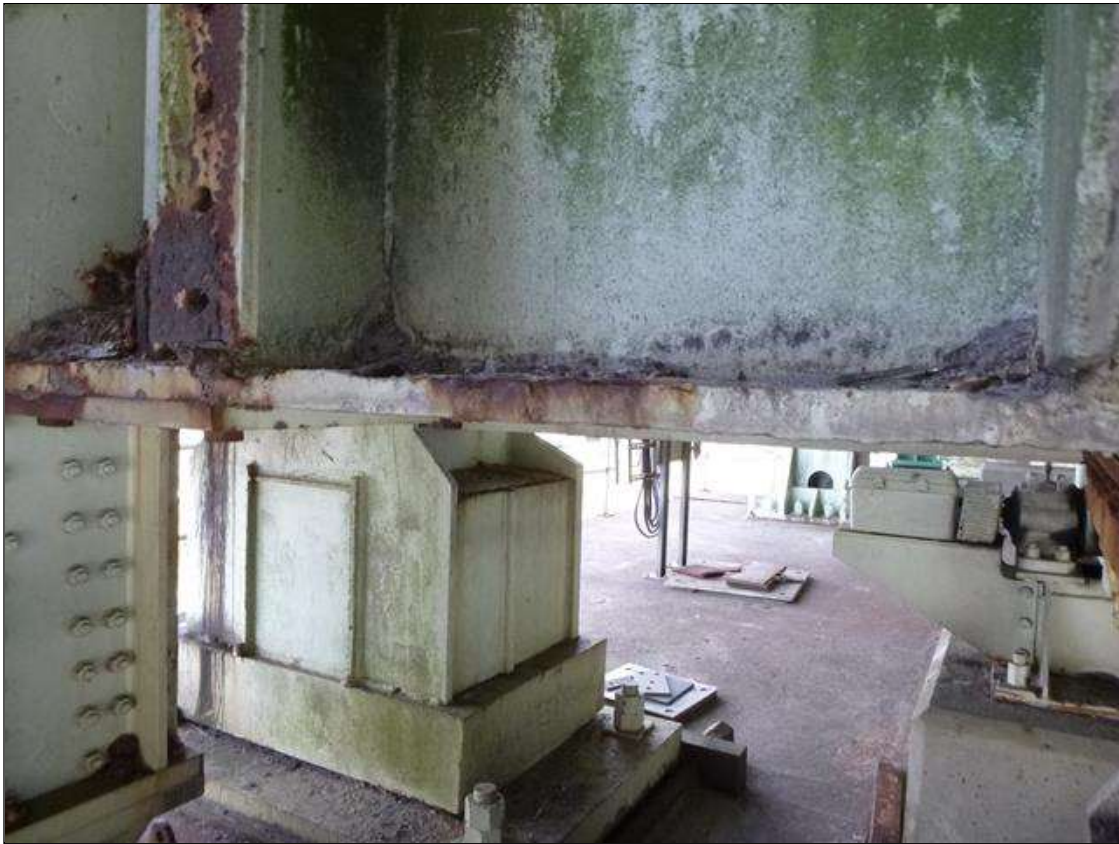
Span 18 Lift Span Floor Beam 12: (PAR) LOSS OF SECTION .341" WITH .967" REMAINING BOTTOM WEST FLANGE, 4' LONG X 2.5" WIDE BEGINING 2' LEFT OF NORTHEAST BEARING.

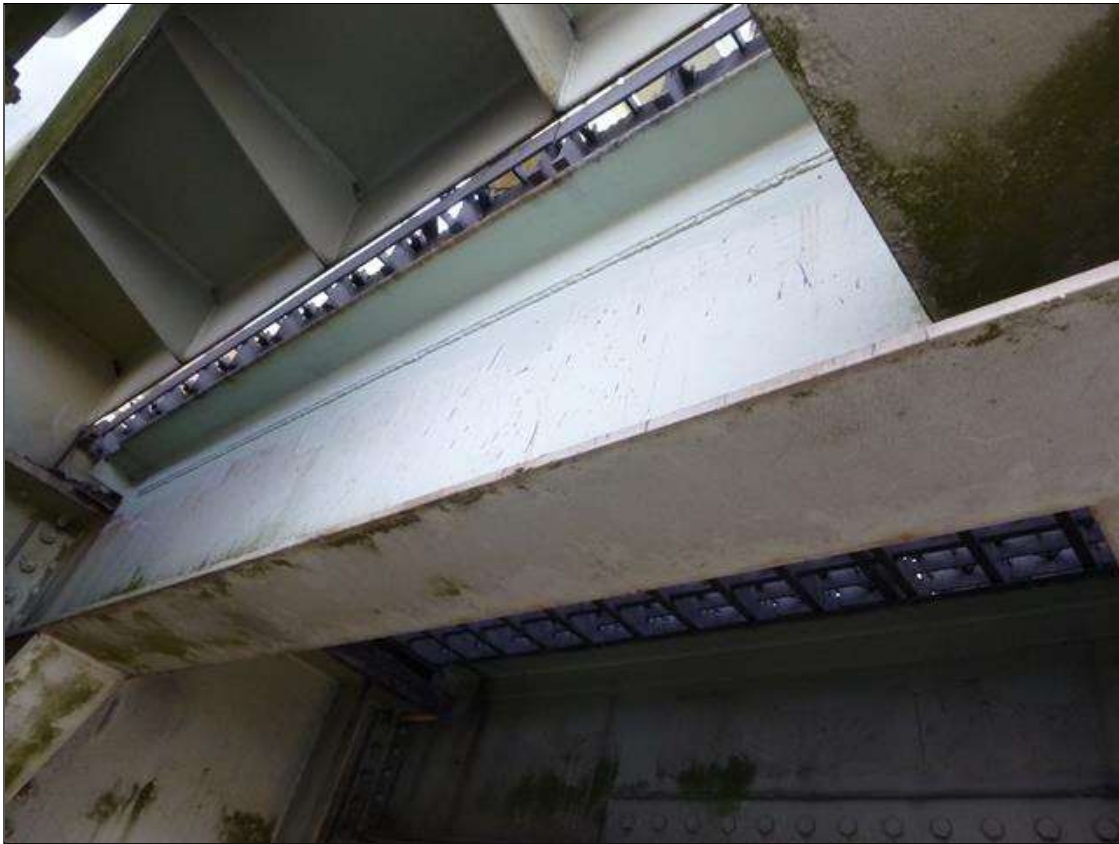
Span 18 Lift Span Stringer 1: REPAIR OBSERVED IN 2021 INSPECTION BETWEEN FB 11 - 12, BEGINNING AT FLOORBEAM 12 FOR 7.5' A 5" X 3.5" X 3/8" THICK ANGLE HAS BEEN WELDED TO BOTH SIDES OF THE TOP FLANGE AND WEB, 2018 REPORT HAD BETWEEN FB's 11-12 - SECTION LOSS TO KNIFE EDGE IN AREAS UP TO 2-1/2"WIDE x 6"LONG SCATTERED ALONG NORTH AND SOUTH SIDES OF TOP FLANGE - UP TO 1" REDUCTION IN FLANGE WIDTH AT SOME LOCATIONS - CLEANED AND PAINTED

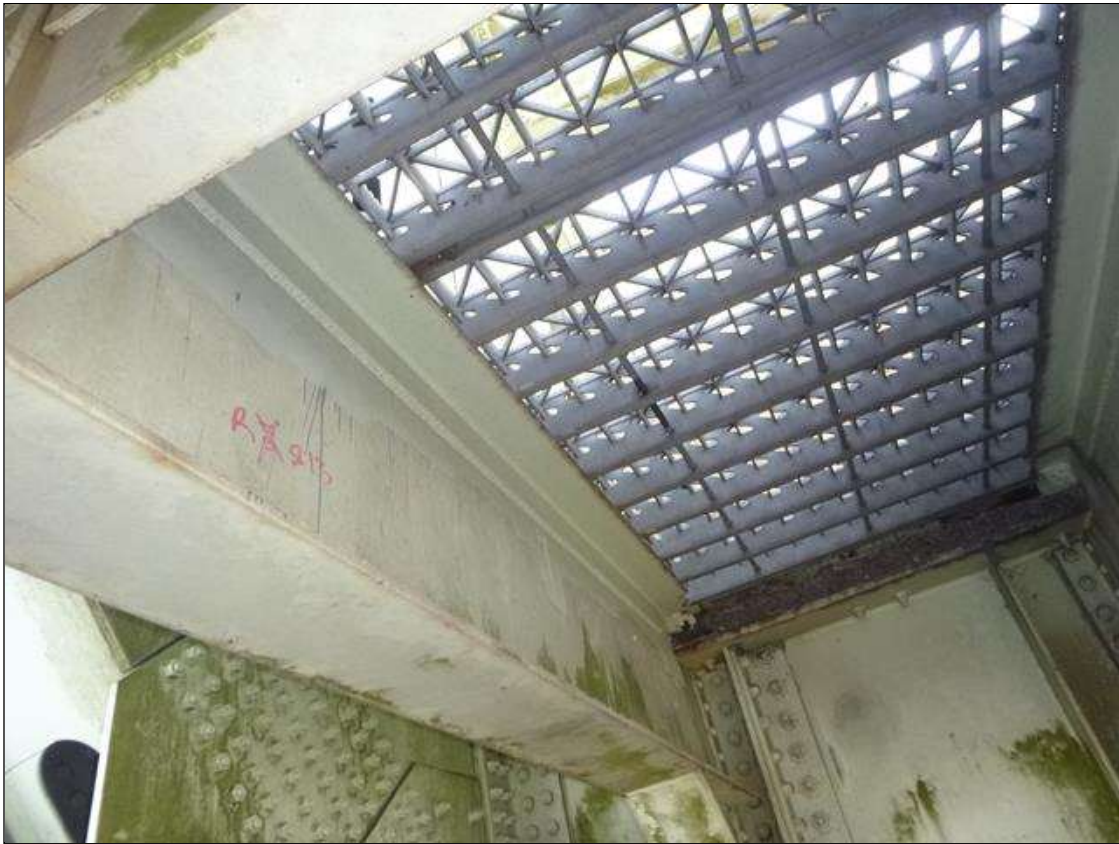
Span 18 Lift Span Stringer 1: REPAIR OBSERVED IN 2021 INSPECTION BETWEEN FB 11 - 12, BEGINNING AT FLOORBEAM 12 FOR 7.5' A 5" X 3.5" X 3/8" THICK ANGLE HAS BEEN WELDED TO BOTH SIDES OF THE TOP FLANGE AND WEB, 2018 REPORT HAD BETWEEN FB's 11-12 - SECTION LOSS TO KNIFE EDGE IN AREAS UP TO 2-1/2"WIDE x 6"LONG SCATTERED ALONG NORTH AND SOUTH SIDES OF TOP FLANGE - UP TO 1" REDUCTION IN FLANGE WIDTH AT SOME LOCATIONS - CLEANED AND PAINTED

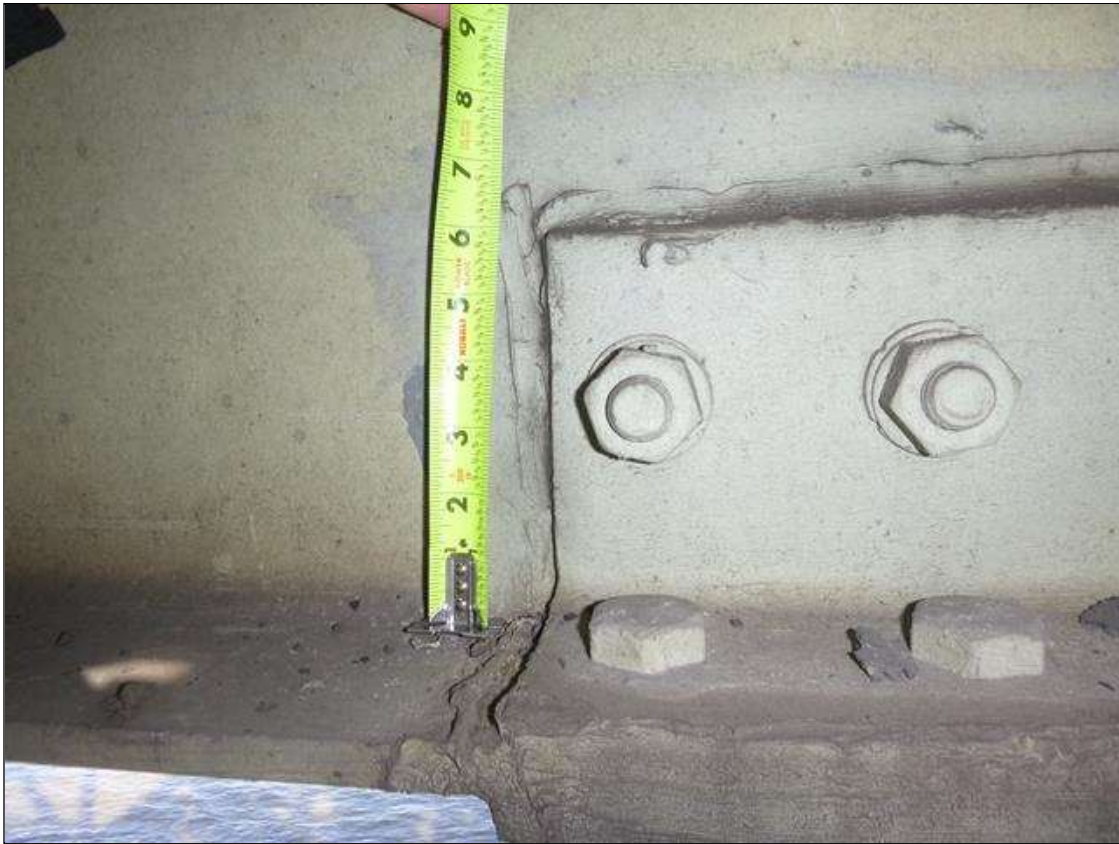
Span 18 Lift Span Stringer 3: REPAIR OBSERVED IN 2020 INSP: BETWEEN FB 10 - 11, REPAIR TO THE BOTTOM FLANGE AND LOWER WEB, 9 FOOT. LONG. 6" X 4" X 3/8" THICK ANGLE HAS BEEN BOLTED TO BOTH SIDES OF THE WEB. A 9" WIDE X 1/2" THICK PLATE HAS BEEN BOLTED TO THE BOTTOM FLANGE IN THE SAME AREA STARTING AT FB 11.

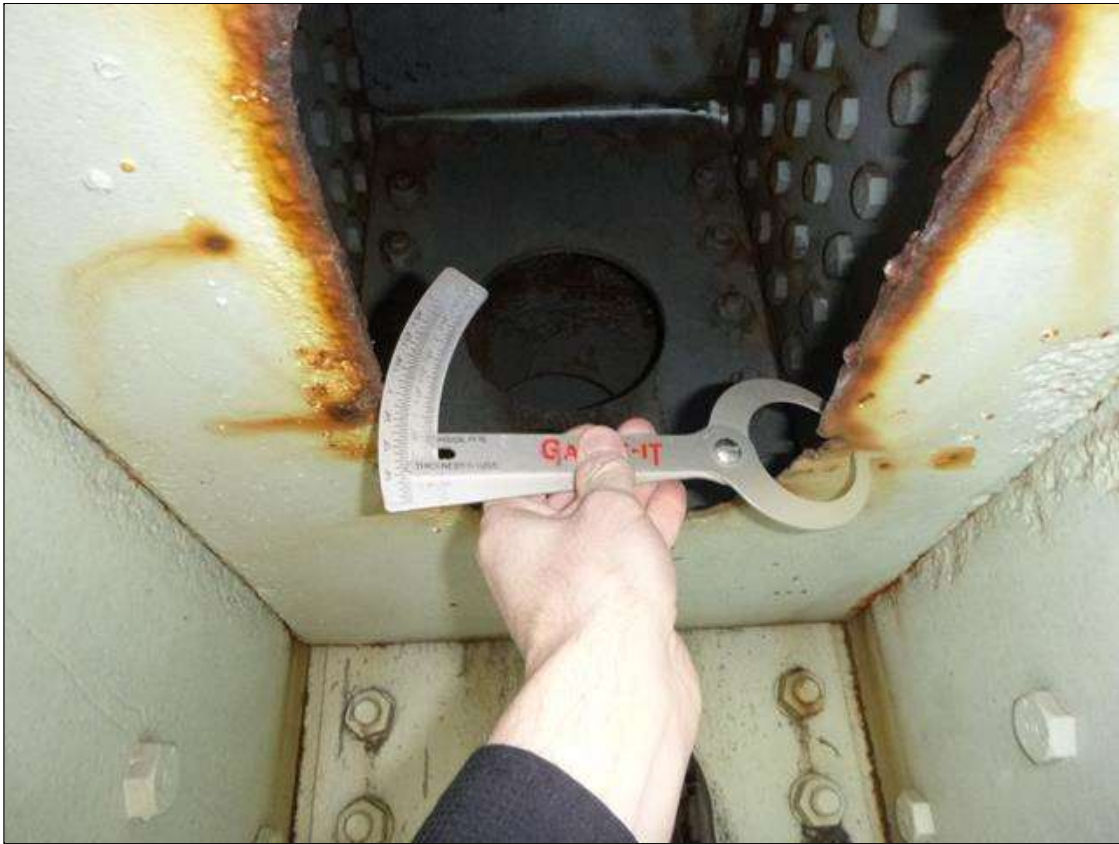
Span 18 Lift Span L11L12 NORTH: OBSERVED IN 2020 INSP: 2" WIDE SECTION AROUND BOTTOM PORTAL AT L12 REDUCED TO 1/16" WIDE/ 100% LOSS TO 1" AREAS AT EDGE - ACTIVE CORROSION PRESENT, PAR ISSUED.

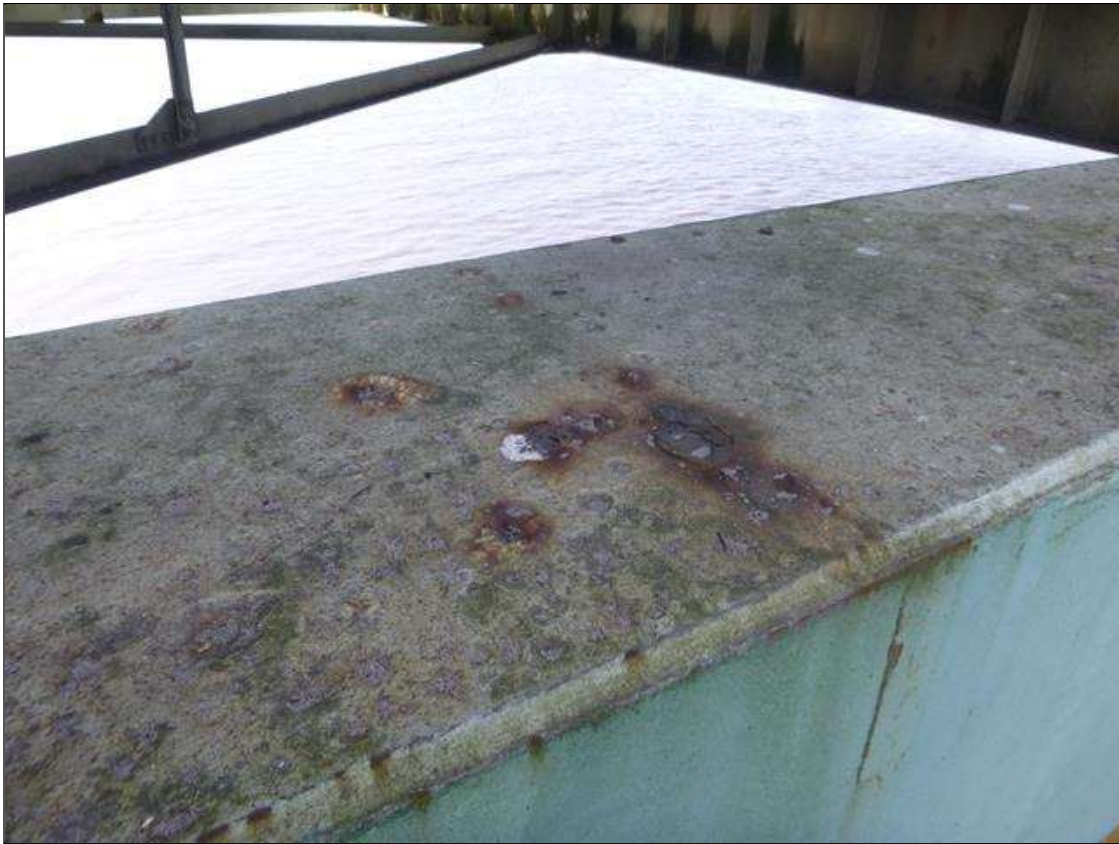
Span 18 Lift Span L11L12 NORTH: OBSERVED IN 2020 INSP: PITTED AREAS UP TO 2" IN DIAMETER x 1/4" DEEP SCATTERED THROUGHOUT TOP OF CHORD - ACTIVE CORROSION PRESENT IN SOME OF THESE AREAS, PAR ISSUED.

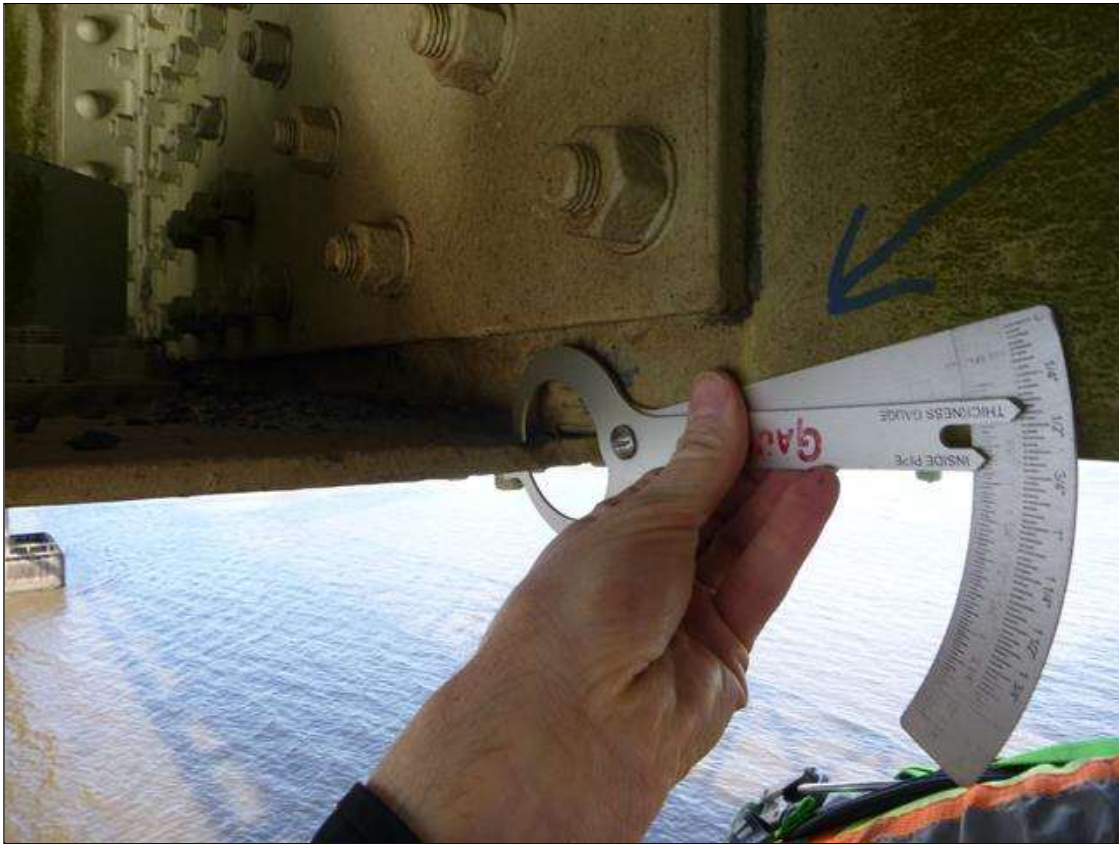
Span 18 Lift Span L10 NORTH: BOTTOM LATERAL GUSSET AT L10 NORTH- 1" WIDE X 4" LONG AREA ON EAST SIDE AT BOTTOM CHORD HAS 1/4" SECTION LOSS WITH 1/4" REMAINING, PAR ISSUED.

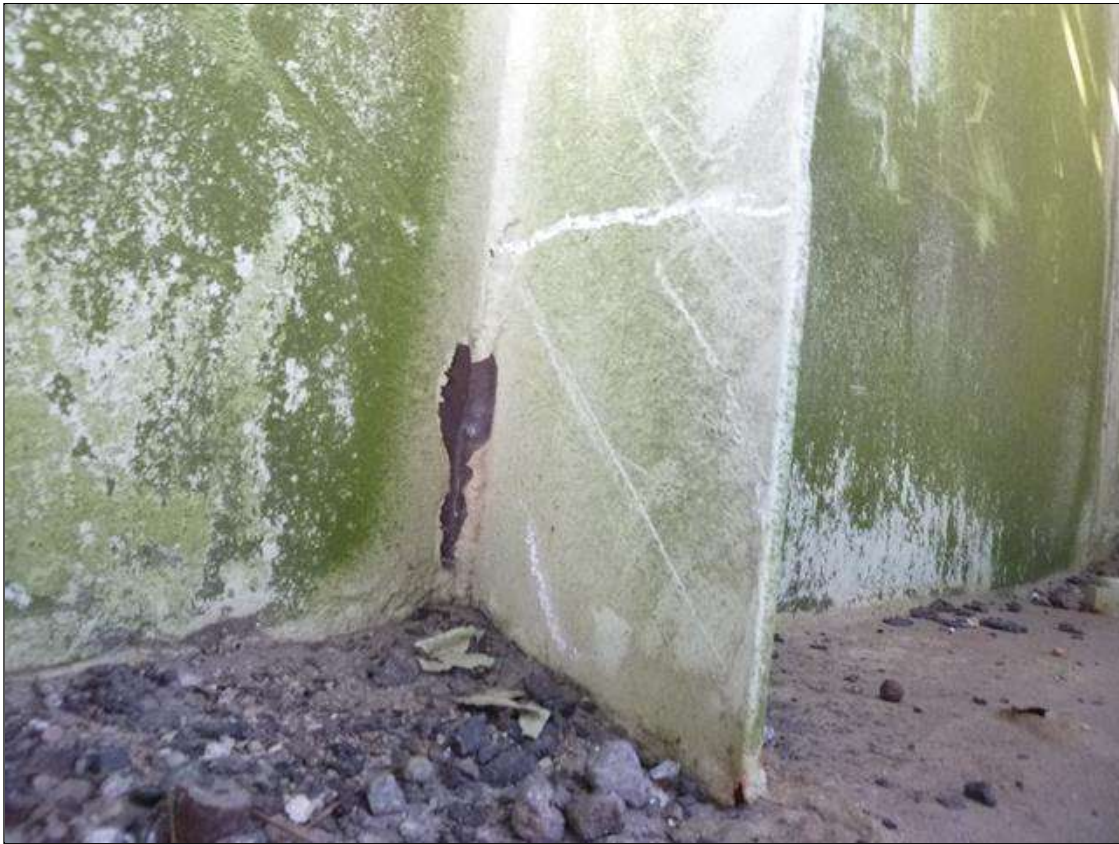
Span 18 Lift Span Floor Beam 10: REPAIR OBSERVED IN 2021 INSP: STIFFENER 1 HAS BEEN REPAIRED FROM THE BOTTOM UP 7" HIGH. 2020 REPORT HAD VERTICAL STIFFENER 1 EAST - 3" HIGH PITTED AREA AT BOTTOM FLANGE WIDE/ ~1/2" DIAMETER HOLES AT EDGES - 1/16" TO 1/8" REMAINING SECTION IN LOWER 1" OF AREA - PROMPT ACTION REQUEST

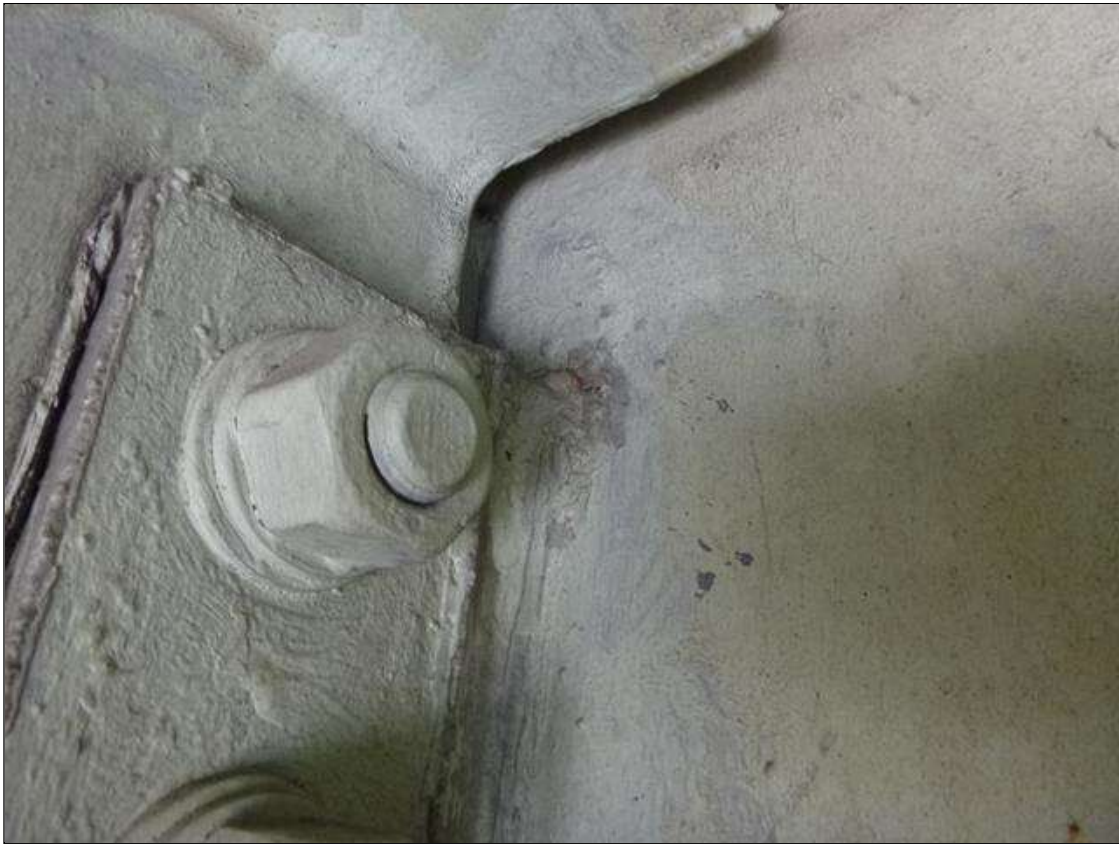
Span 18 Lift Span Stringer 5: BETWEEN FB's 9-10 - CRACK PROPAGATED 1/2" PAST ARREST HOLE AT TOP OF DIAPHRAGM CONNECTION – PROMPT ACTION REQUEST

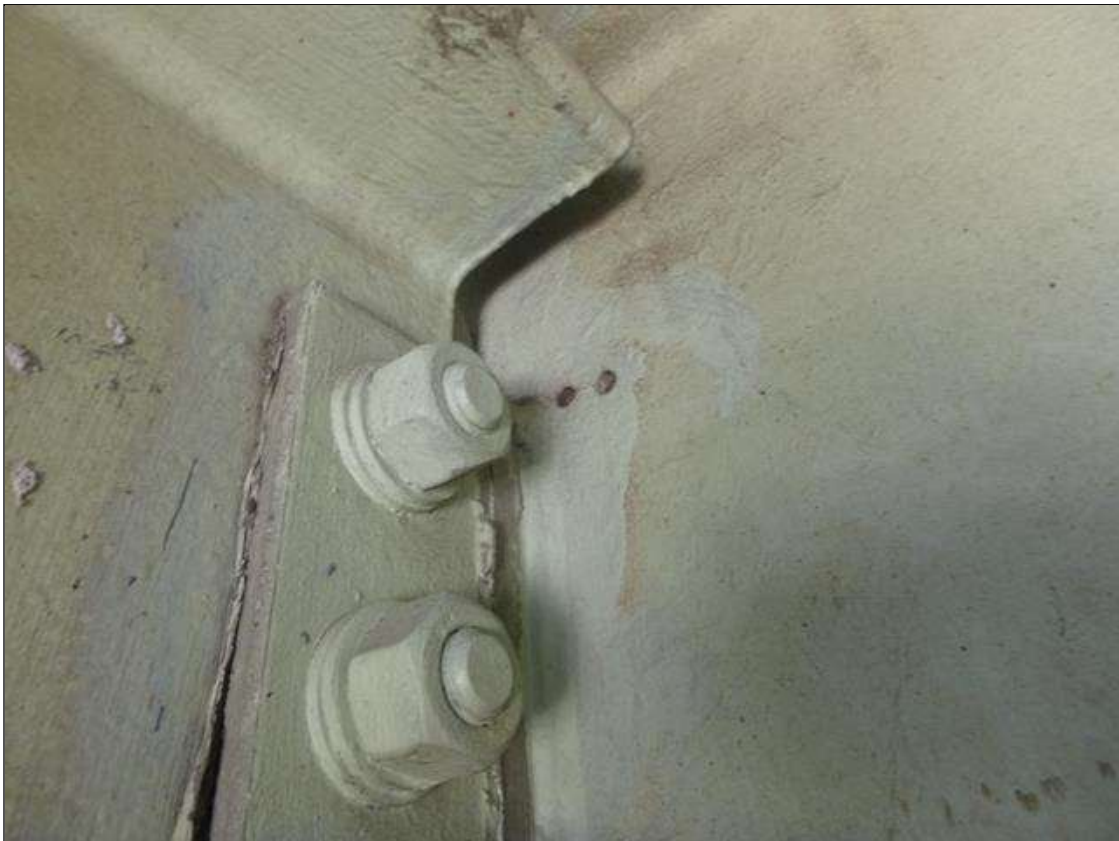
Span 18 Lift Span Stringer 4: BETWEEN FB's 9-10 - ARRESTED CRACK IN WEB AT TOP OF DIAPHRAGM CONNECTION

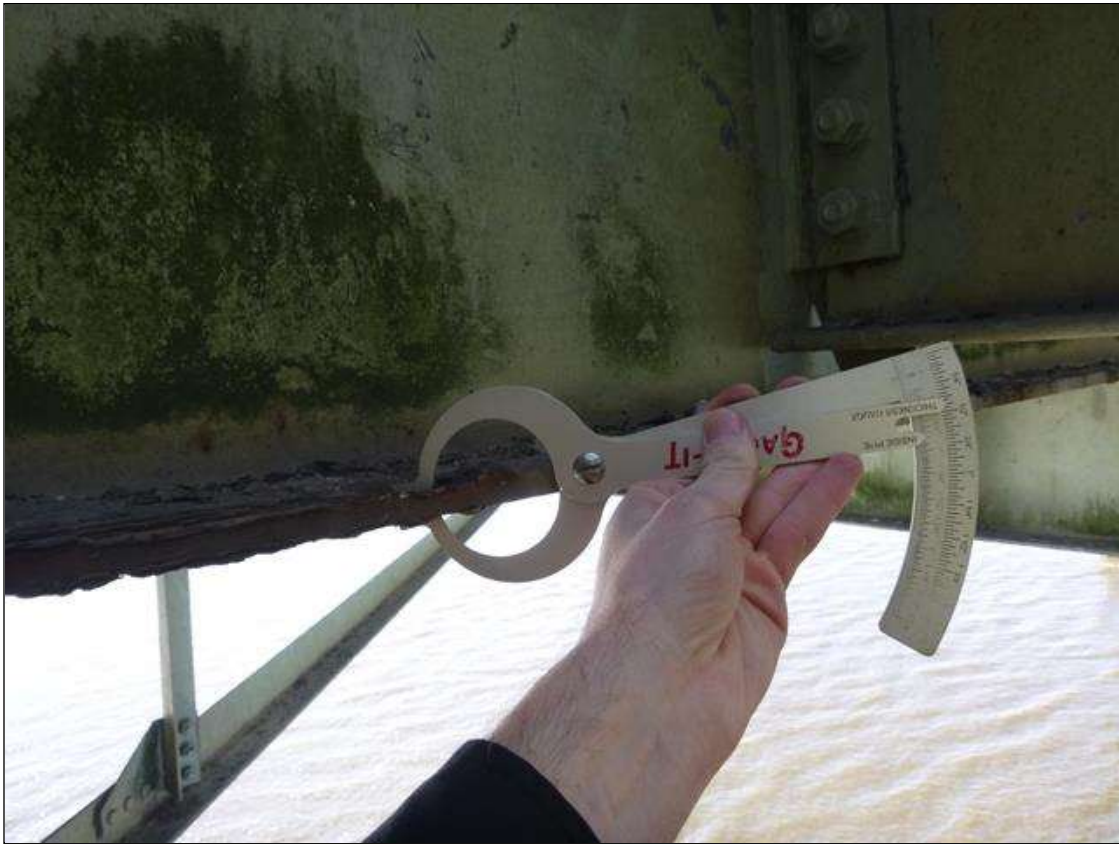
Span 18 Lift Span Stringer 2: (PAR) BETWEEN FB's 9-10 - SCATTERED ALONG THE FULL LENGTH BOTH SIDES OF BOTTOM FLANGE CORROSION WITH 1/4" AVERAGE REMAINING.

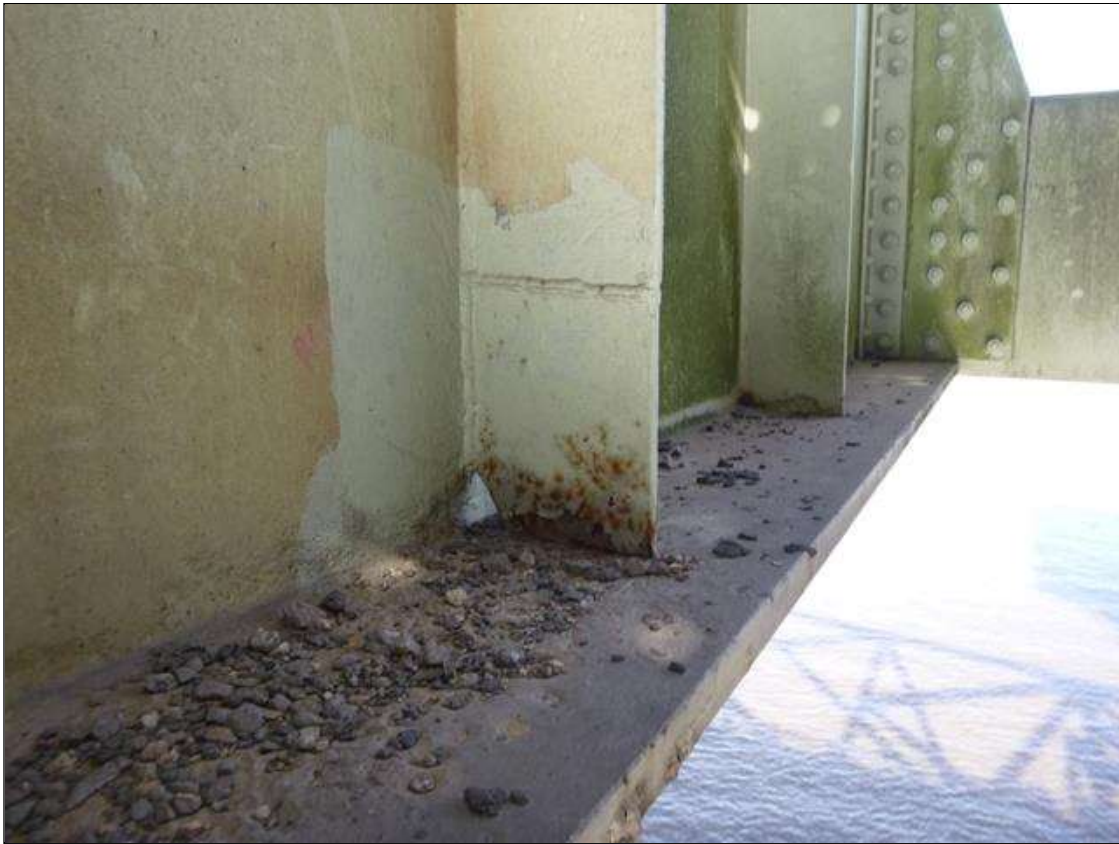
Span 18 Lift Span Floor Beam 9: REPAIR OBSERVED 2021 INSPECTION 7" HIGH REPAIR FROM TOP OF BOTTOM FLANGE WITH SURFACE RUST, 2020 INSPECTION HAD VERTICAL STIFFENER 2 ON EAST SIDE - 3" HIGH PITTED AREA AT BOTTOM FLANGE - LOWER 2" OF AREA REDUCED TO KNIFE EDGE WIDE/ (2) 1/2" TO 1-1/2" DIAMETER HOLES - CLEANED AND PAINTED

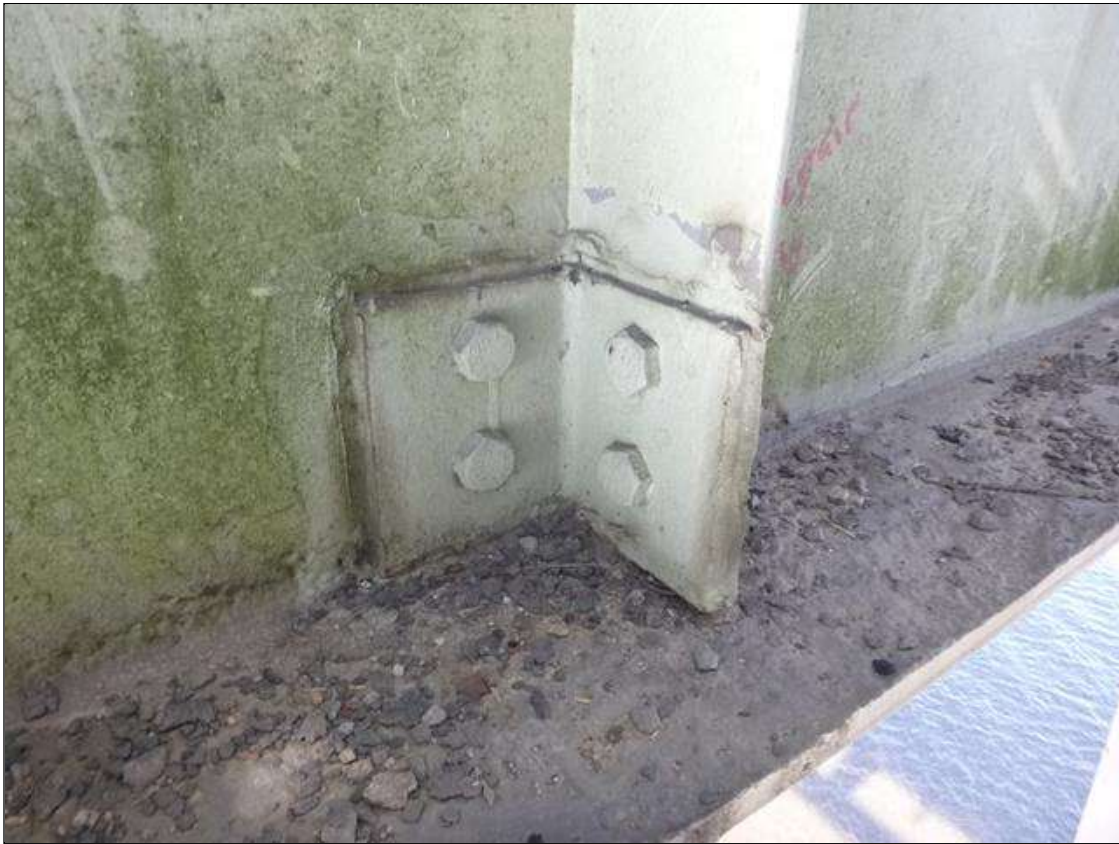
Span 18 Lift Span Floor Beam 9: REPAIR OBSERVED 2021 INSPECTION 7" HIGH 6" X 6" X 3/8" ANGLE BOLTED TO EAST AND WEST FACES ON SOUTH SIDE OF STIFFENER 4, 2020 INSPECTION HAD 7" x 7" PITTED AREA IN WEB AT BOTTOM FLANGE WIDE/ 3/16" DIAMETER HOLE - AREA ADJACENT TO VERTICAL STIFFENER 4 - CLEANED AND PAINTED

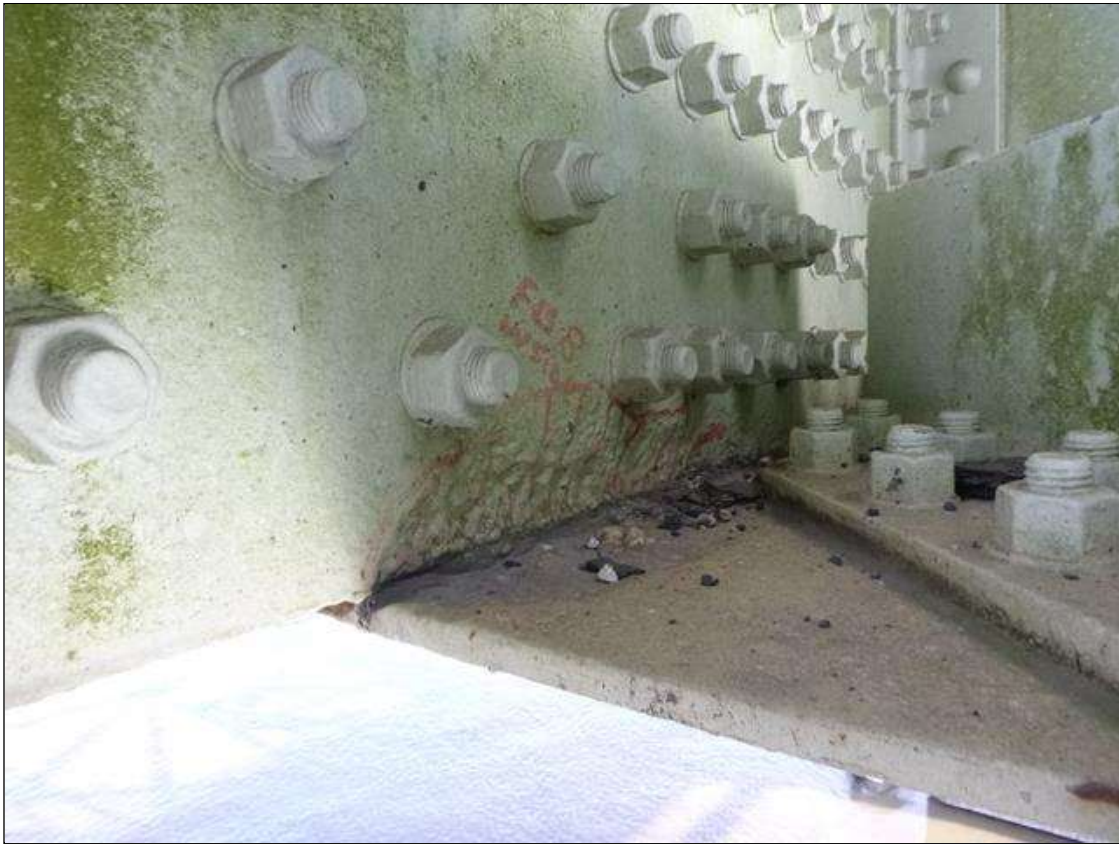
Span 18 Lift Span L8 NORTH: SOUTH PLATE, SOUTH FACE - 3" HIGH x 18" LONG PITTED AREA UP TO 1/4" DEEP ALONG BOTTOM ON WEST SIDE - CLEANED AND PAINTED

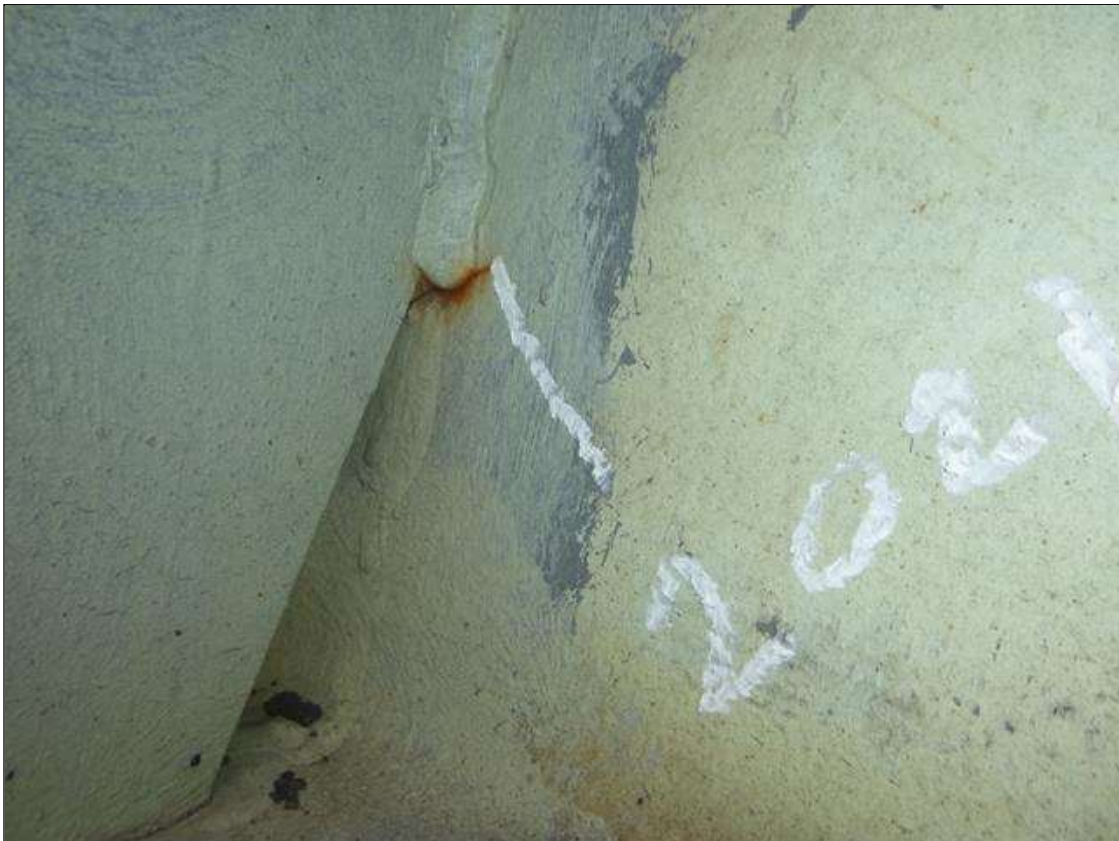
Span 18 Lift Span Stringer 6: BETWEEN FB's 8-9 - 1/2" LONG CRACK AT BOTTOM OF DIAPHRAGM CONNECTION - PROMPT ACTION REQUEST
