NC DEPARTMENT OF TRANSPORTATION
DIVISION OF HIGHWAYS
STRUCTURE MANAGEMENT UNIT

Structure Safety Report

Routine Element Inspection - Contract

DIVISION: 3 COUNTY: NEW HANOVER STRUCTURE NUMBER: 640013 FREQUENCY: 24 MONTHS

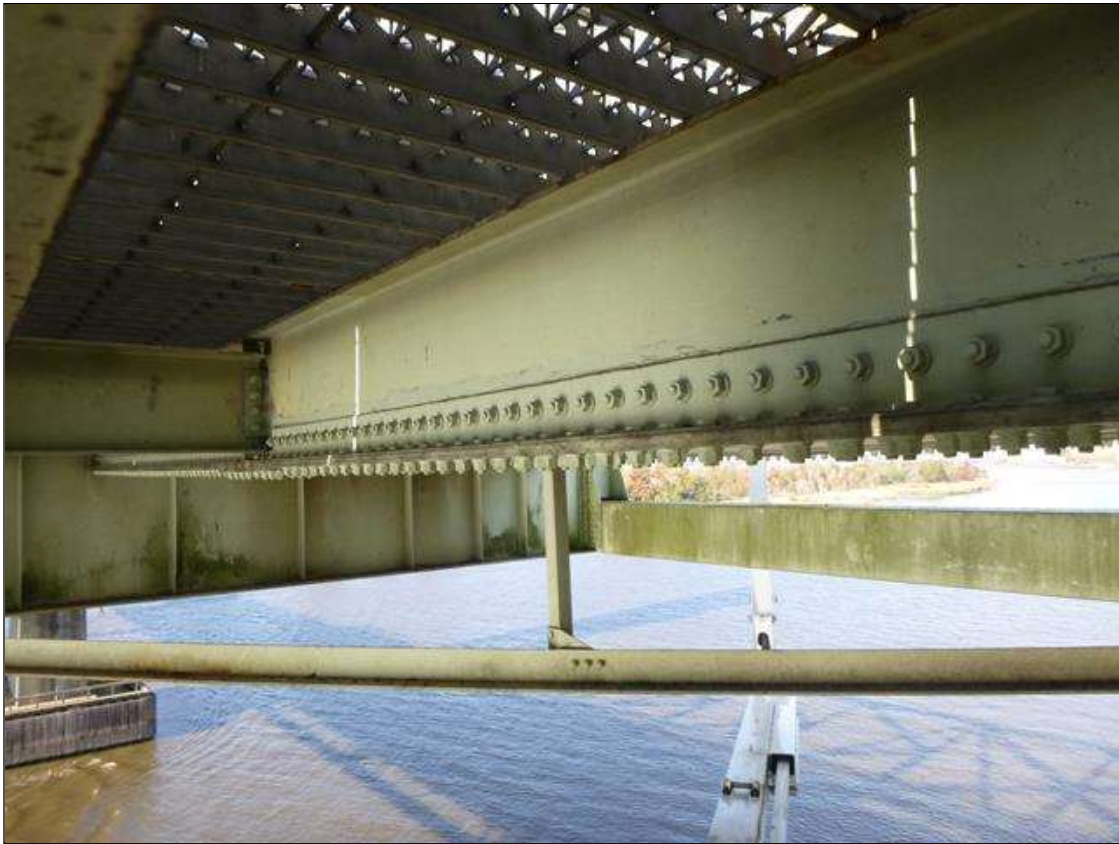
Span 18 Lift Span Stringer 5: REPAIR OBSERVED IN 2021 INSPECTION: 6" X 4" X 3/8" THICK ANGLE AND 9" WIDE X 1/2" THICK PLATE HAS BEEN BOLTED TO BOTH SIDES OF THE WEB AND BOTTOM FLANGE, FULL LENGTH 2020 REPORT HAD BETWEEN FB's 7-8 - PITTED AREAS ON WEB AT BOTTOM FLANGE ON NORTH SIDE UP TO 3"HIGH x 1/8"DEEP SCATTERED ACROSS FULL LENGTH - CLEANED AND PAINTED

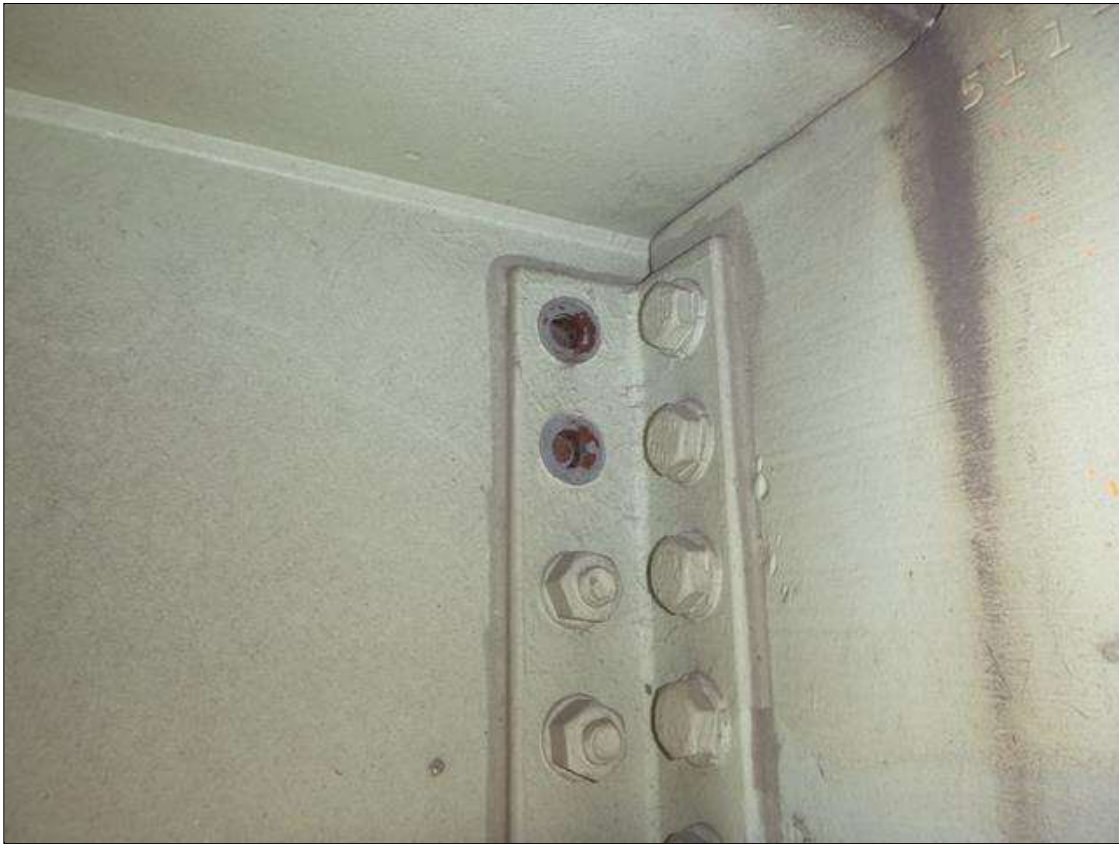
Span 18 Lift Span Stringer 4: BETWEEN FB 7-8, TOP (2) BOLTS HAVE SHEARED AT NORTH SIDE OF STRINGER CONNECTION TO FB. 8, PAR ISSUED.

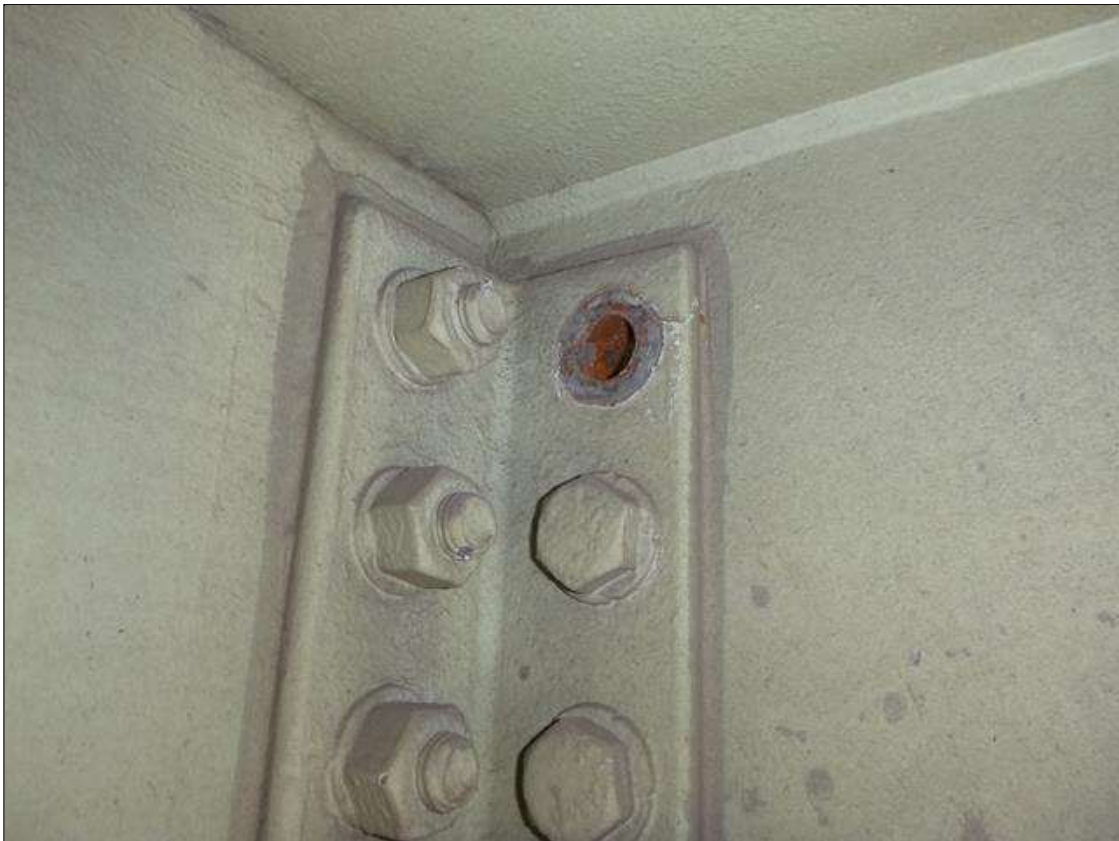
Span 18 Lift Span Stringer 3: BETWEEN FB 7-8, TOP BOLT HAS SHEARED AT SOUTH SIDE OF STRINGER CONNECTION TO FB. 8, PAR ISSUED.

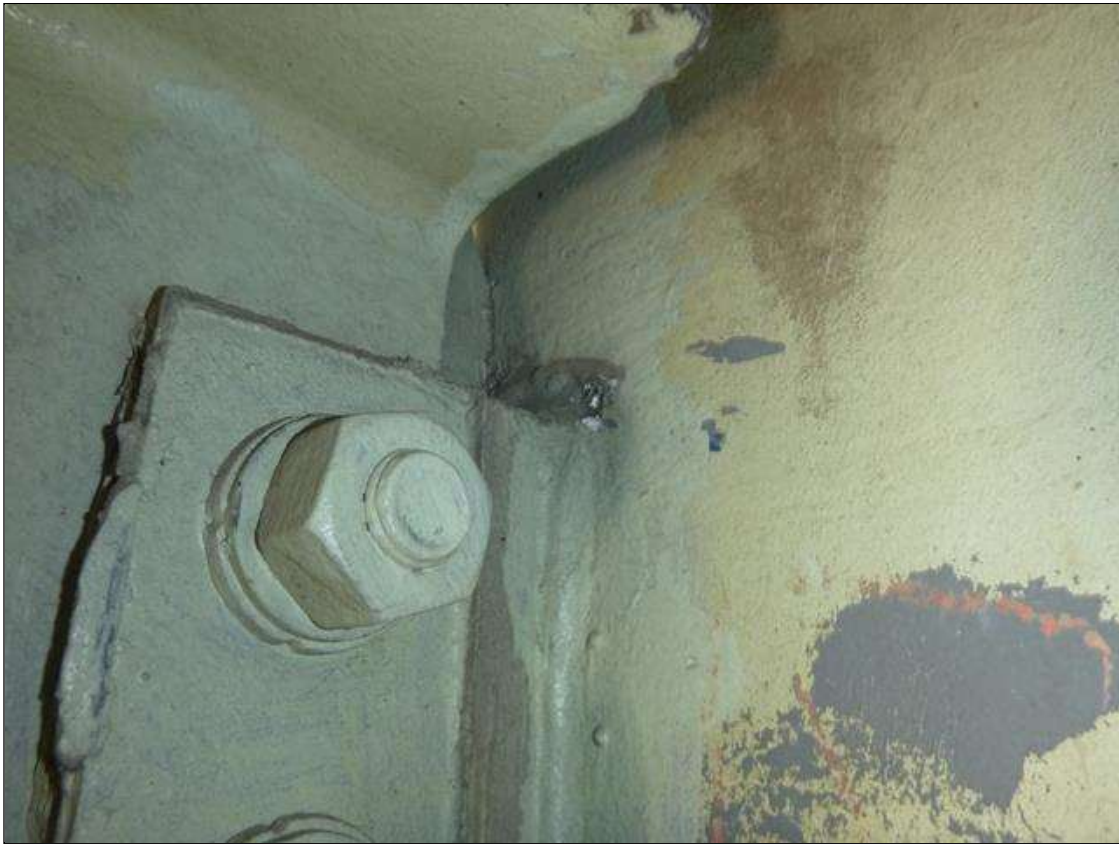
Span 18 Lift Span Stringer 4: BETWEEN FB's 7-8 - CRACK PROPAGATED 1/4" PAST ARREST HOLE AT TOP OF DIAPHRAGM CONNECTION - PROMPT ACTION REQUEST

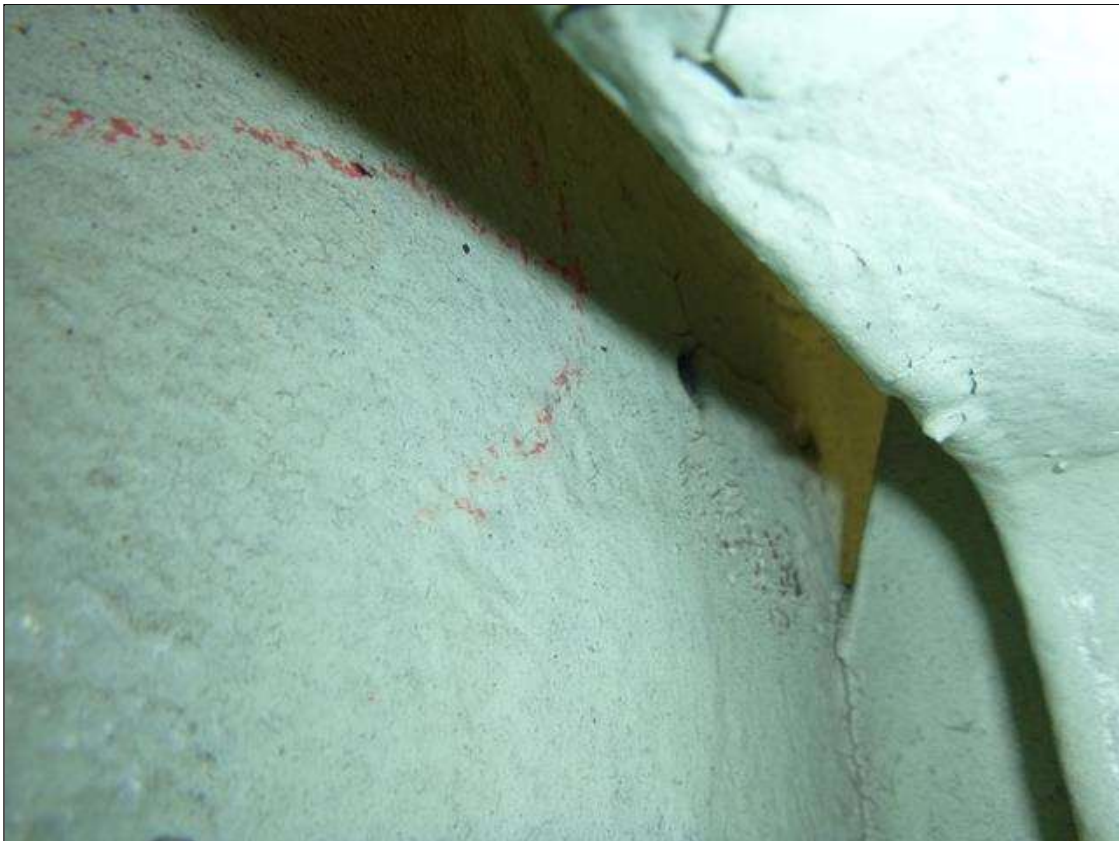
Span 18 Lift Span Stringer 7: OBSERVED IN 2020 INSP: BETWEEN FB's 6-7 - (1) CRACK PROPAGATED UP TO 1/4" PAST EAST ARREST HOLE, PAR ISSUED.

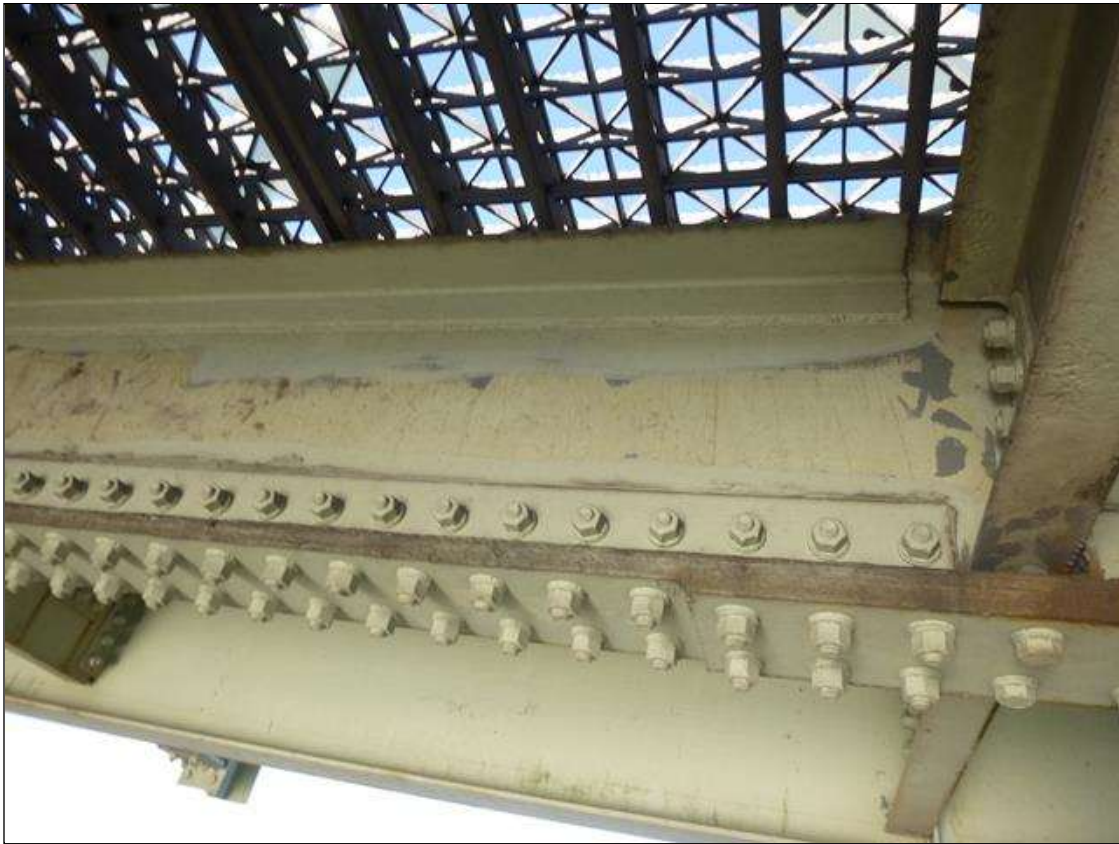
Span 18 Lift Span Stringer 4: BETWEEN FB 6-7, CONNECTION TO FB 7, TOP BOLT AT NORTH SIDE OF STRINGER IS SHEARED, PAR ISSUED.

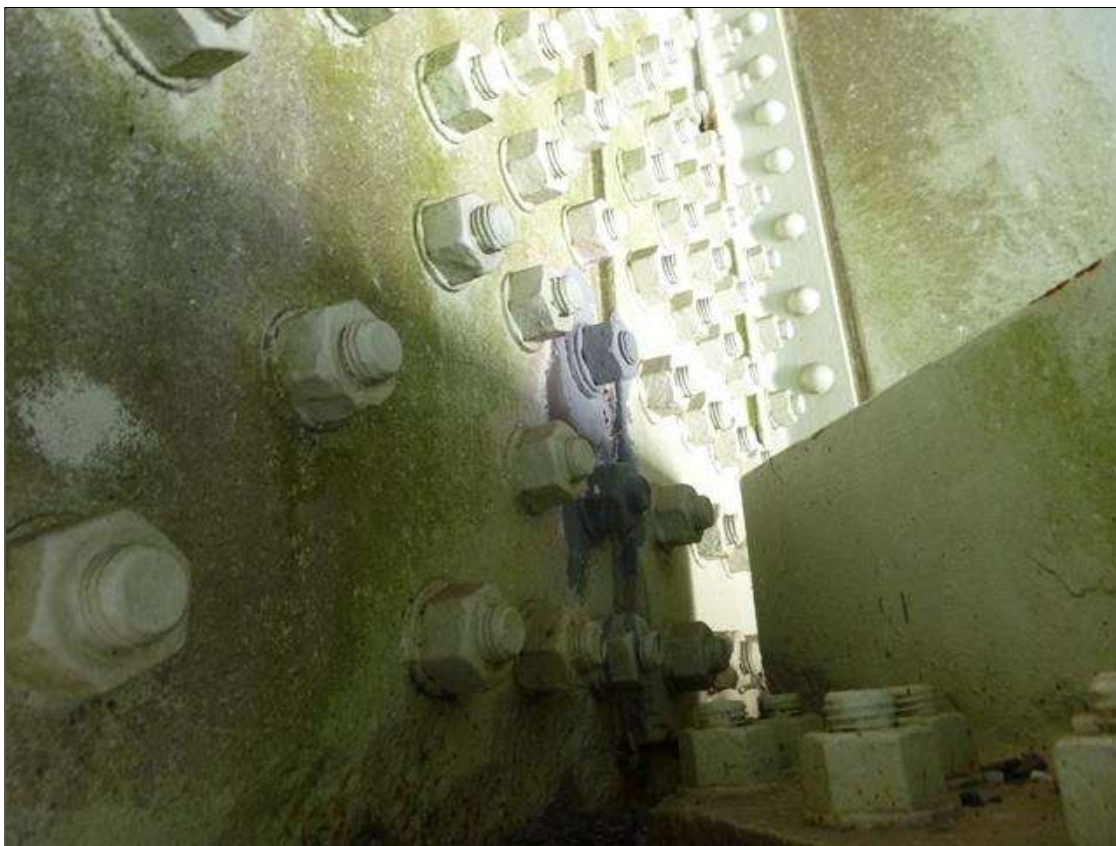
Span 18 Lift Span Stringer 2: REPAIR OBSERVED IN 2020 INSP: BETWEEN FB 5 - 6, REPAIR TO THE BOTTOM FLANGE AND LOWER WEB, 34' LONG. 6" X 5" X 3/8" THICK ANGLE HAS BEEN BOLTED TO BOTH SIDES OF THE WEB. A 9" WIDE X 1/2" THICK PLATE HAS BEEN BOLTED TO THE BOTTOM FLANGE. BEGINNING AT FLOORBEAM 5 FOR 17' A 4.5" X 3" X 1/2" THICK ANGLE HAS BEEN WELDED TO BOTH SIDES OF THE TOP FLANGE AND WEB. 2018 REPORT HAD PITTED AREAS UP TO 1/4" DEEP SCATTERED ACROSS FULL LENGTH OF BOTTOM FLANGE ON SOUTH SIDE.

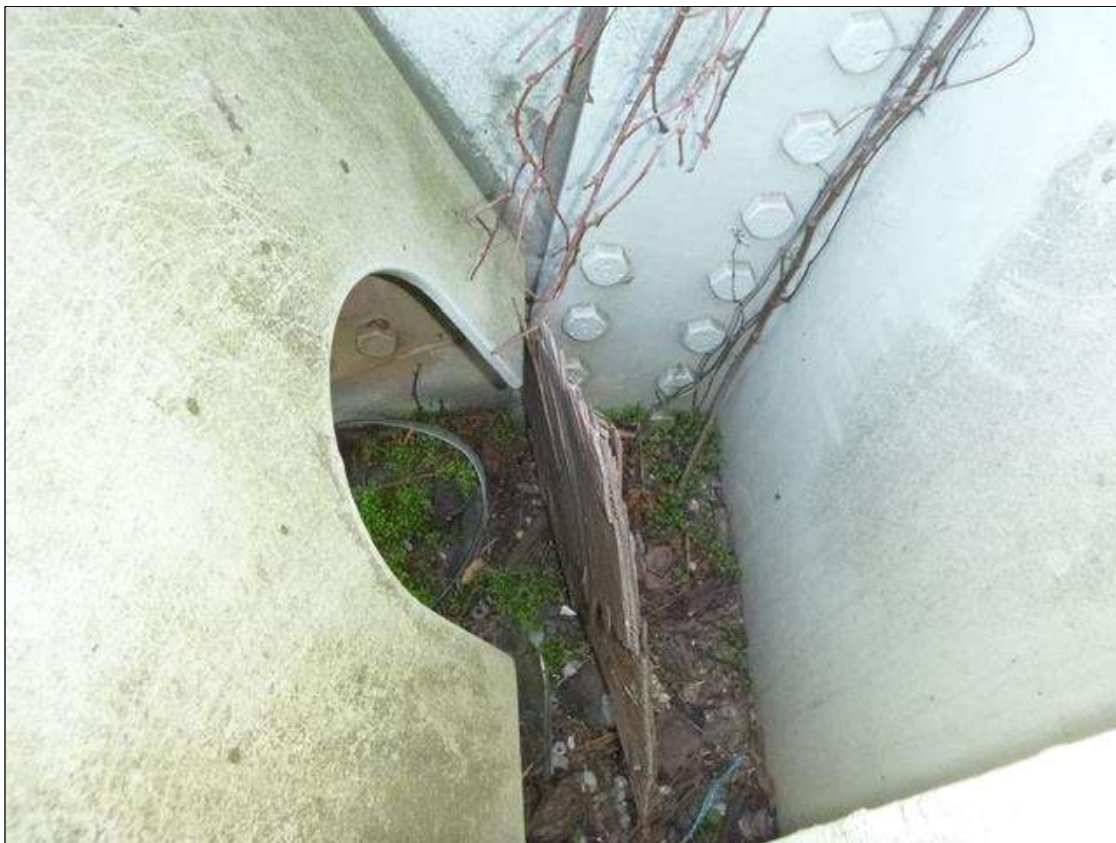
Span 18 Lift Span L6 NORTH: REPAIR OBSERVED IN 2020 INSP: 2 BOLTS HAVE BEEN REPLACED AREA HAS BEEN PAINTED OVER. 2018 REPORT HAD SHEARED BOLT ON INSIDE PLATE - WEST SIDE OF L6.

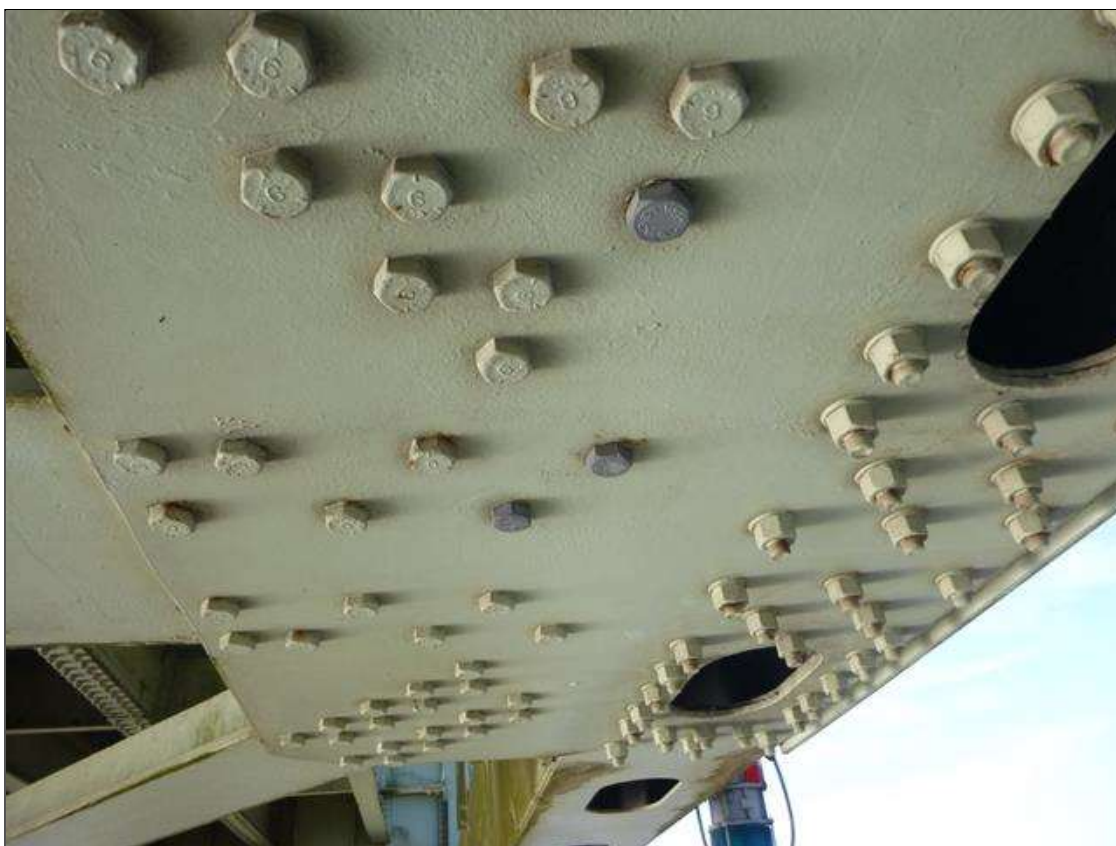
Span 18 Lift Span L6 NORTH: DIRT AND DEBRIS BUILDUP ON TOP OF BOTTOM CHORD.

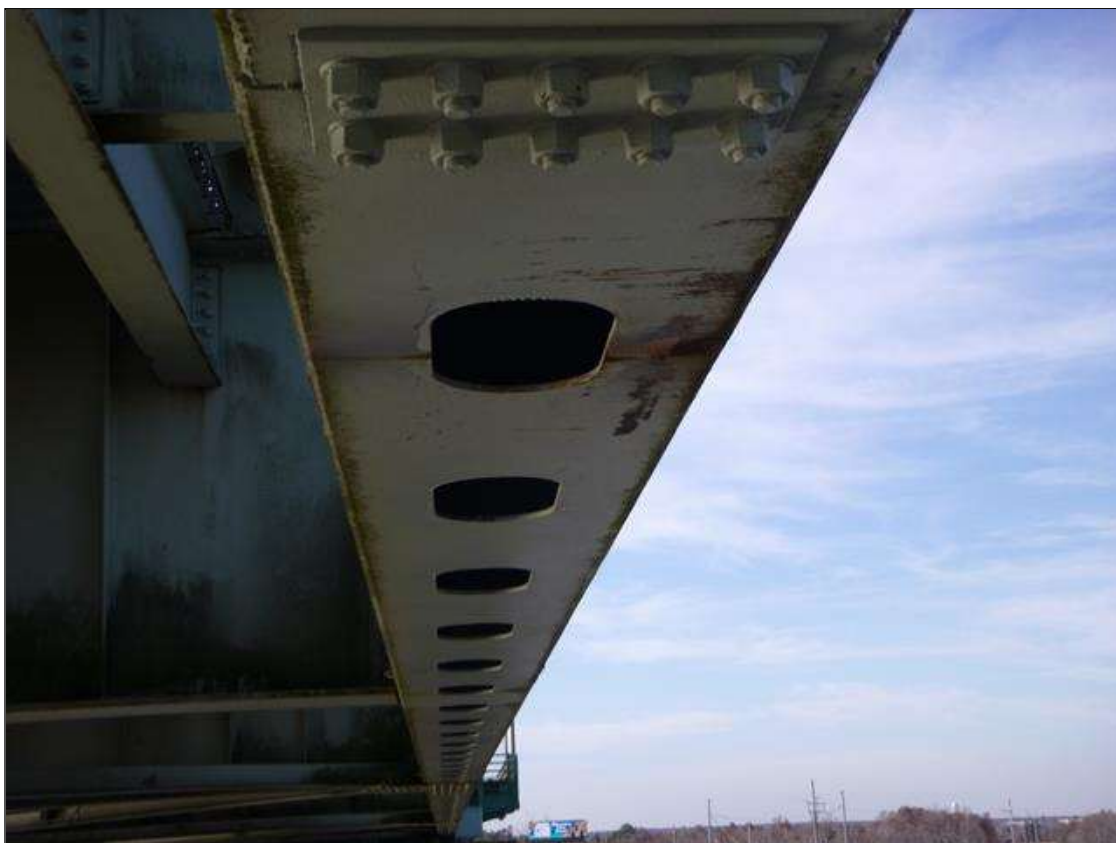
Span 18 Lift Span L6 NORTH: (3) NEW BOLTS IN BOTTOM GUSSET AT FLOORBEAM AND LATERAL BRACING CONNECTION ON EAST SIDE

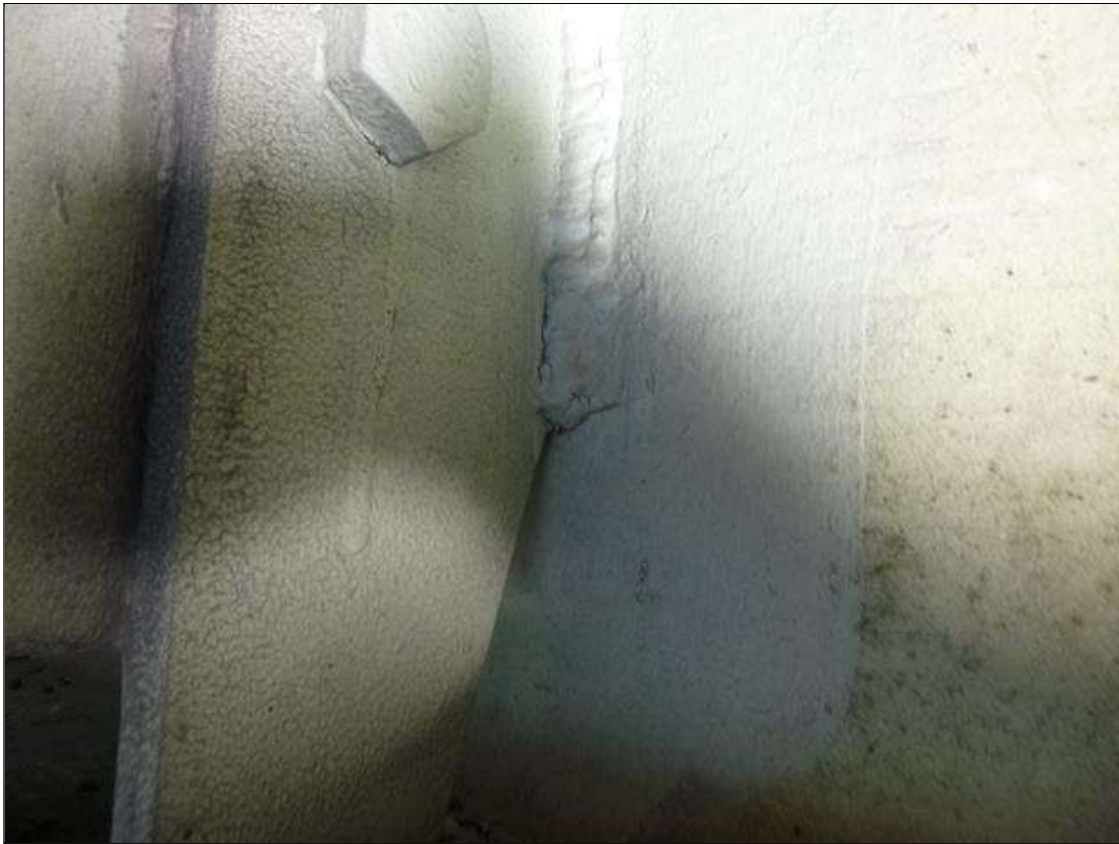
Span 18 Lift Span L5L6 NORTH: IN BOTTOM AT MID-LENGTH SURFACE RUST.

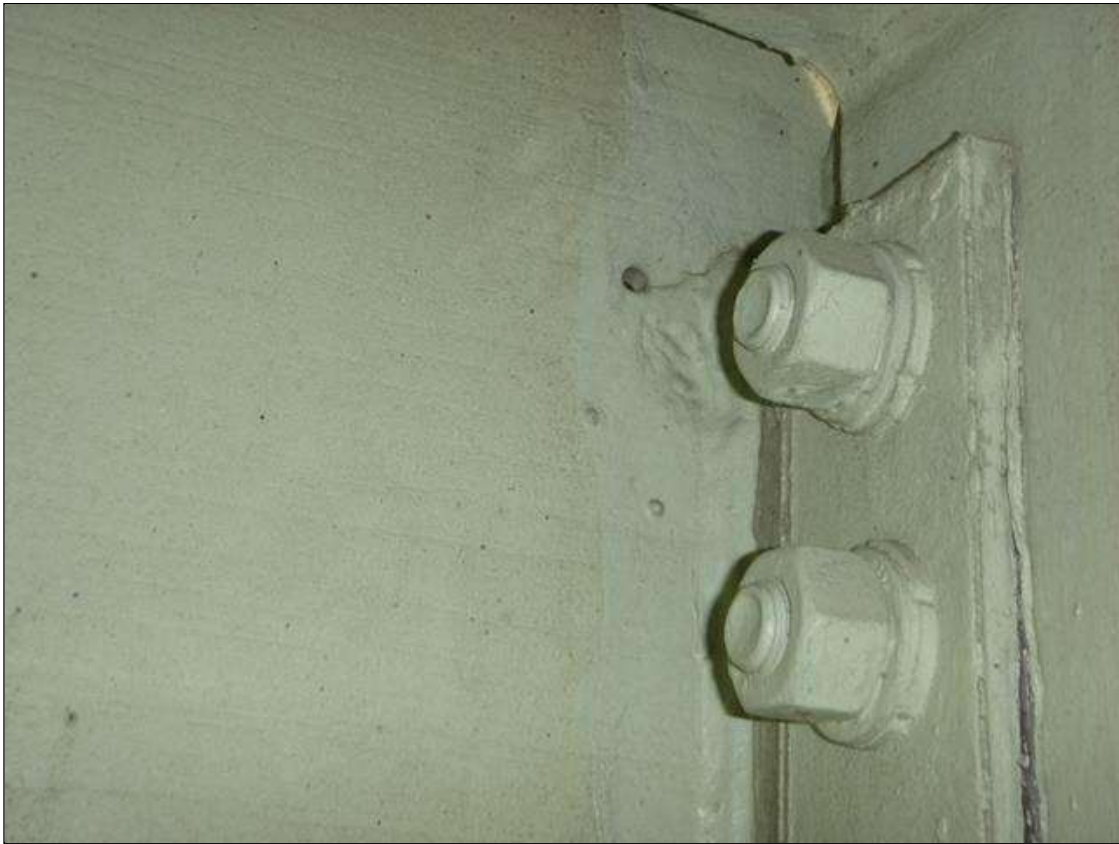
Span 18 Lift Span Stringer 5: BETWEEN FB's 5-6 - 1" LONG CRACK IN WEB ACROSS BOTTOM OF DIAPHRAGM CONNECTION

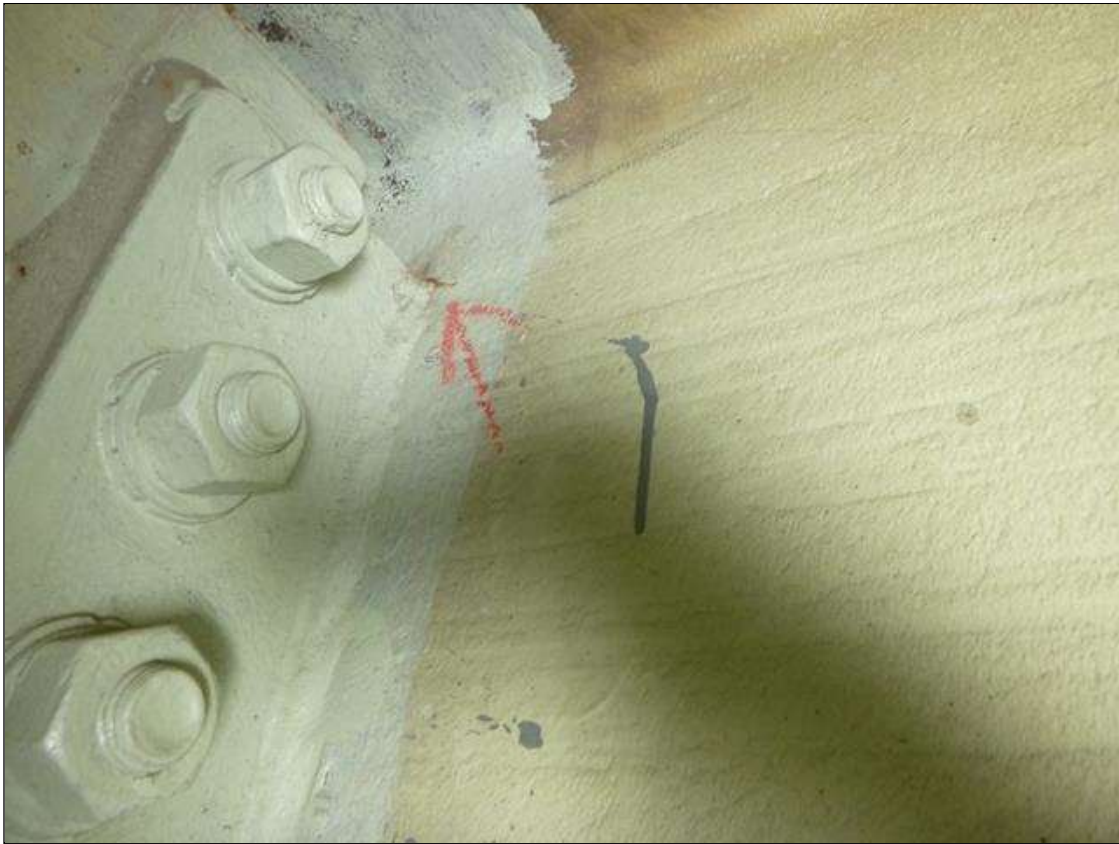
Span 18 Lift Span Stringer 4: REPAIR OBSERVED IN 2021 INSPECTION CRACK NOT VISIBLE, AREA HAS BEEN PAINTED OVER. 2020 REPORT HAD BETWEEN FB's 5-6 - CRACK PROPAGATED 3/16" PAST ARREST HOLE AT TOP OF DIAPHRAGM CONNECTION

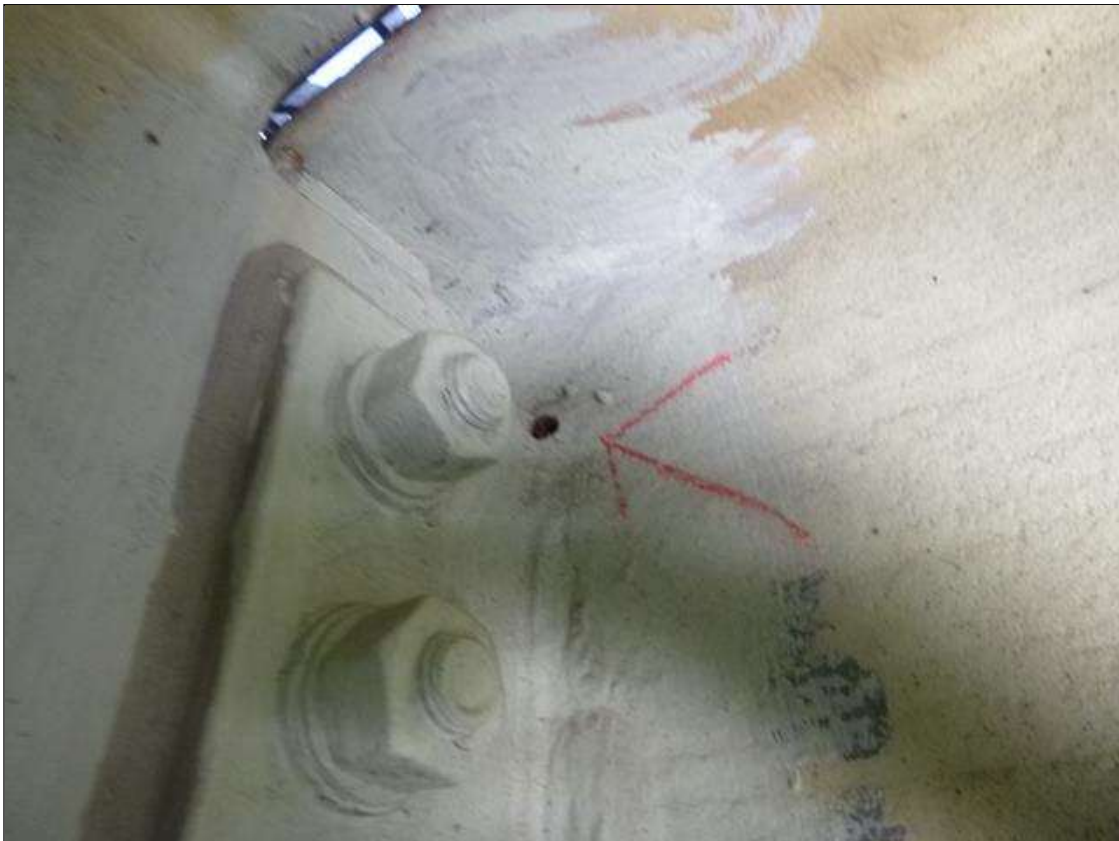
Span 18 Lift Span Stringer 7: BETWEEN FB's 5-6 - 1" CRACK IN WEB ACROSS TOP OF WELD AT DIAPHRAGM CONNECTION - SOUTH SIDE - PROMPT ACTION REQUEST

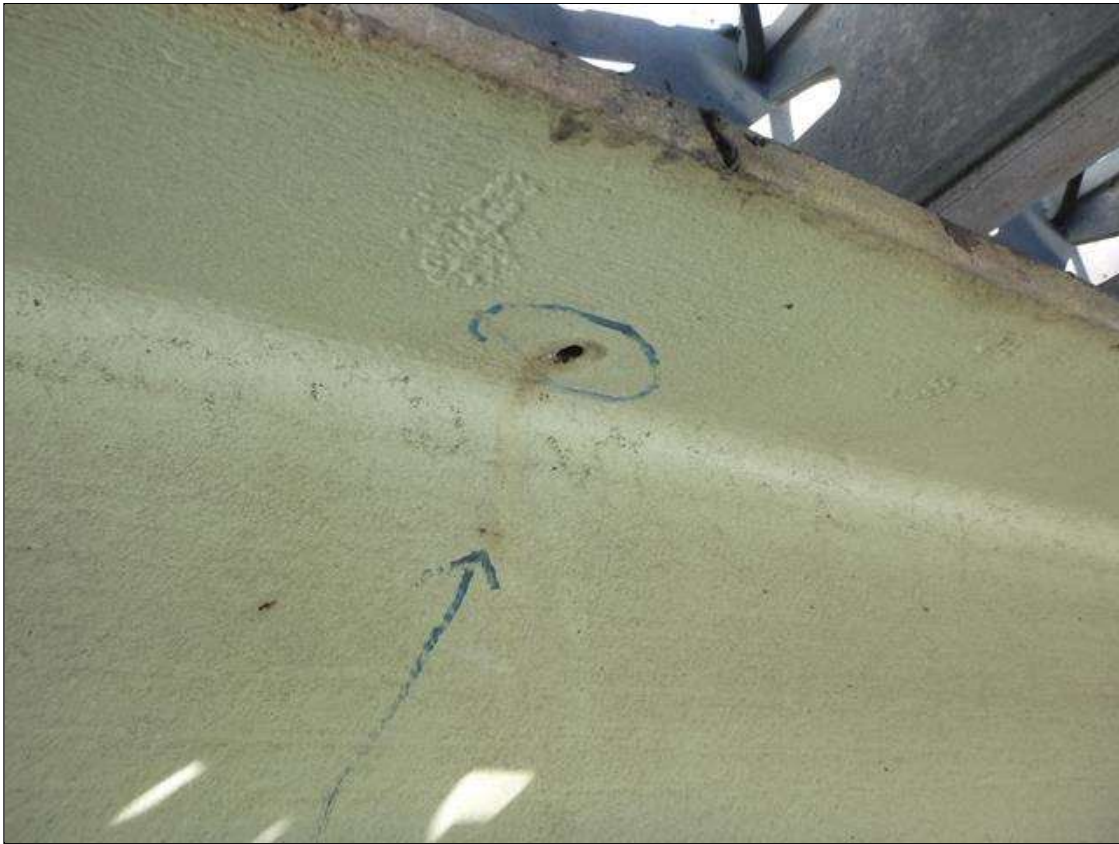
Span 18 Lift Span Stringer 7: OBSERVED IN 2020 INSP: BETWEEN FB's 4-5 - CRACK PROPAGATED 1/4" PAST ARREST HOLE ON EAST SIDE AT TOP OF DIAPHRAGM CONNECTION - PAR ISSUED.

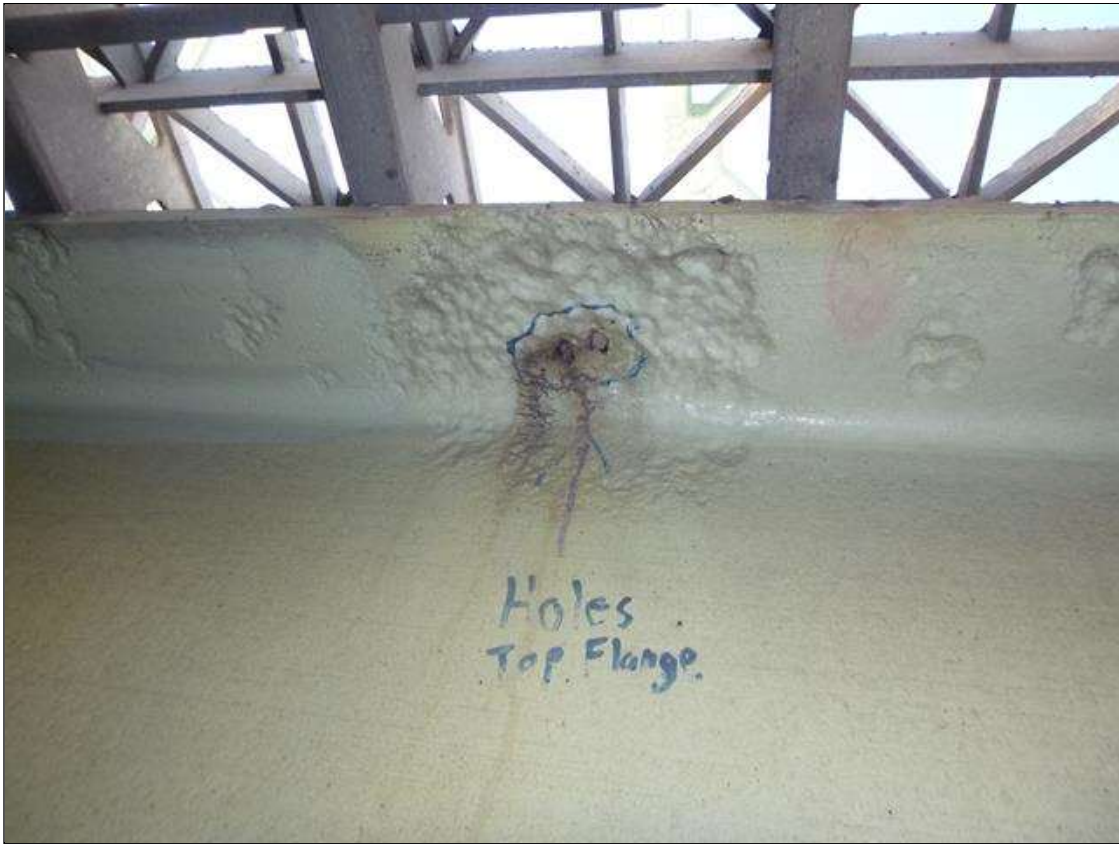
Span 18 Lift Span Stringer 4: BETWEEN FB"s 4-5 - SOUTH SIDE TOP FLANGE 10' FROM FLOORBEAM 4, 3/8" DIAMETER HOLE.

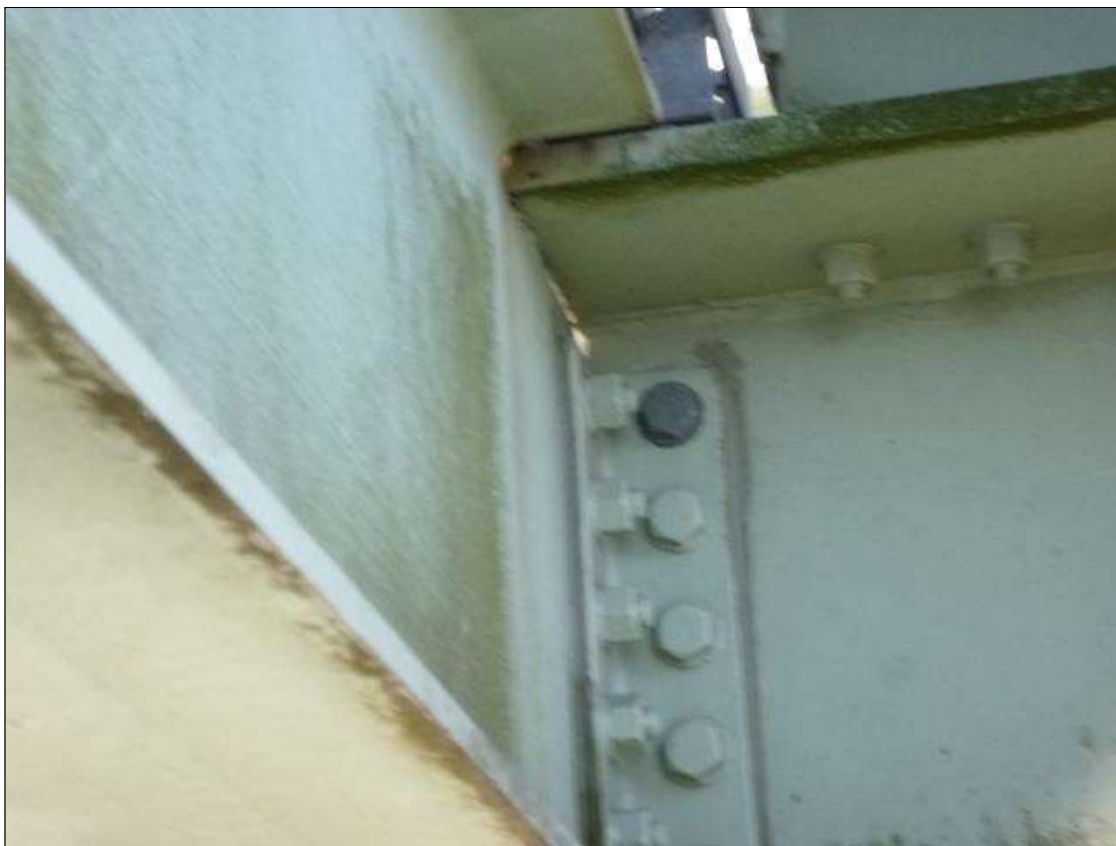
Span 18 Lift Span Stringer 4: BETWEEN FB's 3 & 4 - (2) 1/2" HOLES WIDE/ 6"LONG x 4"WIDE PITTED AREA ON NORTH SIDE OF TOP FLANGE AT 3' FROM FROM FB 4 CONNECTION - AREA CLEANED AND PAINTED, PAR ISSUED.

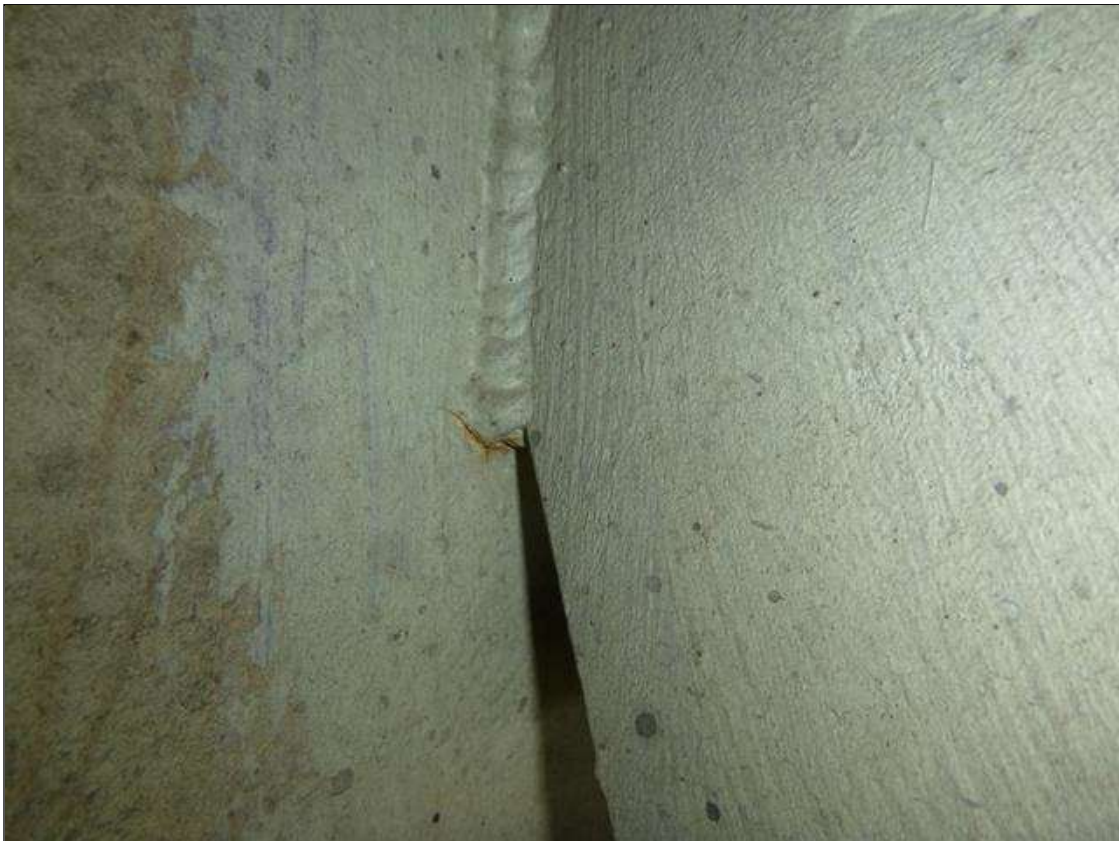
Span 18 Lift Span Stringer 5: BETWEEN FB'S 1- 2 - 1-1/2" LONG CRACK IN WEB ACROSS TOP OF WELD AT DIAPHRAGM CONNECTION

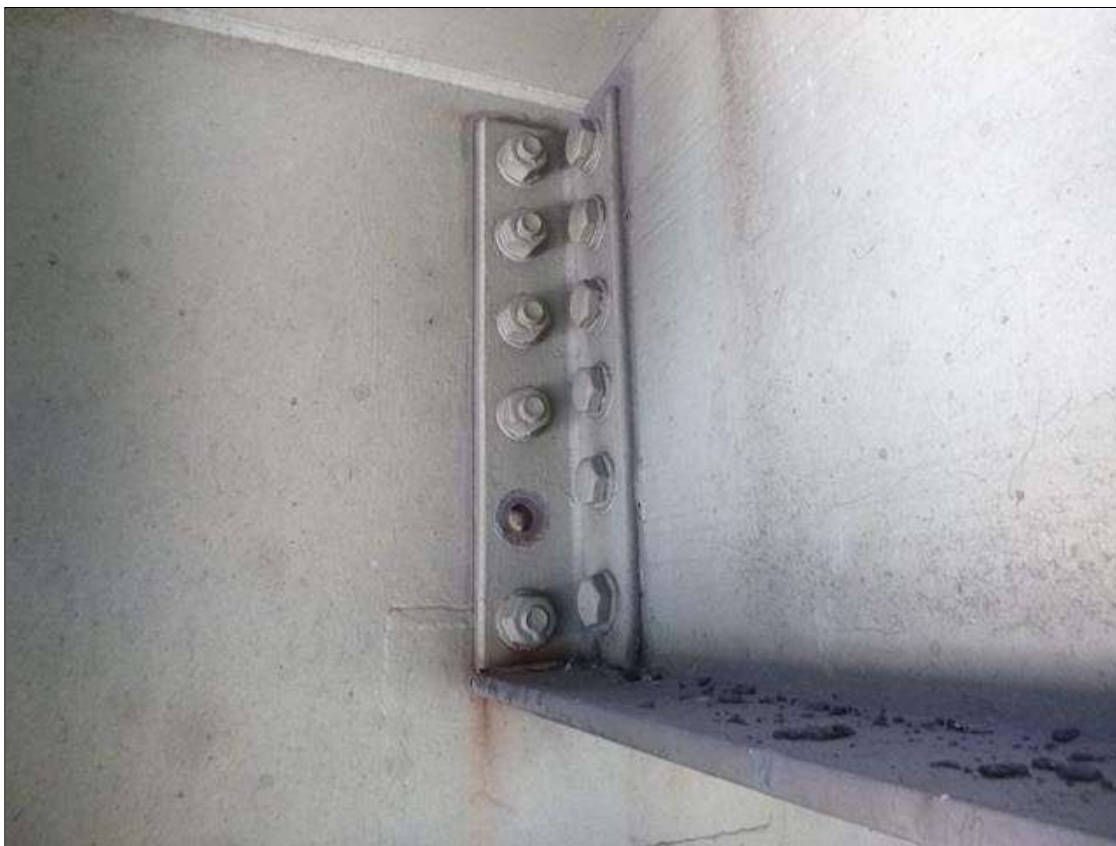
Span 18 Lift Span Stringer 3: BETWEEN FB's 1-2 - 1" CRACK IN WEB ACROSS BOTTOM OF WELD AT DIAPHRAGM CONNECTION - PROMPT ACTION REQUEST

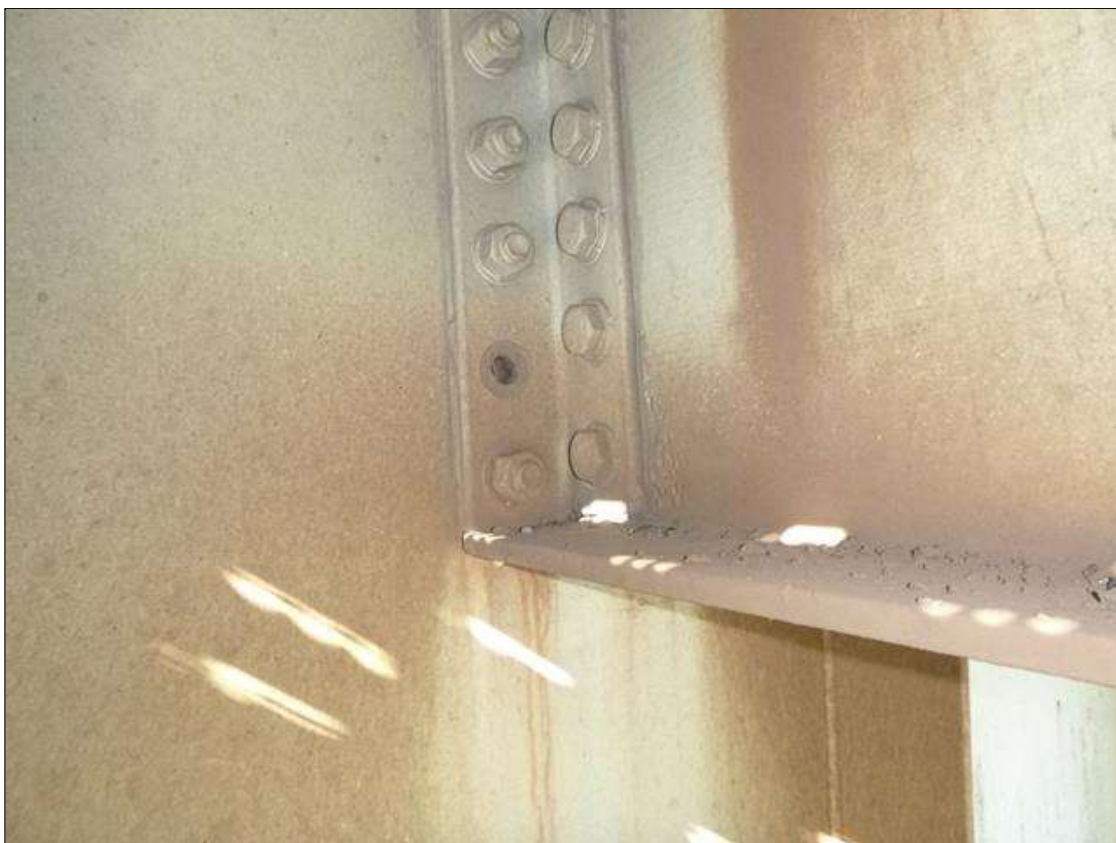
Span 18 Lift Span Stringer 3: ONE BOLT MISSING ON THE SOUTH SIDE OF STRINGER CONNECTION TO FLOOR BEAM 1, PAR ISSUED.

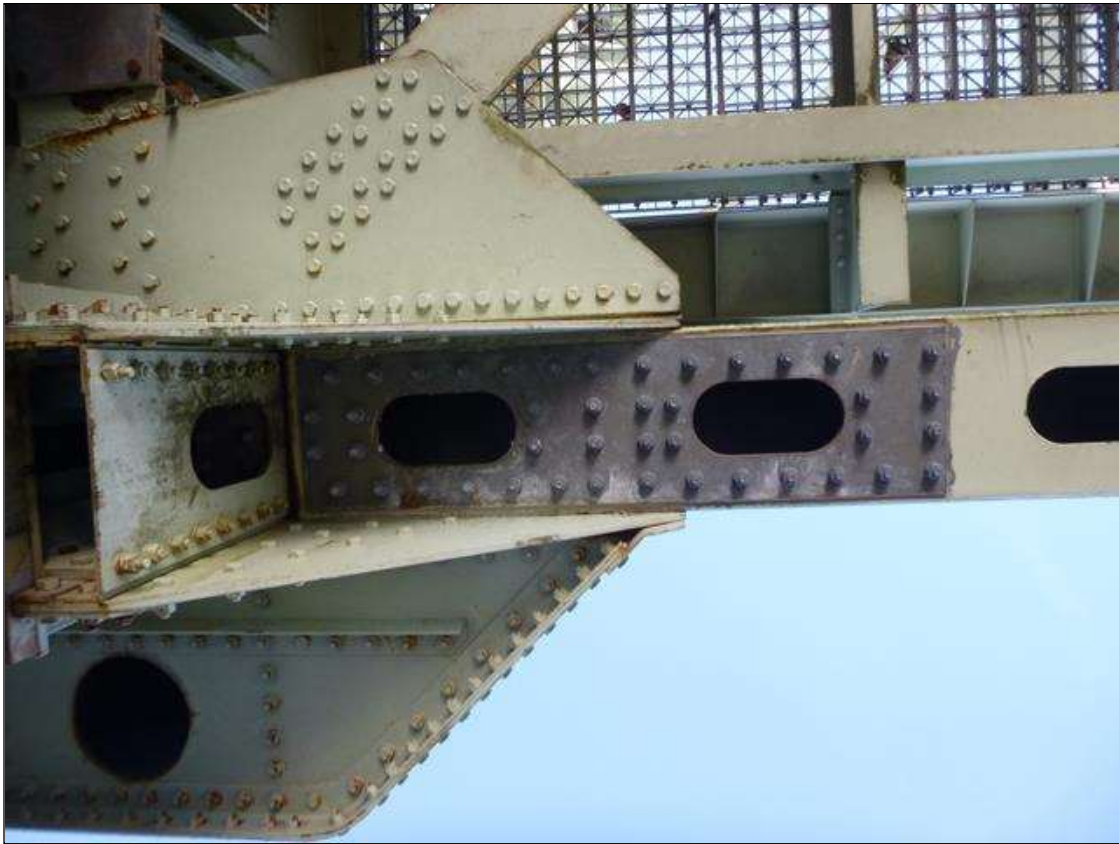
Span 18 Lift Span Stringer 7: REPAIR OBSERVED IN 2020 INSP: ANGLE, 5" X 3.5" X 3/8 THICK HAS BEEN WELDED TO EACH SIDE OF THE WEB AND BOTTOM OF THE TOP FLANGE, FULL LENGTH. AREA HAS BEEN CLEANED AND REPAINTED. 2018 REPORT HAD BETWEEN FB's 0-1 - CRACK IN WEB AT TOP OF DIAPHRAGM CONNECTION PROPAGATED 1/8" PAST ARREST HOLE ON EAST SIDE

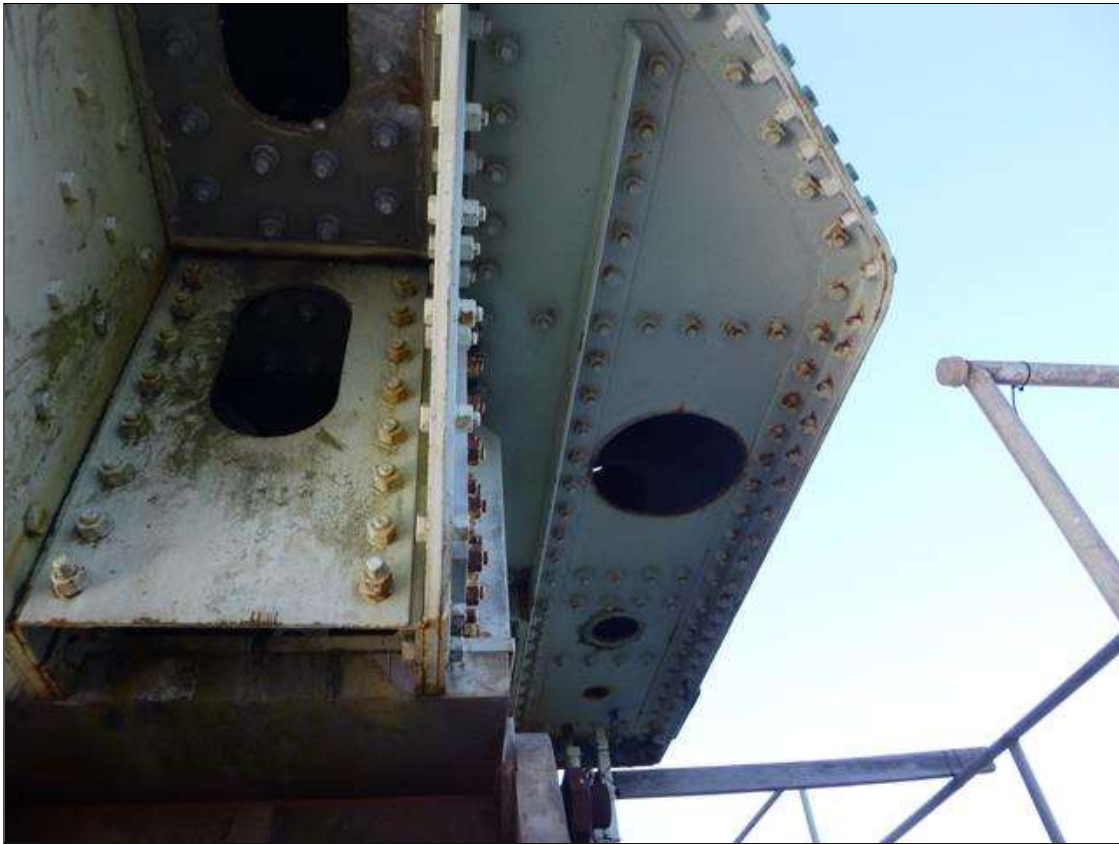
Span 18 Lift Span L0L1 NORTH: REPAIR OBSERVED IN 2020 INSP: A STEEL PLATE HAS BEEN BOLTED OVER THE AREA, 6 FOOT. LONG X 17.5" WIDE X 3/8" THICK. 2018 REPORT HAD 3" WIDE AREA OF SECTION LOSS TO KNIFE EDGE WIDE/ HOLES UP TO 1/2" IN DIAMETER AROUND PORTAL IN BOTTOM OF CHORD AT L0

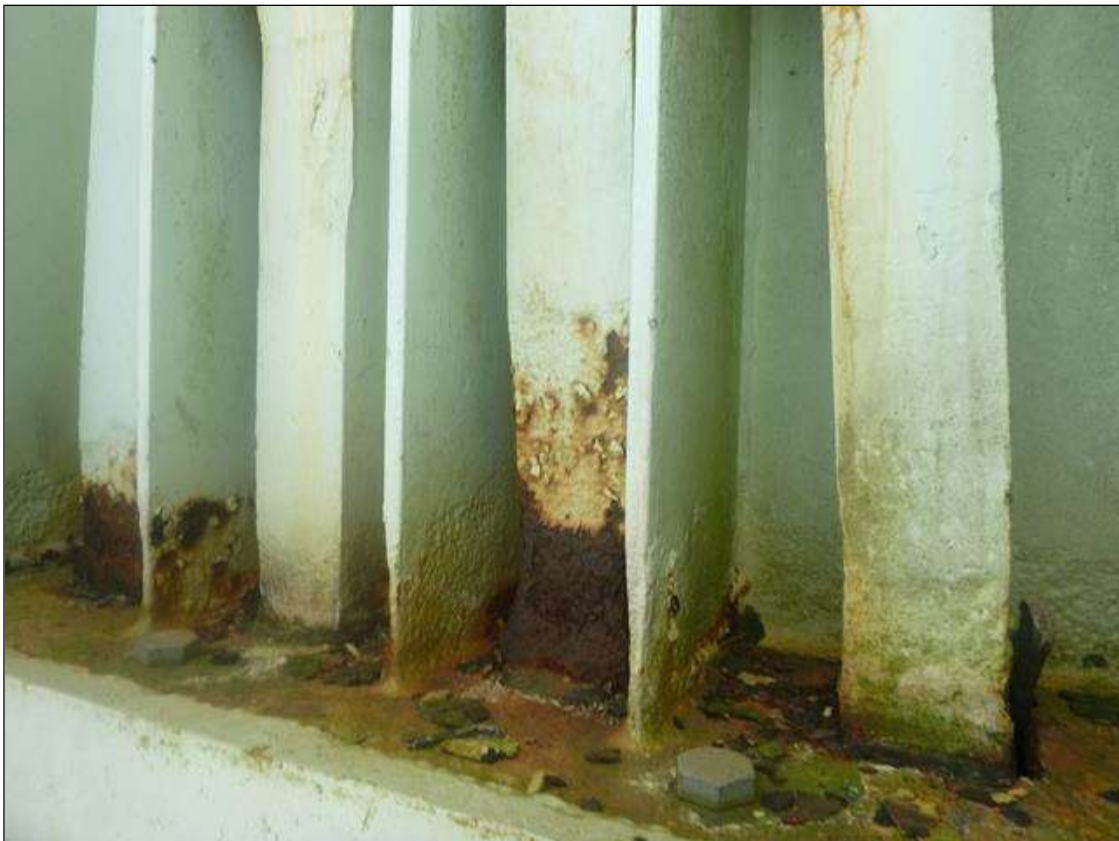
Span 18 Lift Span L0 NORTH: SURFACE RUST ON BOLTS.
