NC DEPARTMENT OF TRANSPORTATION
DIVISION OF HIGHWAYS
STRUCTURE MANAGEMENT UNIT

Structure Safety Report

Routine Element Inspection - Contract

DIVISION: 3 COUNTY: NEW HANOVER STRUCTURE NUMBER: 640013 FREQUENCY: 24 MONTHS

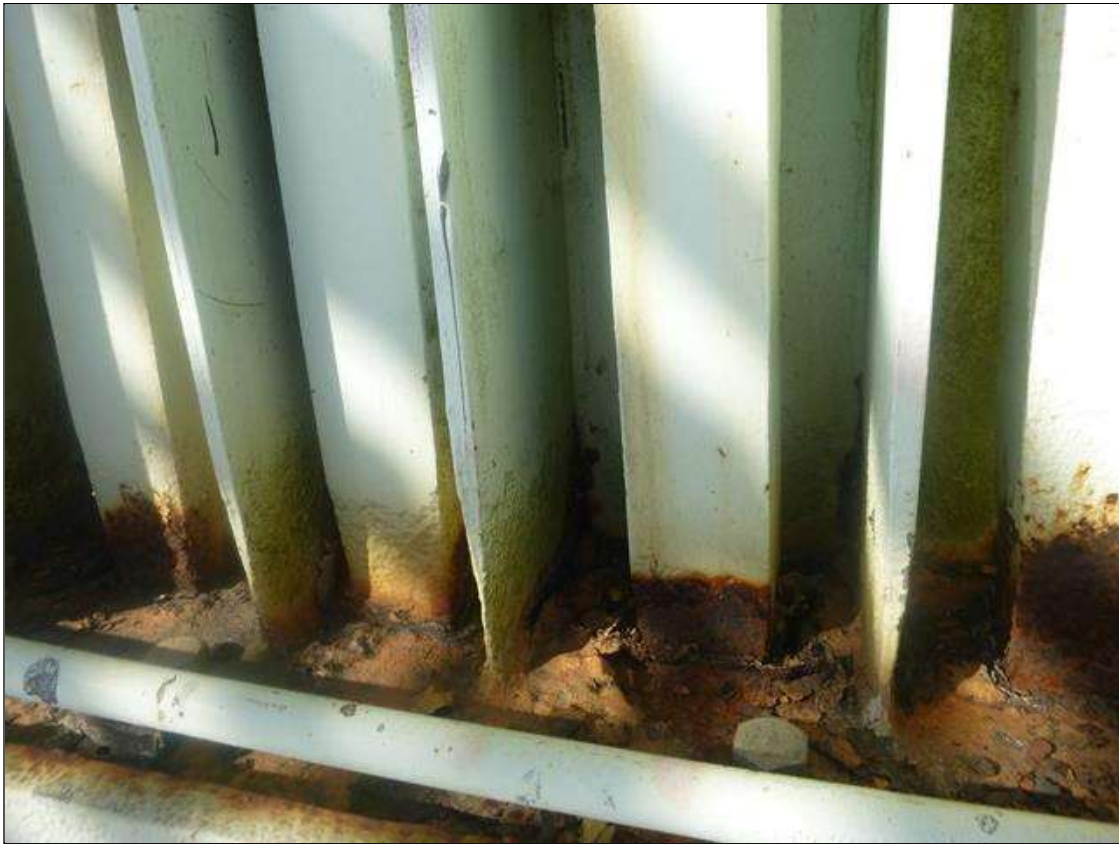
WEST TOWER: NORTHWEST CABLE BANK EAST BOUND LANE, LOSS OF SECTION .258" WITH 3.49" REMAINING

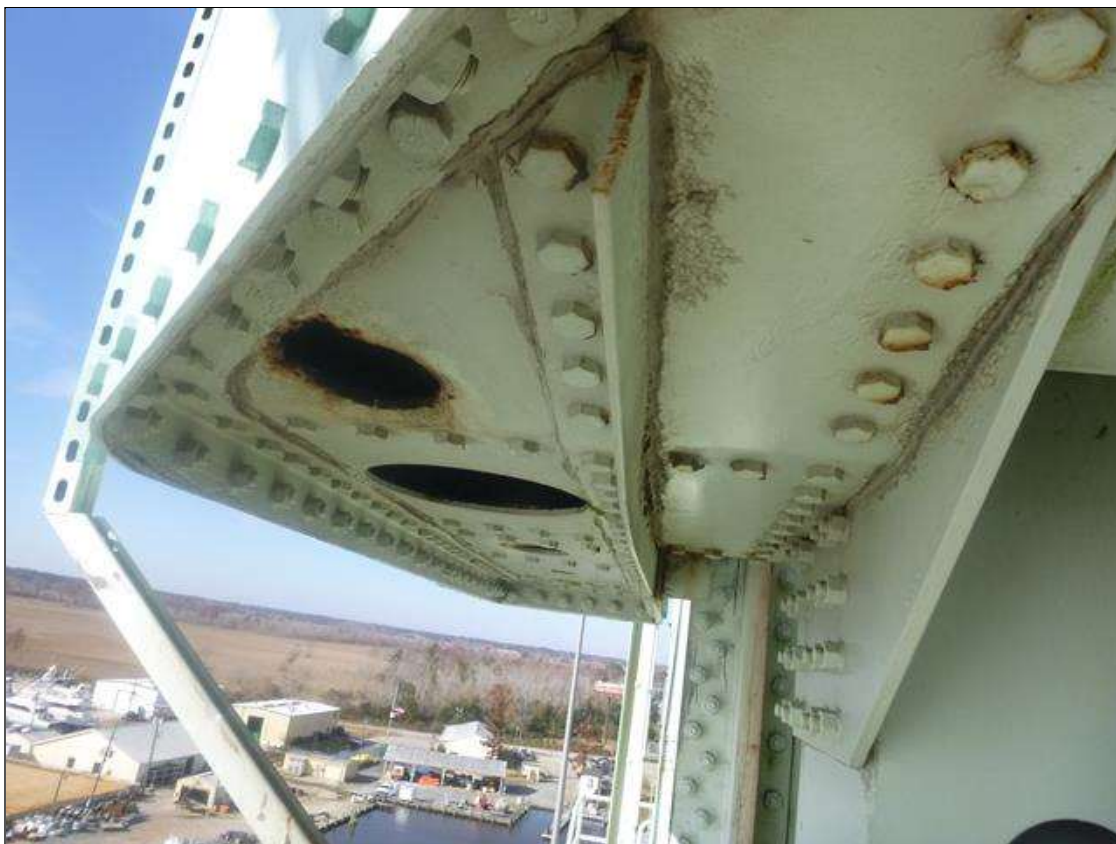
Span 18 Lift Span U0 SOUTH: (PROMPT ACTION REQUEST) BOTTOM PLATE AT ACCESS HOLE CORROSION WITH HOLE 5" X 2" HOLE.

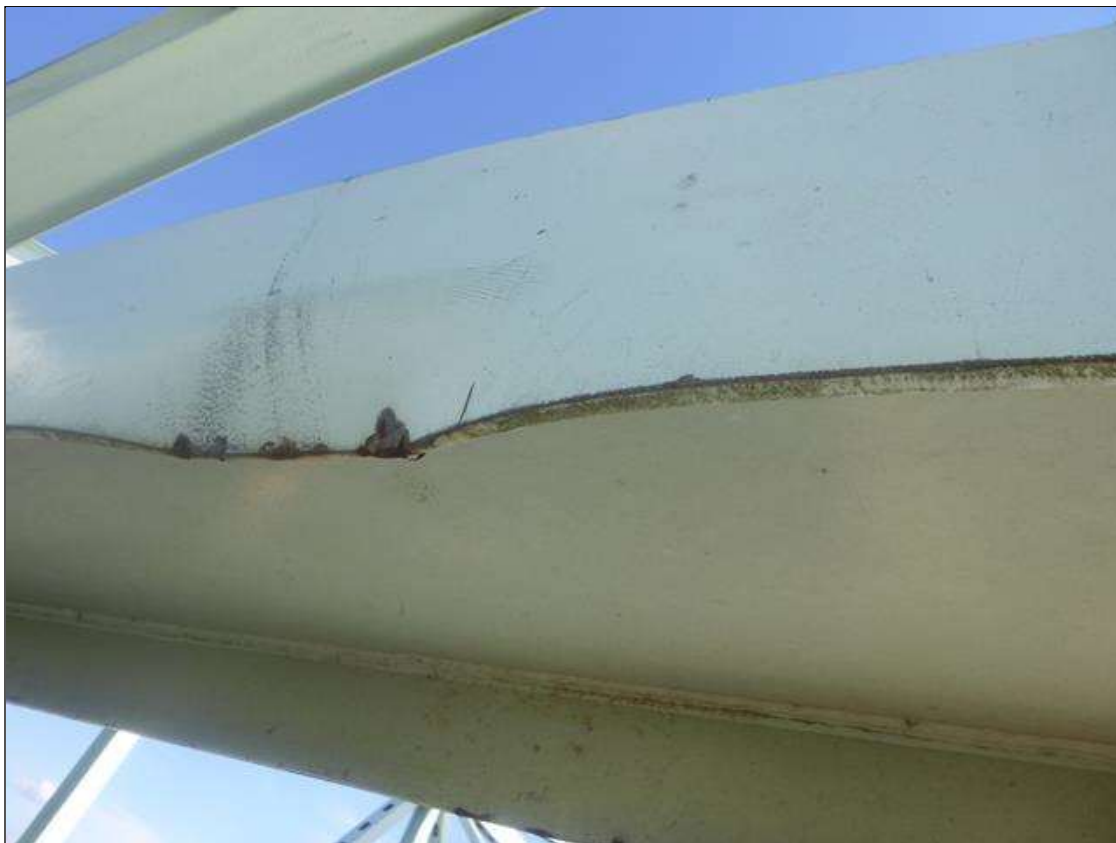
Span 18 Lift Span U2 SOUTH: 1/8" - 3/16" PITTING & SECTION LOSS TO TOP LATERAL BETWEEN U2 FOR A LENGTH OF 15FT (BOTTOM FLANGE)

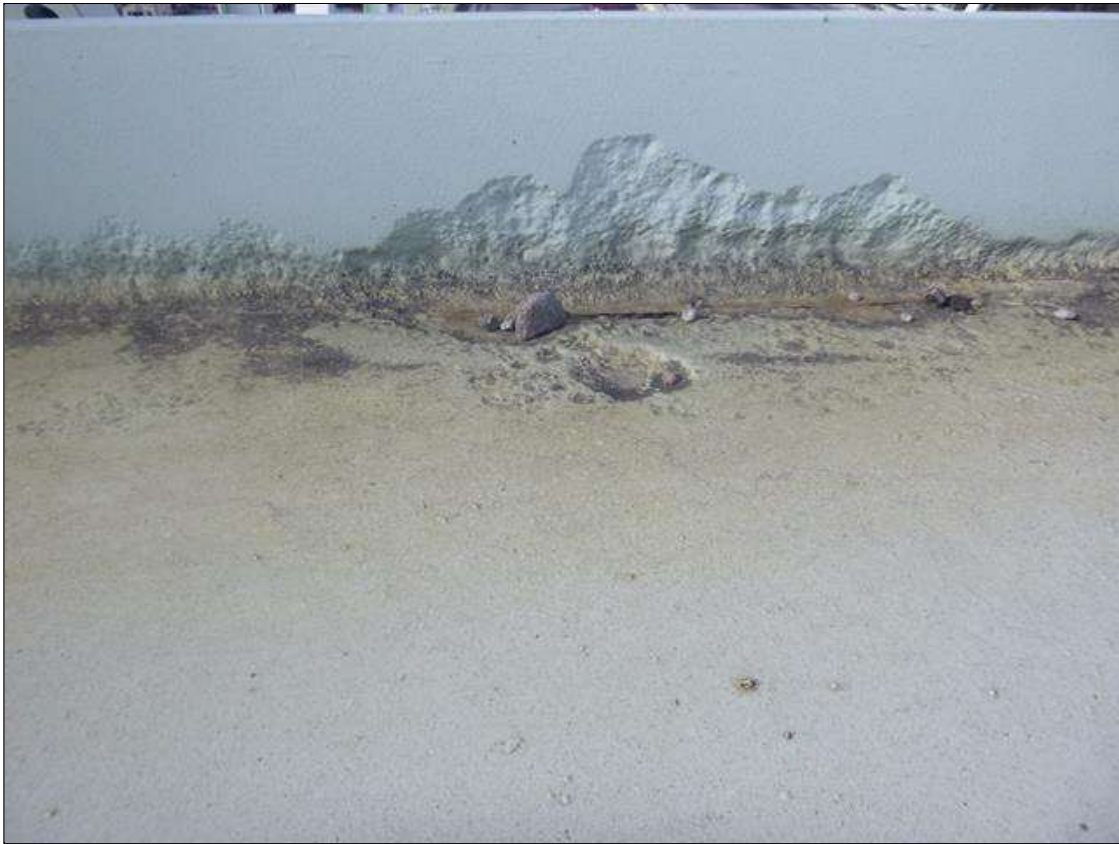
Span 18 Lift Span LB3: IMPACT DAMAGE 16" WIDE X 1-1/2" DEFORMATION IN BOTH FLANGES OVER RIGHT EAST BOUND LANE.

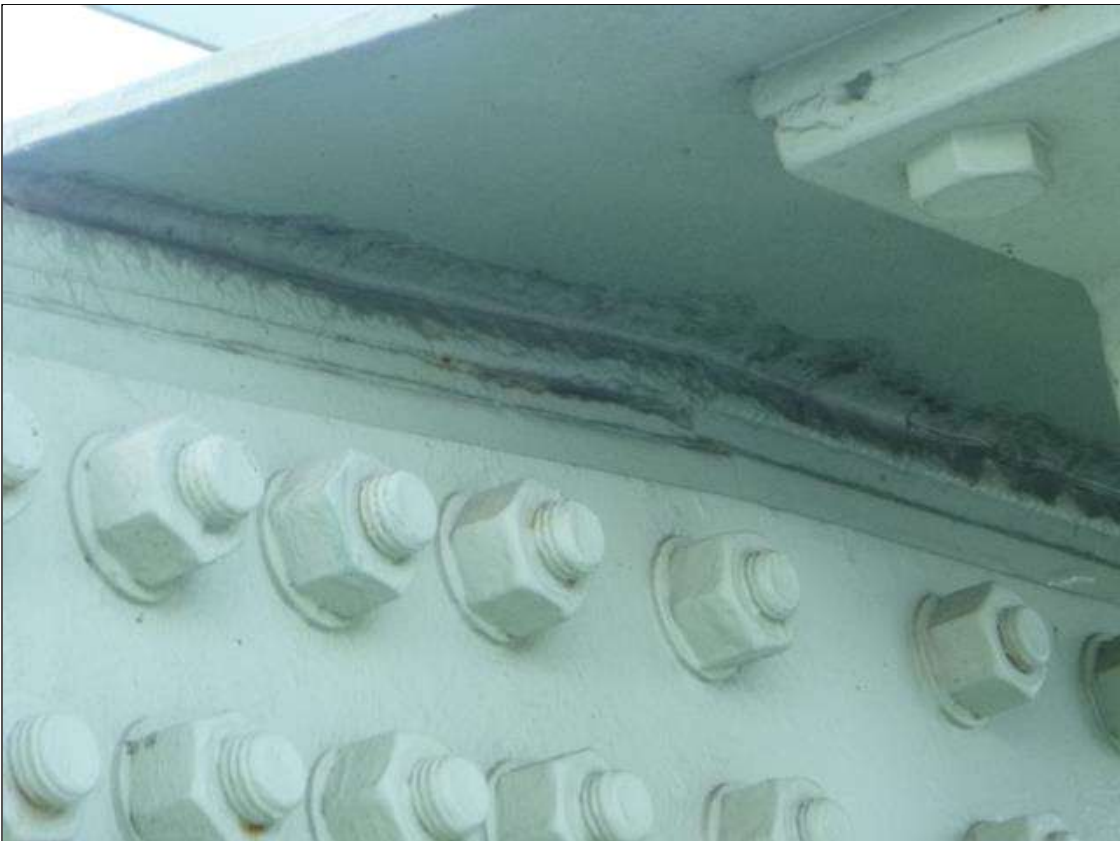
Span 18 Lift Span LB7: IMPACT DAMAGE 20" WIDE X 1-1/2" DEFORMATION IN WEST FLANGE OVER RIGHT EAST BOUND LANE.

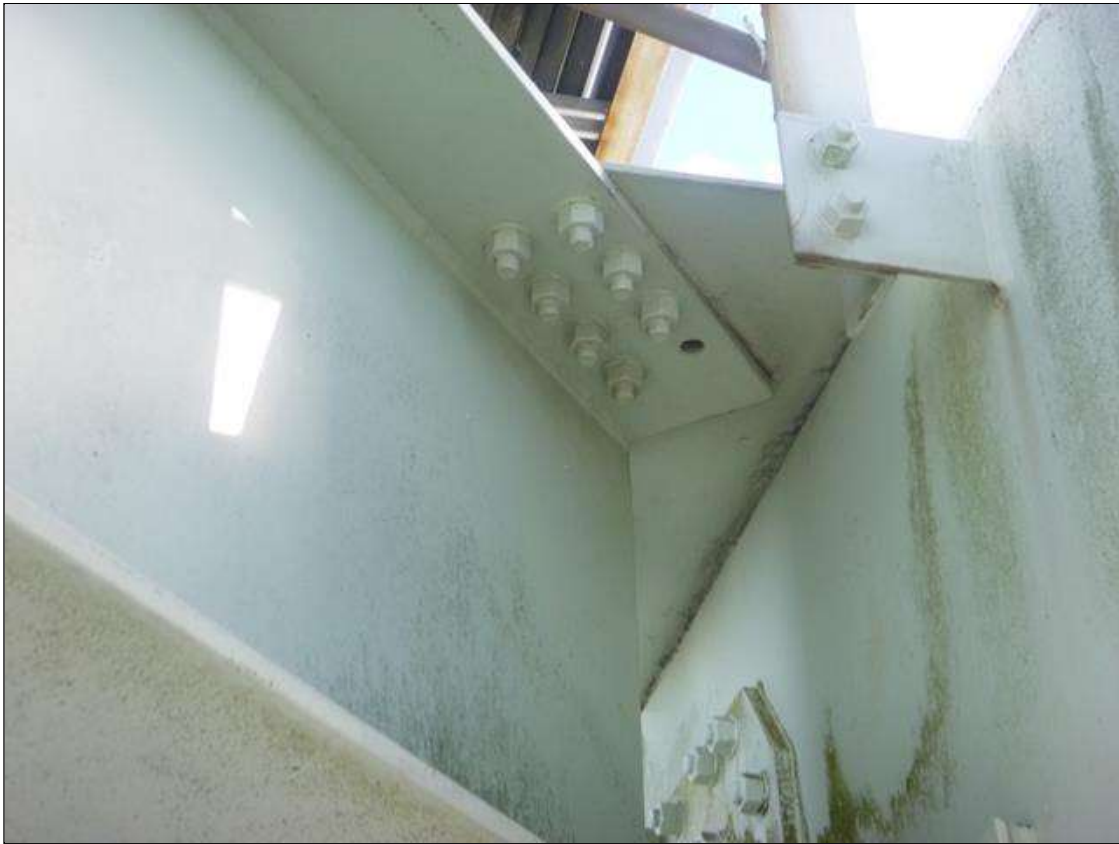
Span 18 Lift Span U7 SOUTH: 40" LONG X 1 1/2" WIDE AREA OF CLEANED AND PAINTED SECTION LOSS TO UNDERSIDE OF GUSSET PLATE SOUTH SIDE. (3/8" REMAINING)

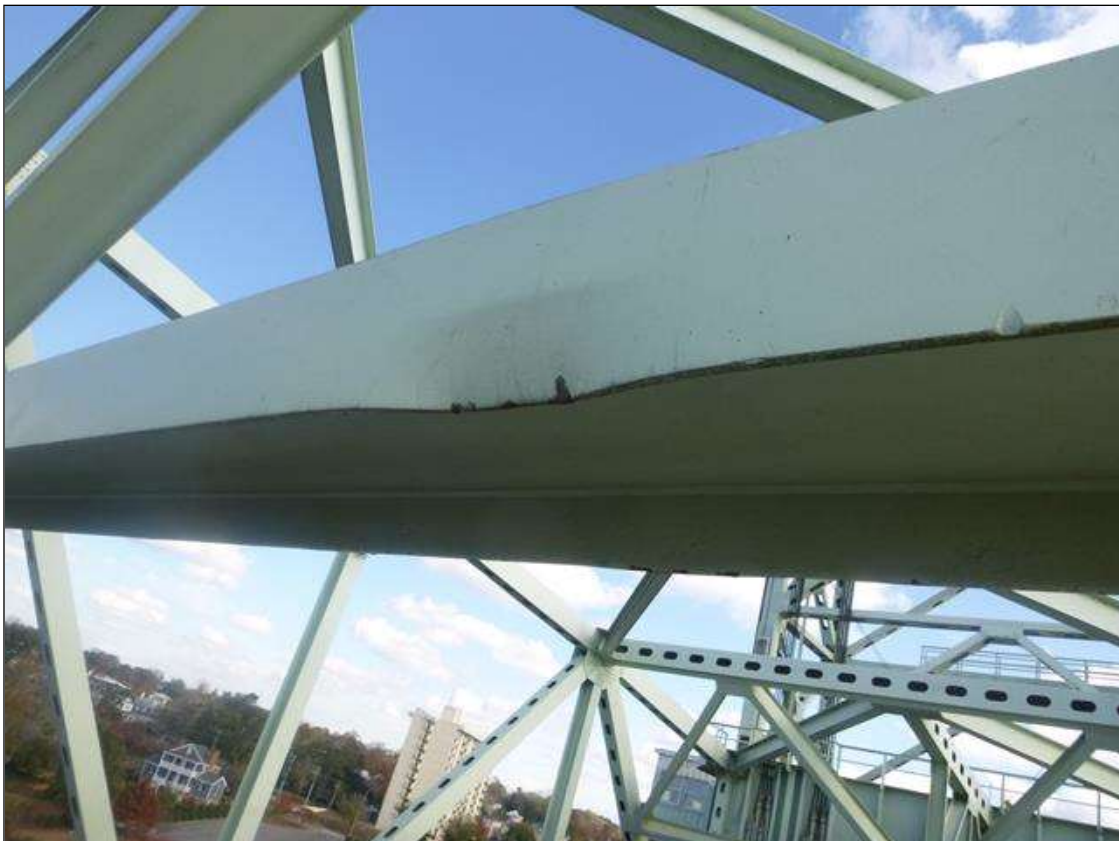
Span 18 Lift Span U8 SOUTH: EAST SIDE TOP CONNECTION TO LATERAL BRACING MISSING (1) BOLT

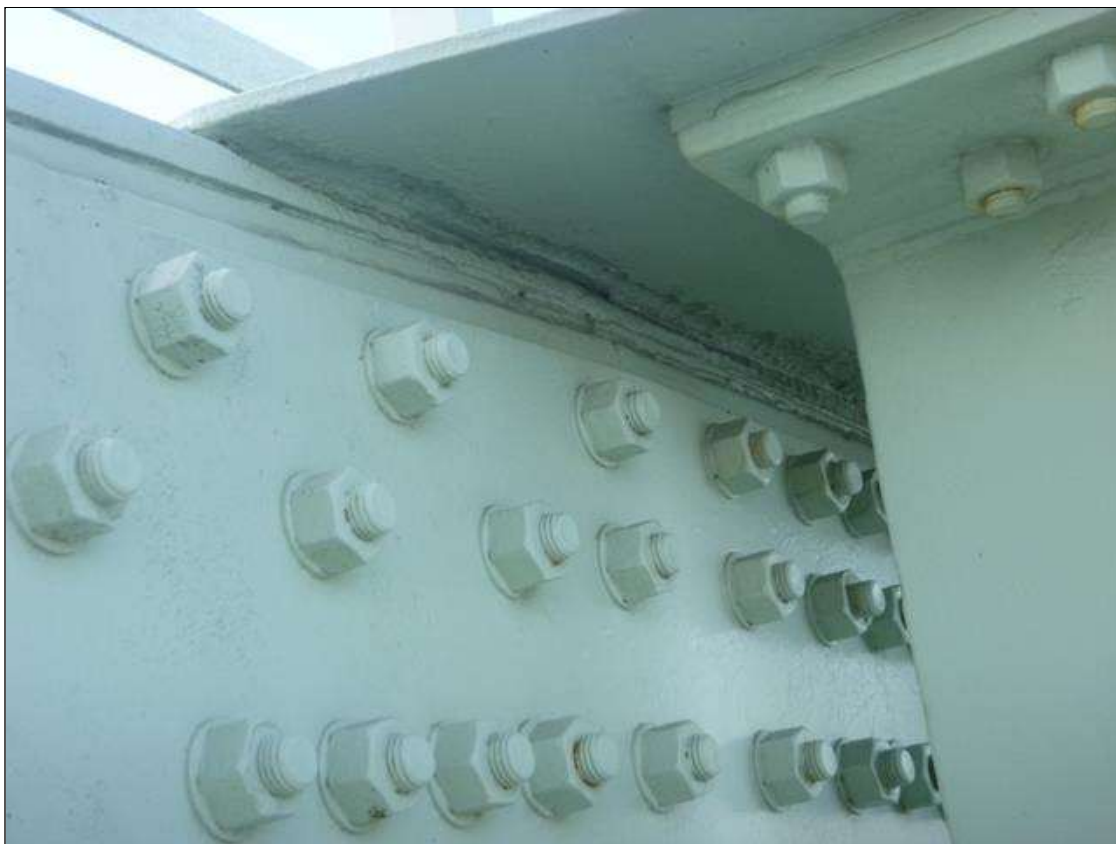
Span 18 Lift Span LB9: IMPACT DAMAGE 22" WIDE X 1-1/2" DEFORMATION ON WEST BOTTOM FLANGE OVER RIGHT EAST BOUND LANE.

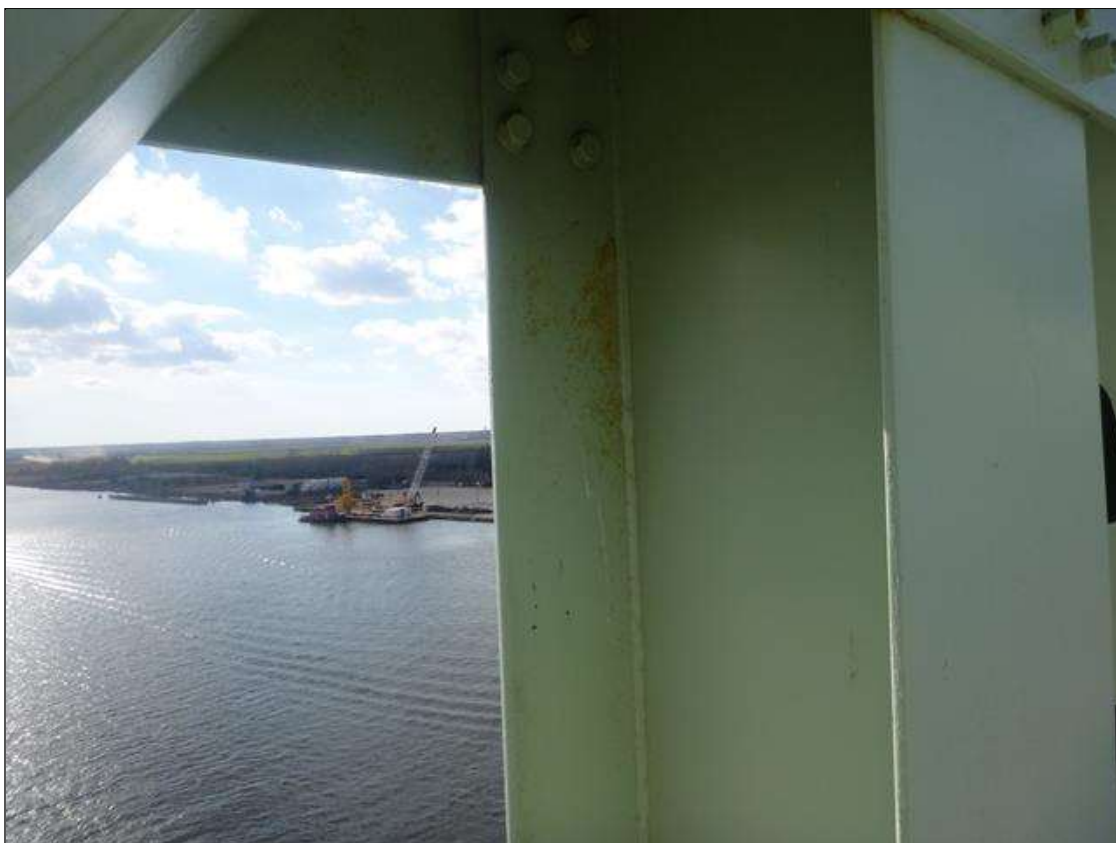
Span 18 Lift Span U9 SOUTH: 32" LONG X 1 1/2" WIDE AREA OF CLEANED AND PAINTED SECTION LOSS TO UNDERSIDE OF GUSSET PLATE @ U9 SOUTH SIDE.

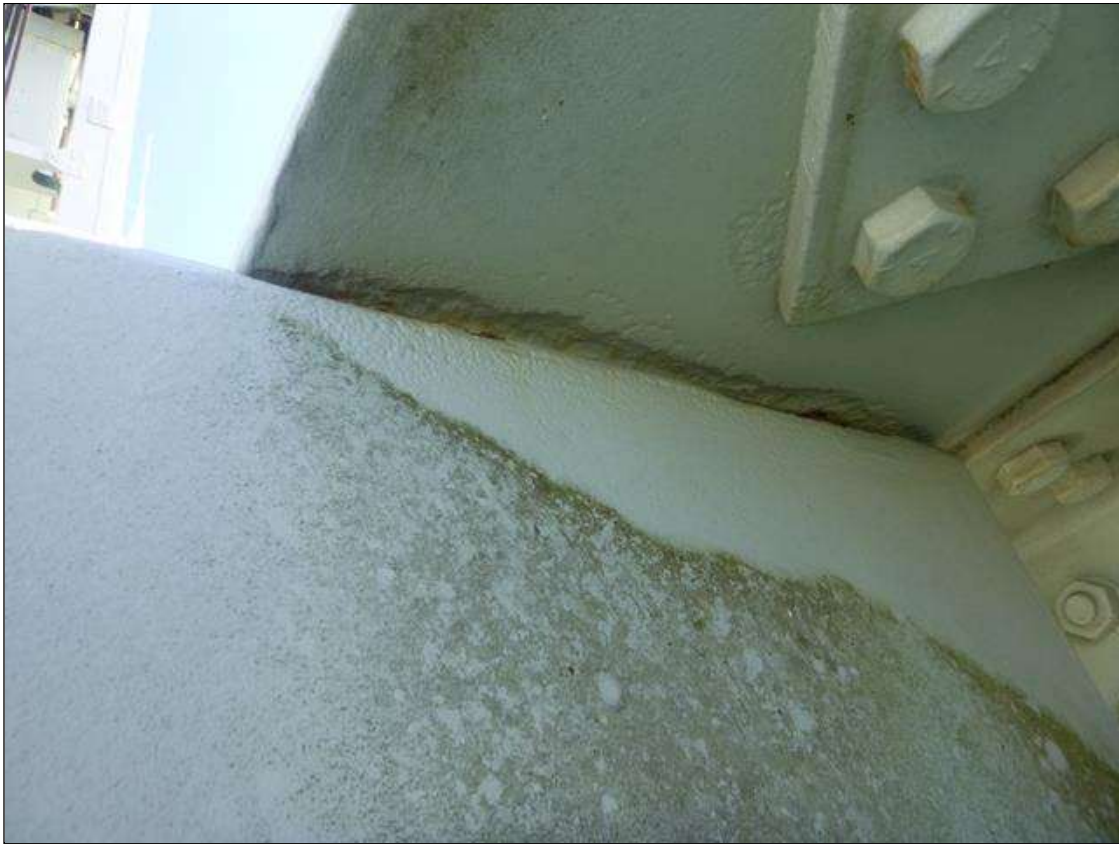
Span 18 Lift Span L9U9 SOUTH: SOUTH FLANGE EAST SIDE NEAR U8 FRECKLED RUST 18" X 6" AREA.

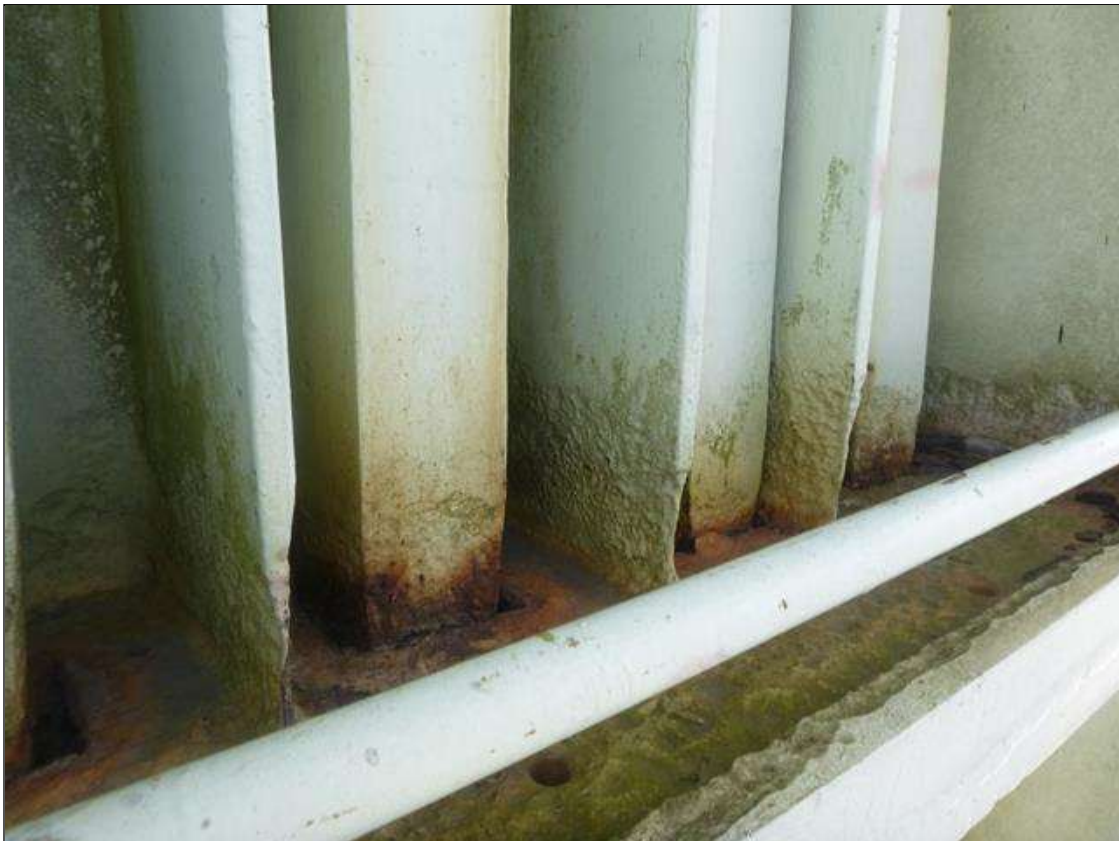
Span 18 Lift Span U11 SOUTH: BOTTOM OF TOP GUSSET PLATE AT LB11 EAST SIDE 15" X 1/2" AREA OF PITTING UP 1/16" DEEP.

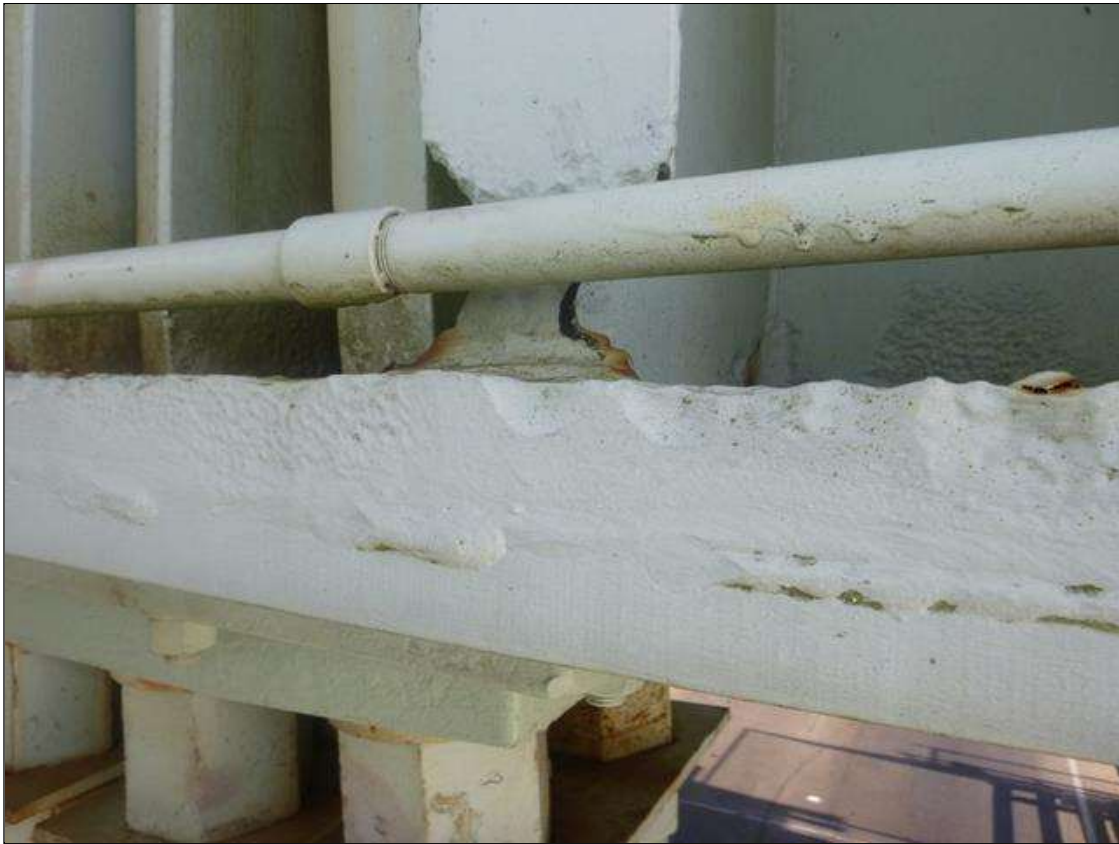
Span 18 Lift Span LB12: [PROMPT ACTION REQUEST] EASTBOUND LANE SOUTHWEST CABLE EYE BAR GUIDE PLATES HAVE LOSS OF SETION .234" WITH .406" REMAINING ALONG BOTTOM 4" HIGH.

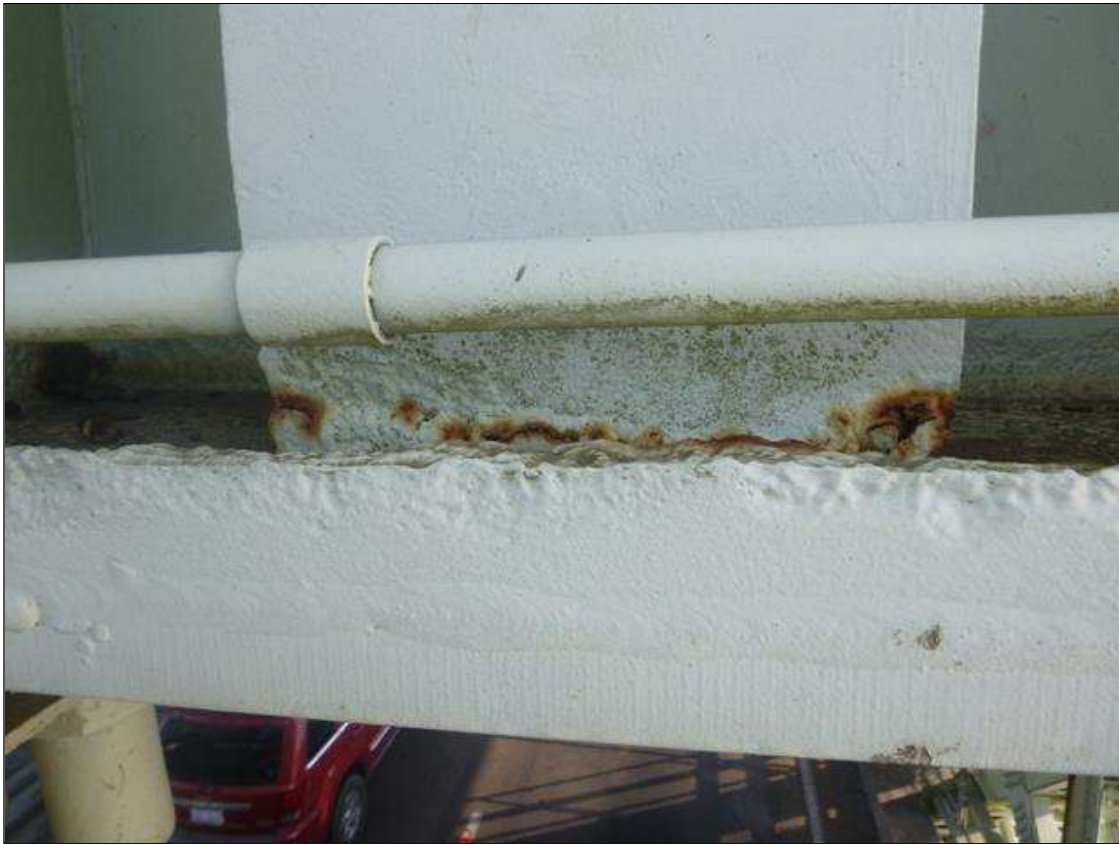
Span 18 Lift Span LB12: [PROMPT ACTION REQUEST] EASTBOUND LANE NORTHWEST CABLE BANK, RIGHT STIFFNER, COMPLETE LOSS OF SECTION 1-1/4" WIDE ON BOTH FLANGE ALONG BOTTOM 4" HIGH.

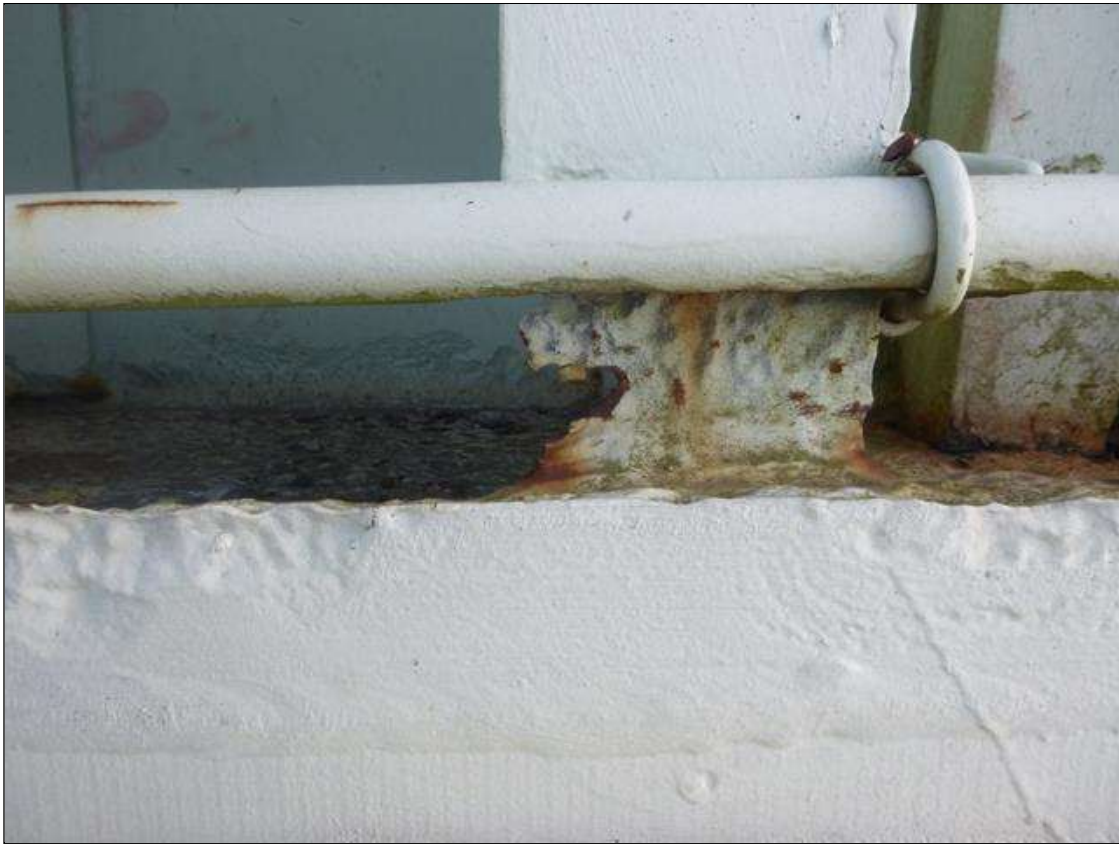
Span 18 Lift Span LB12: [PROMPT ACTION REQUEST] EASTBOUND LANE: 2ND STIFFNER RIGHT OF NORTHWEST CABLE BANK LOSS OF SECTION .334" WITH .321" REMAINING ALONG BOTTOM 4-1/2" HIGH ON WEST FLANGE.

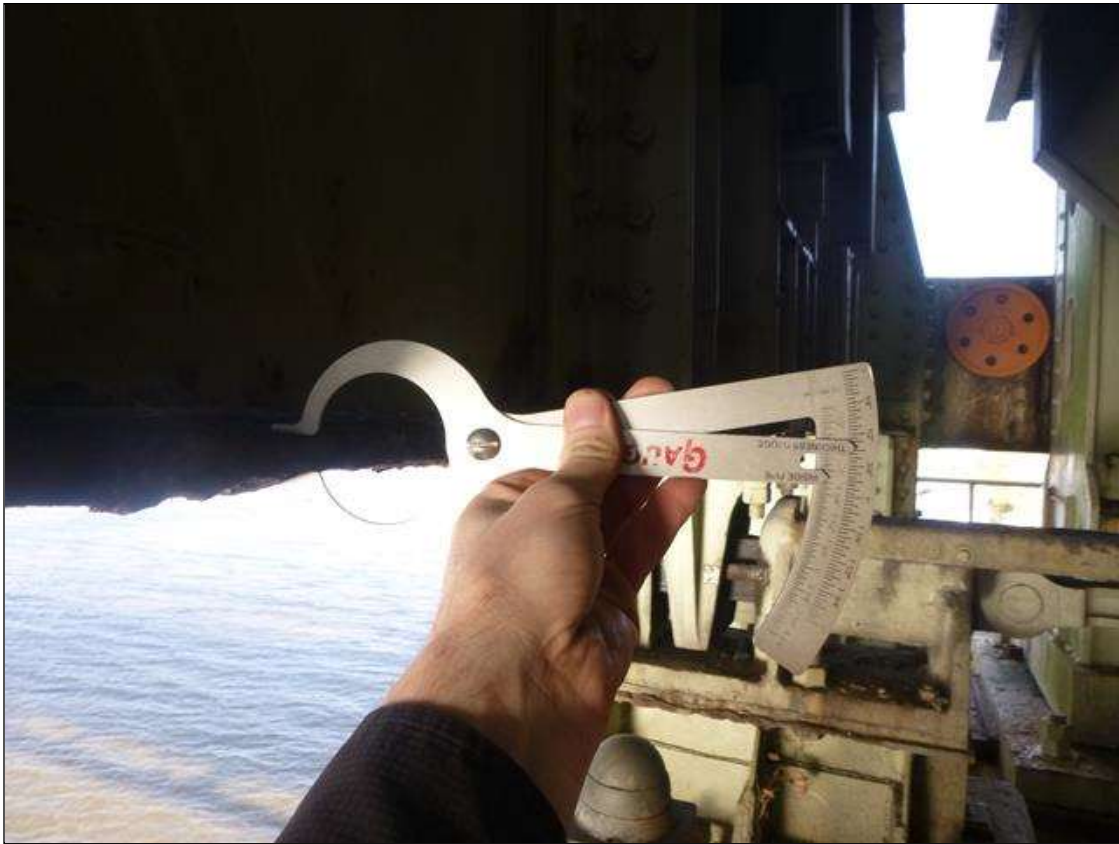
Span 18 Lift Span Floor Beam 12: LOSS OF SECTION .625" WITH .683" REMAINING BOTTOM EAST FLANGE 4' LONG X 3.25" WIDE OVER OLD ANCHOR POINT BEGINNING 2' LEFT OF NORTHEAST BEARING. PAINT HAS FAILED. (PAR)

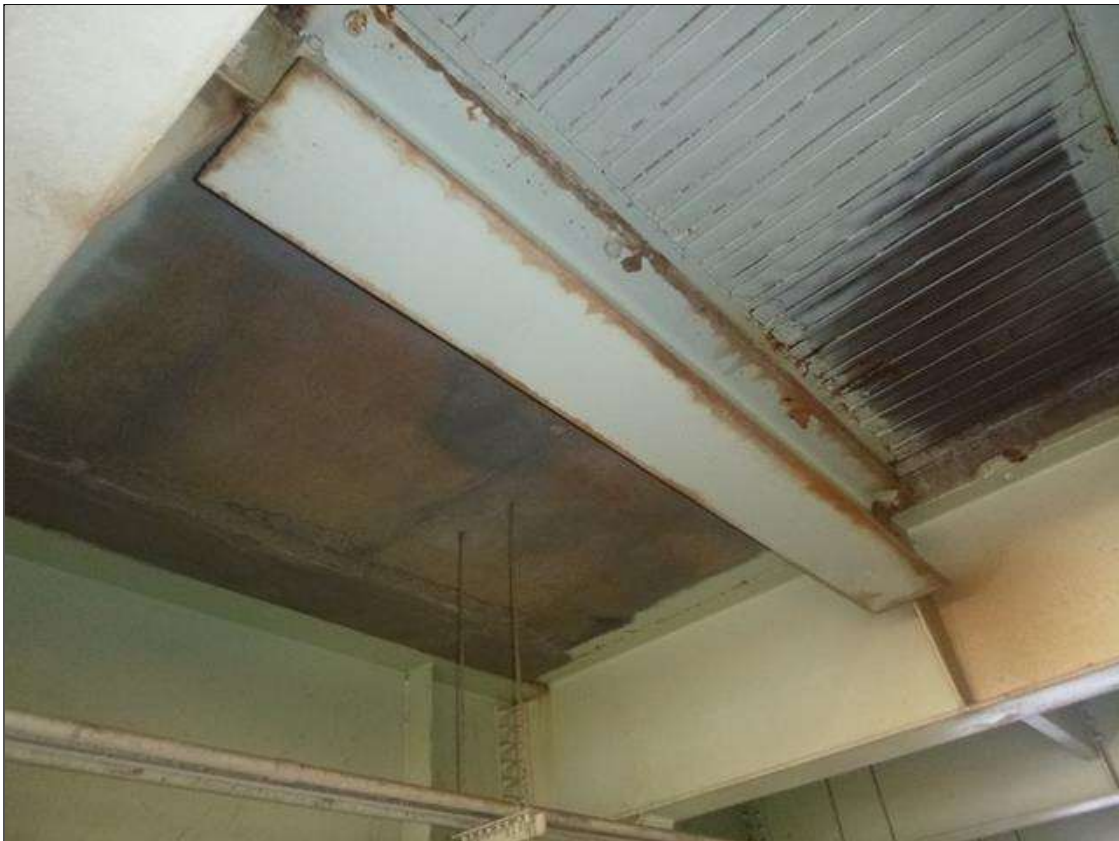
Span 18 Lift Span Floor Beam 12: LOSS OF SECTION .680" WITH .628" REMAINING BOTTOM EAST FLANGE 17' LONG X UP TO 5-1/2" WIDE BETWEEN LEFT LOCK AND CENTERLINE SUPPORT PEDESTAL. (PAR)

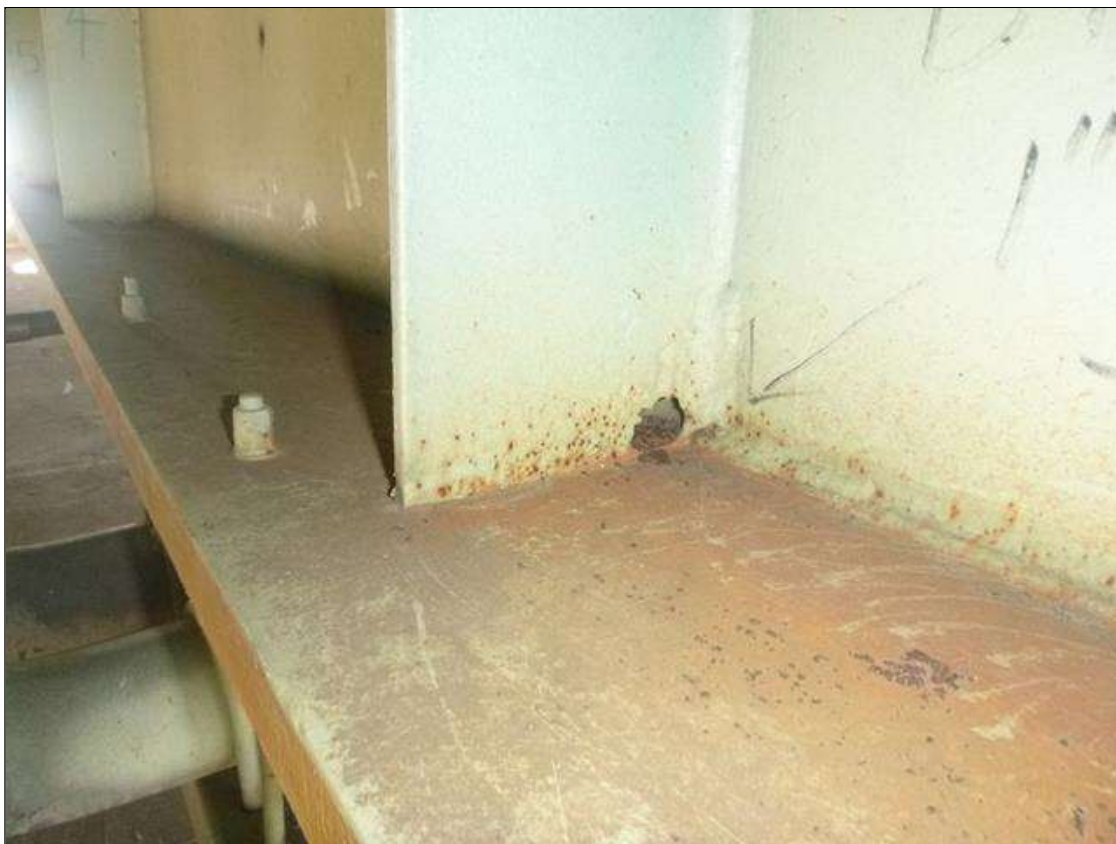
Span 19 Stringer 3: surface corrosion on the edges of the flanges between stringers which are between stringer 3 and

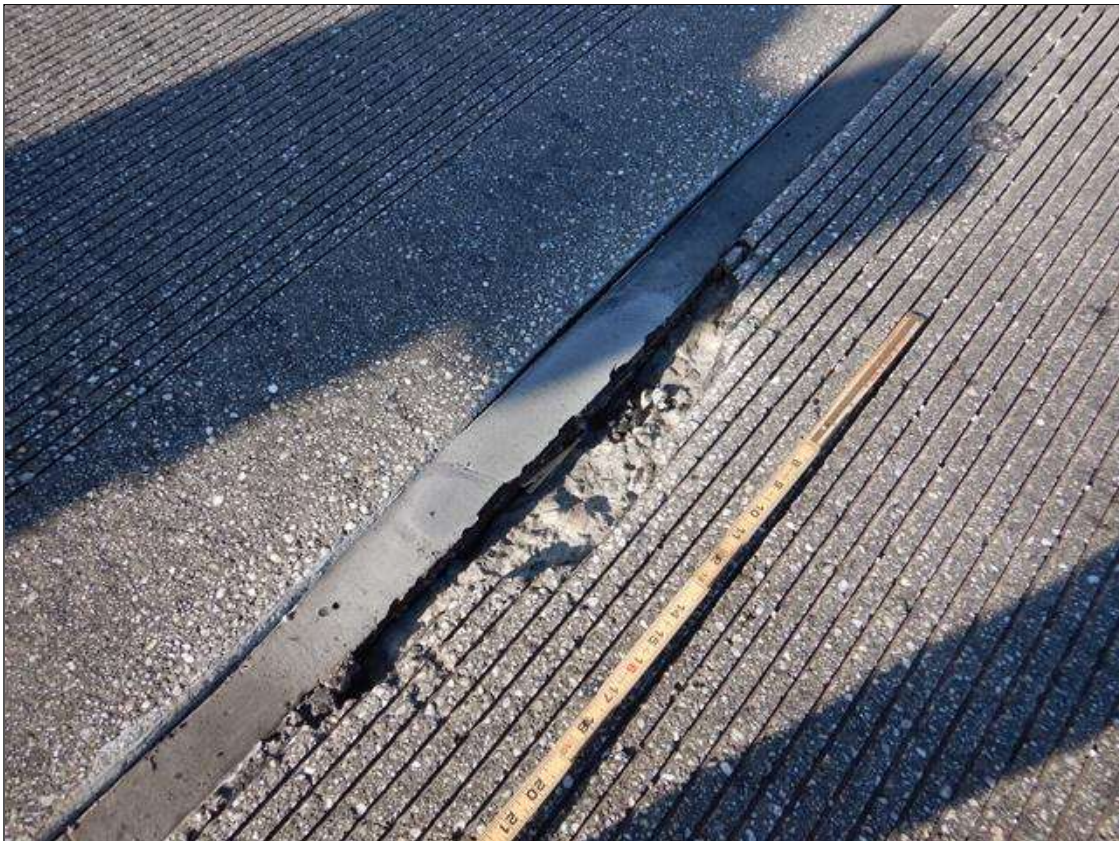
Span 5 Deck: [PROMPT ACTION REQUEST] RIGHT LANES AT BENT 4, TWO SPALLS (18" LONG x 3" WIDE x 1.5" DEEP AT 8' FROM RIGHT CURB) & (8" LONG x 2" WIDE x 3" DEEP AT 2' FROM CENTERLINE)

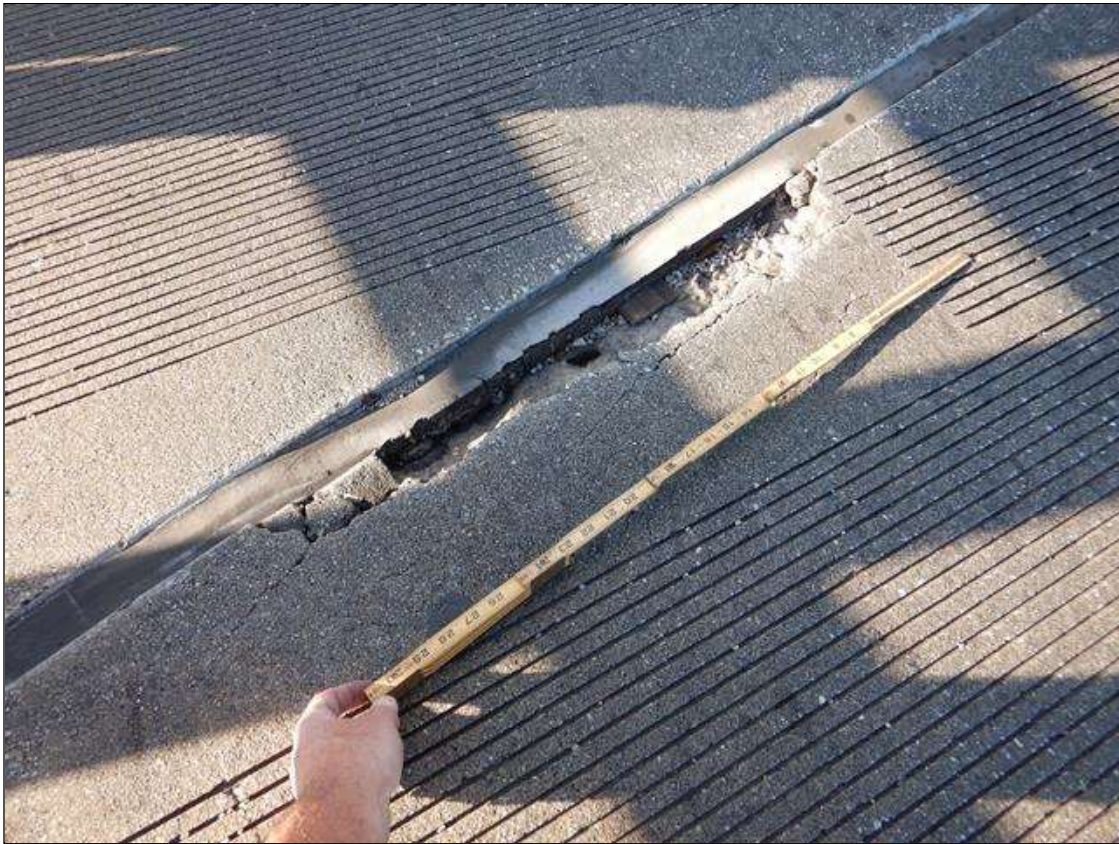
Span 7 Deck: [PROMPT ACTION REQUEST] RIGHT LANES AT BENT 6, SPALL (24" LONG x 4" WIDE x 1.5" DEEP AT 10' FROM RIGHT CURB)

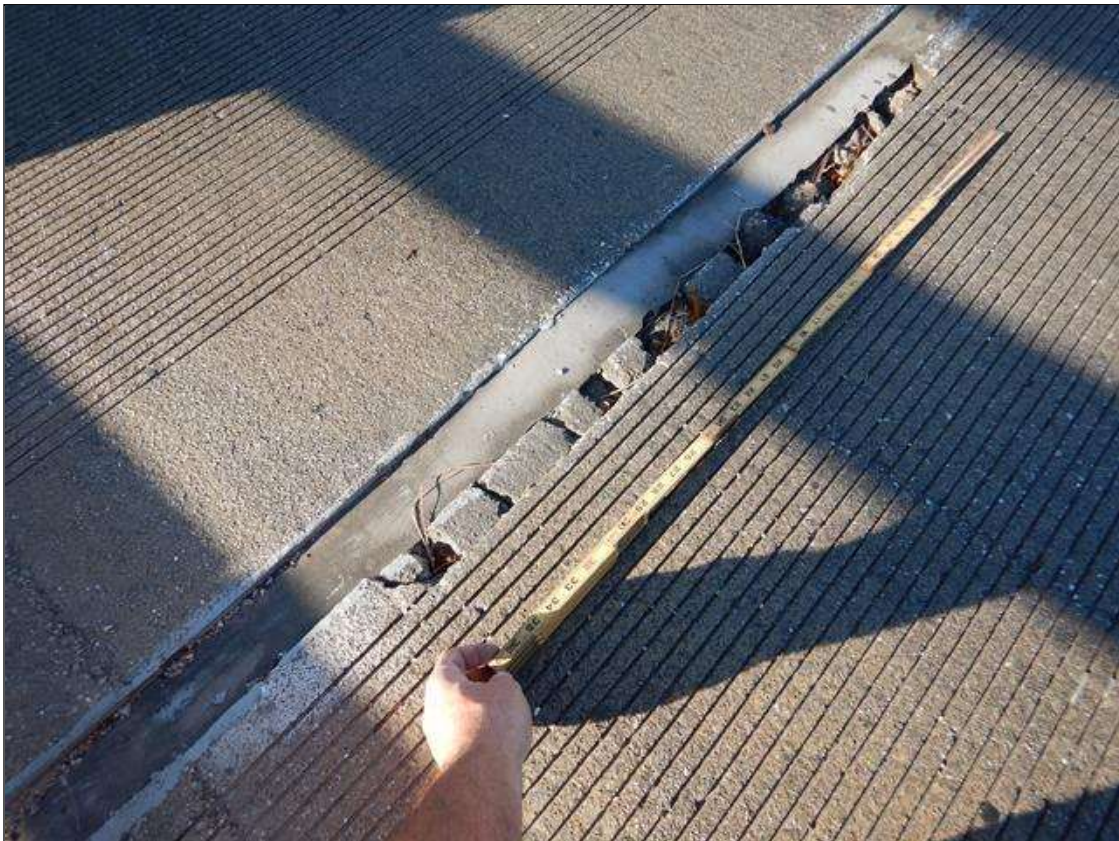
Span 8 Deck: [PROMPT ACTION REQUEST] RIGHT LANES AT BENT 7, SPALL (36" LONG x 3" WIDE x 1.5" DEEP AT 4' FROM RIGHT CURB)

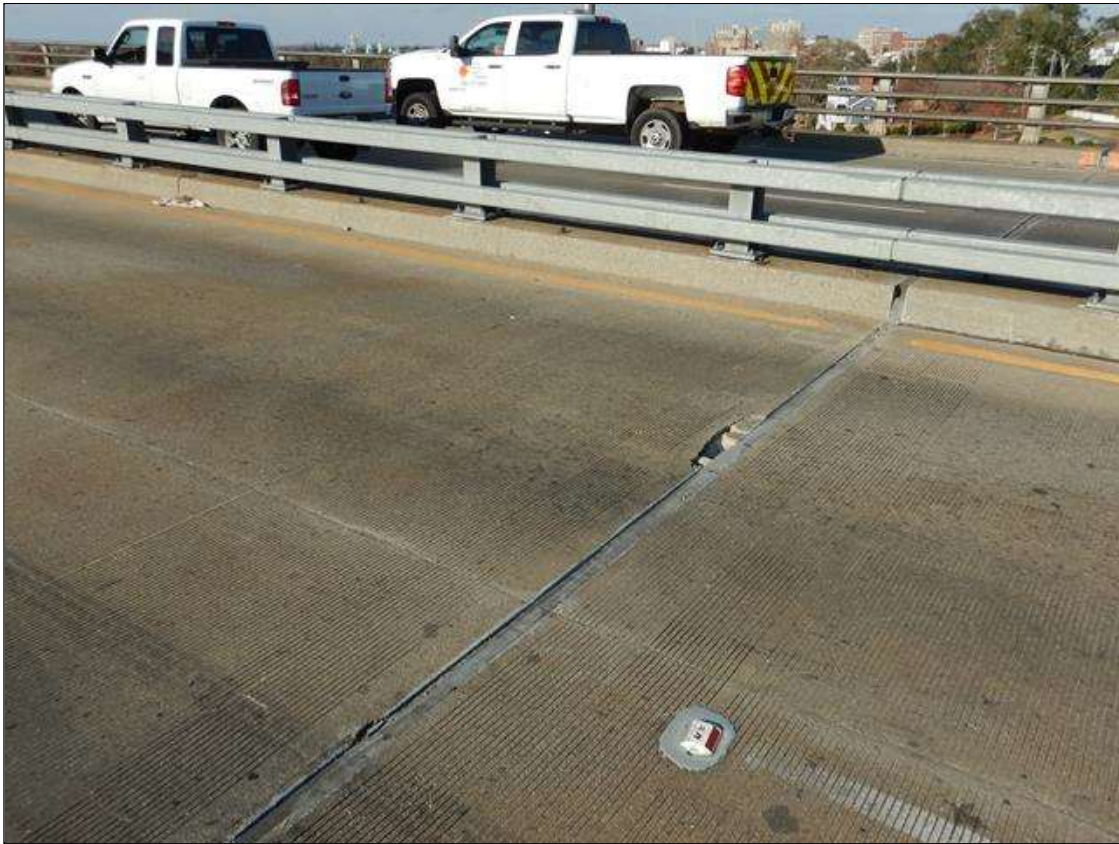
Span 21 Deck: [PROMPT ACTION REQUEST] RIGHT LANES AT BENT 18, SPALL (42" LONG x 2" WIDE x 3.5" DEEP AT 4' FROM RIGHT CURB)

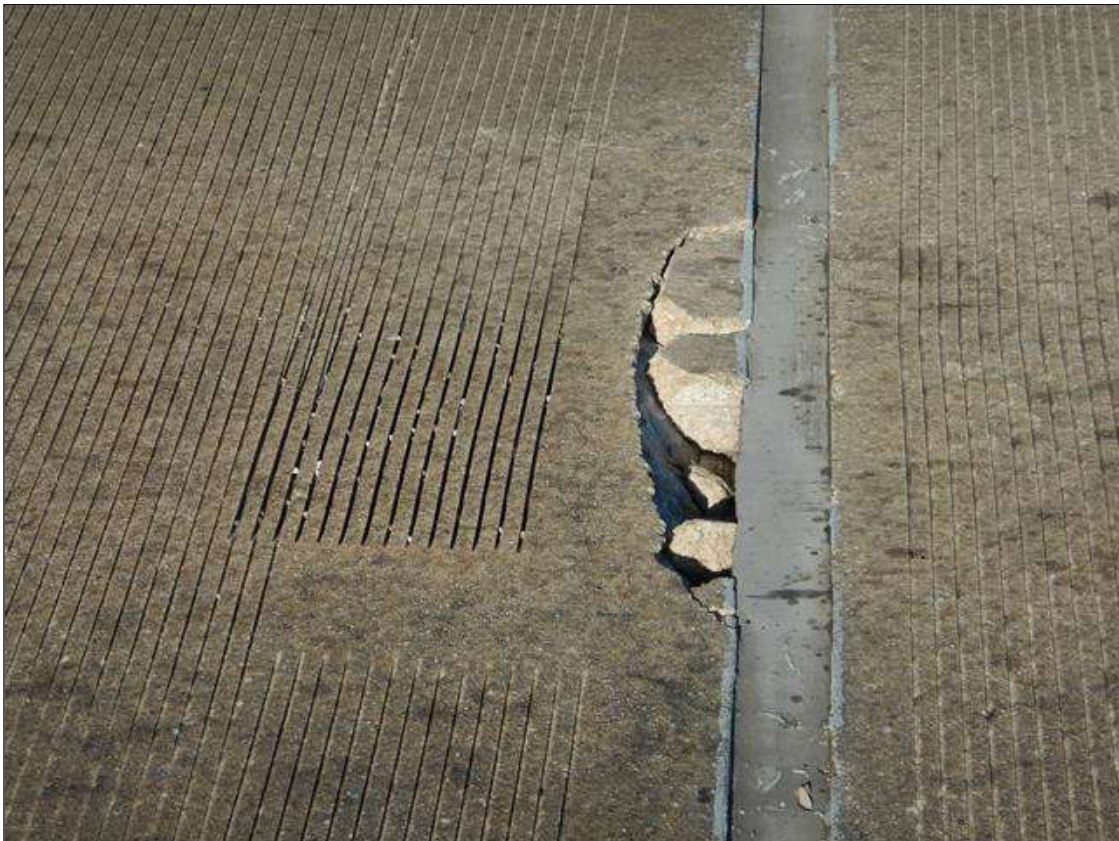
Span 22 Deck: [PROMPT ACTION REQUEST] RIGHT LANES AT BENT 20, SPALL (30" LONG x 3" WIDE x 4" DEEP AT 8' FROM MEDIAN RAIL)

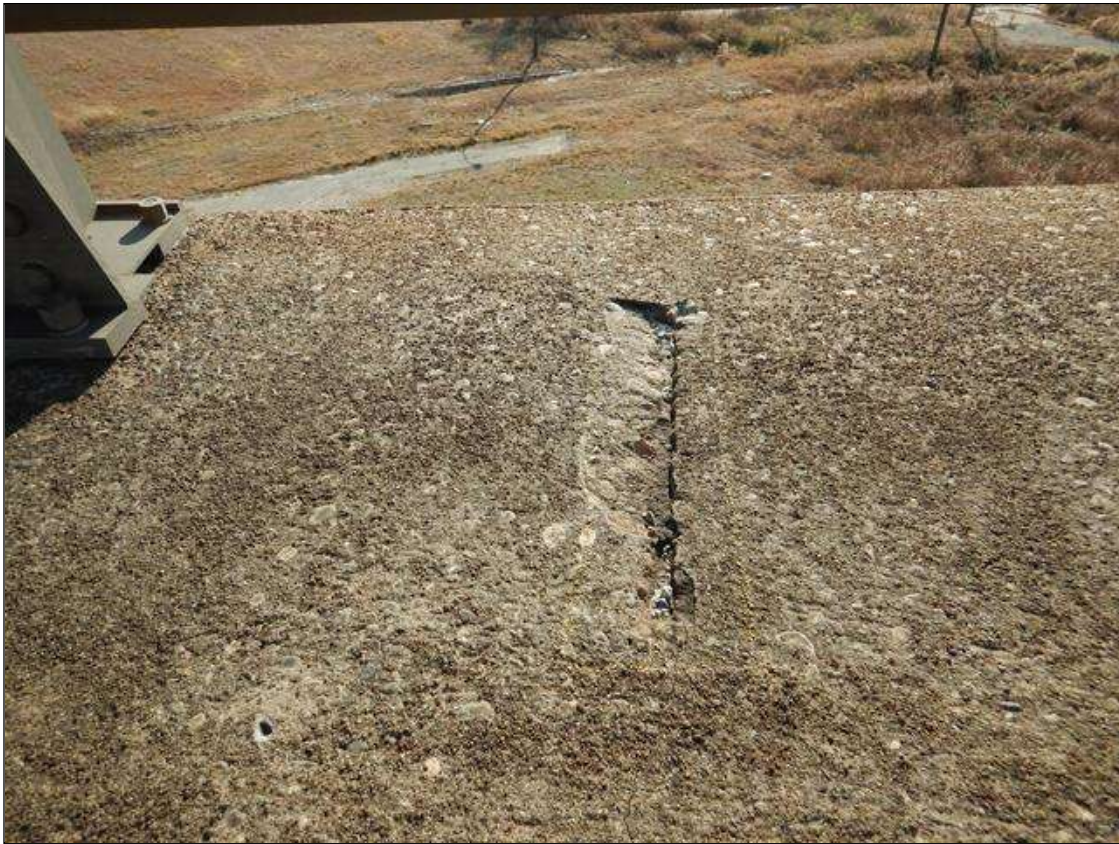
Span 22 Deck: [PROMPT ACTION REQUEST] RIGHT LANES AT BENT 20, SPALL (30" LONG x 3" WIDE x 4" DEEP AT 8' FROM MEDIAN RAIL)
