NC DEPARTMENT OF TRANSPORTATION
DIVISION OF HIGHWAYS
STRUCTURE MANAGEMENT UNIT

Structure Safety Report

Routine Element Inspection - Contract

DIVISION: 3 COUNTY: NEW HANOVER STRUCTURE NUMBER: 640013 FREQUENCY: 24 MONTHS

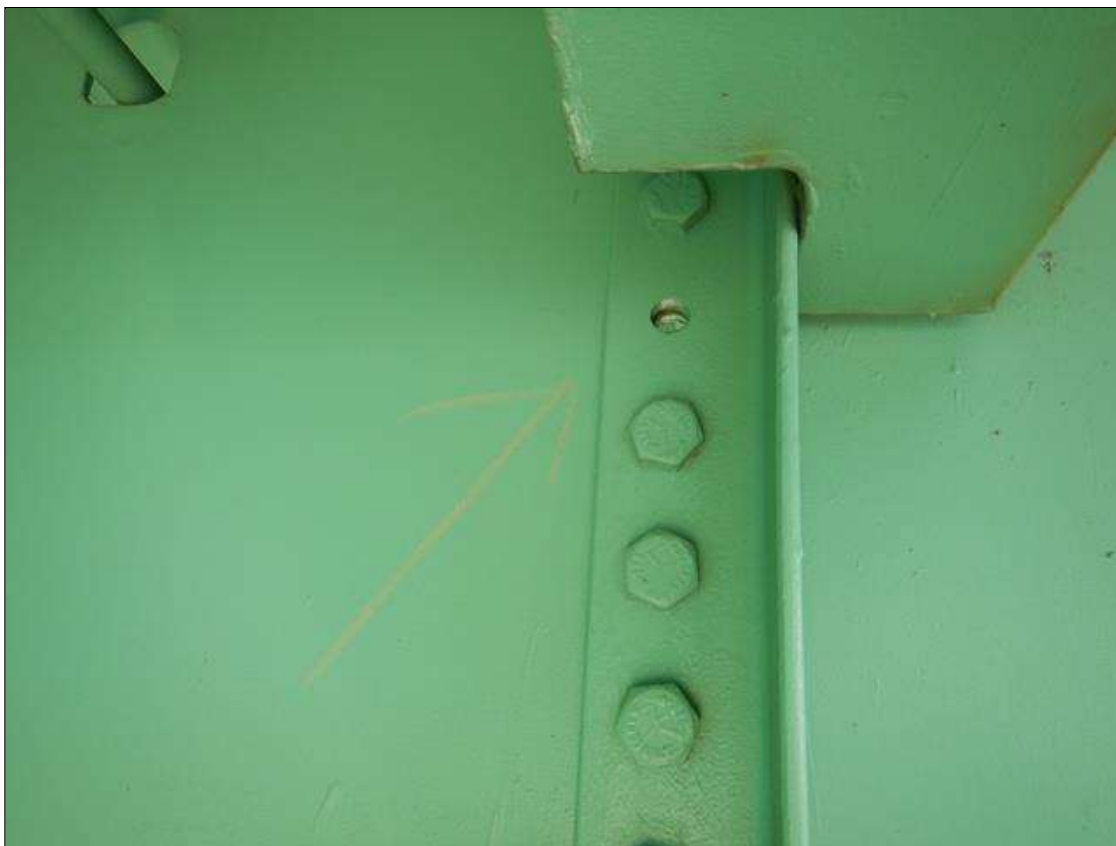
Span 20 Beam 8: [NEW REPAIR - NUT REPLACED] FORMERLY --> Bracket 3 at EB Parking Area West Face: section loss up to 75% section loss on (x1) nut; section loss in the web (6" x 2 1/2") by up to (1/16") into the web

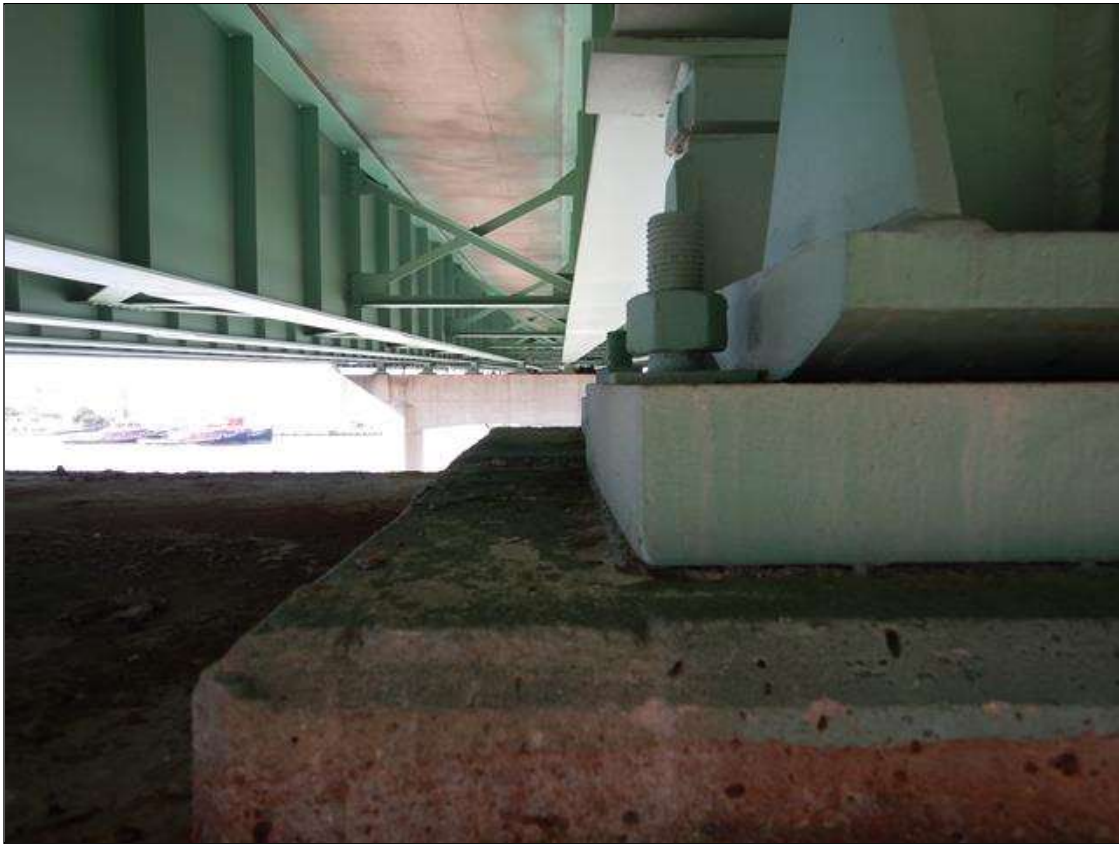
Span 22 Beam 1 - Beam 1 Near Bearing: [PROMPT ACTION REQUEST] LEFT ANCHOR BOLT LIFTED 1/2"

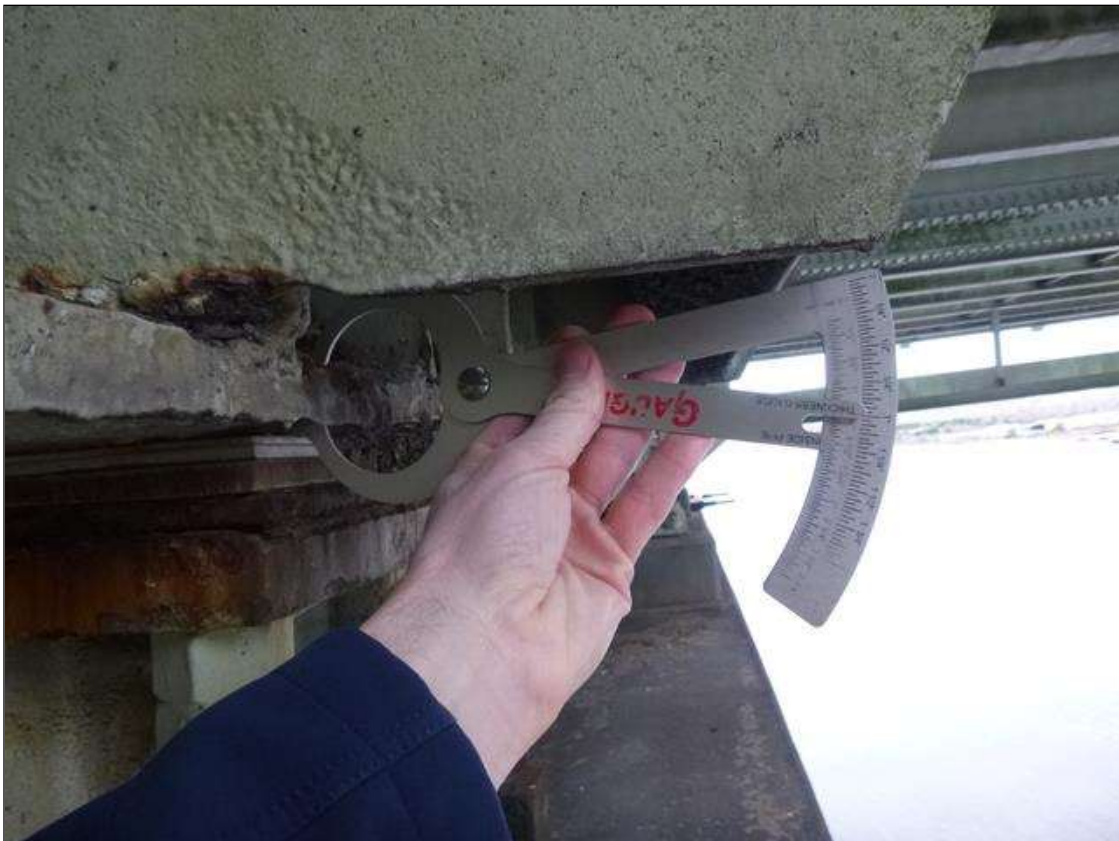
Span 22 Beam 3 - Beam 3 Near Bearing: [PROMPT ACTION REQUEST] RIGHT ANCHOR BOLT LIFTED 3/4"

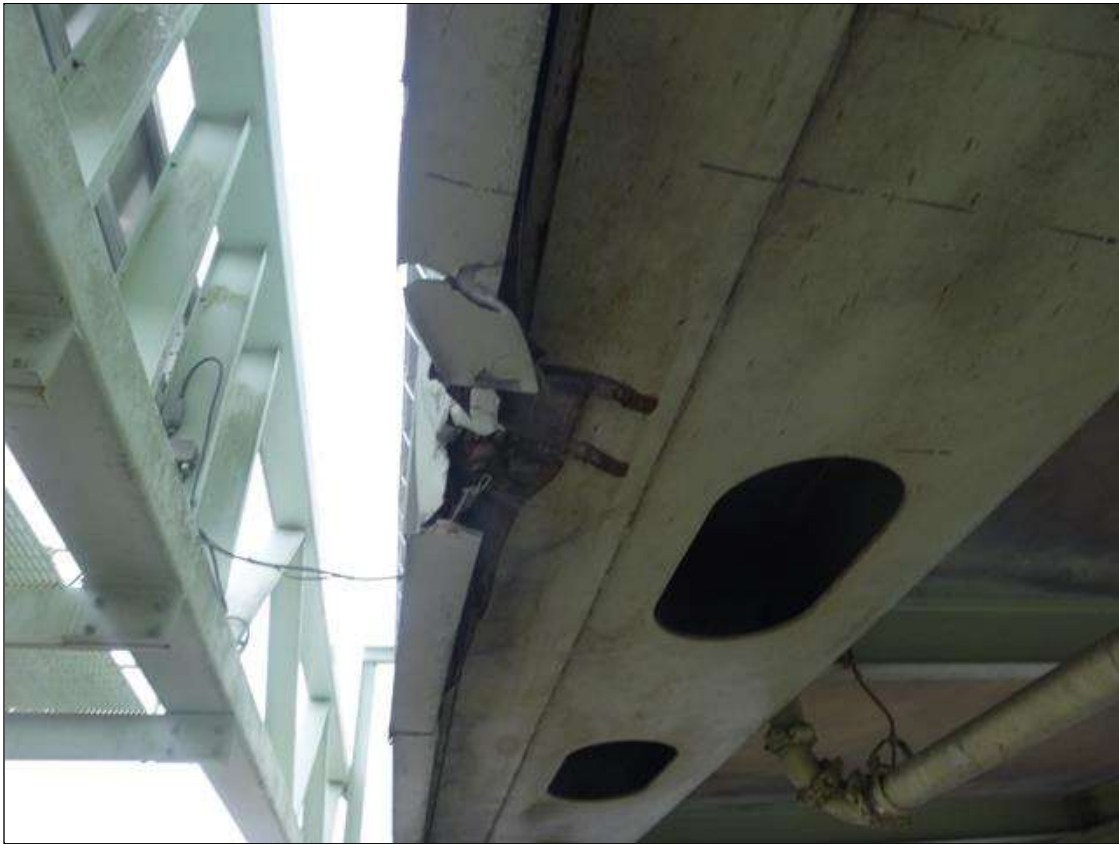
Span 18 Lift Span Floor Beam 12: (PAR) LOSS OF SECTION .341" WITH .967" REMAINING BOTTOM WEST FLANGE, 4' LONG X 2.5" WIDE BEGINING 2' LEFT OF NORTHEAST BEARING.

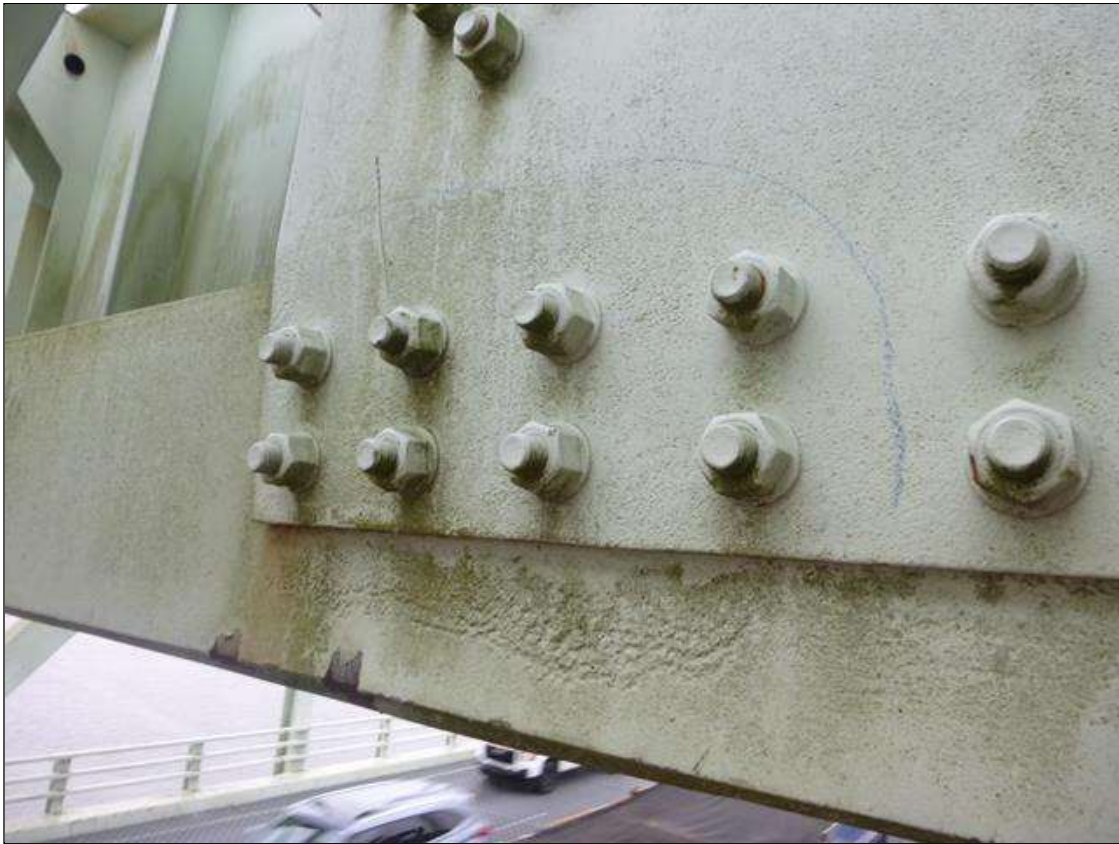
Span 19 EAST TOWER NORTH: 6/2020 - IMPACT DAMAGE - BOTTOM EAST HORIZONTAL TRUSS MEMBER - 32" LONG SECTION OF COVER PLATE ON EAST SIDE BENT UPWARD 1-1/4" WIDE/ (2) 6-1/2" LONG GOUGES UP TO 1/16" DEEP - LOCATED 11' FROM NORTHEAST TOWER LEG - NO DAMAGE TO ACTUAL TRUSS MEMBER (COVER PLATE ONLY)

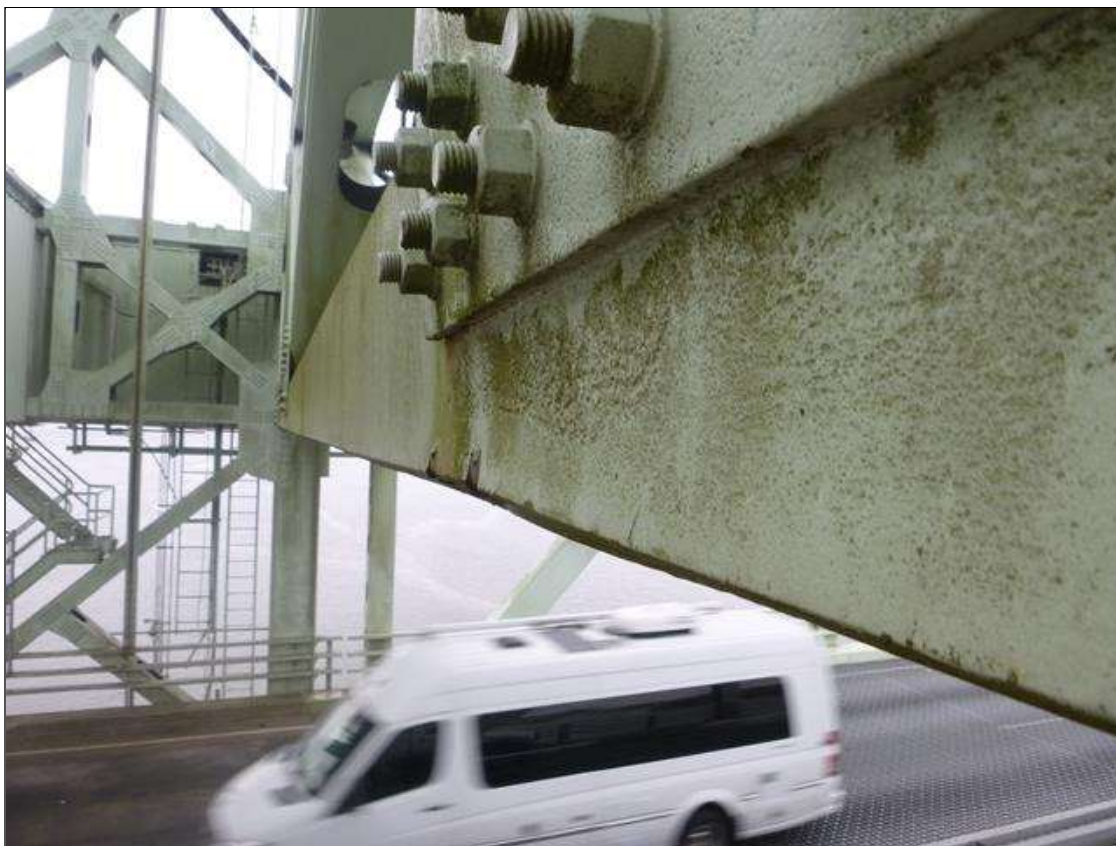
Span 19 EAST TOWER NORTH: 6/2020 - IMPACT DAMAGE - BOTTOM WEST HORIZONTAL TRUSS MEMBER - (2) 1"WIDE x 3/4"LONG x 3/16"DEEP GOUGES, AND (1) ~1/2" DIAMETER x 1/16"DEEP INDENTION ON BOTTOM EAST CORNER AT 11'-3" FROM NORTHWEST TOWER LEG

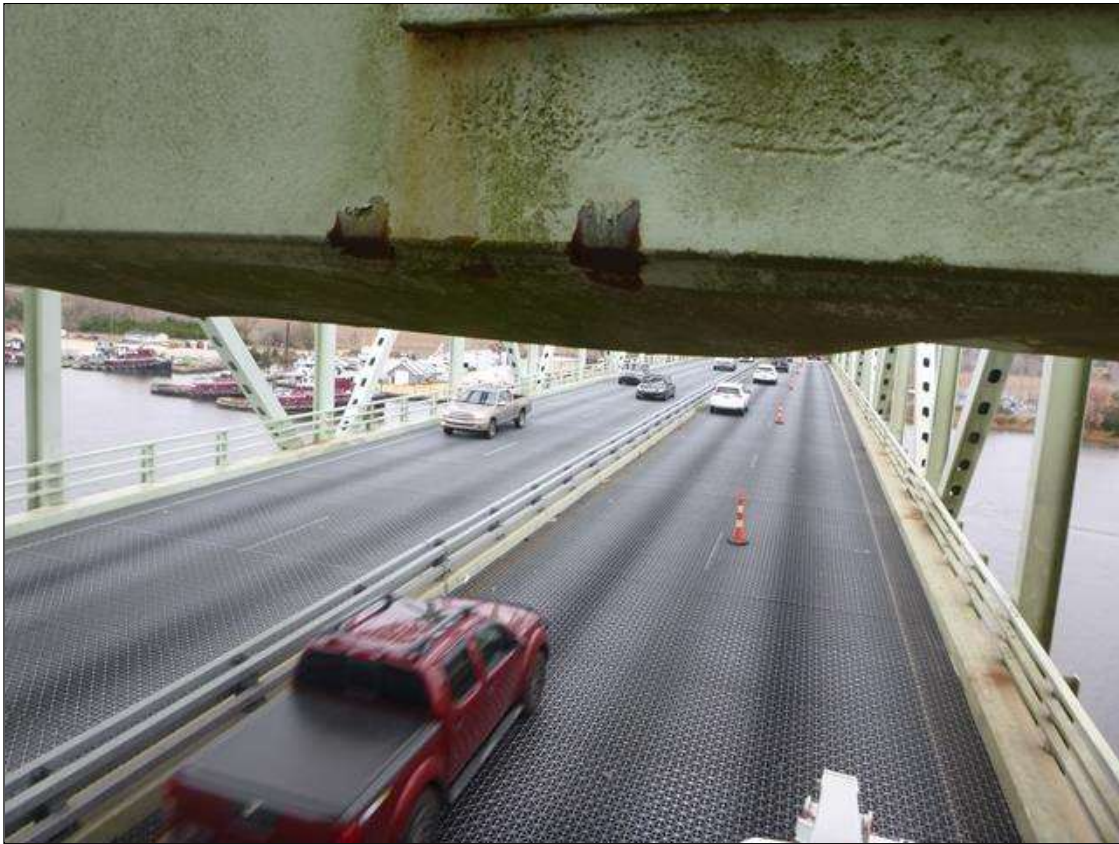
Span 19 EAST TOWER NORTH: 6/2020 - IMPACT DAMAGE - BOTTOM WEST HORIZONTAL TRUSS MEMBER - 3'L SECTION ON EAST SIDE BENT 1/2" TO THE WEST - LOCATED 11'-3" FROM NORTHWEST TOWER LEG (PAR)

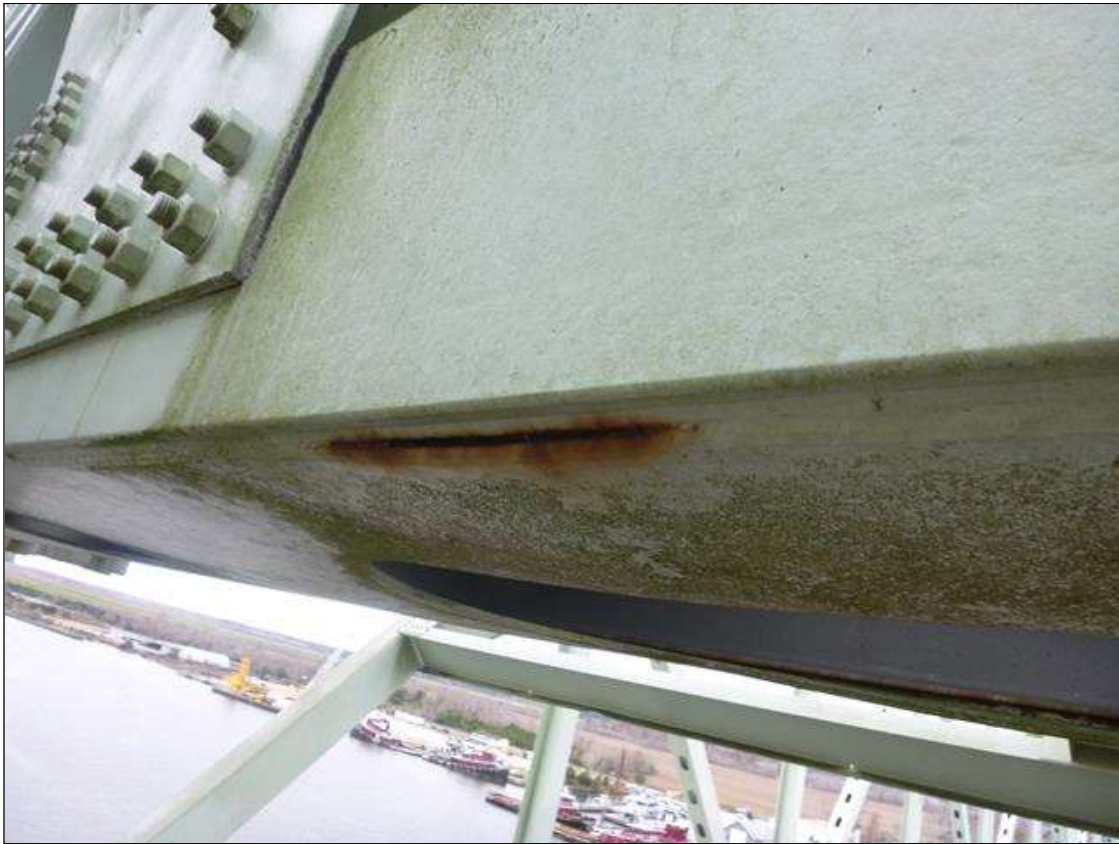
Span 19 EAST TOWER NORTH: 6/2020 - IMPACT DAMAGE - BOTTOM WEST HORIZONTAL TRUSS MEMBER - DEFORMATION IN TOP AND BOTTOM PLATES OF MEMBER BEGINING AT NORTHWEST TOWER LEG AND CONTINUING SOUTH 16'. MOST SEVERE DEFORMATION IN BOTTOM PLATE AT POINT OF IMPACT (11'-3" FROM NORTHWEST TOWER LEG), WITH AREAS BENT UPWARD AND DOWNWARD UP TO 1-1/2" x 3'L (PAR)

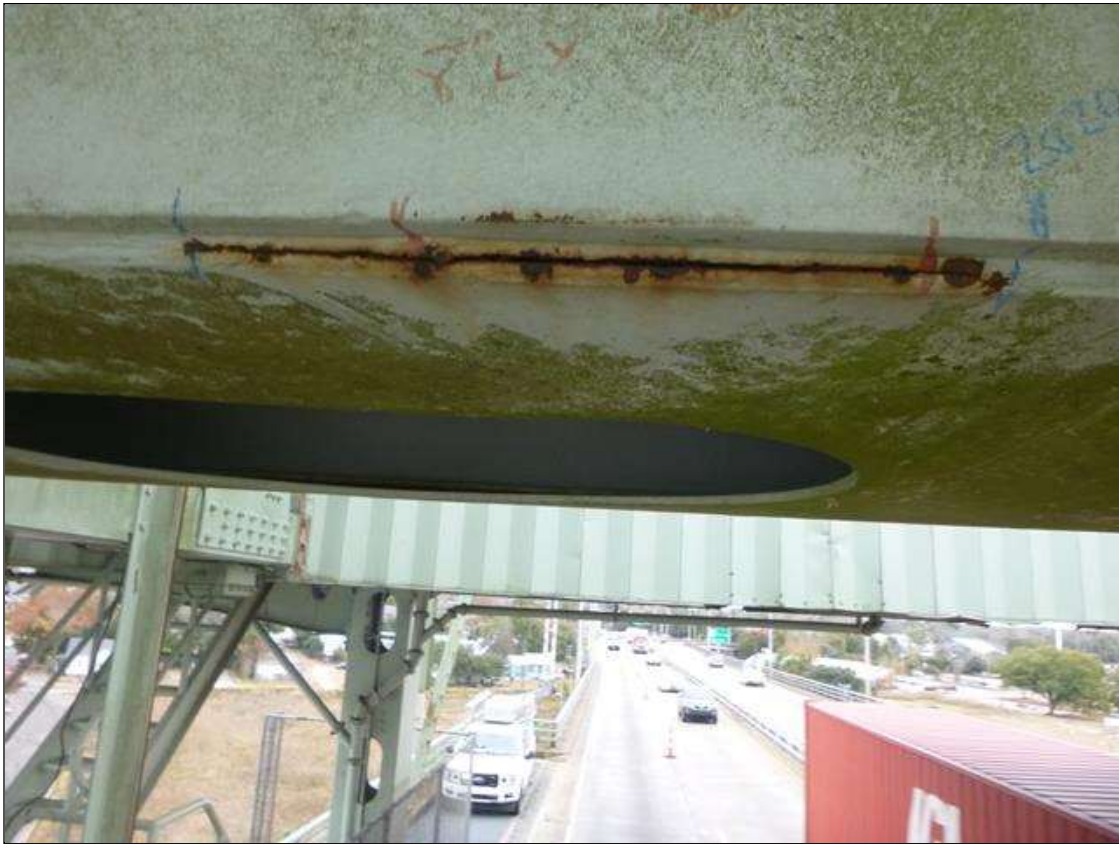
2	Cracking	1	Span 19 EAST TOWER NORTH: CRACK - BOTTOM WEST HORIZONTAL TRUSS MEMBER - CRACK ALONG WELD AT BOTTOM EAST CORNER 9" LONG LOCATED 24' FROM NORTHWEST TOWER LEG (PAR)
2	Damage	0	Span 19 EAST TOWER NORTH: 6/2020 - IMPACT DAMAGE - BOTTOM WEST HORIZONTAL TRUSS MEMBER - 3' LONG SECTION ON EAST SIDE BENT 1/2" TO THE WEST - LOCATED 11'-3" FROM NORTHWEST TOWER LEG (PAR)
2	Damage	0	Span 19 EAST TOWER NORTH: 6/2020 - IMPACT DAMAGE - BOTTOM WEST HORIZONTAL TRUSS MEMBER - DEFORMATION IN TOP AND BOTTOM PLATES OF MEMBER BEGINNING AT NORTHWEST TOWER LEG AND CONTINUING SOUTH 16'. MOST SEVERE DEFORMATION IN BOTTOM PLATE AT POINT OF IMPACT (11'-3" FROM NORTHWEST TOWER LEG), WITH AREAS BENT UPWARD AND DOWNWARD UP TO 1-1/2" x 3'L (PAR)
2	Damage	0	Span 19 EAST TOWER NORTH: 6/2020 - IMPACT DAMAGE - BOTTOM WEST HORIZONTAL TRUSS MEMBER - DIAGONAL CONNECTION GUSSET PLATE - 18" LONG x 8" HIGH SECTION AT BOTTOM SOUTH CORNER BENT 1/2" TO THE WEST - LOCATED AT 11'-3" FROM NORTHWEST TOWER LEG (PAR)

Span 19 EAST TOWER NORTH: CRACK - BOTTOM WEST HORIZONTAL TRUSS MEMBER - CRACK ALONG WELD AT BOTTOM EAST CORNER 9" LONG LOCATED 24' FROM NORTHWEST TOWER LEG (PAR)

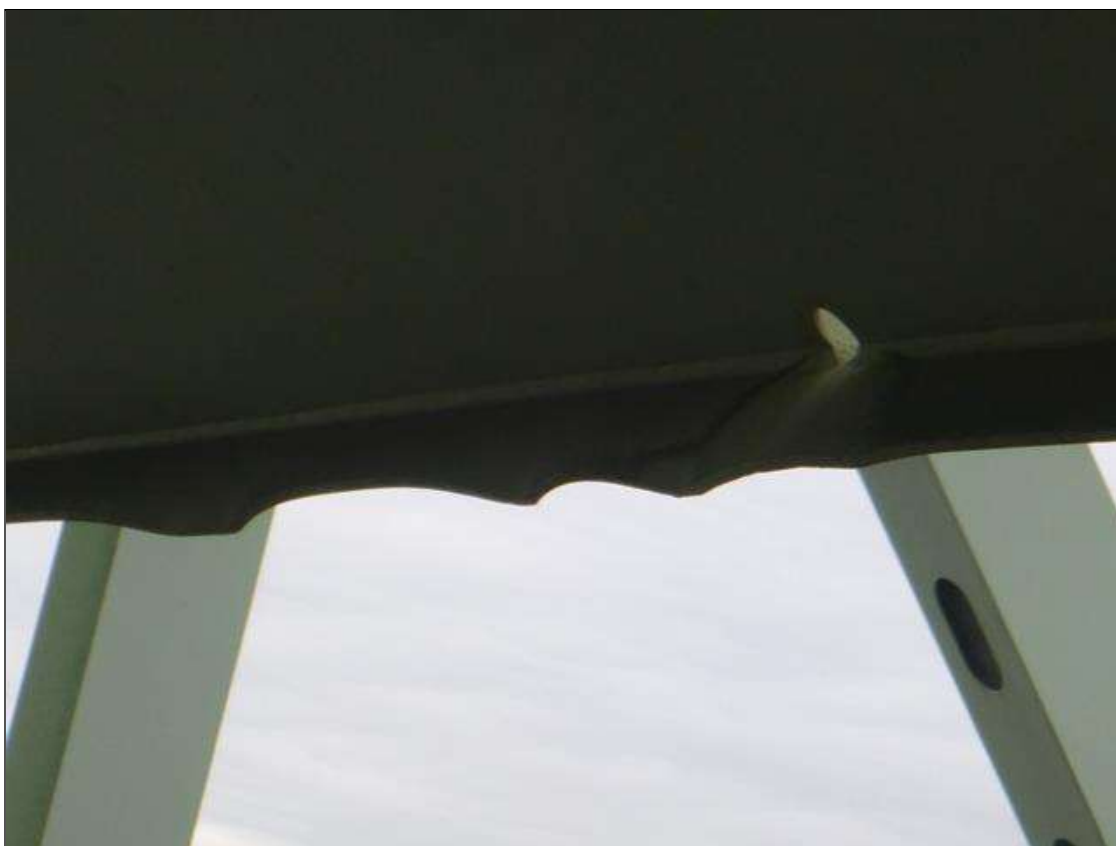
Span 19 EAST TOWER NORTH: 6/2020 - IMPACT DAMAGE - BOTTOM WEST HORIZONTAL TRUSS MEMBER - CRACK ALONG WELD AT BOTTOM WEST CORNER 14" LONG - LOCATED 6' FROM NORTHWEST TOWER LEG (PAR)

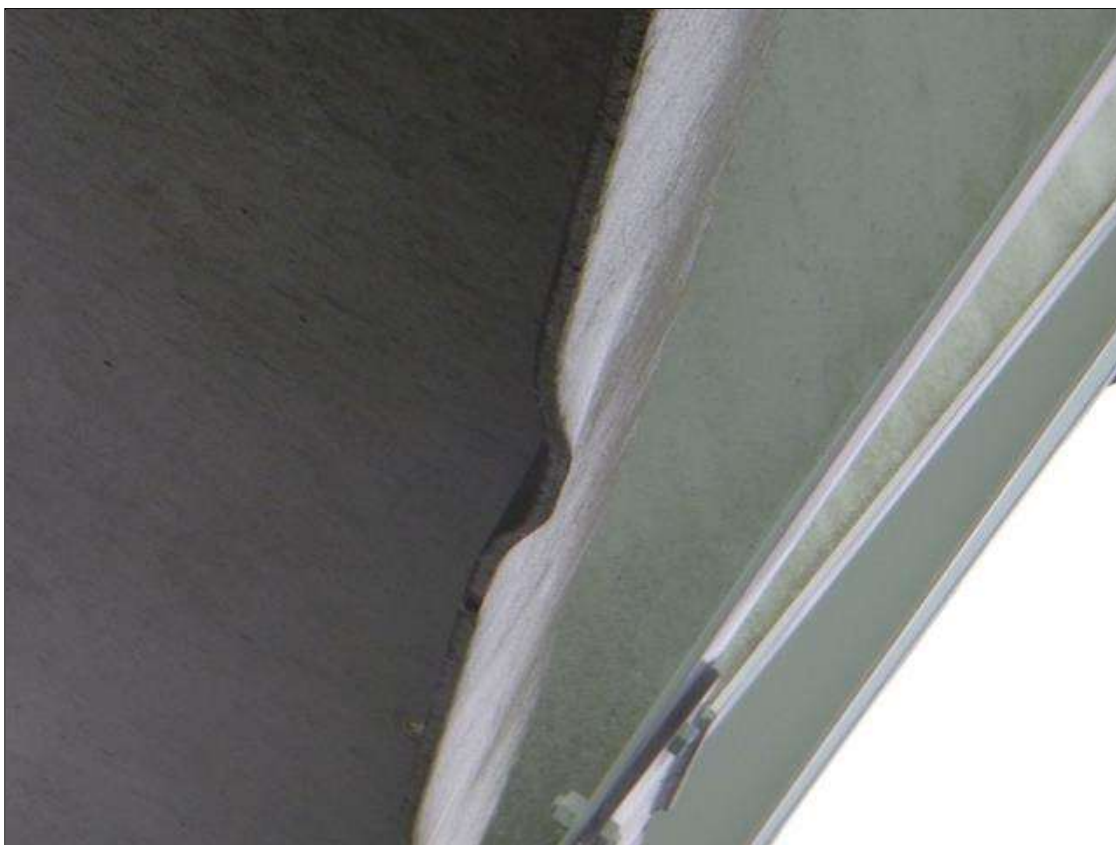
Span 18 Lift Span LB11: BOTTOM SWAY BRACE END PORTAL DAMAGE 3' WIDE X 1-1/2" DEFORMATION OVER LEFT WEST BOUND LANE.

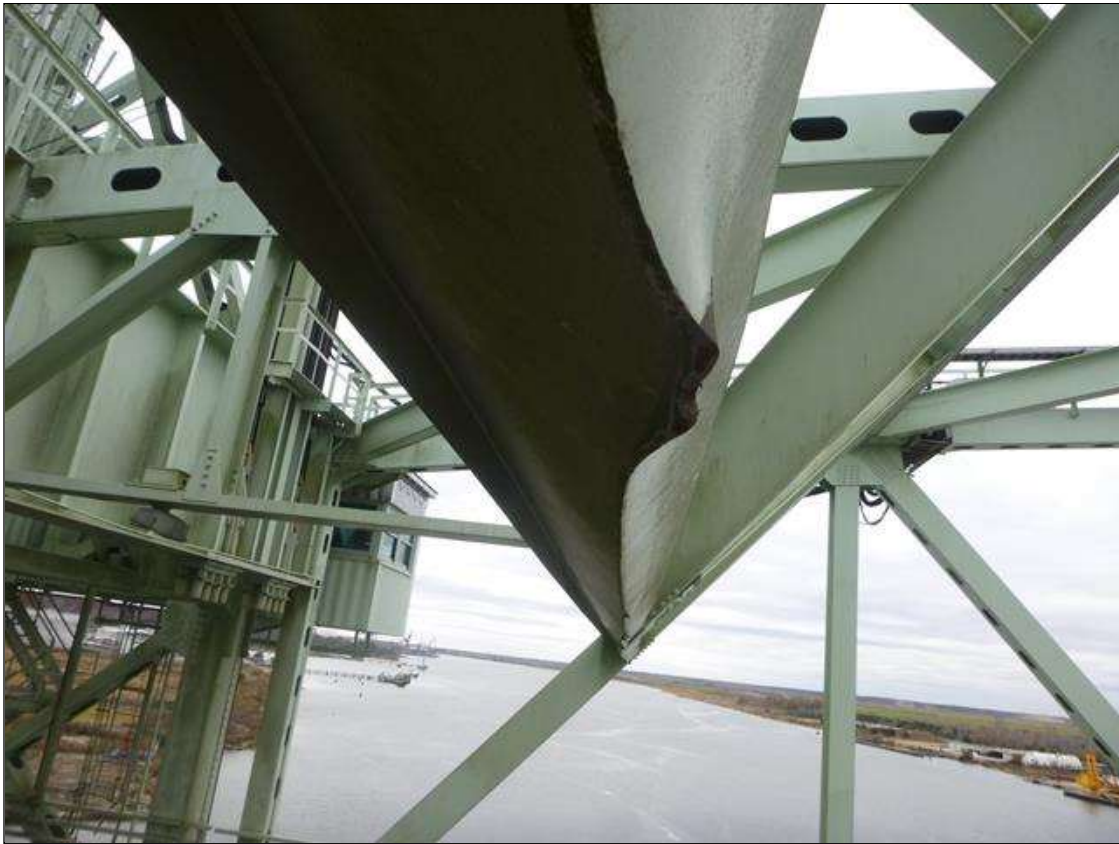
Span 18 Lift Span LB11: BOTTOM SWAY BRACE END PORTAL DAMAGE 1' WIDE X 1/2" DEFORMATION OVER LEFT WEST BOUND LANE.

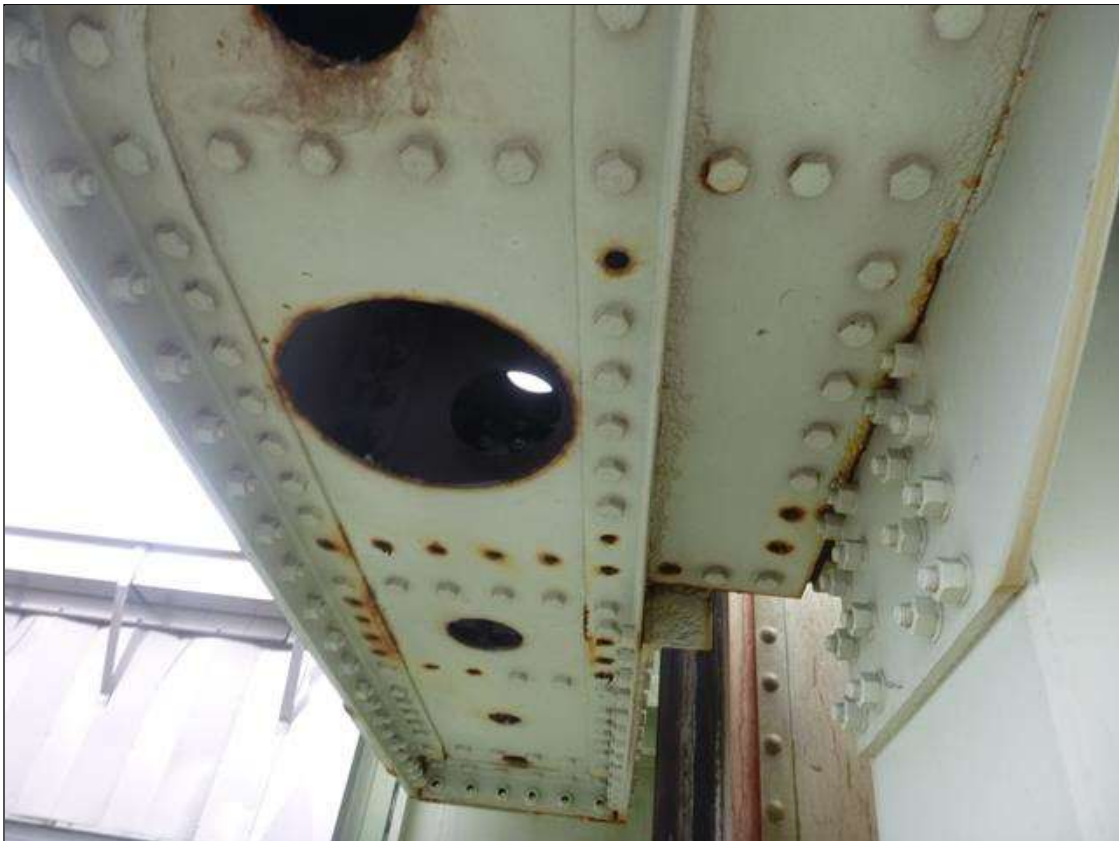
Span 18 Lift Span LB11: BOTTOM SWAY BRACE END PORTAL DAMAGE 30" WIDE X 2-1/4" DEFORMATION OVER RIGHT WEST BOUND LANE.

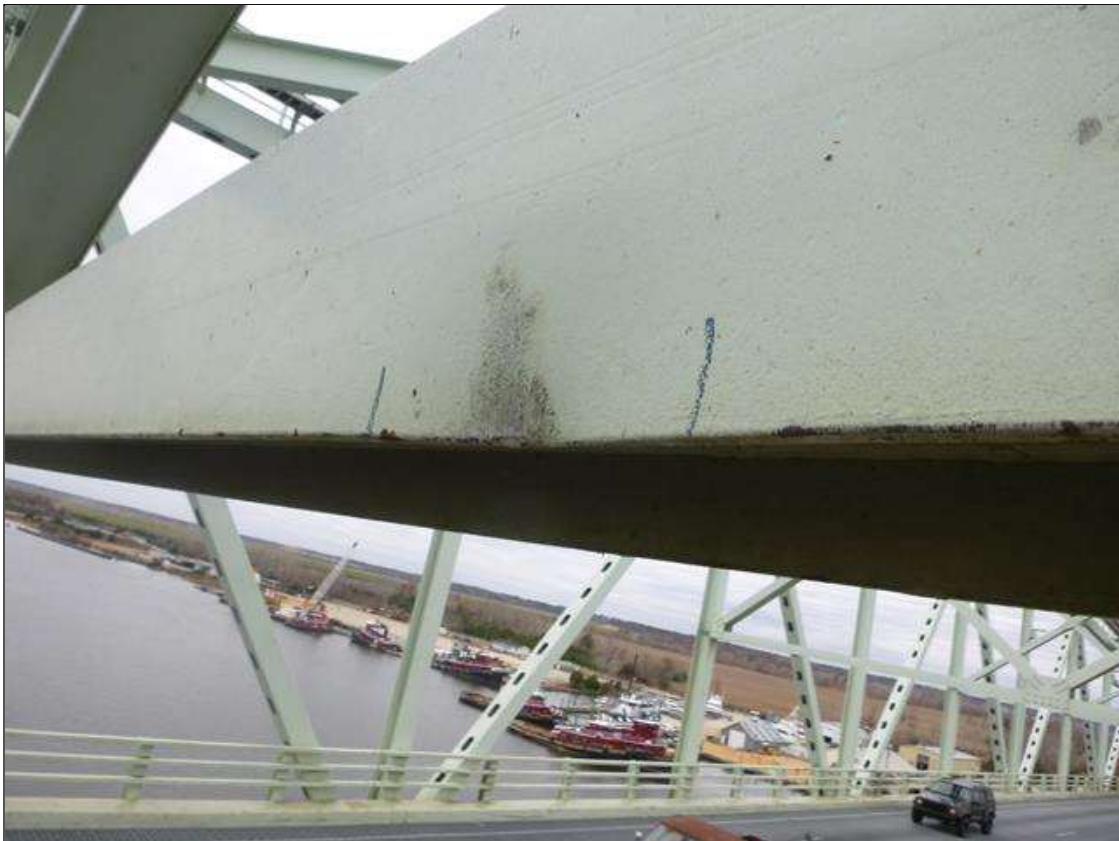
Span 18 Lift Span U10 NORTH: OUT OF PLANE BENDING 3/8" GAP TO BOTTOM OF GUSSET PLATE @ U10 NORTH SIDE.

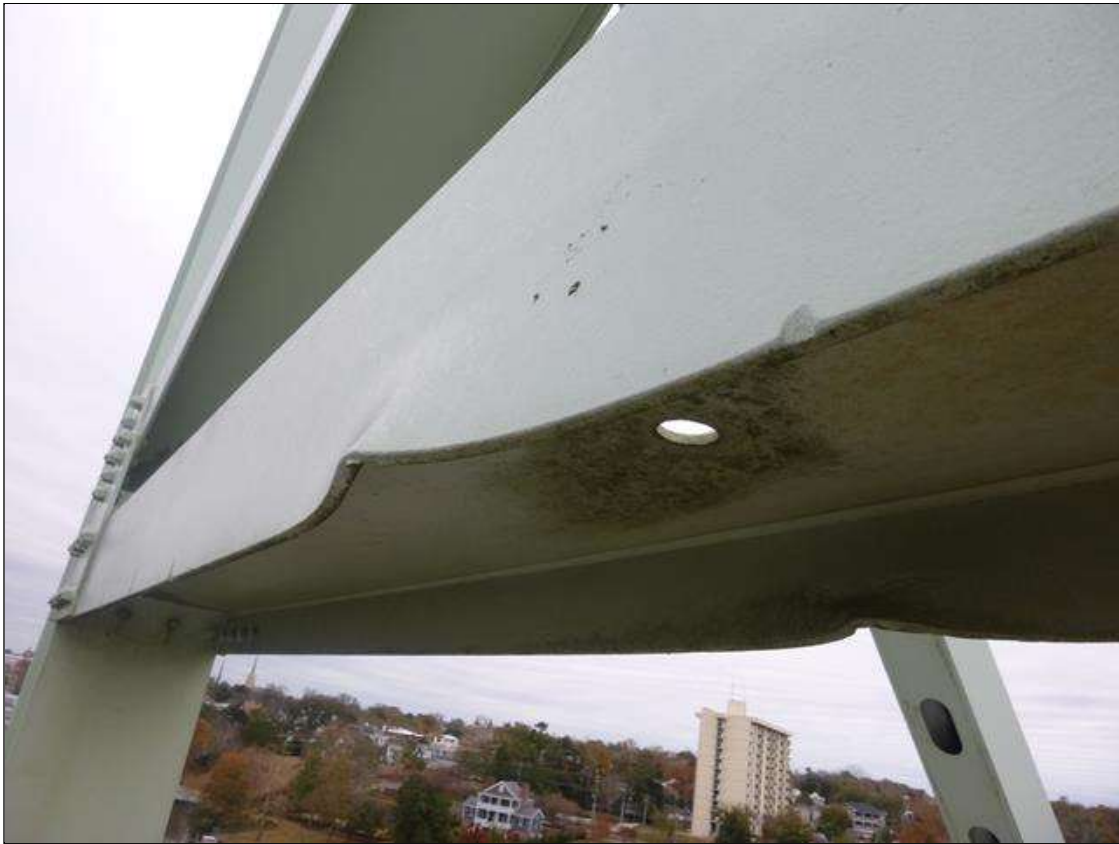
Span 18 Lift Span LB9: IMPACT DAMAGE 8" WIDE X 3/4" DEFORMATION ON EAST BOTTOM FLANGE OVER RIGHT EAST BOUND LANE 12.5 FEET FROM L9-U9 NORTH.

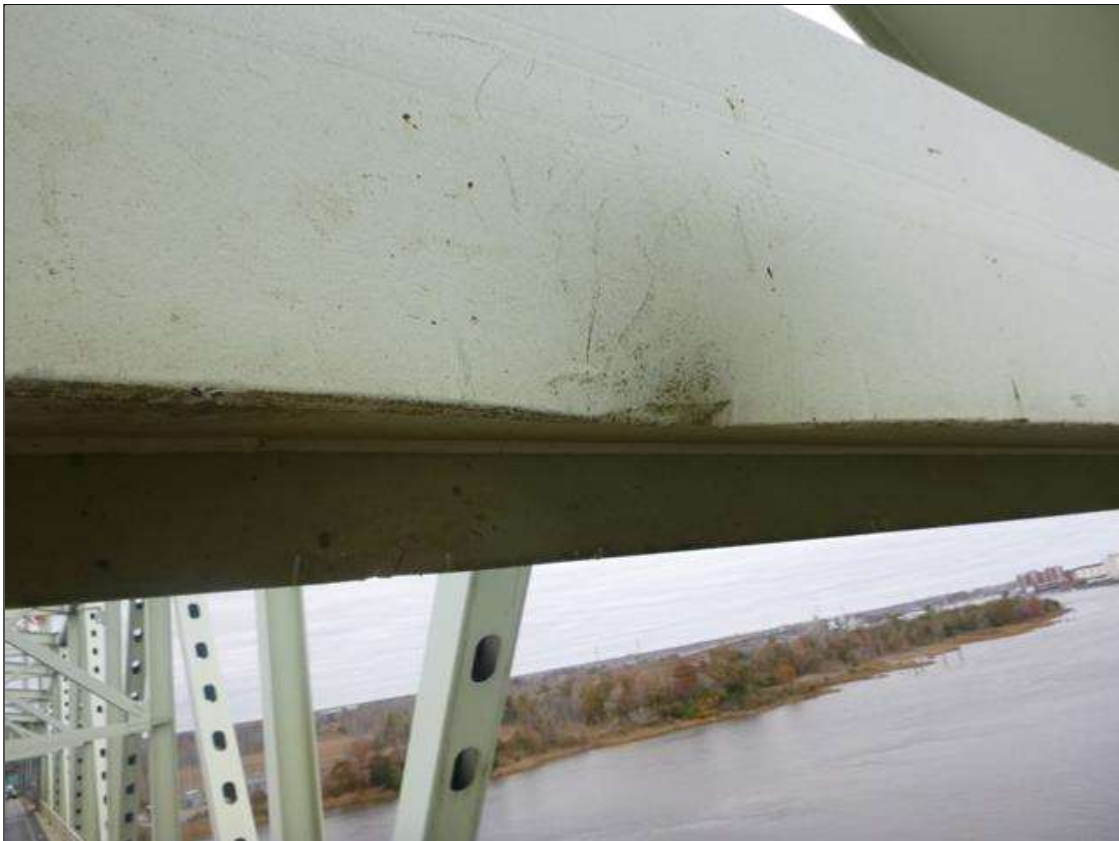
Span 18 Lift Span LB9: 1 3/4" DEEP X 9" LONG IMPACT DAMAGE TO EAST AND WEST FLANGE OVER RIGHT EAST BOUND LANE, LOCATED 7.67' FROM L9-U9 NORTH VERTICAL.

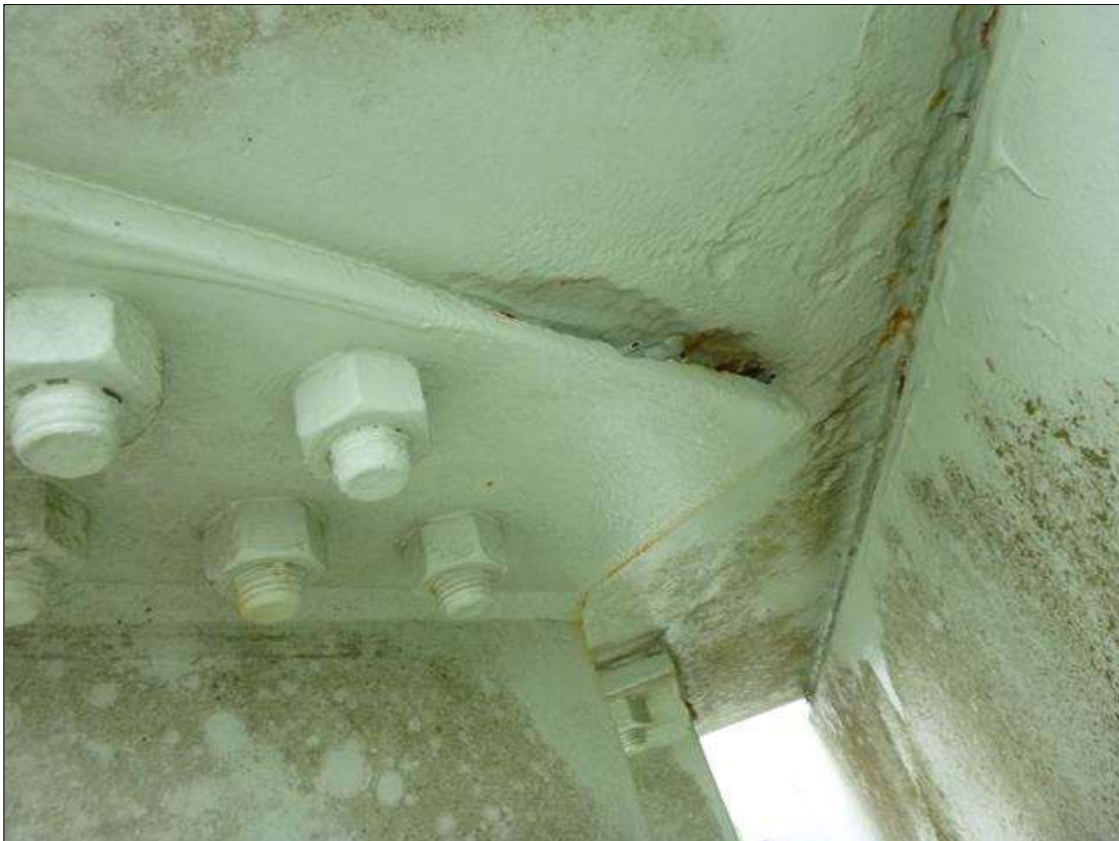
Span 18 Lift Span U9 NORTH: 35" LONG X 1-1/2" WIDE AREA 3/16" SECTION LOSS TO UNDERSIDE OF TOP GUSSET PLATE U9. (AREA IS CLEANED AND PAINTED.)

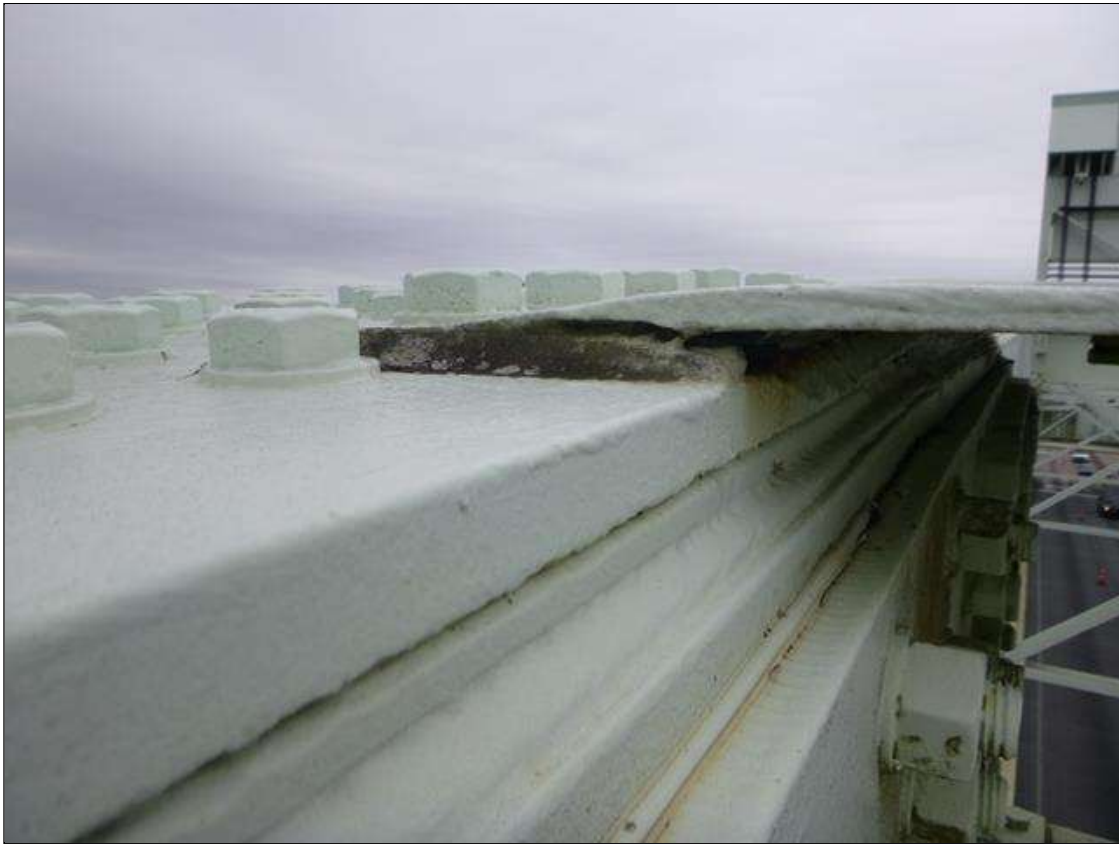
Span 18 Lift Span U4 NORTH: BOTTOM OF TOP GUSSET PLATE AT EAST DIAGONAL BRACE 7" X 1" X 3/16" DEEP PITTING CLEANED AND PAINTED.

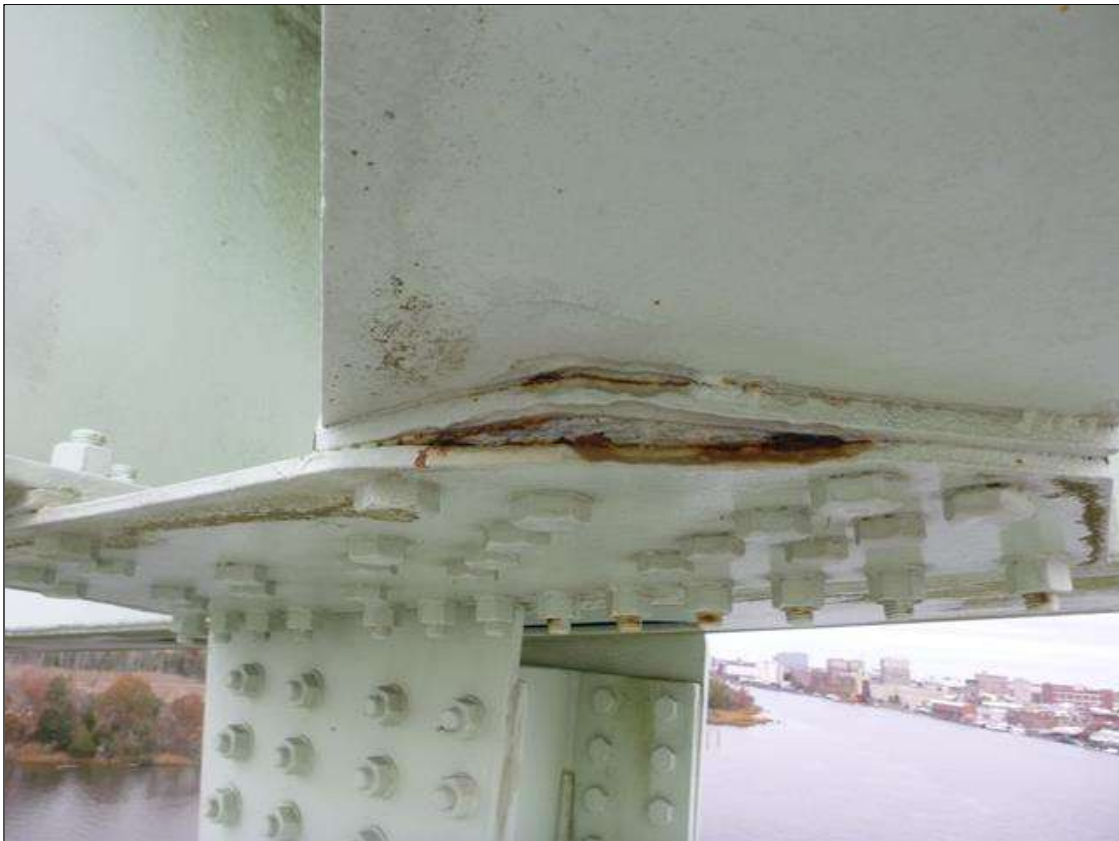
Span 18 Lift Span Truss Panel 1 - U3 NORTH: TOP GUSSET PLATE: OUT OF PLANE BENDING $\frac{1}{2}$ " DUE PACK RUST WITH $\frac{1}{8}$ " LOSS OF SECTION AND $\frac{1}{4}$ " REMAINING ALONG PLATE EDGES. (PAR)

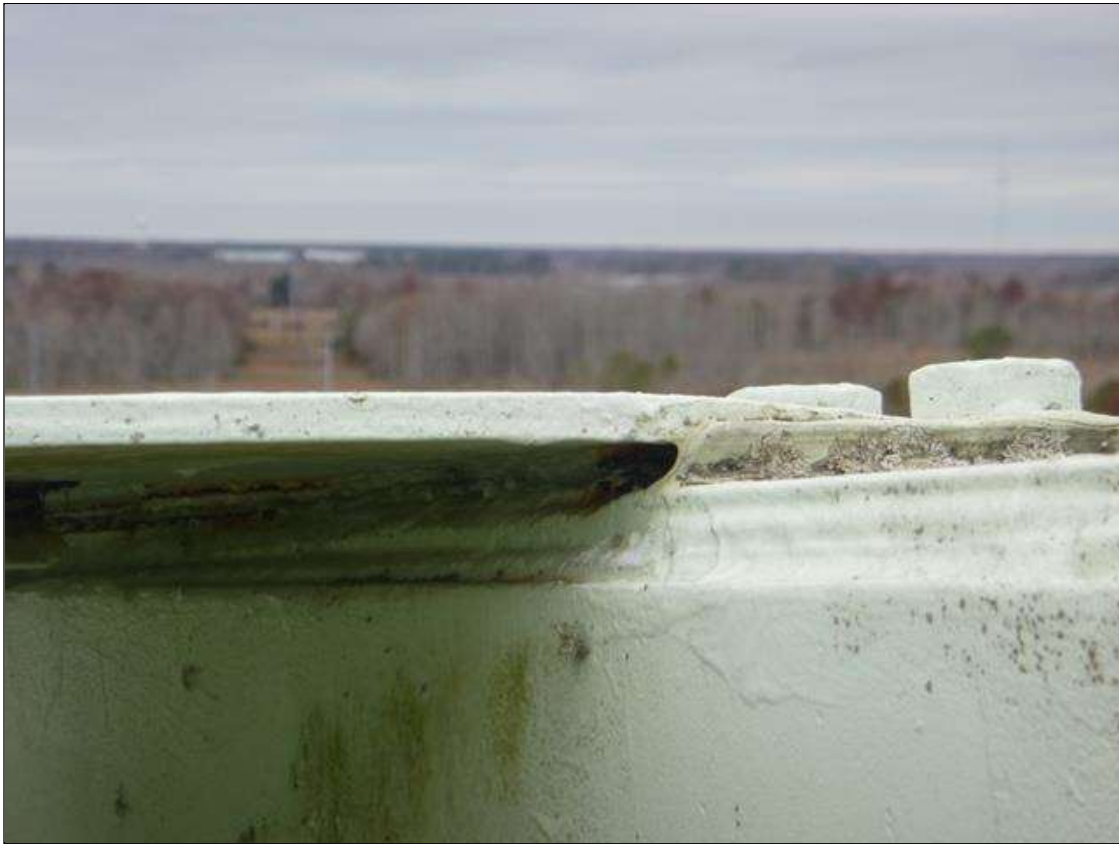
Span 18 Lift Span U2 NORTH: $\frac{1}{2}$ " PACK RUST UNDER BOTTOM GUSSET PLATE CONNECTION TO DIAGONAL EAST SIDE OF U2, ALSO $\frac{7}{32}$ " SECTION LOSS TO BOTTOM FLANGE OF BEAM.

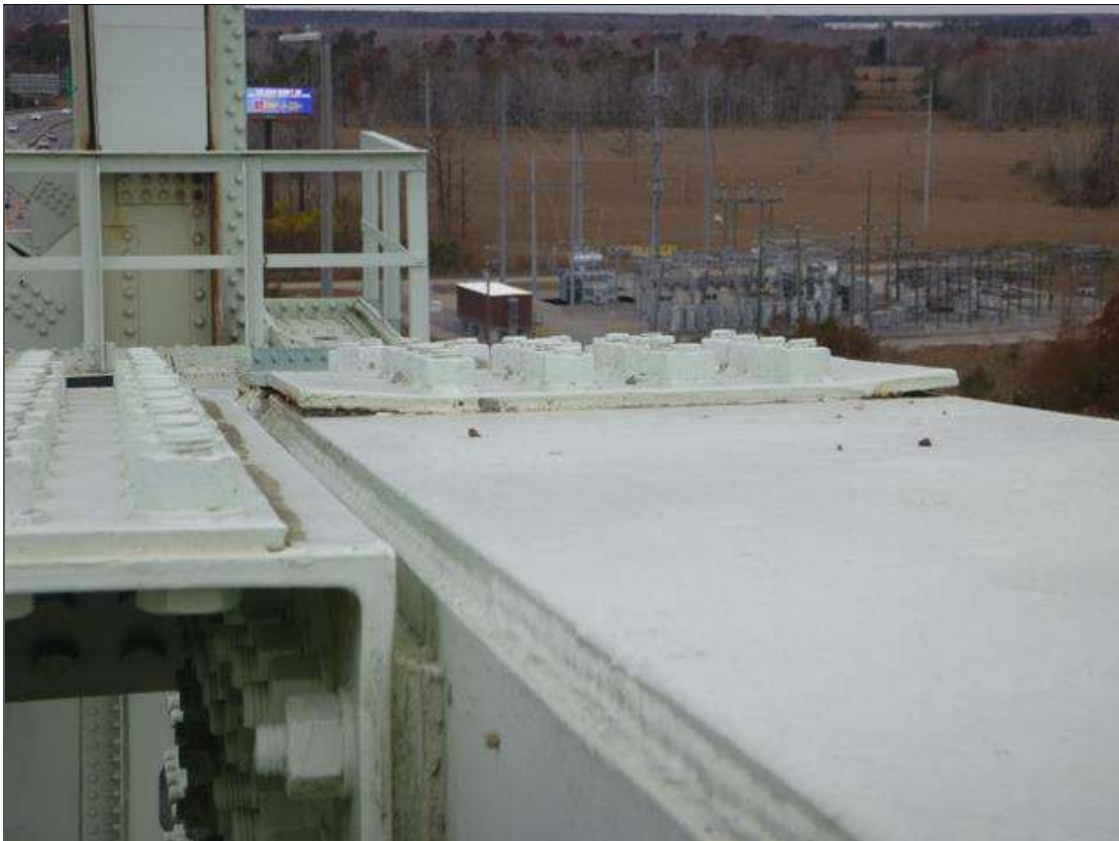
Span 18 Lift Span U2 NORTH: U2 TOP GUSSET PLATE HAS 1/8" OUT OF PLANE BENDING DUE TO PACK RUST BUILD UP BETWEEN MEMBERS. (PAR)

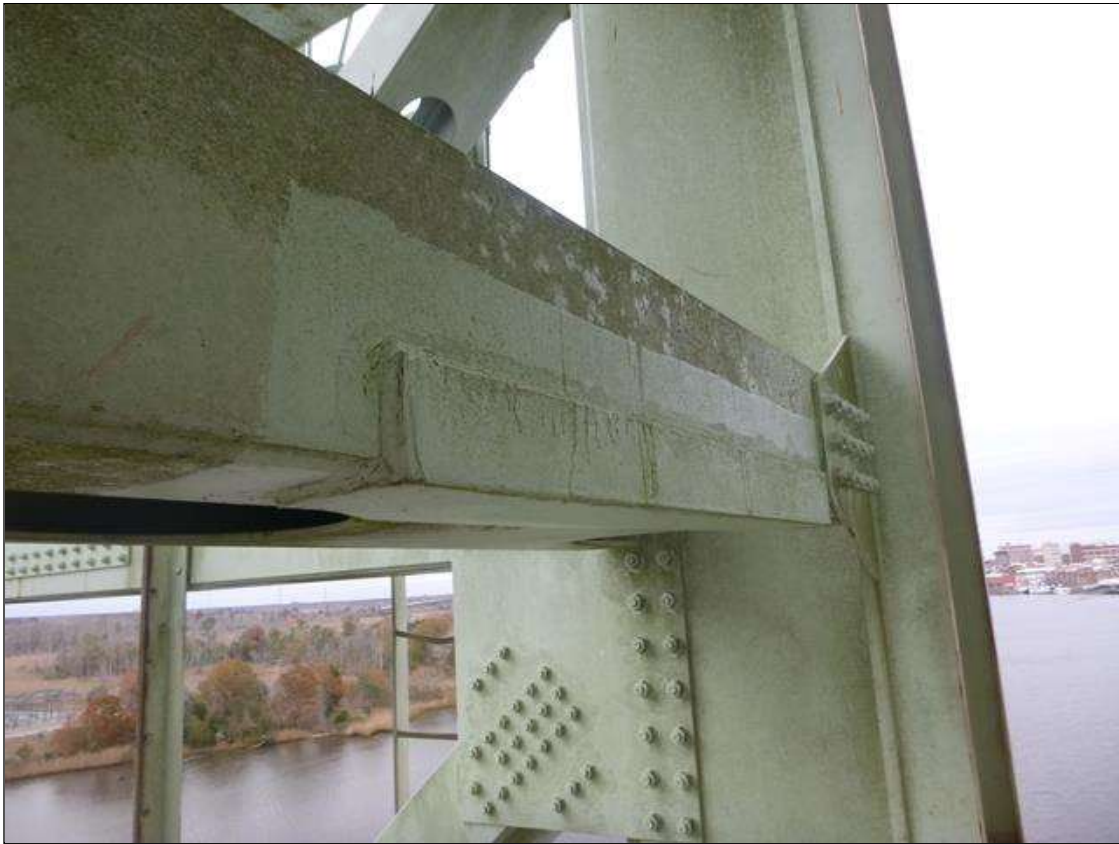
Span 18 Lift Span U1 NORTH: TOP GUSSET CONNECTION HAS 1/4" OUT OF PLANE BENDING WITH PACK RUST BETWEEN PLATES.

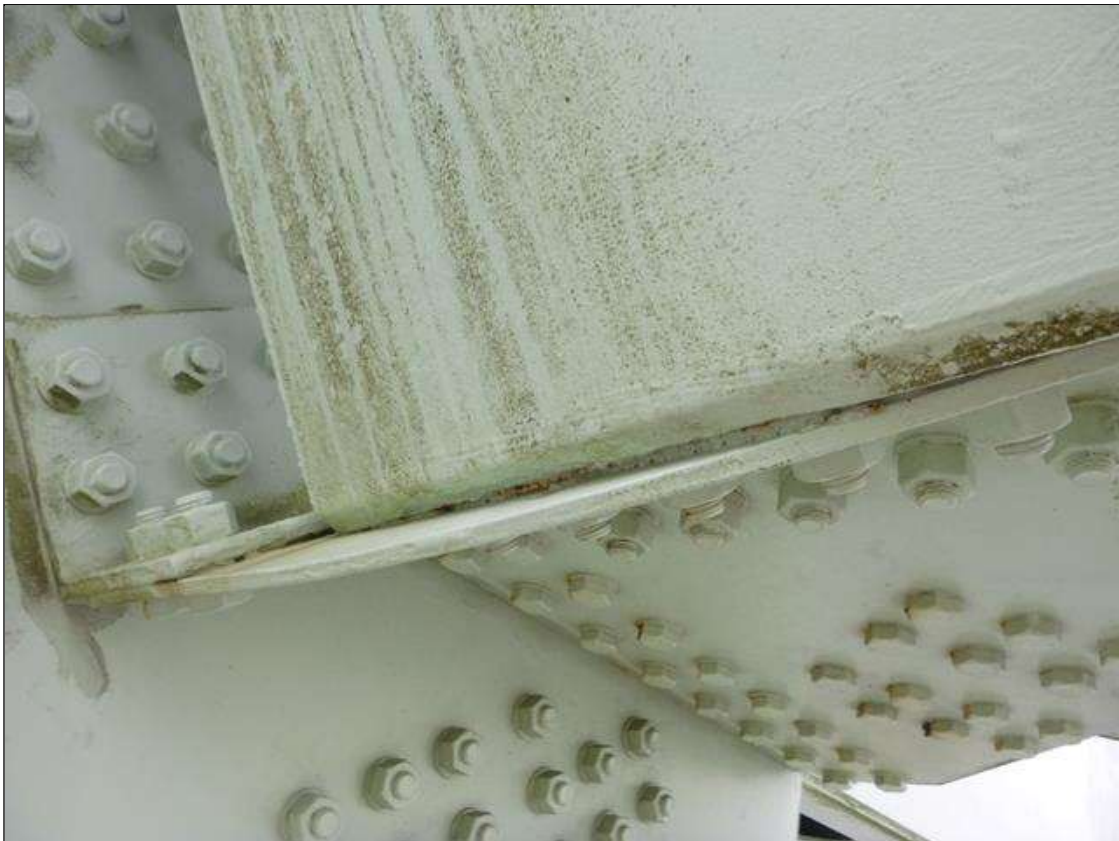
Span 17 WEST TOWER NORTH: HORIZONTAL AT NORTH EAST TOWER LEG 46" LONG 6" X 4" X 3/8" ANGLE REPAIR TO EAST FACE AND BOTTOM BEGINNING 1' FROM NORTHEAST TOWER LEG
