NC DEPARTMENT OF TRANSPORTATION
DIVISION OF HIGHWAYS
STRUCTURE MANAGEMENT UNIT

Structure Safety Report

Routine Element Inspection - Contract

DIVISION: 3 COUNTY: NEW HANOVER STRUCTURE NUMBER: 640013 FREQUENCY: 24 MONTHS

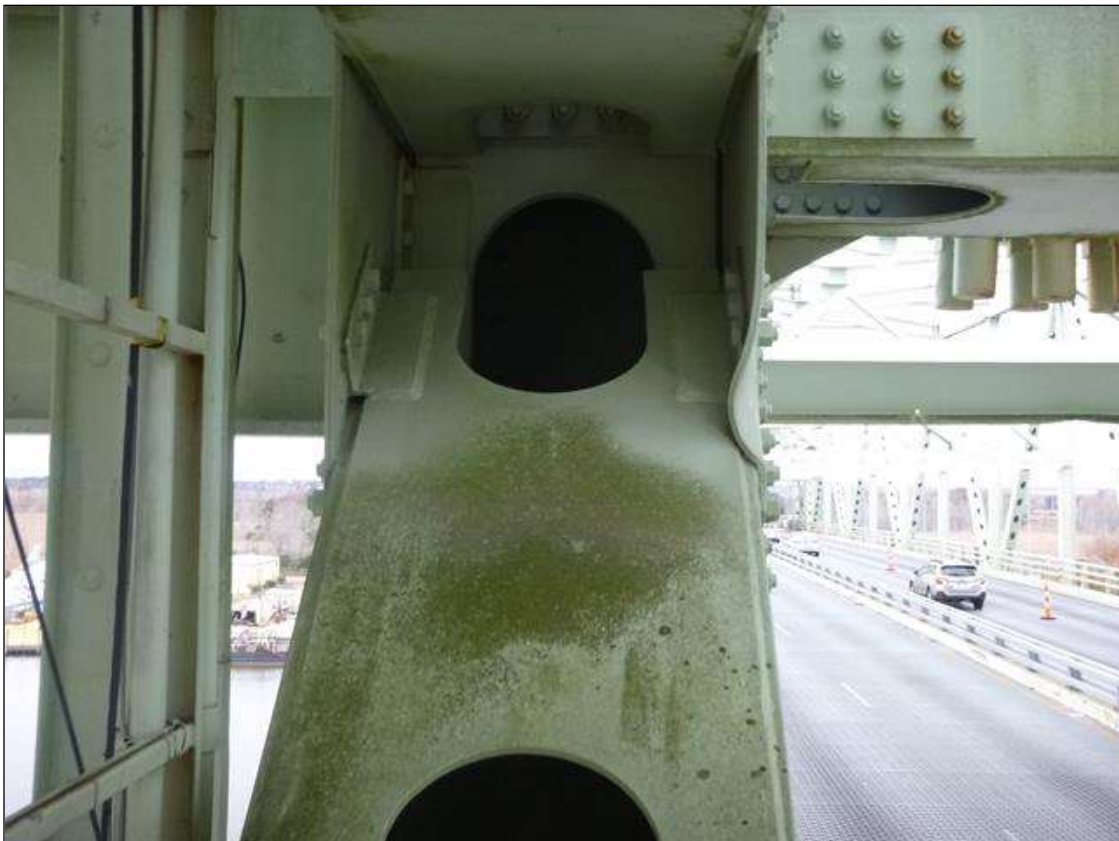
Span 18 Lift Span L0U1 NORTH: SCRAPES ON NORTH FACE 6' ABOVE BRIDGE DECK WITH SURFACE RUST.

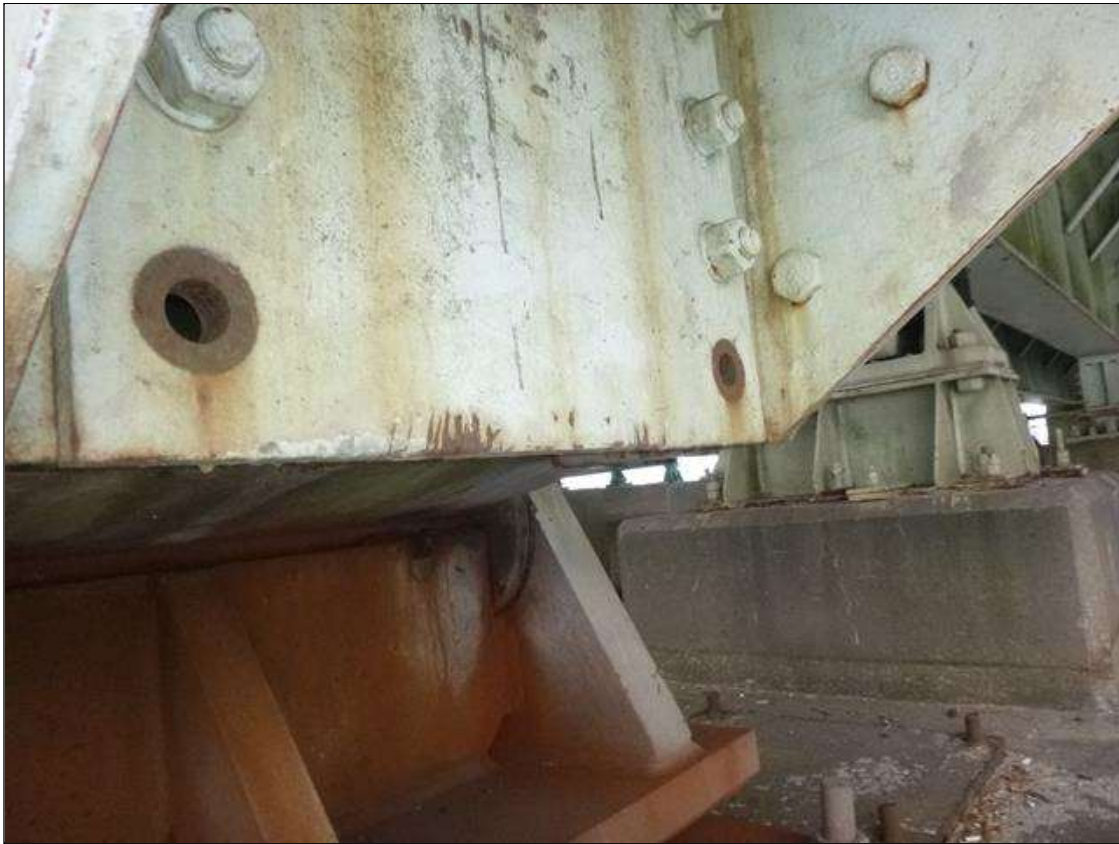
Span 19 EAST TOWER SOUTH: SOUTHWEST TOWER LEG NORTH FACE GUSSET PLATE EAST END 12" X 4" X 1" DISTORTION.

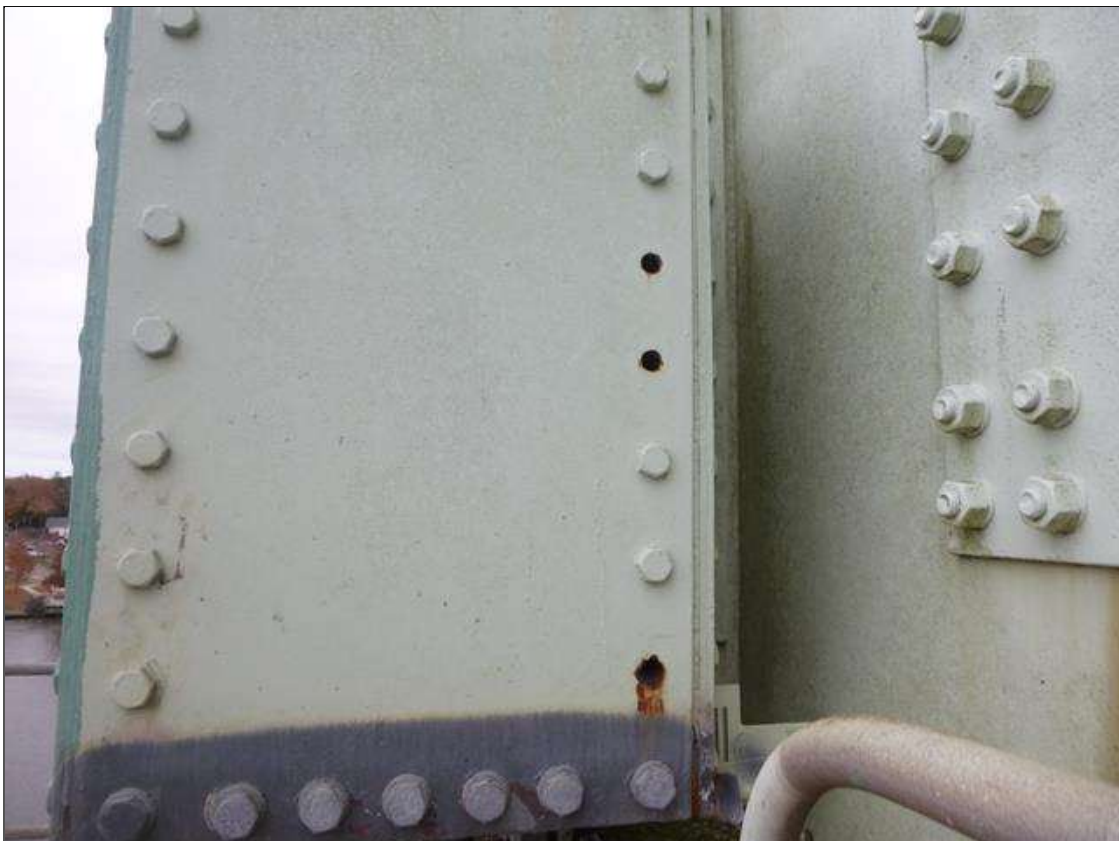
Span 18 Lift Span Truss Panel 2 - L0U0 SOUTH: (2) MISSING BOLTS AT BOTTOM OF EAST GUSSET AT BEARING (PAR)

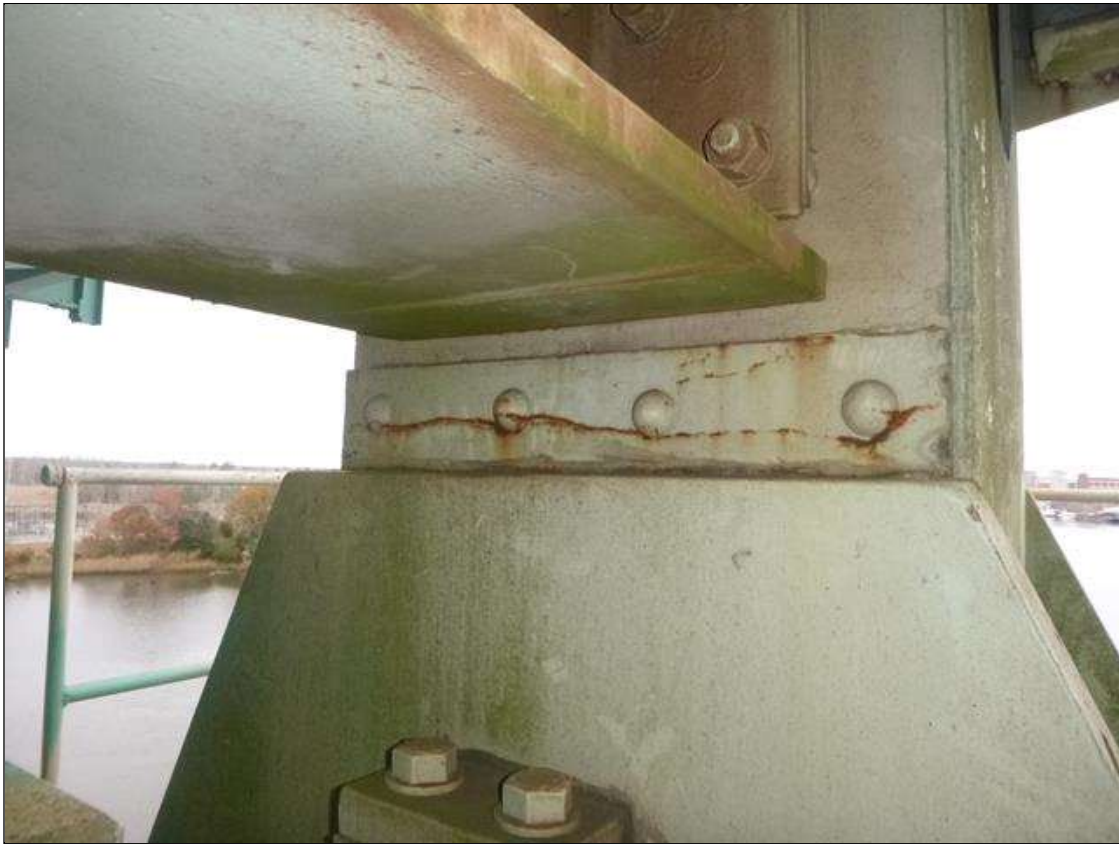
Span 18 Lift Span L0 NORTH: [PROMPT ACTION REQUEST] WHEEL GUIDE WEST PLATE 3 MISSING BOLTS WITH CORROSION AT BOLT HOLES.

3314	Maintain Steel Superstructure Components	LF	1	Span 18 Lift Span L0 NORTH: [PROMPT ACTION REQUEST] WHEEL GUIDE WEST PLATE 3 MISSING BOLTS WITH CORROSION AT BOLT HOLES.

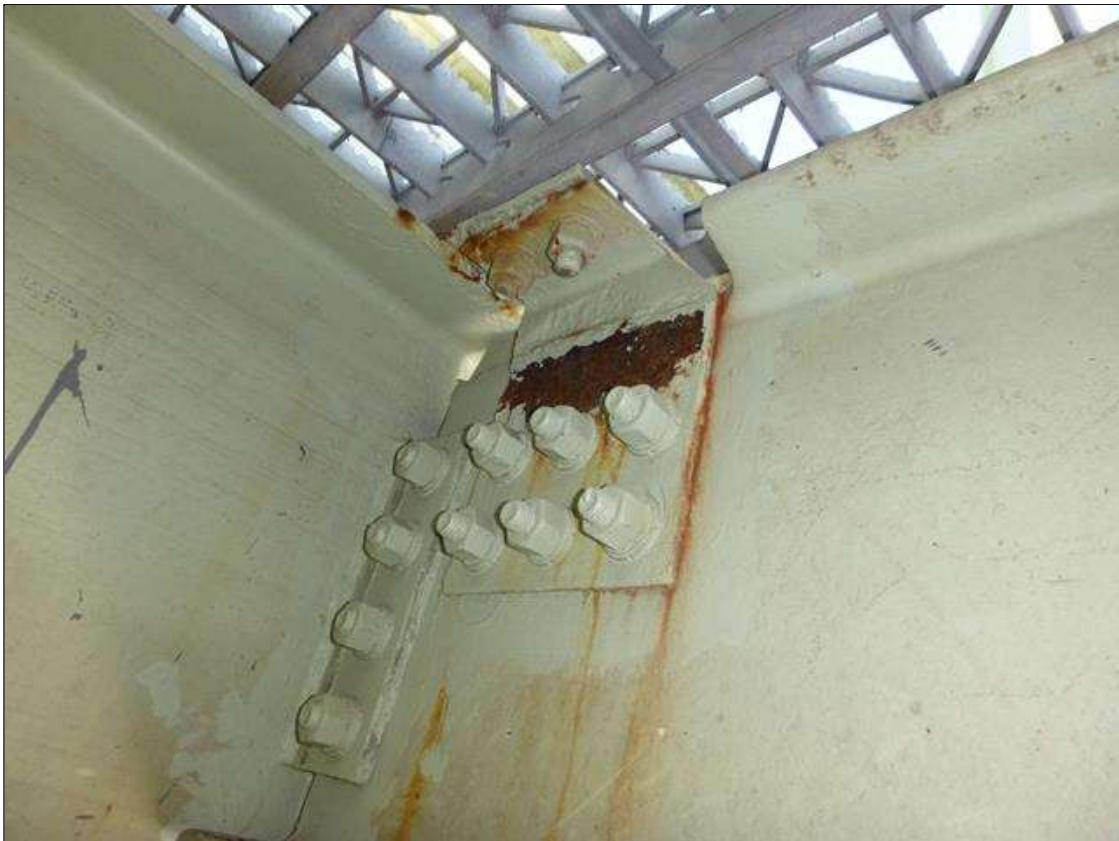
Span 17 WEST TOWER NORTH: WEST TOWER: RUST LEACHING ALONG HAIRLINE CRACK SOUTH FACE IN BRACE PLATE. ULTRASONIC INSPECTION REQUESTED.

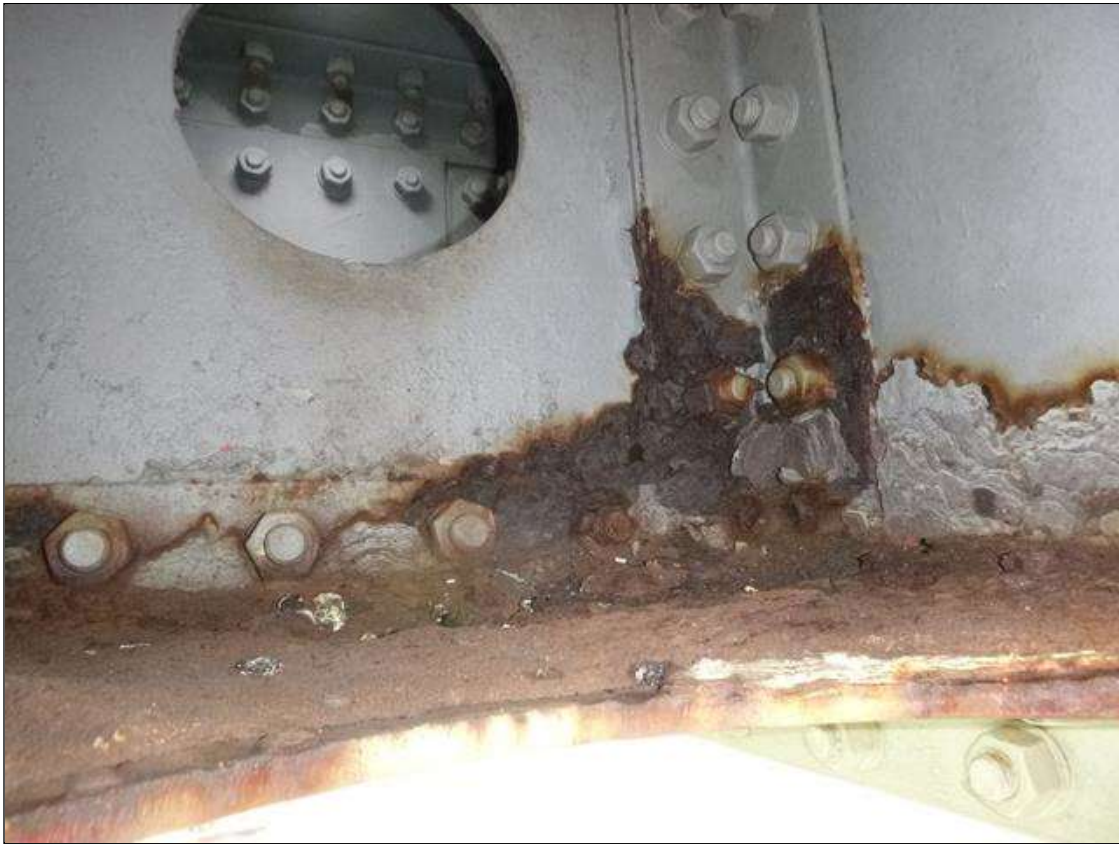
Span 18 Lift Span Stringer 1: BETWEEN FB's 0-12 - DIAPHRAGM CONNECTION TO STRINGER HAS SURFACE RUST.

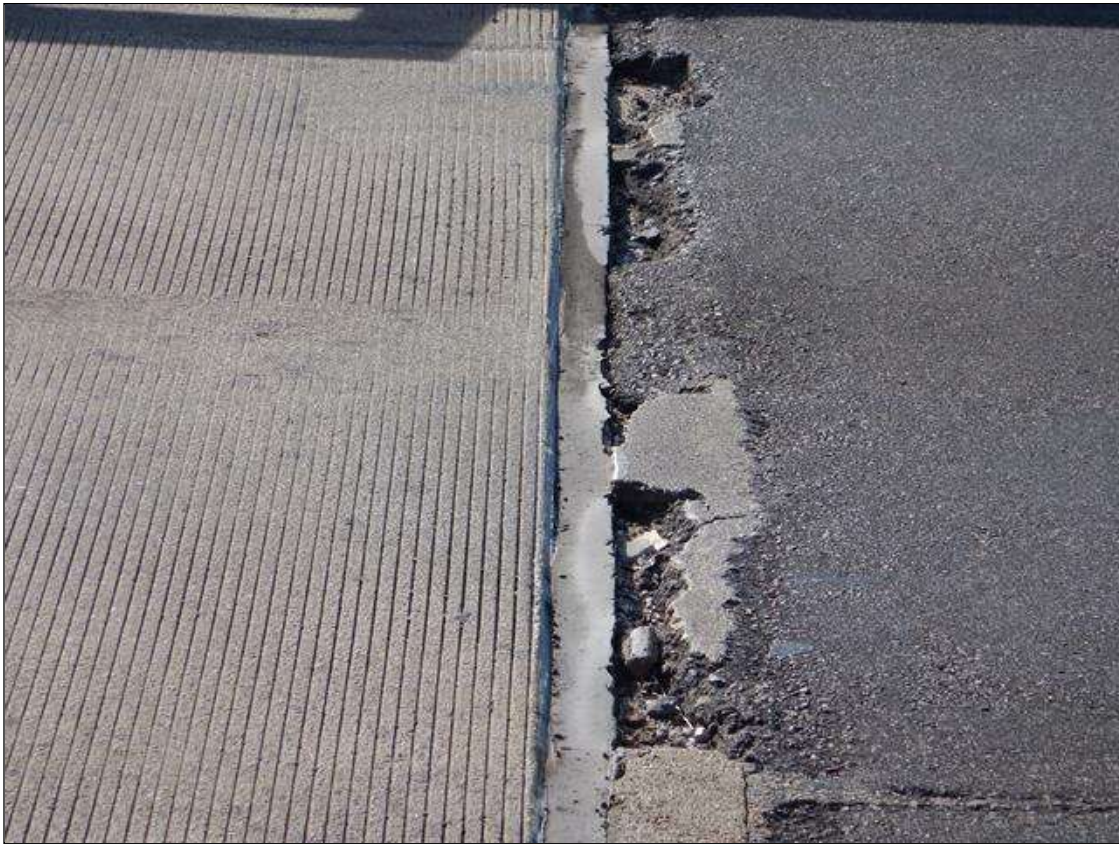
Span 1 Joint at Abutment 1: SCATTERED ALONG THE LENGTH OF THE ADJACENT DECK HEADERS IN THE RIGHT AN LEFT LANES, SPALLING WITH LOSS OF THE HEADER CONCRETE [UP TO 3" DEEP X 5" LONG] WITH LOSS OF ADHESION IN THE AFFECTED AREAS. THE BALANCE OF THE JOINT HEADERS HAVE SCATTERED MAP CRACKING TO 1/4" WIDE.

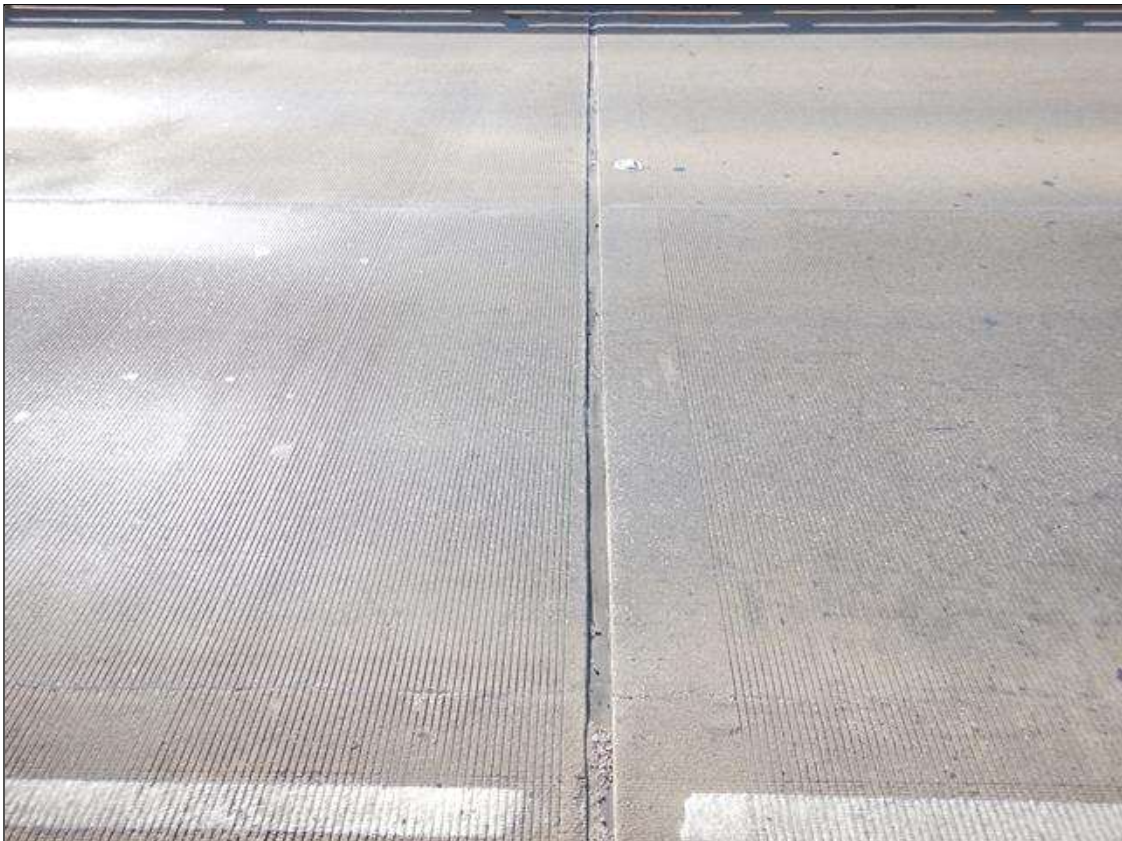
Span 4 Joint at Bent 3: SCATTERED ALONG THE LENGTH, PUNCTURES UP TO 1" DIAMETER IN THE LEFT LANES AND SCATTERED LOSS OF ADHESION IN THE RIGHT.

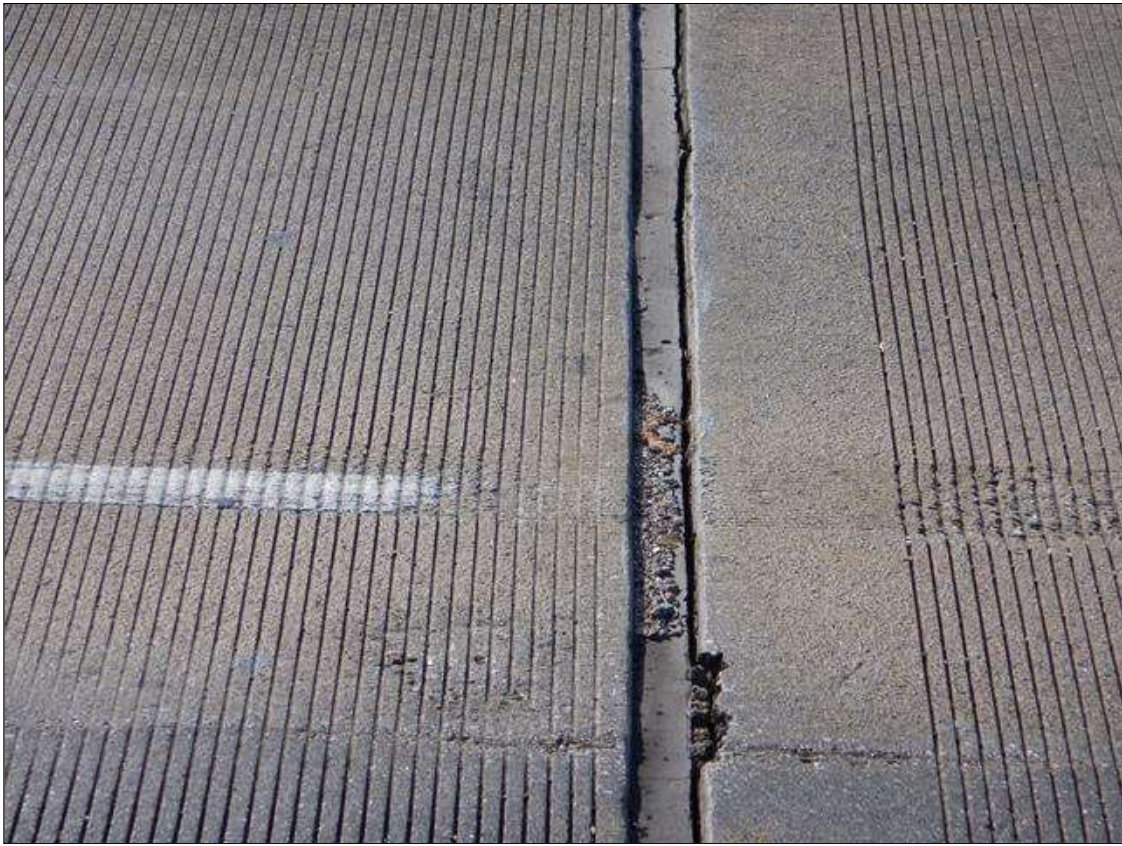
Span 4 Joint at Bent 3: SCATTERED ALONG THE LENGTH, PUNCTURES UP TO 1" DIAMETER IN THE LEFT LANES AND SCATTERED LOSS OF ADHESION IN THE RIGHT.

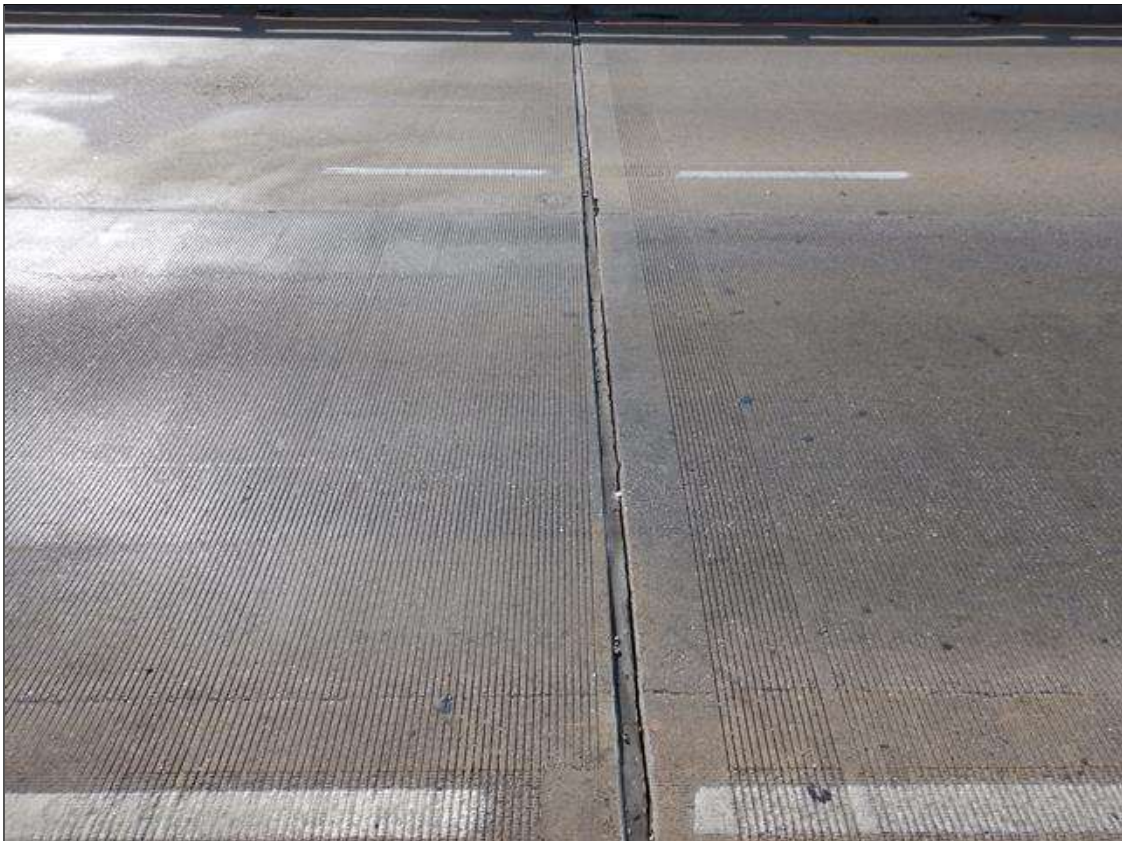
Span 13 Joint at Bent 12: SCATTERED ALONG THE LENGTH, LOSS OF SEAL ADHESION UP TO FULL DEPTH AND SCATTERED EDGE CHIPPING IN THE ADJACENT DECK HEADERS UP TO 1" WIDE

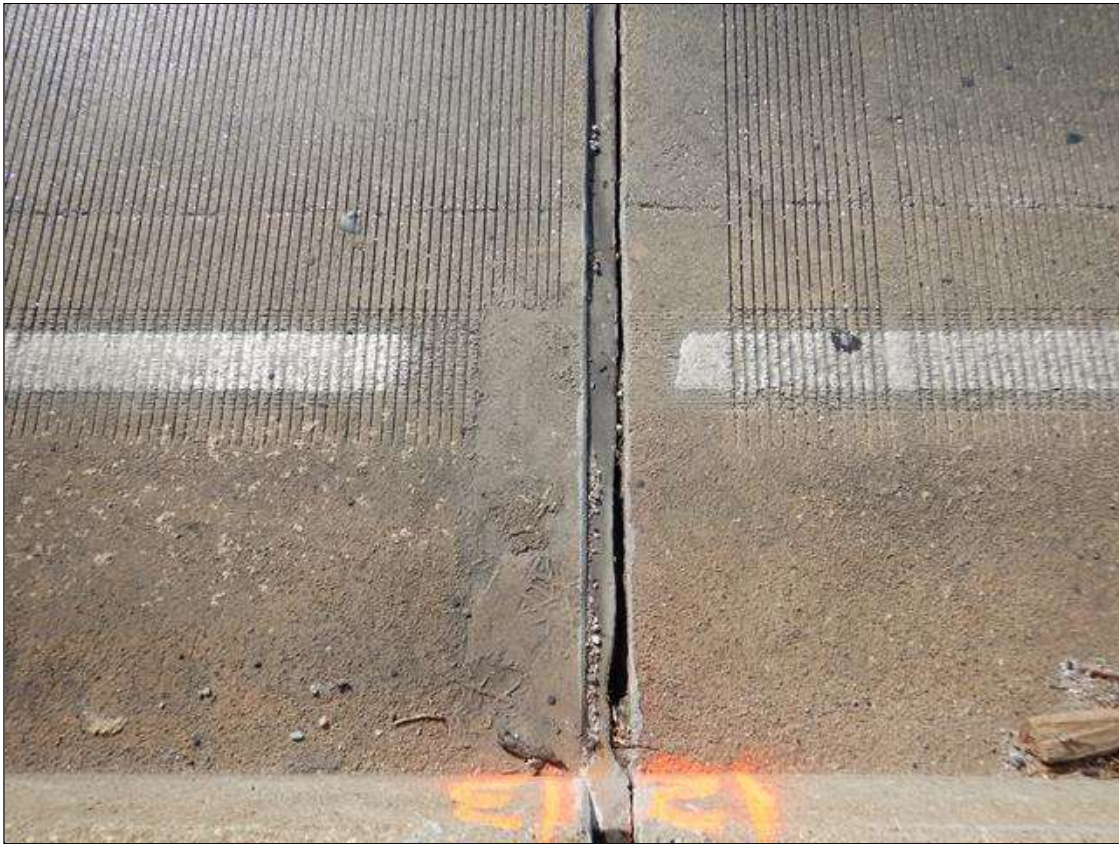
Span 13 Joint at Bent 12: SCATTERED ALONG THE LENGTH, LOSS OF SEAL ADHESION UP TO FULL DEPTH AND SCATTERED EDGE CHIPPING IN THE ADJACENT DECK HEADERS UP TO 1" WIDE

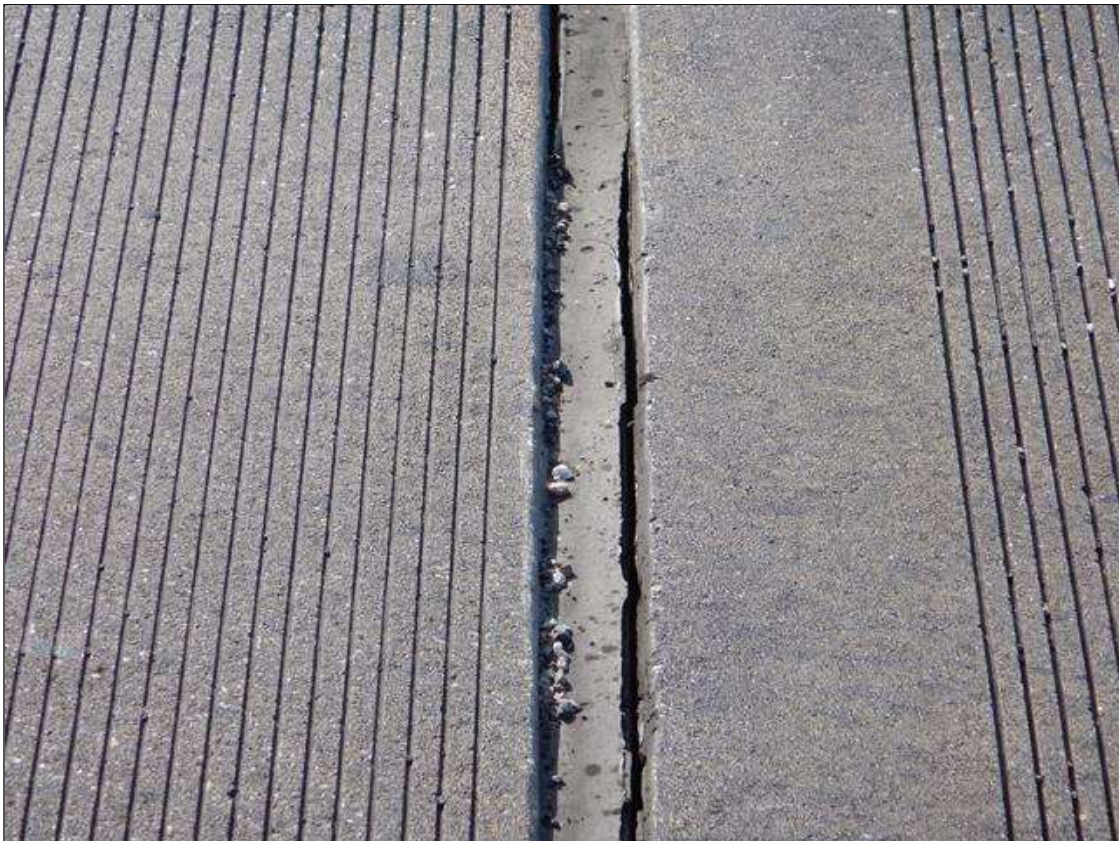
Span 13 Joint at Bent 12: SCATTERED ALONG THE LENGTH, LOSS OF SEAL ADHESION UP TO FULL DEPTH AND SCATTERED EDGE CHIPPING IN THE ADJACENT DECK HEADERS UP TO 1" WIDE

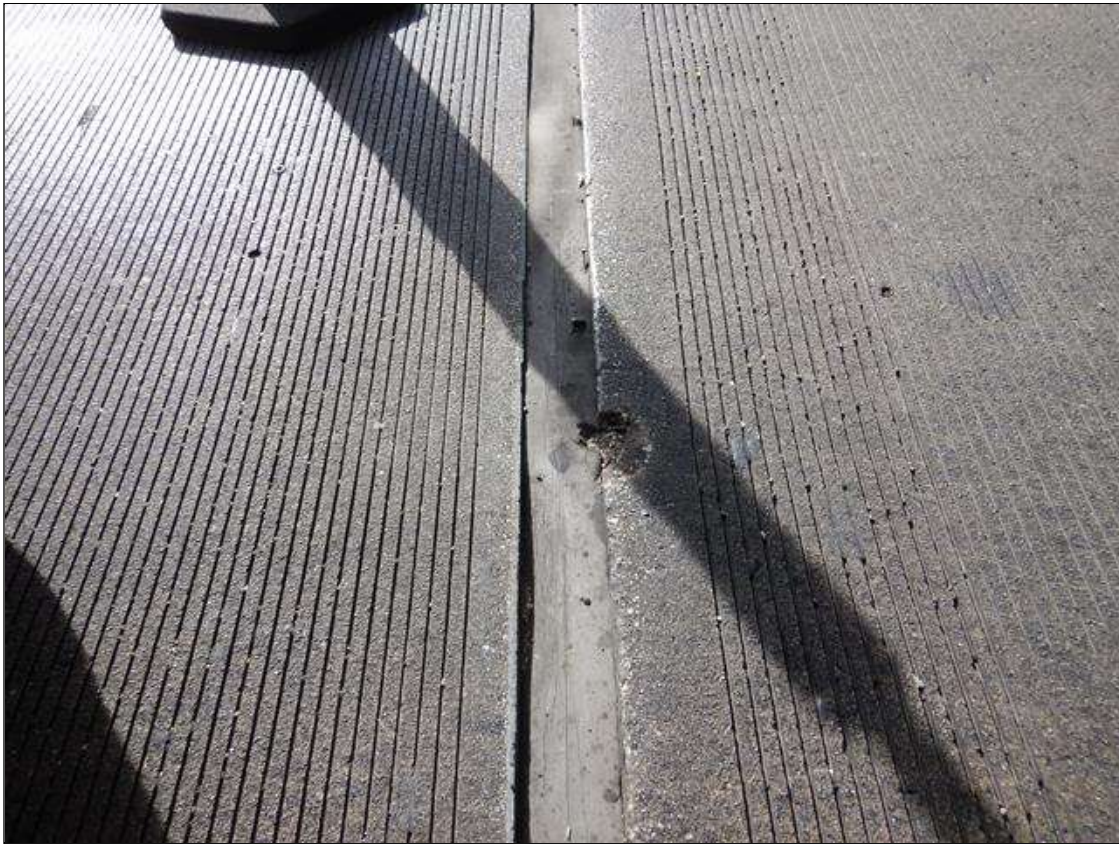
Span 13 Joint at Bent 12: SCATTERED ALONG THE LENGTH, LOSS OF SEAL ADHESION UP TO FULL DEPTH AND SCATTERED EDGE CHIPPING IN THE ADJACENT DECK HEADERS UP TO 1" WIDE

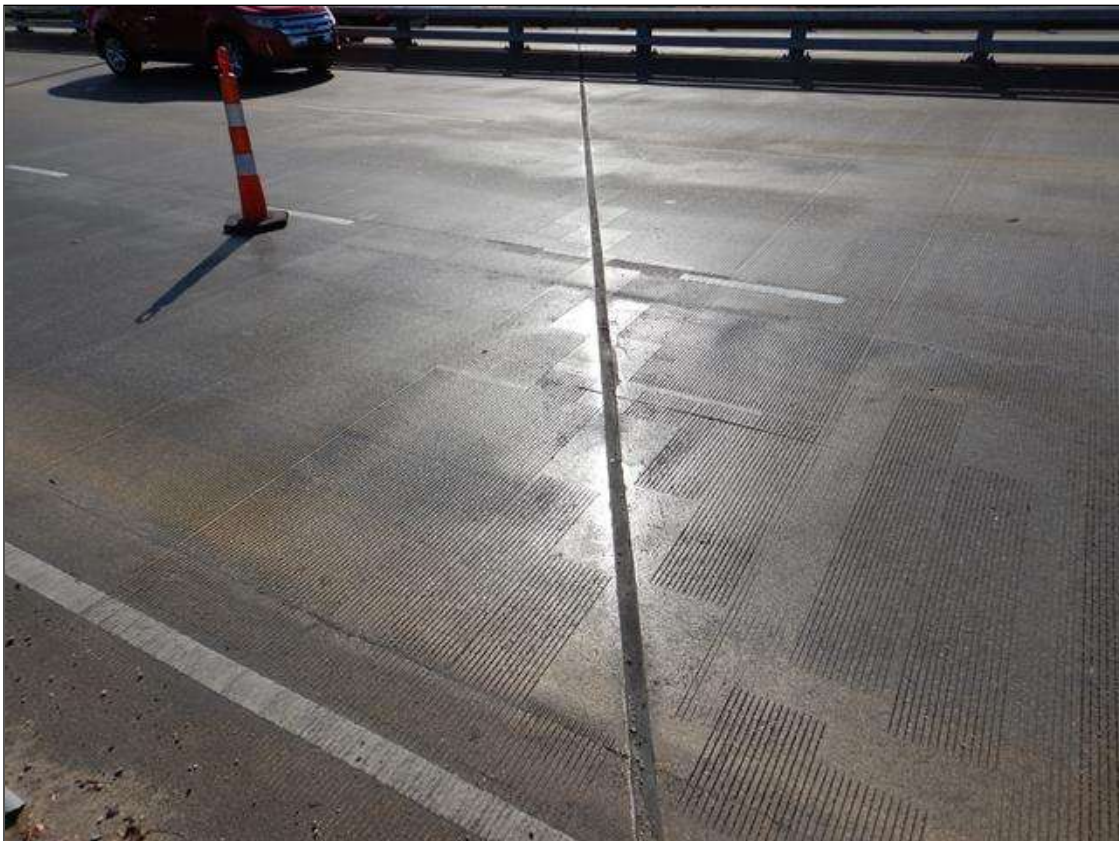
Span 21 Joint at Bent 18: SCATTERED ALONG THE LENGTH, LOSS OF ADHESION UP TO FULL DEPTH

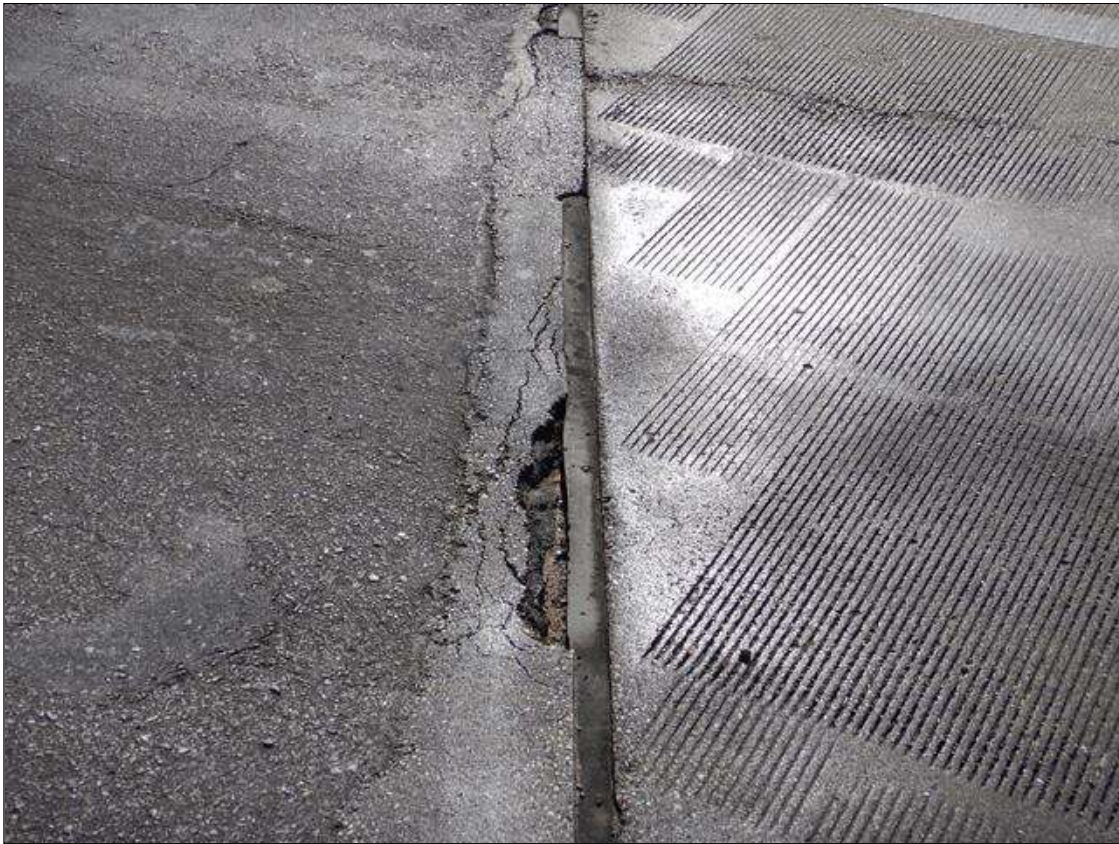
Span 31 Joint at Bent 28: LEFT LANES, THERE IS A TEAR IN THE TOP OF THE SEAL [APPROXIMATELY 2" DIAMETER]

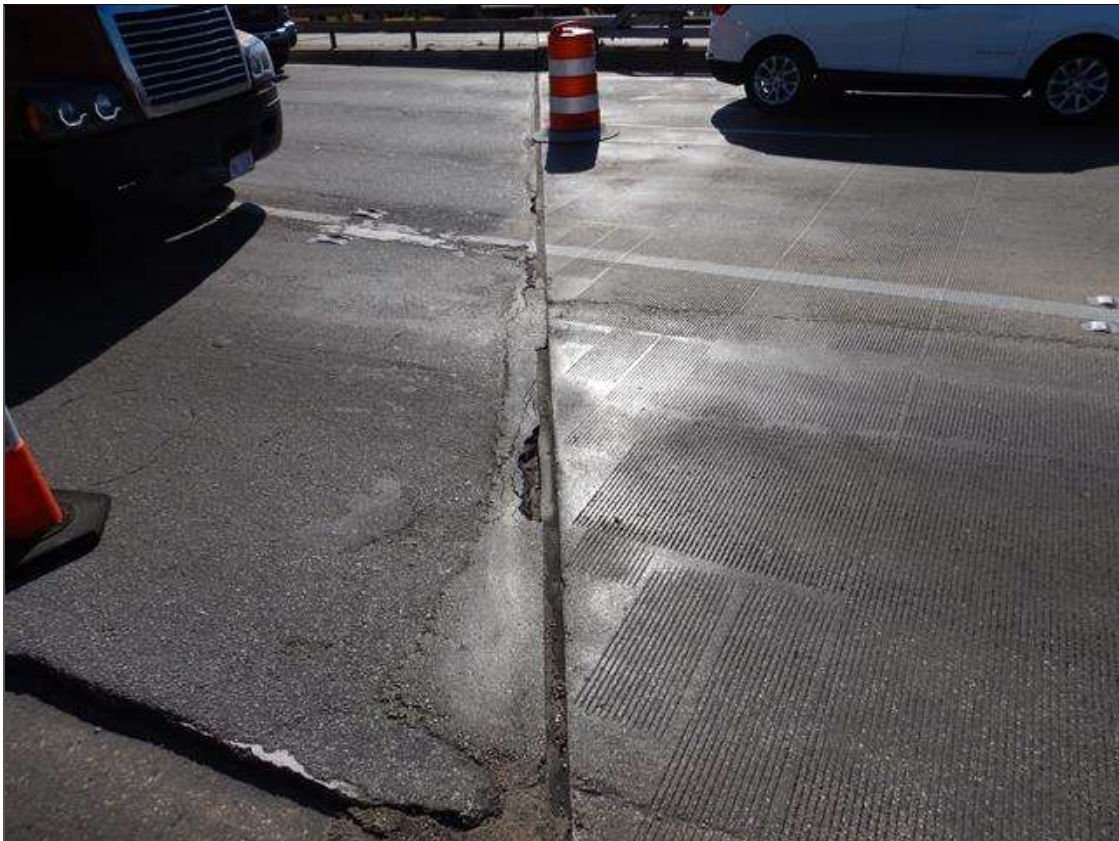
Span 32 Joint at Abutment 2: SCATTERED ALONG THE LENGTHS OF THE ADJACENT DECK HEADERS, SPALLING [UP TO 18" LONG X 3" WIDE X 2" DEEP]

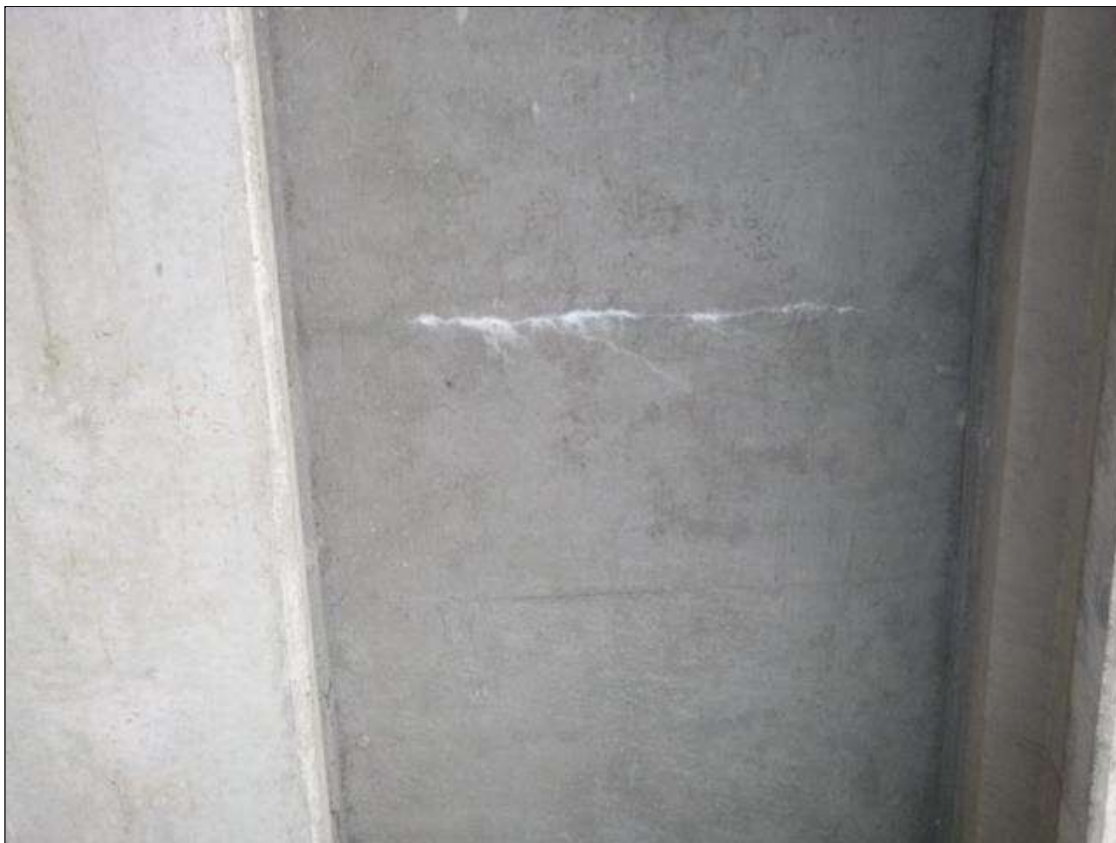
Span 31 Deck: [NEW REPAIR - PATCHING] FORMERLY --> spill with exposed rebar on the deck bottom in bay 7 at 2ft from Bent 28 (18" x 5" x 1/2")

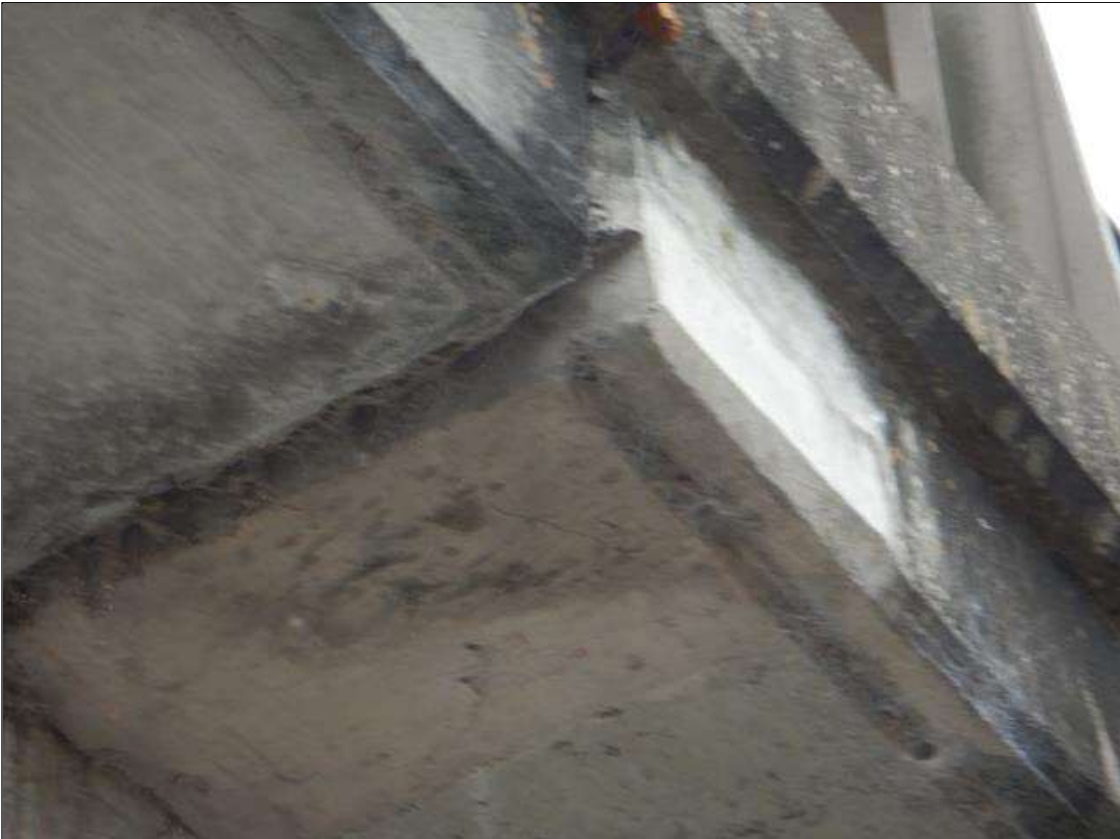
Span 35 - Ramp Span Deck: [NEW REPAIR - PATCHING] FORMERLY --> spall with exposed rebar on the left overhang at Ramp End Bent (20" x 24" x 6")

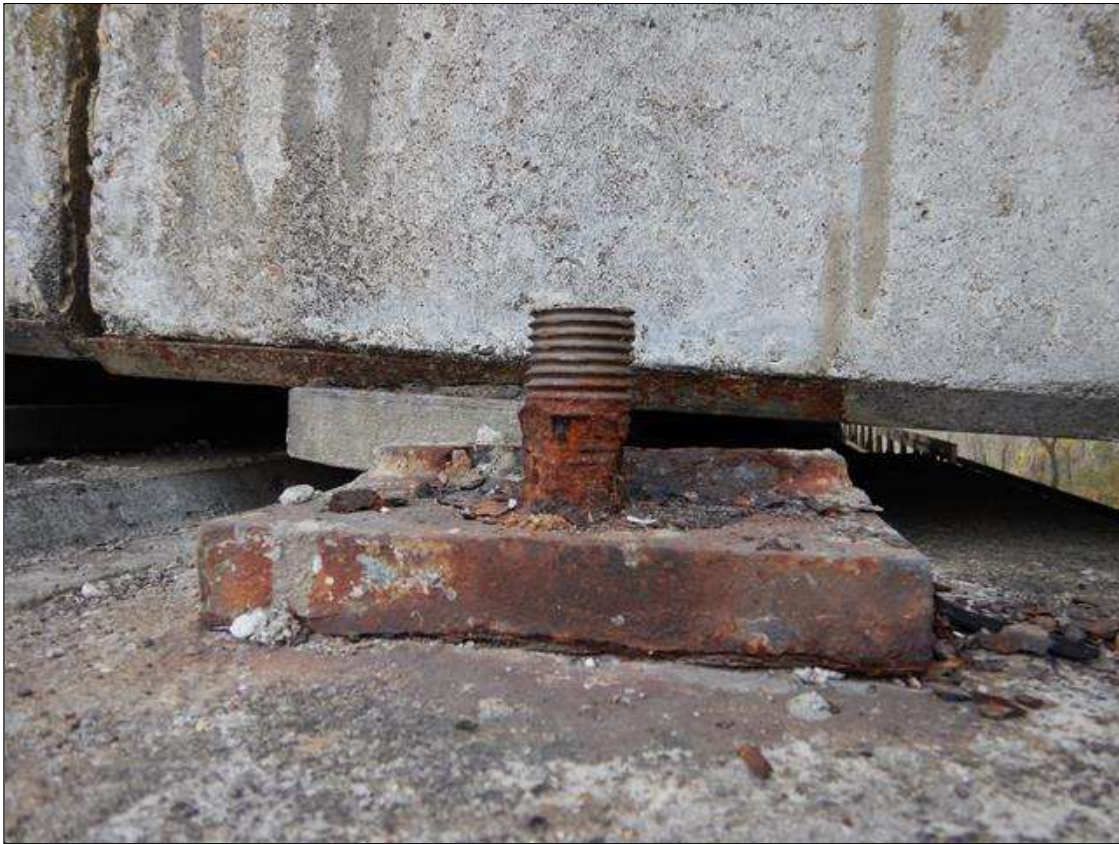
Span 1 Beam 1 - Beam 1 Near Bearing: Active corrosion and 100% section loss on the left anchor rod nut (up to 50% section loss on the right nut) section loss on the masonry plate at the front left corner up to (3/16") into the plate into the top of the plate (3" wide x 2 1/2" long

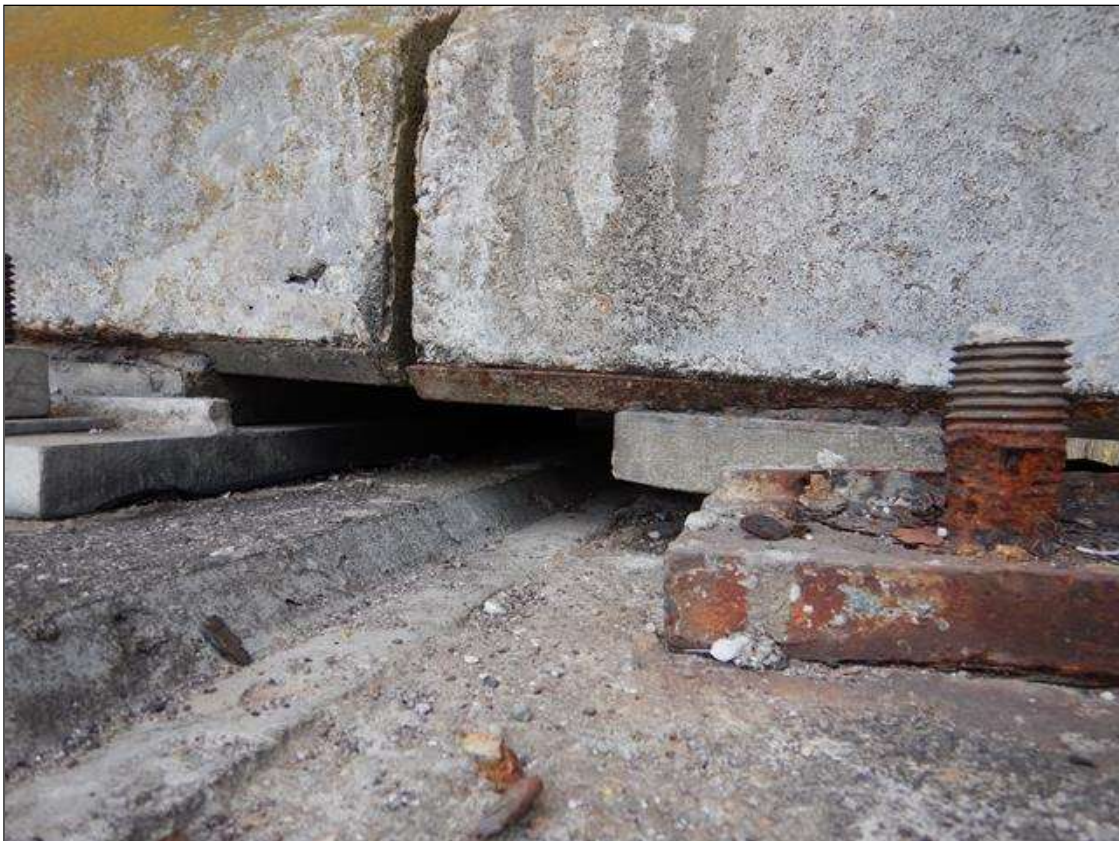
Span 1 Beam 1 - Beam 1 Far Bearing: Up to 100% section loss on the left anchor rod nut

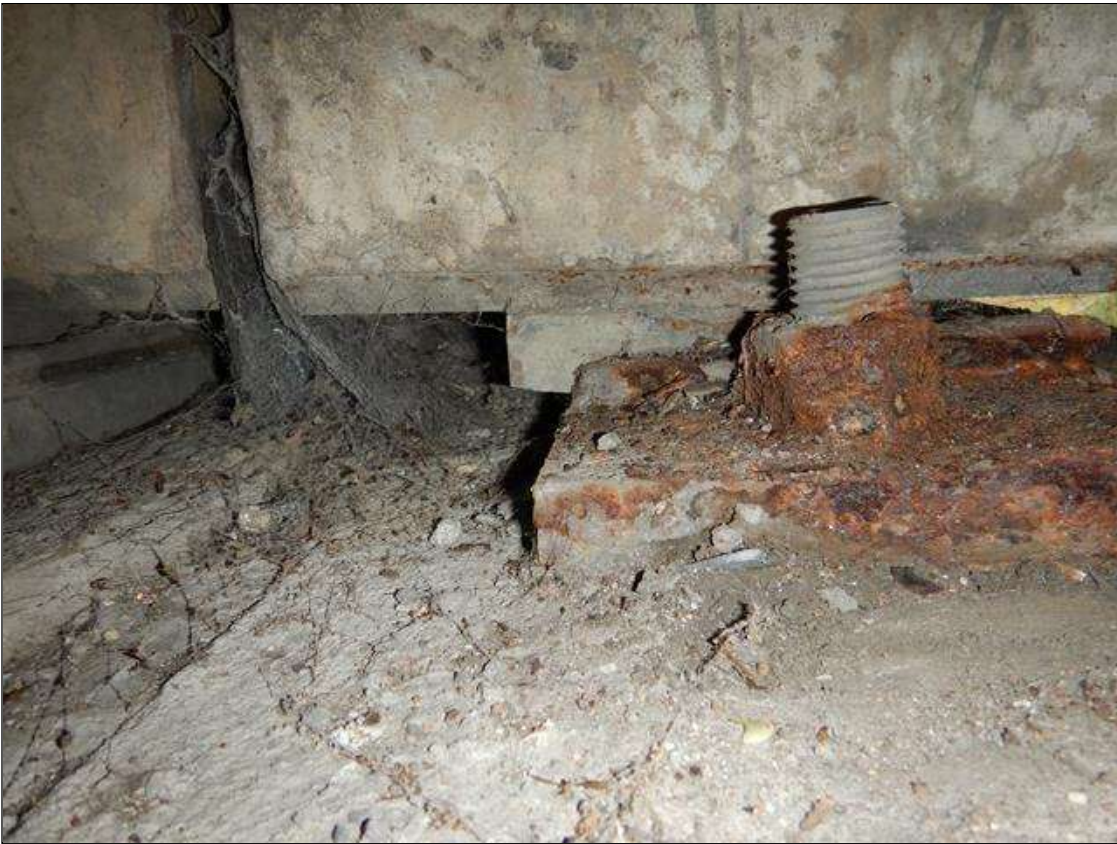
Span 1 Beam 1 - Beam 1 Far Bearing: up to (1-9/16") movement of bearing east beyond masonry plate with 26% loss of bearing

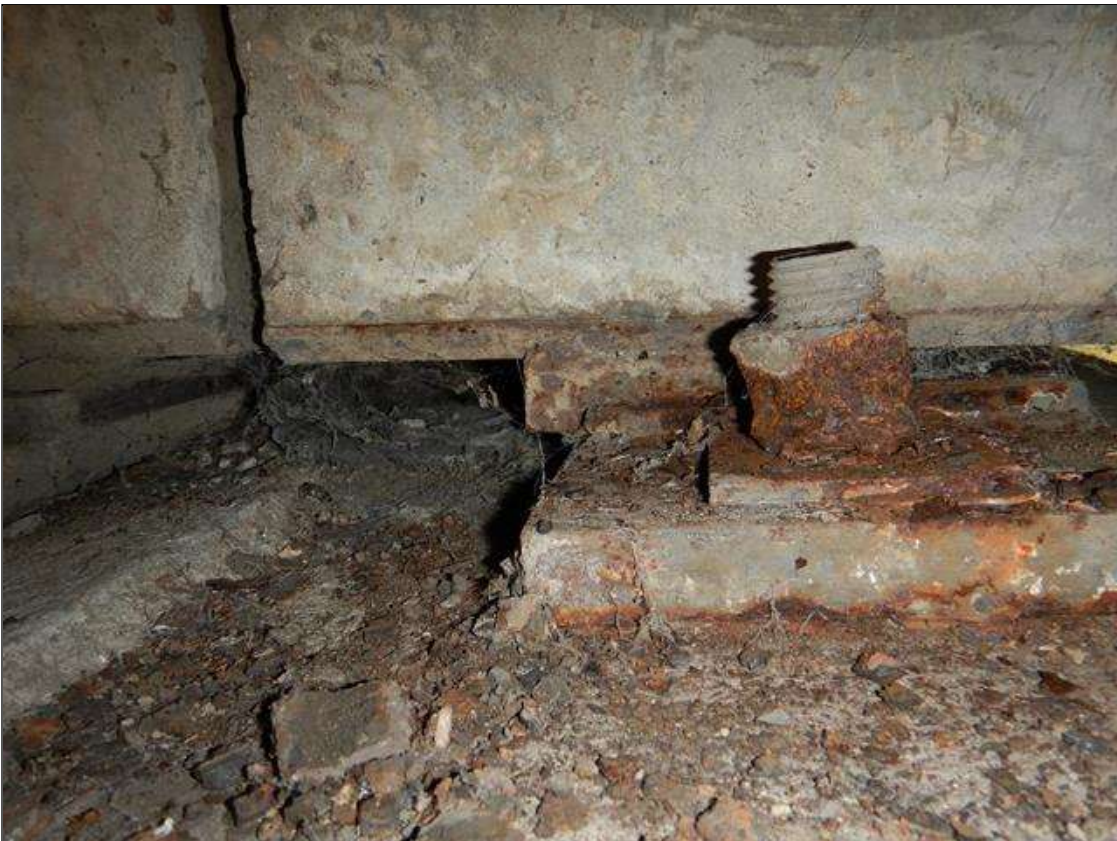
Span 1 Beam 2 - Beam 2 Far Bearing: Up to (3/4") movement of bearing to east beyond masonry plate with 13% loss of bearing.

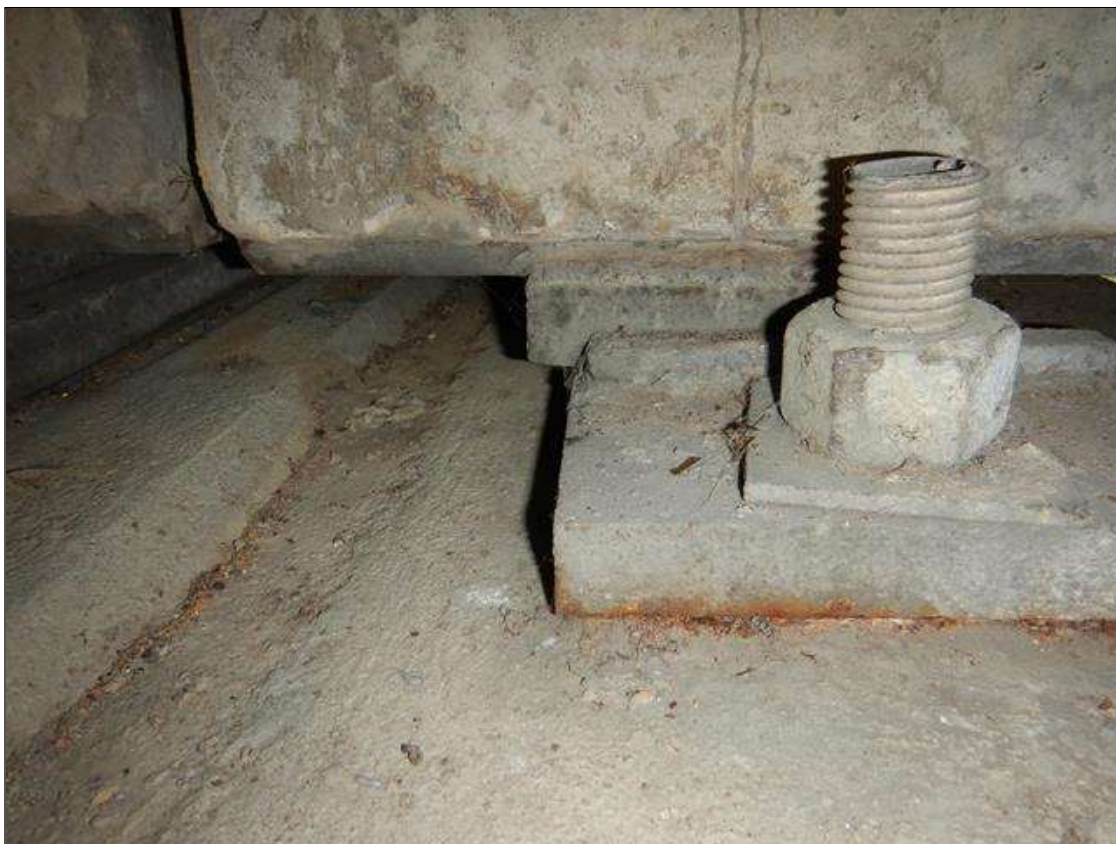
Span 1 Beam 3 - Beam 3 Far Bearing: Up to (3/4") movement of bearing to east beyond masonry plate with 13% loss in bearing
