NC DEPARTMENT OF TRANSPORTATION
DIVISION OF HIGHWAYS
STRUCTURE MANAGEMENT UNIT

Structure Safety Report

Routine Element Inspection - Contract

DIVISION: 3 COUNTY: NEW HANOVER STRUCTURE NUMBER: 640013 FREQUENCY: 24 MONTHS

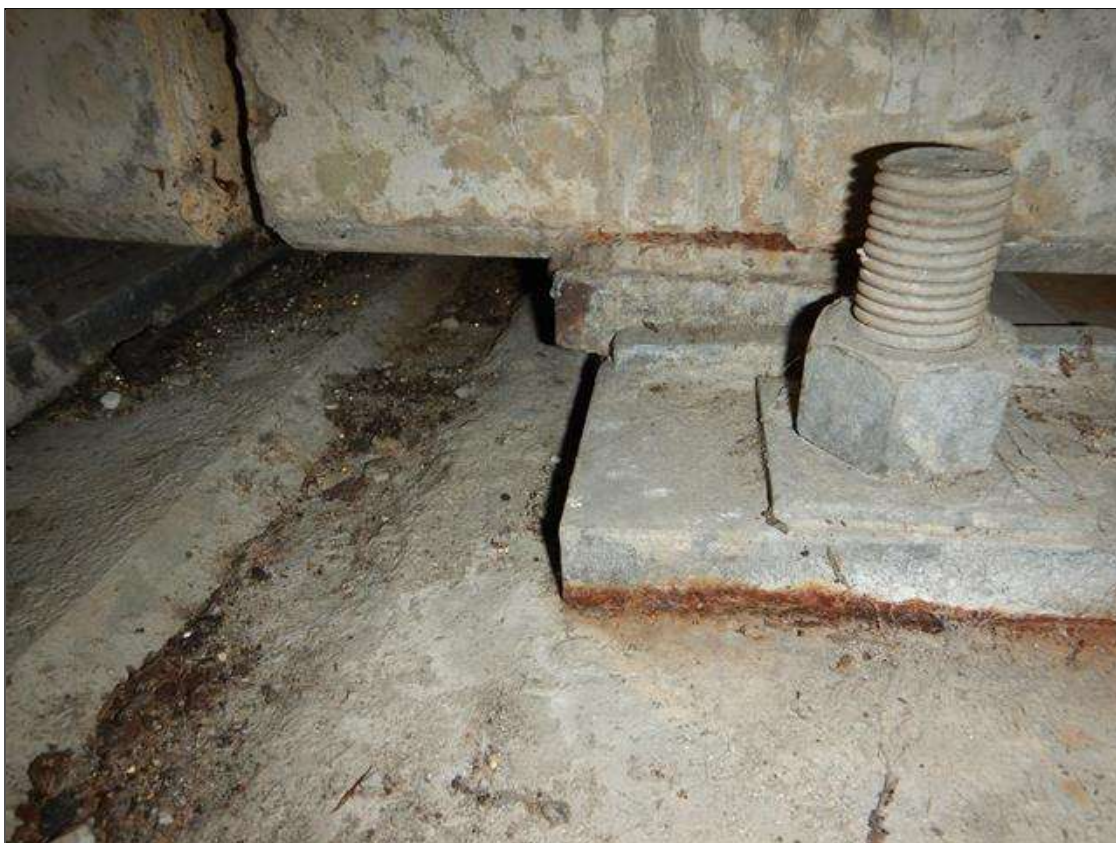
Span 1 Beam 4 - Beam 4 Far Bearing: Up to (1/2") movement of bearing to east beyond masonry plate with 8% loss in bearing

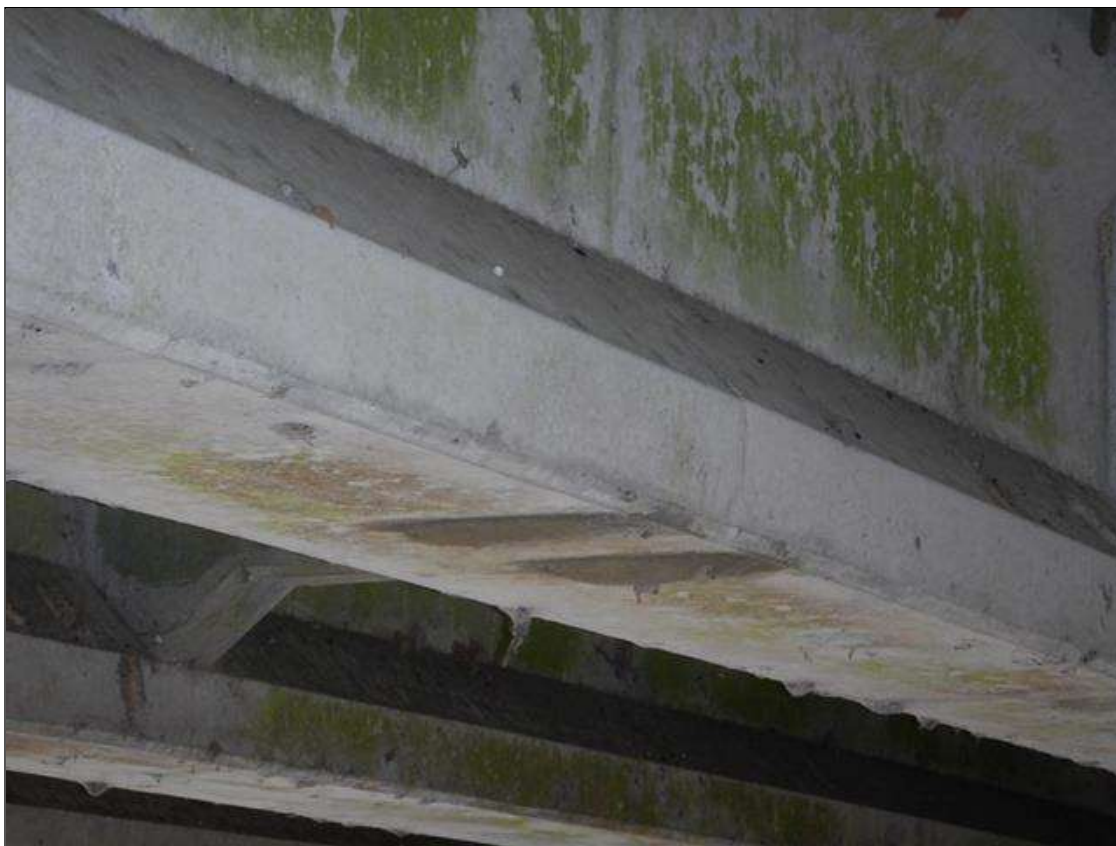
Span 1 Beam 5 - Beam 5 Far Bearing: Up to (1/2") movement of bearing to east beyond masonry plate with 8% loss in bearing

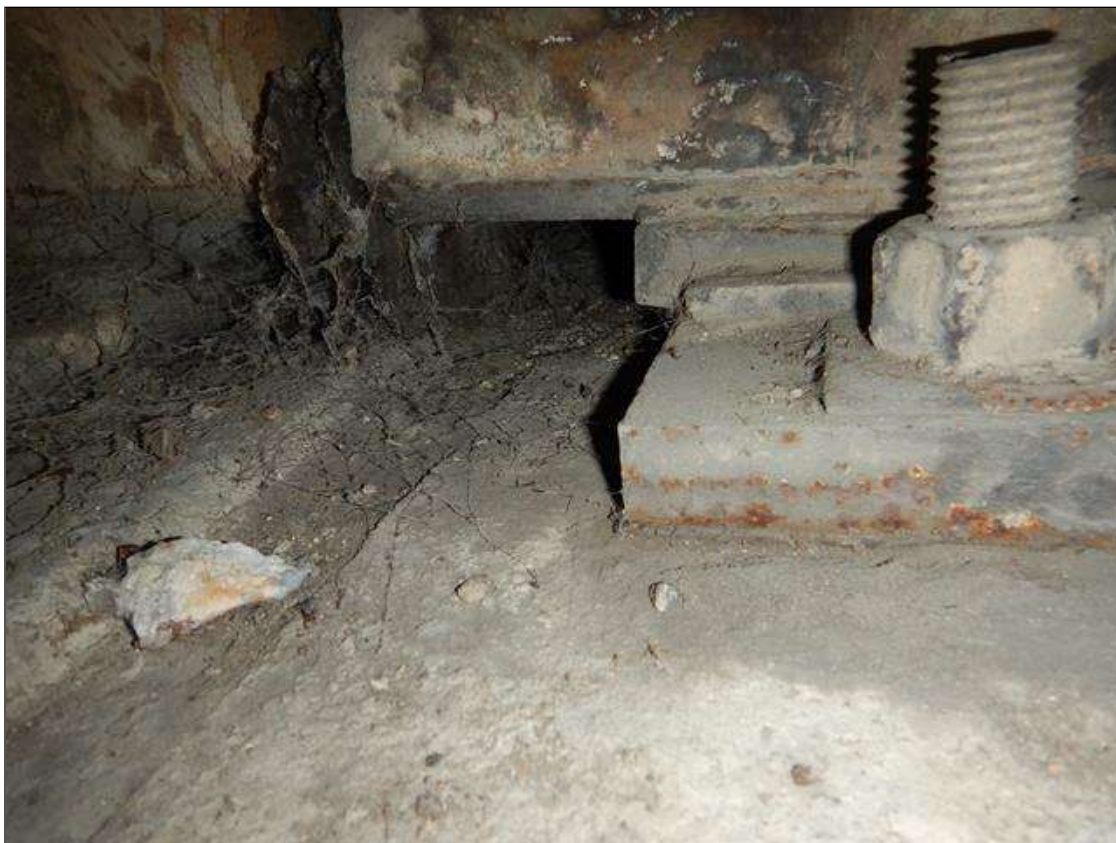
Span 1 Beam 7: spall with exposed rebar on the bottom face at 28ft from bent 1 (7 1/2" x 4 1/2" x 1/8")

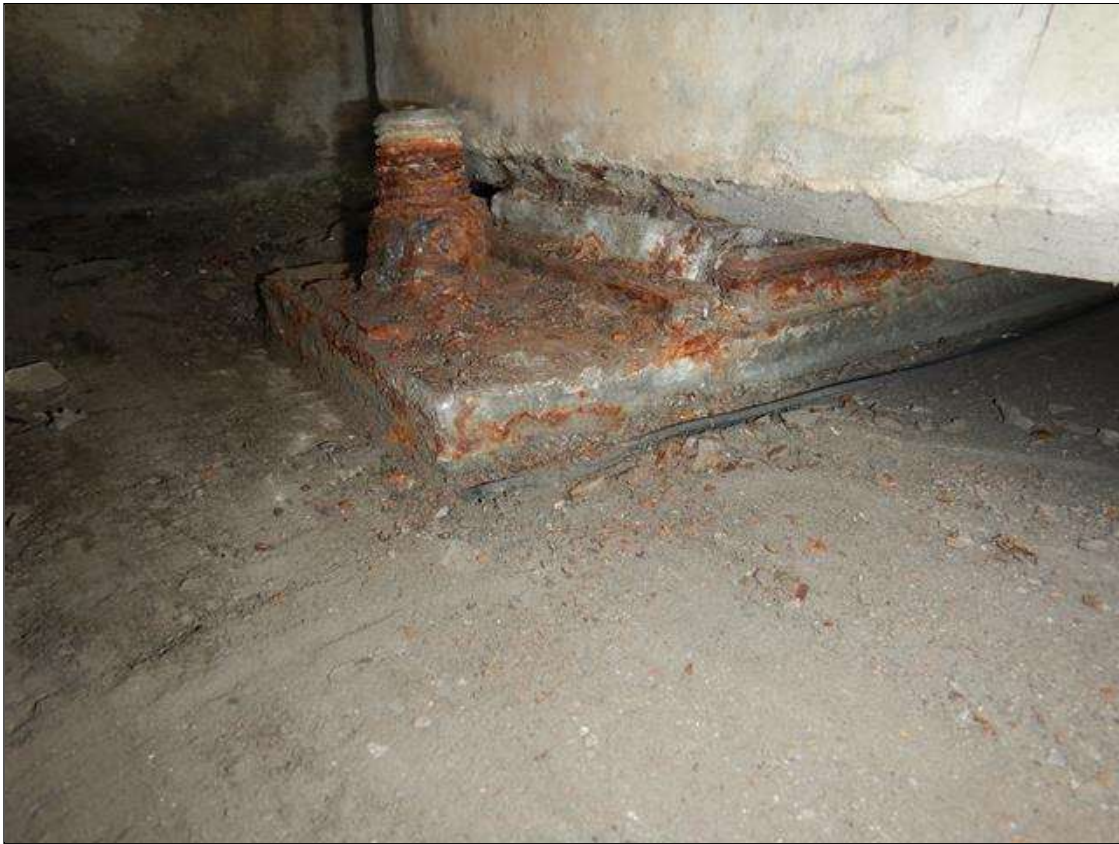
Span 1 Beam 7 - Beam 7 Far Bearing: Up to (1/2") movement of bearing to east beyond masonry plate with 8% loss of bearing

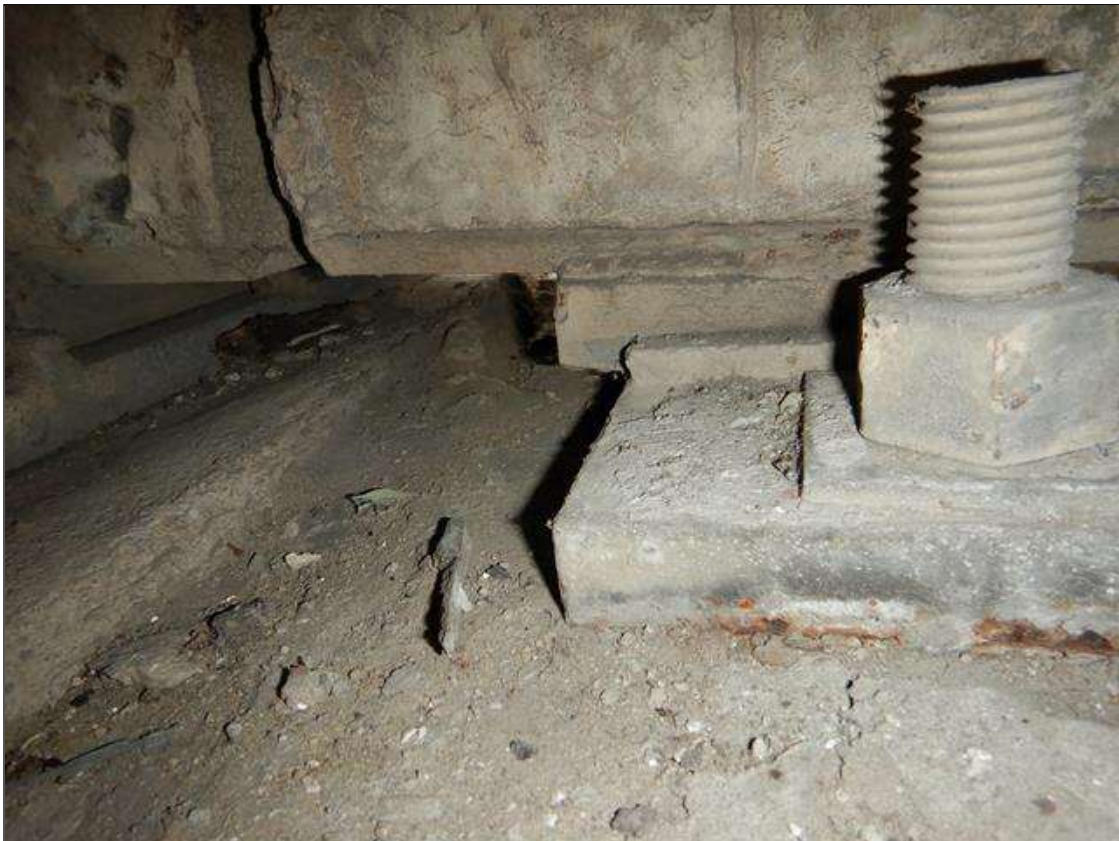
Span 1 Beam 9 - Beam 9 Near Bearing: corrosion and scale with no measureable section loss on the left anchor rod, nut and plate

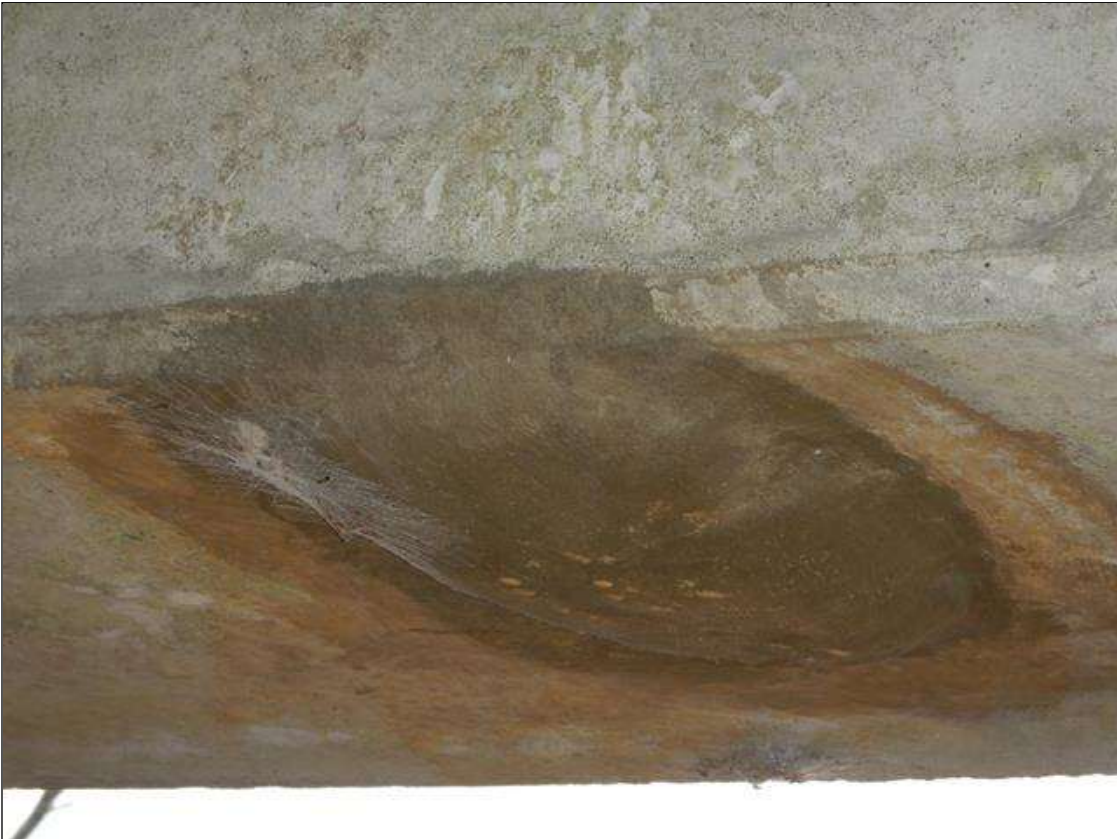
Span 2 Deck: [NEW REPAIR - PATCHING] FORMERLY --> spall with exposed rebar in the right overhang under light pole (27" x 20") DELAMINATION area and (19" x 12" x 2") spall

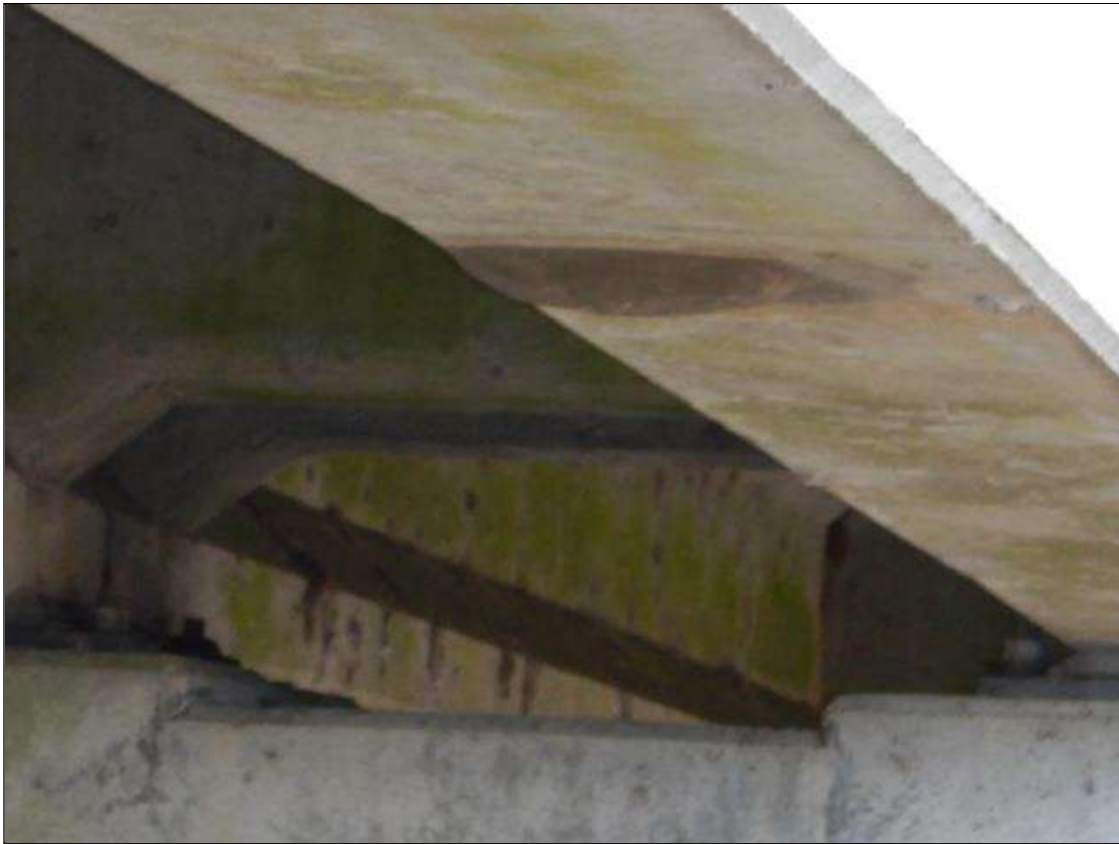
Span 2 Beam 1: [NEW REPAIR - PATCHING] FORMERLY --> spall with exposed rebar on the bottom face at 11ft from bent 1 (5" x 3" x 1/4")

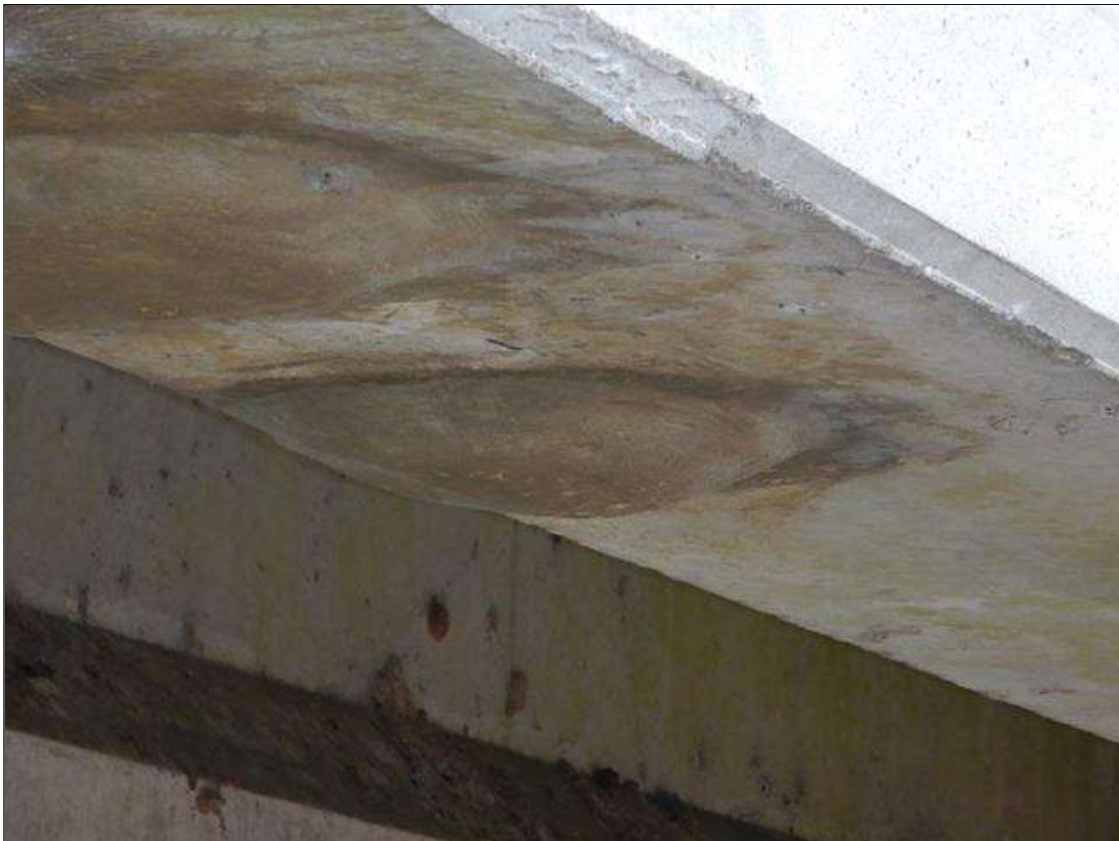
Span 2 Beam 1: [NEW REPAIR - PATCHING] FORMERLY --> spall with exposed rebar on the bottom face at 22.5ft from bent 1 (10" x 6" x 1/2")

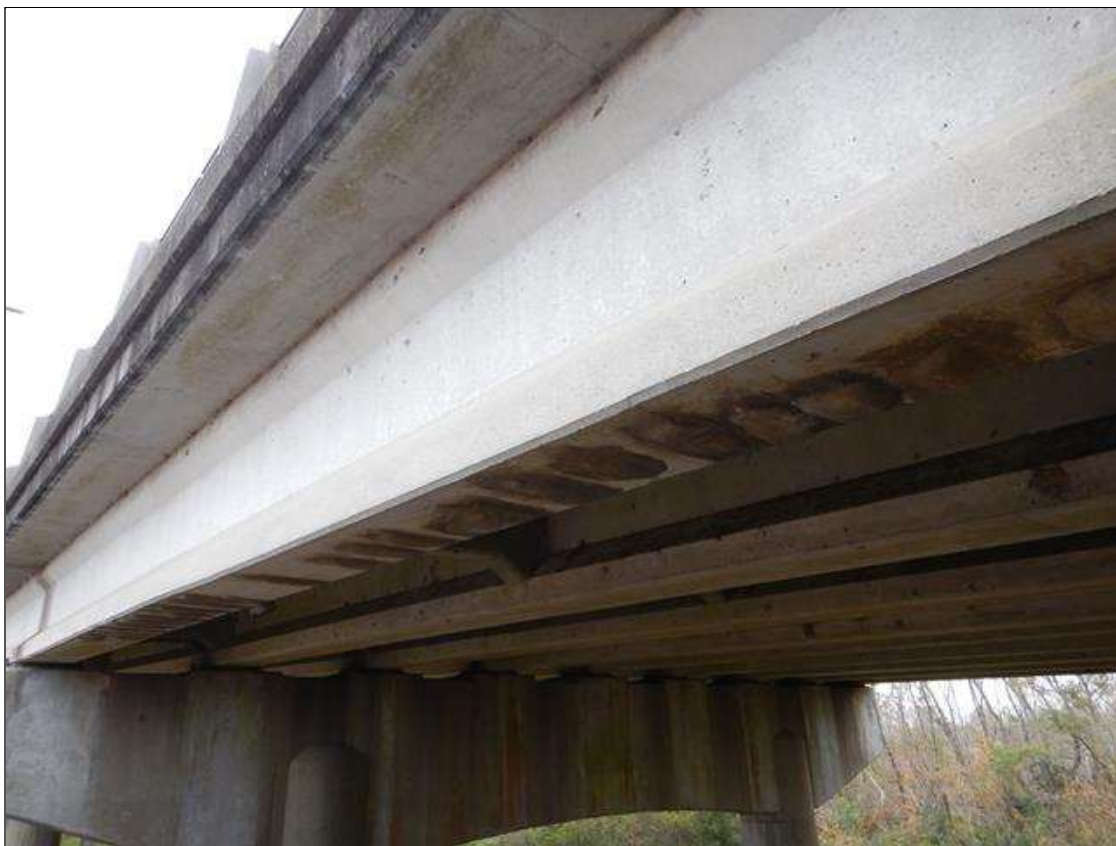
Span 2 Beam 1: [NEW REPAIR - PATCHING] FORMERLY --> spall with exposed rebar on the bottom face at 26ft from bent 1 (10" x 6 1/2" x 1/2")

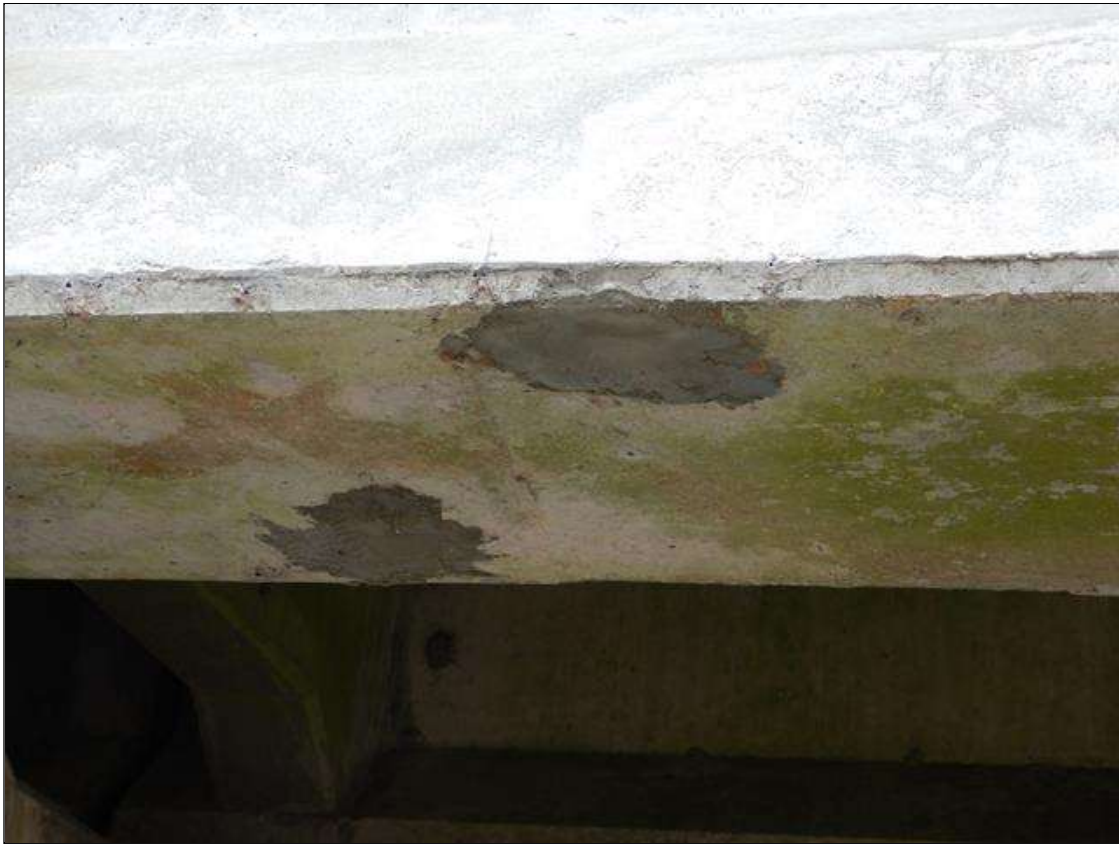
Span 2 Beam 1: [NEW REPAIR - PATCHING] FORMERLY --> multiple spalls with exposed rebar on the bottom face starting at 20.5ft from bent 1 up to (10" x 2 1/2" x 1/2")

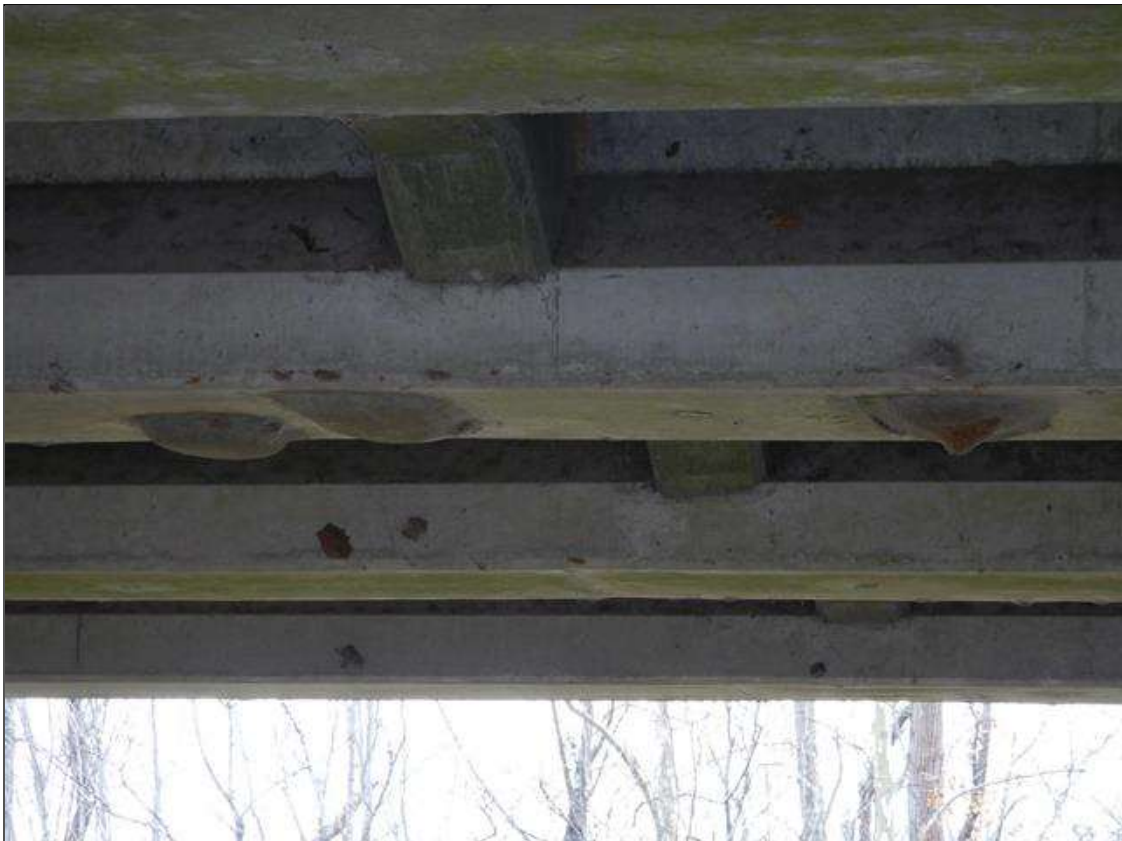
Span 2 Beam 2: [PROMPT ACTION REQUEST] 14" section of 2 areas of exposed rebar in the bottom face at bent 2 up to (6" x 2")

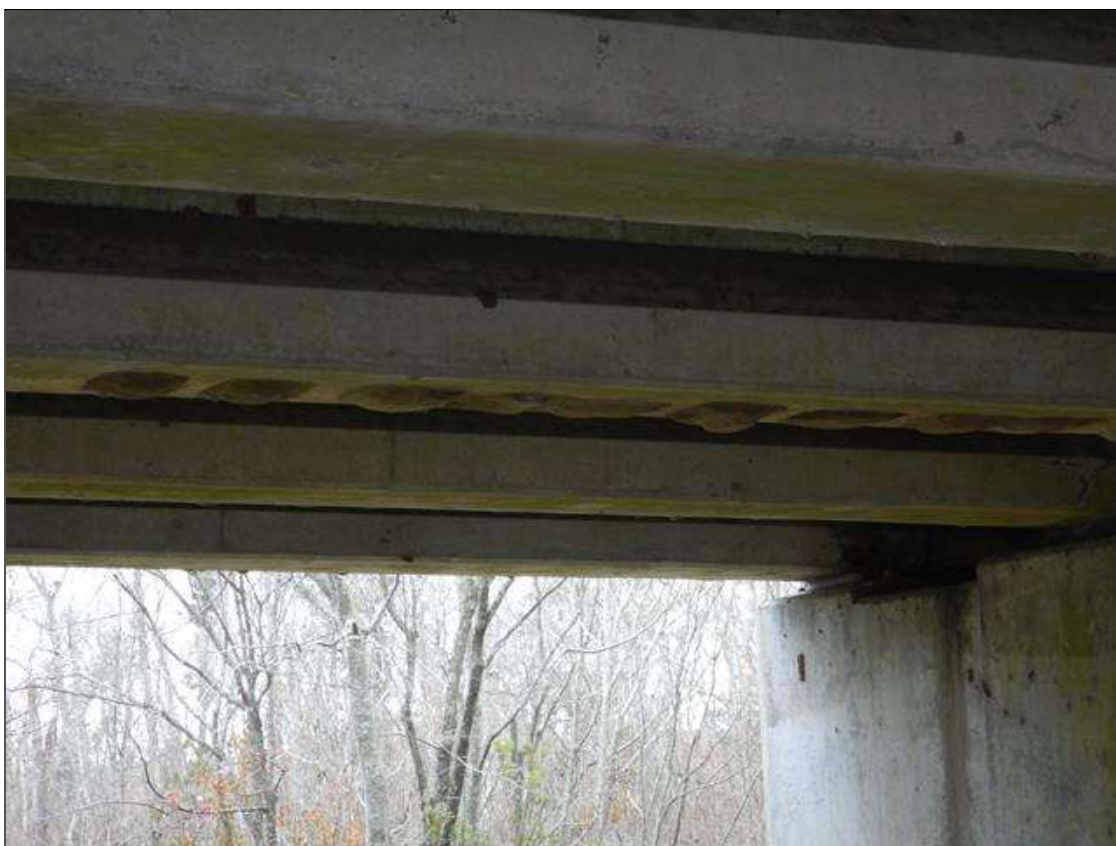
Span 2 Beam 7: [NEW REPAIR - PATCHING] FORMERLY --> (x3) spalls with exposed rebar on the bottom face at 18ft from bent 1 up to (6" X 5" X 1/2")

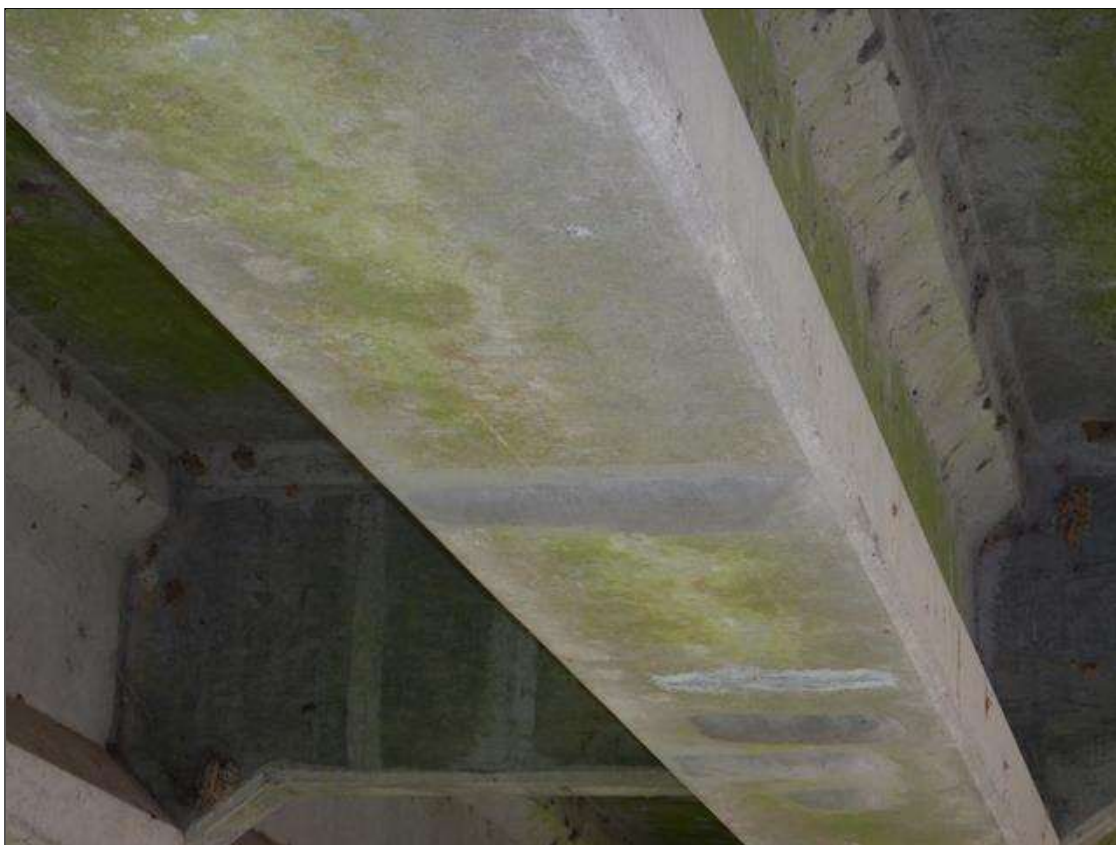
Span 2 Beam 7: [NEW REPAIR - PATCHING] FORMERLY --> 10ft section of 10 spalls with exposed rebar up to (6" x 6" x 1/2") on the bottom face starting 2ft from bent 1

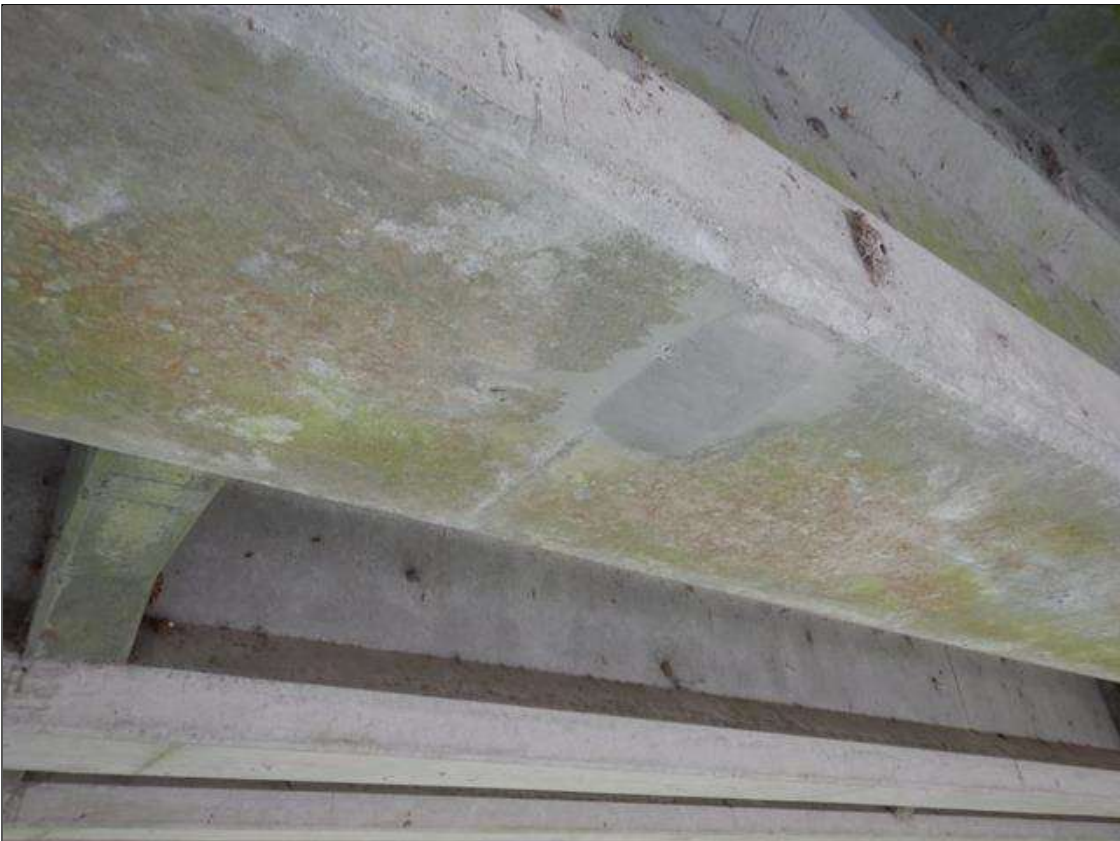
Span 3 Beam 2: [NEW REPAIR - PATCHING] FORMERLY --> (x4) spalls with exposed rebar on the bottom face starting at 24ft from bent 2 up to (8" x 3" x 1/2")

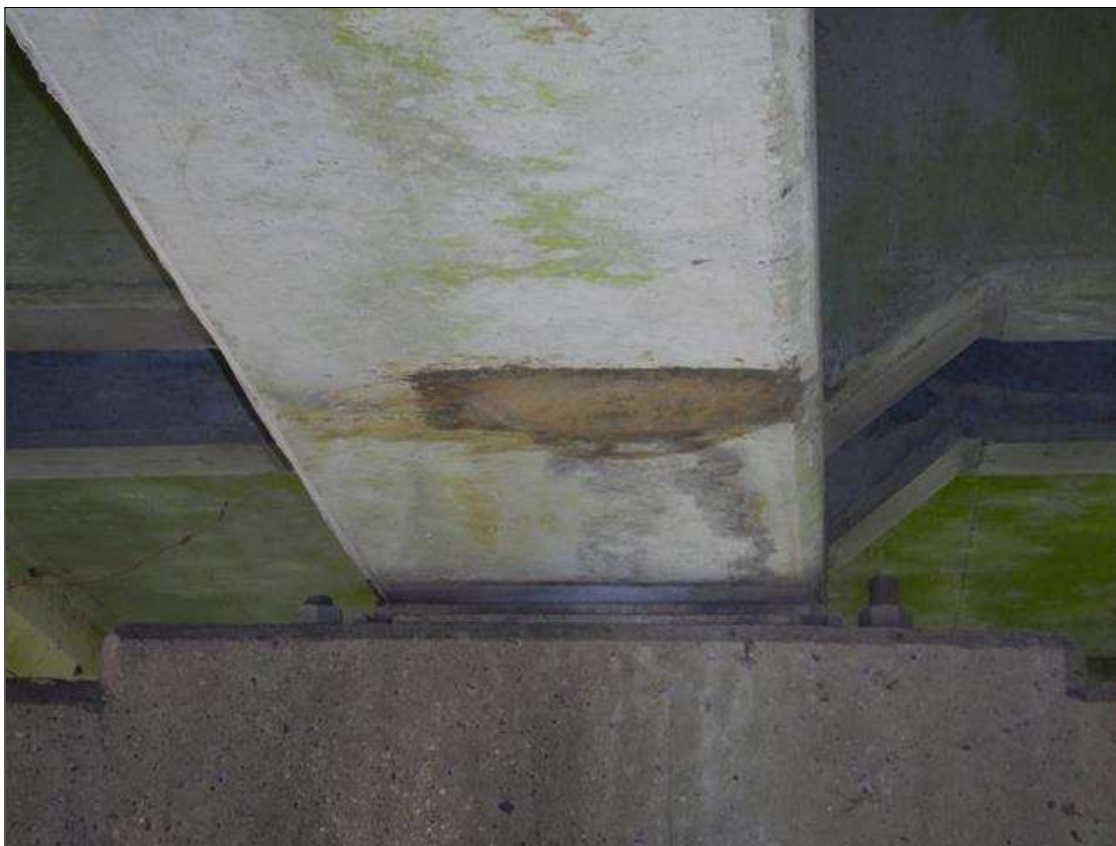
Span 3 Beam 2: [NEW REPAIR - PATCHING] FORMERLY --> area of delamination on the bottom of the girder at 1/3 point, 10" wide x 5" long with 1/8" separation.

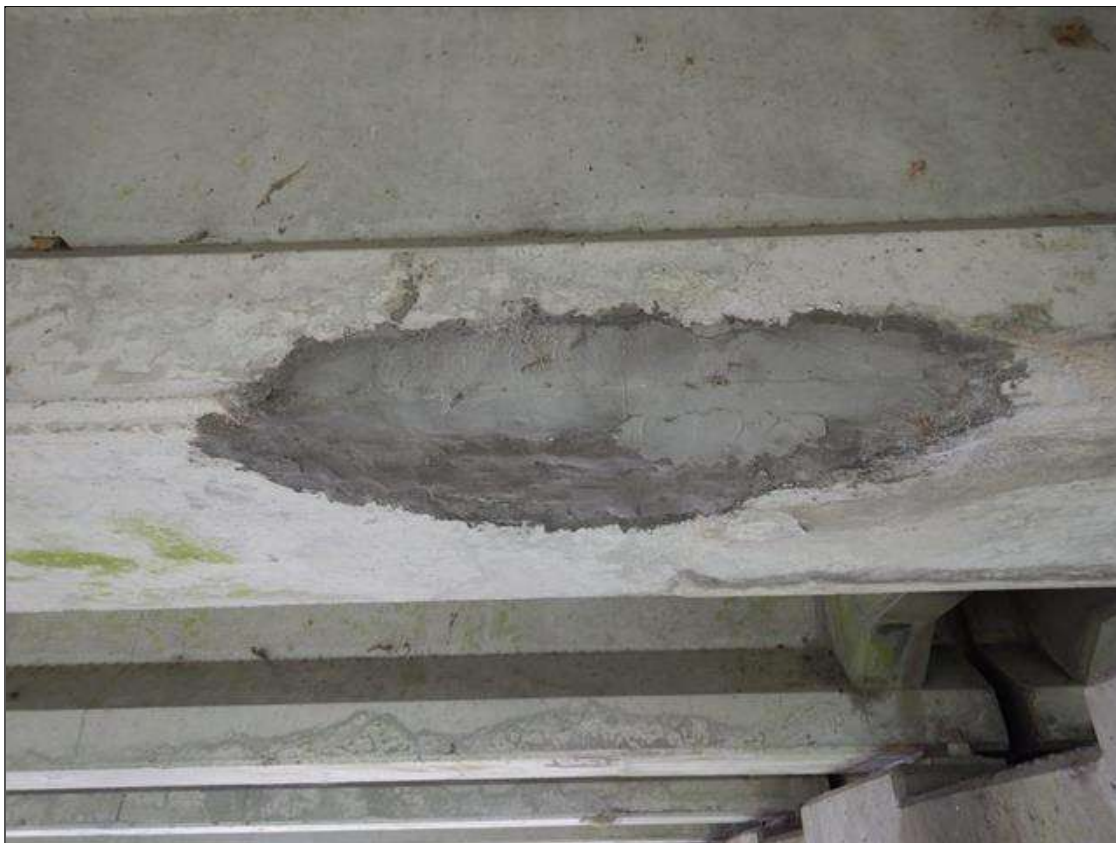
Span 3 Beam 3: [NEW REPAIR - PATCHING] FORMERLY --> spall with exposed rebar on the bottom face at 31in from bent 3 (9" x 3" x 1/2")

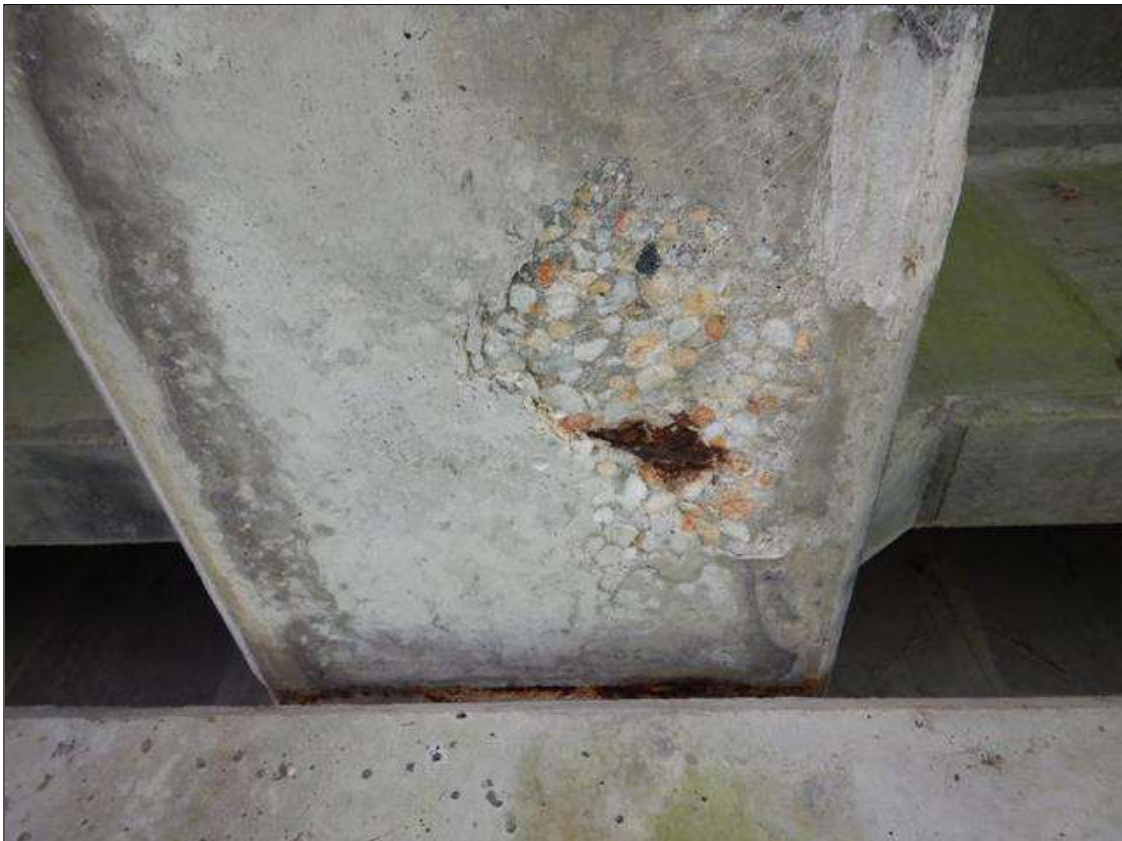
Span 3 Beam 5: [PROMPT ACTION REQUEST] (6" x 2" x 1/4") spall with exposed rebar in the bottom right chamfer at bent 3

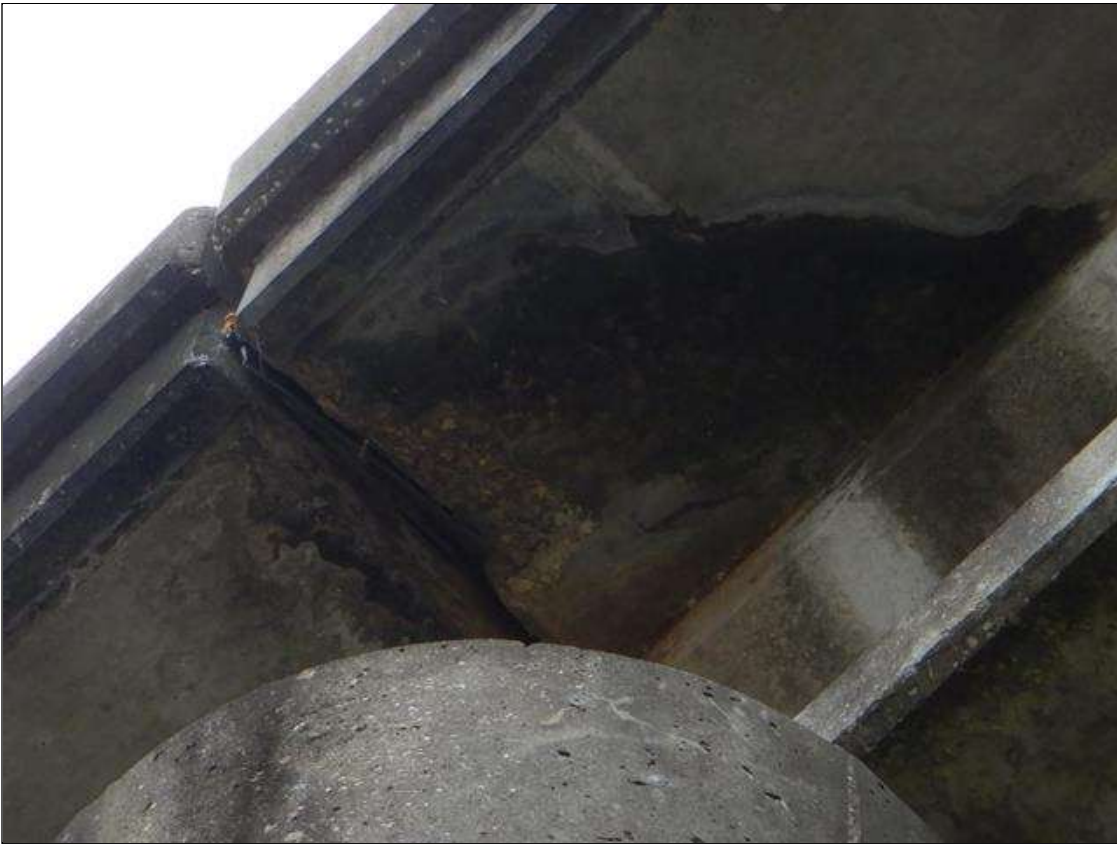
Span 3 Beam 7: [NEW REPAIR - PATCHING] FORMERLY --> (13" x 5" x 3/4") spall with exposed rebar on the bottom face at 32in from bent 3

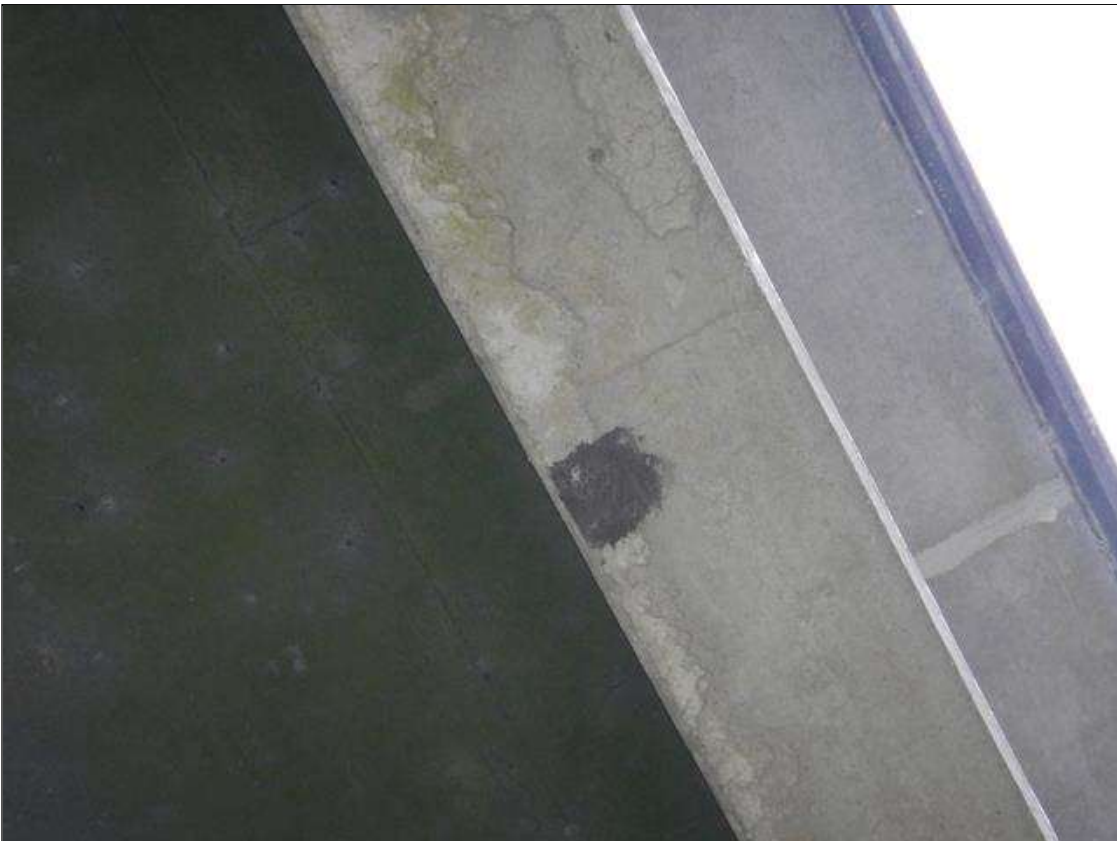
Span 4 Deck: [NEW REPAIR - PATCHING] FORMERLY --> spall with exposed rebar on the left overhang at bent 4 (17' x 6" x 3")

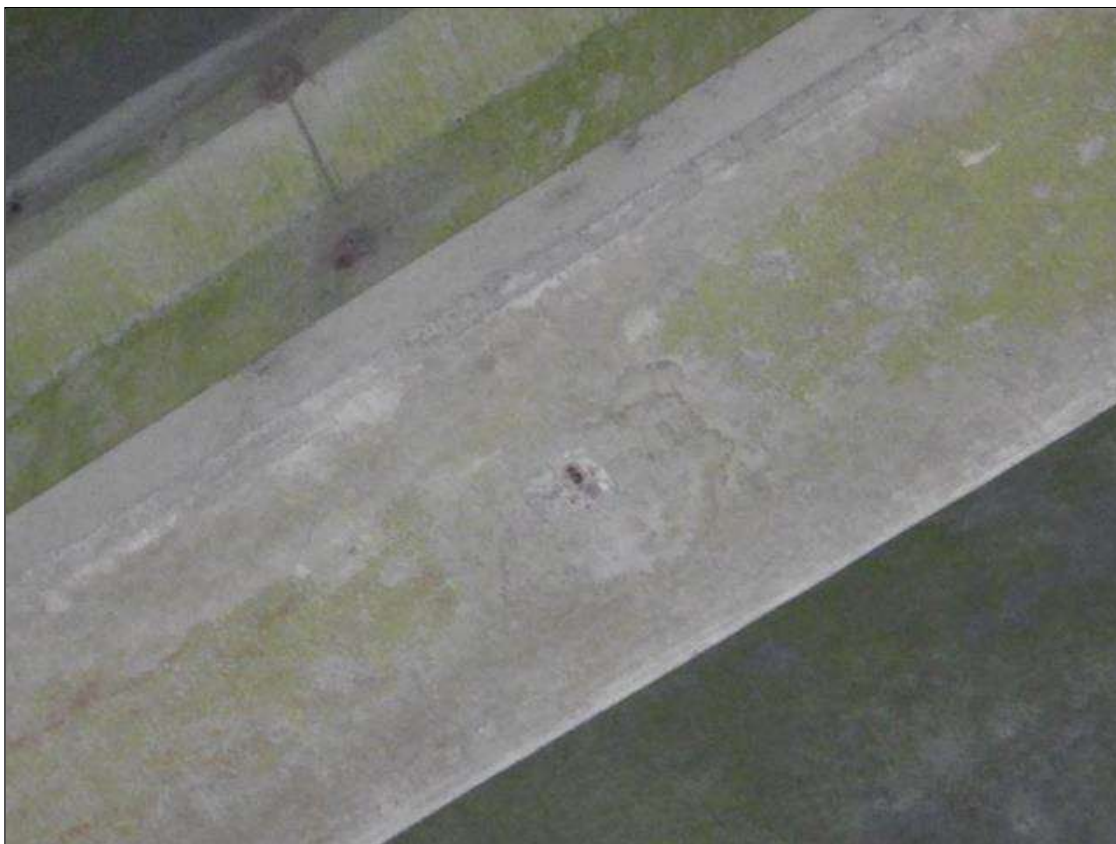
Span 4 Beam 1: [NEW REPAIR - PATCHING] FORMERLY --> (4" x 3" x 1/4") spall with exposed rebar on the bottom face at 13ft from bent 4

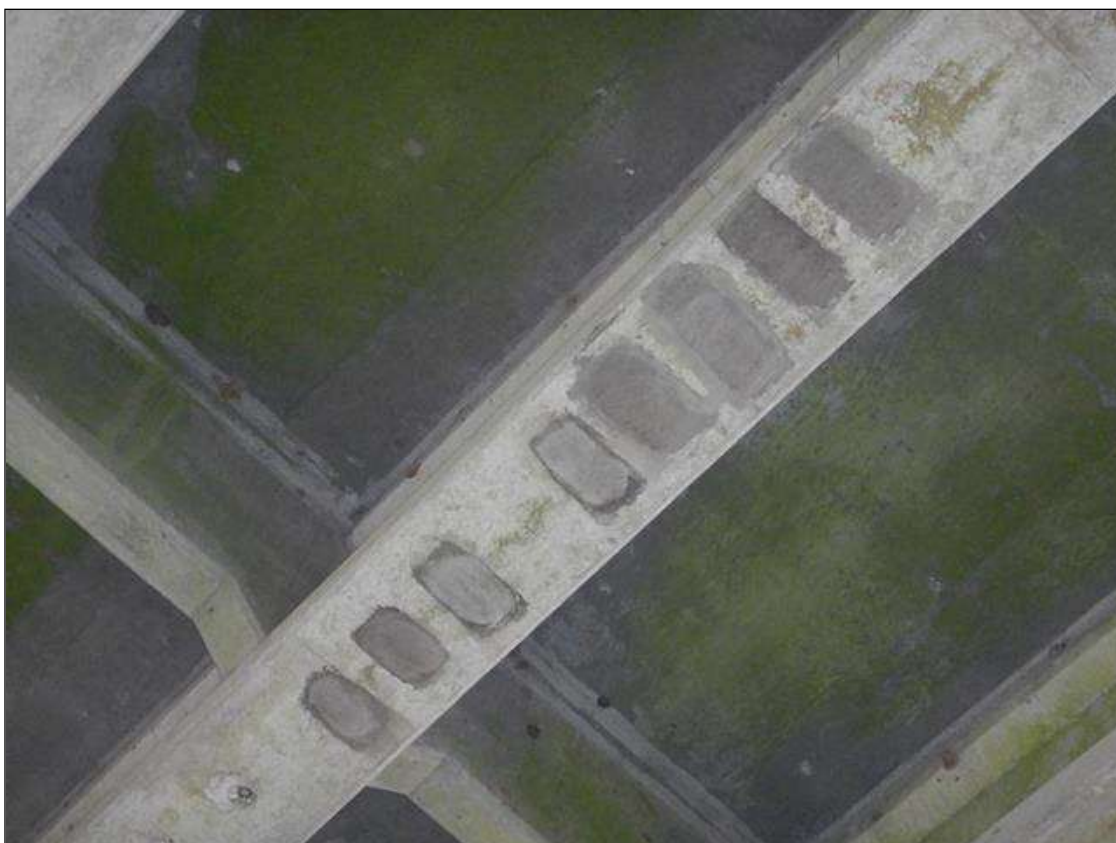
Span 4 Beam 3: (4" x 3" x 1/8") spall with exposed rebar on the bottom face 28ft from bent 3

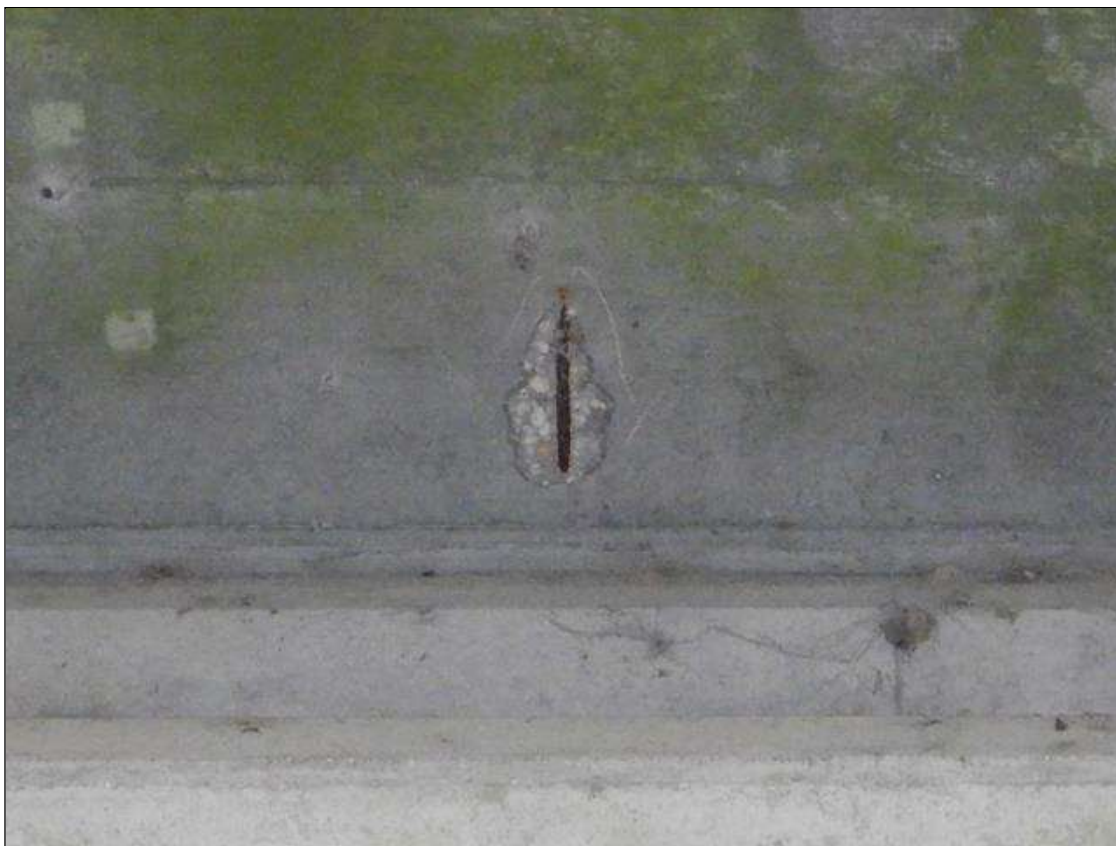
Span 4 Beam 4: [NEW REPAIR - PATCHING] FORMERLY --> (x8) spalls with exposed rebar on the bottom face starting at 21in from bent 3 up to (7" x 4" x 1/2')

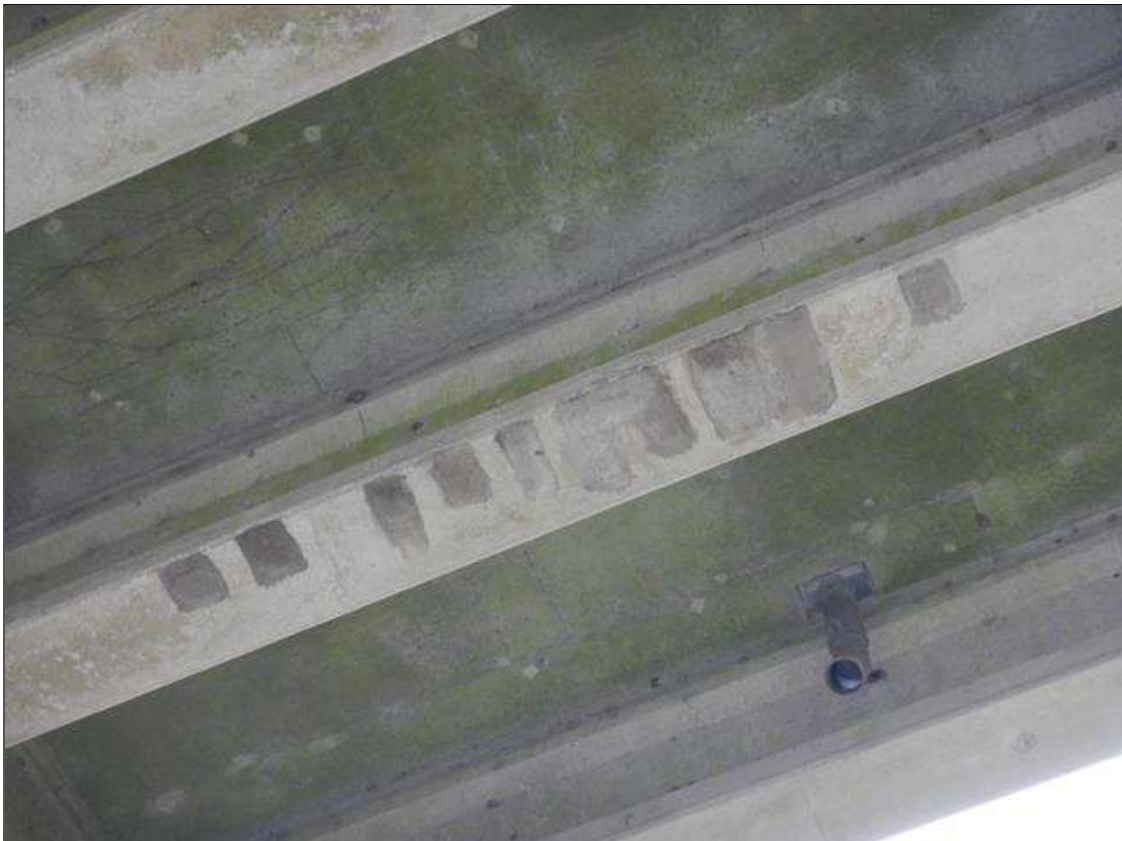
Span 5 Beam 2: [NEW REPAIR - PATCHING] FORMERLY --> (8" x 4" x 1/2") spall with exposed rebar on the bottom face at 14ft from bent 4
