NC DEPARTMENT OF TRANSPORTATION
DIVISION OF HIGHWAYS
STRUCTURE MANAGEMENT UNIT

Structure Safety Report

Routine Element Inspection - Contract

DIVISION: 3 COUNTY: NEW HANOVER STRUCTURE NUMBER: 640013 FREQUENCY: 24 MONTHS

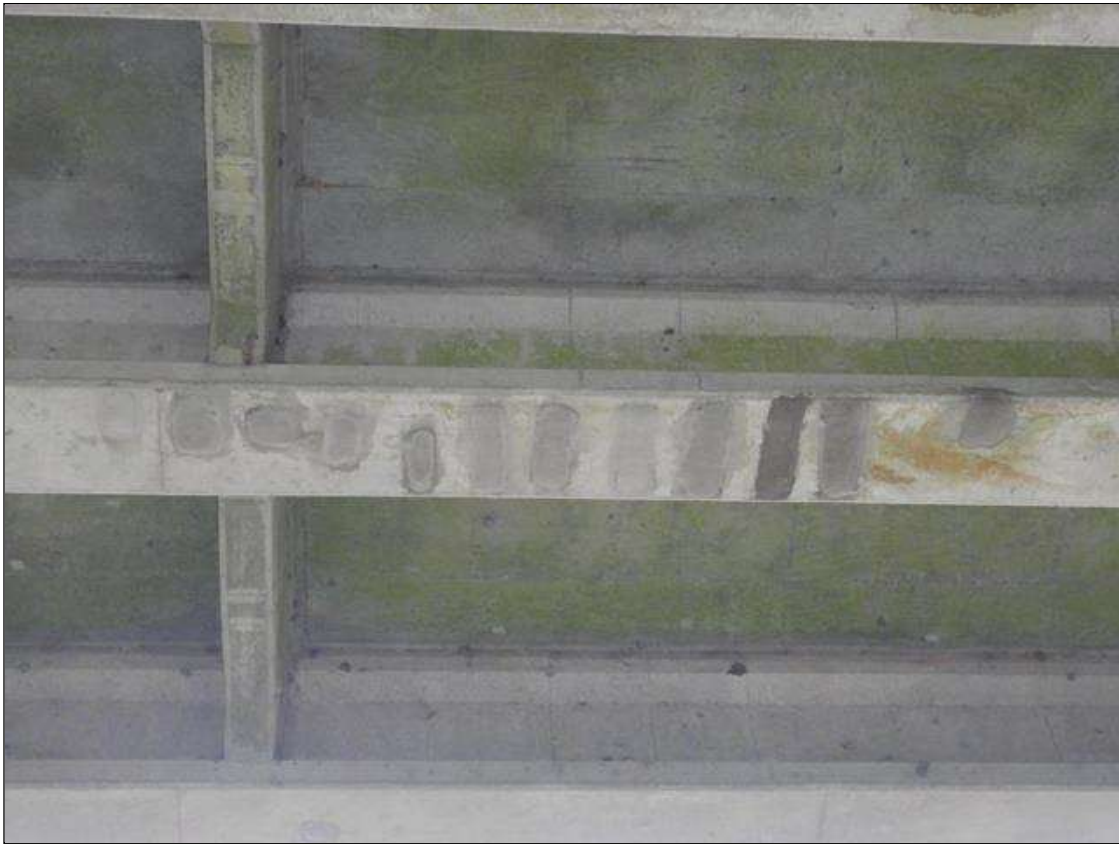
Span 5 Beam 2: [NEW REPAIR - PATCHING] FORMERLY --> (x9) spalls with exposed rebar on the bottom face at mid span up to (12" x 2" x 1/2")

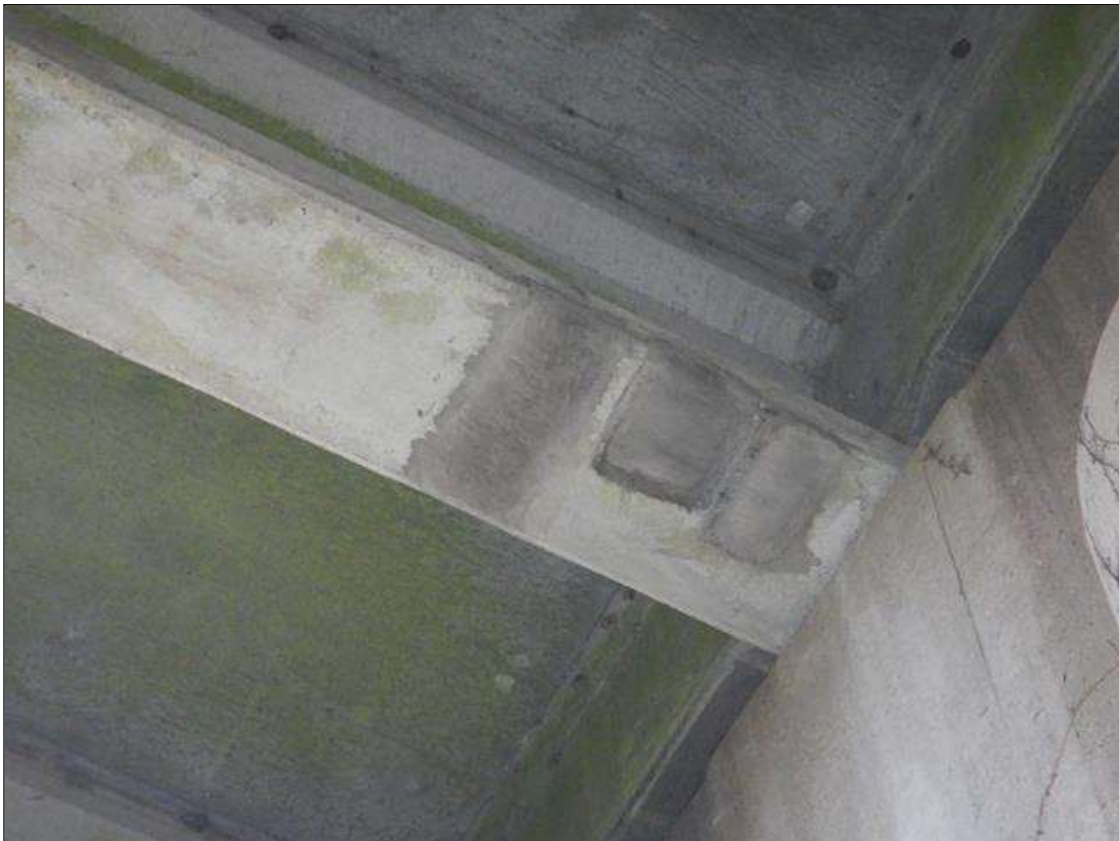
Span 5 Beam 2: [NEW REPAIR - PATCHING] FORMERLY --> mutiple (x13) spalls with exposed rebar on the bottom face starting at 11ft from bent 5 up to (14" x 2" x 1/4")

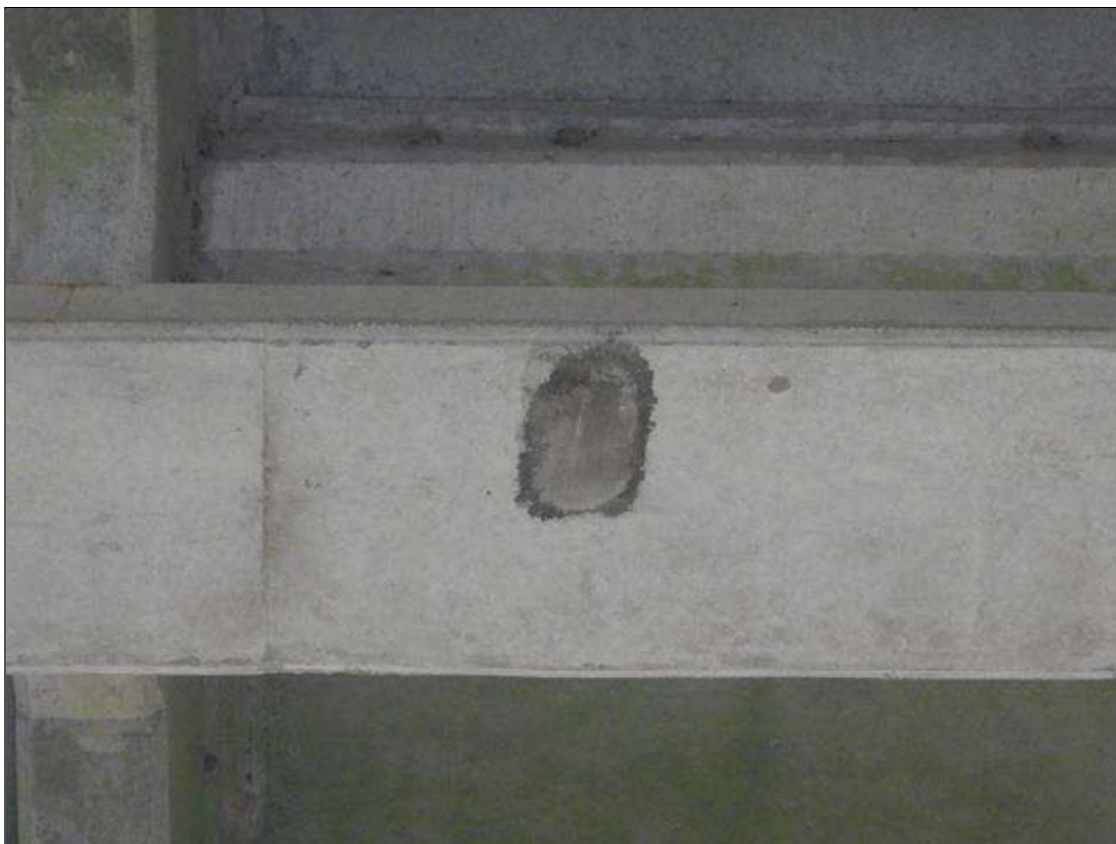
Span 5 Beam 2: [NEW REPAIR - PATCHING] FORMERLY --> (x3) spalls with exposed rebar on the bottom face at bent 5 up to (9" x 7" x 1")

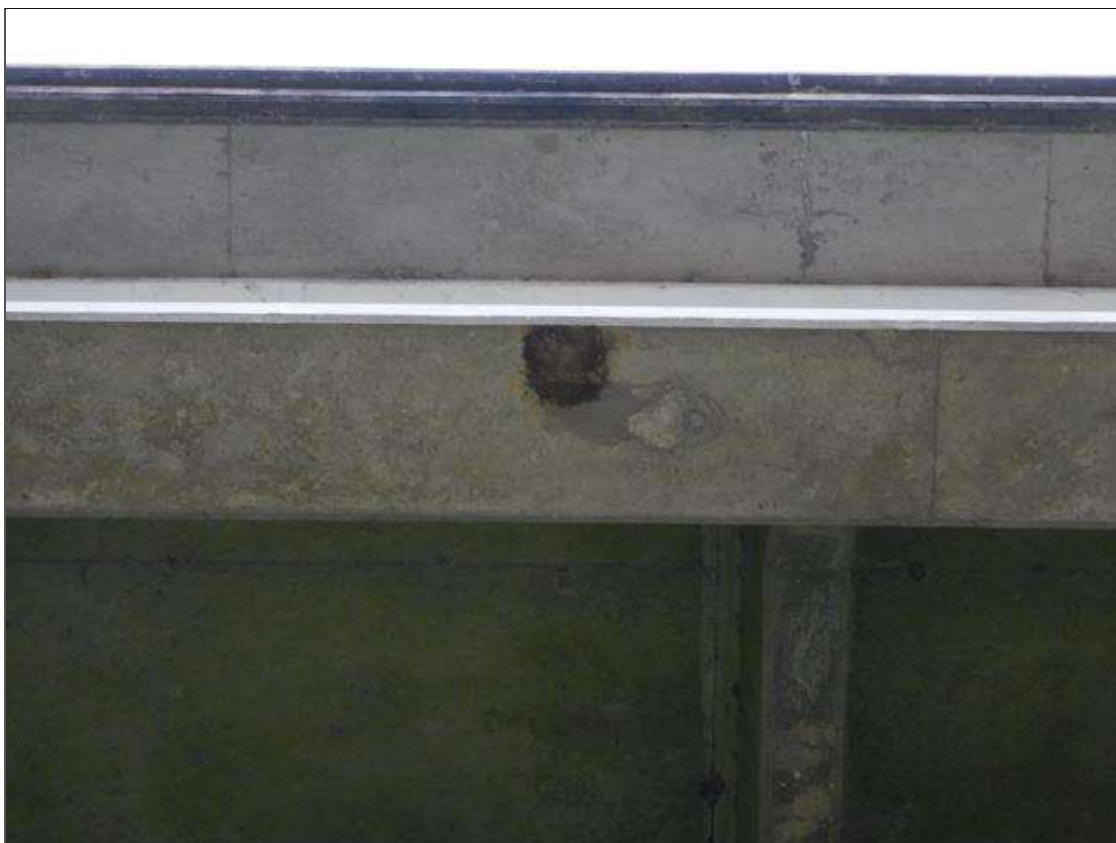
Span 5 Beam 2: [NEW REPAIR - PATCHING] FORMERLY --> (6" x 2" x 1/8") spall with exposed rebar on the bottom face at 24ft from bent 4

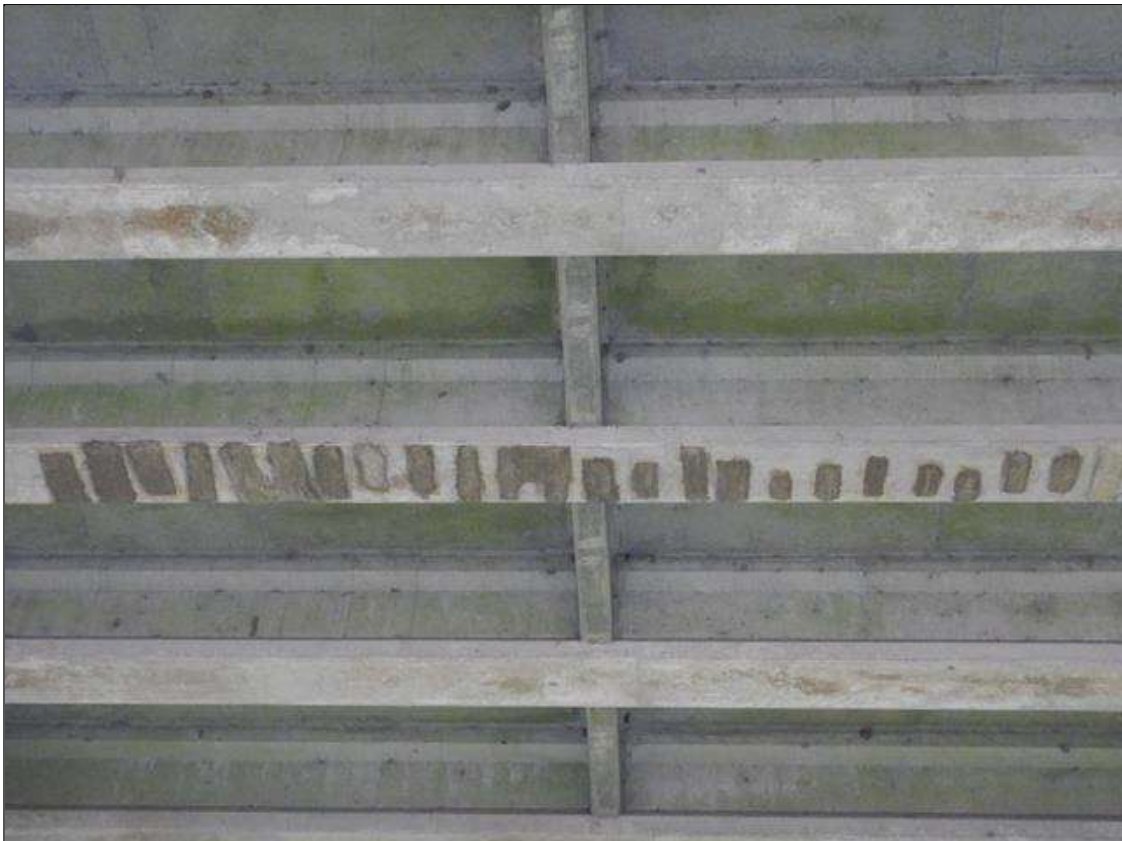
Span 6 Beam 2: [NEW REPAIR - PATCHING] FORMERLY --> (x4) spalls with exposed rebar on the bottom face starting at 22ft from bent 5 up to (16" x 5" x 1/2")

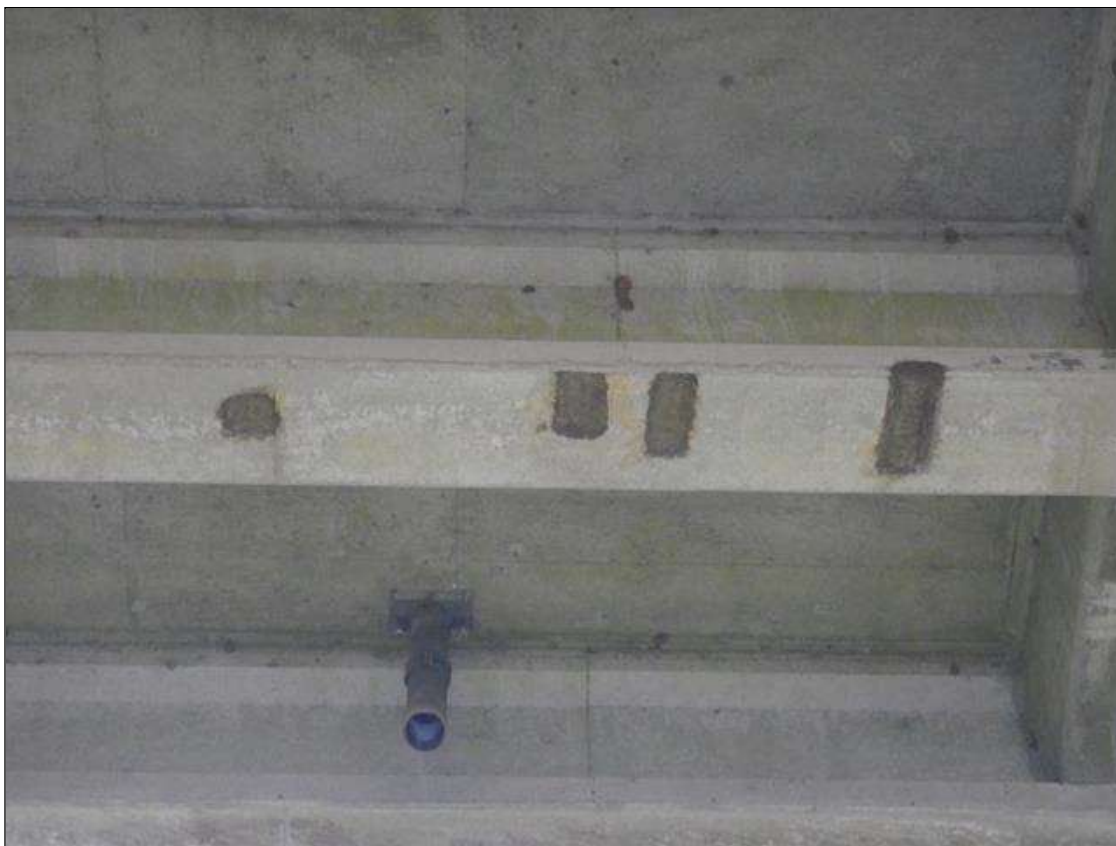
Span 6 Beam 5: [NEW REPAIR - PATCHING] FORMERLY --> 36 feet of spalling with exposed rebar on the bottom face starting at 26ft from bent 5 up to (13" x 4" x 1/2")

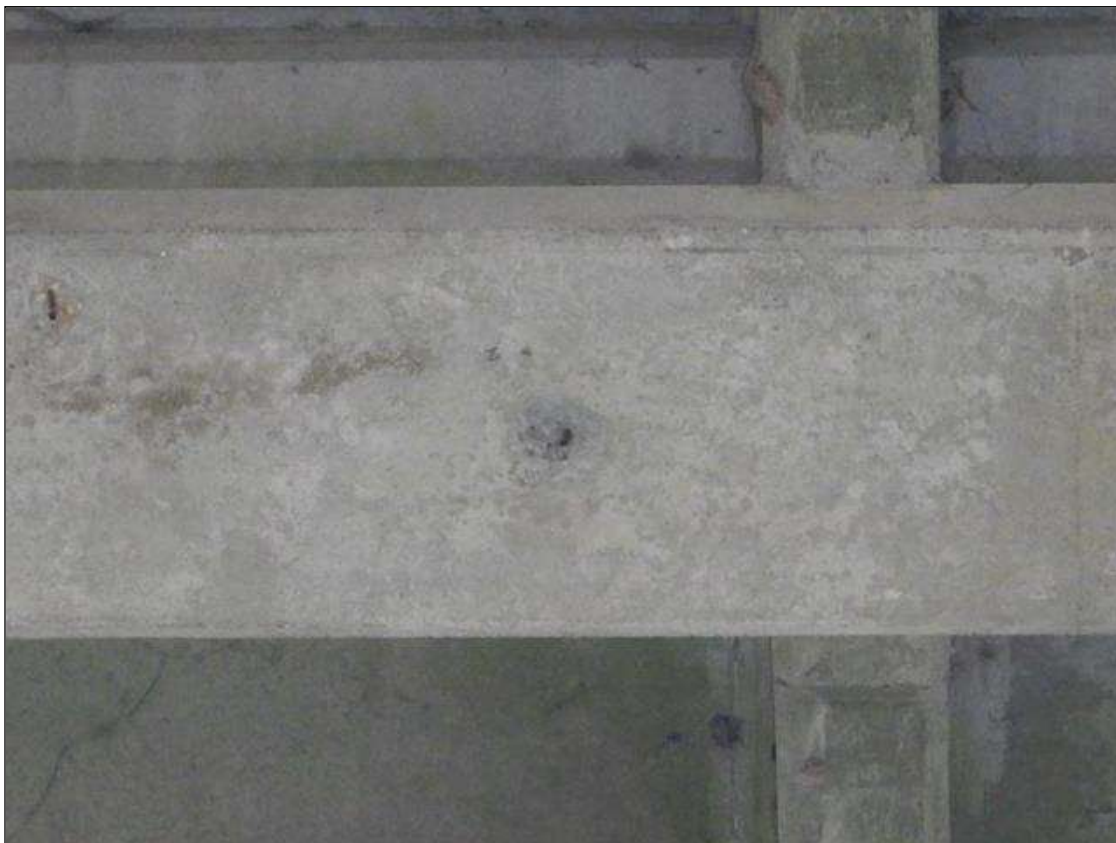
Span 6 Beam 8: [NEW REPAIR - PATCHING] FORMERLY --> (x4) spalls with exposed rebar on the bottom face starting 24.5ft from bent 5 up to (7" x 4" x 1/2")

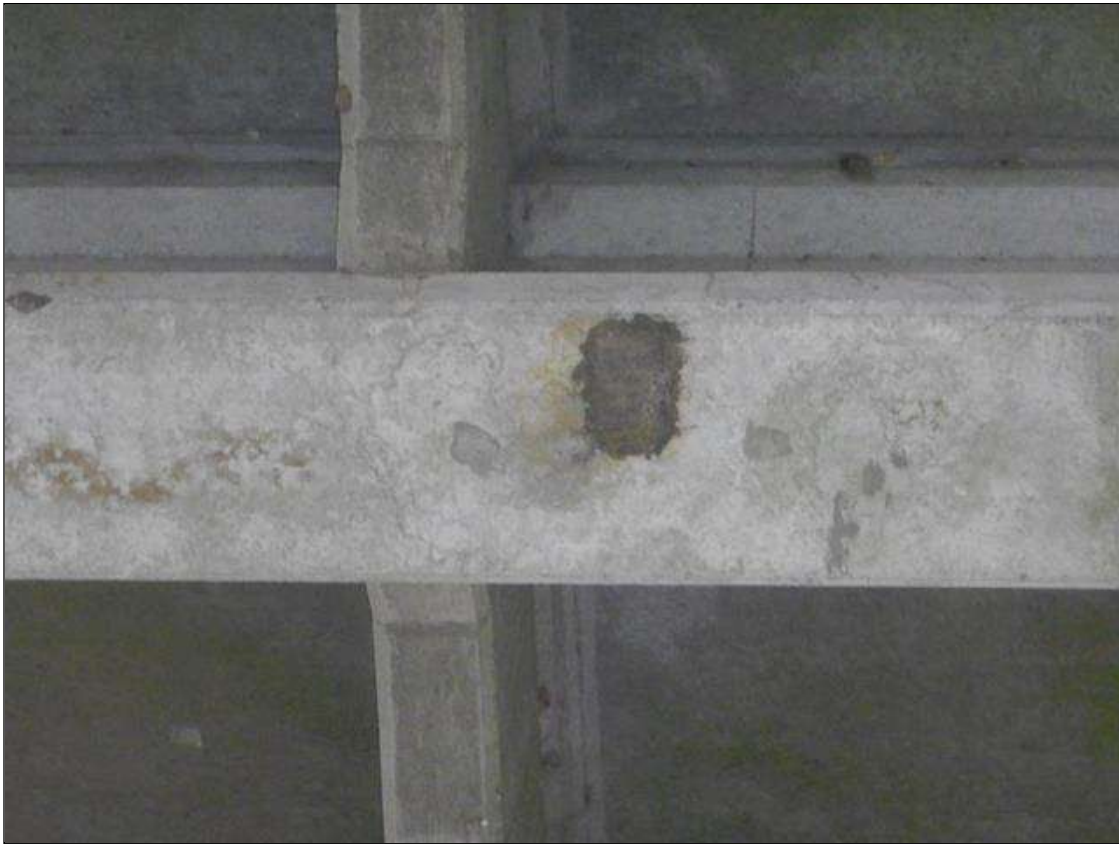
Span 6 Beam 8: spall on the bottom face, 20 FOOT. from bent 6 cap, 2" in diameter x 1/4" deep with exposed rebar

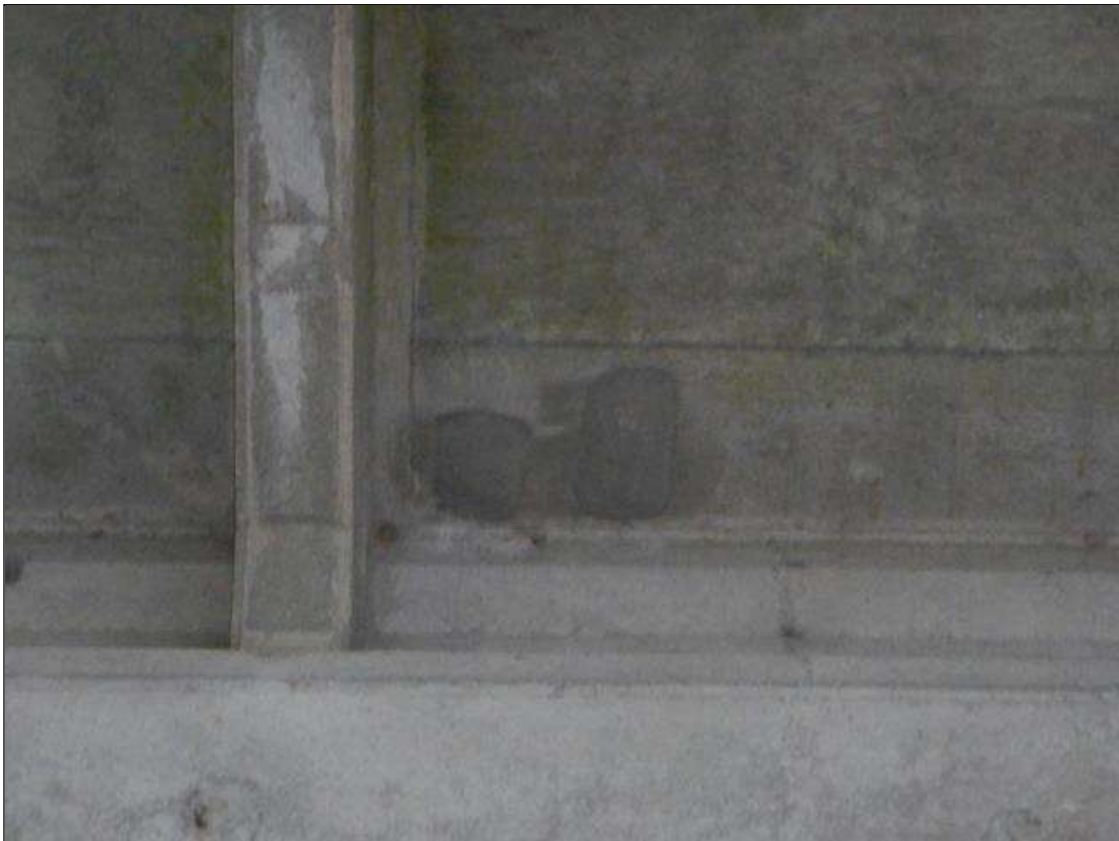
Span 7 Beam 6: [NEW REPAIR - PATCHING] FORMERLY --> area of delamination on the bottom face, 20 FOOT. from bent 7, 8" wide x 12" long with 1/8" separation

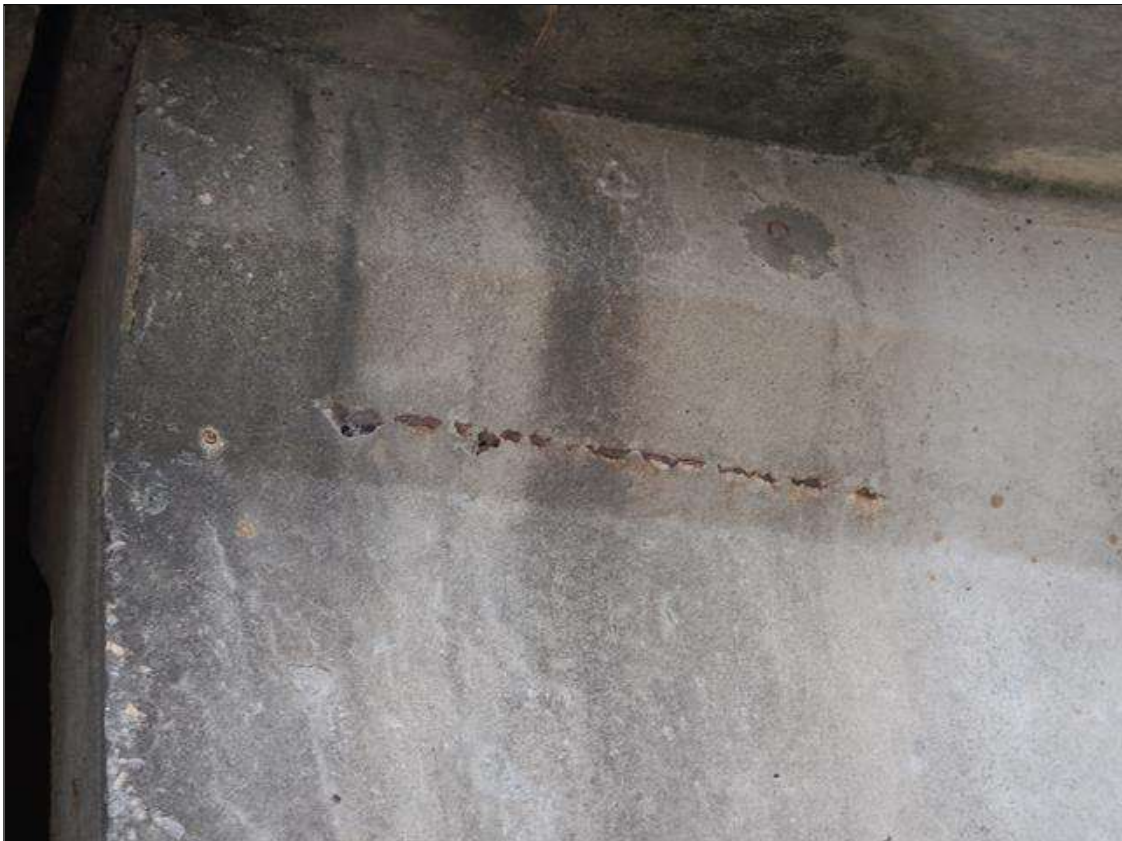
Span 8 Deck: [NEW REPAIR - PATCHING] FORMERLY --> (20" x 9") area of (x2) spalls with exposed rebar on the deck bottom in bay 4, 15.5ft from bent 8 up to (9" x 4" x 1/2')

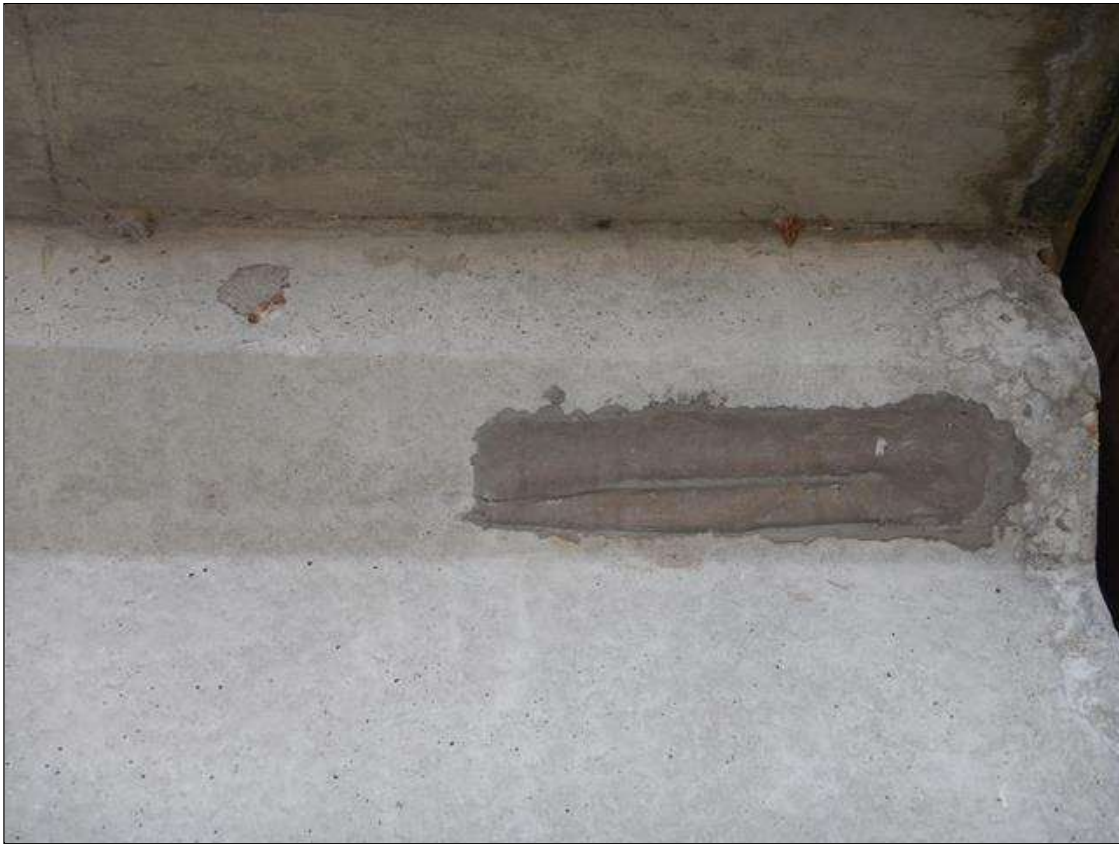
Span 8 Beam 1: [PROMPT ACTION REQUEST] (16" x 1") area of exposed rebar in the top left chamfer at bent 8

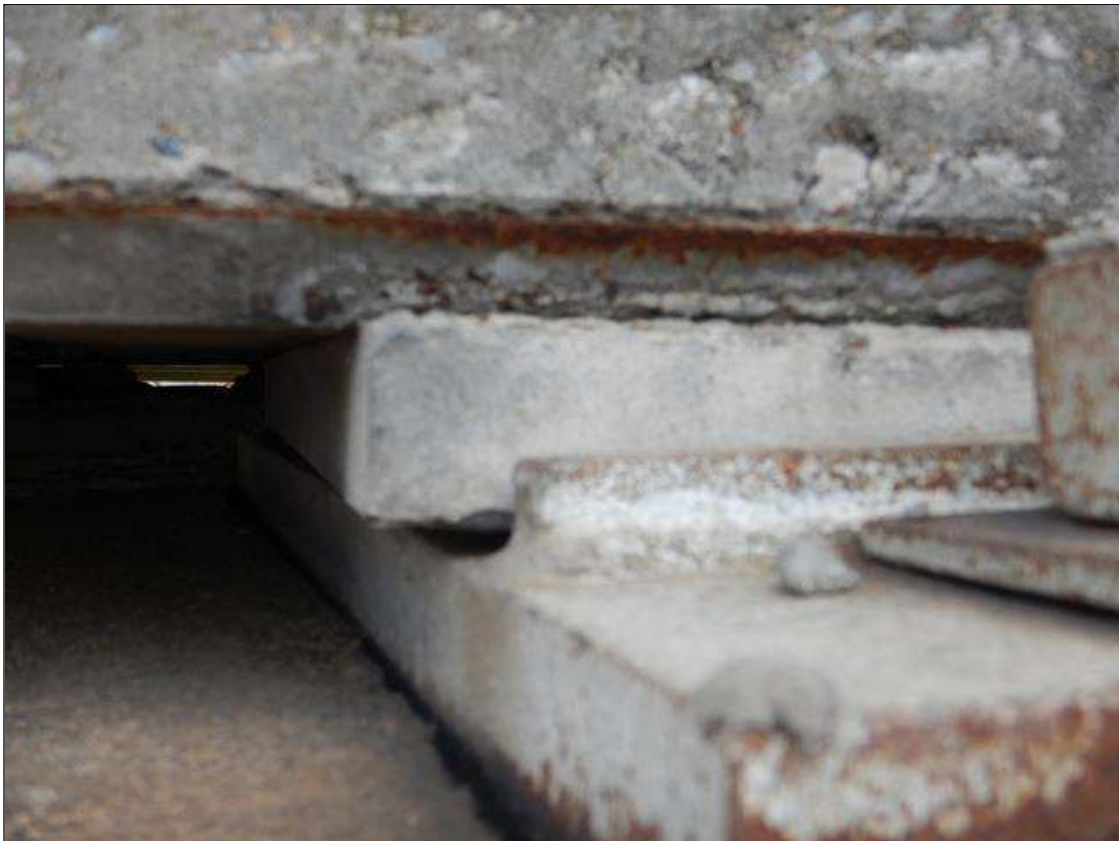
Span 8 Beam 1: [NEW REPAIR - PATCHING] FORMERLY --> (13" x 2 1/2") area of exposed rebar without section loss in the top left chamfer at bent 7

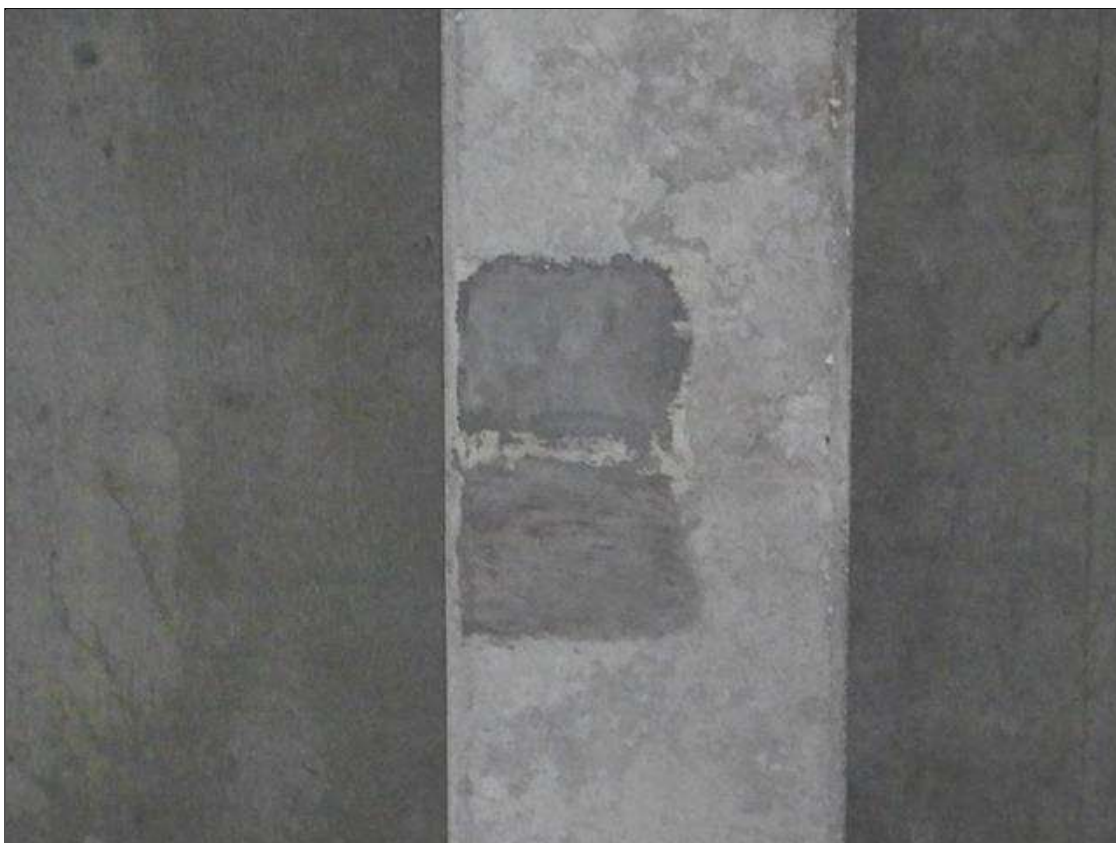
Span 8 Beam 2: [NEW REPAIR - PATCHING] FORMERLY --> (9" x 7" x 1/2") spall with exposed rebar on the bottom face at 17ft from bent 7

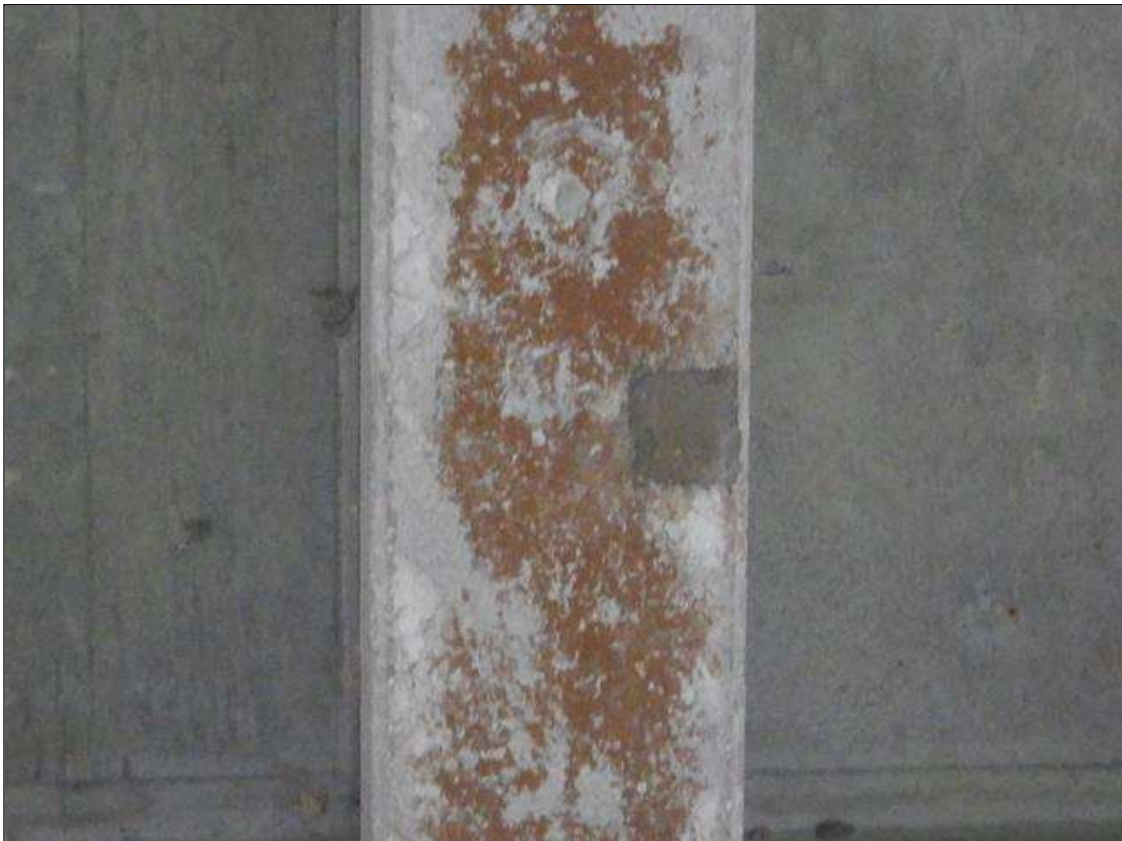
Span 8 Beam 2: [NEW REPAIR - PATCHING] FORMERLY --> (8" x 5" x 1/2") spall with exposed rebar on the bottom face at 28ft from bent 8

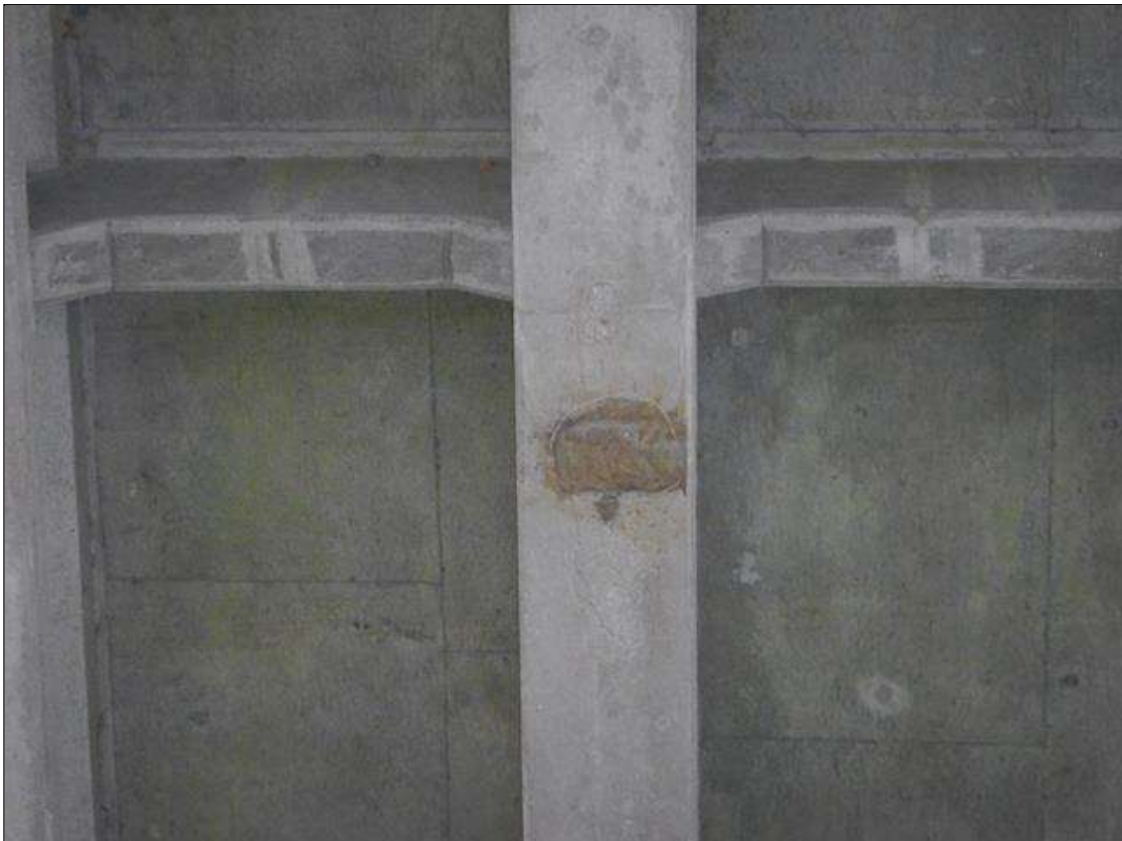
Span 8 Beam 2: [NEW REPAIR - PATCHING] FORMERLY --> (x3) spalls (6" x 3" x 1/2"), (5" x 5" x 1/2") and (6" x 4" x 1/4") with exposed rebar on the bottom face at 26ft, 23ft and 16ft from bent 8 respectively

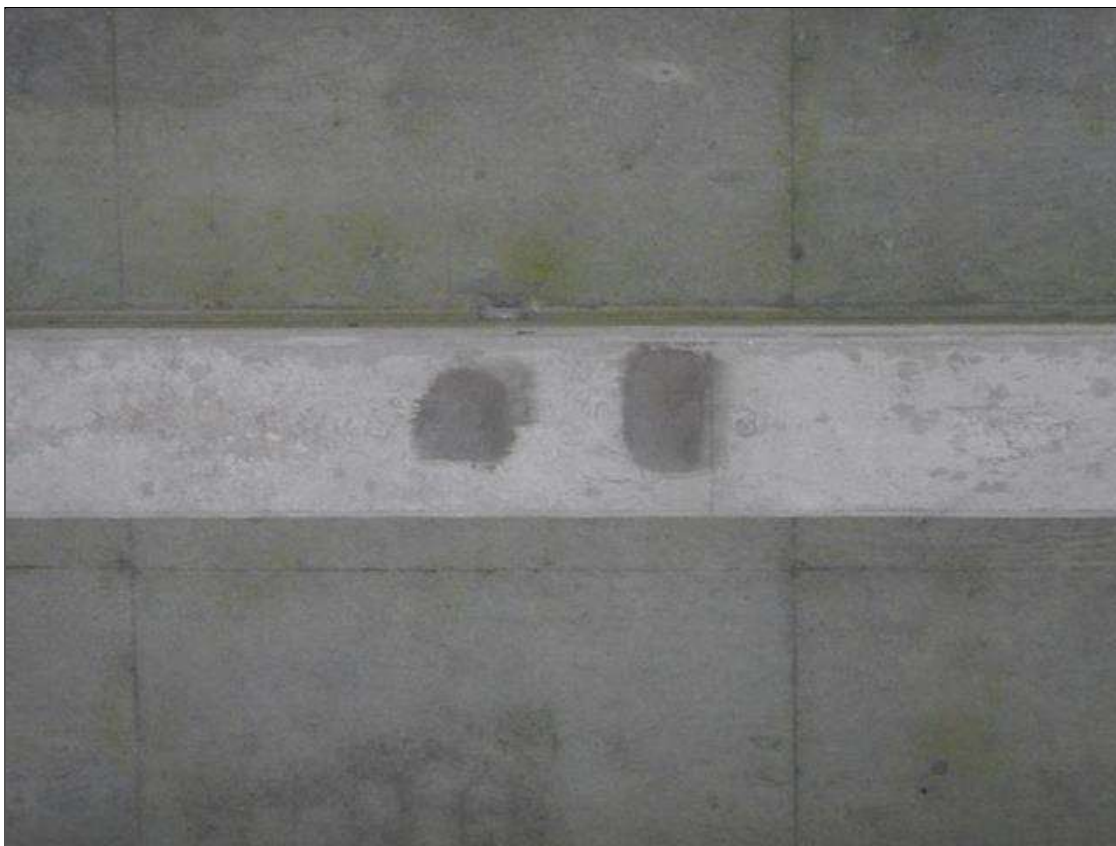
Span 8 Beam 3: [NEW REPAIR - PATCHING] FORMERLY --> (8" x 5" x 1/2") spall with exposed rebar on the bottom face at 21ft from bent 7

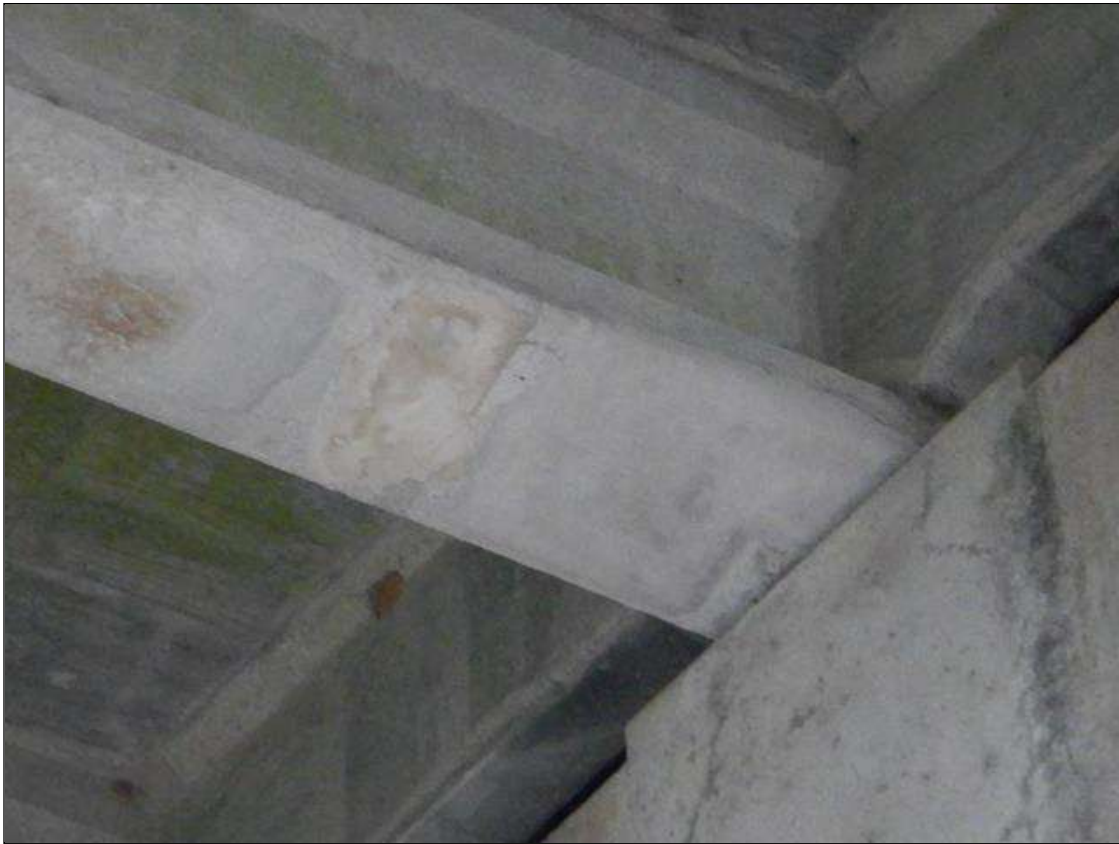
Span 8 Beam 3: [NEW REPAIR - PATCHING] FORMERLY --> (x2) spalls with exposed rebar at mid span on the bottom face up to (8" x 4" x 1/2")

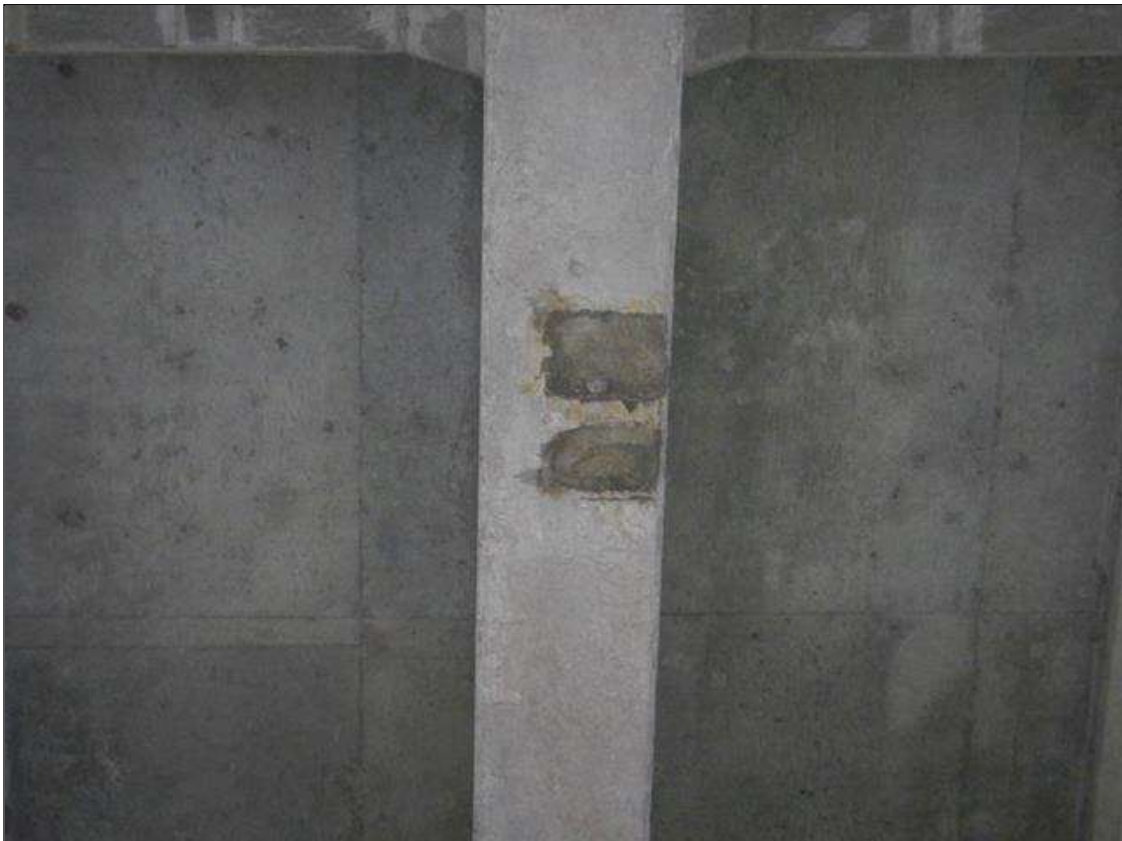
Span 8 Beam 6: [NEW REPAIR - PATCHING] FORMERLY --> (7" x 4" x 1/2") spall with exposed rebar on the bottom face at 20ft from bent 7

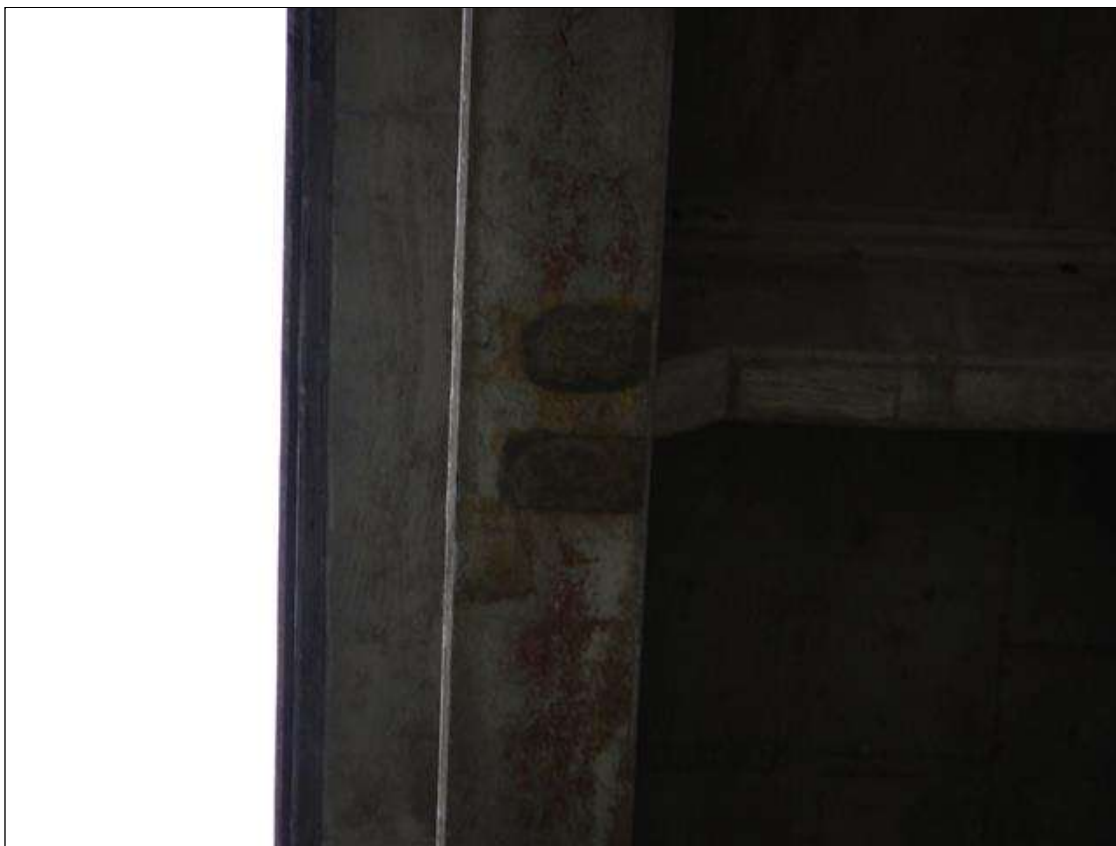
Span 8 Beam 7: [NEW REPAIR - PATCHING] FORMERLY --> (x2) spalls with exposed rebar on the bottom face at 13ft from bent 7 up to (6" x 3" x 1/4")

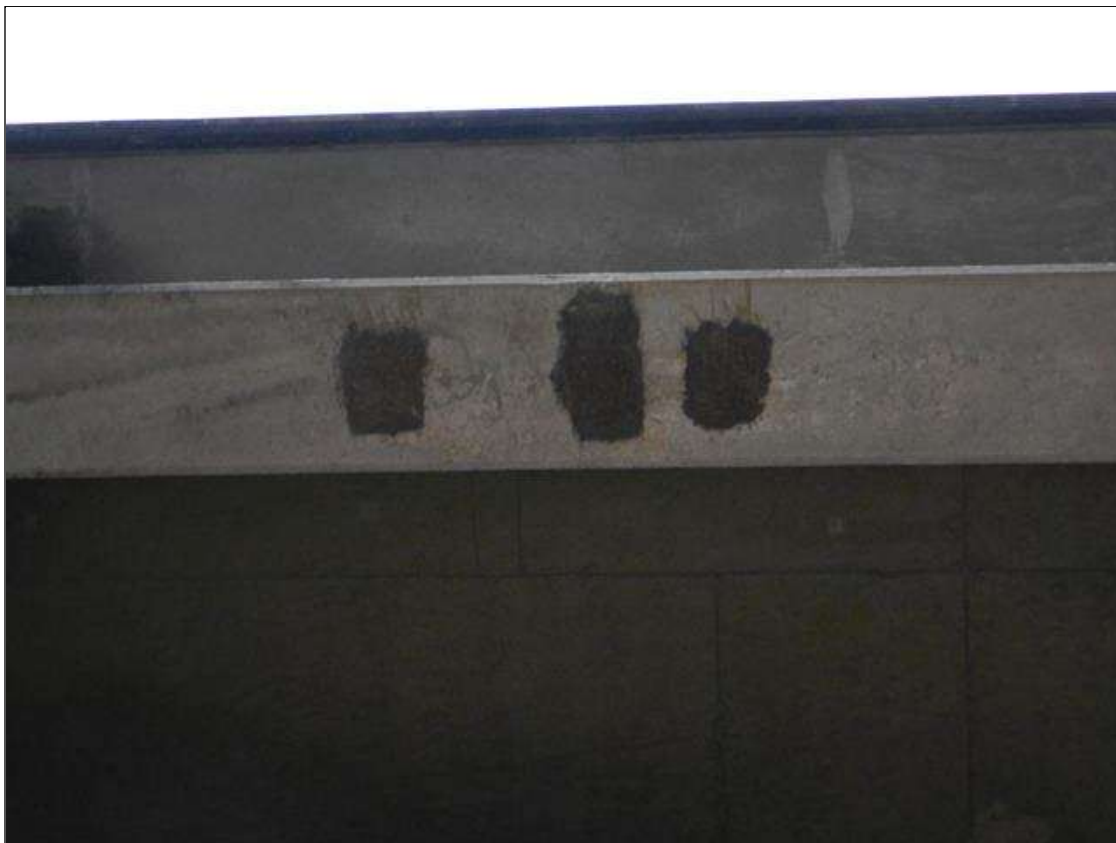
Span 8 Beam 9: [NEW REPAIR - PATCHING] FORMERLY --> 2ft area of (x3) spalls with exposed rebar on the bottom face at 13ft from bent 7 up to (7" x 3" x 1/4")

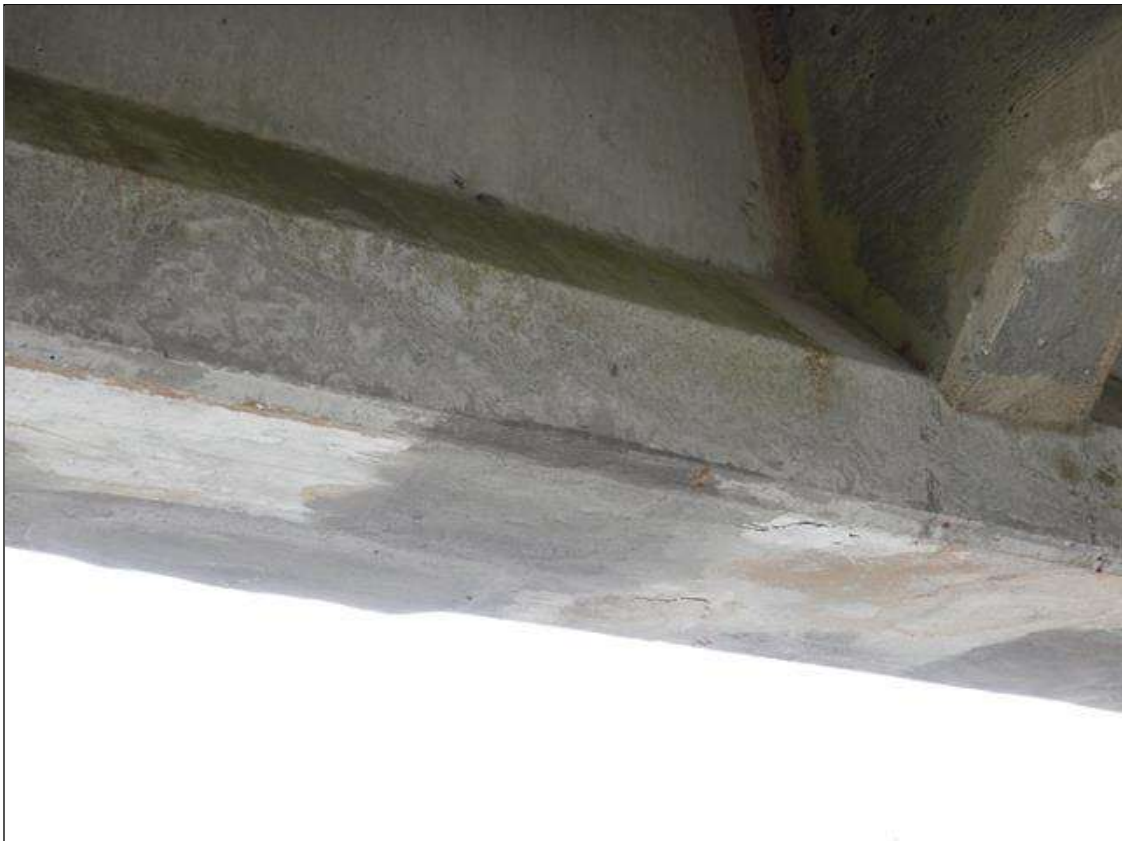
Span 9 Beam 7: [NEW REPAIR - PATCHING] FORMERLY --> (x2) spalls with exposed rebar on the top left chamfer at bent 8 up to (10" x 4" x 1/4")

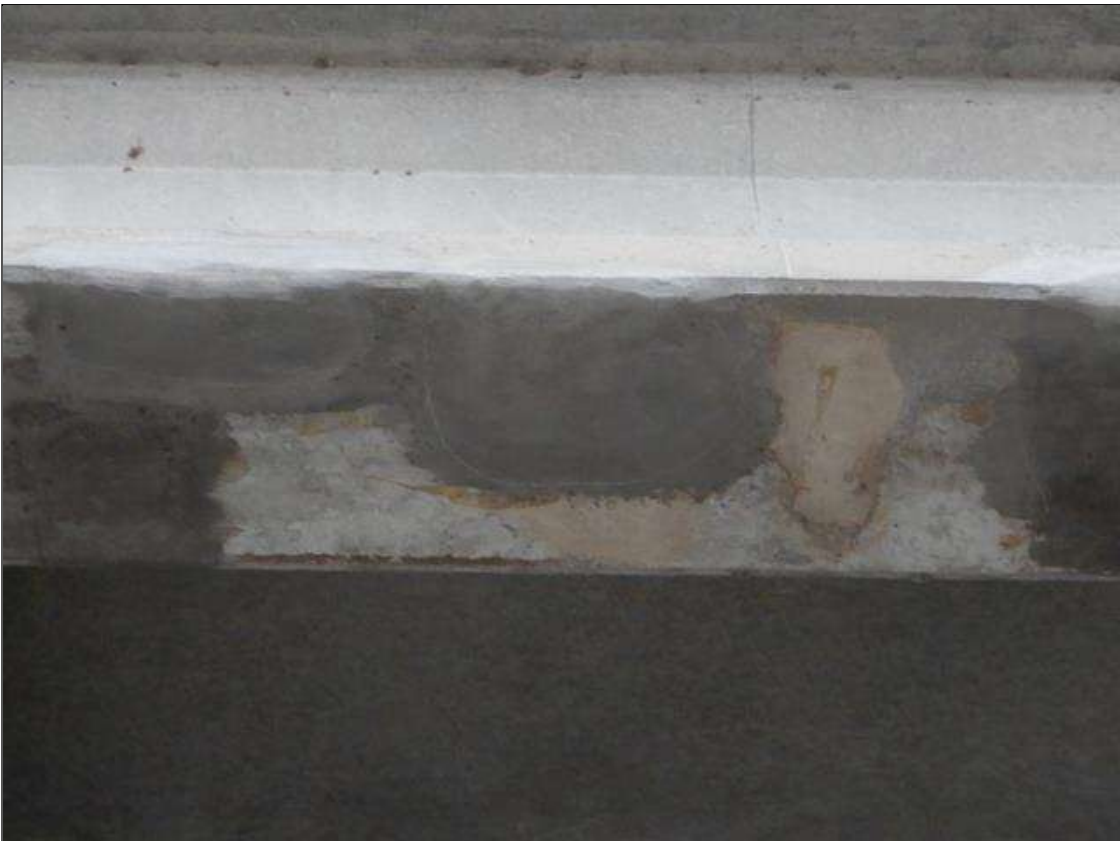
Span 9 Beam 9: [NEW REPAIR - PATCHING] FORMERLY --> (20" x 20") area of failed repair, DELAMINATION and up to 0.025" longitudinal cracking on the bottom face at 4ft from bent 8

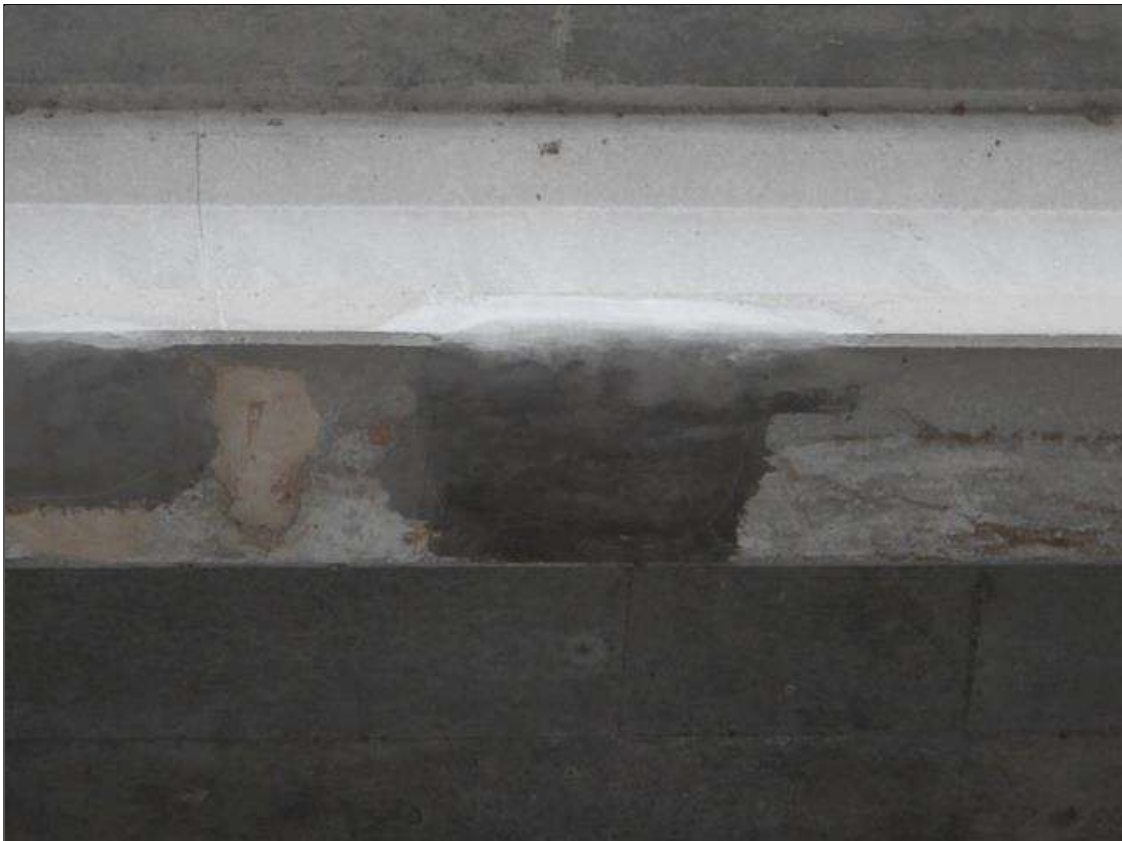
Span 9 Beam 9: [NEW REPAIR - PATCHING] FORMERLY --> PRIORITY MAINTENANCE - spall with exposed strands on the bottom face at 14ft from bent 9 (18" x 7" x 2"), strand exposed for (10") long
