NC DEPARTMENT OF TRANSPORTATION
DIVISION OF HIGHWAYS
STRUCTURE MANAGEMENT UNIT

Structure Safety Report

Routine Element Inspection - Contract

DIVISION: 3 COUNTY: NEW HANOVER STRUCTURE NUMBER: 640013 FREQUENCY: 24 MONTHS

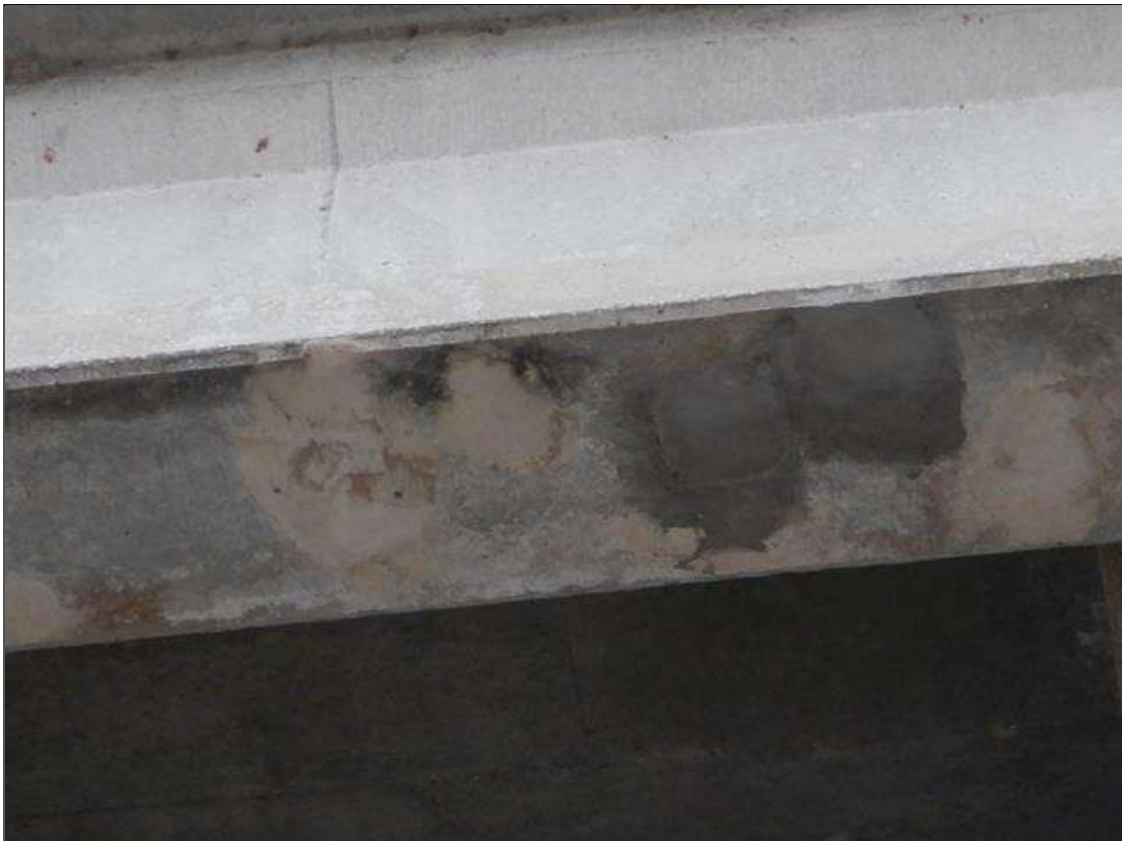
Span 9 Beam 9: [NEW REPAIR - PATCHING] FORMERLY --> PRIORITY MAINTENANCE - spall with exposed strands on the bottom face at 16ft from bent 8 (16" x 13" x 1 1/2"), (x2) strands exposed for (4") long

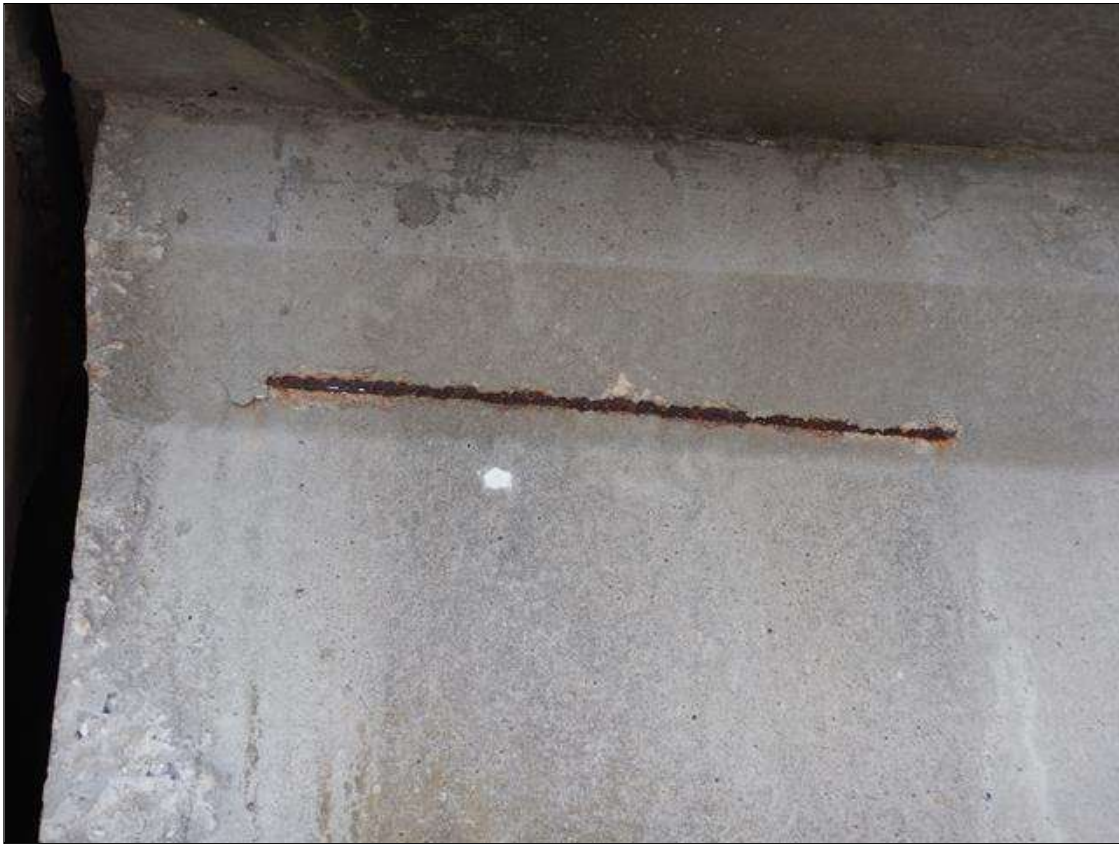
Span 9 Beam 9: [NEW REPAIR - PATCHING] FORMERLY --> (5" x 4" x 1/4") spall with exposed rebar on the bottom face at 10ft from bent 8

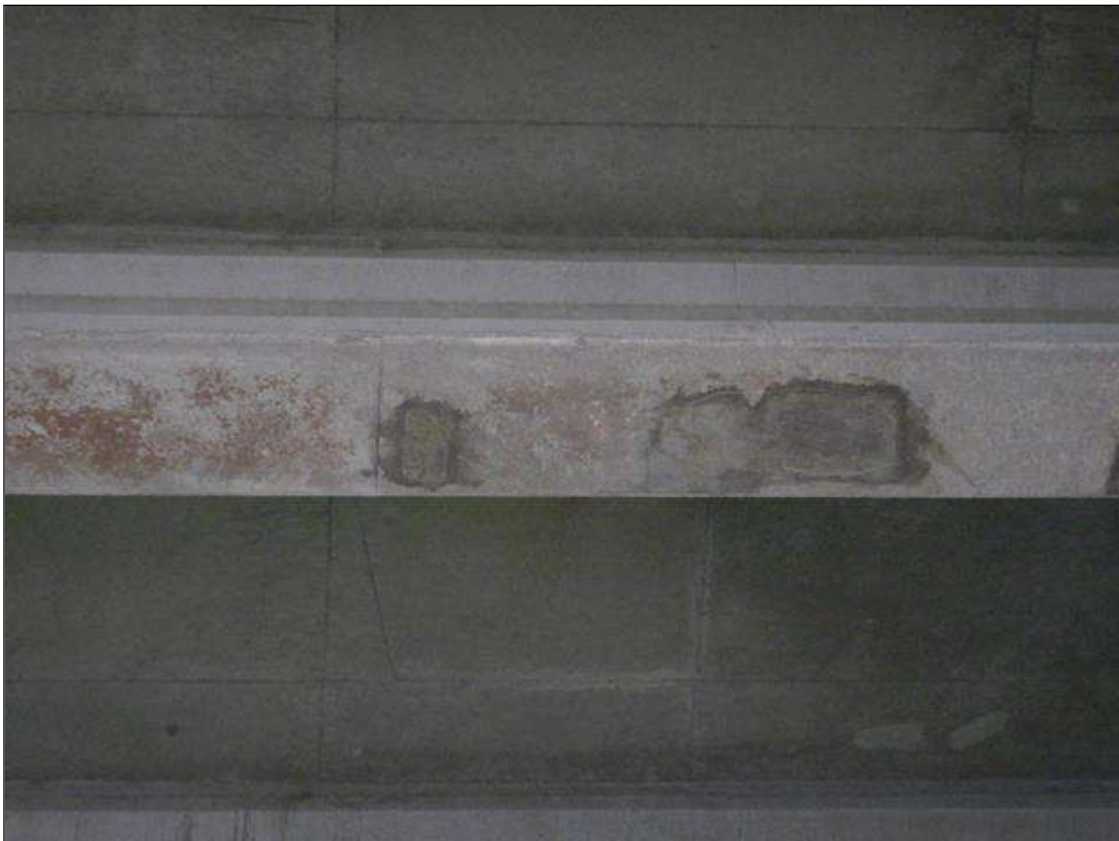
Span 10 Beam 1: [PROMPT ACTION REQUEST] spall with exposed rebar on the top left chamfer at bent 10 (24" x 1").

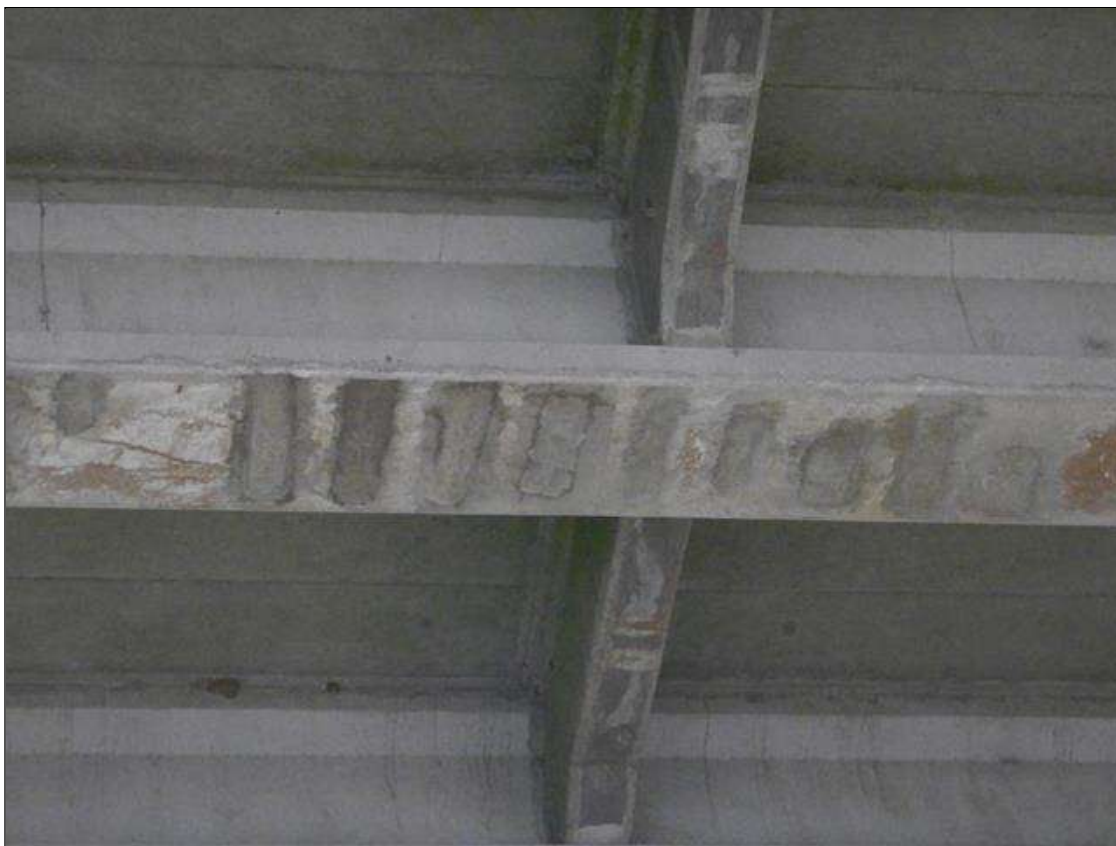
Span 10 Beam 3: [NEW REPAIR - PATCHING] FORMERLY --> (x3) spalls with exposed rebar on the bottom face at 78in from bent 10 up to (10" x 6" x 1/2")

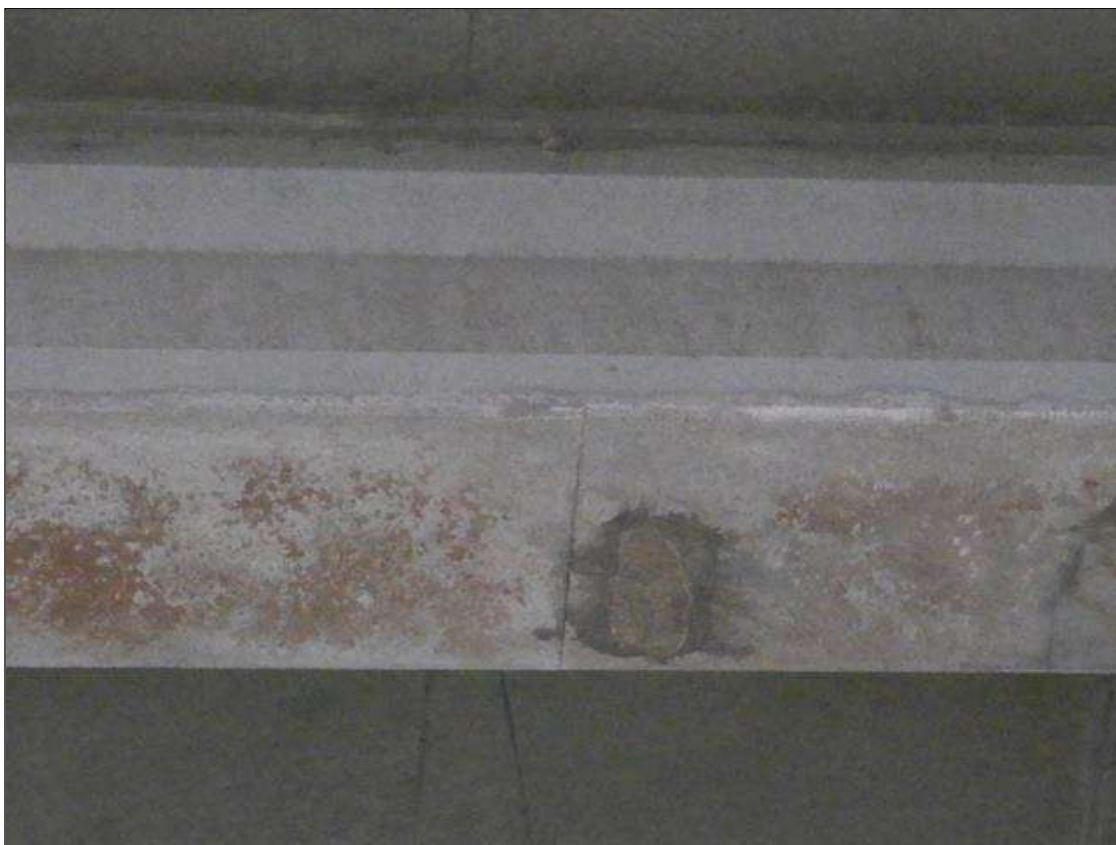
Span 10 Beam 3: [NEW REPAIR - PATCHING] FORMERLY --> multiple spalls with exposed rebar on the bottom face beginning at 17ft from bent 10 up to (12" x 2" x 1/4")

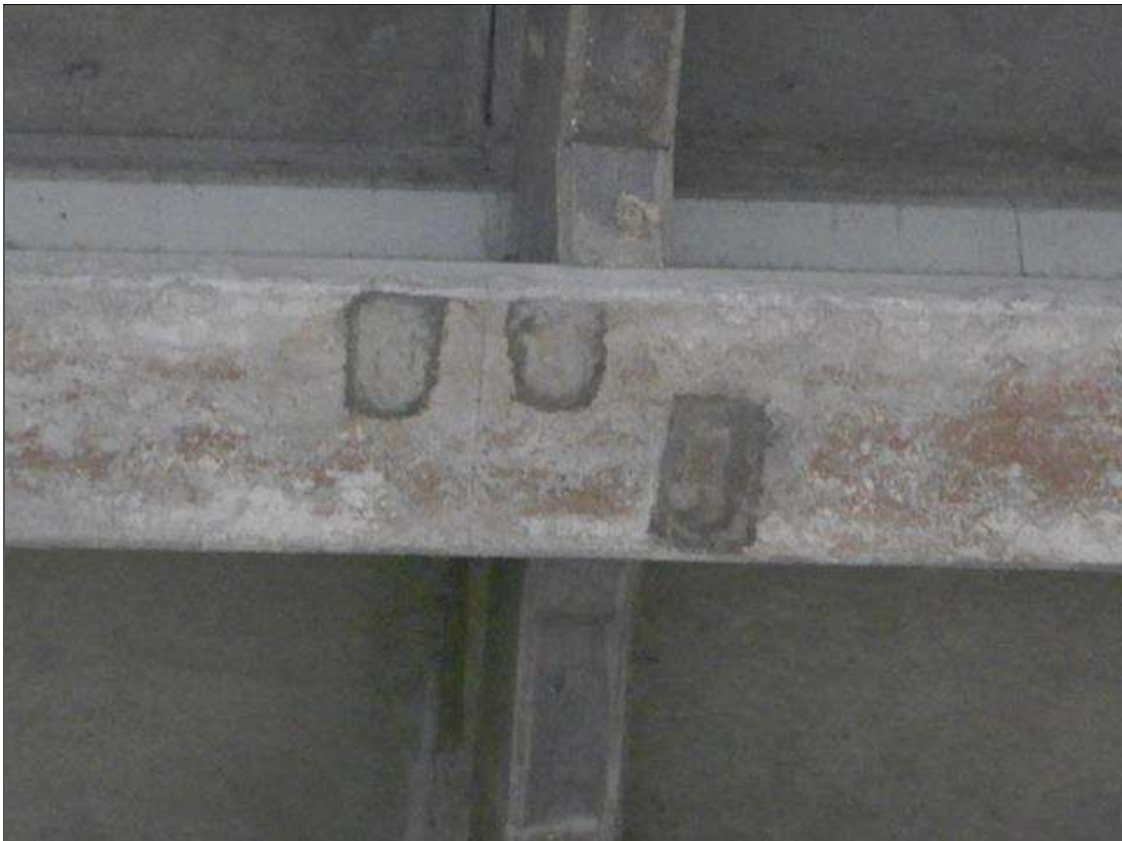
Span 10 Beam 5: [NEW REPAIR - PATCHING] FORMERLY --> (2 1/2" x 1/2") spall with exposed rebar in the bottom face at 22ft from bent 10

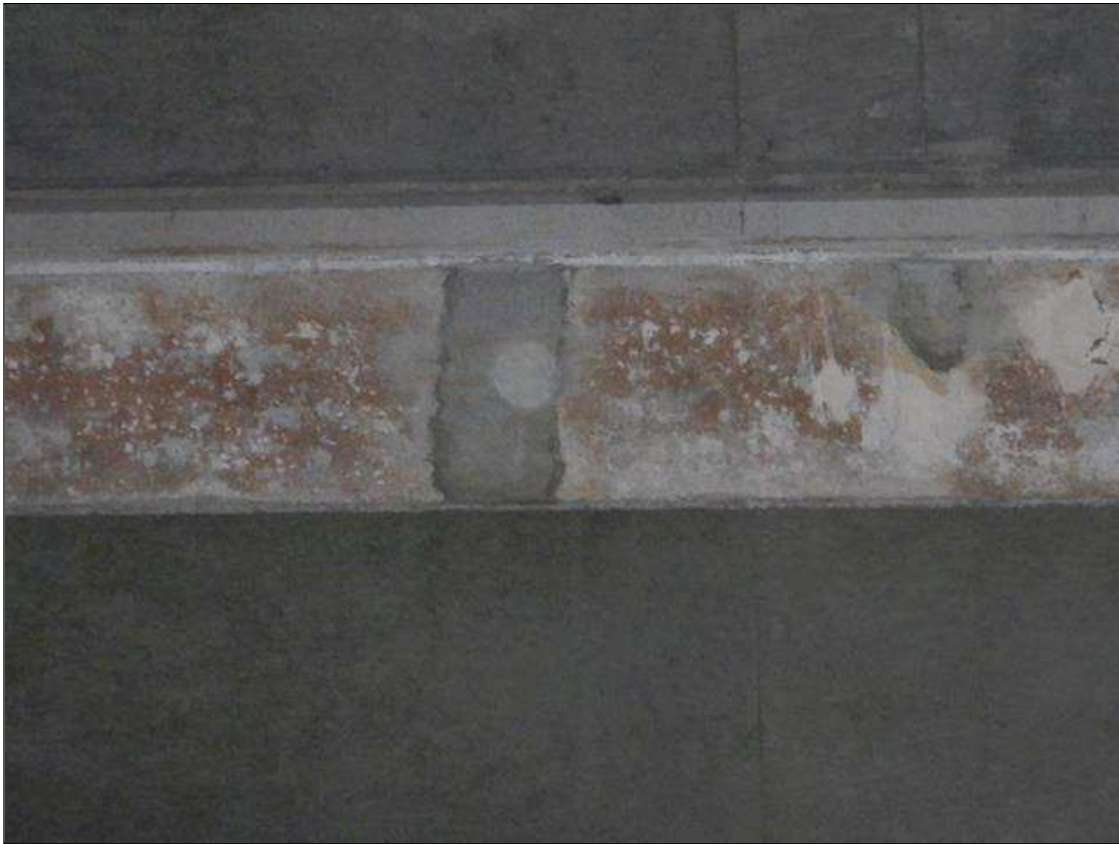
Span 10 Beam 7: [NEW REPAIR - PATCHING] FORMERLY --> (x2) spalls with exposed rebar on the bottom face at 22ft from bent 10 up to (7" x 4" x 1/2")

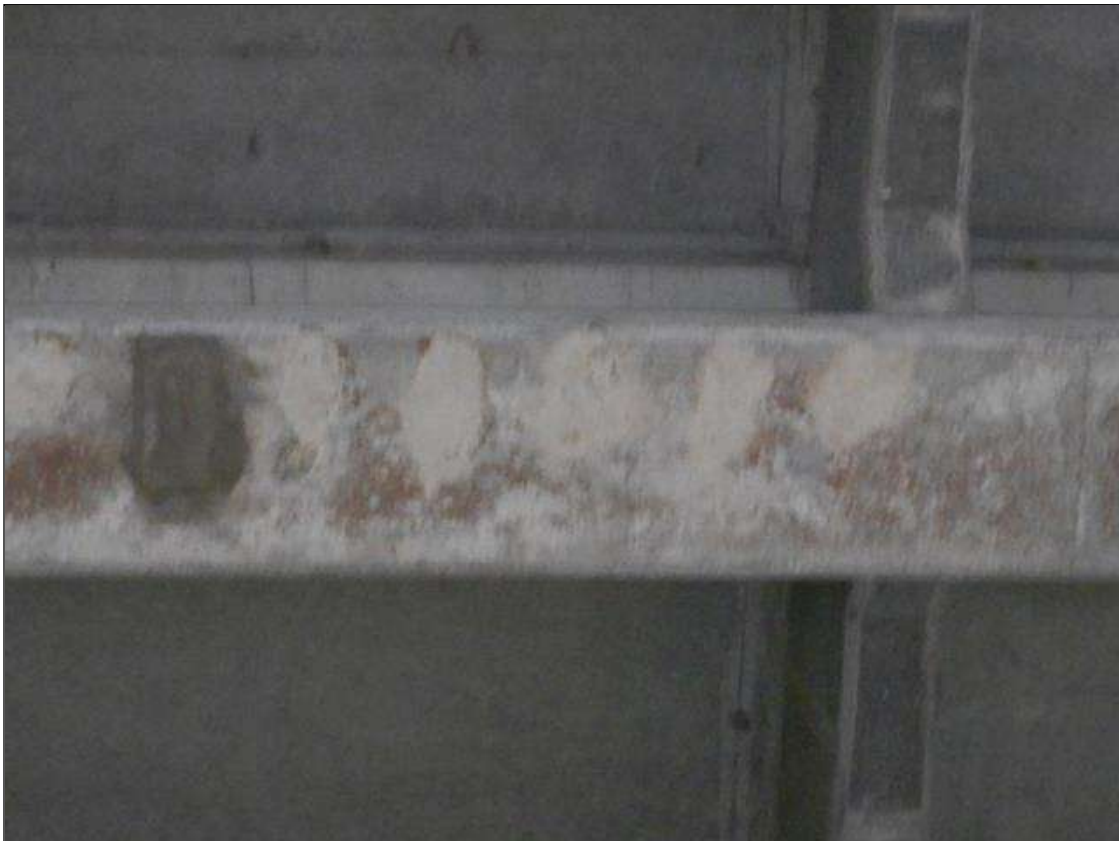
Span 10 Beam 8: [NEW REPAIR - PATCHING] FORMERLY --> 1ft area of (x2) spalls with exposed rebar on the bottom face at 7ft from bent 9 up to (8" x 7" x 1/2")

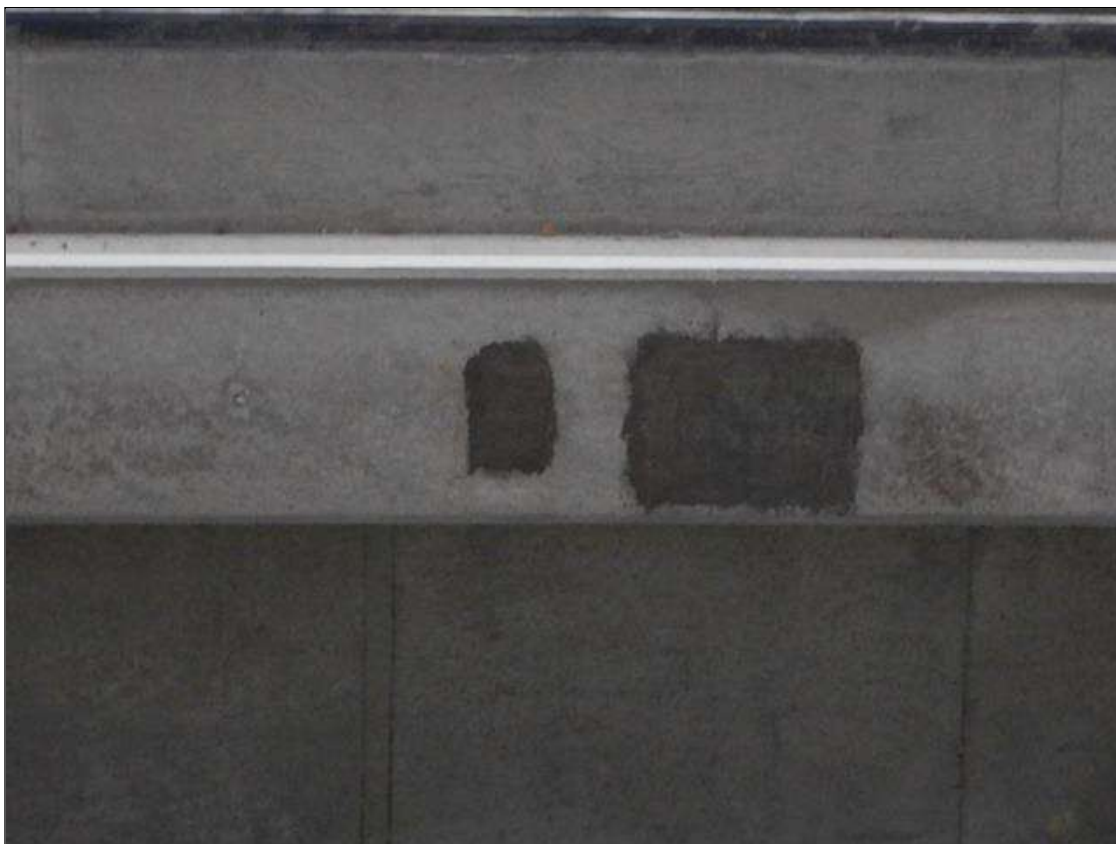
Span 10 Beam 8: [NEW REPAIR - PATCHING] FORMERLY --> (X3) spalls with exposed rebar on the bottom face at 14ft from bent 9 at failed repairs up to (10" x 6" x 1/2")

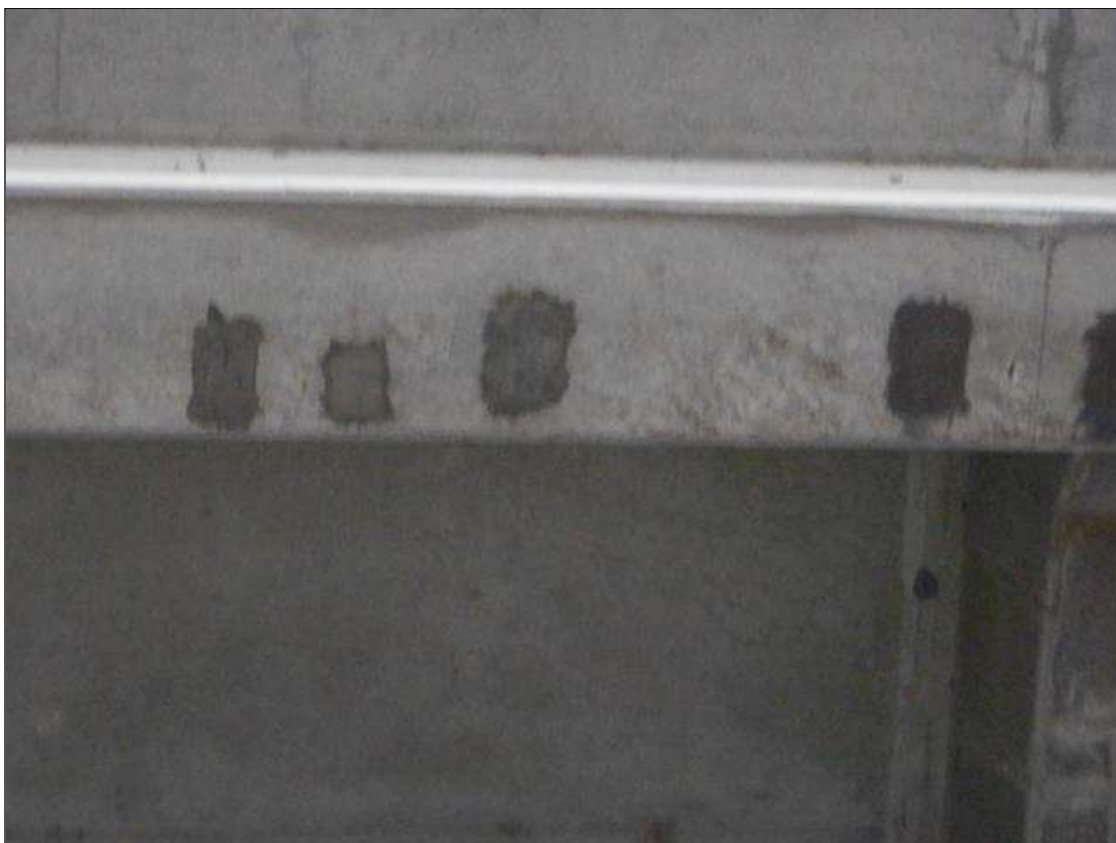
Span 10 Beam 9: [NEW REPAIR - PATCHING] FORMERLY --> (10" x 5" x 1/4") spall with exposed rebar on the bottom face at 25ft from bent 9

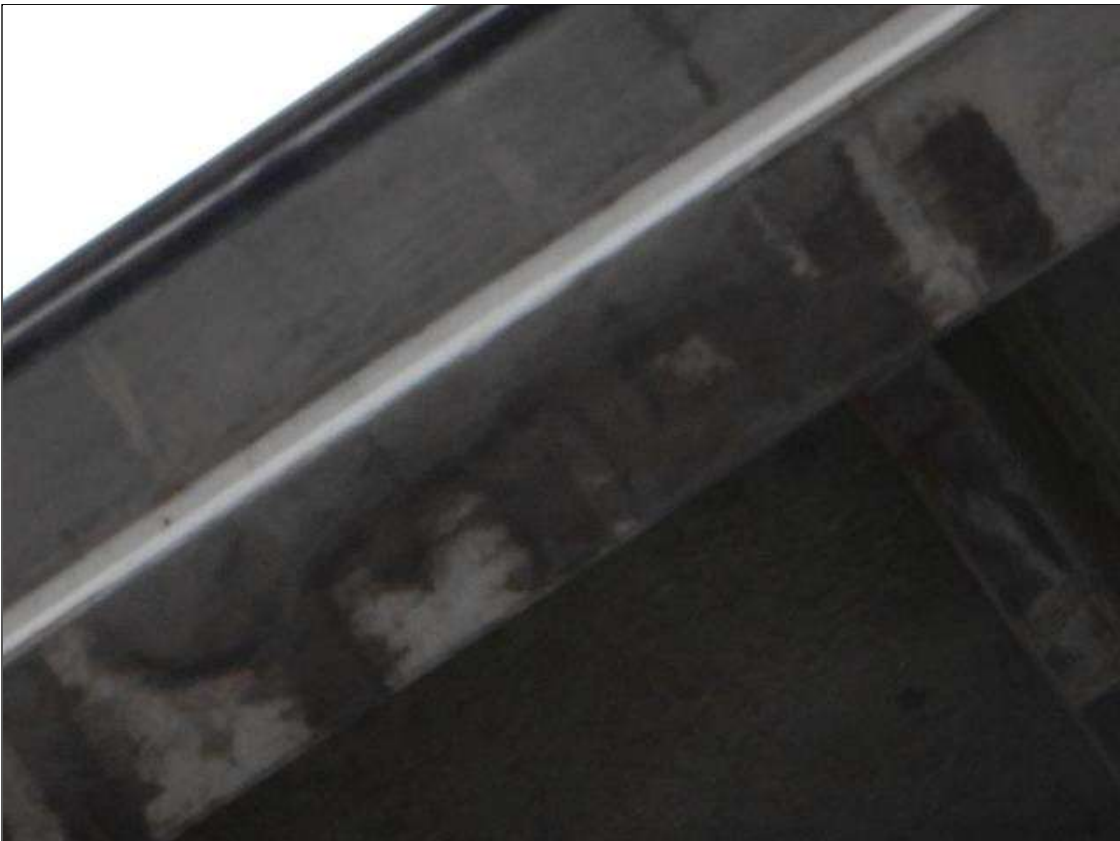
Span 10 Beam 9: [NEW REPAIR - PATCHING] FORMERLY --> (x4) spoalls with exposed rebar on the bottom face at 14ft from bent 9 up to (9" x 2" x 1/4")

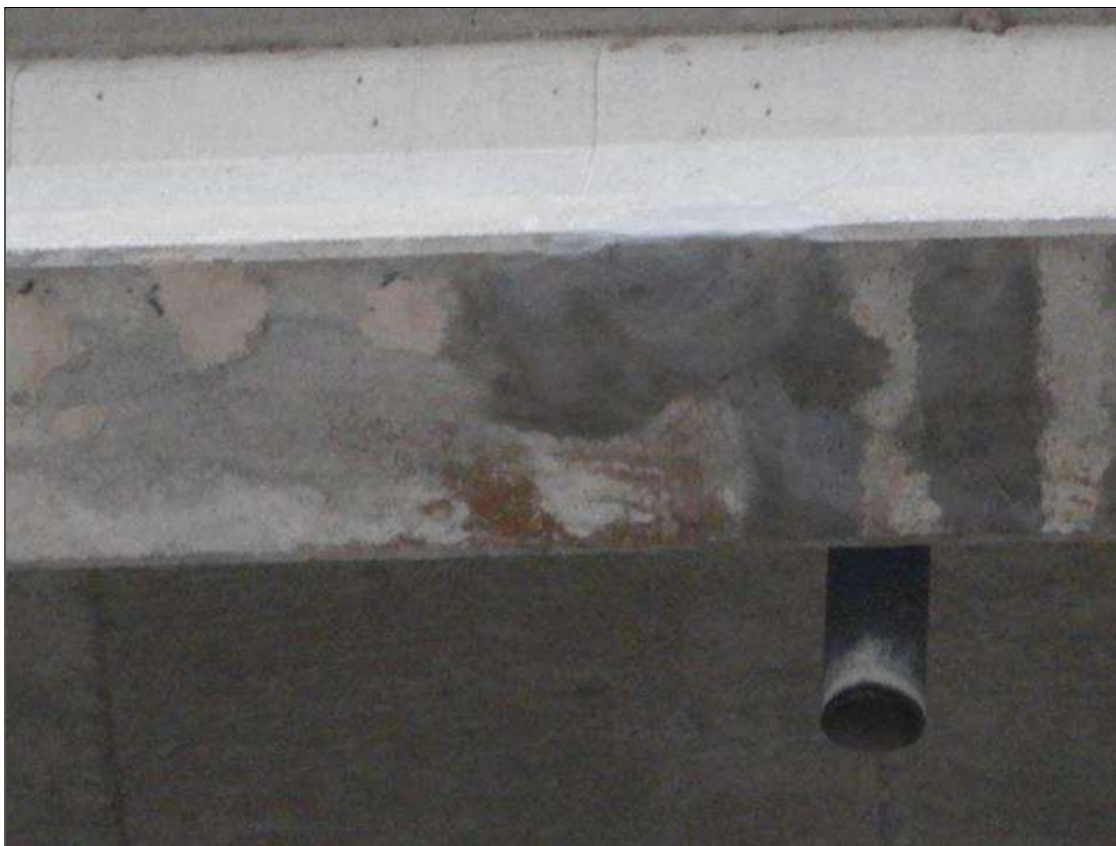
Span 10 Beam 9: [NEW REPAIR - PATCHING] FORMERLY --> (x5) spalls with exposed rebar on the bottom face at 21.5ft from bent 10 up to (9" x 3 1/2" x 1/4")

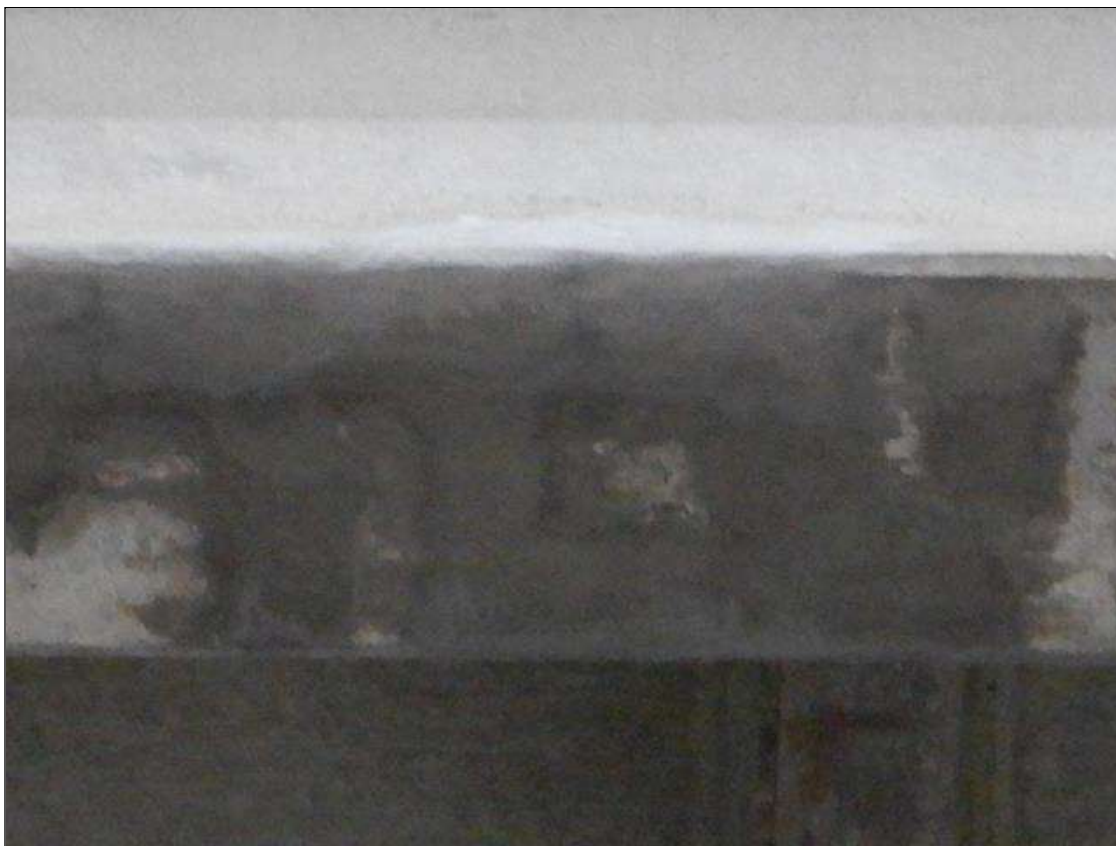
Span 10 Beam 9: [NEW REPAIR - PATCHING] FORMERLY --> PRIORITY MAINTENANCE - spall with exposed strand on the bottom face at 12ft from bent 9 (14" x 6" x 1") in a failed repair with area (18" x 9"), strand exposed for (5")

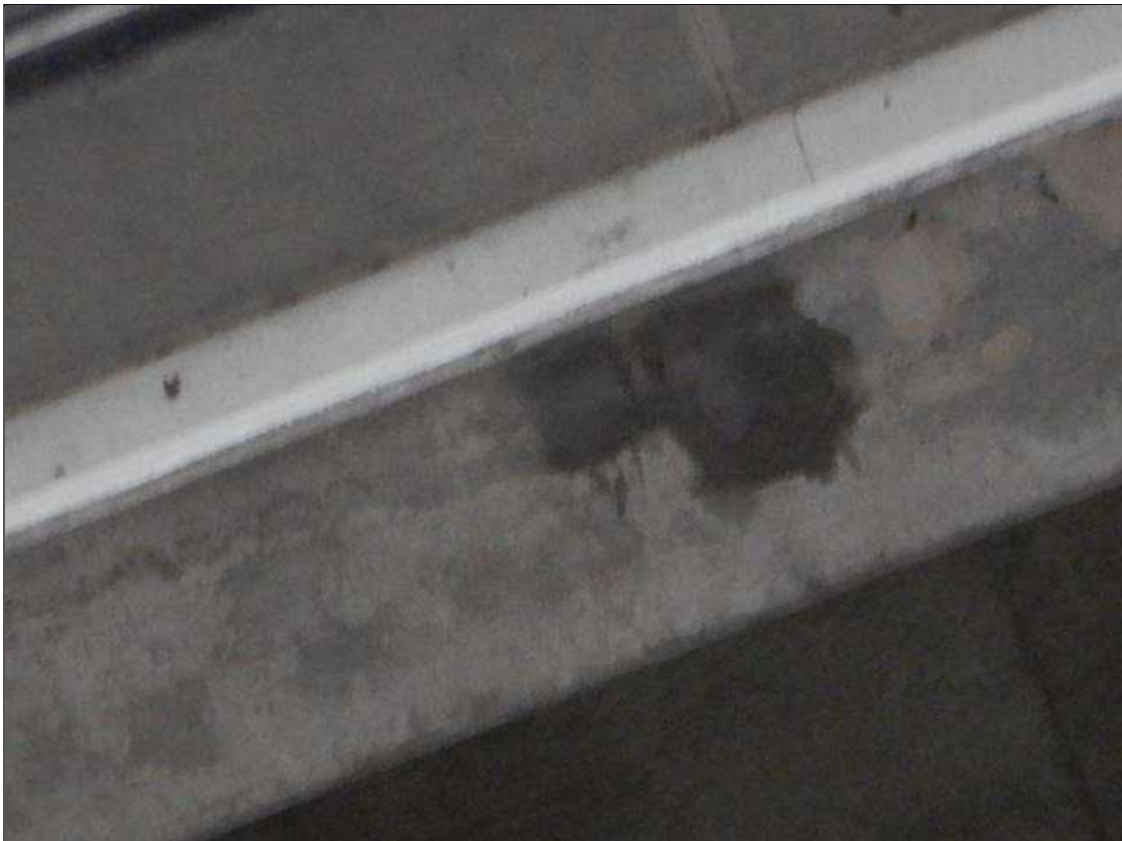
Span 10 Beam 9: [NEW REPAIR - PATCHING] FORMERLY --> (4" x 4" x 1/4") spall with exposed rebar on the bottom face at 11ft from bent 10

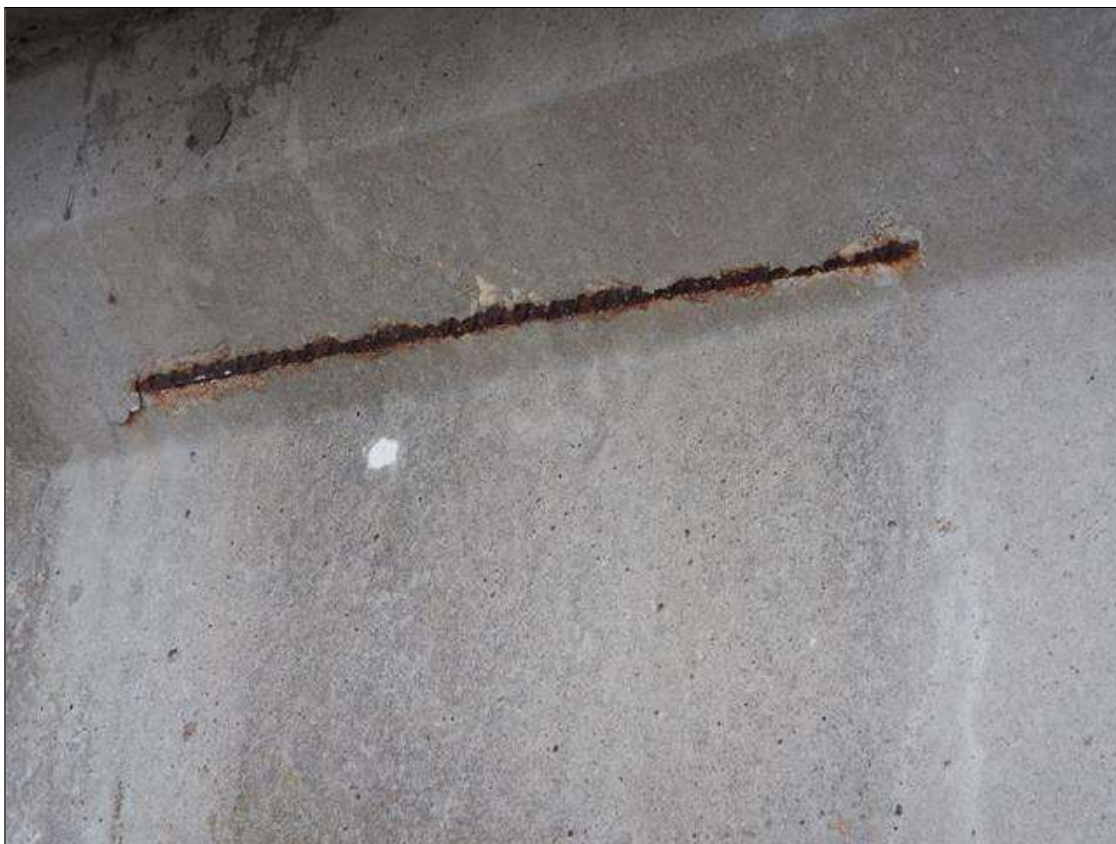
Span 10 Beam 9: [NEW REPAIR - PATCHING] FORMERLY --> 1ft area of (x2) spalls with exposed rebar on the bottom face at 7ft from bent 9 up to (5" x 5" x 1/2")

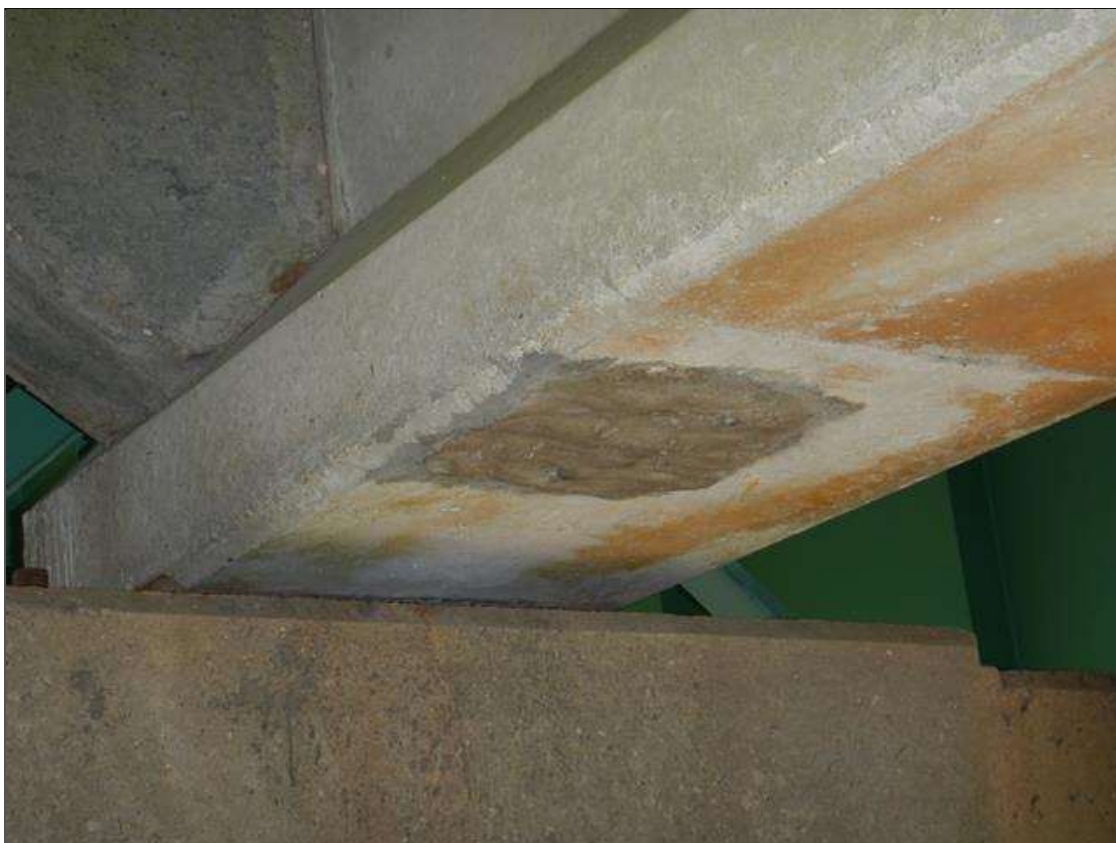
Span 10 Beam 9: [NEW REPAIR - PATCHING] FORMERLY --> (26" x 1") area of exposed rebar in the top left chamfer at bent 10

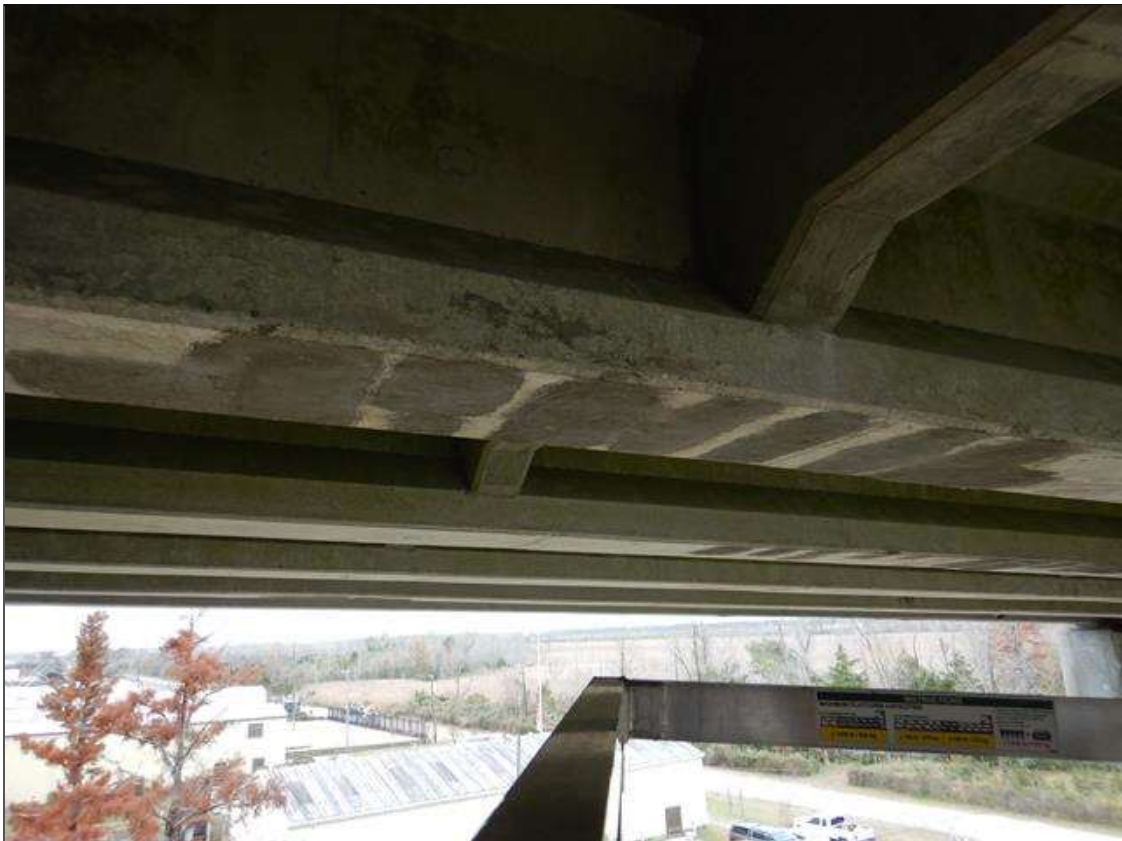
Span 11 Beam 4: [NEW REPAIR - PATCHING] FORMERLY --> (7" x 6" x 1/2") spall with exposed rebar on the bottom face at 27ft from bent 11

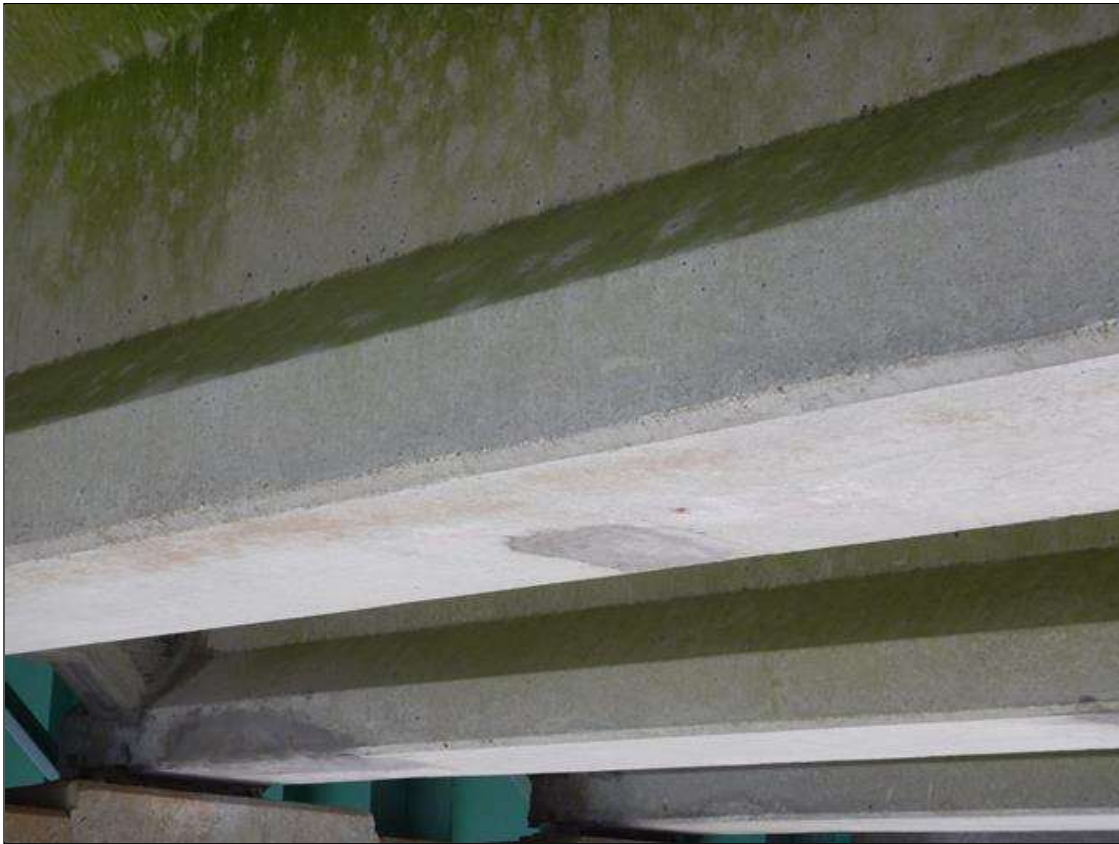
Span 11 Beam 5: [NEW REPAIR - PATCHING] FORMERLY --> (x13) spalls with exposed rebar on the bottom face up to (17" x 5" x 1/2") starting at 16.5ft from bent 11

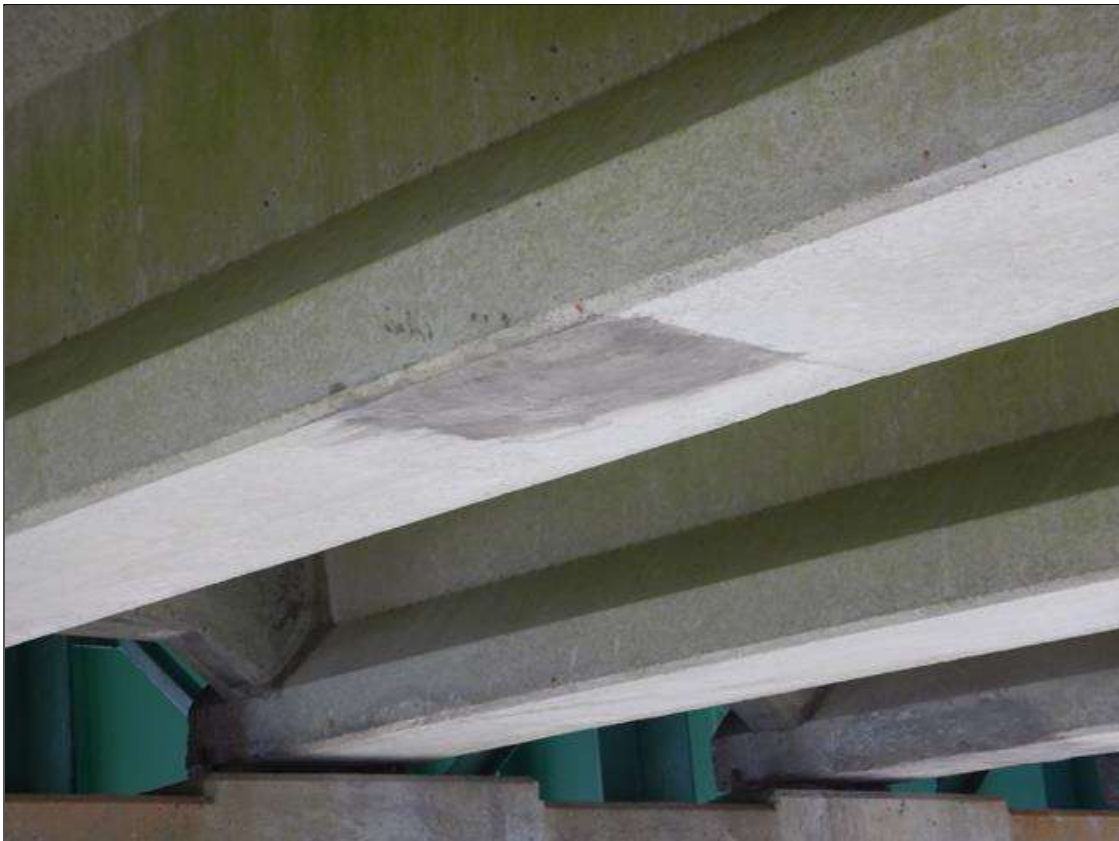
Span 11 Beam 5: [NEW REPAIR - PATCHING] FORMERLY --> (5" x 5" x 1/2") spall with exposed rebar on the bottom face at 12ft from bent 11

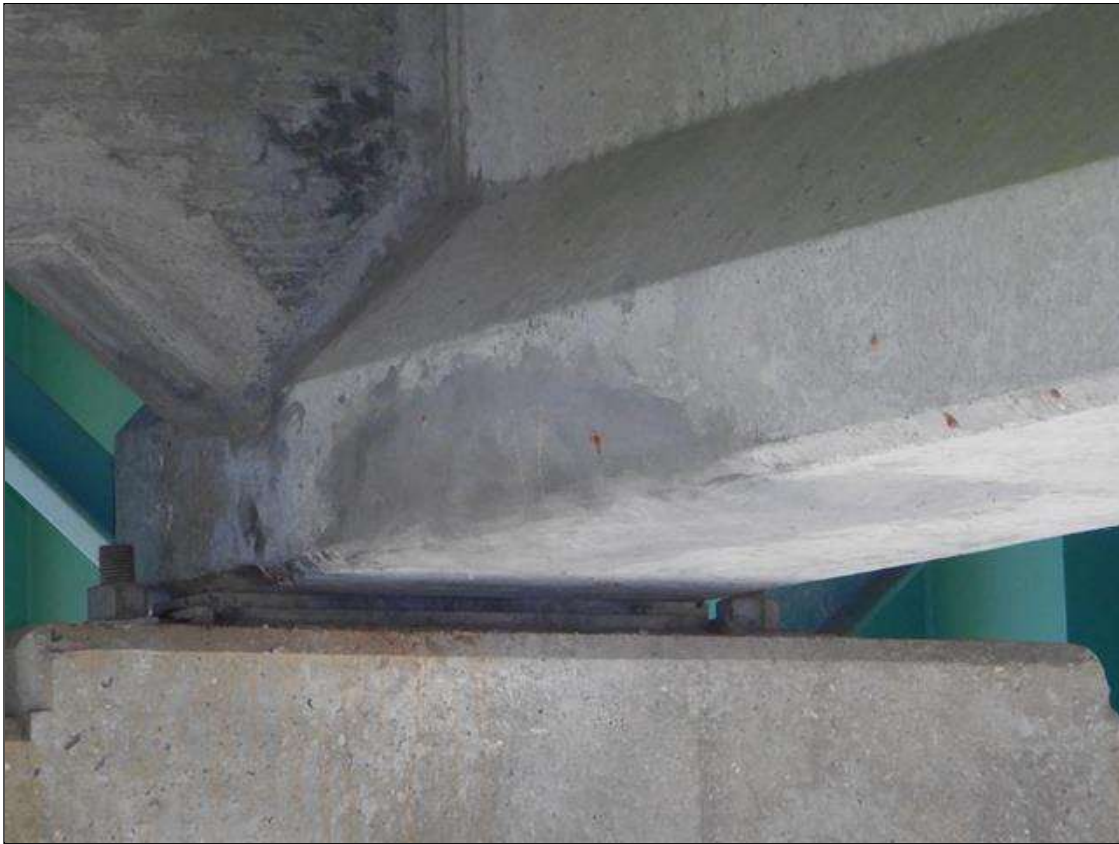
Span 11 Beam 6: [NEW REPAIR - PATCHING] FORMERLY --> (x2) spalls with exposed rebar on the bottom face up to (8" x 7" x 1/2") at 11ft from bent 11

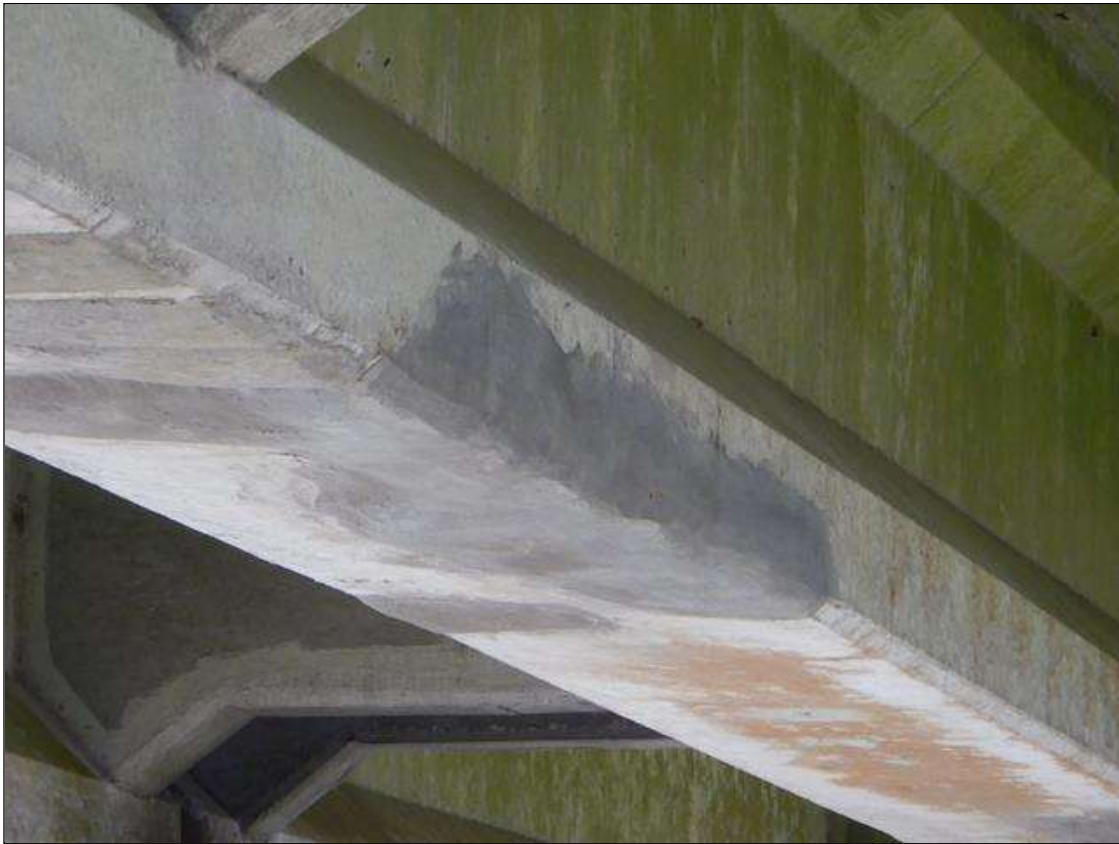
Span 11 Beam 6: [NEW REPAIR - PATCHING] FORMERLY --> PRIORITY MAINTENANCE - (x2) spalls with exposed strands on the bottom face starting at 5in from Bent 11 (8" x 7" x 1") and (7 1/2" x 6 1/2" x 2"), strands exposed for up to (1") long each, cracking up to 0.013" wide at this location for 28" long

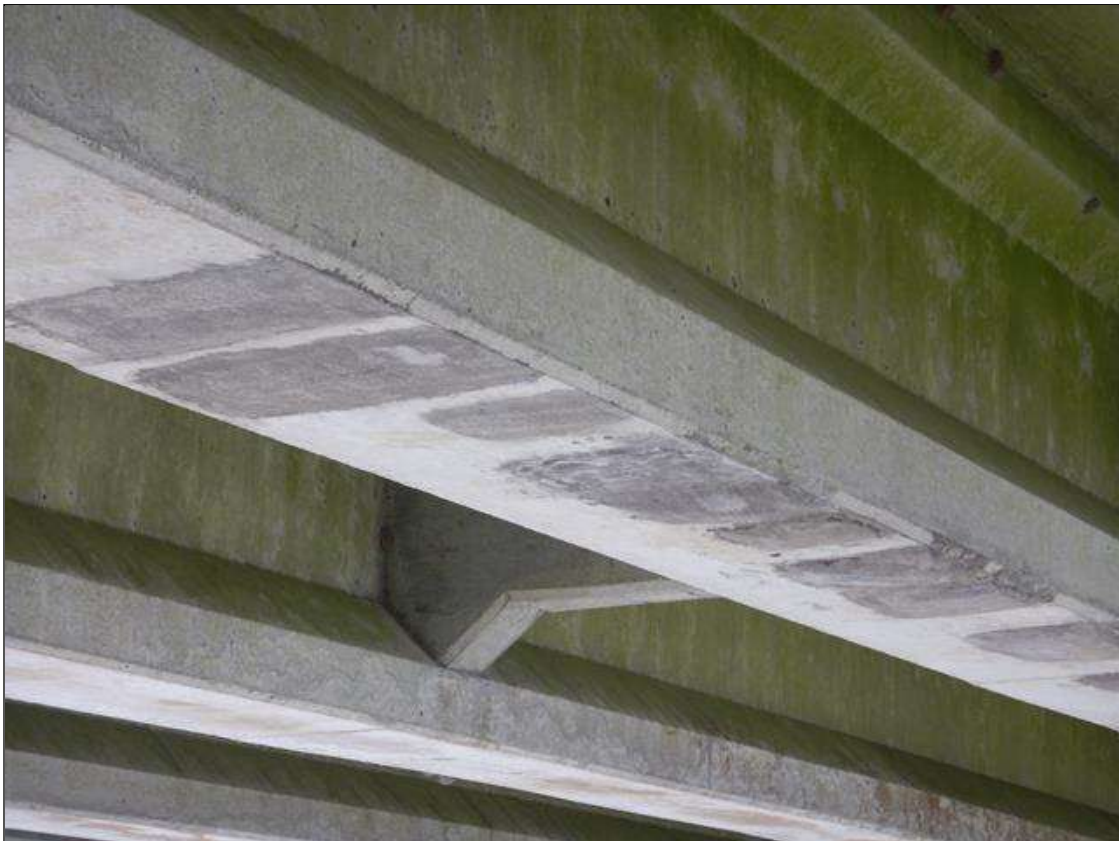
Span 11 Beam 6: [NEW REPAIR - PATCHING] FORMERLY --> (16" x 5" x 1") area of DELAMINATION and cracking up to 0.02" wide on the bottom and left faces at 14ft from bent 10

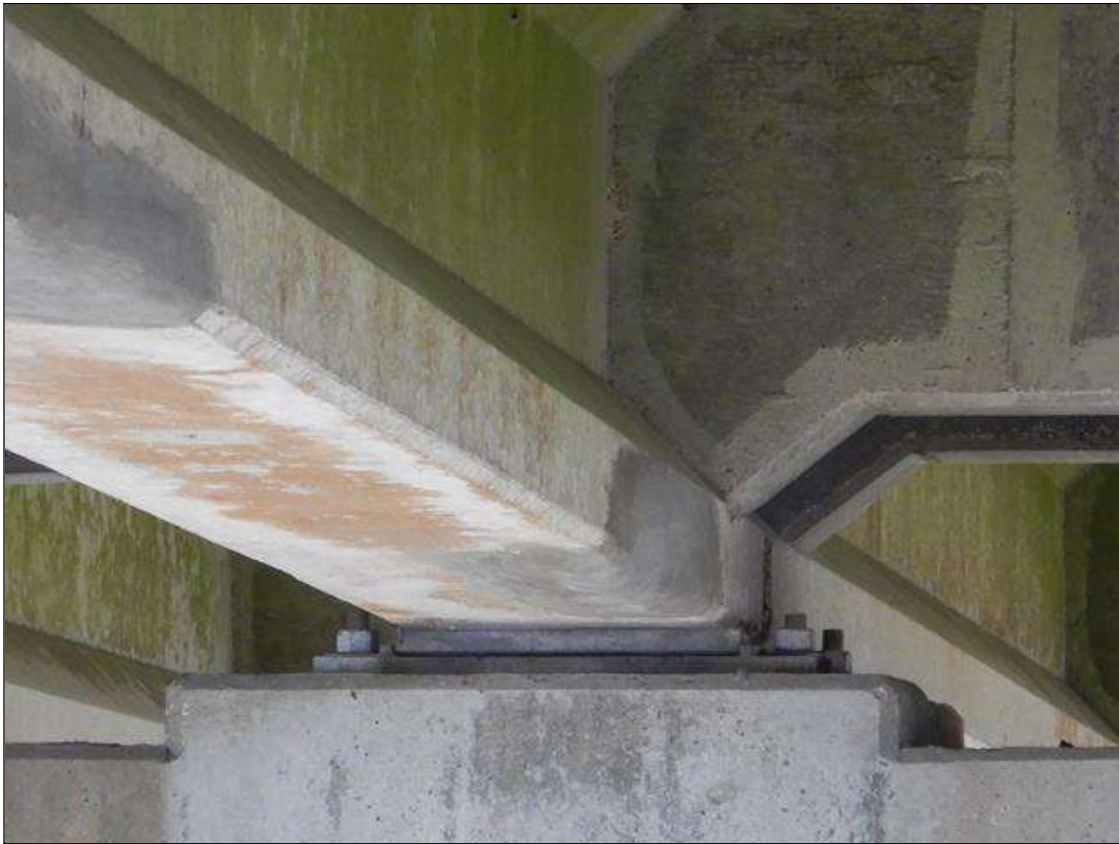
Span 11 Beam 6: [NEW REPAIR - PATCHING] FORMERLY --> multiple spalls with exposed rebar on the bottom face at 18ft from bent 10 up to (16" x 6" x 1/2")
