NC DEPARTMENT OF TRANSPORTATION
DIVISION OF HIGHWAYS
STRUCTURE MANAGEMENT UNIT

Structure Safety Report

Routine Element Inspection - Contract

DIVISION: 3 COUNTY: NEW HANOVER STRUCTURE NUMBER: 640013 FREQUENCY: 24 MONTHS

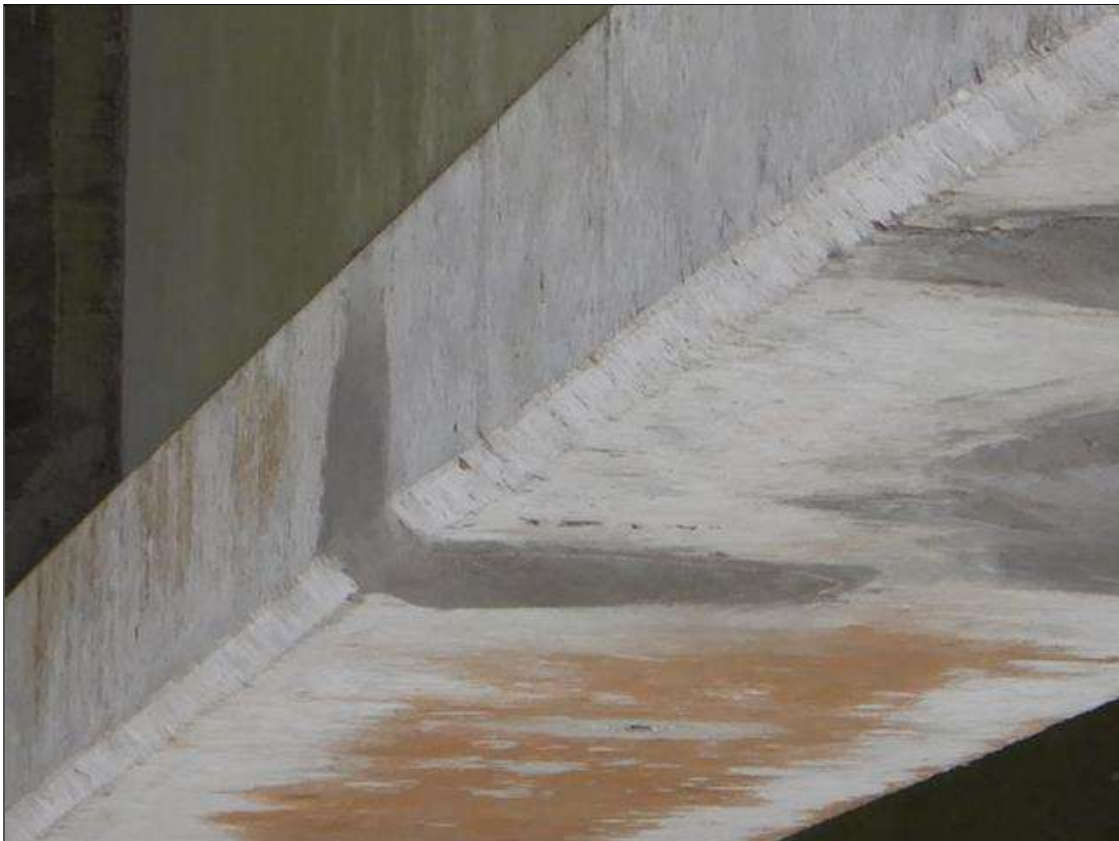
Span 11 Beam 6: ([NEW REPAIR - PATCHING] FORMERLY --> 4" x 4" x 1/2") spall with exposed rebar on the bottom face at bent 10

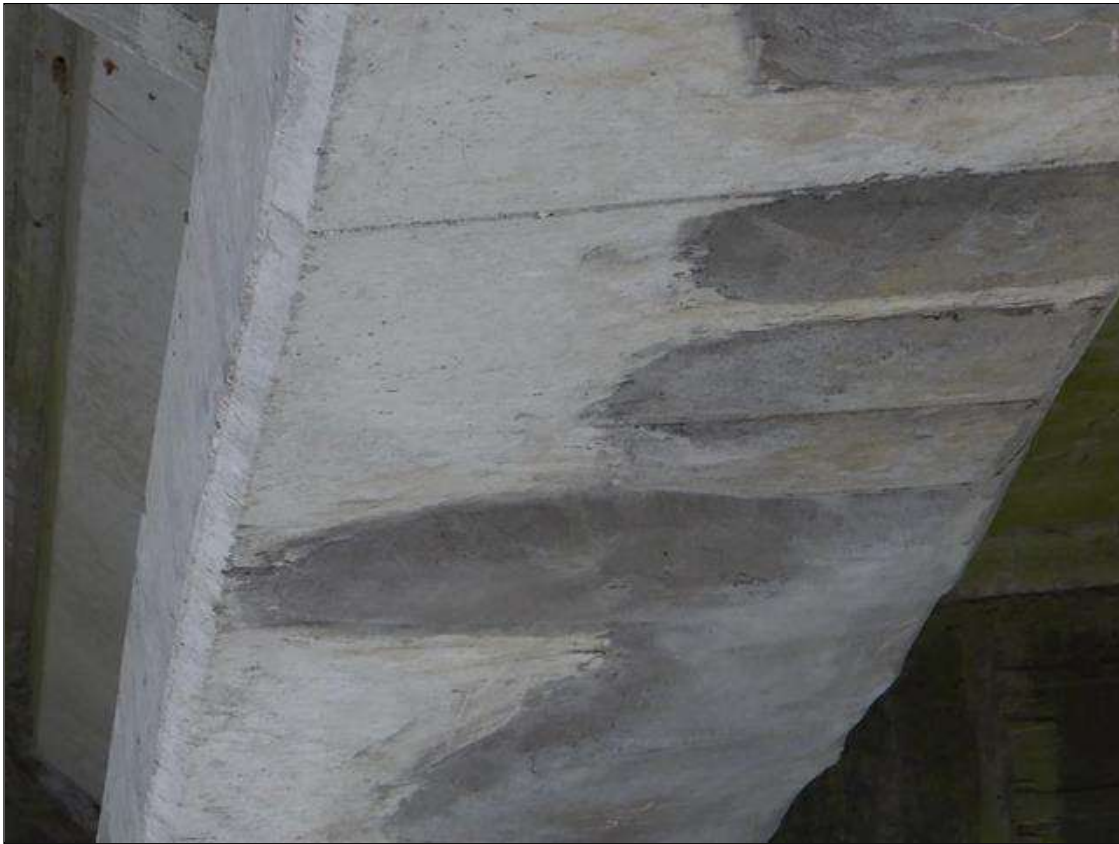
Span 11 Beam 6: [NEW REPAIR - PATCHING] FORMERLY --> PRIORITY MAINTENANCE - spall with exposed strands on the bottom right face at 12ft from bent 10 (34" x 7" x 2"), strand exposed for 20" long

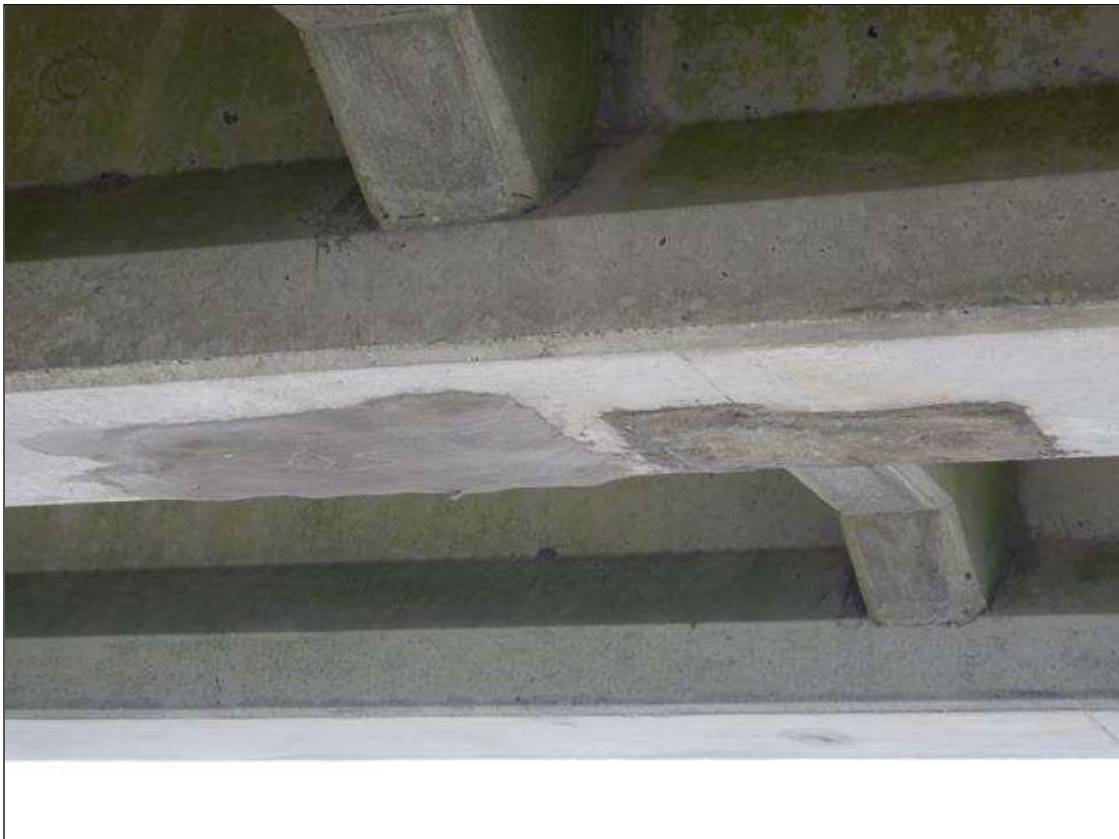
Span 11 Beam 6: [NEW REPAIR - PATCHING] FORMERLY --> (5" x 4" x 1/2") spall with exposed rebar on the bottom face at 13ft from bent 10

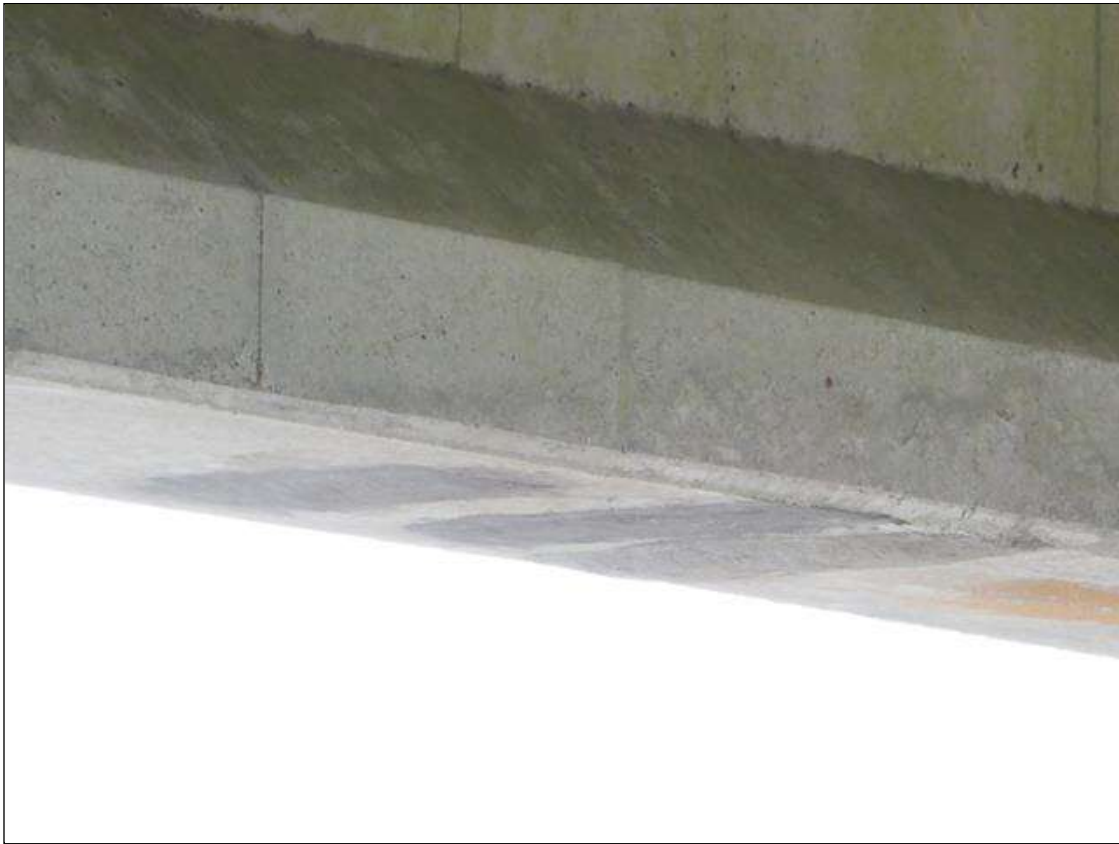
Span 11 Beam 8: [NEW REPAIR - PATCHING] FORMERLY --> (x3) spalls in a 2ft area up to (5" x 5" x 1/2") at 21ft from bent 11

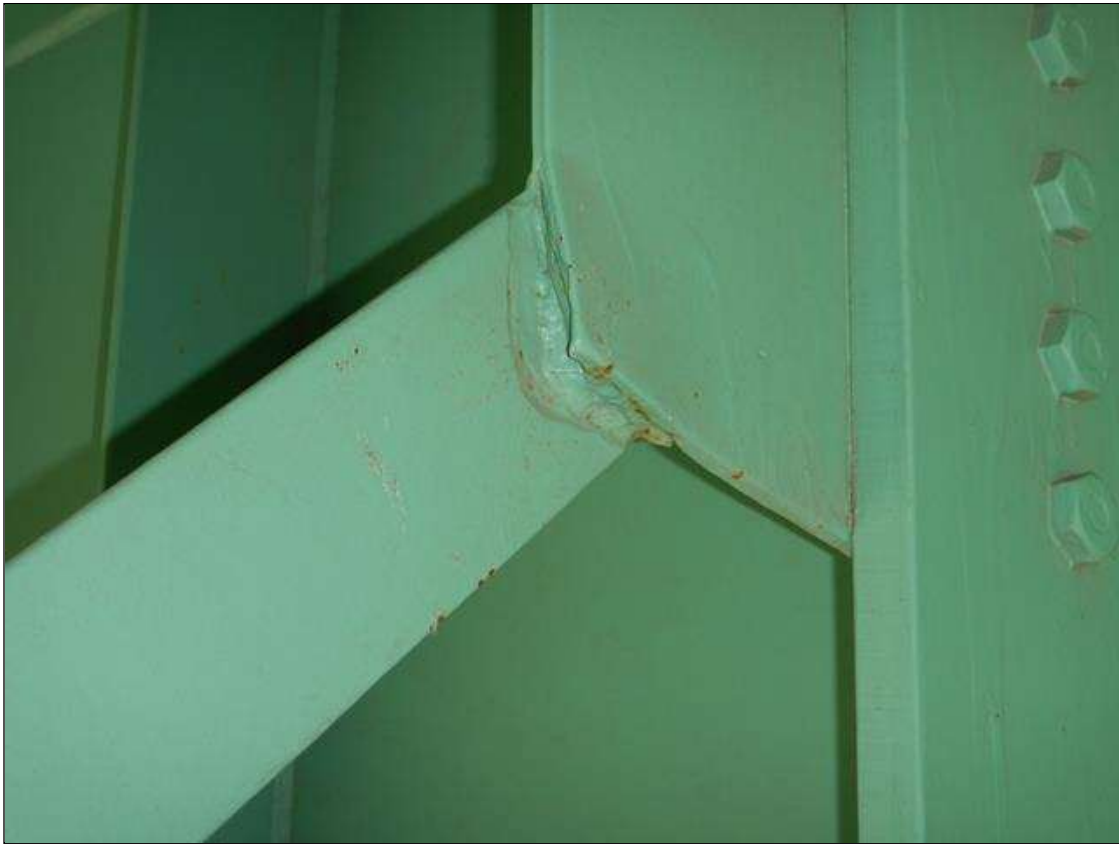
Span 12 Beam 4: Section loss on the bottom right web stiffener at bent 12 (6" x 5") by less than (1/16") into the stiffener and greater than 75% section loss on bottom gusset connection nut

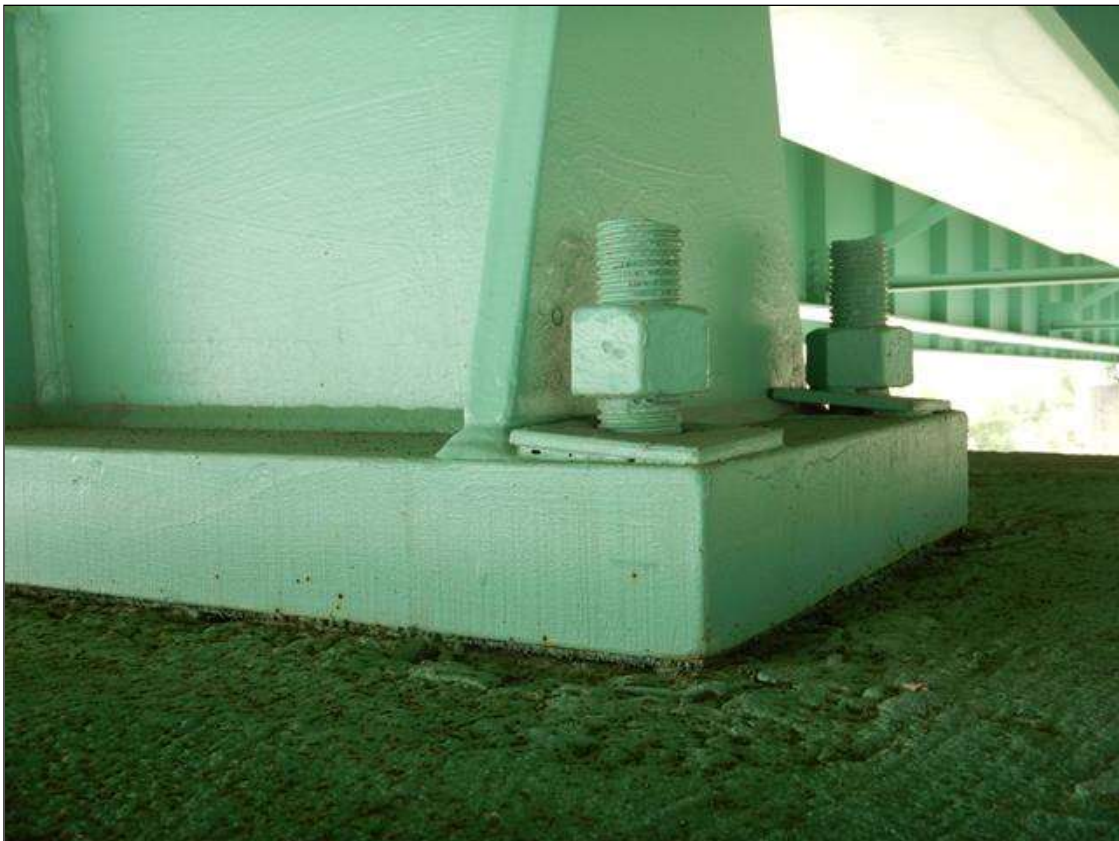
Span 13 Beam 2: corrosion and on the end diaphragm at Bent 13 and pack rust in the gusset plates

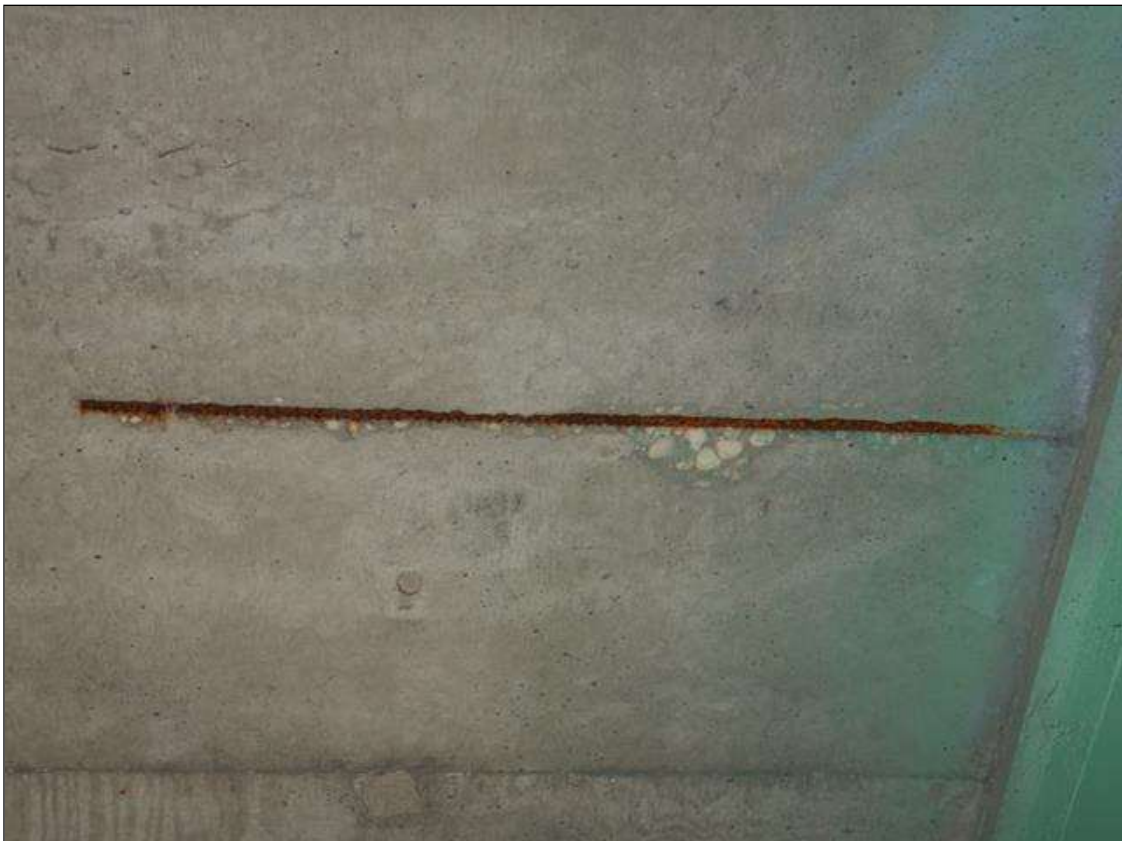
Span 14 Deck: spall with exposed rebar in bay 7 at 6ft from bent 13 (18" x 4" x 1/4")

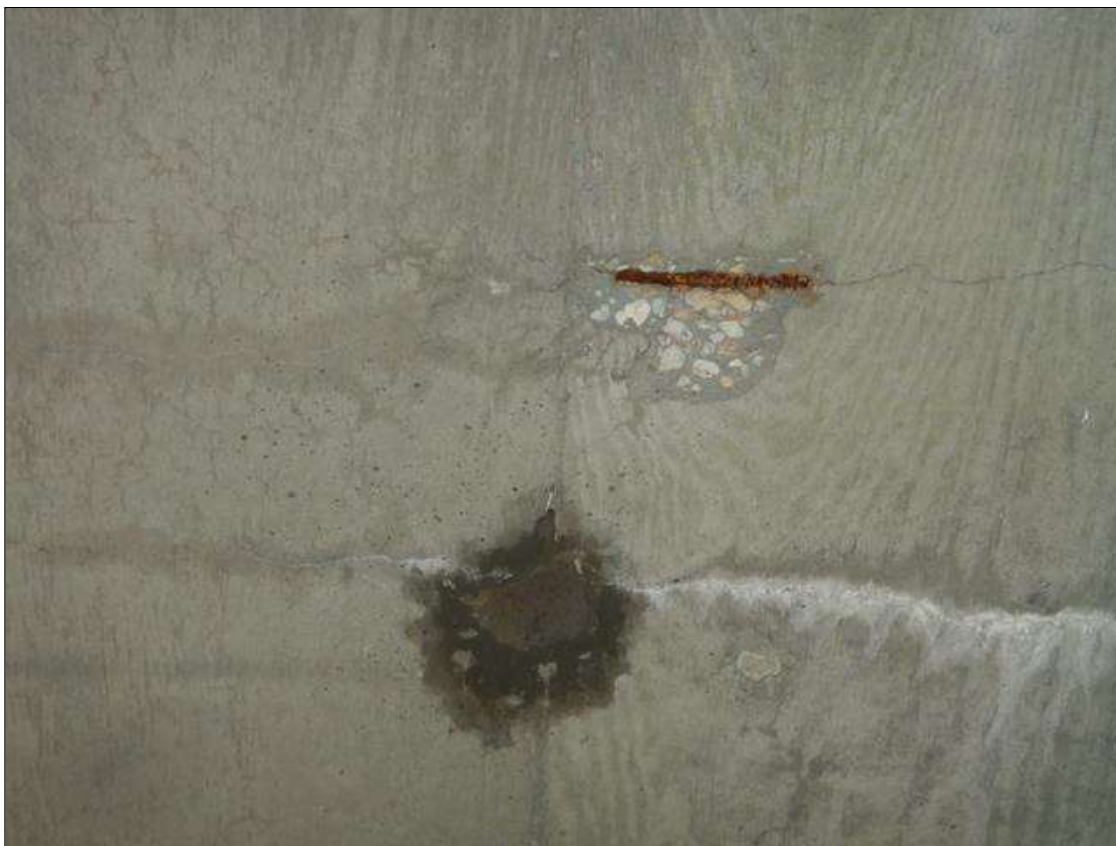
Span 14 Deck: spall with exposed rebar on the deck bottom in bay 5 at 30ft from Bent 13 (48" x 4" x 1/2")

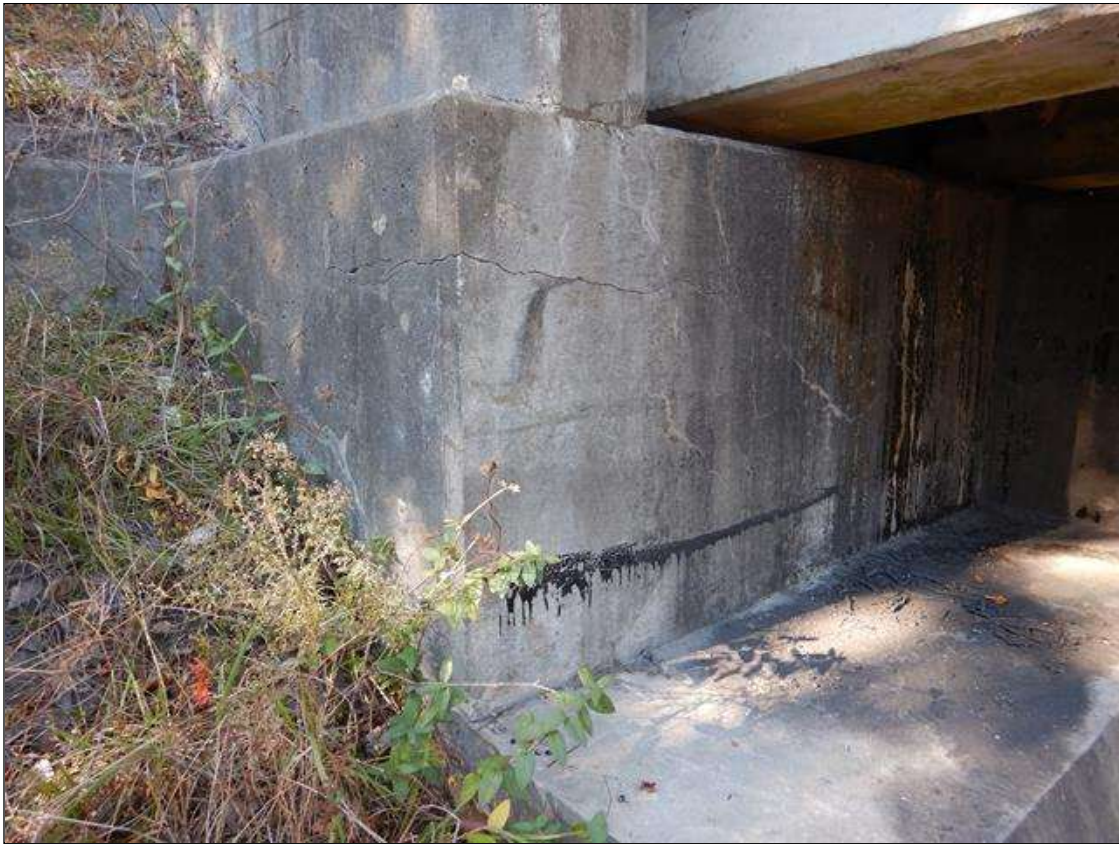
End Bent 1 Cap 1: [NEW REPAIR - CONCRETE PLACED] FORMERLY --> PRIORITY MAINTENANCE - undermining of the cap for its full length and up to its full width, fill has been lost from underneath the cap, no obvious fill has been lost from behind the End Bent

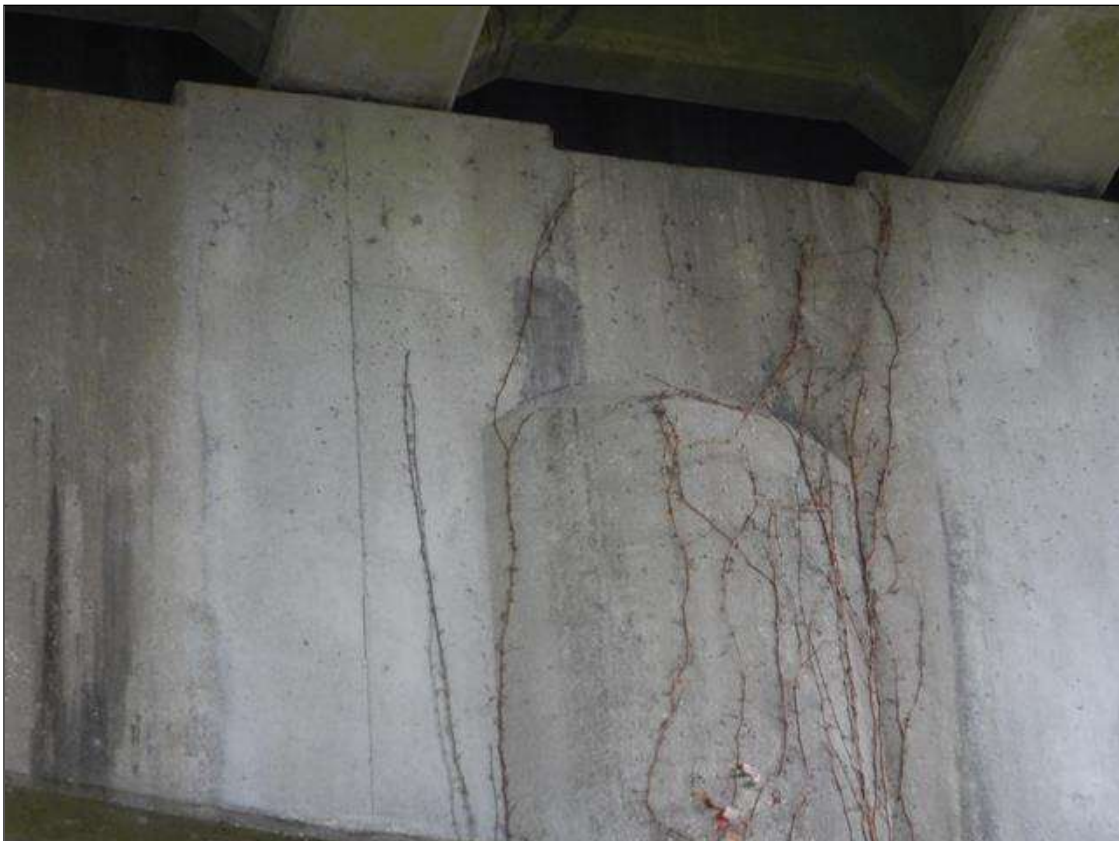
Bent 4 Cap 1: [NEW REPAIR - PATCHING] FORMERLY --> spall with exposed rebar on the east face under girder 3 (16" x 6" x 1")

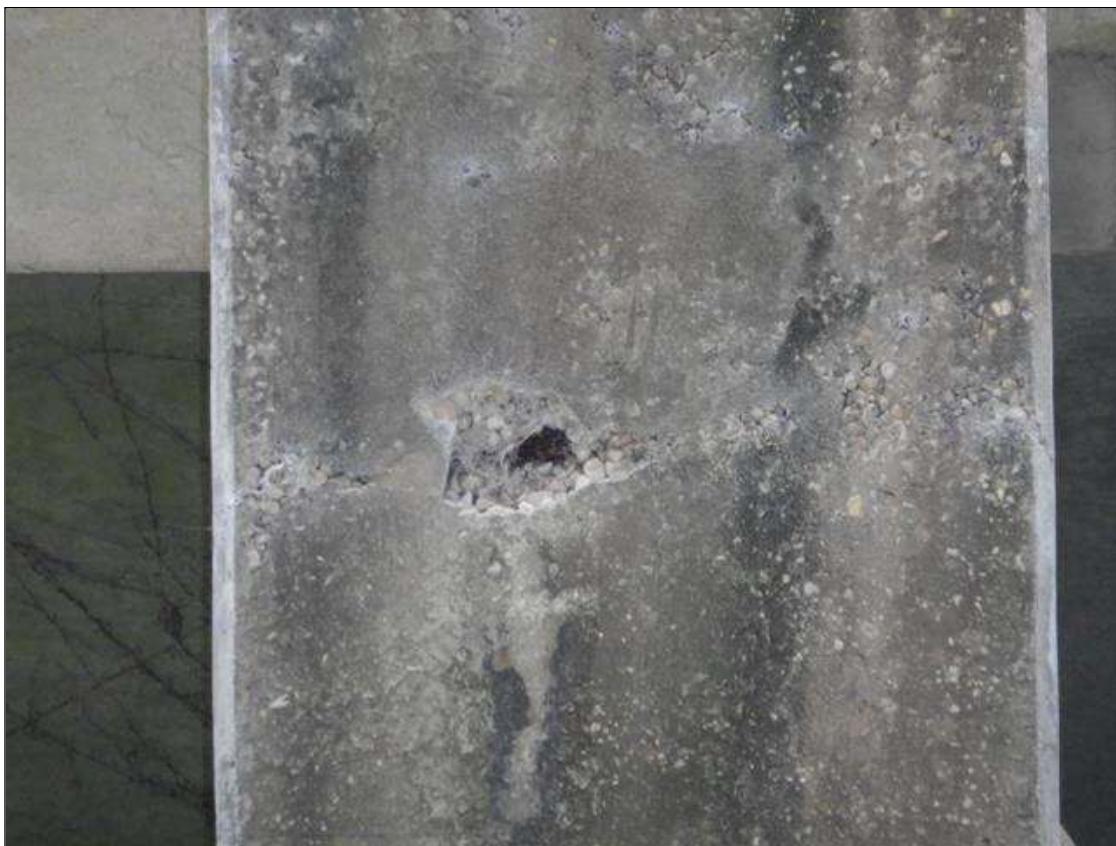
Bent 5 Cap 1: spall with exposed rebar on the bottom face under the left overhang (10" x 8" x 2")

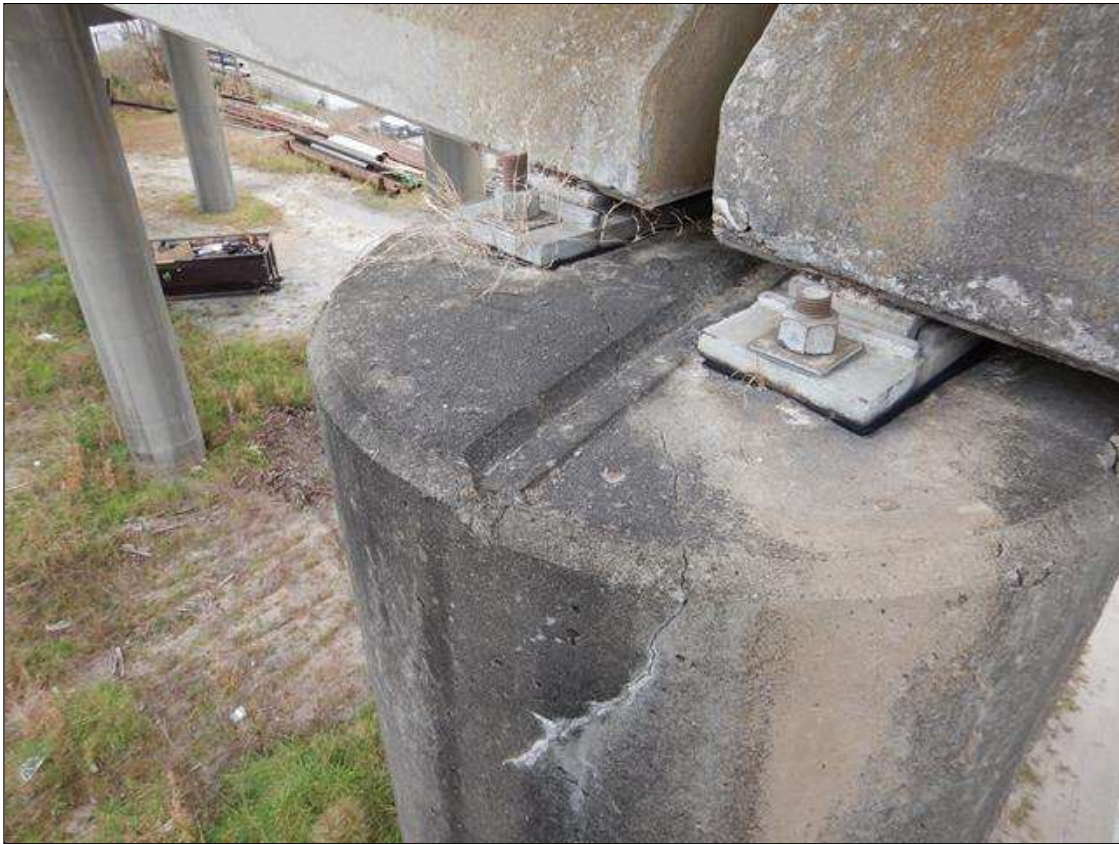
Bent 8 Cap 1: [PROMPT ACTION REQUEST] AT THE SPAN 9 GIRDER 1 NEAR BEARING, OPEN CRACKING TO 3/16" WIDE EMANATES FROM THE LEFT ANCHOR BOLT EXTENDING DOWN THE EAST FACE APPROXIMATELY 4.5', AND THE WEST APPROXIMATELY 1.5'.

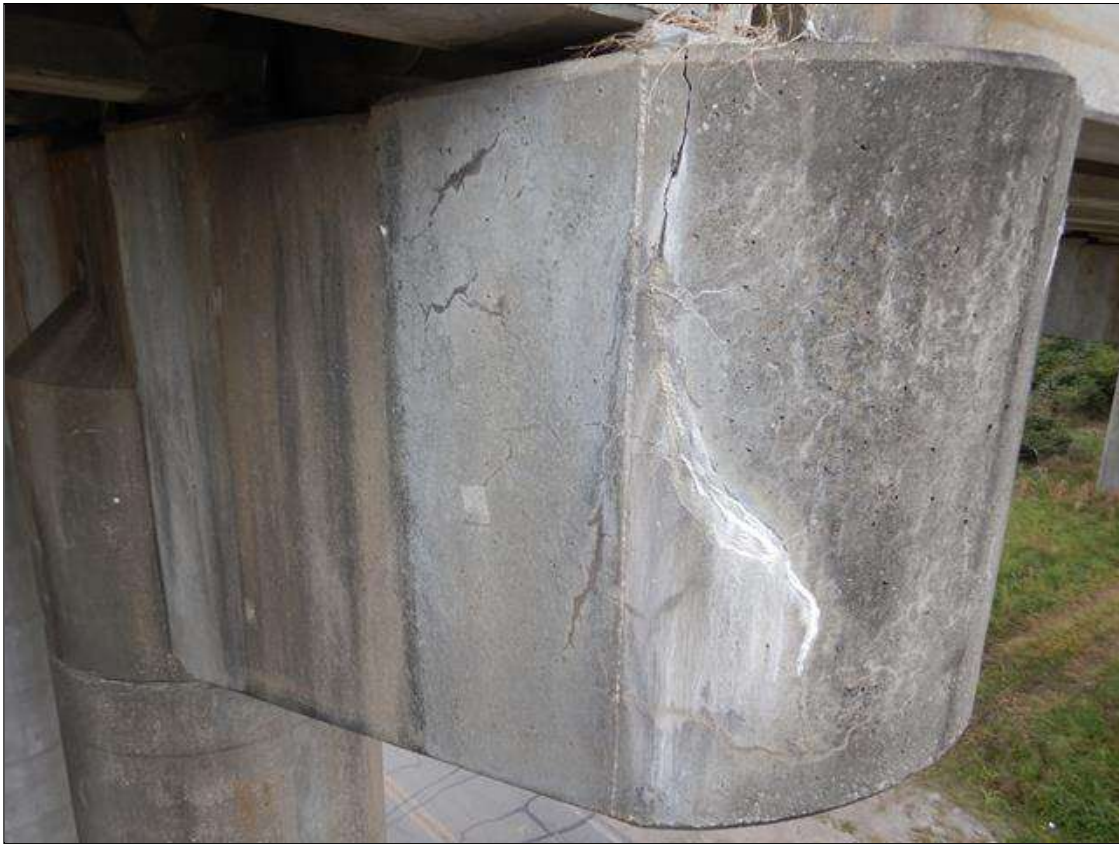
Bent 8 Cap 1: [PROMPT ACTION REQUEST] AT THE SPAN 9 GIRDER 1 NEAR BEARING, OPEN CRACKING TO 3/16" WIDE EMANATES FROM THE LEFT ANCHOR BOLT EXTENDING DOWN THE EAST FACE APPROXIMATELY 4.5', AND THE WEST APPROXIMATELY 1.5'.

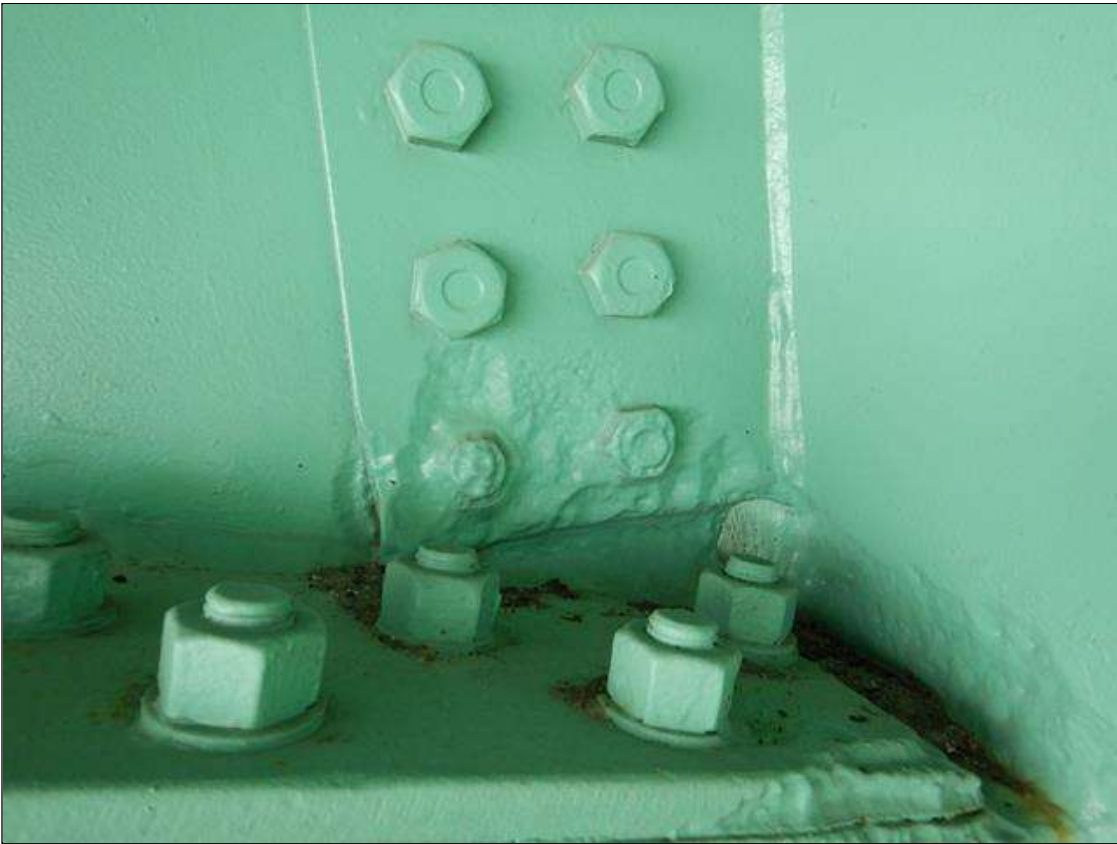
Span 16 Beam 1: PRIORITY MAINTENANCE - Bracket 2 at WB Parking Area both faces: section loss on the bottom flange/plate of the brace beam at the web (7" x 1 3/4") with (11/16") remaining; up to 75% section loss on (x1) nut on the bottom plate on the east face and up to 100% section loss on (x2) nuts on the west face; up to 100% section loss on (x2) nuts on the web plate on the west face; section loss in the web (9" x 4") by up to (1/16") into the web on both sides of the bracket (PROMPT ACTION REQUEST)

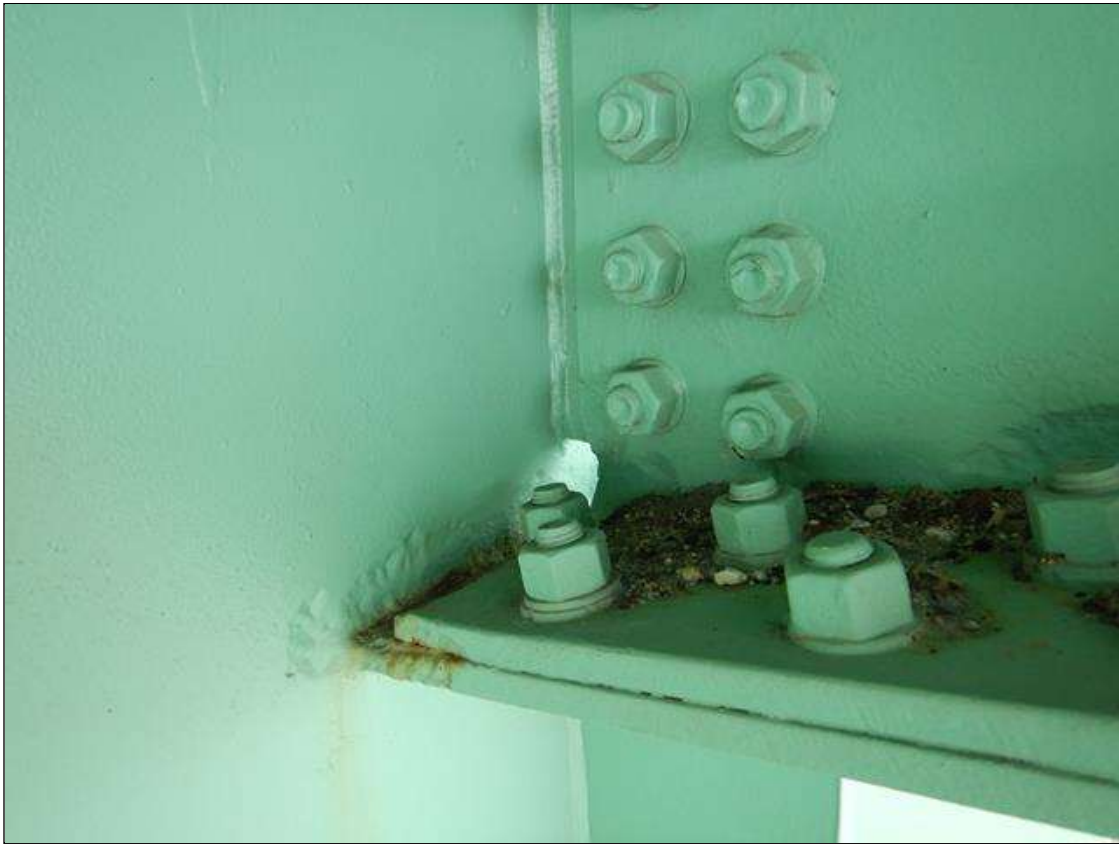
Span 16 Beam 1: [NEW REPAIR - NUTS REPLACED] FORMERLY --> PRIORITY MAINTENANCE - Bracket 1 at WB Parking Area both faces: section loss on the bottom flange/plate of the brace beam at the web (7" x 1 3/4") with (11/16") remaining; up to 100% section loss on (x2) nut on the bottom plate on both faces; active corrosion with no measureable section loss web on both faces (PROMPT ACTION REQUEST)

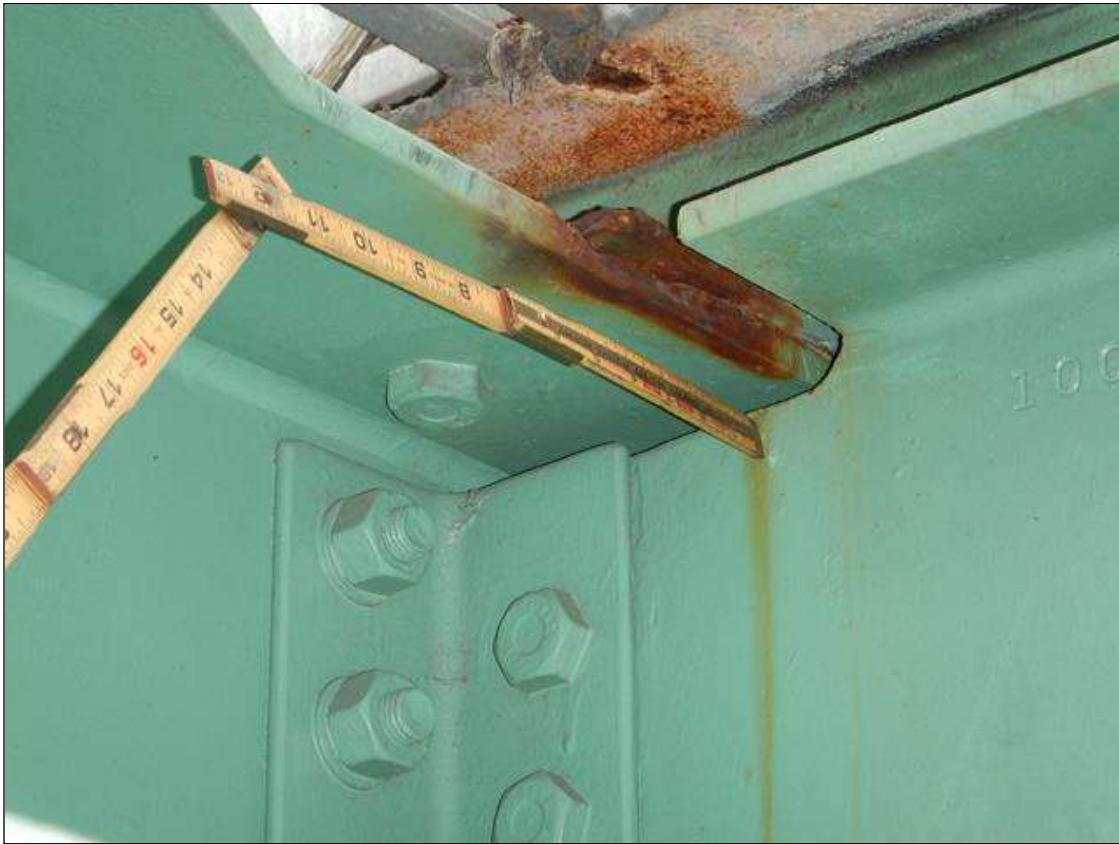
Span 16 Beam 1: [PROMPT ACTION REQUEST] BRACE BEAM 2 AT STRINGER 3 AT THE WESTBOUND PARKING AREA ON THE TOP FLANGE, SECTION LOSS [AVERAGE 1/2" REMAINING] IN A 2" X 2" AREA ON BOTH SIDES OF THE FLANGE.

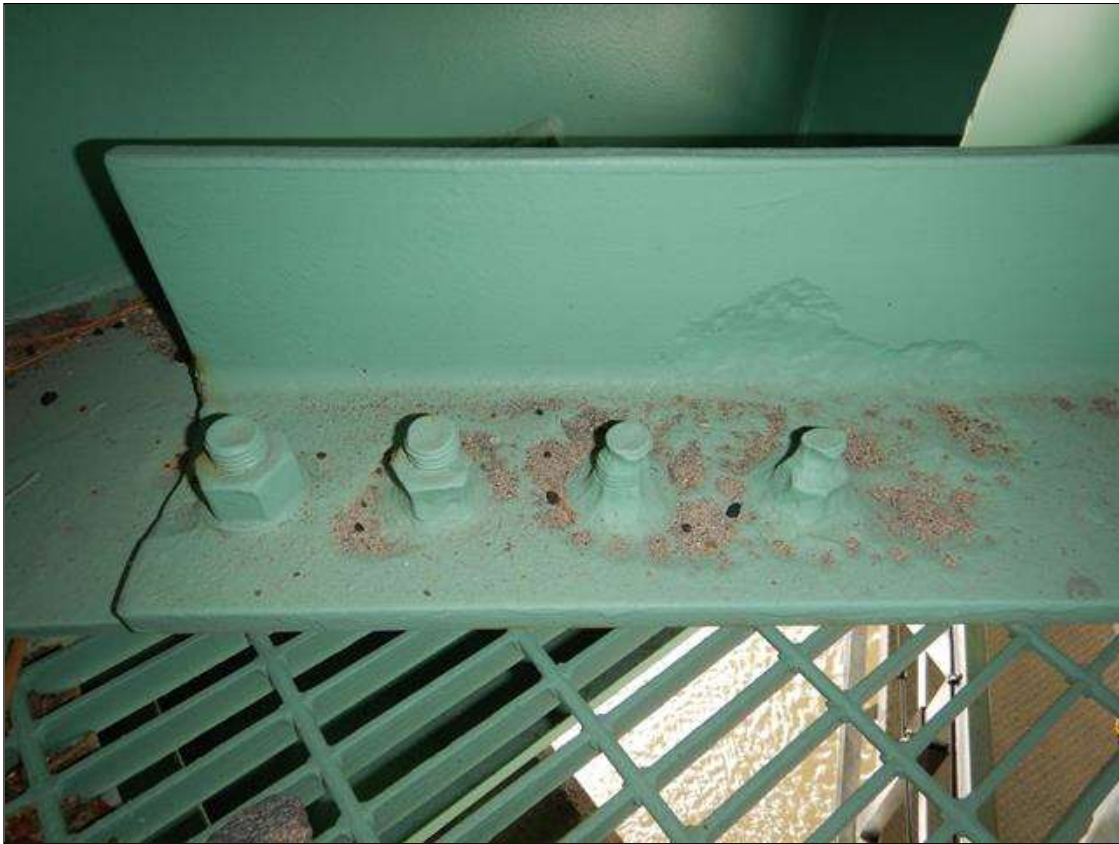
Span 16 Beam 4: [PROMPT ACTION REQUEST] 5/16" section loss on end diaphragm gusset in the right web at bent 15 due to previous rust. (3" x 3") with (1/16") remaining, section loss on 3 nuts up to 60%. area has been cleaned and repainted. section loss in more than 25% of the gusset plate thickness

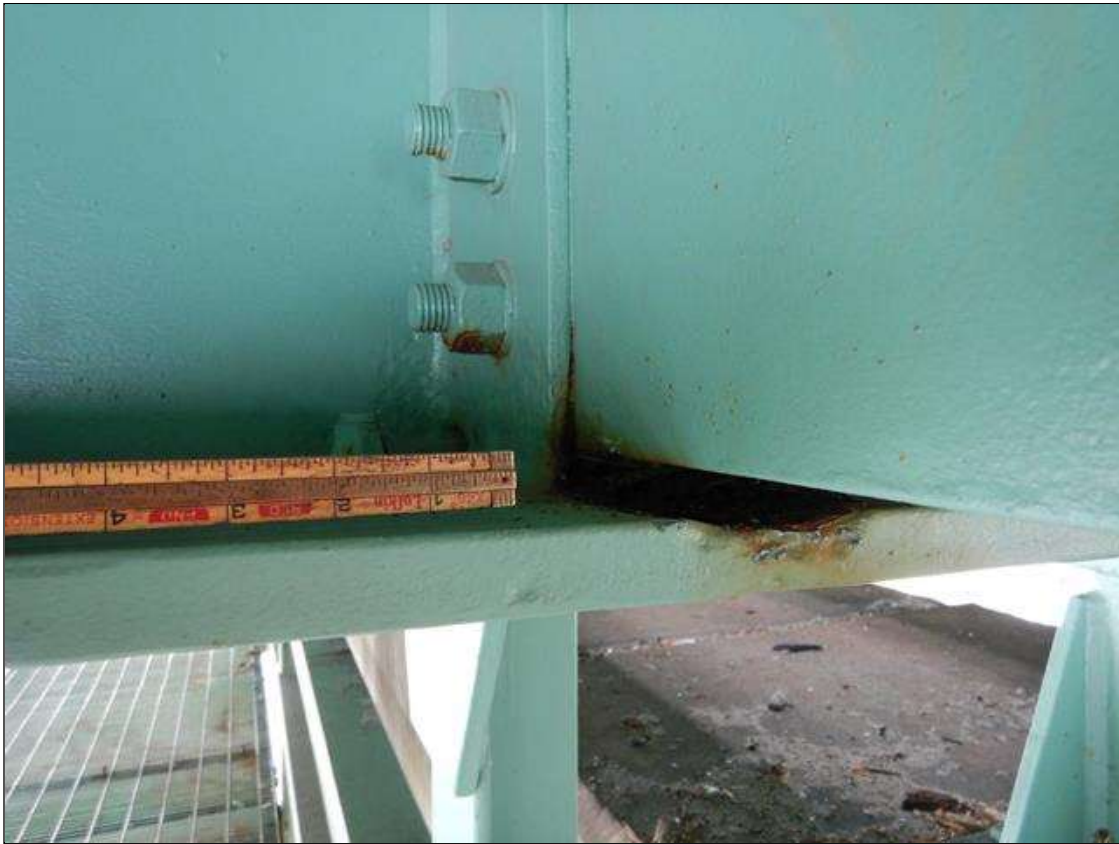
Span 16 Beam 5: [PROMPT ACTION REQUEST] - bottom left web stiffener and platform connection at bent 15: up to 100% section loss on platform nut on the bottom flange; active corrosion on the stiffener, web, flange and diaphragm gusset with no measureable section loss

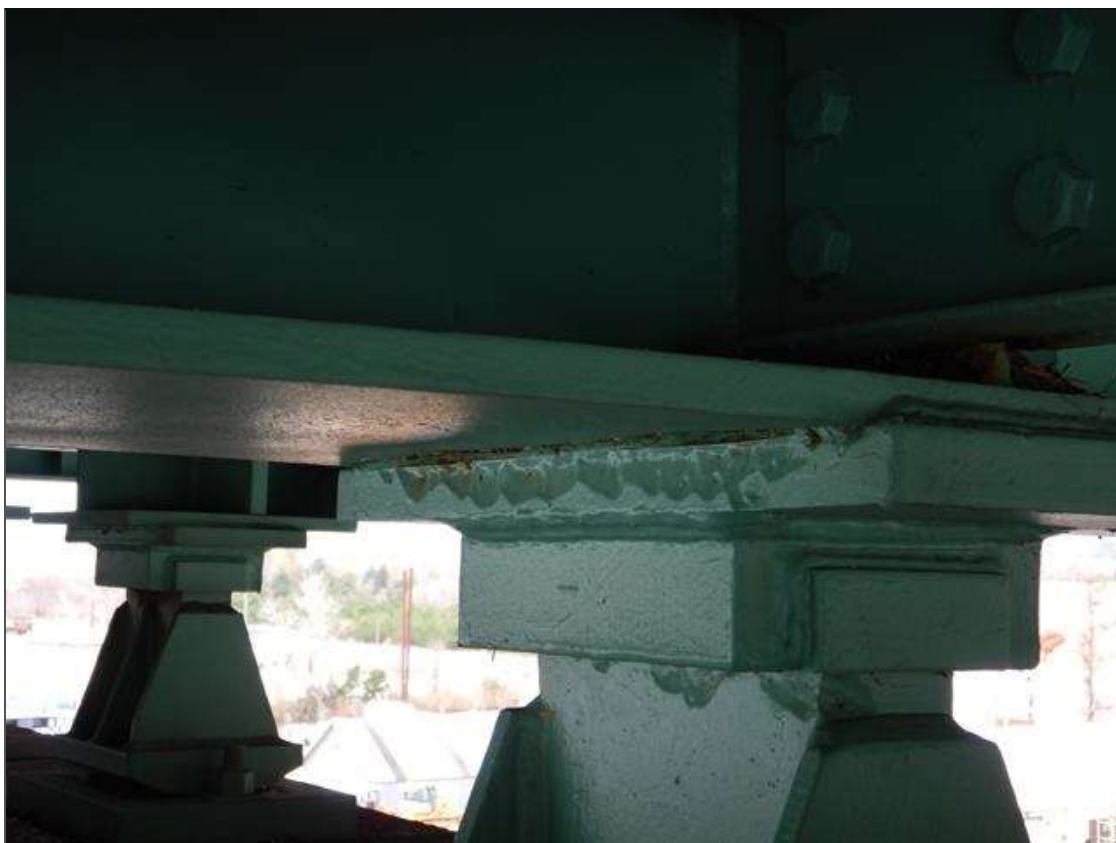
Span 16 Beam 5 - Beam 5 Near Bearing: Section loss in the top plate (18" x 1" x 1/16" into the plate)

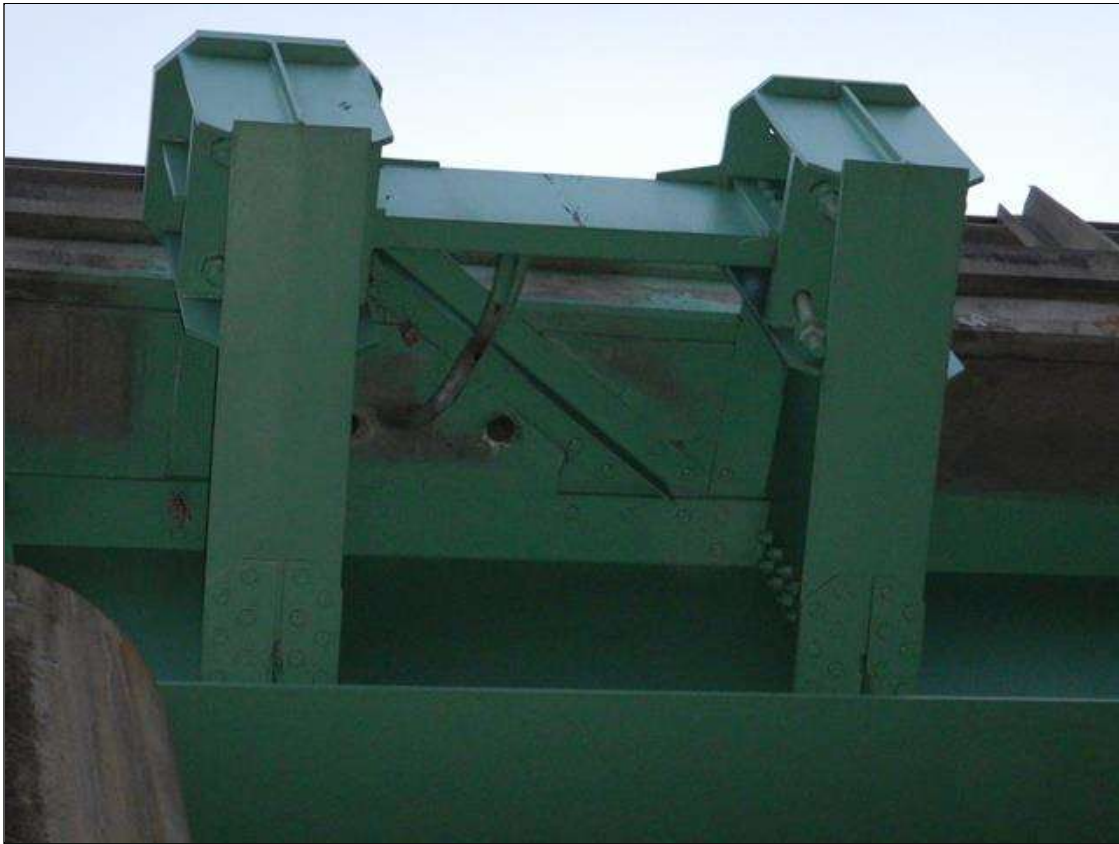
Span 26 Beam 1: [PROMPT ACTION REQUEST] West brace for removed overhead sign: southeastern bolt is loose and over the roadway (bolt could not be removed by hand), bolt has no top nut holding it in place.

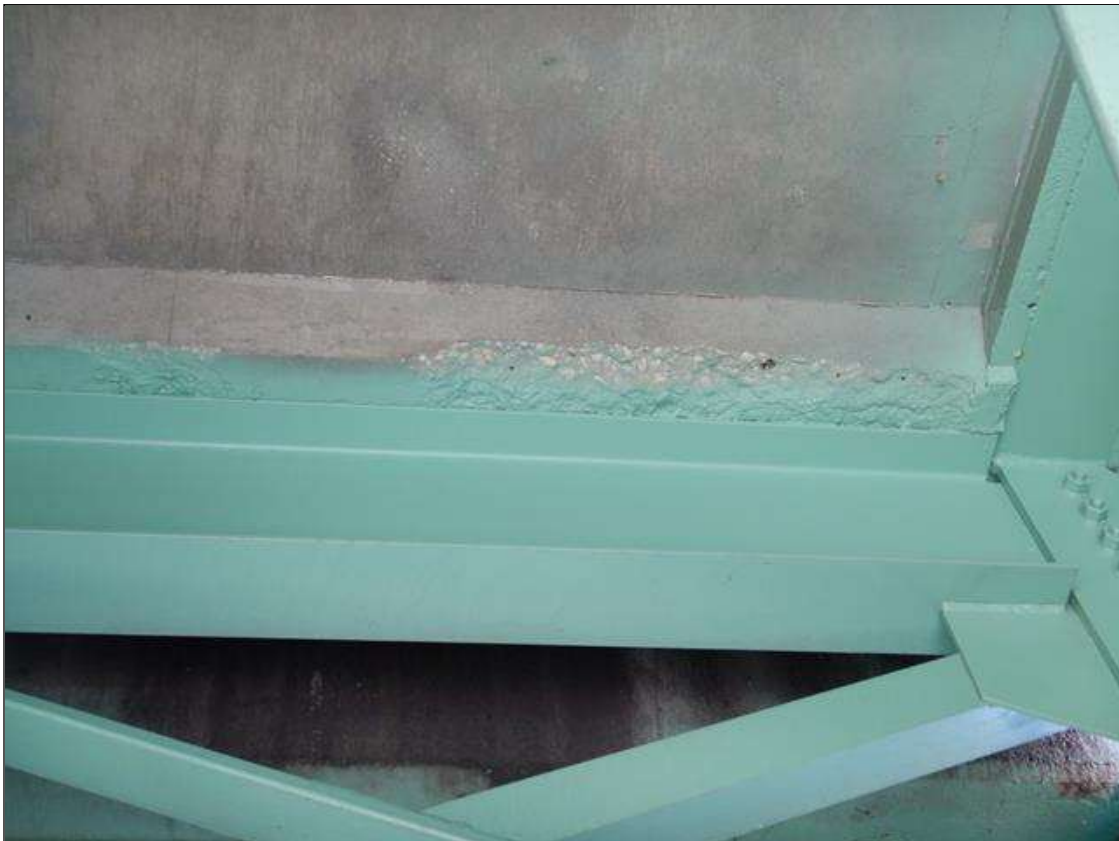
Span 21 Deck: (x2) spalls with no exposed steel on the deck bottom in bay 1 at bent 18 up to (30" x 4" x 1").

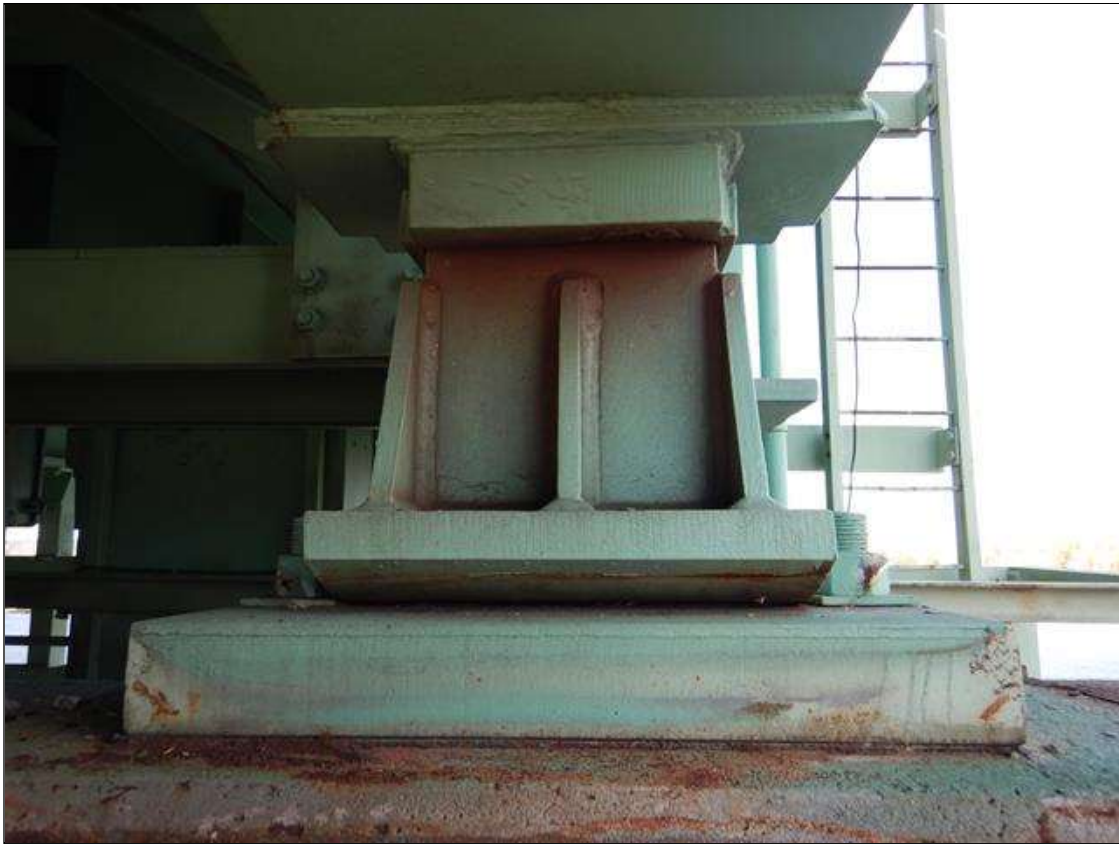
Span 21 Beam 1 - Beam 1 Near Bearing: SCATTERED SURFACE CORROSION

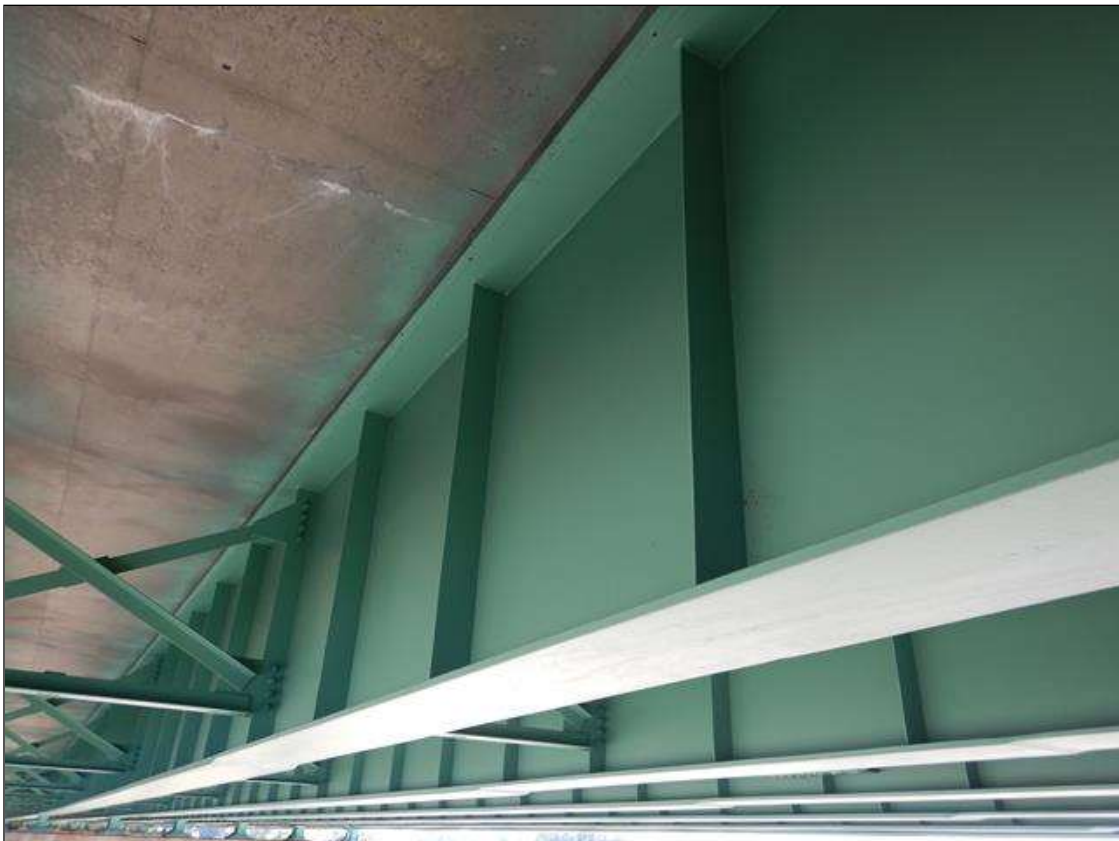
Span 21 Beam 3: REPAIR observed in 2020 insp: areas have been cleaned and repainted, 2018 report had Corrosion and scale on the top flange at Bent 18 with no measureable section loss.
