NC DEPARTMENT OF TRANSPORTATION
DIVISION OF HIGHWAYS
STRUCTURE MANAGEMENT UNIT

Structure Safety Report

Routine Element Inspection - Contract

DIVISION: 3 COUNTY: NEW HANOVER STRUCTURE NUMBER: 640013 FREQUENCY: 24 MONTHS

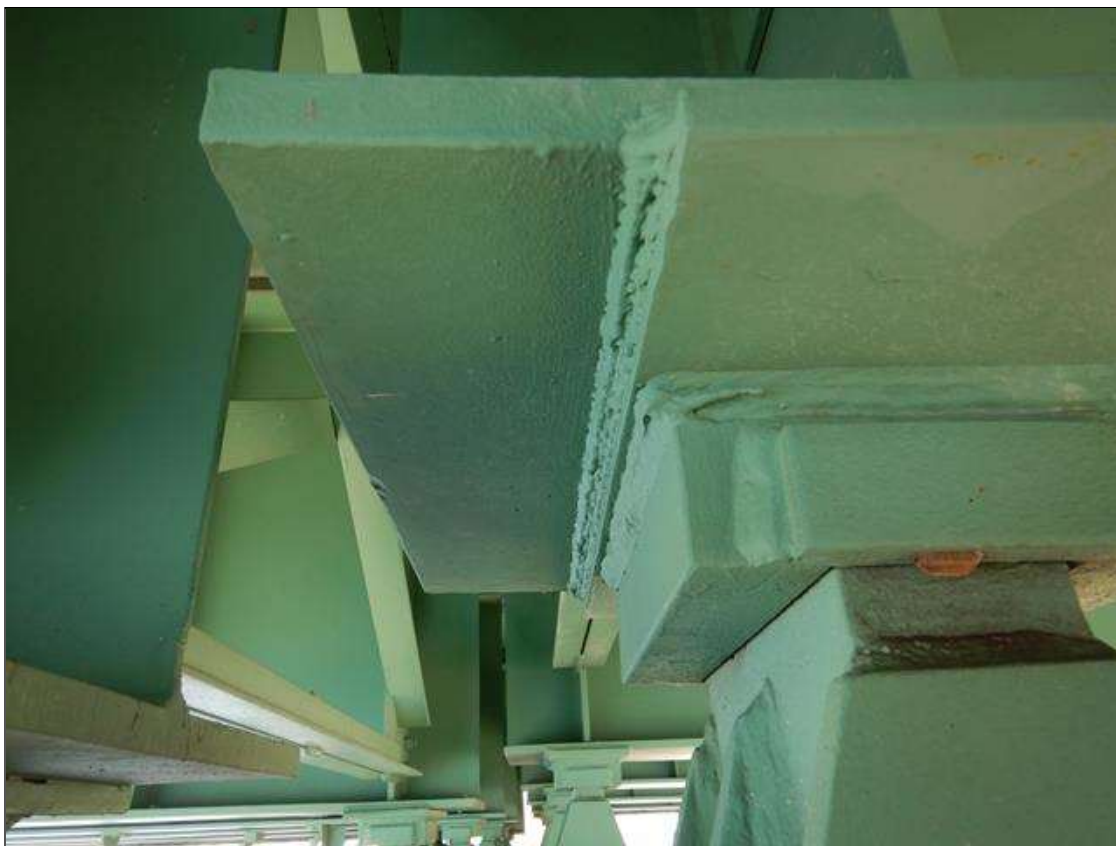
Span 21 Beam 6 - Beam 6 Near Bearing: REPAINTED

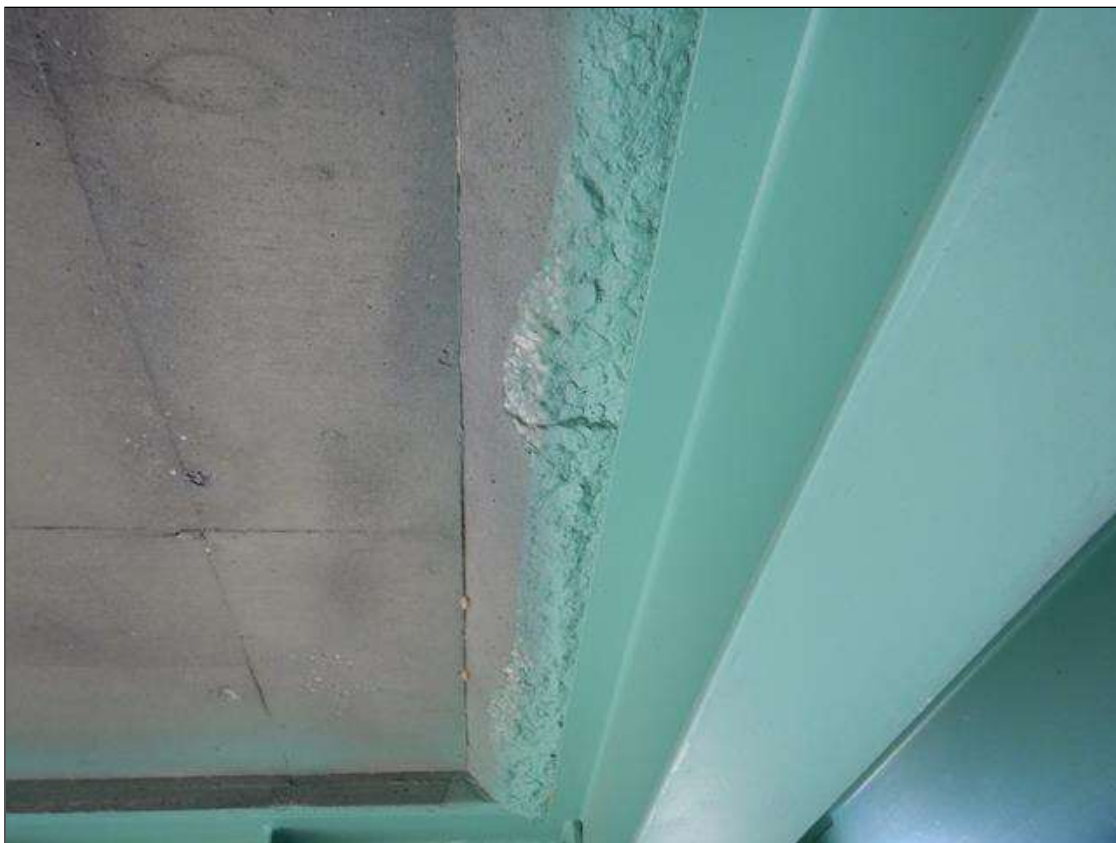
Span 22 Deck: spall with no exposed steel on the deck bottom at bent 20 in bay 1 (7.5ft x 3" x 3").

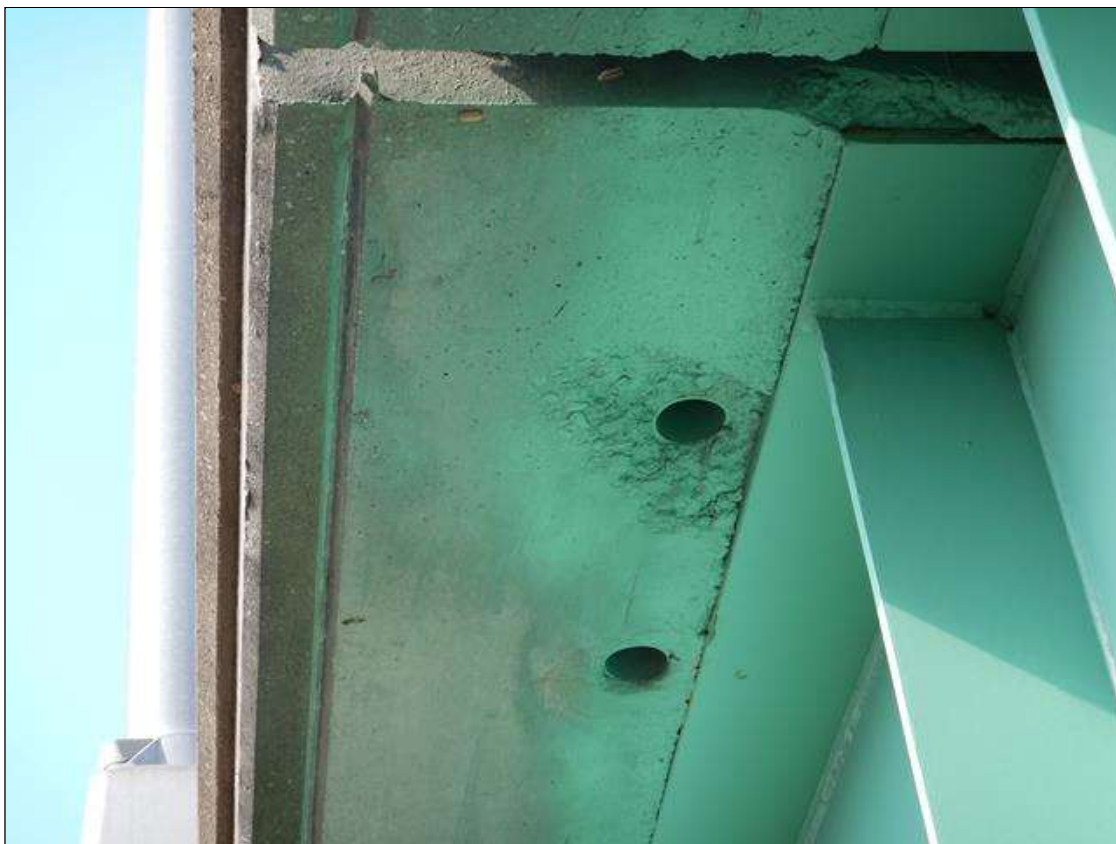
Span 21 Deck: spall with no exposed steel at deck drain on the right overhang at bent 19 (14" x 12" x 1 1/2")

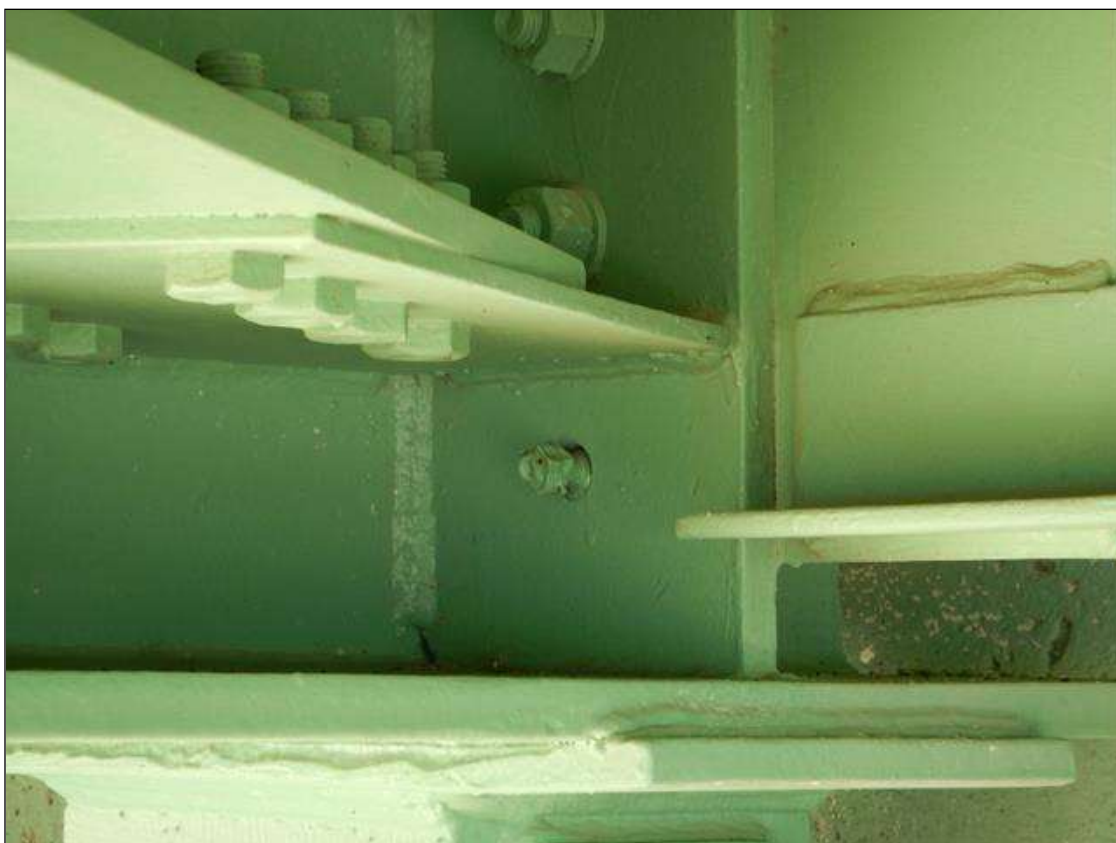
Span 23 Beam 7: Bent 21, bent daphragm attachment at the right side of beam 7, bottom nut is missing

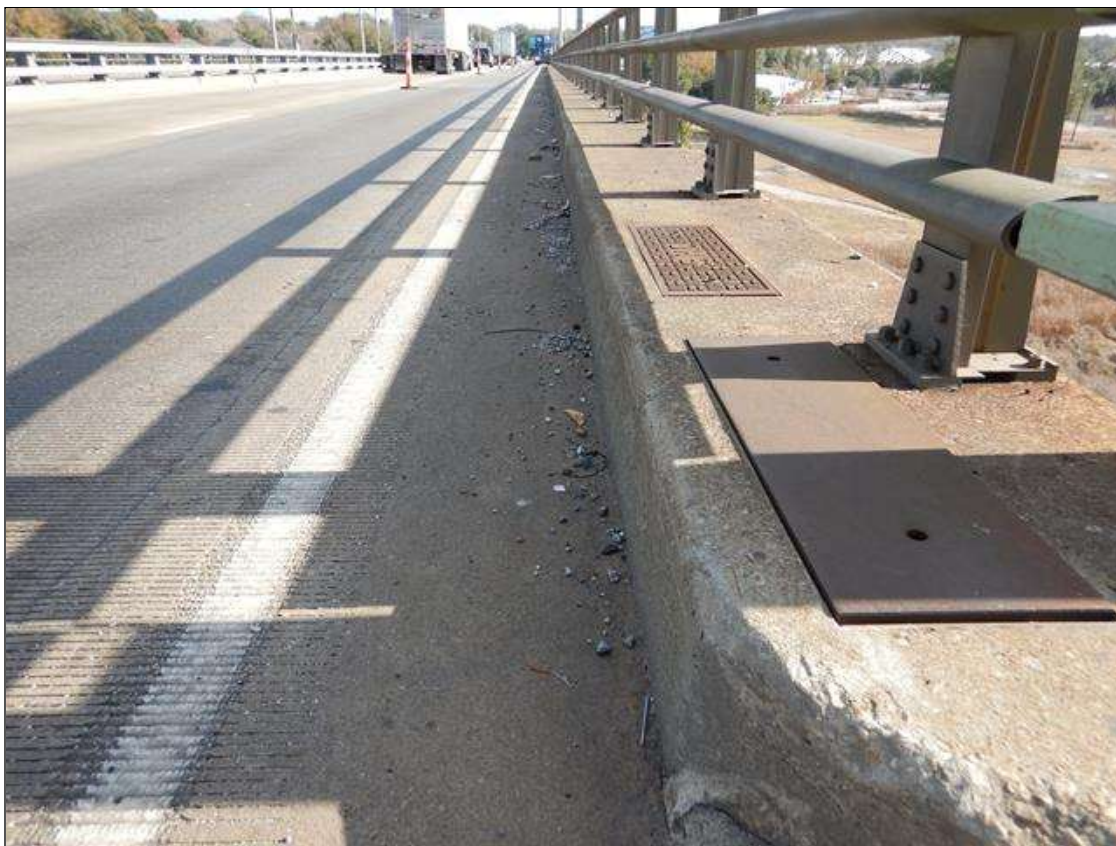
RIGHT AND LEFT GUTTERLINES, DEBRIS ACCUMULATION ALONG THE LENGTHS

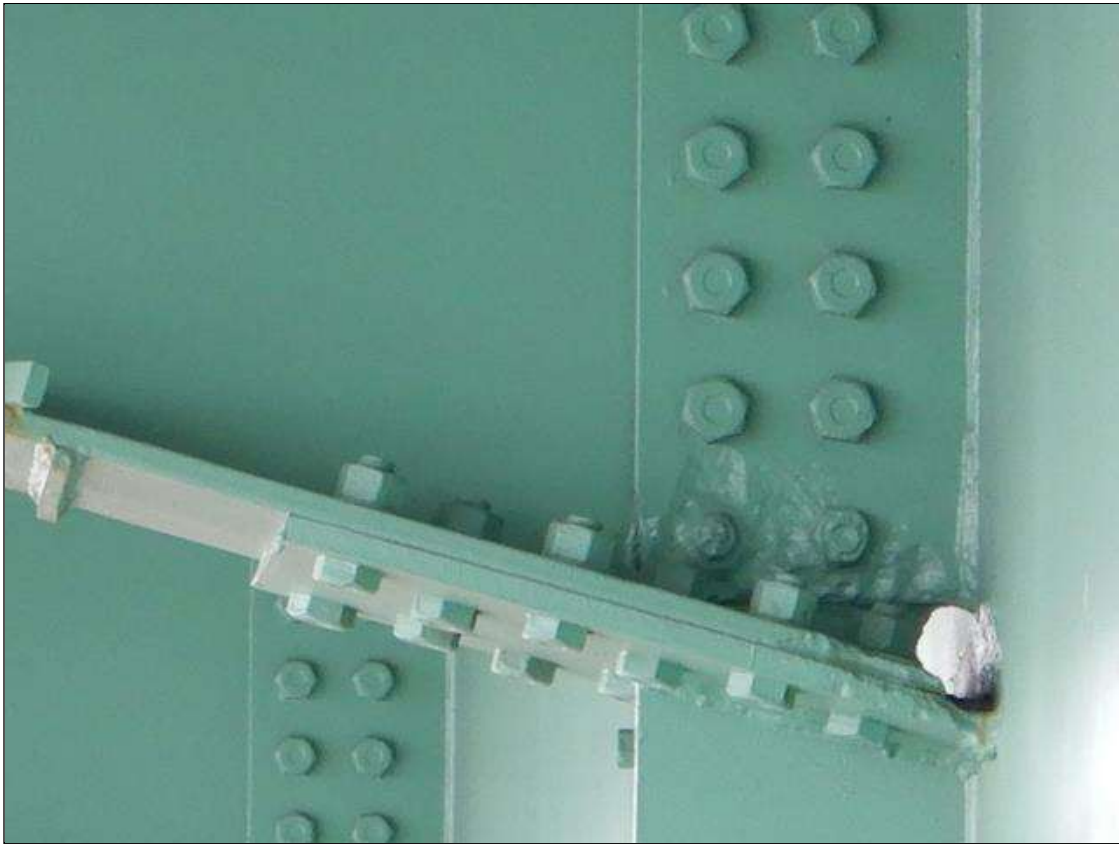
Span 20 Beam 1: PRIORITY MAINTENANCE - Bracket 4 at WB Parking Area East Face: section loss on the bottom flange/plate of the brace beam at the web (7" x 1 3/4") with (5/8") remaining; up to 100% section loss on (x3) nuts on the bottom flange; up to 75% section loss on (x2) nuts on the web plate; section loss in the web (8" x 3") by up to (1/16") into the web; section loss on the bottom of the web plate (8" x 3") by (1/16") into the plate (PROMPT ACTION REQUEST)

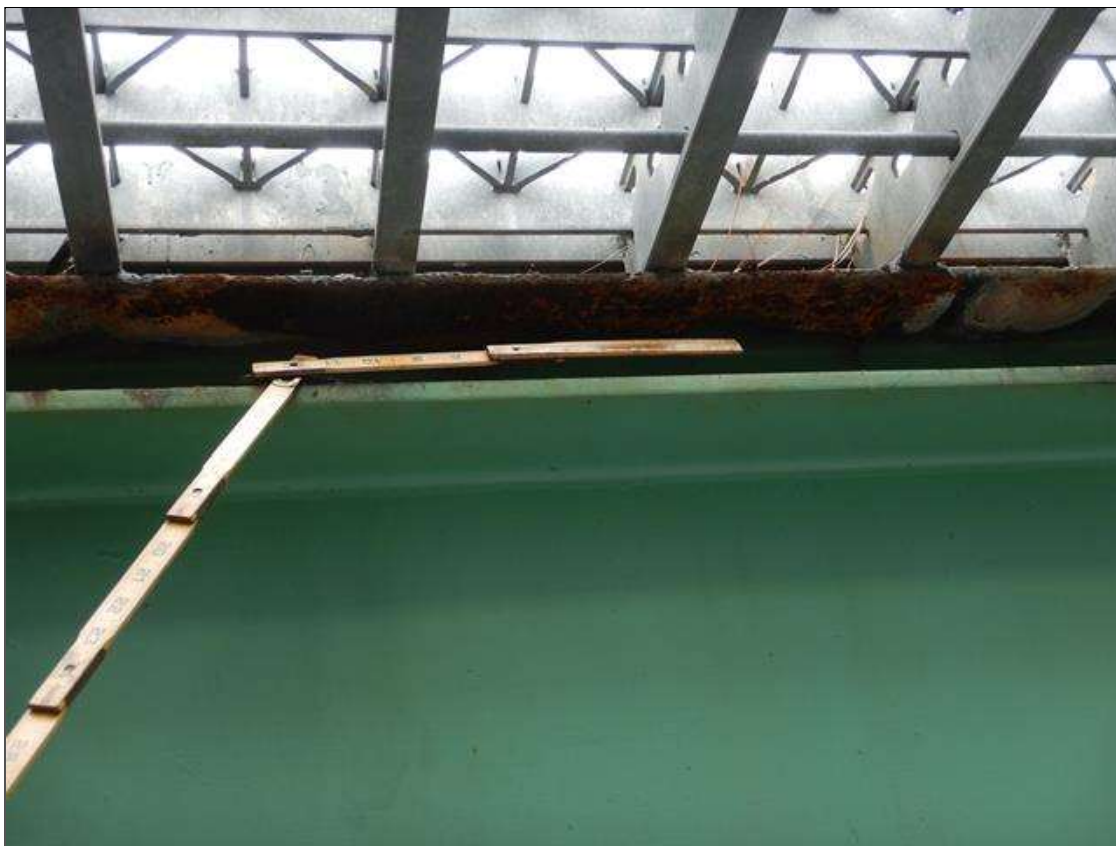
Span 20 Beam 1: PRIORITY MAINTENANCE - "nailer" beam on top of stringer 3 between brace 3 and 4 on the top flange: active corrosion and section loss with (11/32") remaining for the full length and width of the top flange (PROMPT ACTION REQUEST)

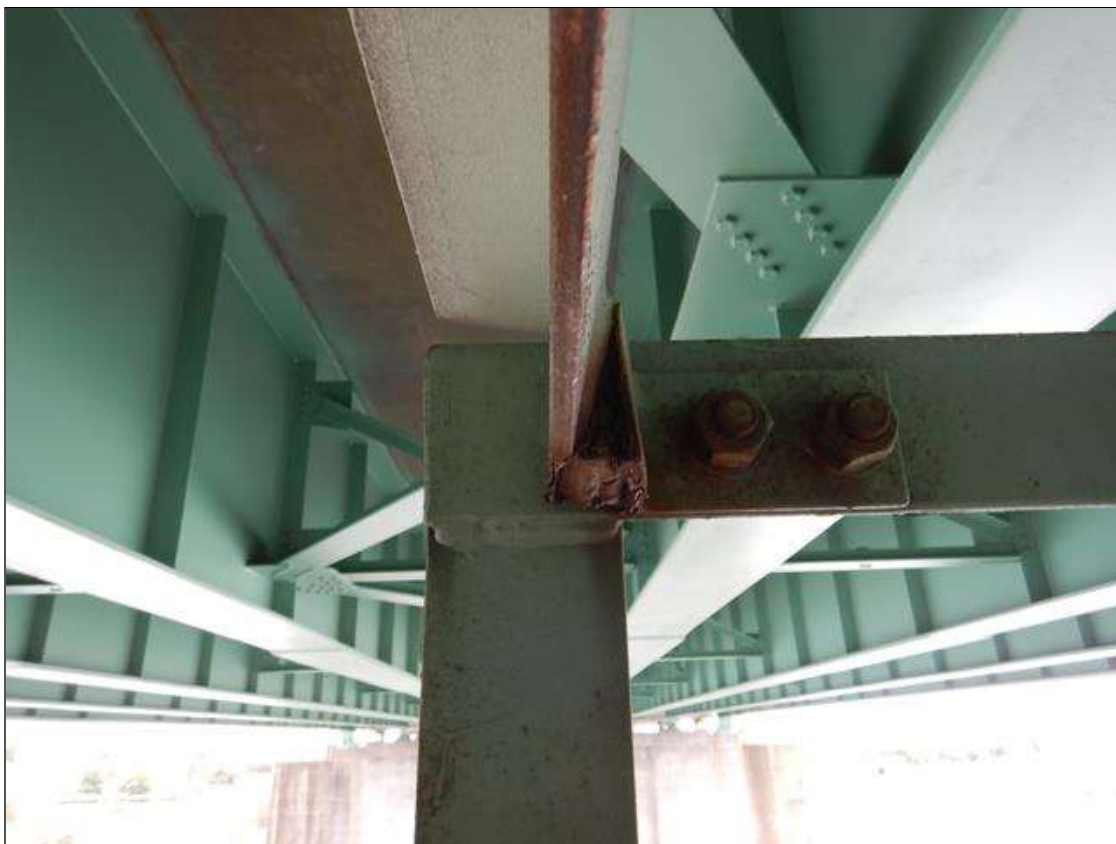
Span 20 Beam 1: surface corrosion and with pack rust between members of the platform attached to the beams at the west face of bent 18

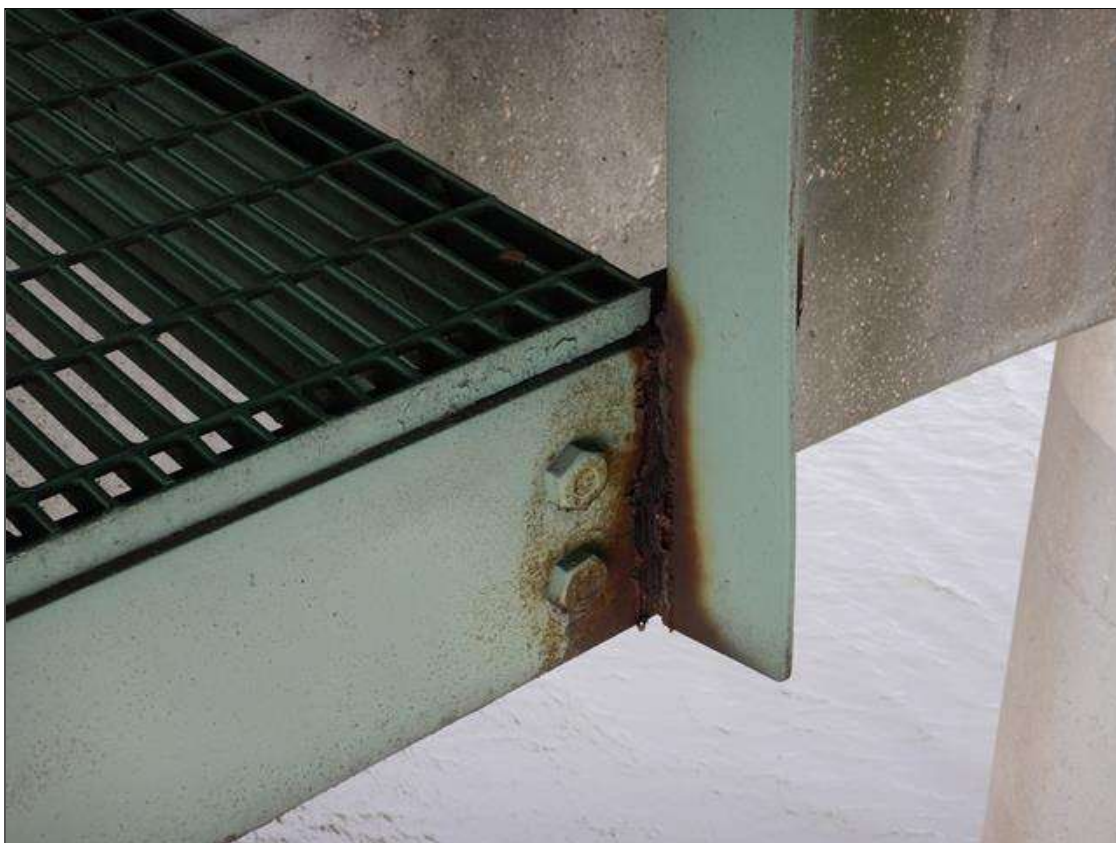
Span 20 Beam 1: surface corrosion and with pack rust between members of the platform attached to the beams at the west face of bent 18

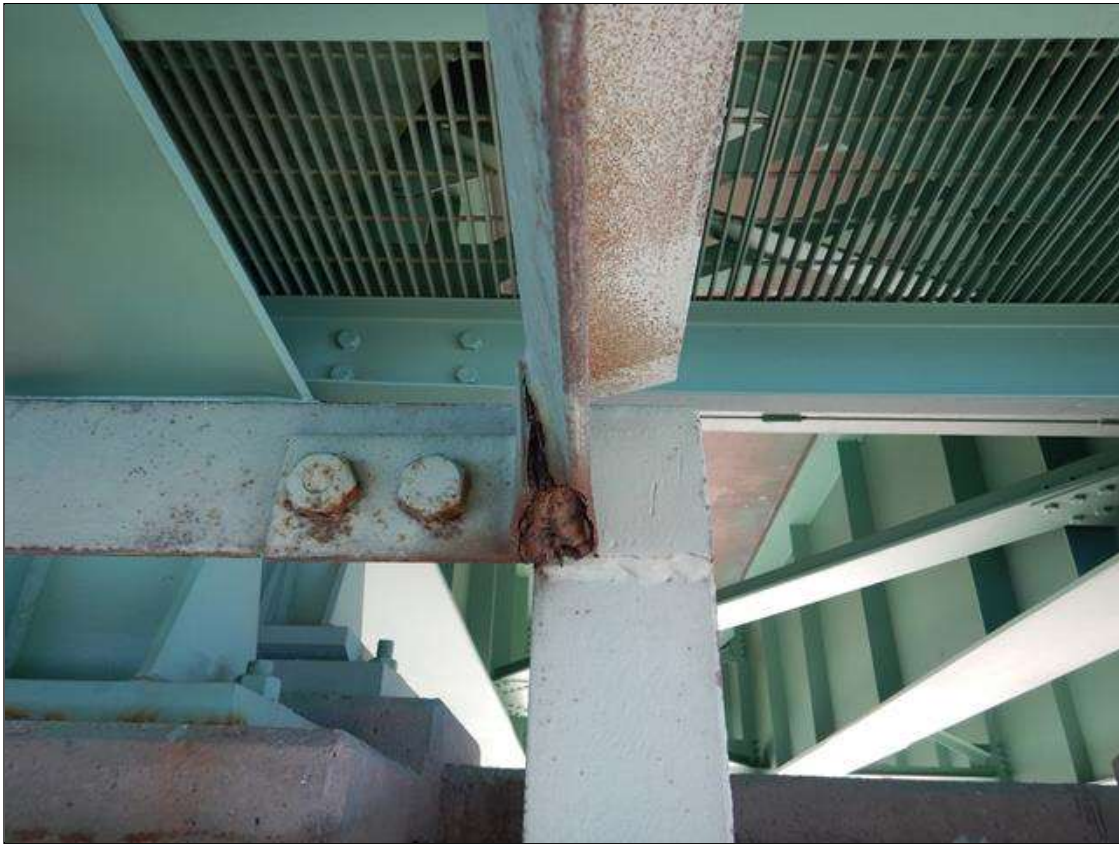
Span 16 Beam 8: Surface corrosion and with pack rust between members of the platform attached to the beams at the east face of bent 15.

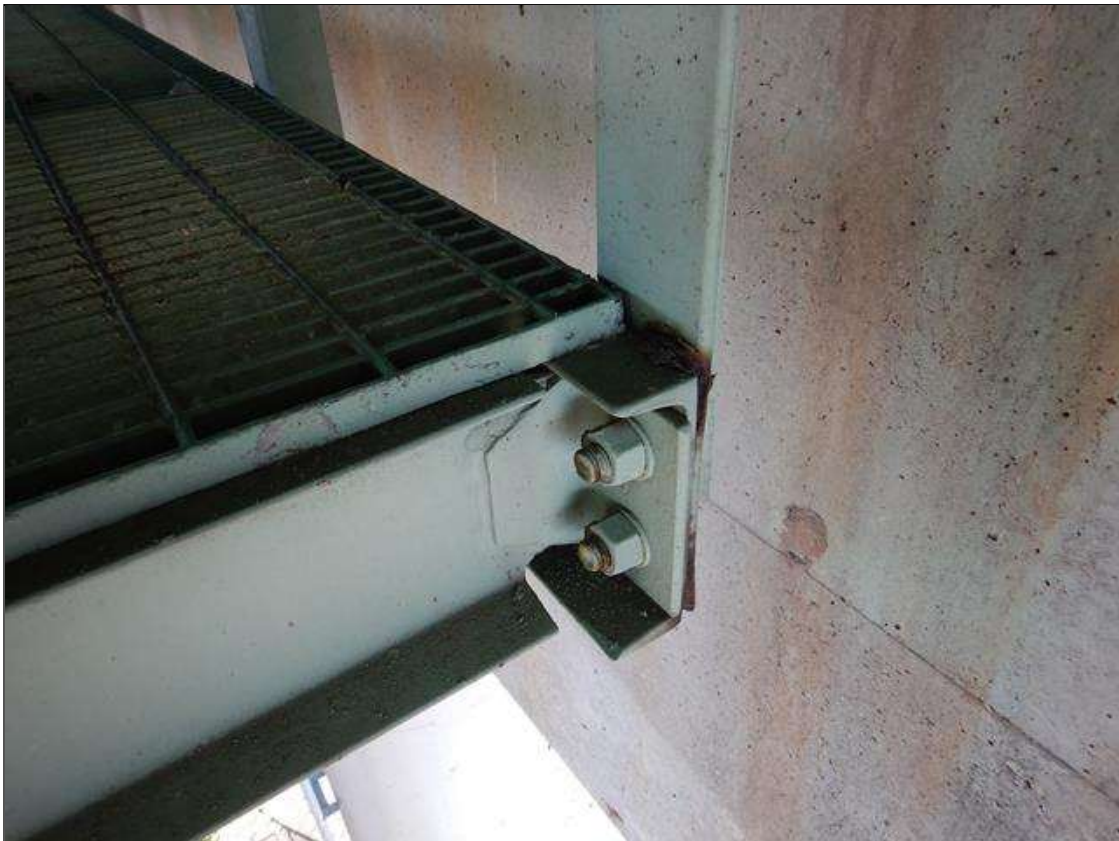
Span 16 Beam 8: Surface corrosion and with pack rust between members of the platform attached to the beams at the east face of bent 15.

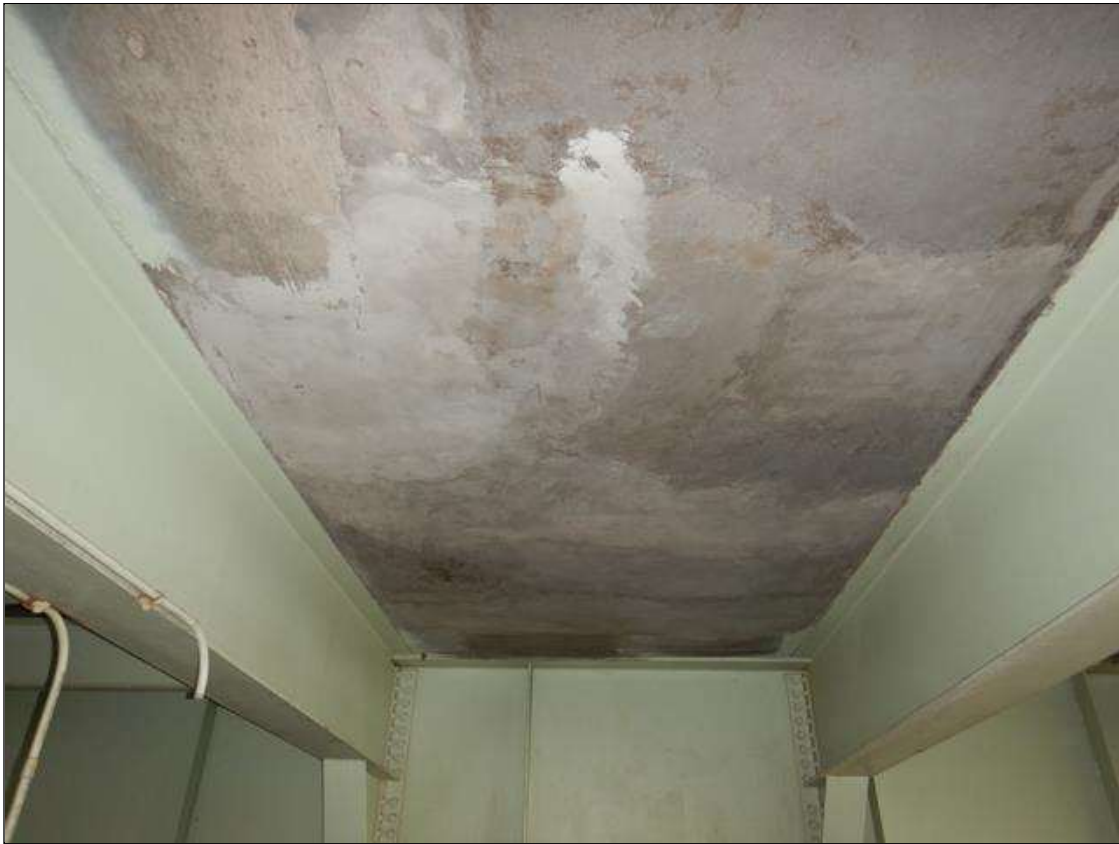
Span 19 Deck: [NEW REPAIR- PATCHING] FORMERLY --> PRIORITY MAINTENANCE - large spall with exposed rebar on the deck bottom between stringer 5 and 6 (16ft x 8ft x 2in)

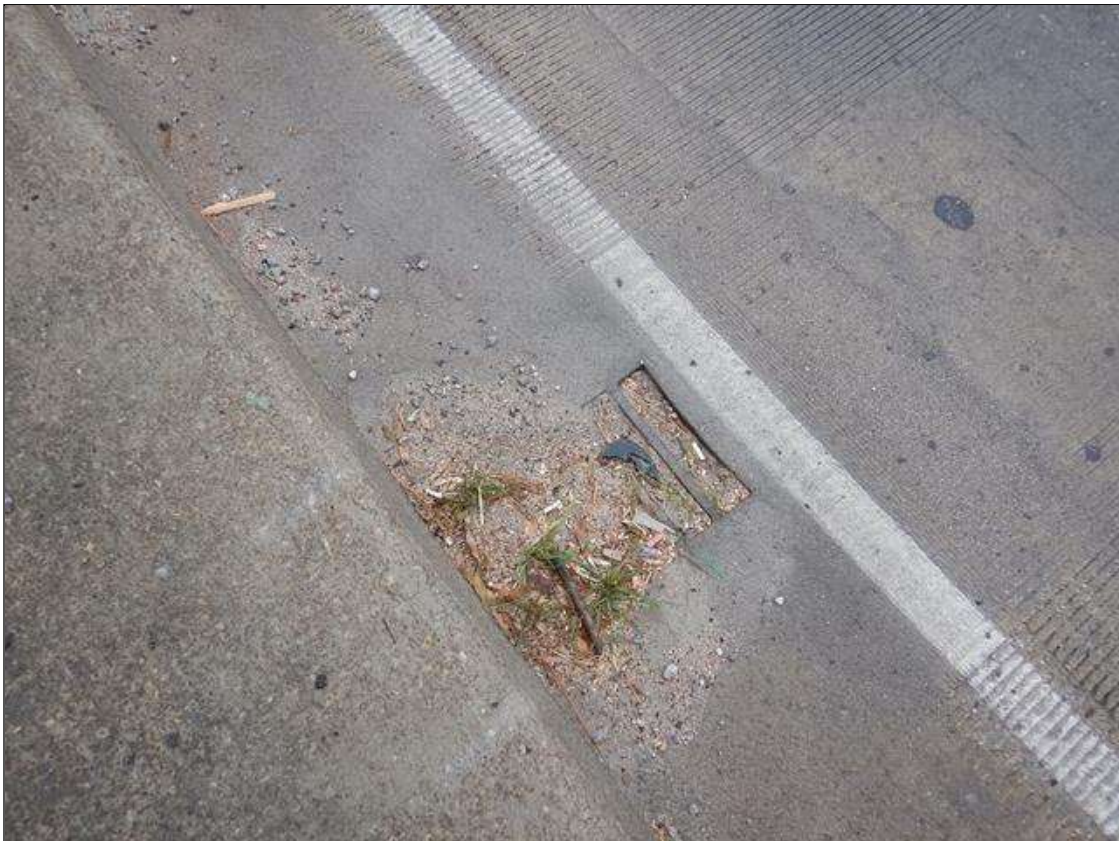
ALONG THE RIGHT & LEFT GUTTERLINES, THE DRAINAGE SYSTEM INLETS ARE IMPACTED WITH DEBRIS IN SCATTERED LOCATIONS.

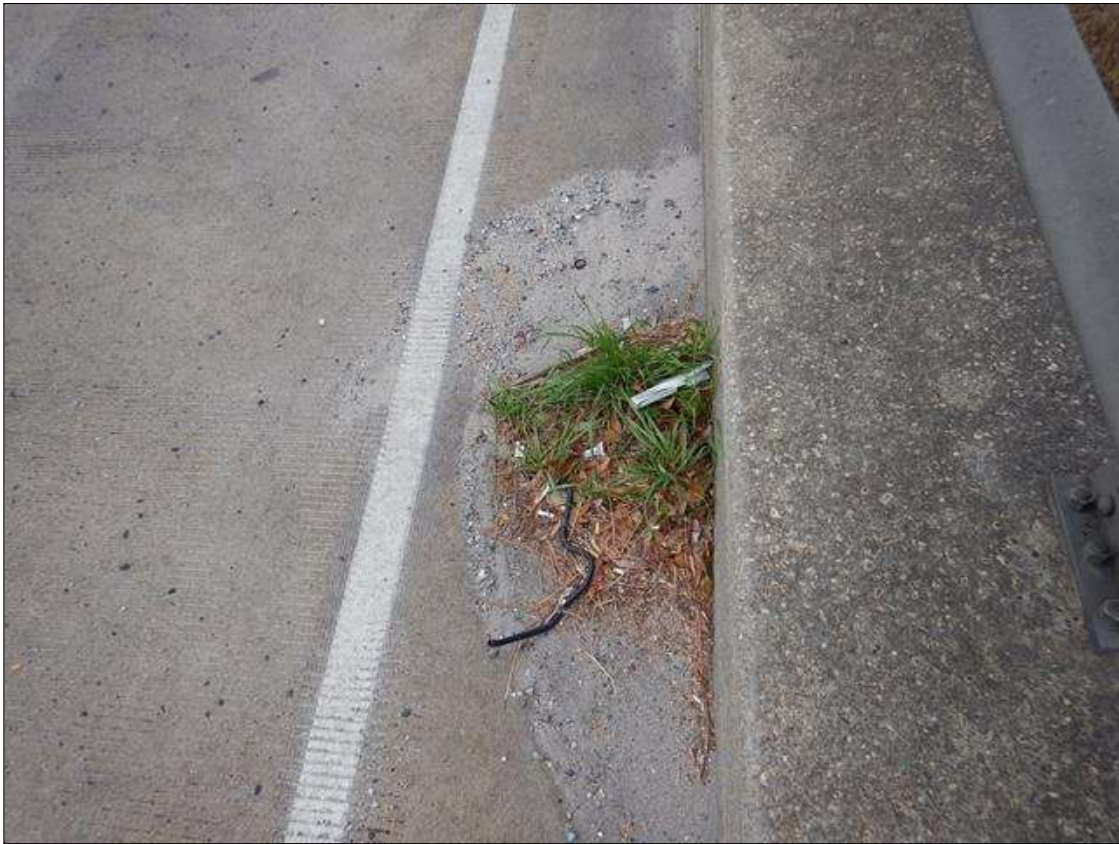
ALONG THE RIGHT & LEFT GUTTERLINES, THE DRAINAGE SYSTEM INLETS ARE IMPACTED WITH DEBRIS IN SCATTERED LOCATIONS.

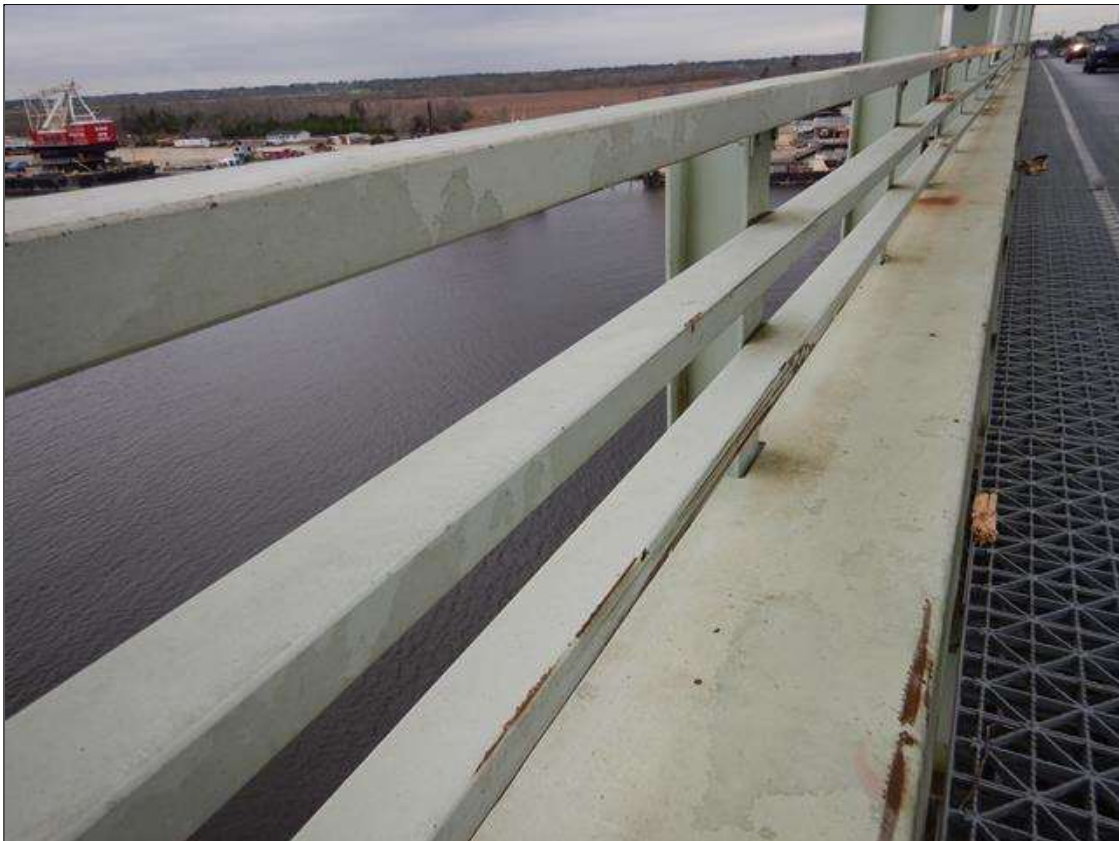
Span 18 Lift Span Left Bridge Rail: IMPACT DAMAGE/SCRAPES ON LEFT CURB WITH ASSOCIATED SURFACE CORROSION.

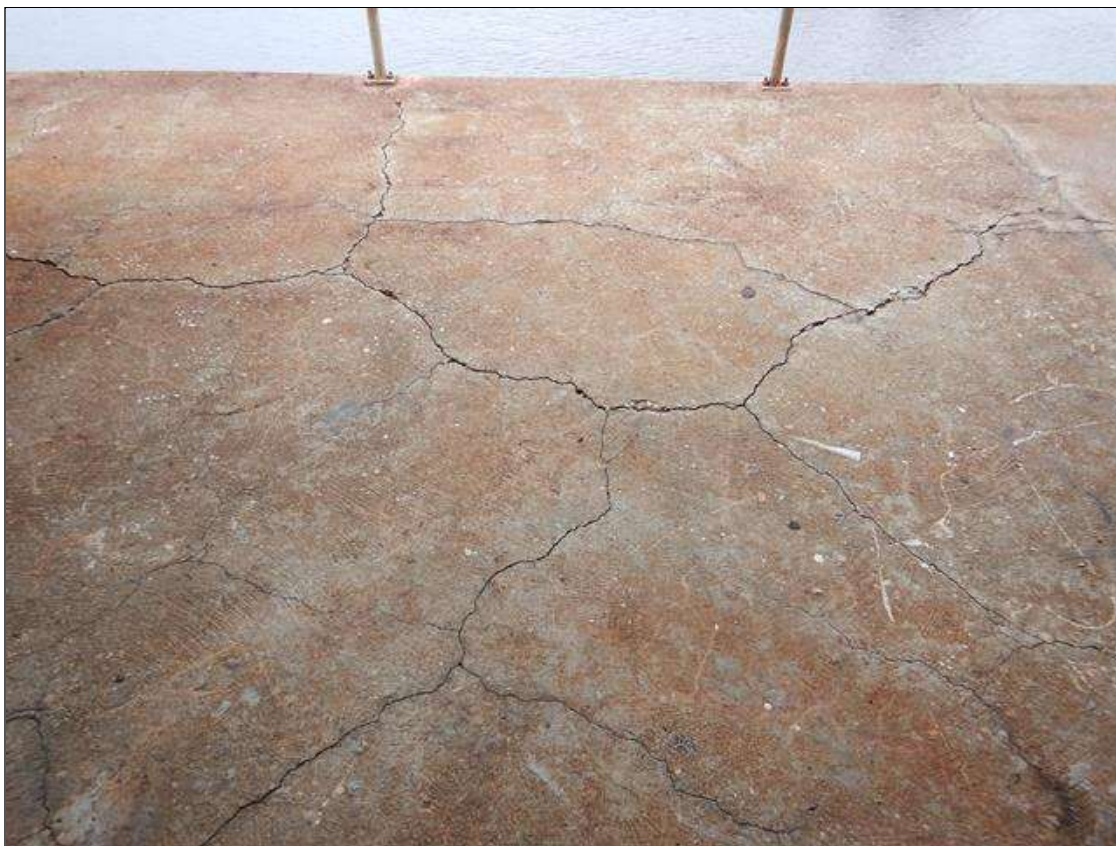
Bent 16 - Lift Span Bent Cap 1: cracking up to (1/8") wide on the top face at the southwest corner

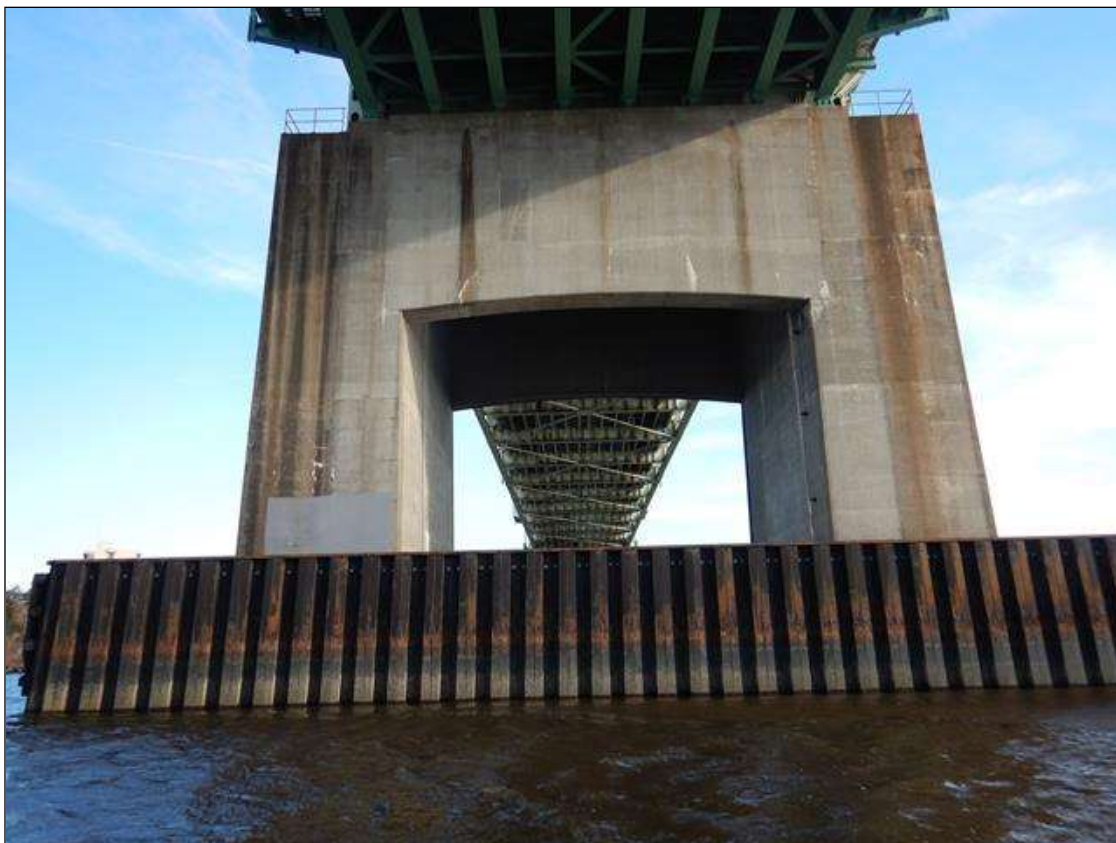
Bent 16 - Lift Span Bent Pile 1: VERTICAL AND MAP CRACKING UP TO 1/16" OPEN WITH EFFLORESCENCE ON EAST FACE.

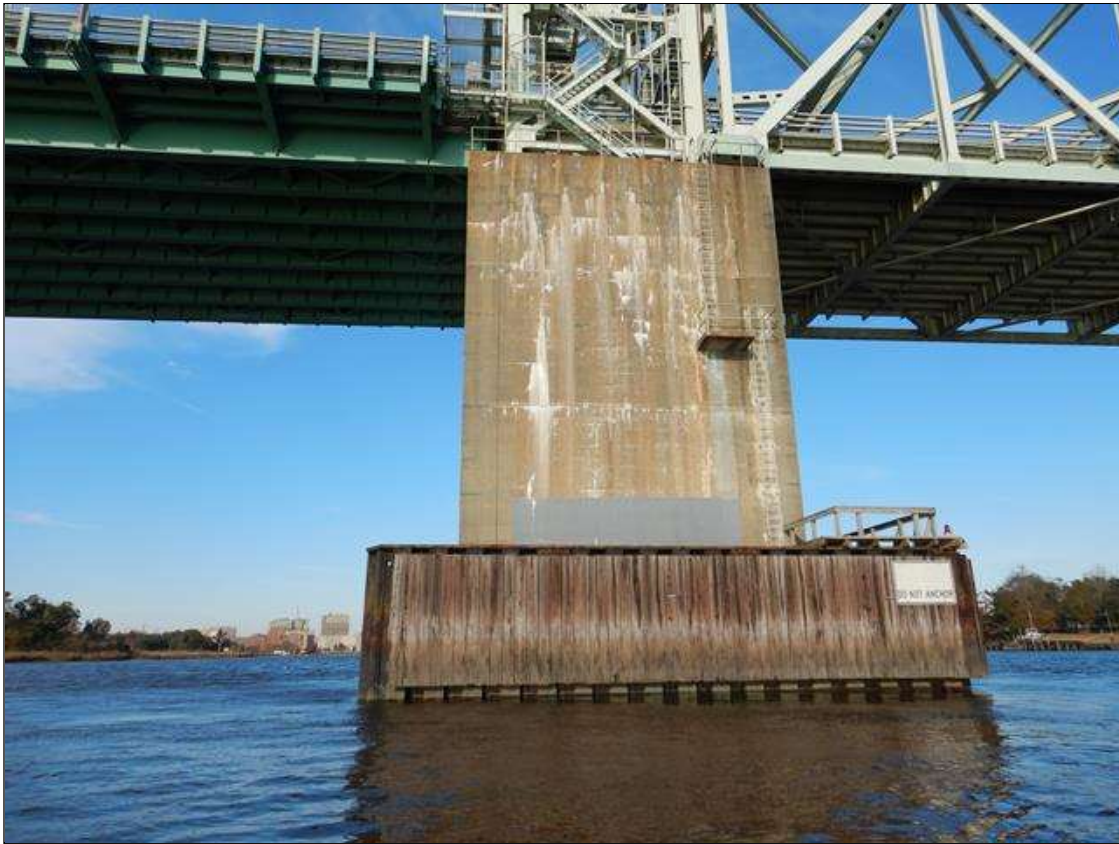
Bent 16 - Lift Span Bent Pile 1: HAIRLINE TO 1/16" WIDE CRACKING WIDE/ EFFLORESCENCE SCATTERED THROUGHOUT 25% OF ALL FACES

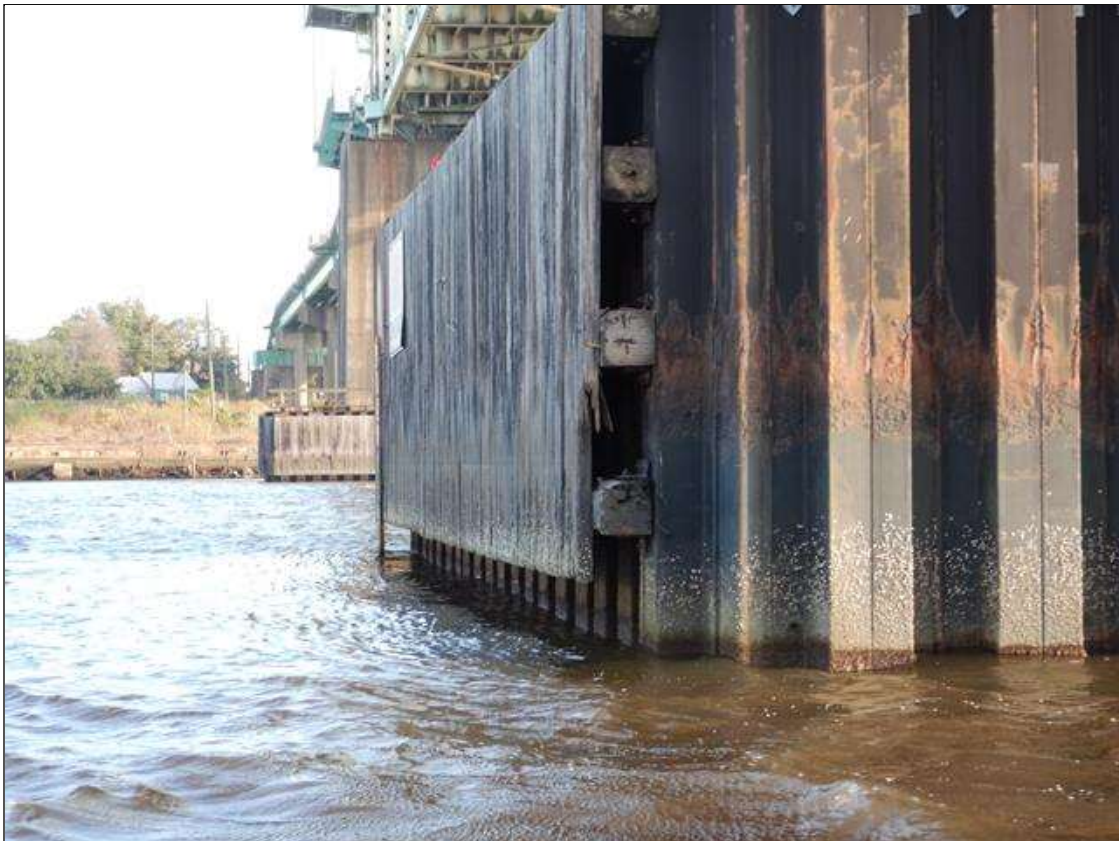
Bent 16 - Lift Span Bent Footing: BROKEN BOARD 5' HIGH NEAR CENTERLINE OF EAST FACE IN TIMBER SHEETING BUFFER.

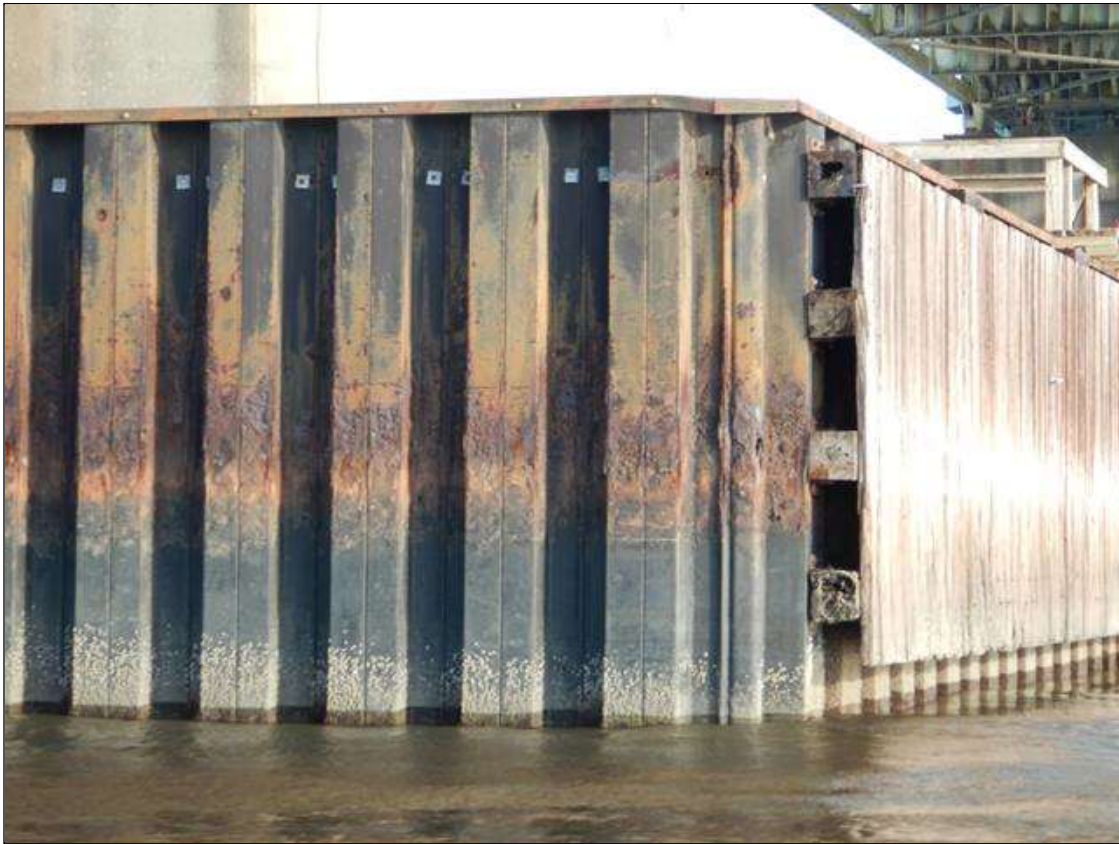
Bent 16 - Lift Span Bent Footing: WEST FACE: STEEL SHEETING HAS SURFACE LOSS OF SECTION UP TO 3/16" IN TIDAL ZONE 5' HIGH.

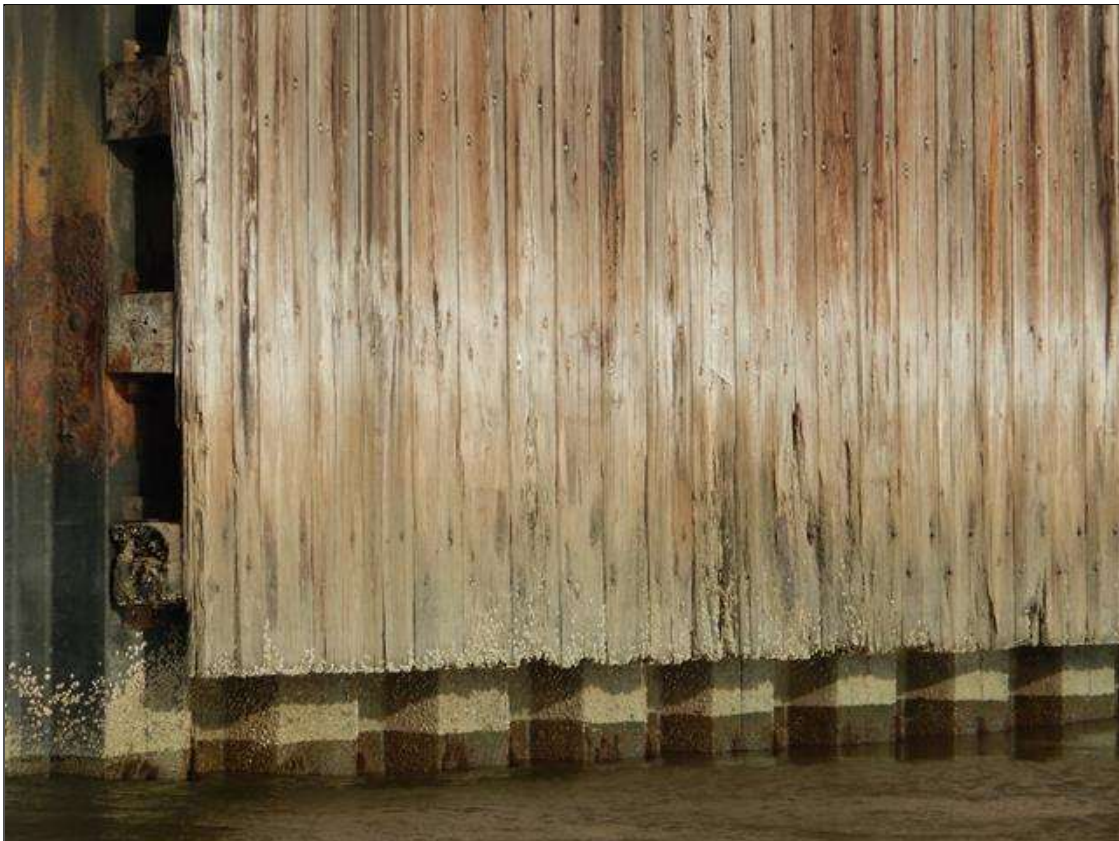
Bent 16 - Lift Span Bent Footing: EAST FACE: TIMBER SHEETING BUFFER BOARDS ARE DECAYED 6' HIGH X UP TO 2" DEEP ALONG TIDAL ZONE.

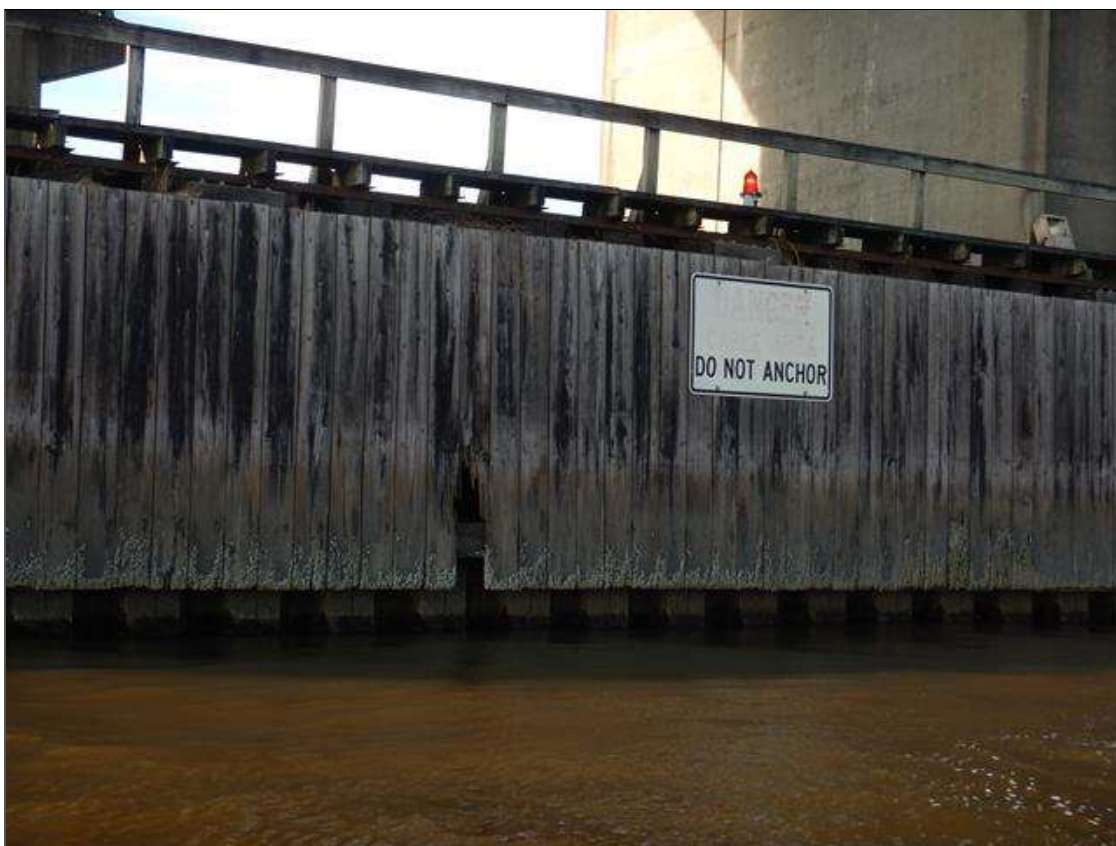
Bent 16 - Lift Span Bent Footing: broken and decayed timber at the bottom of the northwest corner (similar throughout)

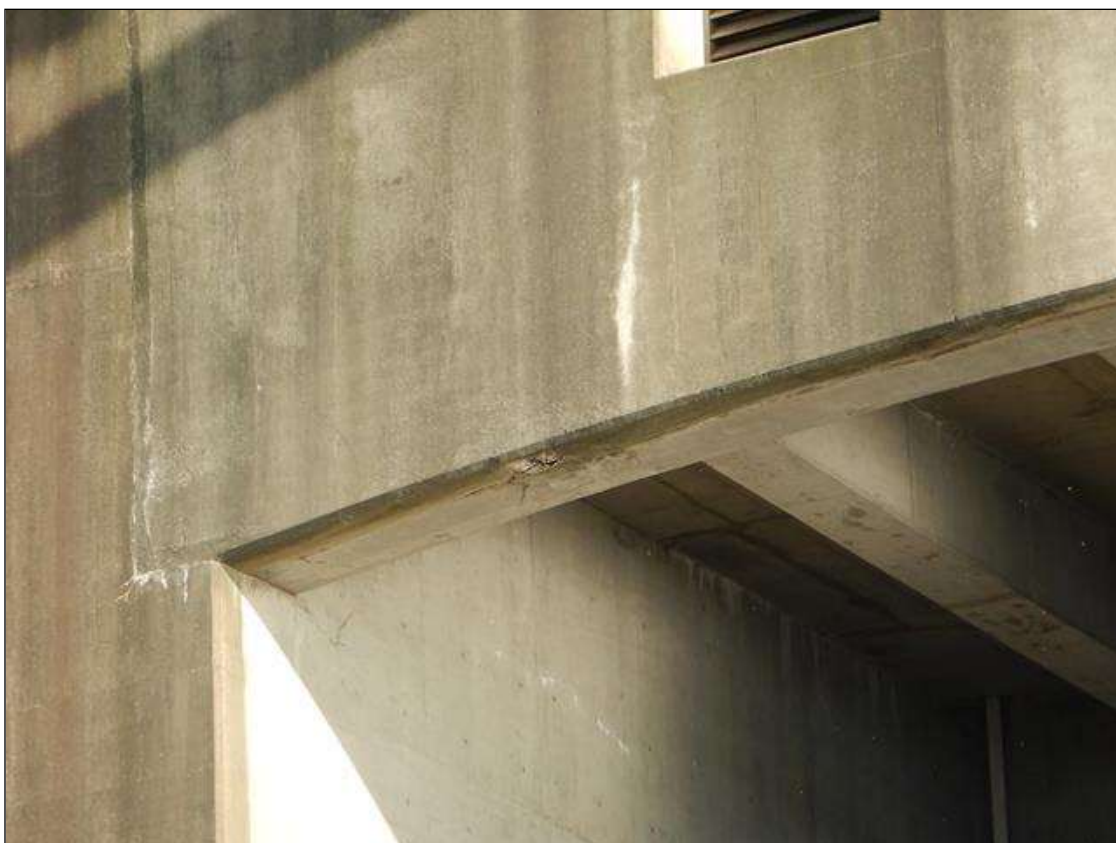
Bent 17 - Lift Span Bent Cap 1: DELAMINATION and spall with exposed rebar on the bottom face of the west arch (24" x 36" x 1 1/2")
