NC DEPARTMENT OF TRANSPORTATION
DIVISION OF HIGHWAYS
STRUCTURE MANAGEMENT UNIT

Structure Safety Report

Routine Element Inspection - Contract

DIVISION: 3 COUNTY: NEW HANOVER STRUCTURE NUMBER: 640013 FREQUENCY: 24 MONTHS

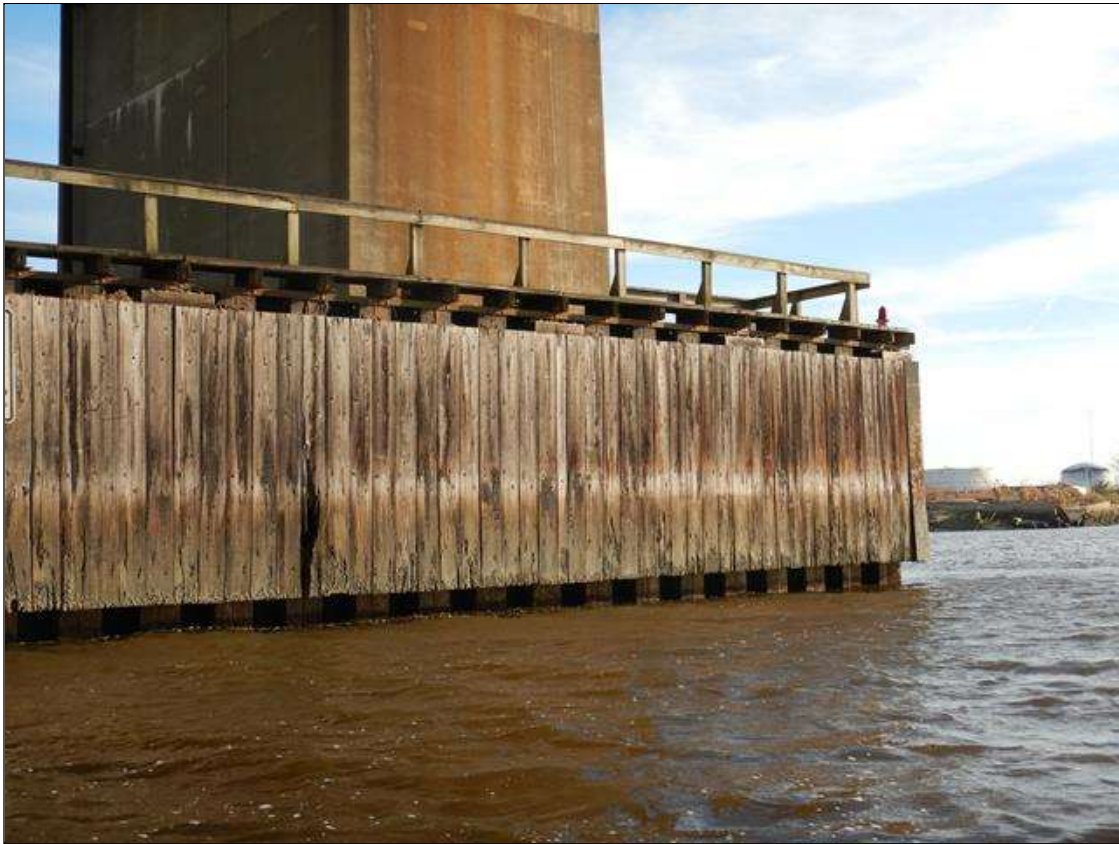
Bent 17 - Lift Span Bent Footing: TIMBER SHEETING BUFFER BOARD IS BROKEN AND MISSING NEAR CENTERLINE ON WEST FACE.

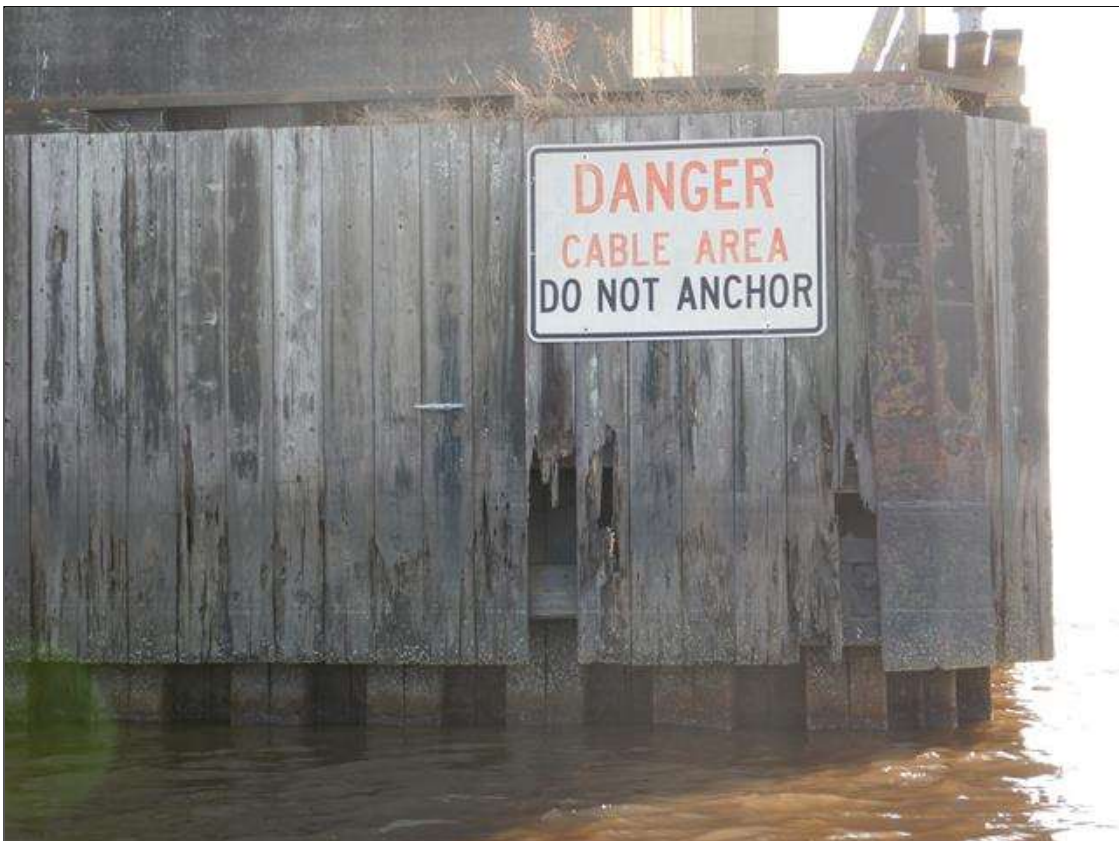
Bent 17 - Lift Span Bent Footing: (5) TIMBER SHEETING BUFFER BOARDS ARE DECAYED/BROKEN ON NORTHWEST SIDE WITH SECTION MISSING.

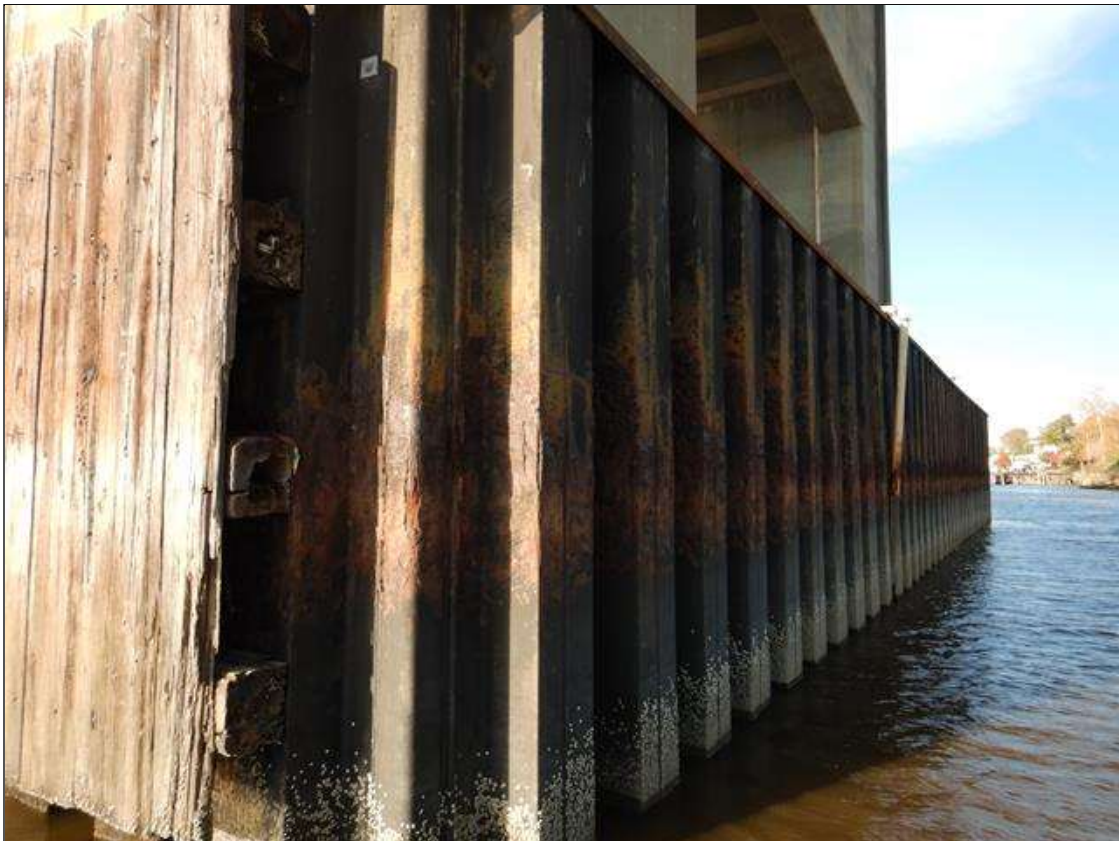
Bent 17 - Lift Span Bent Footing: TIMBER BUFFER WHALERS ARE DECAYED UP TO 2' DEEP ON ENDS AT SOUTH SIDE.

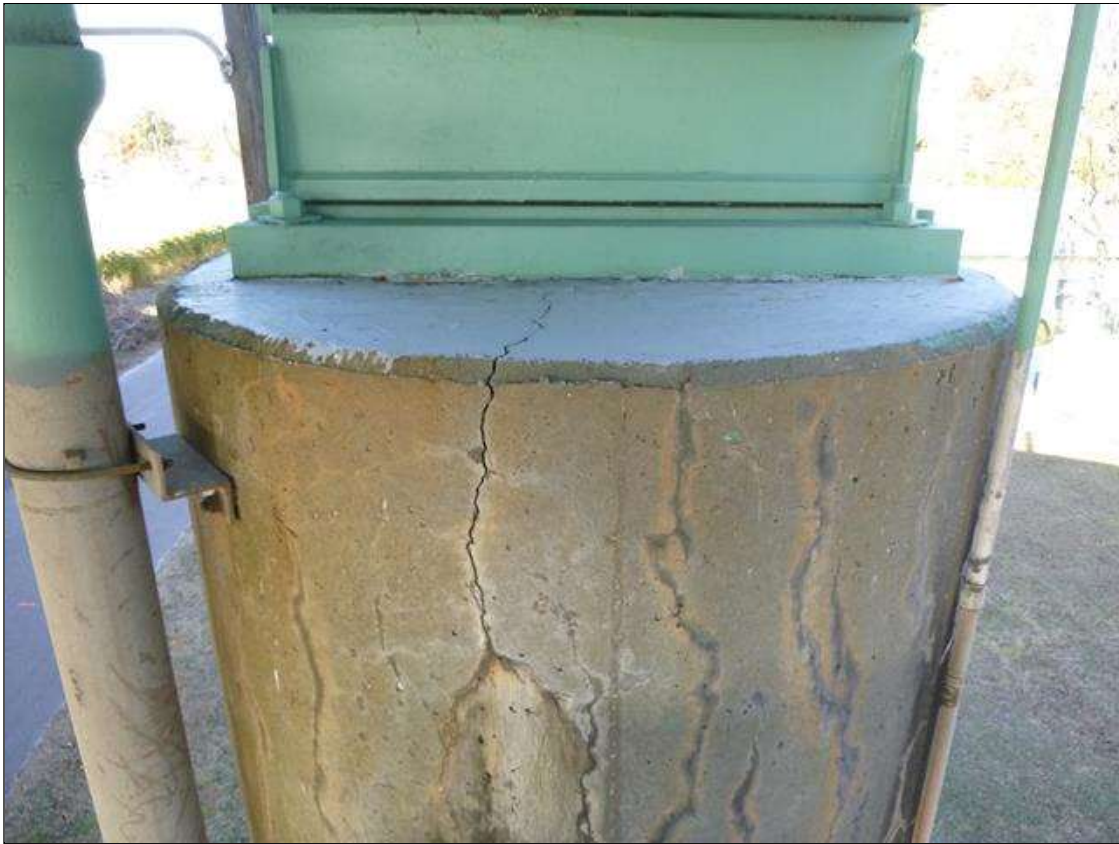
Bent 23 Pile 1: SCATTERED THROUGHOUT THE COLUMN, VERTICAL & MAP CRACKING TO 1/4" WIDE. THIS CRACKING CROSSES THE TOP OF THE COLUMN UNDER THE BEARING AREA.

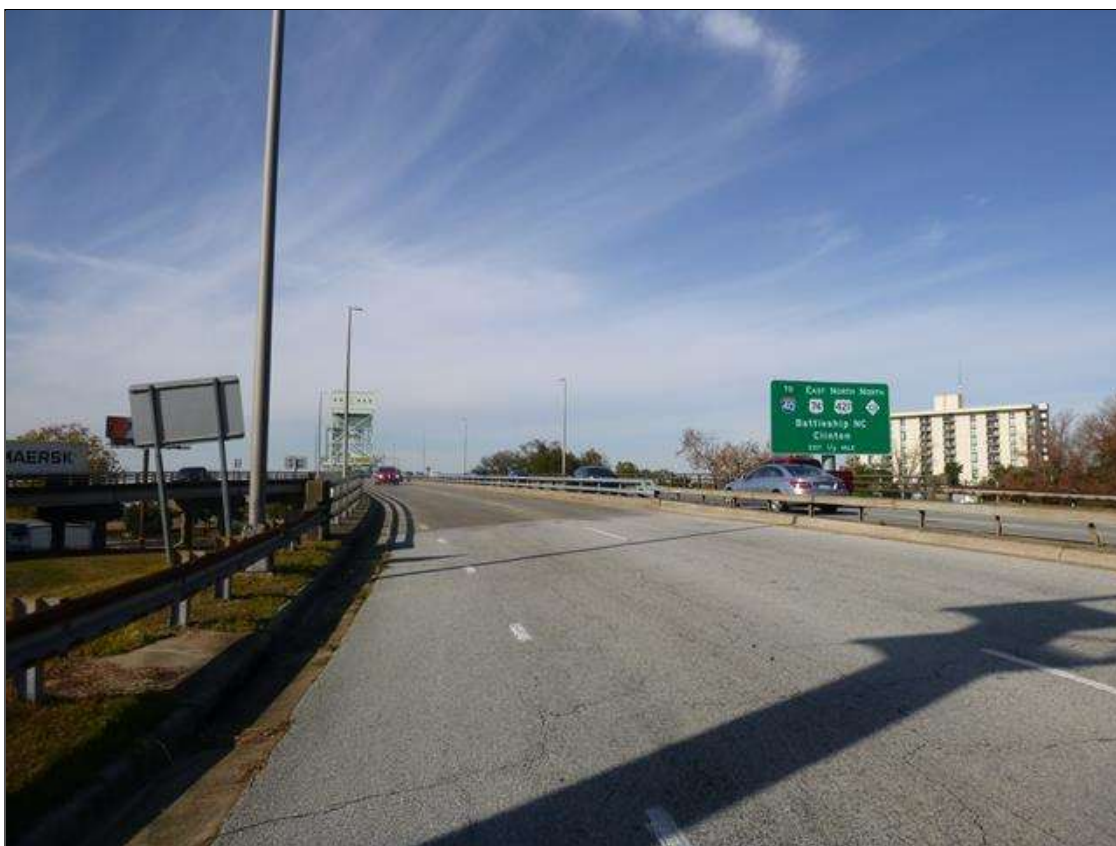
EAST APPROACH, EASTBOUND LANES, LOOKING WEST

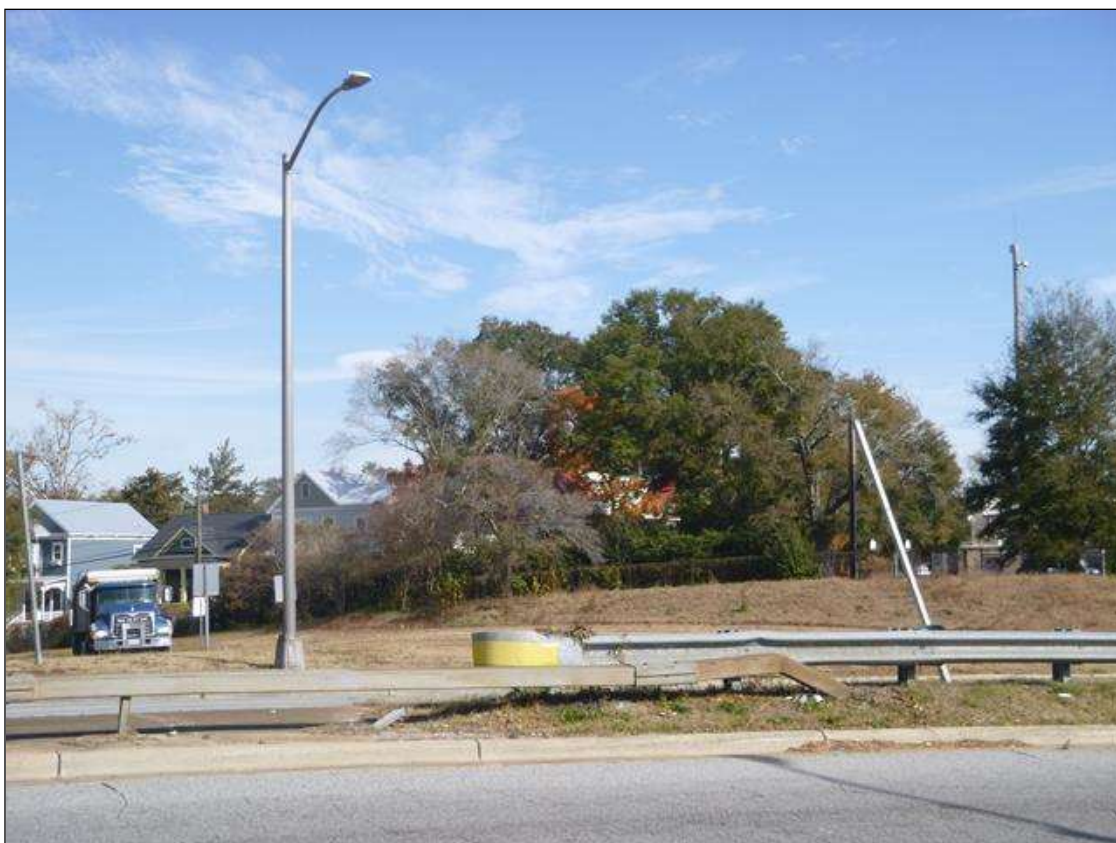
THE MEDIAN RAIL AT THE EAST APPROACH TRANSITIONS TO GUARDRAIL AT AN UNPAVED ISLAND

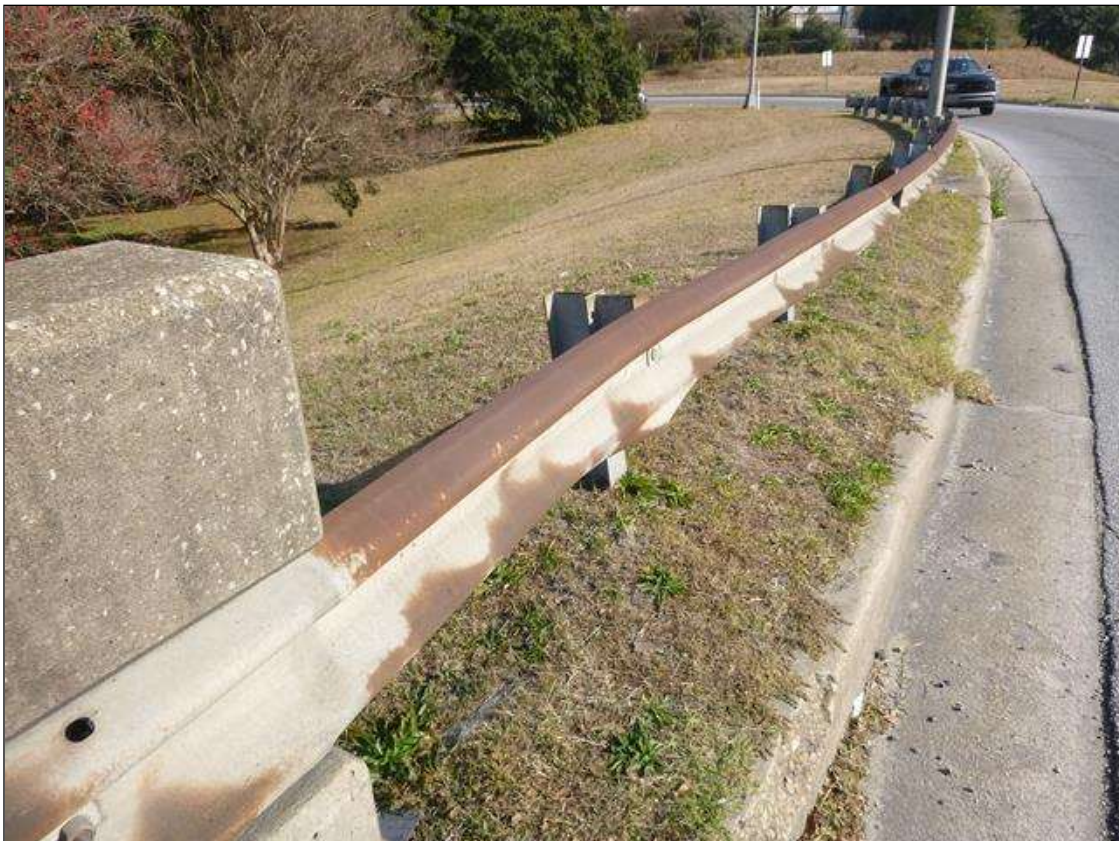
NORTHEAST CORNER GUARDRAIL, IMPACT DAMAGE WITH POSTS DEFLECTED UP TO 6" AT THE TOP
[APPROXIMATELY 10' LONG]

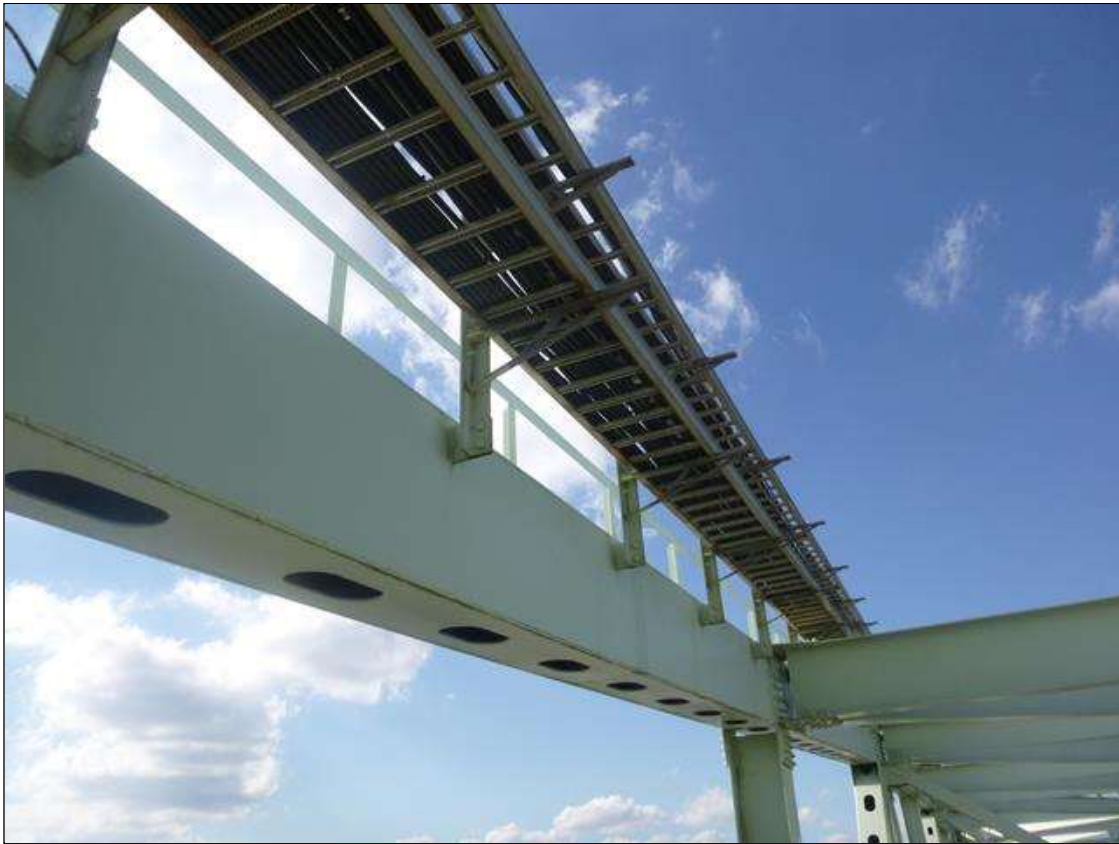
SPAN 20 BAY 3, A 4" STEEL PIPE HANGS FROM STEEL SUPPORTS, FULL SPAN LENGTH

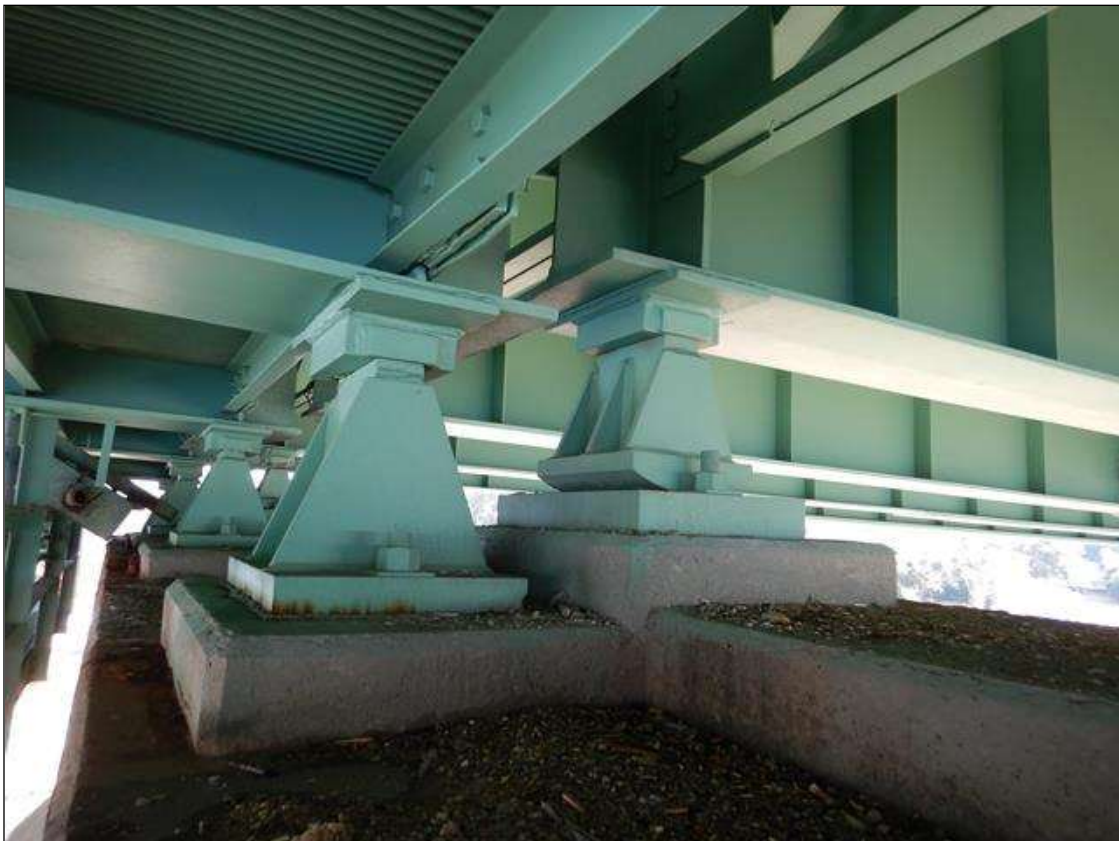
SPAN 20 BAY 6, A 3" INSULATED STEEL PIPE HANGS FROM STEEL SUPPORTS, FULL SPAN LENGTH

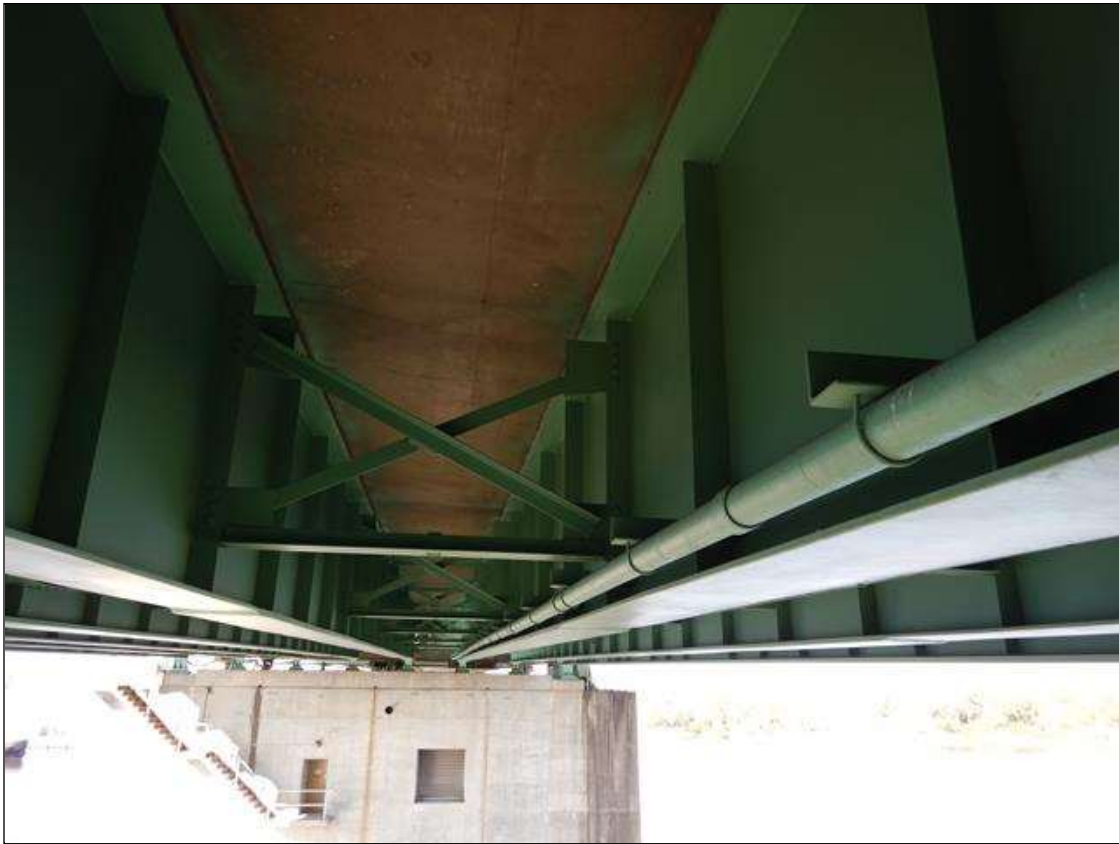
SPAN 20 BAY 2, (3) UP TO 4" DIAMETER STEEL CONDUITS HANG FROM STEEL SUPPORTS, FULL SPAN LENGTH

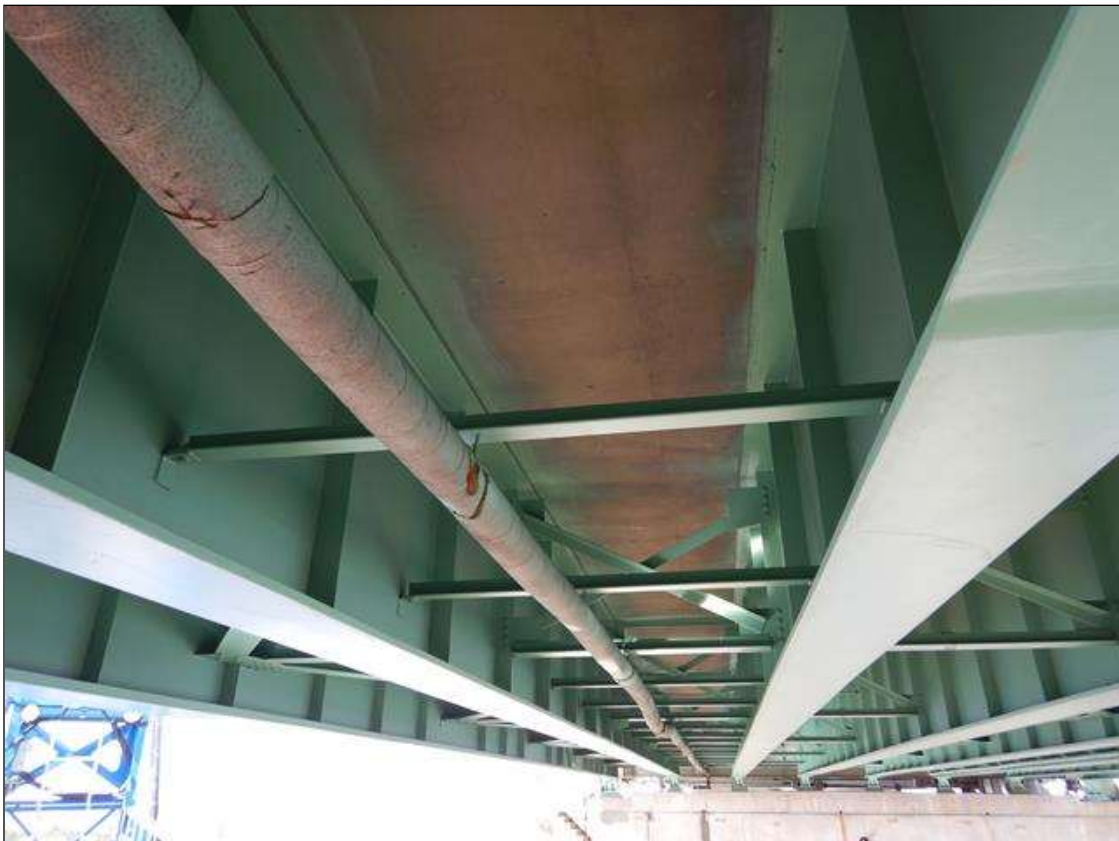
SPAN 20, A STEEL CATWALK HANGS FROM GIRDERS 1-4 [APPROXIMATELY 30' LONG X 3' WIDE X 3' HIGH]

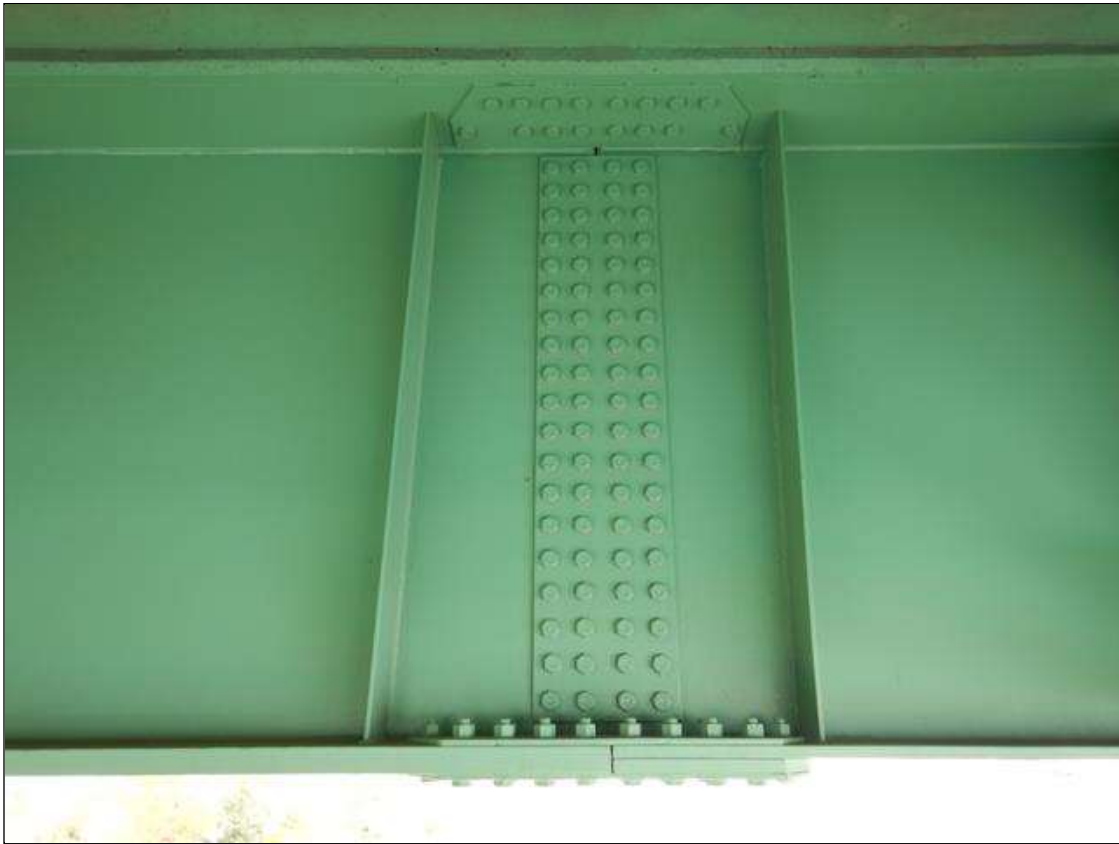
SPAN 14 GIRDER 2 SPLICE [TYPICAL FOR ALL CONTINUOUS SPAN SPLICES]

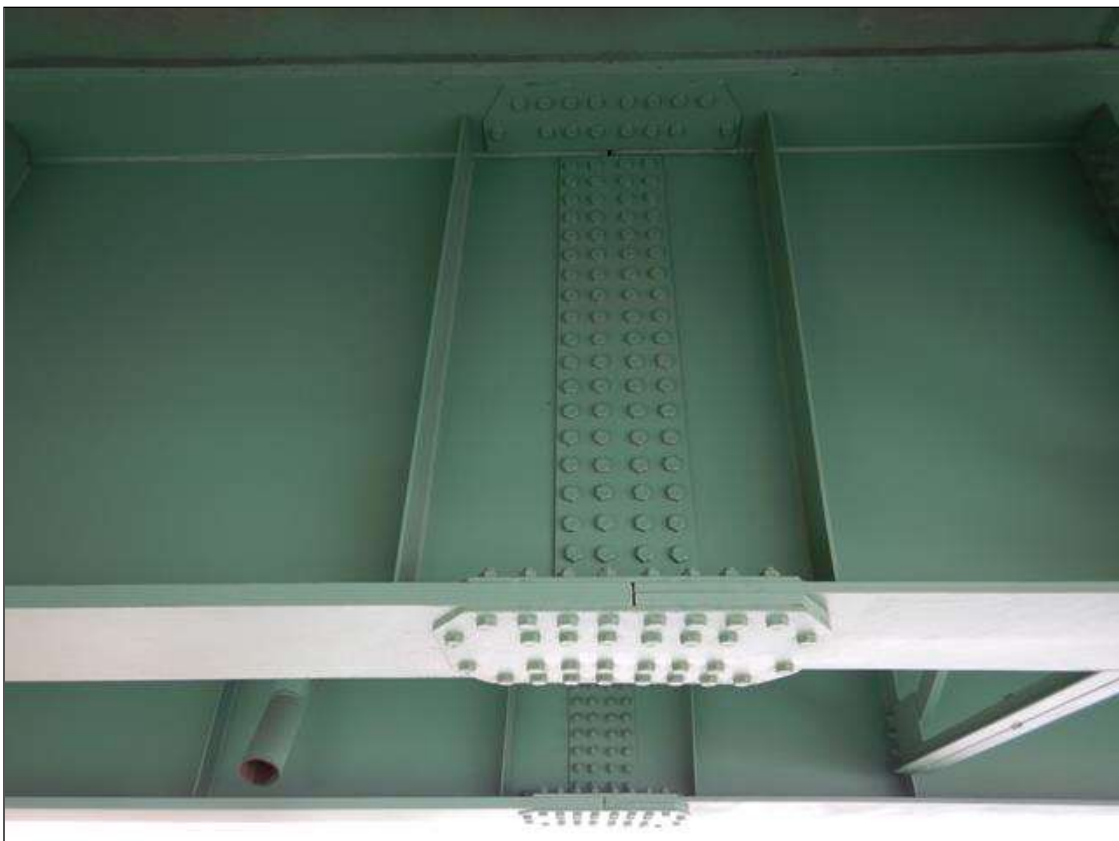
SPAN 14 GIRDER 2 SPLICE [TYPICAL FOR ALL CONTINUOUS SPAN SPLICES]

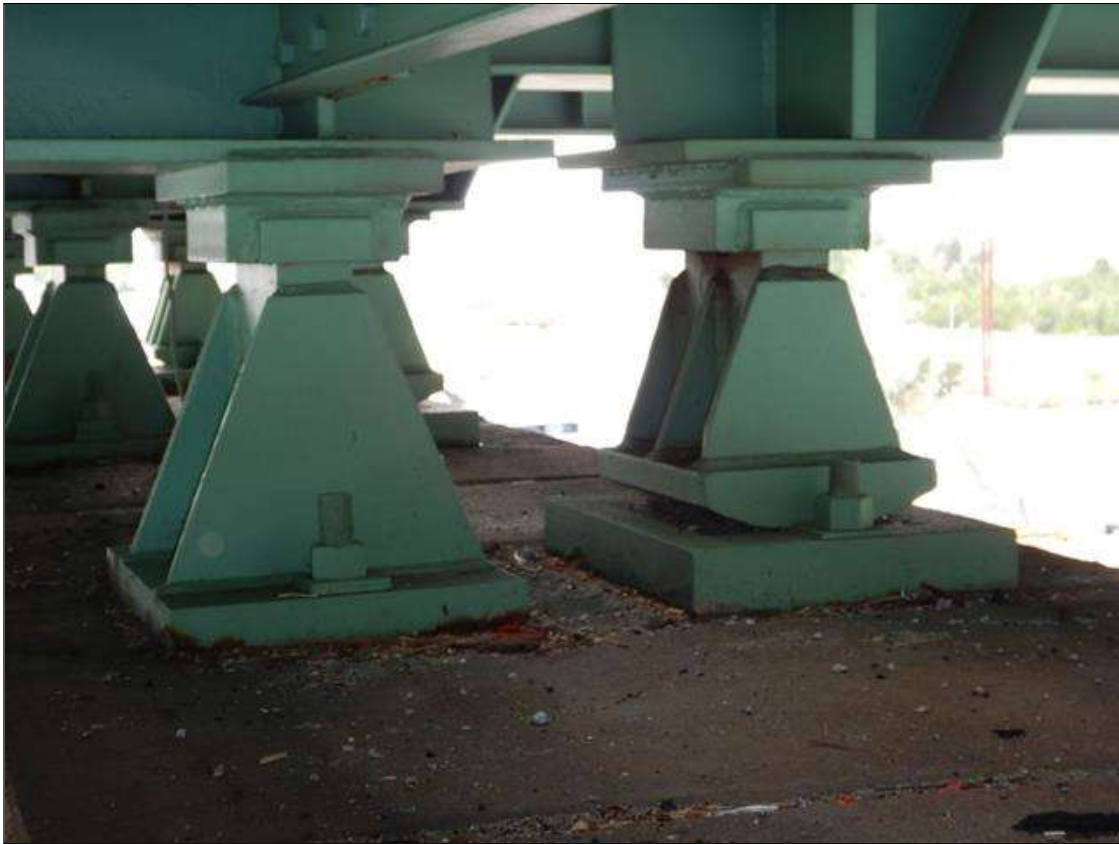
GIRDERS 6 BEARINGS AT BENT 15 [TYPICAL FOR ALL BEARINGS AT BENT 15]

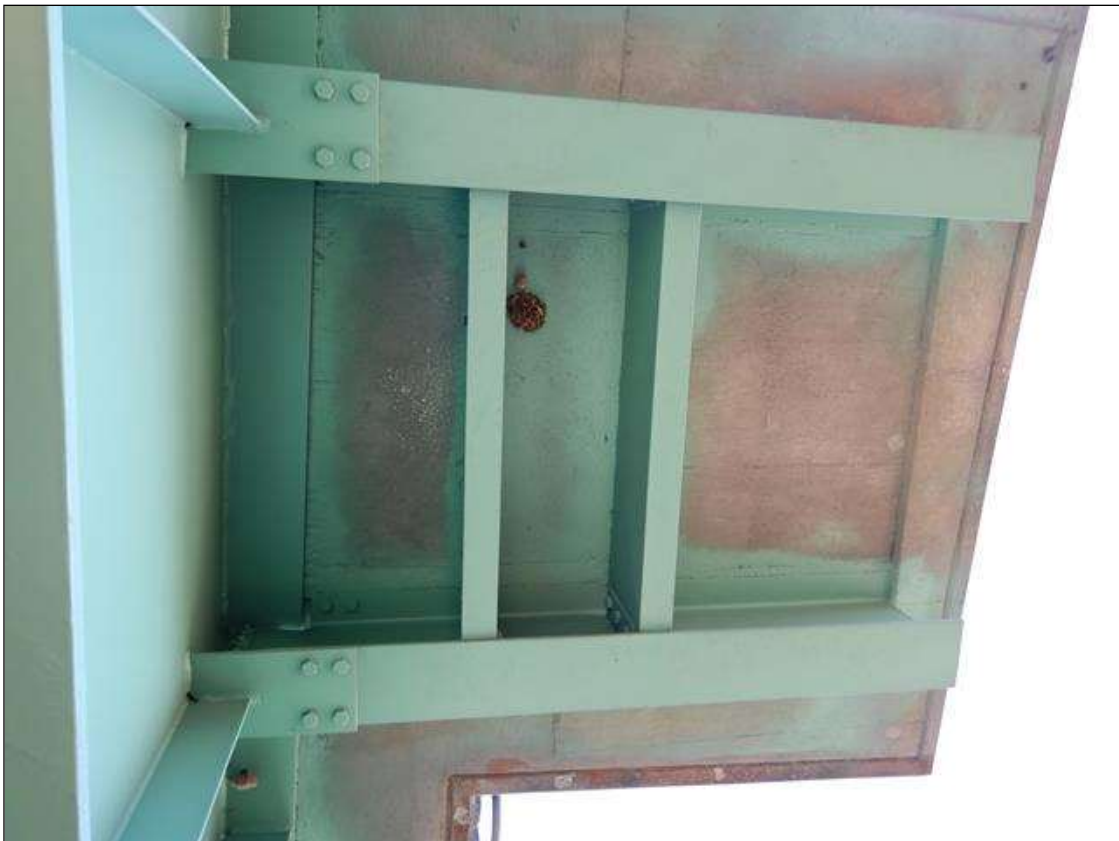
SPAN 23, LEFT SIDE, FRAMING FOR THE TRAFFIC SIGNAL OVERHANG [SIMILAR AT SPAN 13 RIGHT SIDE]

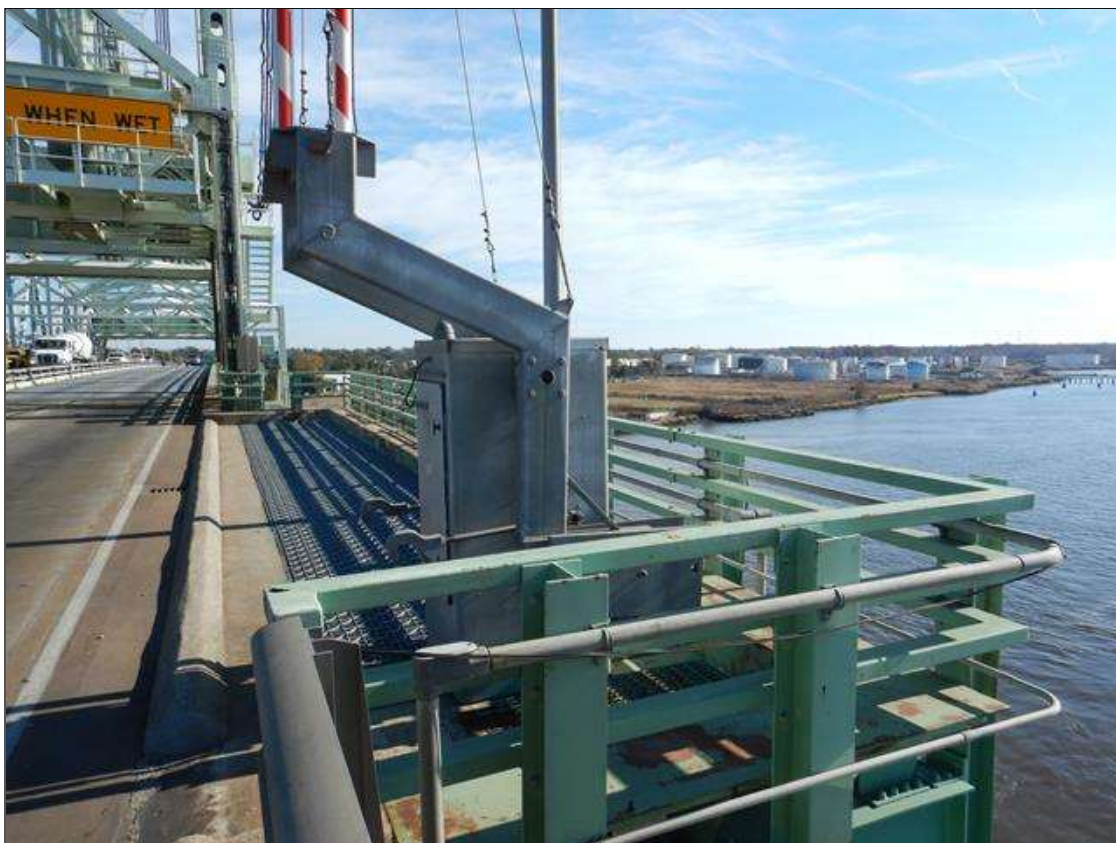
SPAN 16 RIGHT SIDE, STOP ARM [SIMILAR AT SPAN 14 RIGHT SIDE, SPAN 20 LEFT SIDE, AND SPAN 22 LEFT SIDE]

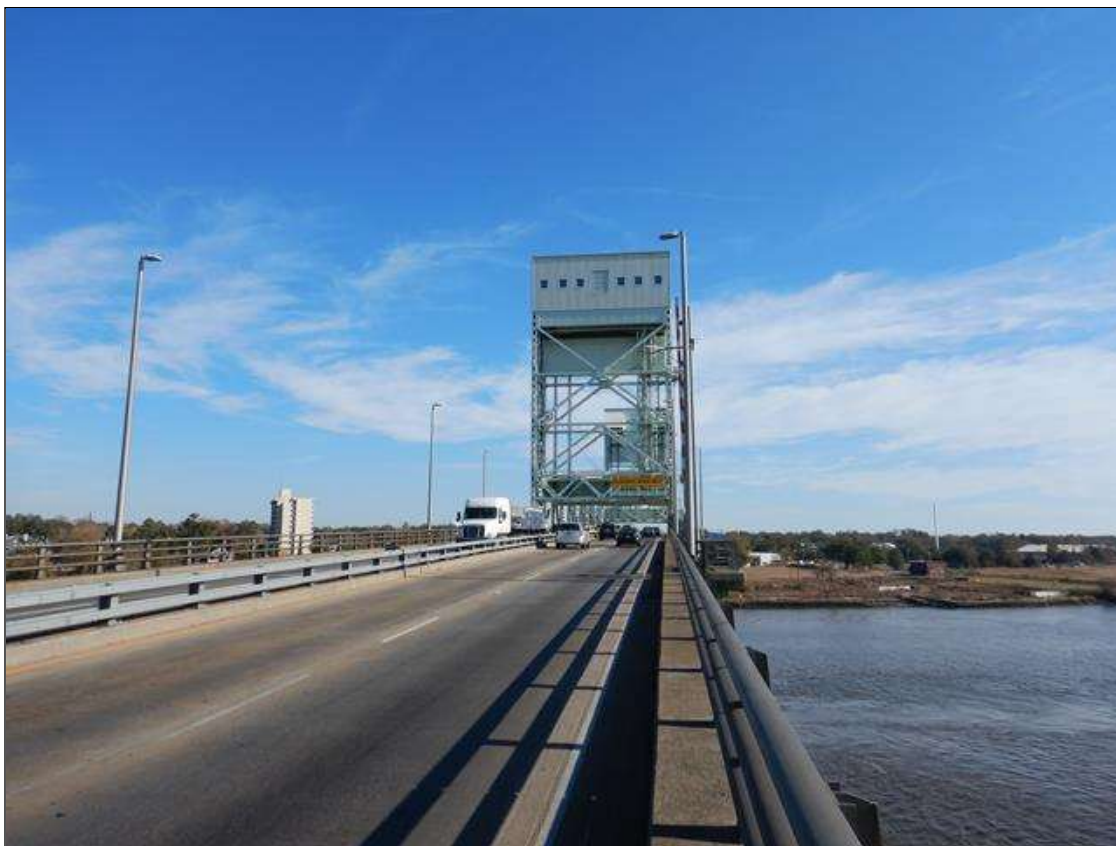
SPAN 16 RIGHT SIDE, PARKING AREA [SIMILAR AT SPAN 16 LEFT SIDE, AND SPAN 20 LEFT & RIGHT SIDES]

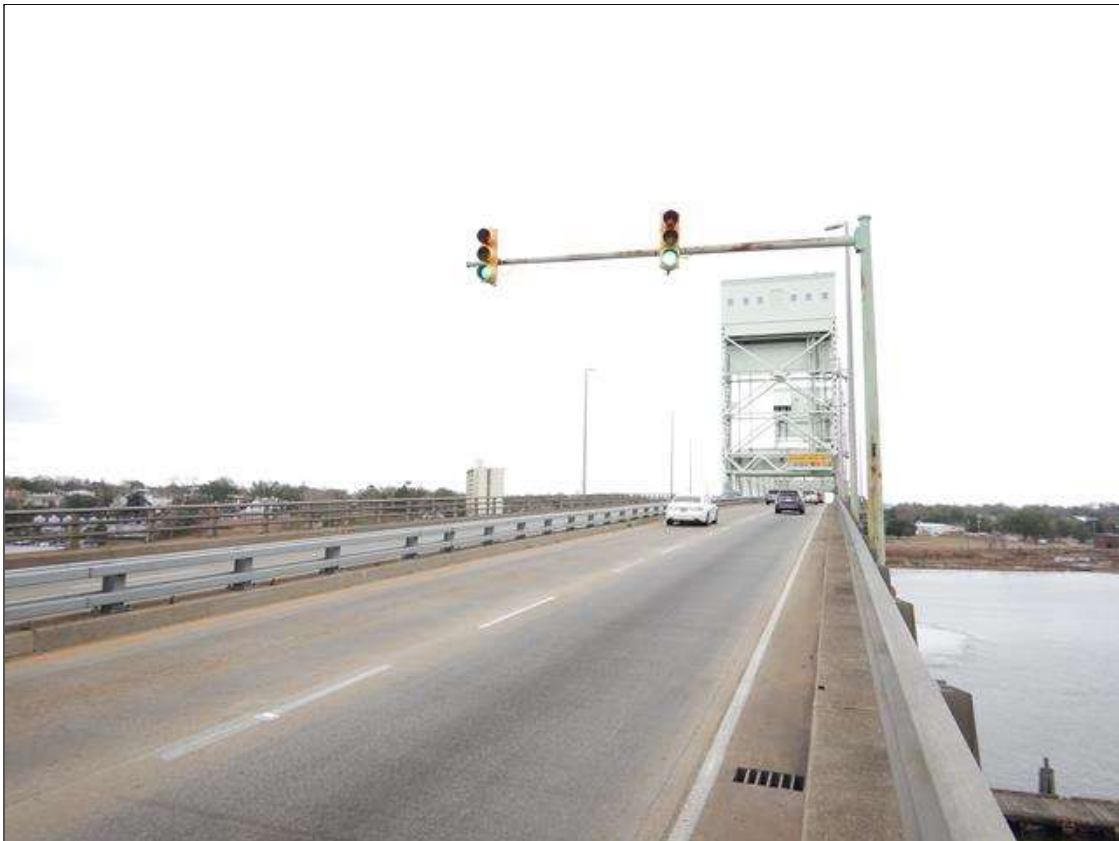
SPAN 15 RIGHT SIDE, LIGHT POLE [SIMILAR AT SPANS 2, 5, 8, 12, 14, 15, 16, 20, 21, 23, 25, 28, 29, 31, & 35 ON THE RIGHT SIDE AND SPANS 1, 3, 7, 10, 13, 14, 15, 16, 20, 21, 22, 25, 27, AND 30 ON THE LEFT SIDE]

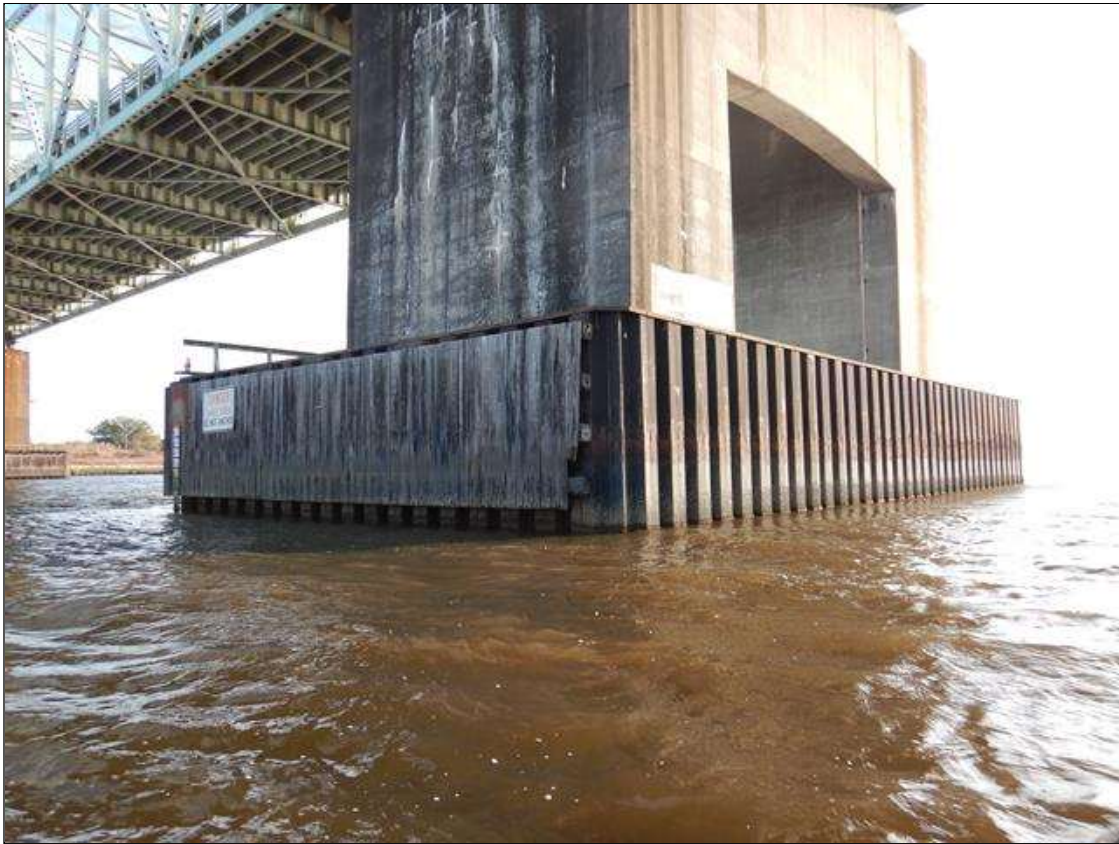
WEST TOWER PROTECTION AT THE WATERLINE, ALL SIDES [PROTECTION AT THE EAST TOWER SIMILAR]

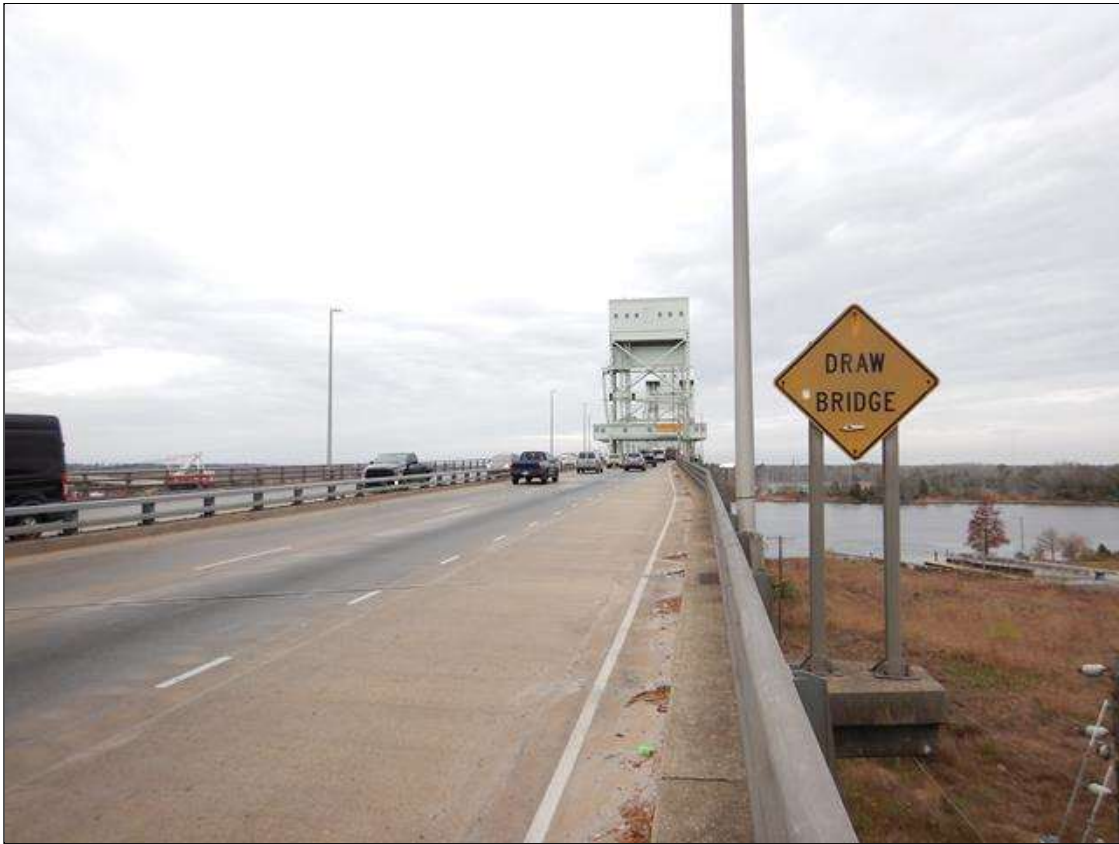
SPAN 25 LEFT SIDE, DRAW BRIDGE SIGN

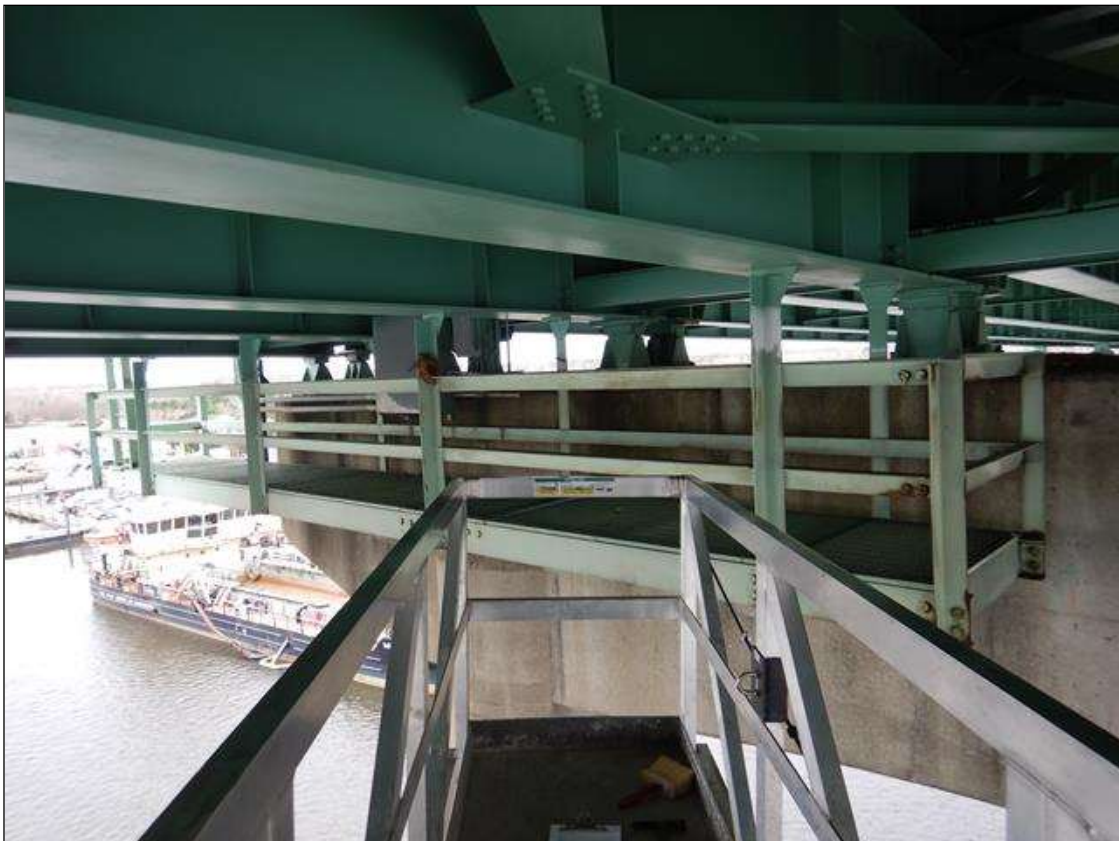
SPAN 20, A STEEL CATWALK [APPROXIMATELY 30' LONG X 50" WIDE X 46" HIGH] HANGS FROM GIRDERS 1-4 ADJACENT TO BENT 18. A SIMILAR CATWALK HANGS FROM SPAN 16 GIRDERS 5-8 ADJACENT TO BENT 15.

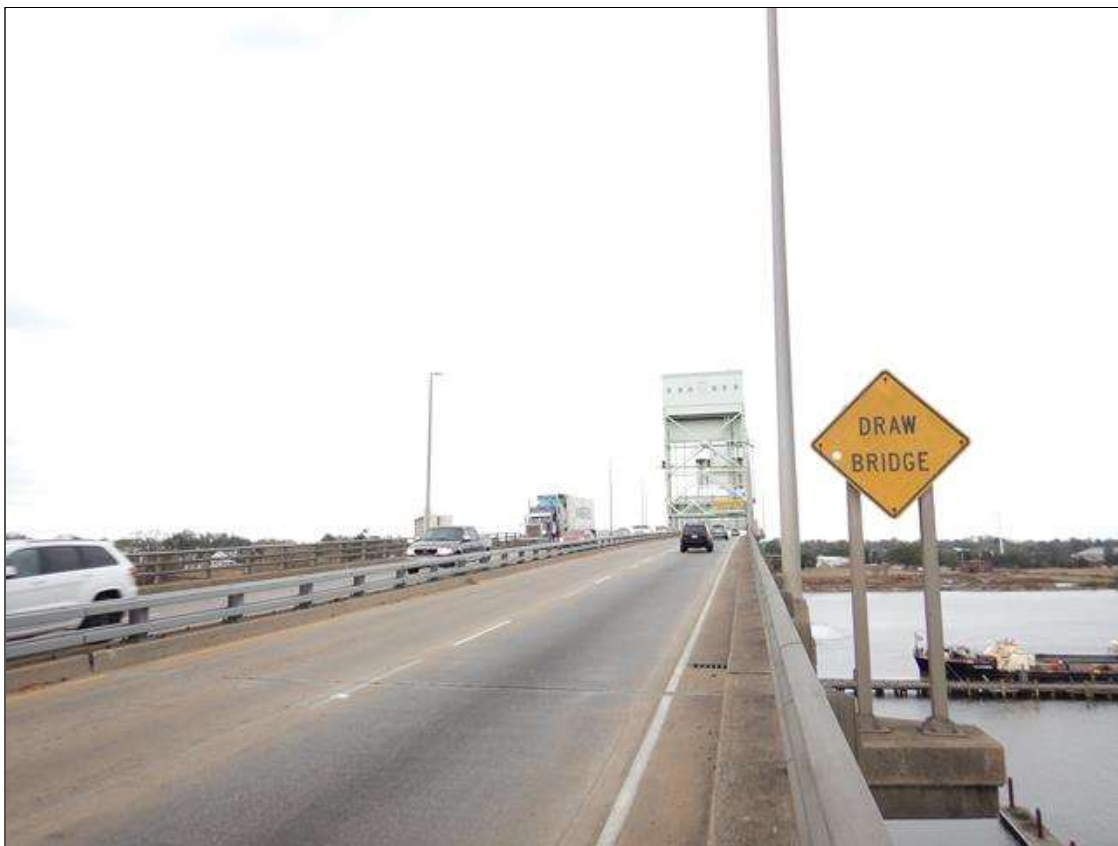
SPAN 11 RIGHT SIDE, DRAW BRIGE SIGN

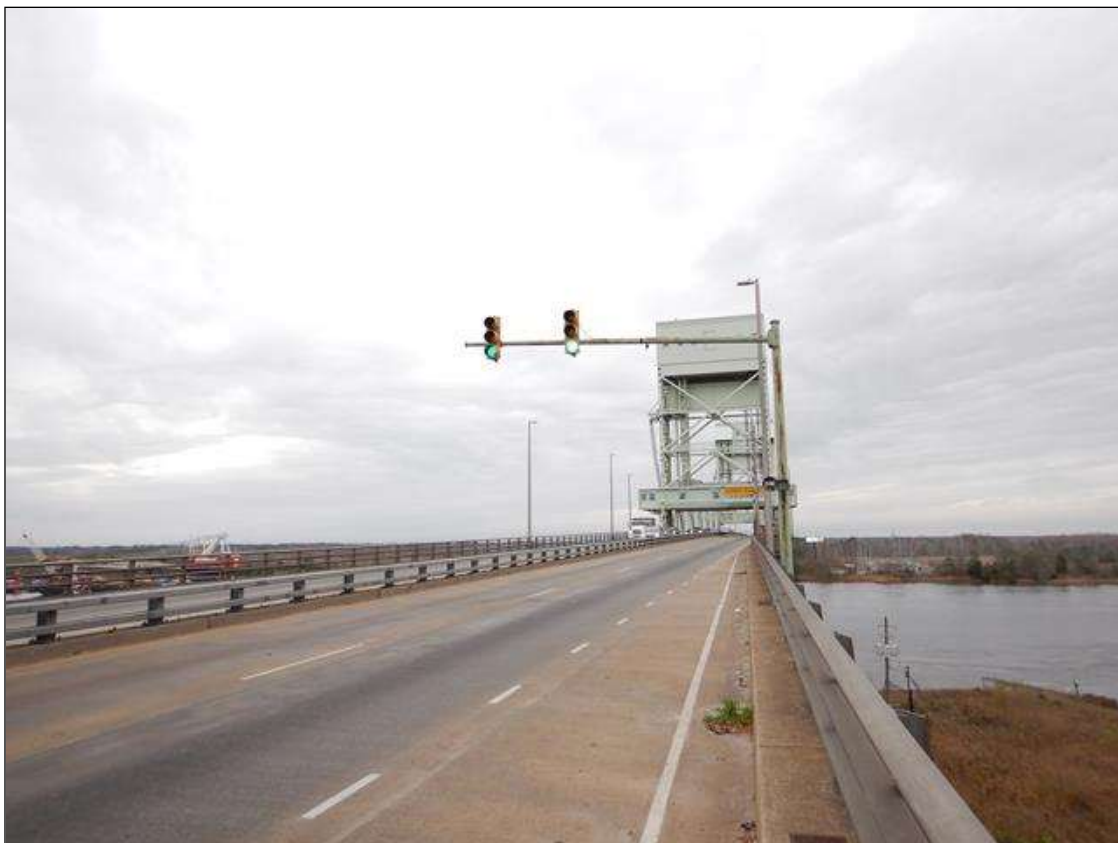
SPAN 23 LEFT SIDE, TRAFFIC SIGNAL

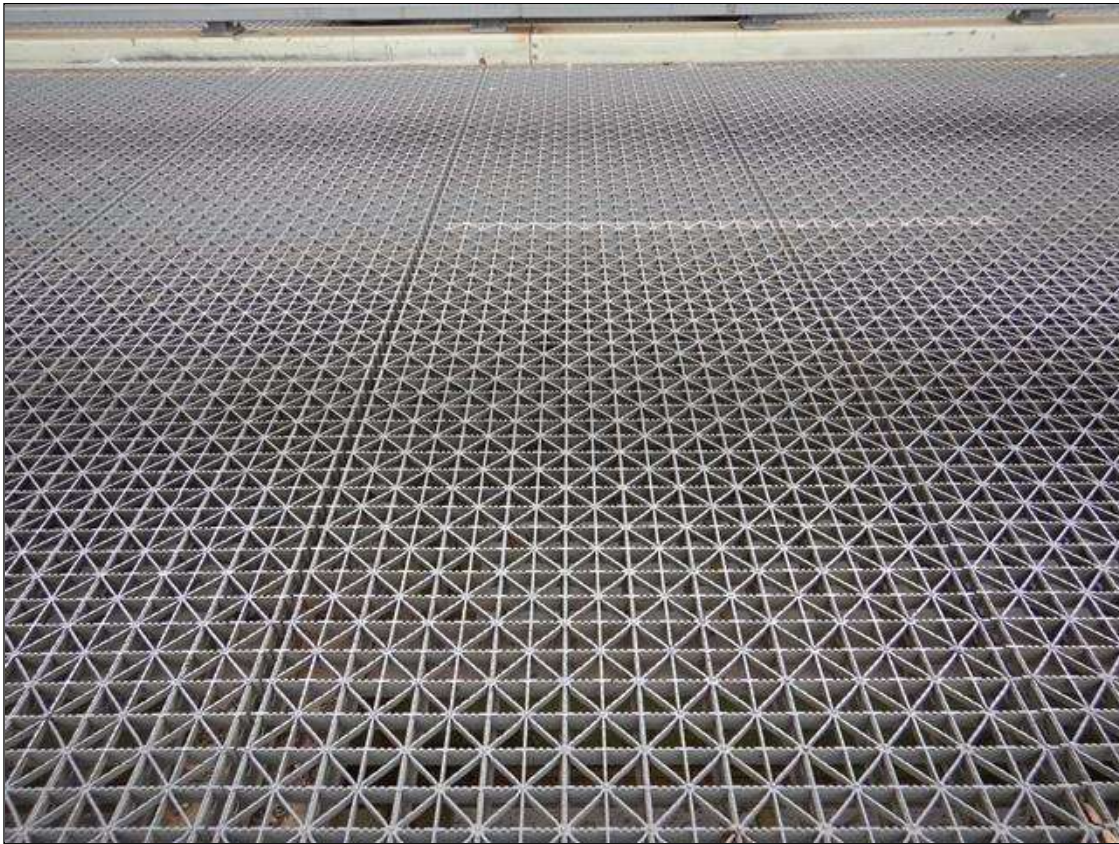
LIFT SPAN TYPICAL STEEL DECKING
