NC DEPARTMENT OF TRANSPORTATION
DIVISION OF HIGHWAYS
STRUCTURE MANAGEMENT UNIT

Structure Safety Report

Routine Element Inspection - Contract

DIVISION: 3 COUNTY: NEW HANOVER STRUCTURE NUMBER: 640013 FREQUENCY: 24 MONTHS

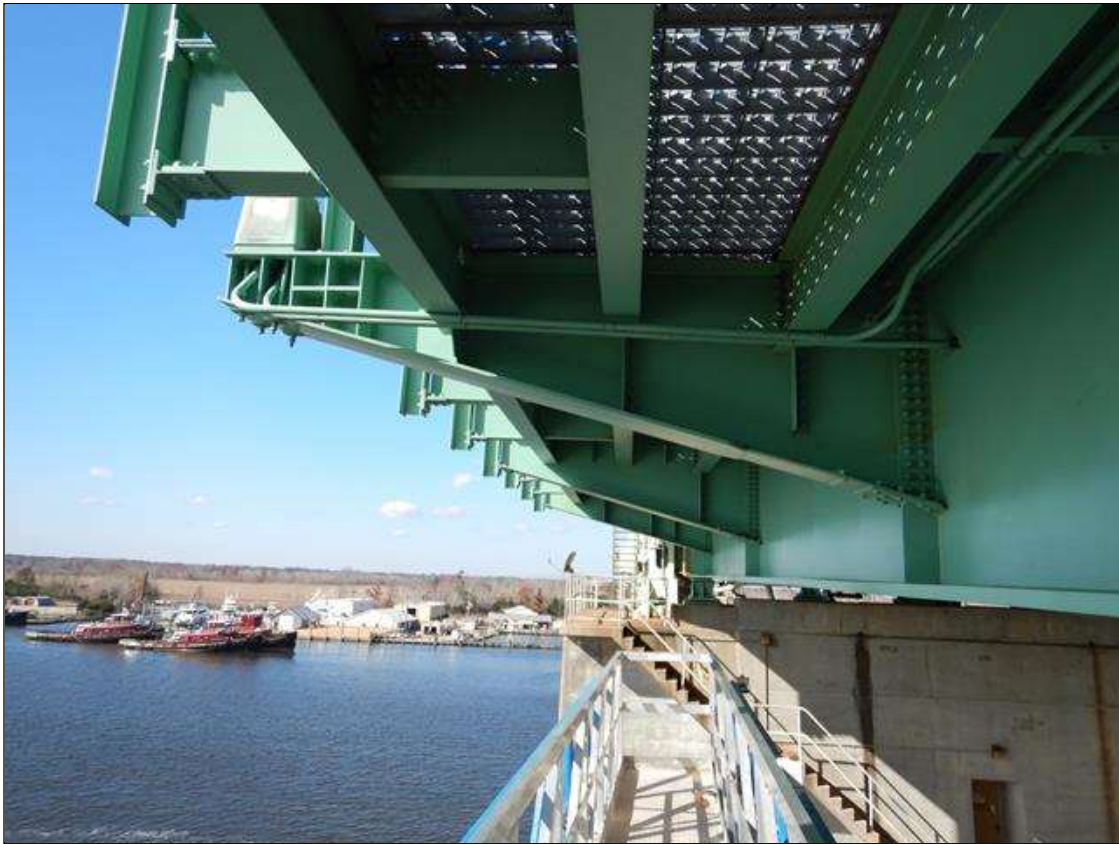
SPAN 20 RIGHT SIDE PARKING AREA FRAMING [SIMILAR ON THE LEFT SIDE AND AT SPAN 16 RIGHT & LEFT SIDES]

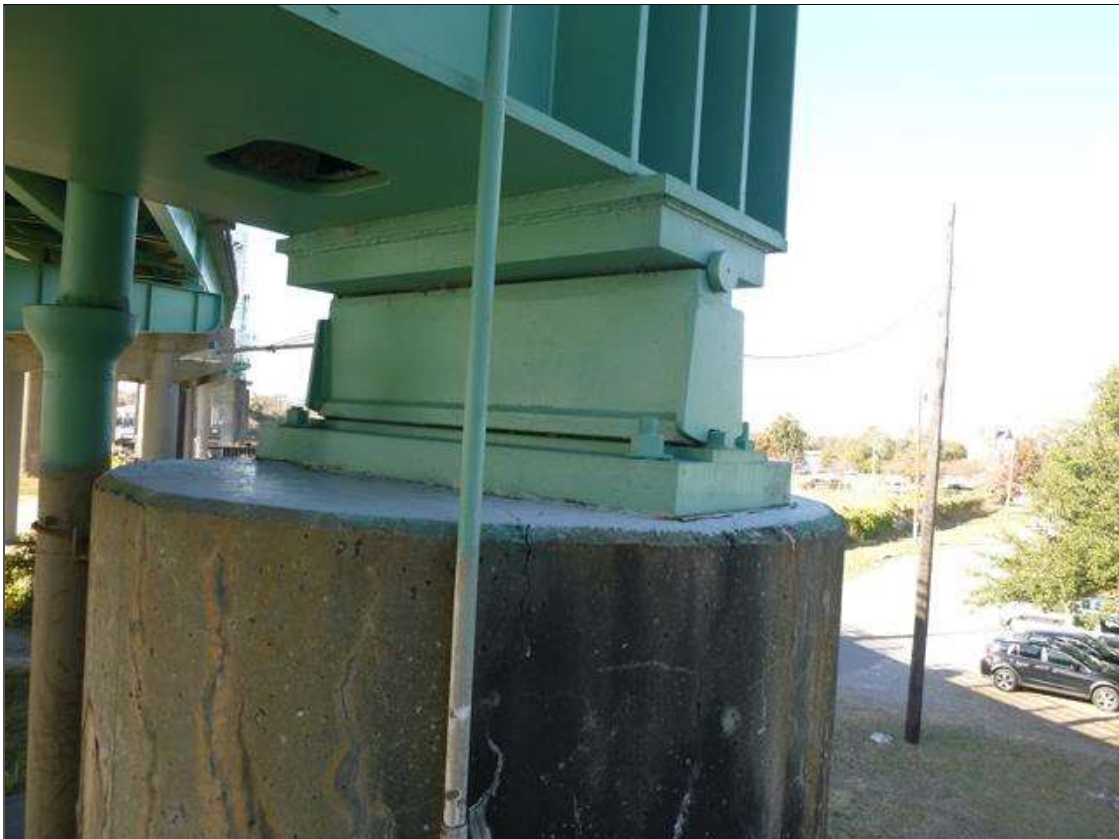
BENT 23 LEFT END MOVABLE BEARING [BENT 22 RIGHT END SIMILAR]

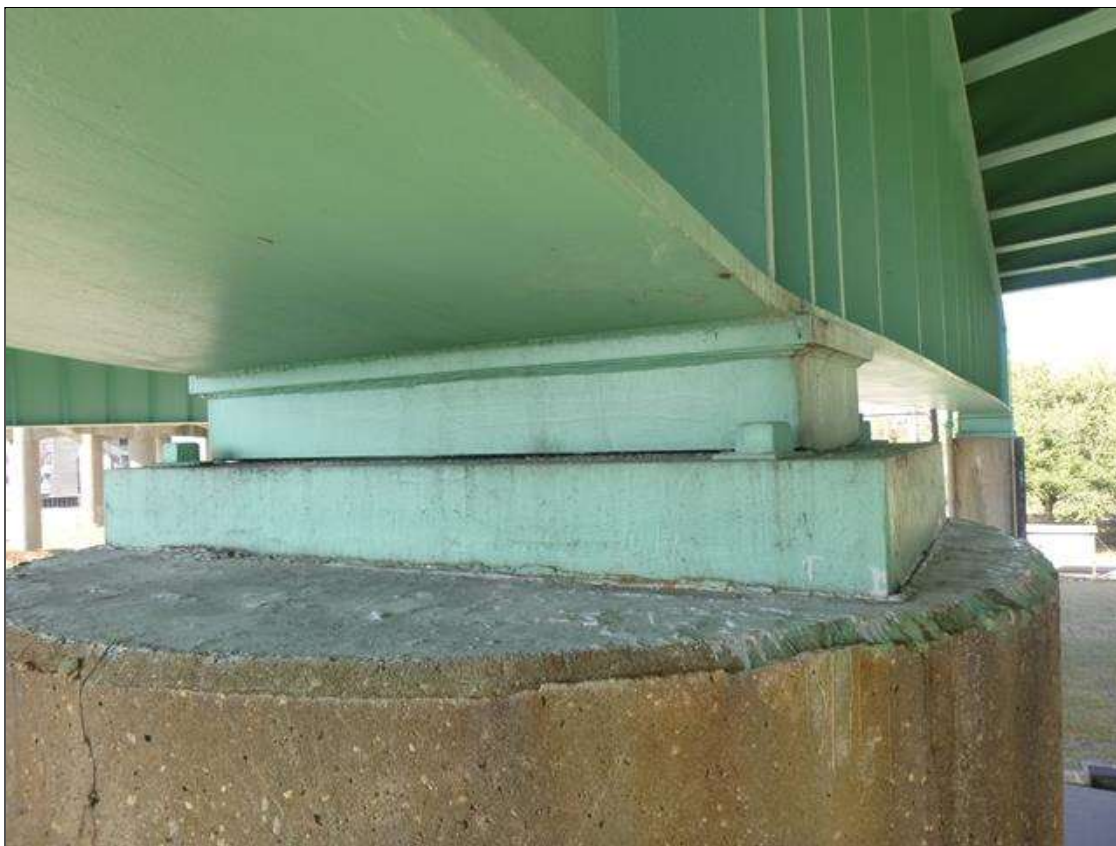
BENT 23 RIGHT END FIXED BEARING [BENT 22 LEFT END SIMILAR]

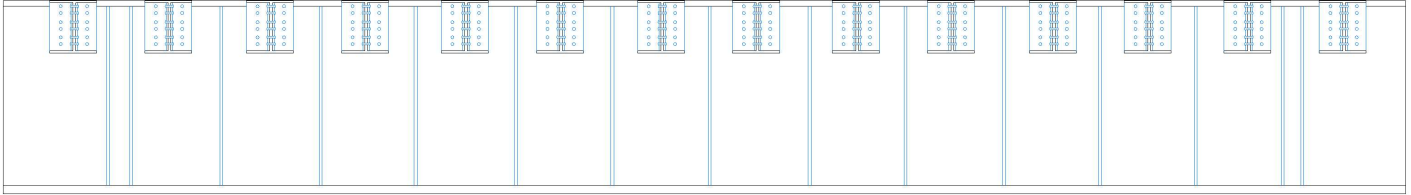
FLOOR BEAM 0 WEST END FLBM

1/4" SL IN WEB AT BOTTOM FLANGE, 2'-3"H x FULL LENGTH OF FLOORBEAM.

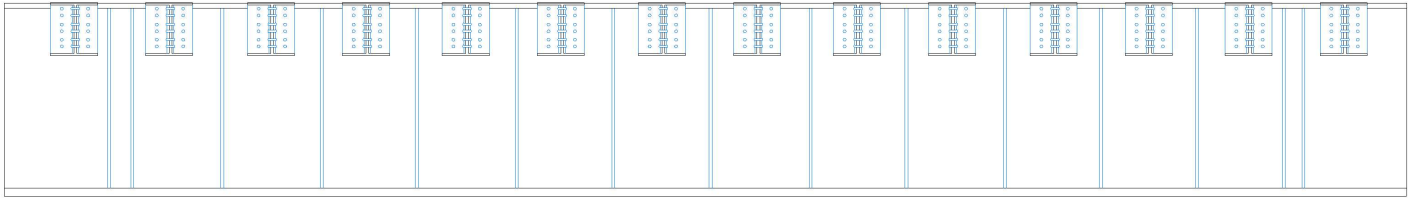
FLOOR BEAM 1

STRINGER 1- FLOOR BEAM NE ANGLE CONN. 3" TOP **REPAIRED**
STRINGER 1- FLOOR BEAM SE ANGLE CONN. 2 1/8" TOP **REPAIRED**
STRINGER 2- FLOOR BEAM NE ANGLE CONN. 4 1/2" TOP 5" TOP BOLT 2 5/8" BTM **REPAIRED**
STRINGER 2- FLOOR BEAM SE ANGLE CONN. 5" TOP 3 1/2" TOP BOLT 2 3/4" X 1" HOLE BTM **REPAIRED**
STRINGER 3- FLOOR BEAM NE ANGLE CONN. 5" TOP 8" TOP BOLT **REPAIRED**
STRINGER 3- FLOOR BEAM SE ANGLE CONN. 6 3/4" TOP 8 3/4" TOP BOLT 2" BTM **REPAIRED**
STRINGER 4- FLOOR BEAM NE ANGLE CONN. 3 3/4" TOP 2 1/2" TOP BOLT **REPAIRED**
STRINGER 4- FLOOR BEAM SE ANGLE CONN. 3" TOP 2 1/2" TOP BOLT **REPAIRED**
STRINGER 11- FLOOR BEAM NE ANGLE CONN. 2 1/4" TOP **REPAIRED**
STRINGER 12- FLOOR BEAM NE ANGLE CONN. 2" TOP 2" TOP BOLT 3" BTM **REPAIRED**
STRINGER 12- FLOOR BEAM SE ANGLE CONN. 7" TOP 3" BTM **REPAIRED**
STRINGER 13- FLOOR BEAM SE ANGLE CONN. 4 1/2" BTM **REPAIRED**

30% SECTION LOSS IN BTM OF NW STR3 TO FLBM CONN ANGLE **REPAIRED**
30% SECTION LOSS IN BTM OF SW STR3 TO FLBM CONN ANGLE **REPAIRED**
10% SECTION LOSS IN BTM OF NW STR4 TO FLBM CONN ANGLE **REPAIRED**
10% SECTION LOSS IN BTM OF SW STR4 TO FLBM CONN ANGLE **REPAIRED**
5% SECTION LOSS IN BTM OF NW STR6 TO FLBM CONN ANGLE **REPAIRED**
5% SECTION LOSS IN BTM OF SW STR6 TO FLBM CONN ANGLE **REPAIRED**

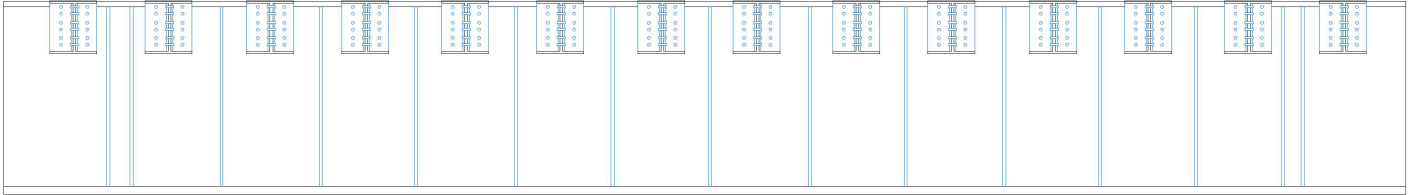
FLOOR BEAM 2 EAST AND WEST

CRACKS IN CONNECTION ANGLES:

STRINGER 1- FLOOR BEAM SE ANGLE CONN. 4 1/2" TOP 2 1/2" TOP BOLT REPAIRED
STRINGER 1- FLOOR BEAM NE ANGLE CONN. 5" TOP 2" BTM REPAIRED
STRINGER 2- FLOOR BEAM NE ANGLE CONN. 6 1/2" TOP 4 3/4" TOP BOLT 3 BTM REPAIRED
STRINGER 2- FLOOR BEAM SE ANGLE CONN. 12" TOP 2" TOP BOLT 4" BTM 2" X 3/4" HOLE REPAIRED
STRINGER 3- FLOOR BEAM NE ANGLE CONN. 9" TOP 2" BTM 5% LOSS IN BTM REPAIRED
STRINGER 3- FLOOR BEAM SE ANGLE CONN. 4" TOP 3 1/2" TOP BOLT 5% LOSS IN BTM REPAIRED
STRINGER 4- FLOOR BEAM NE ANGLE CONN. 4" TOP 2 1/2" TOP BOLT REPAIRED
STRINGER 4- FLOOR BEAM SE ANGLE CONN. 5% LOSS IN BTM REPAIRED
STRINGER 5- FLOOR BEAM NE ANGLE CONN. 1/2" BTM & 15% LOSS IN BTM REPAIRED
STRINGER 6- FLOOR BEAM NE ANGLE CONN. 15% LOSS IN BTM REPAIRED
STRINGER 6- FLOOR BEAM SE ANGLE CONN. 5% LOSS IN BTM REPAIRED
STRINGER 7- FLOOR BEAM NE ANGLE CONN. 10% LOSS IN BTM REPAIRED
STRINGER 11- FLOOR BEAM NE ANGLE CONN. 3 1/2" TOP REPAIRED

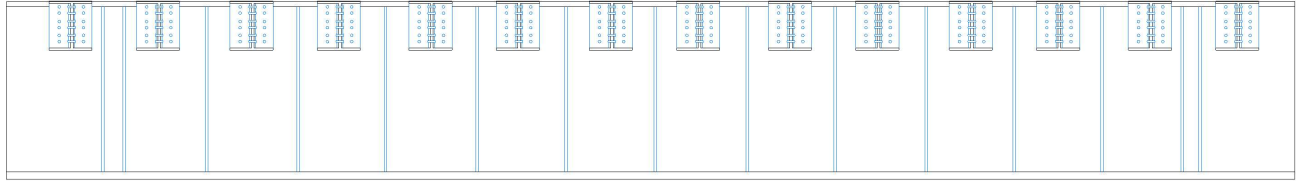
FLOOR BEAM 4 WEST AND EAST SIDE

FLOOR BEAM 4 WEST SIDE STRINGER 3 SOUTH ANGLE 3/16" SECTION LOSS IN BOTTOM 4"H x 4"W **REPAIRED**

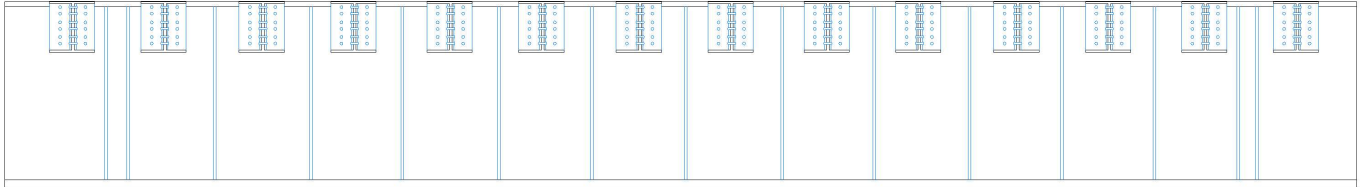
FLOOR BEAM 10 WEST AND EAST

FLBM 10, EAST SIDE, SL TO TOP FLANGE FROM STR 2 TO STR 4, 0.81" REMAINING

FLOOR BEAM 10 EAST SIDE STRINGER 2 SOUTH ANGLE SECTION LOSS 30% IN BOTTOM **REPAIRED**

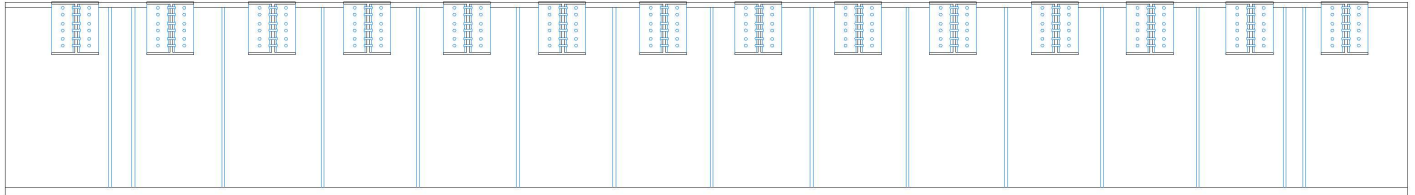
FLOOR BEAM 12 WEST AND EAST

3314	Maintain Steel Superstructure Components	LF	4	Span 18 Lift Span Floor Beam 12: LOSS OF SECTION .625" WITH .683" REMAINING BOTTOM EAST FLANGE 4' LONG X 3.25" WIDE OVER OLD ANCHOR POINT BEGINNING 2' LEFT OF NORTHEAST BEARING. PAINT HAS FAILED. (PAR)

STRINGER TO FLBM CONN KNEE BRACE HAS A 4" HOLE IN WEB UNDER STR 4 **REPAIRED**

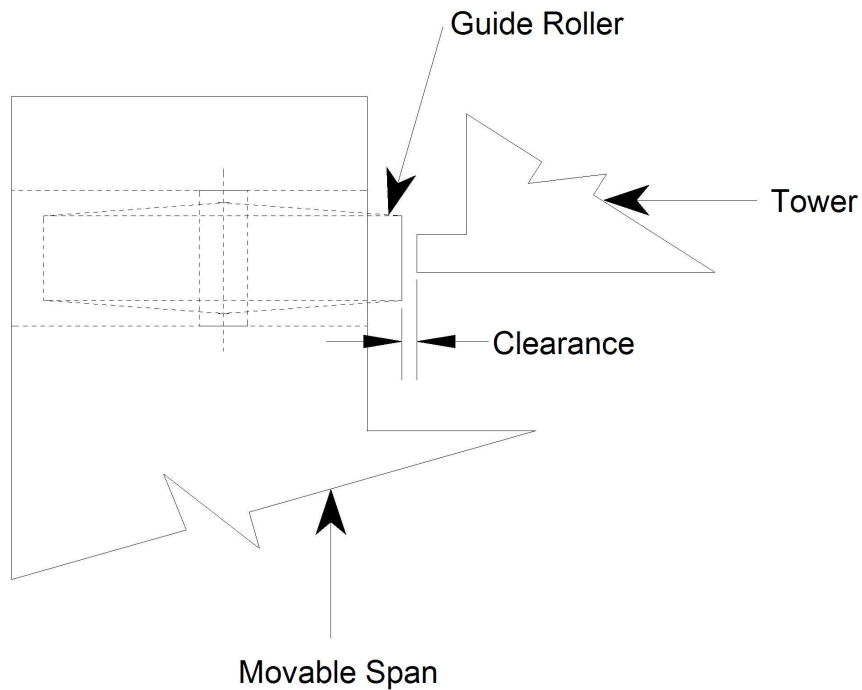
Upper Guide Roller - West

Clearance	Comment
South Side	1"	
North Side	3/16"	Track has 1/4" dent from impact with roller

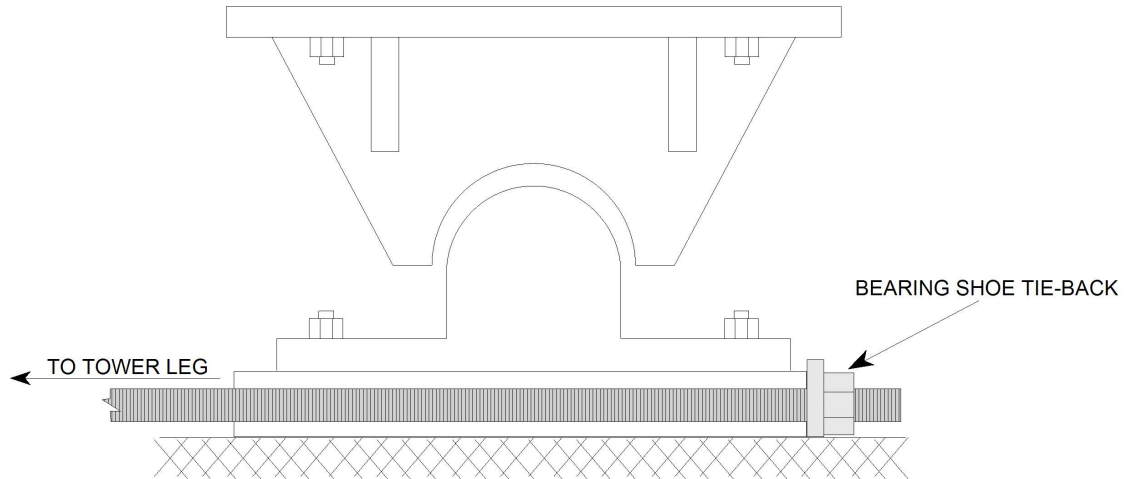
FIXED BEARING EAST END

Bearing shoe/saddle dry w/ surfacae rust
Shoe anchored to tower leg

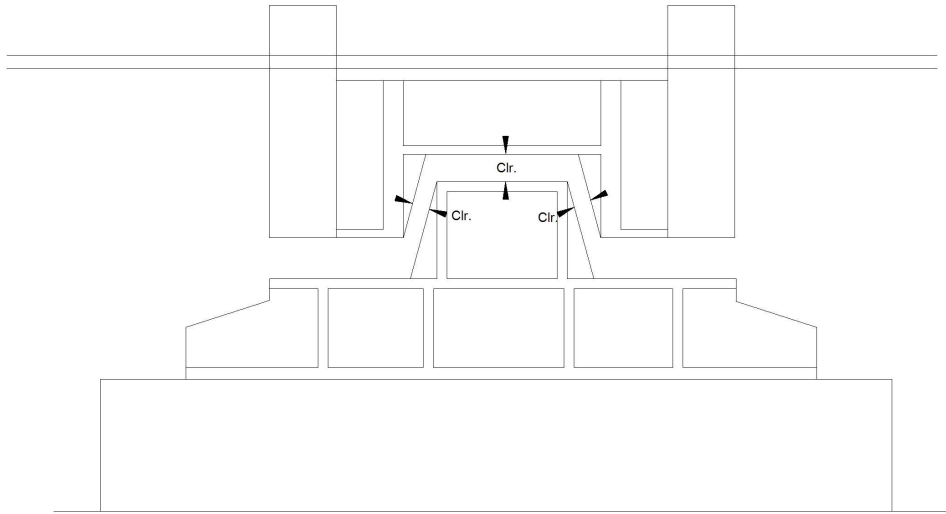
TRANSVERSE CENTERING SHOE

CONNECTION PLATE SECTION LOSS REPAIRED
WEAR PADS DRY w/ SURFACE RUST

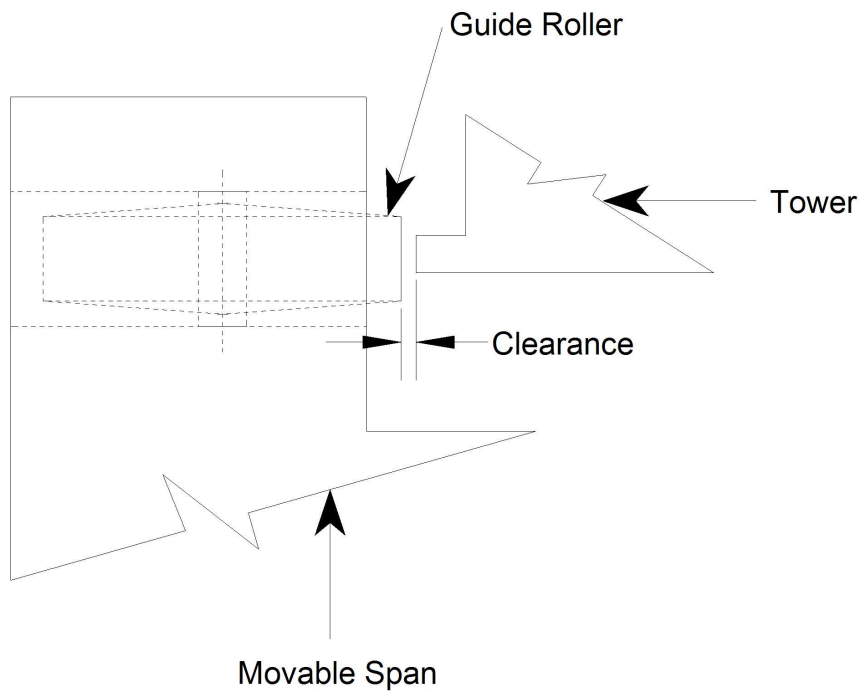
Upper Guide Roller - East

Clearance	Comment
South Side	7/8"	
North Side	1/4"

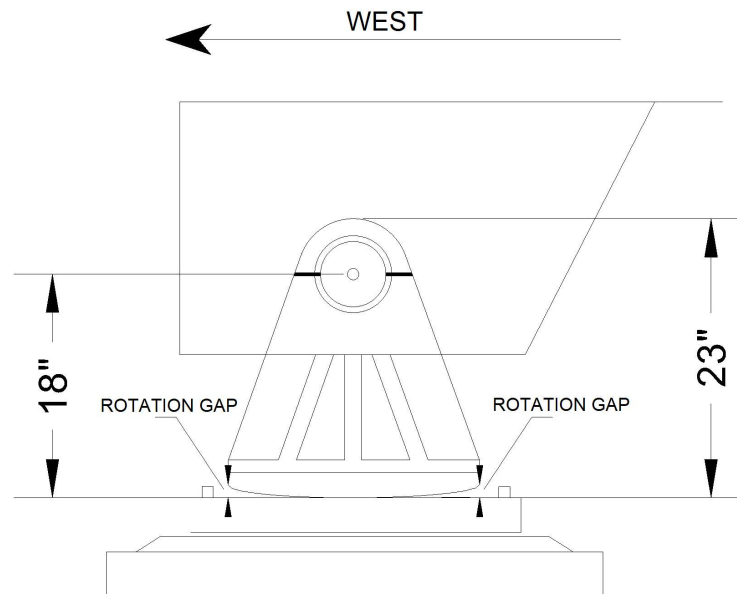
2021 - SURFACE RUST FORMING ON ALL COMPONENTS

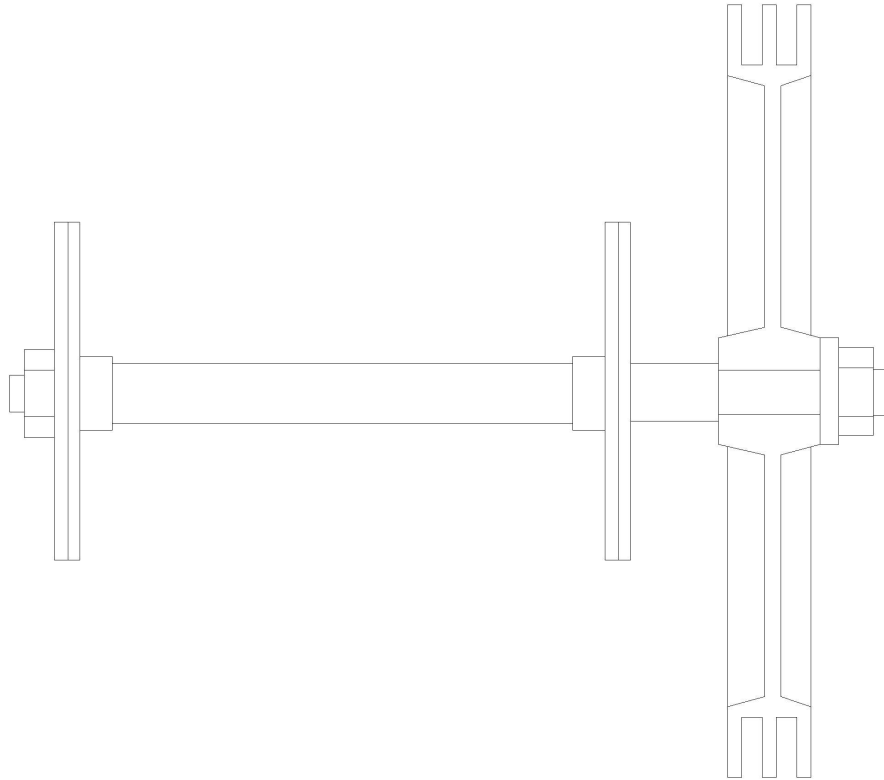
Auxiliary Counterweight Sheave
West End

SURFACE RUST ON EXPOSED SECTIONS OF CABLES - MAINTENANCE REQUESTED

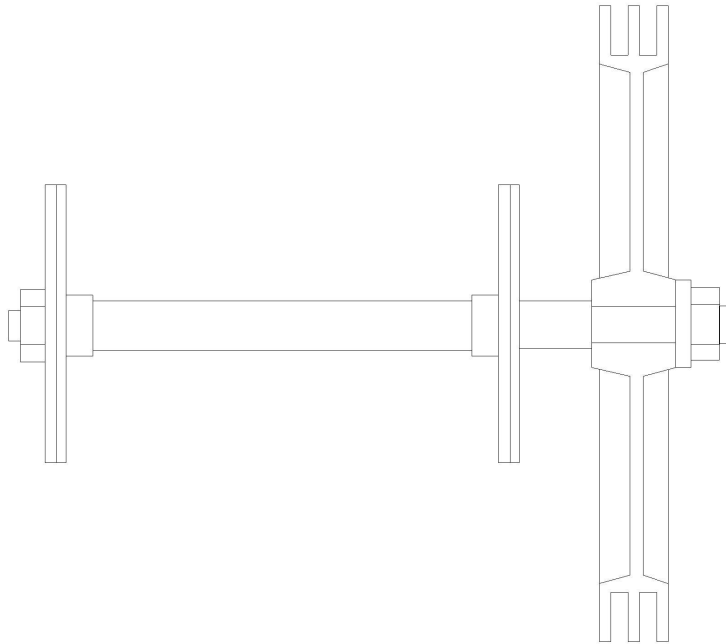
Auxiliary Counterweight Sheave

SURFACE RUST FORMING ON EXPOSED SECTIONS OF CABLES - MAINTENACE REQUESTED

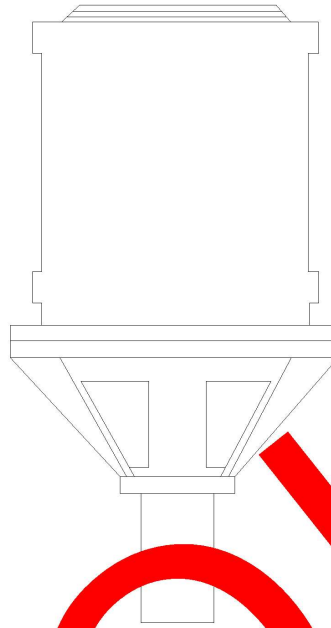
UPPER BUFFER CYLINDERS

SOUTHEAST	GOOD CONDITION
SOUTHWEST	GOOD COND
NORTHEAST	GOOD CONDITION
NORTHWEST	GOOD CONDITION

AIR BUFFERS REPLACED WITH BUMP STOPS 2019

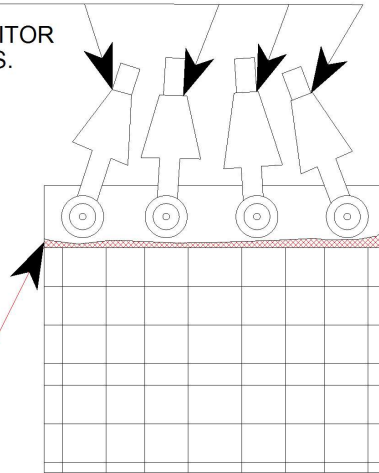
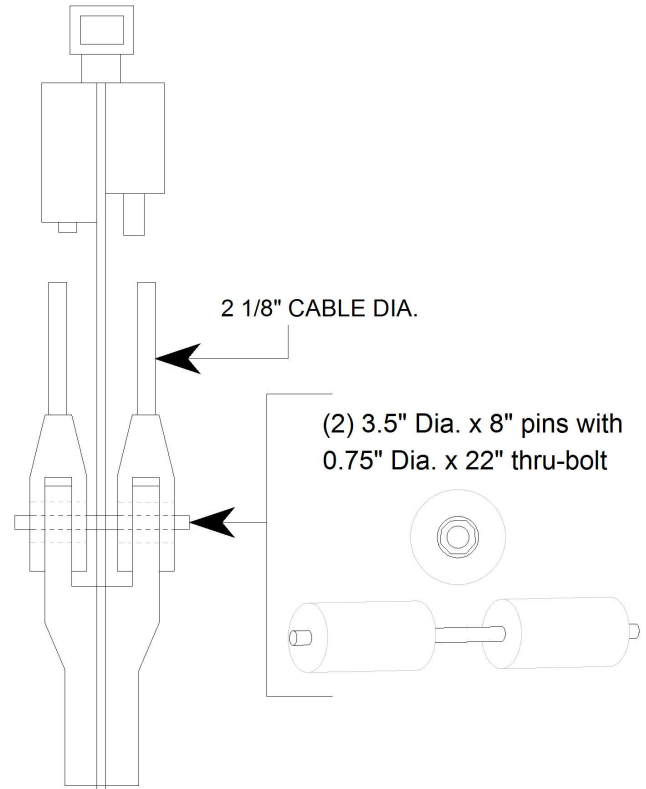
Cable Attachment to Counterweight

(3) ~1/2" DIA. HOLES IN TOP OF SE COUNTERWEIGHT LID.
2'x2' AREA OF ACTIVE CORROSION w/ SCALE ON TOP OF
NE COUNTERWEIGHT LID.

ACTIVE CORROSION w/ PITTING UP TO 3/8"D x 4"H SCATTERED ON COUNTERWEIGHT CONNECTION MEMBER ALONG
TOP OF COUNTERWEIGHT AND BEHIND PIN CARRIER PLATES - ALL CONNECTIONS SIMILAR (PAR SUBMITTED 3/2021)

2021 - NO CHANGE IN LENGTH - ALL CABLES DRY AND NEED GREASE - SURFACE RUST ON EXPOSED AREAS - MAINT. REQUESTED (SEE PHOTO)

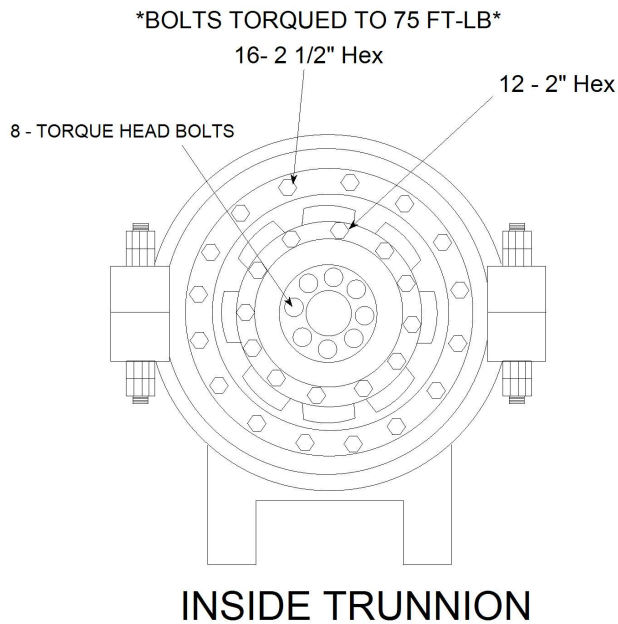
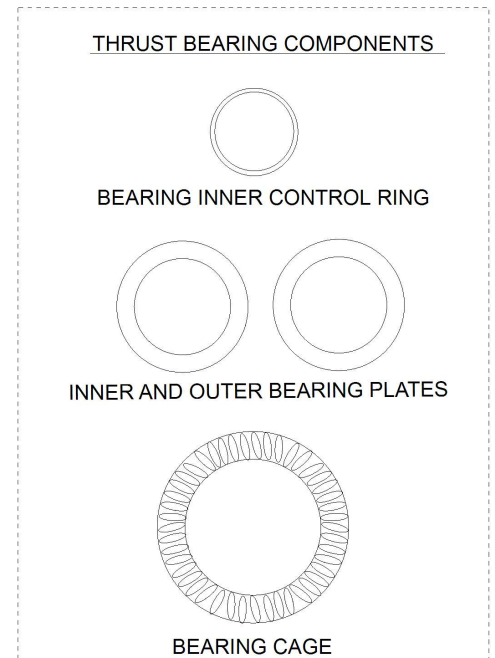
WEST TOWER - SHEAVE #3 - INSIDE BEARING COMPONENTS REPLACED 2019 (BEARING PLATES, CAGE & CONTROL RING)

EAST TOWER - SHEAVE #1 - INSIDE BEARING COMPONENTS REPLACED 2019 (BEARING PLATES, CAGE & CONTROL RING)

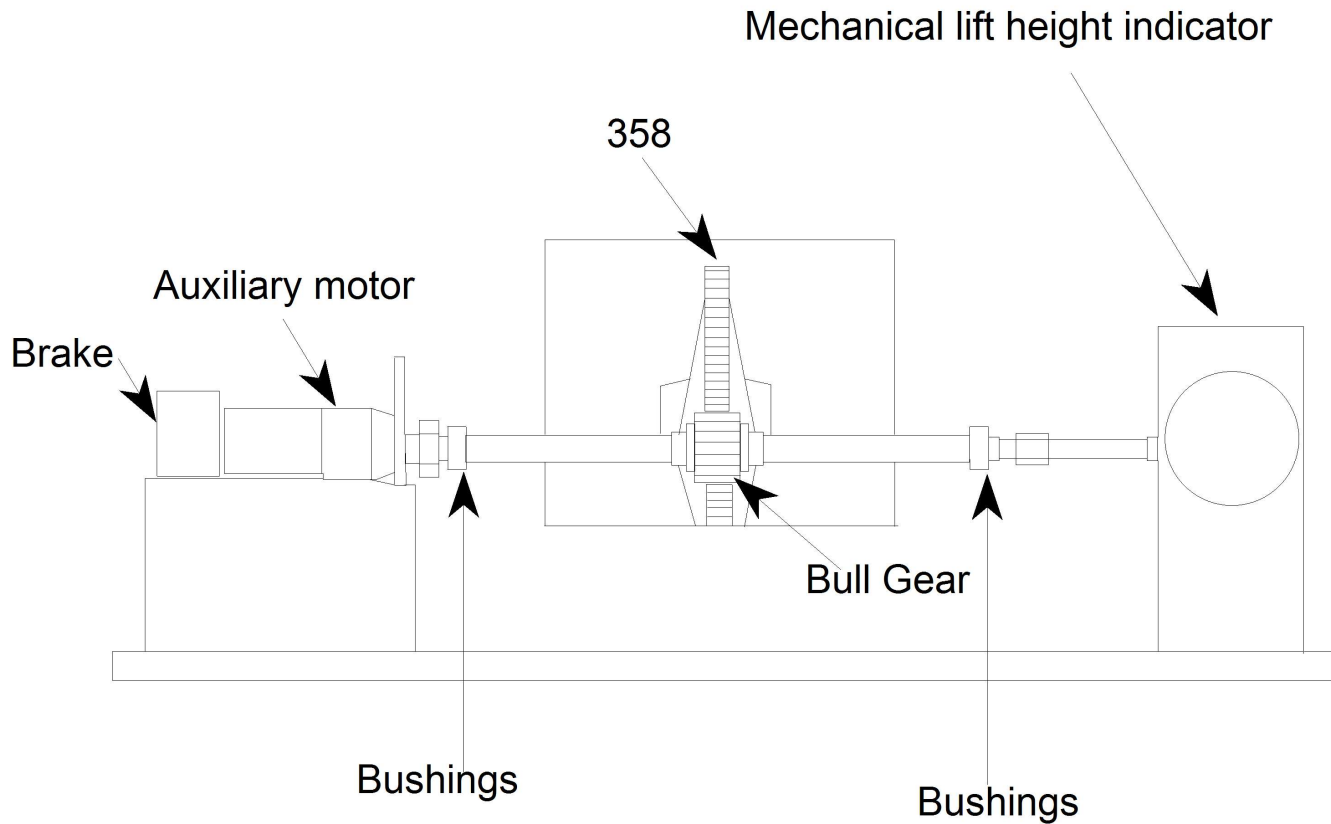
Auxiliary Drive Assembly - East & West Towers

FAIR CONDITION
2020 - MINOR SURFACE RUST ON BRAKE DRUMS

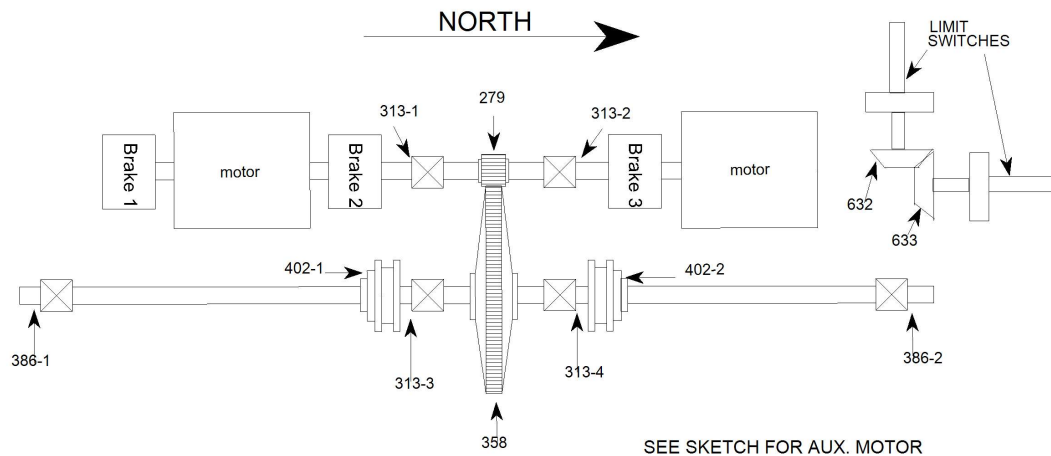
PLAIN VIEW OPERATING MACH. EAST TOWER

PART	COMMENTS
402-1	COMPRESSED SPRING MEASUREMENT VARIES 2" OR LESS (BOLTS REPLACED 2019)
402-2	COMPRESSED SPRING MEASUREMENT VARIES 2" OR LESS (BOLTS REPLACED 2019)
BRAKES	FAIR CON. - MINOR SURFACE RUST, SCORING AND PITTING ON ALL BRAKE DRUMS
632	FAIR CONDITION - MINOR / NORMAL WEAR
633	FAIR CONDITION - MINOR / NORMAL WEAR

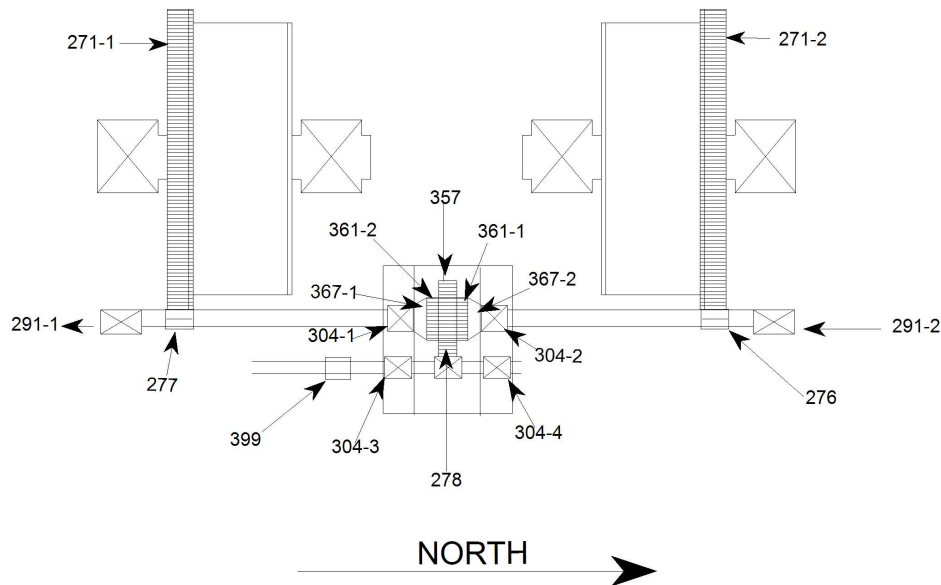
EAST TOWER OPERATING MACHINERY NORTH SIDE

GEAR ASSEMBLIES ROCKING (MINOR) UNDER LL

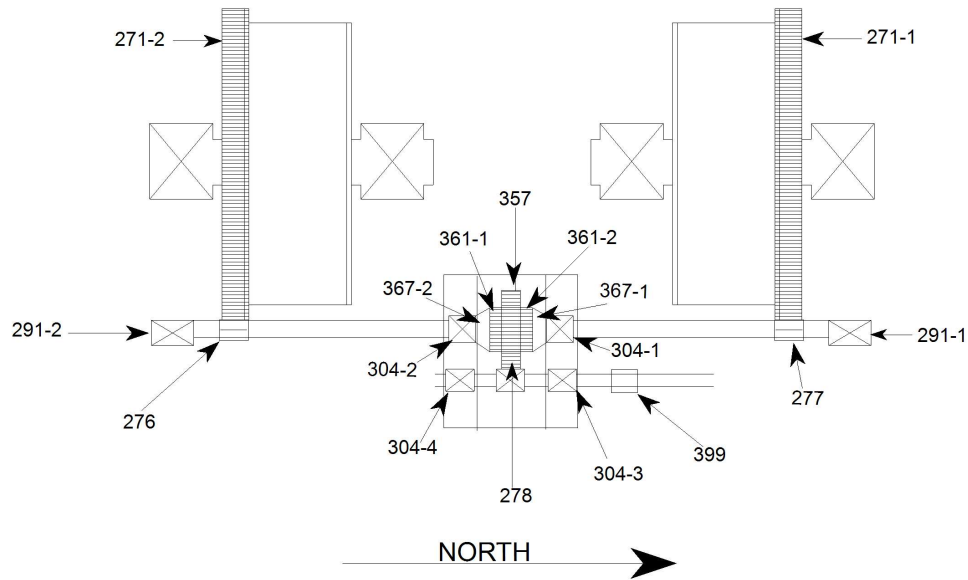
EAST TOWER OPERATING MACHINERY SOUTH SIDE

GEAR ASSEMBLIES ROCKING (MINOR) UNDER LL

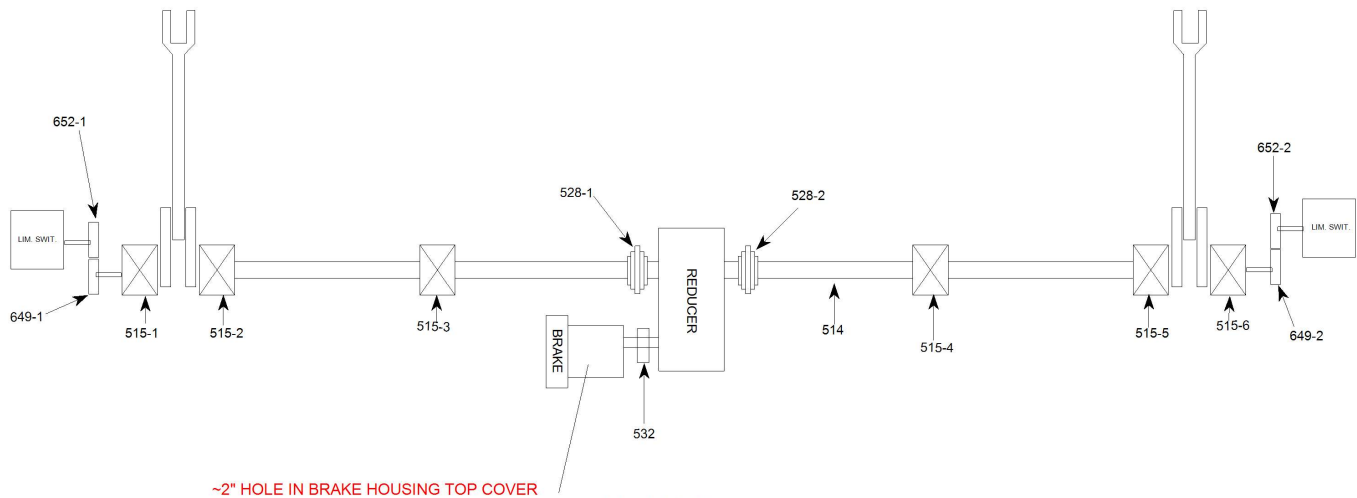
LOCK MACHINERY - WEST END

Part	Review
Reducer	Good con. - Fluid level good
Motor	Good con.
Brake	Fair con. - minor surface rust on all components
532	Fair con. - minor surface rust
528-1	Good con.
528-2	Good con.

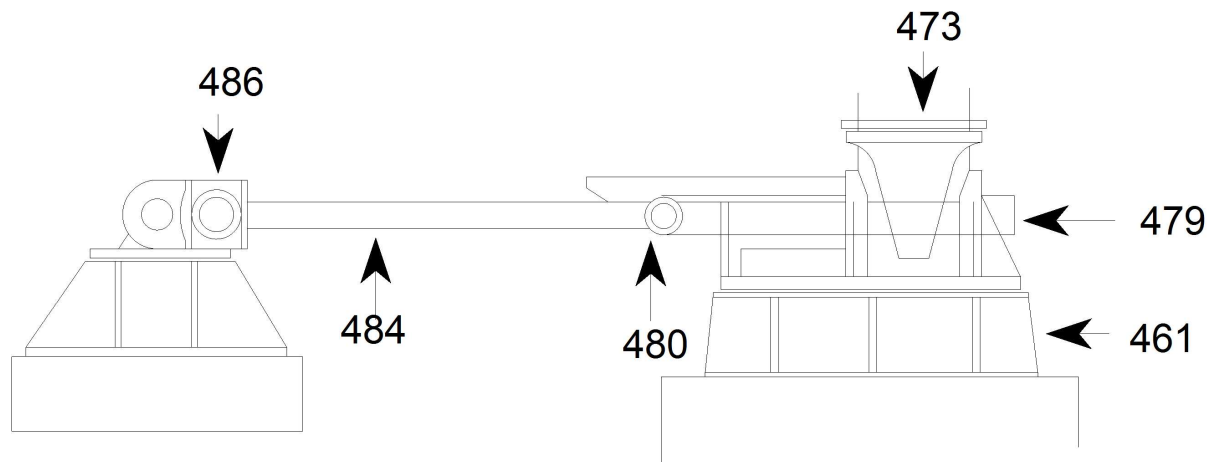
WEST END LOCK

PIECE NO.	SOUTH SIDE	NORTH SIDE
461	ANCHOR BOLTS & NUTS REPAIRED	ANCHOR BOLTS & NUTS REPAIRED
473	GOOD CON.	GOOD CON.
479	LUBE GOOD	LUBE GOOD
480	GOOD CON.	GOOD CON.
484	GOOD CON.	GOOD CON.
486	GOOD CON.	GOOD CON.

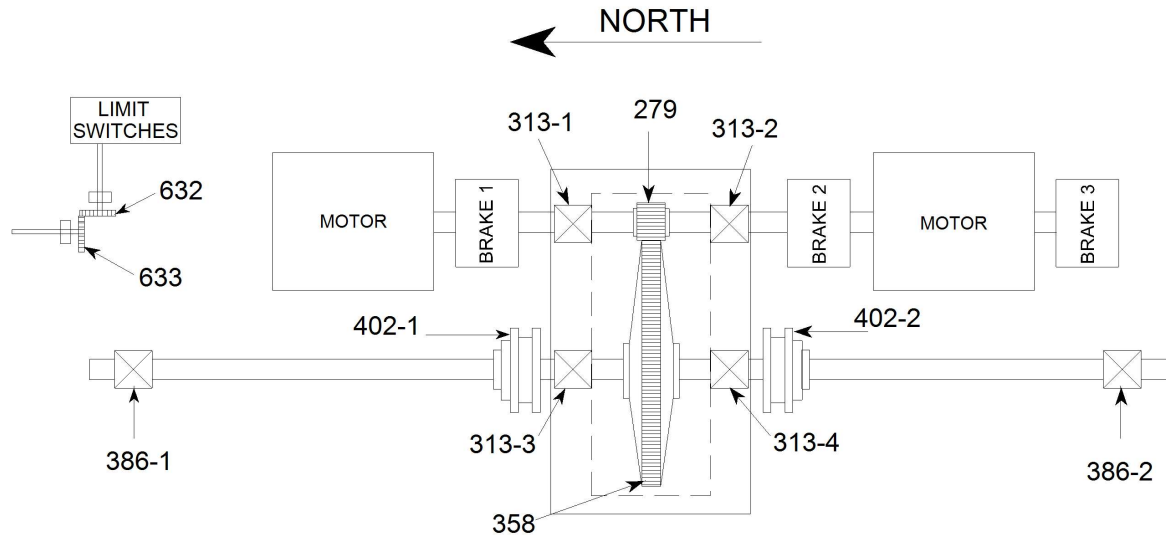
PLAN VIEW- OPERATING MACHINERY WEST TOWER

PART	COMMENT
402-1	COMPRESSED SPRING, MEASUREMENT VARIES 2" +/- (BOLTS REPLACED 2019)
402-2	COMPRESSED SPRING, MEASUREMENT VARIES 2" +/- (BOLTS REPLACED 2019)
BRAKES	FAIR CONDITION - SURFACE RUST & MINOR PITTING ON DRUMS - BRAKE 3 MOST SEVERE FLUID LEVELS GOOD
632	FAIR COND. - MINOR / NORMAL WEAR
633	FAIR COND. - MINOR / NORMAL WEAR
279; 358	FAIR COND. - MINOR / NORMAL WEAR

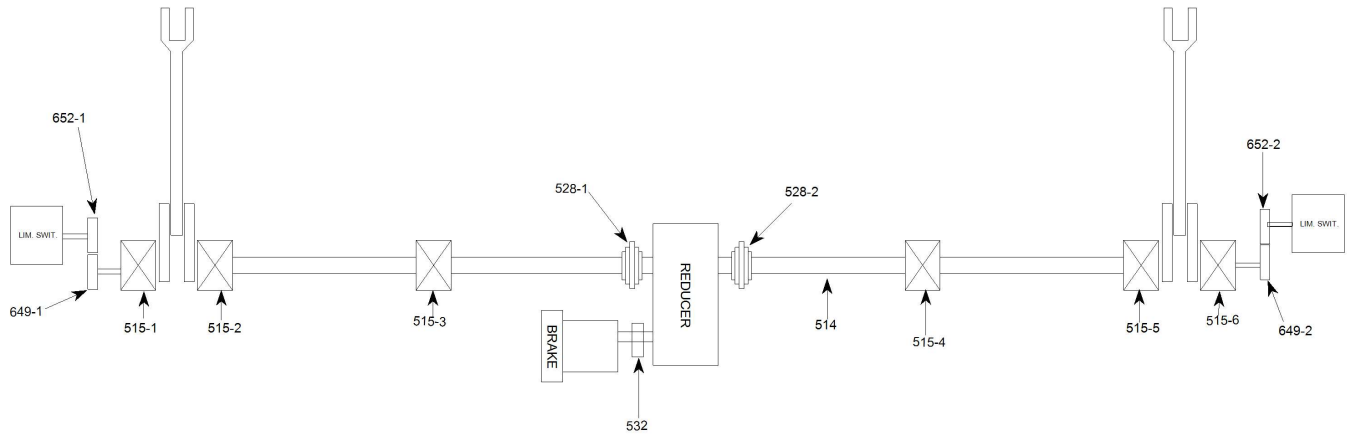
LOCK MACHINERY - EAST END

PART	REVIEW
REDUCER	GOOD CON. FLUID LEVEL GOOD
MOTOR	GOOD CONDITION
BRAKE	FAIR CONDITION; HAND LEVER DOES NOT WORK
532	GOOD CONDITION
528-1	GOOD CONDITION
528-2	GOOD CONDITION
652-1	POOR - APPROX. 1/8" ENGAGEMENT w/ GEAR 649-1 - PAR SUBMITTED 3/2021

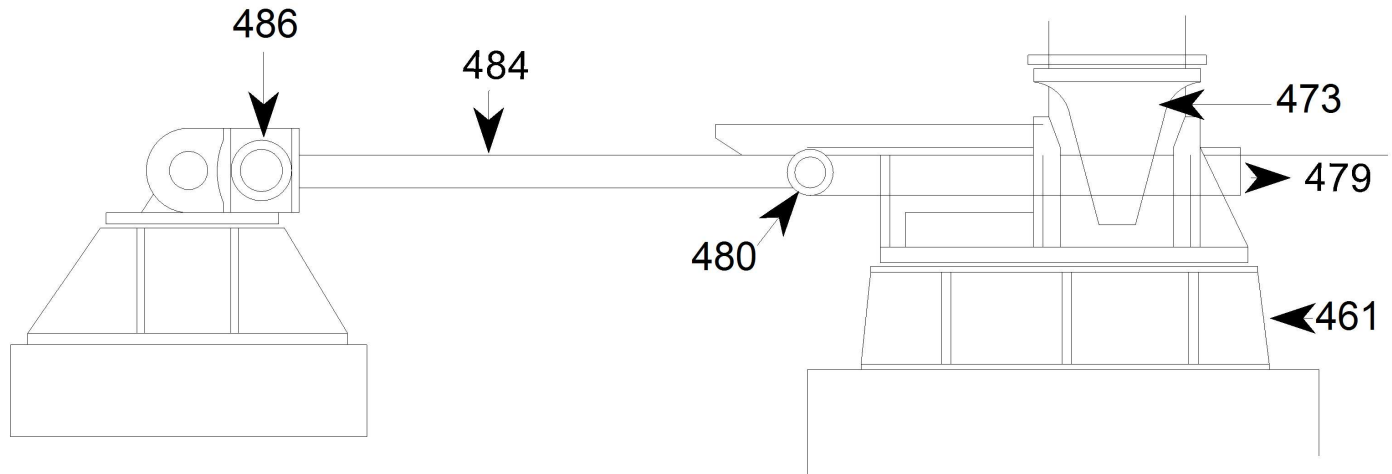
EAST END LOCK

Piece No.	North Side	South Side
461	BASE HAS UP TO 100% SECTION LOST IN RANDOM AREAS THROUGHOUT - REPAIRED	GOOD
473	REPAIRED GOOD CON.	GOOD
479	GOOD CONDITION	GOOD
480	GOOD CONDITION	GOOD CONDITION
484	AREAS OF 1/4" DEEP SECTION LOST ADJ. TO 480 - CLEANED AND PAINTED	GOOD CONDITION
486	GOOD CONDITION	GOOD CONDITION

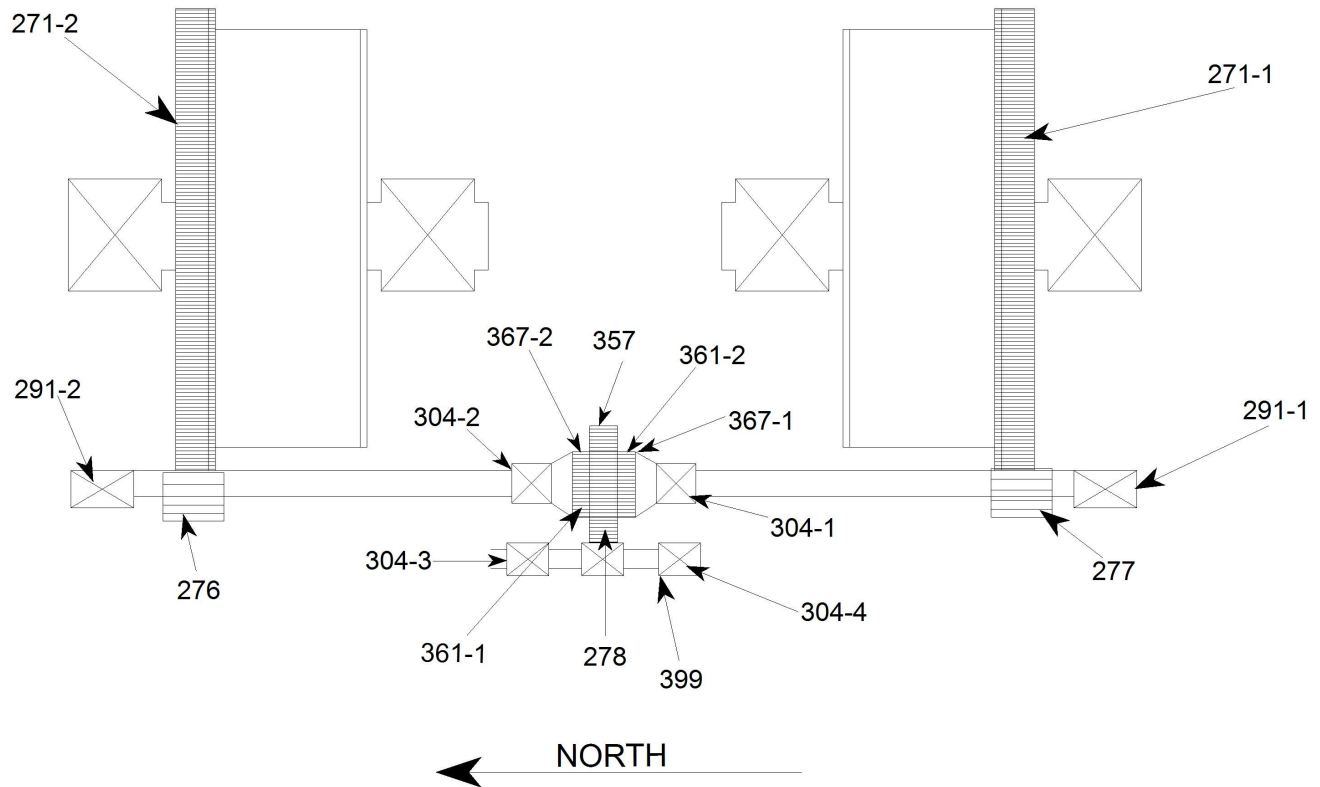
West Operating Machinery - South Side

GEAR ASSEMBLIES ROCKING (MINOR) UNDER LL

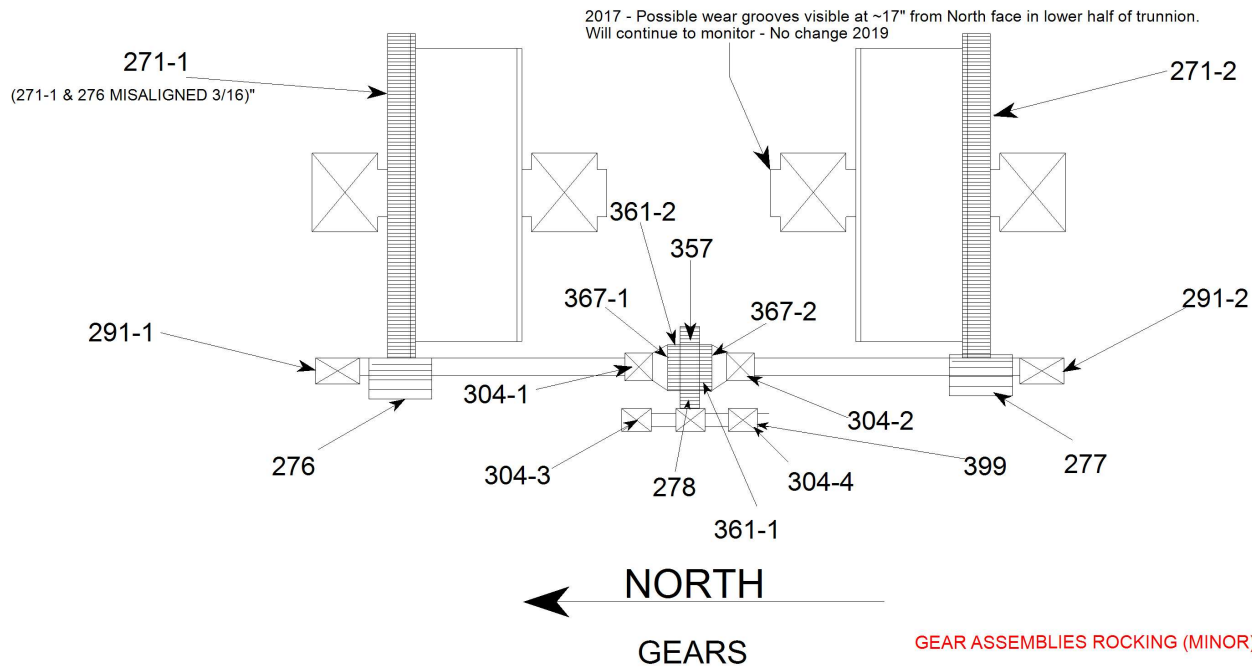
West Operating Machinery - North Side

Piece No.	No. Teeth	Pitch	P. A.	Original Chord Addend.	Original Chord Thickness	Measured Chord Thick.			Backlash	Root/Tip Clearance	Comments
						Left	Center	Right			
271-1	240	2.5 cp	20 deg.	0.7972	1.2300	1.180	1.215	1.208	0.125	0.138	GREASE THIN
271-2	240	2.5cp	20 deg.	0.7972	1.2300	1.200	1.215	1.210	0.104	0.174	GREASE THIN
276	17	2.5cp	20 deg.	0.8246	1.2482	1.218	1.178	1.200	-----	-----	GREASE THIN
277	17	2.5cp	20 deg.	0.8246	1.2482	1.230	1.213	1.230	-----	-----	GREASE THIN
278	17	1.75cp	20 deg.	0.5772	0.8737	0.858	0.855	0.855	-----	-----	GREASE THIN
357	72	1.75cp	20 deg.	0.5620	0.8550	0.830	0.831	0.828	-----	-----	GREASE THIN
361-1	18	1.75cp	20 deg.	0.5760	0.8740	-----	-----	-----	-----	-----	GREASE THIN
361-2	18	1.75cp	20 deg.	0.5760	0.8740	-----	-----	-----	-----	-----	GREASE THIN
367-1	50	1.75cp	20 deg.	0.5640	0.8550	-----	-----	-----	-----	-----	GREASE THIN
367-2	50	1.75cp	20 deg.	0.5640	0.8550	-----	-----	-----	-----	-----	GREASE THIN

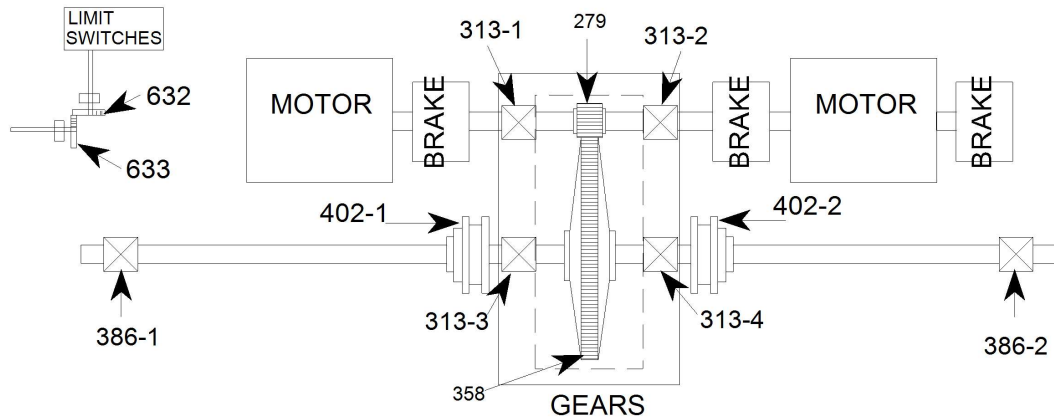
PLAN VIEW- OPERATING MACHINERY WEST TOWER

PART	COMMENT
402-1	COMPRESSED SPRING, MEASUREMENT VARIES 1 15/16" +/-
402-2	COMPRESSED SPRING, MEASUREMENT VARIES 1 15/16" +/-
BRAKE (3)	FAIR CONDITION- ALL BRAKES HAVE BEEN HOT. FLUID IS LOW.
632	FAIR COND. GEARS ARE DRY.
633	FAIR COND. GEARS ARE DRY.
	NORTH SIDE BRAKE PADS ARE OFFSET 1/2" TO SOUTH SIDE.
279, 358	GEARS MISALIGNED
X	X

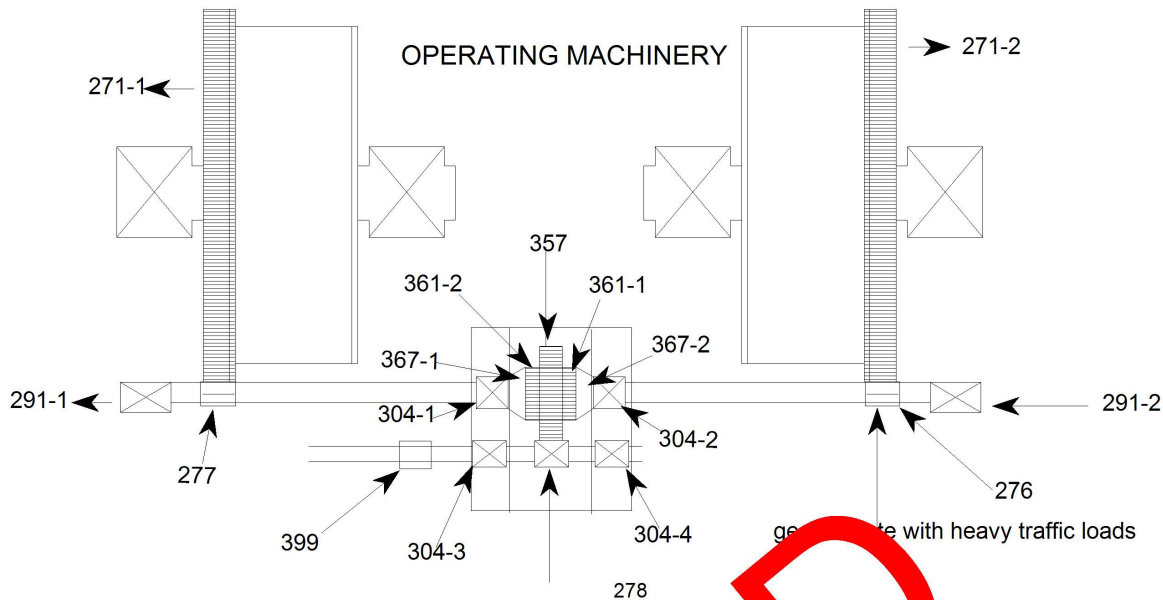
piece no.	no. teeth	pitch	p.a.	or. chord add	or. chord thic.	meas. chord thic.	comments
271-1	240	2.5cp	20deg	0.7972	1.2300	1.220	gears are dry
271-2	240	2.5cp	20deg	0.7972	1.2300	1.224	gears are dry
276-1	17	2.5cp	20deg	0.8146	1.2482	1.234	gears are dry
276-2	17	2.5cp	20deg	0.8146	1.2482	1.236	gears are dry
278	17	1.75cp	20deg	0.5716	0.8737	0.857	gears are dry
357	72	1.75cp	20deg	0.5620	0.8550	0.805	gears are dry
361-1	18	1.75cp	20deg	0.5760	0.8740	---	----
361-2	18	1.75cp	20deg	0.5760	0.8740	---	----
367-1	50	1.75cp	20deg	0.5640	0.8550	---	----
367-2	50	1.75cp	20deg	0.5640	0.8550	---	----

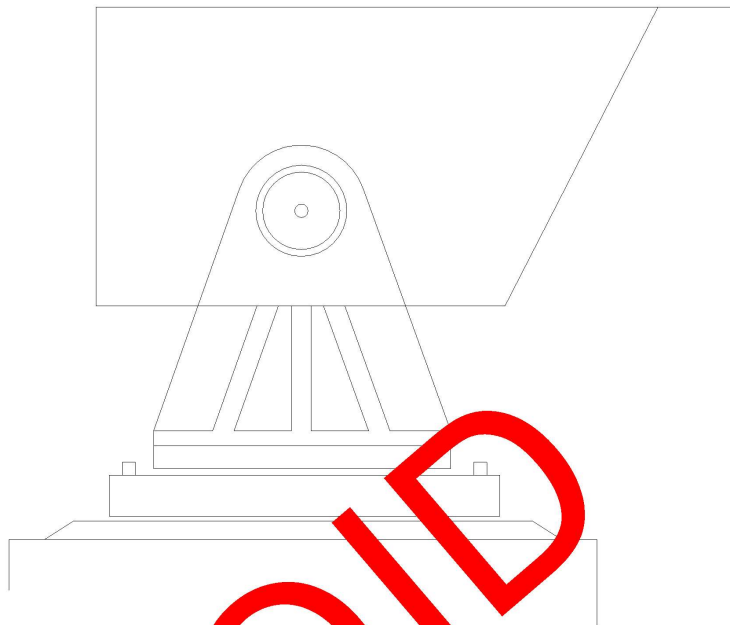
EXPANSION SHOE WEST END

some rust to 1/8"

Front of base toward east
tower barely moves up & down rust to 1/8" thick
in areas.

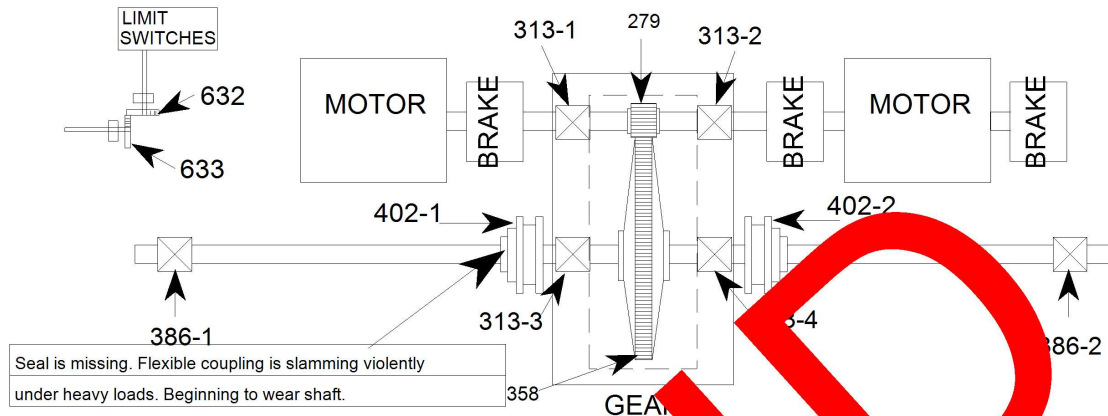
PLAN VIEW- OPERATING MACHINERY WEST TOWER

PART	COMMENT
402-1	COMPRESSOR SPRING, MEASURED VARIES 1 15/16" +/-
402-2	COMPRESSOR SPRING, MEASURED VARIES 1 15/16" +/-
BRAKE (3)	FAIR CONDITION- ALL BRAKES HAVE BEEN HOT. FLUID IS LOW.
632	FAIR COND.
633	FAIR COND.
	NORTH SIDE BRAKE PADS ARE OFFSET 1/2" TO SOUTH SIDE.
279, 358	GEARS MISALIGNED
X	X
