NC DEPARTMENT OF TRANSPORTATION  
DIVISION OF HIGHWAYS  
STRUCTURE MANAGEMENT UNIT

## Structure Safety Report

### Routine Element Inspection - Contract

STRUCTURE NUMBER: 500082 SAP STRUCTURE NO: 0510082 FHWA STRUCTURE NO: 000000001010082  
DIVISION: 4 COUNTY: JOHNSTON INSPECTION DATE: 04/16/2024 FREQUENCY: 24 MONTHS  
FACILITY CARRIED: I95N MILE POST: 90.5  
LOCATION: 0.8 MI N JCT US70/US301  
FEATURE INTERSECTED: BLACK CREEK  
LATITUDE: 35° 27' 58.66" LONGITUDE: 78° 22' 50.4"  
SUPERSTRUCTURE: RC DECK ON I-BEAMS  
SUBSTRUCTURE: EBTS;RC CAP H-PILES;INT.BTS.RCP&BEAM  
SPANS: 4 SPANS. SEE SPAN PROFILE SHEET FOR SPAN DETAILS  
☐ FRACTURE CRITICAL ☐ TEMPORARY SHORING ☐ SCOUR CRITICAL ☐ SCOUR PLAN OF ACTION  
GRADES: (Inspector/NBI Coding) DECK 6 / 6 SUPERSTRUCTURE 7 / 7 SUBSTRUCTURE 6 / 6 CULVERT N / N  
POSTED SV: Not Posted POSTED TTST: Not Posted  
OTHER SIGNS PRESENT: 2- DELINEATORS

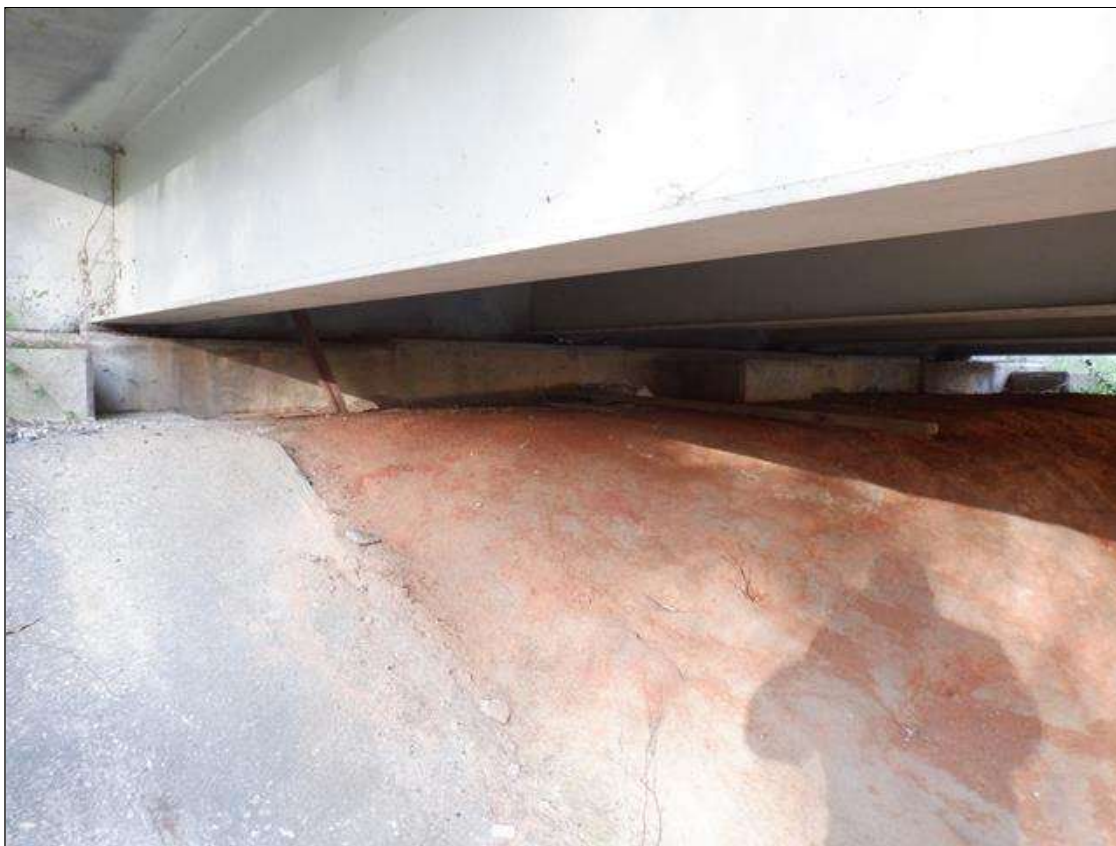
END BENT 1 ELEVATION

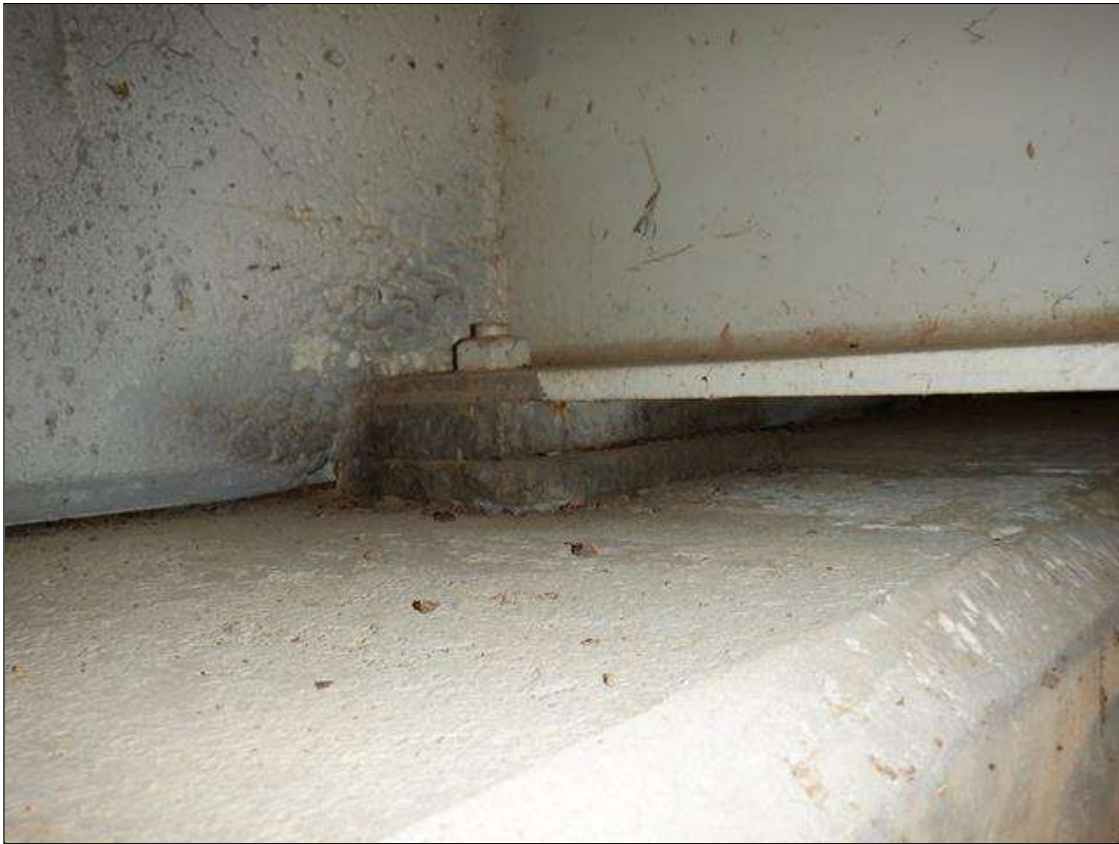
| Element Number | Defect Type | Defect Description | CS | CS Qty | Maint Qty | |
|---|---|---|---|---|---|---|
| <input checked="" type="checkbox"/> 311 | Corrosion | ARRESTED SECTION LOSS IN ANCHOR BOLT NUTS. | 2 | 1 | | Each |

BEAM 2 BEARING ASSEMBLY AT END BENT 1 (OTHERS SIMILAR)

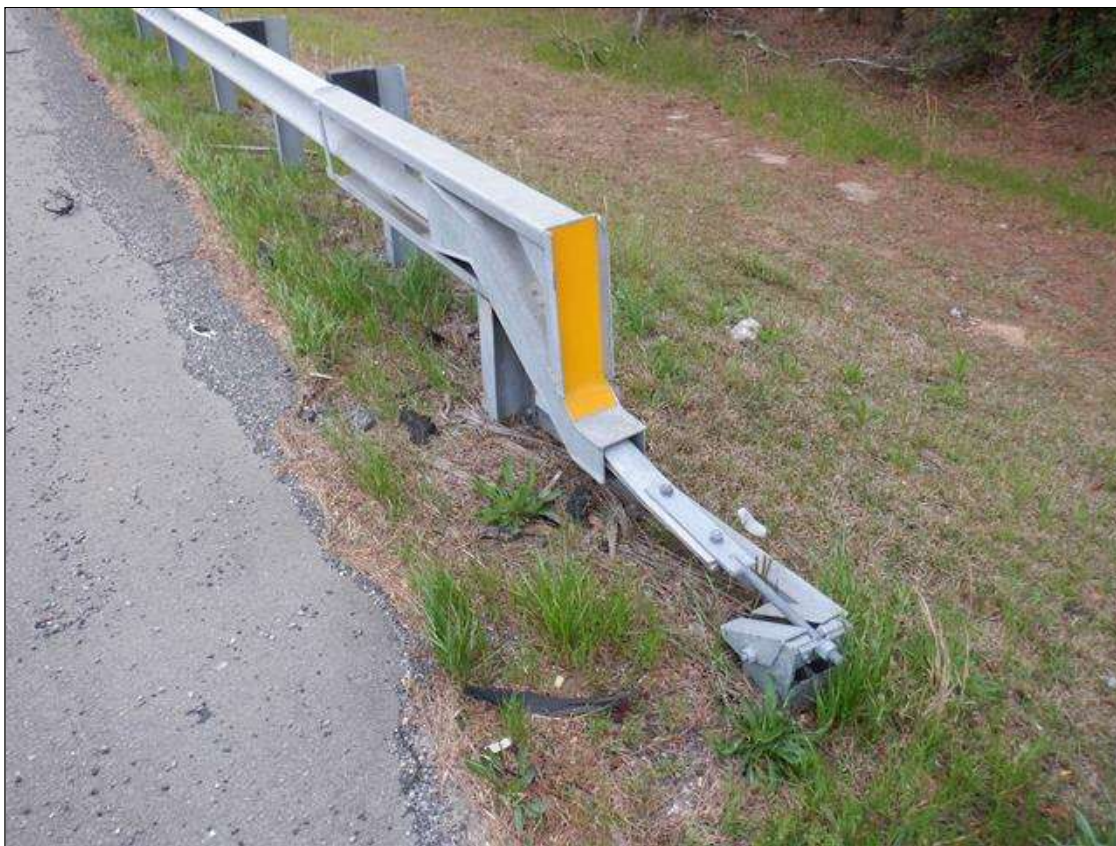
| Priority Level | Defect Type | Quantity | Defect Description |
|---|---|---|---|
| 2 | | 15 | (PAR) 15 FEET OF IMPACT DAMAGE WITH 11- UP TO 4 INCHES X 2 INCHES GOUGES IN SOUTHEAST GUARDRAIL AT END BENT 1. |

SOUTHEAST GUARDRAIL TERMINAL

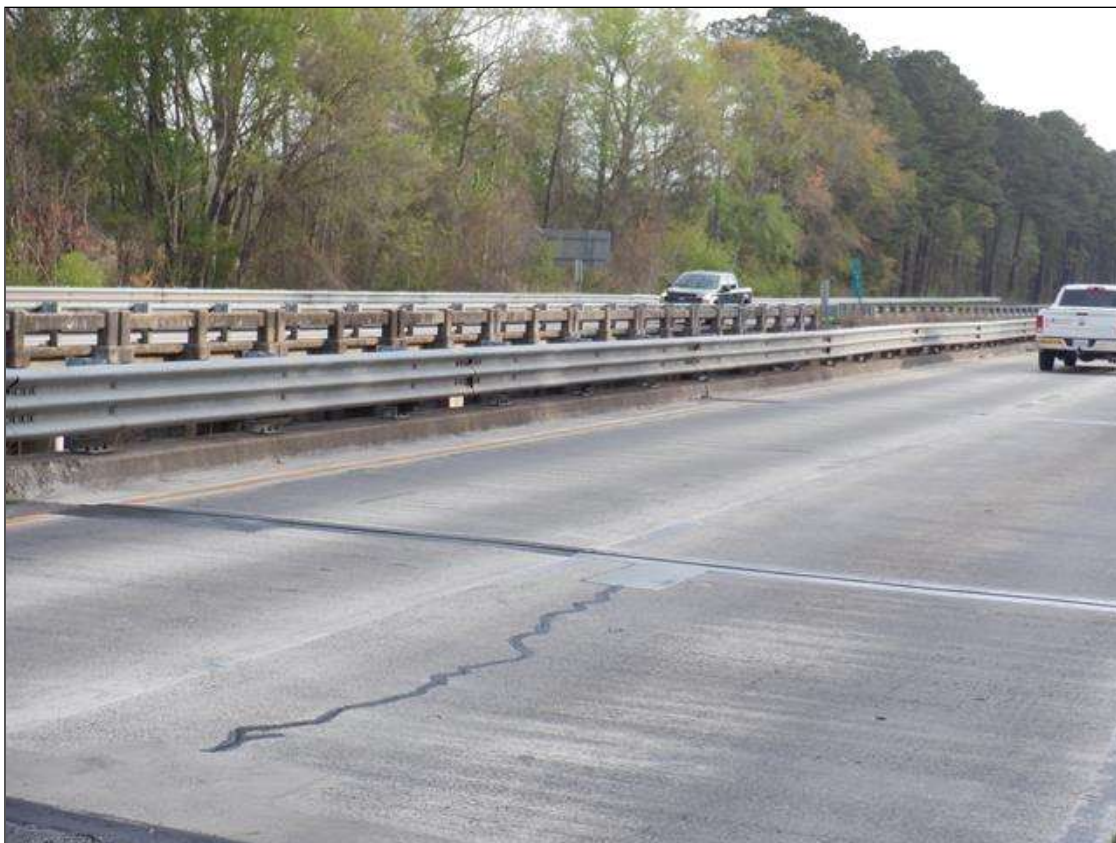
WEST BRIDGE RAIL

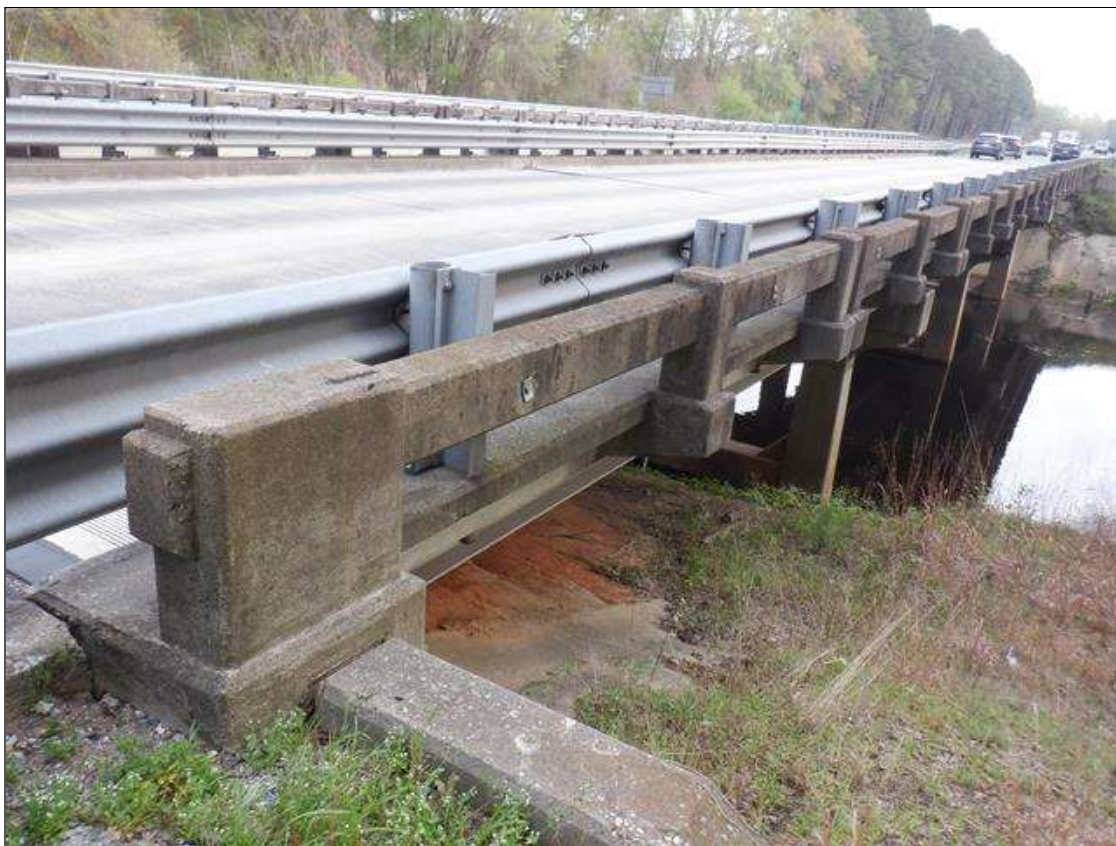
| Priority Level | Defect Type | Quantity | Defect Description |
|---|---|---|---|
| 2 | Distortion | 52 | Span 1 Right Metal Rail: (PAR) 52 FEET OF IMPACT DAMAGE WITH SCRAPES AND 4- UP TO 3 INCHES X 1.5 INCHES GOUGES. |

EAST BRIDGE RAIL

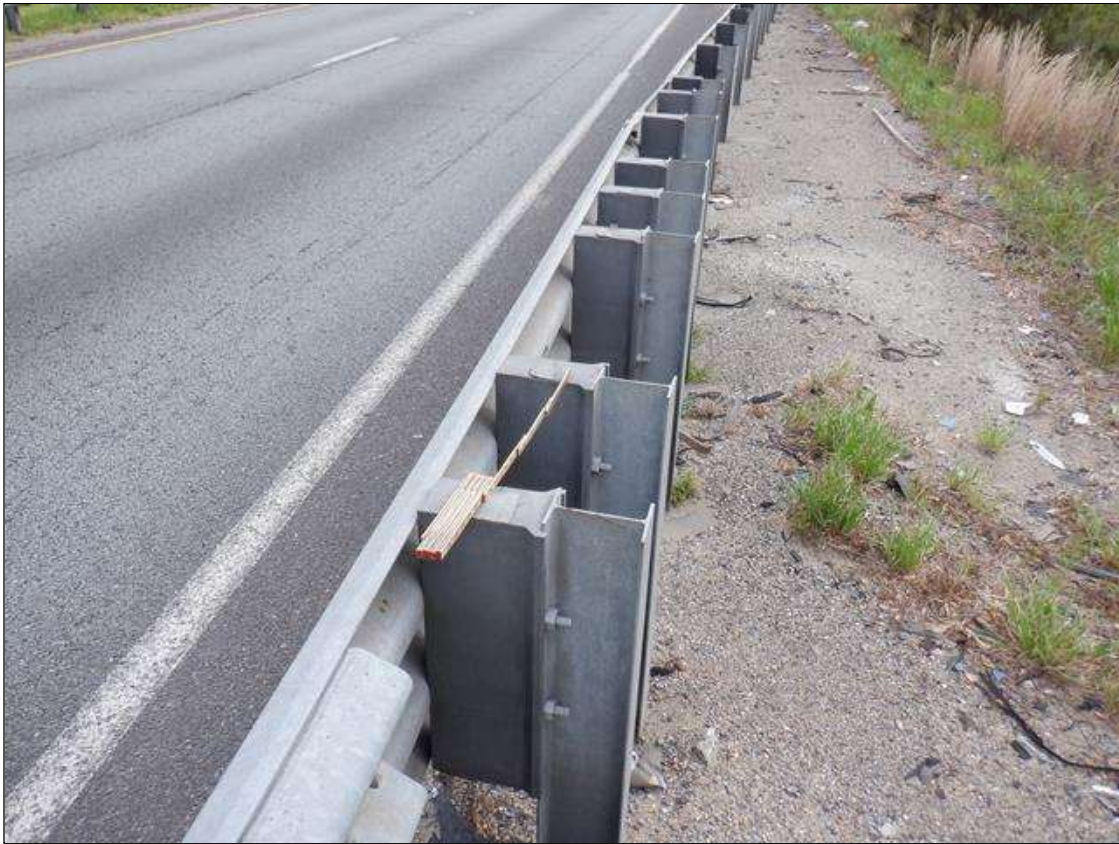
| Priority Level | Defect Type | Quantity | Defect Description |
|---|---|---|---|
| 2 | | 15 | (PAR) 15 FEET OF IMPACT DAMAGE WITH 4- UP TO 3 INCHES X 1 INCHES GOUGES IN NORTHEAST GUARDRAIL, 50 FEET FROM END BENT 2. |

NORTHEAST GUARDRAIL POST SPACING AT BRIDGE 18 INCHES (OTHERS SIMILAR)
