## BALLANCE FARM INSPECTION REPORT

MITIGATION SITE NAME Ballance Farm	TIP # R-2228WM	WBS # N/A	INSPECTION DATE 10/27/2014
---------------------------------------	-------------------	--------------	-------------------------------

**Division 1 - Ballance Farm**  
NCDOT Site Inspection Program  
Currituck County, North Carolina  
November 2014

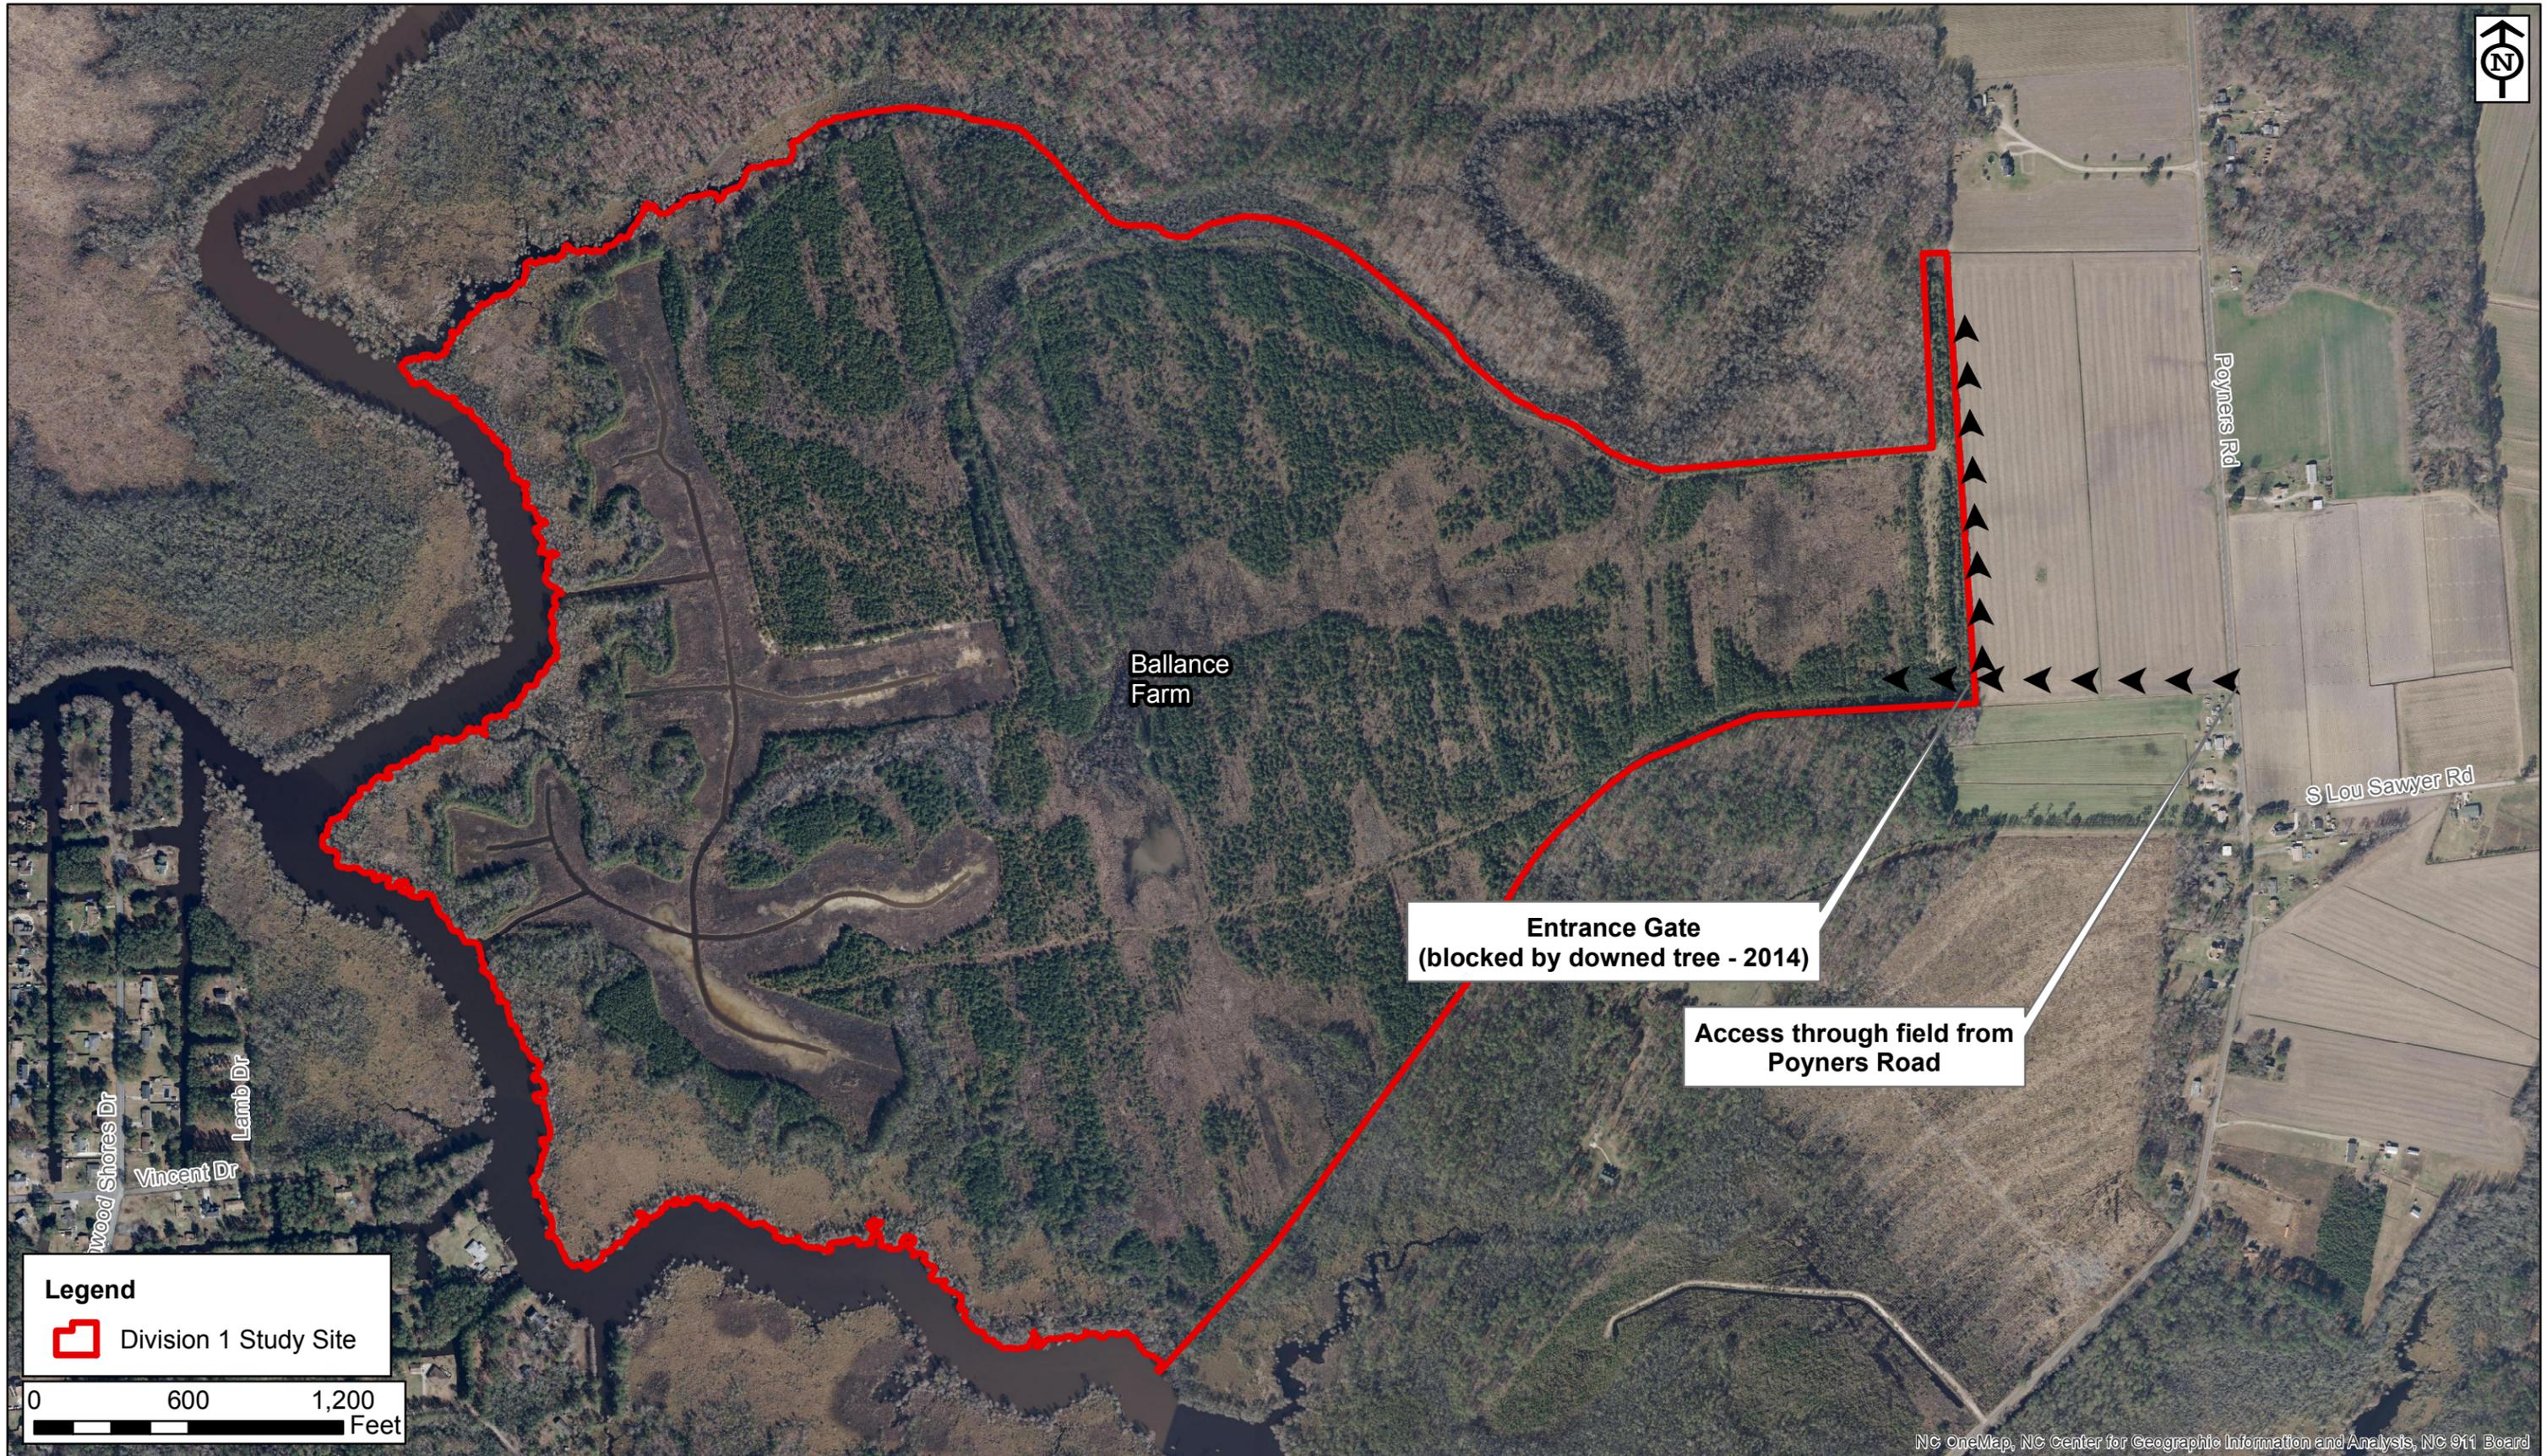
Ballance Farm

**Explain:**  
 A tree has fallen next to the gate and is blocking access into the site.

Entrance Gate  
(blocked by downed tree - 2014)
