# ANNUAL REPORT FOR 2023

**Long Branch Site #5A Mitigation Site**

**TIP No. R-2519B**

Prepared By:  
Roadside Environmental Unit and Environmental Analysis Unit  
North Carolina Department of Transportation  
October 2023

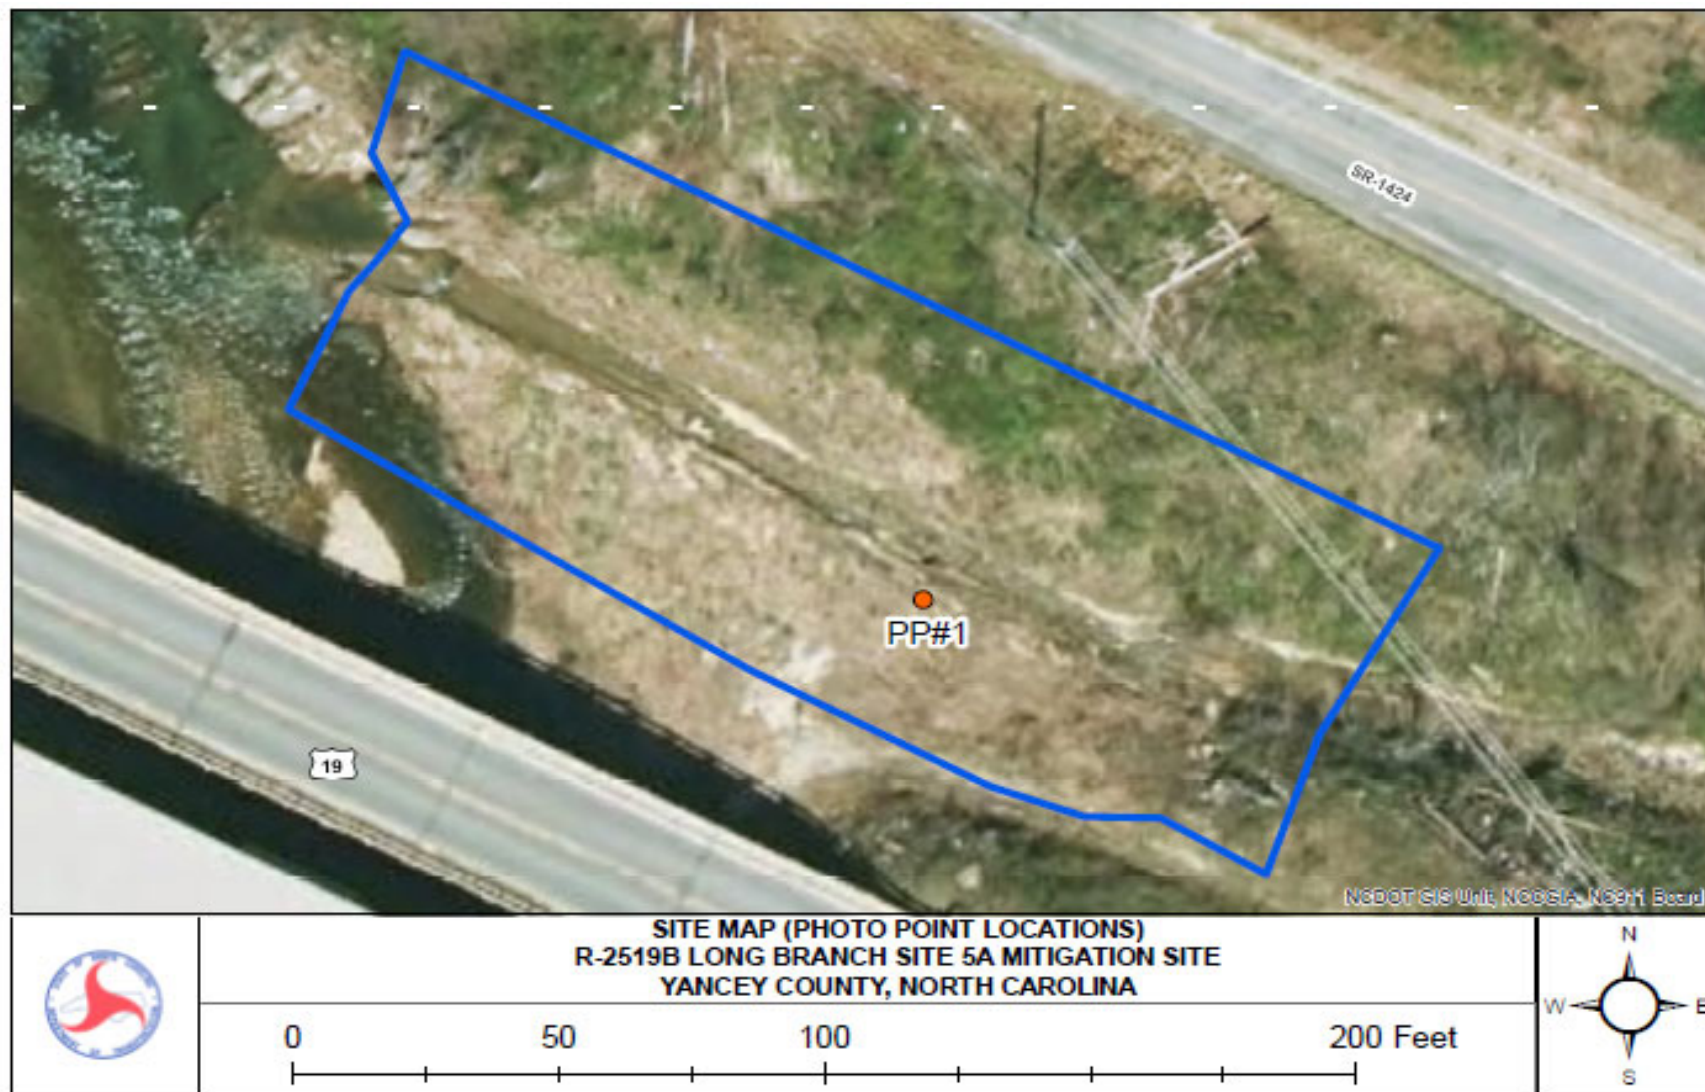
Figure 4. Site #5A Map

The visual assessment of the stream noted that the channel appears stable with some minor undercutting along the left bank. Little to no change was noted along the left bank from the previous year. A wrack line noted along the stream indicated a bankfull event had recently occurred. NCDOT will continue to monitor the channel stability at Site #5A in 2024.
