ANNUAL REPORT FOR 2023

UT to Brushy Creek Site #30 Mitigation Site ONE ID #: 061-004 Mitchell County TIP No. R-2519B

COE Action ID: SAW-2004-9987181 / 2004-30631

Prepared By:
Environmental Analysis Unit and Roadside Environmental Unit
North Carolina Department of Transportation
December 2023

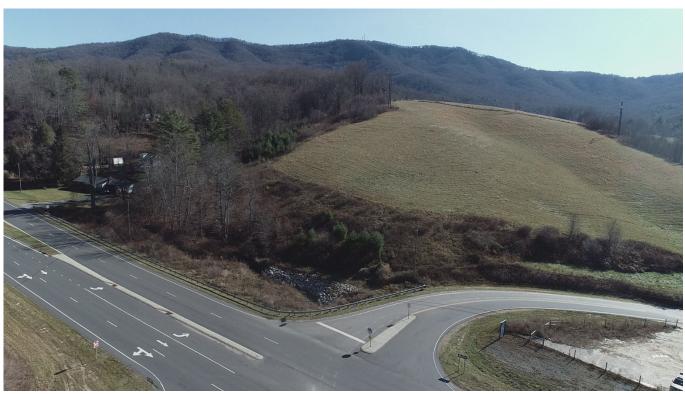
Aerial View of Upper Stream Segment

Remediation work was completed at the site upstream of the US 19 highway crossing in August of 2022. The remediation work comprised of grading the left bank back and installing boulder toe protection to repair bank erosion that had continued throughout the monitoring period. A visual inspection of this area in 2023 indicates the left bank is stable and erosion has subsided. Photos of the remediation area are shown in Appendix B.

Site #30 Remediation Work
