Channel Mitigation Monitoring Sheets I, II, III, AND IV
Monitoring Data Record

Project Title: R-5206 COE Action ID: 2015-00451
Stream Name: UT to Blanton Branch – Permit Site 5 DWR Number: 2015-0216
City, County and other Location Information: The project is located on Cope Creek Rd, SR 1449 just off US 74 in Jackson County, NC.
Date Construction Completed: Final Planting: April 10, 2018 Monitoring Year: (3) of 3
Ecoregion: Southern Crystalline Ridges and Mountains 8 digit HUC unit 06010203
USGS Quad Name and Coordinates: Sylva North 35.390942°, -83.185654°

Length of Project: 277 linear feet
Urban or Rural: Rural Watershed Size: 0.65 sq. miles
Monitoring DATA collected by: M. Green Date: 7-11-20

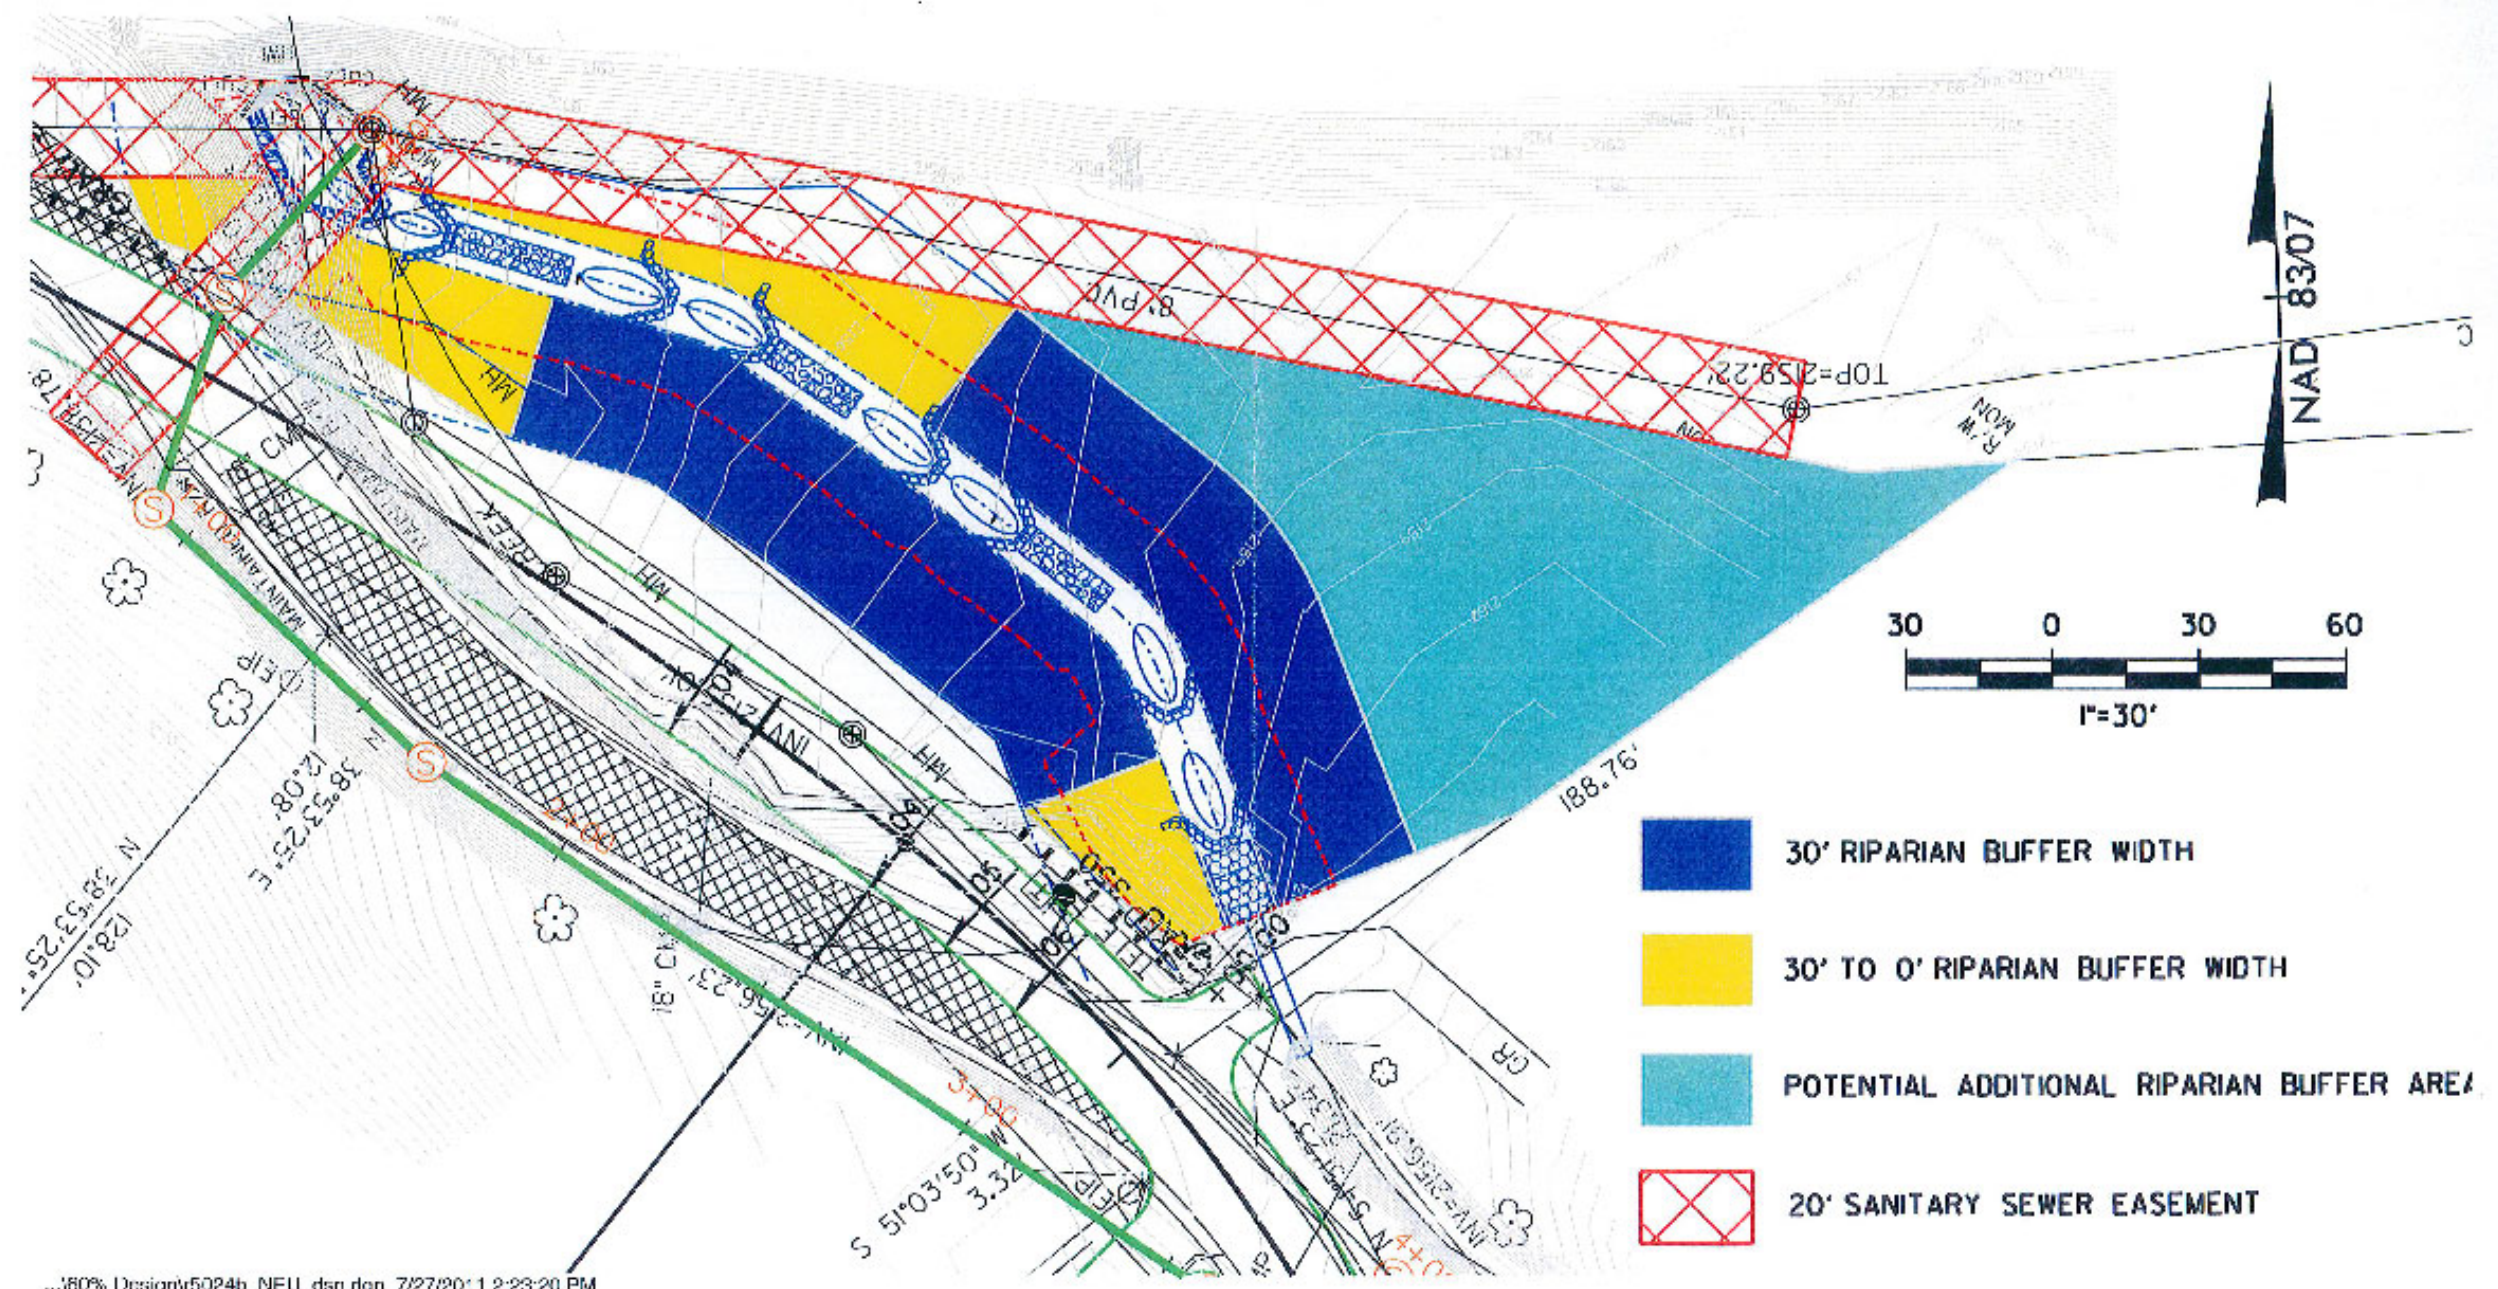
July 2020

The UT to Blanton Branch onsite stream mitigation is stable for the Year 3 evaluation. No instability was noted along the stream and all structures were functioning properly. A wrack line was noted within the floodplain during the monitoring evaluation indicating a bankfull event had occurred. NCDOT proposes to discontinue monitoring the channel stability at the UT to Blanton Branch Mitigation Site.

Overview photo looking upstream
