Channel Mitigation Monitoring Sheets I, II, III, AND IV  
Monitoring Data Record

Project Title: U-2579B COE Action ID: SAW-2008-03183  
Stream Name: Permit Sites 3A and 3B DWR Number: 2014-0090v2  
City, County and other Location Information: Temporary impact Sites 3A and 3B are located at the intersection of the Winston-Salem Northern Beltway and US 158 (Reidsville Road)  
Date Construction Completed: Streambank reforestation completed in March 2019  
Monitoring Year: ( 2 ) of 2  
Ecoregion: Southern Outer Piedmont 8-digit HUC unit 03040101  
USGS Quad Name and Coordinates: Walkertown 36.148420°, -80.153487°

# Sites 3A and 3B

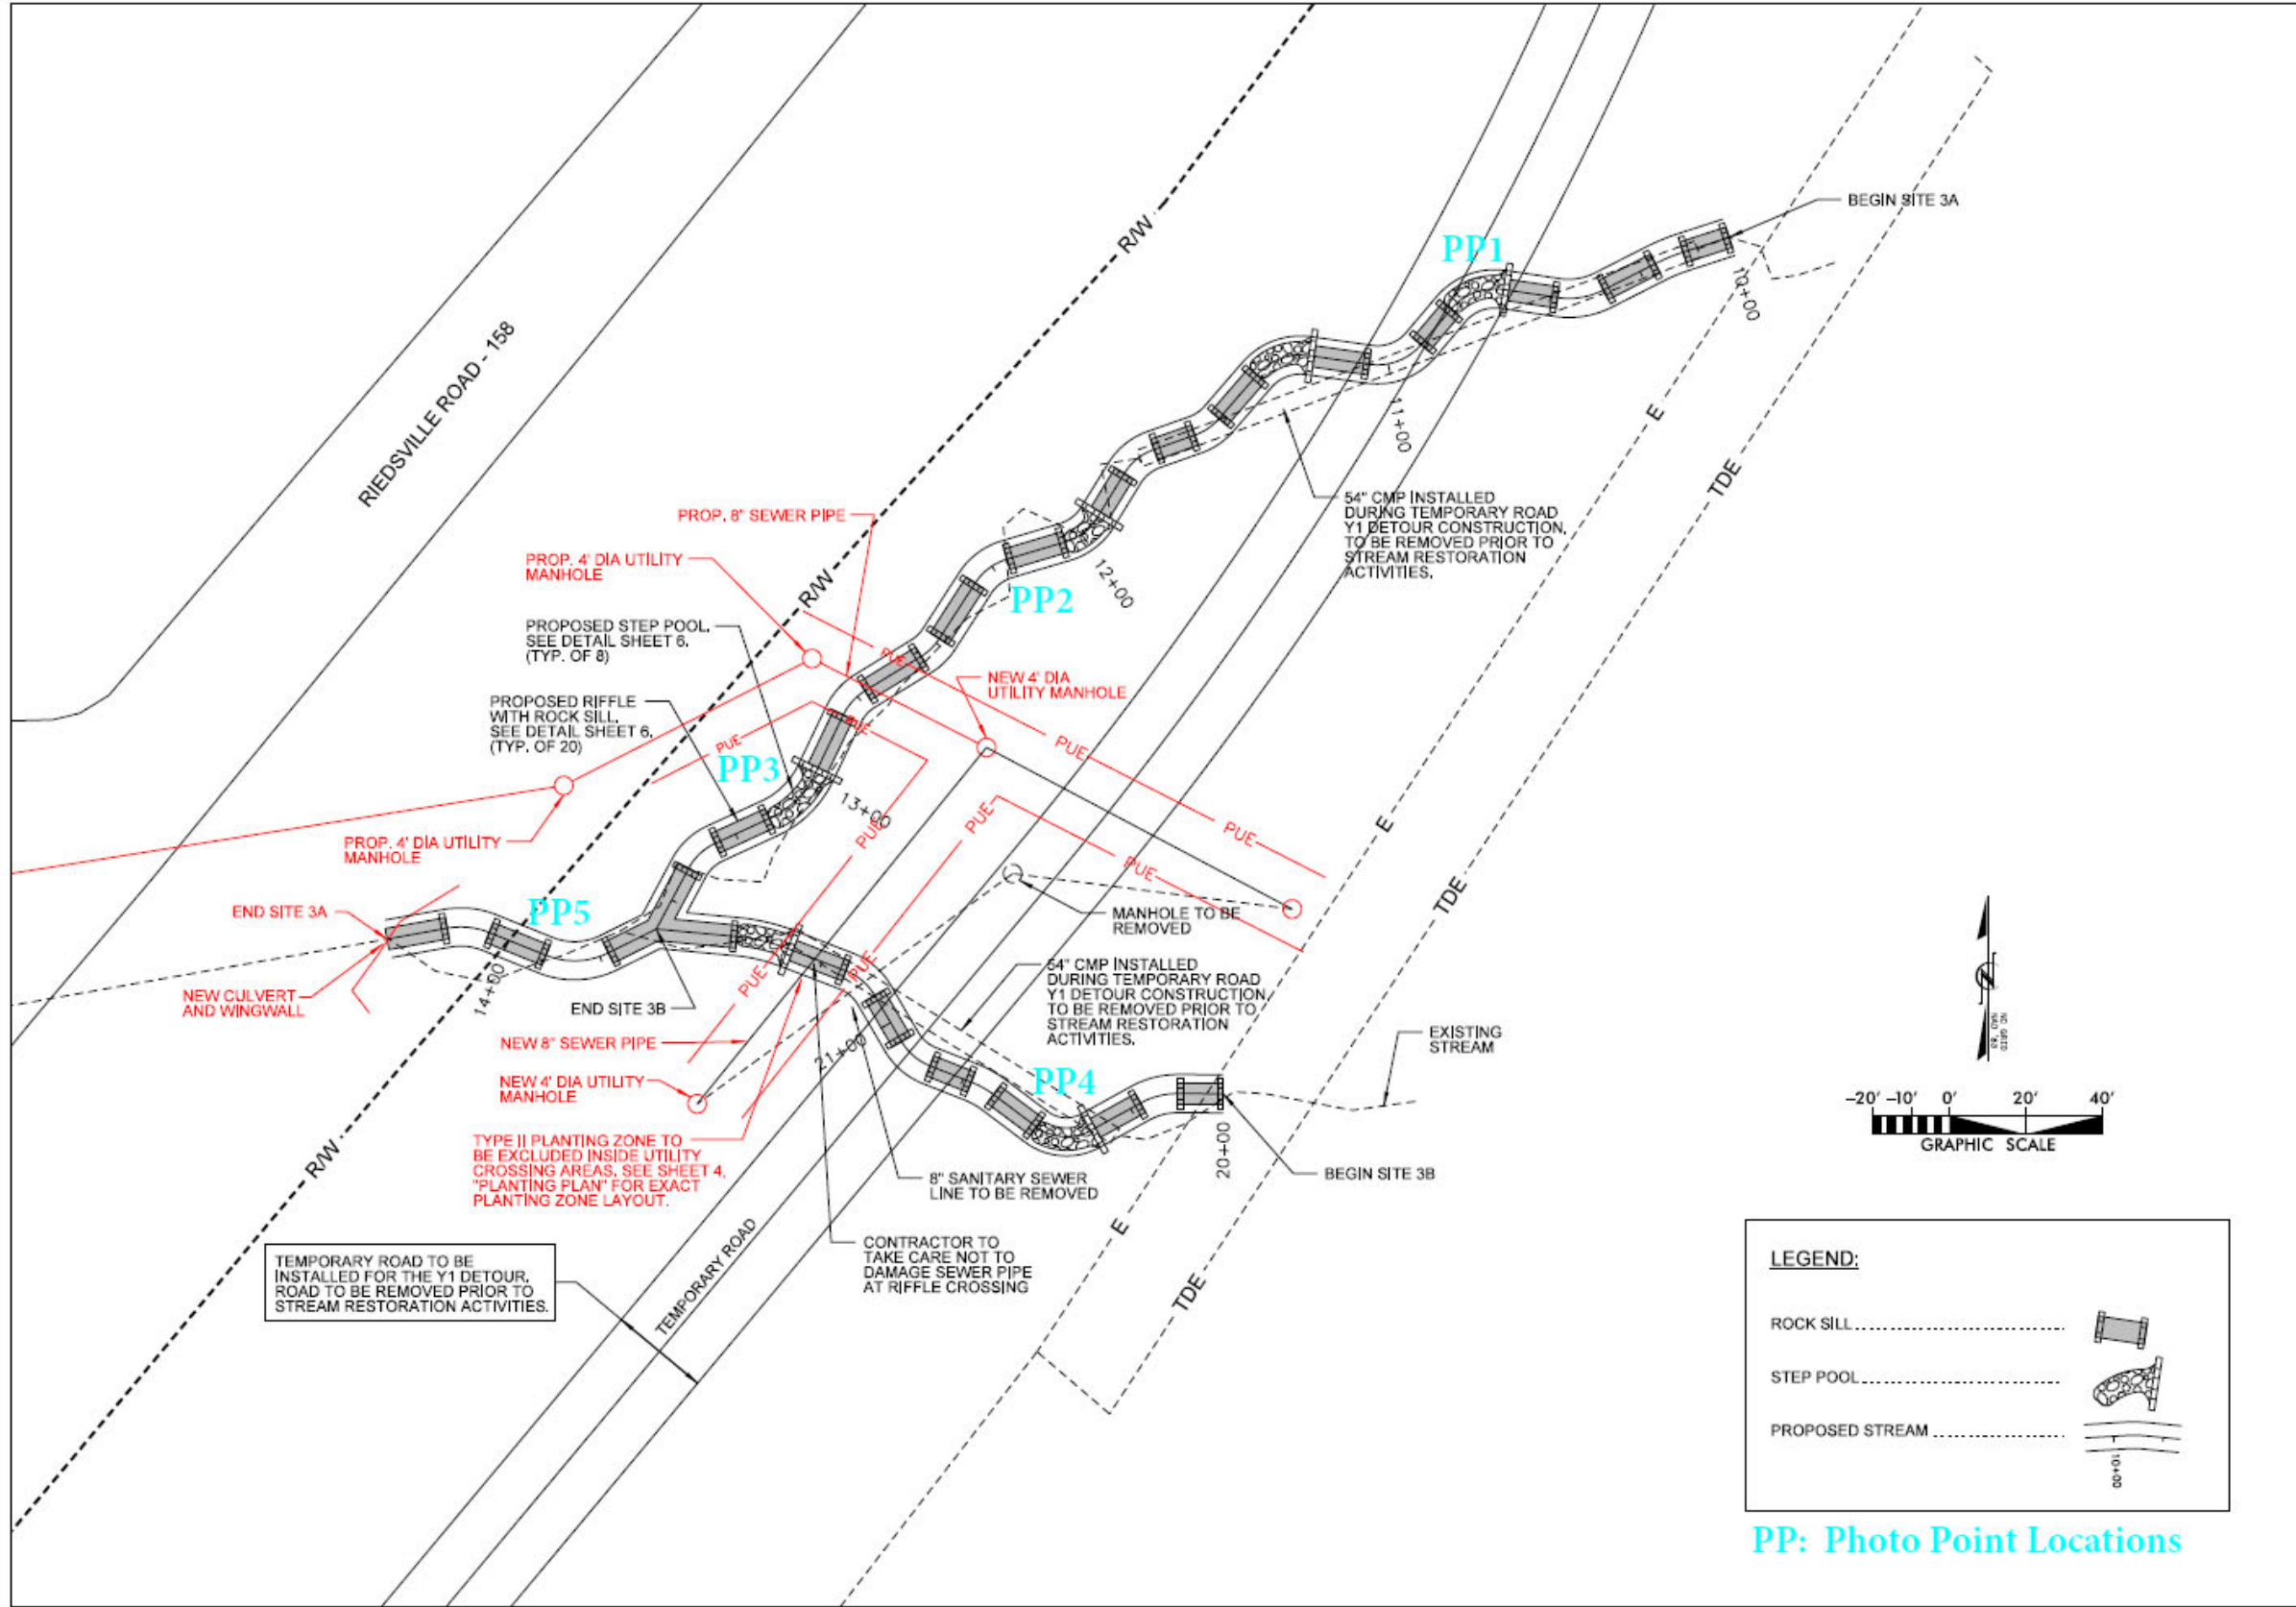
Overview taken from US 158

Sites 3A and 3B temporary impact streams are stable for the Year 2 evaluation. No instability was noted along the streams. A wrack line was visible within the floodplain indicating a bankfull event had occurred. NCDOT proposes to discontinue monitoring channel stability at the Sites 3A and 3B temporary impact streams.
