Channel Mitigation Monitoring Sheets I, II, III, AND IV

Monitoring Data Record

Project Title: B-4191 (Br. No. 82 over Jacktown Creek on NC 226)

Stream Name: Jacktown Creek

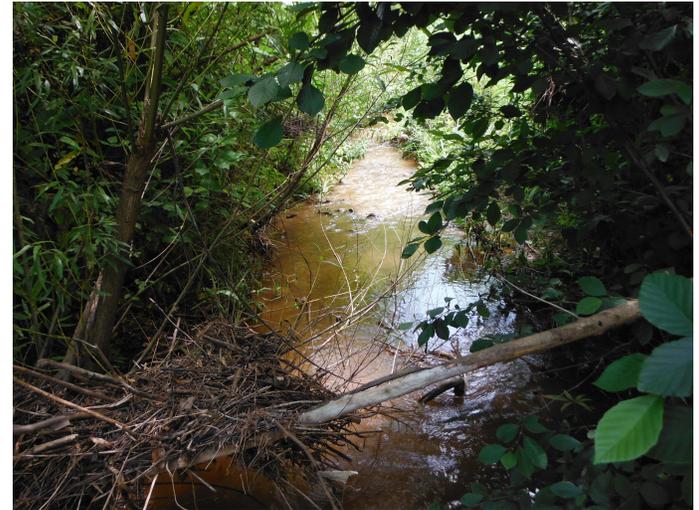
Photo Point #2 (Downstream)

A small area of kudzu was noted within the east buffer adjacent to Photo Point #2.

Estimated causes, and proposed/required remedial action: NCDOT applied a herbicide application on the kudzu on 7/11/16.

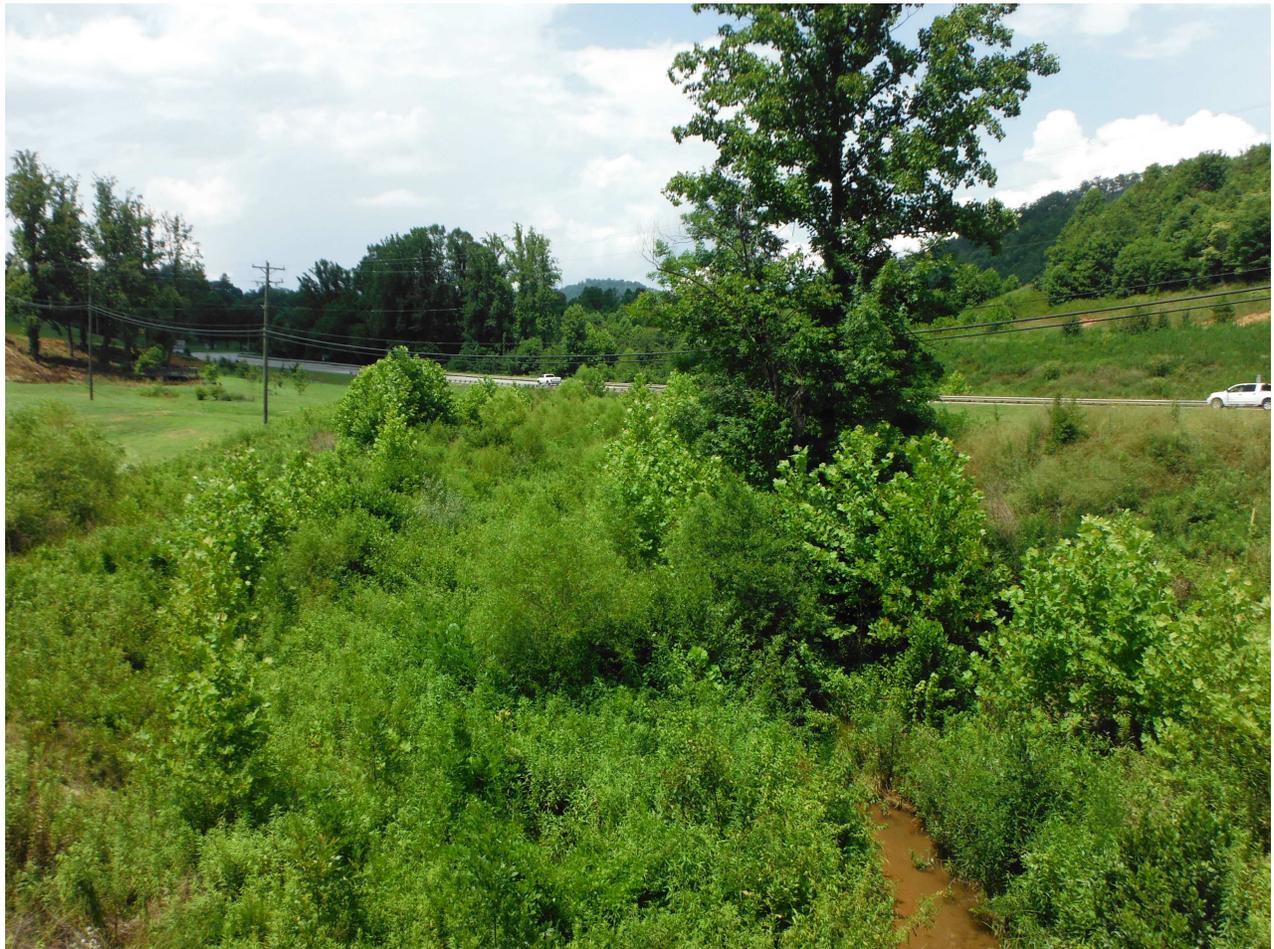
Overview Photo Looking Upstream from SR 1832

The Jacktown Creek stream restoration site is stable for the Year 5 Summer evaluation, except for, some right bank erosion at Sta. 11+90 and left bank erosion at Sta. 12+50. Bank pins were set at both locations. See the bank full dates throughout the monitoring period below and how the bankfull events were noted. This site has met the bankfull requirement of two bankfull events must occur over the five year monitoring period. NCDOT proposes to discontinue channel stability monitoring. NCDOT will schedule a field close out meeting in 2017 and at this time the bank pins will be evaluated to see if further bank erosion has occurred.
