ANNUAL REPORT FOR 2010

**Unnamed Tributaries to Doby Creek Mitigation Site
Mecklenburg County
TIP No. I-3803A**

Prepared By:
Natural Environment Unit & Roadside Environmental Unit
North Carolina Department of Transportation
December 2010

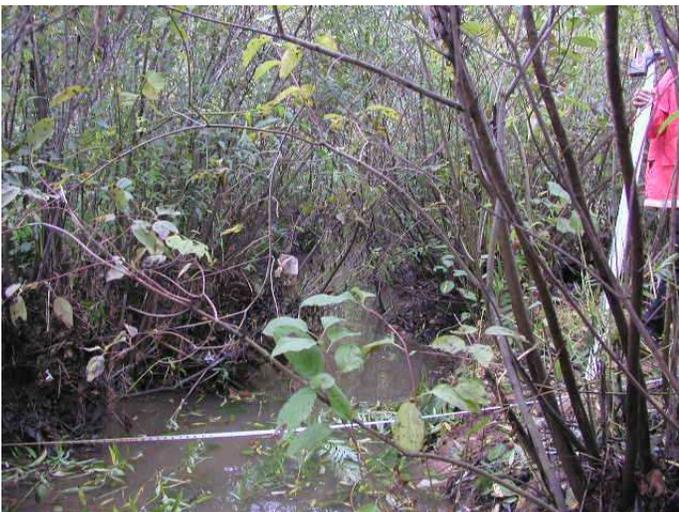
Photo Point #2 (Downstream @ X-Section #2)
October 2010

Based on comparisons of the monitoring data, both cross sections appear stable with little or no active bank erosion. It was noted on the graph for cross section #2 pool that some of the sediment deposited into the channel from last year has moved downstream. The beaver dam located on the restoration project at photo point #3 has been removed by NCDOT Maintenance
