Monitoring Data Record

Project Title: R-977A US 64 COE Action ID: 2005301150
Stream Name: UT to Hiwassee River (Site 11) DWQ Number: 3487
City, County and other Location Information: Murphy, Cherokee County, US 64, from
US 19-74-129 in Murphy to East of NC 141 in Peachtree (Sta. 12+20 to 15+50)
Date Construction Completed: March 2007 Monitoring Year: (5) of 5
Ecoregion: _____ 8 digit HUC unit 06020002
USGS Quad Name and Coordinates: _____

Year 5 Winter – February 2012

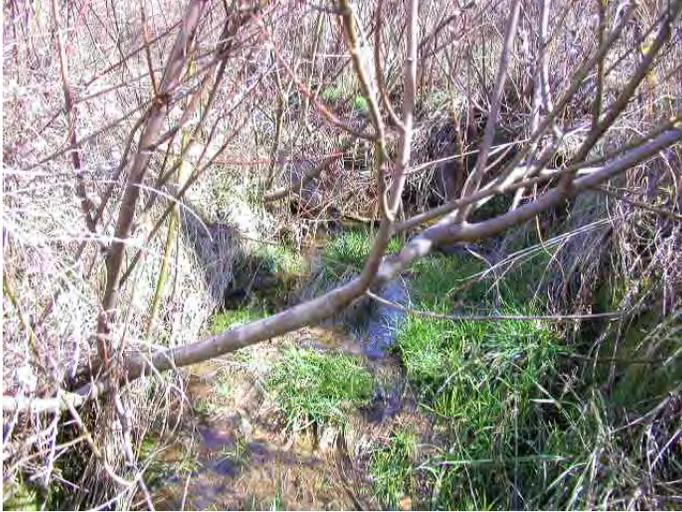
Photo Point #7 (Upstream)

Date Inspected 2/20/12	Up and Downstream of PP#6	Downstream of PP#7	Station Number	Station Number	Station Number
Structure Type		Crossvanes			
Is water piping through or around structure?	No flow in channel. Water is piping underground due to blasting to relocate the channel.	Water piping under two crossvanes			
Head cut or down cut present?					
Bank or scour erosion present?					
Other problems noted?
