# ANNUAL REPORT FOR 2004

**Cedar Point Mitigation Site  
Carteret County  
Project No. 6.16901T  
TIP No. R-2105 AB**

Prepared By:  
Office of Natural Environment & Roadside Environmental Unit  
North Carolina Department of Transportation  
December 2004

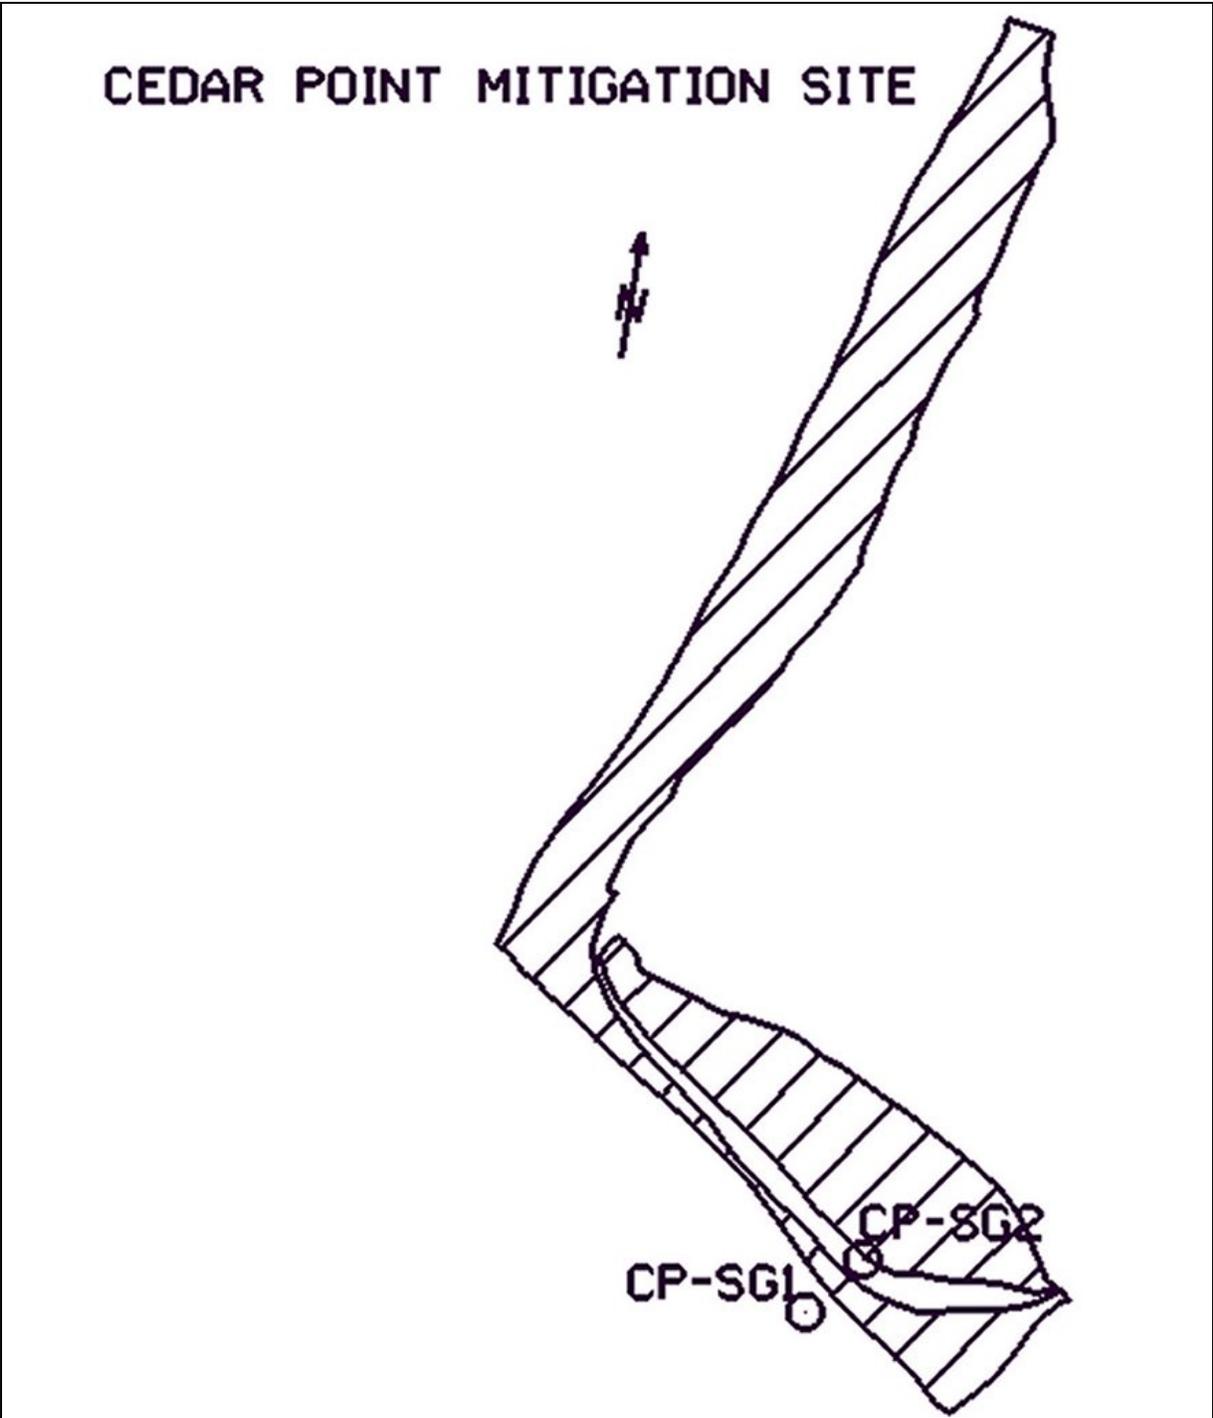
Figure 2. Gauge Location Map

Due to the site's proximity to the White Oak River, as well as the constructed channel designed to increase tidal exchange, the Cedar Point Site is monitored by surface water gauges (Figure 2). These gauges should indicate if the site is flooded twice daily as is required for success. The flooding regime of the site is expected to be the same as that measured for the biological benchmarks for *Spartina alterniflora*, since it can reflect long-term tidal fluctuations. A rain gauge was not installed as surface water is the primary hydrologic input to this site.

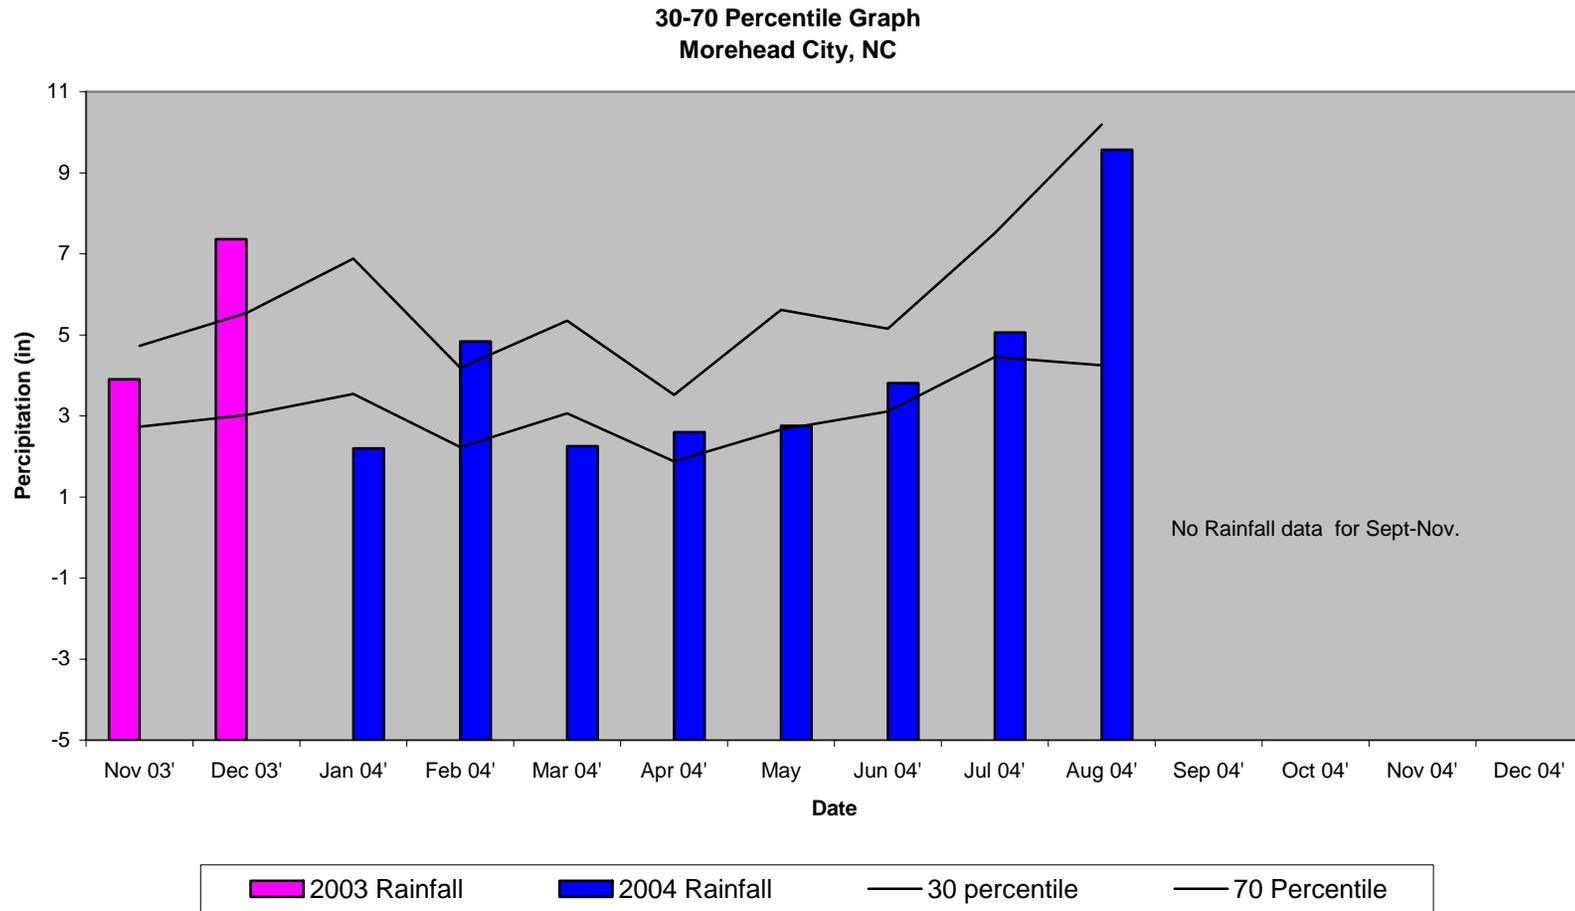
Figure 4. 30-70 Percentile Graph

Figure 4 is a comparison of monthly rainfall (November 2003- August 2004) to historical precipitation for the area. The rainfall data for the months of September-November 2004 were not available, therefore were not included in the graph. The two lines represent the 30<sup>th</sup> and 70<sup>th</sup> percentiles of monthly precipitation for Morehead City, NC. These percentiles represent monthly rainfall data collected between 1973 and 2004. The State Climate Office of North Carolina at NC State University provided the data.

For the 2004-year, December (03') and February experienced above average rainfall. The months of January, March and May recorded below average rainfall for the site. November (03'), April, June, July, and August experienced average rainfall. Overall, the site met the hydrologic criteria in a year of average climate conditions. However, precipitation is not the primary hydrologic input for the site; thus, it is expected that the site would show the required flooding regardless of area rainfall totals.
