ANNUAL REPORT FOR 2006

**Cedar Point Mitigation Site
Carteret County
TIP No. R-2105 AB**

Prepared By:
Natural Environment Unit & Roadside Environmental Unit
North Carolina Department of Transportation
January 2007

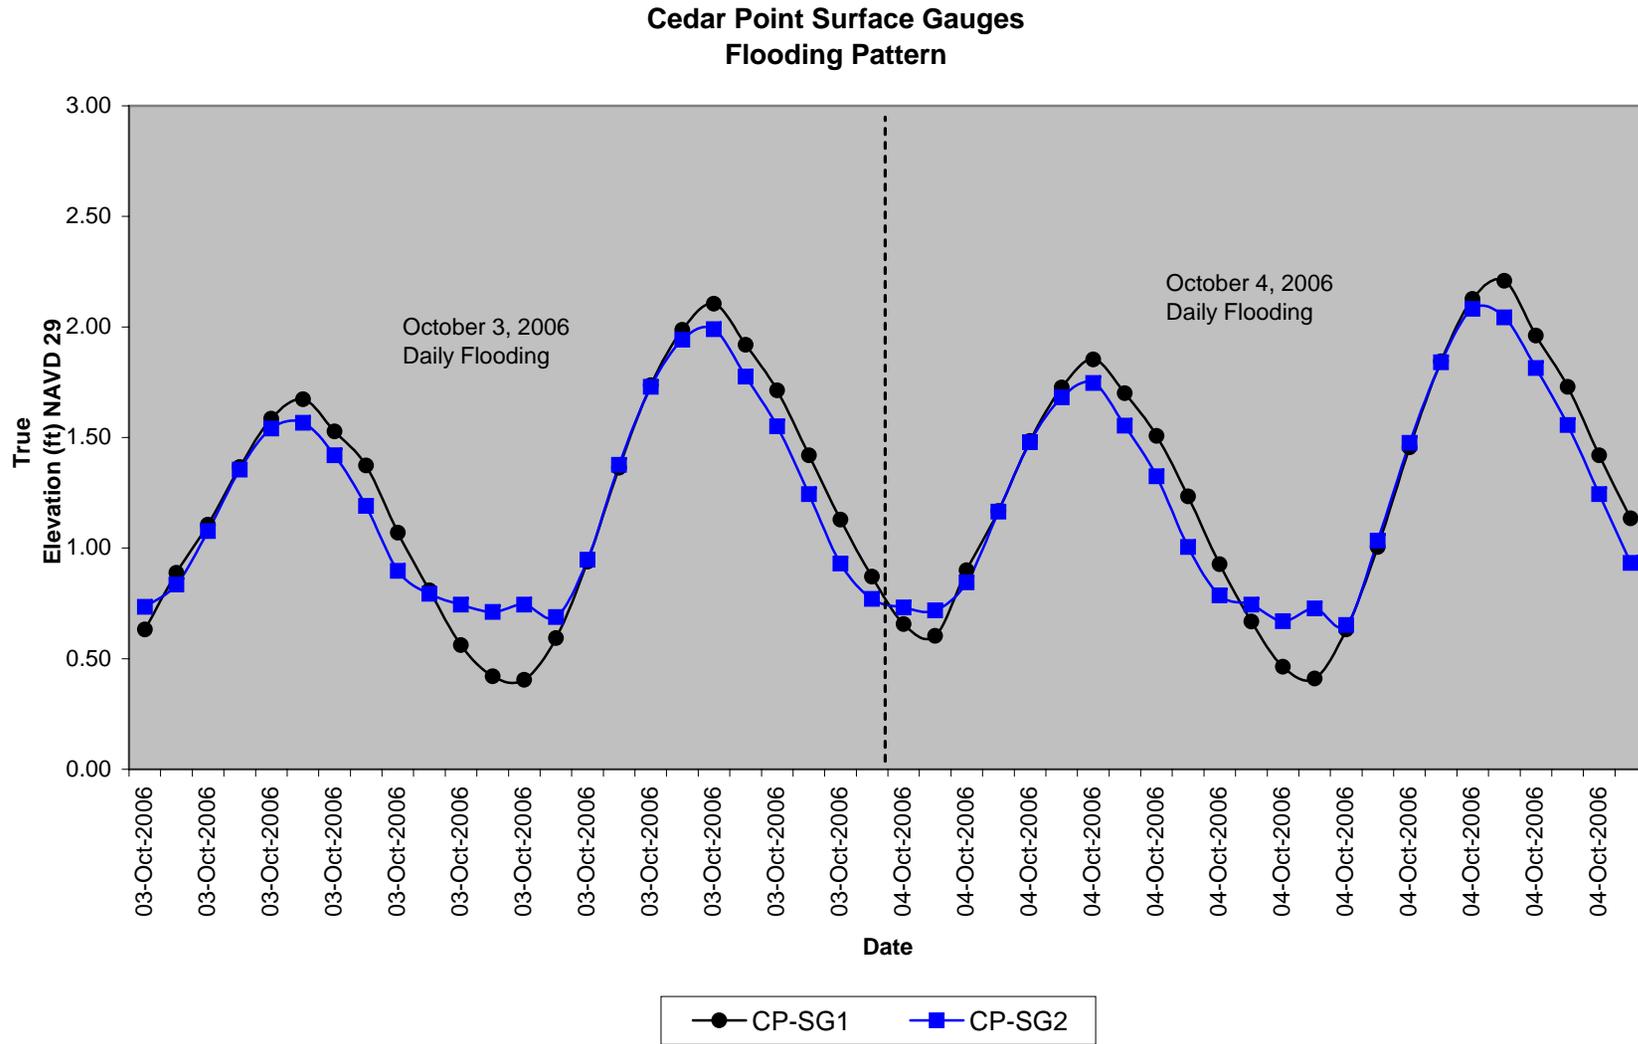
Figure 3. Plot of Daily Flooding Pattern

Figure 3 is a surface water plot of the data recorded at both gauges over a two-day period. This figure illustrates that flooding occurs twice daily as required in the permit conditions. The two days in the plot were chosen at random and are representative of conditions throughout the growing season.

The surface gauges indicate that the site is being flooded twice daily during the growing season. An examination of the water levels over a two-day period (Figure 3) illustrates that the site floods twice daily under average climatic conditions. The two days in the plot were chosen at random and are representative of typical conditions during the growing season.

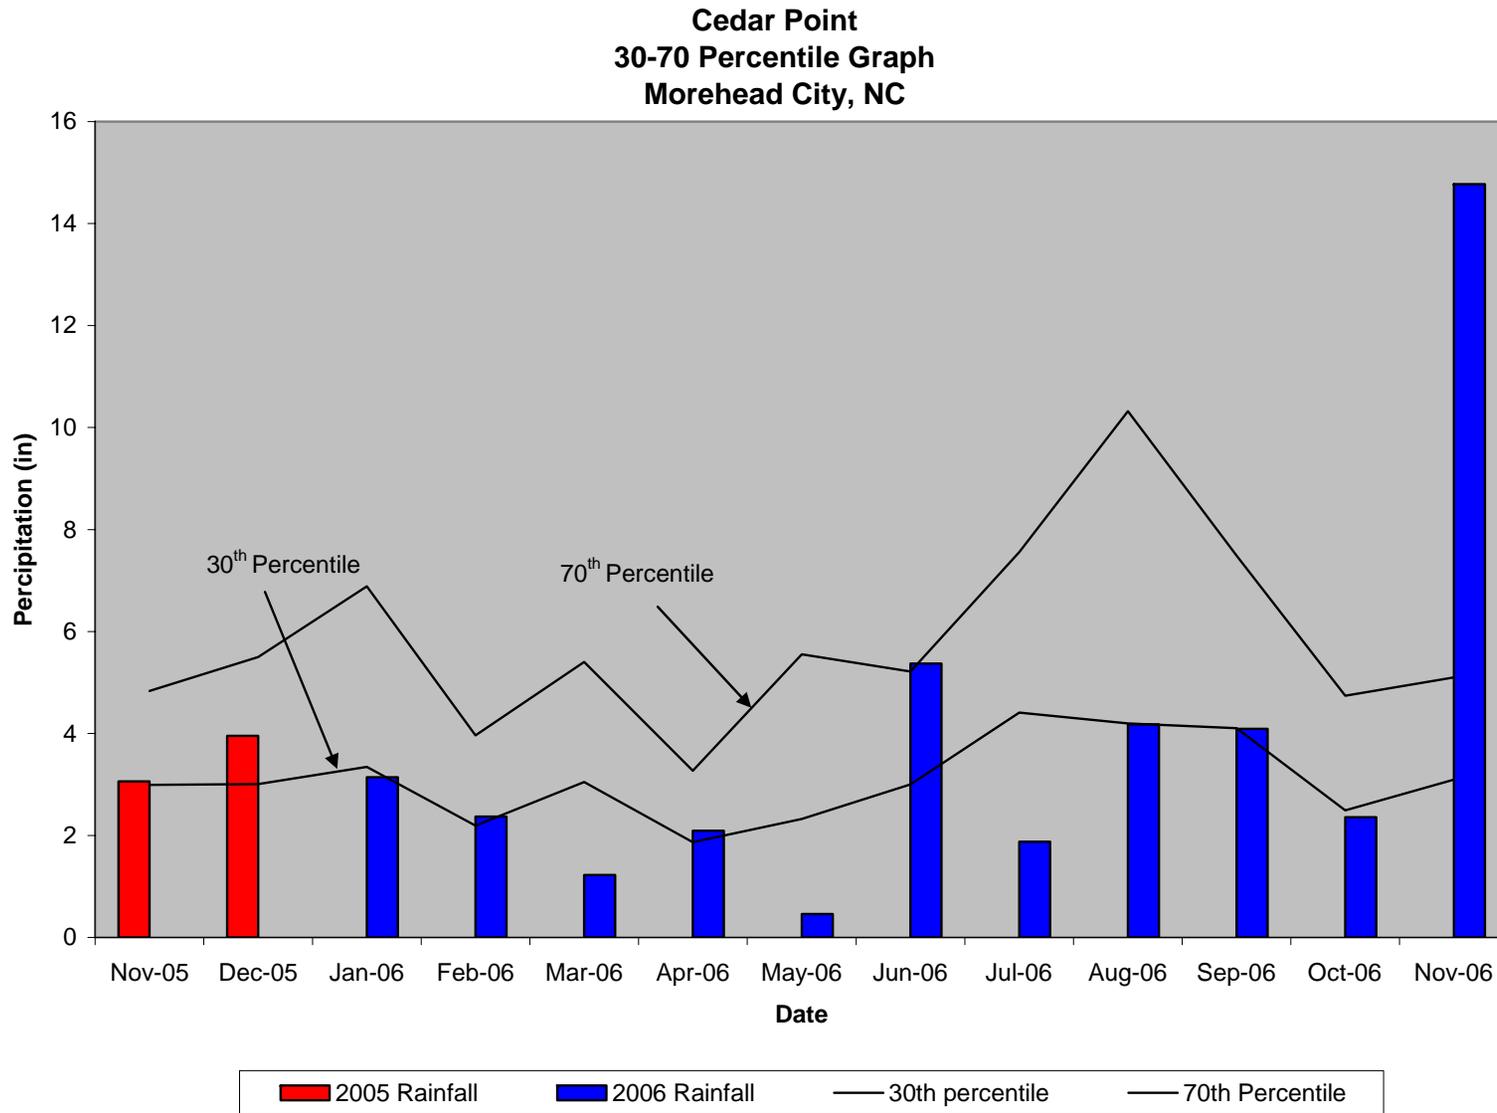
Figure 4: 30-70 Percentile Graph

A comparison of monthly rainfall for the period of January through November 2006 to historical precipitation (collected between 1975 and 2006) for Morehead City, North Carolina is represented in Figure 4. This comparison gives an indication of how 2006 relates to historical data in terms of climate conditions. The NC State Climate Office provided all of the local rainfall information.
