Monitoring Data Record

Project Title: R-2248D – Charlotte Outer Loop COE Action ID: 200131321  
 Stream Name: Trib. to Dixon Branch (Site 16) DWQ Number: 011231  
 City, County and other Location Information: Mecklenburg County, Charlotte Outer Loop, R-2248D Right of Project Station 13+50 Ramp 2D  
 Date Construction Completed: February 2005 Monitoring Year: ( 3 ) of 5  
 Ecoregion: \_\_\_\_\_ 8 digit HUC unit 03050103  
 USGS Quad Name and Coordinates: \_\_\_\_\_

# UT to Dixon Branch

## Site 16

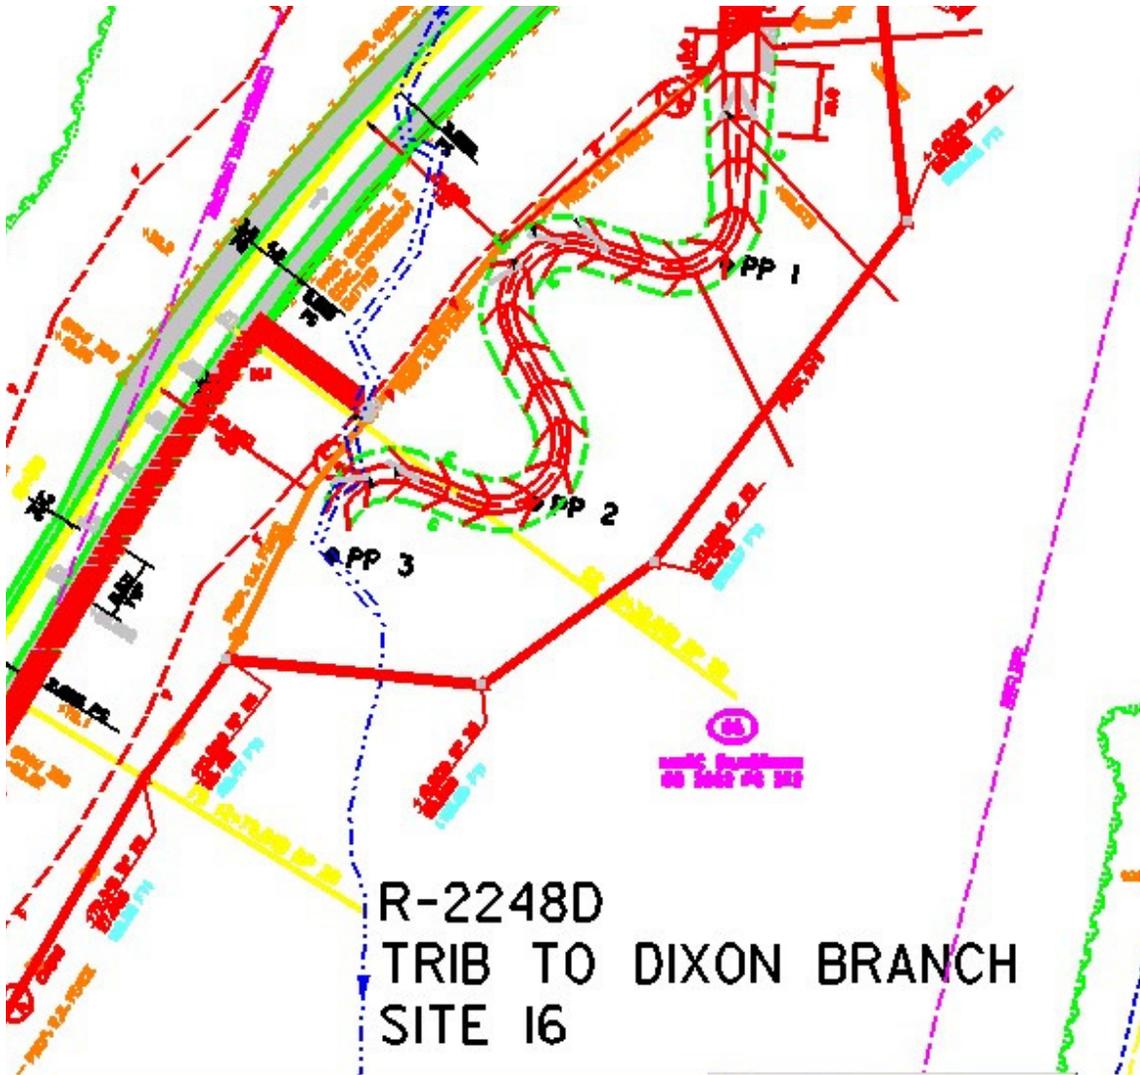
Date 3/2/11	Between PP#1 and PP#2	Station Number	Station Number	Station Number	Station Number
Structure Type	Log Sills				
Is water piping through or around structure?	Water is piping under or around three of the four installed log sills				
Head cut or down cut present?	Headcut				
Bank or scour erosion present?					
Other problems noted?

Headcut upstream of Log Sill #1  
Year 3 Winter – March 2011
