Monitoring Data Record

Project Title: R-2248D – Charlotte Outer Loop COE Action ID: 200131321
 Stream Name: Trib. to Dixon Branch (Site 24) DWQ Number: 011231
 City, County and other Location Information: Mecklenburg County, Charlotte Outer Loop, R-2248D Sta. 378+15 to 379+40 –L- Left and Sta.380+16 to 381+23 –L- Left
 Date Construction Completed: February 2005 Monitoring Year: (5) of 5
 Ecoregion: 8 digit HUC unit 03050103
 USGS Quad Name and Coordinates: _____

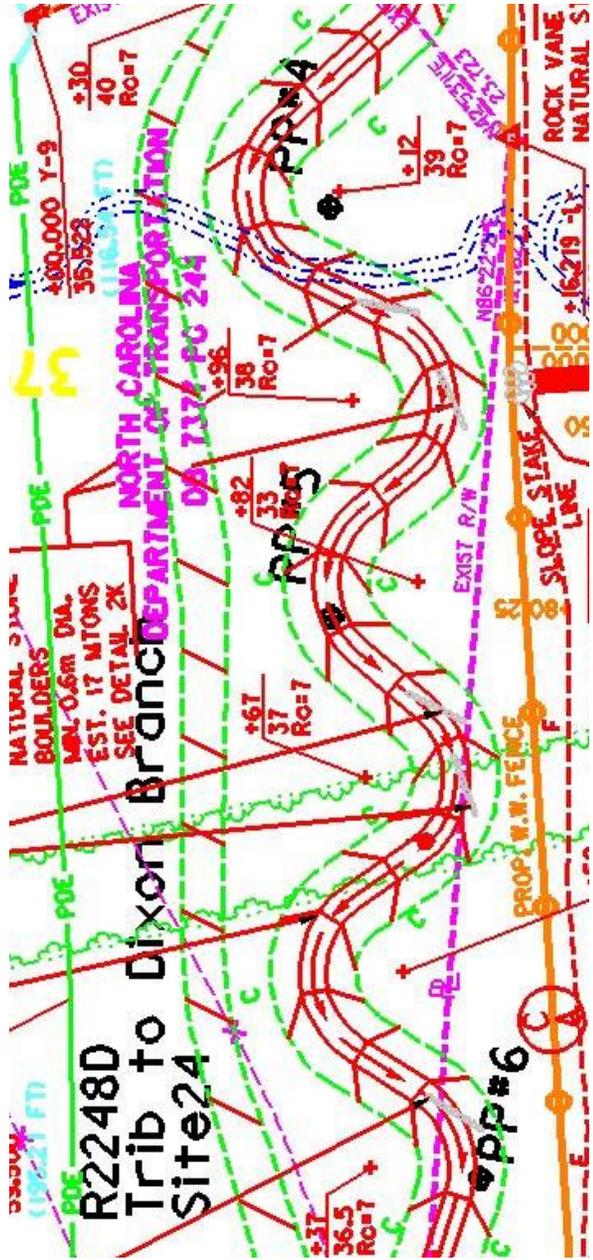
UT to Dixon Branch (Site 24) stream relocation is stable for the Year 5 Winter evaluation. The eroded right bank at the log sill at Sta. 380+40-L- that was previously noted was repaired on 10/9/12. This log sill continues to have water piping under it but remains stable at this time. NCDOT will continue to monitor the channel stability.

Repaired right bank at Sta. 380+40-L-
