ANNUAL REPORT FOR 2015

**Middle Fork Creek Site E Mitigation Site
Madison County
TIP No. R-2518A
COE Action ID: SAW-2007-2197-357/300
DWR #: 20071134**

Prepared By:
Natural Environment Section & Roadside Environmental Unit
North Carolina Department of Transportation
November 2015

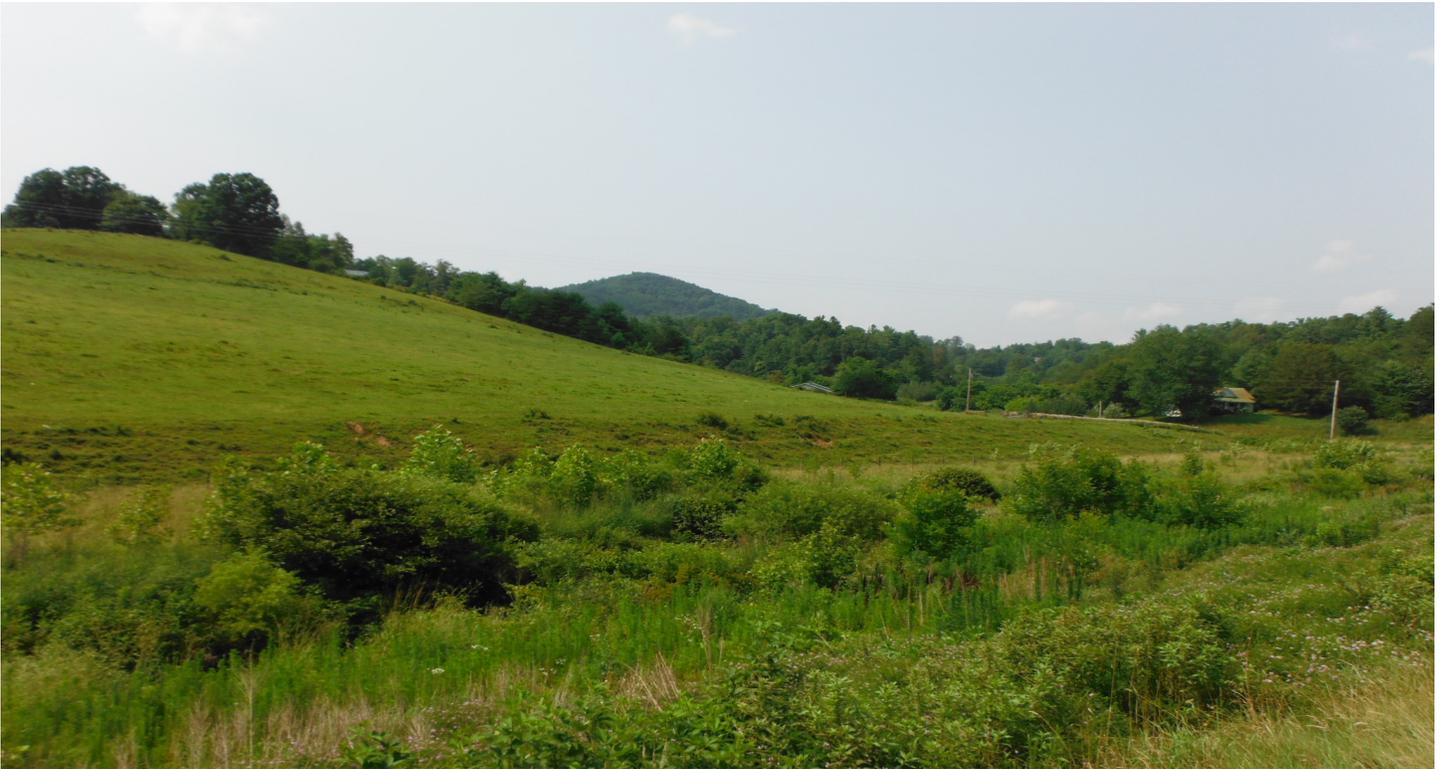
Vegetation Overview Photo (Looking Upstream from US 19)

Streambank & Buffer Vegetation: The streambank reforestation was completed in March 2012. A supplemental planting took place in March 2015. The Year 4 vegetation monitoring evaluation noted: Type I: Black Willow, Silky Dogwood, and Type II: Sycamore, Green Ash, Tulip Poplar and White Oak were surviving at the time of the monitoring evaluation. A small area of Japanese Knotweed was sprayed in July 2015 around Cross Section #5.
