# ANNUAL REPORT FOR 2012

**Middle Fork Creek Site I Mitigation Site  
Madison County  
TIP No. R-2518A  
COE Action ID: SAW-2007-2197-357/300  
DWQ #: 20071134**

Prepared By:  
Natural Environment Section & Roadside Environmental Unit  
North Carolina Department of Transportation  
December 2012

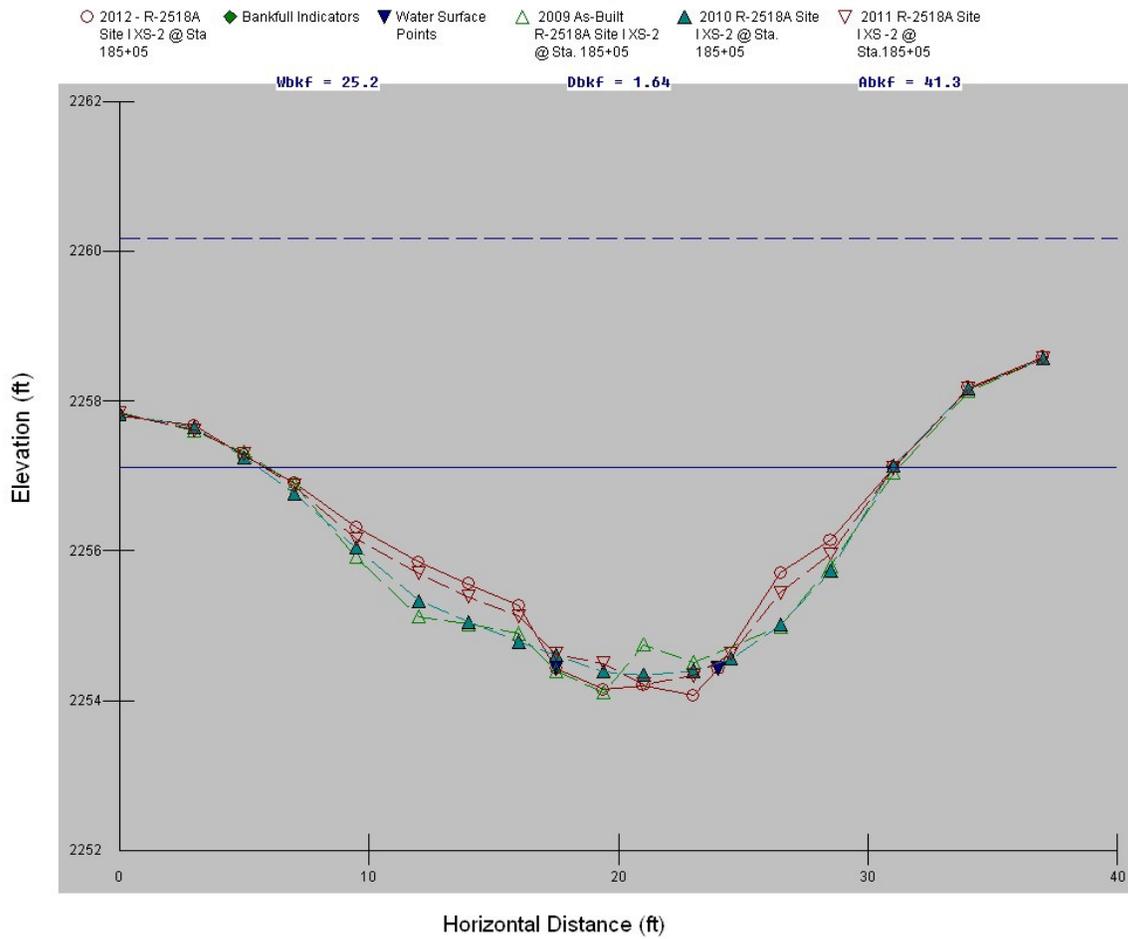
### R-2518A Site I XS-2 @ Sta 185+05

Site I: Cross-Section #2 (Riffle) Abbreviated Morphological Summary					
	2010	2011	2012	2013	2014
Bankfull Cross Sectional Area (ft <sup>2</sup> )	46.76	42.04	41.31		
Maximum Bankfull Depth (ft.)	2.8	2.89	3.05		
Width of the Floodprone Area (ft.)	37	37	37		
Bankfull Mean Depth (ft.)	1.83	1.67	1.64		
Width/Depth Ratio	13.96	15.05	15.35		
Entrenchment Ratio	1.45	1.47	1.47		
Bankfull Width (ft.)	25.54	25.14	25.17

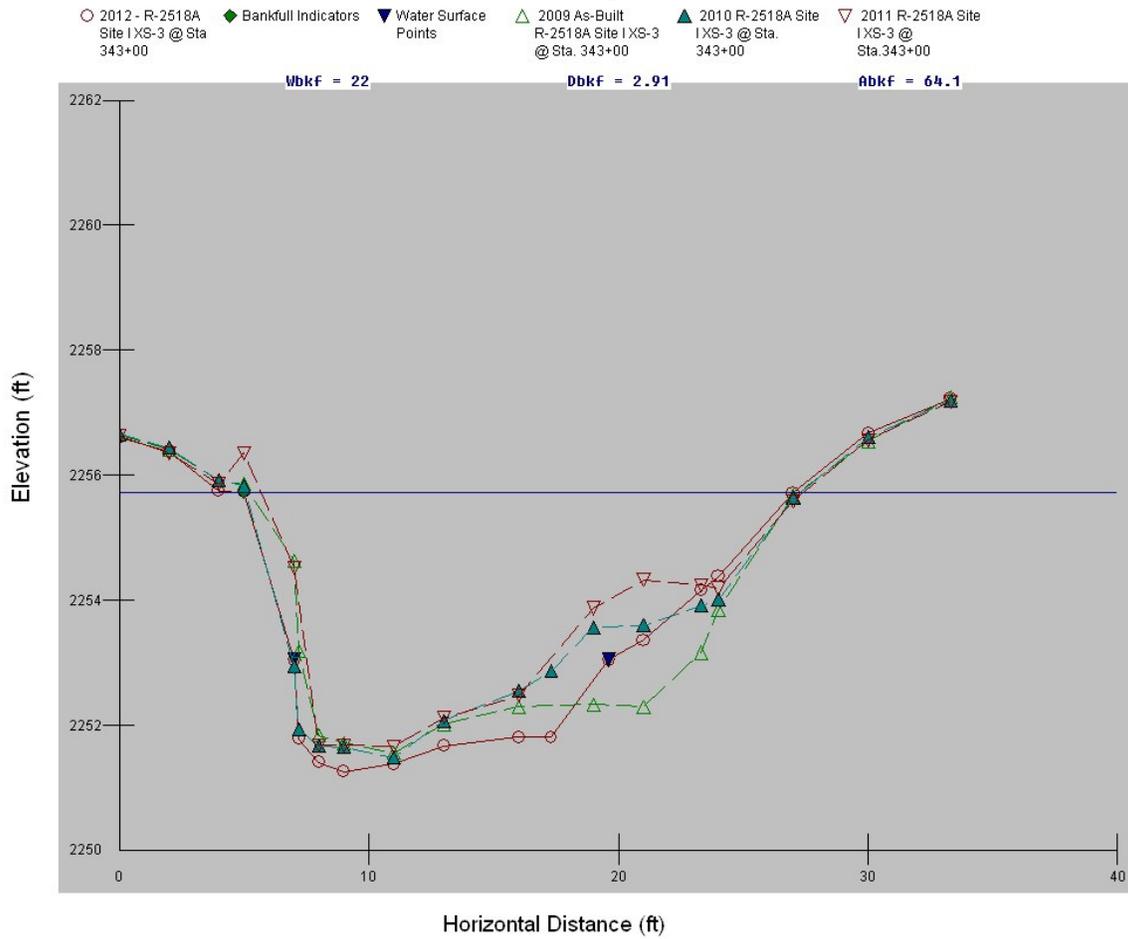
### R-2518A Site I XS-3 @ Sta 343+00

Site I: Cross-Section #3 (Pool) Abbreviated Morphological Summary					
	2010	2011	2012	2013	2014
<b>Bankfull Cross Sectional Area (ft<sup>2</sup>)</b>	60.29	65.99	64.06		
<b>Maximum Bankfull Depth (ft.)</b>	4.35	4.7	4.47		
<b>Bankfull Mean Depth (ft.)</b>	2.67	2.71	2.91		
<b>Bankfull Width (ft.)</b>	22.59	24.38	22.03

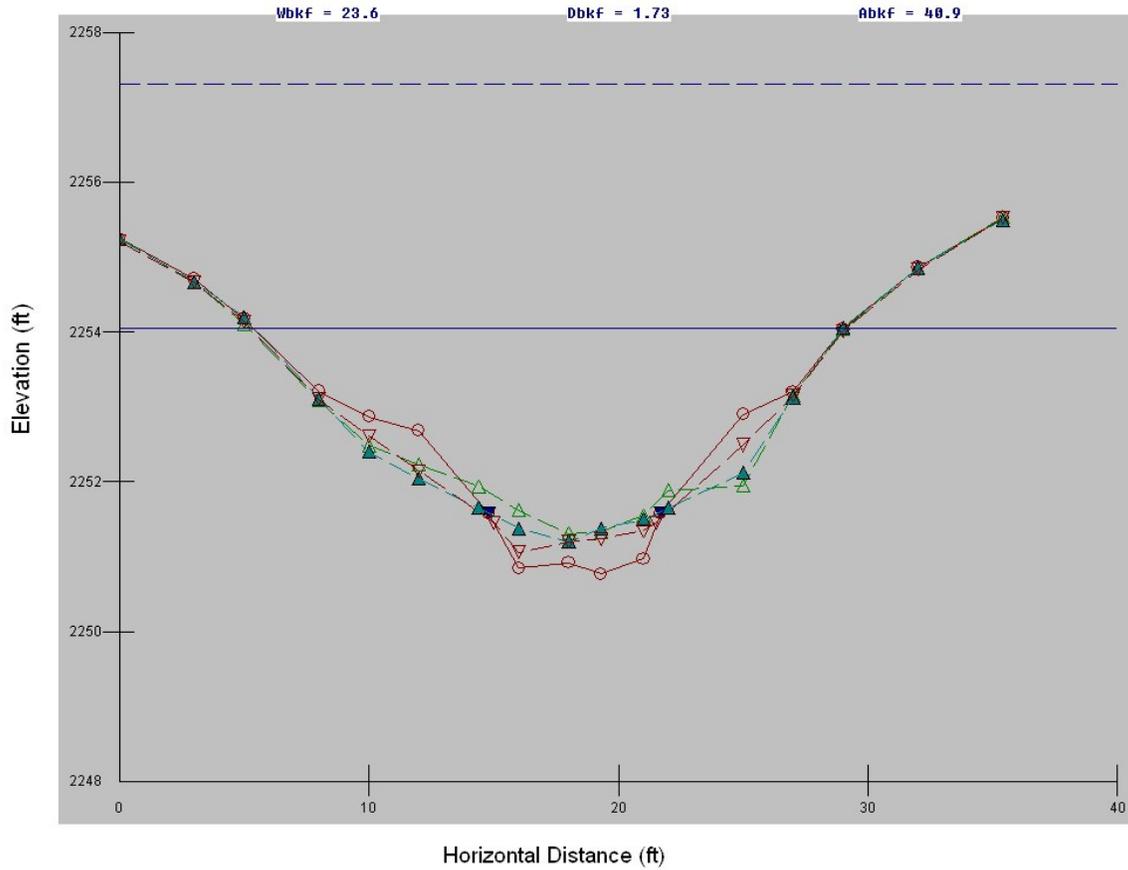
### R-2518A Site | XS-4 @ Sta 483+00

Site I: Cross-Section #4 (Riffle) Abbreviated Morphological Summary					
	2010	2011	2012	2013	2014
Bankfull Cross Sectional Area (ft <sup>2</sup> )	43.32	41.82	40.88		
Maximum Bankfull Depth (ft.)	2.86	2.95	3.27		
Width of the Floodprone Area (ft.)	35.4	35.4	35.4		
Bankfull Mean Depth (ft.)	1.83	1.77	1.73		
Width/Depth Ratio	12.9	13.35	13.62		
Entrenchment Ratio	1.5	1.5	1.5		
Bankfull Width (ft.)	23.61	23.63	23.57

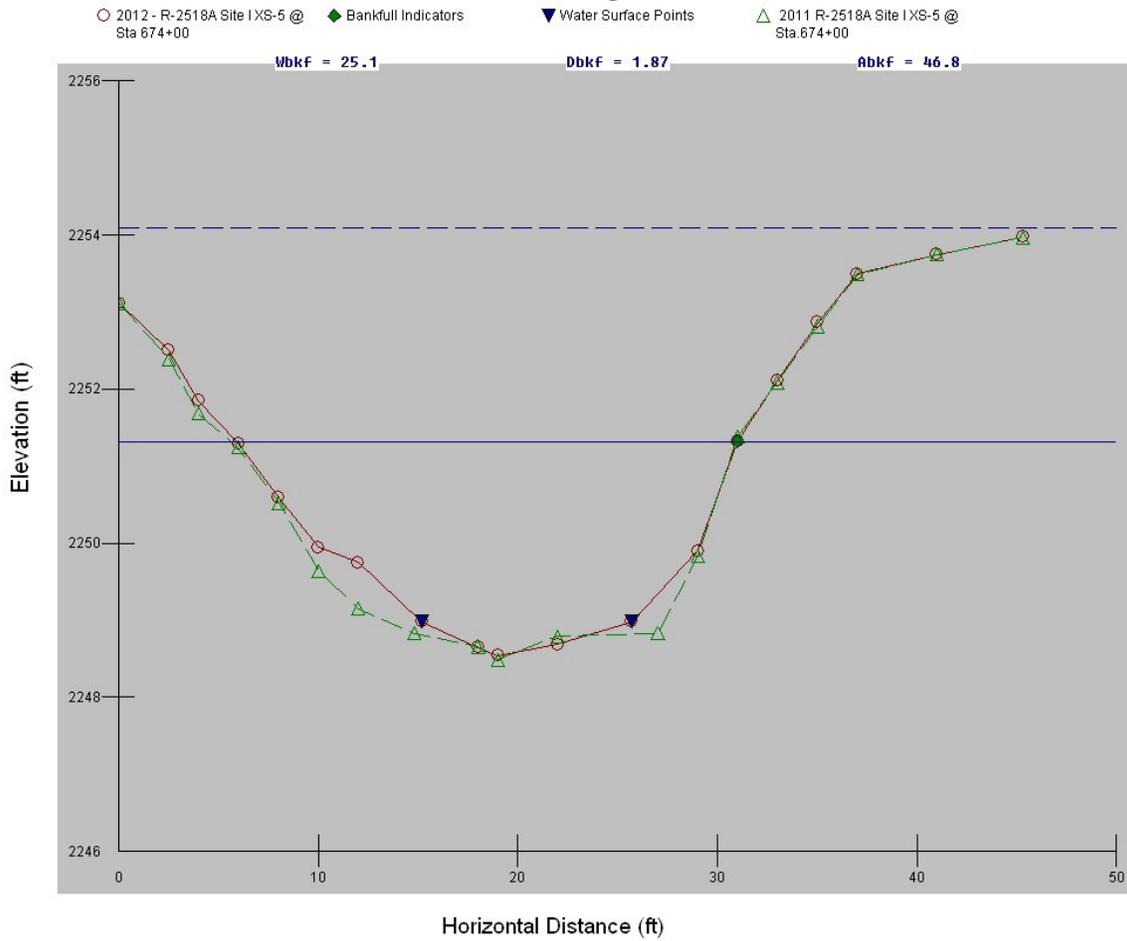
### R-2518A Site I XS-5 @ Sta 674+00

Site I: Cross-Section #5 (Riffle) Abbreviated Morphological Summary				
	2011	2012	2013	2014
Bankfull Cross Sectional Area (ft <sup>2</sup> )	52.26	46.77		
Maximum Bankfull Depth (ft.)	2.89	2.78		
Width of the Floodprone Area (ft.)	45.3	45.3		
Bankfull Mean Depth (ft.)	2.04	1.87		
Width/Depth Ratio	12.57	13.41		
Entrenchment Ratio	1.77	1.81		
Bankfull Width (ft.)	25.64	25.07

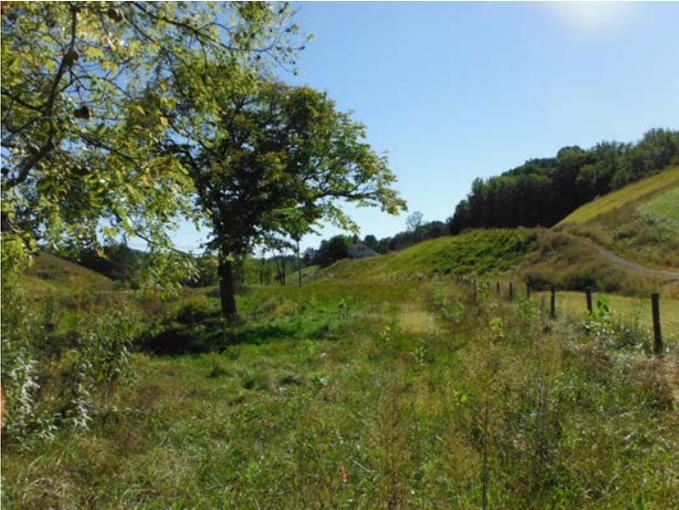
Vegetation Overview Photo

**Streambank & Buffer Vegetation:** The streambank reforestation was completed in March 2012. The Year 1 vegetation monitoring evaluation noted: Type I: Black Willow and Type II: Sycamore, Green Ash, Tulip Poplar, and White Oak were surviving at the time of the monitoring evaluation. It was noted during the monitoring evaluation that the power line easement has been sprayed with an herbicide application.
